Maffei Property Inspections

Property Inspection Report

912 Salem St , Chico, CA
Inspection prepared for: Brian Harrison
Date of Inspection: 7/31/2023 Time: 12:30pm
Age of Home: approx 83 yrs Size: unknown
Weather: Sunny and dry

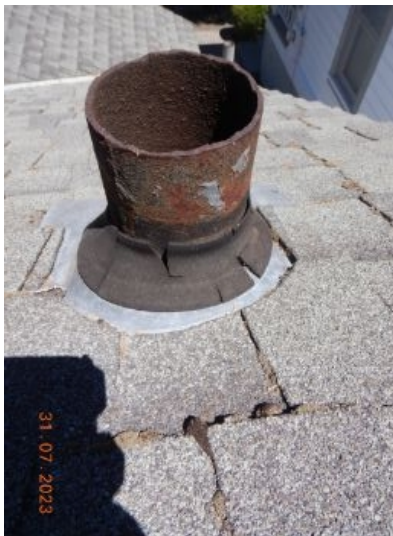
Observations:
 • The seals around the plumbing vents on the east side of the home have failed.

Example of failed seal

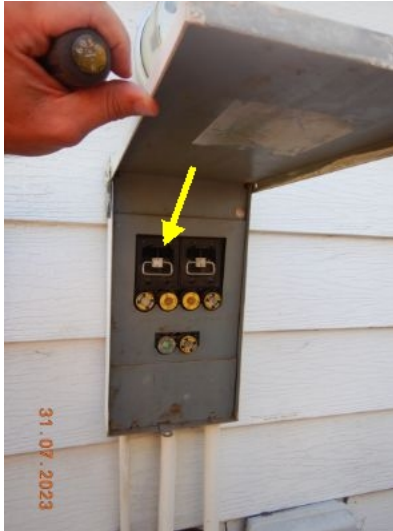
Location: Main Location: North side of home.
 Location: Sub Panel Location: furnace closet
 Observations:
 • Appeared functional at time of inspection.

Main fuse block

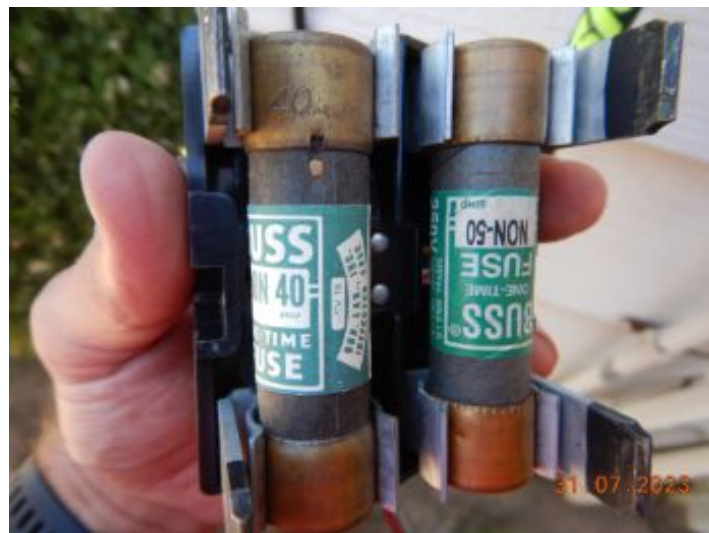
Observations:
 • The maximum service to the home was limited by the size of the fuses in the main panel. The smallest fuse was 40amps. This may not be enough for your electrical needs

Fuses in for main fuse block

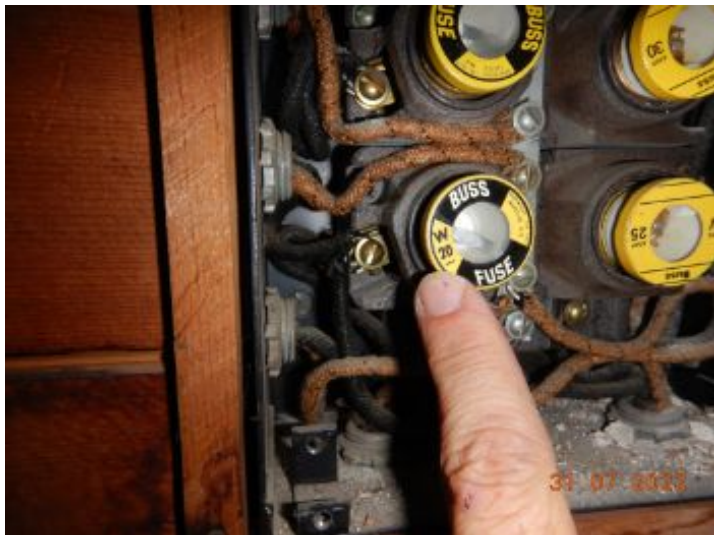
- The fuses used in the main panel and subpanel can easily be oversized, and this can result in overheating.
- Double tapping noted in the subpanel.
- Some of the wiring in the subpanel appeared to solid aluminum.
- When viewed through an infrared camera the left leg of the main fuse block showed a temperature anomaly that indicates overheating when compared to the rest of the panel. Cause unknown.

Example of double tapping and aluminum wiring

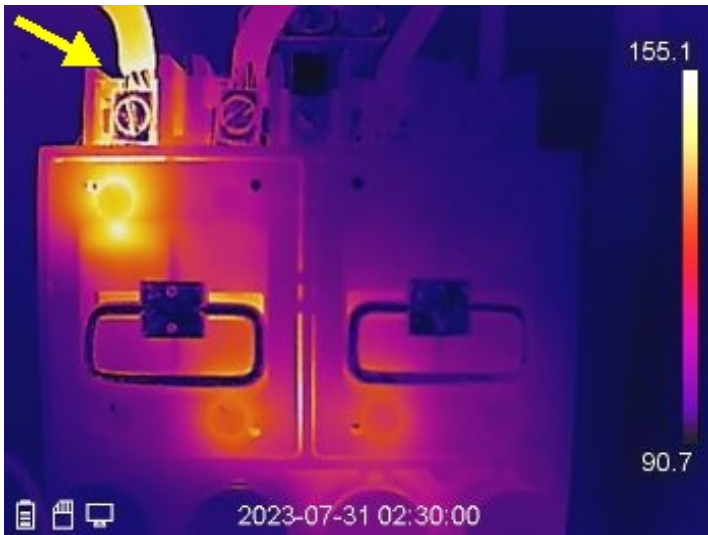
Warm leg

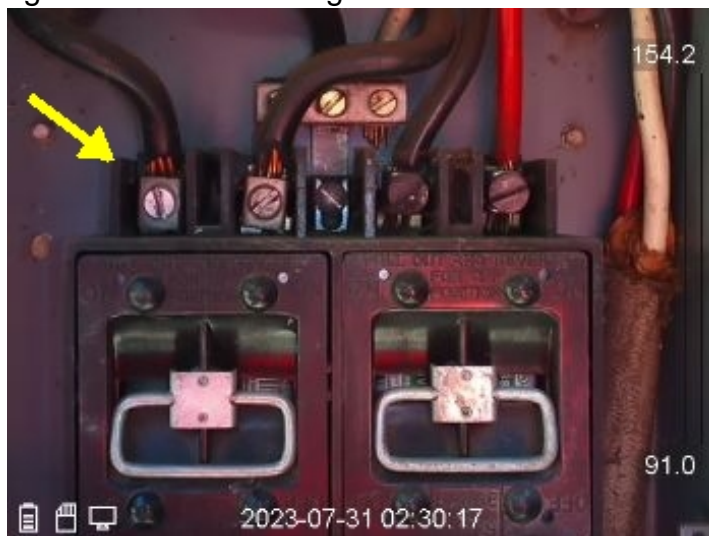
Same area without infrared

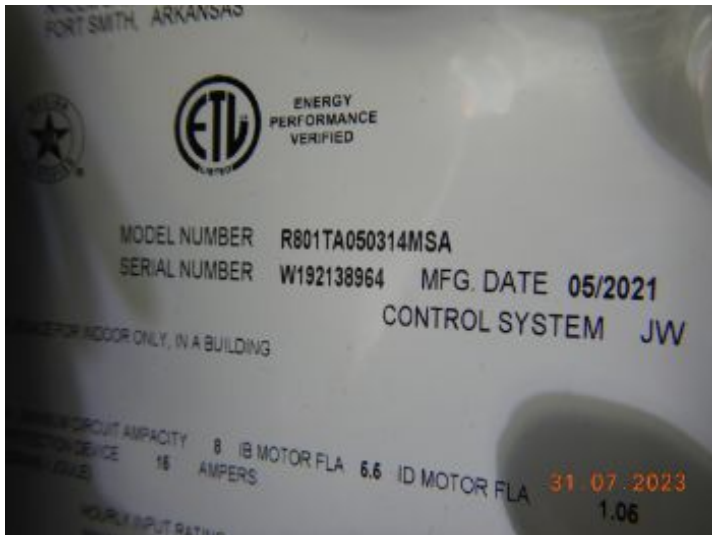
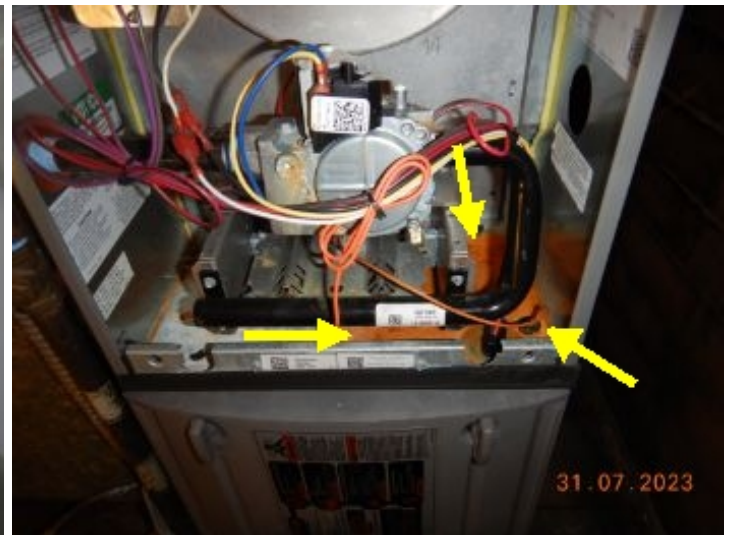
- Make: Goodman (manufactured around 2021)
- **Rust noted in the burner compartment of the furnace. The area was dry at time of inspection but the rust indicates at least a past leak.**

Rust in heater compartment

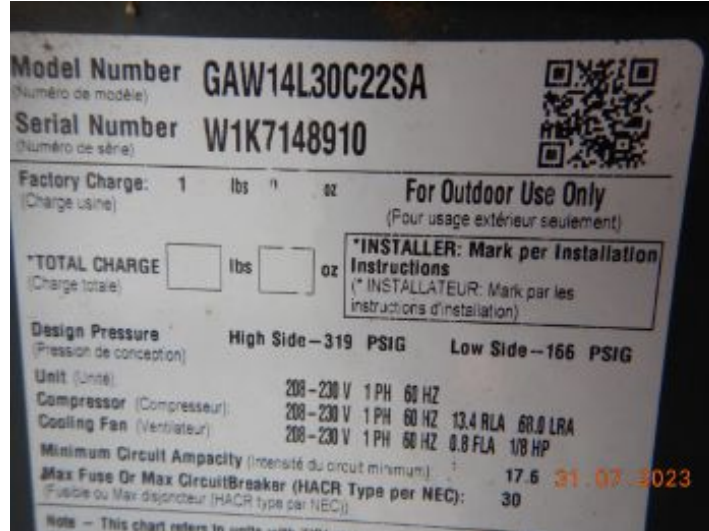
Location: The AC condenser was located on the west side of the home.

- Appeared functional at the time of inspection.
- Make: Evcon (manufactured around 2017)

- **Recommend cleaning condenser fins.**
