Confidential Inspection Report

3807 Pirate Dr.

Rancho Palos Verdes CA 90275

July 20, 2021

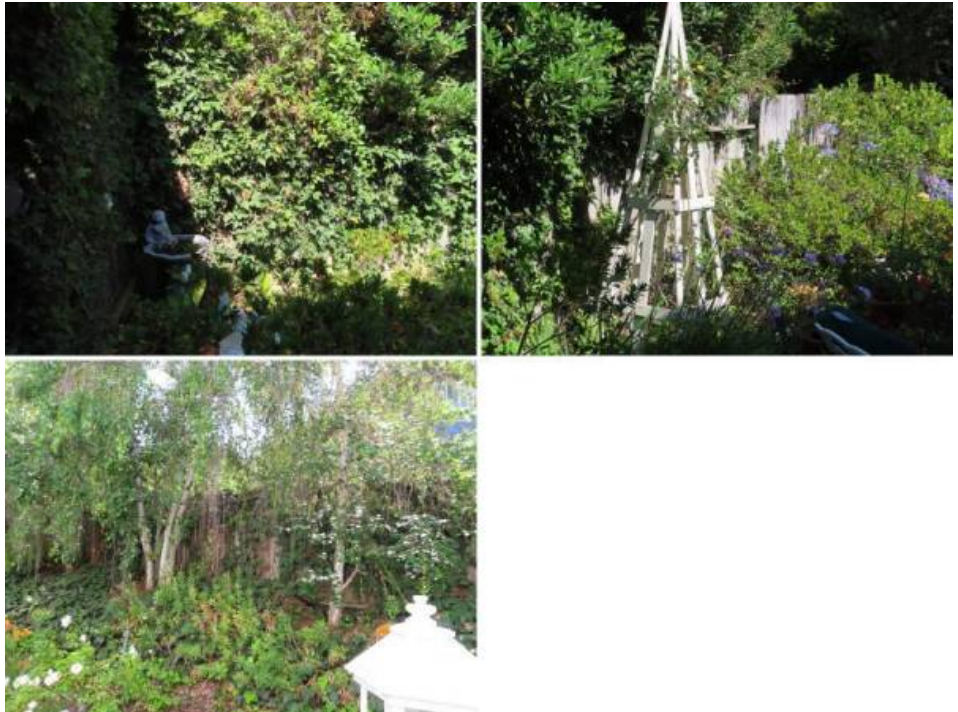
DEFERRED: Some of the fence is concealed with vegetation.

MAINTENANCE: Some loose/rotted posts and/or broken/missing boards.

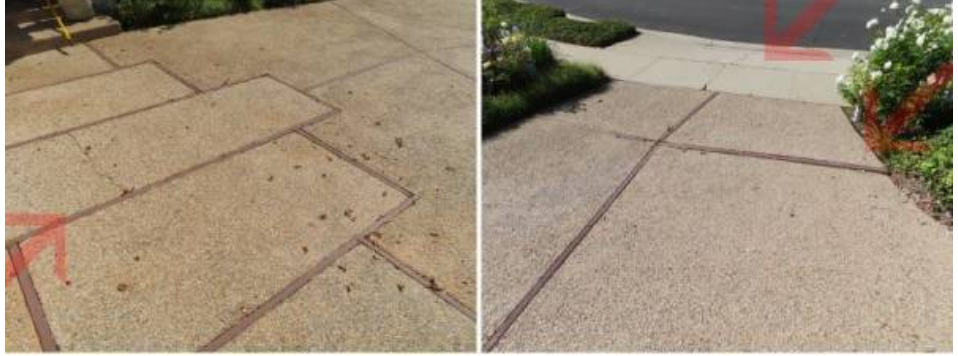
MONITOR: Small cracks viewed in the paving appear to be typical of settlement or shrinkage. We recommend monitoring cracks from time to time. Change in the size or number of cracks may be symptomatic of other conditions such as defective drainage, settlement or soil movement and should be further evaluated by a licensed masonry contractor.

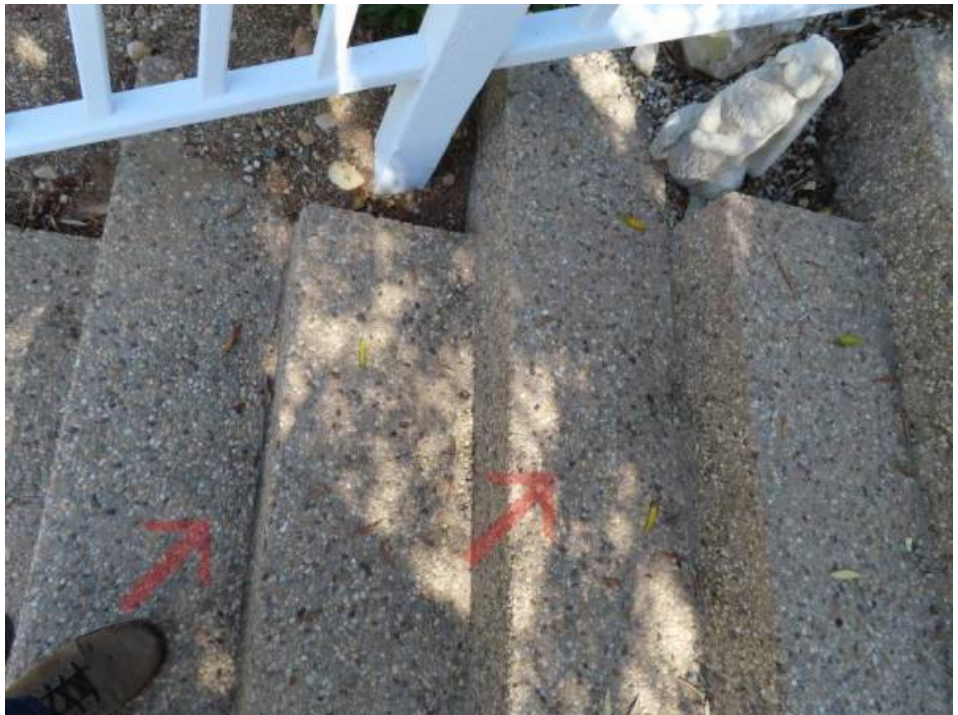
DEFERRED: Hairline crack noted.

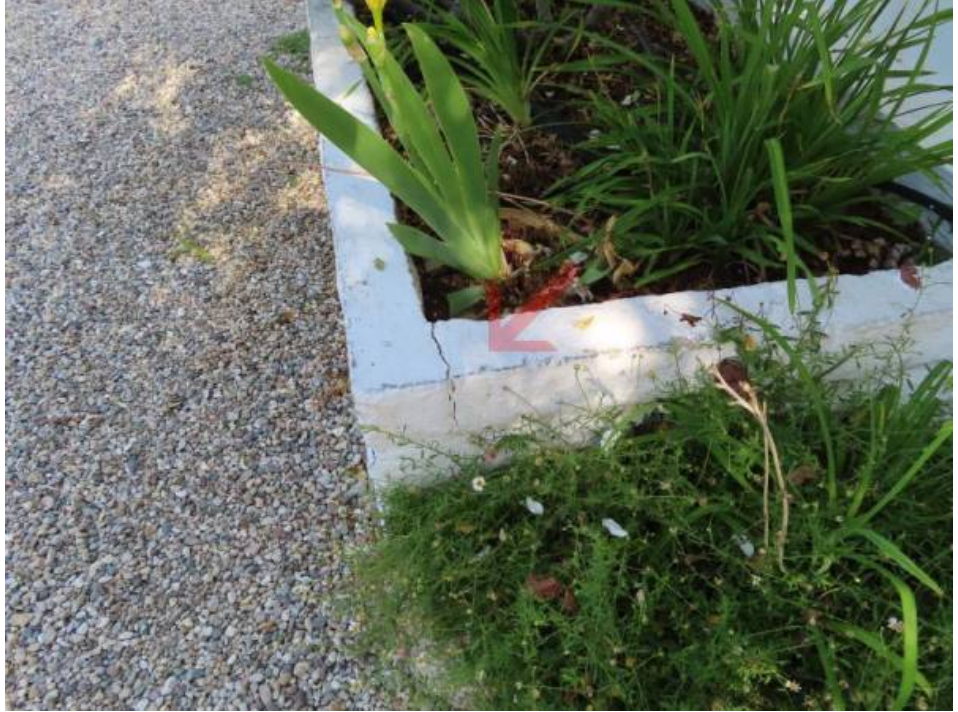
Front.
DEFERRED: Hairline crack noted.

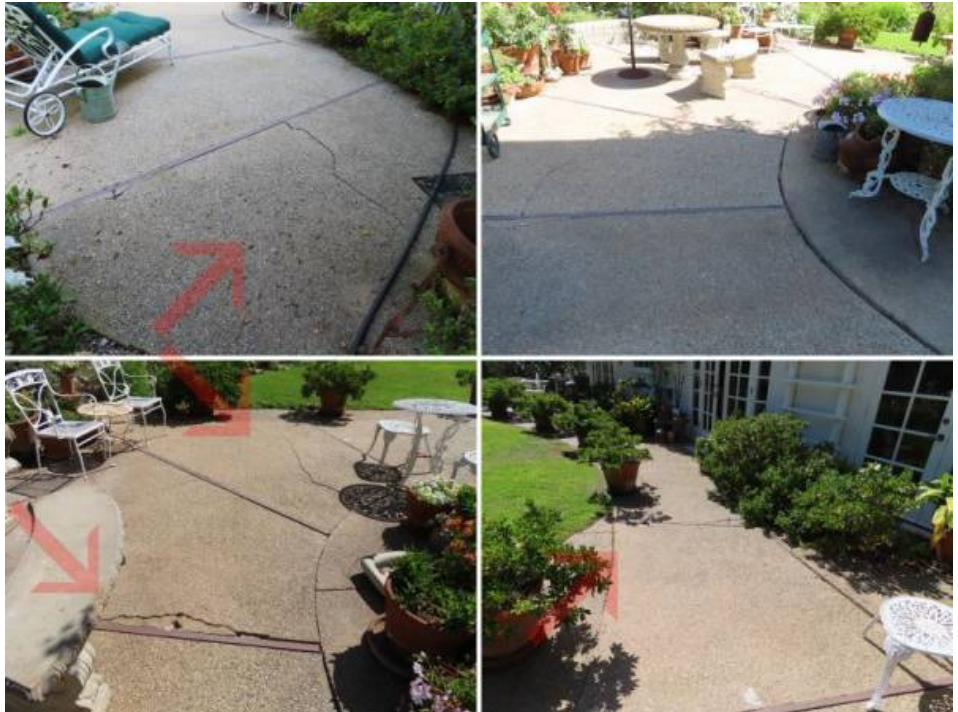
DEFERRED: Moderate settlement observed. We suggest monitoring this condition and obtaining further evaluation by a licensed concrete contractor if any further change is observed.

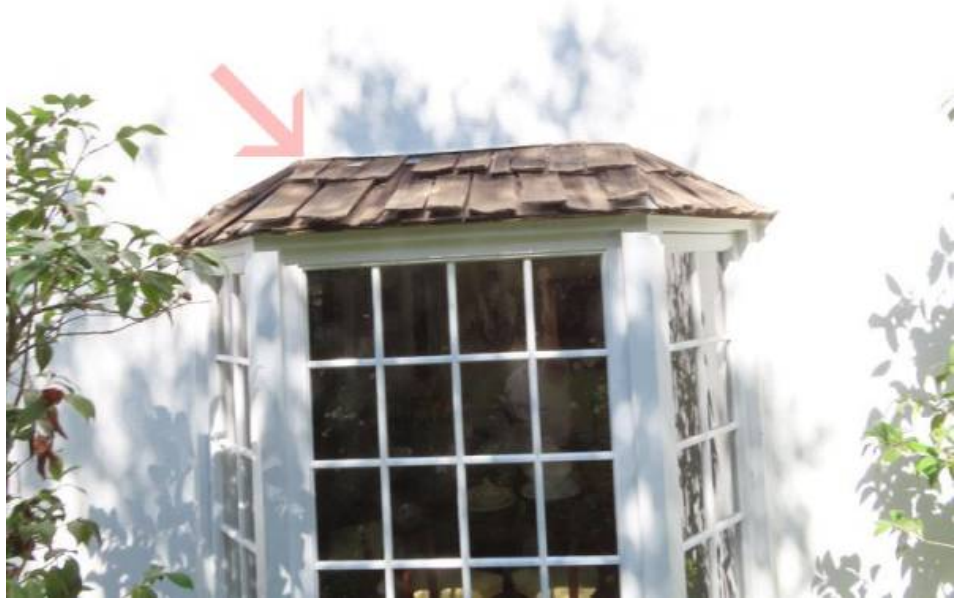
DEFERRED: Older roof, at or near the end of its design life. We suggest budgeting for a new roof in the near future.

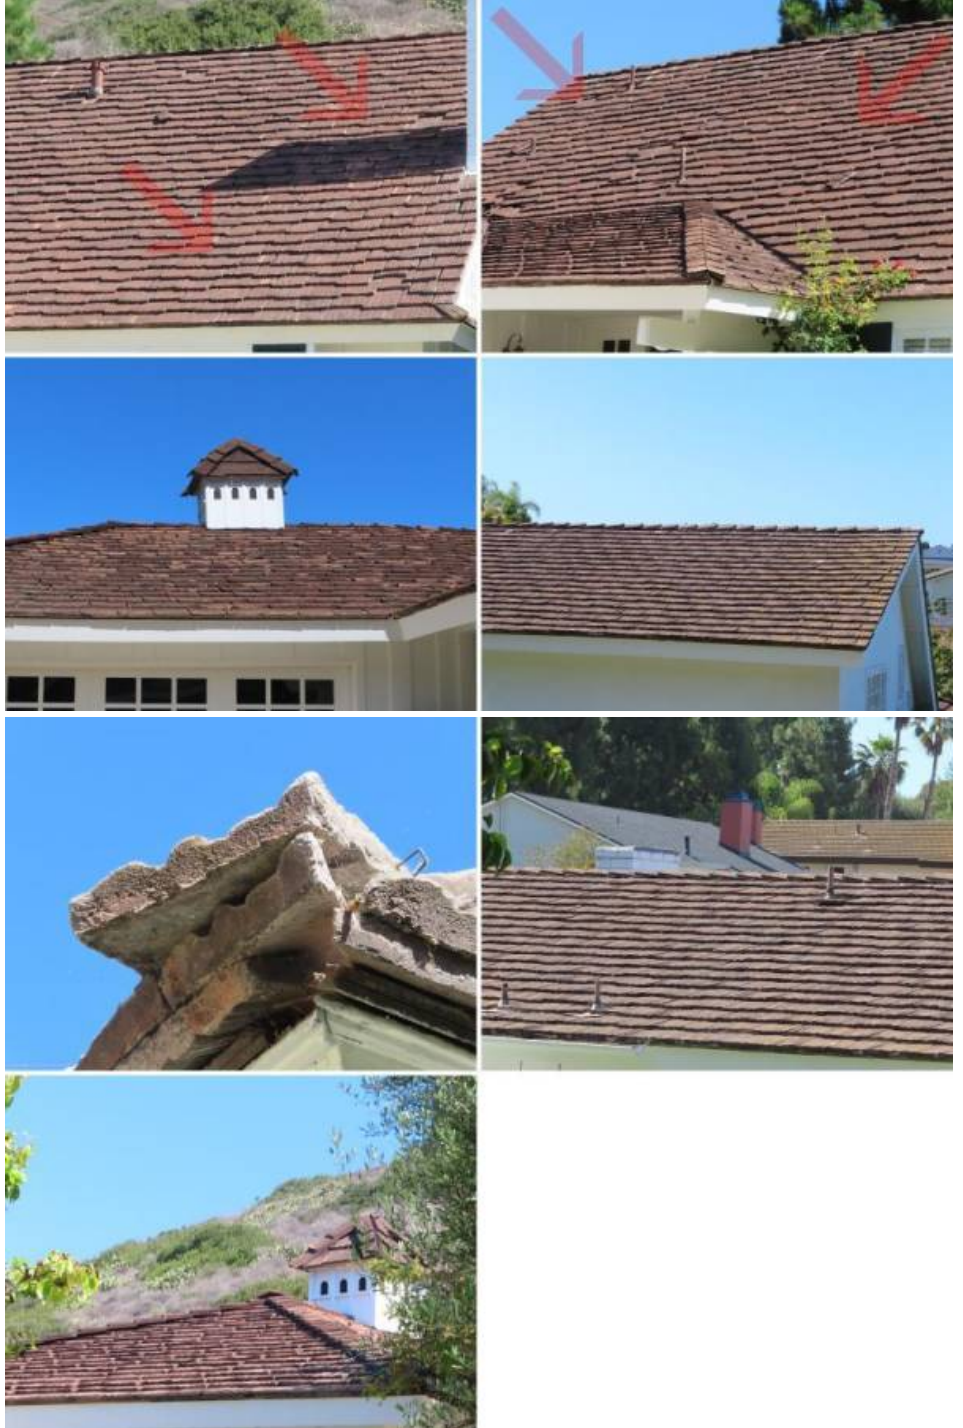
DEFECTIVE: Some broken/cracked or loose tiles observed. Tiles protect the waterproof membrane from exposure to damaging UV rays and broken or loose tiles may fall causing injury to persons or property. We recommend further evaluation and repairs as needed by a licensed roofer at this time.

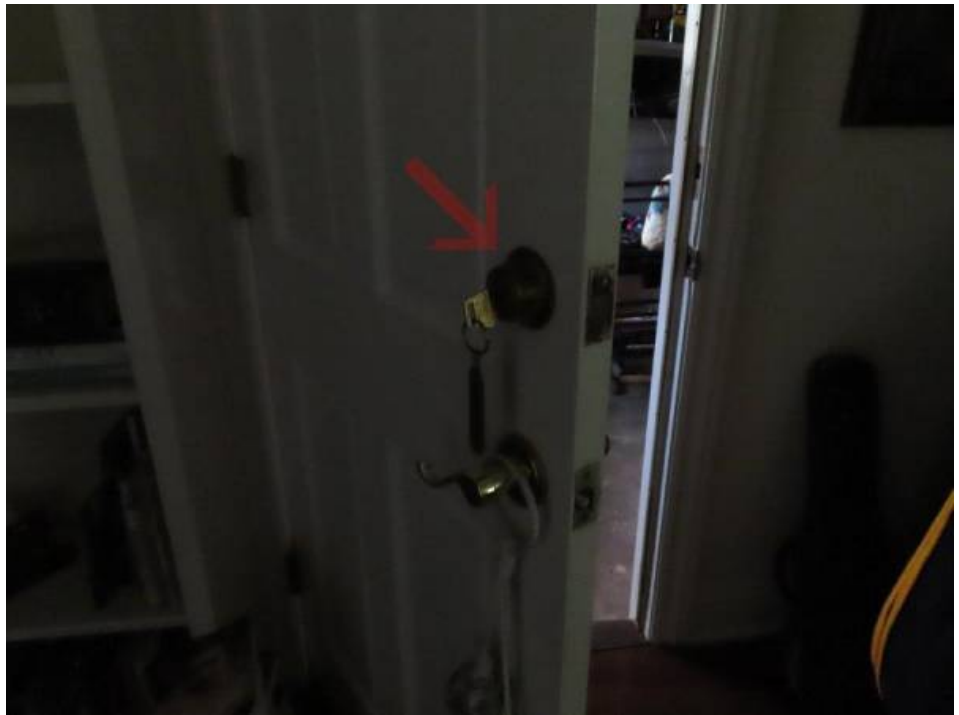
DEFECTIVE: Panel door. This type door may not be fire rated to retard the spread of flames into the living space. We did not see a fire rating label and recommend installing a properly rated fire door prior to occupancy.

DEFECTIVE: No automatic closing hardware is installed as required for fire protection.

SAFETY: Deadbolt is a double-keyed cylinder and may impede emergency exiting. We recommend replacing double-keyed cylinders with a single-keyed deadbolt for enhanced safety.

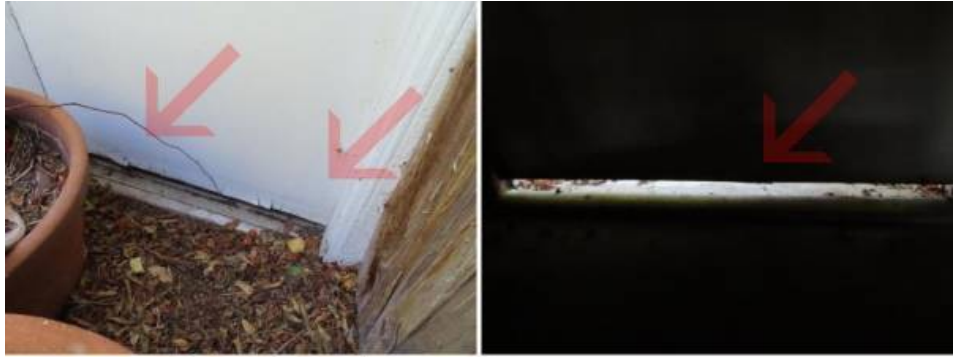
DEFECTIVE: Evidence of moisture intrusion at one or more doors sampled.

MAINTENANCE: Weather-stripping or threshold not installed or in disrepair at one or more doors sampled. We recommend installing/maintaining thresholds and weather-stripping on exterior doors to guard against air infiltration and water intrusion.

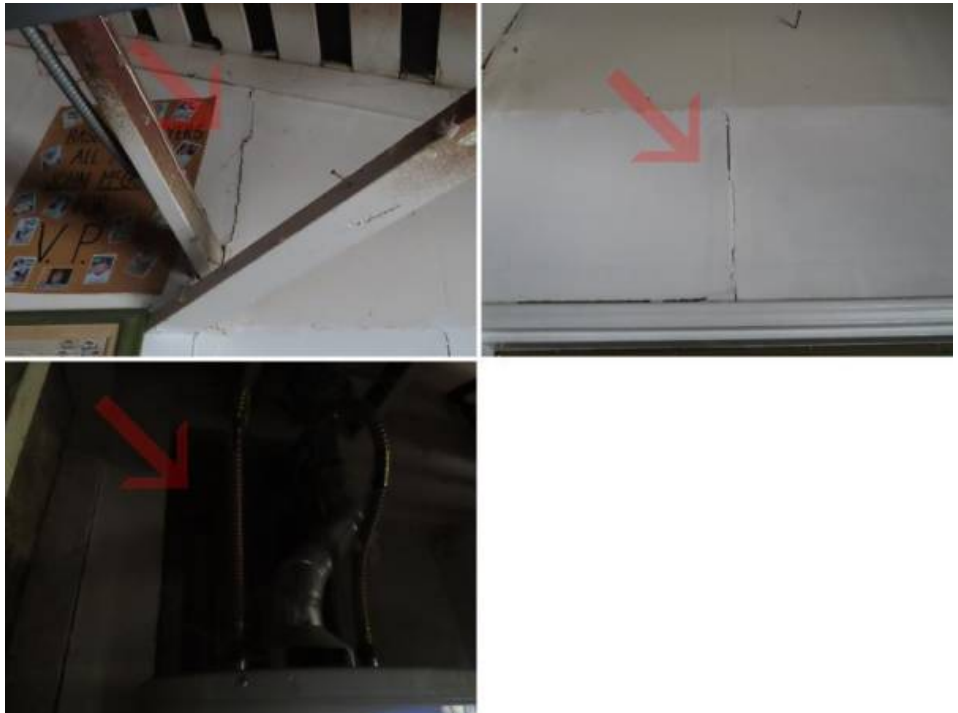
Tape cracks noted.

Hole from plumbing repair.

DEFECTIVE: Holes or other damage noted. Fire separation is designed to slow the spread of fire originating in the garage. We recommend repairs as needed by a licensed drywall or plastering contractor prior to occupancy for safety concerns.

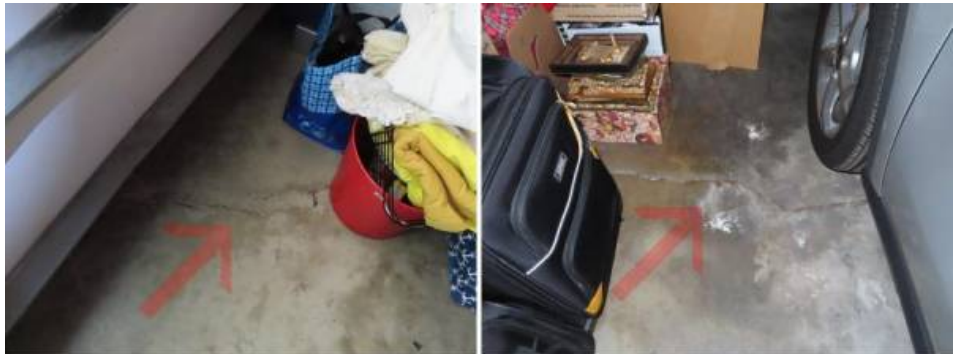
MONITOR: Hairline to moderate sized cracks observed. These appear to be typical settlement/shrinkage cracks and generally do not have structural significance. We suggest monitoring them from time to time. If any changes are observed we recommend further evaluation by a licensed concrete contractor.

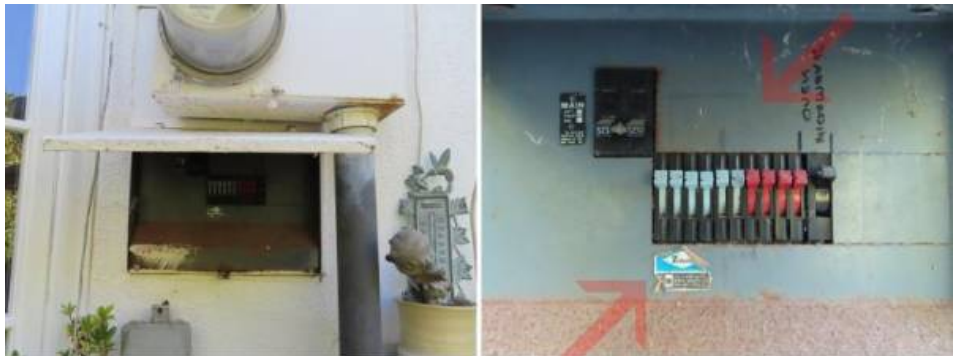
SAFETY: Federal Pacific or Zinsco brand panel present. Electrical panels and circuit breakers are known to deteriorate with age. Many older panels have aluminum bus bars that are susceptible to oxidization, which can compromise the electrical connections. Also, older breakers have a higher failure rate than do modern breakers. Both of these conditions can lead to arcing and overheating, sometimes resulting in an electrical fire. A visual inspection cannot determine if these panels and breakers are performing to their original design specifications. Federal Pacific and Zinsco brands in particular are problematic and we routinely recommend replacing these panels as a safety upgrade.

SAFETY: Circuit breakers are not adequately labeled for area/items served. We recommend permanently labeling each breaker for emergency needs. breakers. Both of these conditions can lead to arcing and overheating, sometimes resulting in an electrical fire. A visual inspection cannot determine if these panels and breakers are performing to their original design specifications. Federal Pacific and Zinsco brands in particular are problematic and we routinely recommend replacing these panels as a safety upgrade.

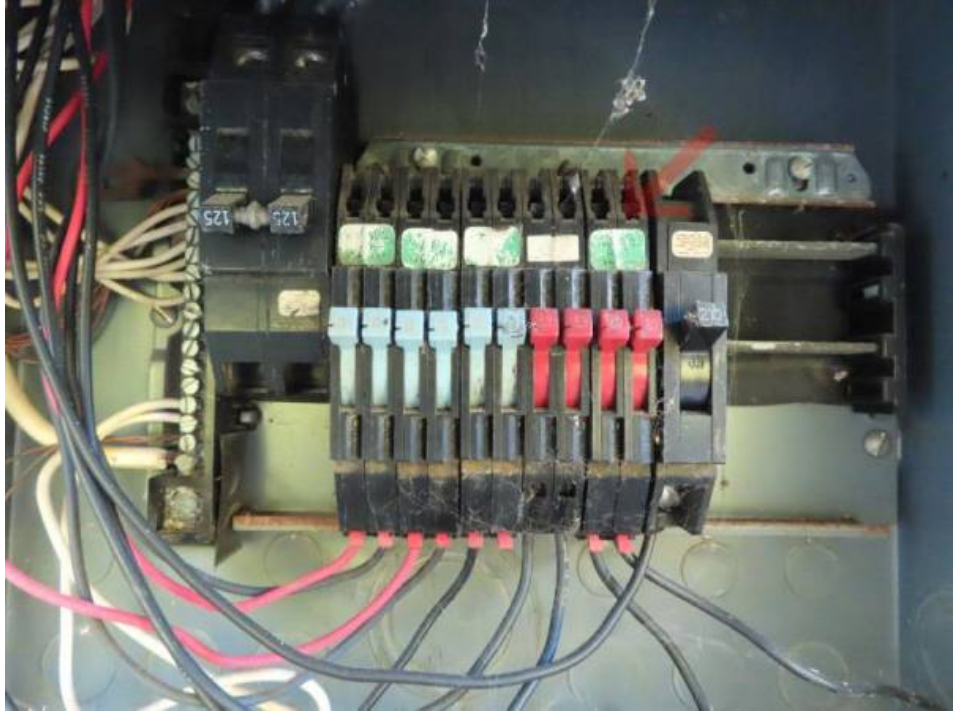
SAFETY: Federal Pacific or Zinsco brand breakers present. Electrical panels and circuit breakers are known to deteriorate with age. Many older panels have aluminum bus bars that are susceptible to oxidization, which can compromise the electrical connections. Also, older breakers have a higher failure rate than do modern breakers. Both of these conditions can lead to arcing and overheating, sometimes resulting in an electrical fire. A visual inspection cannot determine if these panels and breakers are performing to their original design specifications. Federal Pacific and Zinsco brands in particular are problematic and we routinely recommend replacing these panels as a safety upgrade.

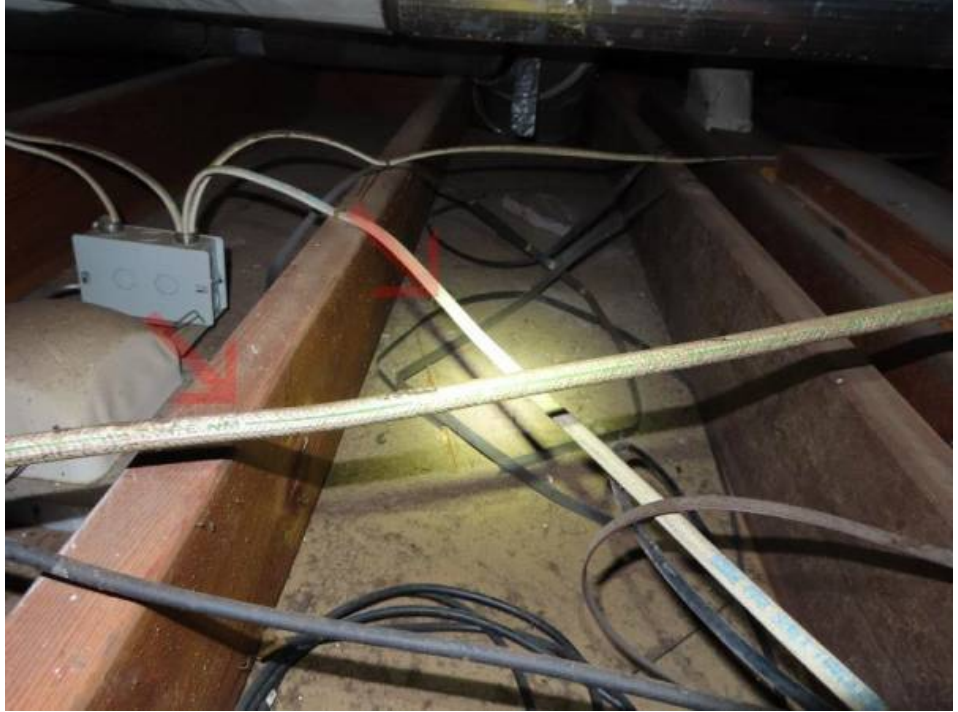
DEFERRED: Cloth covered wiring. This type of covering (no longer used) can become brittle and deteriorate with age. Most of the wiring is concealed and we routinely recommend further evaluation by a licensed electrician.

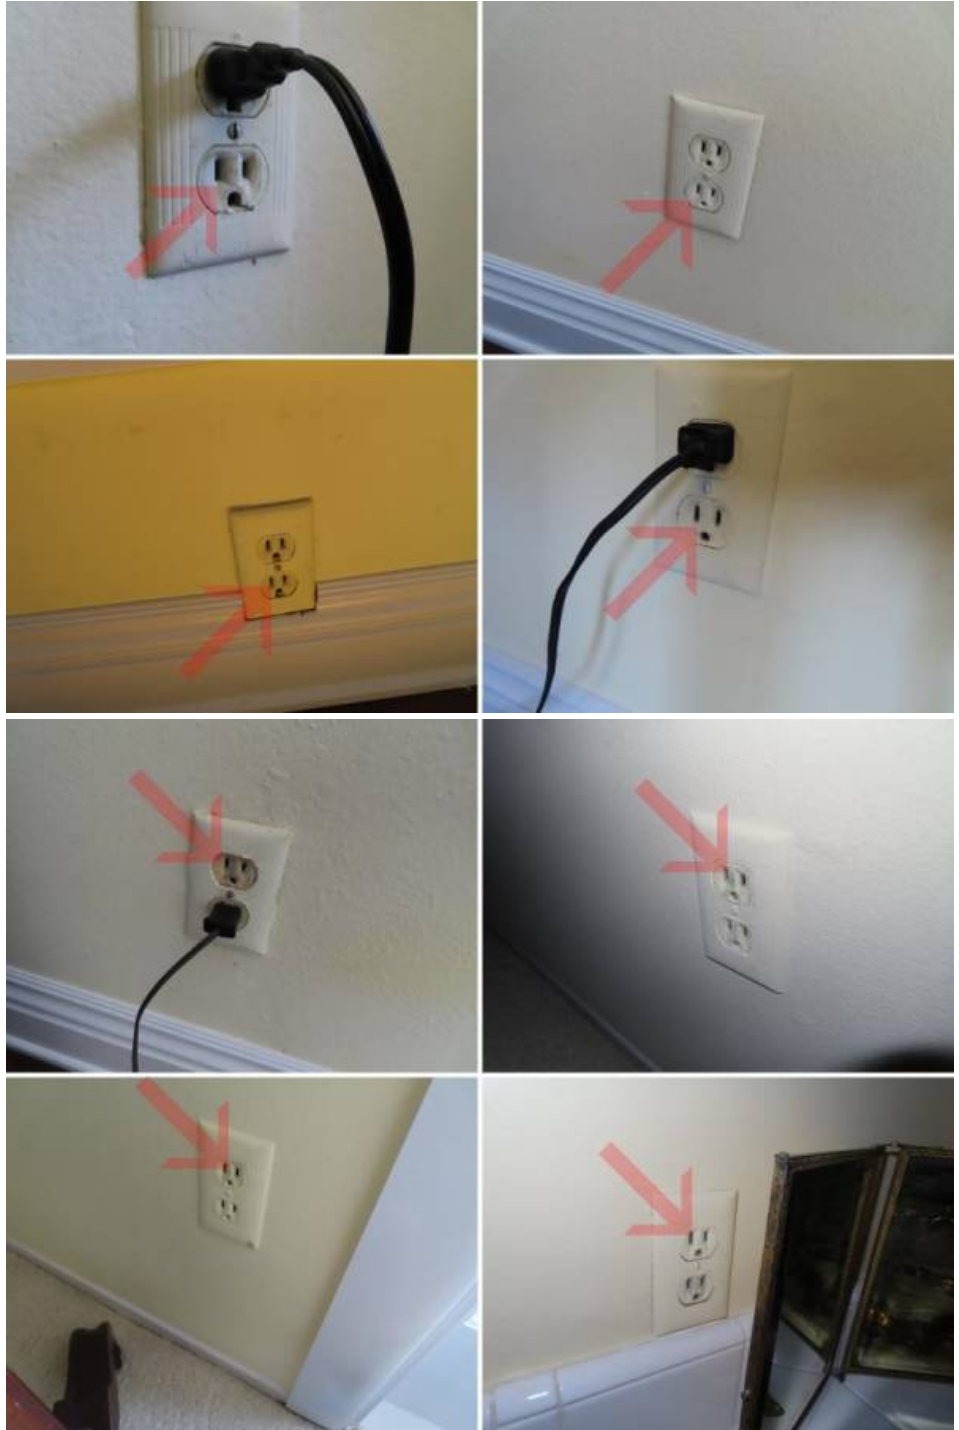
DEFECTIVE: 3-prong grounded type receptacle sampled at one or more locations was not properly grounded.

DEFECTIVE: Receptacle sampled was painted at one or more locations. Painting receptacles can block the openings or otherwise compromise the connection at the receptacle. We recommend having all painted receptacles replaced by a licensed electrician.

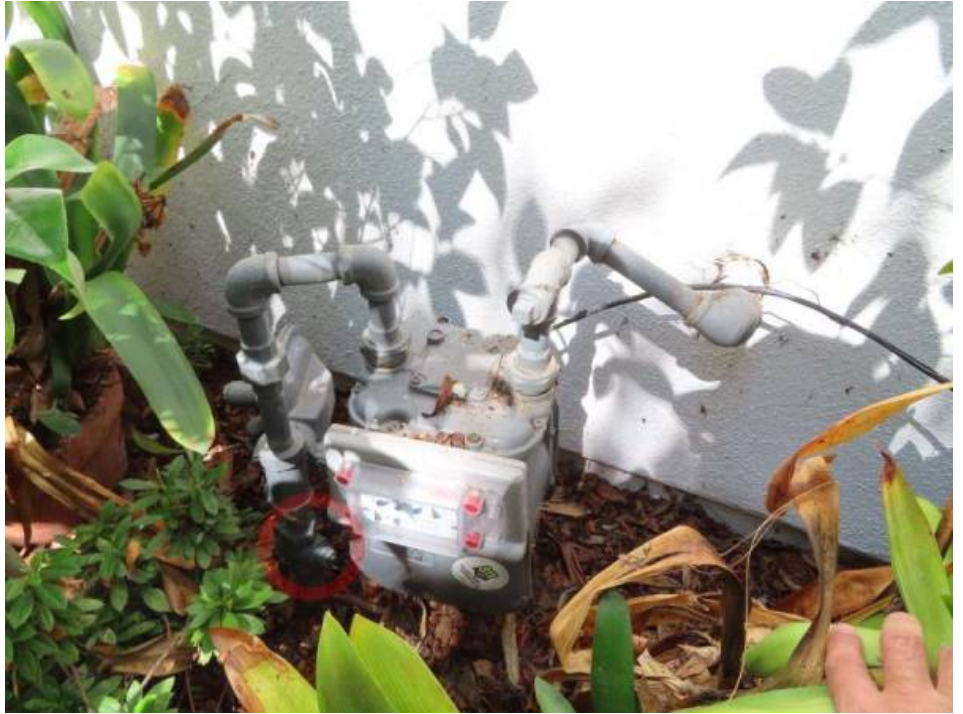
SAFETY: We recommend keeping a wrench attached to the meter to turn off the gas for emergency needs (available in most hardware stores).

SAFETY: No seismic shutoff valve. We recommend installing a seismic shutoff valve on the gas meter for protection against fire loss in the event of a damaging earthquake. (A seismic shutoff valve is required to be installed on the gas system of residences in the City of Los Angeles prior to the transfer of title.)

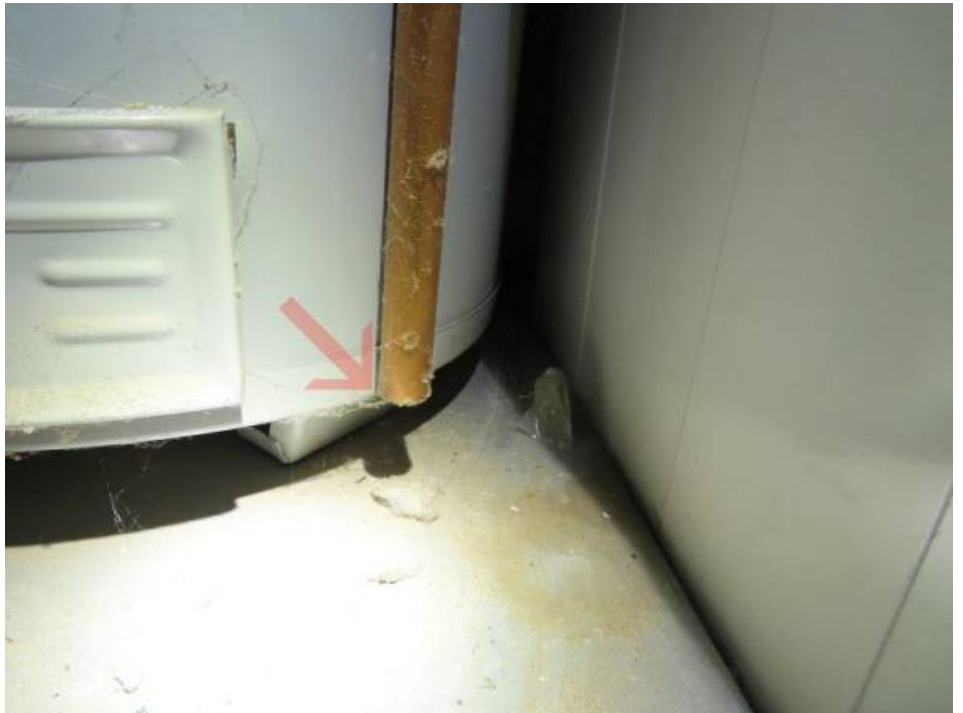
DEFECTIVE: Improper termination of discharge line. The end of the discharge line should terminate at the exterior of the building or other approved location.

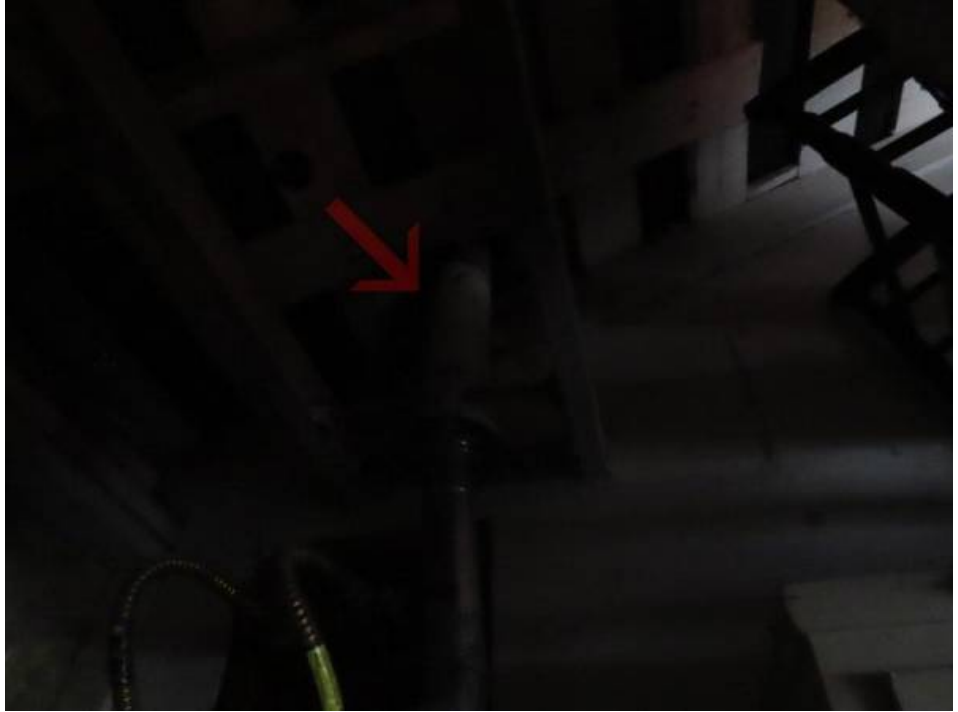
DEFECTIVE: Metal vent into a transite vent is no longer approved and the transite vent will need to be replaced.

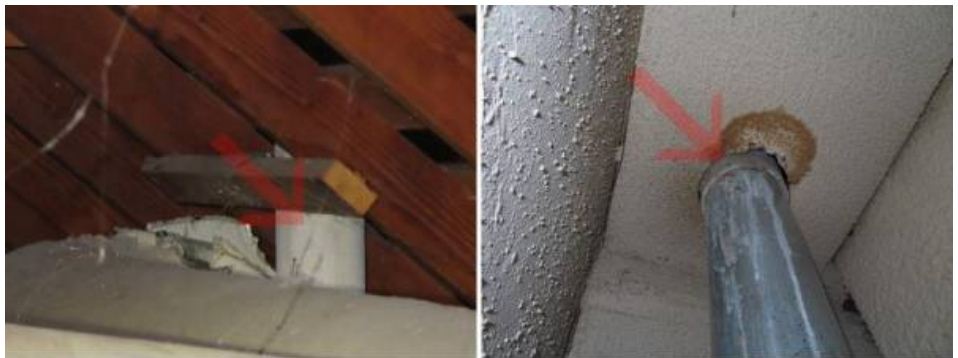
DEFECTIVE: Metal vent into a transite vent is no longer approved and the transite vent will need to be replaced.

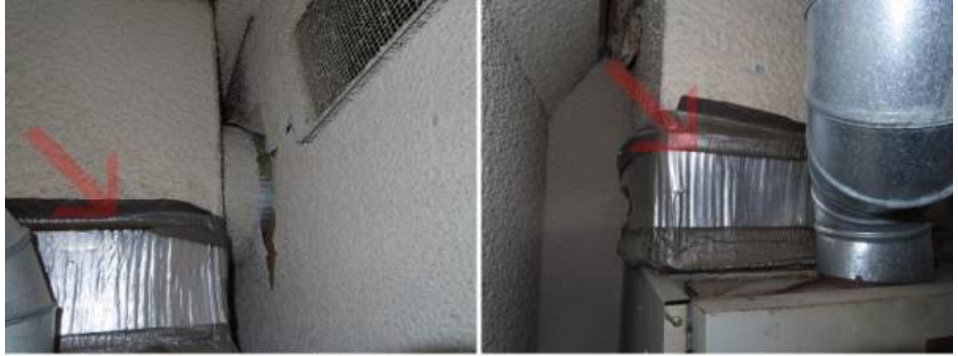
SAFETY: Suspect asbestos insulating material visible on the plenum is in damaged condition. Removal or encapsulation is generally recommended when material is

damaged and/or in friable condition. Positive identification of asbestos can only be made from samples sent to a certified laboratory. If you have any concerns we recommend further evaluation by a licensed asbestos assessor .

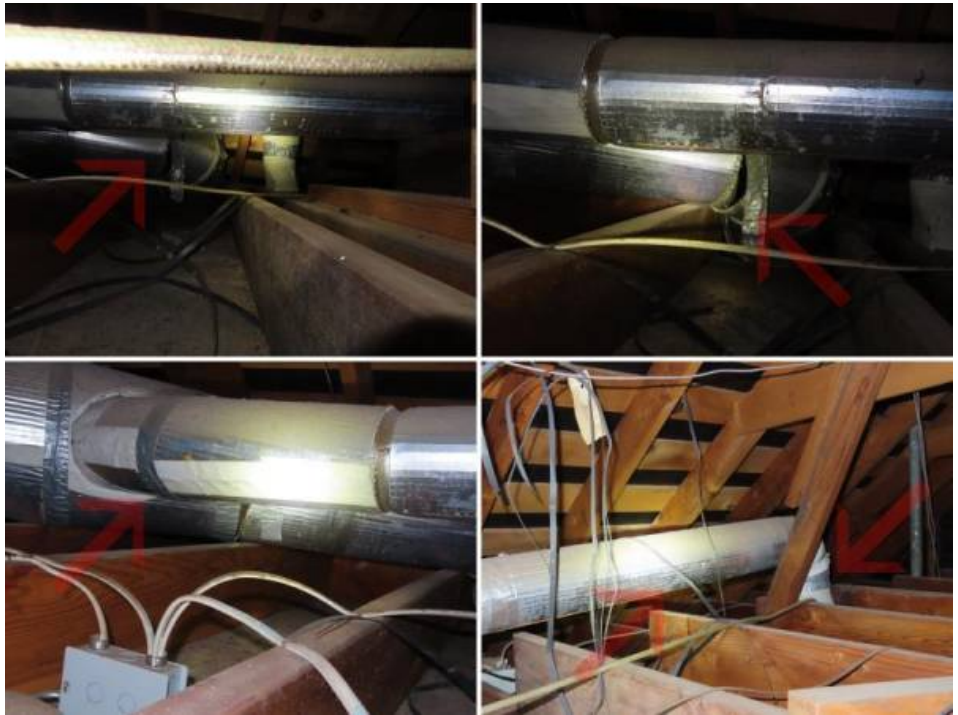
SAFETY: Suspect asbestos material damaged, loose or in friable condition. We recommend further evaluation by a licensed asbestos assessor.
MAINTENANCE: Disconnected section(s) or leaky joints noted in the attic. We recommend sealing all joints at this time for energy conservation.

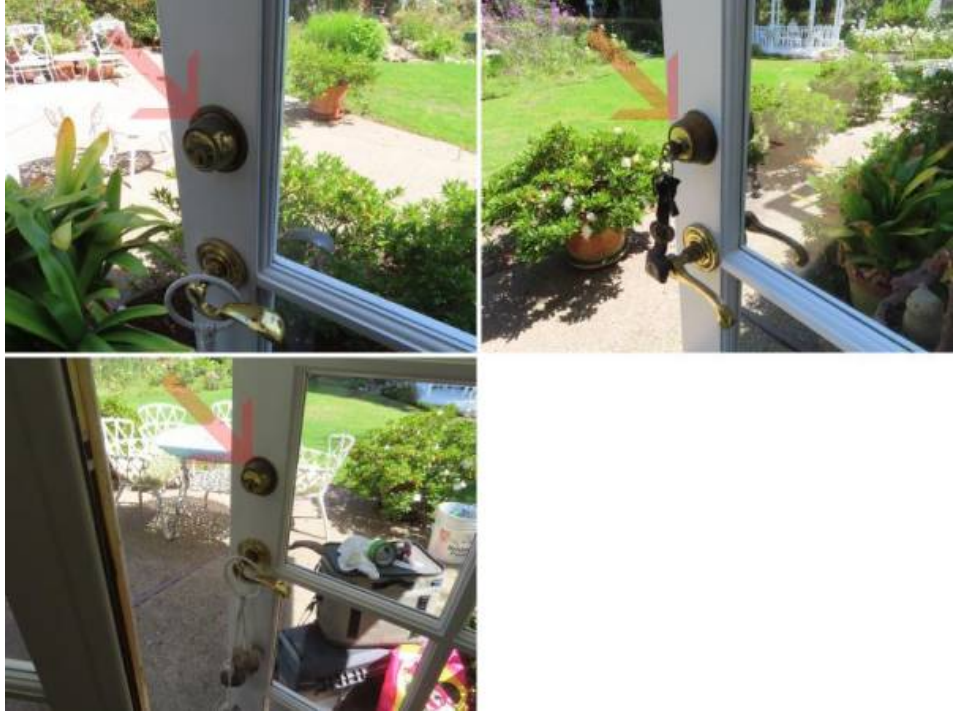
SAFETY: Some deadbolts are double-keyed cylinders that can impede emergency exiting at one or more doors sampled. We recommend replacing double-keyed cylinders with single-keyed cylinder deadbolts for enhanced safety.

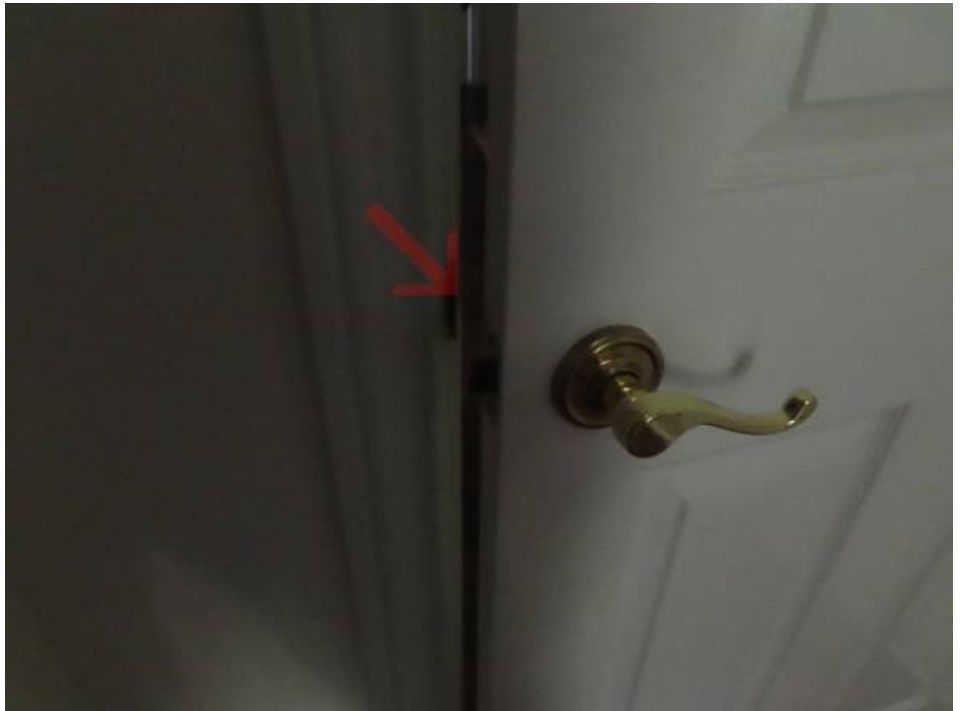
MAINTENANCE: Low hallway adjust strike plate.

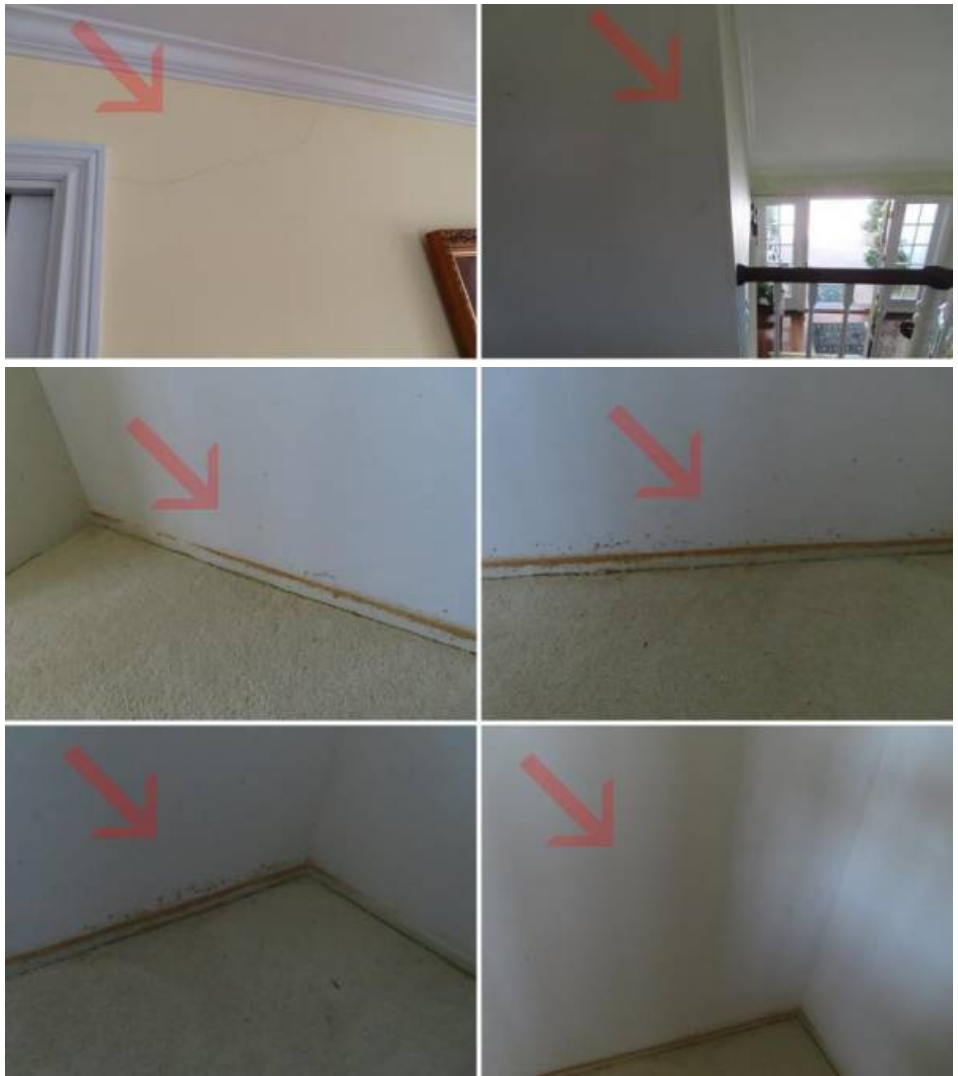
MONITOR. Some cracks in the walls and ceilings viewed at various locations likely indicate moderate settlement/movement or seismic racking. We suggest monitoring and if any changes are observed we recommend further evaluation by a licensed plastering contractor.

SAFETY: Mold/mildew viewed on the walls/ceiling. Mold can cause illness in humans or pets. Babies, children, the elderly and persons with respiratory disease, allergies or compromised immune systems can be especially at risk. We recommend further evaluation by a qualified Environmentalist or Industrial Hygienist to determine if harmful microorganisms are present.

DEFERRED: Paint peeling.

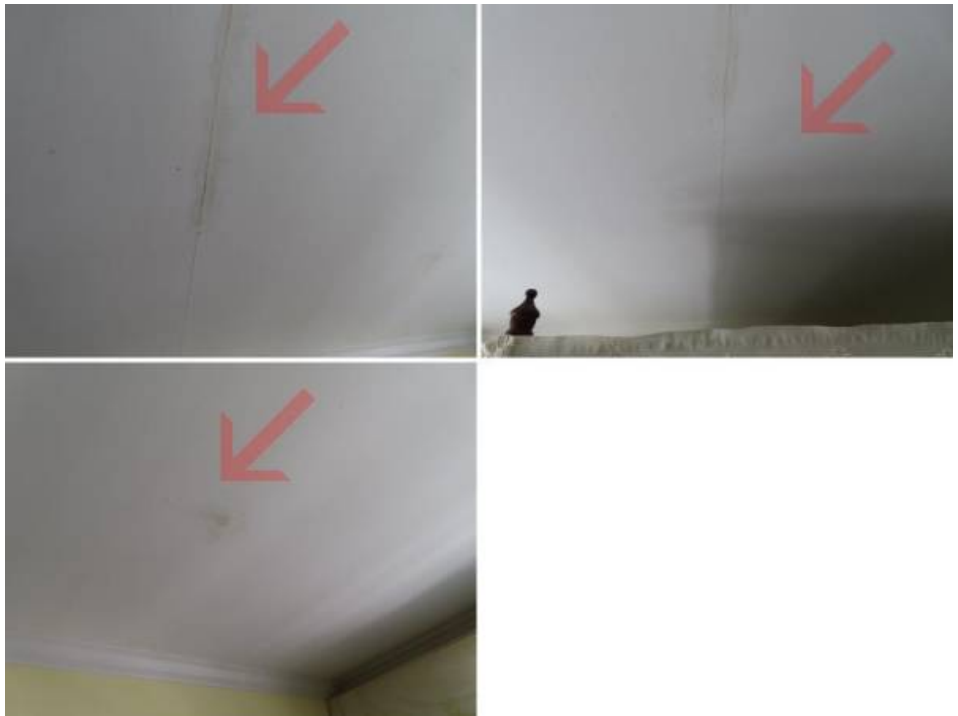
MONITOR: Some cracks in the walls and ceilings viewed at various locations likely indicate moderate settlement/movement or seismic racking. We suggest monitoring and if any changes are observed we recommend further evaluation by a structural engineer.

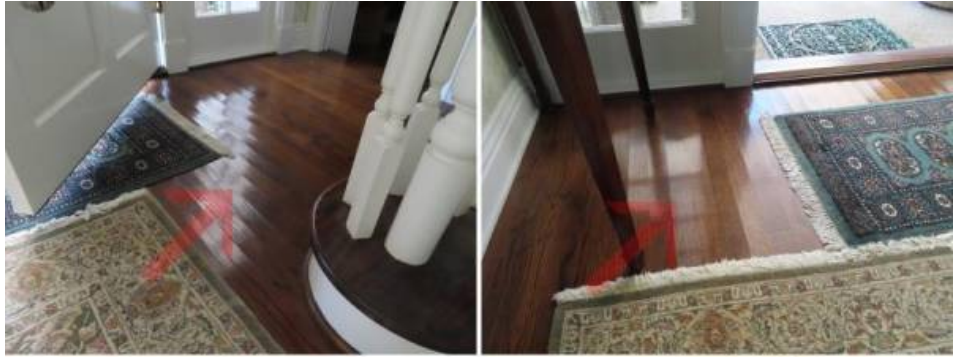
DEFERRED: Buckled wood or open joints indicate excessive moisture.

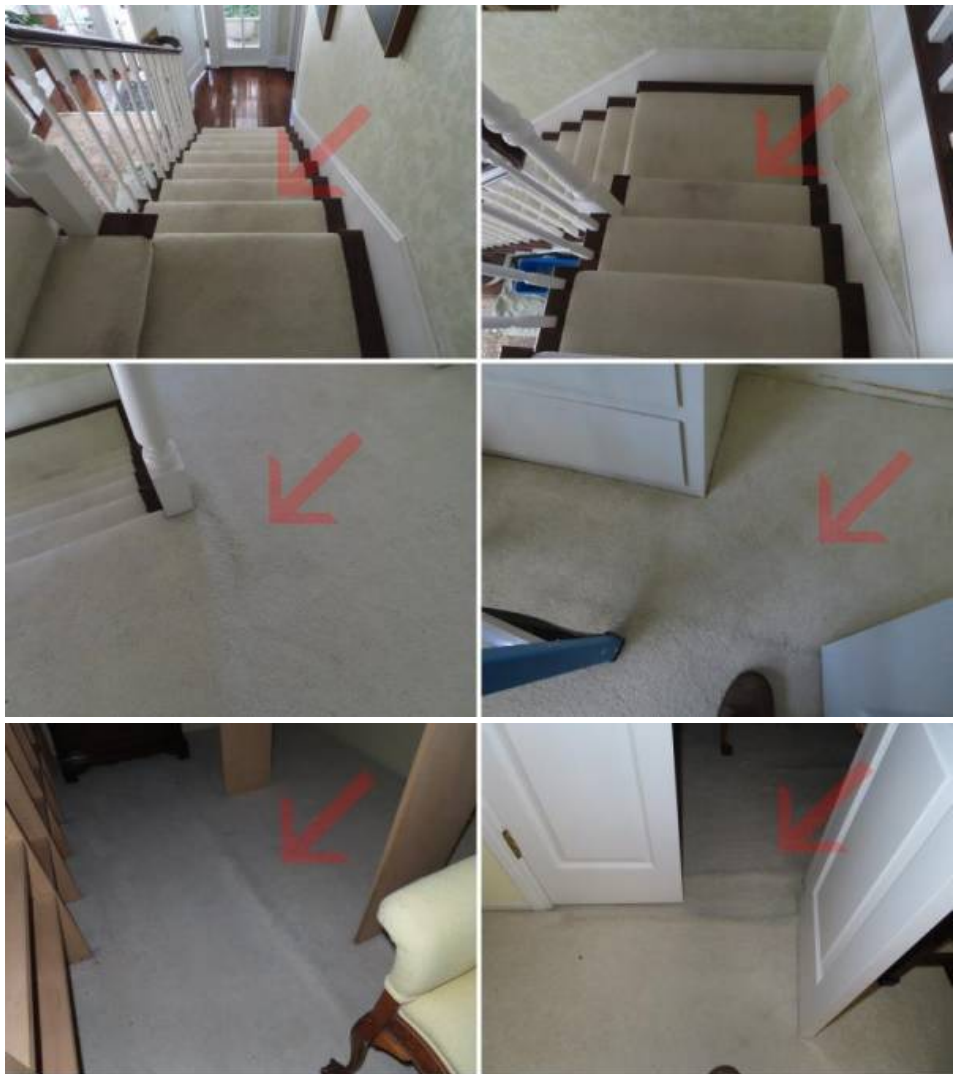
MAINTENANCE: Possible stains/discoloration viewed.
MAINTENANCE: Carpet is noticeably worn with some damage.

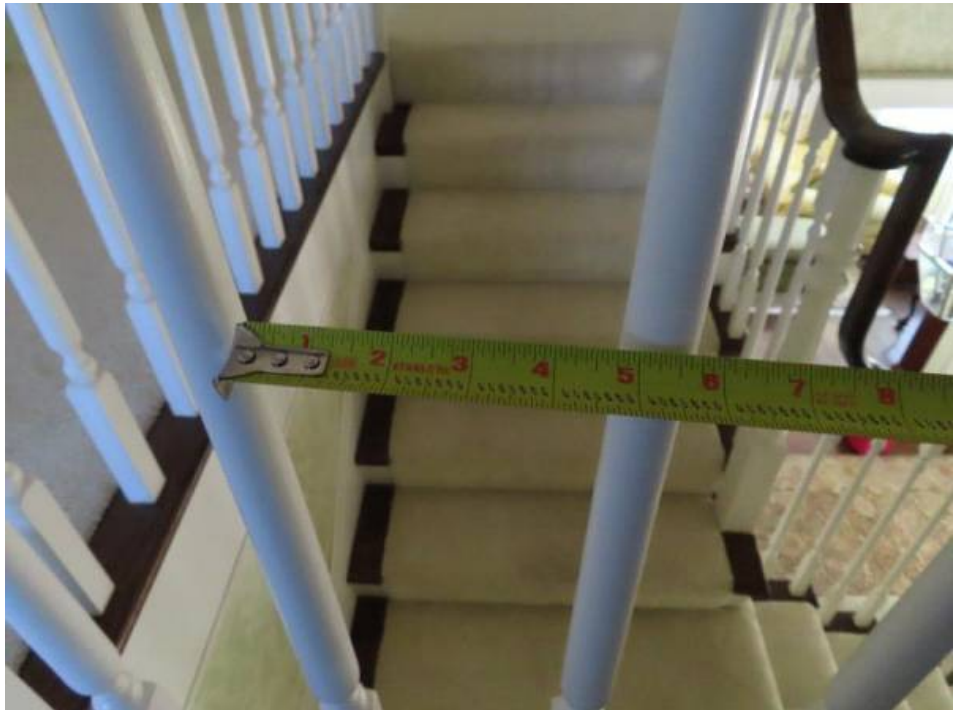
SAFETY: Spacing of balusters at railings is too wide. Current standards require less than 4" space between balusters to prevent children and pets from falling through or becoming entrapped. Upgrading or using safety netting is desirable where children and pets are present.

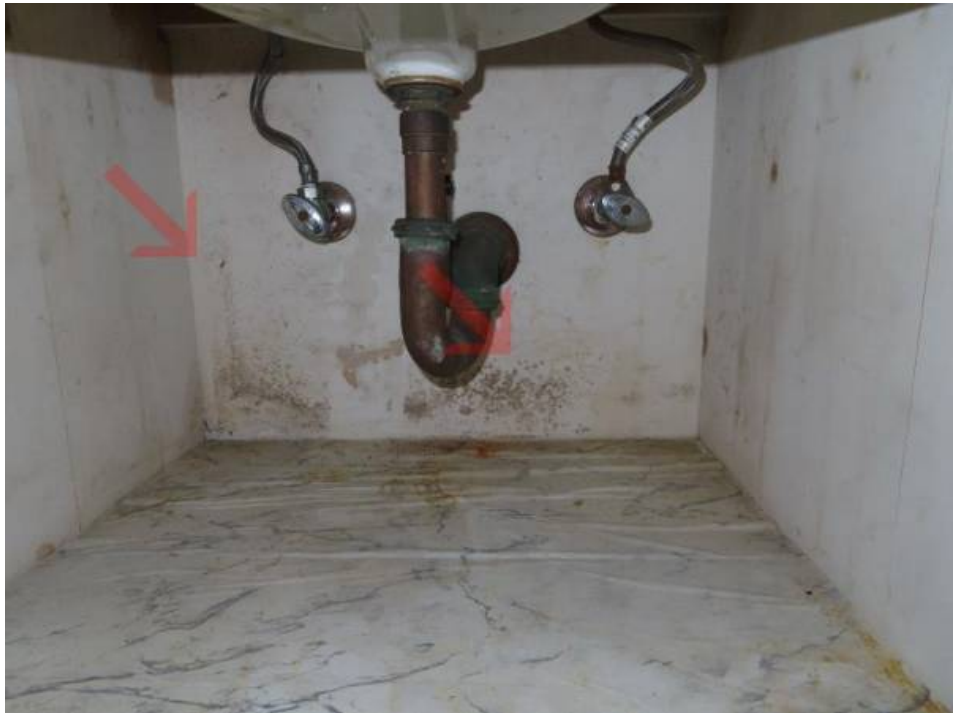
MAINTENANCE: Water damage below the sink from a past or intermittent leak.

Possible mold condition present.

SAFETY: Mold/mildew viewed on the walls/ceiling. Mold can cause illness in humans or pets. Babies, children, the elderly and persons with respiratory disease, allergies or compromised immune systems can be especially at risk. We recommend further evaluation by a qualified Environmentalist or Industrial Hygienist to determine if harmful microorganisms are present.

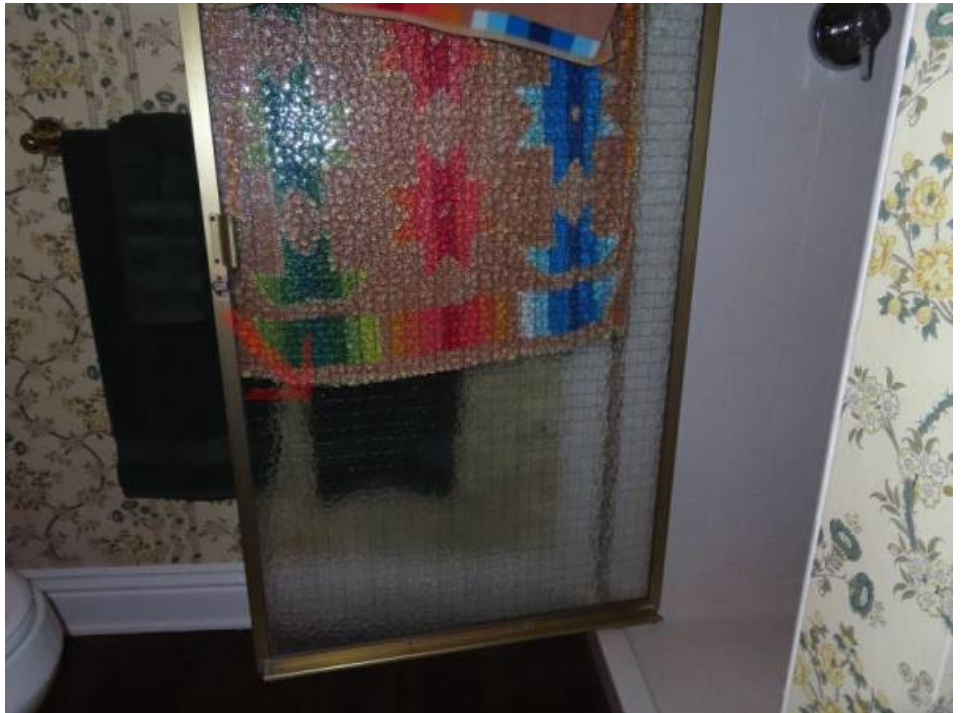
SAFETY: Wire glass is not an approved type of safety glass by today's standards. We recommend replacing with safety glass (may require replacing the entire enclosure).
