Confidential Inspection Report

3807 Pirate Dr.

Rancho Palos Verdes CA 90275

July 20, 2021

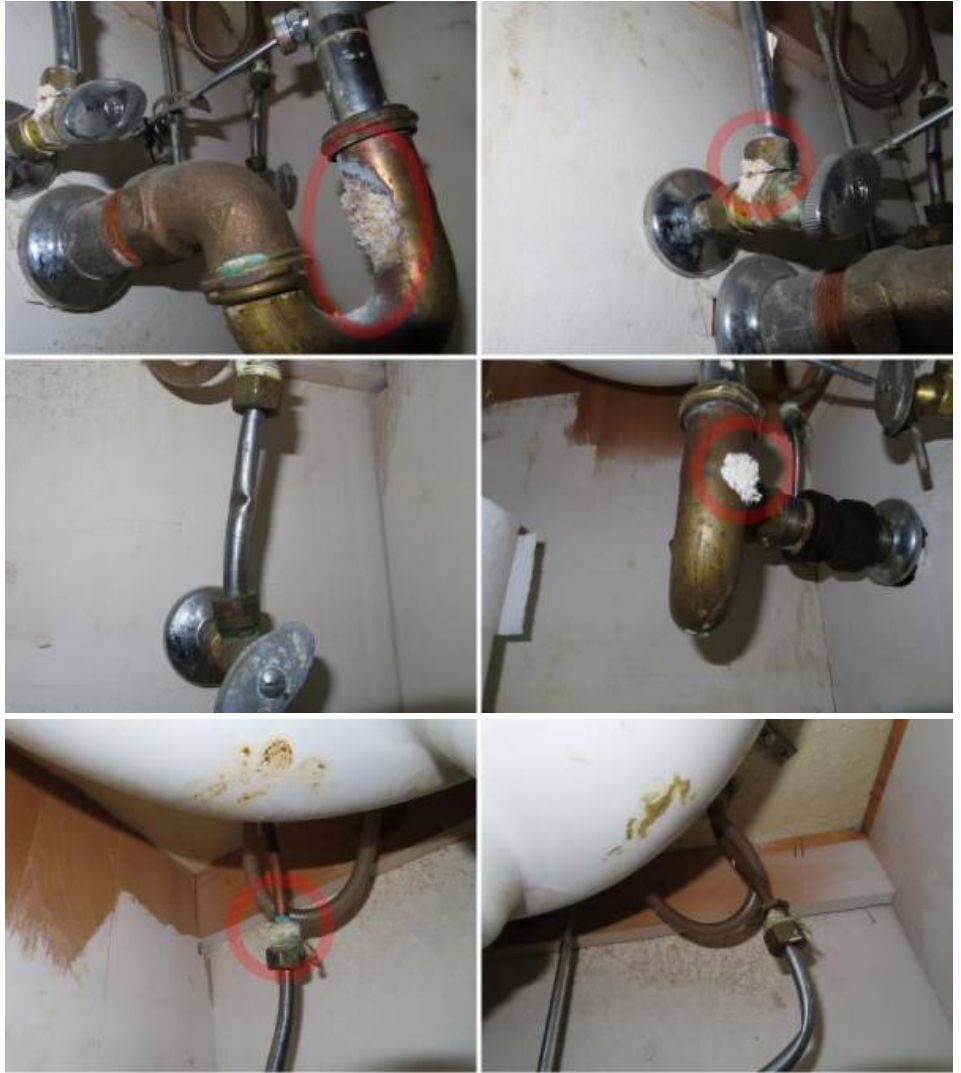
Main bath.
Both sinks.
MAINTENANCE: Moderate corrosion on the drain line. We recommend replacing corroded components before they begin to leak.
MAINTENANCE: Shutoff valve or connector is corroded. Corroded components will eventually fail; we recommend replacing corroded components when observed.

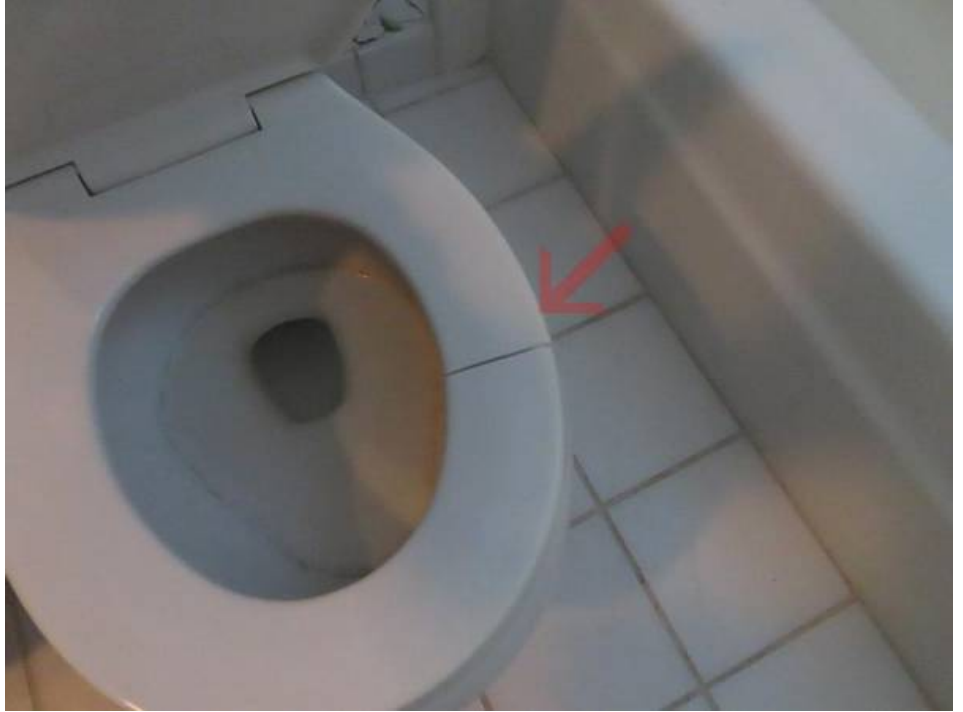
DEFECTIVE: Seat is damaged or missing.
1.6.

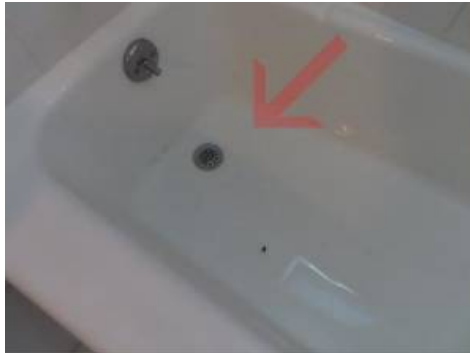
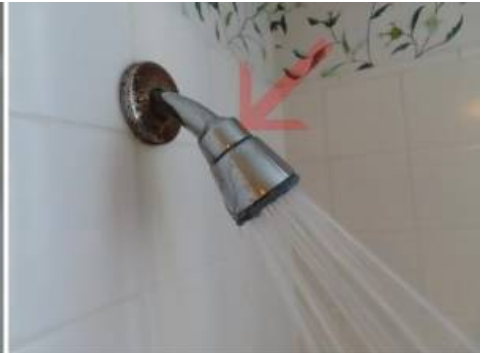
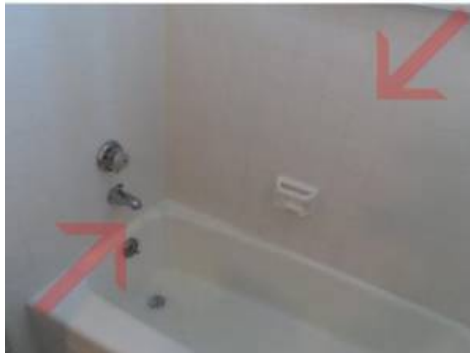
MAINTENANCE: Shower diverter valve does not fully divert water to the shower head. We recommend repairs as needed for water and energy conservation.

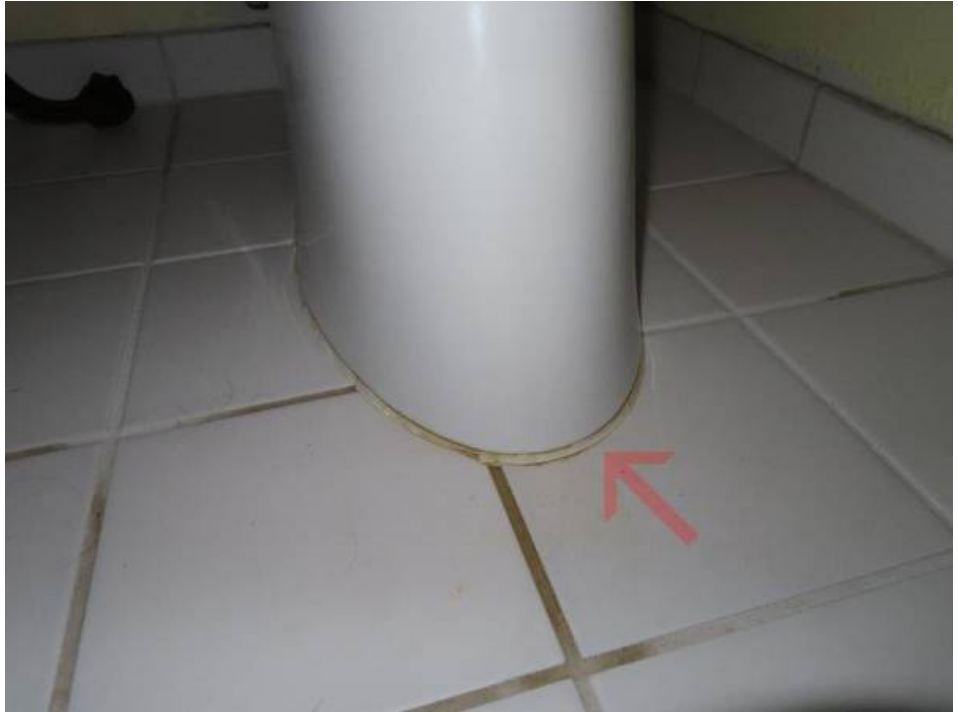
Master bath.
Caulking is cracked.
MAINTENANCE: We recommended caulking at the base of the bowl to prevent sewer gases from escaping into the bathroom if the primary wax seal fails.

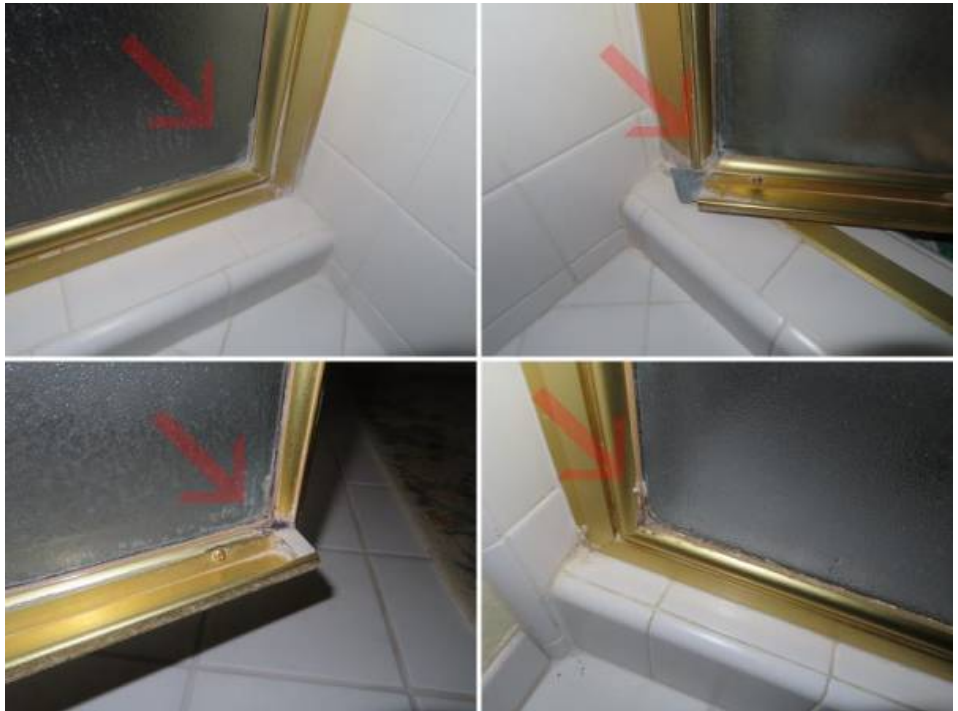
MAINTENANCE: Needs general re-caulking or the vinyl strip at the bottom of the door needs repair.

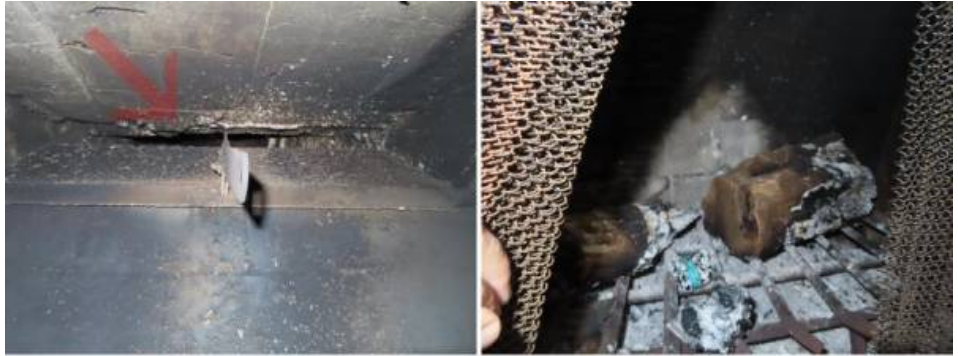
DEFERRED: Buildup of soot and creosote obscured our view of the interior. We recommend cleaning and further evaluation by a qualified fireplace professional prior to use.

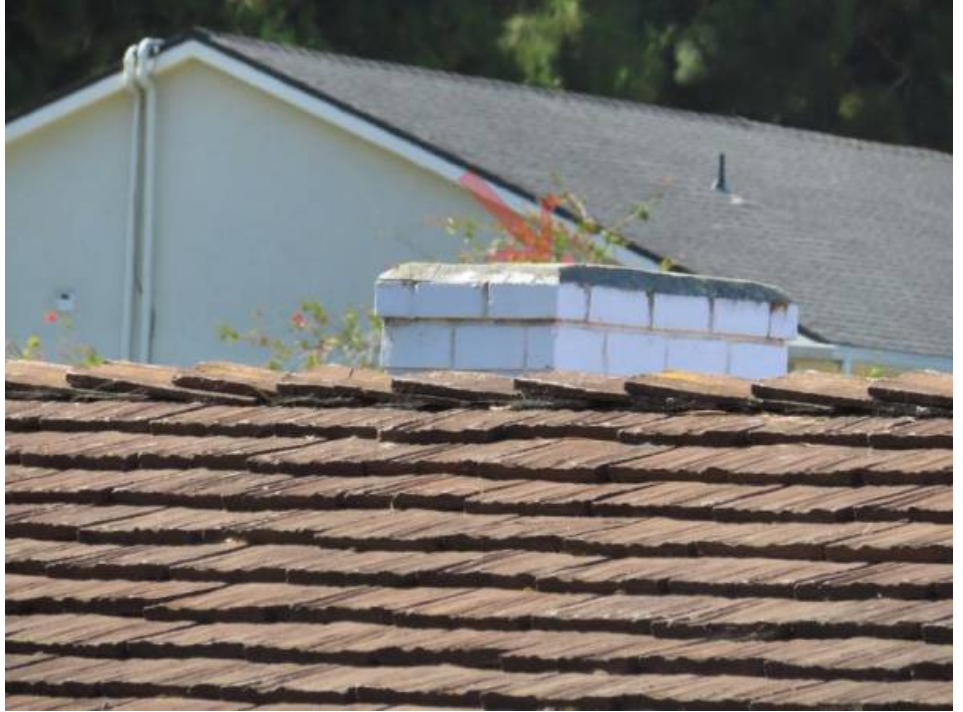
DEFECTIVE: No spark arrestor or improper spark arrestor. All fireplaces are required to have an approved spark arrestor installed to contain burning embers. We recommend correction by a qualified fireplace professional as needed prior to using this fireplace for safety reasons.

MAINTENANCE: No rain cap. Rain caps are not required on masonry chimneys; however, they protect the chimney and firebox from deterioration and we recommend installing them on all chimneys.
