817 E 107th St

Inspection date: Tuesday, April 30, 2024

Report number: 043/24

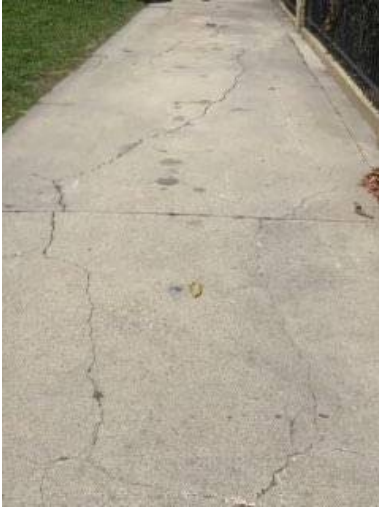
Photo 1-1

Minor deterioration (e.g. cracks, holes, settlement, heaving) was found in the driveway, but no trip hazards were found. The client may wish to have repairs made for cosmetic reasons.

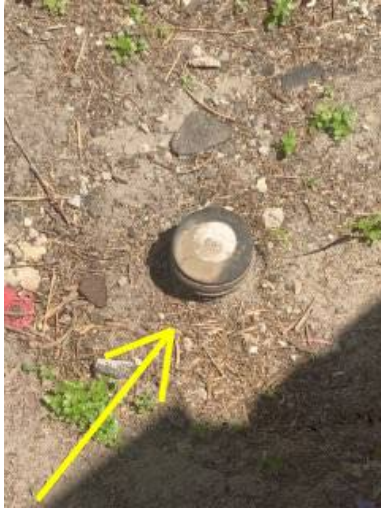
Photo 4-1

At the side of the kitchen Significant erosion was found in one or more areas. Recommend having a qualified person evaluate and make repairs as necessary to repair erosion, and to prevent erosion in the future.

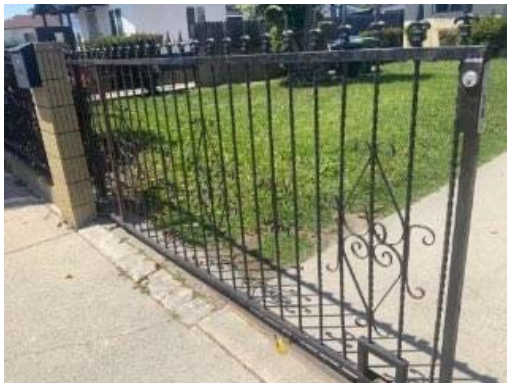
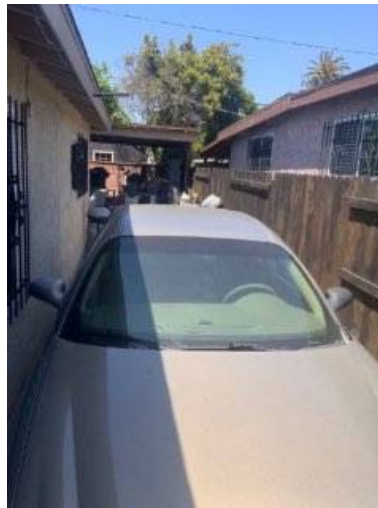
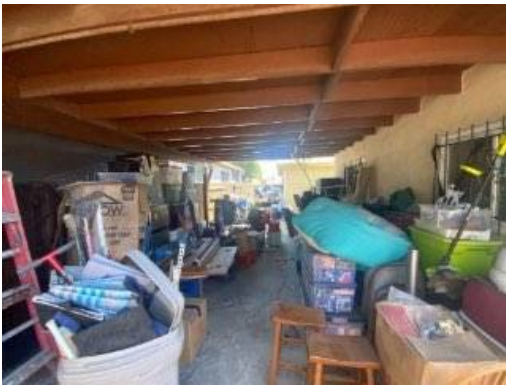
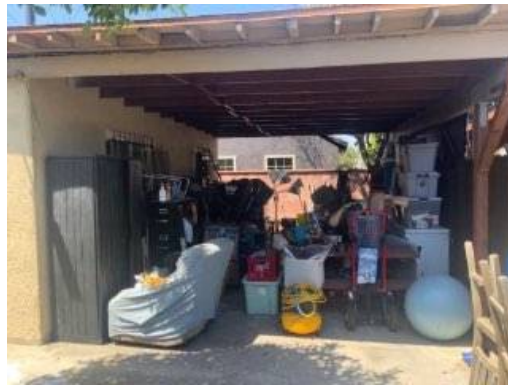
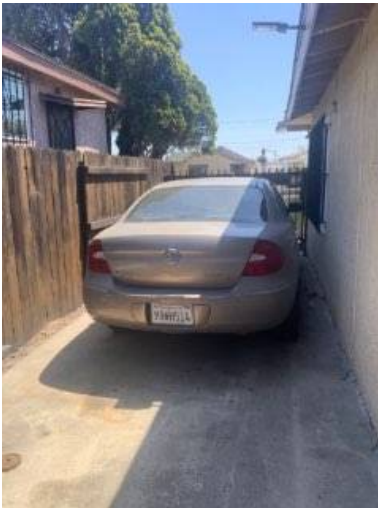
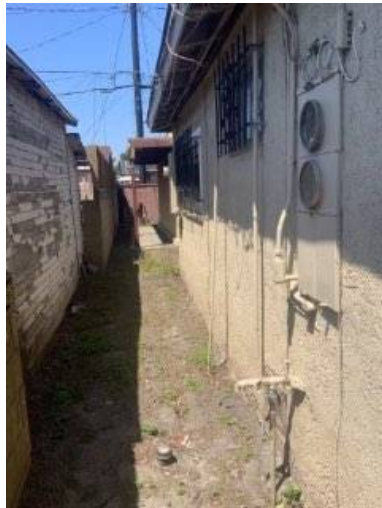
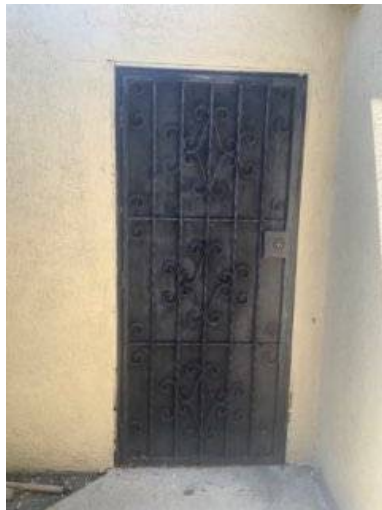
At the time of the inspection, the exterior of the property was in serviceable and good condition. Retain walls and fences were fine.

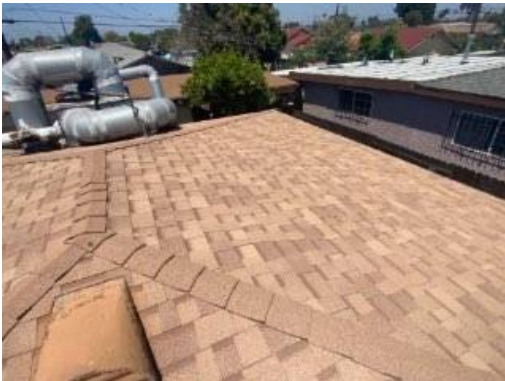
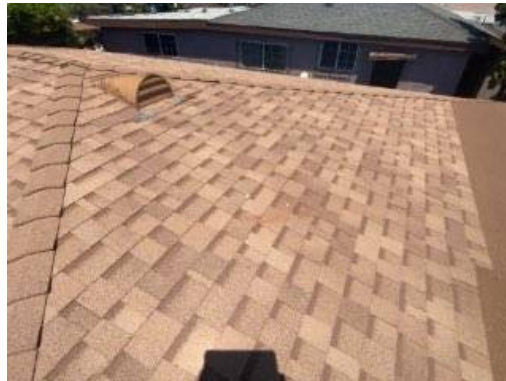
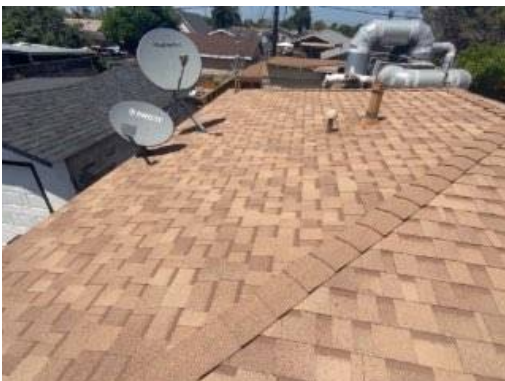
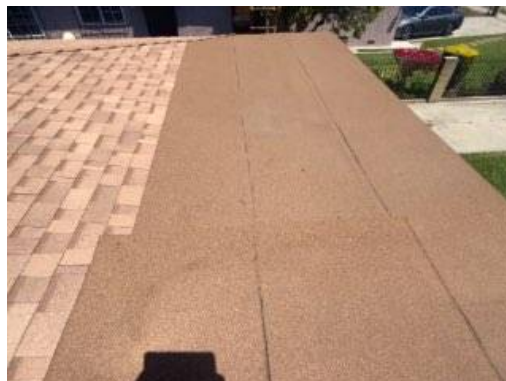
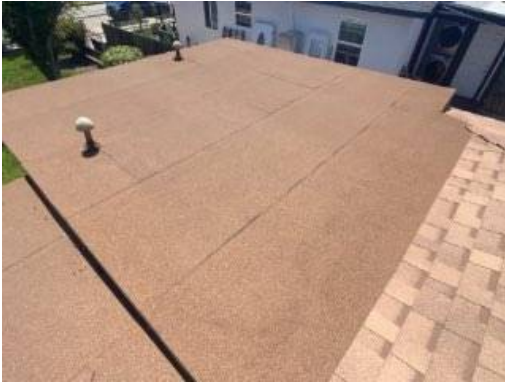
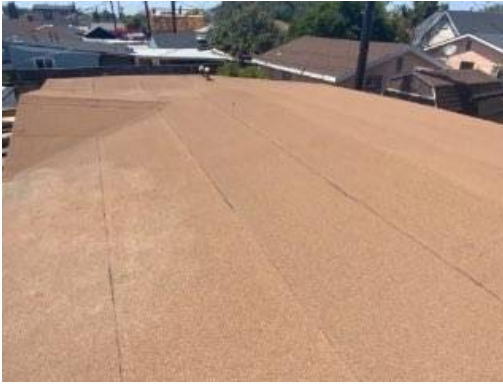
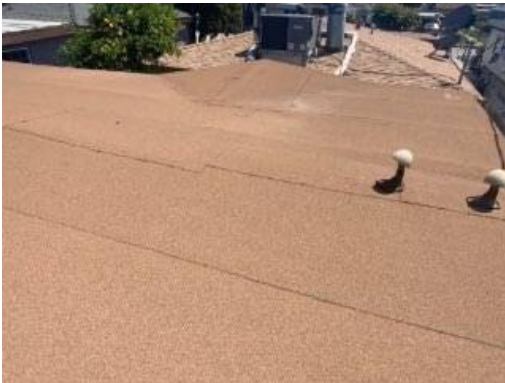
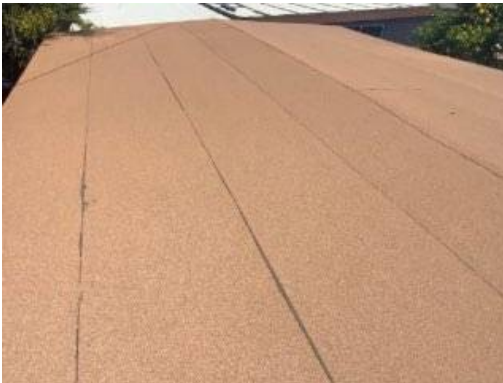
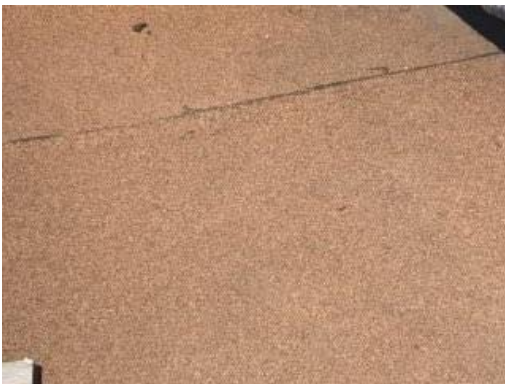
8) ✓ In general, the roof surface was in serviceable and good condition.

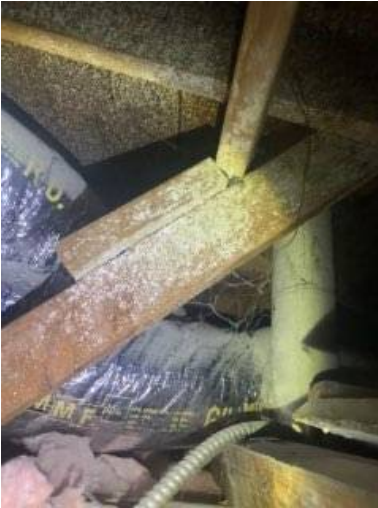
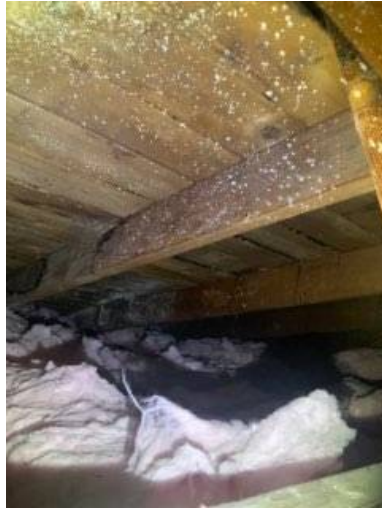
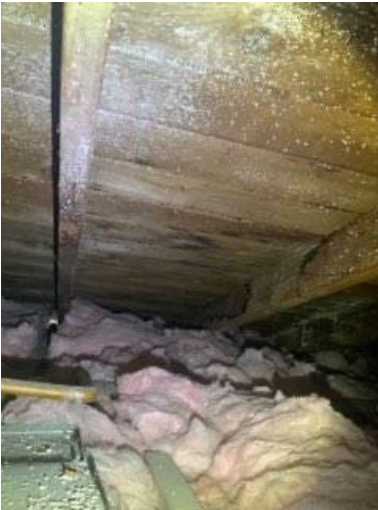
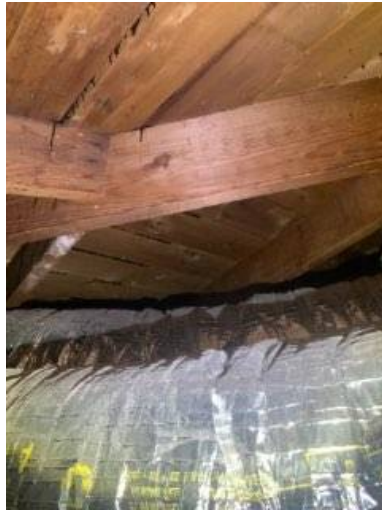
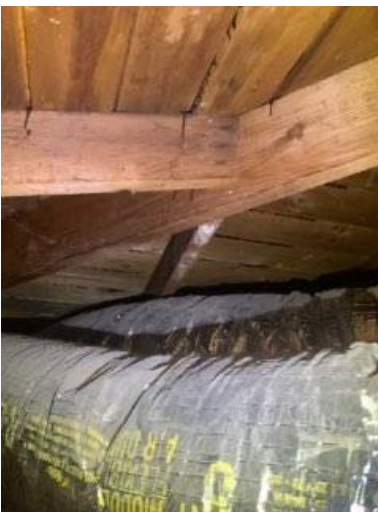
9) ✓ Attic and roof structure were in serviceable condition. Ventilation and insulation were fine.

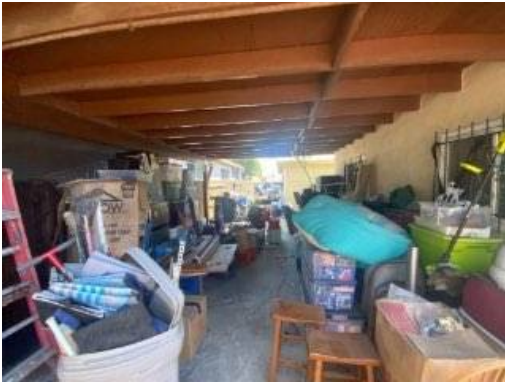
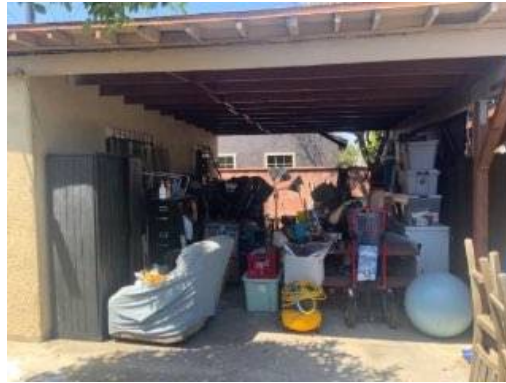
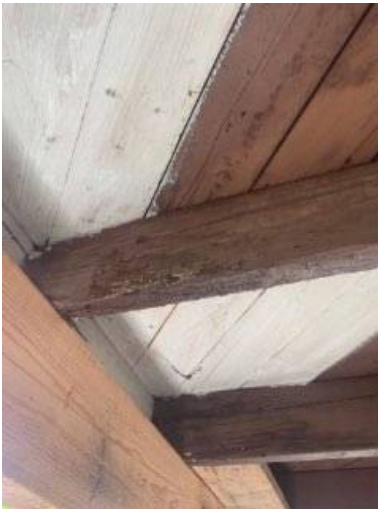
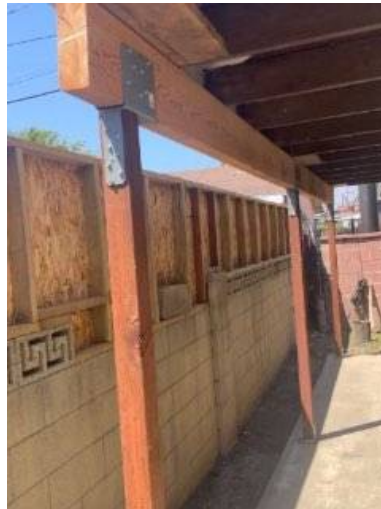
The property did not have garage. The carport floor areas were obscured by stored items and vehicle and couldn't be fully evaluated.

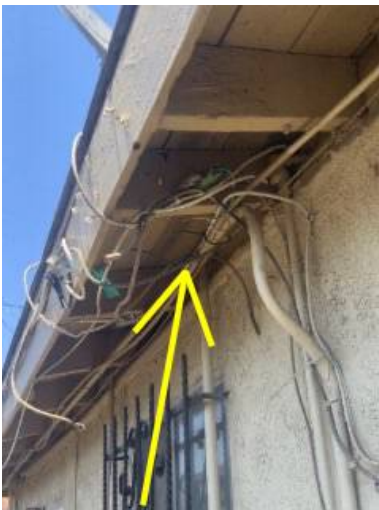
Photo 12-1

One or more sections of outdoor wiring were exposed and subject to damage. This is a potential shock hazard. Recommend that a qualified electrician repair per standard building practices. For example, by installing conduit, re-routing wires or replacing wiring.

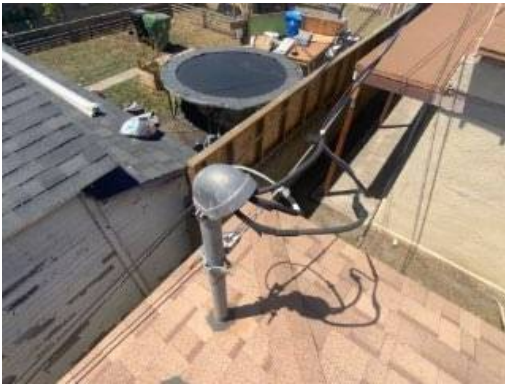
Photo 14-1

At the time of the inspection, we could determine that some repairs and/or upgrade were recently done at the electric system. However, the electric system should be reevaluated and some repairs should be done (see details in this report) as necessary and per standard building regulations

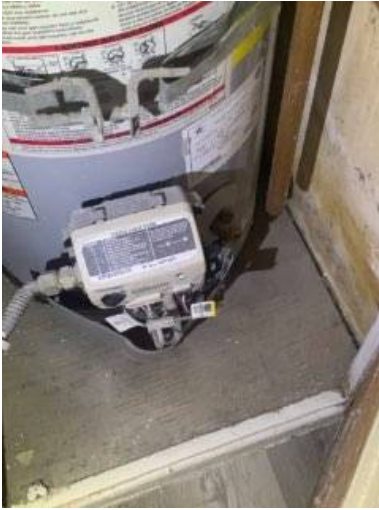
Photo 17-1

No drain line was installed for the temperature-pressure relief valve. This is a potential safety hazard due to the risk of scalding if someone is standing next to the water heater when the valve opens. Recommend that a qualified plumber install a drain line per standard building practices

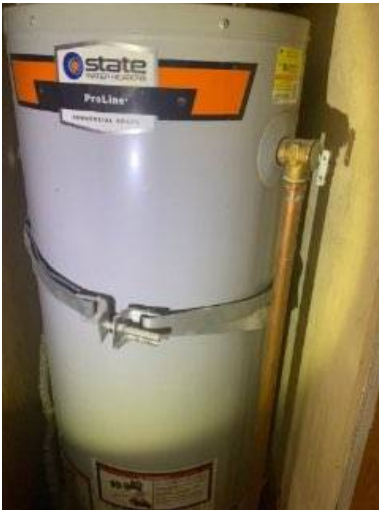
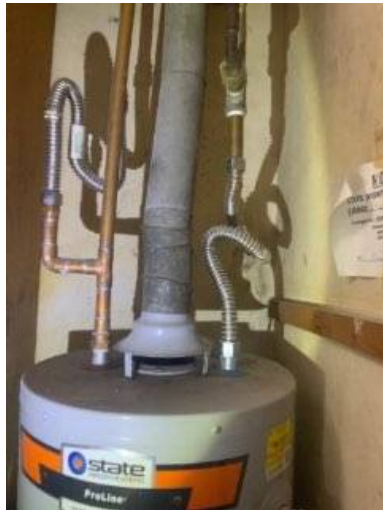
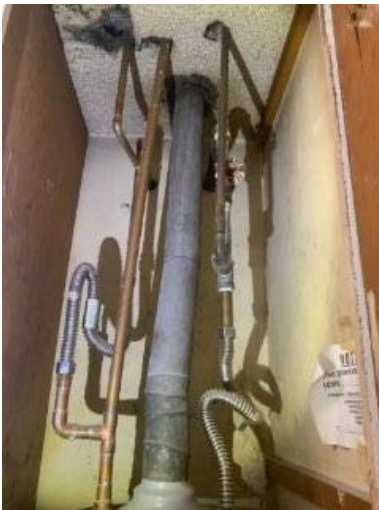
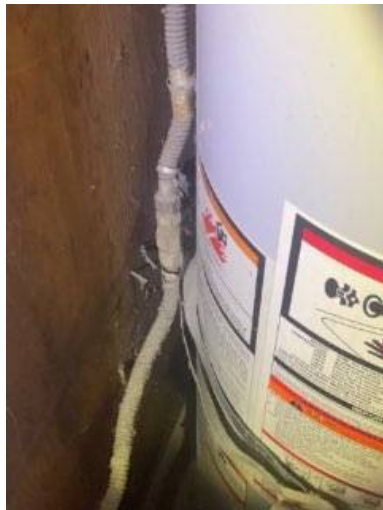
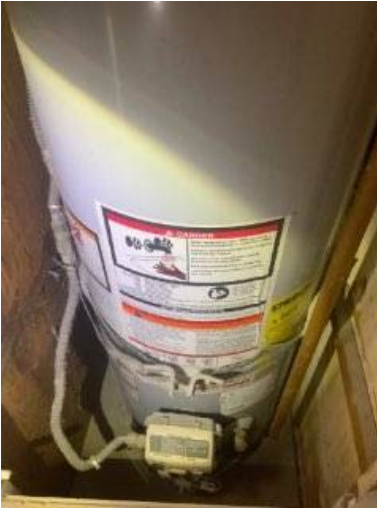
18) ✓ The water heater was in serviceable working condition. There was hot water at the kitchen and bathroom.

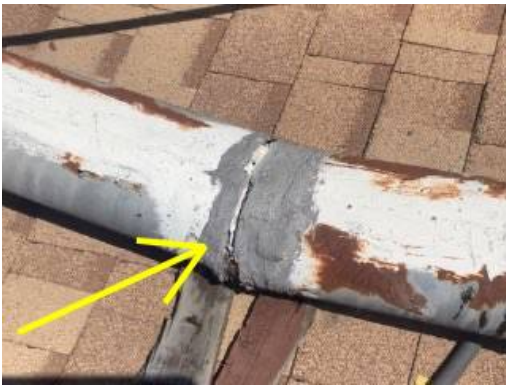
Photo 20-1

1) Some heating or cooling ducts had significant amounts of corrosion or rust. Holes may develop and result in reduced energy efficiency or return air being drawn in from locations other than intended. Recommend that a qualified HVAC contractor repair as necessary. For example, by replacing ducts or sections of ducts.

2) One or more heating or cooling ducts have come apart, or had significant gaps at junctions. This can result in reduced energy efficiency and increased moisture in surrounding spaces. Recommend that a qualified HVAC contractor make permanent repairs as necessary. For example, by securely supporting ducts and installing approved tape or mastic at seams.

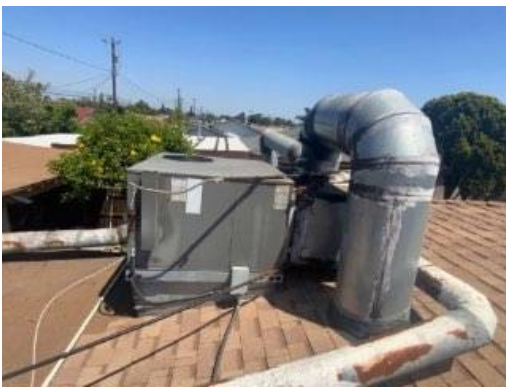
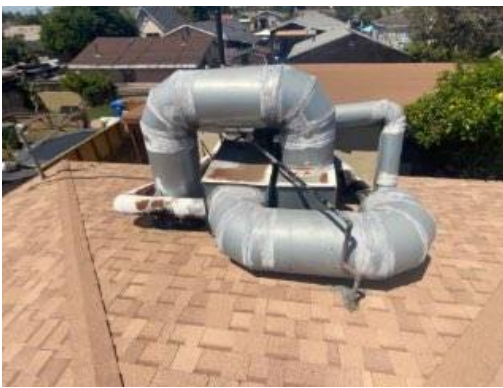
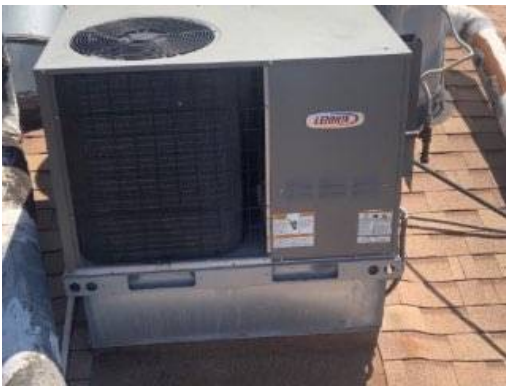
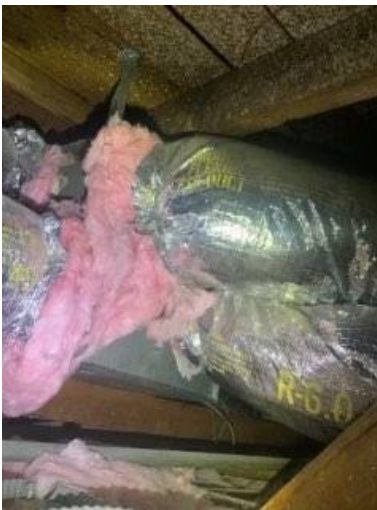
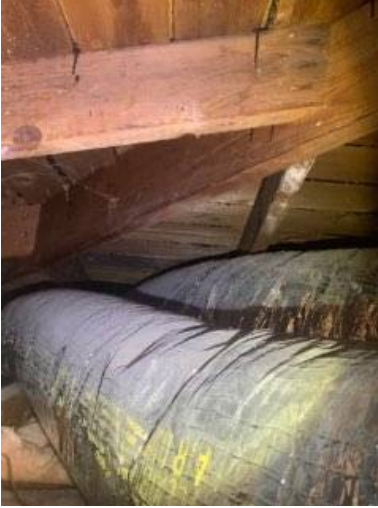
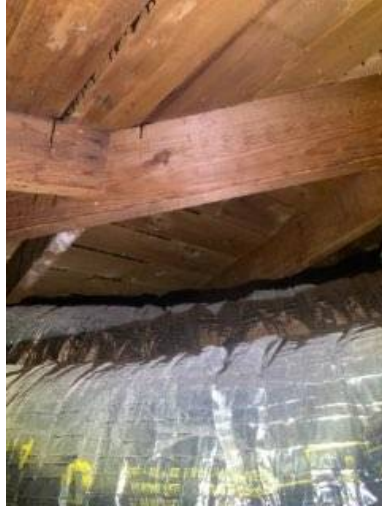
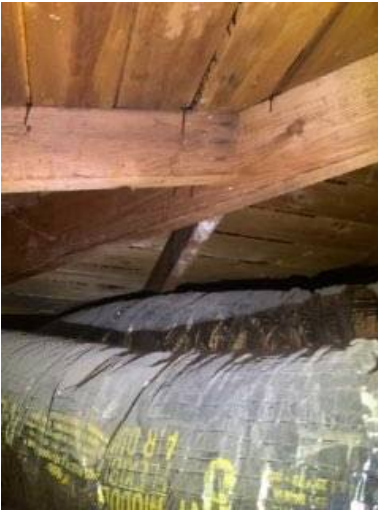
21) ✓ At the time of the inspection, the air conditioning and heater units were in serviceable working condition.

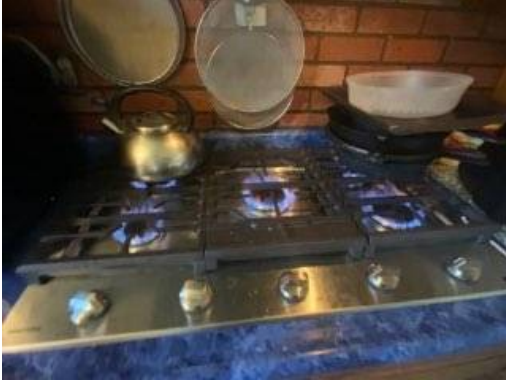
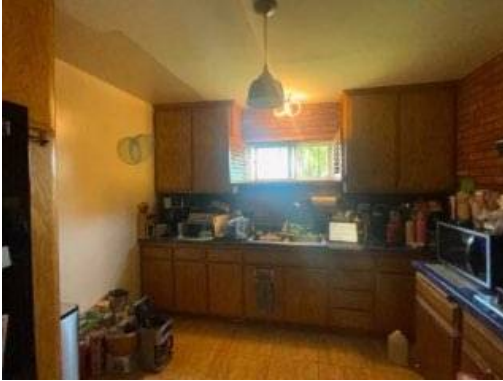
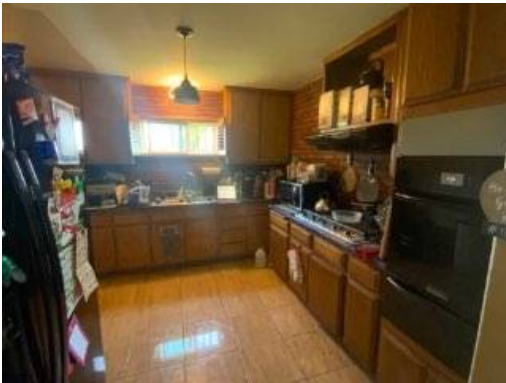
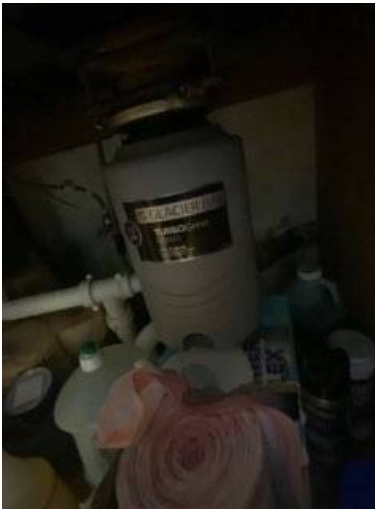
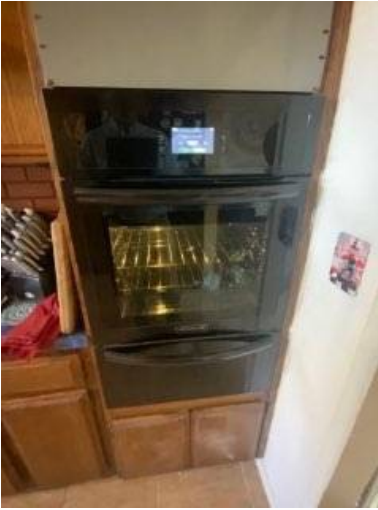
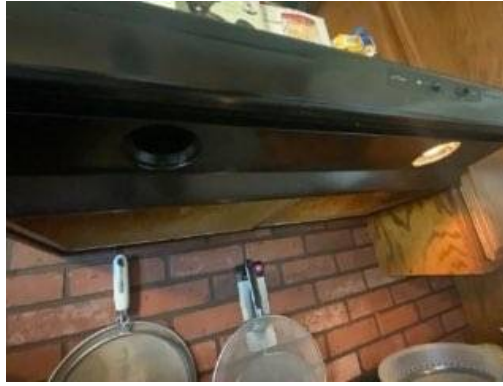
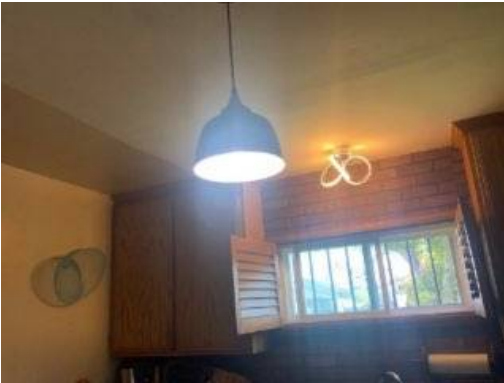
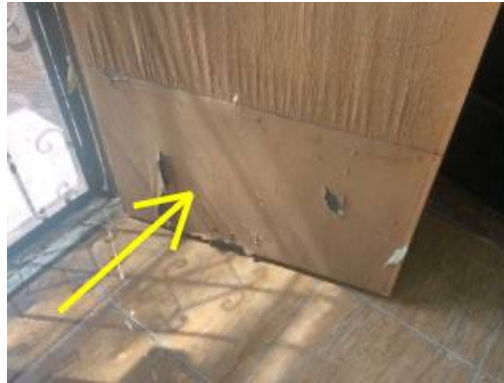
22) 🛠️✔️ 1) Kitchen was in serviceable condition. Appliances were in good working condition. Cabinets and counter tops were fine.
2) Kitchen door should be repair as necessary.

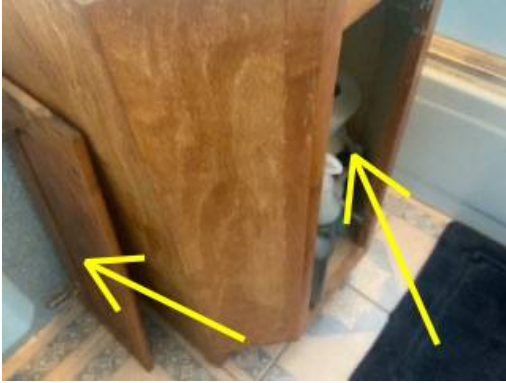
Photo 23-1

-
- 23) 🛠️ 1) One or more cabinets, drawers and/or cabinet doors at location(s) #A were damaged or deteriorated. Recommend that a qualified person repair or replace as necessary.
 2) Shelving or other components were missing from one or more cabinets at location(s) #A. Recommend that a qualified person

replace as necessary.

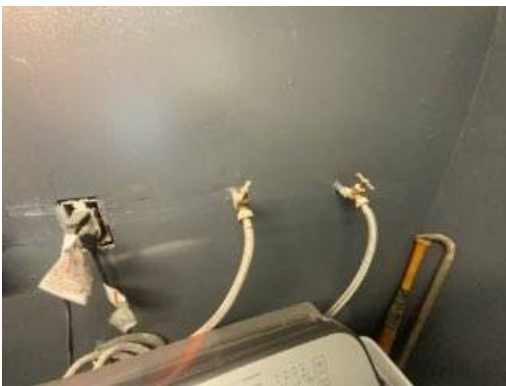
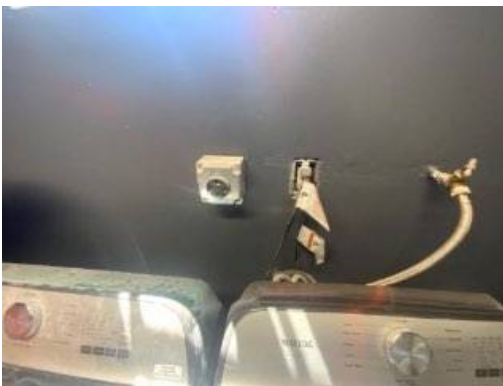
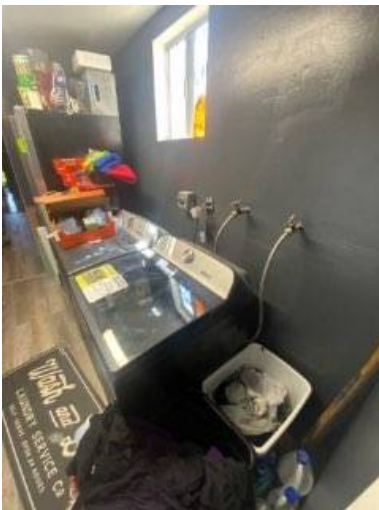
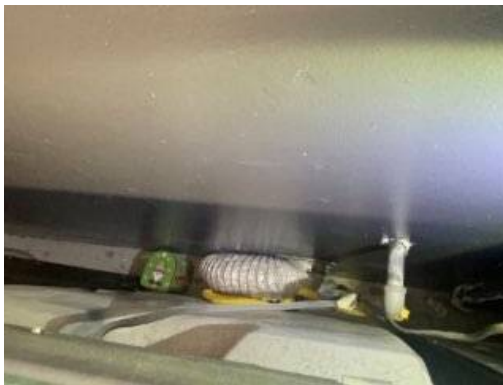
25) 🛠️✅ Connections for washer and dryer machines were in serviceable condition. Washer and dryer were not evaluated. Cover plates was missing from the outlet.

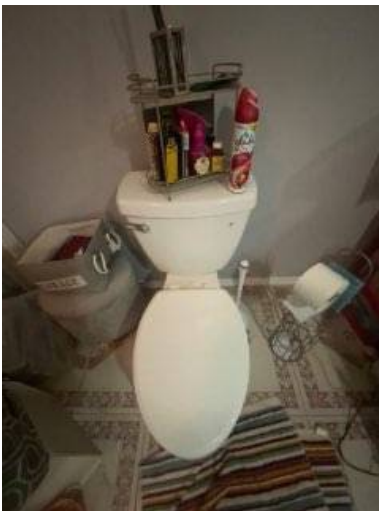
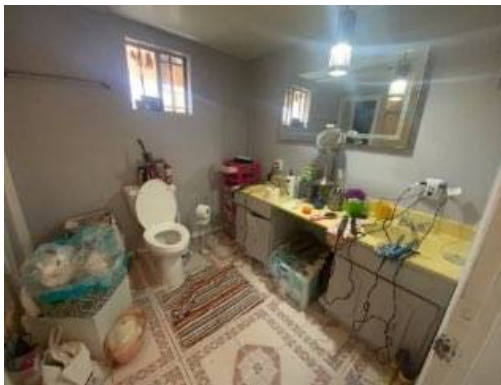
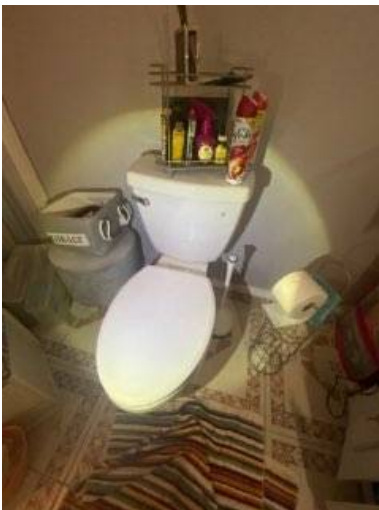
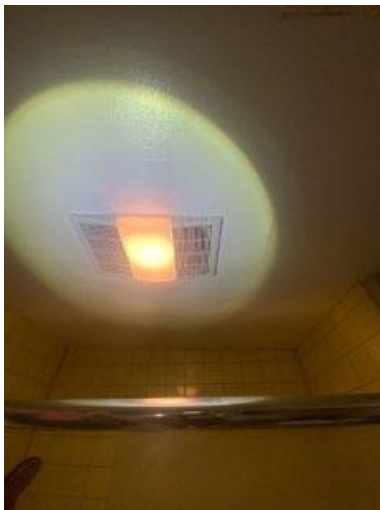
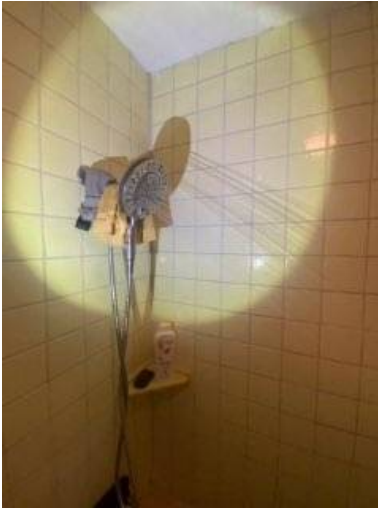
26) ✓ Master bathroom

The bathroom was in serviceable condition. Toilet, sink shower and bathtub were in good working condition. There was hot water and no active leaks were found, at the time of the inspection .

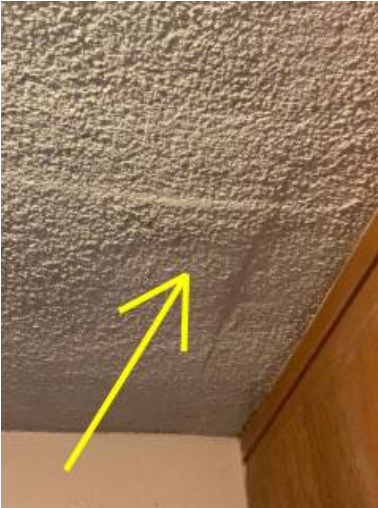
Photo 27-1

One or more walls and ceilings were damaged and/or had substandard repairs. Recommend that a qualified person repair as necessary.

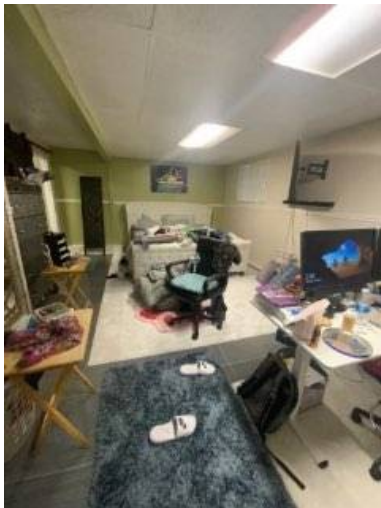
Photo 28-1

2) Tile, stone and/or grout in the flooring in one or more areas was deteriorated (e.g. loose or cracked tiles, missing grout) or substandard. If in a wet area, water can damage the sub-floor. Recommend that a qualified contractor repair as necessary.

3) Extension cords were being used as permanent wiring at one or more locations. They should only be used for portable equipment on a temporary basis. Using extension cords as permanent wiring is a potential fire and shock hazard, and indicates that wiring is inadequate and needs updating. Extension cords may be undersized. Connections may not be secure resulting in power fluctuations, damage to equipment, overheating and sparks that could start a fire. Recommend that a qualified electrician repair per standard building practices and eliminate extension cords for permanently installed equipment.

4) Substandard wiring was found in the interior room. For example, exposed wiring and loose wiring. This is a safety hazard. Recommend that a qualified electrician evaluate and repair as necessary and per standard building practices.

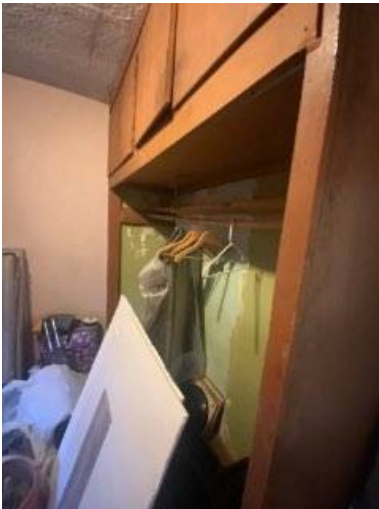
Photo 29-1

- 1) One or more walls /ceiling were damaged . Recommend that a qualified person repair as necessary.
- 2) Carpeting in one or more areas was damaged or deteriorated. Recommend that a qualified contractor replace as necessary.
- 3) One or more closet doors were missing.
- 4) This room should be deeply cleaned.

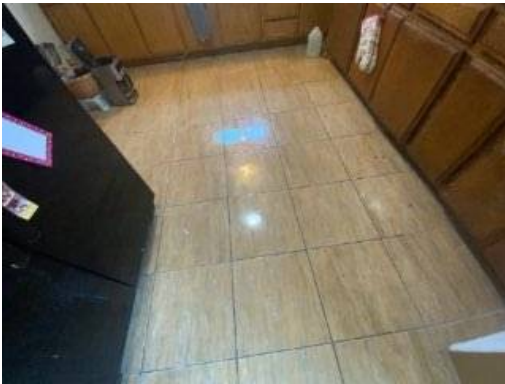
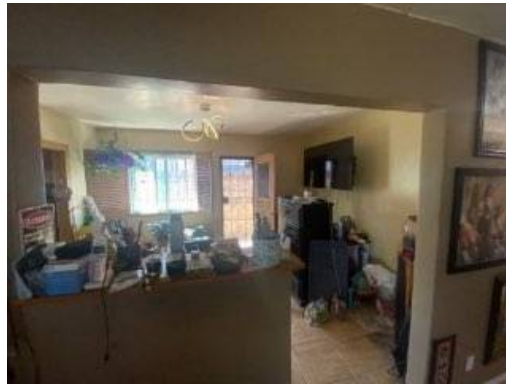
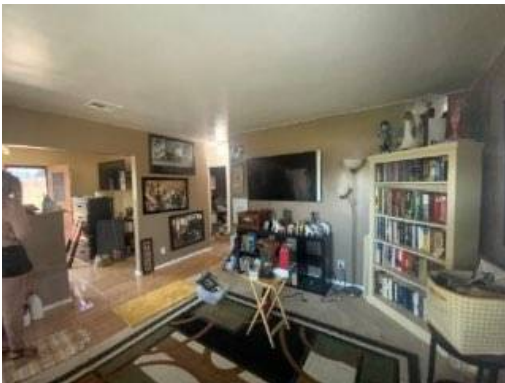
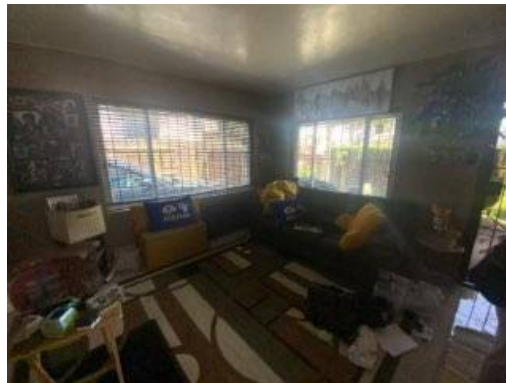
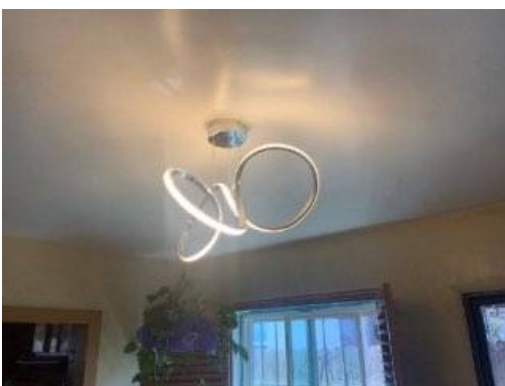
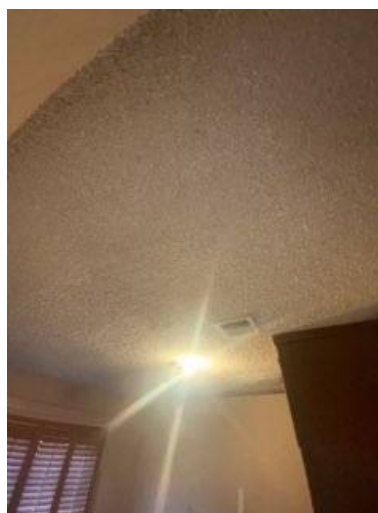
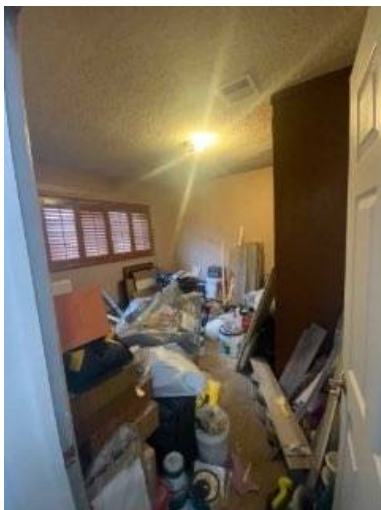
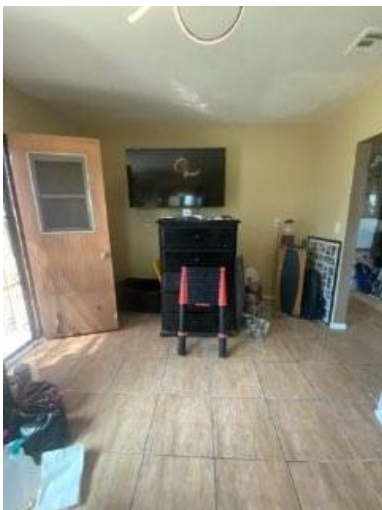
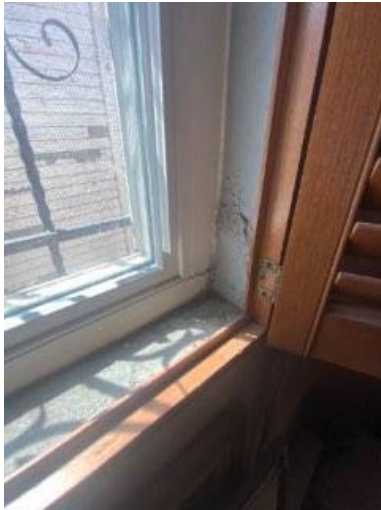
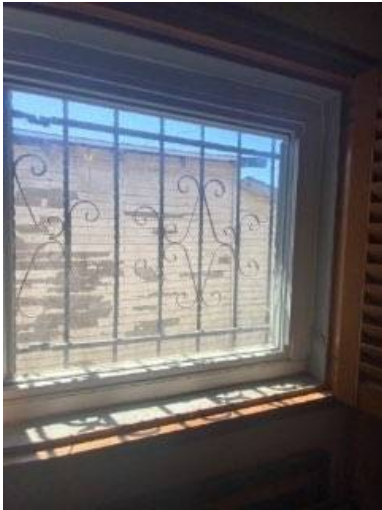
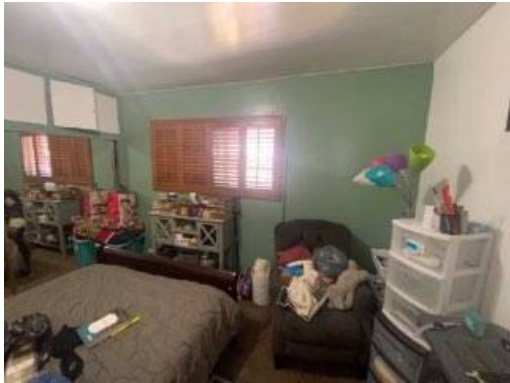
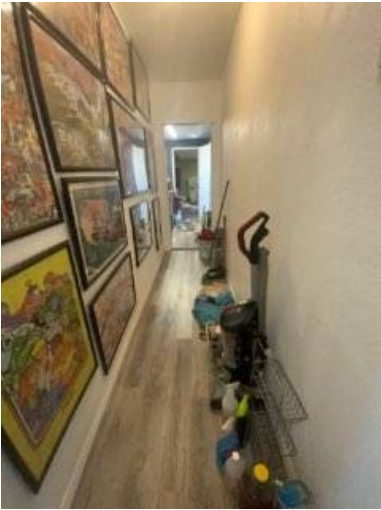
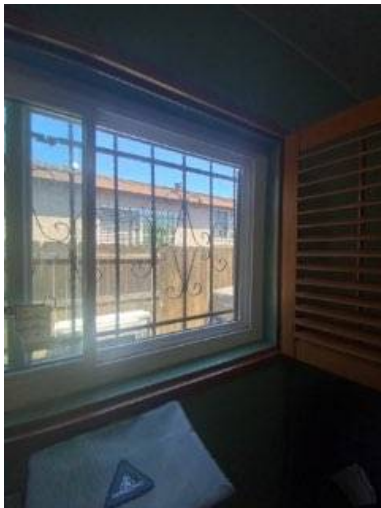
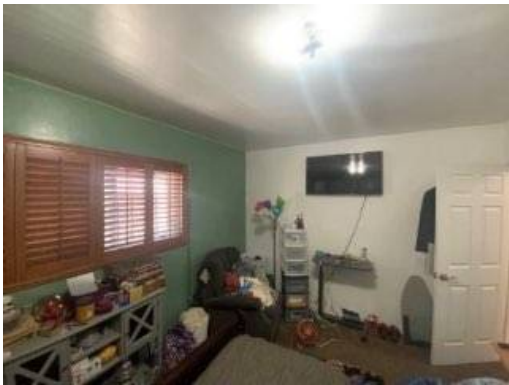
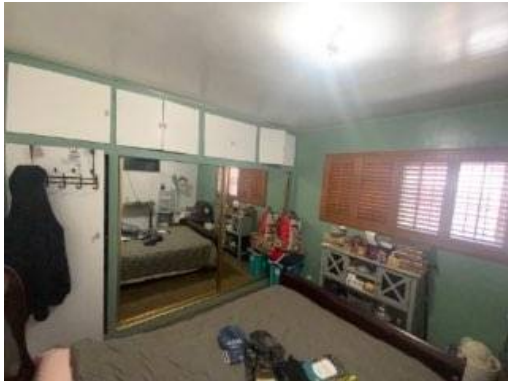
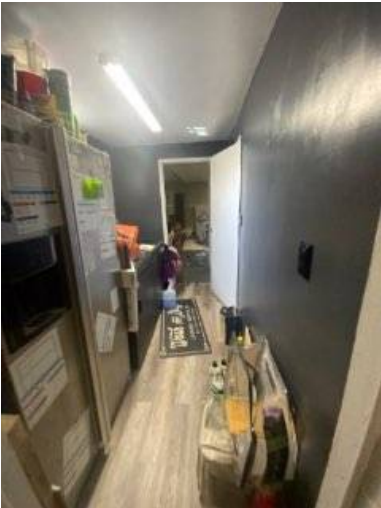
30) ✓ 1) Many areas and items at this property were obscured by furniture and stored items . This often includes but is not limited to walls, floors, windows, inside and under cabinets, under sinks, on counter tops, in closets, behind window coverings, under rugs or carpets, and under or behind furniture. Areas around the exterior, under the structure, in the garage and in the attic may also be

obscured by stored items. The inspector in general does not move personal belongings, furnishings, carpets or appliances. When furnishings, stored items or debris are present, all areas or items that are obscured, concealed or not readily accessible are excluded from the inspection. The client should be aware that when furnishings, stored items or debris are eventually moved, damage or problems that were not noted during the inspection may be found.

2) In general the interior of the house was in serviceable condition. Most windows and doors opened and closed properly. Floor was fine.
