# CROSSWIND HOME INSPECTION

## HOME INSPECTION

4338 Carfax Ave  
Lakewood, CA 90713

03/05/2024

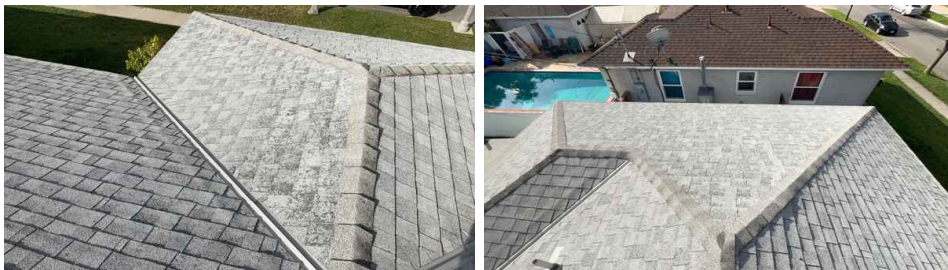
During the roof inspection I observed granular material loss, this is indicative of a roof covering that is nearing the end of its lifespan, as the granules are swept away by wind and rain the roof becomes more exposed to UV light and will deteriorate faster. Recommend further evaluation by a licensed roofer.

Contact a qualified professional.

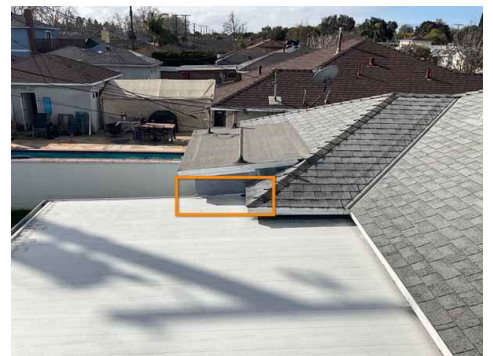
## 2.2.1 Flashing

**MISSING FLASHING**

I observed areas where flashing was missing. Not installed. Improper installation of flashing. These areas of missing flashing are prone to water penetration. Flashing is installed to provide protection against roof leaks and to divert water away from certain areas. Correction and further evaluation is recommended.

Contact a qualified roofing professional.

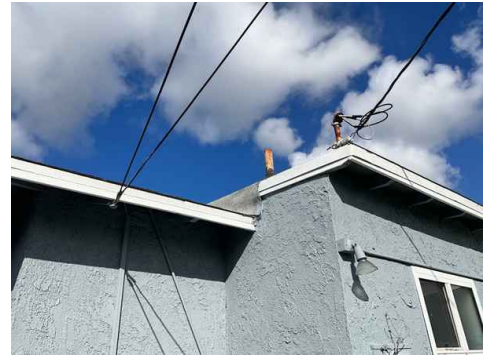
## 2.2.2 Flashing

**IMPROPERLY INSTALLED FLASHING.**

I noted indications that flashing in one or more locations was improperly installed. i recommend repair by a qualified roofer to maintain the water-shed qualities of the roof system.

Contact a qualified professional.

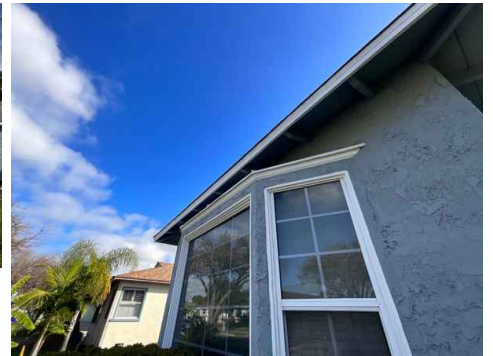
## 2.5.1 Gutters &amp; Downspouts

**GUTTERS MISSING**

Gutters are necessary to properly collect rain water from the roof, control it, divert it, and discharge that water away from the house and its foundation. A missing gutter is a defect. This is a defect that should be corrected by a professional contractor.

Contact a qualified gutter contractor

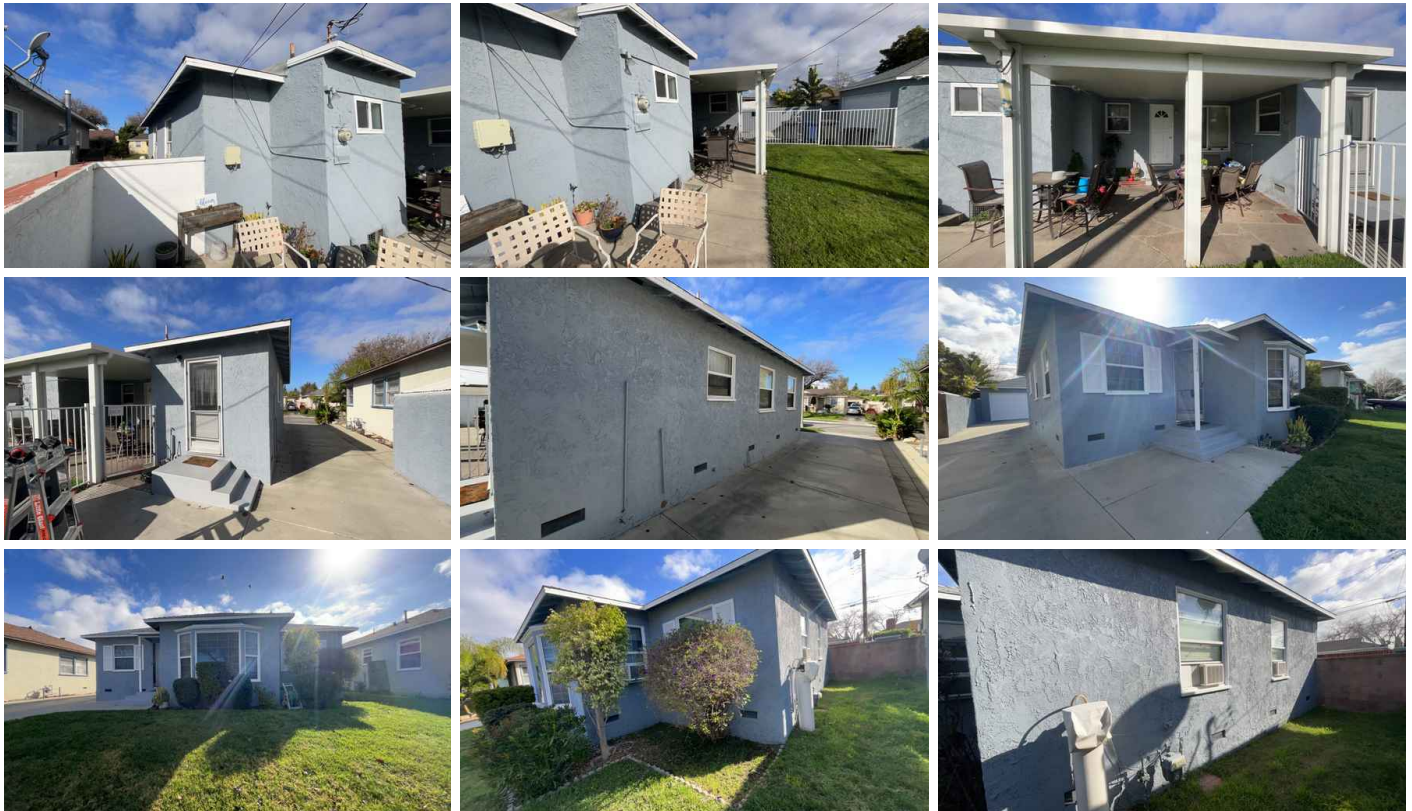
#### General: Exterior Was Inspected

I inspected the exterior of the house.

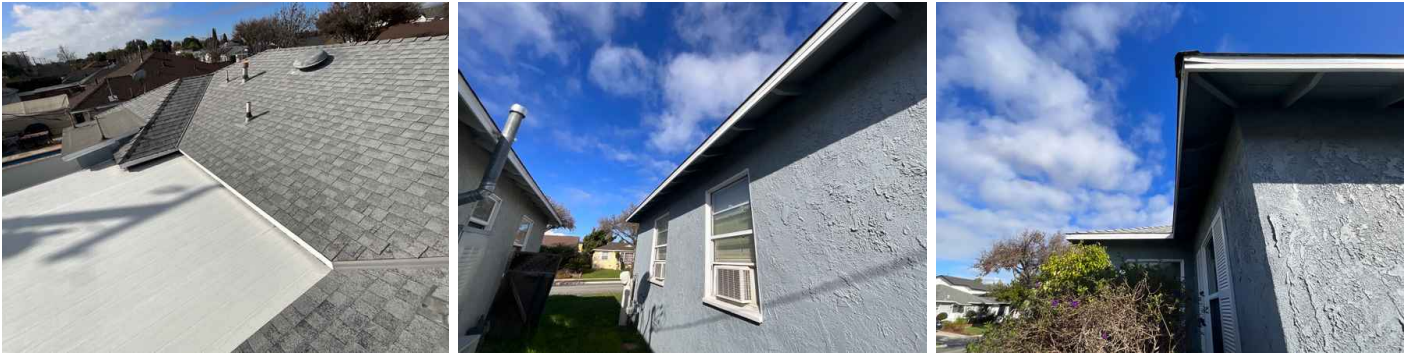
#### Eaves, Soffits & Fascia: Eaves, Soffits and Fascia Were Inspected

I inspected the eaves, soffits and fascia. I was not able to inspect every detail, since a home inspection is limited in its scope.

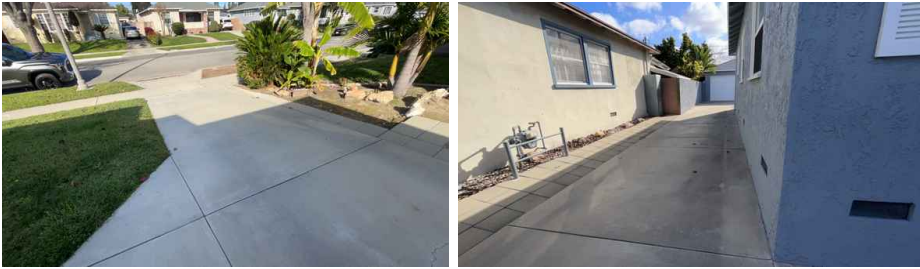
### Walkways & Driveways: Walkways & Driveways Were Inspected

I inspected the walkways and driveways that were adjacent to the house. The walkways, driveways, and parking areas that were far away from the house foundation were not inspected.

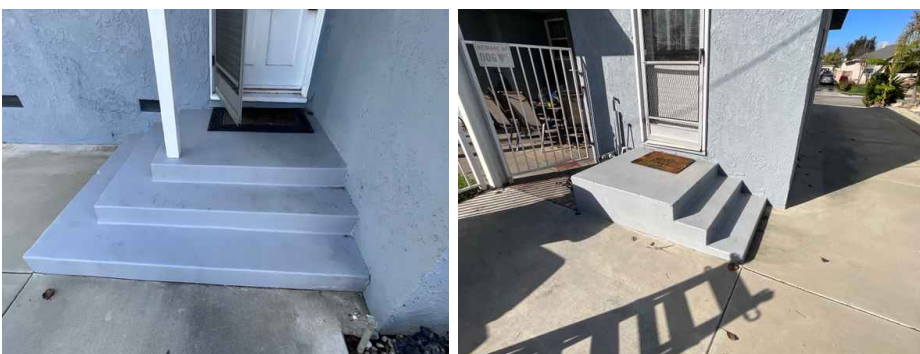
### Stairs, Steps, Stoops, Stairways & Ramps: Stairs, Steps, Stoops, Stairways & Ramps Were Inspected

I inspected the stairs, steps, stoops, stairways and ramps that were within the scope of my home inspection.

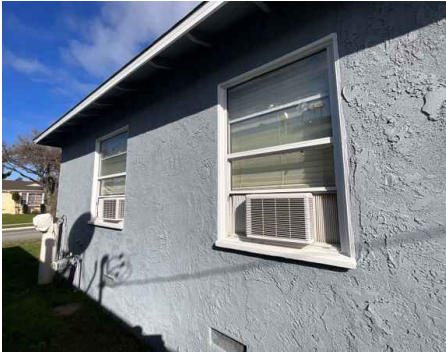
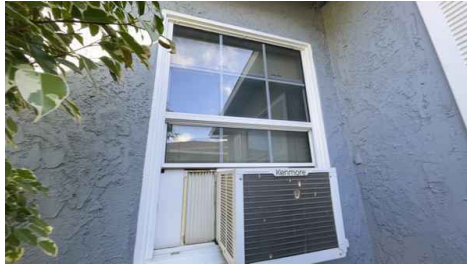
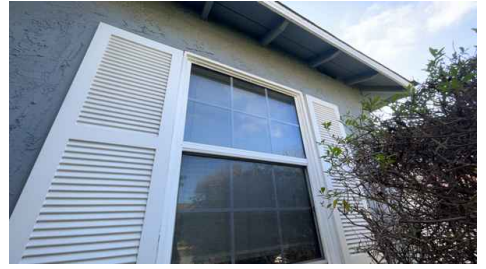
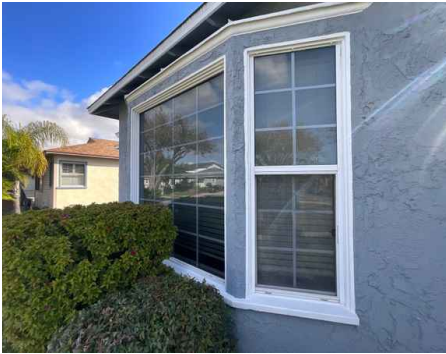
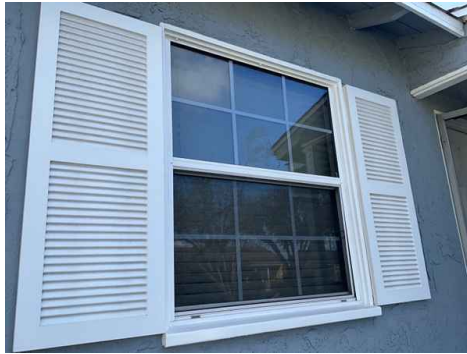
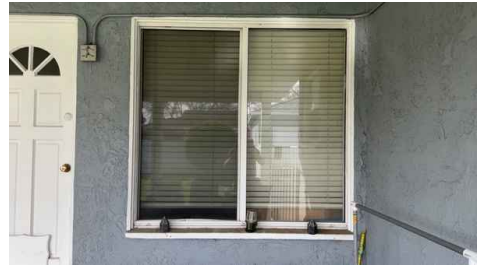
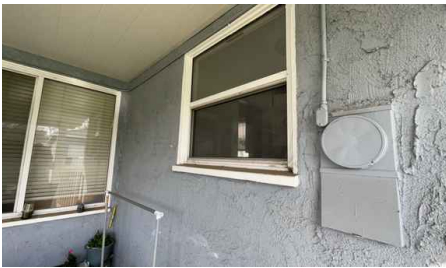
## Windows: Windows Inspected

A representative number of windows from the ground surface were inspected.

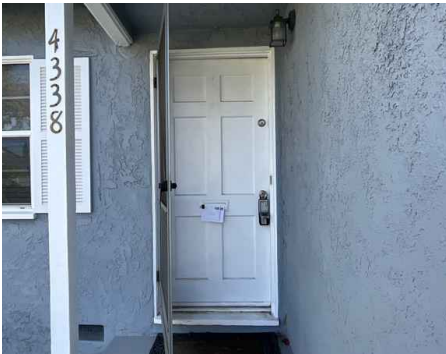
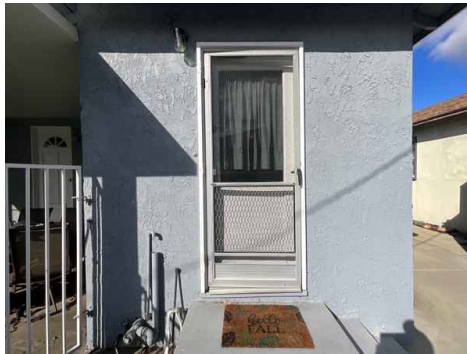
## Exterior Doors: Exterior Doors Inspected

I inspected the exterior doors.

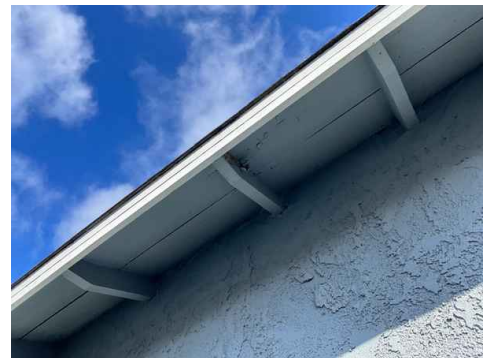
**PAINT SURFACE IN POOR CONDITION**

I observed indications of paint or staining in poor condition. Flaking, cracking, and worn areas.

Contact a qualified painting contractor.

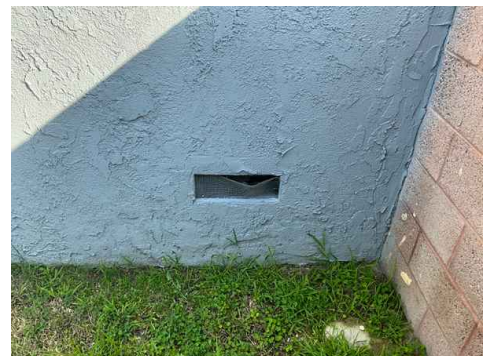
## 3.3.1 Wall-Covering, Flashing &amp; Trim

**DAMAGED OR LOSE VENT SCREEN**

I noted a damaged or loose vent screen, recommend correction.

Contact a qualified professional.

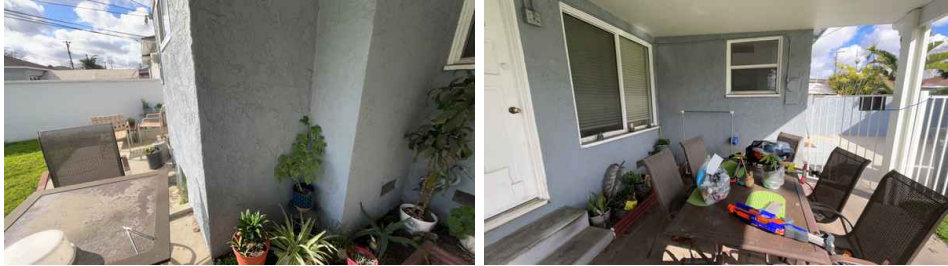
## 3.5.1 GFCIs &amp; Electrical

**INADEQUATE NUMBER OF EXTERIOR RECEPTACLES.**

Contact a qualified electrical contractor.

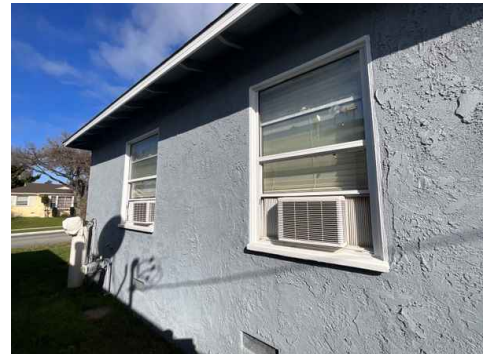
## 3.8.1 Windows

**MISSING WINDOW SCREEN**

I observed a missing window screen.

Contact a qualified handyman.

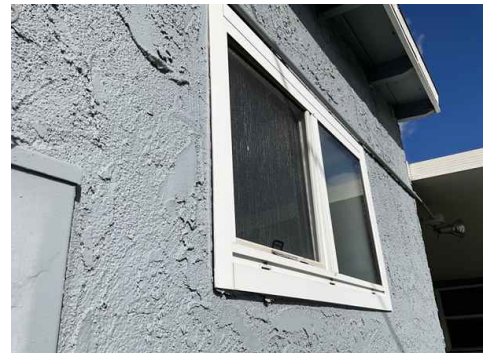
## 3.8.2 Windows

**CRACKED SEAL AROUND WINDOW FRAME.**

Contact a qualified professional.

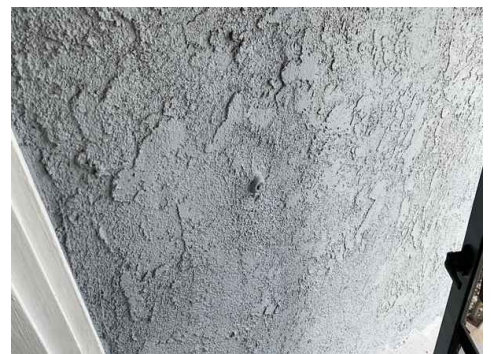
## 3.9.1 Exterior Doors

**DOORBELL DOES NOT RING**

Contact a handyman or DIY project

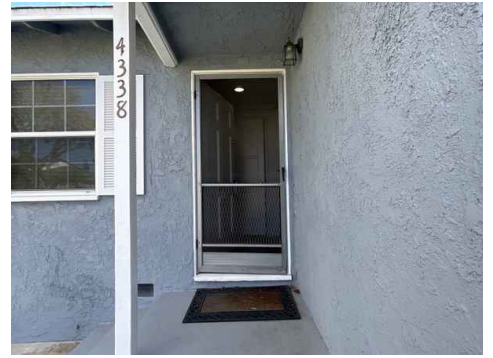
## 3.9.2 Exterior Doors

**SCREEN DOOR DOES NOT LATCH PROPERLY**

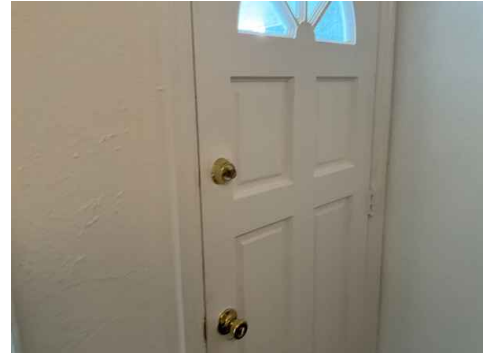
## 3.9.3 Exterior Doors

**INTERIOR KEYED DEADBOLT**

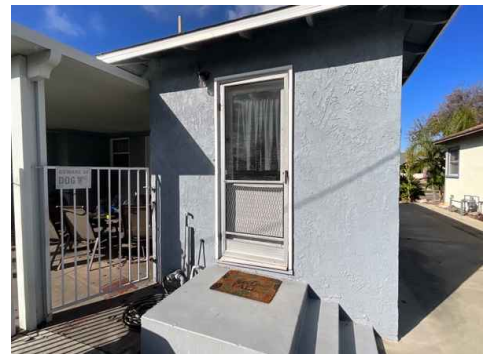
## 3.9.4 Exterior Doors

**SCREEN DOOR, BENT DAMAGED**

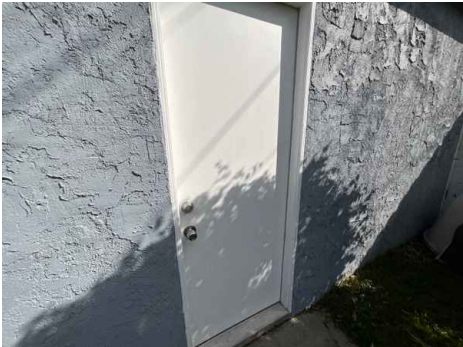
**Exterior Door: Exterior Doors Inspected**  
I inspected the exterior doors of the detached garage.

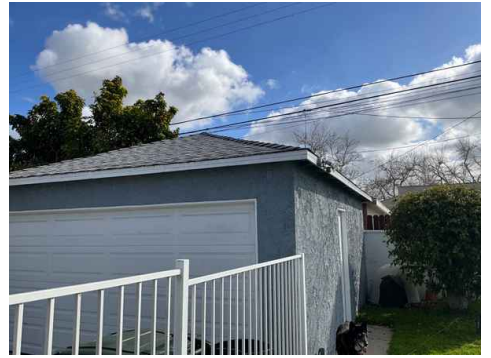
**GUTTERS MISSING**

Gutters are necessary to properly collect rain water from the roof, control it, divert it, and discharge that water away from the house and its foundation. A missing gutter is a defect. This is a defect that should be corrected by a professional contractor.

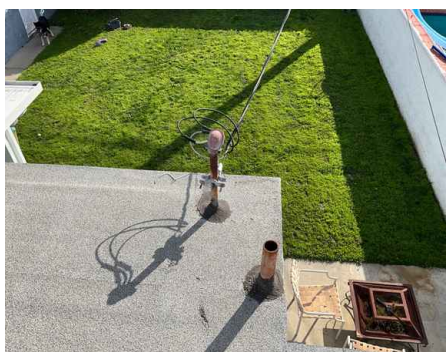
#### Service Head, Gooseneck & Drip Loops : Inspected the Service Head, Gooseneck & Drip Loops

I inspected the electrical service head, gooseneck and drip loops.

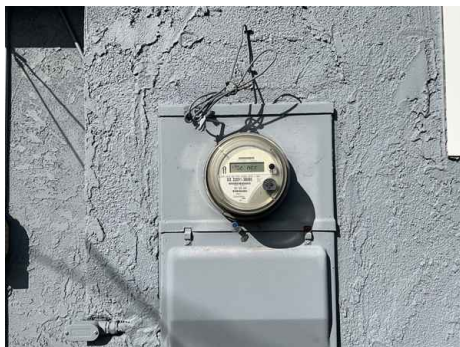
#### Electric Meter & Base: Inspected the Electric Meter & Base

I inspected the electrical electric meter and base.

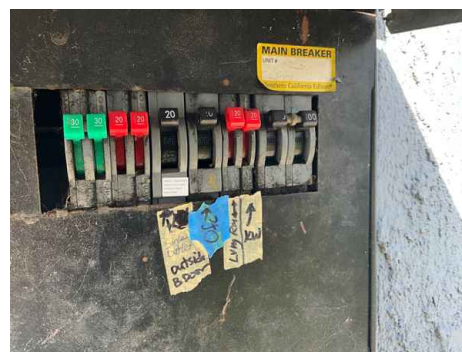
#### Main Service Disconnect: Inspected Main Service Disconnect

I inspected the electrical main service disconnect.

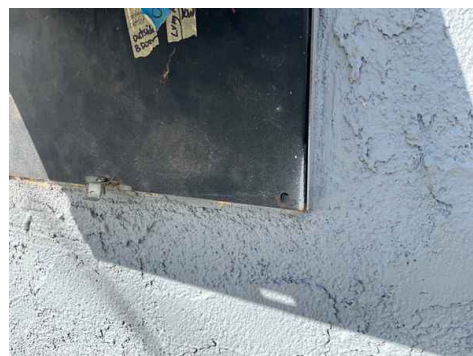
**MISSING HARDWARE**

At the panel I noted missing screws, this is a defect, recommend correction

Contact a qualified professional.

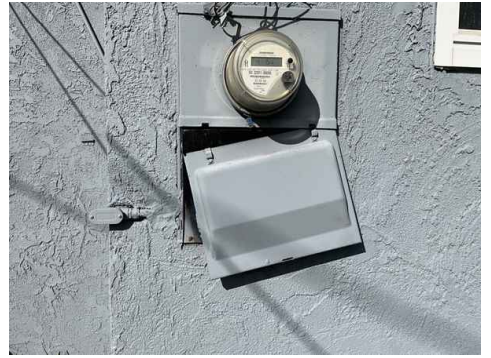
I noted the circuit breaker panel cover is not properly secured, recommend correction.

Contact a qualified professional.

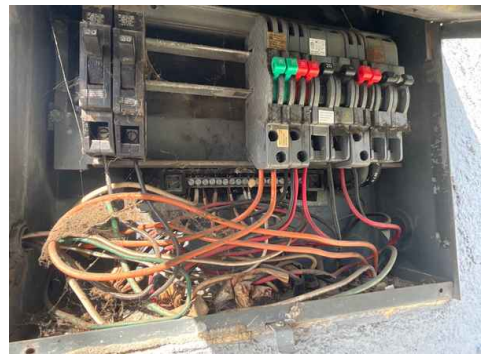
I observed doubled hot conductor wires connected to the same single breaker disconnect.

Contact a qualified professional.

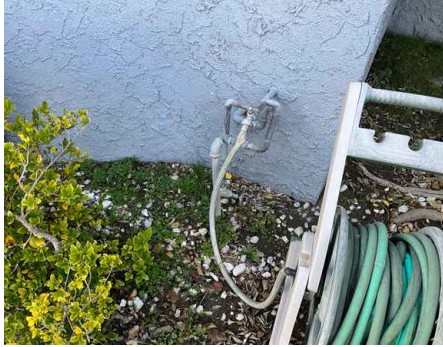
**Main Water Shut-Off Valve:**  
**Location of Main Shut-Off Valve**  
 Outside of House

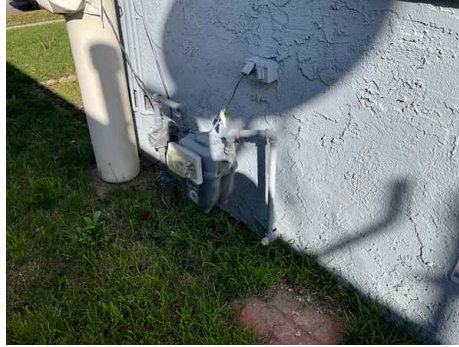
**Main Fuel Supply Shut-Off Valve :**  
**Location of Main Shut-Off Valve**  
 Side of House

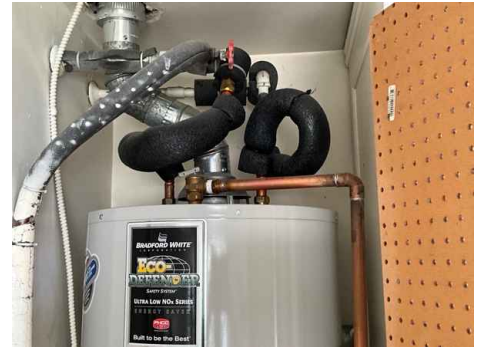
**Hot Water Source: Inspected TPR Valve**

I inspected the temperature and pressure relief valve.

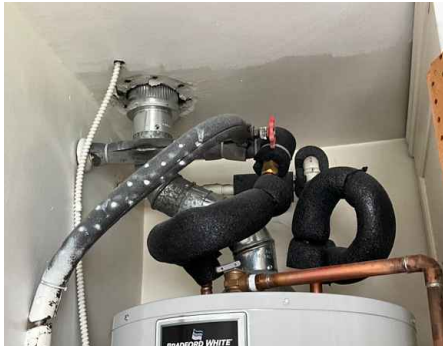
**Hot Water Source: Inspected Venting Connections**

I inspected the venting connections.

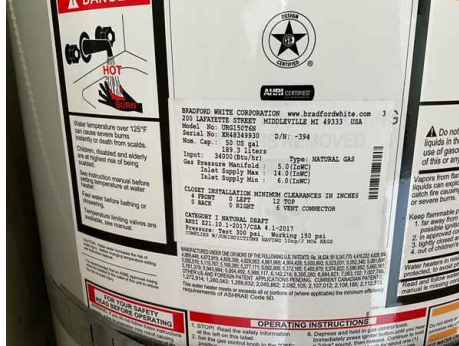
**Hot Water Source: Water heater age( as indicated by serial number)**  
 3 years

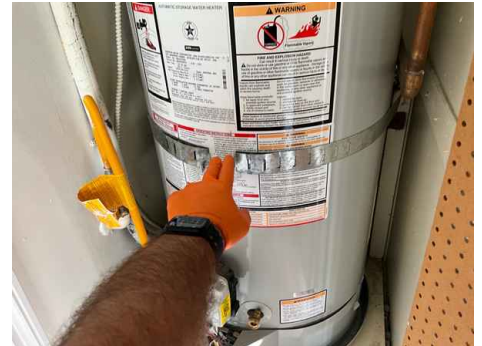
**Hot Water Source: Inspected Seismic Bracing**

I inspected the seismic bracing for the hot water tank.

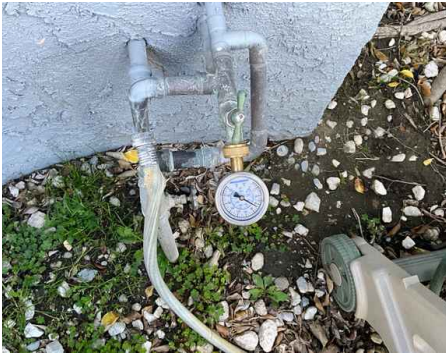
66 PSI

I attempted to measure the water pressure with a pressure gauge attached to an exterior hose bib.

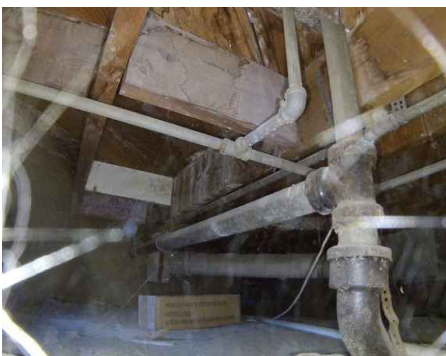
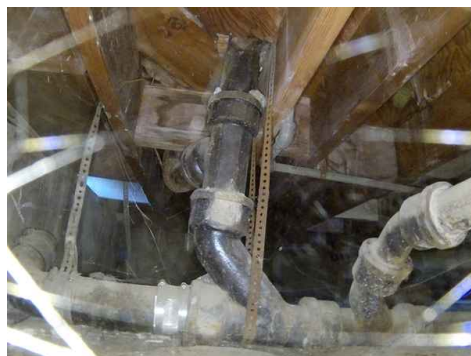
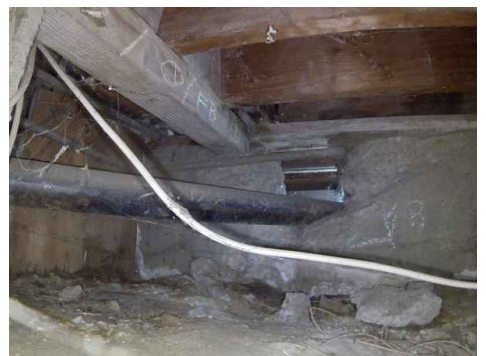
### Drain, Waste, & Vent Systems: Inspected Drain, Waste, Vent Pipes

I attempted to inspect the drain, waste, and vent pipes. Not all of the pipes and components were accessible and observed. Inspection restriction. Ask the homeowner about water and sewer leaks or blockages in the past.

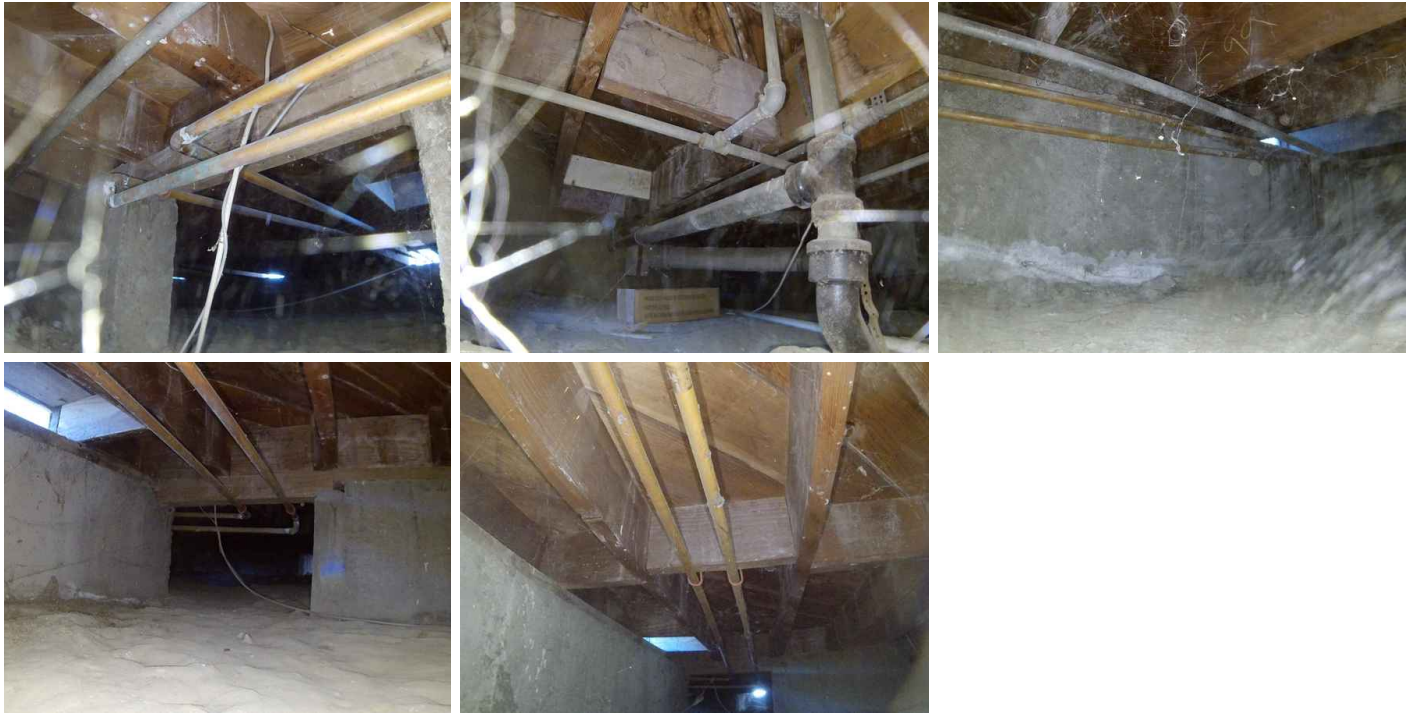
## Water Supply & Distribution Systems: Inspected Water Supply & Distribution Pipes

I attempted to inspect the water supply and distribution pipes (plumbing pipes). Not all of the pipes and components were accessible and observed. Inspection restriction. Ask the homeowner about water supply, problems with water supply, and water leaks in the past.

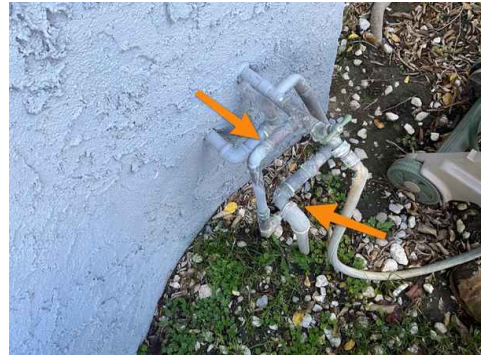
**MISSING DIELECTRIC FITTINGS**

I noted an absence of dielectric fittings. Dielectric fittings are used to keep pipes from corroding when multiple metal types are used. Galvanized pipes don't like copper pipes and vice versa-when they are attached to each other they will start to corrode and will eventually leak. I recommend review and correction by a licensed plumber.

Contact a qualified professional.

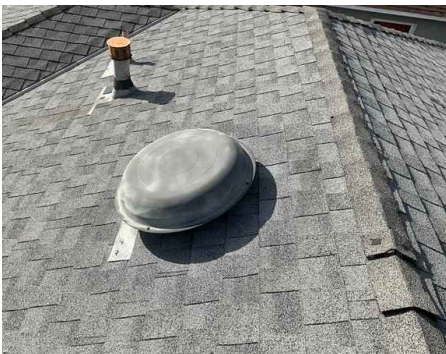
During the home inspection, I inspected for ventilation in unfinished spaces, including attics, crawlspaces and foundation areas. And I inspected for mechanical exhaust systems.

I report as in need of correction the general absence of ventilation in unfinished spaces.

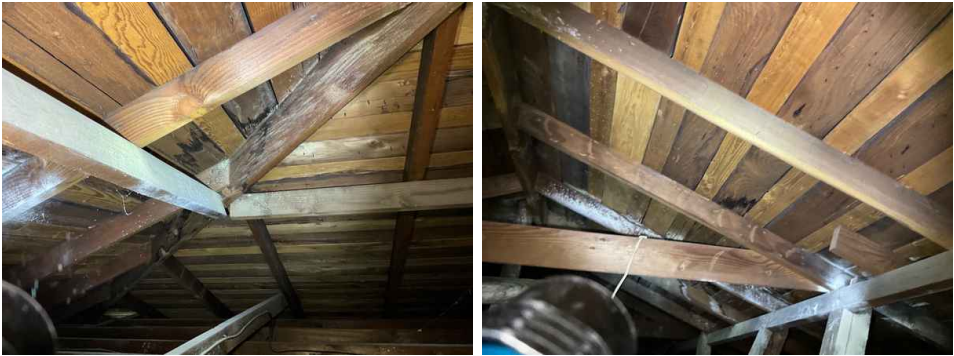
**PRIOR WATER PENETRATION OBSERVED**

I observed indications that sometime in the past there was water penetration or intrusion into the attic. Water marks were observed. Correction and further evaluation is recommended.

Recommend monitoring.

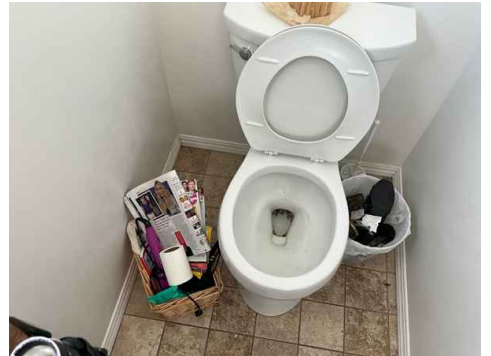
I observed that the toilet did not flush as expected.

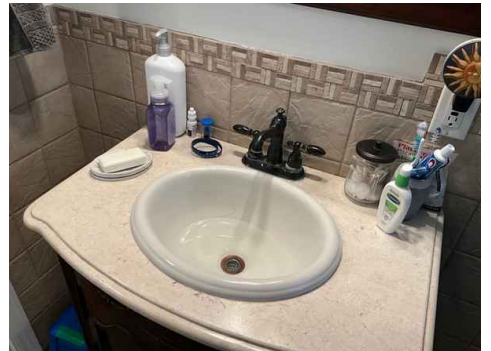
#### **SLOW DRAIN**

I noted a drain that was slow to drain. Recommend evaluation and correction by a licensed plumber.

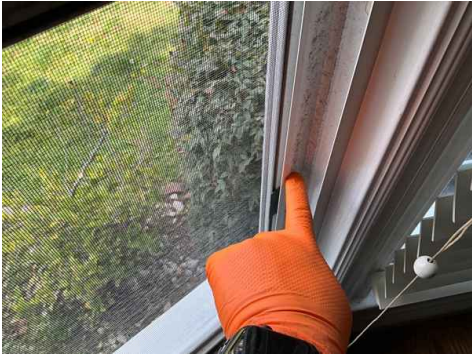
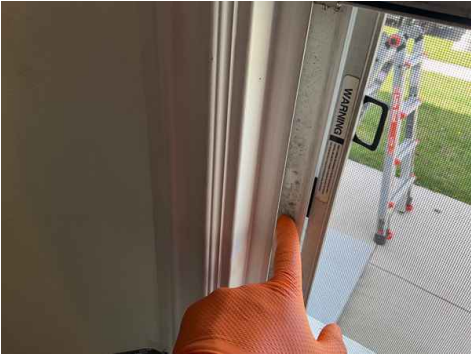
I observed apparent mold growth at one or more windows at the time of the. Inspection, I recommend testing the substance to either confirm or deny the presence of mold.

Contact a qualified professional.

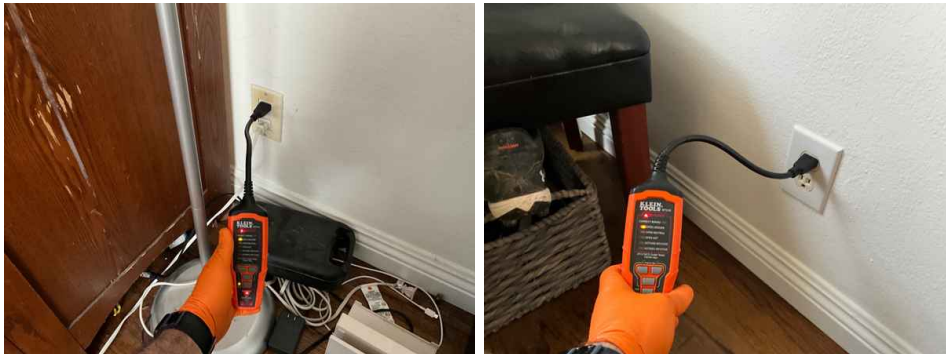
## 10.3.1 Switches, Fixtures &amp; Receptacles

**MISSING GROUND AT RECEPTACLE**

Contact a qualified electrical contractor.

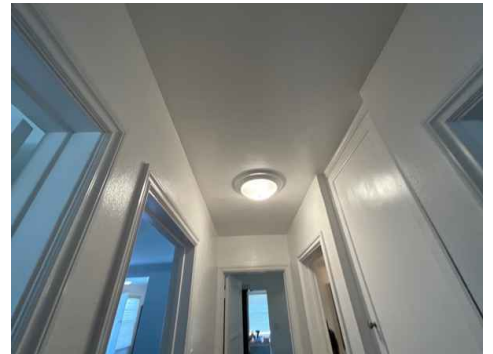
## 10.5.1 Presence of Smoke and CO Detectors

**MISSING SMOKE DETECTOR**

Contact a qualified professional.

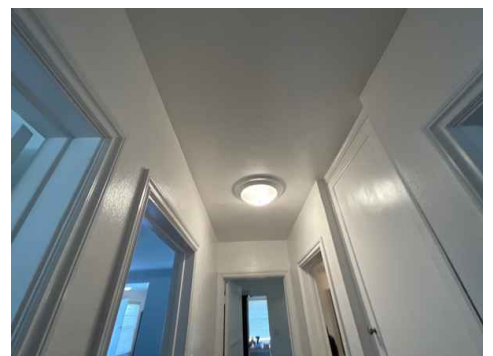
## 10.5.2 Presence of Smoke and CO Detectors

**MISSING CO DETECTOR**

Contact a qualified professional.

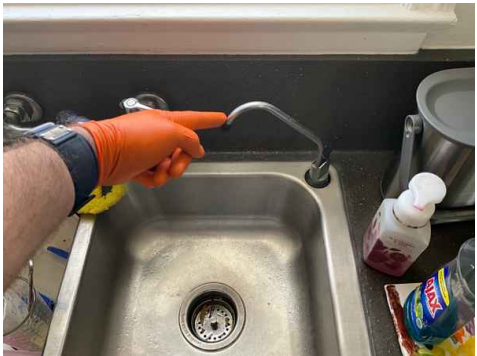
I noted inadequate water flow at the kitchen sink. I recommend further review by a licensed plumber.

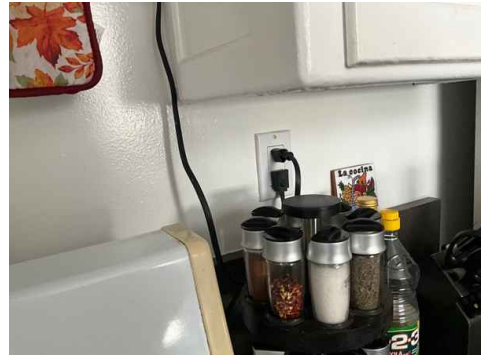
## 11.3.1 GFCI

**MISSING GFCI PROTECTION**

Contact a qualified electrical contractor.

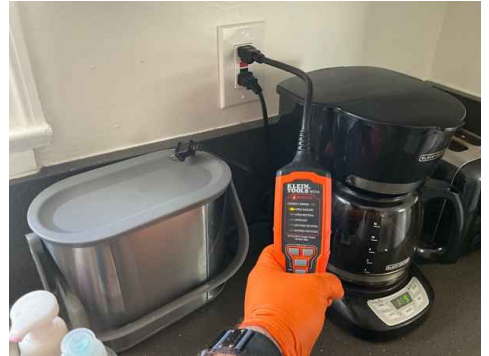
## 11.3.2 GFCI

**GFCI RECEPTACLE WOULD NOT TRIP WHEN TESTED**

Contact a qualified electrical contractor.

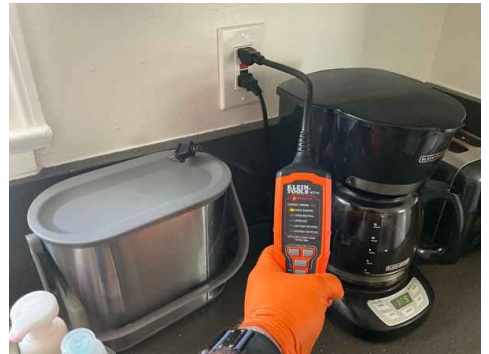
## 11.3.3 GFCI

**OPEN GROUND**

Contact a qualified electrical contractor.

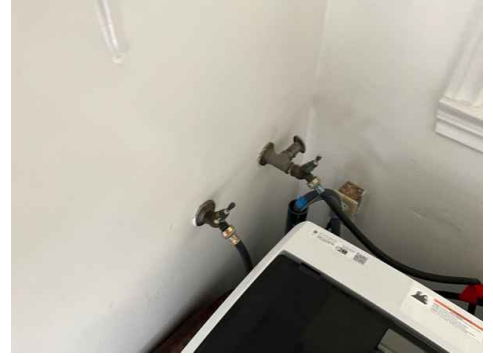
I observed hoses that were not reliable. Not pressure tested. Replacement of the hoses is recommended.

Recommended DIY Project

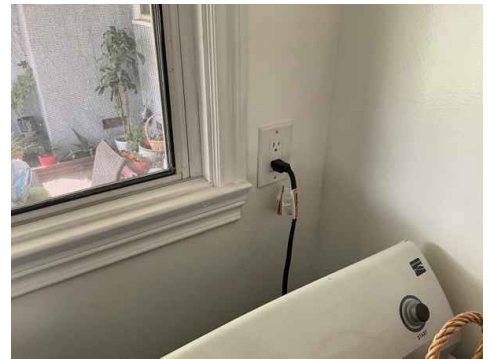
#### **MISSING GFCI PROTECTION**

I observed that there is missing GFCI protection at the receptacles in the laundry room.

Contact a qualified electrical contractor.

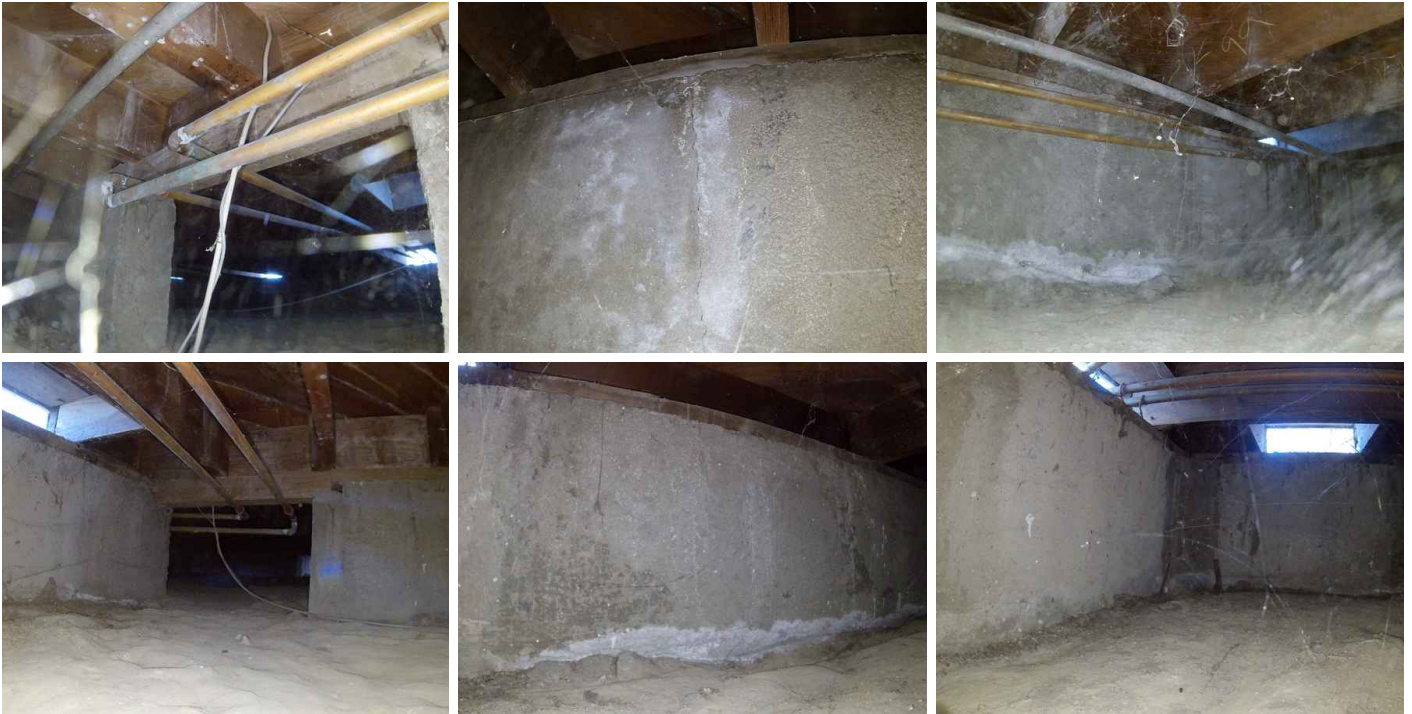
## 13.1.1 Under-Floor CrawlSpace

**EFFLORESCENCE OBSERVED**

I observed efflorescence from the crawlspace.

Efflorescence is the white chalky powder that you might find on the surface of a concrete or brick wall. It can be a cosmetic issue, or it can be an indication of moisture intrusion that could lead to major structural and indoor air quality issues.

I noted the presence of efflorescence in the inspection report because it generally occurs where there is excess moisture, a condition that also encourages the growth of mold.

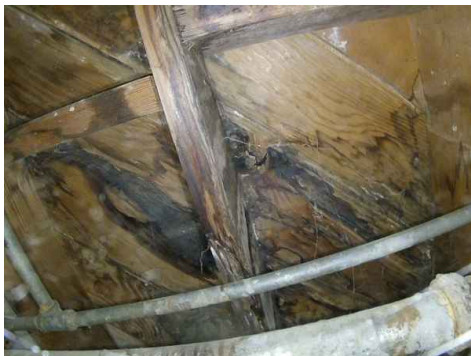
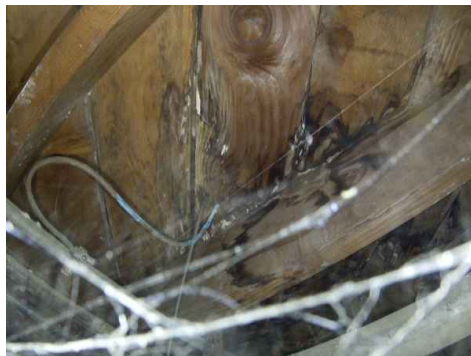
## 13.1.2 Under-Floor CrawlSpace

**DAMAGED SUB FLOOR**

Inspection Observed Moisture damage to some of the frame members and excess of wood rot and mold growth

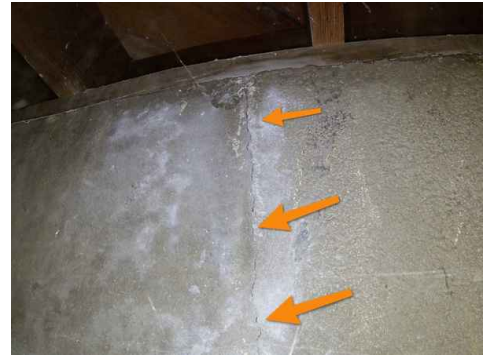
## 13.1.3 Under-Floor CrawlSpace

**FOUNDATION CRACK, MINOR BUT LEAKING.**

I noted a foundation crack. The size and direction of the crack is not necessarily concerning to me, however it is allowing water to leak through. This can become a significant issue. Recommend correction by a licensed foundation contractor.
