PROPERTY INSPECTION REPORT

3511 Cameo Dr. Unit 75
Oceanside, CA 92056

Todd Moeller
SEPTEMBER 20, 2022

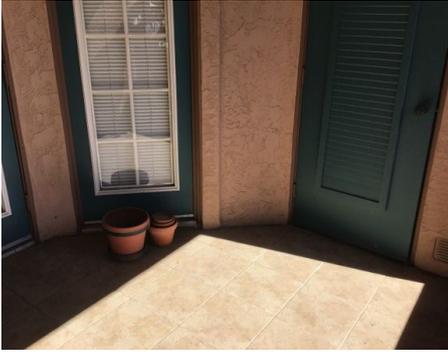
**Patio: Serviceable**

The patio areas appear to be in serviceable condition. There is cracking in the concrete.

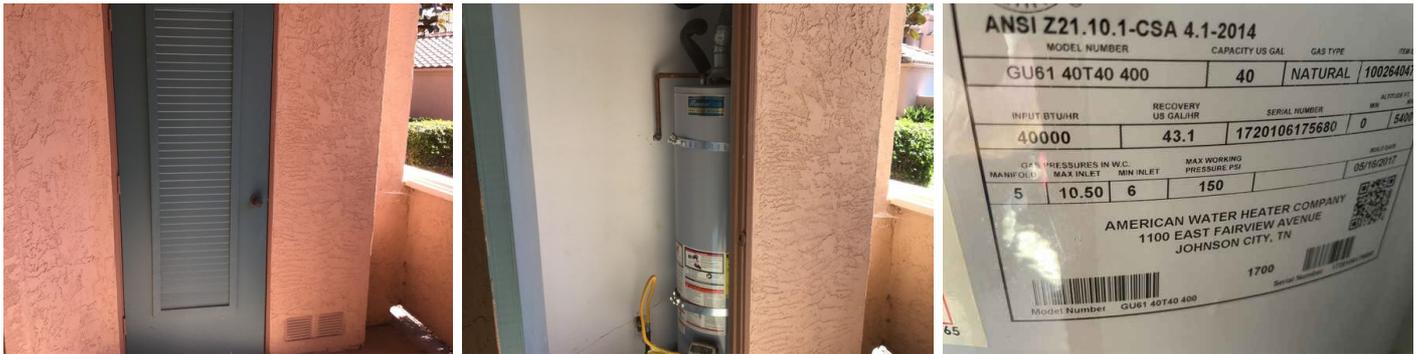
Water Heater: Water Heater Photo with Make/Model

Model #GU6140T 400

Serial #1720106175680

Mfg. Date: 05/2017

The water heater appears to be in serviceable condition.

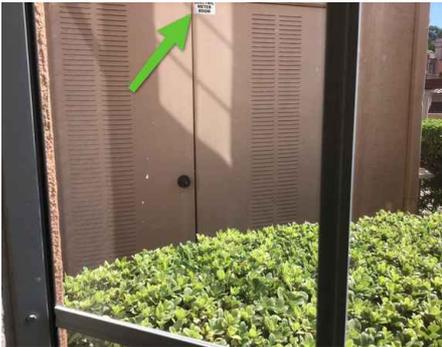
Main Electrical Panel: Main

breaker
100 amp

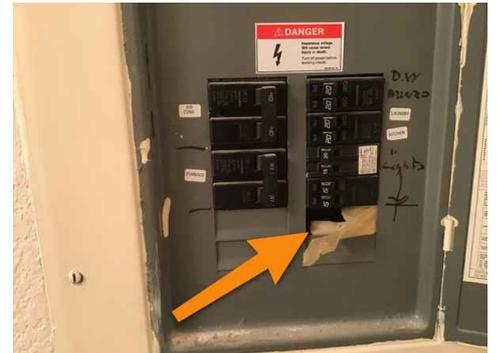
UNSEALED OPENINGS IN ELECTRICAL PANEL ENCLOSURE

There are unsealed openings in the back of the panel enclosure. This type of panel is rated for both indoor and outdoor use. The openings in the panel enclosure should be sealed to prevent water intrusion into the panel. I recommend evaluation by a licensed electrical contractor.

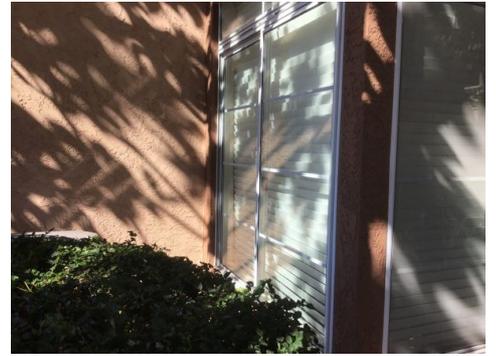
SCREEN REMOVED

The screens have been removed from all the windows. I recommend replacing the window screens.

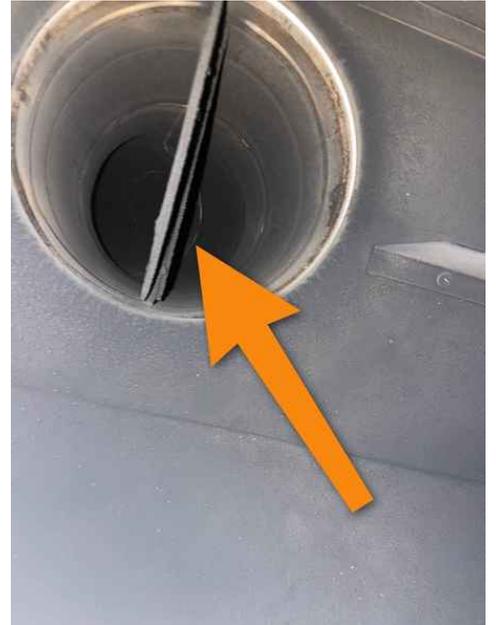
11.8.1 Fireplace

FIREPLACE DAMPER NOT PERMANENTLY OPEN

A vented natural gas log set has been installed within the fireplace. The damper has not been blocked permanently open, as required. I recommend evaluation by a licensed contractor.

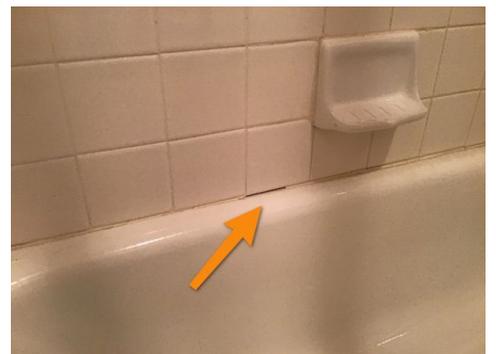
13.6.1 Tub/Shower Walls

CAULKING/GROUT DETERIORATED

The caulking and/or grout at the shower floor/walls is deteriorated. I recommend evaluation by a licensed contractor.

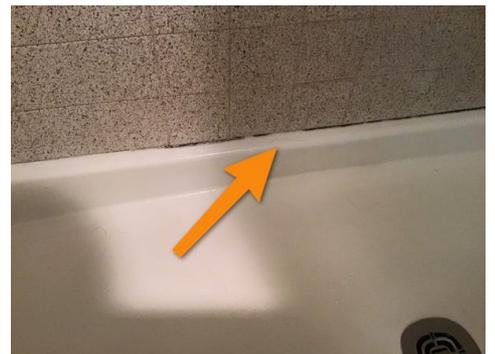
CAULKING/GROUT DETERIORATED

The caulking and/or grout at the shower floor/walls is deteriorated. I recommend evaluation by a licensed contractor.

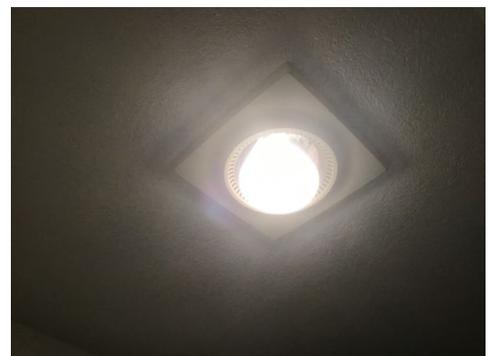
14.8.1 Bath Ventilation

NOT WORKING

The ceiling fan was not operational at time of inspection. Recommend further evaluation by general contractor.

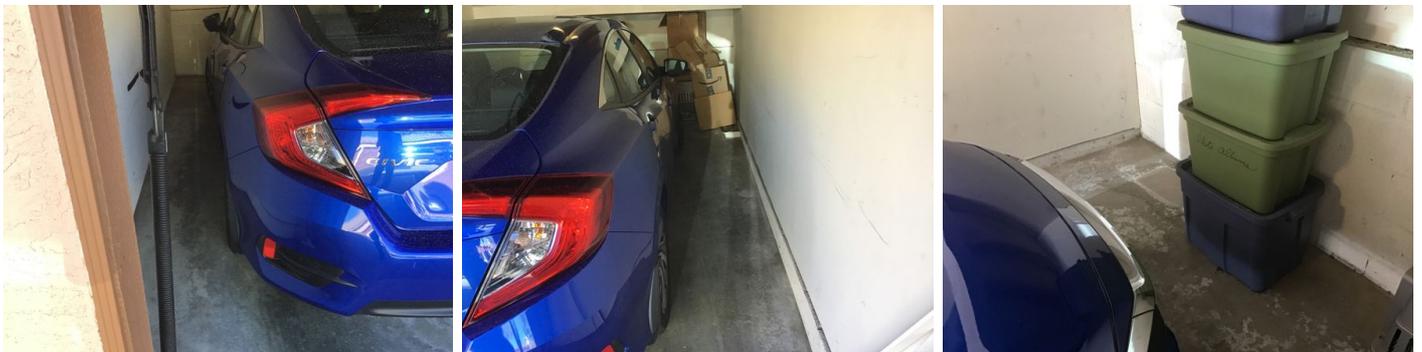
Garage Floor: Visible portions serviceable

The visible portions of the garage floor appear to be in serviceable condition. The view is partially blocked by the current occupants' personal belongings. There is cracking in the concrete. I recommend carefully checking the entire garage once the current occupants' belongings are removed and prior to the close of escrow.
