WOOD DESTROYING PESTS AND ORGANISMS INSPECTION REPORT

Building No. 5840	Street VALLEY DR	City FONTANA	ZIP 92336	Date of Inspection 05/28/2024	Number of Pages 4
----------------------	---------------------	-----------------	--------------	----------------------------------	----------------------

Report # : 11245

CORRECTED REPORT

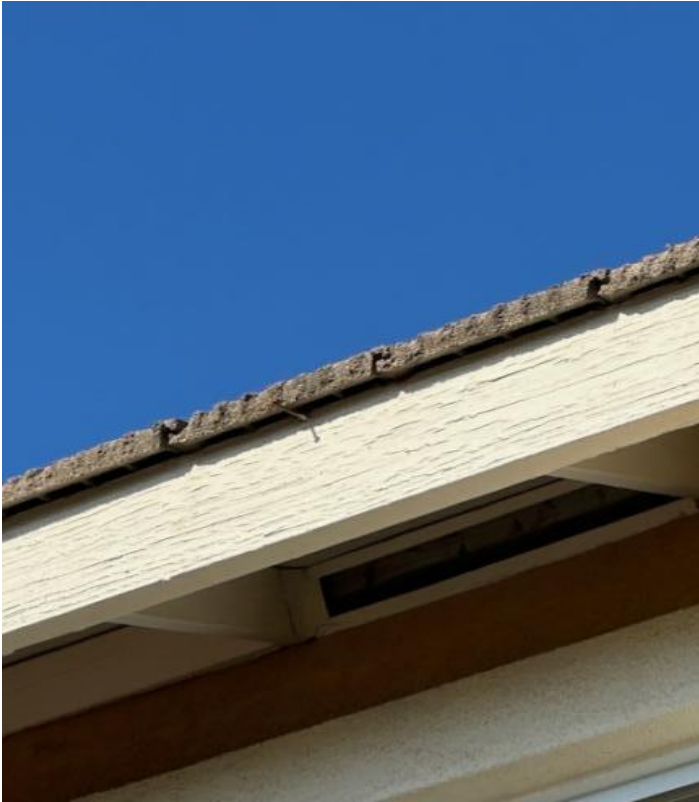
FINDING - Weathering/peeling paint/cracking wood members on the as noted on the diagram.

4A - WEATHERING/PEELING PAINT/CRACKING WOOD MEMBERS

RECOMMENDATION - Scrape/Repair/Paint the weathering/peeling paint/cracking wood members that is described in the above.

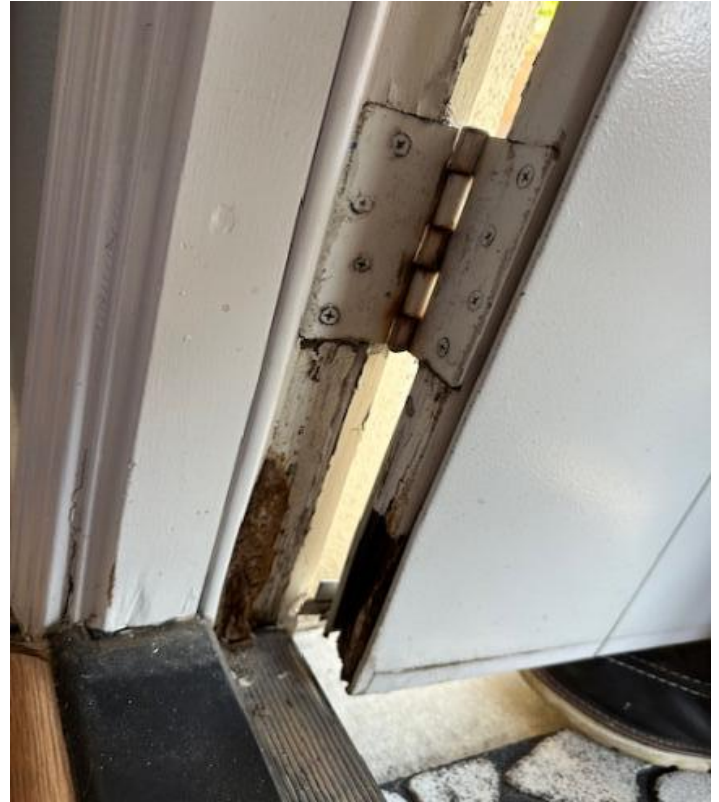
FINDING - Fungus damage to the back 1-lite over sized special order exterior door as noted in the diagram.

3D - FUNGUS DAMAGE TO THE BACK 1 LITE EXTERIOR DOOR

RECOMMENDATION - Replace the fungus damaged wood member(s) noted in the above.

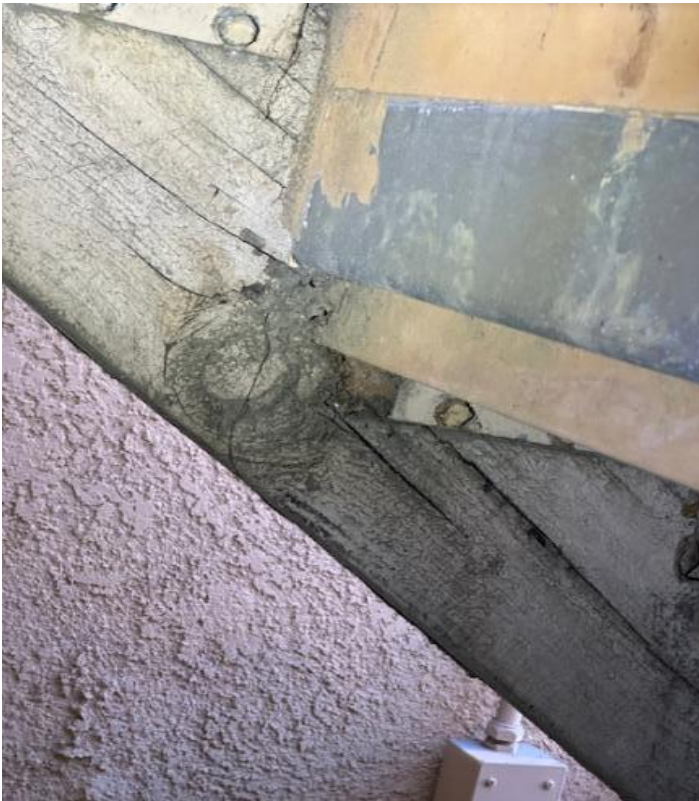
FINDING - Fungus damage to the front stair stringer 6x12x8 as noted in the diagram.

3C - FUNGUS DAMAGE TO THE STAIR STRINGER
(UNDER STAIRS VIEW)

RECOMMENDATION - Replace the fungus damaged wood member(s) noted in the above. Included in the bid is primer/paint close to match

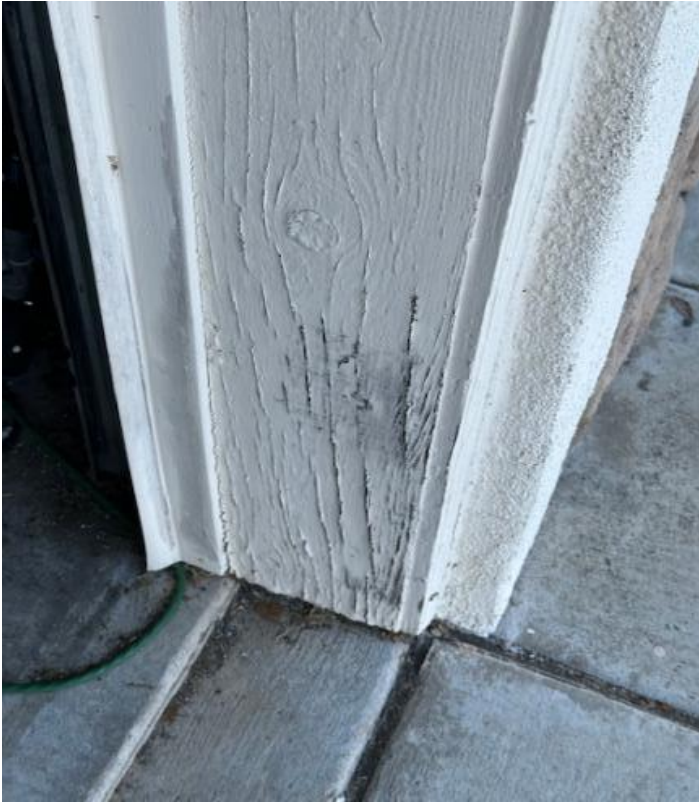
4A - WEATHERING/PEELING PAINT/CRACKING WOOD MEMBERS

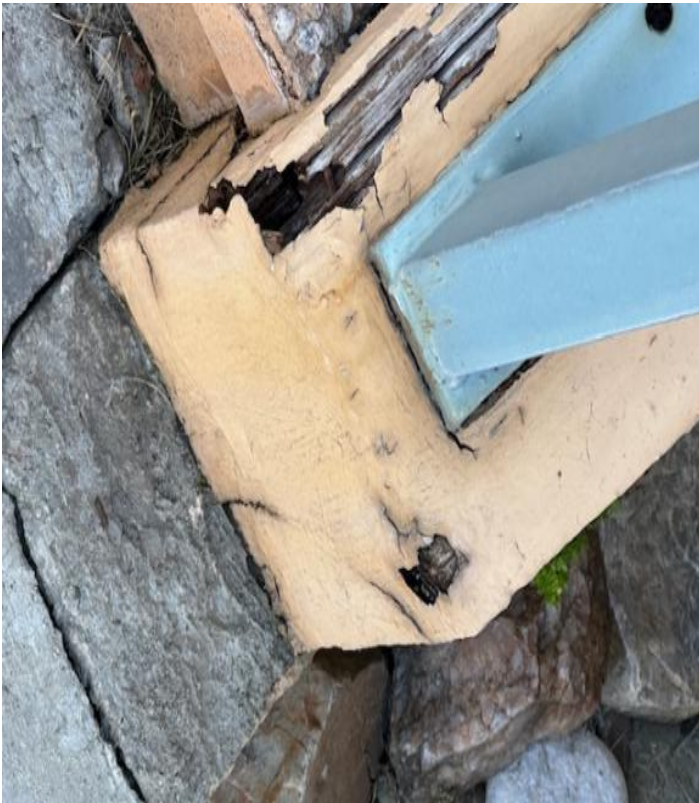
3C - FUNGUS DAMAGE TO THE STAIR STRINGER

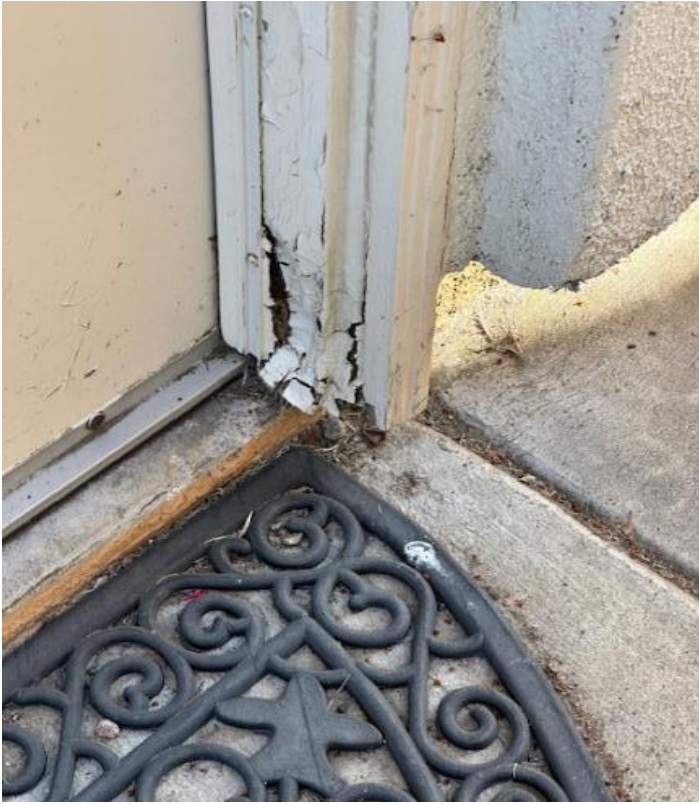
FINDING - Fungus damage to the garage man door as noted in the diagram.

3B - FUNGUS DAMAGE TO THE GARAGE MAN DOOR JAMB

RECOMMENDATION - Replace the fungus damaged wood member(s) with metal/wood prehung door as noted in the above.

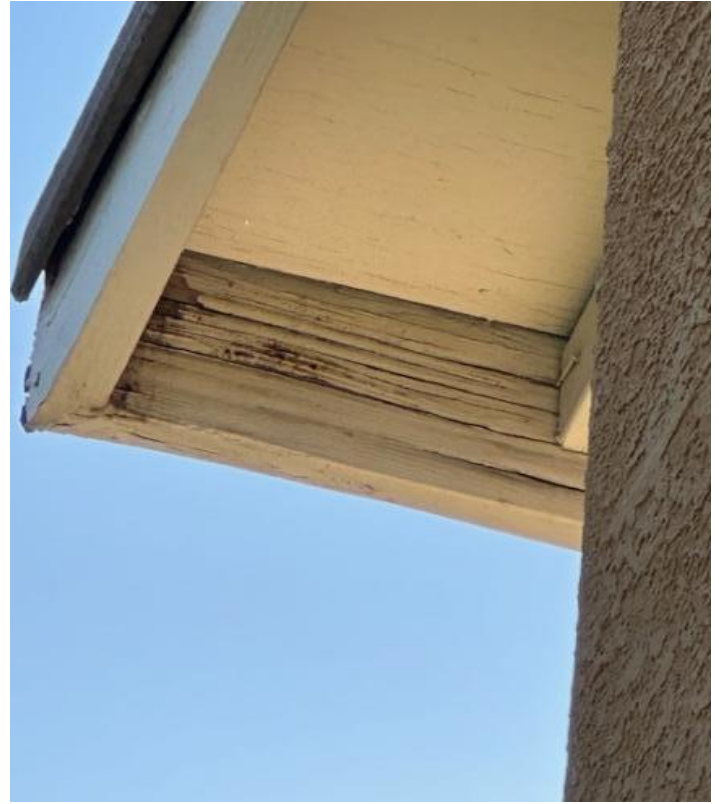
FINDING - Fungus damage to the 2nd story fascia 2x8x20 and 2x8x12 as noted in the diagram.

3A - FUNGUS DAMAGE TO THE FASCIA

RECOMMENDATION - Replace the fungus damaged wood member(s) noted in the above. Included in the bid is primer/paint close to match

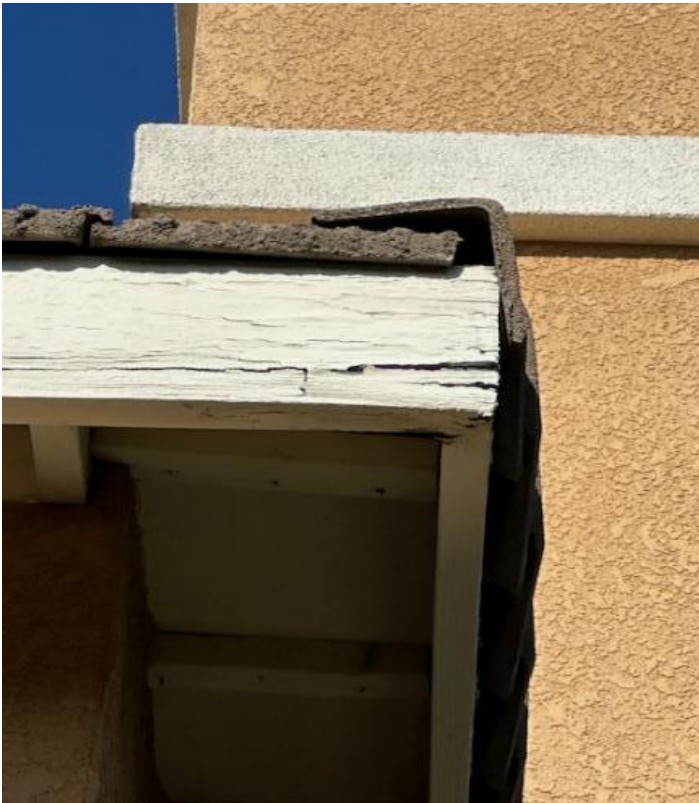
3A - FUNGUS DAMAGE TO THE FASCIA
