Inspection No.: 202603007
Inspection Date: March 5, 2026
Address: 18528 Kingsdale Avenue, Redondo Beach, CA 90278

This is a single-family dwelling; one story structure built on a flat lot. Estimated age is approximately 68 to 72 years old. Weather at the time of inspection was sunny.

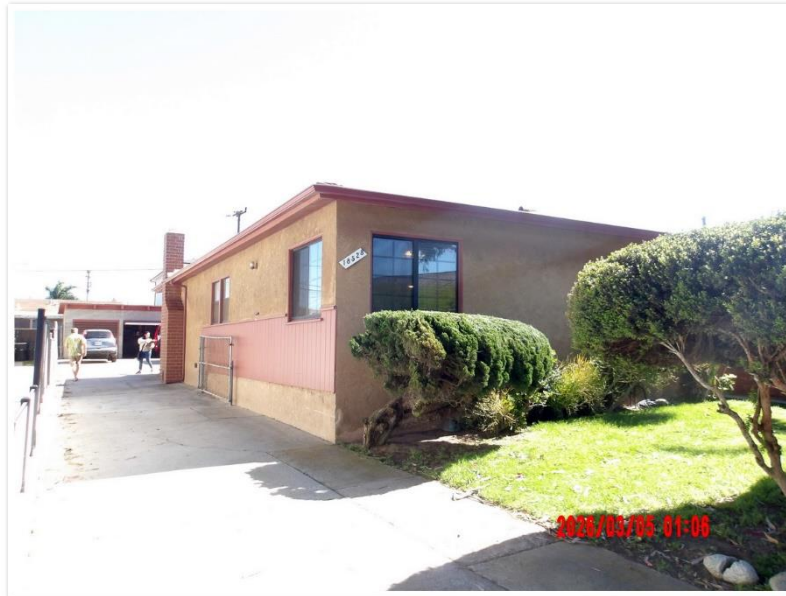
101 Driveway:	Concrete. Common cracks noted.
102 Walks:	Serviceable; concrete.
103 Fences/Walls:	Block/chain link. Loose and missing block noted behind garage.
103a Gates:	Serviceable; chain link.
104 Siding:	Brick/stucco/wood. Flaking at right side and front noted.
105 Trim:	Serviceable; wood.
106 Window Frames:	Serviceable; metal/vinyl. House is equipped with <i>some</i> thermo-pane windows for added insulation. Verifying the seal between the two panes of glass is beyond the scope of this inspection.
106a Screens:	Serviceable.
107 Electrical Fixtures:	There is no ground fault interrupter noted at right side outlet and rear outlet which may not have been standard at the time of construction. However, today's standards require ground fault interrupters at all areas within five feet of running water and external outlets. We suggest installing a ground fault interrupter in this area as a safety upgrade. Open ground noted at all exterior outlets; please see number 408.

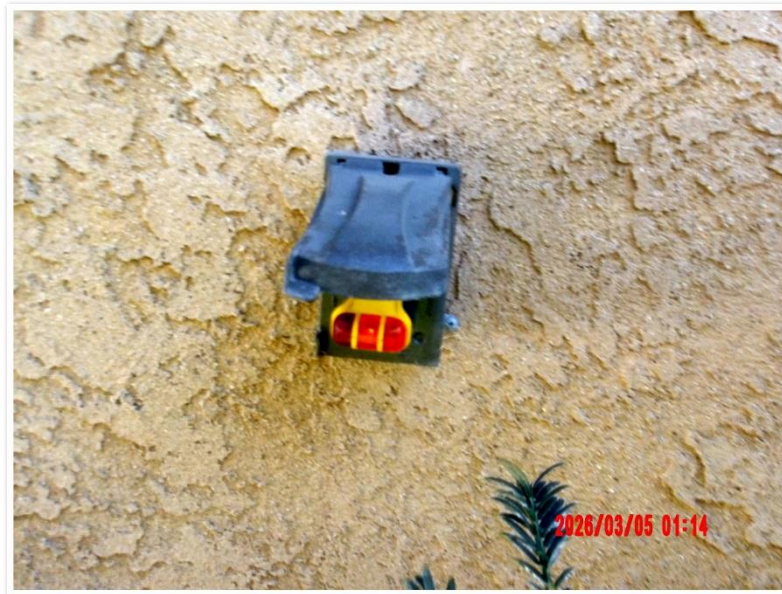
108	Gutters/Downspouts:	Serviceable; metal.
109	Sprinklers:	A timing device controls this sprinkler system. Timing devices are beyond the scope of this inspection. We advise that you obtain verification of this system's performance prior to closing.
110	Exterior Doors:	Serviceable.
111	Bell/Chime:	Non-Applicable.
112	Chimney:	Serviceable. A spark arrester is installed as a safety feature.
112a	Steps/Railing:	Serviceable.
112b	Hose Bib:	Serviceable.
113	Lot grade/Drainage:	Home is built on a flat lot. Grade at foundation appears to be adequate.
114	Gas Meter:	Serviceable. Located at right side. Seismic valve noted has been installed as a safety upgrade.

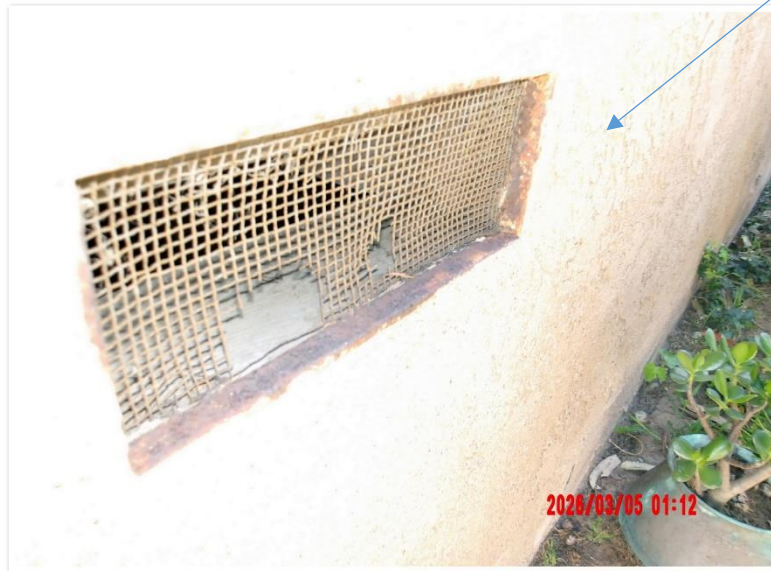
116 Sub-Floor:

Accessible at right side. Plumbing leaking: **Slight leak noted at cleanout by crawl access; we advise making necessary corrections.**

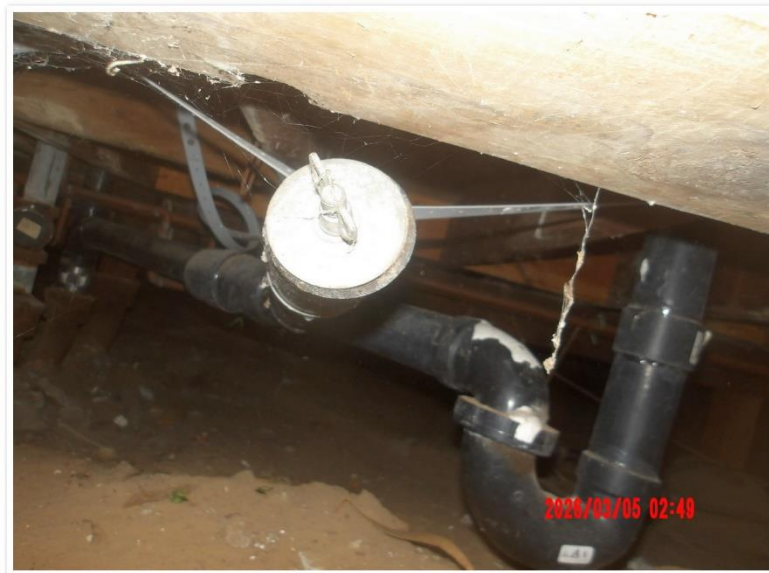
116 Sub-Floor Cont'd:

Corrosion noted at drain lines; no evidence of leakage at time of inspection.

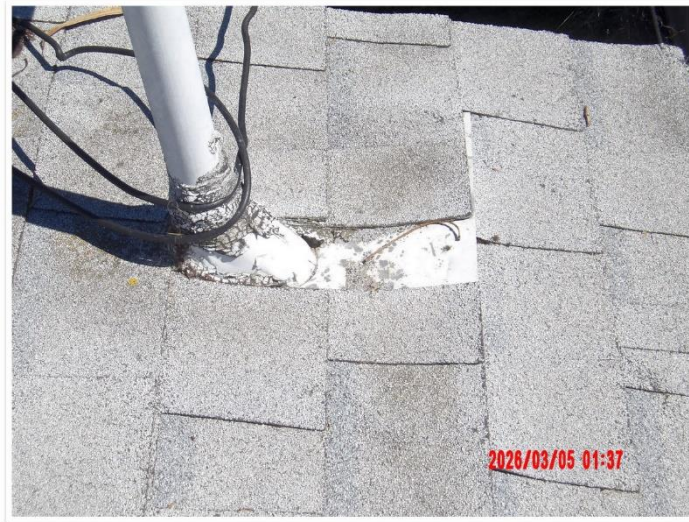
127 Roof Comments: Roof shows normal wear for its age and type; appears to be in serviceable condition.
Lifted flashing noted by electrical mount; we advise making necessary corrections.

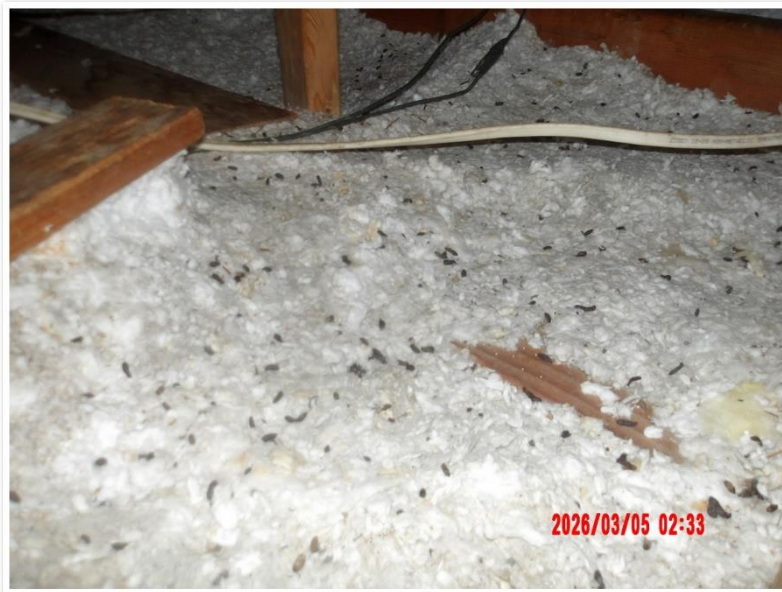
- 136 Hatch Location: Hall.
- 137 Accessible: Yes.
- 138 Sheathing: Serviceable; 1x6.
- 139 Evidence of Leaking: No.
- 140 Insulation: Yes, where visible approximate thickness is 2-5 inches.
- 141 Ventilation: Appears to be adequate.
- 142 Attic Comments: **Evidence of animals/pests noted in attic space. Animals/pests may chew and/or damage electrical wiring and other components. We advise consulting with a pest exterminator for a complete review and for removal of any animals/pests.**

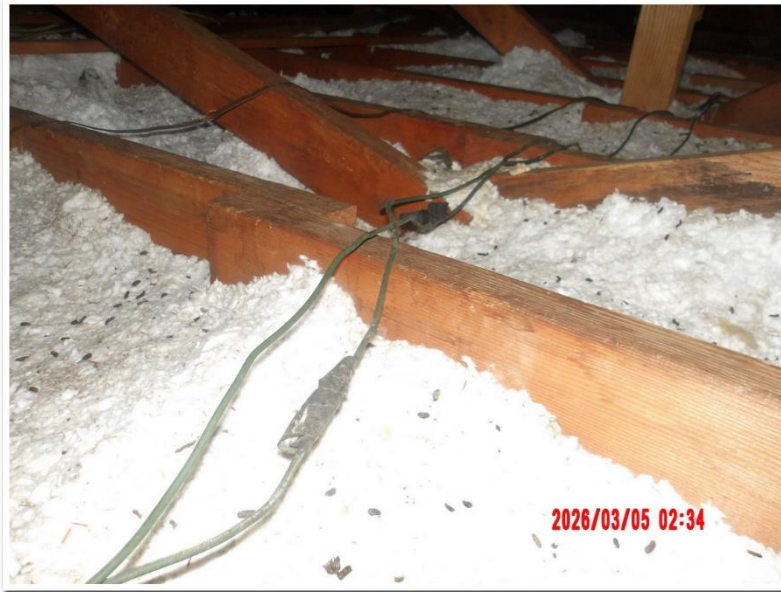
142 Attic Comments Cont'd: **Open splices noted and single strand wiring being used; observed in attic. This is a safety concern. Whenever an electric wire is cut and reconnected, the "splice" should be encased in a covered junction box to prevent shocks and separation of the splice. Client is advised to consult with a licensed electrician prior to closing for repairs/replacement as needed to ensure safety.**

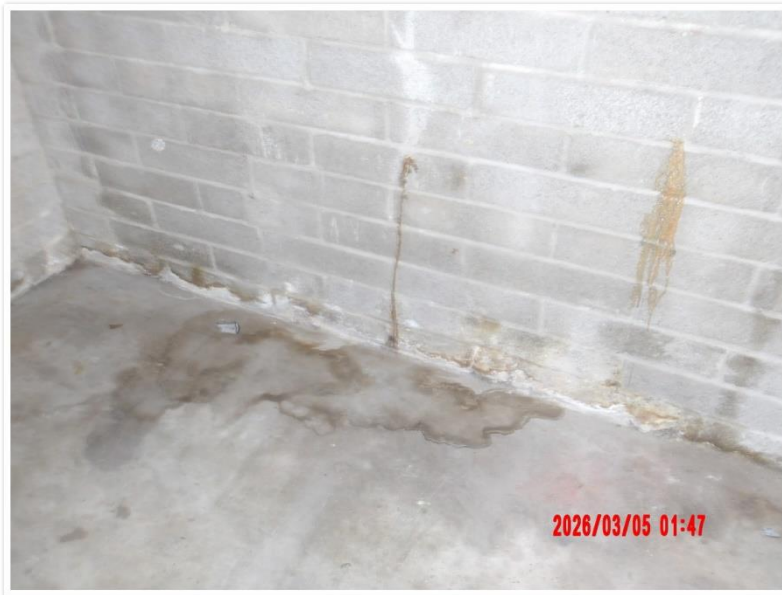
301 Exterior:	Serviceable; block.
302 Roof:	Please see roof comments.
303 Slab:	Serviceable; concrete.
304 Overhead Doors:	RIGHT: Serviceable; metal. LEFT: Metal. Unable to test left garage door; there was no key present at the time of the inspection. The client(s) may wish to review this area prior to close of escrow.
305 Garage Door Hardware:	Serviceable.
306 Door Opener:	Non-Applicable.
307 Windows:	Serviceable.
308 Access Door:	Non-Applicable.
309 Fire Door:	Non-Applicable.
310 Fire Wall:	Non-Applicable.
311 Vent Screens:	Non-Applicable.
312 Walls:	Small hole noted in right wall; suggest sealing. Evidence of water intrusion noted at base; suggest consulting with specialist for further review prior to close of escrow.

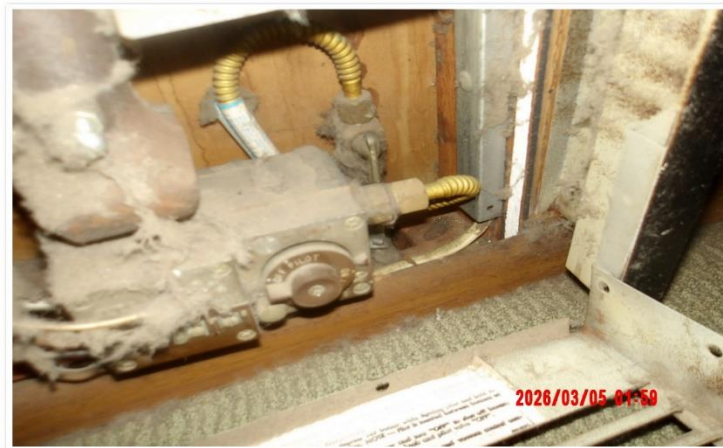
401 Heating #1: Gas wall heater located in family room. Gas shut off noted.

Brass flex gas line noted; suggest replacing with newer flex line.

Suggest cleaning heater.

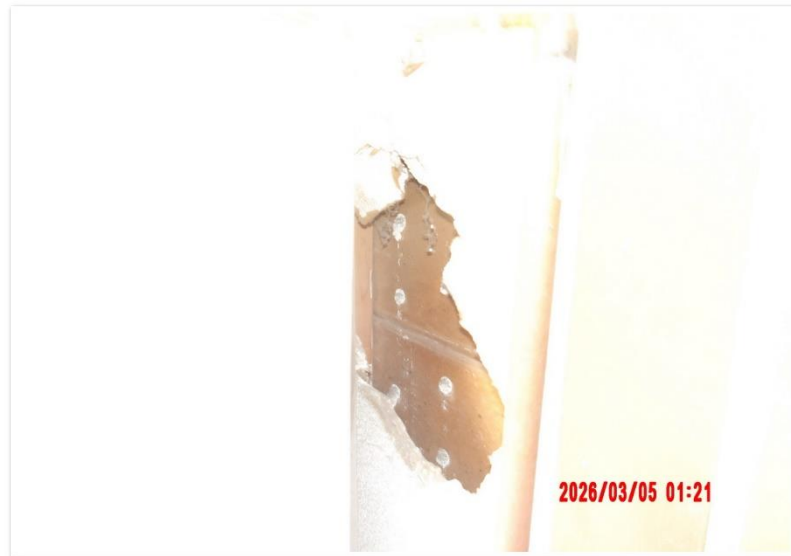
406 Drain/Waste Vent:	Serviceable.
407 Water Heater:	<p>Approximately 40 gallons, gas water heater located in right side closet. Cold water shut-off: Intact. Temperature and pressure relief valve installed as a safety feature. Two earthquake straps are installed as a safety measure.</p> <p>Suggest sealing holes noted in water heater closet.</p>

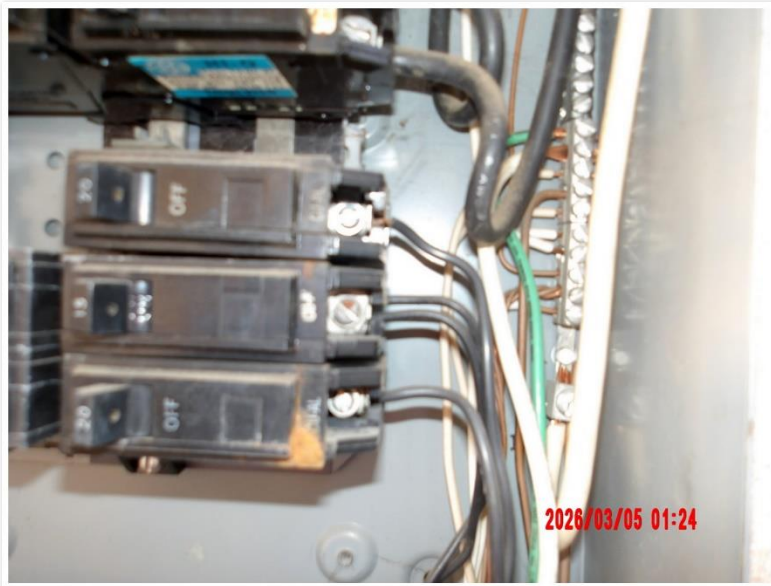
408 Electrical:

The main electrical service is approximately 100 amps. Service entrance is overhead with main panel located at right side. Overload protection is provided by breakers. Main disconnect noted. Futures provided for possible expansion. Wiring where visible is copper. Copper is preferred for durability and low maintenance. Sub panels located at right side and in garage.

Open ground noted at receptacles, which may have been standard at the time of construction. Receptacles near water sources and at exterior locations ideally should be grounded. Due to the age or configuration of this system, we are unable to determine if grounding is in place or can occur. Suggest consulting a licensed electrician for further review.

Doubled-up circuitry noted at one 15-amp breaker in main panel. This condition can add to the load of the affected electrical circuits causing a possible overload and tripping of the breakers. Ideally, doubled-up circuitry should be independently fused. We advise contacting a licensed electrician for review and/or repair.

As a safety upgrade, we always recommend installing GFCI outlets, in all areas that they are currently required; such as garages, laundry areas, exterior outlets, pool and spa lights and all outlets within five feet of running water.

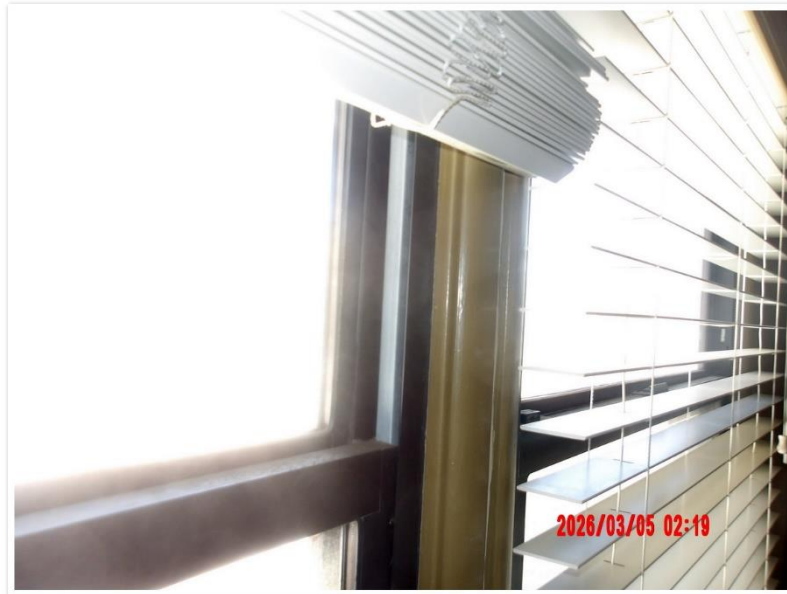
Broken sash wire/cord noted on both windows at time of inspection, this is a potential safety concern. Adjustments and/or repairs may be needed for safe and proper operation.

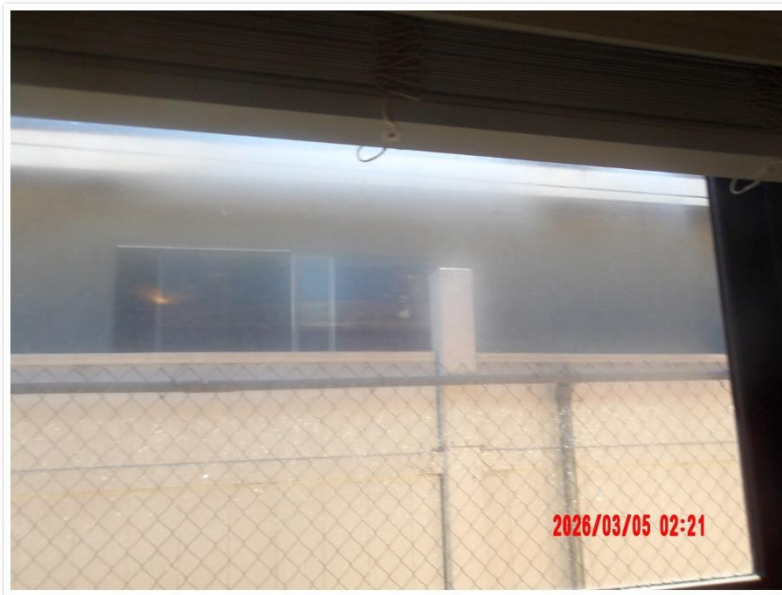
1315 Windows: **Broken sash wire/cord noted on front window at time of inspection, this is a potential safety concern. Adjustments and/or repairs may be needed for safe and proper operation.**

Oxidation noted at both windows.
