## Confidential Inspection Report

LOCATED AT:  
2011 Gates Ave Unit B  
Redondo Beach, CA 90278

INSPECTED ON:  
Wednesday, June 8, 2016

Inspector, John Buckley  
Equity Building Inspection  
310-746-7610

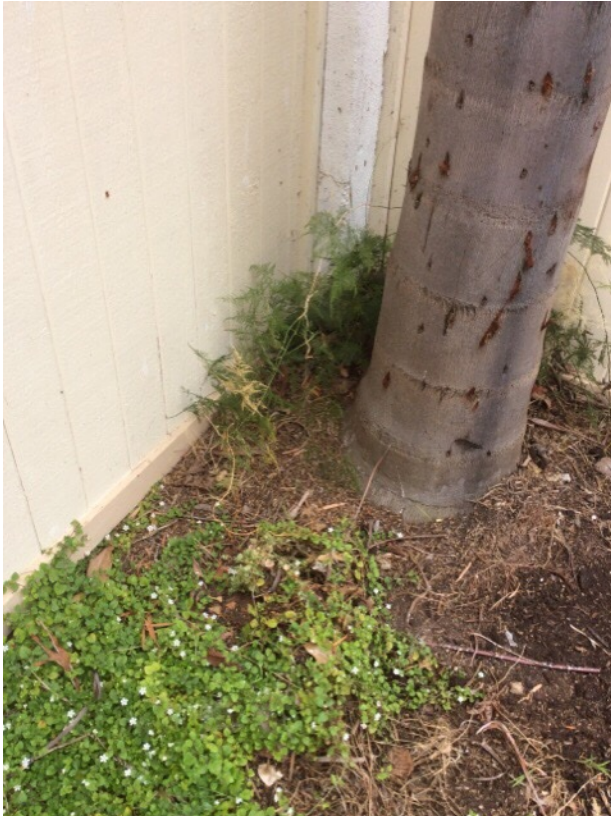
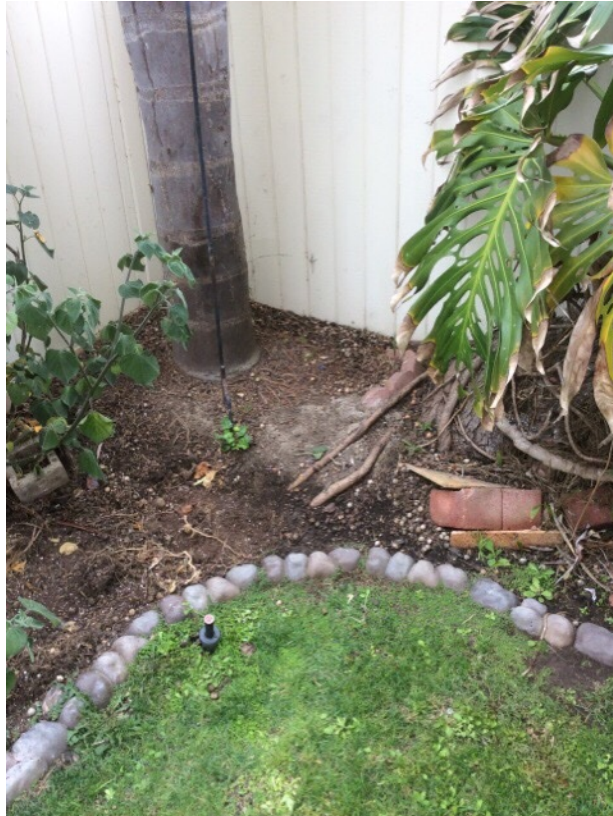
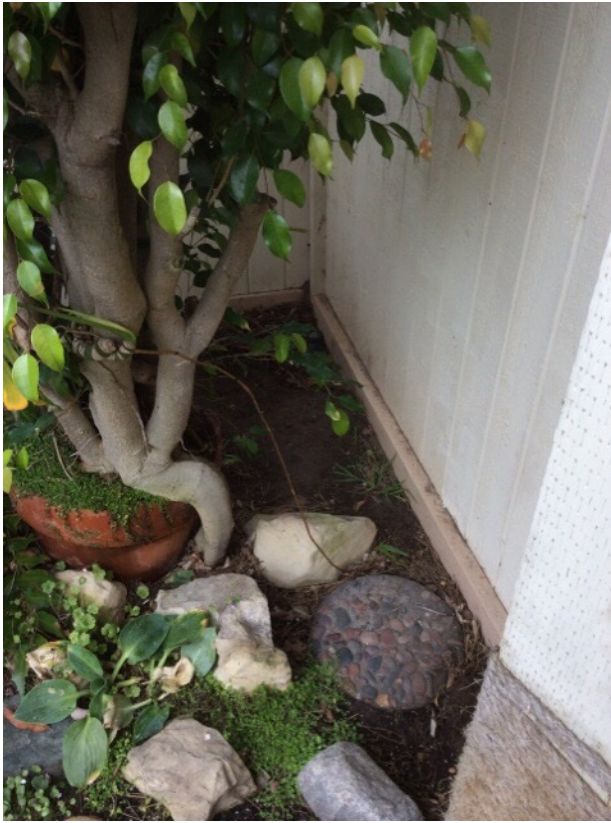
**CR 1:** - The fence at the rack yard has dirt piled against it. In time, this will rot the fence and/or push it over. We recommend the dirt be dug away and pulled back from the fence.

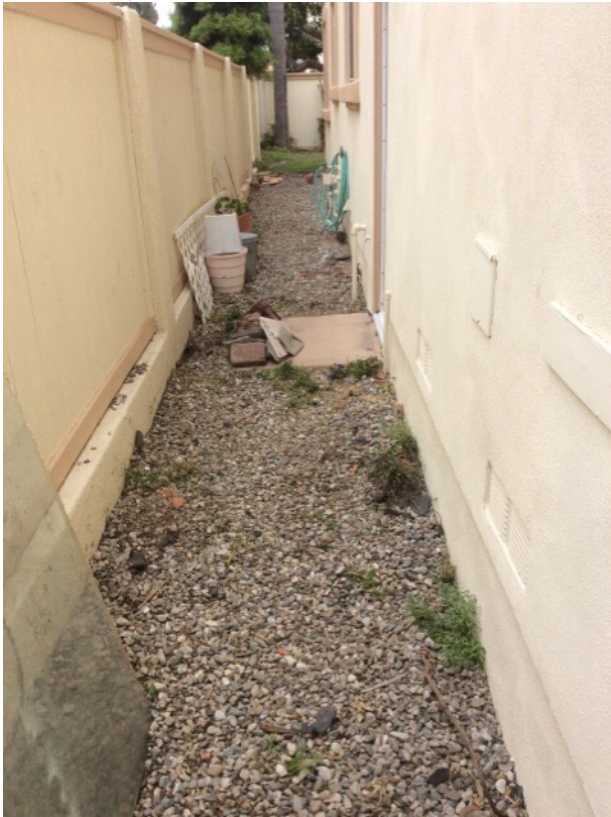
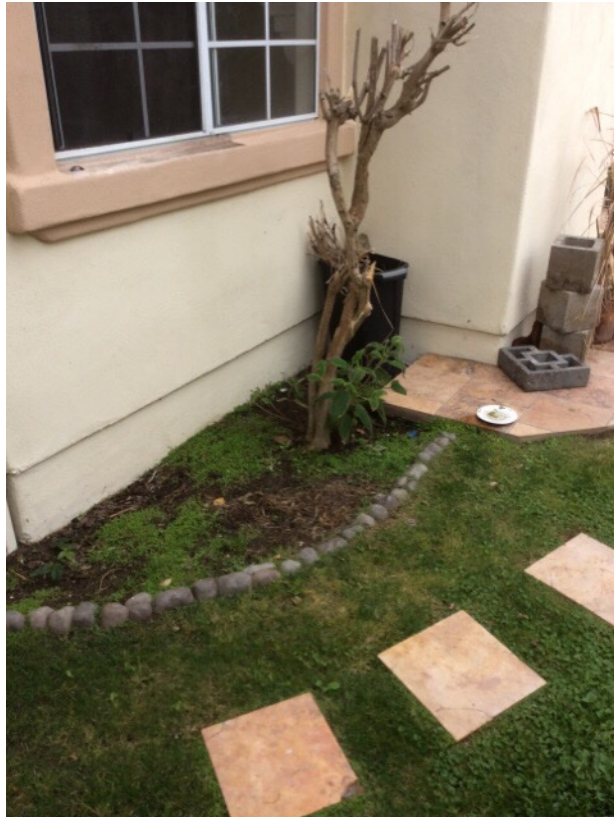
**FE CR 2:** - Grading is sloped toward the structure in some areas. Low spots and negative grading promote water accumulation near the building, leading to foundation problems. Regrading of landscape or concrete would help ensure that surface water flows away from the structure.

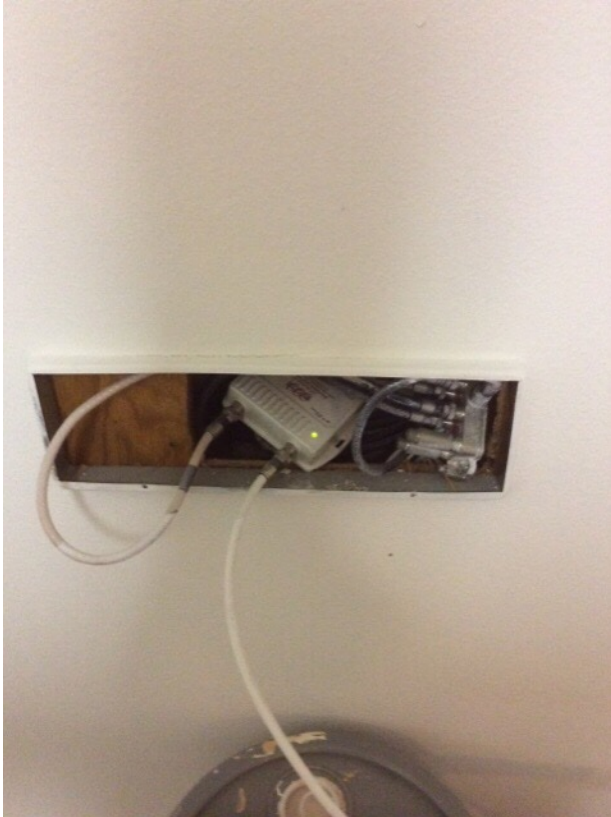
**SC CR 4:** - There are voids in the fire-resistive barrier between the garage and interior. We recommend these voids be patched to restore the required fire separation between the garage and the occupied interior.

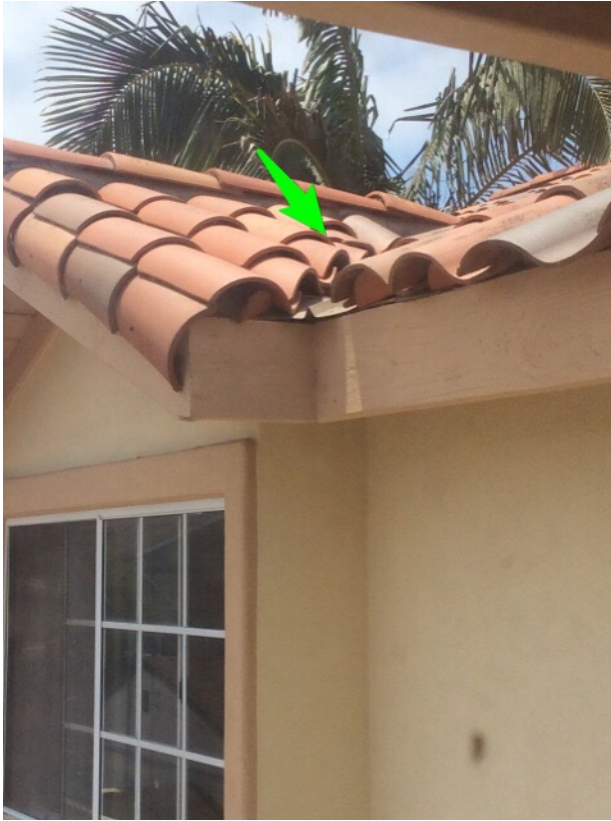
**FE CR 7:** - There are individual cracked, chipped and displaced tiles along the ridge and/or in the field. The number of affected tiles is small, but felt underlayment is exposed and we recommend repair to prevent its deterioration.

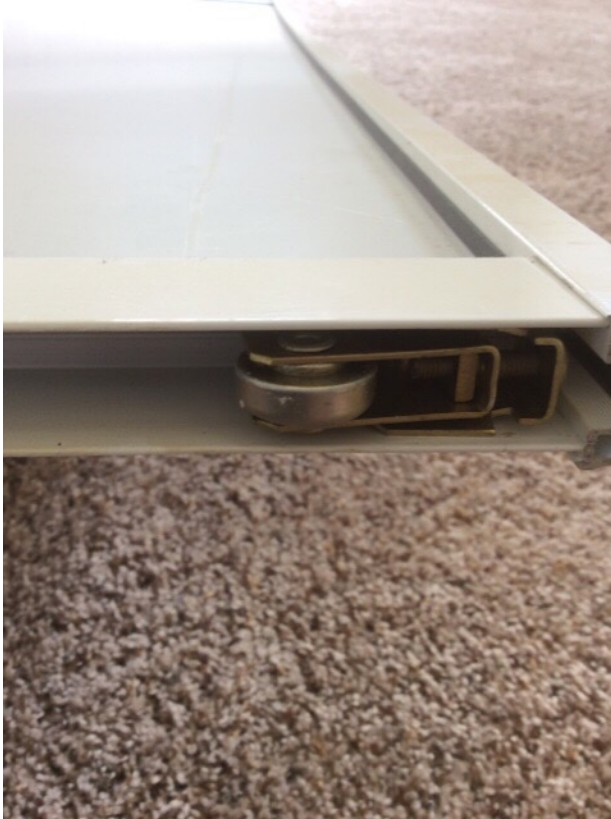
**CR 10:** - One of the rollers on the sliding glass closet door is not the correct style (does not have a slot to receive the track). We recommend changing the roller to the correct style.

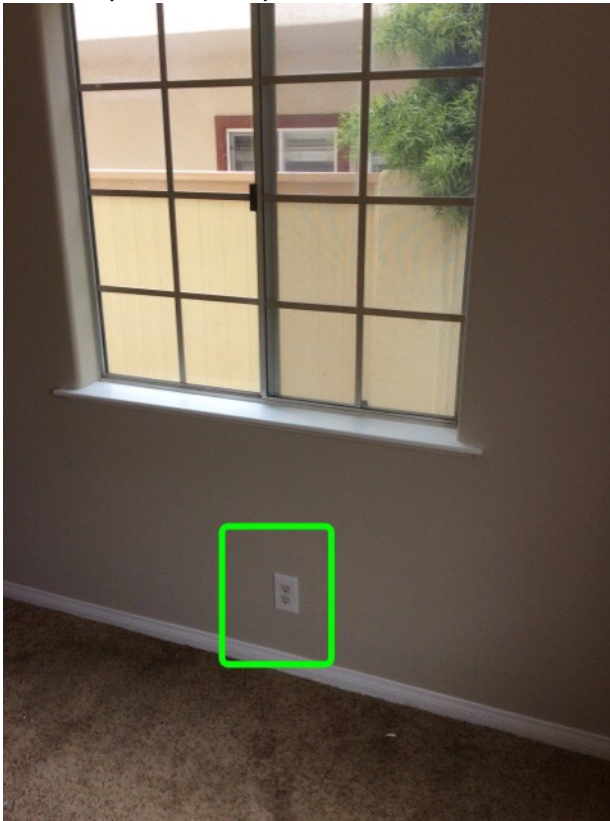
**SC** **CR** **13:** - A receptacle at the left wall is wired with reversed polarity. Under some circumstances, this can be a shock hazard and/or damage electronic equipment. It is easy to correct this condition and we recommend the receptacle be repaired.

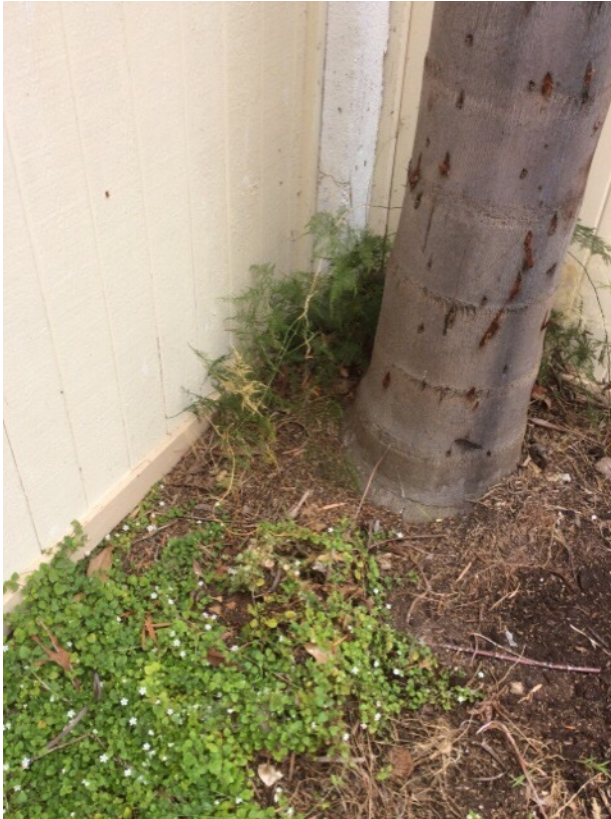
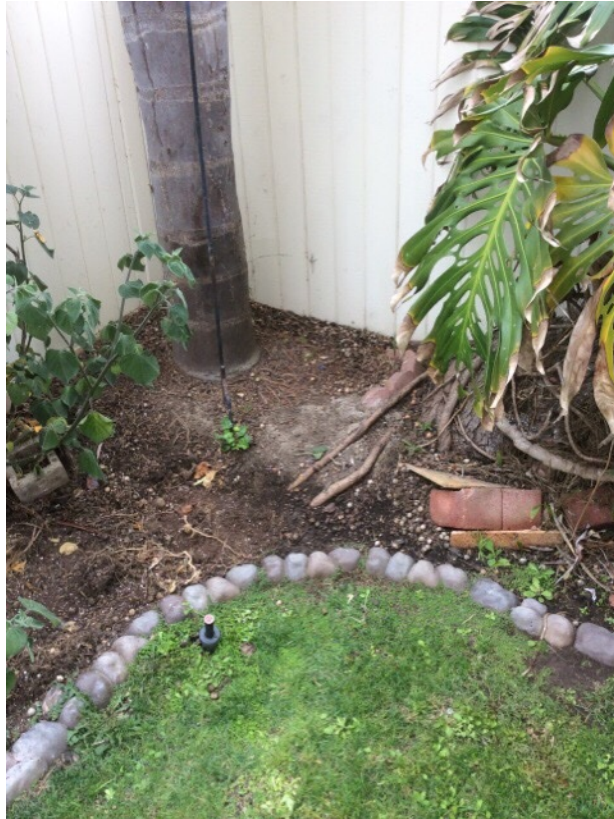
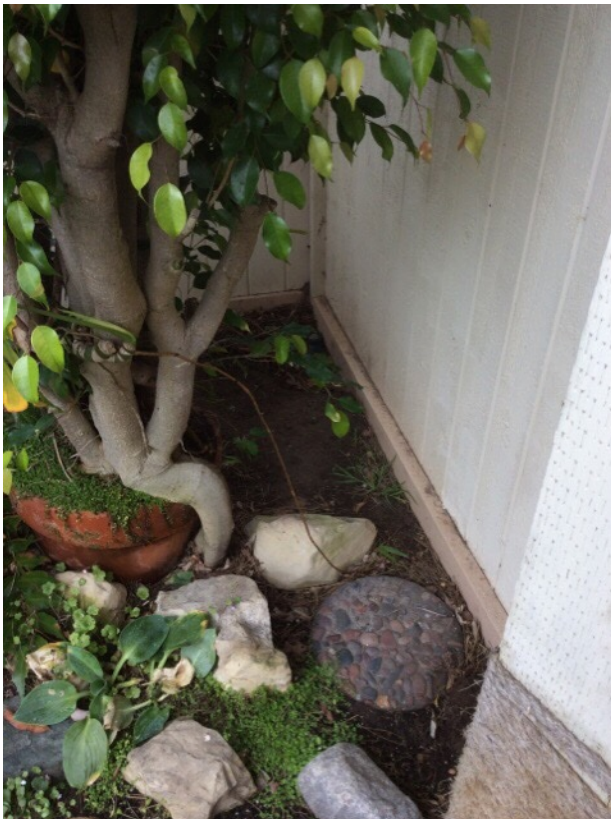
**CR** The fence at the rack yard has dirt piled against it. In time, this will rot the fence and/or push it over. We recommend the dirt be dug away and pulled back from the fence.

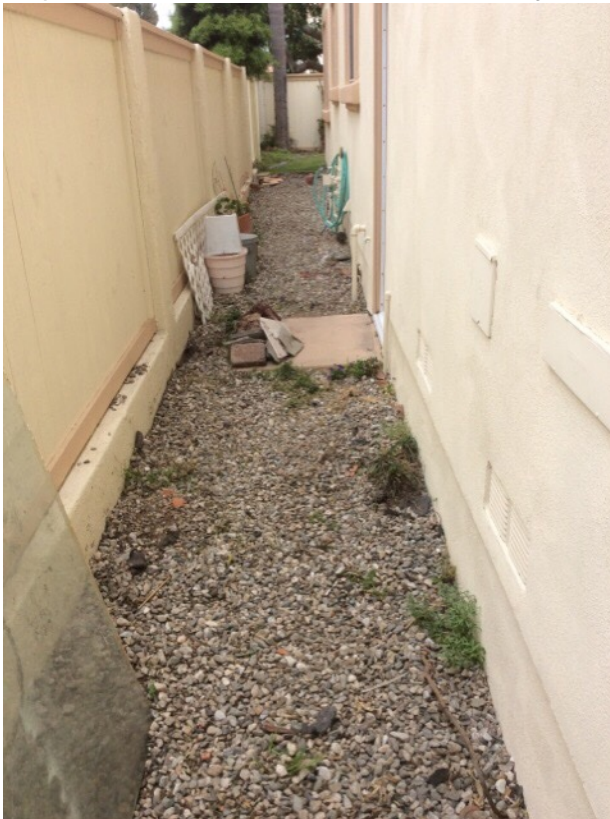
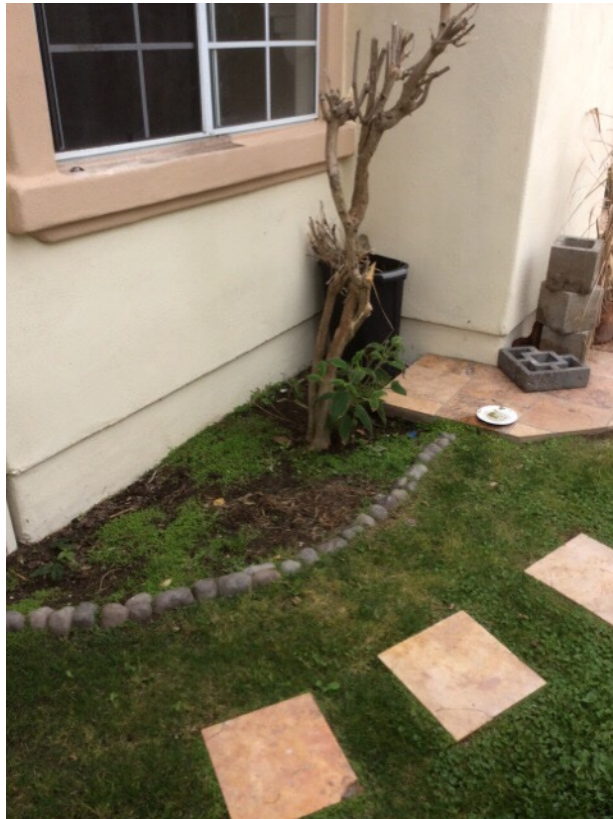
**FE CR** Grading is sloped toward the structure in some areas. Low spots and negative grading promote water accumulation near the building, leading to foundation problems. Regrading of landscape or concrete would help ensure that surface water flows away from the structure.

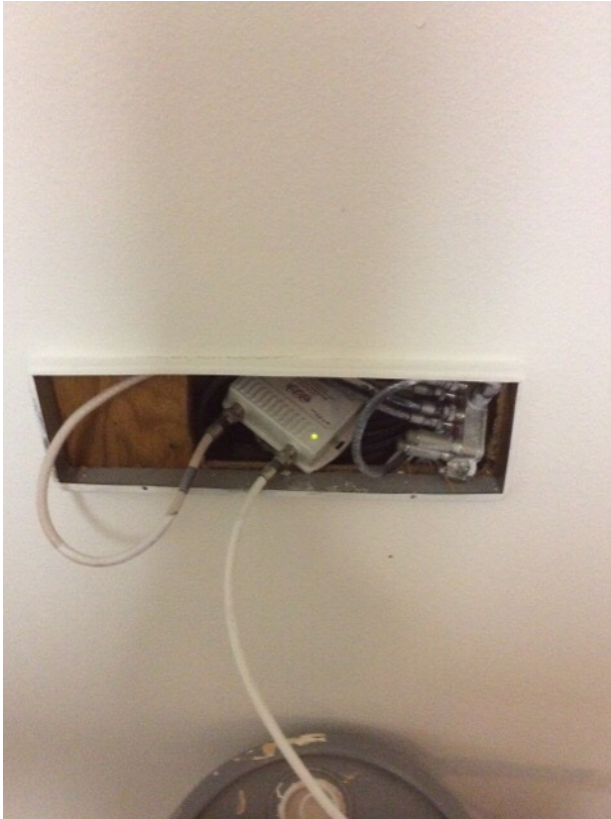
**SC CR** There are voids in the fire-resistive barrier between the garage and interior. We recommend these voids be patched to restore the required fire separation between the garage and the occupied interior.

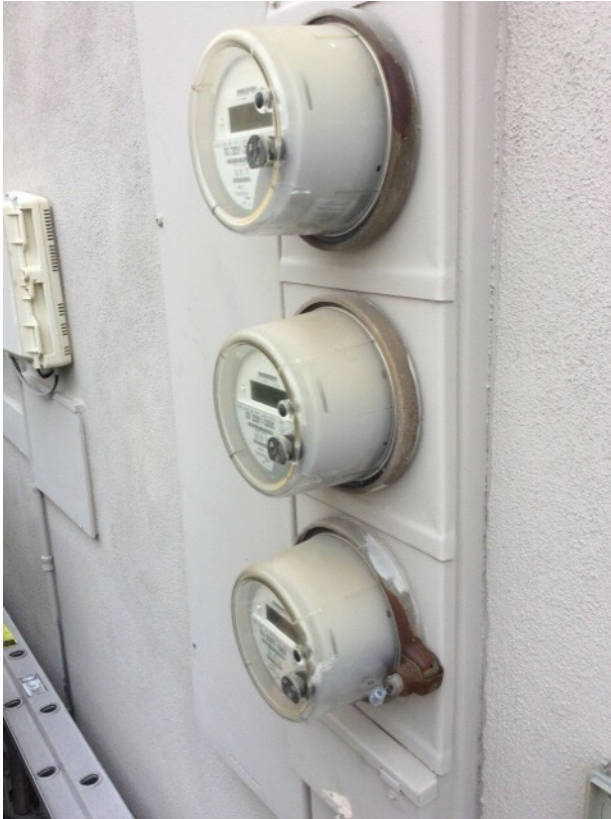
The meter and main electrical service panel are outside on the left-front corner of the front building.

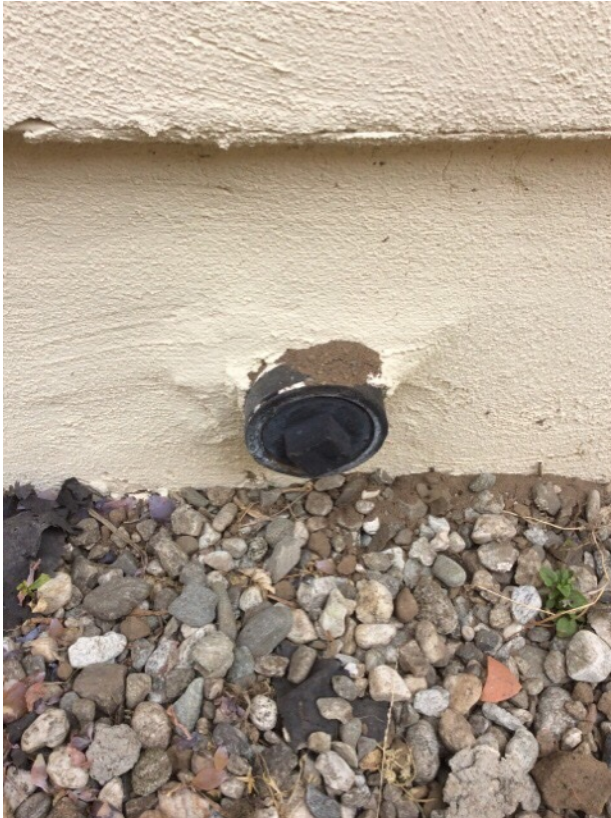
The sewer cleanout is located on the left side of the structure.

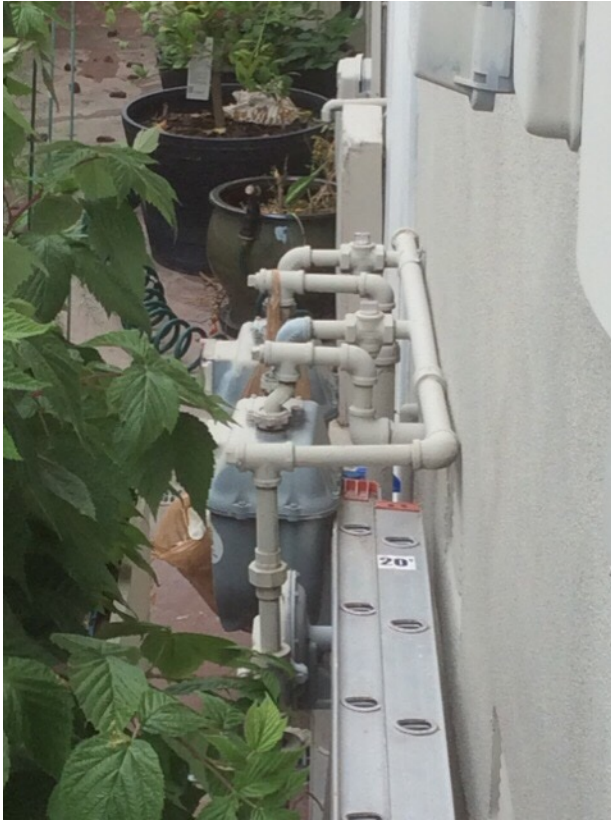
The gas meter is outside on the left side of the front building. The main gas supply shutoff valve is located on the riser pipe between the ground and the meter. This valve should be turned 90 degrees (either way) in order to shut off the gas.

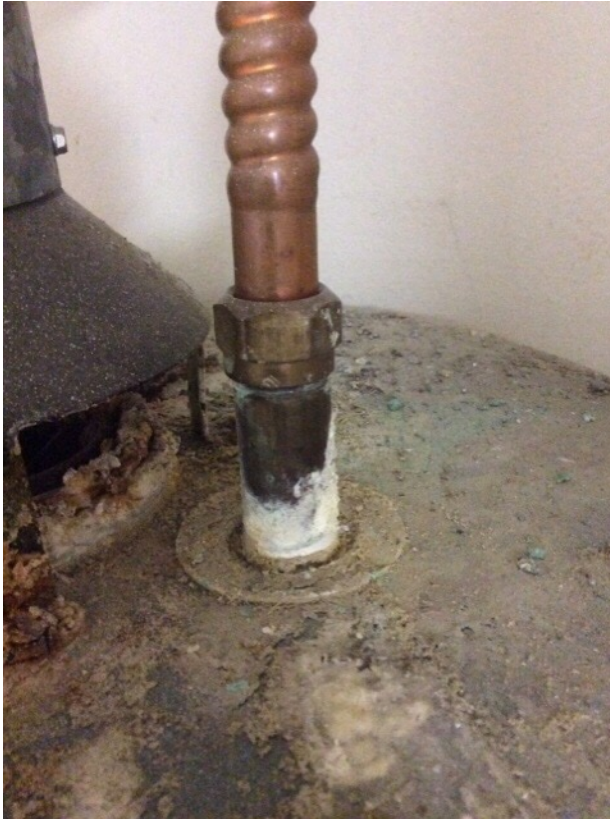
**FE** The water connections are corroded and leakage may become apparent over time. These connections should be monitored for leakage and repaired or replaced if necessary.

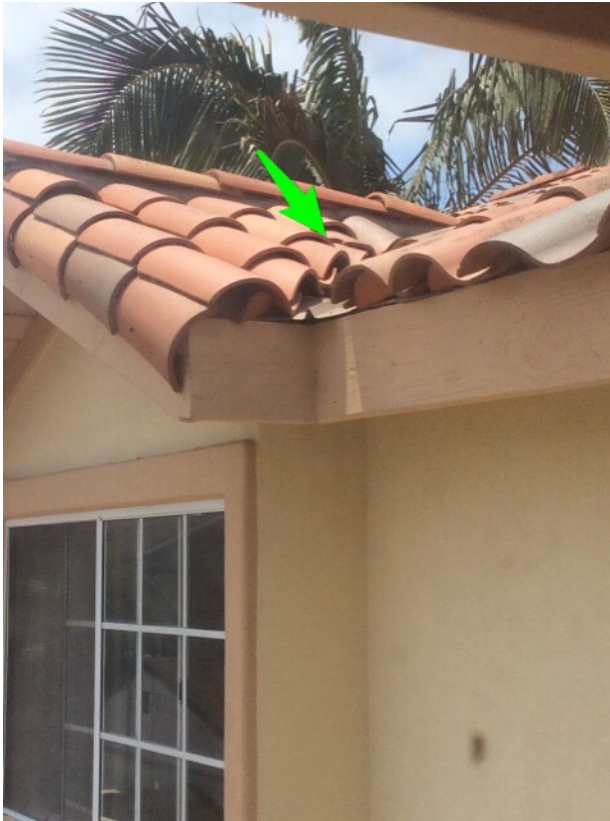
**FE CR** There are individual cracked, chipped and displaced tiles along the ridge and/or in the field. The number of affected tiles is small, but felt underlayment is exposed and we recommend repair to prevent its deterioration.

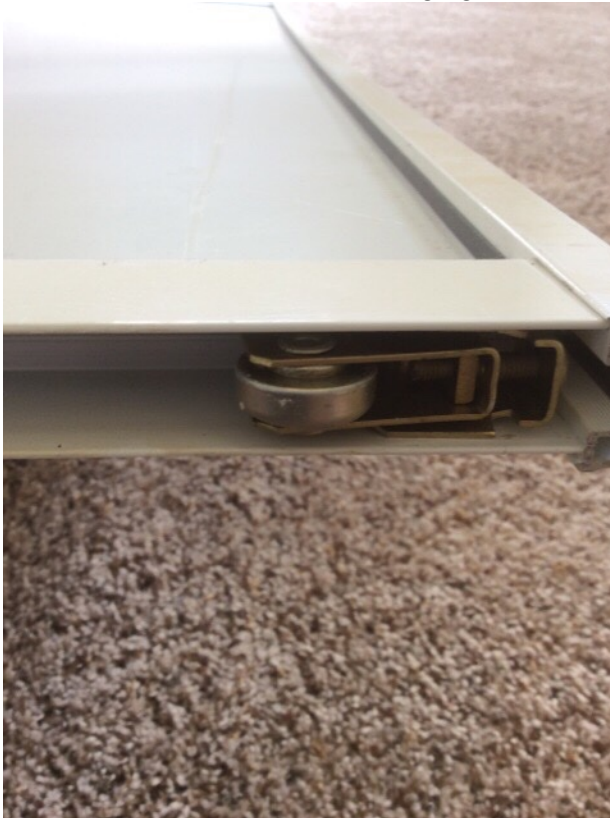
**CR** One of the rollers on the sliding glass closet door is not the correct style (does not have a slot to receive the track). We recommend changing the roller to the correct style.

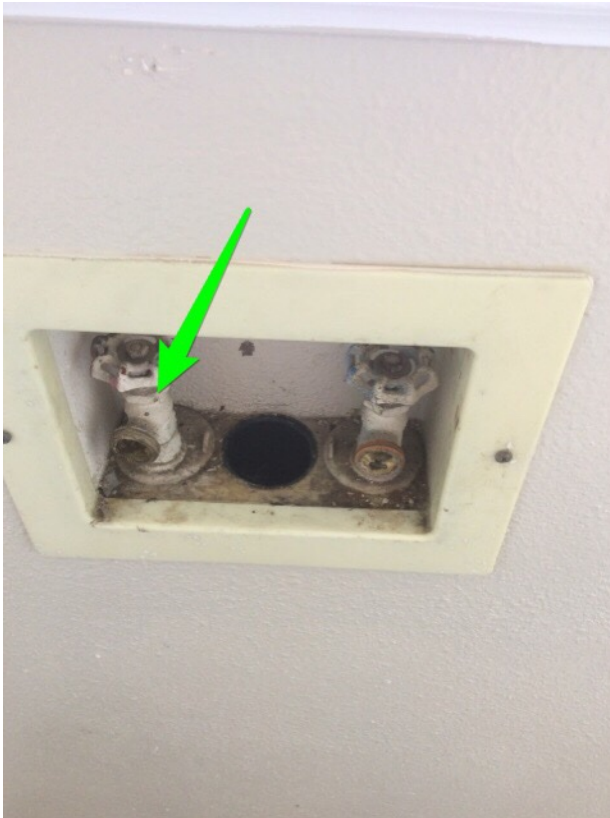
**CR** One of the washer hookups is dripping. We recommend repair or replacement.

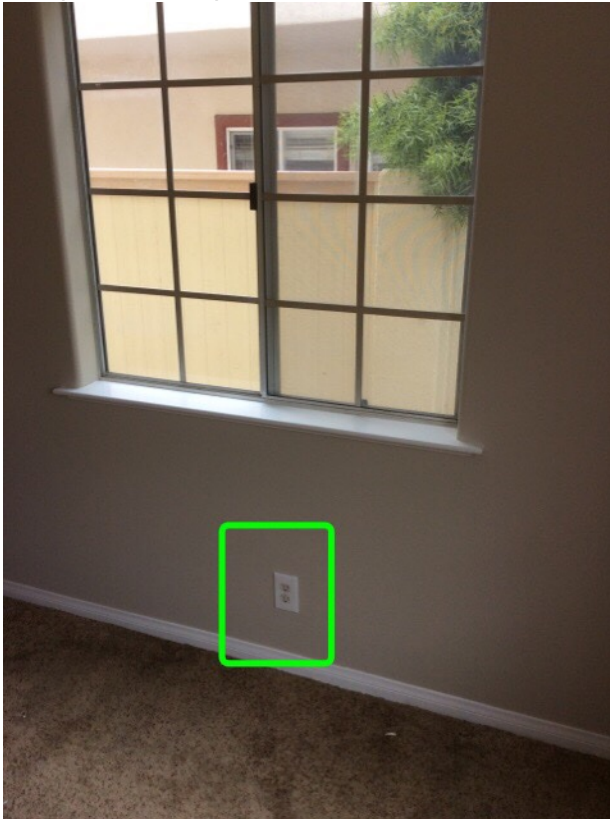
A receptacle at the left wall is wired with reversed polarity. Under some circumstances, this can be a shock hazard and/or damage electronic equipment. It is easy to correct this condition and we recommend the receptacle be repaired.
