## Your report details

**Report #:** 1  
**Type of Property:** Single Family Reside  
**Address:** 14826 Firmona Ave, Lawndale, 90260, California  
**Inspector name:** Stephen Ramirez  
**Date of inspection:** 2020-10-27  
**Buyer:** Prospective Buyer  
**Agent:** Luis Venegas  
**Year built:** 1921  
**Attendees:**  
**Property status:** NA

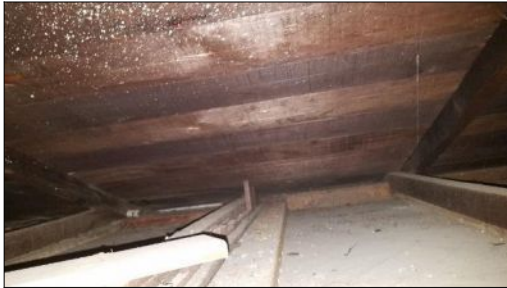
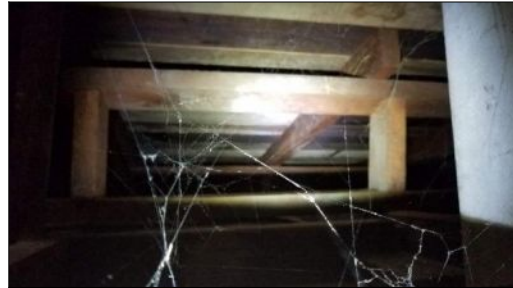
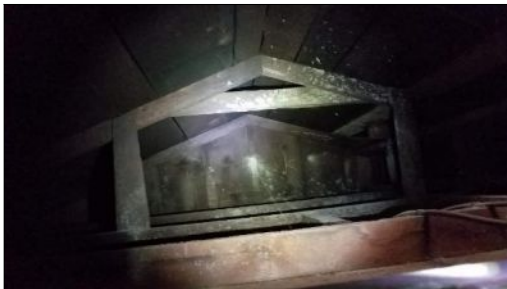
5) Overall serviceable

- **Description:** The overall evaluation of the attic structure and its perimeters appeared to be in good serviceable condition at the time of inspection.

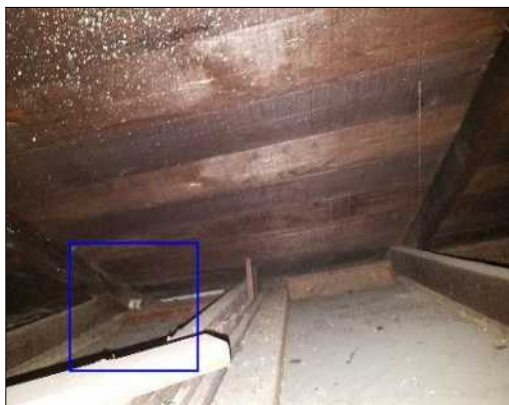
25) Considered unsafe by today's standards

- **Description:** At the time of inspection live "knob and tube" wiring was found in the home. This type of wiring is ungrounded and it is considered unsafe by today's

standards. Over time the wire insulation will become brittle and fall apart which will result in exposed wiring and the risk of shock. It is recommended to have a qualified electrical contractor evaluate and remove or replace wiring as needed.

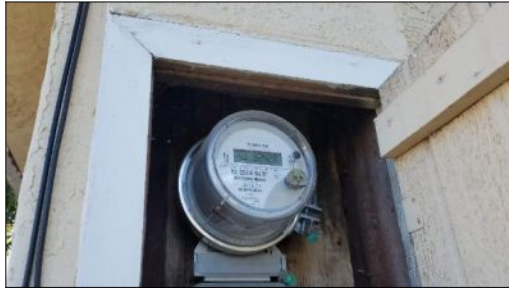
26) Overall serviceable

- **Description:** The overall evaluation of the electric meter(s) appeared to be in normal serviceable condition at the time of inspection.

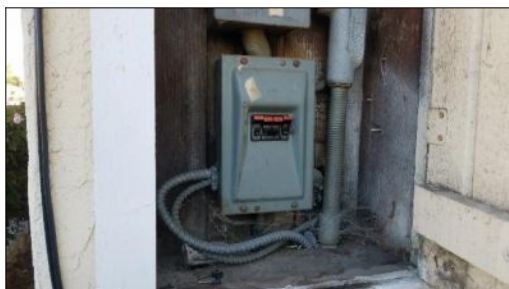
29) Overall serviceable

- **Description:** The overall evaluation of the main service electrical panel appeared to be in nor and serviceable condition at the time of inspection.

30) ✘ This home is equipped with a Federal Pacific Electric (FPE) Stab-lok brand electrical panel. Stab-lok load centers and their components are considered problematic by industry professionals due to their high failure rate as documented by the Consumer Products Safety Commission. Failure of any component within the electrical system may result in fire and/or electrocution. Evaluation of the panel by a qualified electrician is advised to determine its safety, integrity and performance.

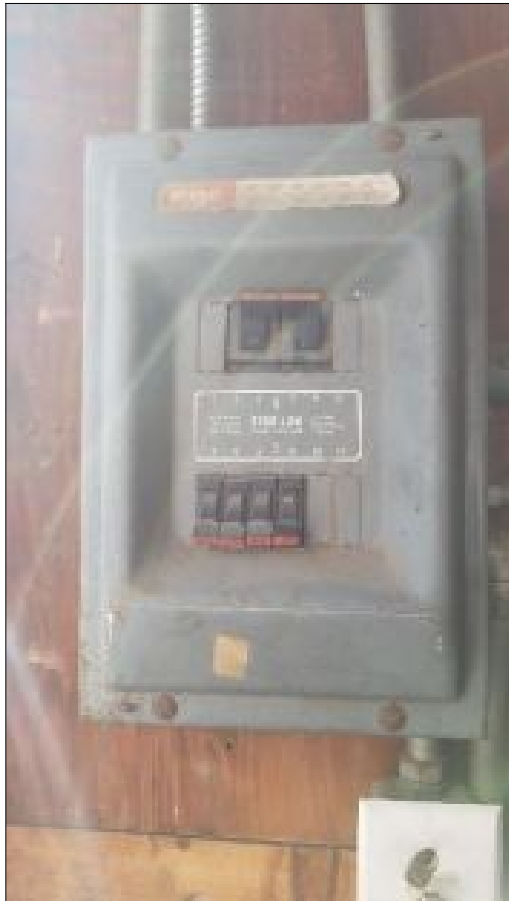
31) Overall serviceable

- **Description:** The overall evaluation of sub-panel(s) appeared to be in normal serviceable condition at the time of inspection.

32) ✘ The electrical sub panel was manufactured by the Federal Pacific Electric company and used "Stab-Lok" circuit breakers. There is significant evidence that both single and double pole versions of these breakers fail by not tripping when they are supposed to. and as such present a fire hazard. It is recommended to have a qualified electrical contractor replace the sub panel with an up to date model.

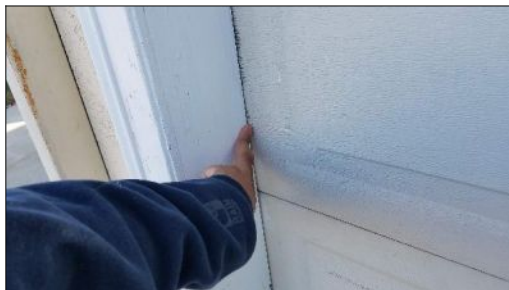
37) ⚠️ ❌ Weather strip missing

- **Description:** Garage vehicle door is missing weather strip. It is recommended to install weather strip as needed to prevent vermin and water intrusion.

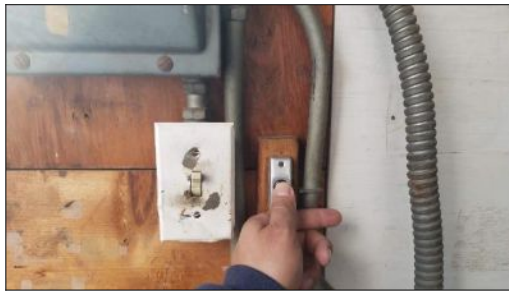
38) ⚠️ ❌ Opener not responding

- **Description:** Garage door opener was not responding when operated. It is recommend to have a qualified specialist evaluate and repair garage door opener as necessary.

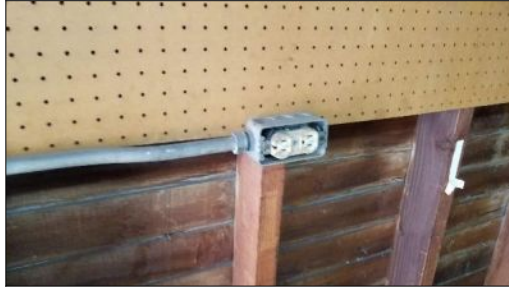
42) ⚠️✂️ Receptacle/switch missing cover plates

- **Description:** One or multiple electric receptacles are missing cover plates. This condition poses a safety hazard due to the risk of shock. Recommend having a qualified electrician install cover plates as necessary

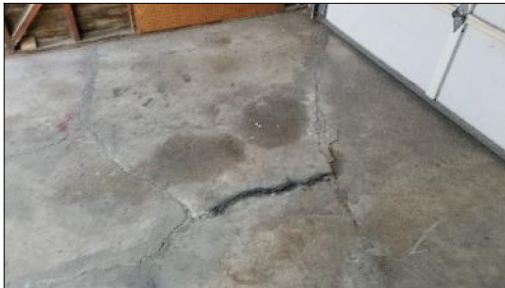
44) Cracks on floor

- At the time of the inspection it was noted that one or more areas of the garage floor had cracks and or deterioration. Recommend having a licensed contractor further evaluate and make necessary repairs.

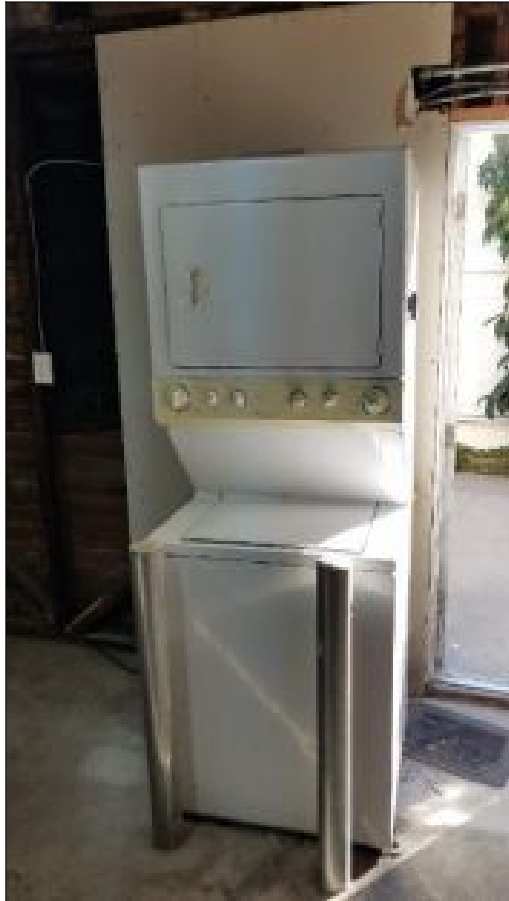
48) Overall serviceable

- **Description:** The overall evaluation of the laundry room perimeter appeared to be in serviceable condition during the inspection, except as noted.

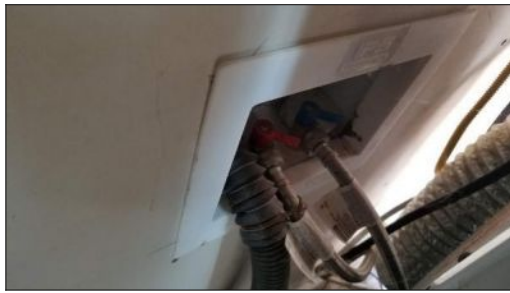
49) Overall serviceable

- **Description:** The overall evaluation of the laundry room perimeter appeared to be in serviceable condition during the inspection, except as noted.

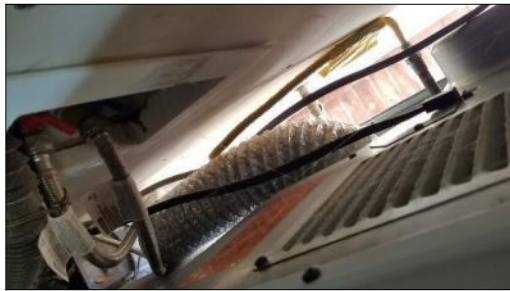
50) ⚠️✂️ Mylar (foil) duct installed

- **Comment:** Inspector found a mylar (foil) duct for dryer. Foil ducts are substandard and consider unsafe by today's standards. It is recommended to replace duct soon.

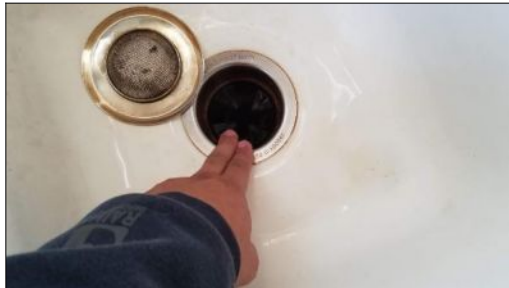
54) ⚠️🔧 Food disposal noisy

- **Description:** At the time of inspection it appears the food disposal was noisy. It is recommended that a qualified appliance contractor evaluate and make repairs as necessary.

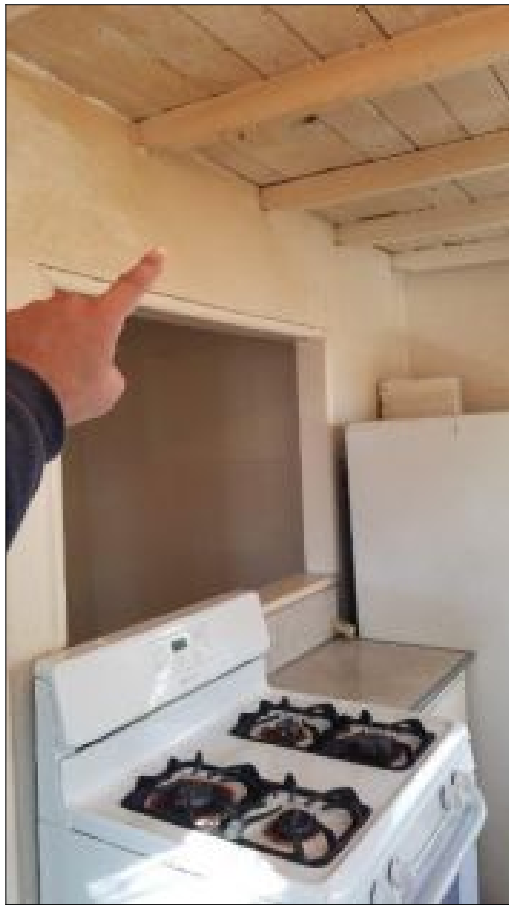
56) 🚫⚠️ No range hood installed

- **Description:** No range hood was visible at the time of inspection. It is recommended to have a qualified contractor evaluate and install range hood as and if necessary.

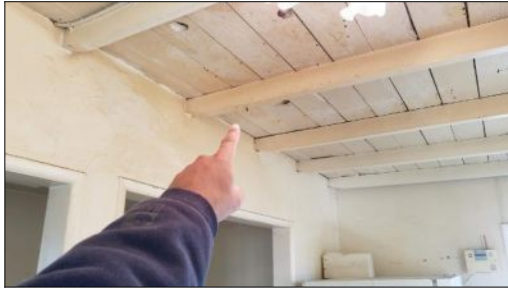
59) 🛠️🚧 Paint failing

- **Description:** Paint appeared to be failing in one or more areas of the ceiling. It is recommended to have a qualified painting contractor prep, prime and paint areas as needed.

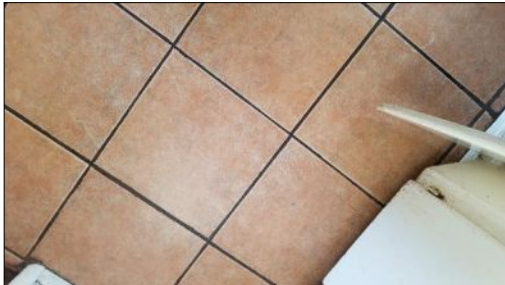
61) ⚠️🔪 Tiles damaged or deteriorated

- **Description:** Tiles appeared to be damaged and/or deteriorated at the time of inspection. It is recommended to have a qualified contractor evaluate and repair or replace tiles as necessary.

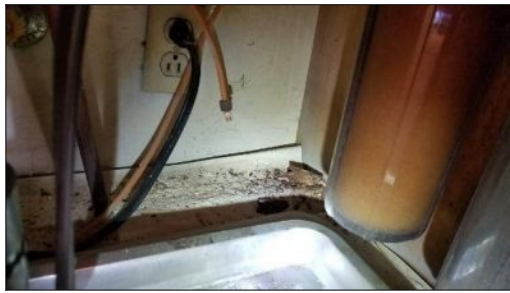
63) ⚠️🔪 Shelves damaged

- **Description:** Cabinet shelving components appeared to be damaged or deteriorated. A qualified contractor should evaluate and repair or replace shelving components as necessary.

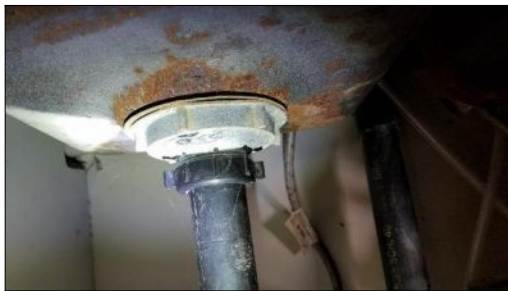
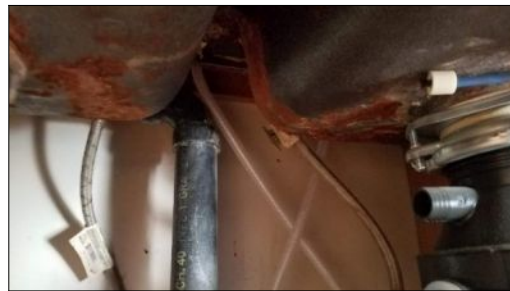
65) ⚠️🔪💬 Minor deterioration on countertops

- **Comment:** Kitchen sink was rusted in areas
- **Description:** What appeared to be minor deterioration was observed in one or more areas of the countertops. No immediate action is recommended, but the client may have a qualified contractor evaluate and repair conditions as necessary.

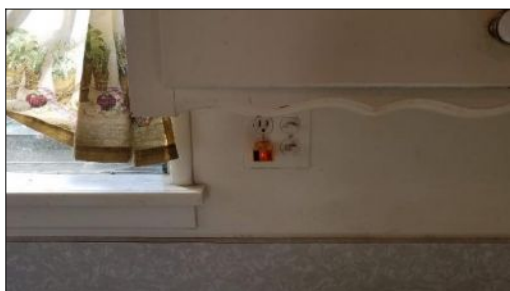
66) ⚡️🔪🚫 Open ground receptacles

- **Description:** One or more three-prong electric receptacles were found to have open ground. A qualified electrical contractor should evaluate and make repairs as necessary.

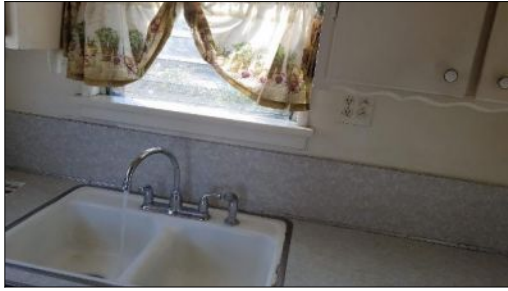
No GFCI receptacle within 6' feet of sink

- **Description:** No ground fault circuit interrupter (GFCI) electric receptacles were found within 6? feet of sink in bathroom. Conditions pose a safety hazard due to the risk of shock. It is recommended to have a qualified electrical contractor install GFCI receptacles as needed.

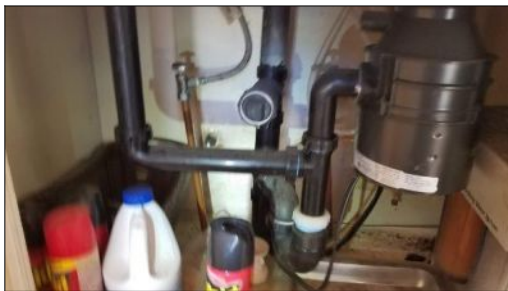
68) Overall serviceable

- **Description:** Kitchen plumbing and drainage components appeared to be in overall normal and serviceable condition at the time of inspection except as noted.

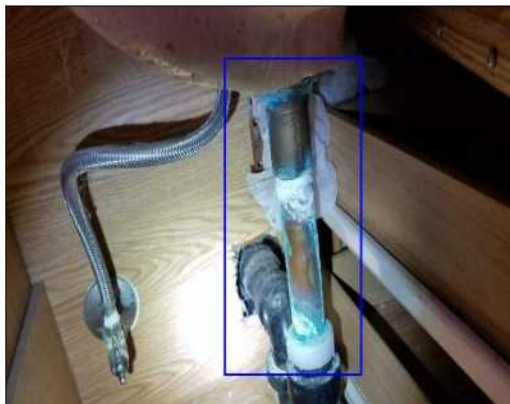
79) ⚠️✂️ Corrosion observed

- **Comment:** Corrosion was observed on one or more facet handles, base, etc. It is recommended to have a qualified plumber evaluate conditions and repair or replace as necessary.

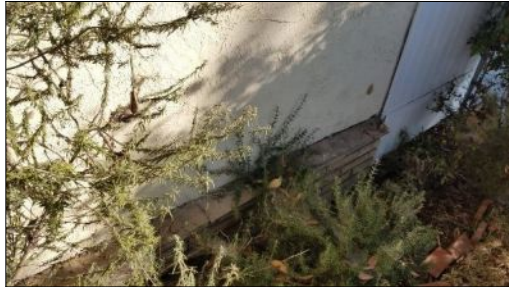
- 89) ⚠️✂️ Mortar deteriorated

- **Description:** The mortar to exterior brick, stone or block is deteriorated and should be evaluated for repairs by a qualified contractor.

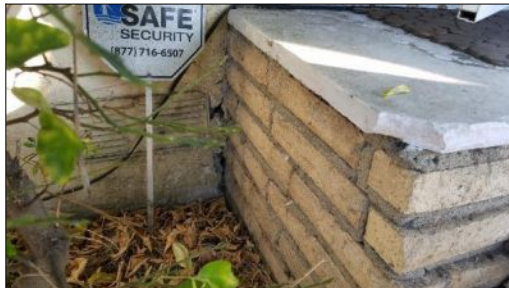
- 90) ⚠️✂️ Siding is damaged or deteriorated

- **Description:** Exterior siding is damaged and/or deteriorated and should be evaluated for repairs or replacement by a qualified contractor.

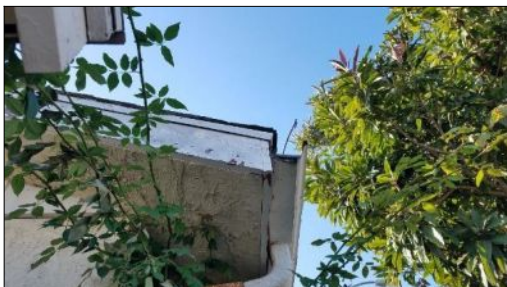
95) ⚠️ ❌ Gutter missing end caps

- **Description:** Gutter missing end-caps in one or more areas. It is recommended to have a qualified contractor install end-caps as needed.

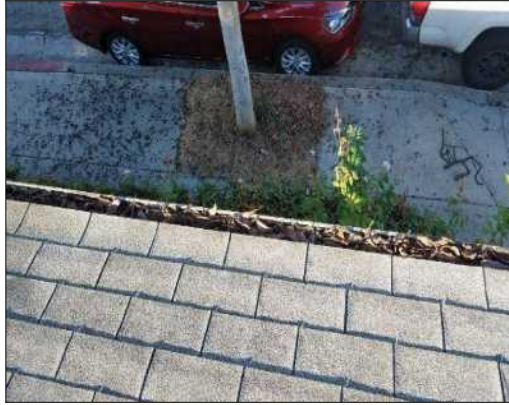
96) 🛠️🚧 Dirty gutters

- **Description:** Cleaning gutters on a regular basis or as needed is recommended for adequate performance.

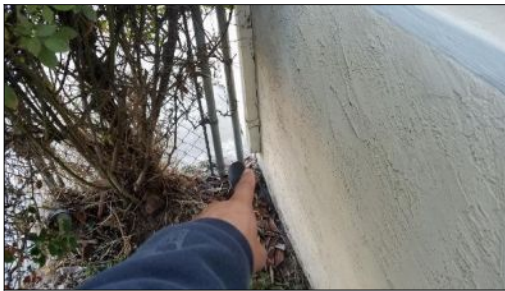
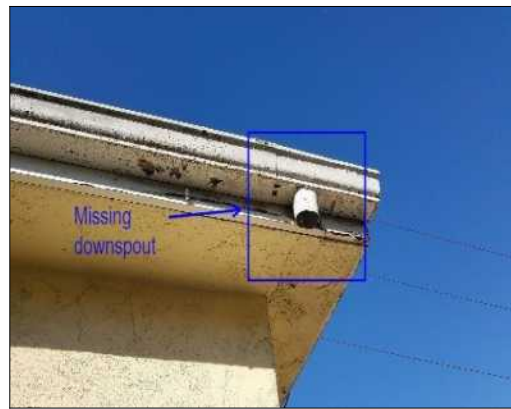
97) ⚠️🚧 Improper downspout termination

- **Description:** Termination to one or more downspouts is inadequate and may allow water to run toward the structure's foundation. It is recommended to have a qualified contractor repair or replace sections as needed.

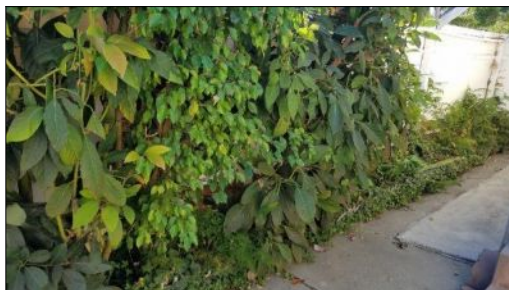
98) 🛠️🚧 Yard maintenance required

- **Description:** It is recommended to have a landscape professional maintain yard as needed. This will prevent rodent and other types of infestations as well as drainage problems.

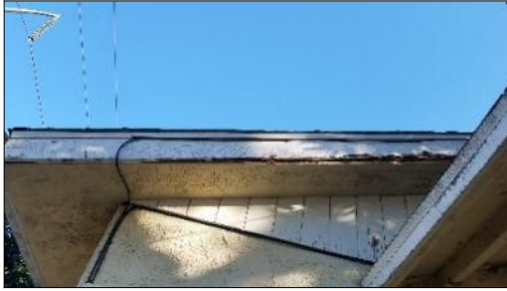
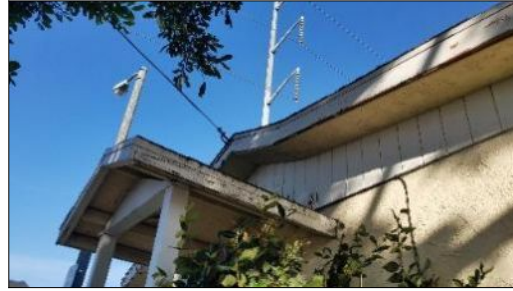
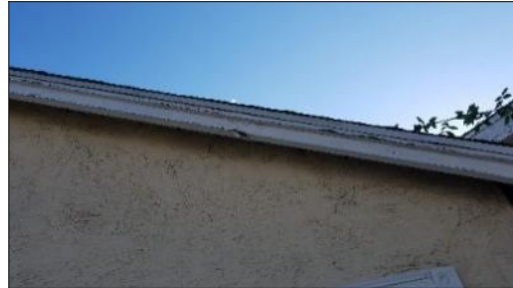
- ⚠️❌ Fascia board deteriorated
- **Description:** Deterioration was found on one or more areas of the fascia boards. It is recommended to have a qualified contractor repair or replace wood as necessary.
- ⚠️❌ Paint failing

- **Description:** Paint is failing on one or more areas. It is recommended to have a licensed painter prep, prime, and paint wood as necessary to prevent water damage.

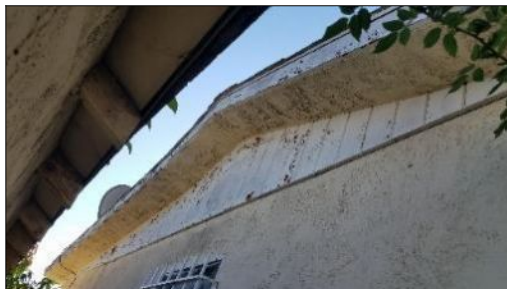
- ⚠️❌ Paint failing

- **Description:** Paint is failing in one or more areas. It is recommended to have a qualified painter prep, prime, and paint wood as necessary to prevent water damage.

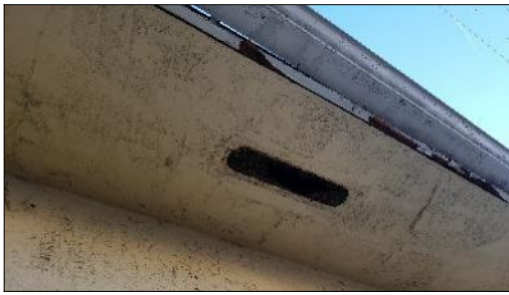
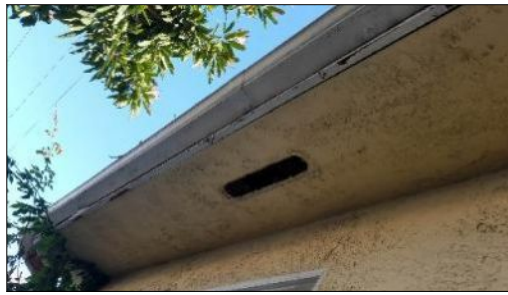
- ⚠️❌ Damaged soffits

- **Description:** Soffit vents are damaged or deteriorated in one or more areas. It is recommended to have a qualified contractor evaluate and repair affected areas as necessary.

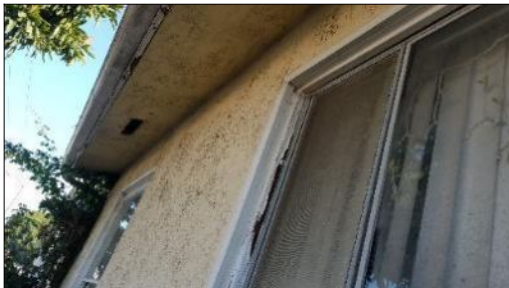
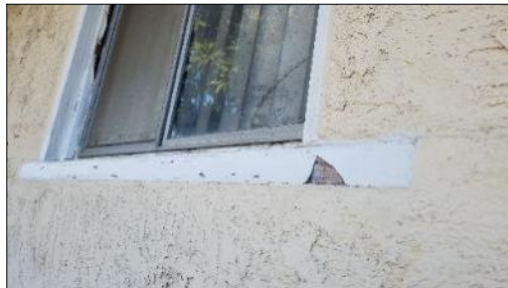
#### 103) Window trim

- At the time of the inspection several areas of the windows (trim, glass, screens) were found to be in deteriorated conditions. It is recommended to have a qualified contractor further evaluate these areas and make repairs

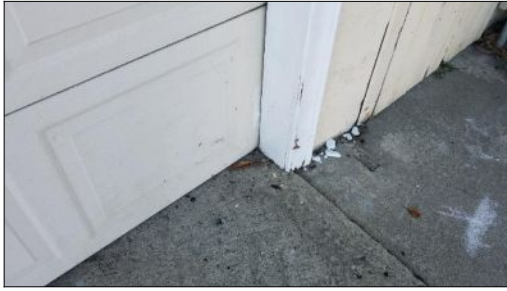
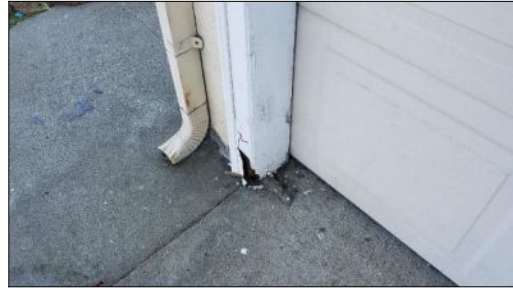
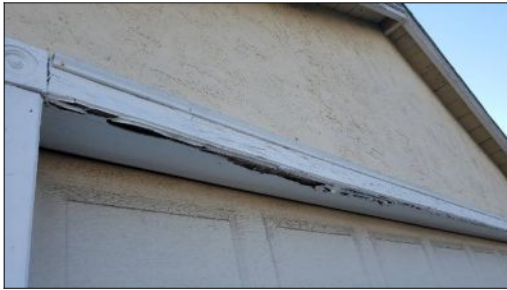
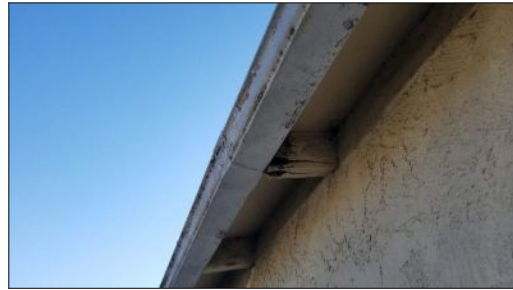
106) Evidence of wood-destroying infestation

- **Description:** The inspector noticed evidence of wood-destroying insects or organisms. It is recommended to have a pest control specialist assess conditions and treat the property as needed.

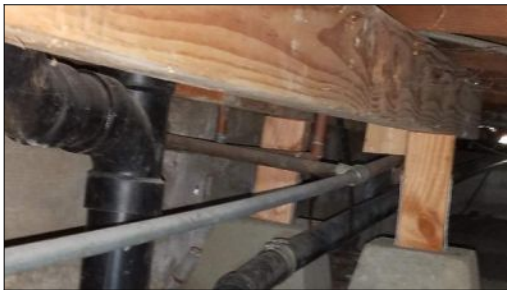
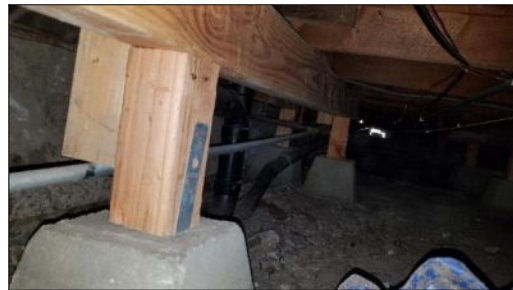
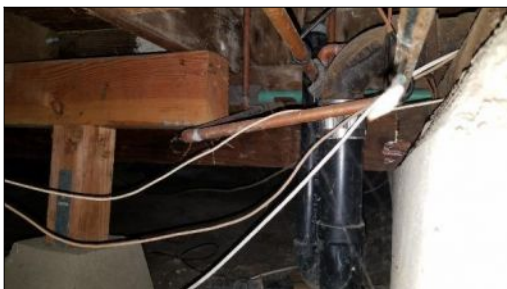
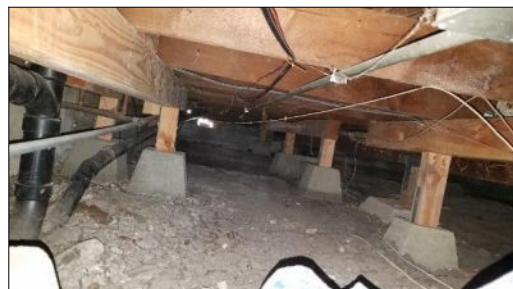
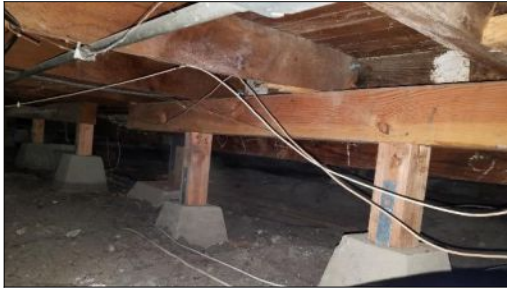
114) Overall serviceable

- **Description:** The overall view of the structure appeared to be in normal serviceable condition during the inspection, except as noted.

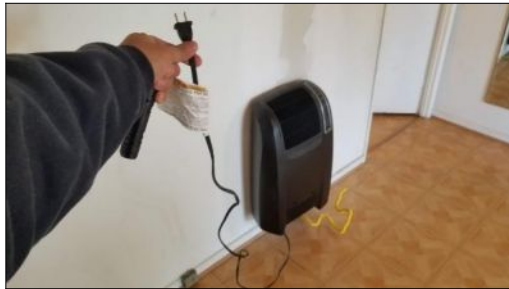
122) ⚠️❌ Other

- **Comment:** Wall heater was installed within range of a power outlet. recommend having condition repaired to allow for use of the wall heater

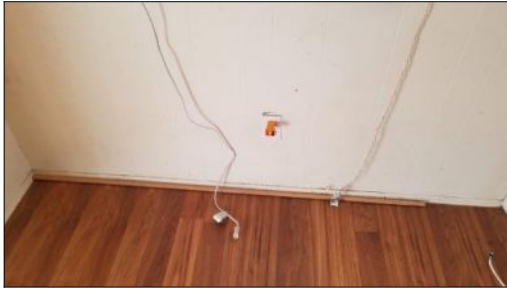
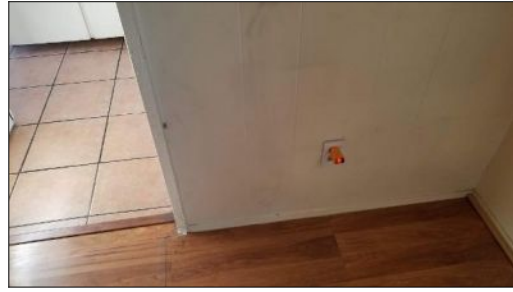
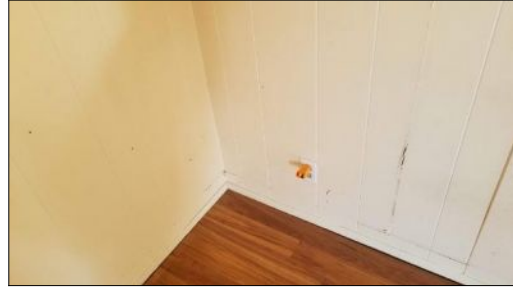
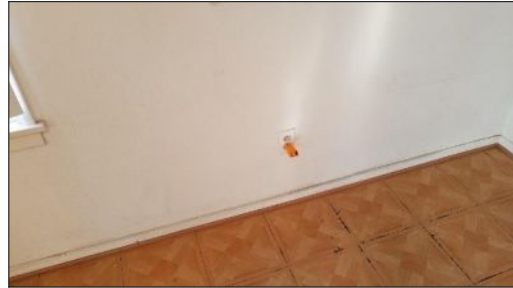
130) 🚫⚠️❌ Open ground receptacle

- **Description:** One or more open ground, three pronged electric receptacles were found at the time of inspection. Conditions pose a safety concern due to the risk of shock. A qualified electrical contractor should repair conditions or replace receptacles as necessary.

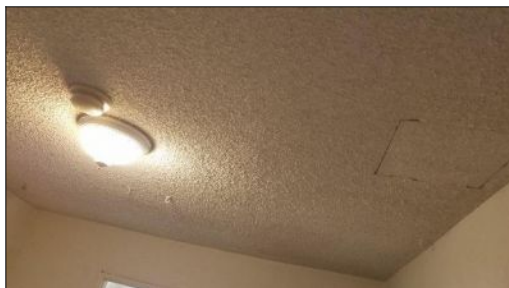
132) Possible Pre-1980 asbestos popcorn ceiling

- **Description:** This property was built prior to 1979 and some ceiling area have "popcorn" textured surfaces which may have been installed prior to 1979> This material may contain asbestos, which is a known carcinogen and poses a health hazard. The client may have a qualified lab test a sample of the ceiling material and determine if it does contain asbestos.

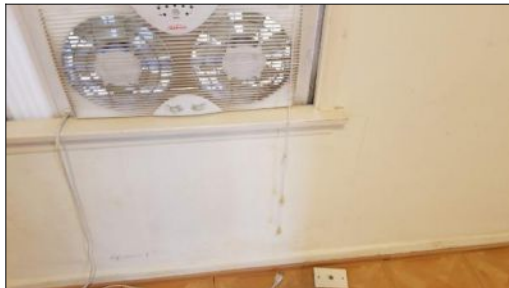
134) One or more hairline cracks on walls

- **Description:** One or more hairline cracks were observed in one or more interior wall areas. Conditions do not appear to pose a structural concern, but the client may have a qualified contractor patch cracks as needed for aesthetic reasons.

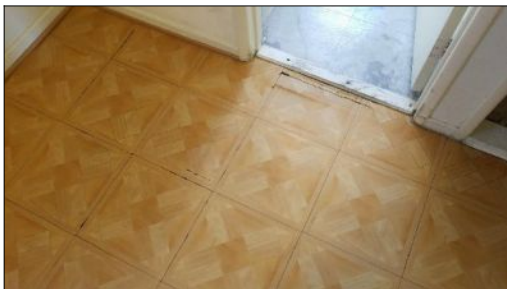
136) ⚠️ Vinyl/laminate is deteriorated or damaged

- **Description:** At the time of inspection, vinyl flooring material was missing, deteriorated or damaged in one or more areas of the interior rooms. It is recommended to have a qualified contractor evaluate conditions and make repairs to flooring as necessary.

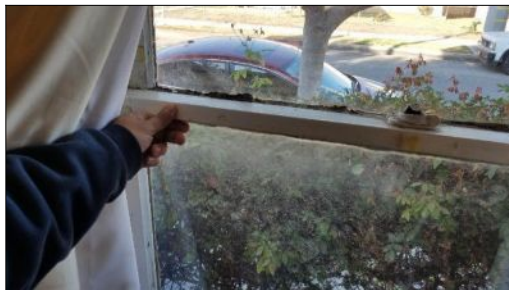
- 137) ⚠️ 🚫 Window(s) won't open/difficult to open

- **Description:** One or more windows that were built to open did not open or were difficult to operate at the time of inspection. Conditions may pose a safety concern if this window(s) is the only access of escape in the event of fire or other emergencies. It is recommended to have a qualified contractor repair conditions as necessary.

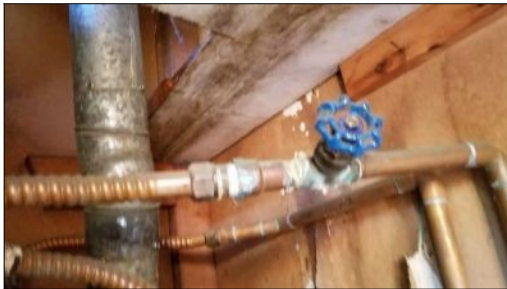
149) ⚠️🔧 Fittings are rusted or corroded

- **Description:** Corrosion was found in one or multiple areas of the plumbing lines and/or fittings. It is recommended to have a qualified contractor evaluate and repair condition as needed.

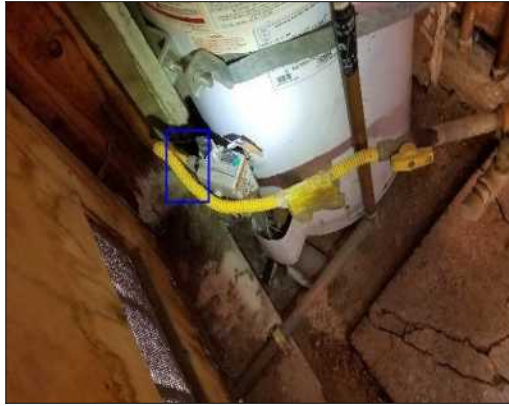
151) ⚠️🔧 Drip leg/Sediment trap missing or inadequate

- **Description:** Not drip leg was observed on the water heater gas supply line. The purpose of drip legs is to trap oil, scale, water condensation and/or debris from the gas supply lines before they reach and damage the water heater components. It is recommended to have a qualified contractor evaluate and repair conditions as necessary.

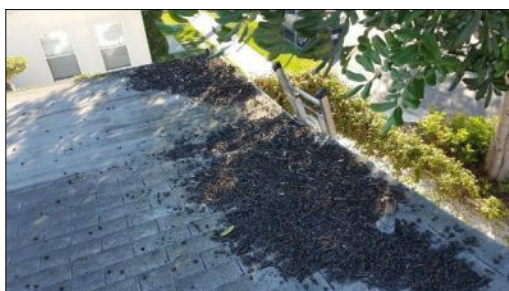
155) 🚧 Note

- **Comment:** Recommend clearing leaves and debris from roof and continued maintenance . to prevent accelerated deterioration of roofing material

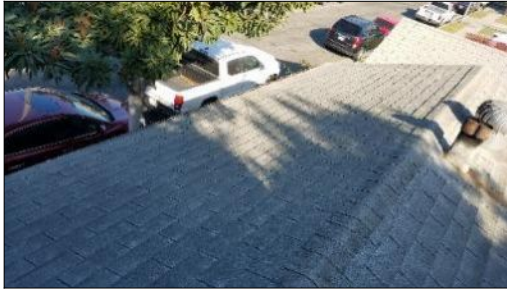
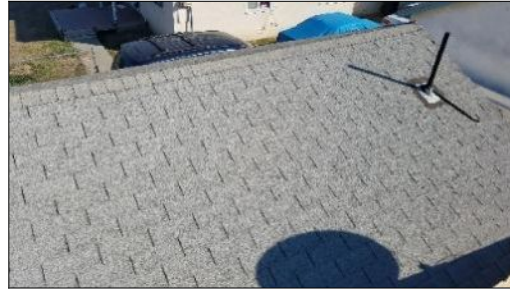
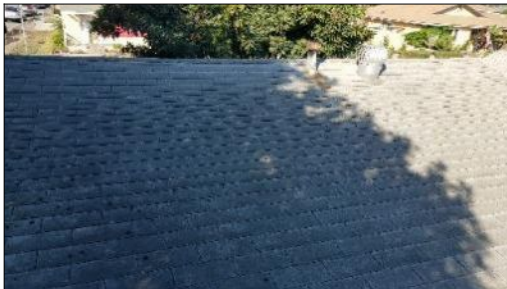
157) Composition

- **Description:** The overall view of the composition roof appeared to be in good serviceable condition at the time of inspection.
- ⚠️✂️ Shingles are missing

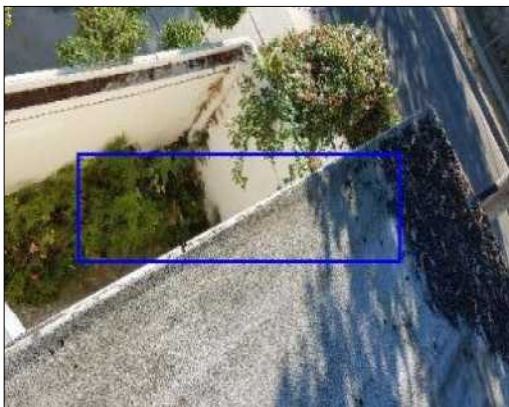
- ⚠️🔪 Gaps found at seams

- **Description:** Roof surface gaps were found at seams in one or more areas. These may result in leaks now or in the near future. A qualified roofing contractor should evaluate and repair affected areas as needed.

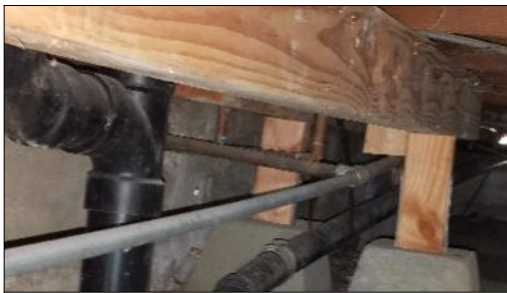
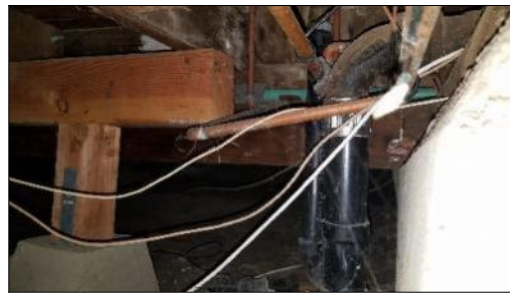
171) Copper

- **Description:** The overall evaluation of the of the copper supply lines appeared to be in nor and serviceable condition at the time of inspection.

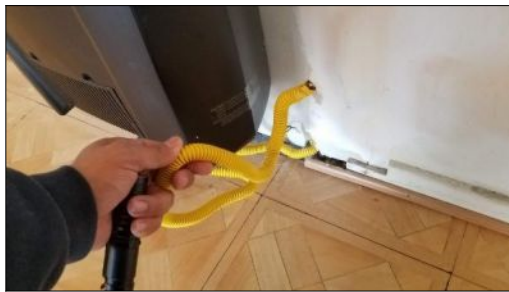
175) ⚠️✂️ Gas line loose

- **Comment:** The gas line for the former wall heater was out in the open and not capped recommend capping or if no longer in use removal by qualified contractor.
