PEAK TO PEAK HOME INSPECTIONS INC.

RESIDENTIAL REPORT

597 Old Mill Rd
Crestline, CA 92325

OCTOBER 12, 2023

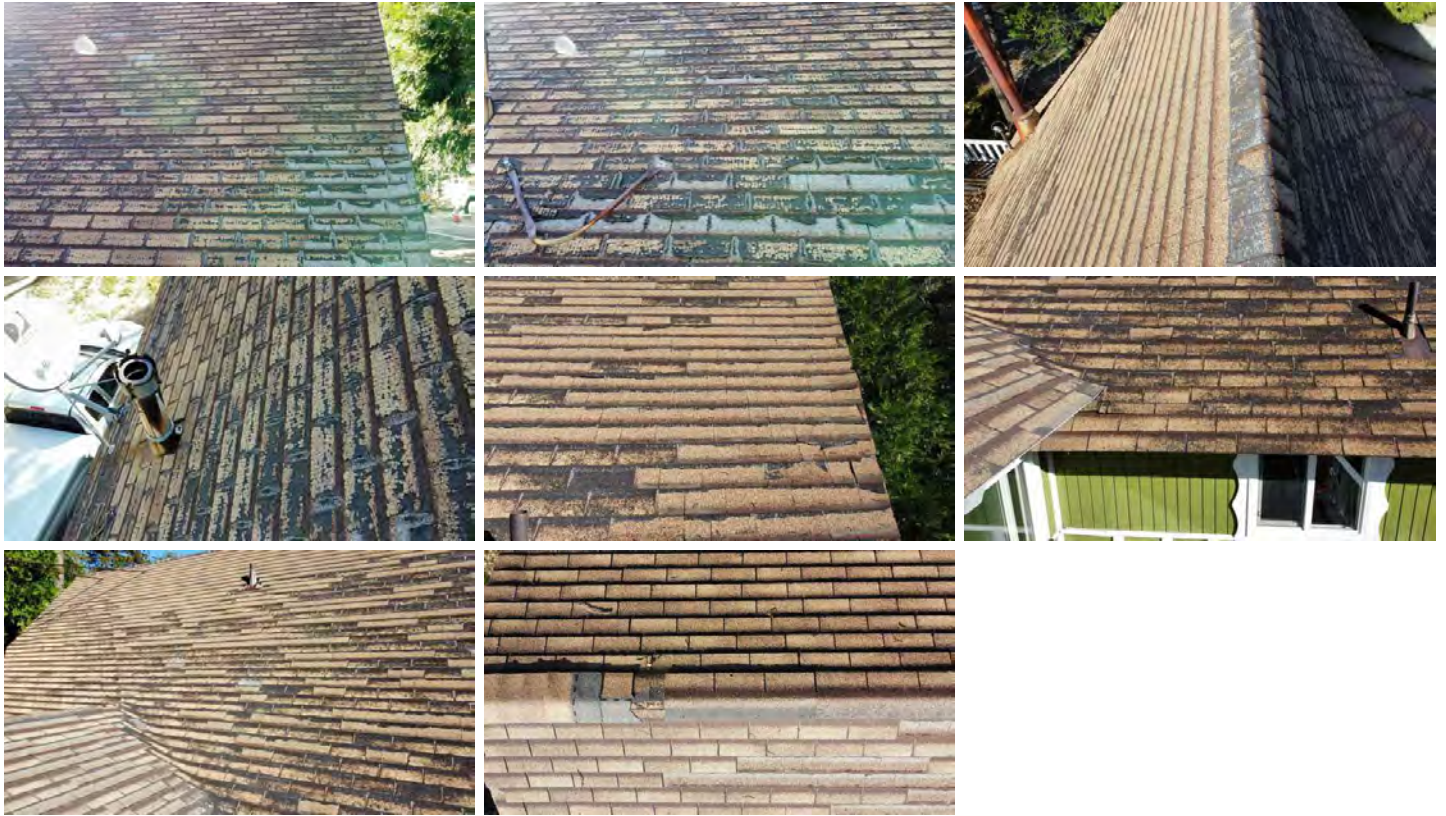
Asphalt shingles covering this roof were severely deteriorated and at the ends of their useful lives. Consult with a qualified roofing contractor to gain an idea of options and costs for replacement.

Recommendation

Contact a qualified roofing professional.

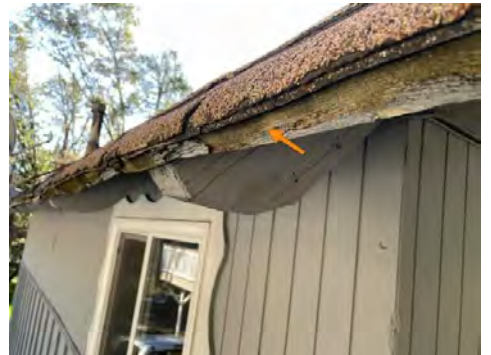
Drip edge flashing was missing.

Recommendation

Contact a qualified roofing professional.

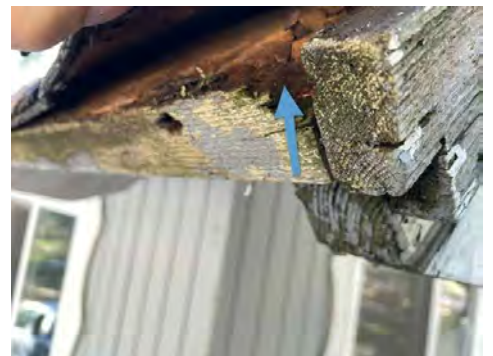
Prior water penetration observed. Moisture content low at the time of inspection

Recommendation

Recommend monitoring.

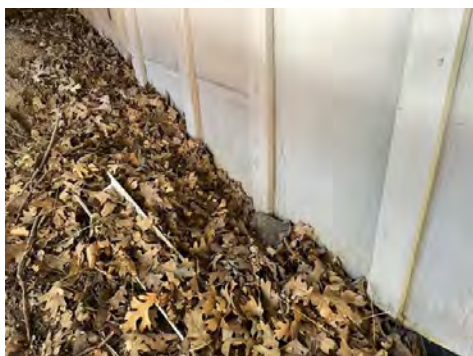
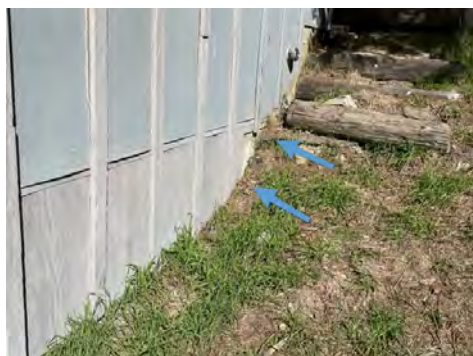
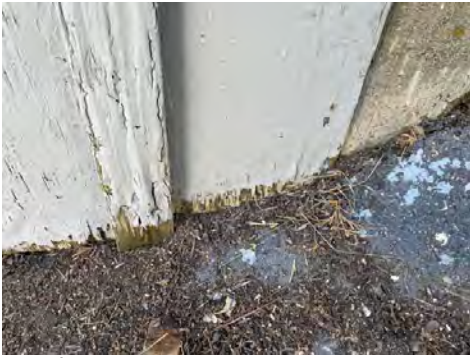
3.1.6 Siding, Flashing, Trim, Facia & Eaves

Inadequate clearance between the siding and ground surface. Recommend a minimum ground clearance between bottom of siding and ground of 4". Siding in contact with the ground or soil is a concern because that condition can provide direct access for wood destroying insects and allow moisture damage to the siding.

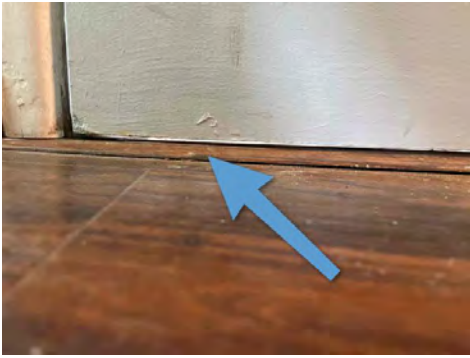
3.2.2 Exterior Doors

WEATHERSTRIPPING NOT PRESENT

[Here is a DIY guide on weatherstripping.](#)

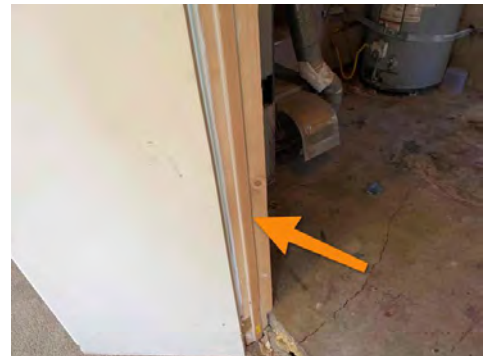
3.2.3 Exterior Doors

LOOSE KNOB

Contact a qualified professional.

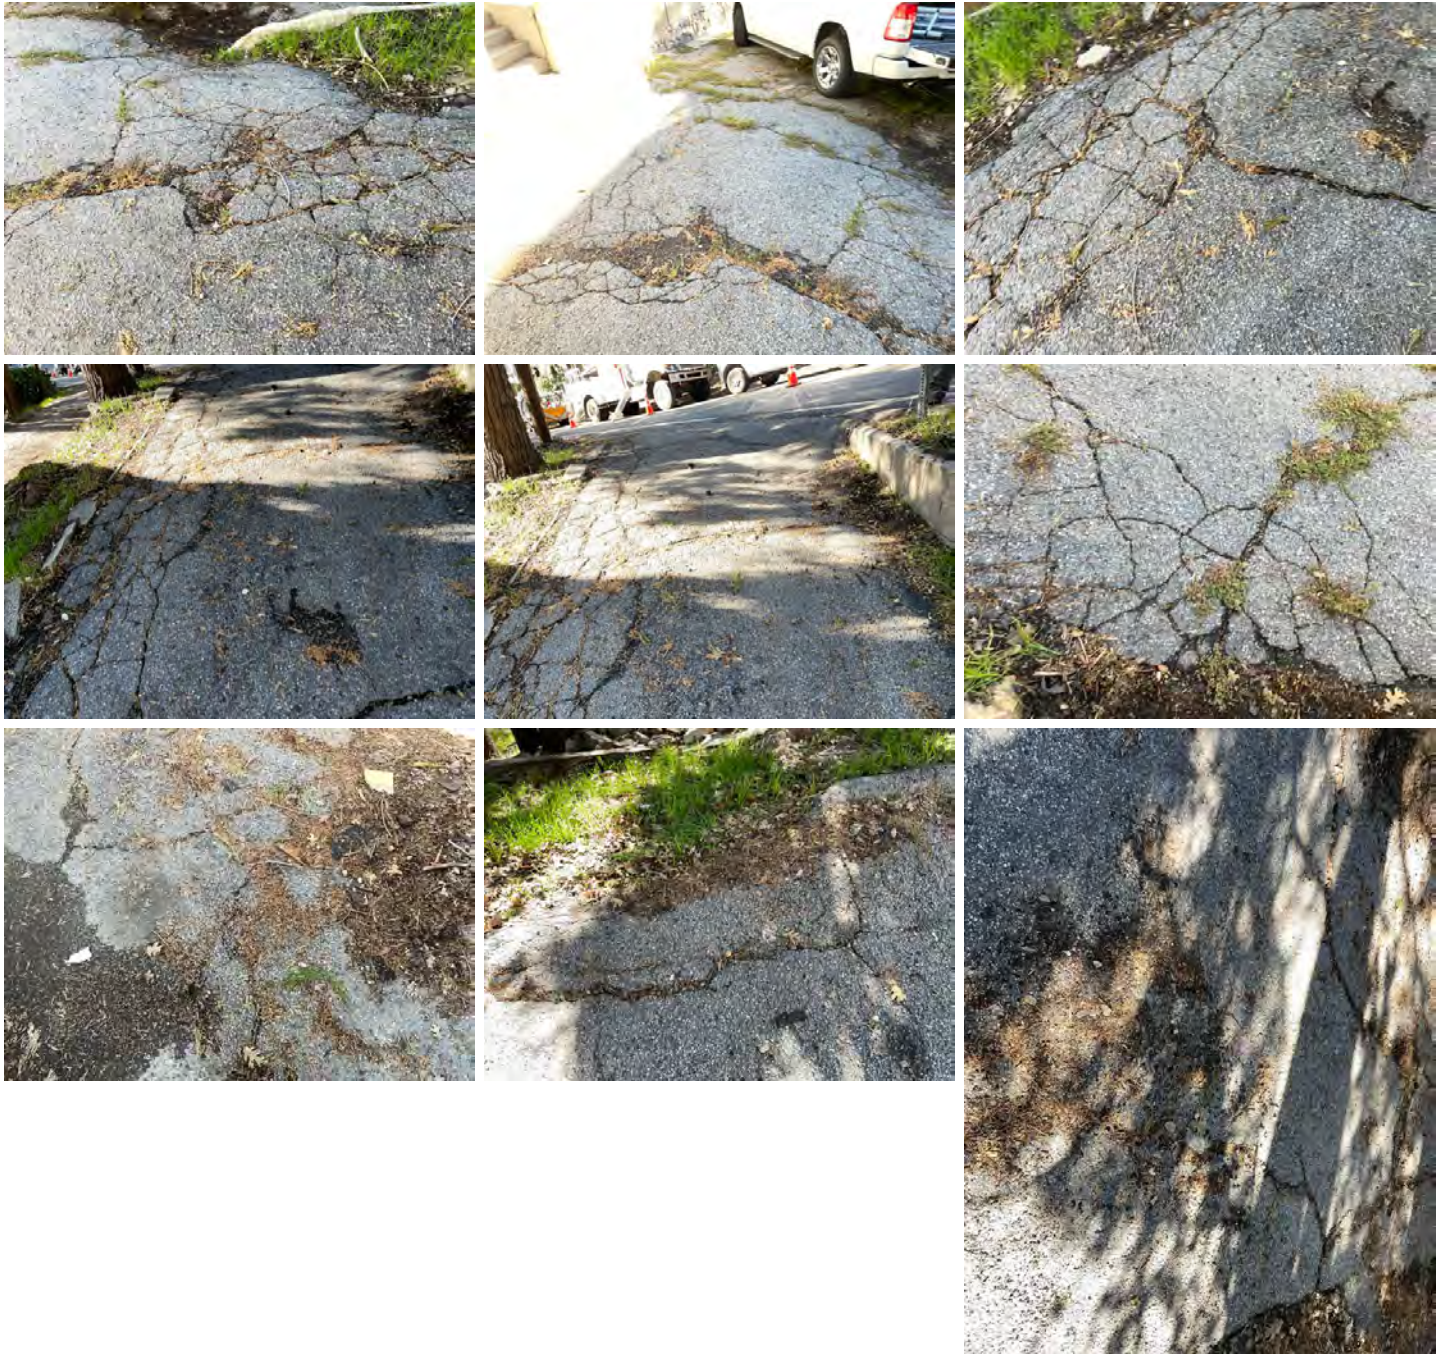
Cracks noted in driveway surface.

Recommendation

Contact a qualified professional.

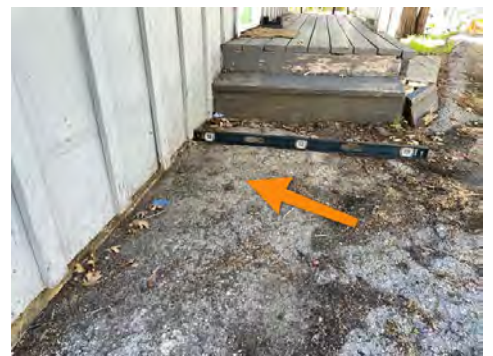
Front

I observed that the driveway has a negative slope and drains towards the house. This condition is prone to water penetration into the house structure.

Correction and further evaluation is recommended.

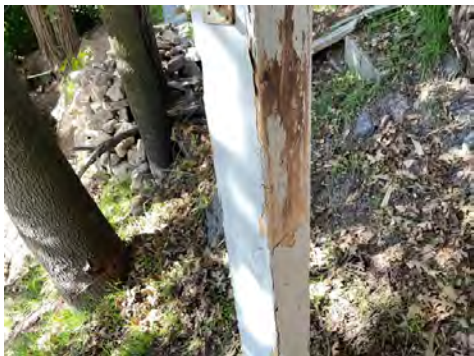
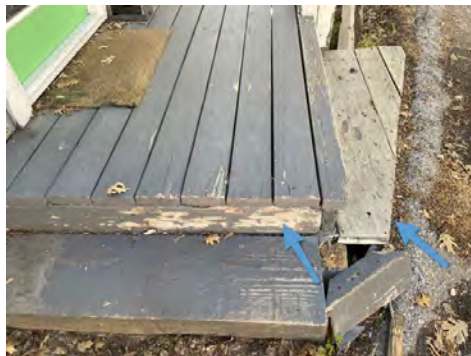
DECK - FINISH COATING DETERIORATION

Finish coating designed to protect the deck exhibited deterioration. Failure of the finish coating will allow Ultra Violet (UV) radiation from sunlight, heat, moisture and freezing moisture to reduce the lifespan of bare wood exposed to weather. Maintenance performed on an appropriate schedule can significantly extend the lifespan of wood deck components.

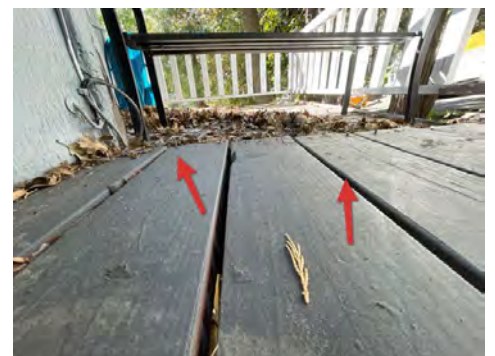
Front right

Nails used to fasten deck planking were protruding from the deck surface and are a trip hazard. These nails should be driven flush with or below the surface. Protruding nails are a sign of aging and will re-emerge over time. The Inspector recommends re-fastening as needed.

Contact a qualified carpenter.

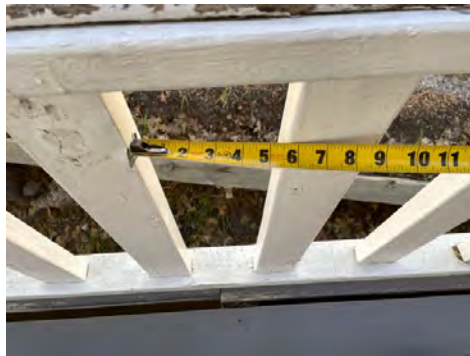
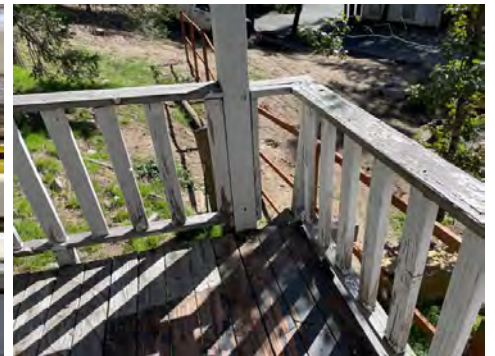
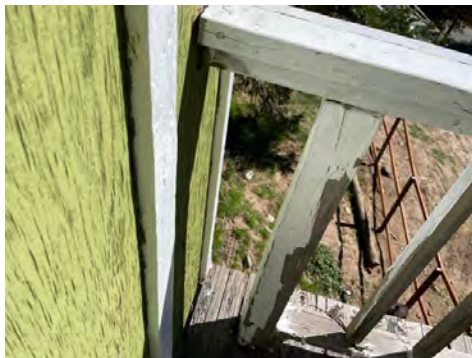
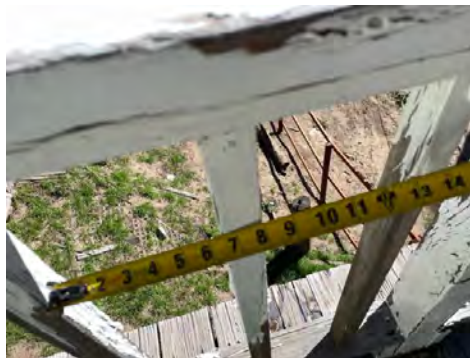
Spaces between deck guardrails balusters, beneath the guardrails or at the sides of the guardrails were too wide. Widely-accepted modern safety standards mandate that a 4-inch sphere may not pass through the handrail at any point. This condition is hazardous to small children.

Front

South

Top right deck

Contact a qualified carpenter.

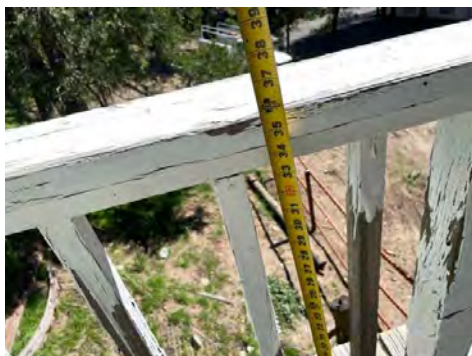
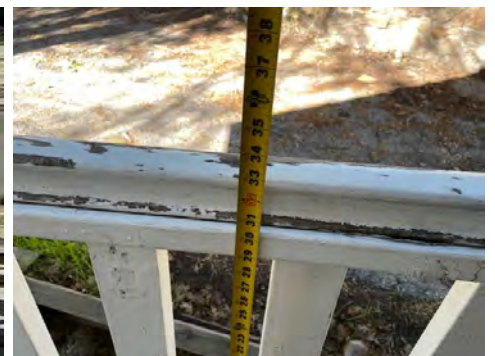
This condition is a safety concern.

South top deck

Front

Contact a qualified carpenter.

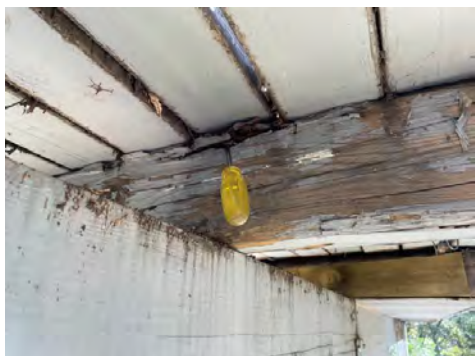
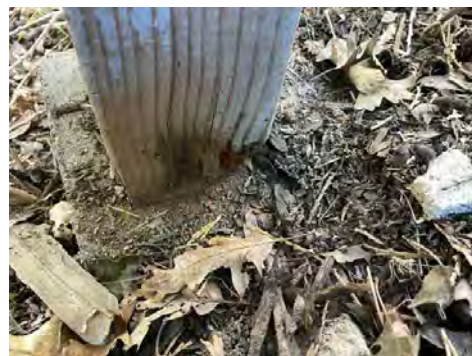
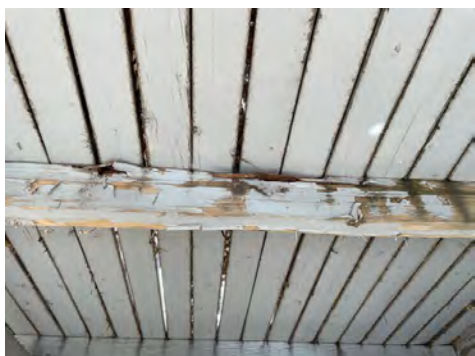
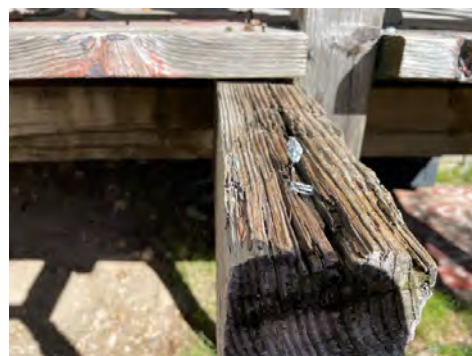
I observed wood rot at the deck. This condition is a structural defect.

Right front

Front

Front right

South

Correction and further evaluation of the deck is recommended.

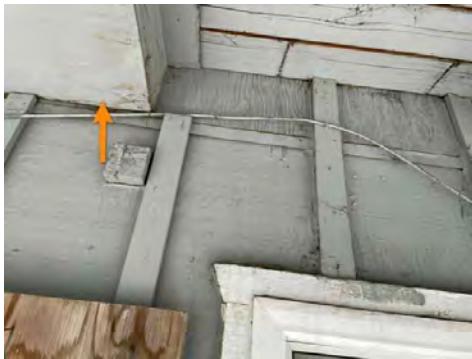
Deck was observed to have general poor construction. The top and lower deck on the South side were not constructed properly and there was a room built on top of the top deck. Recommend qualified deck contractor and engineer evaluate.

Cant see under the sheeting under the room addition

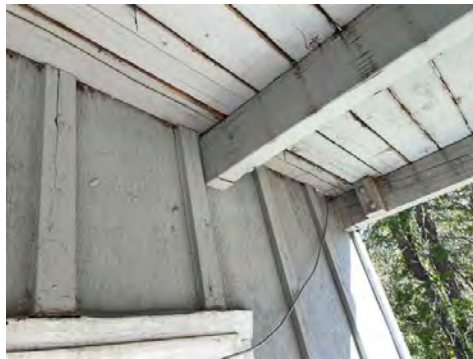
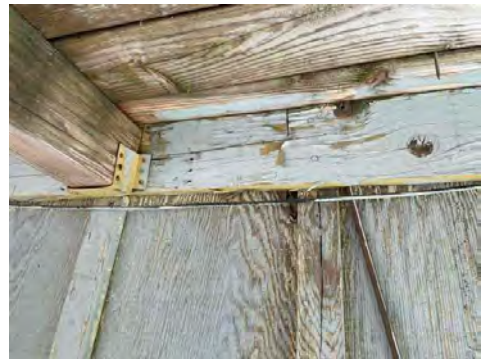
South ledger board not secured to home correctly

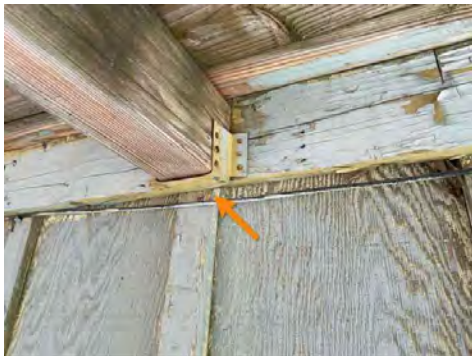
South Small Hangers

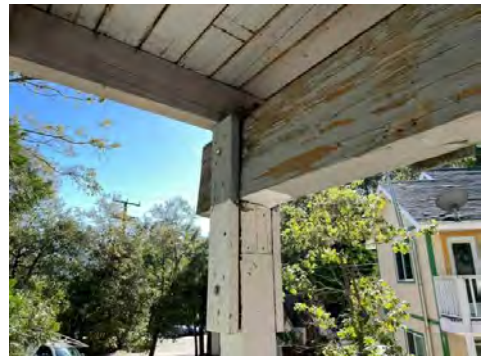
South/ Spliced post, Not properly bracketed.

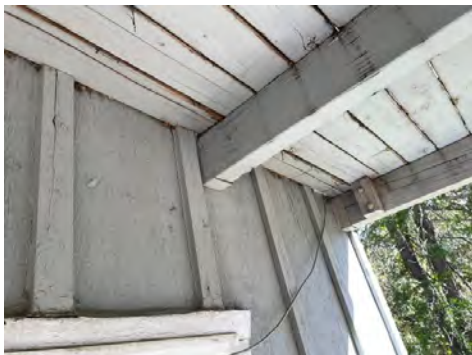
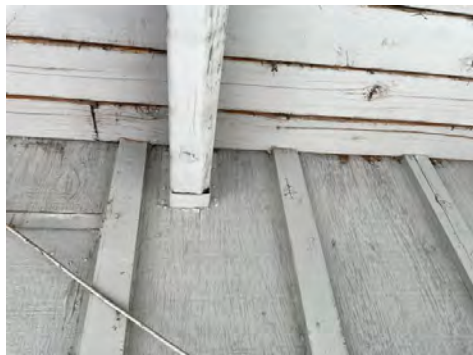
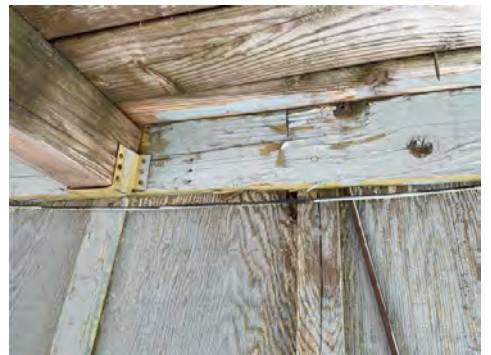
I observed indications of a defect at the ledger board of the deck.

The ledger board is not properly attached to the building. Incorrect fasteners were used. This can cause the deck to pull away from the building and possibly collapse. Modern code calls for "ledgerlok" type fastener to be used.

Contact a qualified deck contractor.

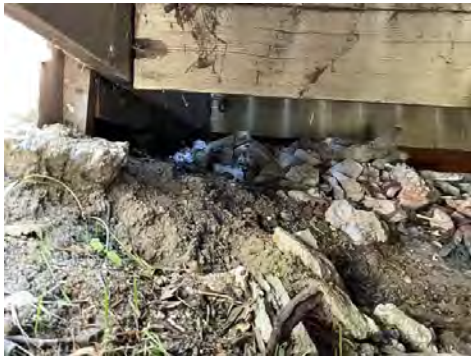
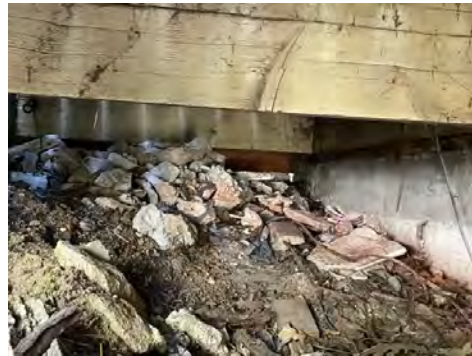
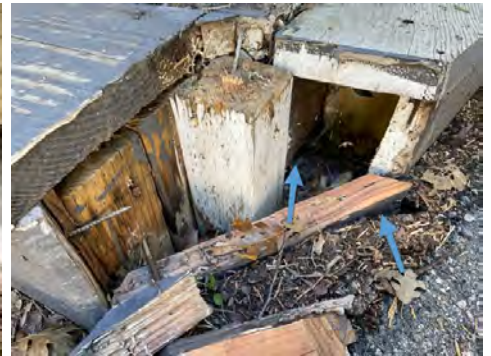
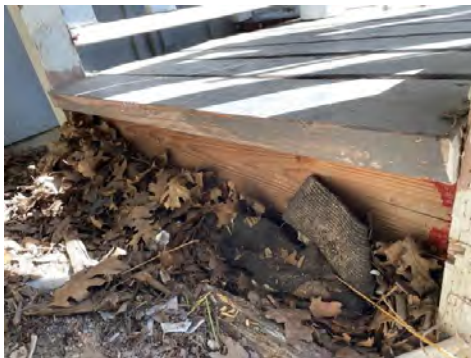
One or more posts or/and structural framing which support this deck and stairway had contact with soil at the time of the inspection. Wood in contact with soil will eventually decay. The decayed area will crush under the weight of the load it supports. This condition may eventually result in damage to the stairway or the development of unsafe structural conditions. The Inspector recommends that all posts and structural components supporting the stairway and deck be protected from contact with soil.

Contact a qualified carpenter.

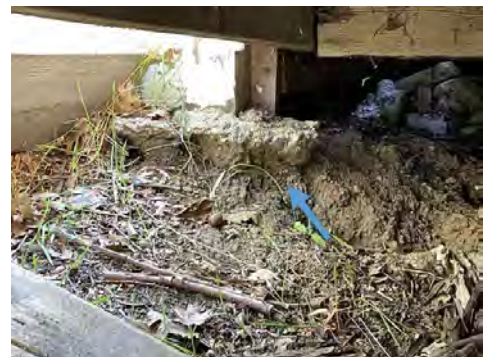
West

Foundation pier footing was undermined. Recommend repairs to eliminate settling / further damage.

Contact a qualified professional.

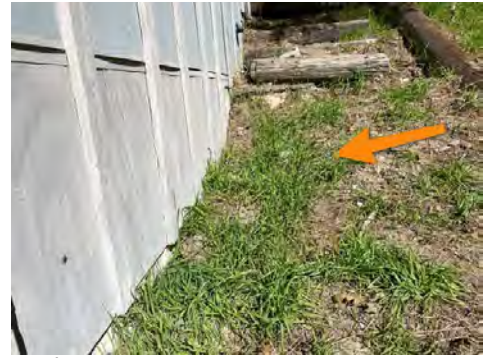
Back

Grading is sloping towards the home in some areas. This could lead to water intrusion and foundation issues.

The ground around a house should slope away from all sides, ideally 6 inches for the first 10 feet from the house foundation perimeter. Downspouts, surface gutters and drains should also be directing water away from the foundation.

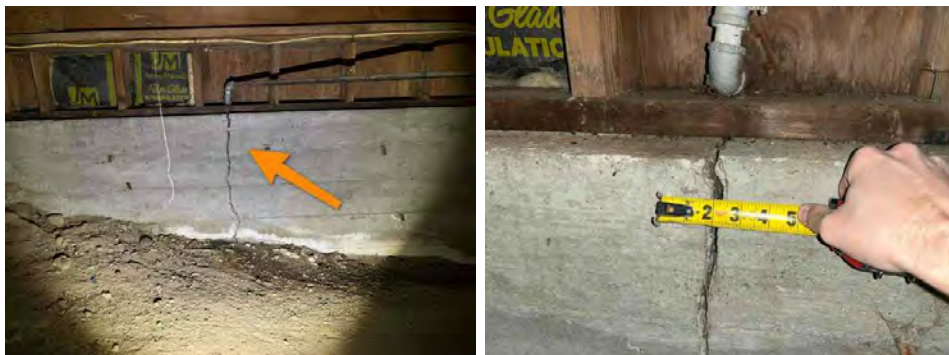
Foundation had major cracking. Recommend a structural engineer evaluate and provide a report on course of action and remedy.

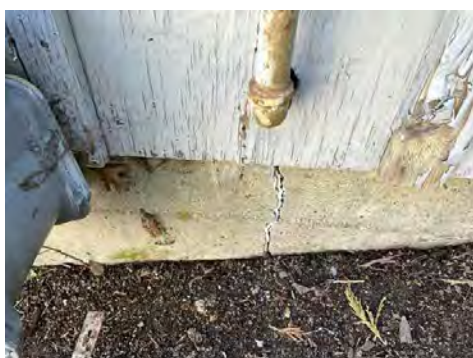
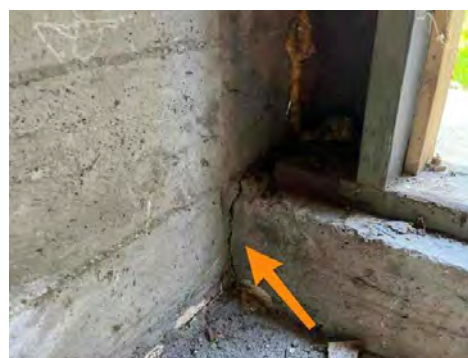
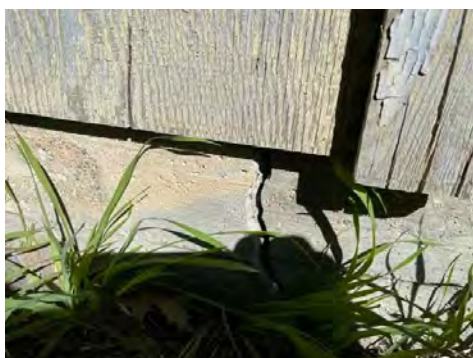
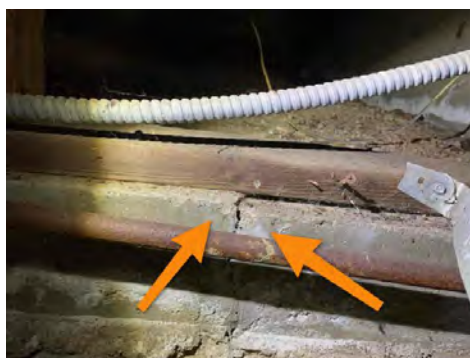
Foundation had moderate to major cracking. Recommend a structural engineer evaluate and provide a report on course of action and remedy.

North

Back left corner

South

Stem wall

Contact a qualified professional engineer

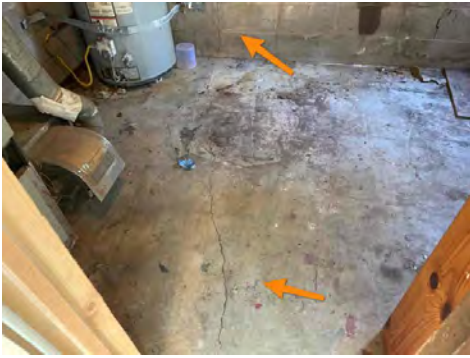
The floor slab shows movement/settling due to soil movement.

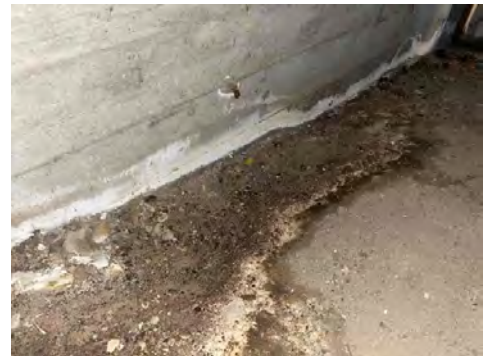
I observed indications of active water penetration into the crawlspace.

Correction and further evaluation is recommended.

Contact a qualified professional.

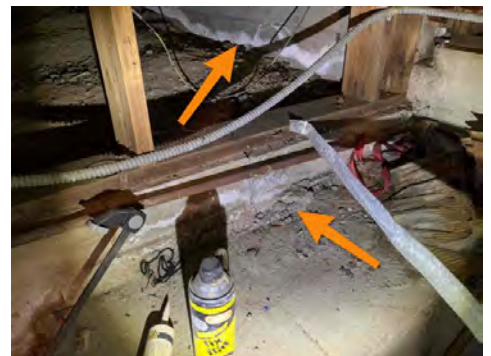
In the crawlspace, efflorescence was visible at some of the interior surfaces of the foundation walls. Efflorescence is a white, powdery residue left by moisture seeping through the foundation wall and its presence indicates high moisture levels in soil near the foundation. Excessively high moisture levels in soil supporting the foundation can cause various structural problems related to soil movement. The source of moisture should be identified and the condition corrected.

Contact a qualified professional.

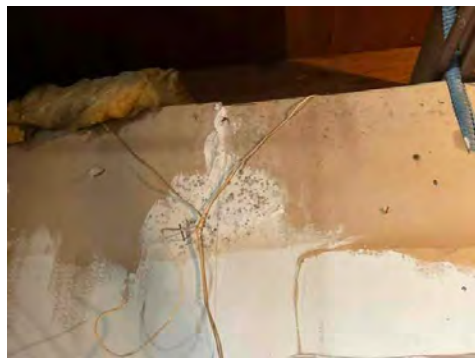
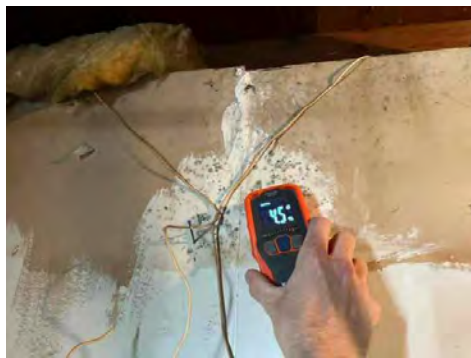
Crawlspace

We found evidence of microbial growth in the crawlspace. Recommended a mold inspection to further evaluate as well as remediation if necessary. We can provide a mold inspection if needed.

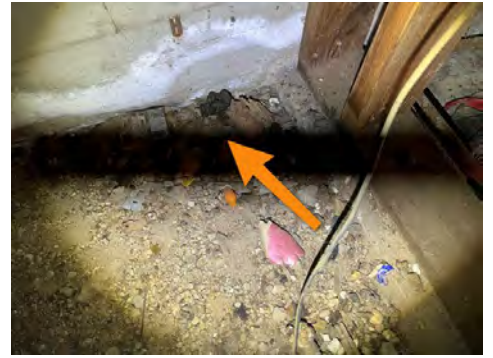
Raccoon feces was visible in the crawlspace. Raccoons can transmit serious or fatal diseases to humans, such as raccoon roundworm encephalitis and Leptospirosis. They can also transmit serious or fatal diseases to pets, such as distemper, rabies, and parvovirus. The Inspector recommends that you contact a qualified wildlife control contractor to discuss methods for discouraging raccoon presence near the home. After ensuring that any animals have been removed from the crawlspace, all possible points of animal entry should be blocked.

Contact a qualified pest control specialist.

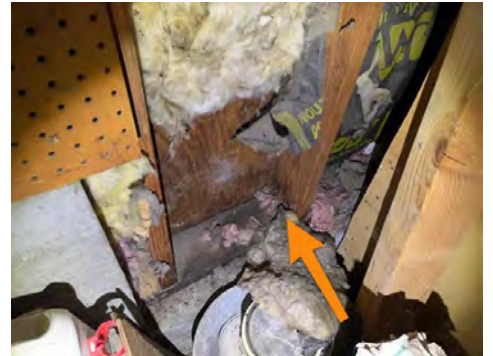
Back side

I observed indications that sometime in the past, there was water penetration or intrusion into the crawlspace.

Correction and further evaluation is recommended.

Recommend monitoring.

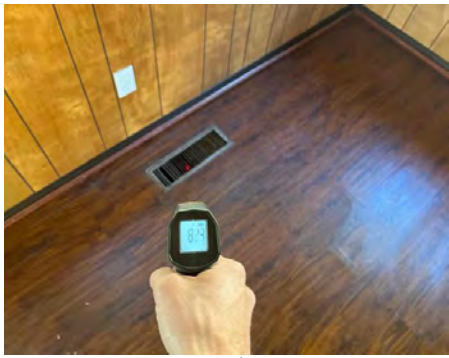
Supply

Temperature was taken at the supply and return air registers. The photos show the difference between the cooler air going into the furnace and the heated air exiting the unit at the air register.

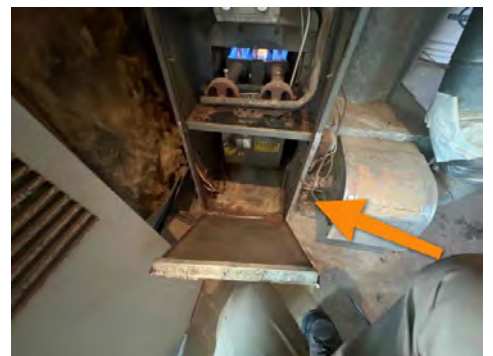
The safety switch located at the panel of the circulating blower fan for the furnace did not operate or function when I inspected it. Safety issue. Correction and further evaluation is recommended.

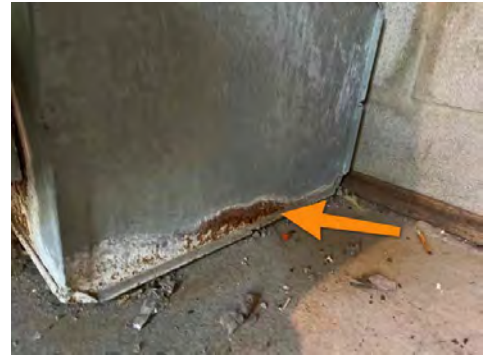
Furnace was corroded in one or more areas. This could be the result of improper venting, which the source would need to be identified. Recommend a HVAC contractor evaluate and repair.

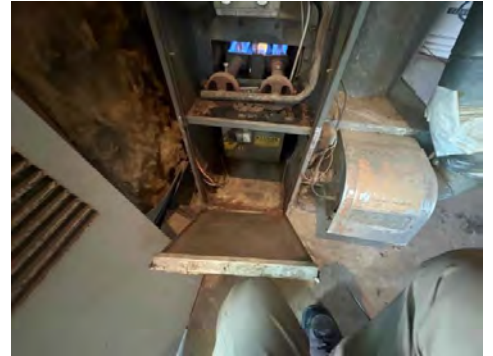
5.1.2 Equipment

CORROSION

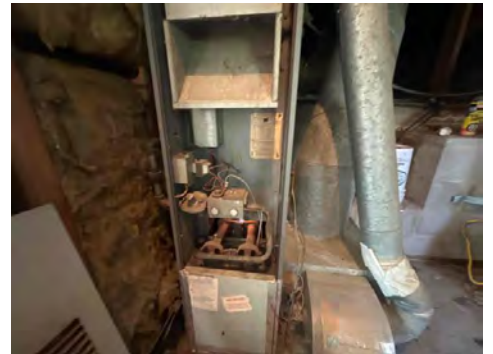
5.1.4 Equipment

OLD SYSTEM

I observed during my inspection that the system appeared to be old and at the end of its service life. It may not be reliable. Ask the homeowner or occupant about its recent performance. Regular maintenance and monitoring of its condition is recommended. Budgeting for repairs and future replacement is recommended. [InterNACHI's Standard Estimate Life Expectancy Chart for Homes](#)

Recommend monitoring.

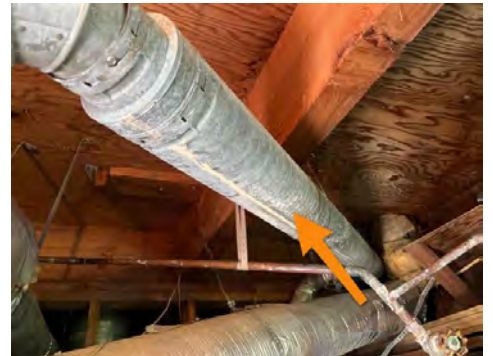
5.1.5 Equipment

B VENT CORROSION

B vent for furnace was corroded. This can lead to further damage if not repaired or replaced.

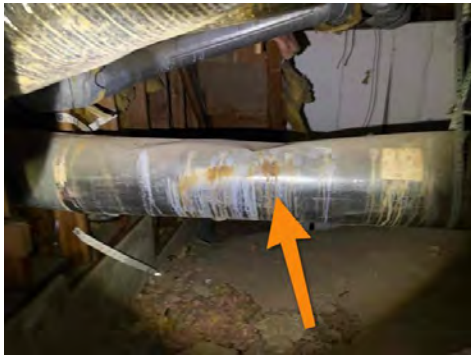
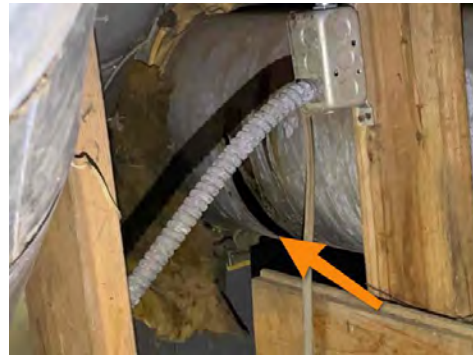
DAMAGED DUCT

Air supply duct was damaged. Recommend a qualified HVAC contractor repair.

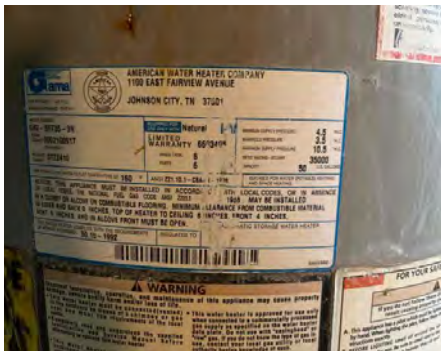
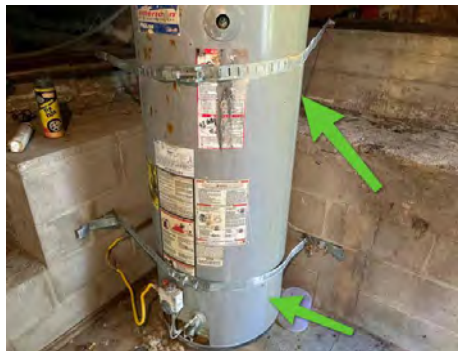
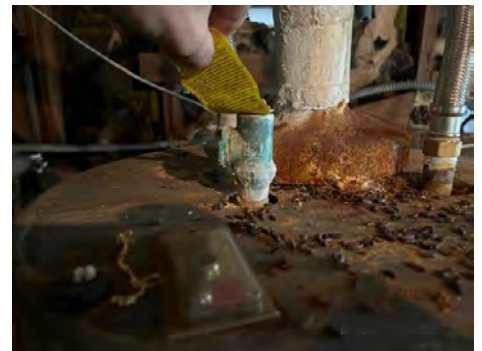
Photos: TPR Photo

This photo shows the TPR valve and discharge pipe.

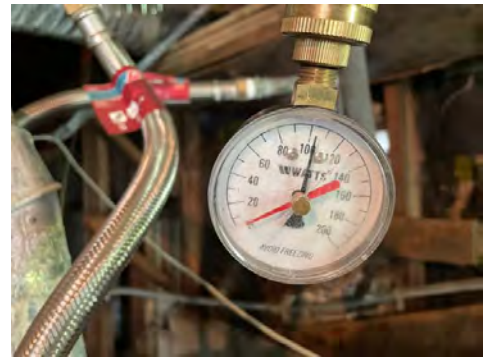
Your water pressure was observed to be above 80 PSI. We found your water pressure to be 102 PSI.

Contact a qualified professional.

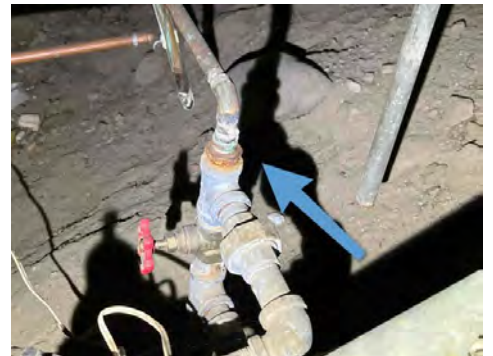
6.2.2 Water Distribution Systems & Fixtures

ELECTROCHEMICAL REACTION - GALVANIZED PIPE

You should not connect a brass fitting directly to a galvanized steel pipe because electrochemical reactions between the two metals will cause corrosion. We recommend you use instead an insulating fitting to connect them.

Contact a qualified professional.

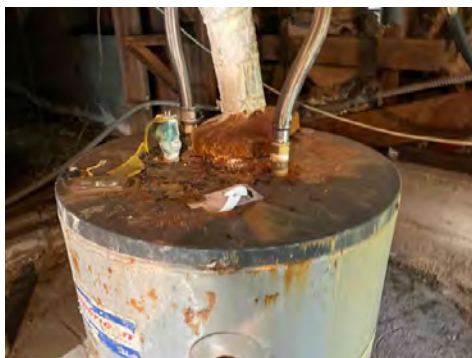
6.4.1 Hot Water Heater

CORROSION

Corrosion was noted at the water heater. Recommend a qualified plumber evaluate for repair/replacement.

Contact a qualified plumbing contractor.

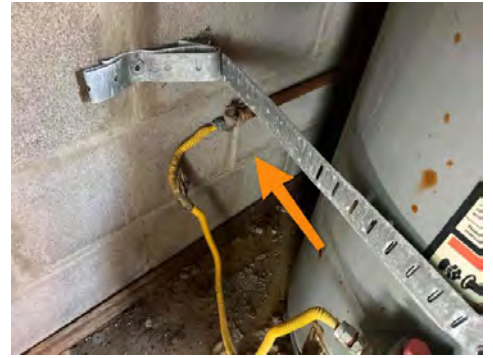
6.4.2 Hot Water Heater

GAS WATER HEATER: FUEL SUPPLY, NO DRIP LEG

The gas supply pipe had no drip leg. A drip leg is generally recommended but not always required, depending on the local Authority Having Jurisdiction (AHJ). The purpose of a drip leg is to prevent particulates or moisture from condensation from entering and clogging the water heater gas valve, which can cause the water heater to shut down. You may wish to consult with local plumbing contractors concerning the advisability of installing a drip leg in the gas line.

Contact a qualified plumbing contractor.

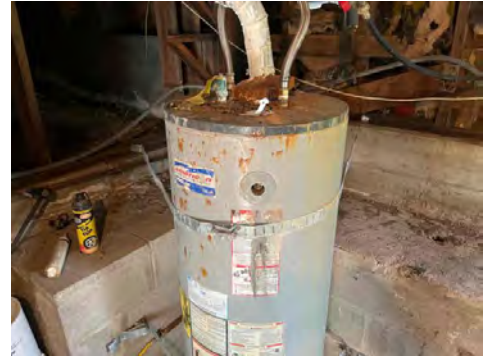
6.4.3 Hot Water Heater

NEAR END OF LIFE

Water heater showed normal signs of wear and tear. Recommend monitoring it's effectiveness and replacing in the near future.

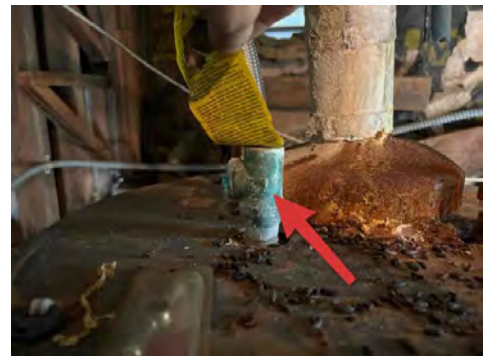
The water heater temperature/pressure relief (TPR) valve had no discharge pipe installed. If the valve were to activate while a person was nearby, that person could be badly scalded. The Inspector recommends that a properly-configured TPR discharge pipe be installed by a qualified plumbing contractor.

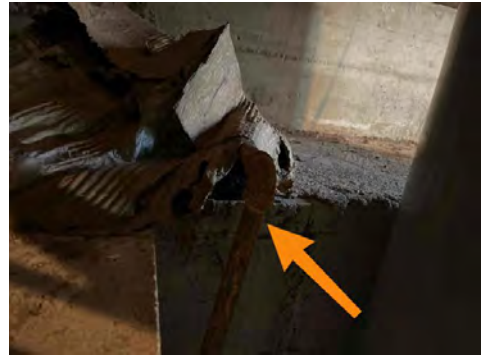
Gas pipes were corroded. This can lead to gas leaks. Recommend contacting local utility company for evaluation and repair.

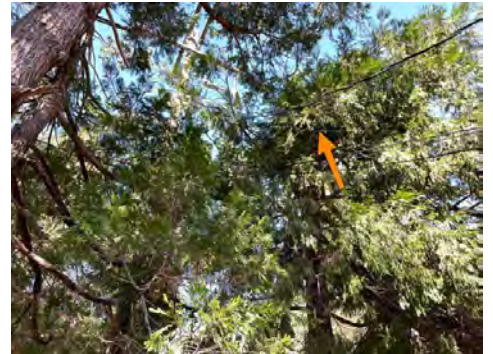
The overhead electrical line is in contact with the tree. Hazardous.

Contact a qualified electrical contractor.

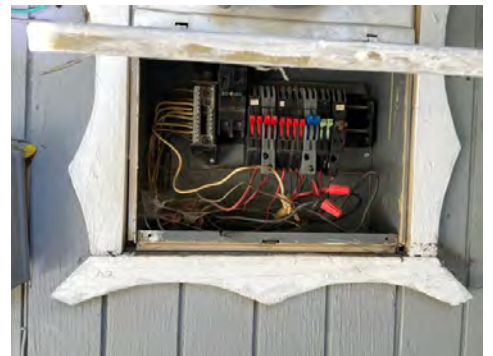
7.2.1 Main Panel, Service & Grounding,

DEAD FRONT COVER: COVER MISSING

The Dead front cover of the service panel was missing and energized electrical components were exposed to touch. This condition is a shock/electrocution hazard and should be corrected immediately.

Contact a qualified electrical contractor.

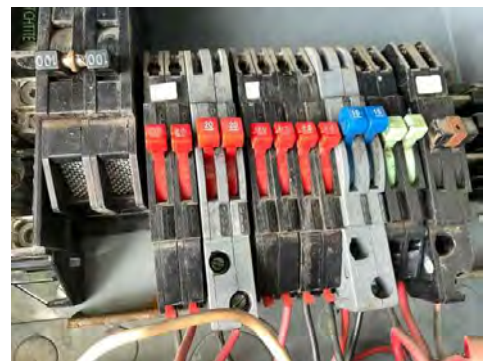
I observed indications that the panelboard was manufactured by Zinsco. These panels have a reputation for being problematic and further evaluation by a qualified electrician is recommended. Information about defective Zinsco panels is widely available on the internet.

I could not determine the fact that the panel is a Zinsco for absolute positive as the cover and labels are missing. But, the colored breakers indicate the the panel is a Zinco or Sylvania panel.

Recommendation

Contact a qualified electrical contractor.

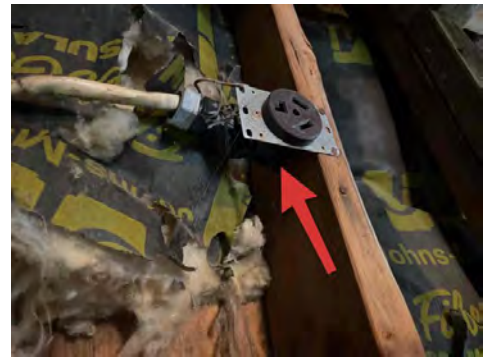
MISSING JUNCTION BOX

220 wiring was not protected or secured by a junction box. This is a safety hazard and should be corrected.

Contact a qualified professional.

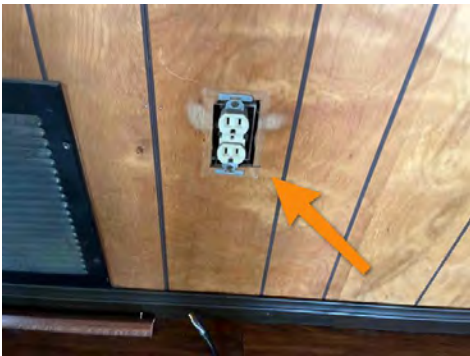
Living Room

COVER PLATES MISSING

One or more receptacles are missing a cover plate. This causes short and shock risk. Recommend installation of plates.

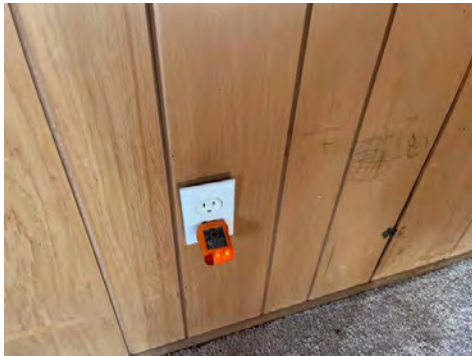
3rd Floor Bedroom

LOOSE OUTLET

Outlet was loose and should be secured properly.

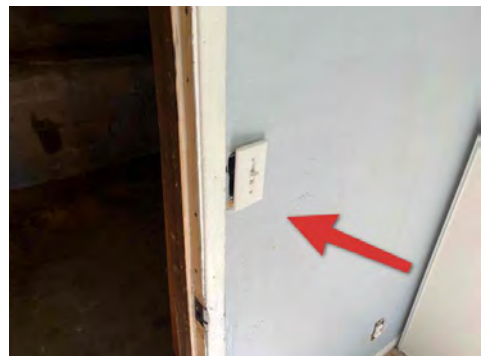
1ST FLOOR

Switch was loose and arced when moved left to right. Safety hazard.

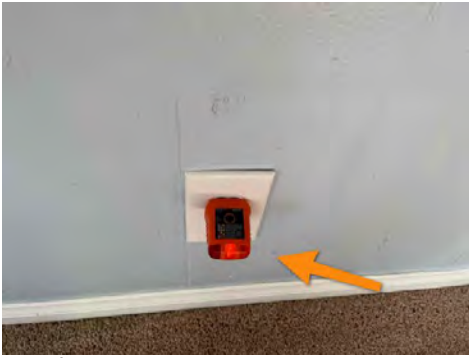
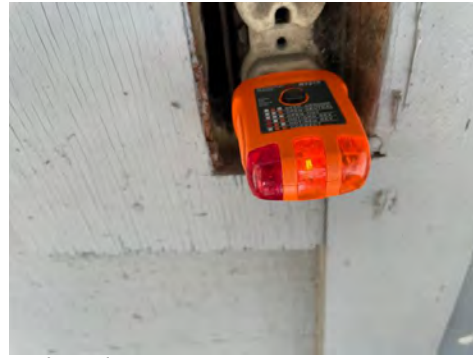
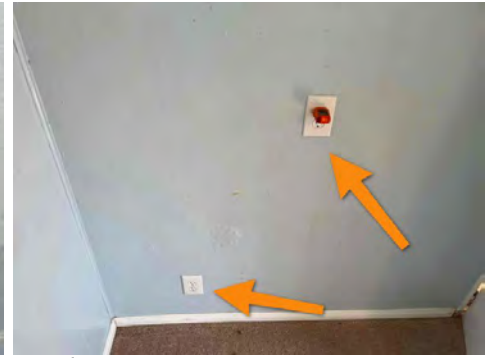
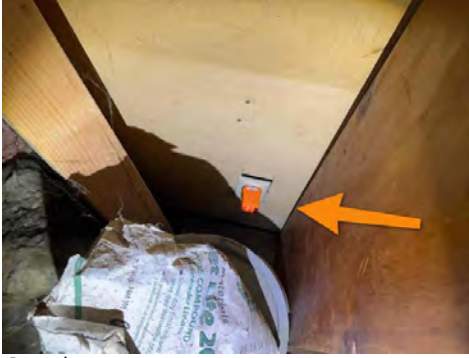
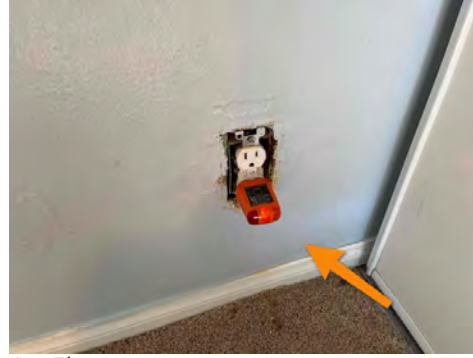
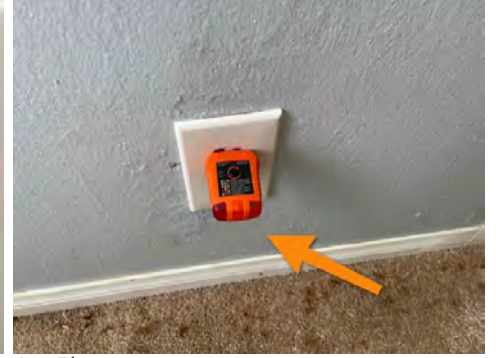
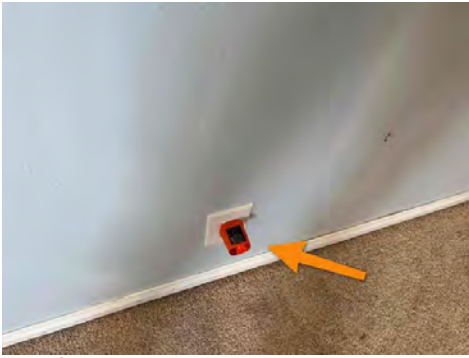
UNGROUND RECEPTACLE

One or more receptacles are ungrounded. To eliminate safety hazards, all receptacles in kitchen, bathrooms, garage & exterior should be grounded.

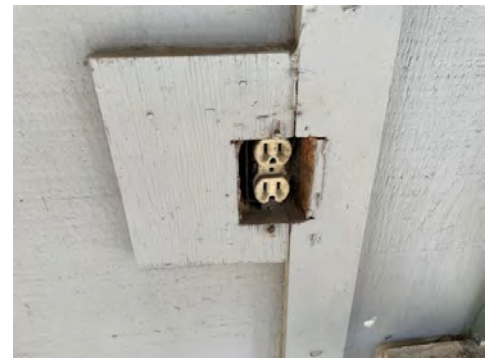
Right side

EXTERIOR OUTLET COVER DEFECT

Exterior outlet was missing an approved weather proof exterior outlet cover.

Contact a qualified professional.

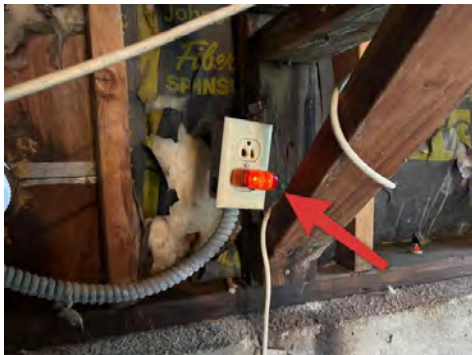
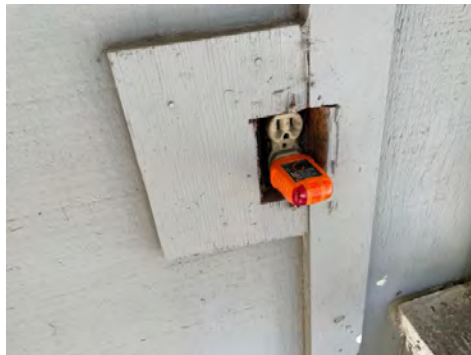
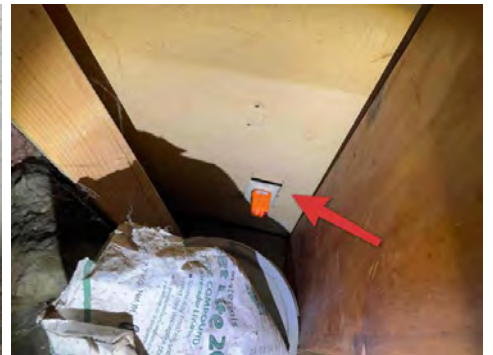
Although GFCI protection may not have been required at the time the home was built, for safety reasons, the Inspector recommends that electrical receptacles located in basements, crawlspaces, garages, the home exterior, and interior receptacles located within 6 feet of a plumbing fixture be provided with ground fault circuit interrupter (GFCI) protection in good working order to avoid potential electric shock or electrocution hazards. This can be achieved relatively inexpensively by: 1. Replacing an individual standard receptacle with a GFCI receptacle (will protect that receptacle and all those downstream). 2. Replacing the electrical circuit receptacle located closest to the overcurrent protection device (usually a breaker) with a GFCI receptacle (will protect that receptacle and all those downstream). 3. Replacing the breaker currently protecting the electrical circuit that contains the receptacles of concern with a GFCI breaker (will protect all receptacles on that circuit).

Contact a qualified electrical contractor.

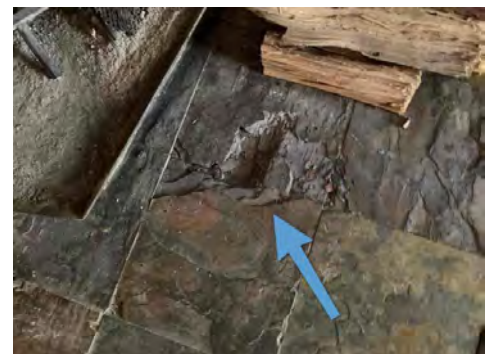
HEARTH DAMAGE

I observed indications of damage to the hearth.

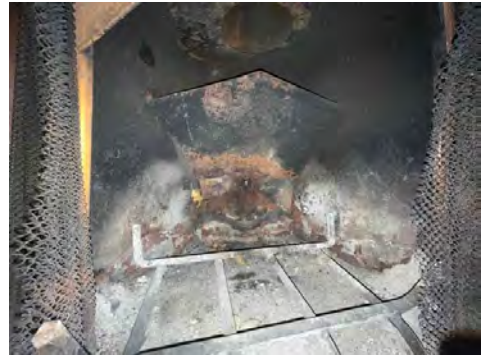
METAL FIREBOX RUST NOTED

The metal firebox shows evidence of rust and/or rusting.
Recommend cleaning and monitoring.

Contact a qualified chimney contractor.

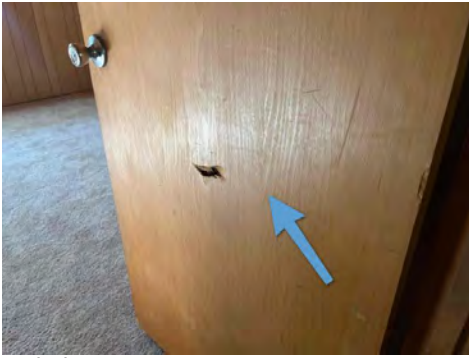
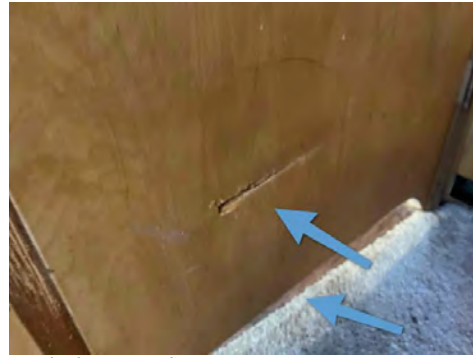
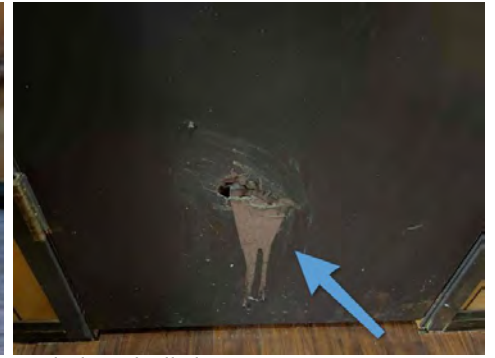
DAMAGED DOOR

Observed minor damage at doors.

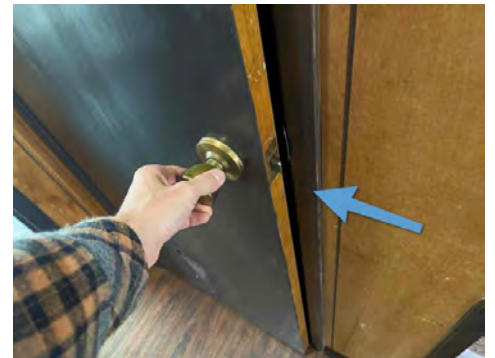
2nd Floor hall closet

Door latch and/or strike plate is out of alignment. Recommend a handyman repair.

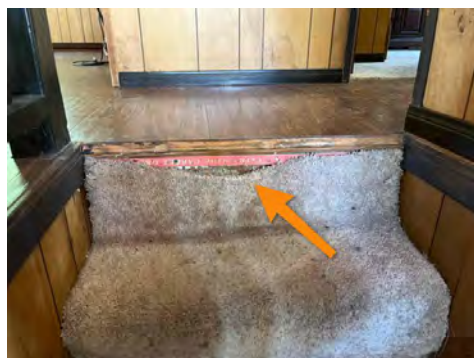
Stairway

DAMAGED (GENERAL)

The home had general moderate damage visible at the time of the inspection.

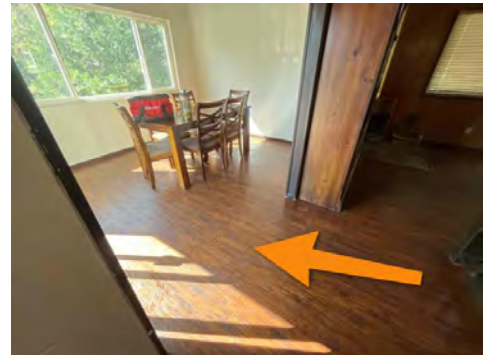
Flooring was observed to be uneven in portions of the house. Recommend further evaluation and repairs by qualified professional

Contact a qualified professional.

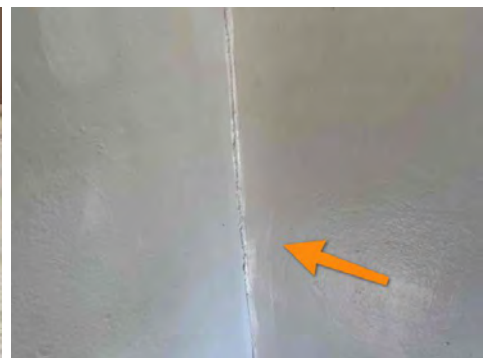
DRYWALL CRACKING

Minor to Moderate cracking was found. Appeared to be the result of long-term settling.

Contact a qualified professional.
