PEAK TO PEAK HOME INSPECTIONS INC.

RESIDENTIAL REPORT

597 Old Mill Rd
Crestline, CA 92325

OCTOBER 12, 2023

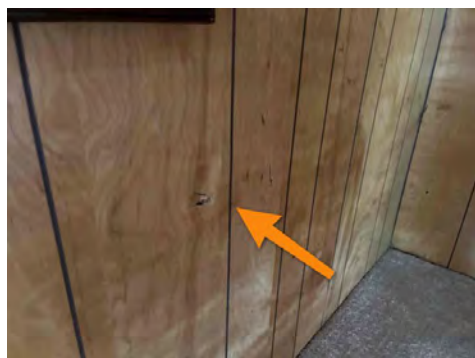
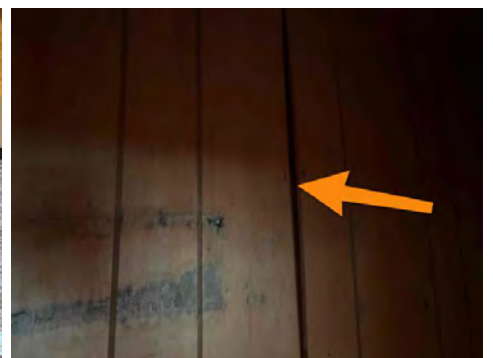
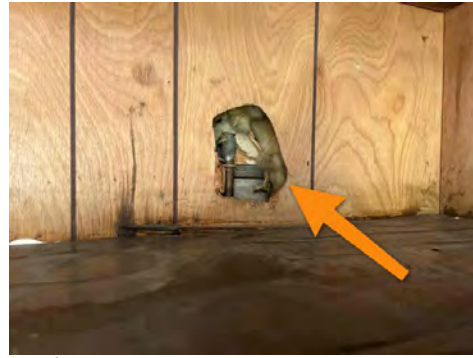
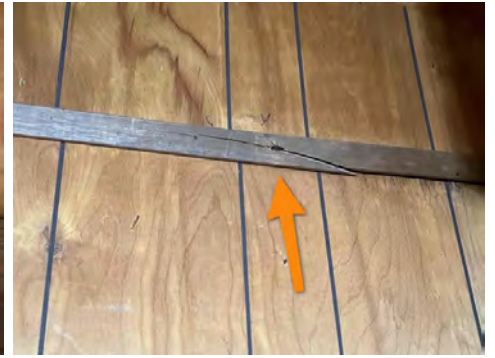
DAMAGED PANNELING

Wall paneling had missing/damaged sections.

Contact a qualified professional.

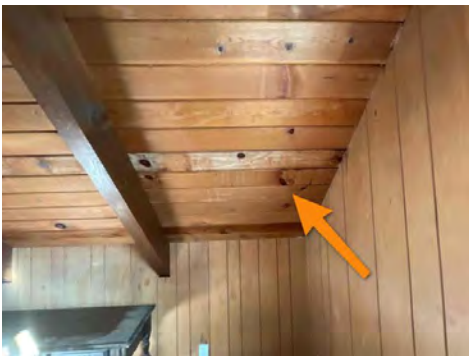
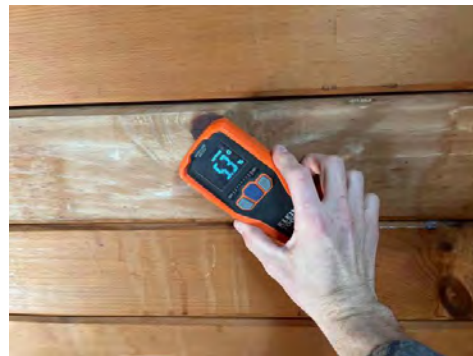
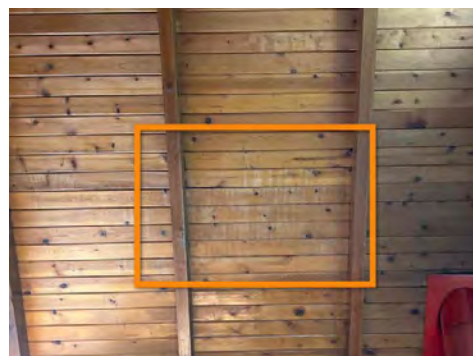
Ceiling was observed to have stains from prior water intrusion. Correction and further evaluation is recommended

Contact a qualified professional.

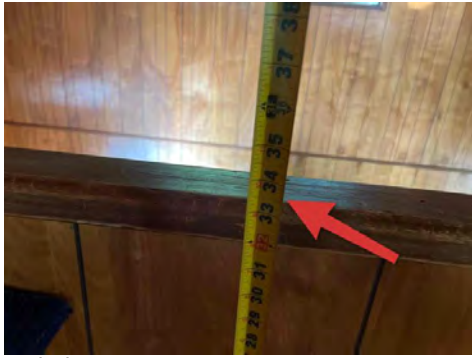
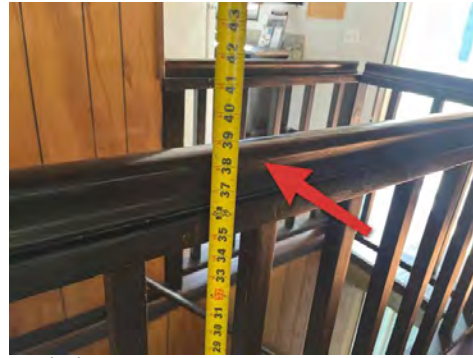
The horizontal guardrails protecting this stairwell were less than 42 inches in height. Although this condition is now considered a potential fall hazard, it is not uncommon in older homes such as this one, built during a time period during which safety standards were different from generally-accepted current safety standards. Homes are not required to be updated to comply with newly enacted safety standards. Because this is a safety issue, the Inspector recommends having the guardrails altered or replaced with guardrails at least 42 inches in height to comply with modern safety standards.

Contact a qualified professional.

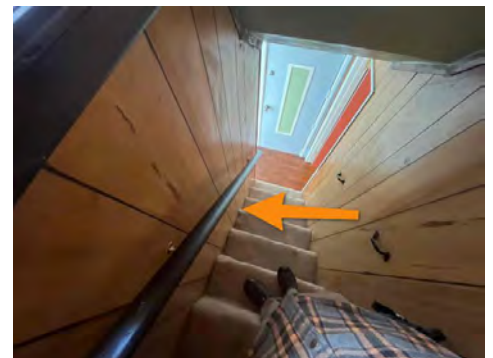
HANDRAIL IS LOOSE

On the right side when going up the stairs is loose

Contact a qualified professional.

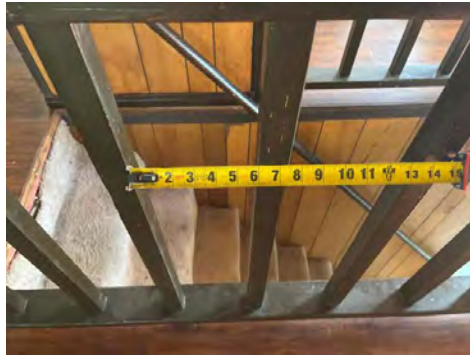
Stair-railing-spacing

STAIR BALUSTER SPACES TOO WIDE

I observed improper spacing between intermediate balusters, spindles and rails. This is a safety hazard, especially for small children.

- 4 3/8" Sphere
- 6" Sphere

Correction and further evaluation is recommended.

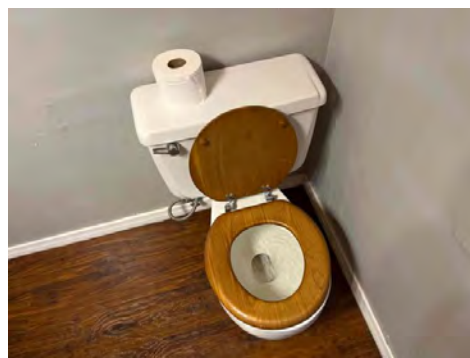
1st Floor

DEFECT AT FLUSHING MECHANISM

I observed indications of a defect at the flushing mechanism in the toilet tank.

Contact a qualified plumbing contractor.

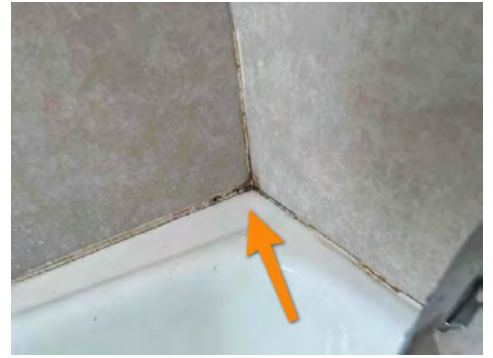
Sealant at the tub/shower was old and had visible discoloration consistent with microbial growth such as mold. The Inspector recommends that this sealant be removed and replaced to help prevent the development of unhealthy conditions.

Contact a qualified handyman.

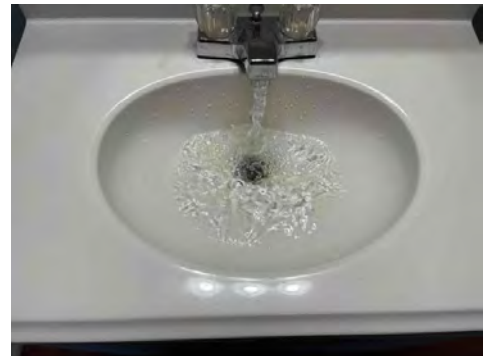
SINKS: SLOW TO DRAIN

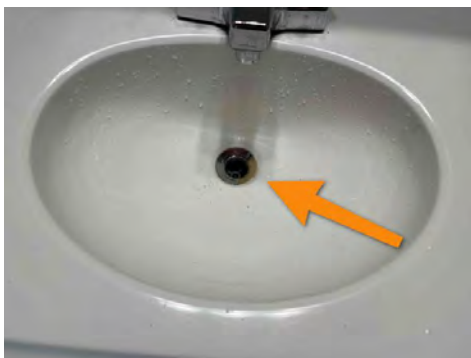
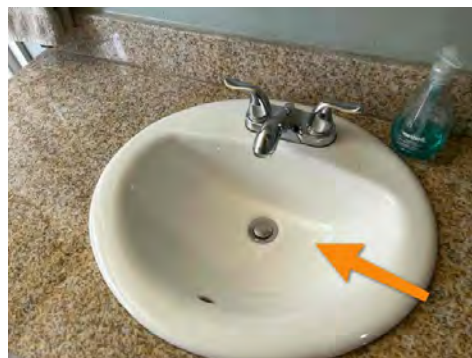
SINK: STOPPER INOPERABLE

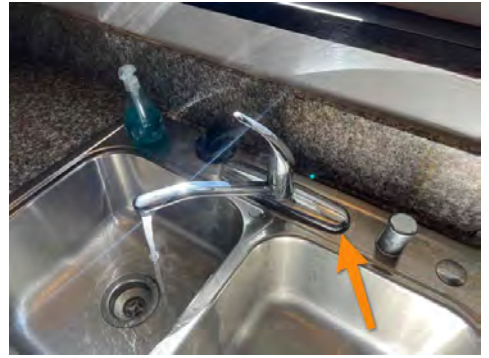
DEFECT AT SINK FIXTURE

I observed a defect at the kitchen sink fixture. Fixture is loose.

Recommended DIY Project

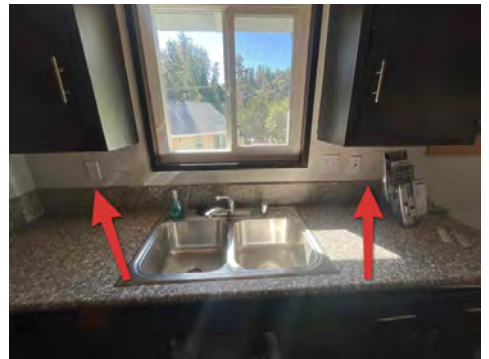
12.3.1 GFCI

GFCI WOULDN'T RESET

Recommendation

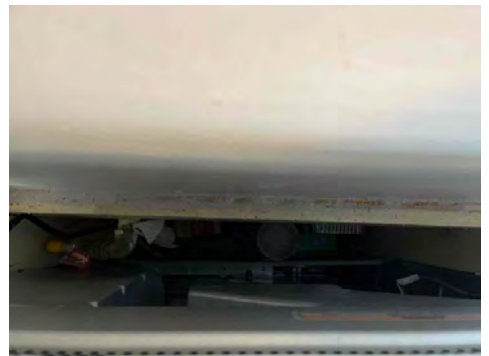
12.4.1 Range/Oven/Cooktop

MISSING ANTI-TIP

I observed that the stove and oven appliance was not fastened to the wall. Anti-tip device is missing. This poses a safety hazard to children.

Recommendation

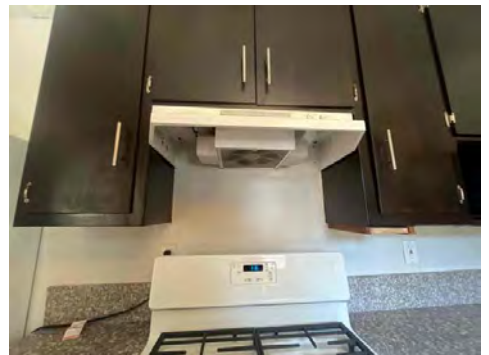
12.5.1 Exhaust Fan

FAN DID NOT TURN ON

I observed that the kitchen exhaust fan did not turn on as expected.

Recommendation

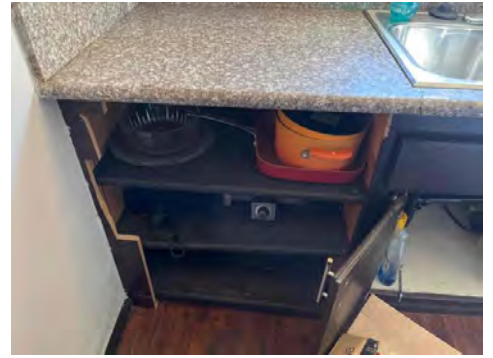
12.7.1 Countertops & Cabinets

DAMAGED CABINET

I observed damage at the kitchen cabinet.

Contact a qualified cabinet contractor.

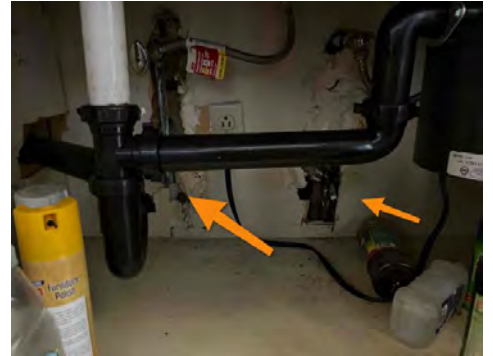
12.7.2 Countertops & Cabinets

HOLE UNDER SINK

Damaged drywall behind sink cabinet.

Recommendation

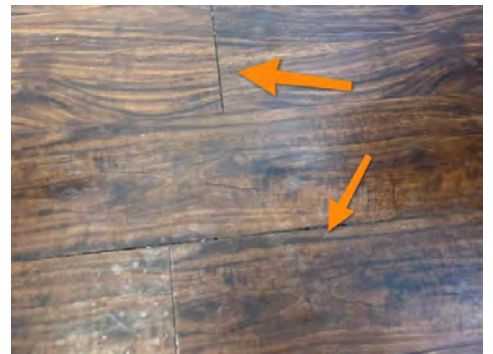
12.8.1 Floors, Walls, Ceilings

DAMAGED (GENERAL)

The floor had general moderate damage visible at the time of the inspection. Recommend service by a qualified contractor.

Recommendation
