INSPECTION REPORT
21011 North Hampton Way
Lake Forest CA 92630

INSPECTED BY
Ernest Lefferman
PRO
INSPECTIONS

INSPECTION DATE
📅 6/14/2024
🕒

Report ID
061424-02

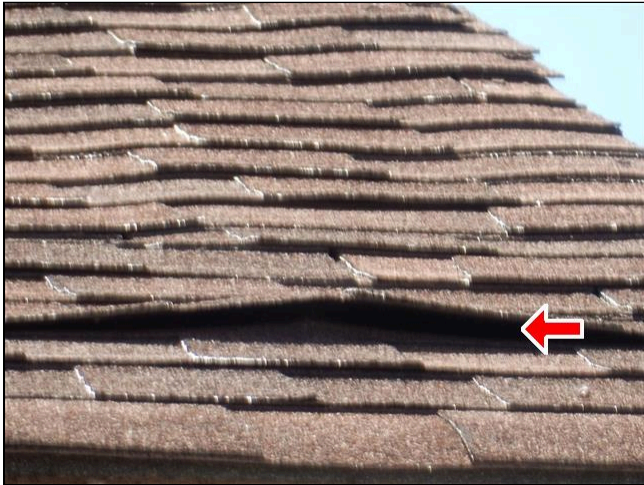
1.0 Item 1 (Picture)

1.0 Missing torn cracked and weathered shingles noted at various areas of the roof.

Nails are extracting at several areas and lifting the shingles. Advise to have a Roofer inspect and repair as needed.

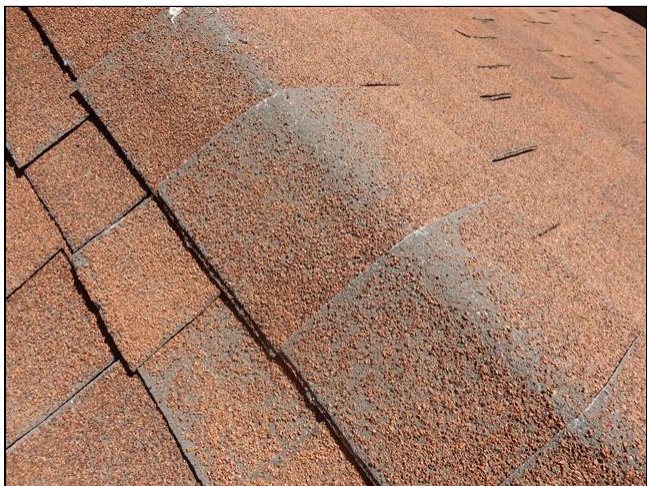
1.2 Item 1 (Picture)

1.2 Cracked and weathered shingles noted at Ridge caps. Advise to have a Roofer inspect and repair as needed.

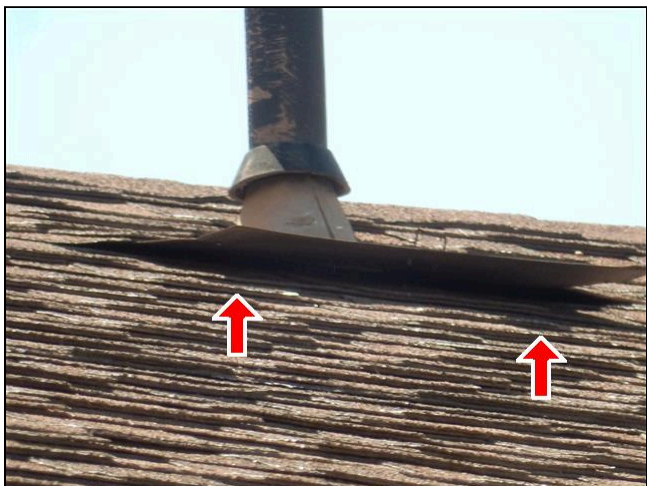
1.5 Item 1 (Picture)

1.5 The plumbing vent pipes need caulking or sealant around the perimeter of pipe and boot where boot flange has failed. Advise to have a Roofer inspect and repair as needed.

Vent pipe boot has lifted and is not sealed at the front slope. Advise to have a Roofer inspect and repair as needed.

Sealant along the chimney flashing is failing. Advise to have a Roofer inspect and repair as needed.

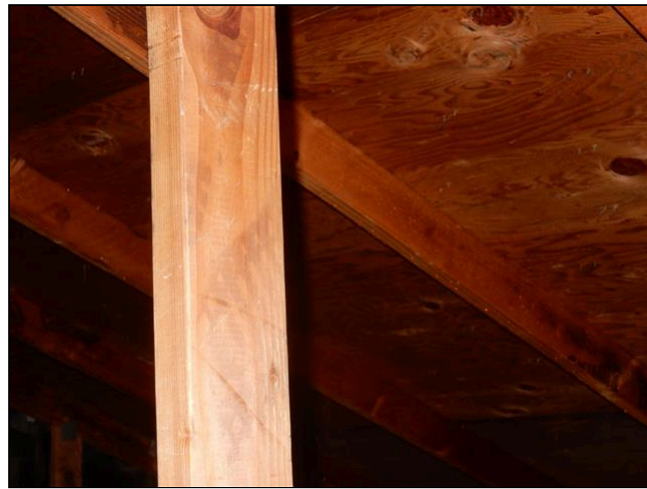
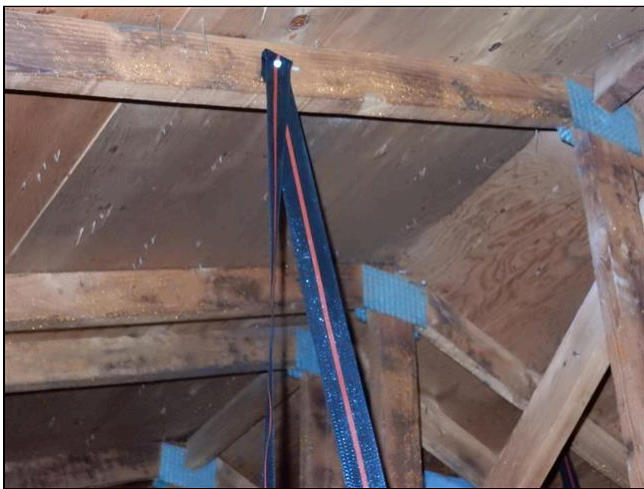
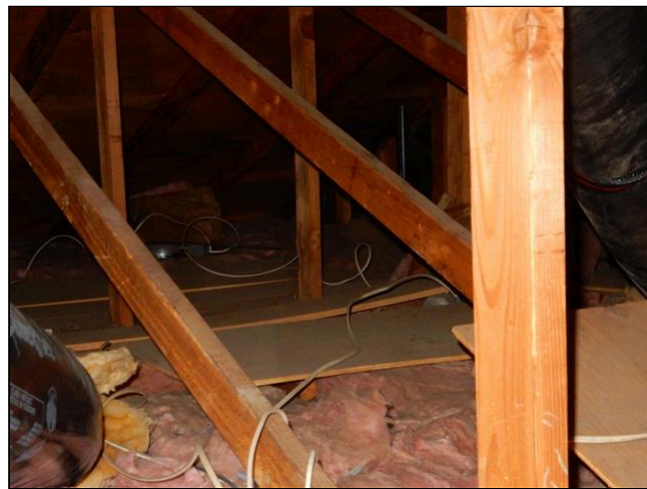
1.10 View of the rafters and supports.

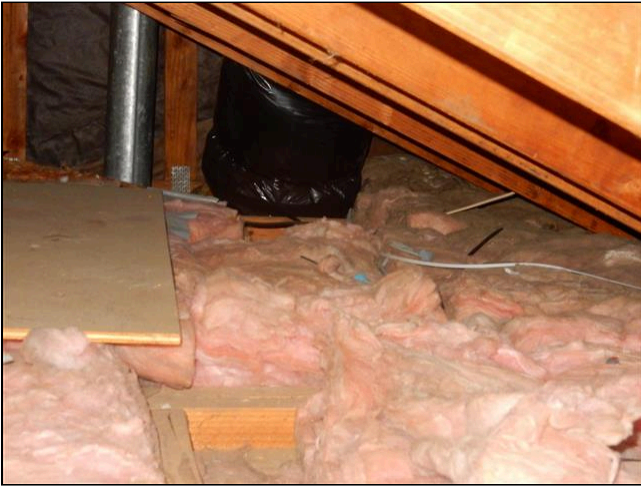
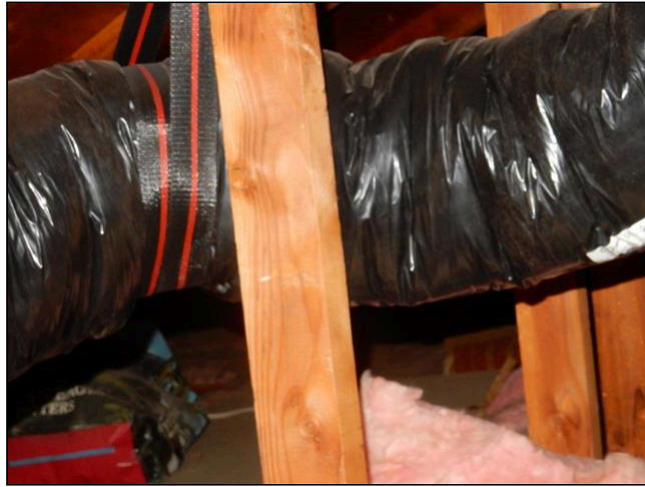
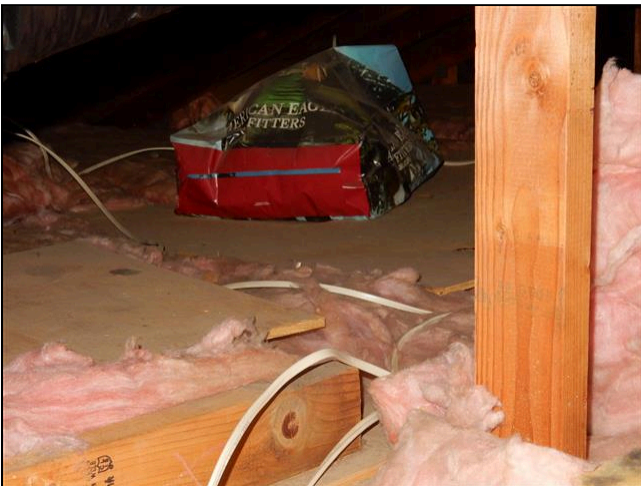
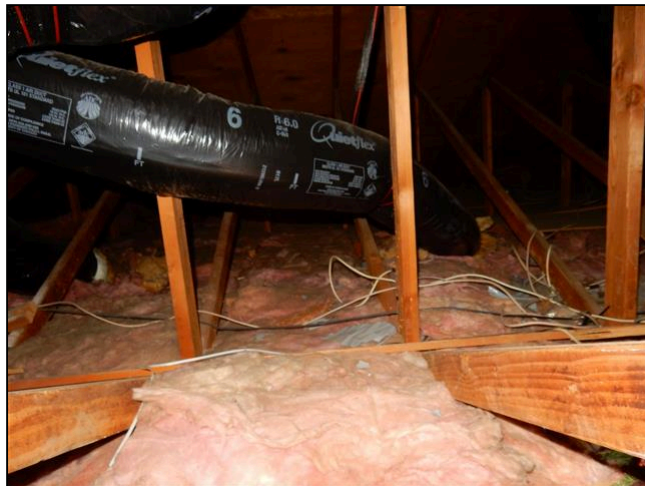
1.12 View of the insulation.

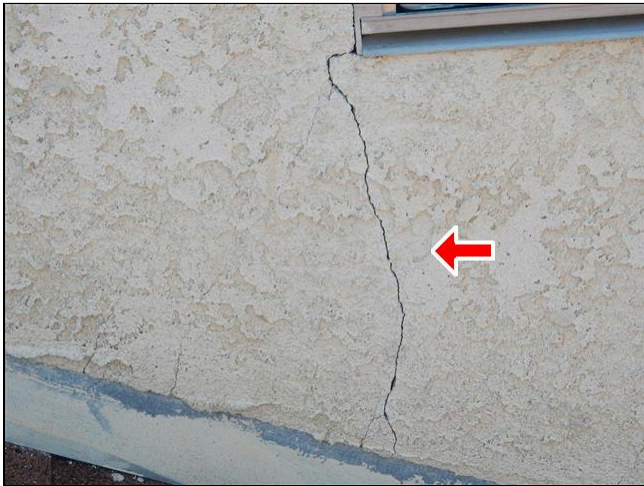
2.0 Item 1 (Picture)

2.0 Stucco siding is deteriorated at the left side behind the condenser.

Cracks and or chips noted to the stucco siding at several areas.

Patchwork noted to the stucco siding around the window rear of the house.

Doggy door is not water proof. Advise to repair as needed.

Stucco siding is not sealed properly at the side of the planter box.

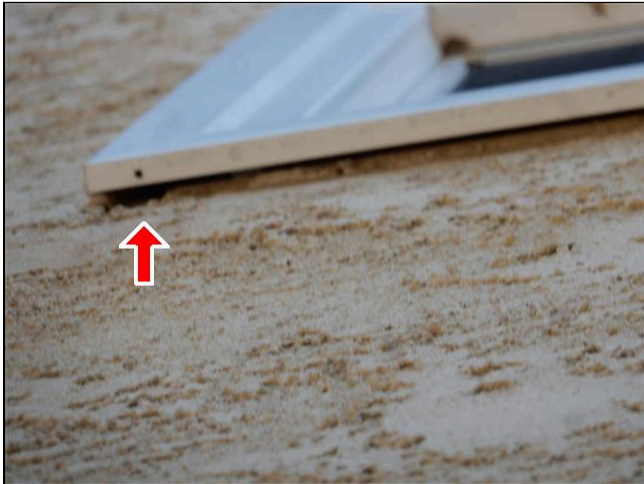
2.2 Item 1 (Picture)

2.2 One window is not sealed properly at the right side of the house. Advise to have a Contractor inspect and repair as needed.

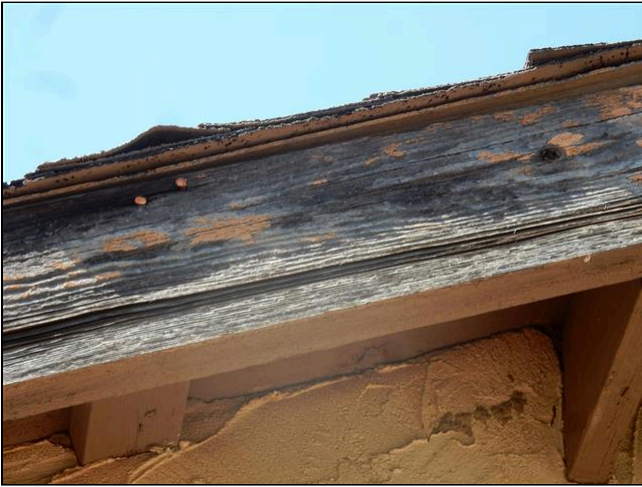
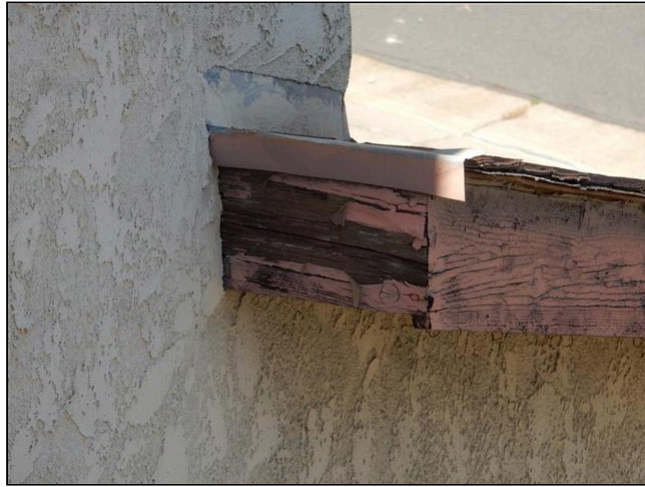
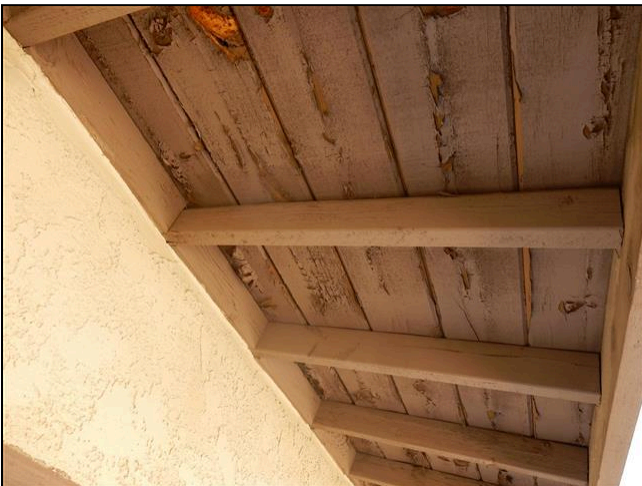
2.5 Paint is peeling at the fascia boards and eaves.

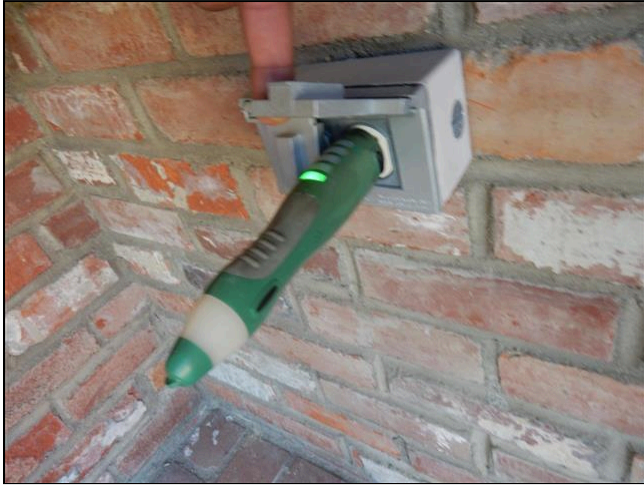
2.7 Item 1 (Picture)

Three prong outlet at the rear yard is not grounded or a GFCI. Advise to have a Electrician inspect and repair as needed.

Junction box and conduit are loose at the rear of the house. Advise to repair as needed.

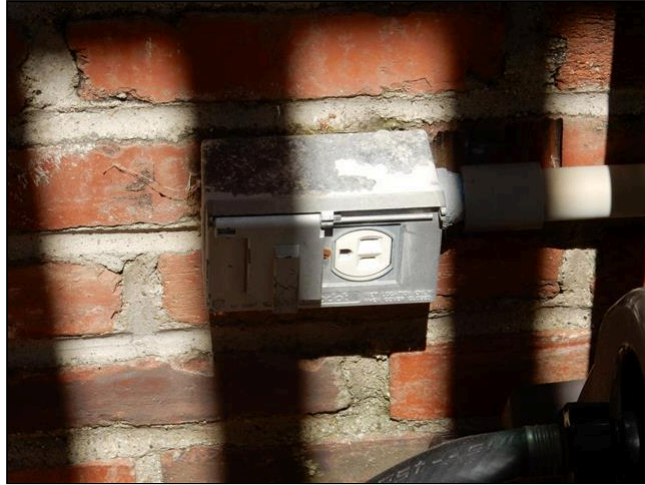
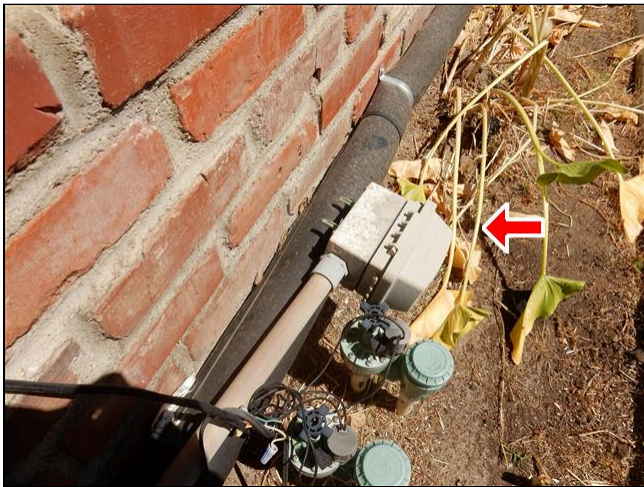
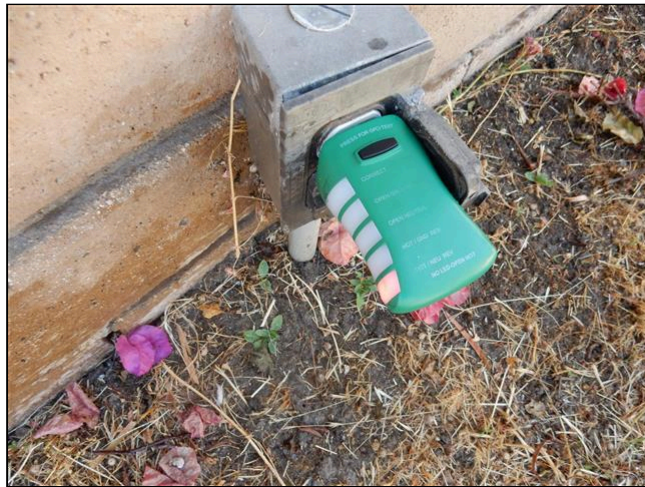
2.7 Exterior outlets are three prong grounded outlets. Advise to have a Electrician inspect and upgrade to GFCI with weather covers.

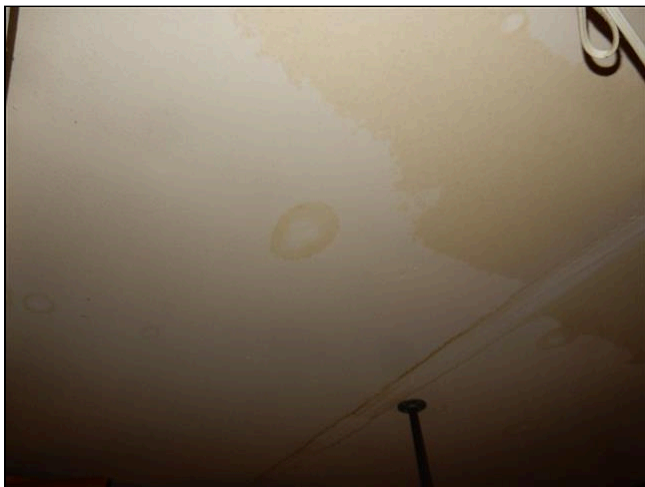
3.0 Item 1 (Picture)

3.0 Water stains noted to the ceiling at several areas.

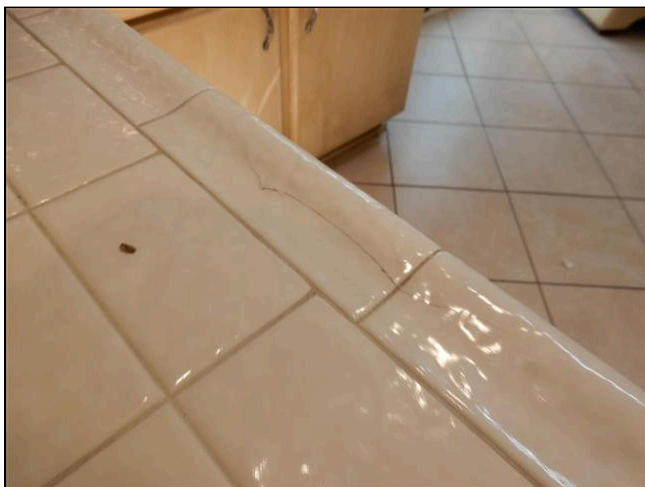
4.3 Item 1 (Picture)

4.3 Cracks noted to the tiled countertop at several areas.

Chips noted to the sink at several areas.

Laminate countertop edge is weathered.

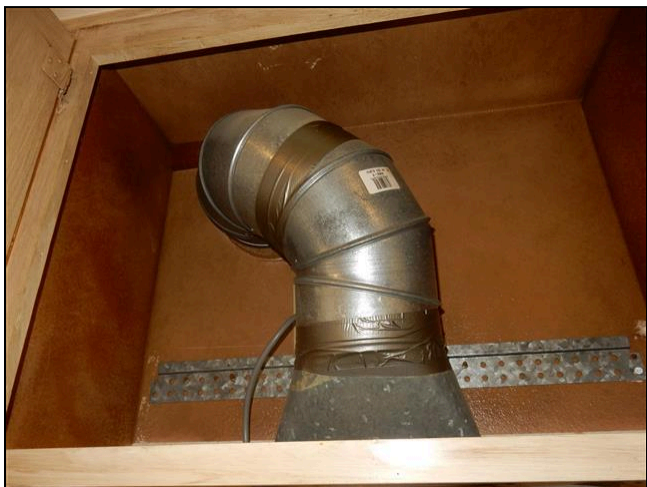
4.9 Item 1 (Picture)

4.9 Improper type of tubing tape used for vent pipe. Advise to replace with Aluminum tape.

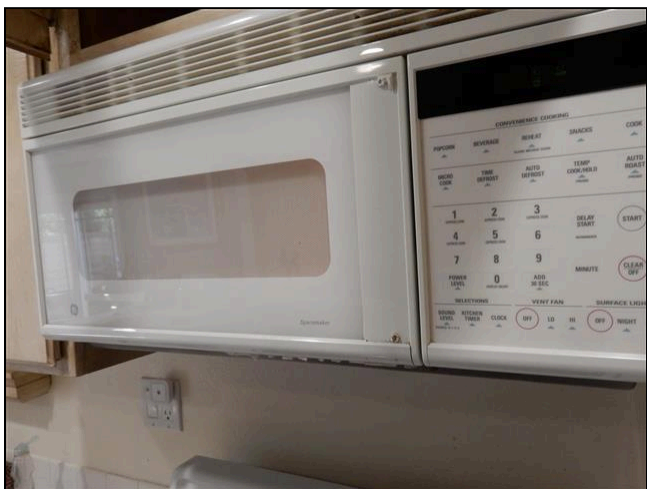
4.11 Item 1 (Picture)

4.11 Microwave door handle is missing. Advise to repair or replace as needed.

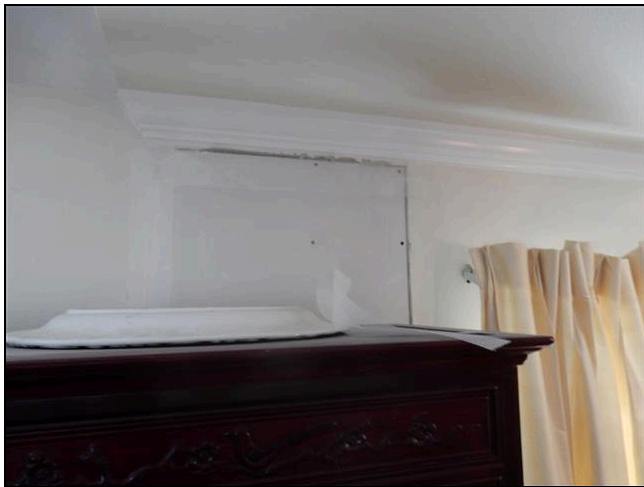
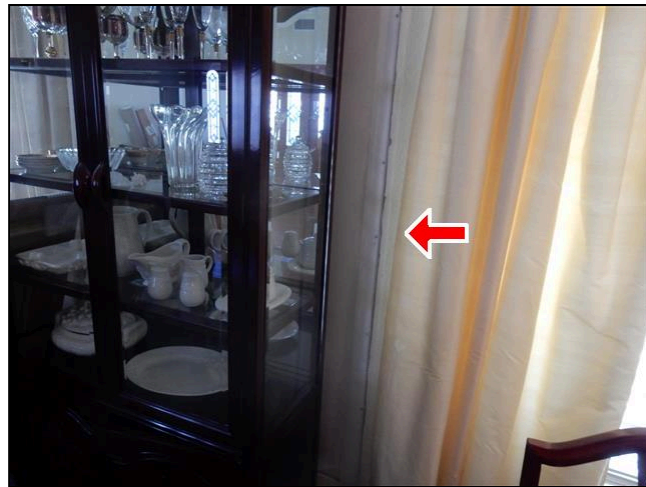
5.2.A Item 1 (Picture)

5.2.A Wall has been cut open and improperly repaired or unfinished.

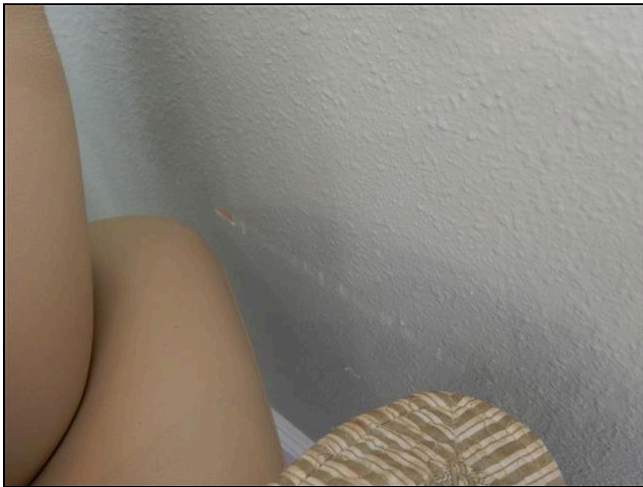
5.1.C Item 1 (Picture)

5.1.C Wall is damaged at several areas.

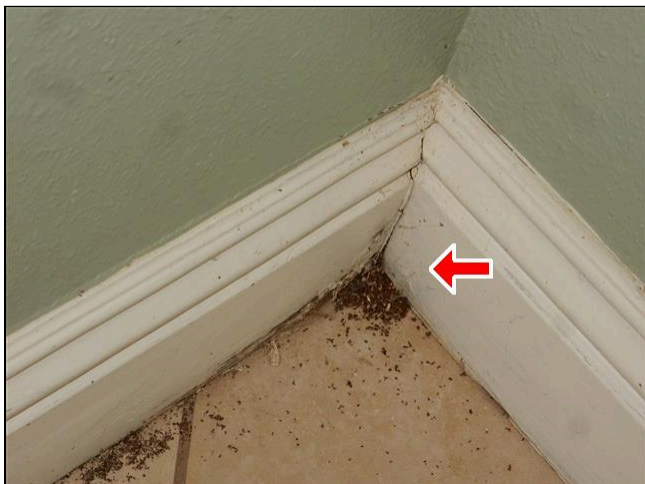
5.2.C Item 1 (Picture)

5.2.C Water damage noted to the wall base trim at the right side of the slider door. Advise to have a Contractor inspect and repair as needed.

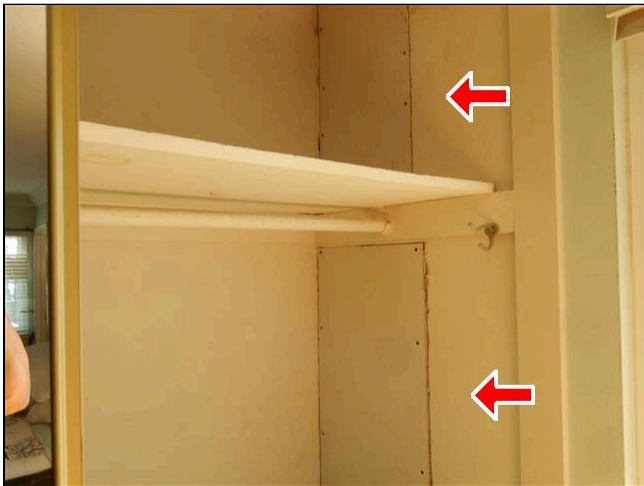
5.2.D Item 1 (Picture)

5.2.D Wall has been cut open in the closet and improperly repaired or unfinished.

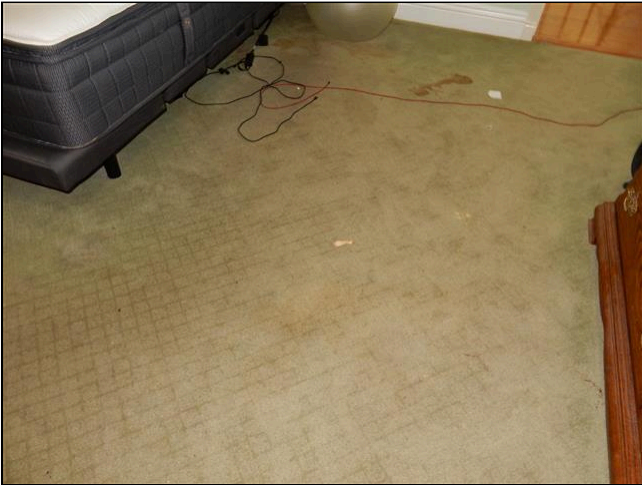
5.3.D Item 1 (Picture)

5.3.D Carpet is stained and worn.

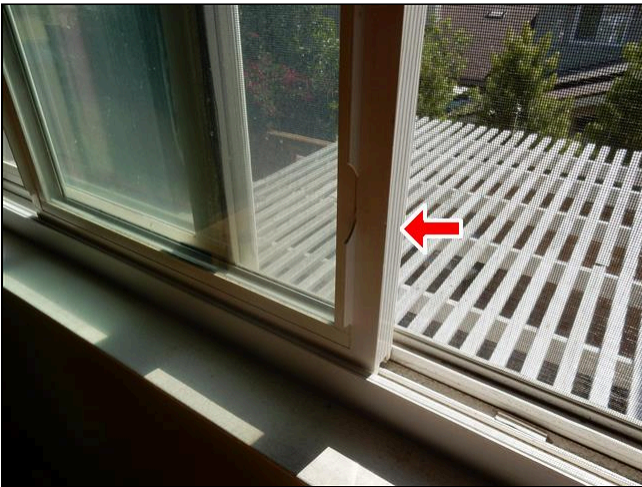
5.5.D Item 1 (Picture)

5.5.D Window trim is damaged. Advise to repair or replace as needed.

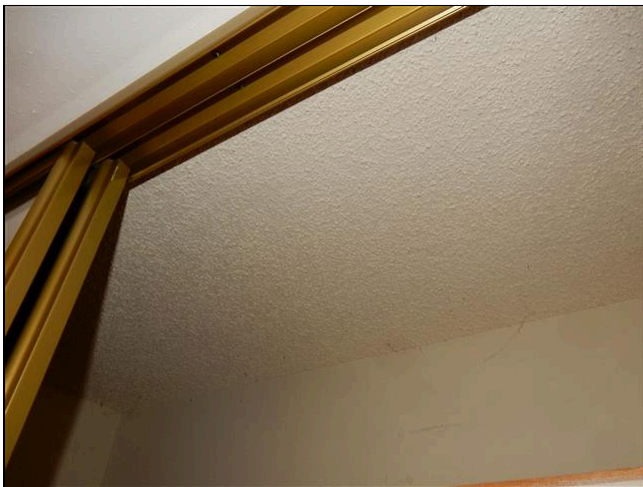
5.1.E Item 1 (Picture)

5.1.E The Texture on the ceiling may be Asbestos material at the bedroom closet. . A qualified contractor should inspect and remove as needed.

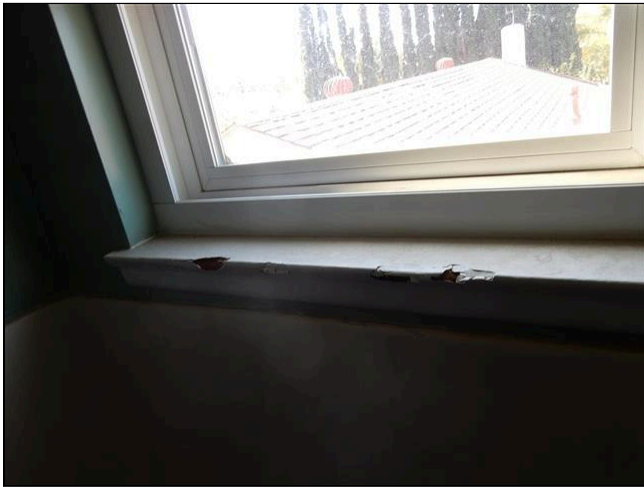
5.5.E Item 1 (Picture)

5.5.E Decay noted to the window ledge. Refer to the termite report.

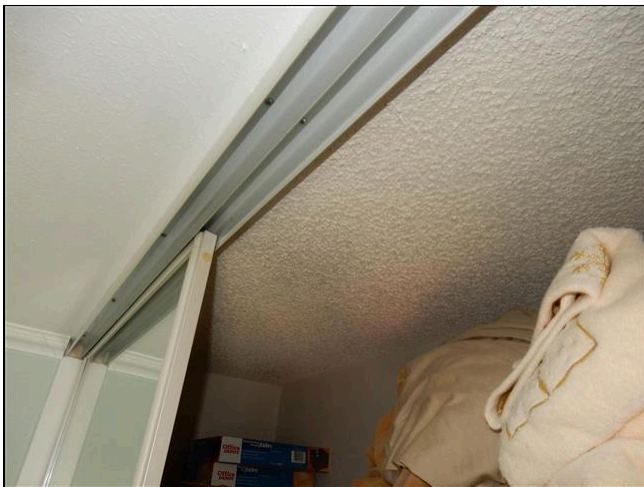
5.1.F Item 1 (Picture)

5.1.F The Texture on the ceiling may be Asbestos material at the bedroom closet. . A qualified contractor should inspect and remove as needed.

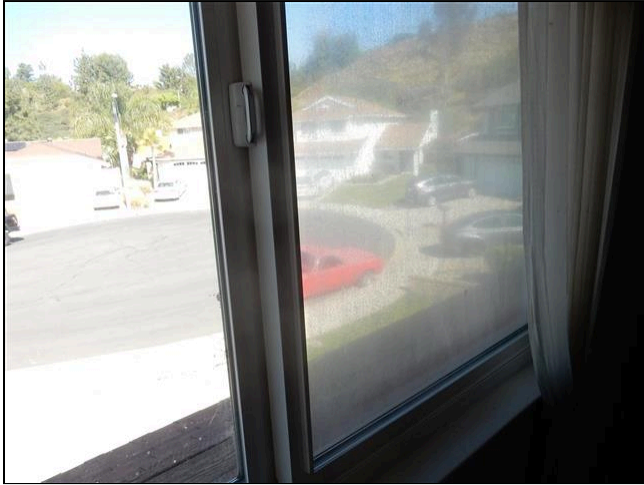
5.5.F Item 1 (Picture)

5.5.F One window is cloudy (lost seal) at the Bedroom. Further deterioration may occur if not repaired. A qualified contractor should inspect and repair as needed.

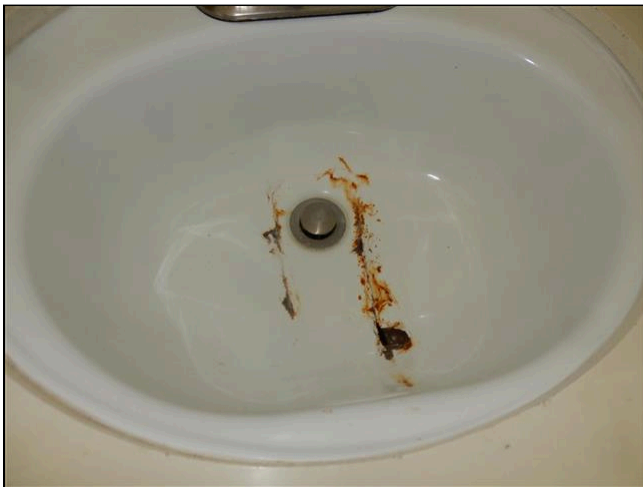
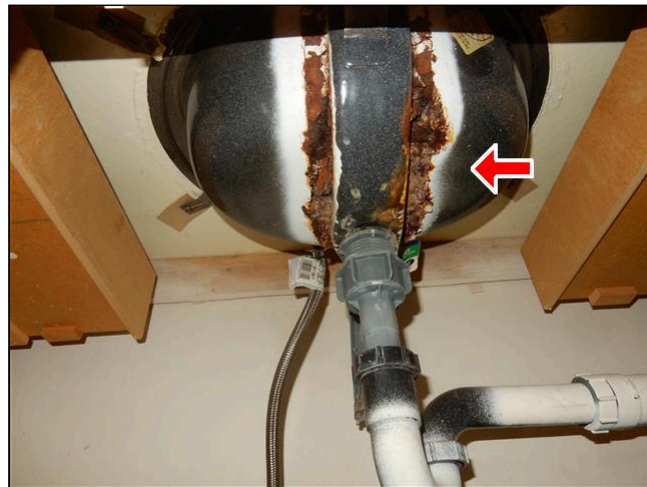
6.3.A Item 1 (Picture)

6.3.A Sink is corroded rusted and deteriorated and will leak. Advise to replace as needed.

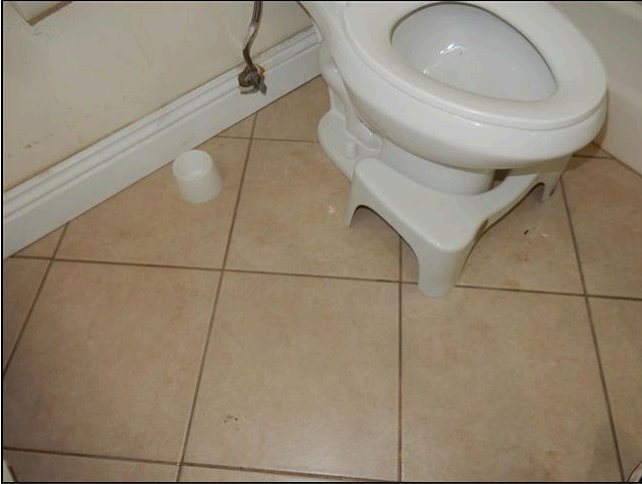
6.7.A Item 1 (Picture)

6.7.A The toilet is loose at floor at the bath. Repairs may involve re-setting the toilet on a new wax seal. I recommend a qualified licensed plumber repair or correct as needed.

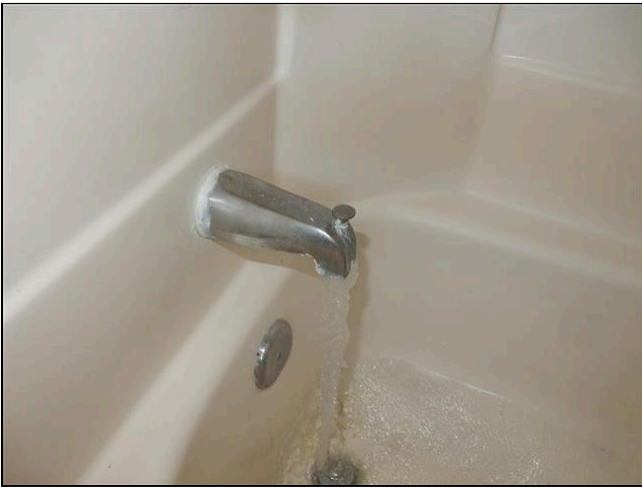
6.8.A Item 1 (Picture)

6.8.A Bathtub spout diverter is no working. Advise to have a Plumber inspect and repair or replace as needed.

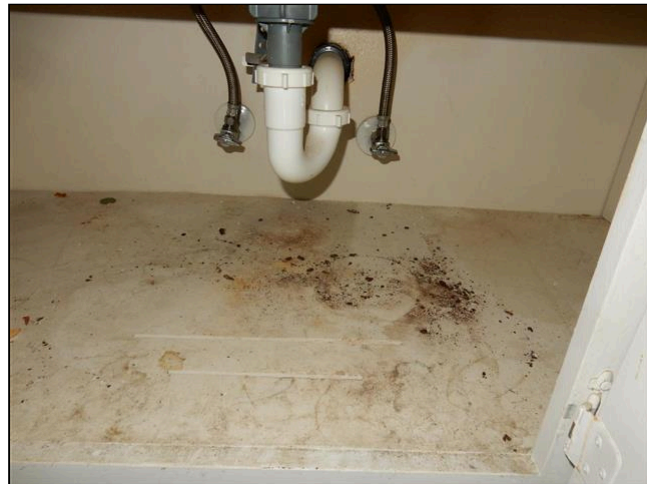
6.3.B Item 2 (Picture)

6.3.B Sink is corroded rusted and deteriorated underneath and will leak. Advise to have a Contractor inspect and replace as needed.

Cabinet baseboard is stained and blemished.

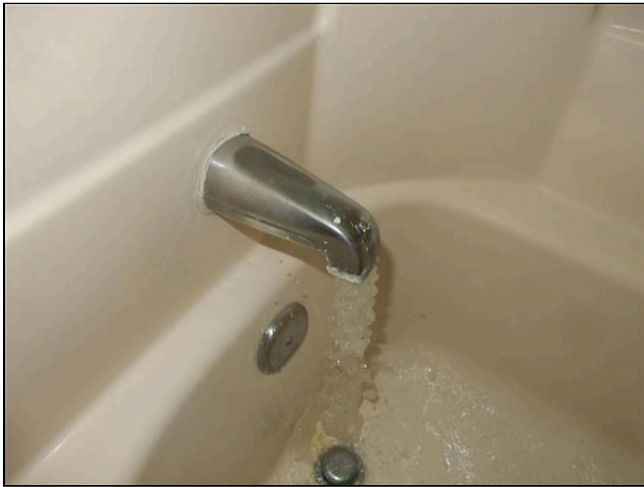
6.8.B Item 1 (Picture)

6.8.B Bathtub spout diverter is missing. Advise to replace as needed.

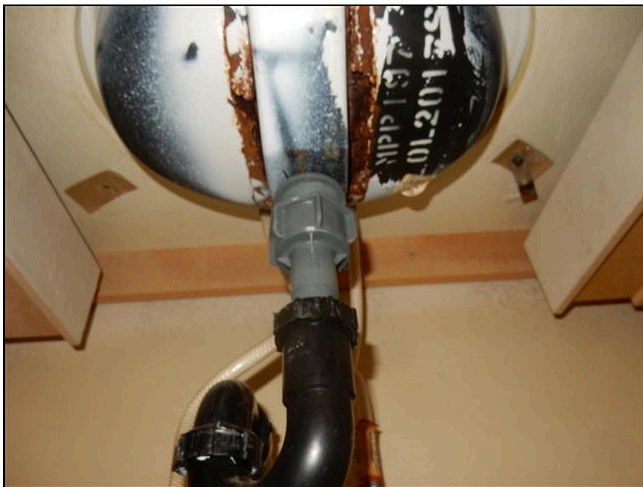
6.3.C Item 1 (Picture)

6.3.C Sink is corroded rusted and deteriorated and will leak. Advise to have a Contractor inspect and replace as needed.

Countertop is cracked. Advise to repair or replace as needed.

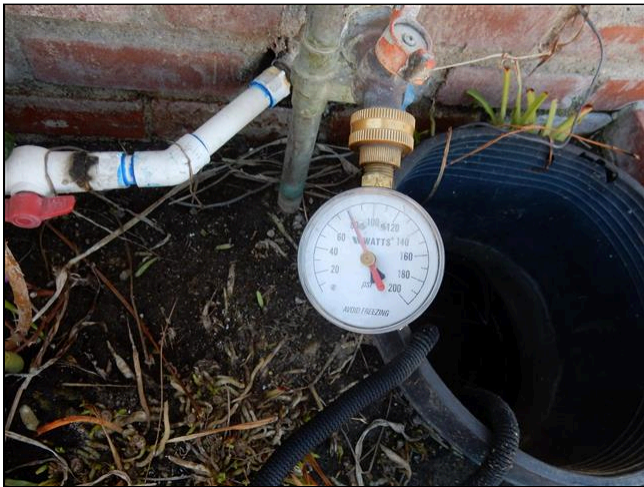
8.3 Item 1 (Picture)

8.3 Volume pressure is good, 80 PSI.

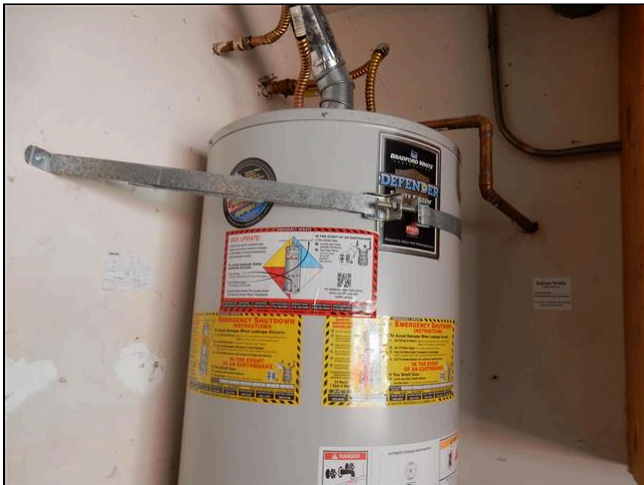
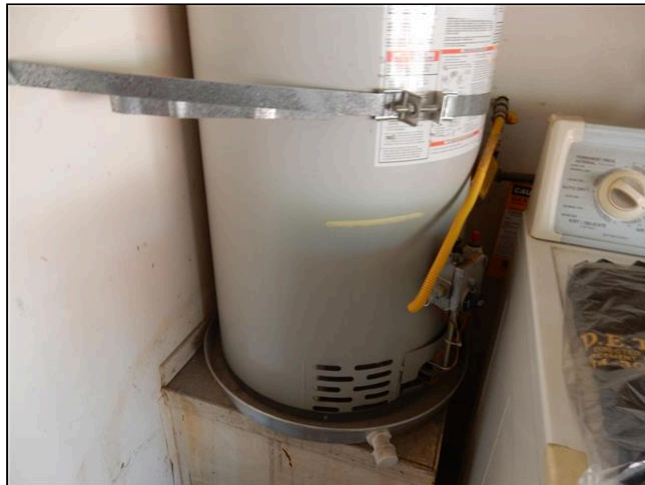
8.4 View of the water heater.

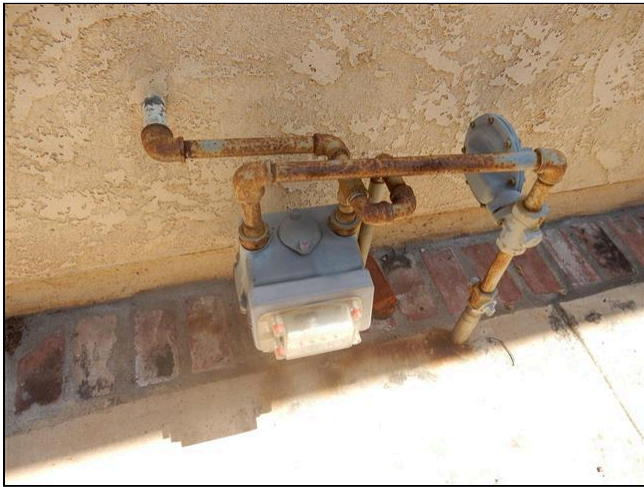
8.12 Item 1 (Picture)

8.12 View of the gas meter.

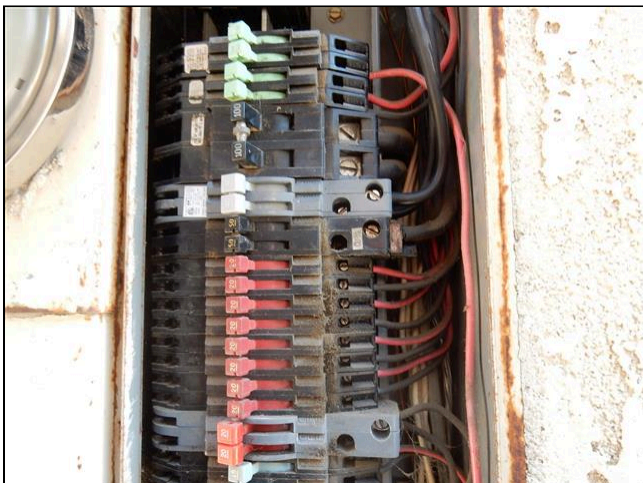
9.2 Item 1 (Picture)

9.2 View of the wiring inside the panel.

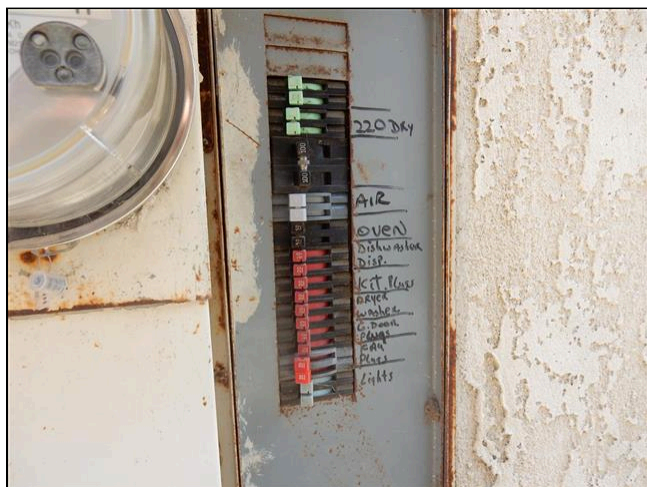
9.6 Item 1 (Picture)

9.6 View of the labeled panel.

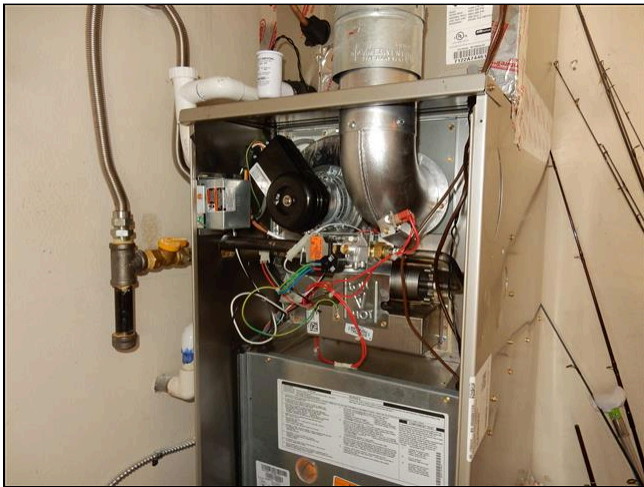
10.0 Item 1 (Picture)

10.0 View of the heater.

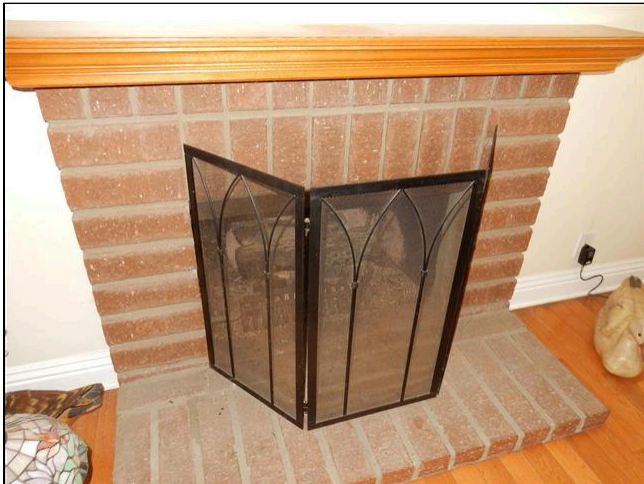
10.7 Item 1 (Picture)

10.7 The damper for fireplace at the family room is missing a clamp or lock that forces lid to stay open (required for Vented Gas/LP logs). . .

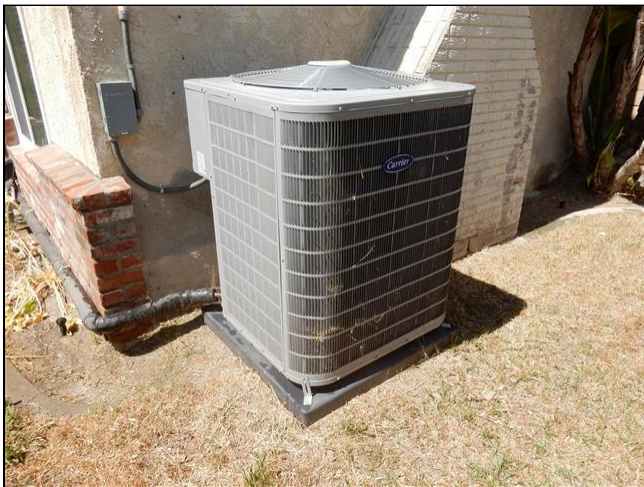
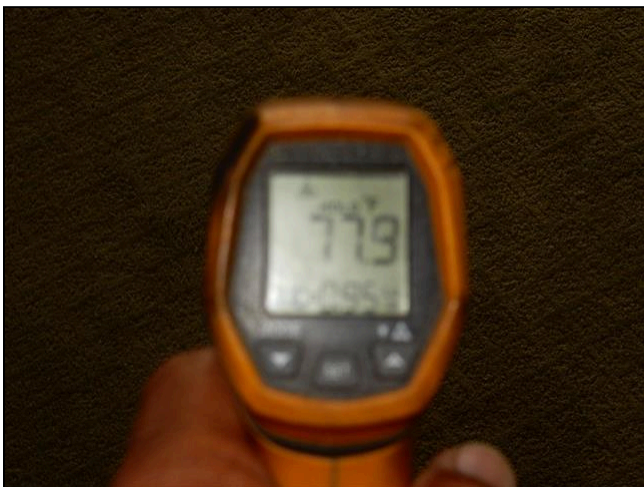
10.9 Item 1 (Picture)

10.9 The ambient air test was performed by using thermometers on the air handler of Air conditioner to determine if the difference in temperatures of the supply and return air are between 14 degrees and 22 degrees which indicates that the unit is cooling as intended. The supply air temperature on your system read 60 degrees, and the return air temperature was 77 degrees. This indicates the range in temperature drop is normal.

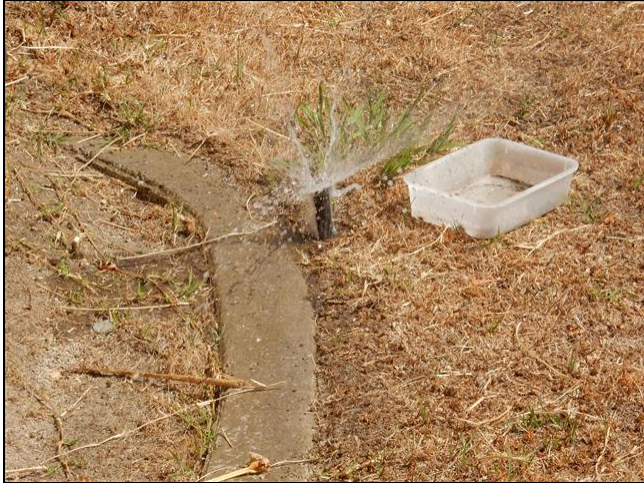
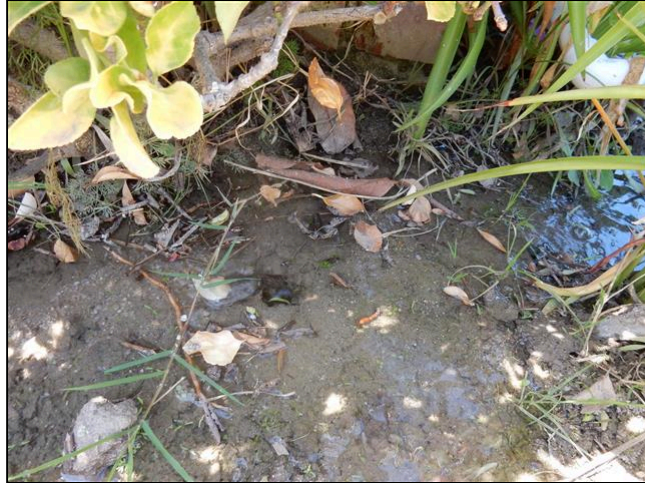
11.0 Several sprinkler heads and piping are damaged and leaking.
