INSPECTION REPORT
21011 North Hampton Way
Lake Forest CA 92630

INSPECTED BY
Ernest Lefferman
PRO
INSPECTIONS

INSPECTION DATE
📅 6/14/2024
🕒

Report ID
061424-02

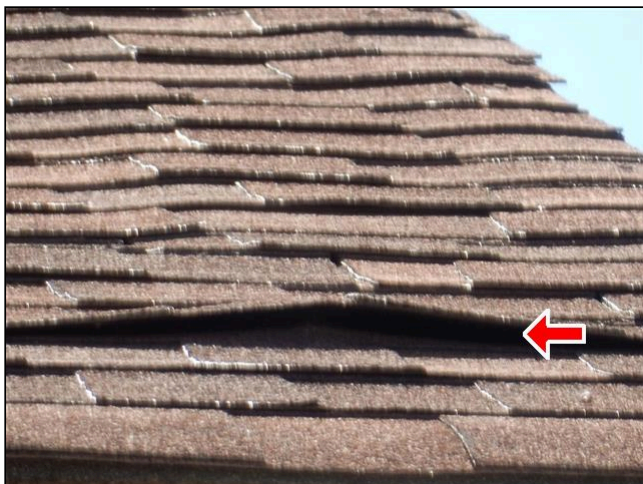
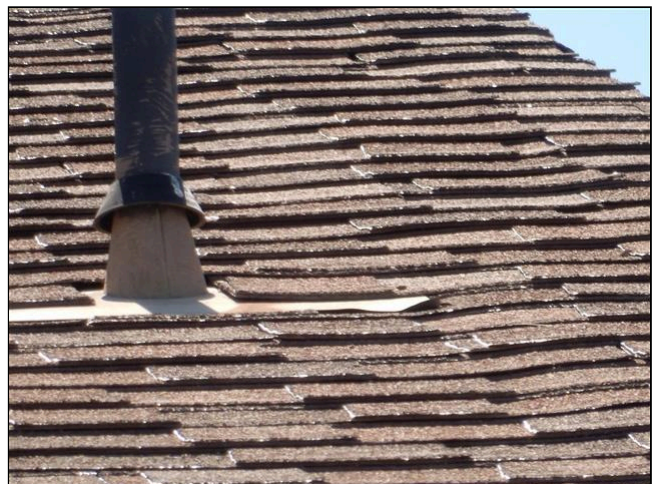
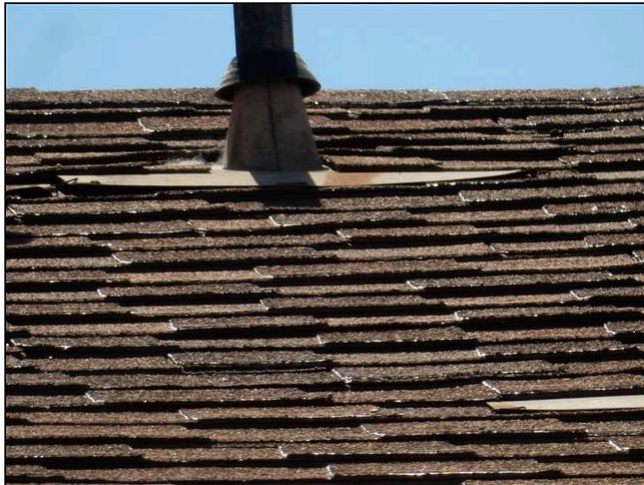
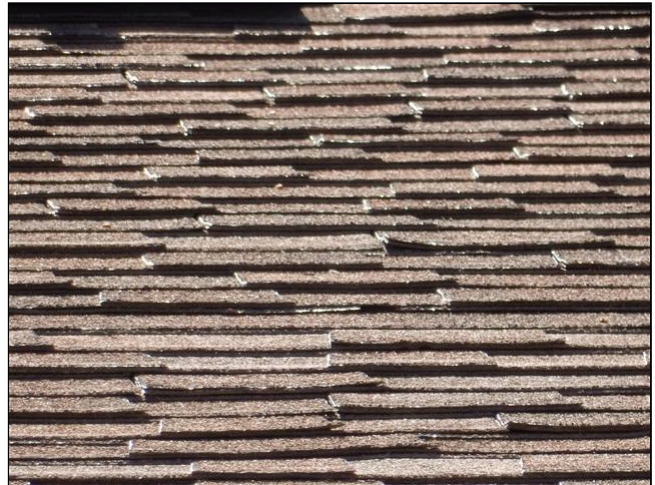
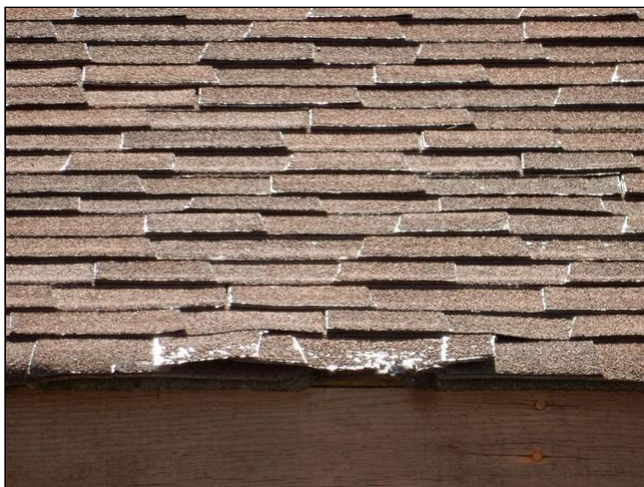
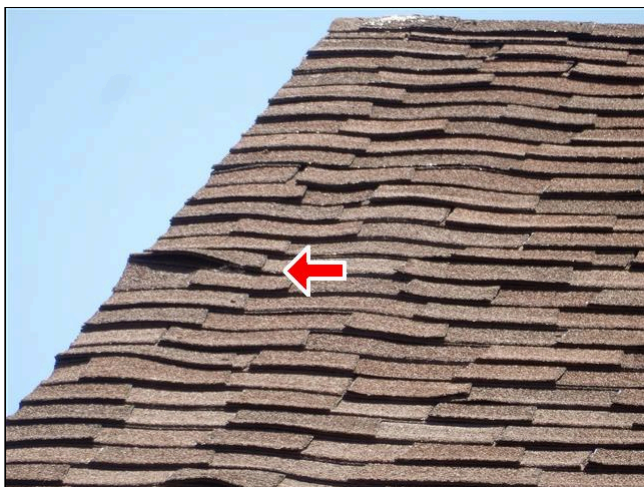
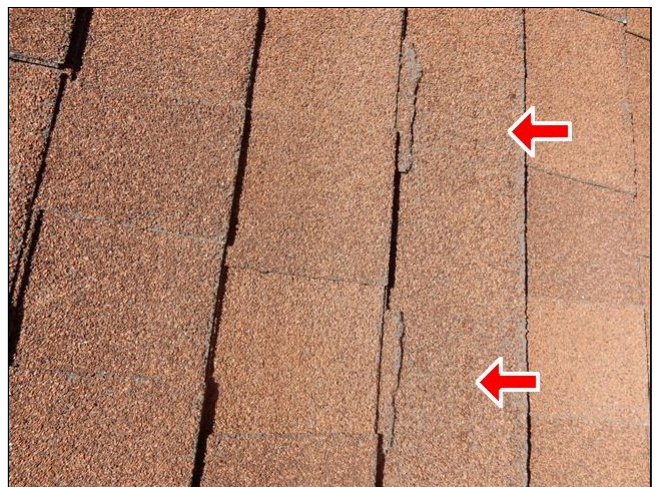
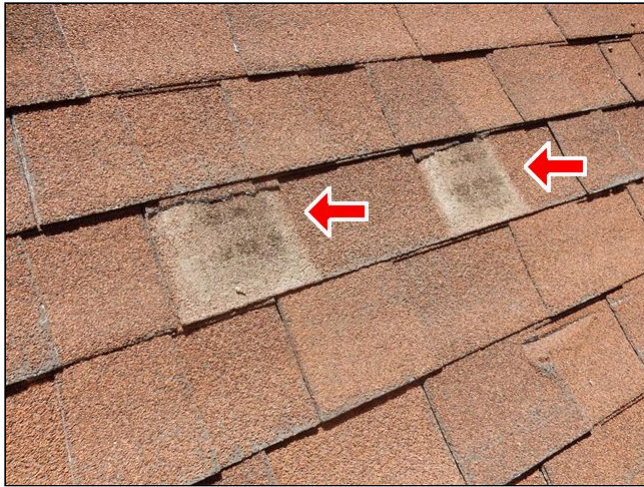
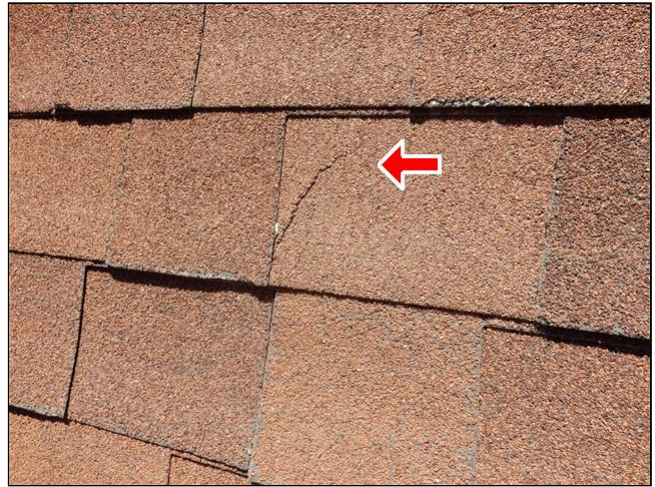
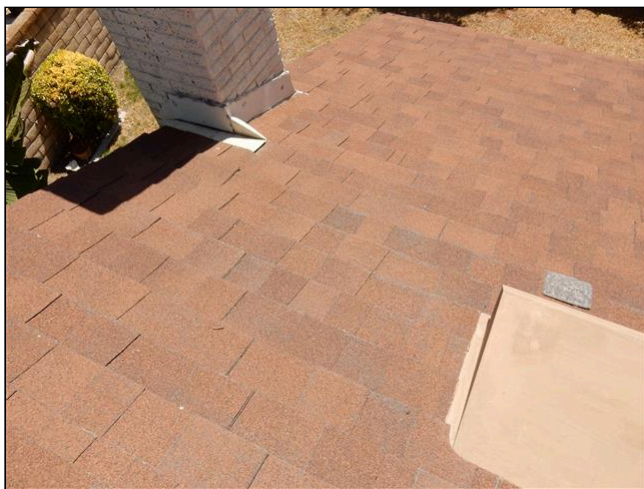
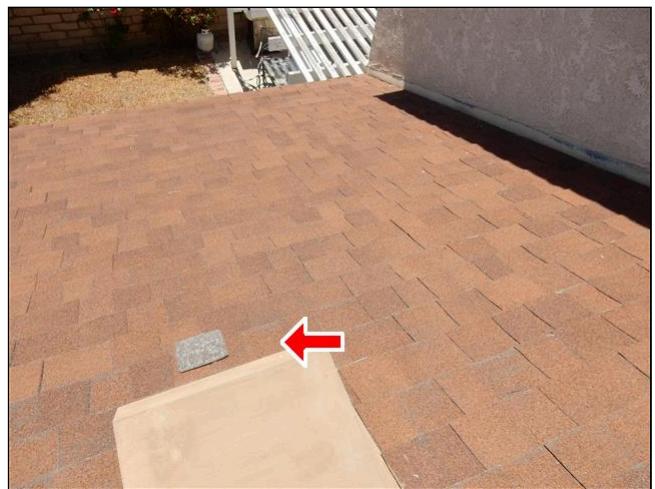
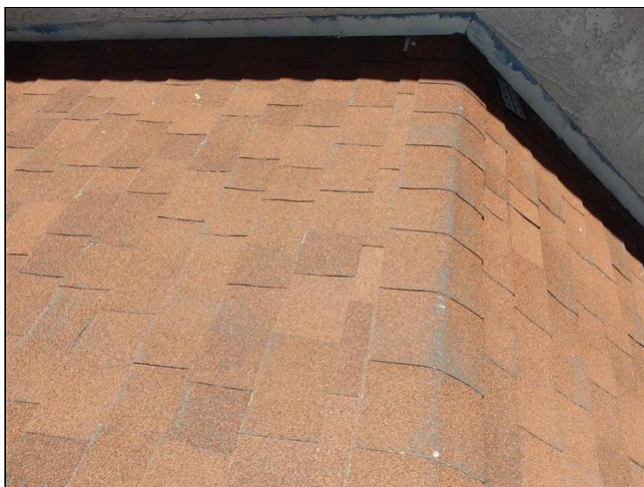
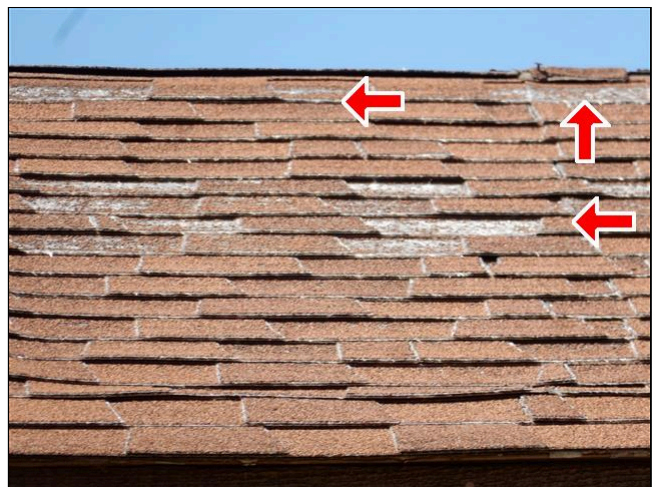
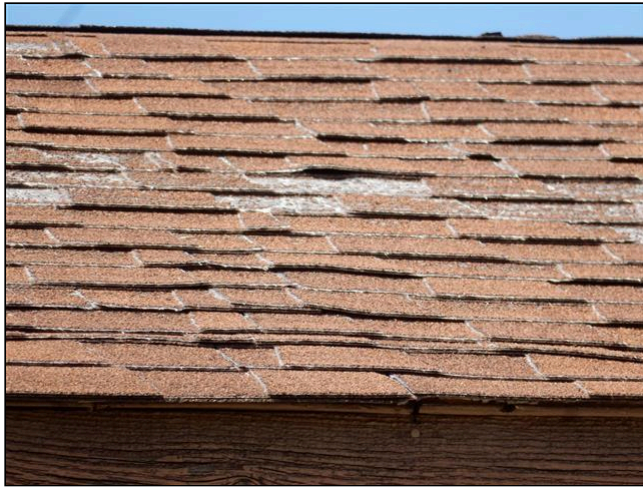
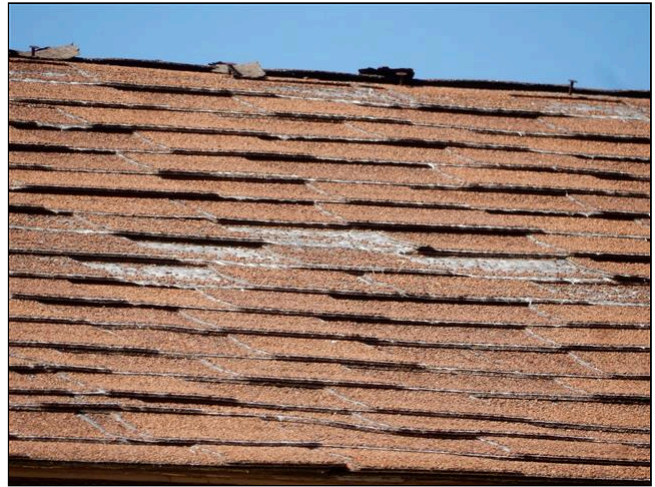
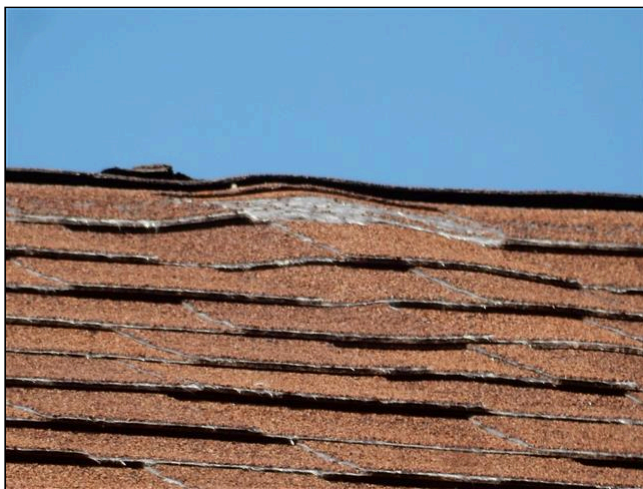
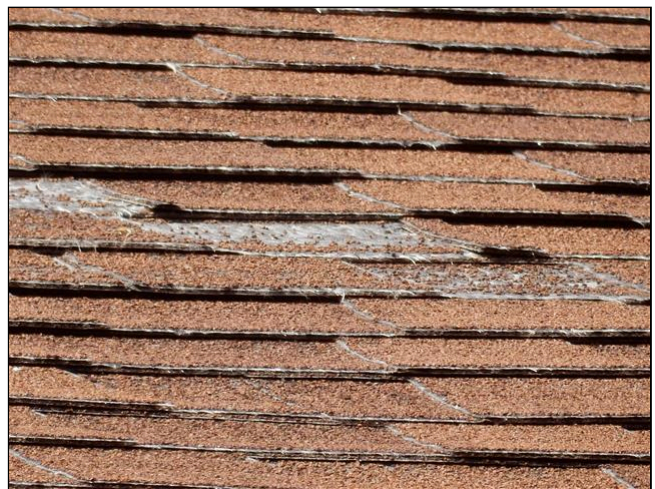
Missing torn cracked and weathered shingles noted at various areas of the roof.

Nails are extracting at several areas and lifting the shingles. Advise to have a Roofer inspect and repair as needed.

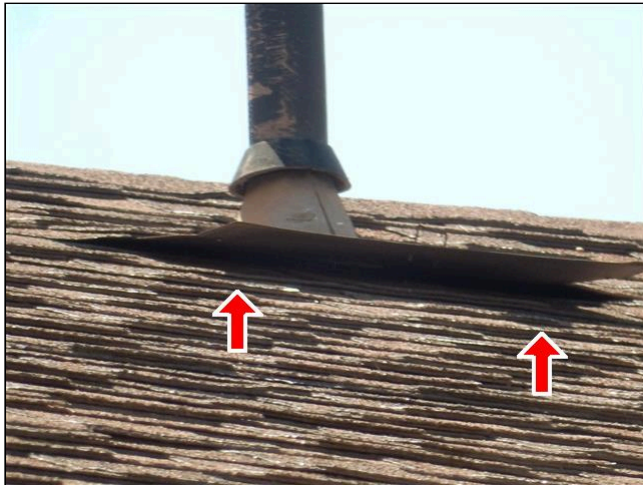
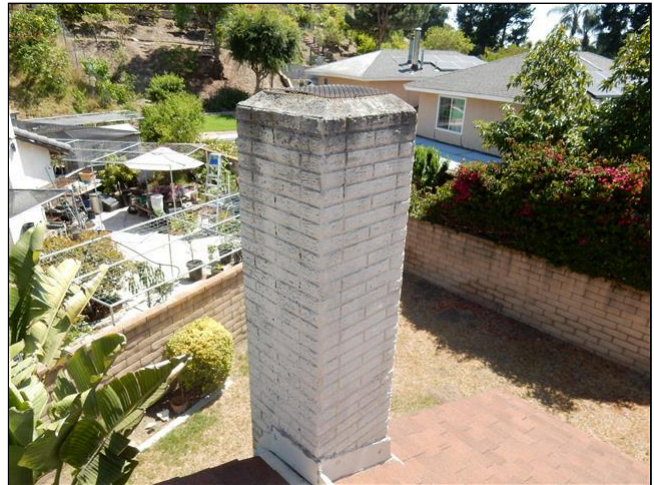
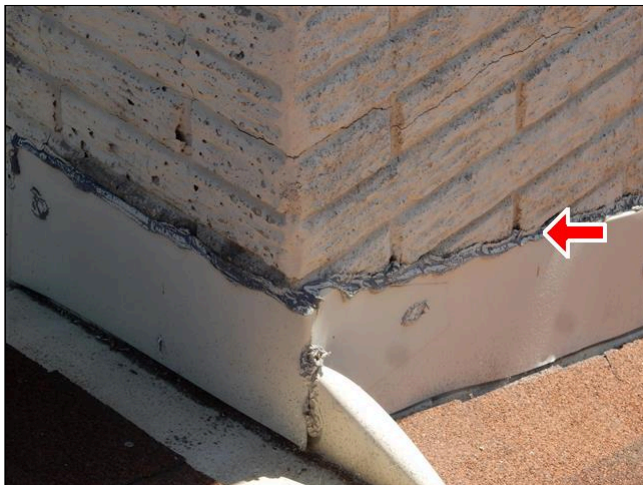
Vent pipe boot has lifted and is not sealed at the front slope. Advise to have a Roofer inspect and repair as needed.

Sealant along the chimney flashing is failing. Advise to have a Roofer inspect and repair as needed.

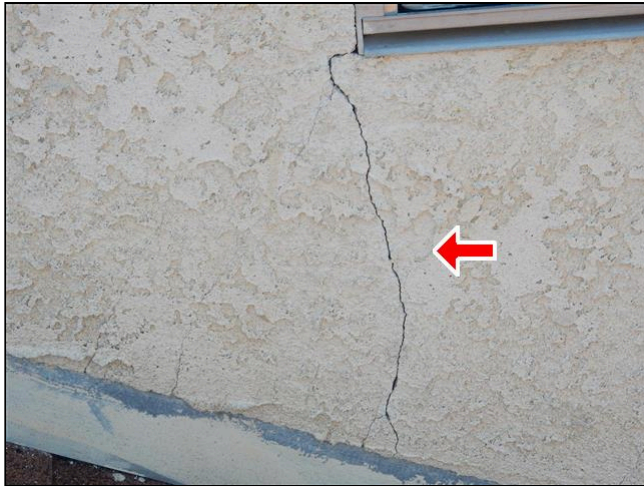
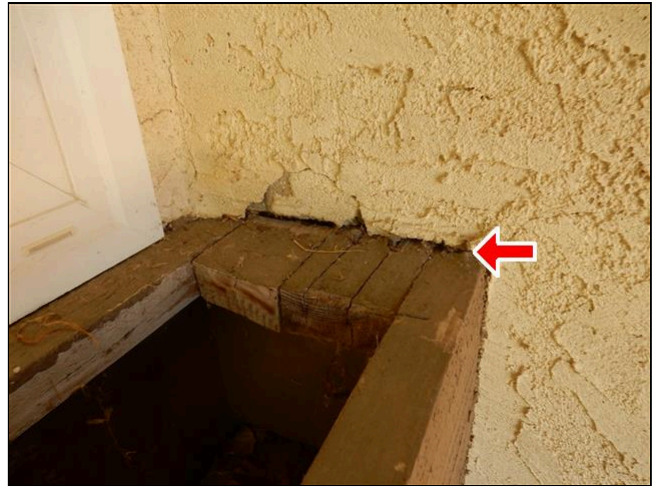
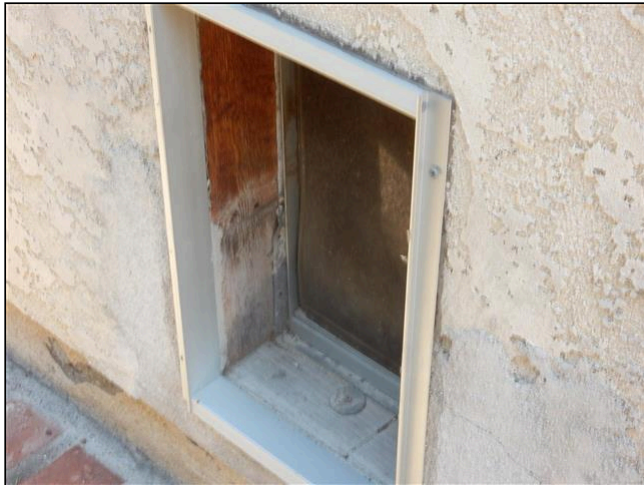
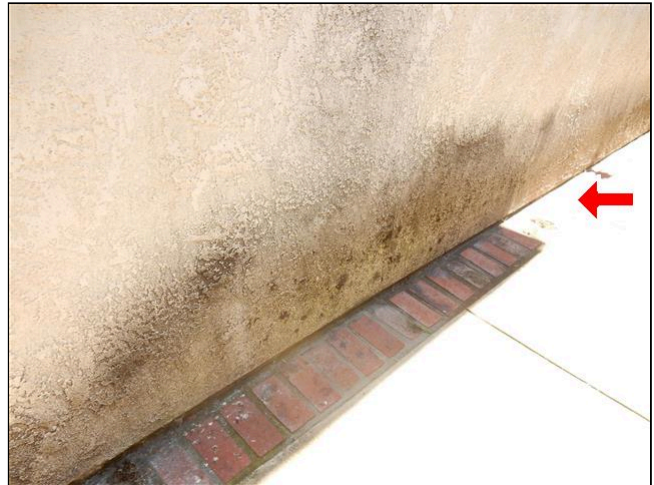
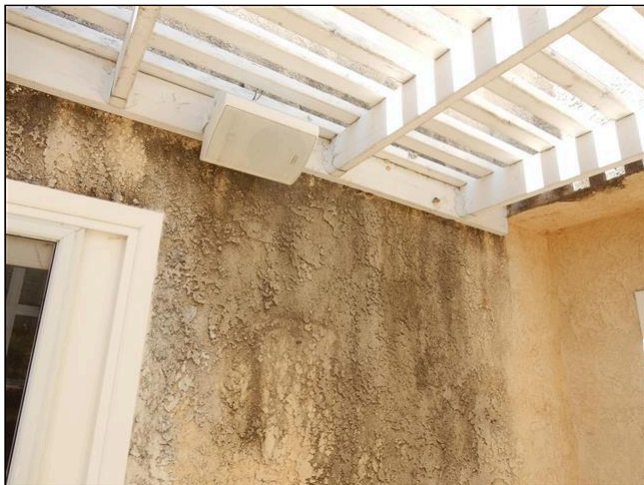
Cracks and or chips noted to the stucco siding at several areas.

Doggy door is not water proof. Advise to repair as needed.

Stucco siding is not sealed properly at the side of the planter box.

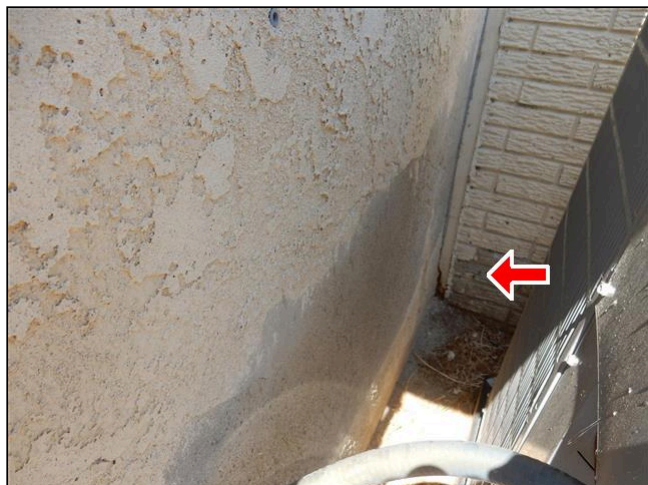
2.0 Item 6 (Picture)

Patchwork noted to the stucco siding around the window rear of the house.

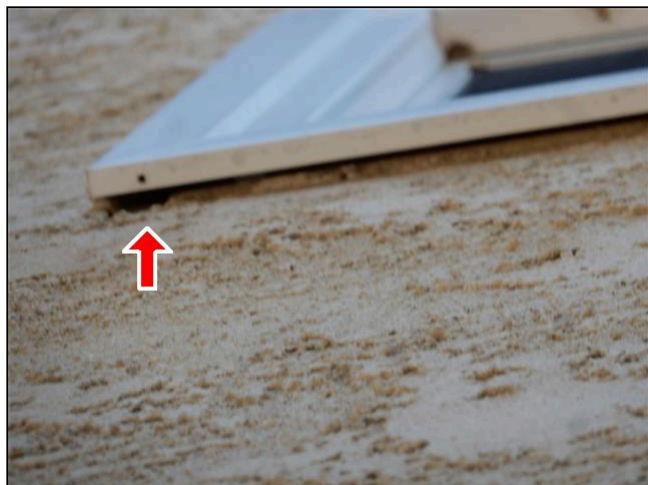
2.2 Item 1 (Picture)

One window is not sealed properly at the right side of the house. Advise to have a Contractor inspect and repair as needed.

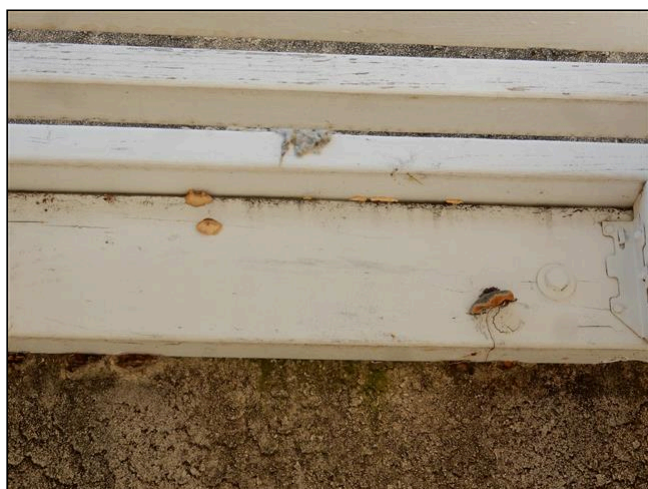
2.3 Item 1 (Picture)

Bio-Organic growth is present on the patio awning. Advise to have a Contractor inspect and repair as needed.

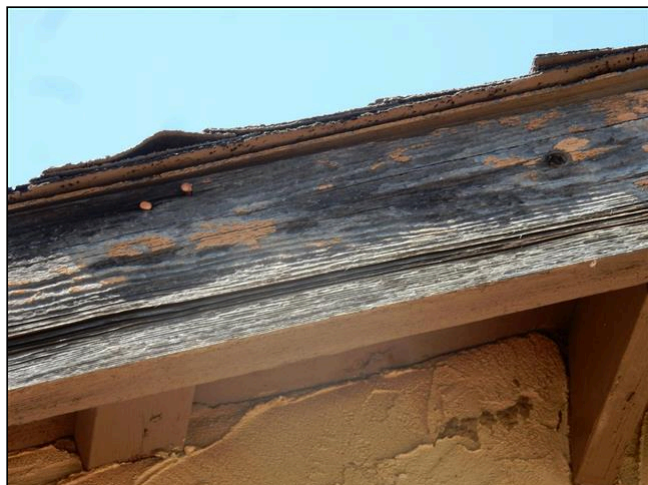
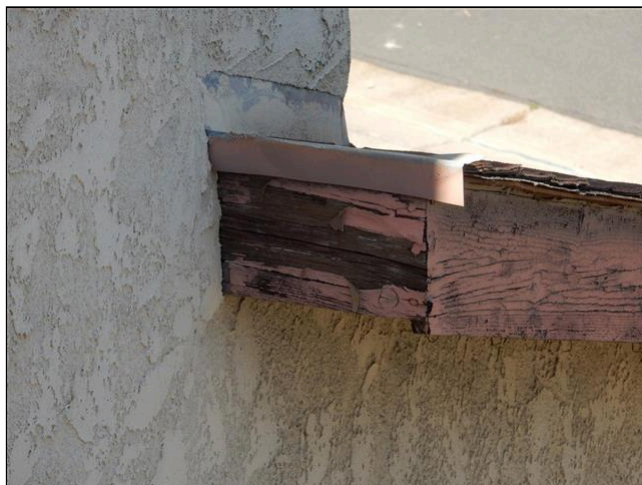
2.5 Item 1 (Picture)

Paint is peeling at the fascia boards and eaves.

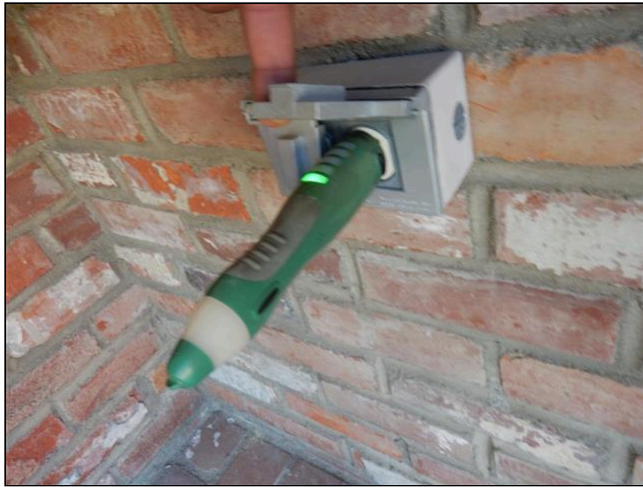
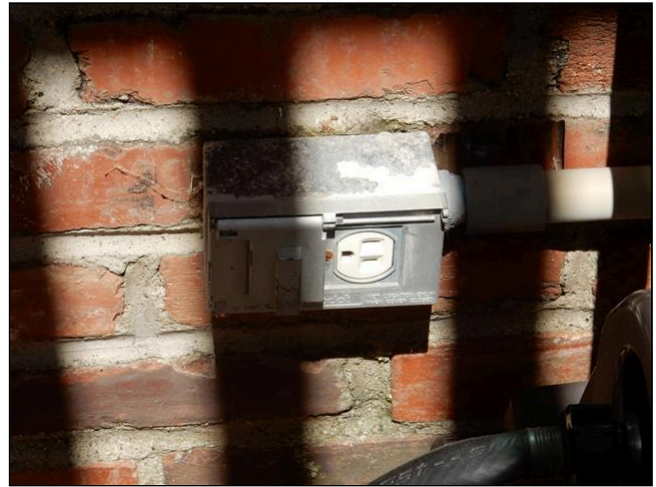
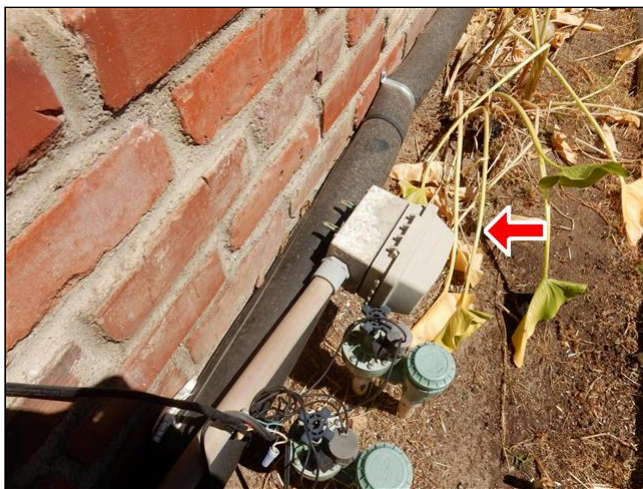
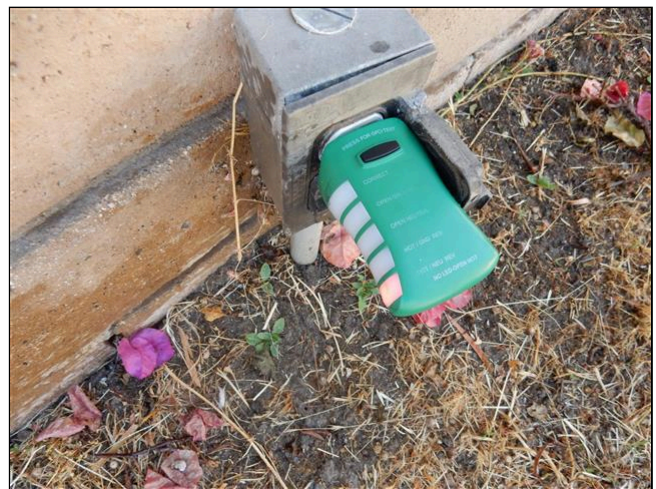
2.7 Item 1 (Picture)

Three prong outlet at the rear yard is not grounded or a GFCI. Advise to have a Electrician inspect and repair as needed.

Junction box and conduit are loose at the rear of the house. Advise to repair as needed.

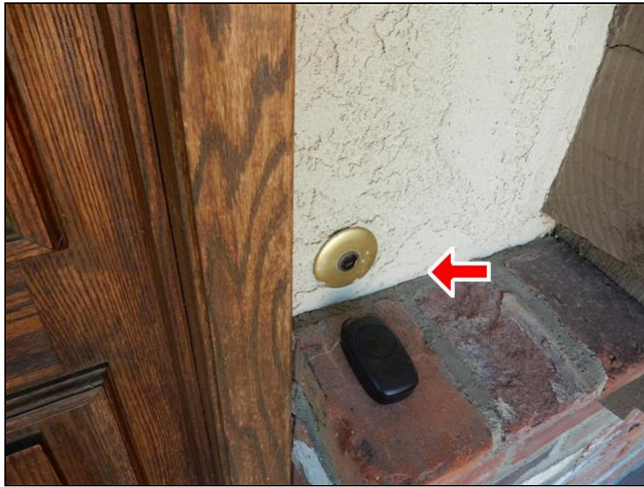
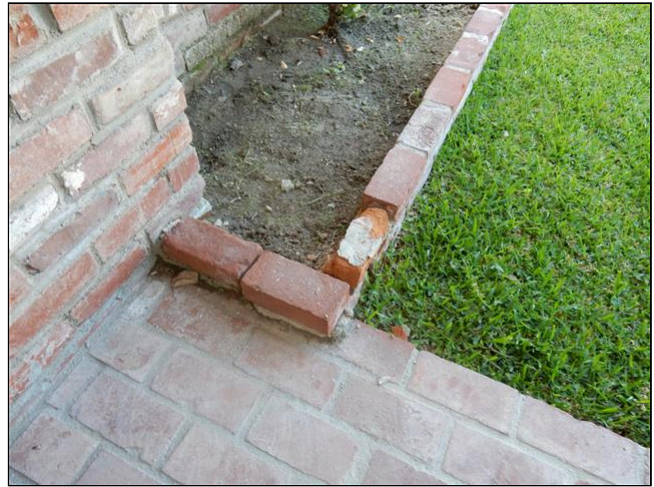
2.9 Item 1 (Picture)

Iron gate post is loose. Advise to repair or replace as needed.

Set back is not proper at the rear of the house. Advise to have a Contractor inspect further.

Bricks at the planter are loose damaged and missing. Advise to repair and replace as needed.

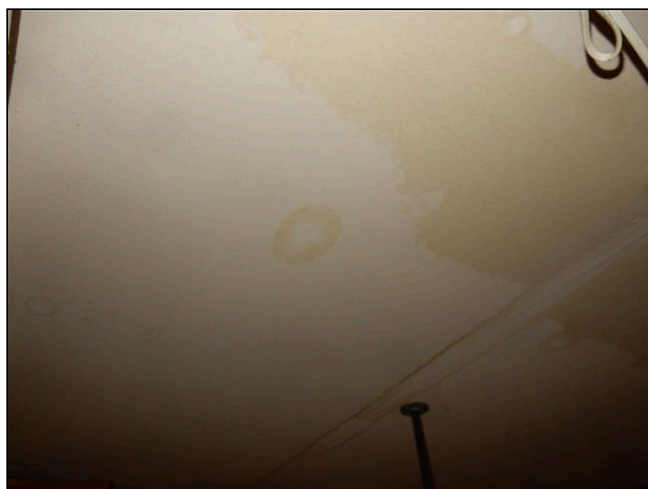
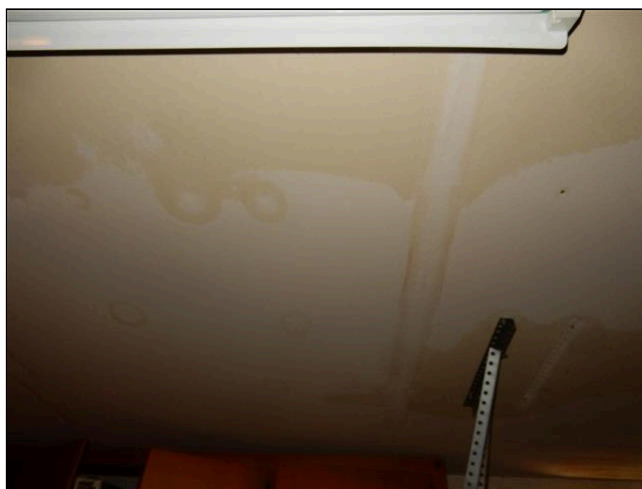
3.0 Item 1 (Picture)

Water stains noted to the ceiling at several areas.

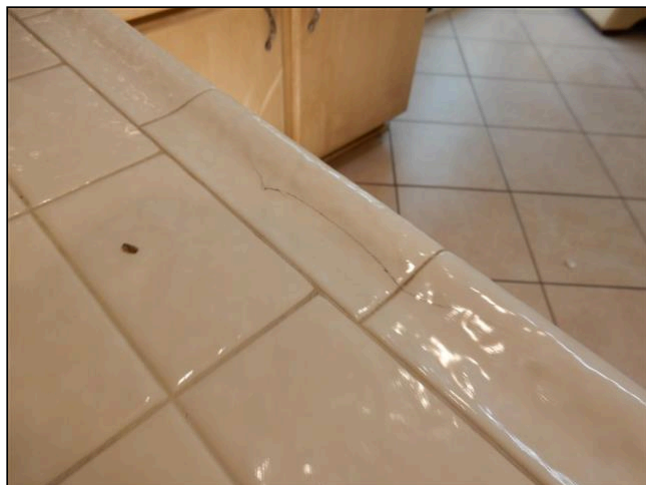
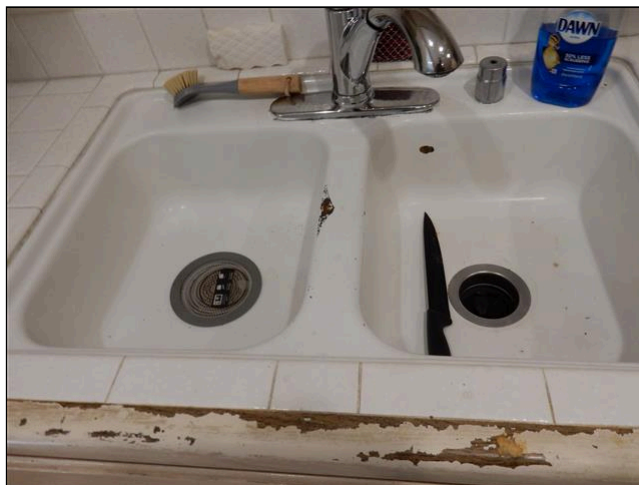
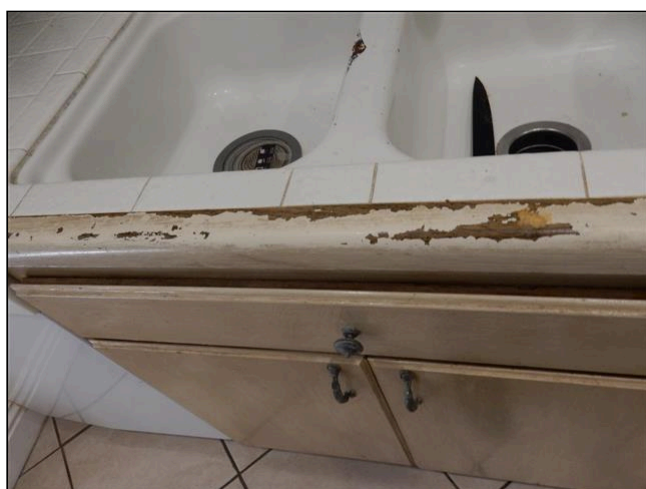
4.3 Item 1 (Picture)

Cracks noted to the tiled countertop at several areas.

Chips noted to the sink at several areas.

Laminate countertop edge is weathered.

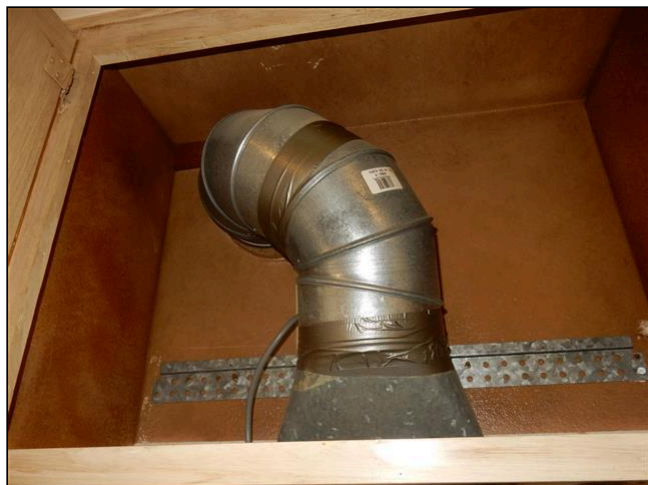
4.9 Item 1 (Picture)

Improper type of tubing tape used for vent pipe. Advise to replace with Aluminum tape.

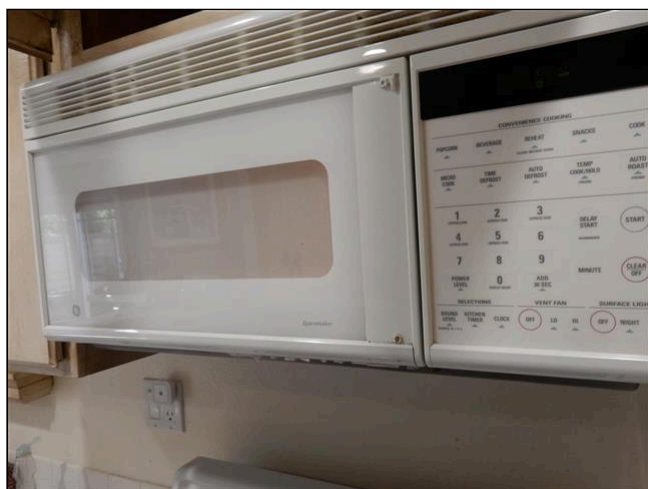
4.11 Item 1 (Picture)

Microwave door handle is missing. Advise to repair or replace as needed.

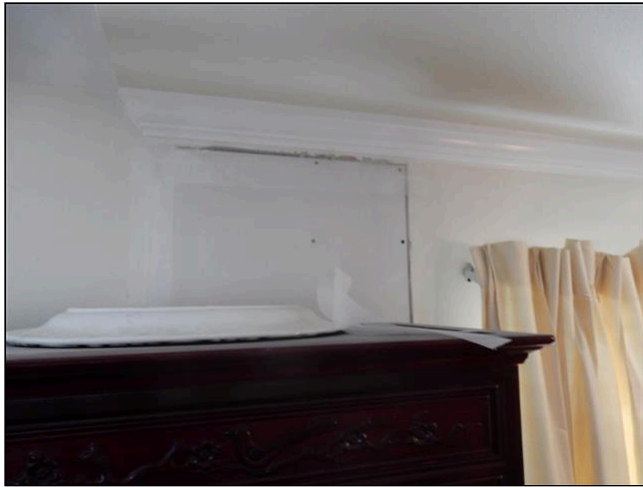
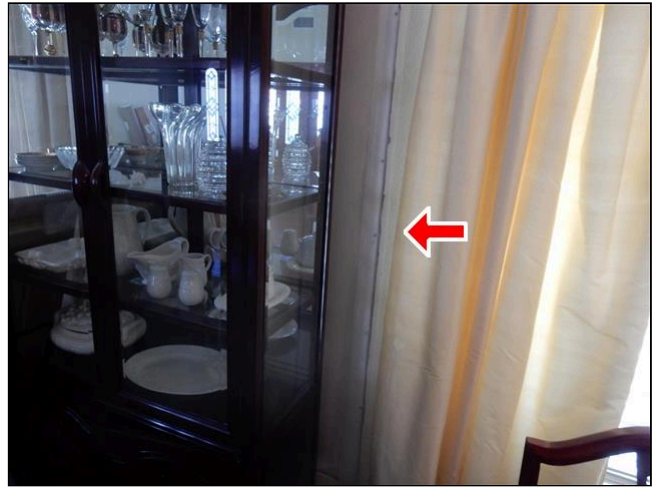
5.2.A Item 1 (Picture)

Wall has been cut open and improperly repaired or unfinished.

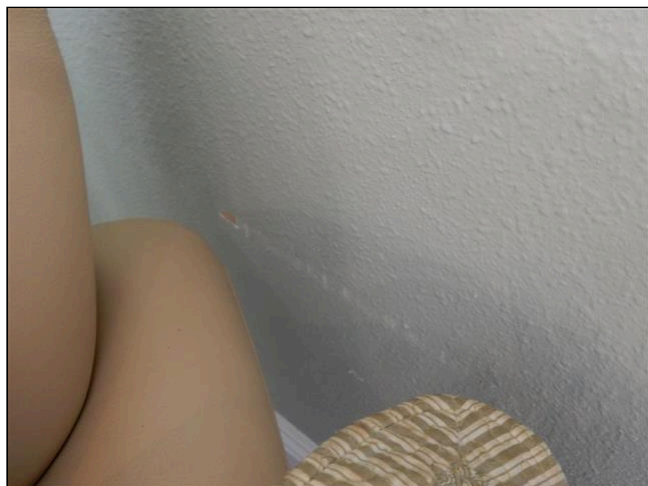
5.1.C Item 1 (Picture)

Wall is damaged at several areas.

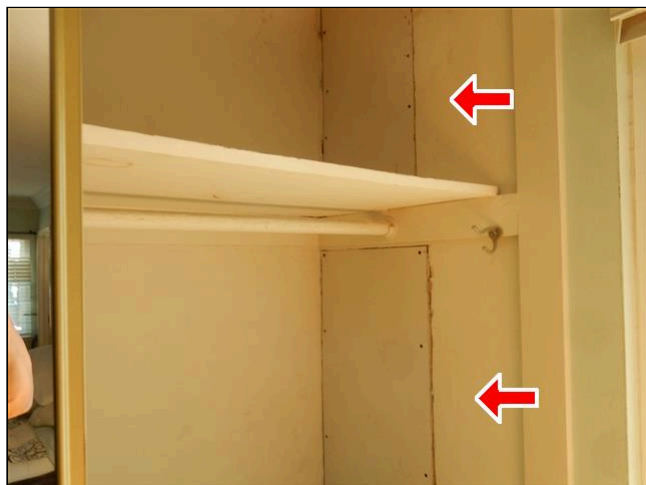
5.2.D Item 1 (Picture)

Wall has been cut open in the closet and improperly repaired or unfinished.

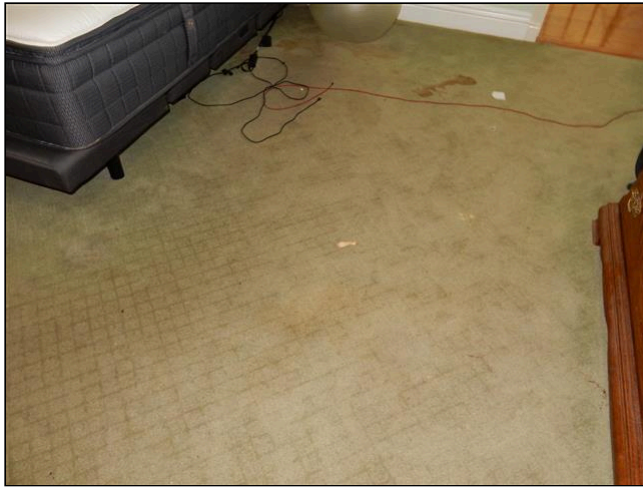
5.3.D Item 1 (Picture)

Carpet is stained and worn.

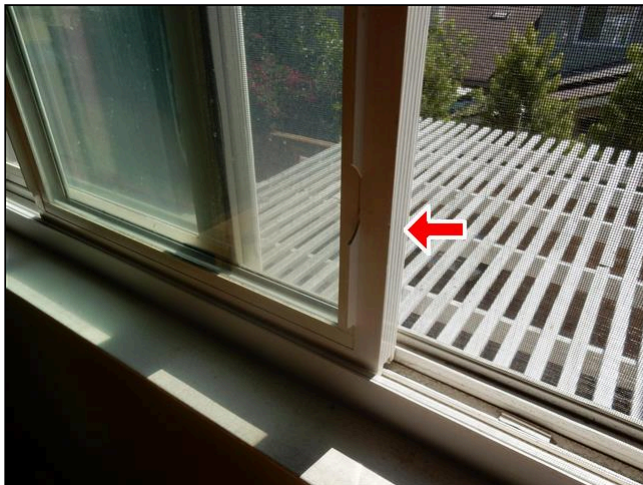
5.5.D Item 1 (Picture)

Window trim is damaged. Advise to repair or replace as needed.

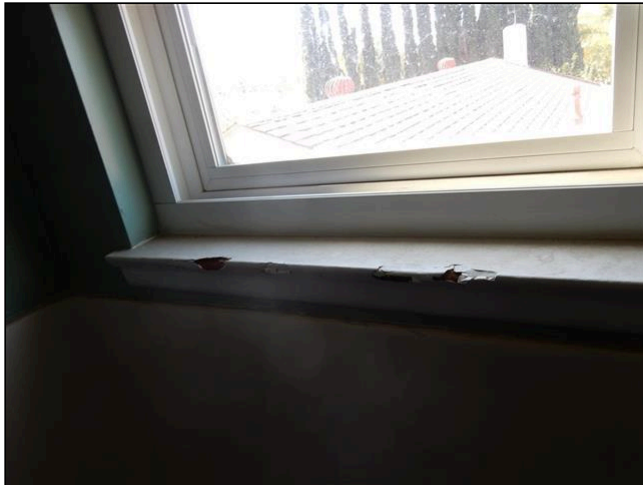
5.5.E Item 1 (Picture)

See Comments
Decay noted to the window ledge. Refer to the termite report.

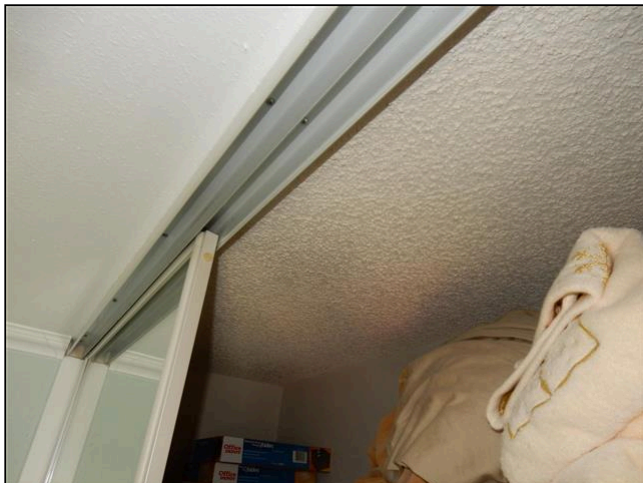
5.1.F Item 1 (Picture)

The Texture on the ceiling may be Asbestos material at the bedroom closet. . A qualified contractor should inspect and remove as needed.

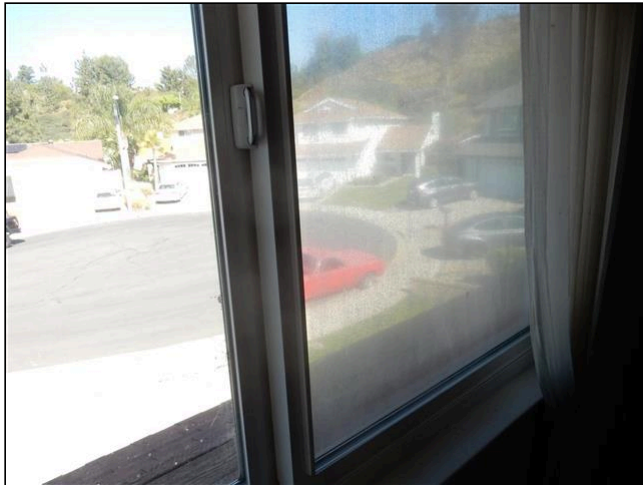
5.5.F Item 1 (Picture)

One window is cloudy (lost seal) at the Bedroom. Further deterioration may occur if not repaired. A qualified contractor should inspect and repair as needed.

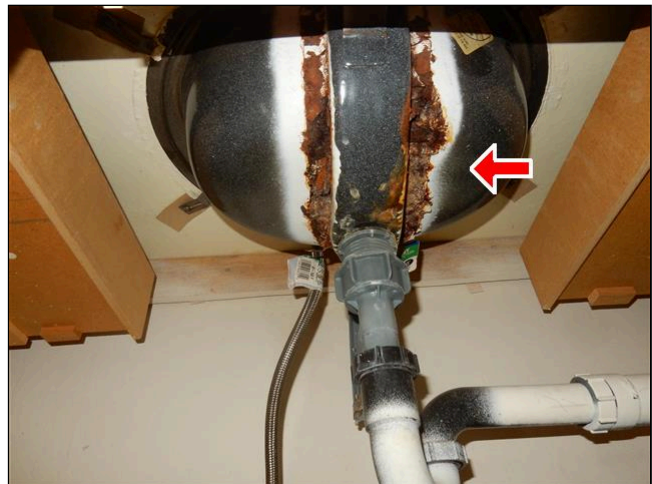
6.3.A Item 2 (Picture)

Sink is corroded rusted and deteriorated and will leak. Advise to replace as needed.

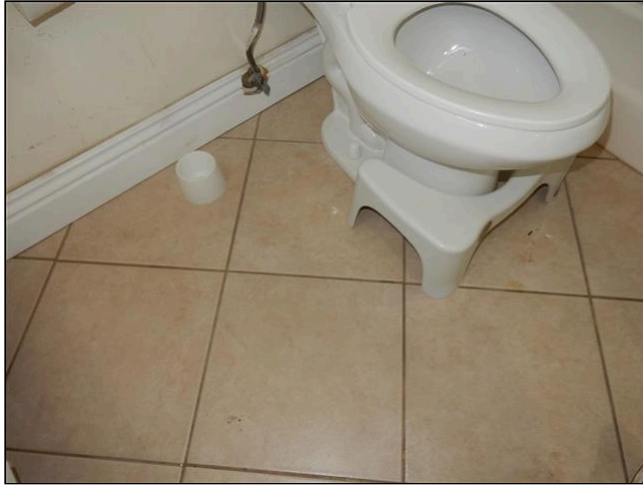
6.7.A Item 1 (Picture)

The toilet is loose at floor at the bath. Repairs may involve re-setting the toilet on a new wax seal. I recommend a qualified licensed plumber repair or correct as needed.

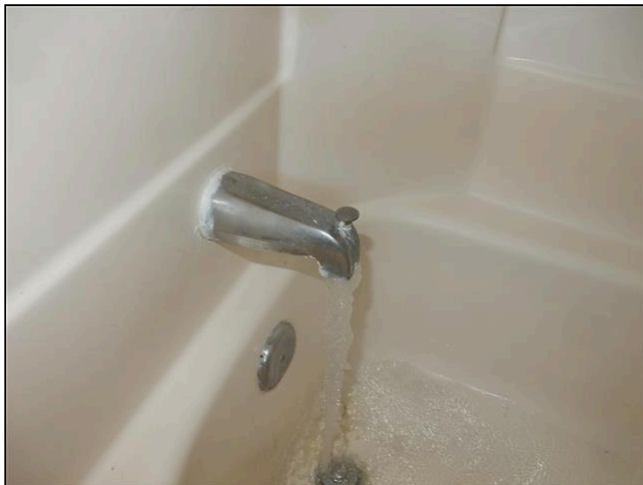
6.8.A Item 1 (Picture)

Bathtub spout diverter is no working. Advise to have a Plumber inspect and repair or replace as needed.

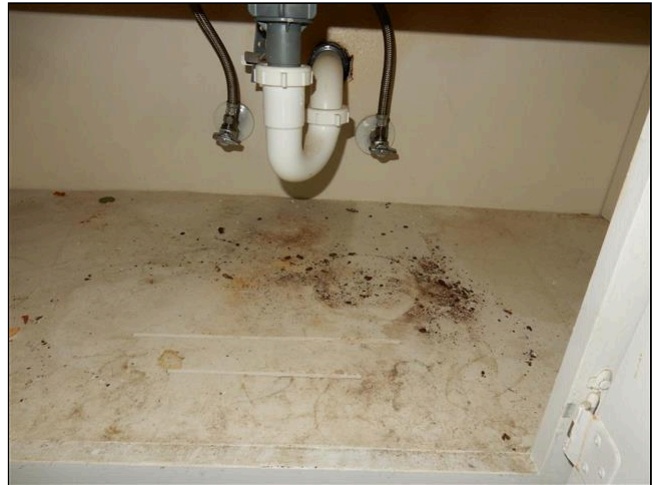
6.3.B Item 2 (Picture)

Sink is corroded rusted and deteriorated underneath and will leak. Advise to have a Contractor inspect and replace as needed.

Cabinet baseboard is stained and blemished.

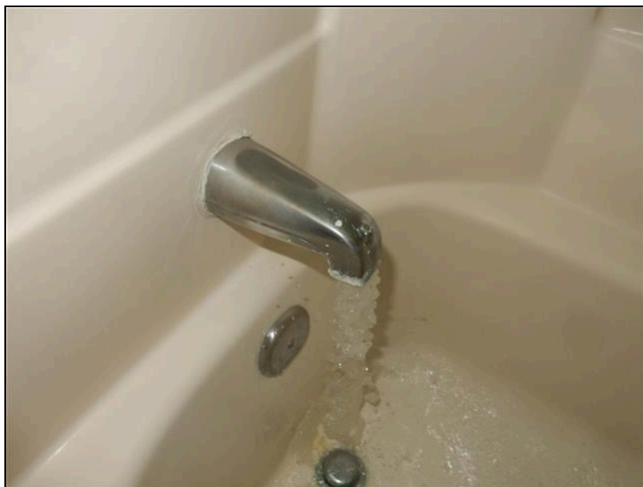
6.8.B Item 1 (Picture)

Bathtub spout diverter is missing. Advise to replace as needed.

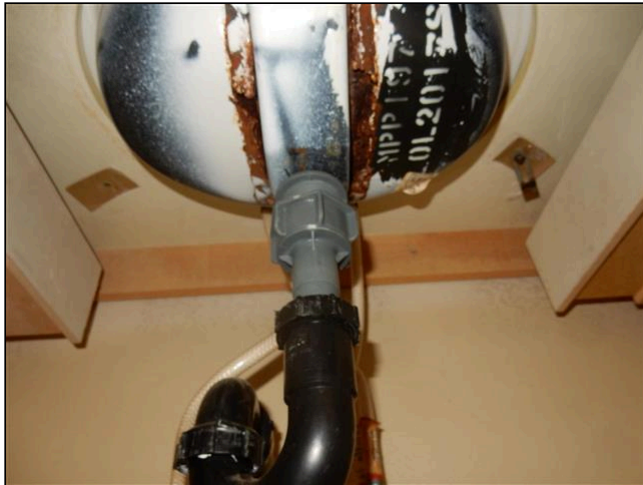
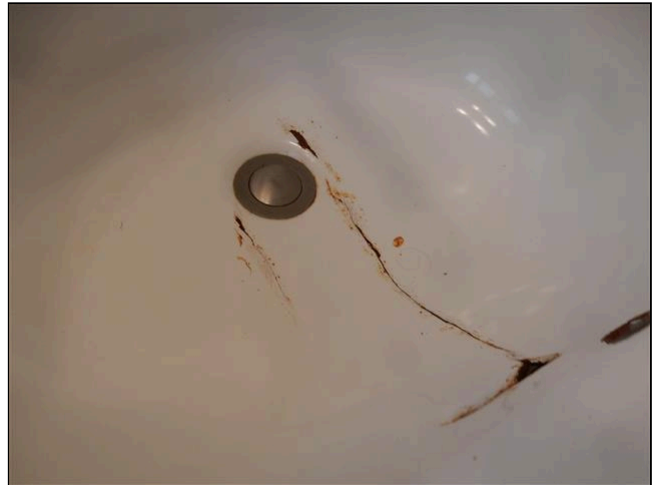
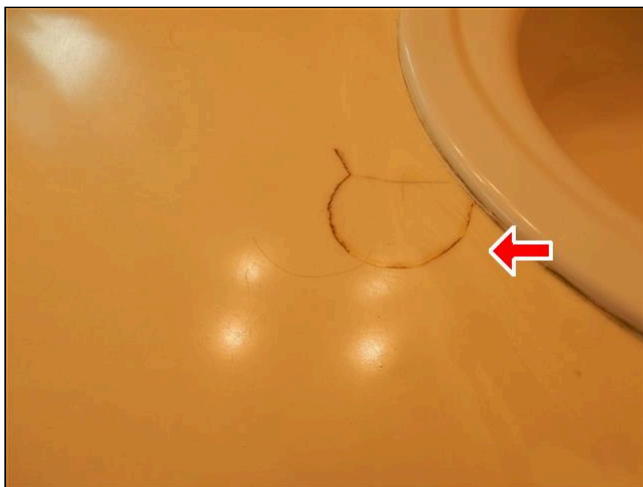
6.3.C Item 1 (Picture)

Sink is corroded rusted and deteriorated and will leak. Advise to have a Contractor inspect and replace as needed.

Countertop is cracked. Advise to repair or replace as needed.

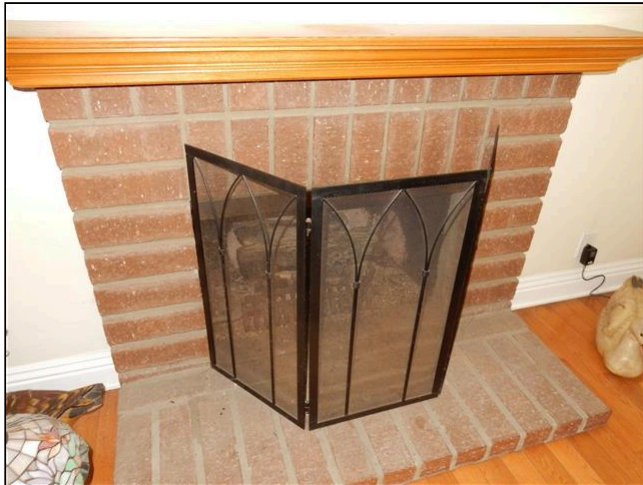
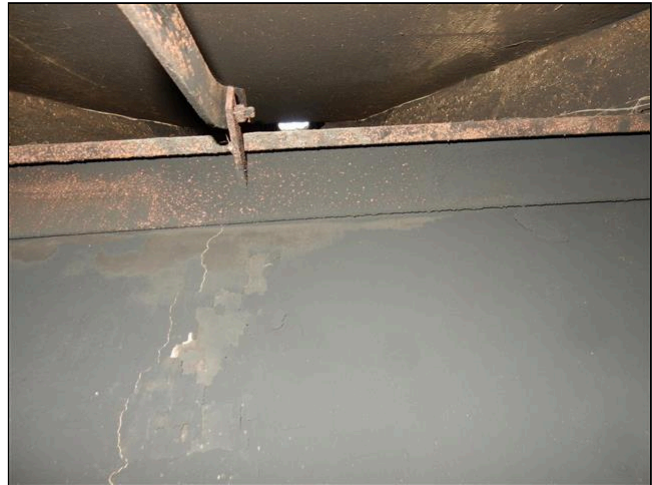
10.7 Item 1 (Picture)

10.7 The damper for fireplace at the family room is missing a clamp or lock that forces lid to stay open (required for Vented Gas/LP logs). . .

The damper for fireplace at the family room is missing a clamp or lock that forces lid to stay open (required for Vented Gas/LP logs). . .

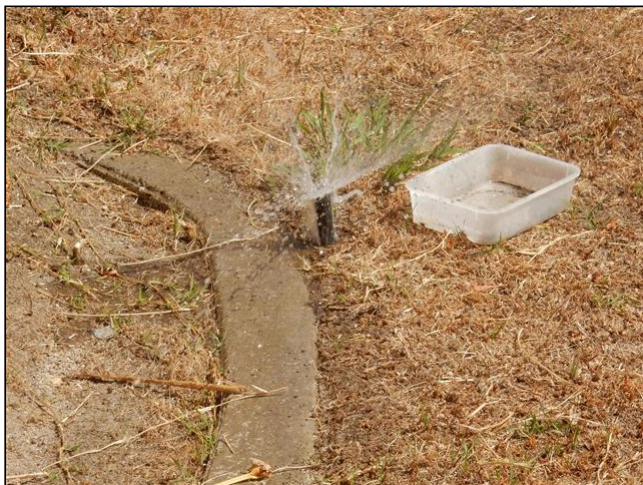
11.0 Item 1 (Picture)

11.0 Several sprinkler heads and piping are damaged and leaking.

Several sprinkler heads and piping are damaged and leaking.
