Maffei Property Inspections

Property Inspection Report

918 Salem St , Chico, CA
Inspection prepared for: Brian Harrison
Date of Inspection: 7/31/2023 Time: 9am
Age of Home: approx 136 Size: unknown
Weather: Sunny and dry

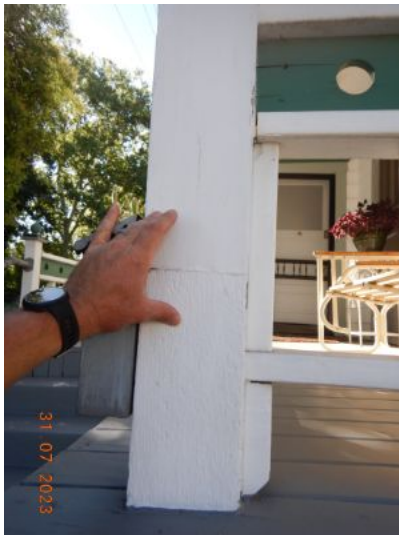
Splice in posts

- The center and north support post for the roof over the front porch have been spliced at the bottom. About 10-12" at the bottom of each post has been replaced. This creates a hinge point in the post that could break during an earthquake.

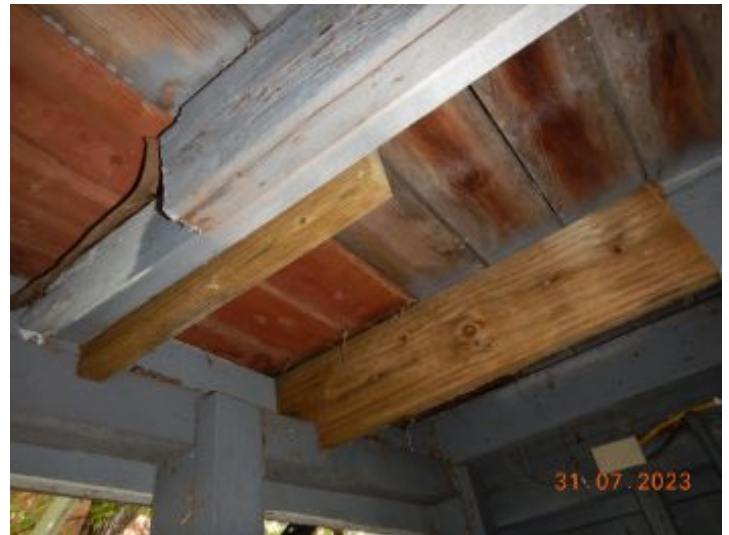
- Wood decay noted at the top of the center support post along the south edge of the back porch.
- The floor joists of the back porch have been spliced together. This may indicate damage from wood decay.

Spliced floor joist

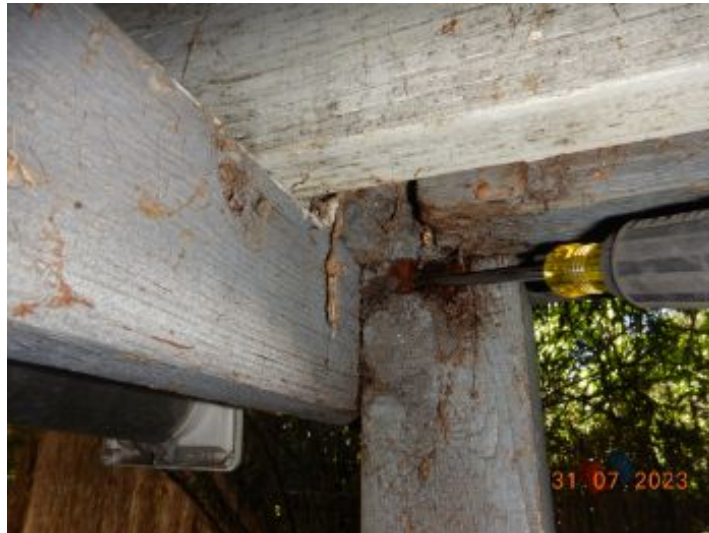
Wood decay at top of support post

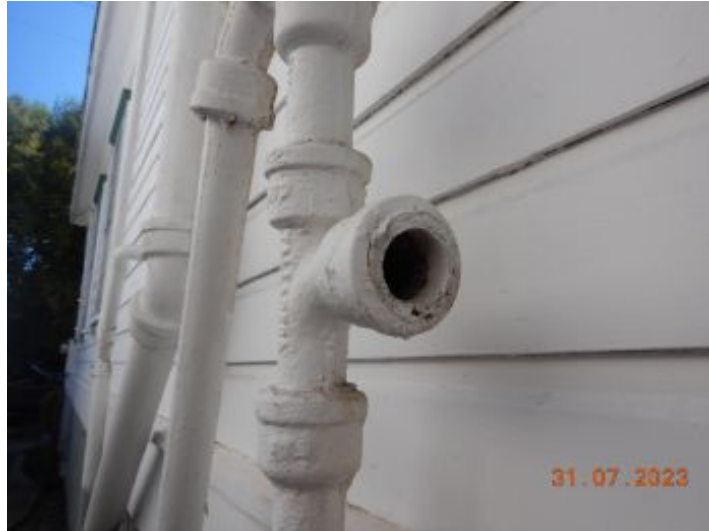
Observations:
• There was an open wye in the plumbing on the north side of the home. This can allow the odor of sewer gases to escape the plumbing
• The inspector did not observe a main water shutoff next to the home. There should be a shutoff valve in the meter box as well.

Open wye

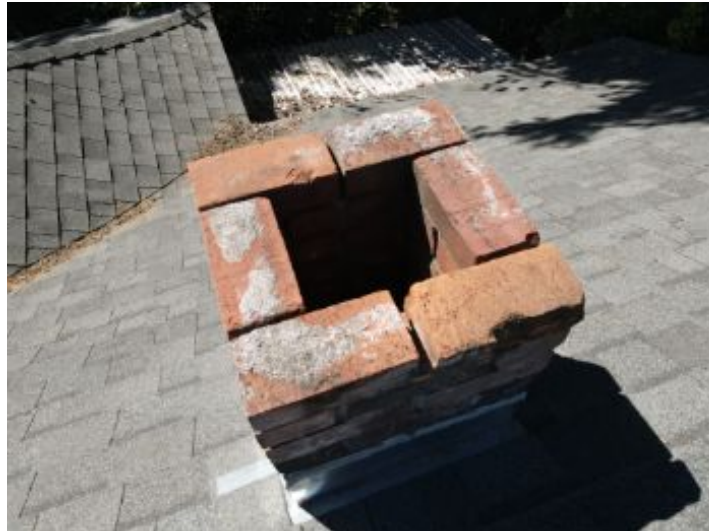
Observations:
 • The flue of the chimney did not appear to be lined.
 • The mortar between the bricks at the top of the chimney flue was missing.
 This will leave the bricks loose.

Observations:
 • Recommend installing a rain cap/spark arrestor.

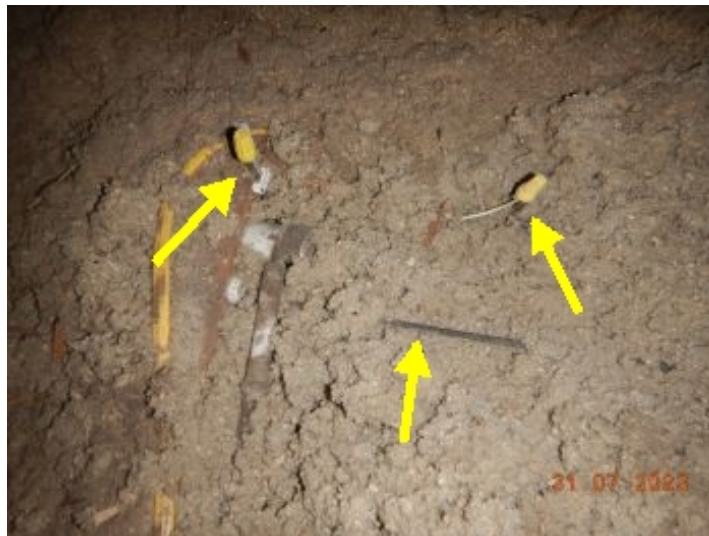
- Active knob and tube wiring noted in the attic. The extent of the active knob and tub wiring was unknown because it was covered with insulation.
- Covering knob and tub wiring with insulation can cause it to overheat.
- Many of the wire splices observed in the attic were made outside of junction boxes.

Example of knob and tube wiring

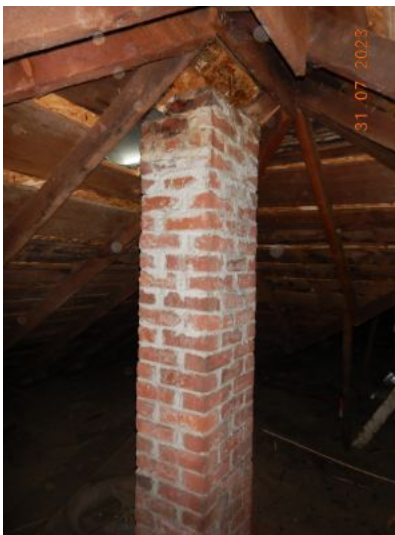
- There were two chimney chases in the attic. The east chase did not extend above the roof line and was not supported. This could make the chimney chase unstable during an earthquake.

Unsupported chimney chase

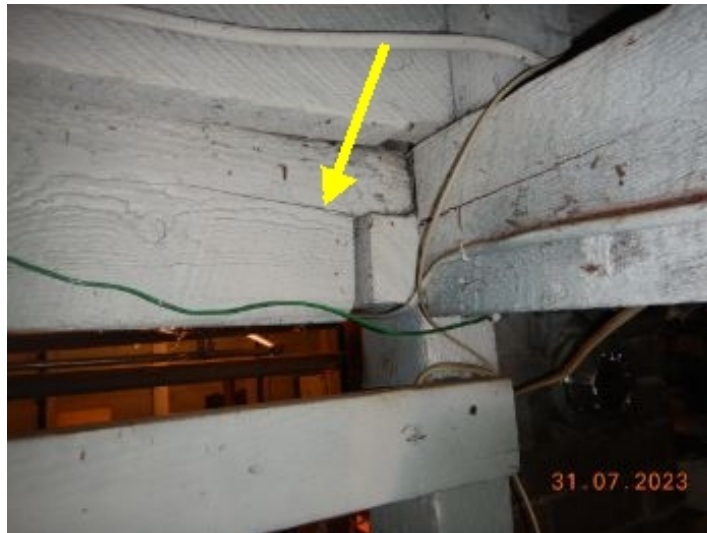
- The east and west ends of the girder under the home, were not supported where they met other structural components. They were spliced using an old method that has allow the west end of the girder to split and has likely allow the girder to sag overall.
- The north end of the girder running under the kitchen has been spliced in the same way mentioned above. The lack of support for this girder has likely also allowed it to sag.

Crack in girder

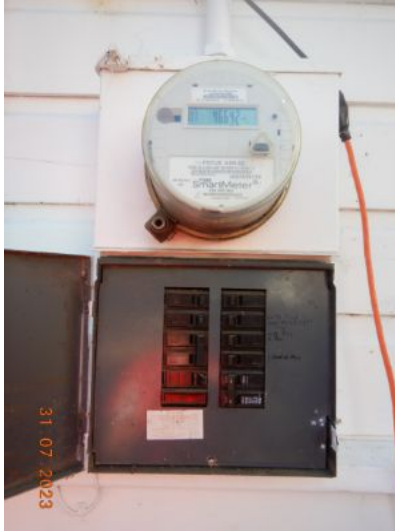
Main panel

- For safety it is recommend that no more than six hand movements be required to shut off all power to the home. Currently, there are 9 breakers in the main panel that would need to be tripped to shut off all power to the home.

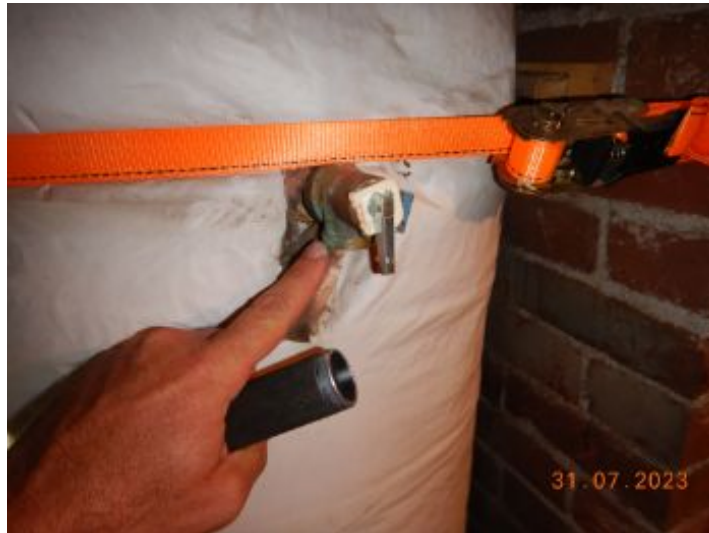
Observations:
 • An overflow line was not attached to the T&P valve at time of inspection.

Missing T&P valve

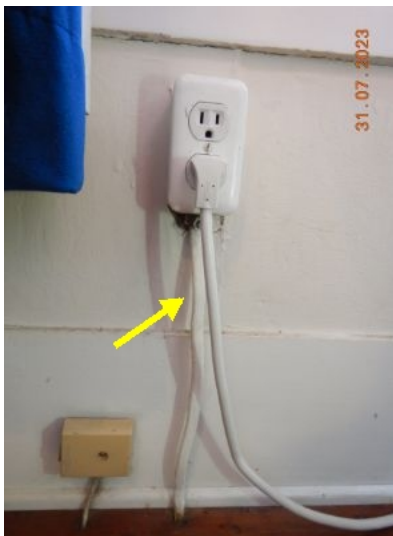
- The wires that power the outlet under the window in the second bedroom were unprotected.

Unprotected wiring

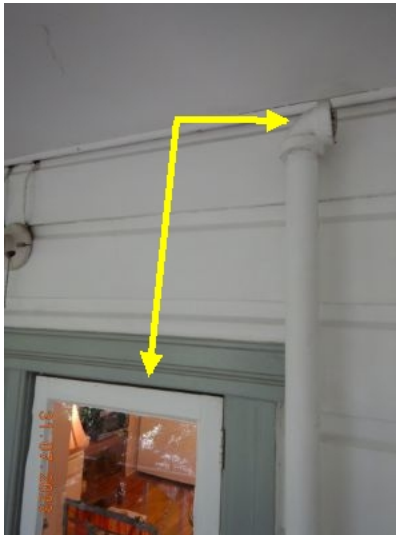
- The laundry area plumbing vent terminated with 3' of an operable window. This can allow sewer gases to be drawn into the window.

Window and open plumbing vent
