# Inspection Report

**Property Address:**  
531 Esplanade #901  
Redondo Beach CA 90277

## Professional Inspection Network

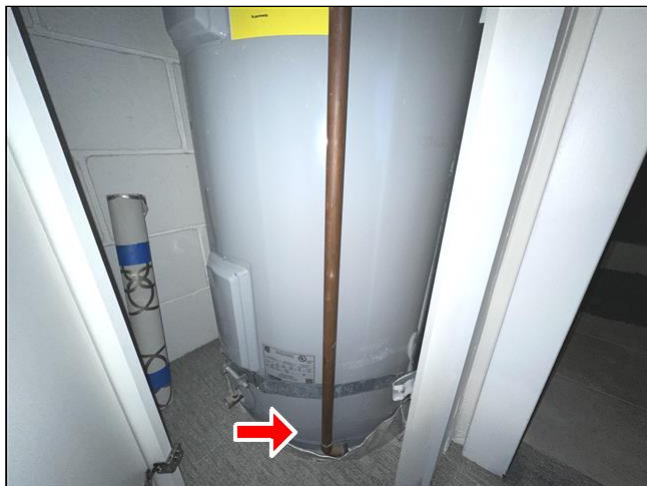
Item 1 - Item 1(Picture) Plumbing System

1. (1) **Improve/Safety Issue:** The water heater Temperature and Pressure Relief valve discharge pipe terminates inside of the home. Although acceptable at the time of original construction, the current building standards require that the discharge pipe be routed to the exterior of the home and terminate in a safe location. Also, PVC is not approved for hot water use. Recommend repair by a qualified person.

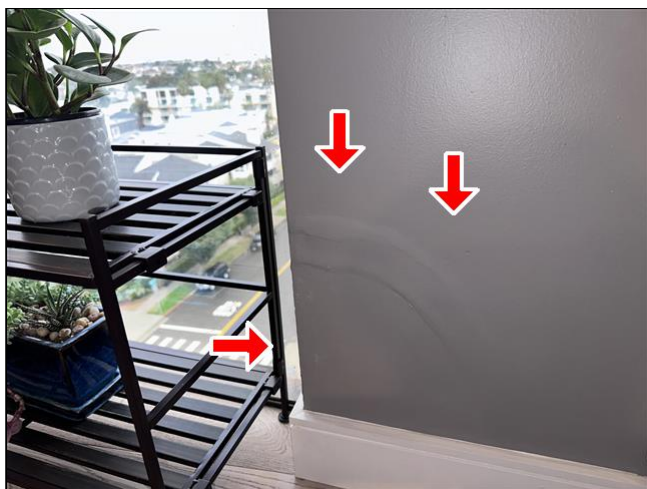
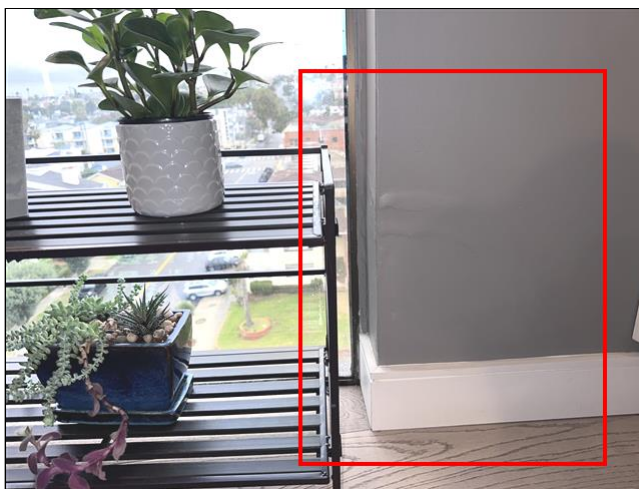
Item 2 - Item 1(Picture) Interiors

2. (1) **Repair or Replace:** Evidence of water damage/water intrusion was observed at the first floor East interior wall adjacent to the window frame. A higher than average moisture reading was observed in this location. This would suggest that the window is leaking. The source of the leak(s) should be identified and repairs performed as necessary. Areas of past and present moisture are favorable for growing many fungal like organisms. There is an extra risk of hidden damage/fungus/mold to be present in this location. The identification of molds, fungus and other microbial organisms is outside the

scope of this inspection. Suggest further investigations and repair by a qualified contractor.

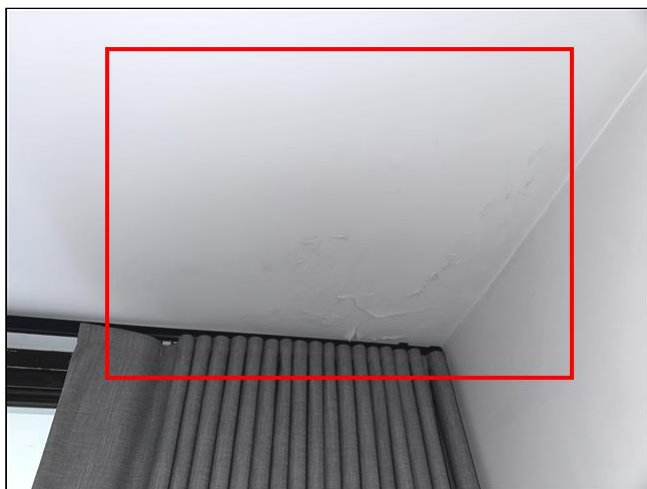
Item 3 - Item 1(Picture) Interiors

3. (2) **Repair or Replace:** Evidence of water damage/water intrusion was observed at the primary bedroom ceiling along the North-West corner. A higher than average moisture reading was observed in this location. This would suggest that an active leak(s) is present. The source of the leak(s) should be identified and repairs performed as necessary. Areas of past and present moisture are favorable for growing many fungal like organisms. There is an extra risk of hidden damage/fungus/mold to be present in this location. The identification of molds, fungus and other microbial organisms is outside the scope of this inspection. Suggest further investigations and repair by a qualified contractor.

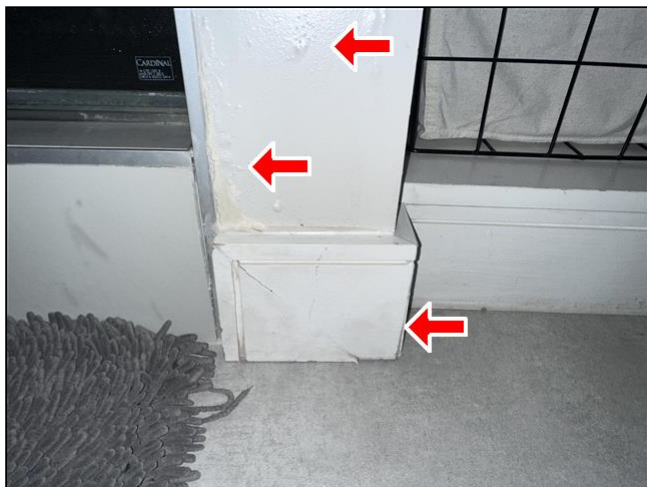
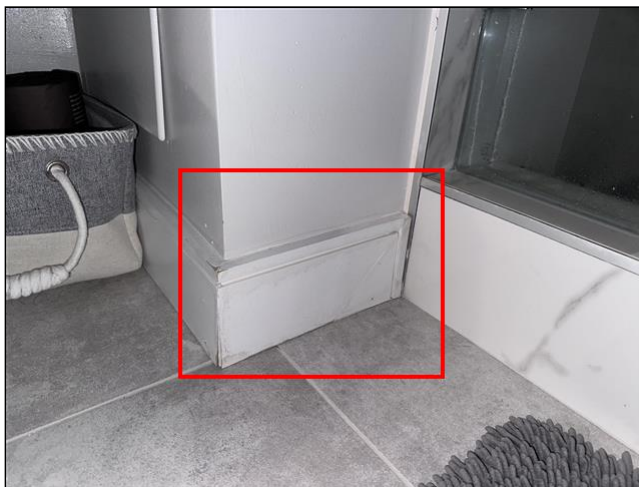
Item 4 - Item 1(Picture) Interiors

4. (3) **Repair or Replace:** Evidence of water damage/water intrusion was observed at the first floor East interior wall adjacent to the window frame. This appears to be from water leaking from the shower door and/opening and closing of the shower door. The source of the leak(s) should be identified and repairs performed as necessary. Areas of past and present moisture are favorable for growing many fungal like organisms. There is an extra risk of hidden damage/fungus/mold to be present in this location. The identification of molds, fungus and other microbial organisms is outside the scope of this inspection. Suggest further investigations and repair by a qualified contractor.

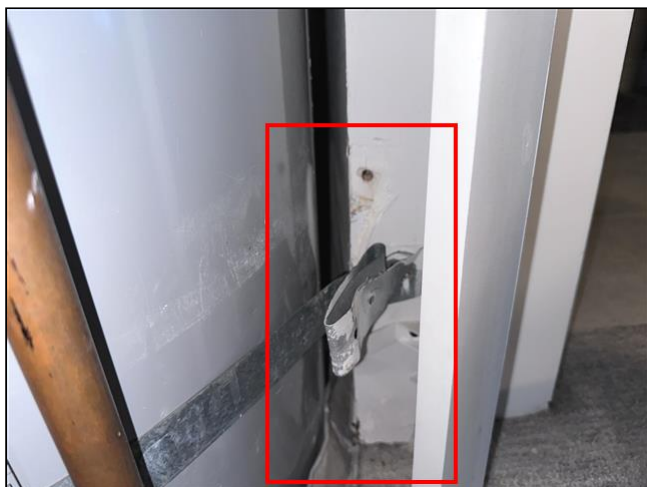
Item 5 - Item 1(Picture) Interiors

5. (4) **Repair/Replace/Monitor:** Evidence of water damage was observed at the wall adjacent to the water heater. Water damage appears to be from a past leak. Areas of past and present moisture are favorable for growing many fungal like organisms. There is an extra risk of hidden damage/fungus/mold to be present in this location. The identification of molds, fungus and other microbial organisms is outside the scope of this inspection. Suggest further investigations and repair by a qualified contractor.

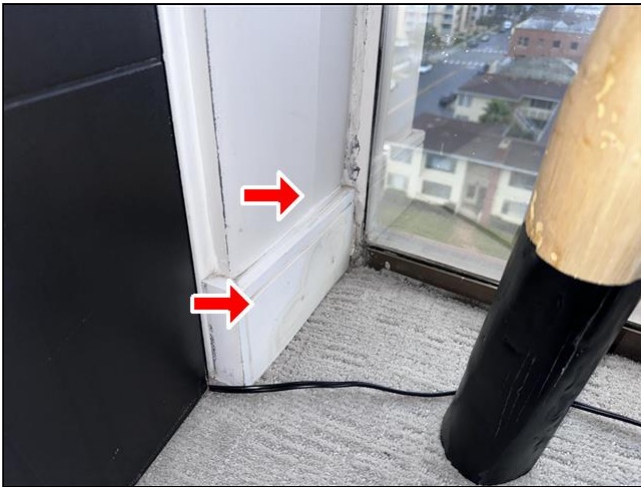
Item 6 - Item 1(Picture) Interiors

6. **Repair or Replace:** The second floor South bedroom front wall windows are leaking. Water staining and current water was observed on the interior side of the windows. Also, water staining was observed at the baseboard adjacent to the window frame. The source of the leak(s) should be identified and repairs performed as necessary. Areas of past and present moisture are favorable for growing many fungal like organisms. There is an extra risk of hidden damage/fungus/mold to be present in this location. The identification of molds, fungus and other microbial organisms is outside the scope of this inspection. Suggest further investigations and repair/replacement of the windows by a qualified contractor.

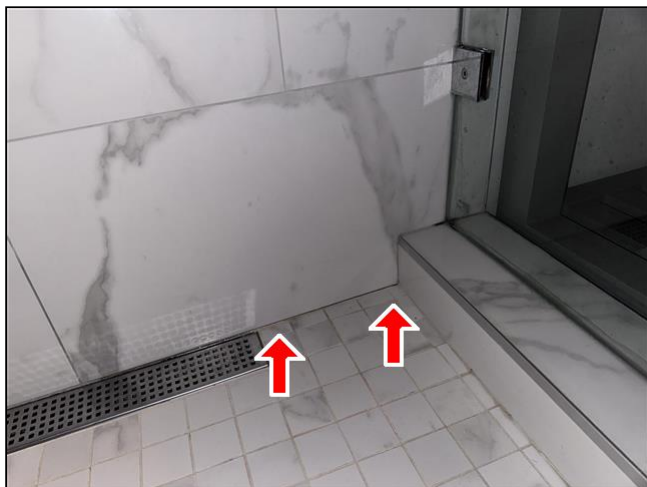
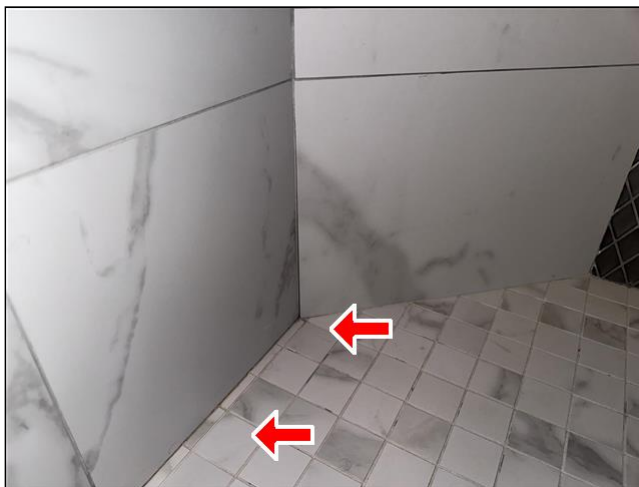
Item 8 - Item 1(Picture) Interiors

8. (1) **Repair or Replace:** The grout/caulking at the primary bathroom shower floor to wall intersection is in need of repair and/or replacement to prevent water damage/moisture intrusion.

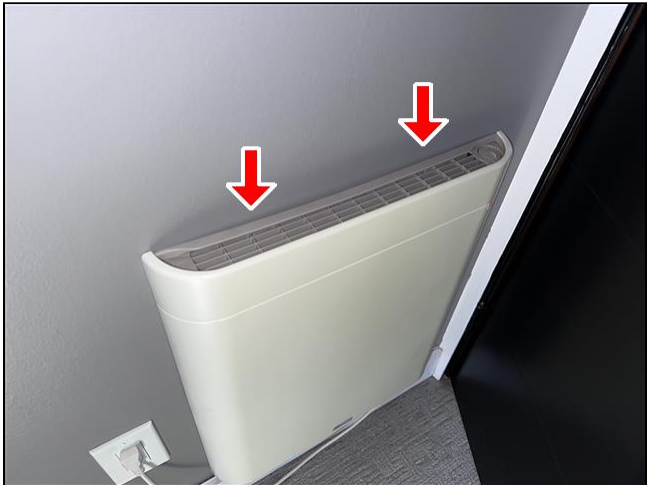
4.0 Item 1(Picture) Heating/Central Air

(1) **Safety Issue:** Smoke was observed when operating the second floor South bedroom electrical wall heater. This appears to be from dust/hair. It is suggested that the electric wall heater be cleaned prior to operation.

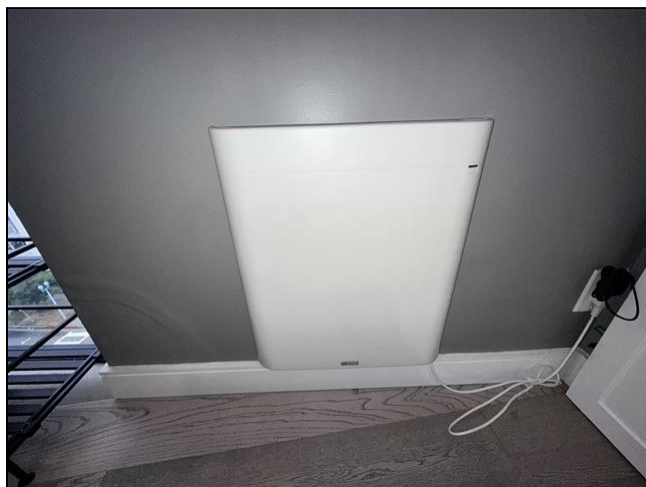
4.0 Item 2(Picture) Heating/Central Air

(2) **Monitor:** The living room electric wall heater furnace was operational and produced heat at time of

inspection.

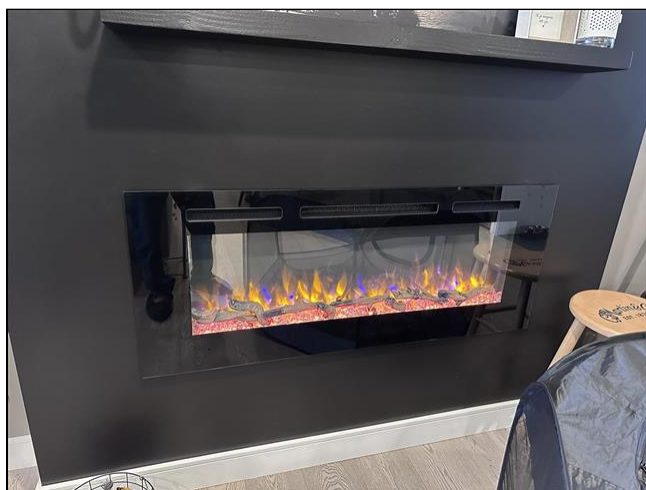
4.0 Item 3(Picture) Heating/Central Air

(3) **Monitor:** The living room decorative electric wall heater furnace was operational and produced heat at time of inspection.

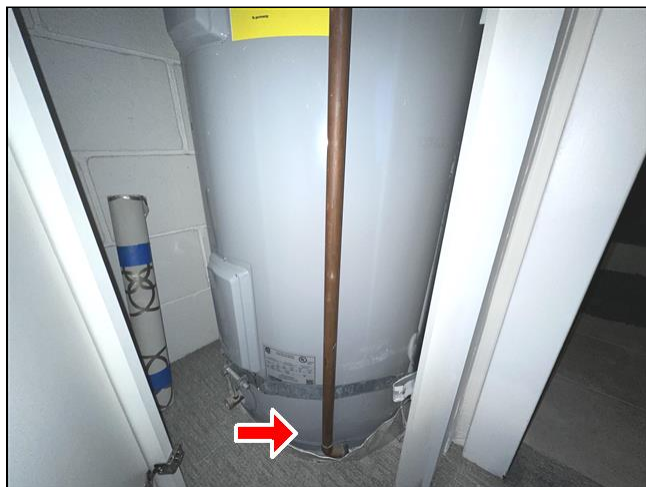
5.2 Item 1(Picture) Plumbing System

(1) **Improve/Safety Issue:** The water heater Temperature and Pressure Relief valve discharge pipe terminates inside of the home. Although acceptable at the time of original construction, the current building standards require that the discharge pipe be routed to the exterior of the home and terminate in a safe location. Also, PVC is not approved for hot water use. Recommend repair by a qualified person.

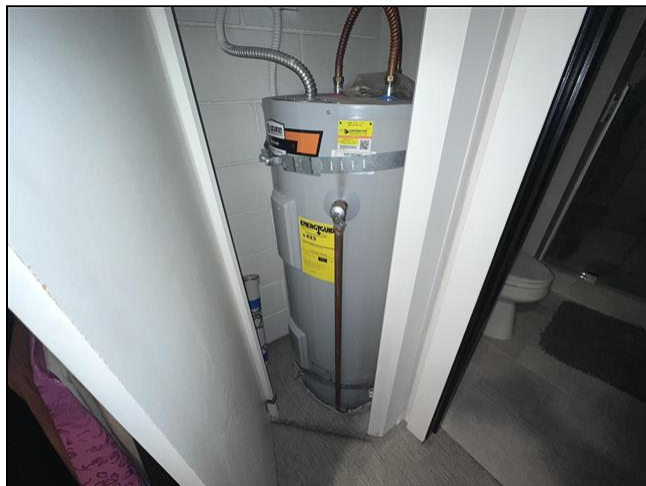
5.2 Item 2(Picture) Plumbing System

(2) **Note/Monitor:** The water heater was operational and produced hot water at time of inspection.

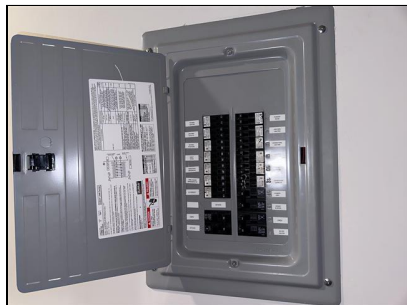
6.4 Item 1(Picture) Electrical System

**Inspected:** The main electrical service disconnect is located at the exterior. The electrical sub-panel is located at the interior wall of the condominium.

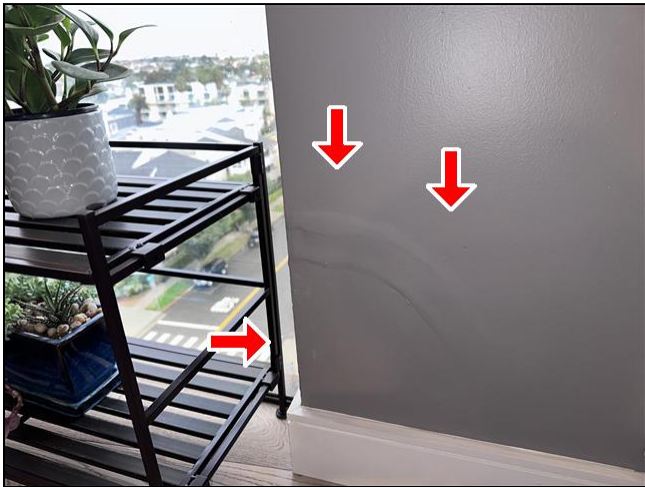
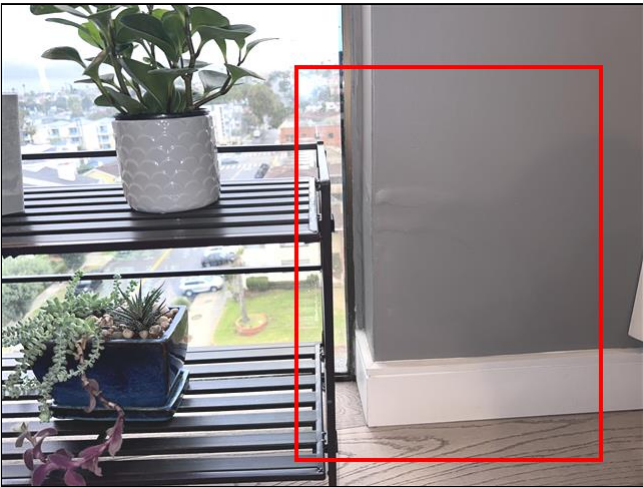
8.1 Item 1(Picture) Interiors

(1) **Repair or Replace:** Evidence of water damage/water intrusion was observed at the first floor East interior wall adjacent to the window frame. A higher than average moisture reading was observed in this location. This would suggest that the window is leaking. The source of the leak(s) should be identified and repairs performed as necessary. Areas of past and present moisture are favorable for growing many fungal like organisms. There is an extra risk of hidden damage/fungus/mold to be present in this location. The identification of molds, fungus and other microbial organisms is outside the scope of this inspection. Suggest further investigations and repair by a qualified contractor.

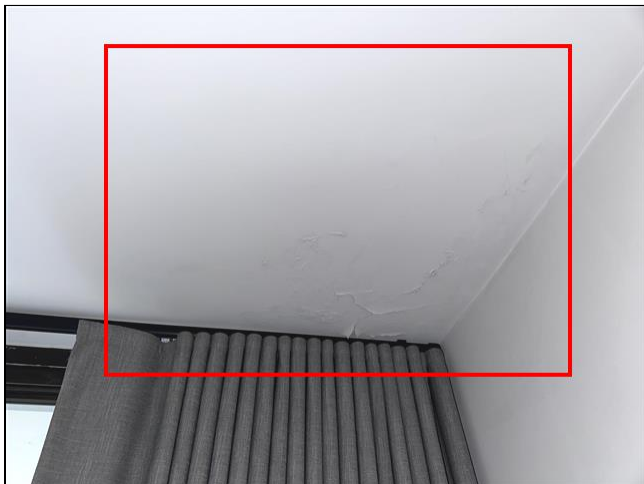
8.1 Item 3(Picture) Interiors

(2) **Repair or Replace:** Evidence of water damage/water intrusion was observed at the primary bedroom ceiling along the North-West corner. A higher than average moisture reading was observed in this location. This would suggest that an active leak(s) is present. The source of the leak(s) should be identified and repairs performed as necessary. Areas of past and present moisture are favorable for growing many fungal like organisms. There is an extra risk of hidden damage/fungus/mold to be present in this location. The identification of molds, fungus and other microbial organisms is outside the scope of this inspection. Suggest further investigations and repair by a qualified contractor.

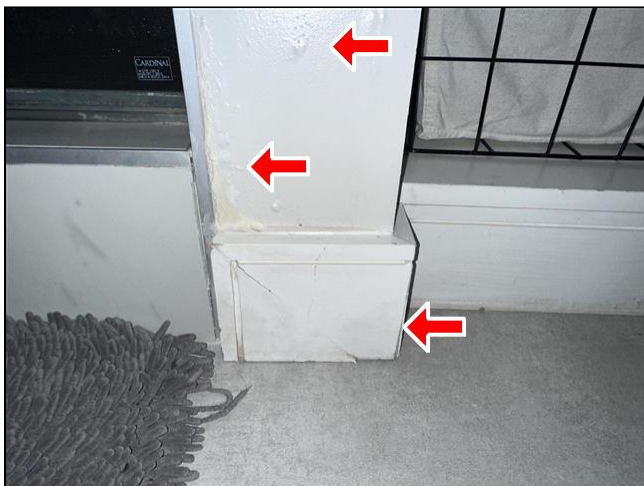
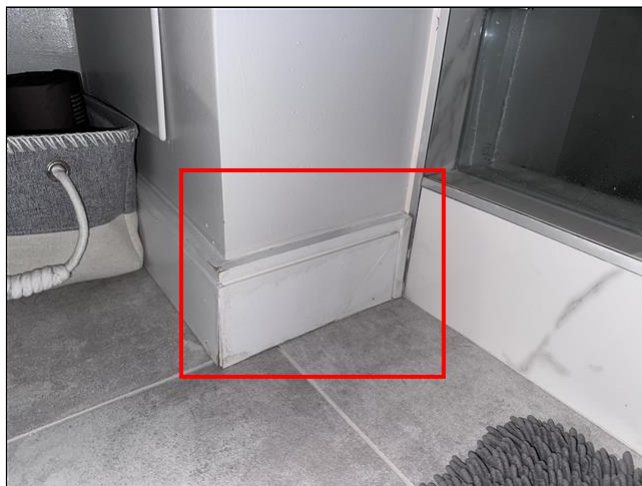
8.1 Item 4(Picture) Interiors

(3) **Repair or Replace:** Evidence of water damage/water intrusion was observed at the first floor East interior wall adjacent to the window frame. This appears to be from water leaking from the shower door and/opening and closing of the shower door. The source of the leak(s) should be identified and repairs performed as necessary. Areas of past and present moisture are favorable for growing many fungal like organisms. There is an extra risk of hidden damage/fungus/mold to be present in this location. The identification of molds, fungus and other microbial organisms is outside the scope of this inspection. Suggest further investigations and repair by a qualified contractor.

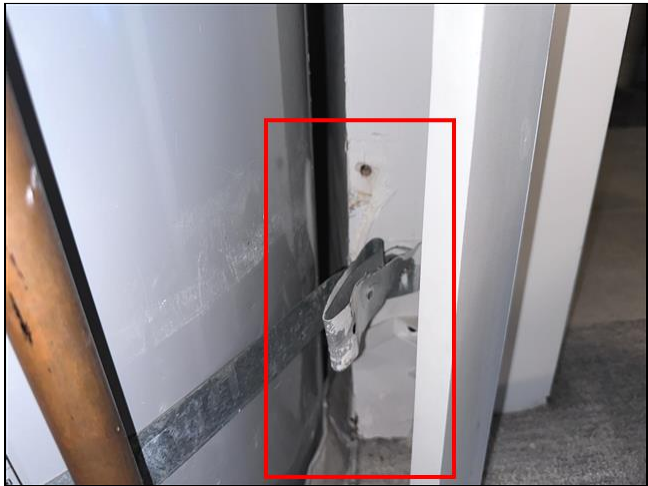
8.1 Item 6(Picture) Interiors

(4) **Repair/Replace/Monitor:** Evidence of water damage was observed at the wall adjacent to the water heater. Water damage appears to be from a past leak. Areas of past and present moisture are favorable for growing many fungal like organisms. There is an extra risk of hidden damage/fungus/mold to be present in this

location. The identification of molds, fungus and other microbial organisms is outside the scope of this inspection. Suggest further investigations and repair by a qualified contractor.

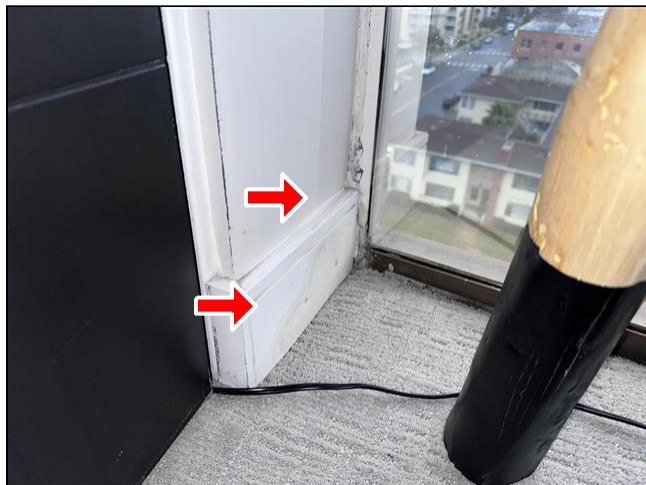
8.3 Item 1(Picture) Interiors

**Repair or Replace:** The second floor South bedroom front wall windows are leaking. Water staining and current water was observed on the interior side of the windows. Also, water staining was observed at the baseboard adjacent to the window frame. The source of the leak(s) should be identified and repairs performed as necessary. Areas of past and present moisture are favorable for growing many fungal like organisms. There is an extra risk of hidden damage/fungus/mold to be present in this location. The identification of molds, fungus and other microbial organisms is outside the scope of this inspection. Suggest further investigations and repair/ replacement of the windows by a qualified contractor.

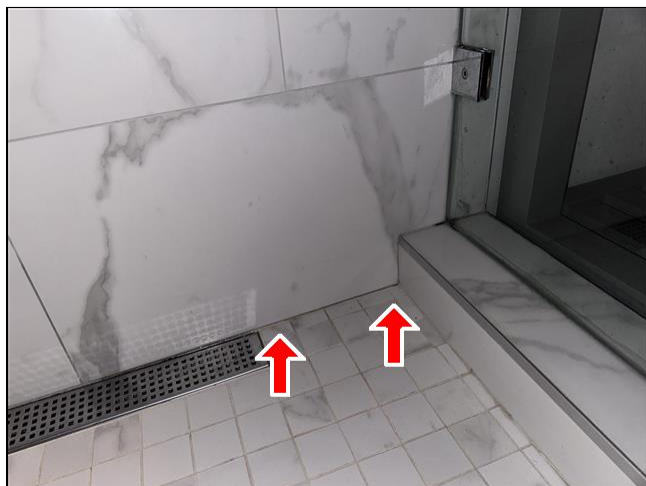
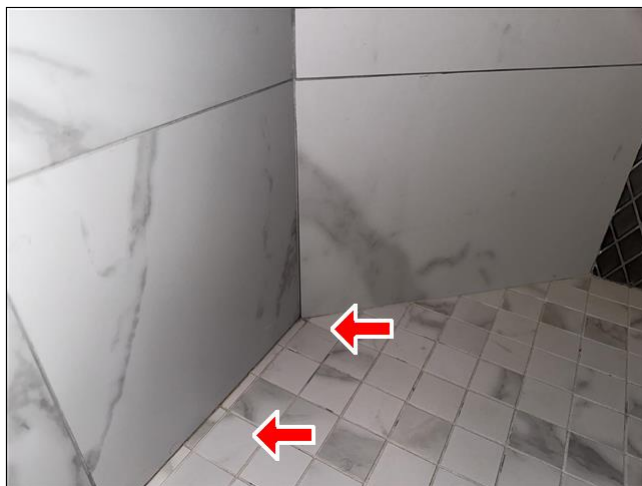
8.9 Item 1(Picture) Interiors

(1) **Repair or Replace:** The grout/caulking at the primary bathroom shower floor to wall intersection is in need of repair and/or replacement to prevent water damage/moisture intrusion.
