OMNI INSPECTIONS LLC

3734 Kamp Dr
Pleasanton, CA 94588

Javier Rodriguez
09/15/2025

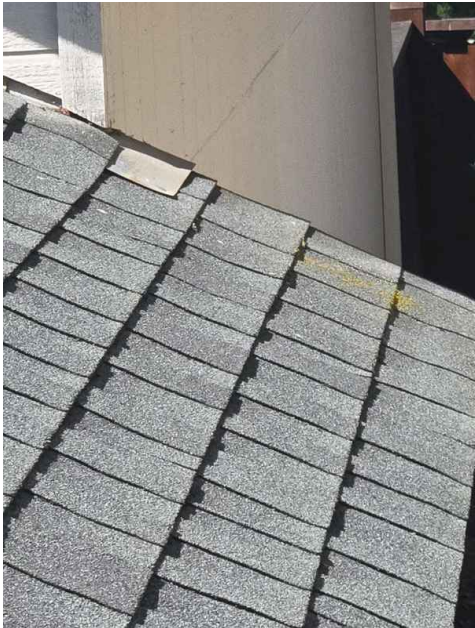
2.2.1 Coverings

ORGANIC GROWTH ON ROOF

Can cause premature failure of roof coverings. Have cleaned and removed by specialists.

Contact a qualified professional.

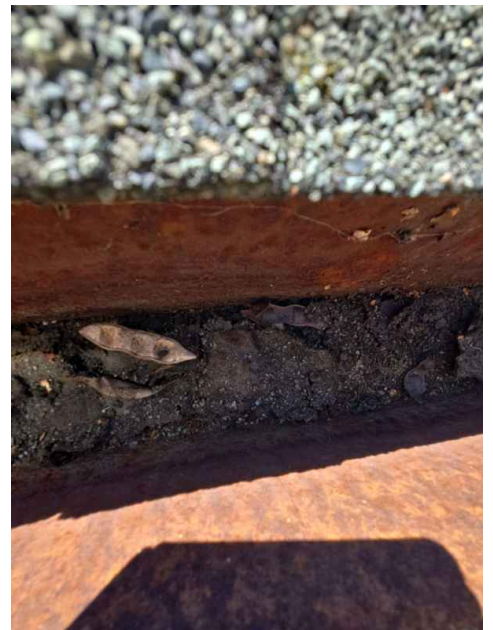
2.3.1 Roof Drainage Systems**DEBRIS**

Debris has accumulated in the gutters. Recommend cleaning to facilitate water flow.

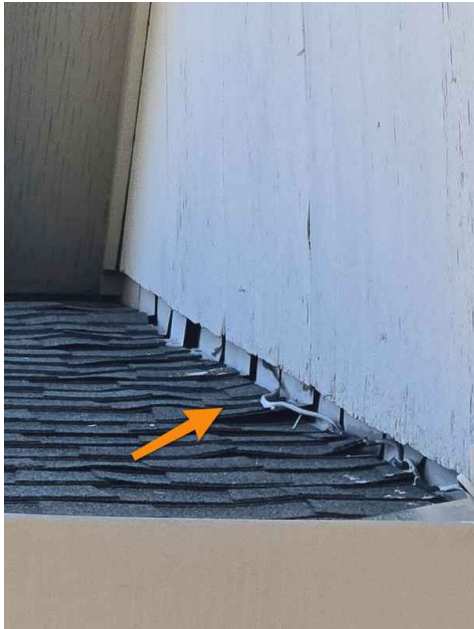
2.4.1 Flashings**LOOSE/SEPARATED**

Flashings observed to be loose or separated, which can lead to water intrusion and/or mold. Recommend a qualified roofing contractor repair.

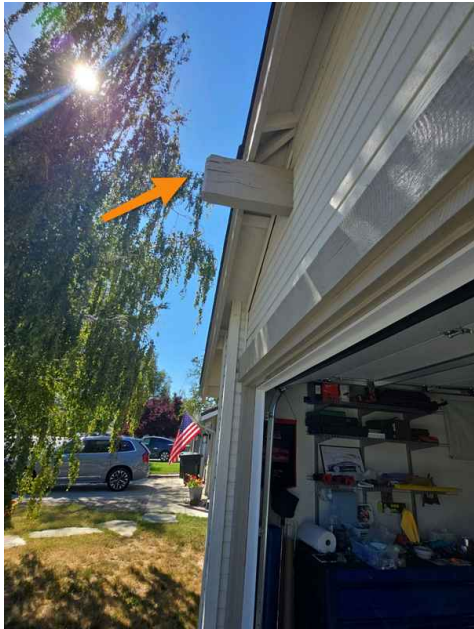
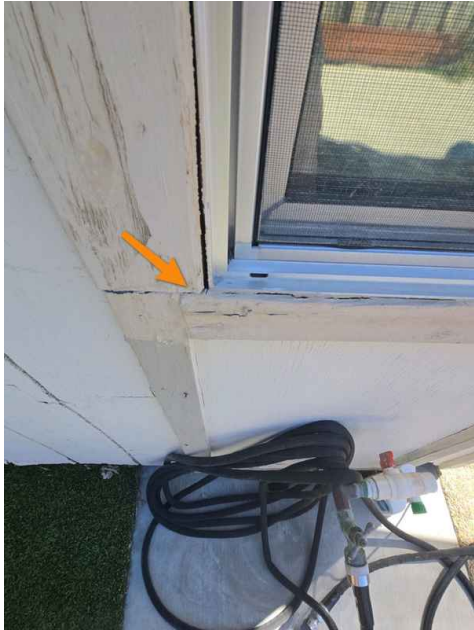
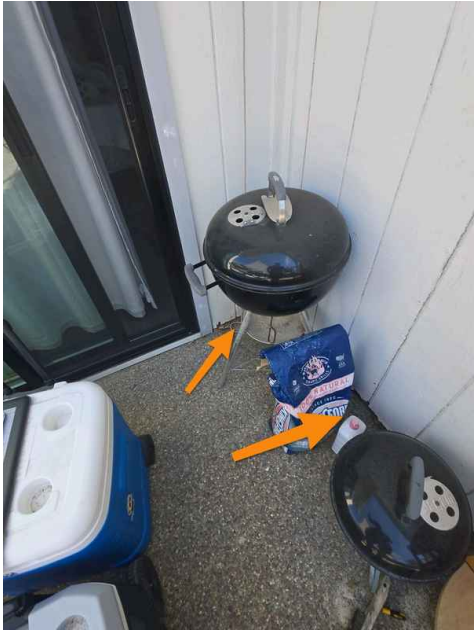
3.2.1 Siding, Flashing & Trim

ROT IN MULTIPLE LOCATIONS

What is Wood Rot? It is decay caused by fungal growth in damp wood. When timber becomes damp enough to have 20% or more moisture content, and isn't able to dry out quickly or is repeatedly dampened, it creates the ideal conditions for wood-eating fungi. Repairing the cause of the wood rot first is recommended then repair the rot.

Contact a qualified professional.

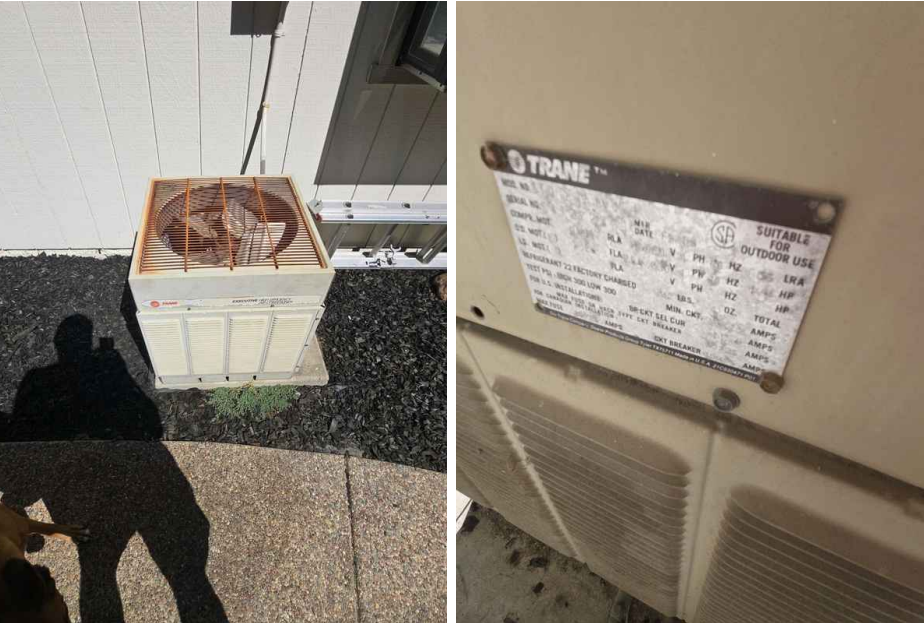
6.1.1 Cooling Equipment

Cooling Equipment: Energy Source/Type Electric	Cooling Equipment: Location Patio Area	Normal Operating Controls: Mounted on wall
Distribution System: Configuration Split		
Cooling Equipment: Brand Trane

DATED UNIT NEARING END OF LIFE

Should be replaced

Contact a qualified professional.

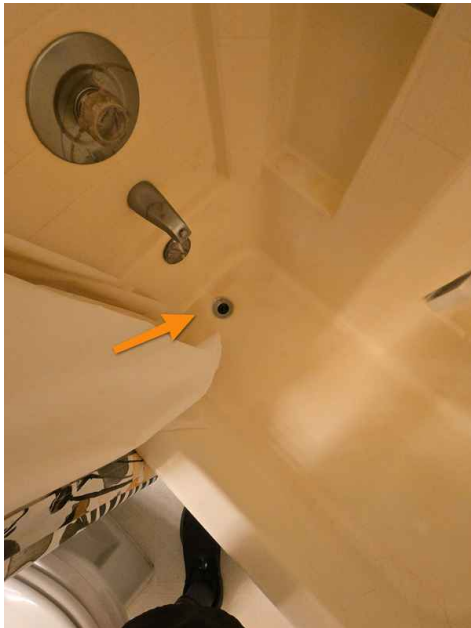
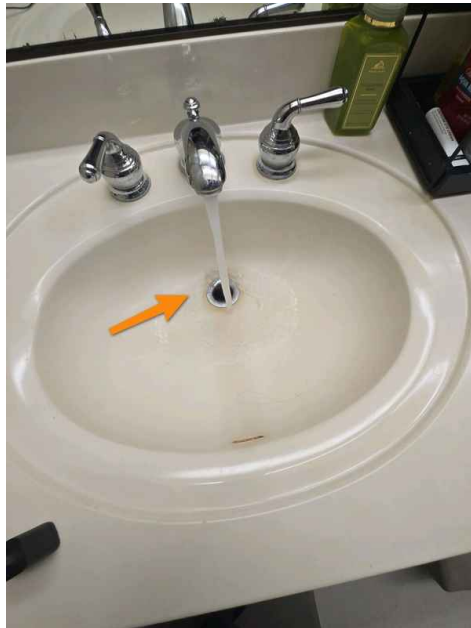
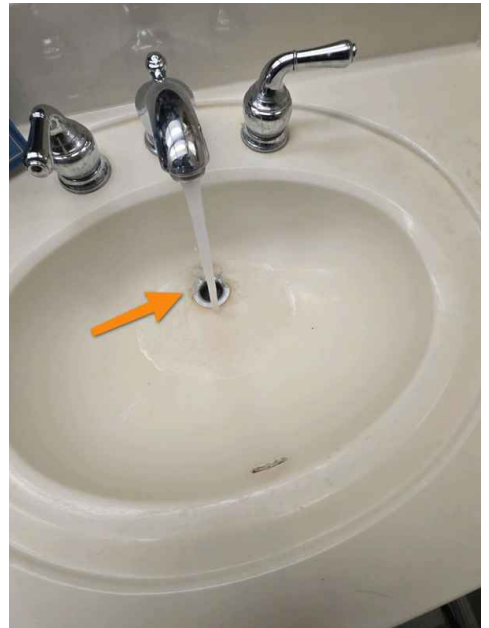
7.3.1 Drain, Waste, & Vent Systems

MISSING CATCH AT DRAIN

Have installed

Contact a qualified professional.

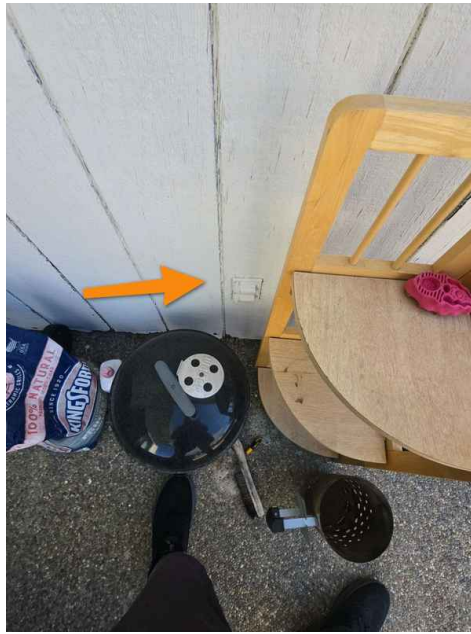
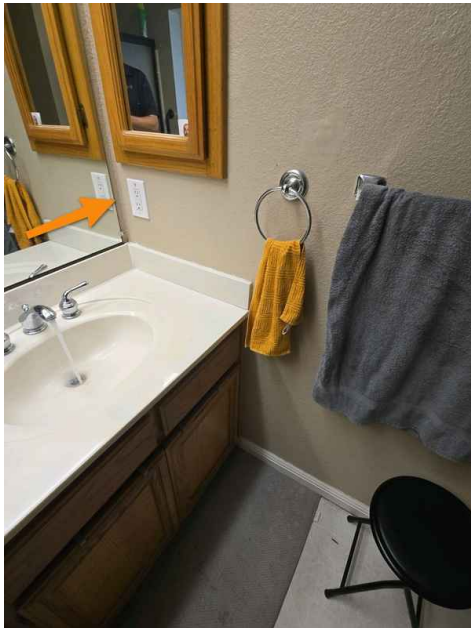
8.5.1 GFCI & AFCI

NO GFCI PROTECTION INSTALLED

No GFCI protection present in some locations. Recommend licensed electrician upgrade by installing ground fault receptacles in all locations.

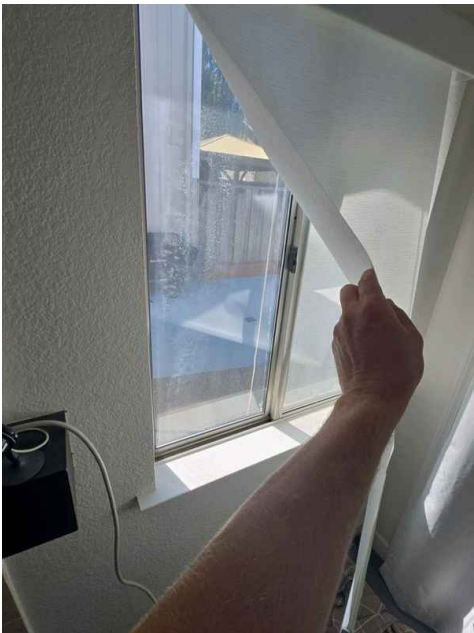
11.2.1 Windows

FAILED SEAL

Observed condensation between the window panes, which indicates a failed seal. Recommend qualified window contractor evaluate & replace.

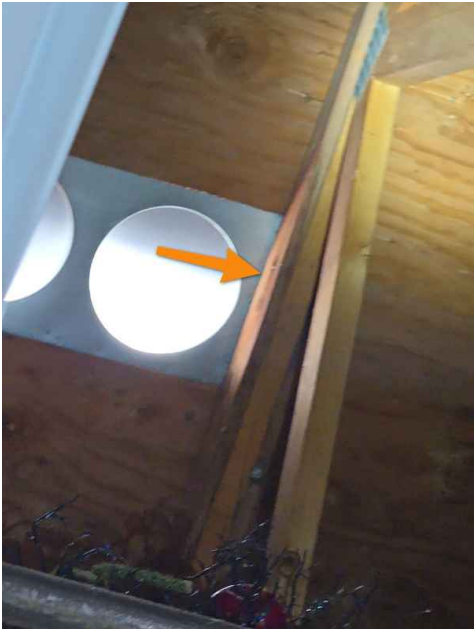
12.1.1 Ceiling

SPLIT RAFTER AND STAINING NOTED IN GARAGE

Rafter sistered as a repair and the stain appears to be old non structural issue

Recommendation
Contact a qualified professional.
