Titus
Inspections

Inspection Report

2121 Marshallfield Ln Unit A
2121 Marshallfield Ln Unit B
Redondo Beach CA 90278

| Property Address 2121 Marshallfield Ln Unit A 2121 Marshallfield Ln Unit B Redondo Beach CA 90278 | Date of Inspection 8/26/2025 | Report ID 250826-01 |

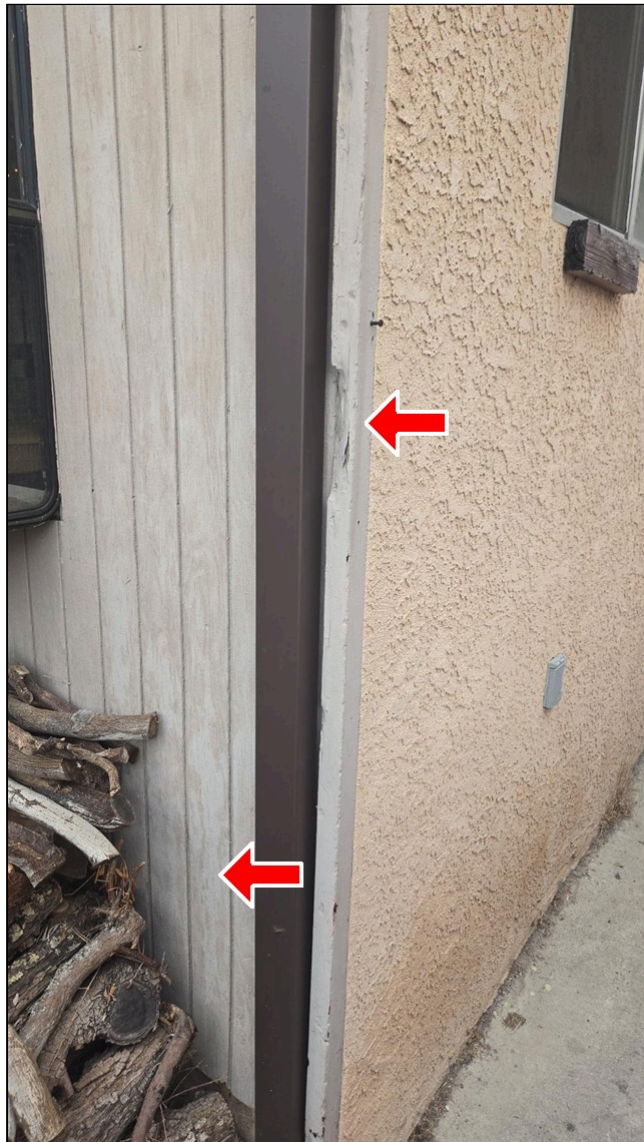
1.0 (1) Unit A front wood siding has wood damage. Recommend a qualified person further inspect for repair or replacement recommendations.

1.0 Item 1(Picture) Unit A front wood siding

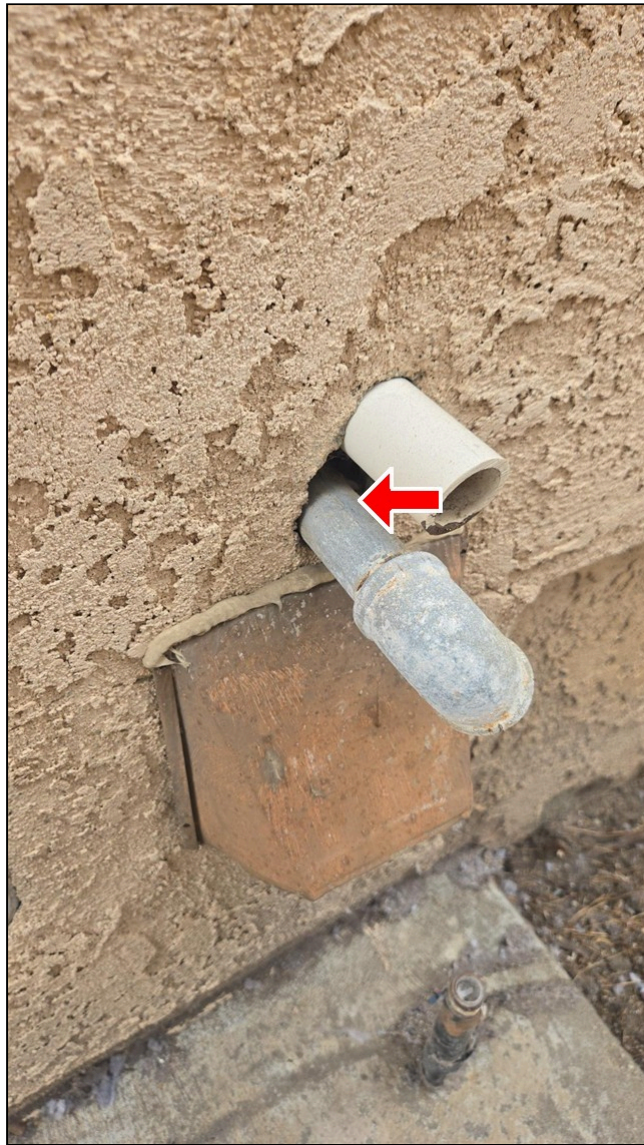
1.0 (2) Visible gap in exterior stucco siding around plumbing accesses on multiple sides of home. Recommend sealing all gaps to prevent insects from nesting and to prevent water intrusion. Repair as needed.

1.0 Item 2(Picture) Gaps, east exterior siding

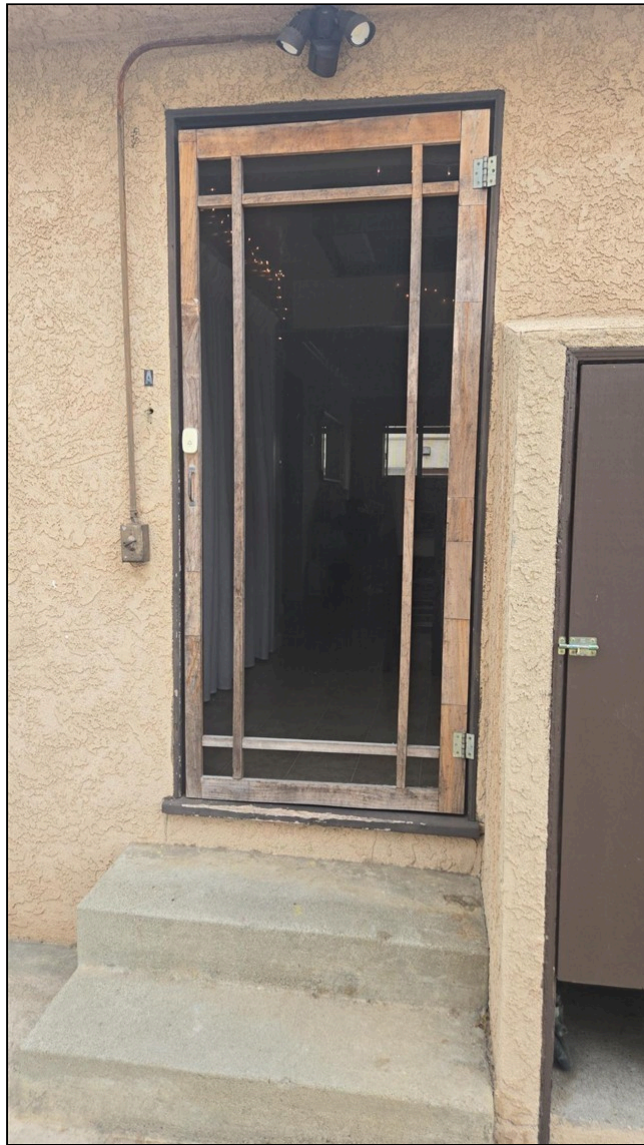
1.2 (1) Screen door on the west entry to unit A has exposed wood. Recommend a qualified person further inspect and properly seal wood as needed.

1.2 Item 1(Picture) Screen door, exposed wood, unit A side entry

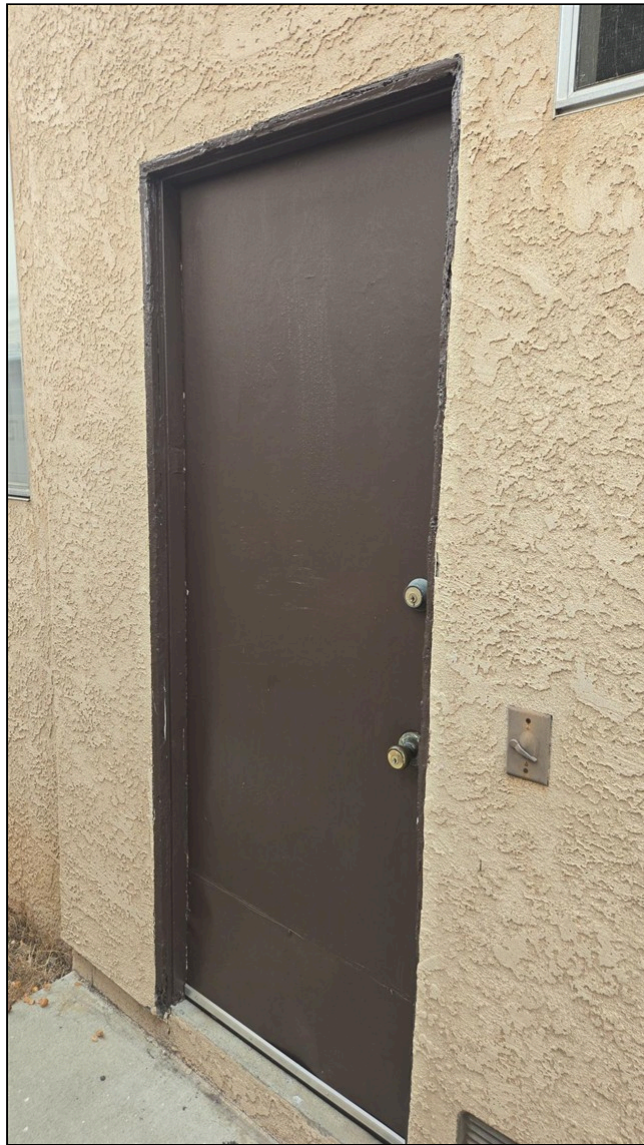
1.2 (2) East exterior entry door for laundry room has wood damage on door jamb and casing. Recommend a qualified person further inspect for repair or replacement recommendations.

1.2 Item 2(Picture) East laundry room door

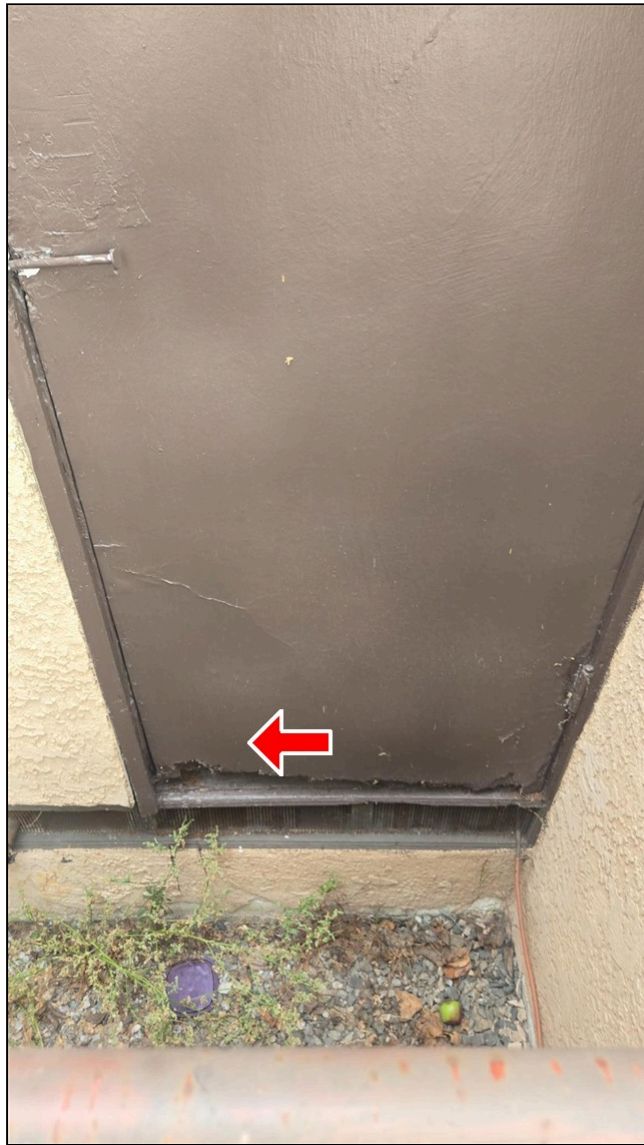
1.2 (3) Exterior heat system closet door is in damaged condition. Recommend a qualified person further inspect for repair or replacement recommendations.

1.2 Item 3(Picture) West exterior heater closet door

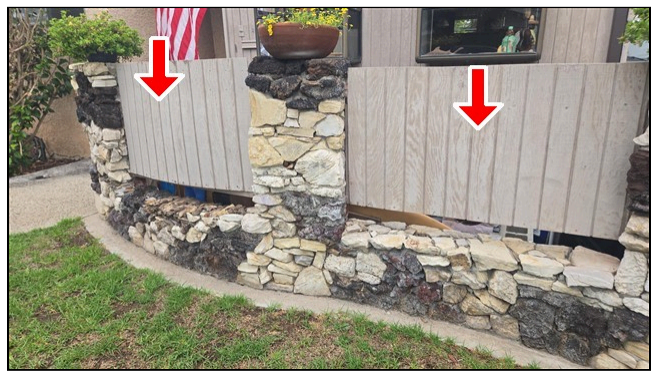
1.5 Wood damage found to wood fencing and gates at front of unit A. Gates at the east of unit A do not operate properly. Recommend a qualified person further inspect for repair or replacement recommendations.

1.5 Item 1(Picture) Wood fencing

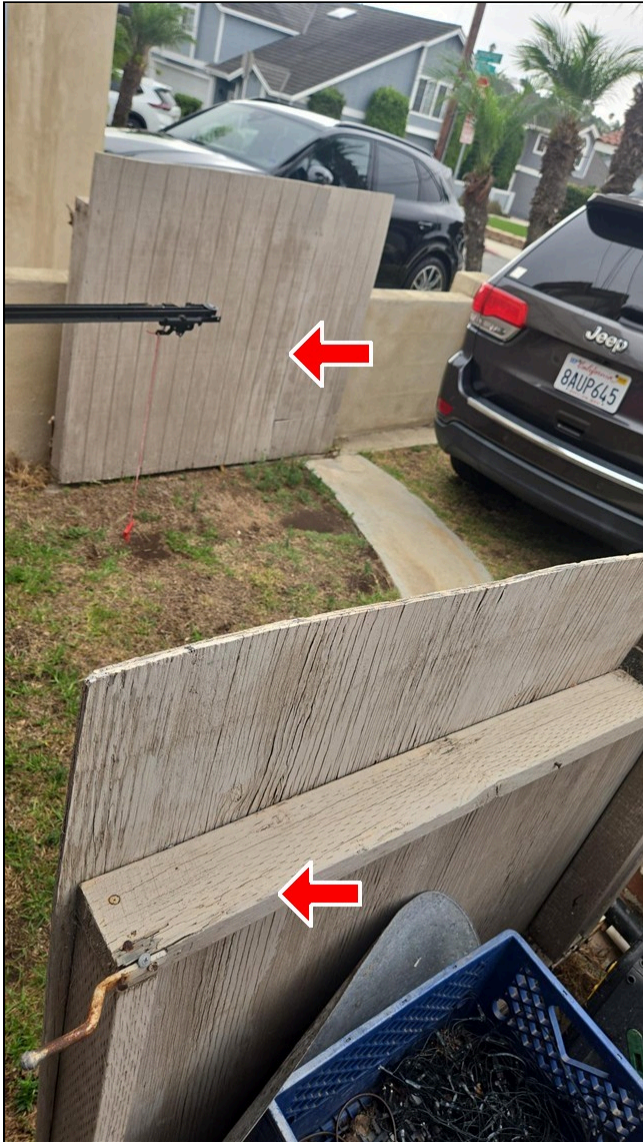
1.5 Item 3(Picture) Wood gates

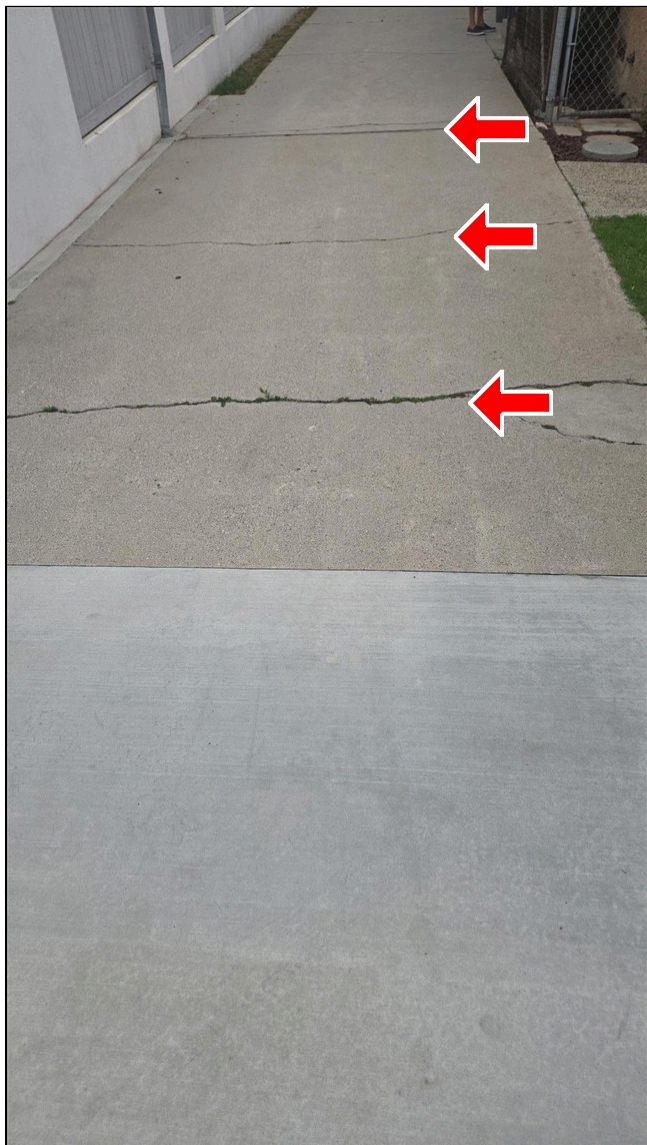
1.6 (1) Multiple settlement cracks along driveway. Recommend properly sealing all settlement cracks to prevent water intrusion and further cracking. Repair as needed.

1.6 Item 1(Picture) Driveway settlement cracks

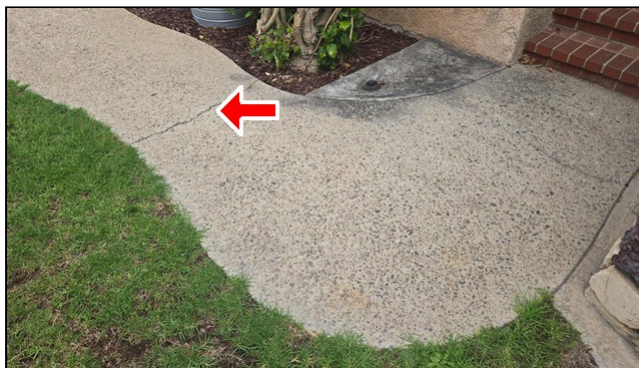
1.6 Item 3(Picture) Settlement cracks, front entry, unit A

1.6 (2) Settlement cracks found on walkways leading to unit A front entry. Recommend a qualified person further inspect for repair recommendations.

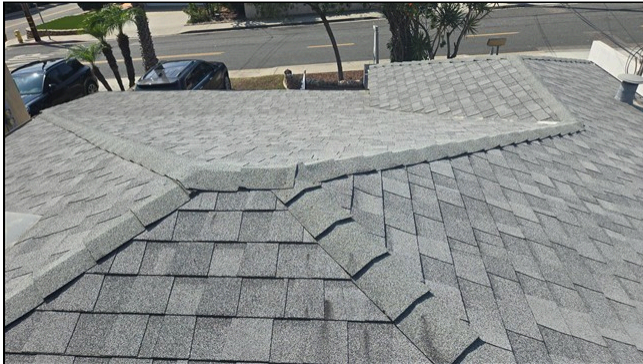
2.0 Item 1(Picture) Roof covering

2.0 Roof covering is in good, serviceable condition. Minor signs of pooling were found on the flat portion of roof covering. This is common on flat roof coverings. Recommend a qualified roof specialist further inspect for options on preventing minor pooling.

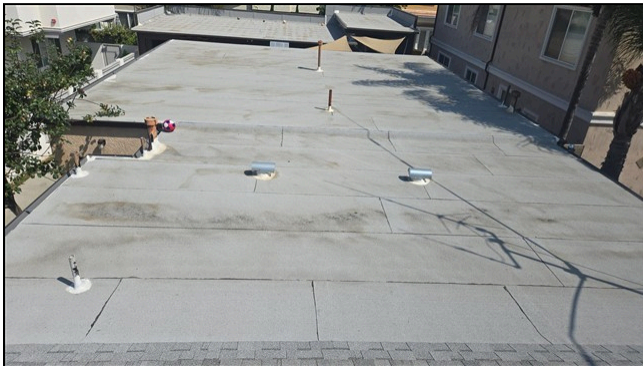
2.0 Item 3(Picture) Minor signs of pooling

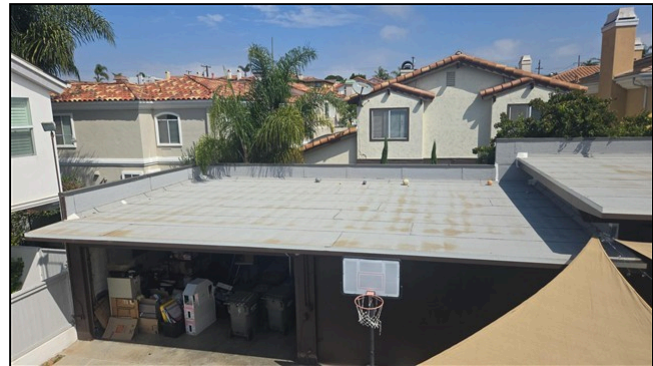
2.0 Item 4(Picture) Minor signs of pooling

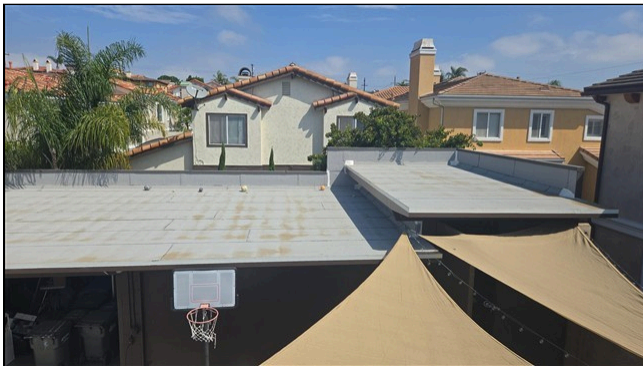
2.0 Item 5(Picture) Minor signs of pooling

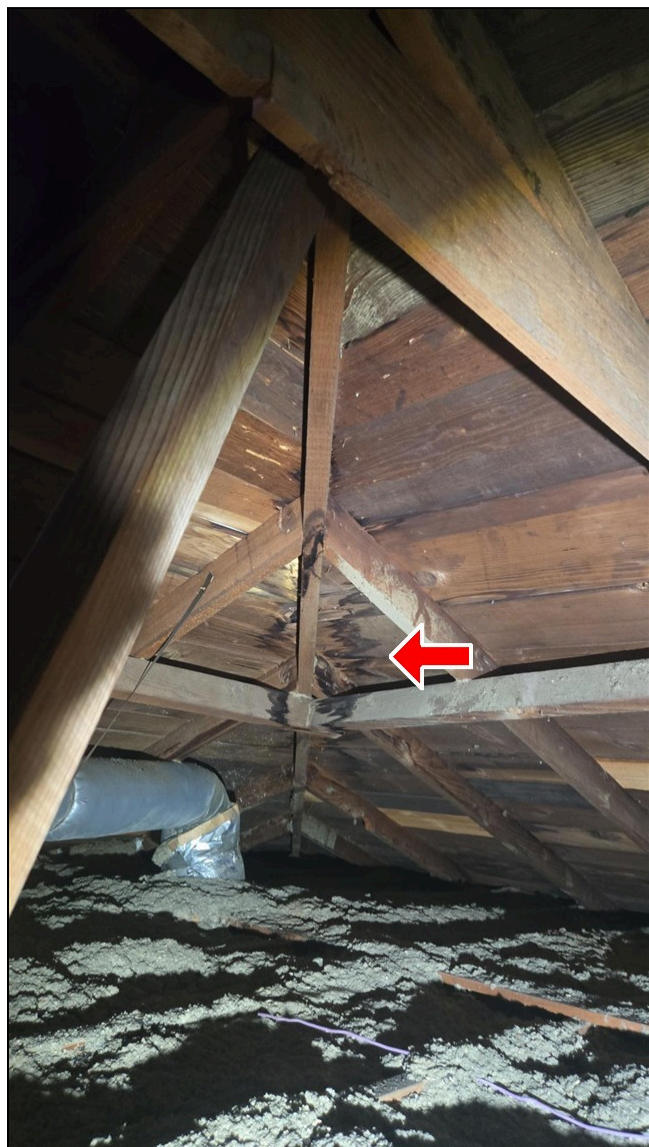
2.4 Water stains found on the roof structure inside the attic of unit A. Water stains are believed to be from previous roof issues. No current signs of leaking were found at time of inspection. This is for your information.

2.4 Item 1(Picture) Water stains, unit A attic

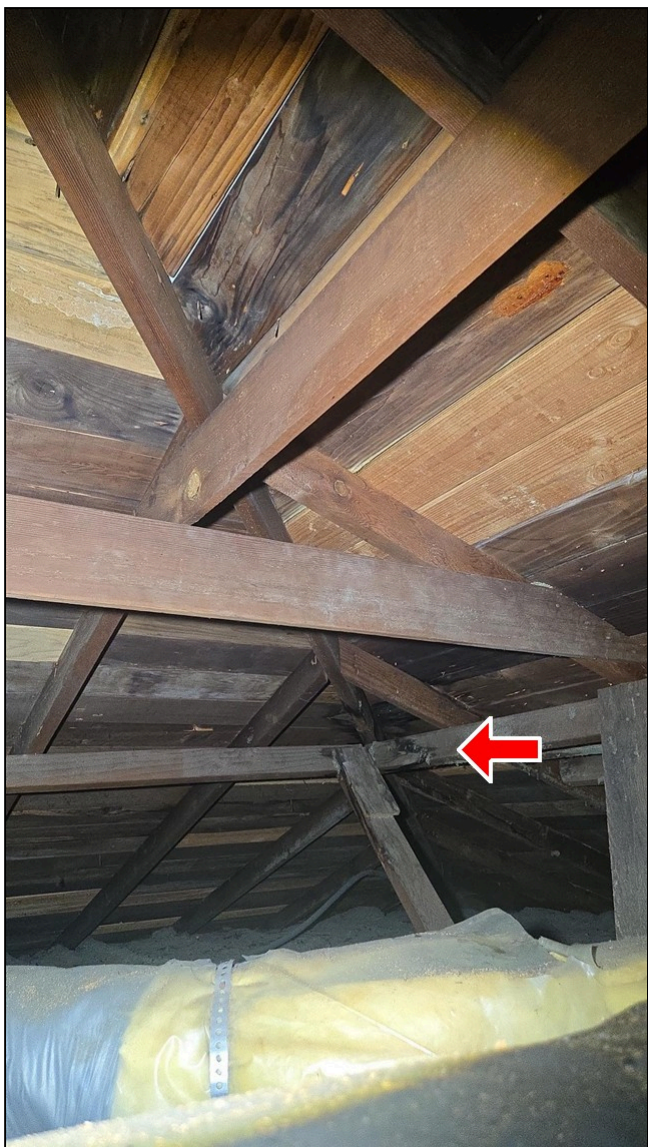
2.4 Item 2(Picture) Water stains, unit A attic

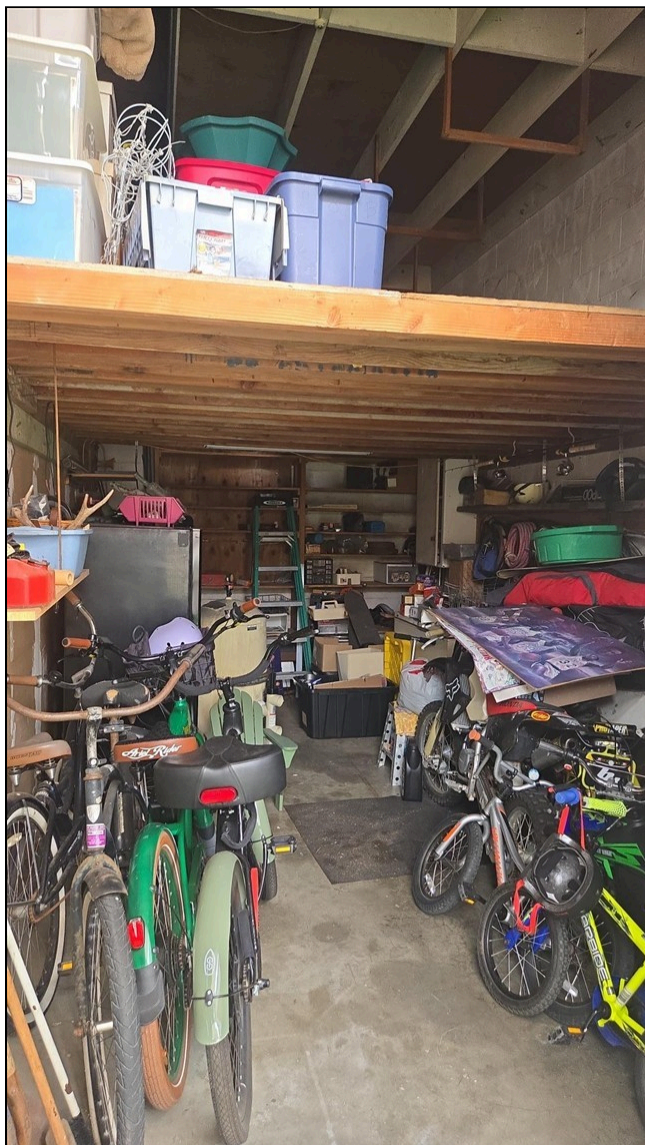
3.0 Personal belongings in garages prevented a full visual inspection of the areas. Recommend a qualified person fully inspect garage once personal belongings have been removed.

3.0 Item 1(Picture) Personal belongings, east garage

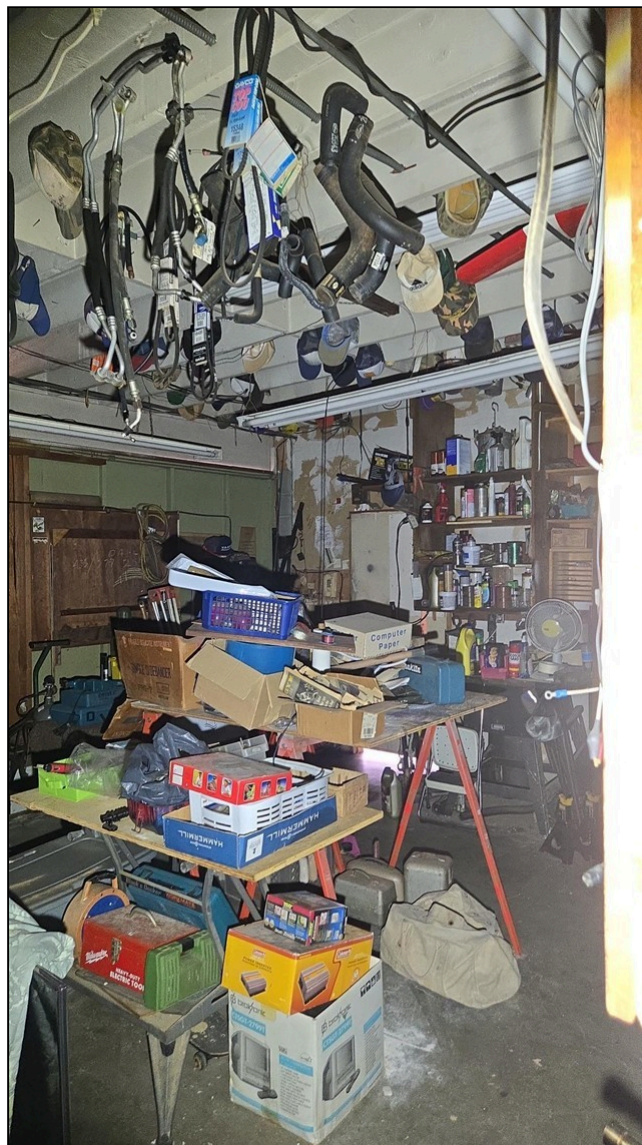
3.0 Item 2(Picture) Personal belongings, middle garage

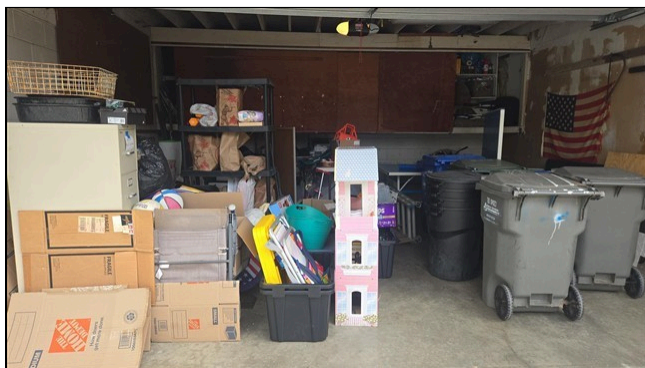
3.0 Item 3(Picture) Personal belongings, west garage

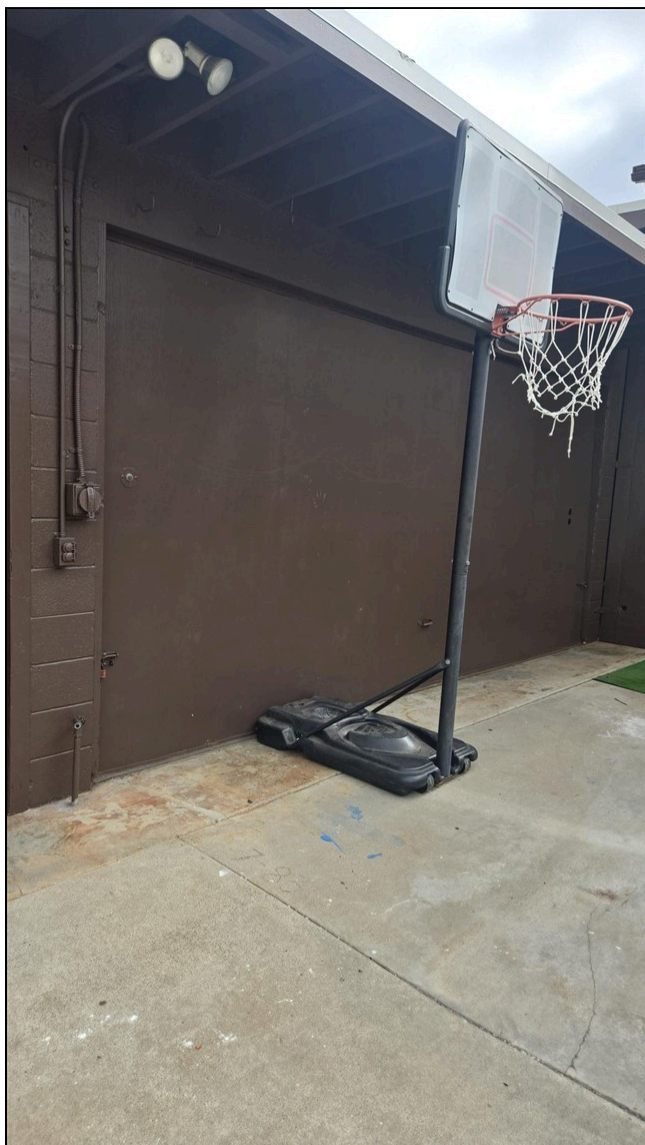
3.5 Middle garage is not operable as personal belongings, shelving, and electrical wiring is mounted to the inside of door. Recommend a qualified person further inspect and confirm garage door operates (opens and closes) properly as needed.

3.5 Item 1(Picture) Middle vehicle garage door

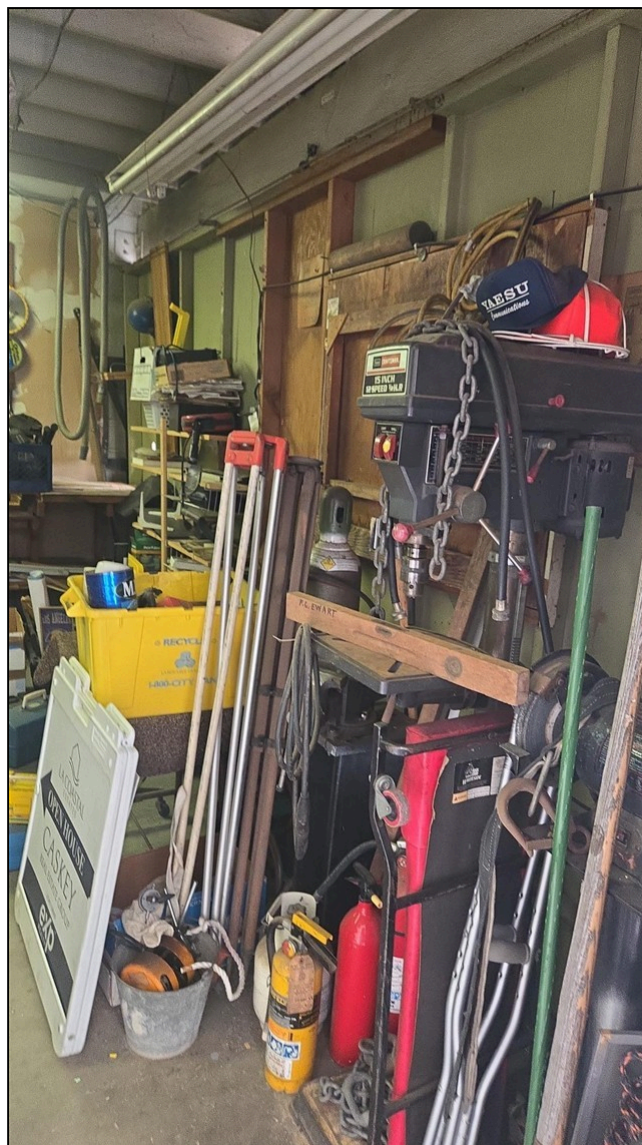
3.5 Item 2(Picture) Middle vehicle garage door/
personal belongings

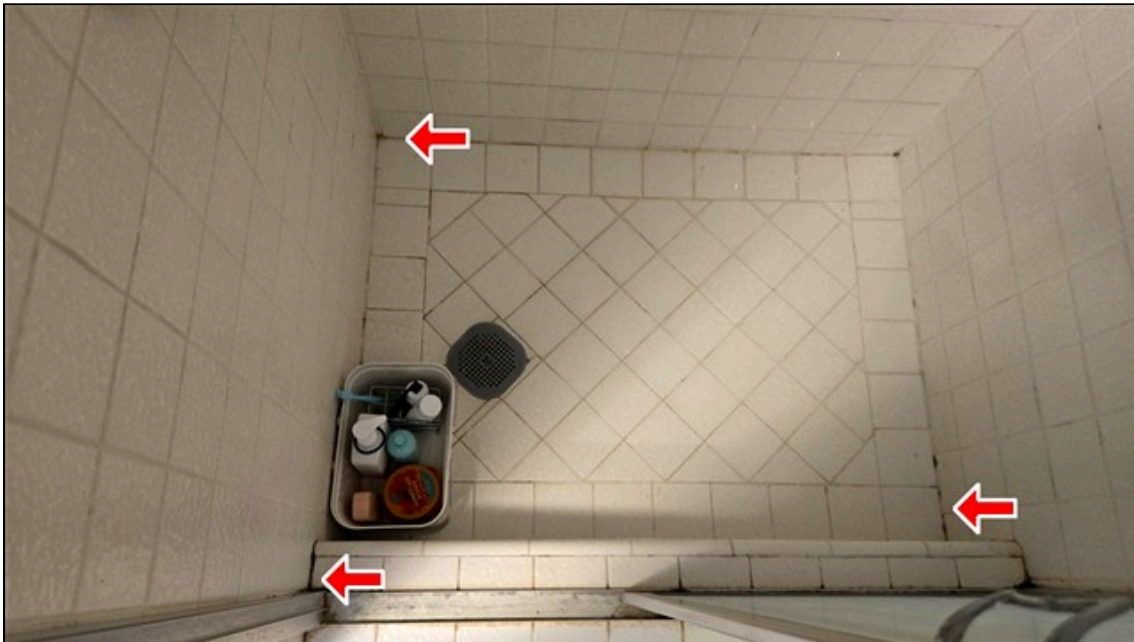
4.3 Unit A hall bathroom shower has deteriorated grout and seals between tile. Recommend a qualified person further inspect for repair recommendations.

4.3 Item 1(Picture) Unit A hall bathroom shower walls/surface

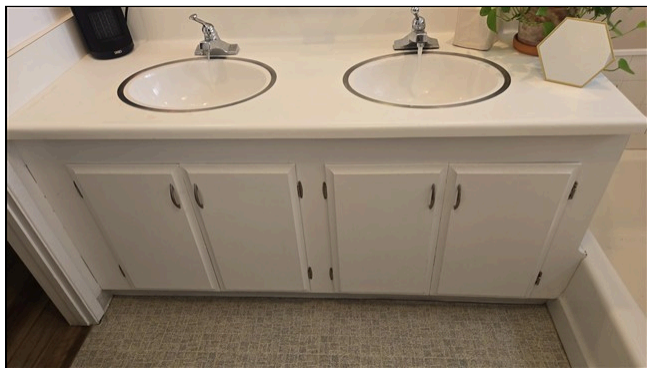
4.5 (1) Kitchen and bathroom cabinets and counter tops throughout unit A are dated and have normal wear and tear. Recommend a qualified person further inspect for repair recommendations.

4.5 Item 1(Picture) Hall bathroom base cabinet/counter top, unit A

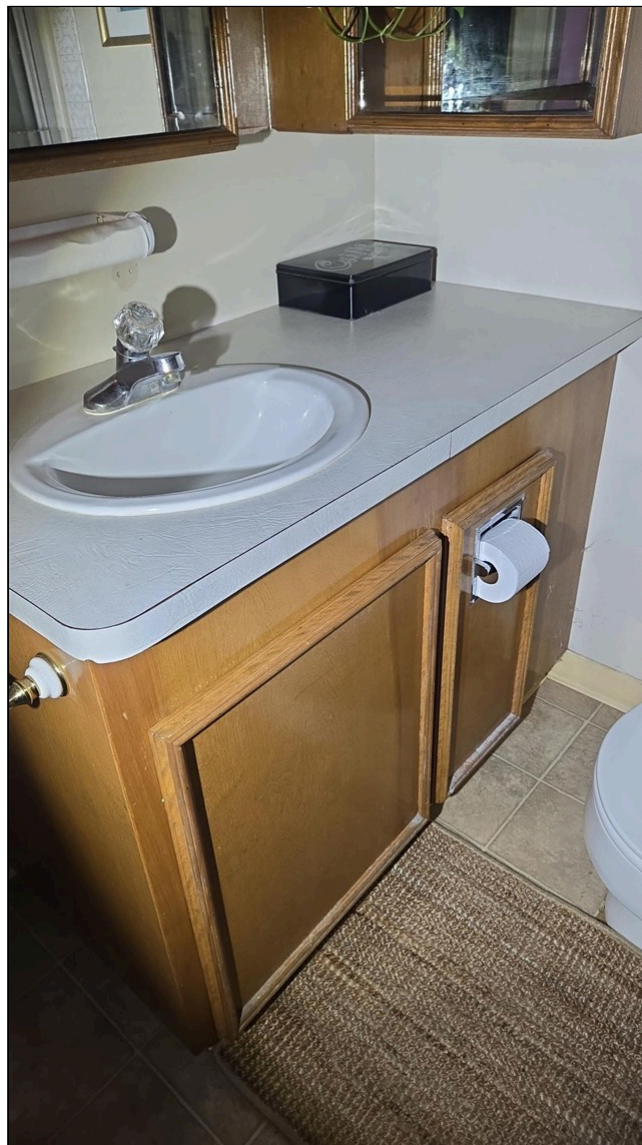
4.5 Item 2(Picture) Primary bedroom bathroom cabinet, unit A

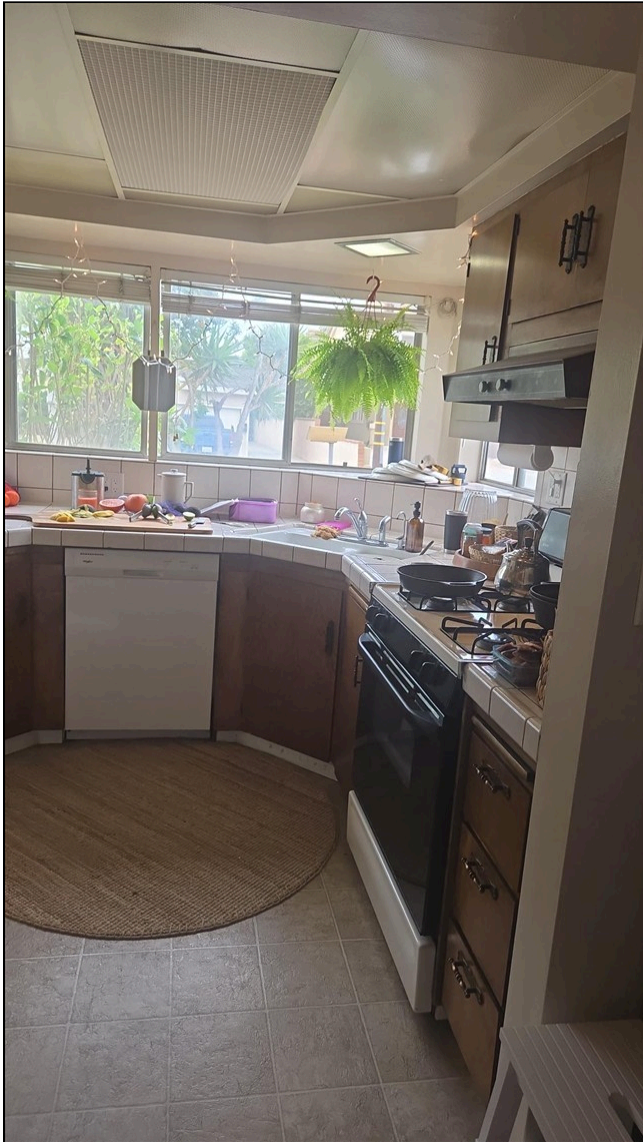
4.5 Item 3(Picture) Kitchen cabinets, unit A

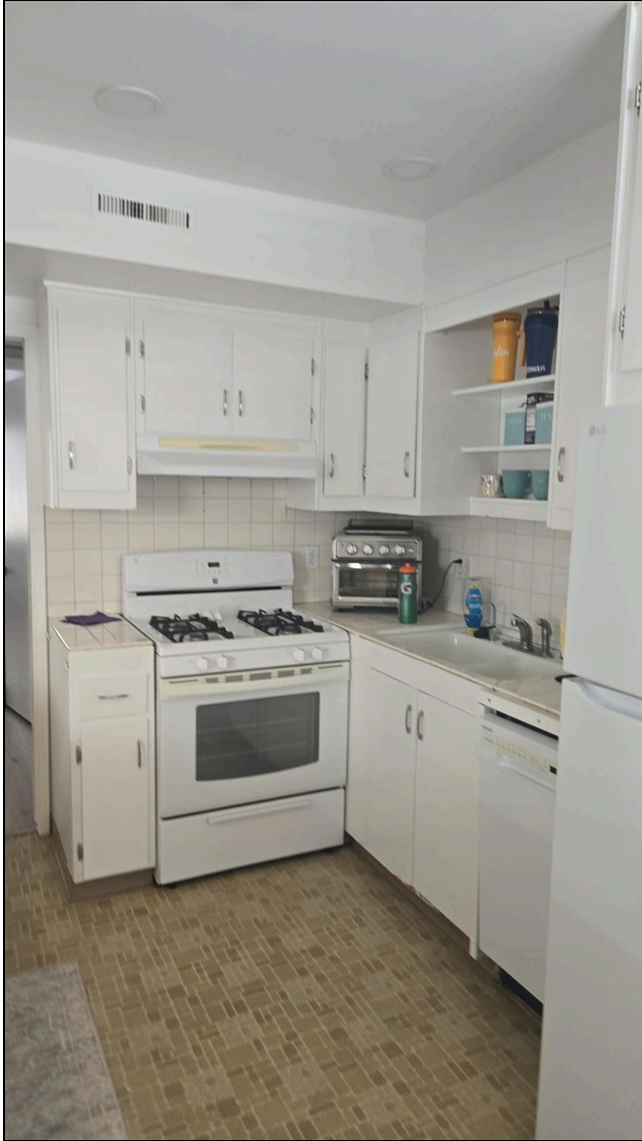
4.5 (2) Kitchen and bathroom cabinets and counter tops throughout unit B are dated and have normal wear and tear. Recommend a qualified person further inspect for repair recommendations.

4.5 Item 4(Picture) Unit B kitchen cabinets

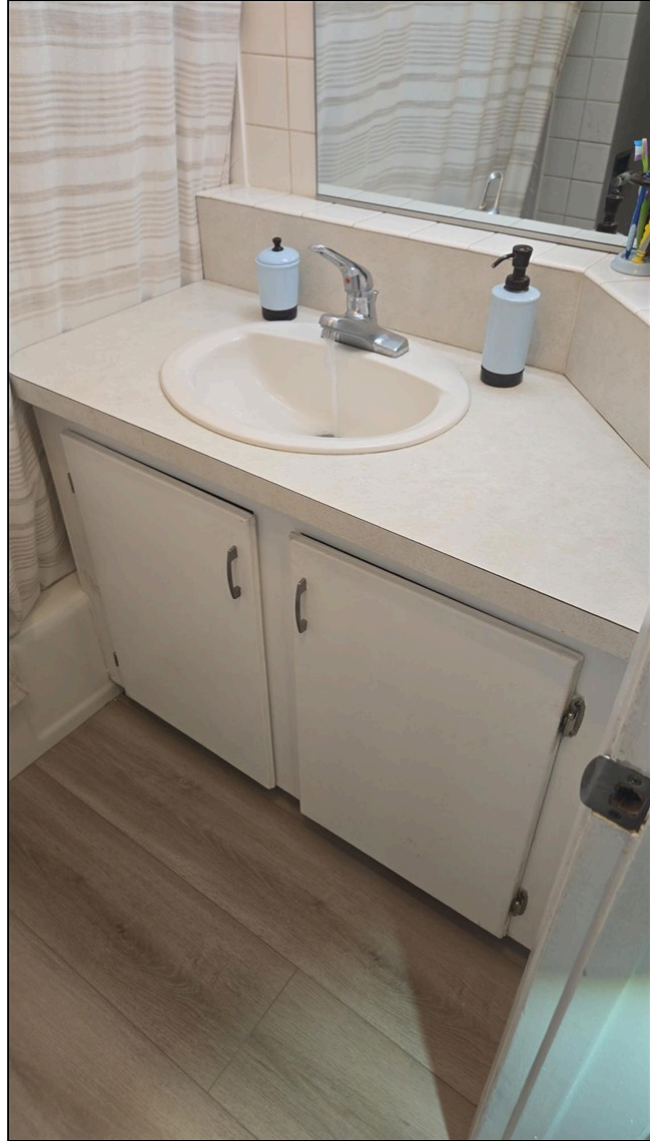
4.5 Item 5(Picture) Unit B hall bathroom cabinet

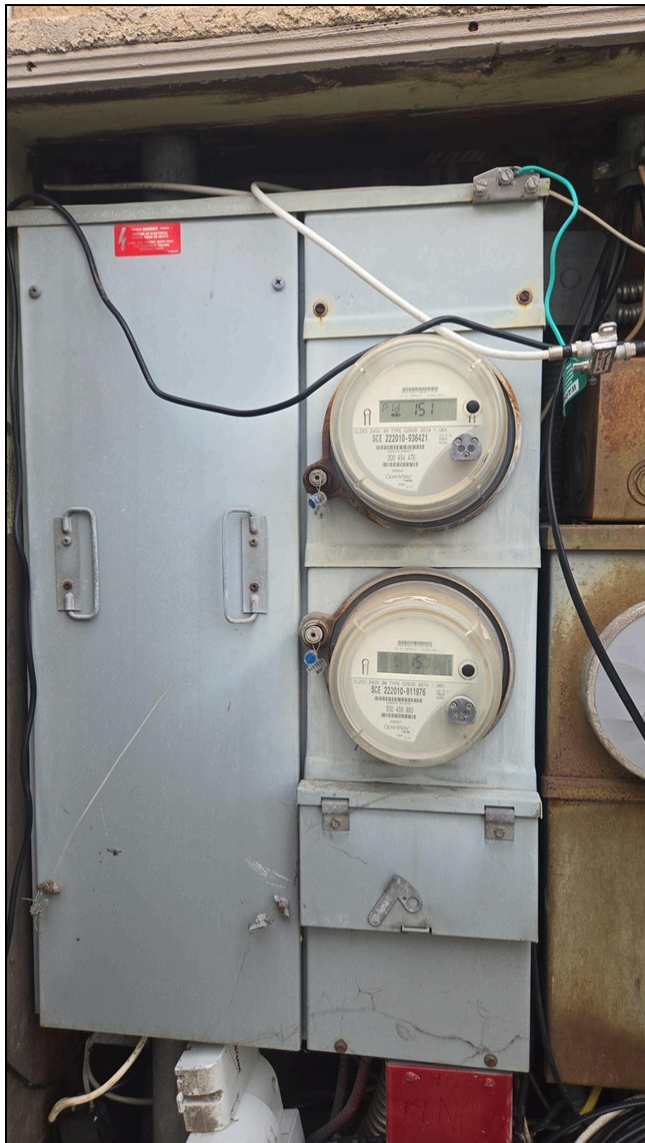
5.1 Item 1(Picture) Electric meter and main shut off (unit A and unit B)

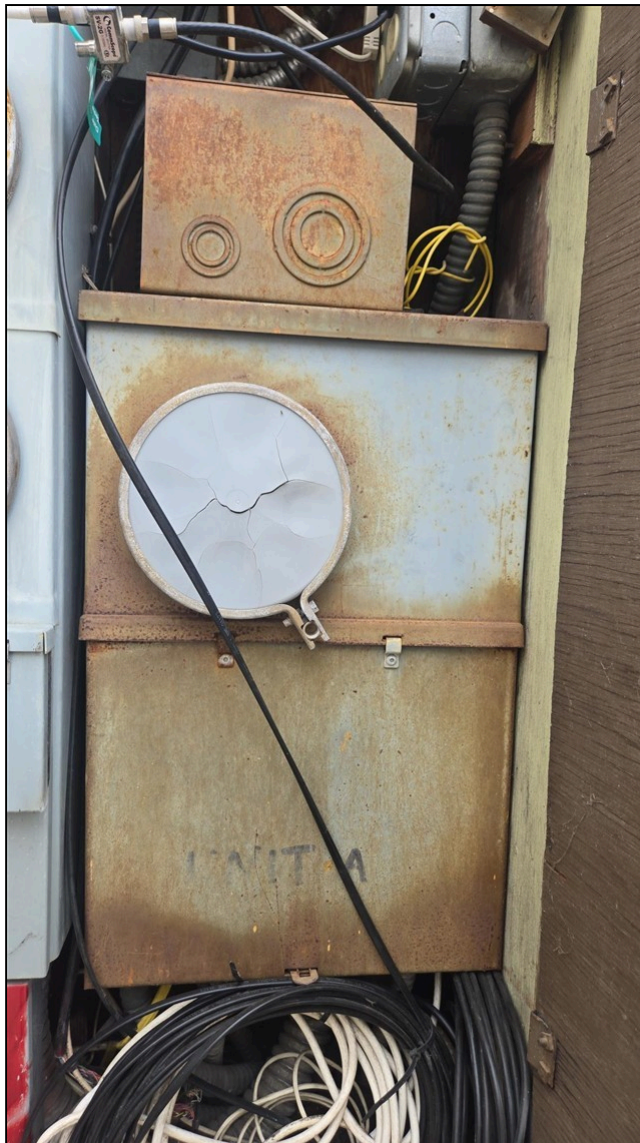
Main distribution panel for unit A is located inside the exterior wall closet on the west side of unit A.

5.1 Item 2(Picture) Main distribution panel, unit A

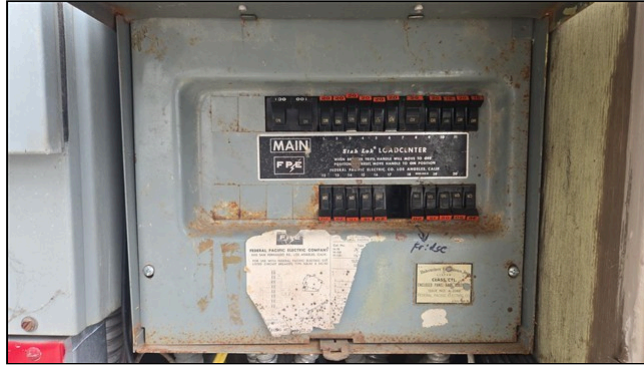
5.2 (1) Unit A distribution panel is missing labels, which properly identify each breaker. Recommend a qualified electrician further inspect and label panel to properly identify each breaker as needed.

5.2 Item 1(Picture) Missing labels, unit A main distribution panel

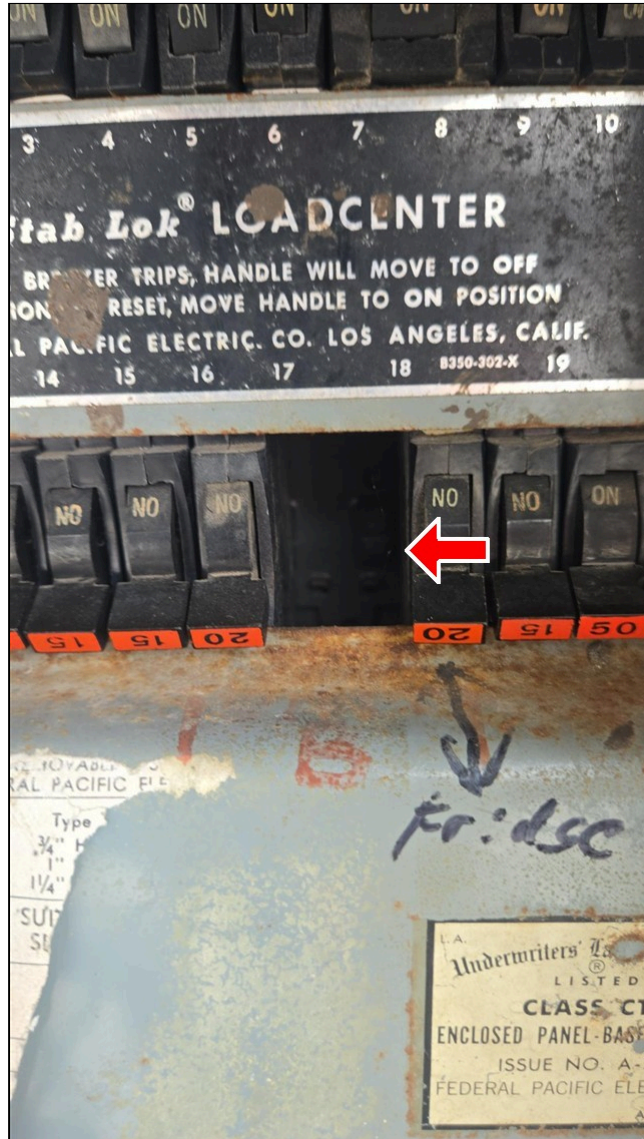
5.2 (2) Unit A main distribution panel is missing circuit breakers creating gaps that could allow foreign objects to enter behind circuit breaker cover panel. Recommend a qualified electrician further inspect and install knockout covers on open slots as needed.

5.2 Item 2(Picture) Missing circuit breakers, unit A main distribution panel

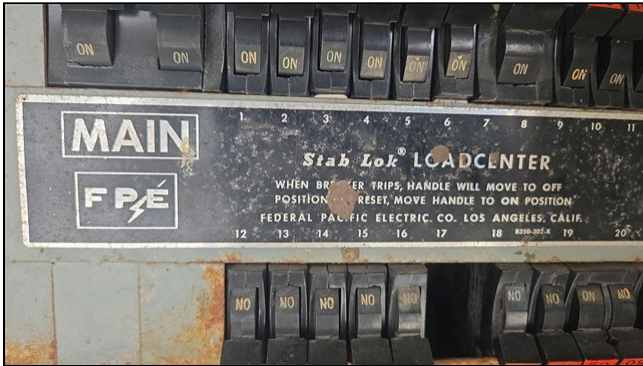
5.3 (2) Unit A and detached garage panels are Federal Pacific panels, which is legal, but there is a possibility that the circuit breakers may not trip when shorted possibly causing an electrical hazard. Opinions by licensed electricians on this panel varies between safe and unsafe. Recommend consulting a licensed electrician for an opinion and correct if necessary.

5.3 Item 1(Picture) Unit A, Federal Pacific panel

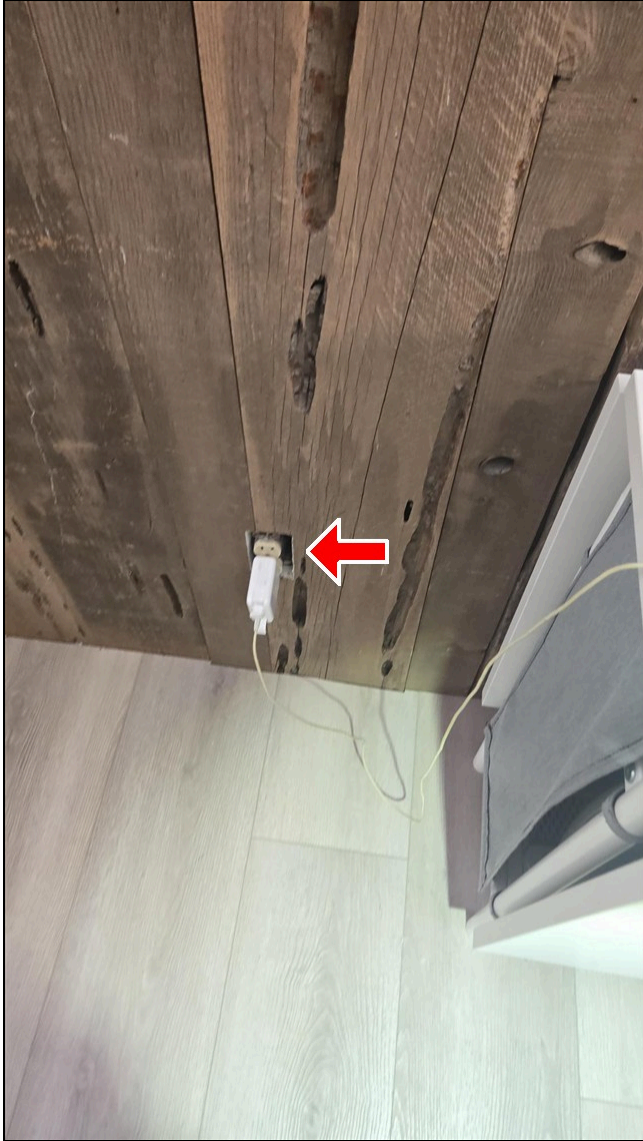
5.4 (1) Missing cover plates on multiple light switches and outlets throughout unit B. Recommend installing cover plates as needed.

5.4 Item 1(Picture) Unit B living room outlet, missing cover

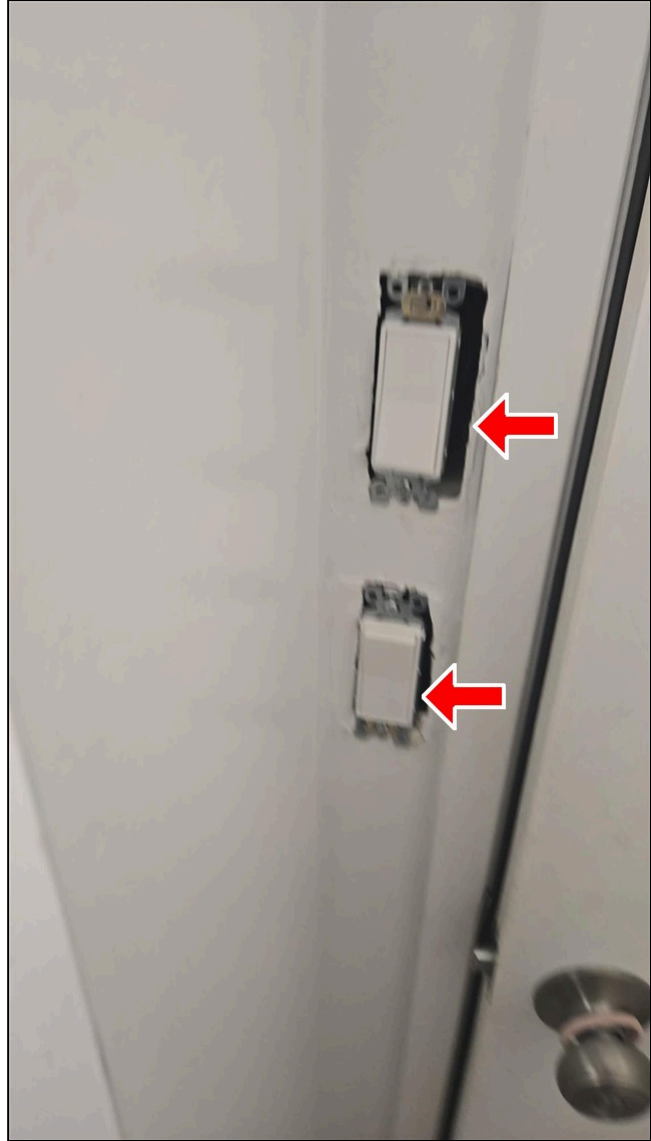
5.4 Item 2(Picture) Unit B switches, missing covers

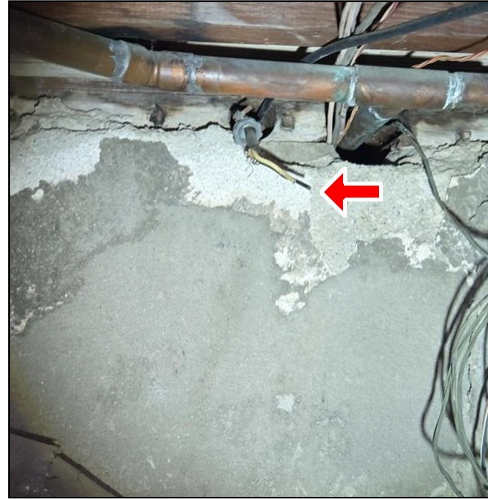
5.4 (2) Exposed wiring found in crawlspace is abandoned or cut off. Recommend a qualified licensed electrician further inspect for repair or removal recommendations.

5.4 Item 3(Picture) Exposed wiring, crawlspace

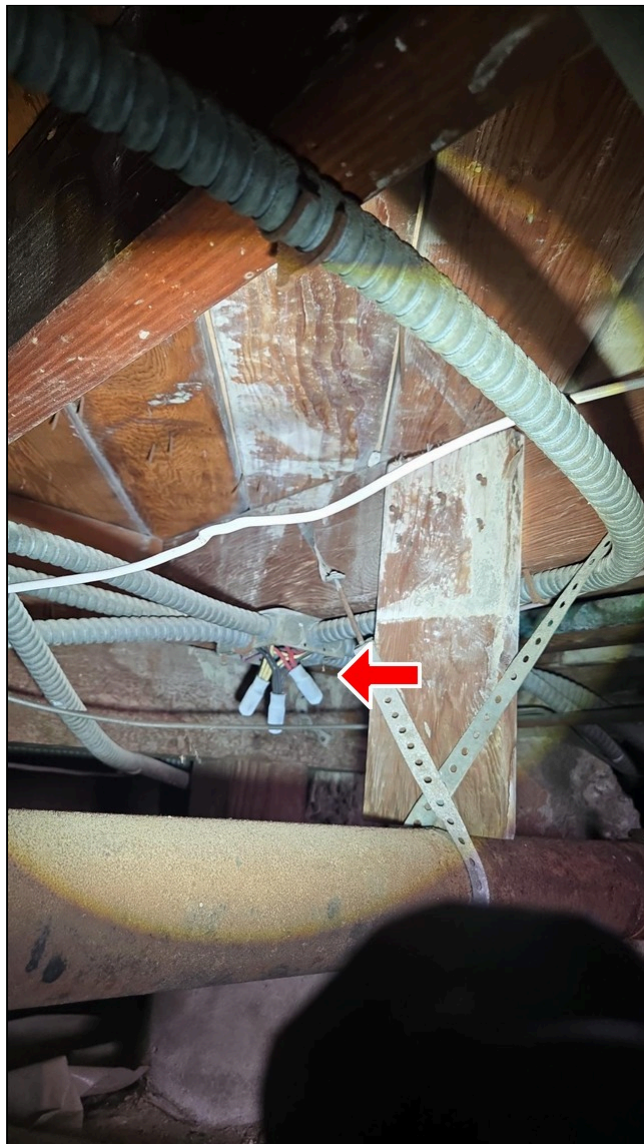
5.4 (3) Junction boxes located inside crawlspace are missing cover plates. Exposed wire connections are present. Recommend a qualified person further inspect and install cover plates to conceal wiring as needed.

5.4 Item 4(Picture) Missing cover plate, crawlspace

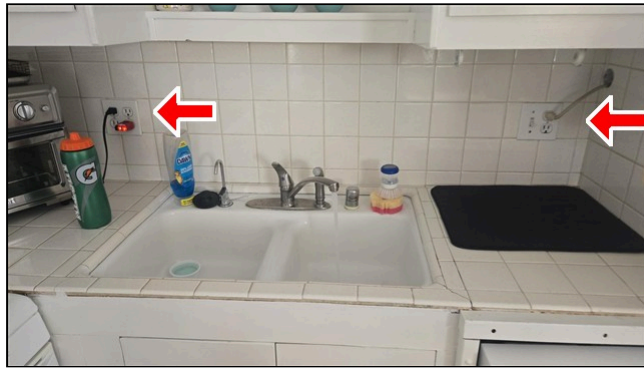
5.5 (1) The kitchen outlets next to kitchen sink in unit B are non protected outlets. Receptacles within six feet of a water source are required to be GFCI protected. These outlets are outdated and considered a safety issue until corrected. Recommend a qualified electrician further inspect and repair or replace as needed.

5.5 Item 1(Picture) Unit B kitchen outlets

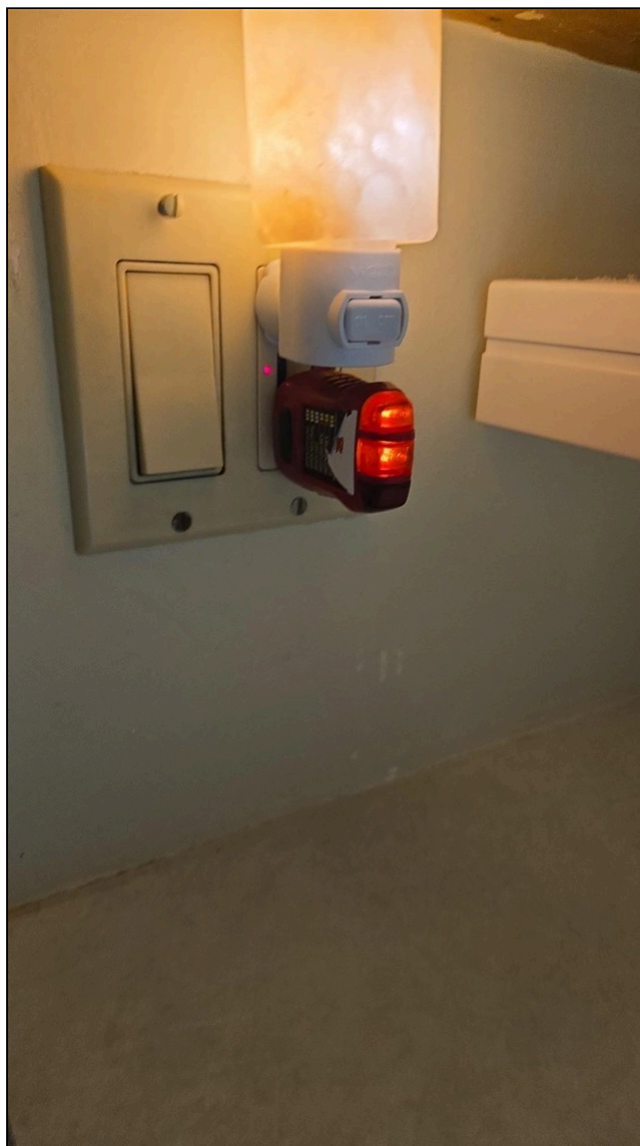
5.6 GFCI outlet located inside unit
A primary bedroom bathroom did
not operate properly. Recommend a
qualified person repair or replace
outlet as needed.

5.6 Item 1(Picture) Unit A primary bedroom bathroom GFCI outlet
