Titus
Inspections

Inspection Report

2121 Marshallfield Ln Unit A
2121 Marshallfield Ln Unit B
Redondo Beach CA 90278

| Property Address 2121 Marshallfield Ln Unit A 2121 Marshallfield Ln Unit B Redondo Beach CA 90278 | Date of Inspection 8/26/2025 | Report ID 250826-01 |

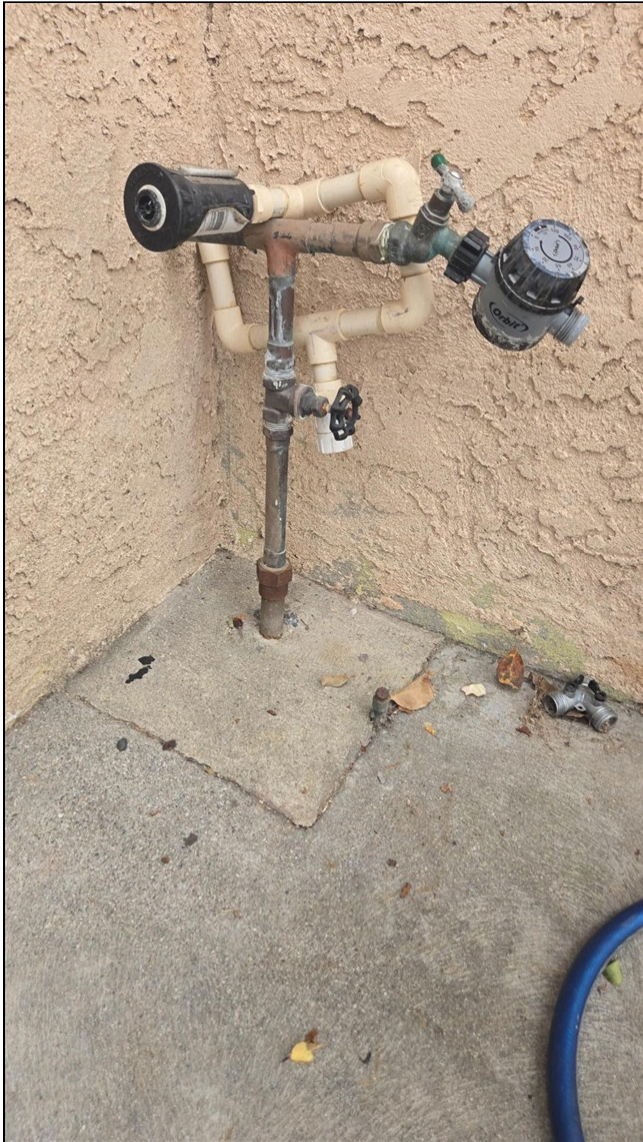
Additional main water shut off valve for unit B is located on the west side of unit A.

6.0 Item 3(Picture) Additional main water shut off, Unit B

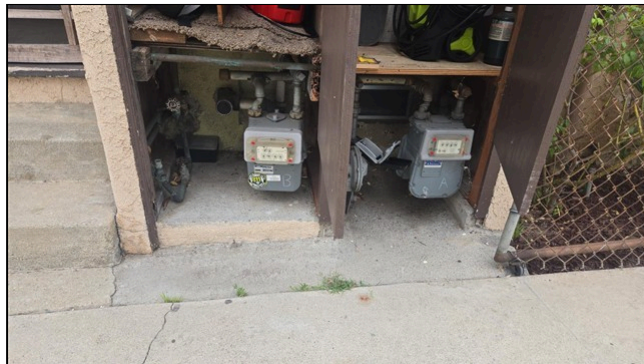
6.1 The gas meters and main shutoffs for unit A and B are located inside the exterior closet on the west side of unit A.

6.1 Item 1(Picture) Gas meter and main shut off, unit A and B

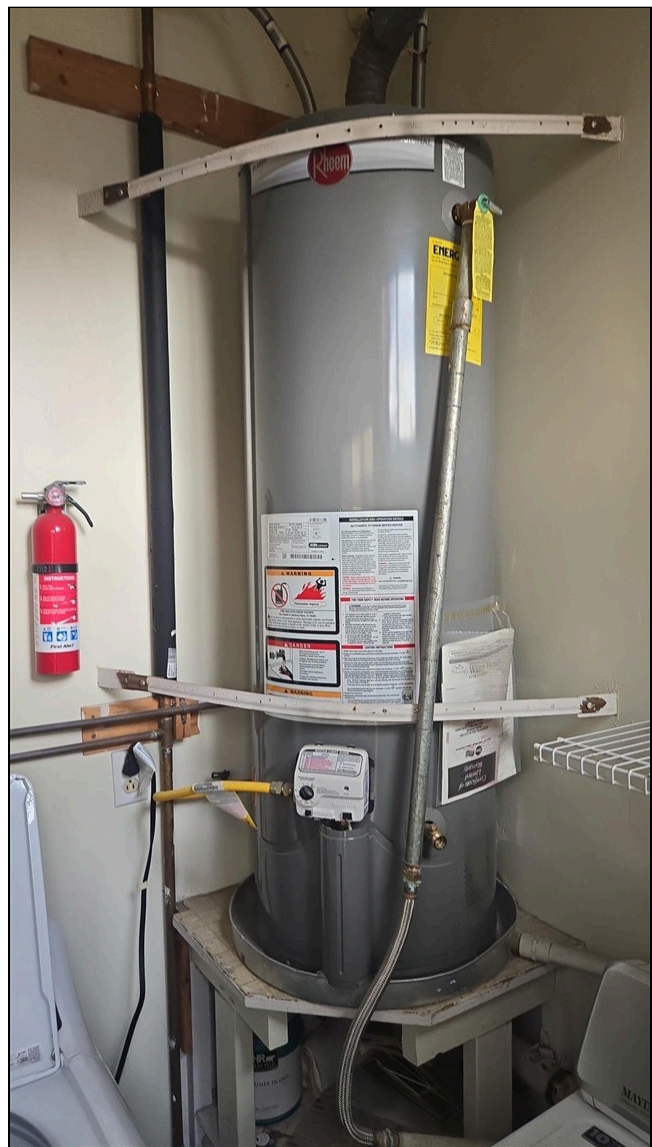
6.2 Item 1(Picture) Water heater

6.2 (1) Water heater provides hot water to unit A unit B and is located inside unit A laundry room.

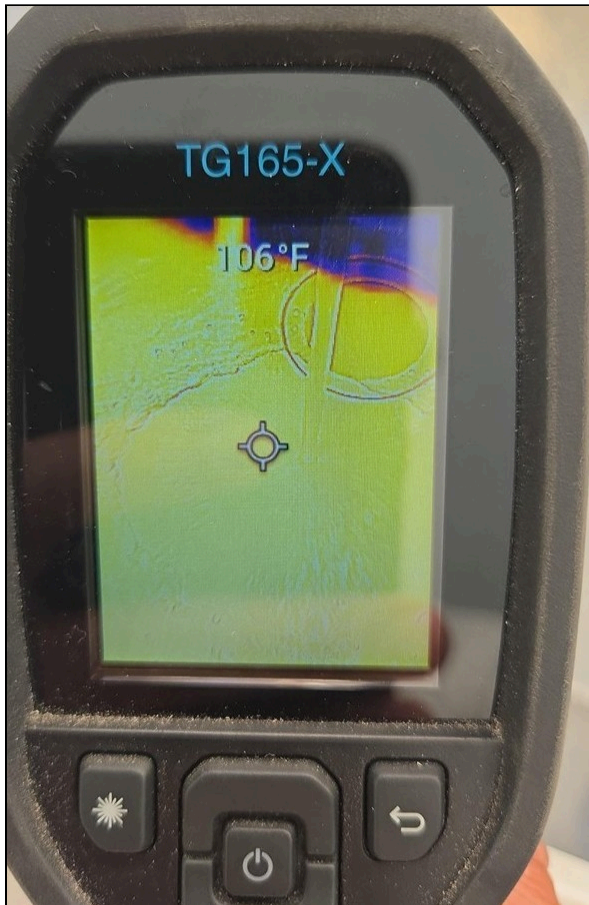
Hot water temperature was 106 degrees at kitchen sink inside unit A at time of inspection. Hot water was present to all fixtures throughout unit A and B.

6.2 Item 3(Picture) Hot water temperature, unit A kitchen sink

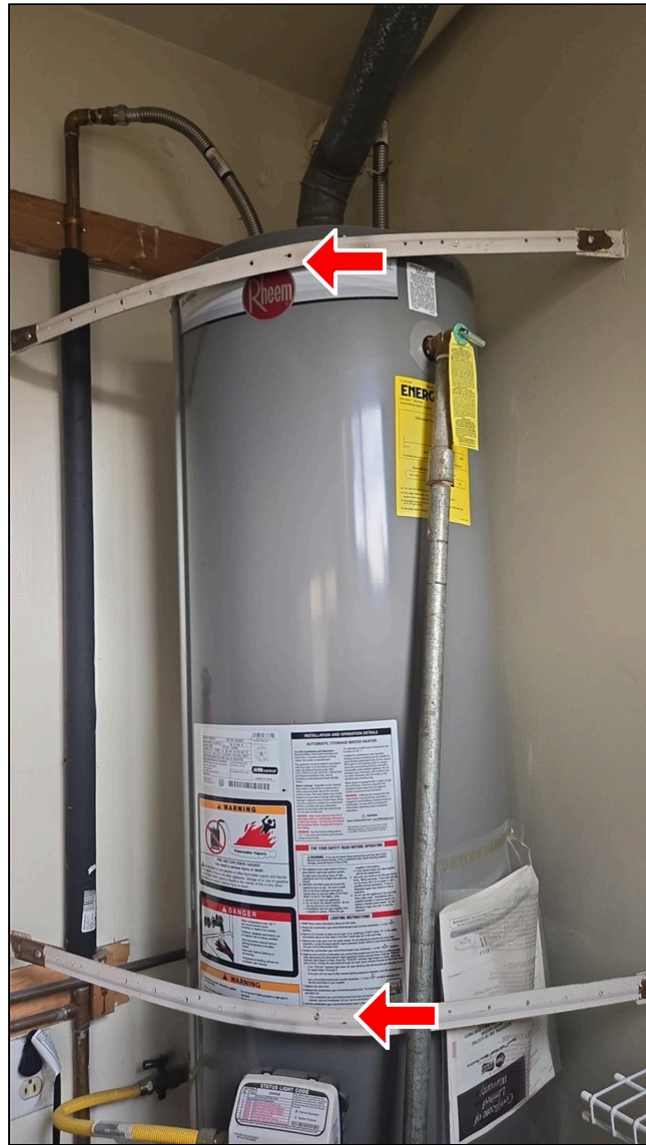
6.2 (2) Earthquake seismic straps for water heater do not secure water heater properly. Recommend a qualified person further inspect for repair or replacement recommendations.

6.2 Item 4(Picture) Water heater, earthquake seismic straps

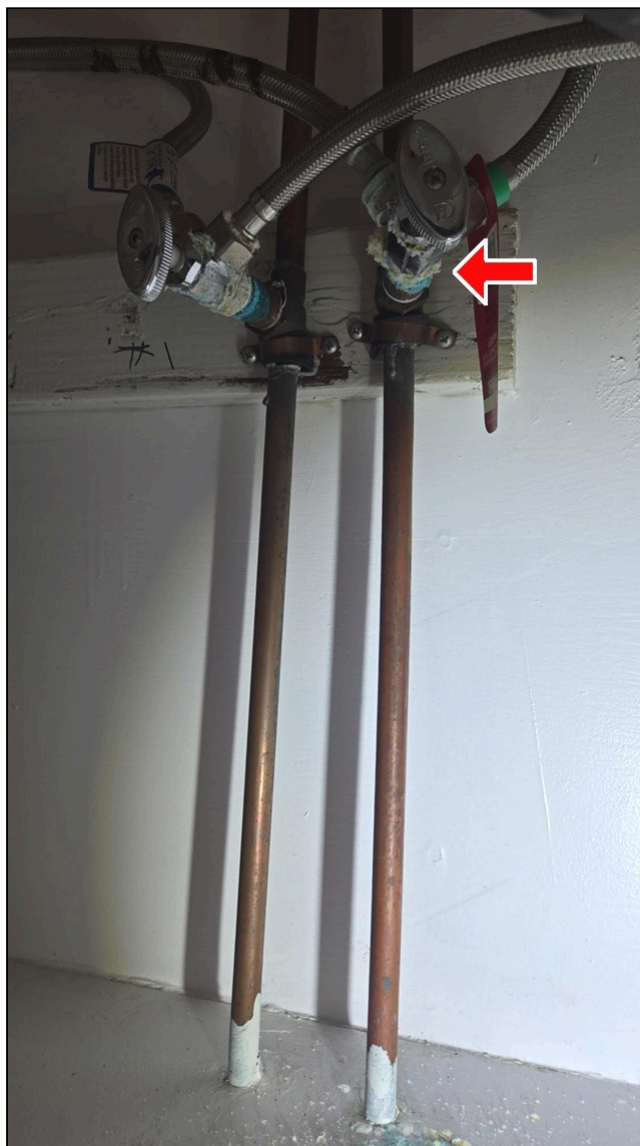
6.3 (1) Corrosion found on water supply shut off valves below hall bathroom sinks inside unit A. Water supply fixtures throughout unit are dated but did operate properly. Recommend a qualified plumber further inspect for repair recommendations.

6.3 Item 1(Picture) Corrosion, unit A hall bathroom water supply shut off valves

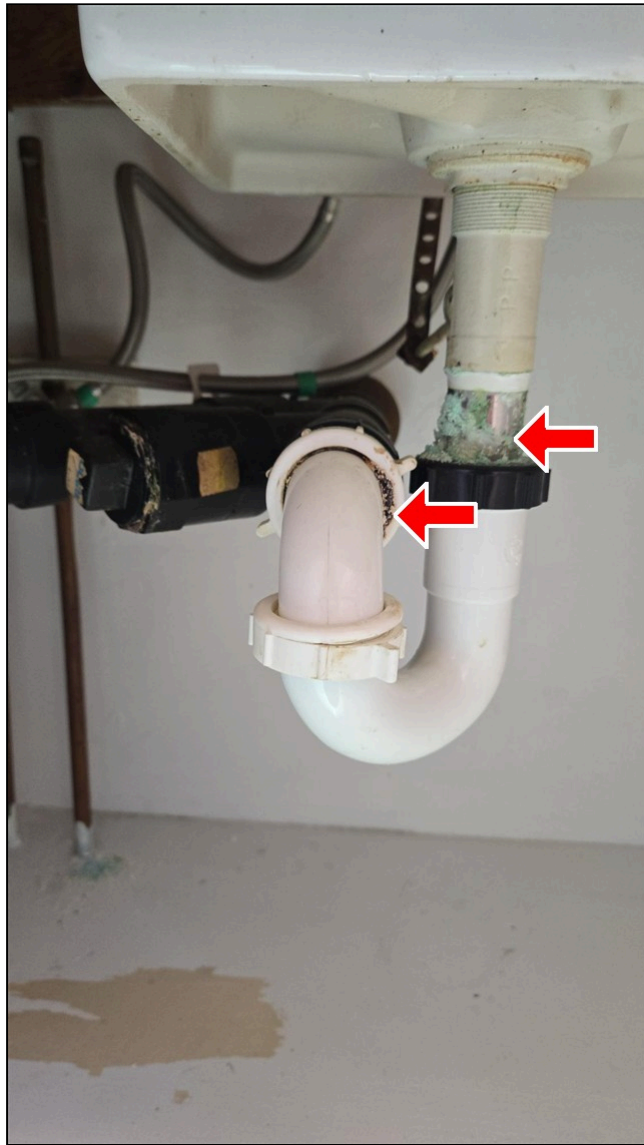
6.5 (1) Corrosion found on drain lines below unit A hall bathroom sinks. Recommend a qualified person further inspect for repair recommendations.

6.5 Item 1(Picture) Unit A hall bathroom sink drains

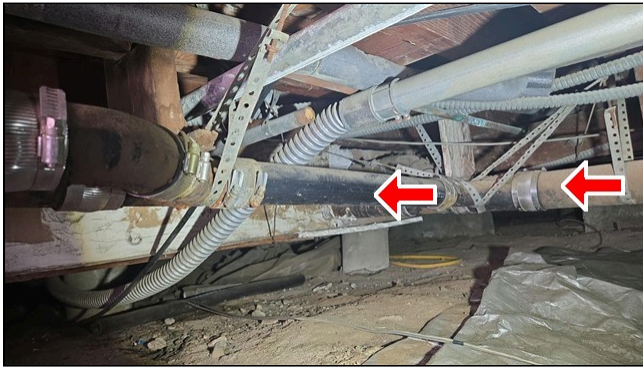
6.5 (2) Old cast iron drain lines are present below home in crawlspace. Some repairs and replacement of drain lines with ABS drains are present. Drain lines are dated and inspector is unable to confirm condition of interior of drain line. Active leaking found below unit A and unit B hall bathrooms. Recommend a qualified plumber perform a sewer line inspection to inspect the interior condition of drain line, and repair leaking as needed.

6.5 Item 2(Picture) Cast iron drain lines/ABS repairs, crawlspace

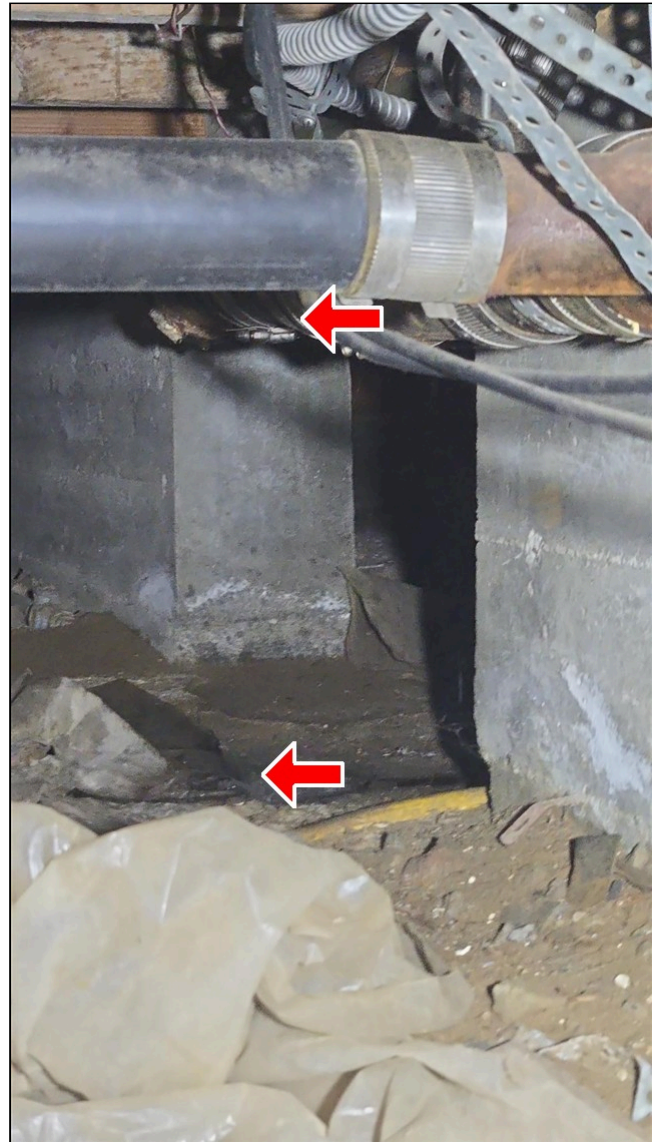
6.5 Item 3(Picture) Active leaking, crawlspace

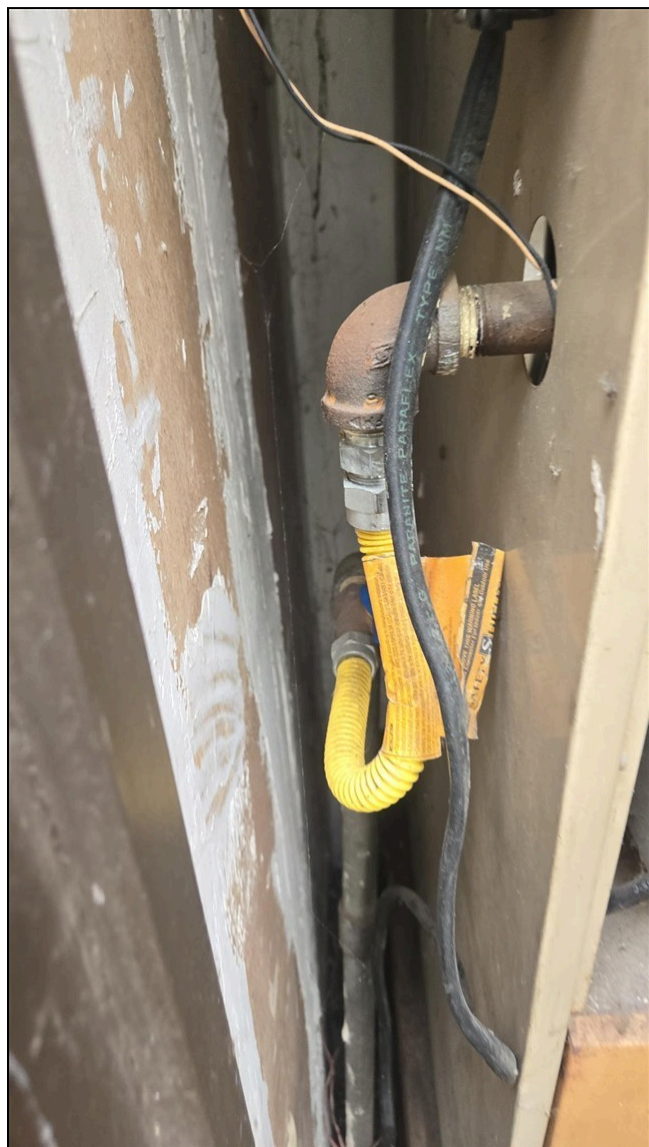
6.6 Gas furnace and water heater do not have sediment traps installed. Sediment traps are intentionally installed to prevent sediments in gas from restricting the gas valve and burners of the appliance. Recommend a qualified person install sediment traps as needed.

6.6 Item 1(Picture) Heat system #1 gas line

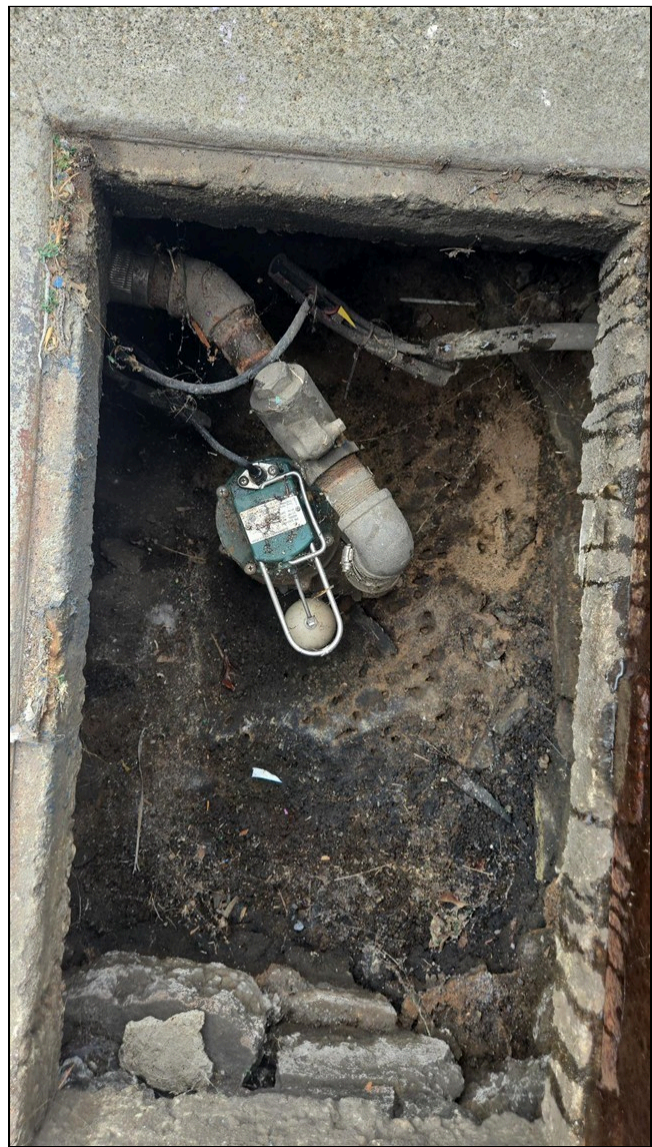
6.7 Item 1(Picture) Sump pump

6.7 Sump pump is located in the driveway along the northwest corner. Pump system did operate using float switch.

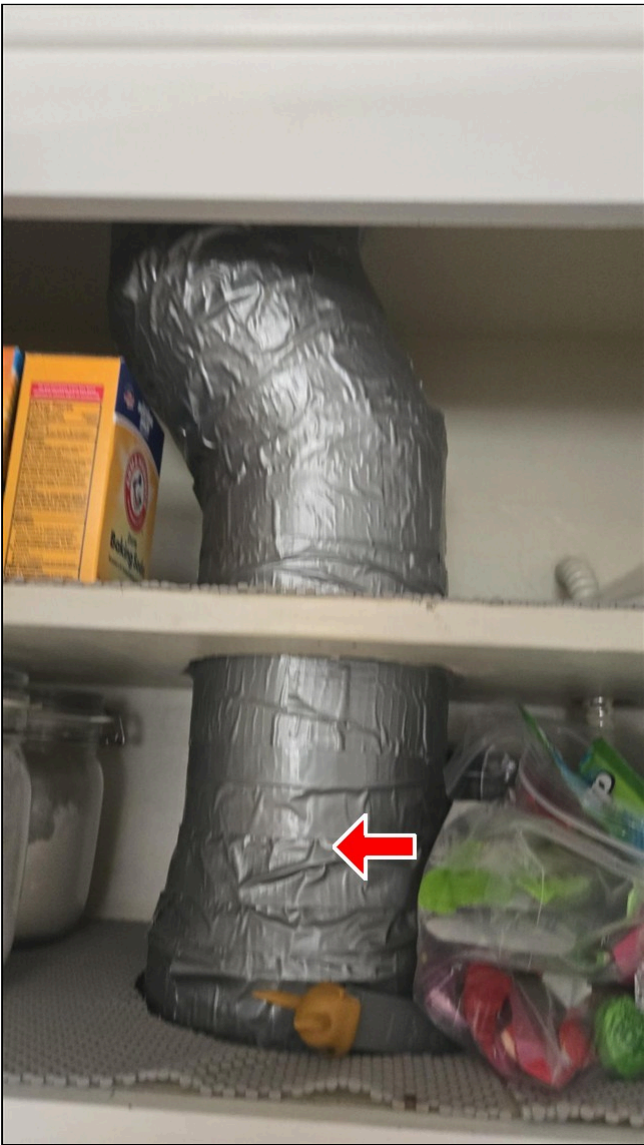
7.2 Vinyl tape on unit B kitchen range hood inside the upper cabinet. Vinyl tape will deteriorate over time. Tape covers the entire vent. Recommend a qualified person further inspect for repair or replacement recommendations.

7.2 Item 1(Picture) Unit B range hood vent

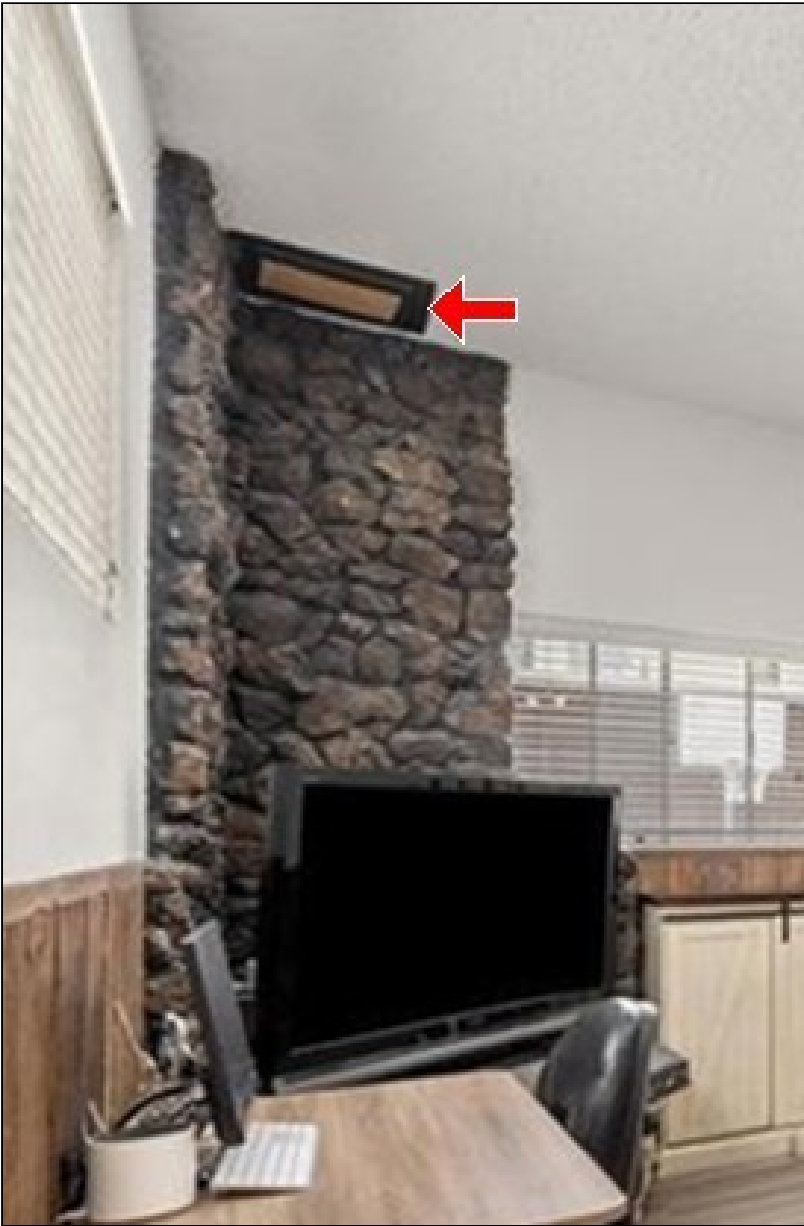
8.2 Standalone fireplace has been removed from unit B living room. Flue is still present inside the ceiling cavity. Recommend a qualified person further inspect and install fireplace, or remove flue as desired.

8.2 Item 1(Picture) Flue opening, unit B

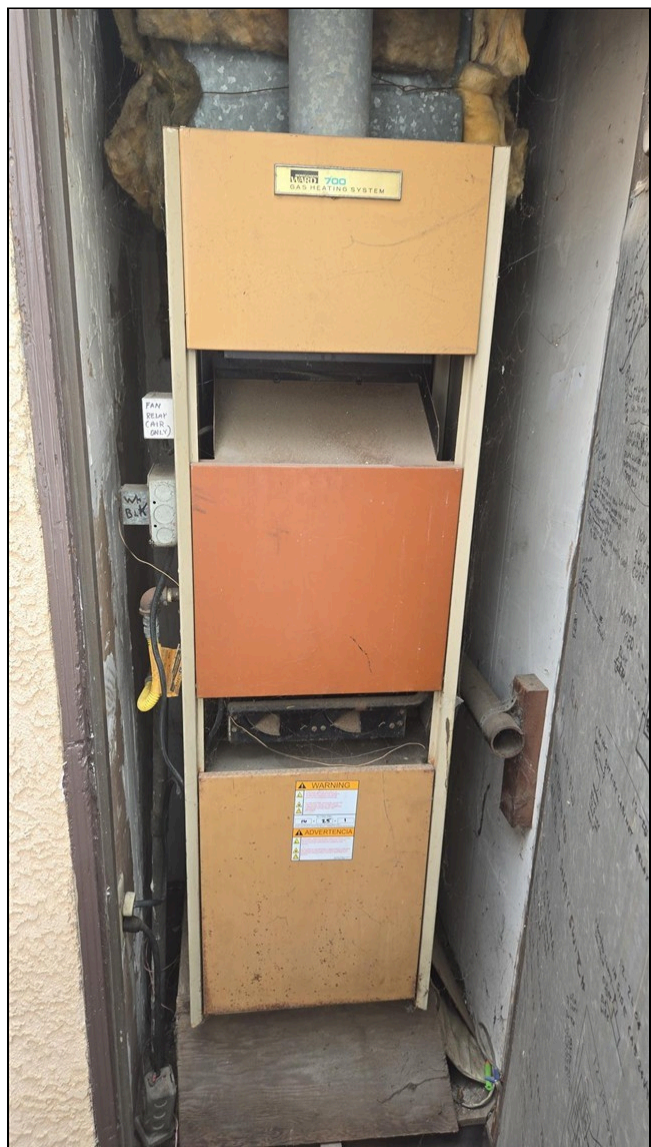
9.0 Item 1(Picture) Heat system #1

Model: SRM 54369A

Serial: KN3D104 F3676 3267

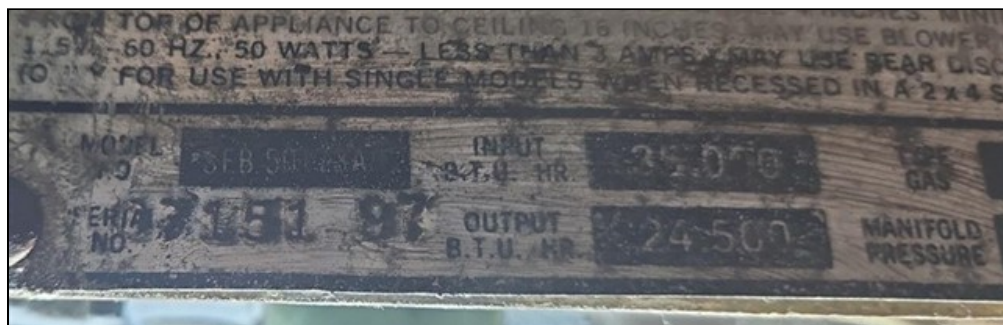
9.0 Item 4(Picture) Heat system #2 information Wall heat system #2 information

Model: BDF 50

Serial: 07151 07

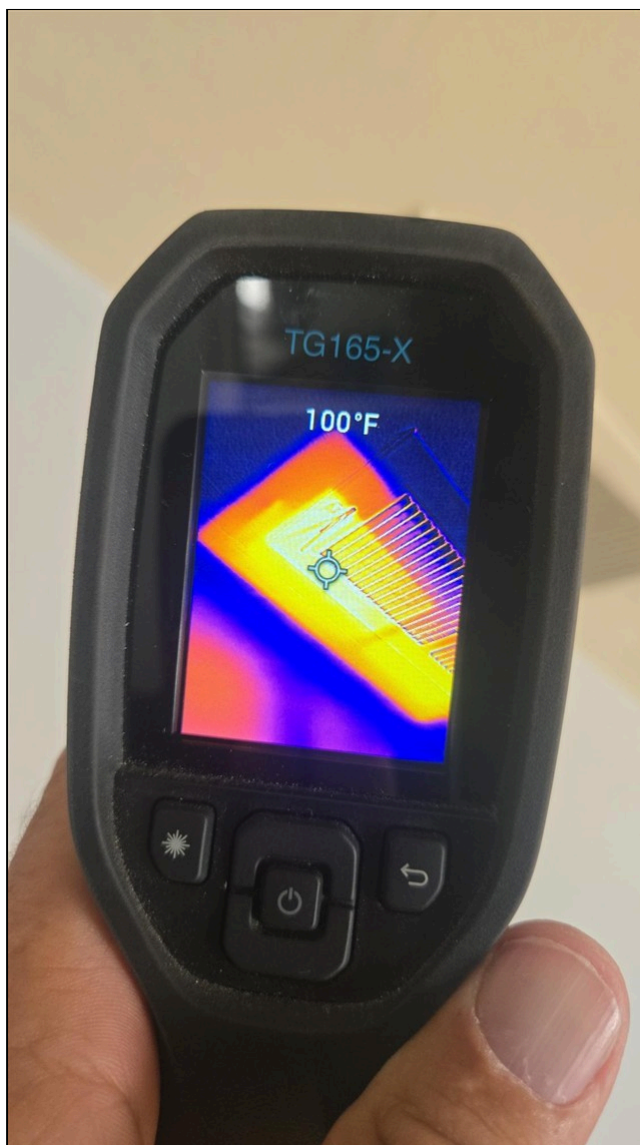
9.1 (1) Heating system #1 temperature at unit A registers was 100 degrees at time of inspection.

9.1 Item 1(Picture) Heat system #1 temperature, unit A

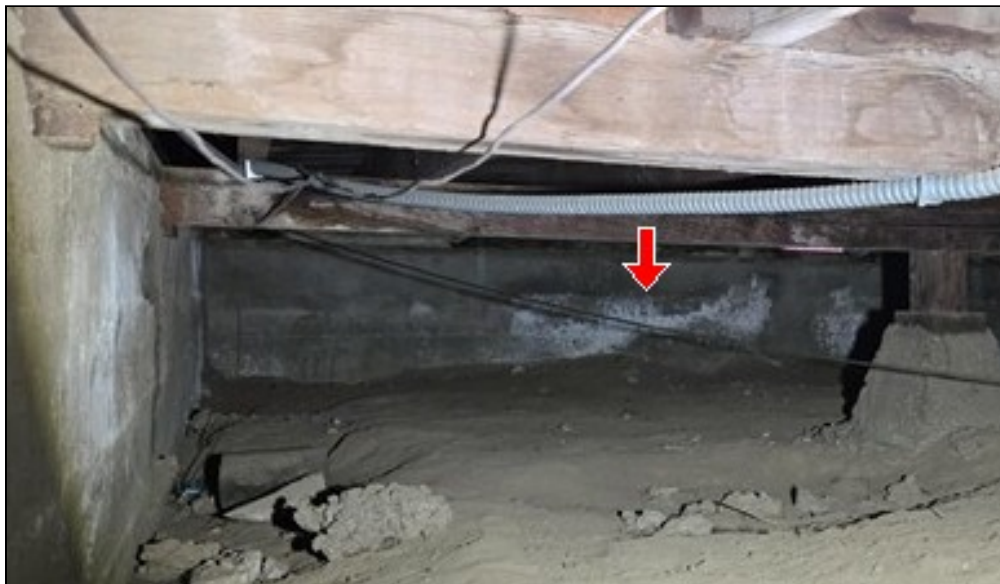
11.0 (1) White efflorescence (powder substance) found on block wall in the crawlspace indicates moisture is in contact with the masonry. This does not necessarily indicate that intrusion will occur. Recommend checking the gutters and the downspout drain lines for proper operation. Also, a water proofing paint could be applied to the interior side of the block if necessary. Efflorescence is found on many homes without water intrusion occurring inside the home. But, it should alert you to the possibility that future steps may be needed.

11.0 Item 1(Picture) Efflorescence, crawlspace

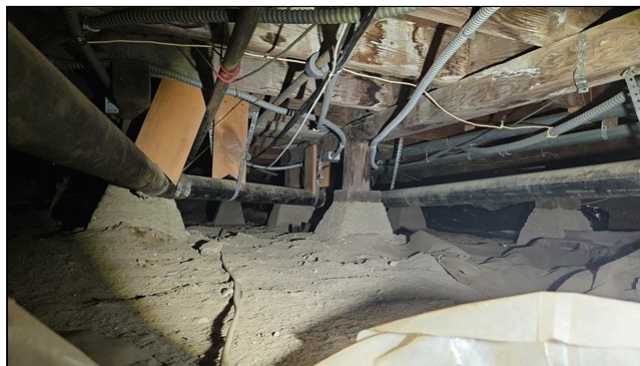
11.0 (2) Restricted access to unit A crawlspace, below kitchen area. Recommend a qualified person further inspect once access is provided.

11.0 Item 2(Picture) Restricted access, plumbing

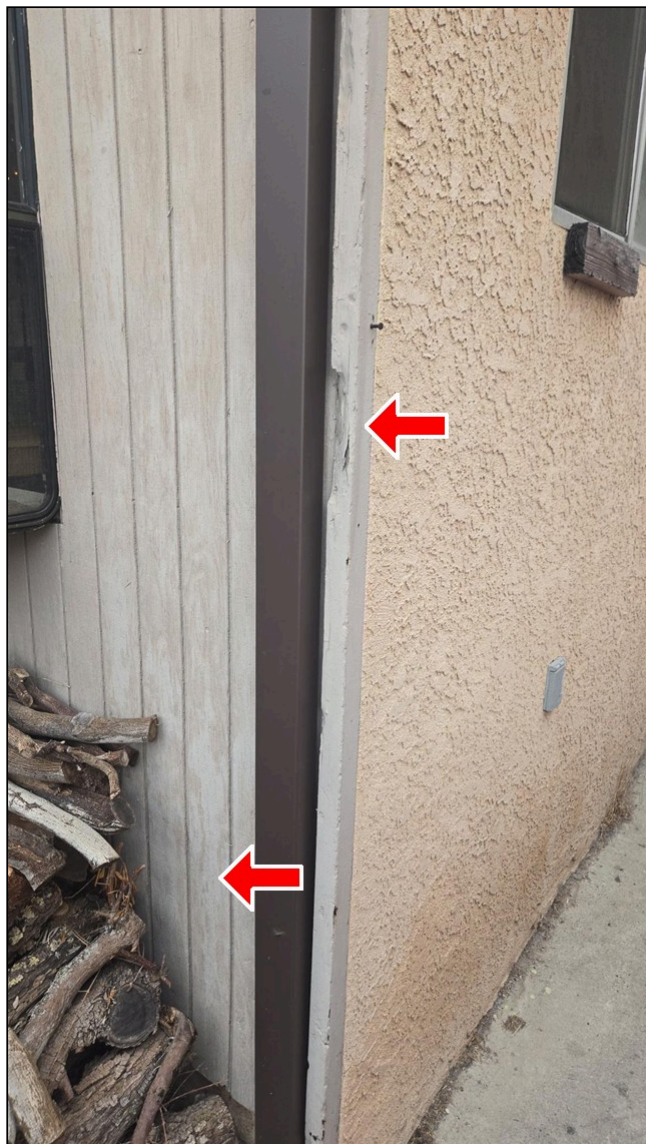
(1) Unit A front wood siding has wood damage. Recommend a qualified person further inspect for repair or replacement recommendations.

1.0 Item 1(Picture) Unit A front wood siding

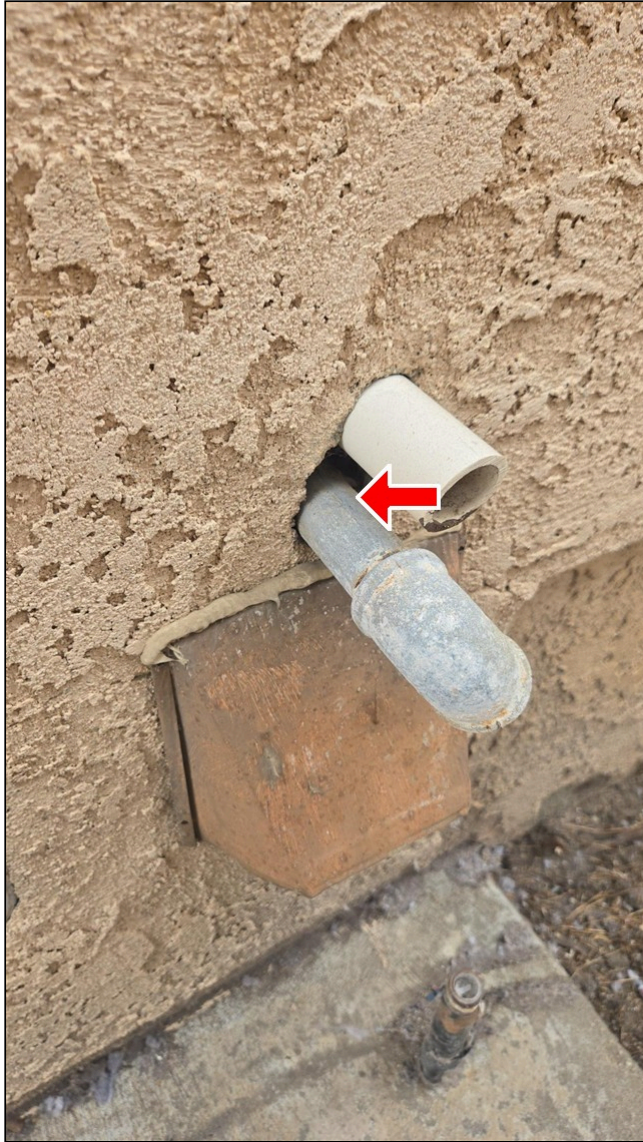
(2) Visible gap in exterior stucco siding around plumbing accesses on multiple sides of home. Recommend sealing all gaps to prevent insects from nesting and to prevent water intrusion. Repair as needed.

1.0 Item 2(Picture) Gaps, east exterior siding

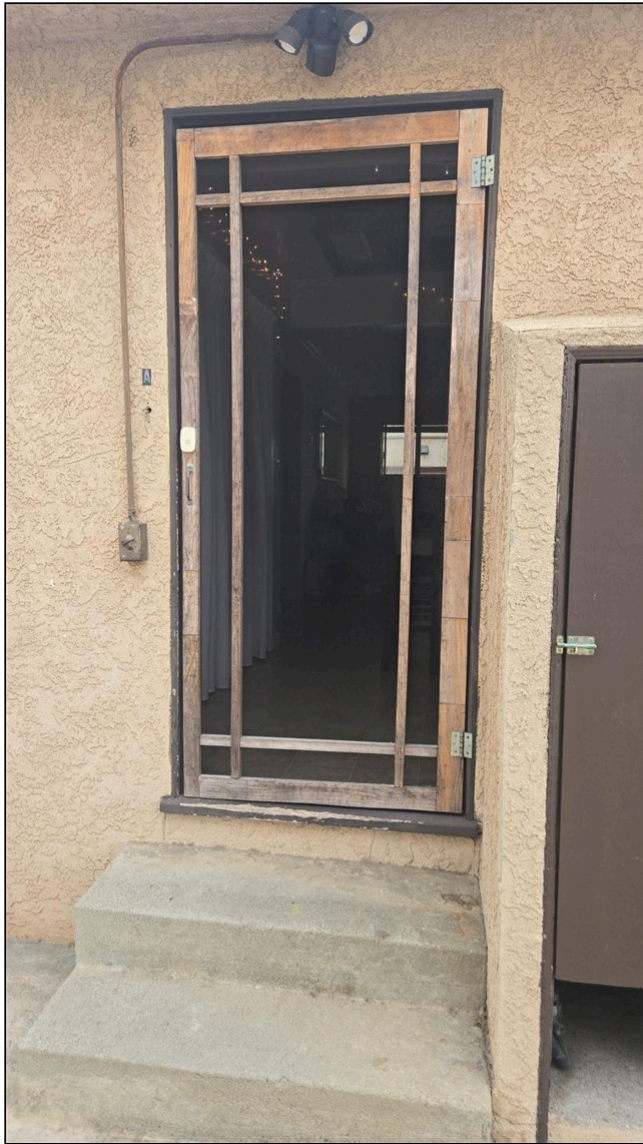
(1) Screen door on the west entry to unit A has exposed wood. Recommend a qualified person further inspect and properly seal wood as needed.

1.2 Item 1(Picture) Screen door, exposed wood, unit A side entry

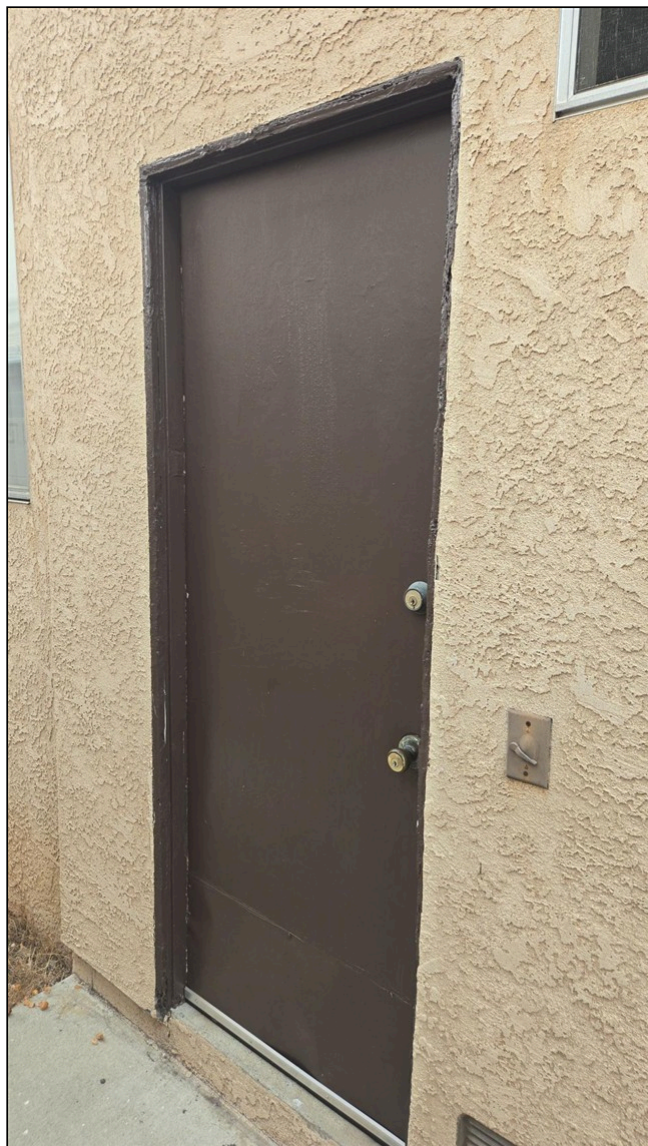
(2) East exterior entry door for laundry room has wood damage on door jamb and casing. Recommend a qualified person further inspect for repair or replacement recommendations.

1.2 Item 2(Picture) East laundry room door

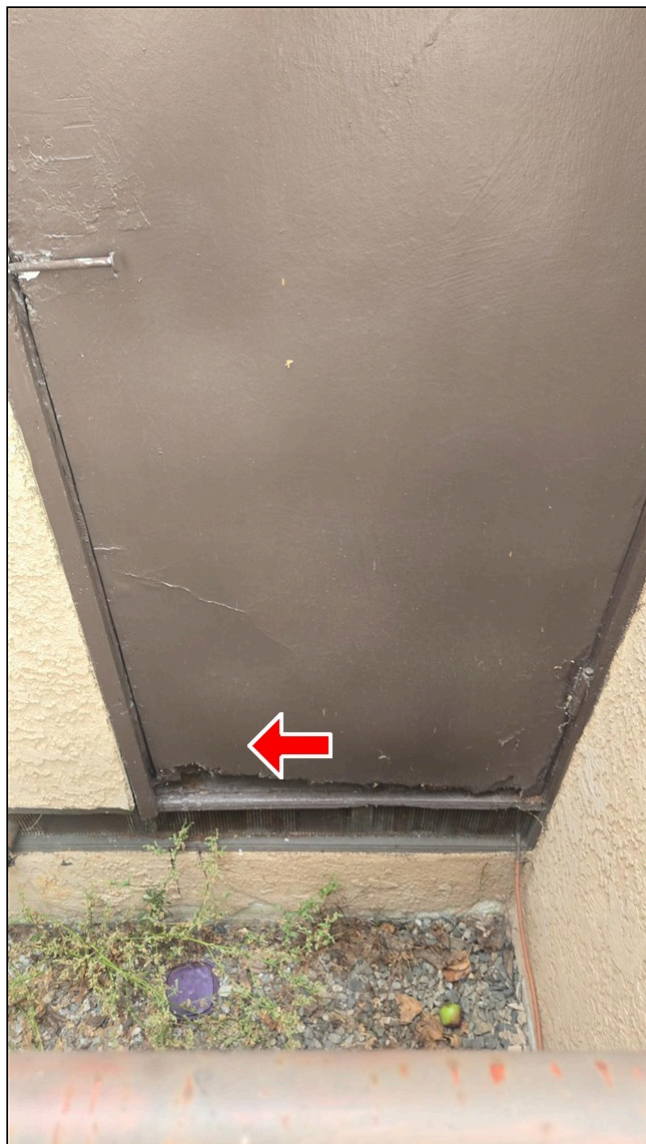
(3) Exterior heat system closet door is in damaged condition. Recommend a qualified person further inspect for repair or replacement recommendations.

1.2 Item 3(Picture) West exterior heater closet door

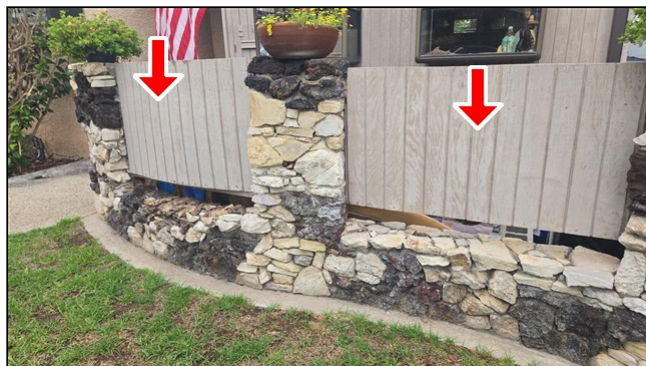
1.5 Item 1(Picture) Wood fencing

Wood damage found to wood fencing and gates at front of unit A. Gates at the east of unit A do not operate properly. Recommend a qualified person further inspect for repair or replacement recommendations.

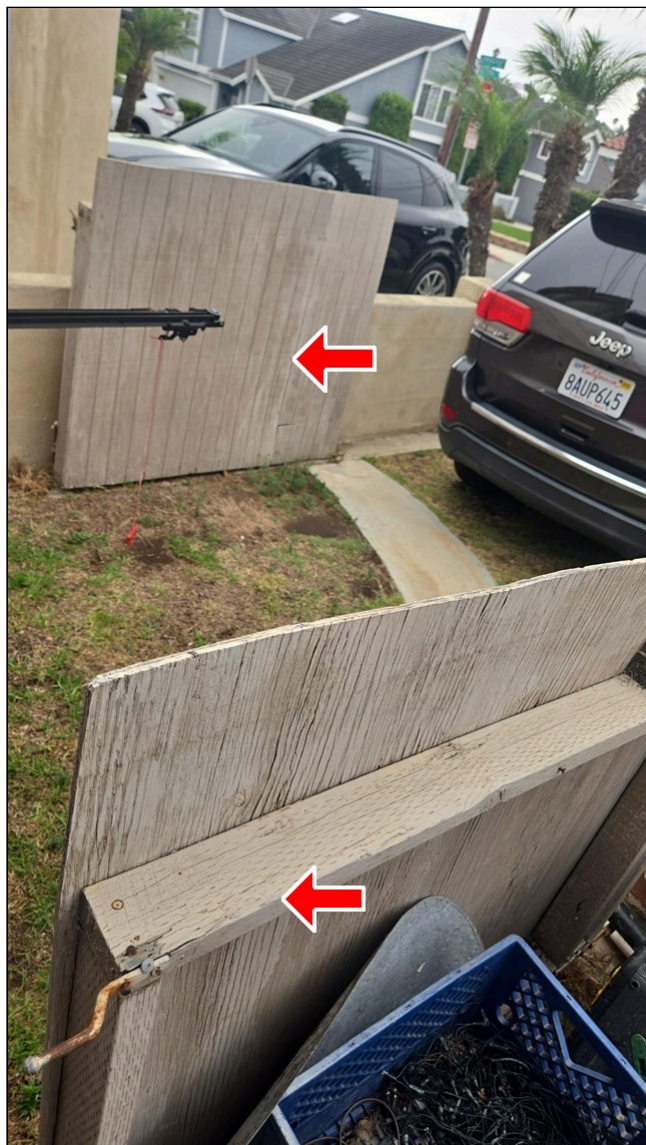
1.5 Item 3(Picture) Wood gates

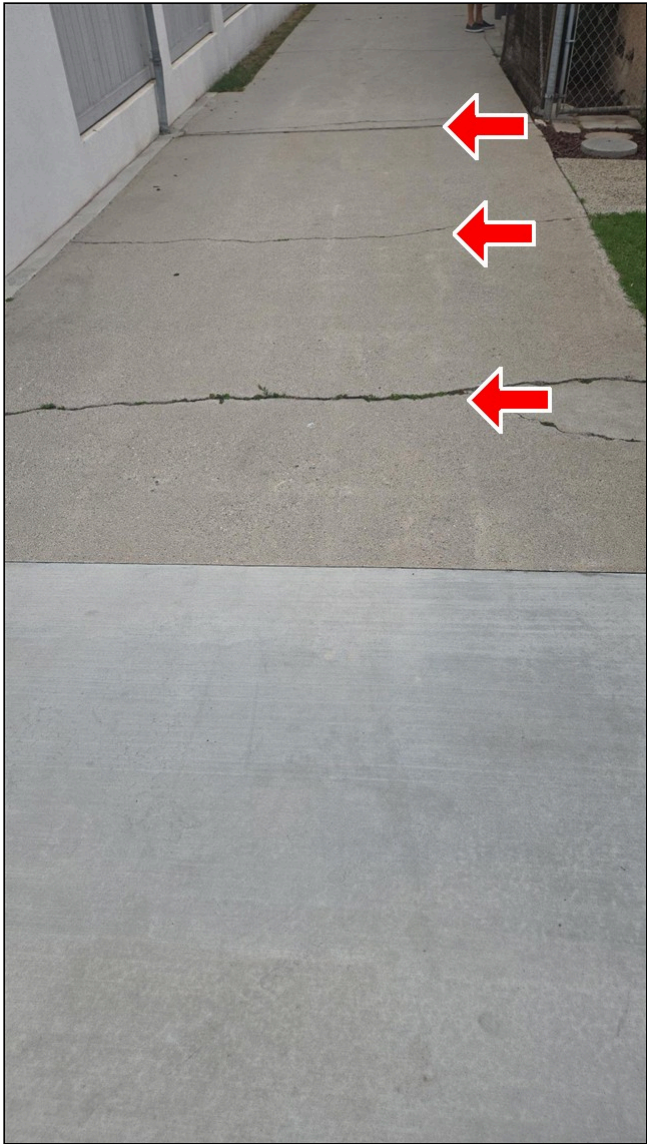
(1) Multiple settlement cracks along driveway. Recommend properly sealing all settlement cracks to prevent water intrusion and further cracking. Repair as needed.

1.6 Item 1(Picture) Driveway settlement cracks

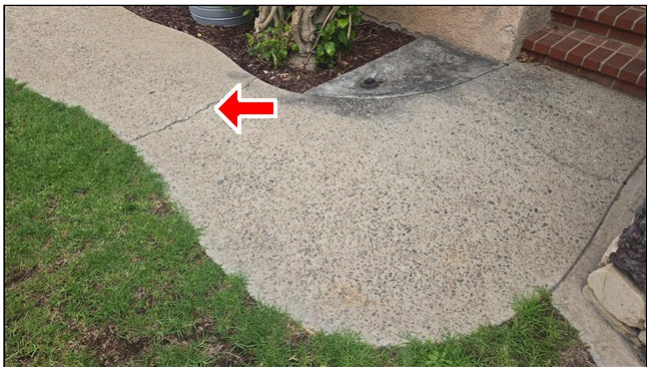
(2) Settlement cracks found on walkways leading to unit A front entry. Recommend a qualified person further inspect for repair recommendations.

1.6 Item 3(Picture) Settlement cracks, front entry, unit A

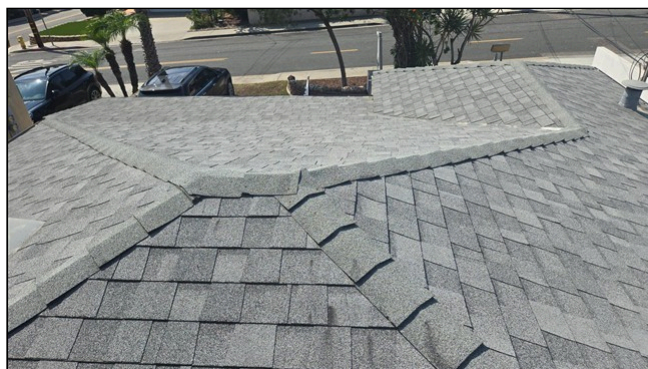
2.0 Item 1(Picture) Roof covering

Roof covering is in good, serviceable condition. Minor signs of pooling were found on the flat portion of roof covering. This is common on flat roof coverings. Recommend a qualified roof specialist further inspect for options on preventing minor pooling.

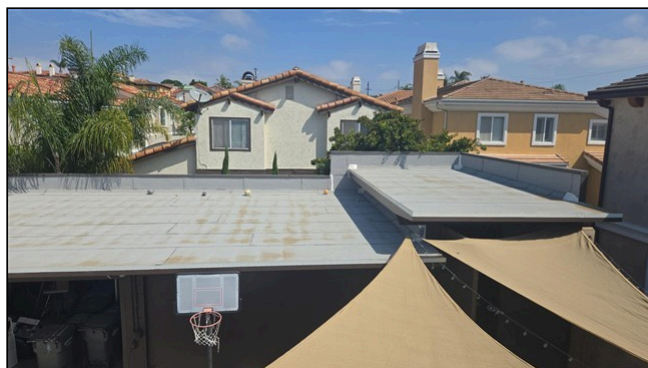
2.0 Item 5(Picture) Minor signs of pooling

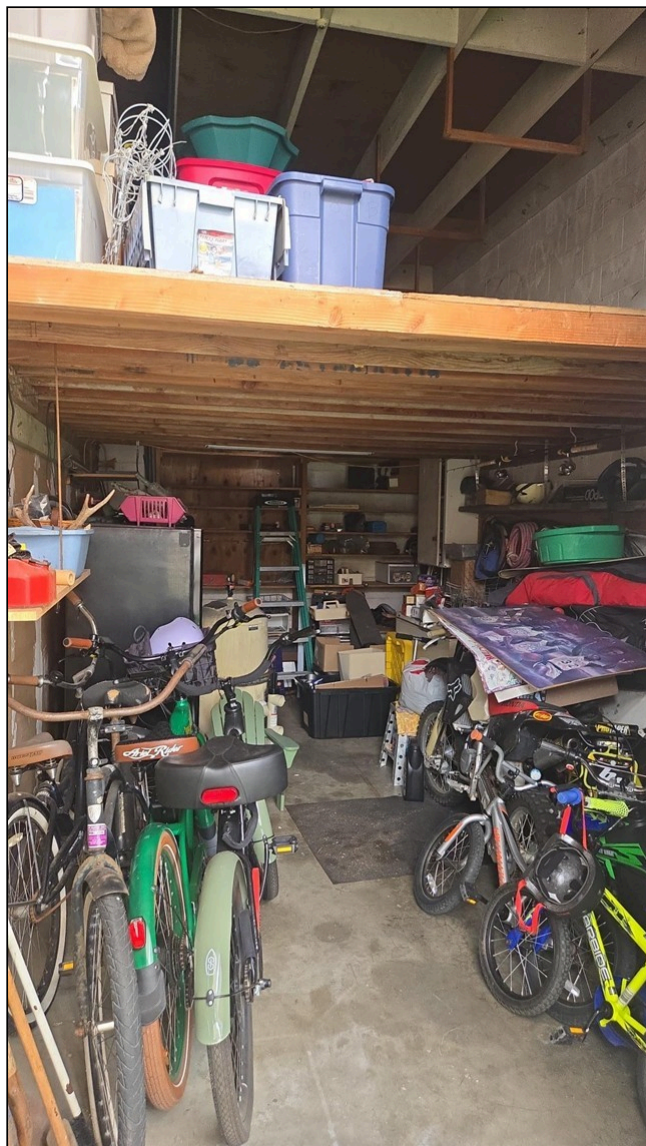
Personal belongings in garages prevented a full visual inspection of the areas. Recommend a qualified person fully inspect garage once personal belongings have been removed.

3.0 Item 1(Picture) Personal belongings, east garage

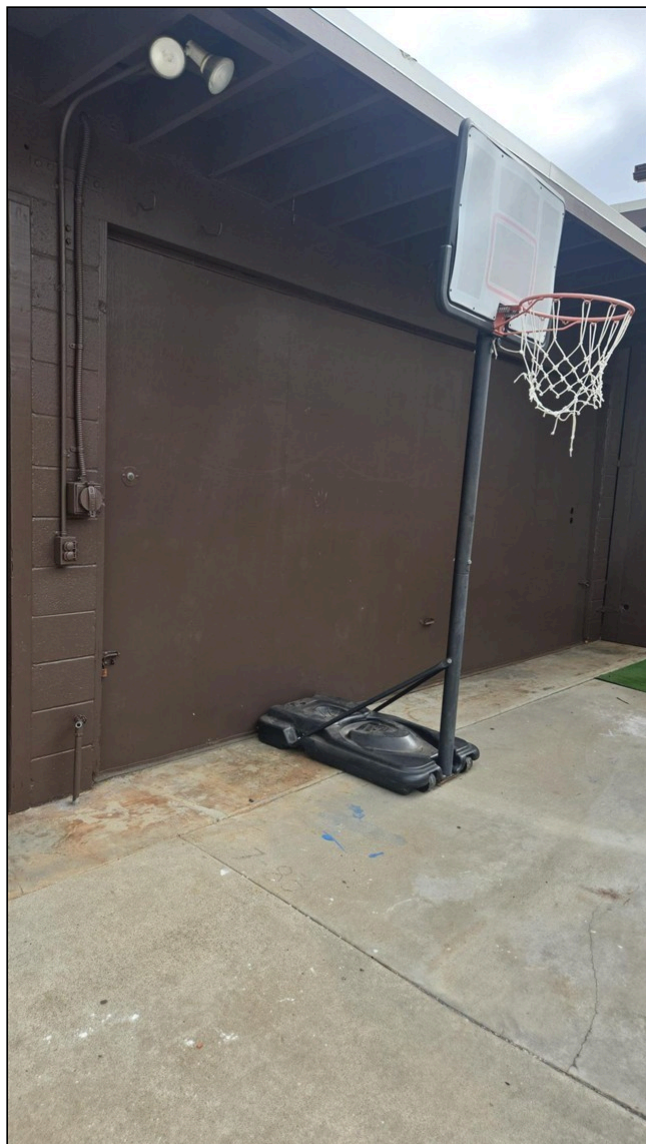
Middle garage is not operable as personal belongings, shelving, and electrical wiring is mounted to the inside of door. Recommend a qualified person further inspect and confirm garage door operates (opens and closes) properly as needed.

3.5 Item 1(Picture) Middle vehicle garage door

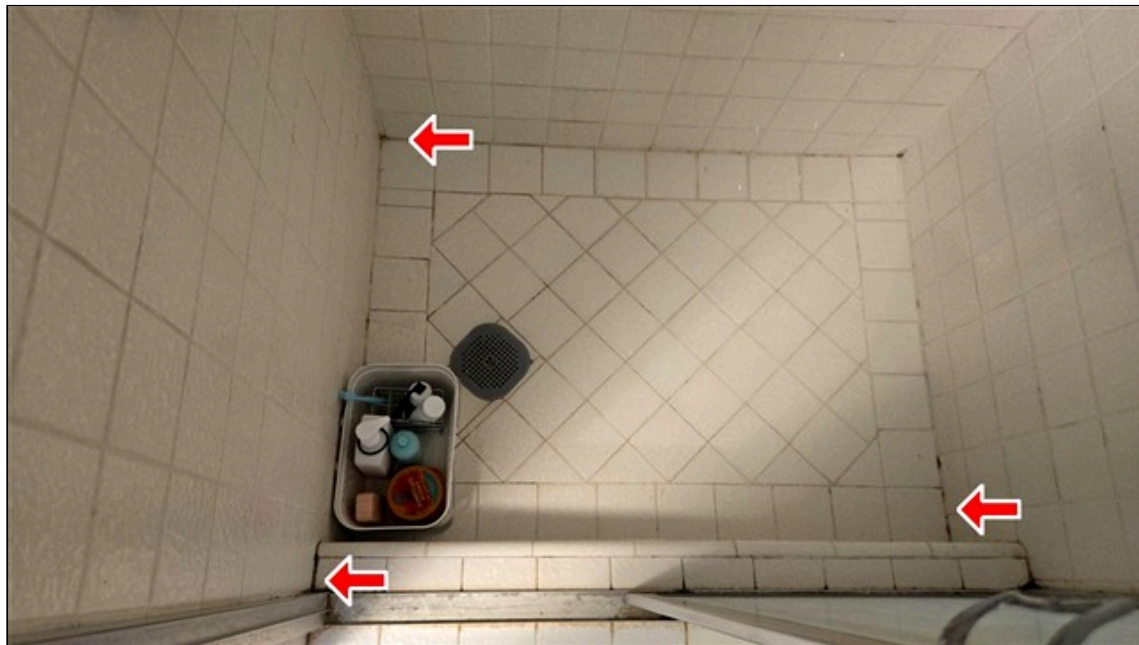
Unit A hall bathroom shower has deteriorated grout and seals between tile. Recommend a qualified person further inspect for repair recommendations.

4.3 Item 1(Picture) Unit A hall bathroom shower walls/surface

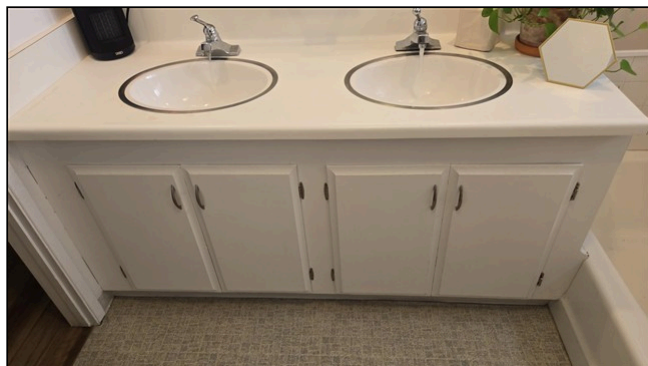
4.5 Item 1(Picture) Hall bathroom base cabinet/ countertop, unit A

(1) Kitchen and bathroom cabinets and counter tops throughout unit A are dated and have normal wear and tear. Recommend a qualified person further inspect for repair recommendations.

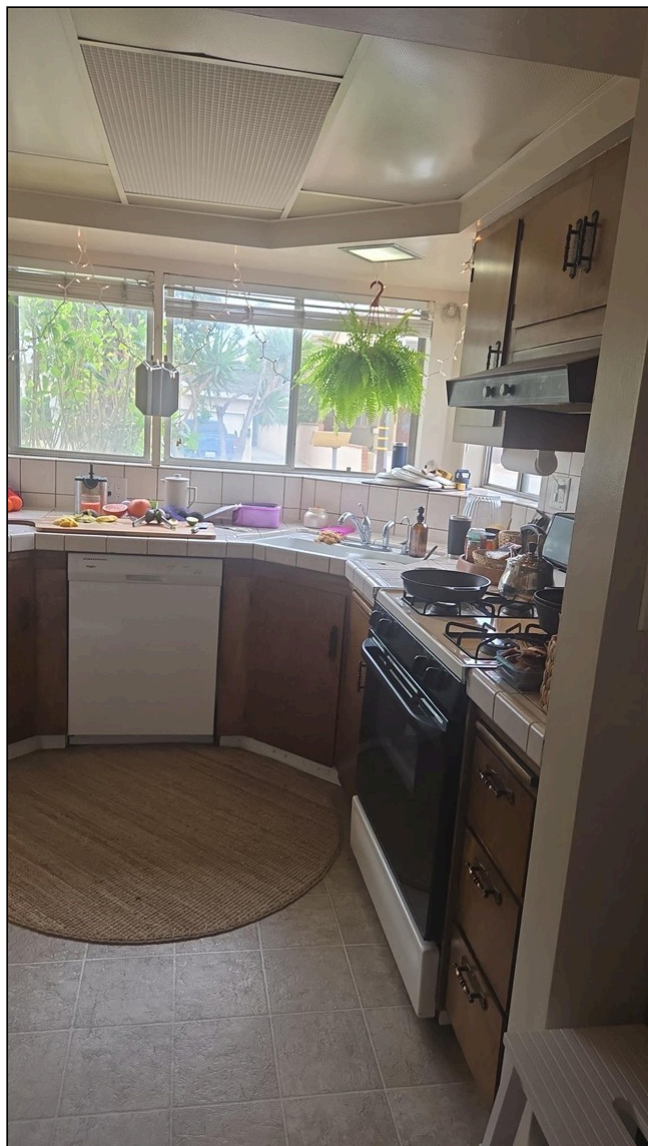
4.5 Item 3(Picture) Kitchen cabinets, unit A
