Titus
Inspections

Inspection Report

2121 Marshallfield Ln Unit A
2121 Marshallfield Ln Unit B
Redondo Beach CA 90278

| Property Address 2121 Marshallfield Ln Unit A 2121 Marshallfield Ln Unit B Redondo Beach CA 90278 | Date of Inspection 8/26/2025 | Report ID 250826-01 |

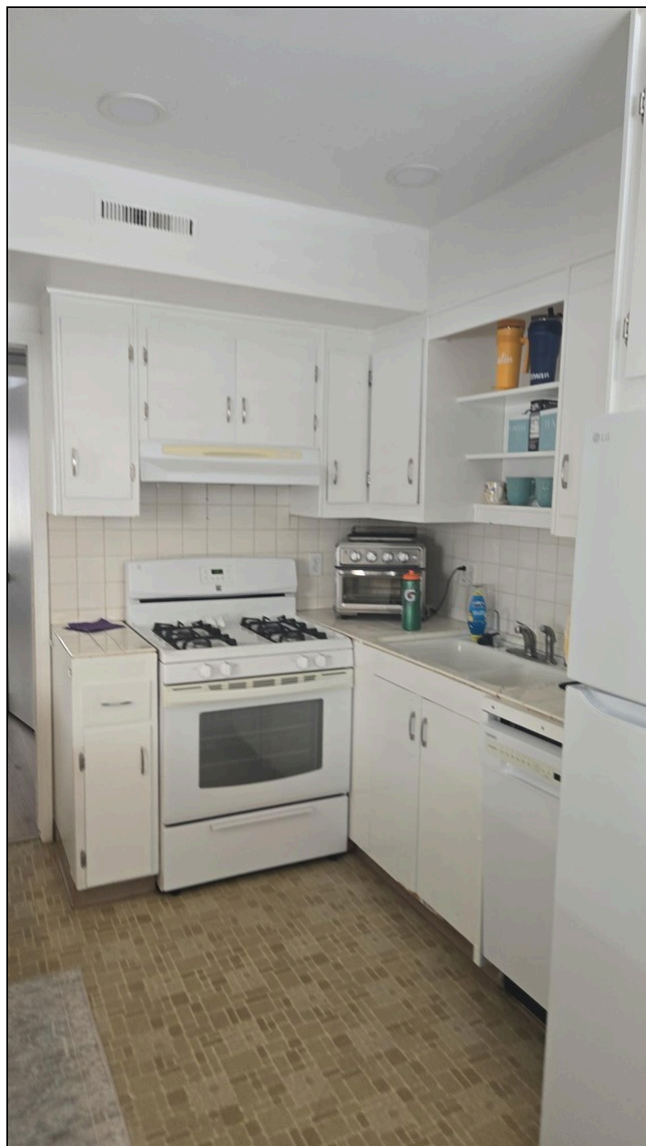
(2) Kitchen and bathroom cabinets and counter tops throughout unit B are dated and have normal wear and tear. Recommend a qualified person further inspect for repair recommendations.

4.5 Item 4(Picture) Unit B kitchen cabinets

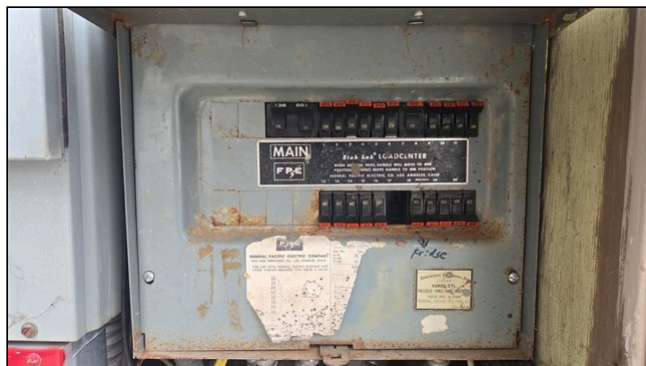
5.2 Item 1(Picture) Missing labels, unit A main distribution panel

(1) Unit A distribution panel is missing labels, which properly identify each breaker. Recommend a qualified electrician further inspect and label panel to properly identify each breaker as needed.

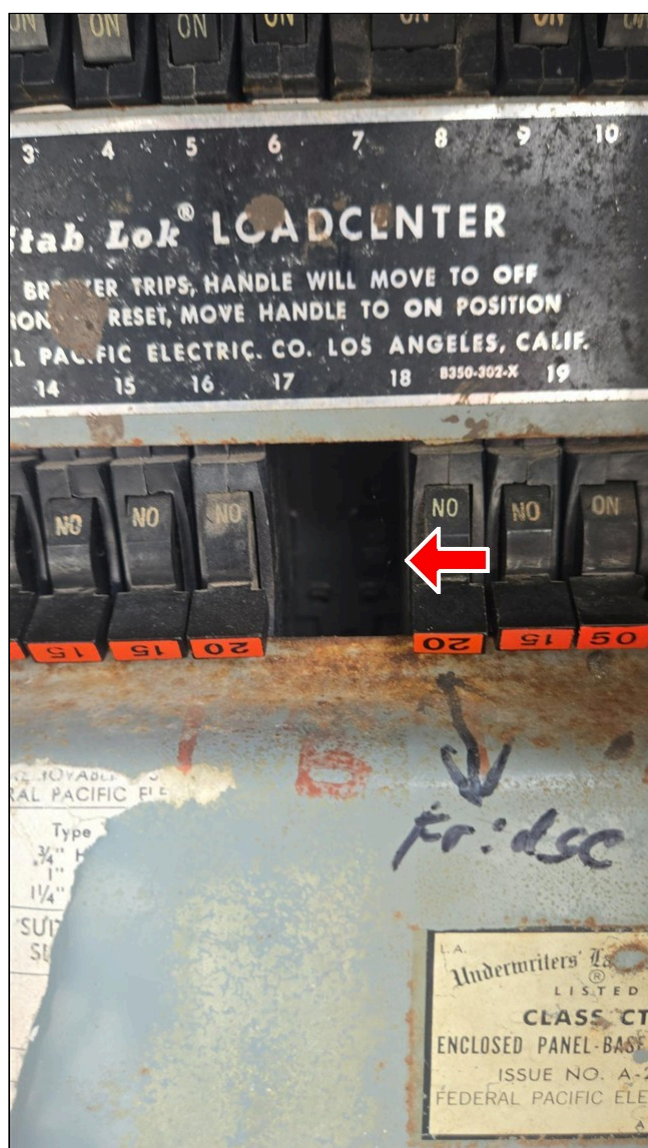
(2) Unit A main distribution panel is missing circuit breakers creating gaps that could allow foreign objects to enter behind circuit breaker cover panel. Recommend a qualified electrician further inspect and install knockout covers on open slots as needed.

5.2 Item 2(Picture) Missing circuit breakers, unit A main distribution panel

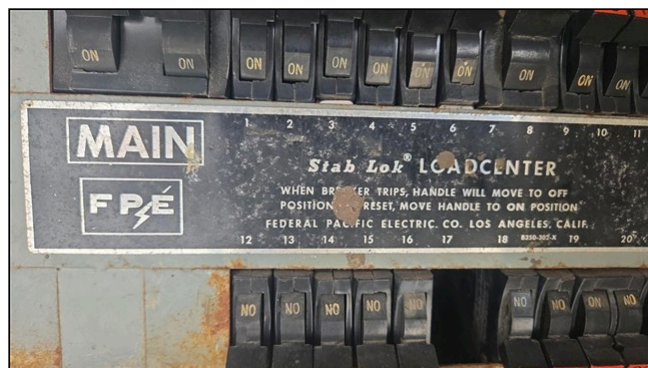
(2) Unit A and detached garage panels are Federal Pacific panels, which is legal, but there is a possibility that the circuit breakers may not trip when shorted possibly causing an electrical hazard. Opinions by licensed electricians on this panel varies between safe and unsafe. Recommend consulting a licensed electrician for an opinion and correct if necessary.

5.3 Item 1(Picture) Unit A, Federal Pacific panel

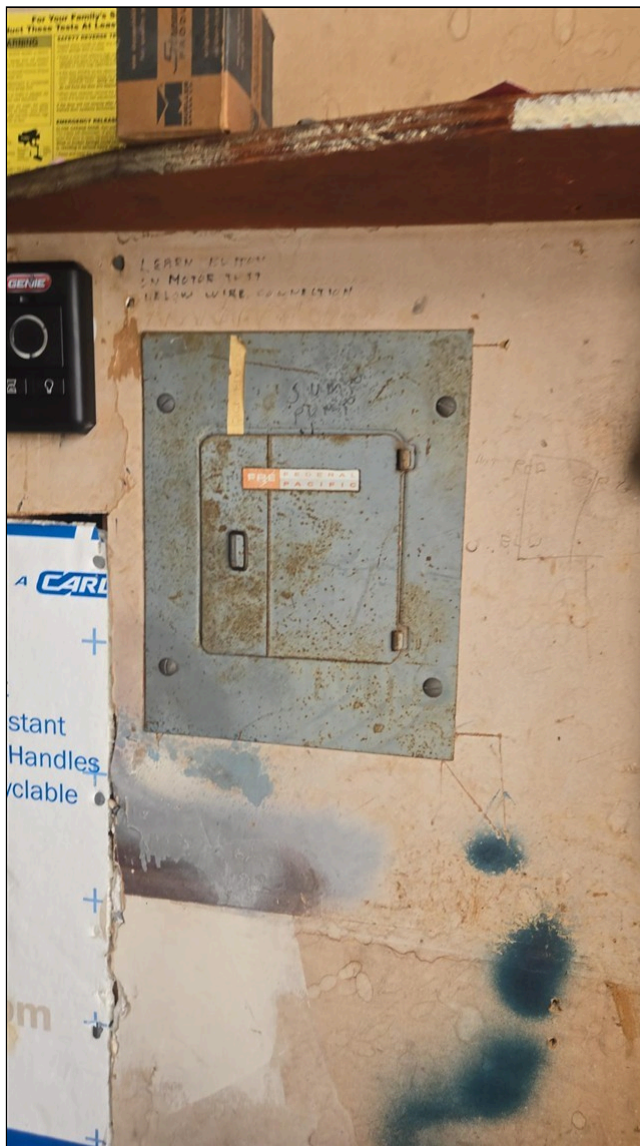
5.3 Item 2(Picture) Detached garage, Federal Pacific panel

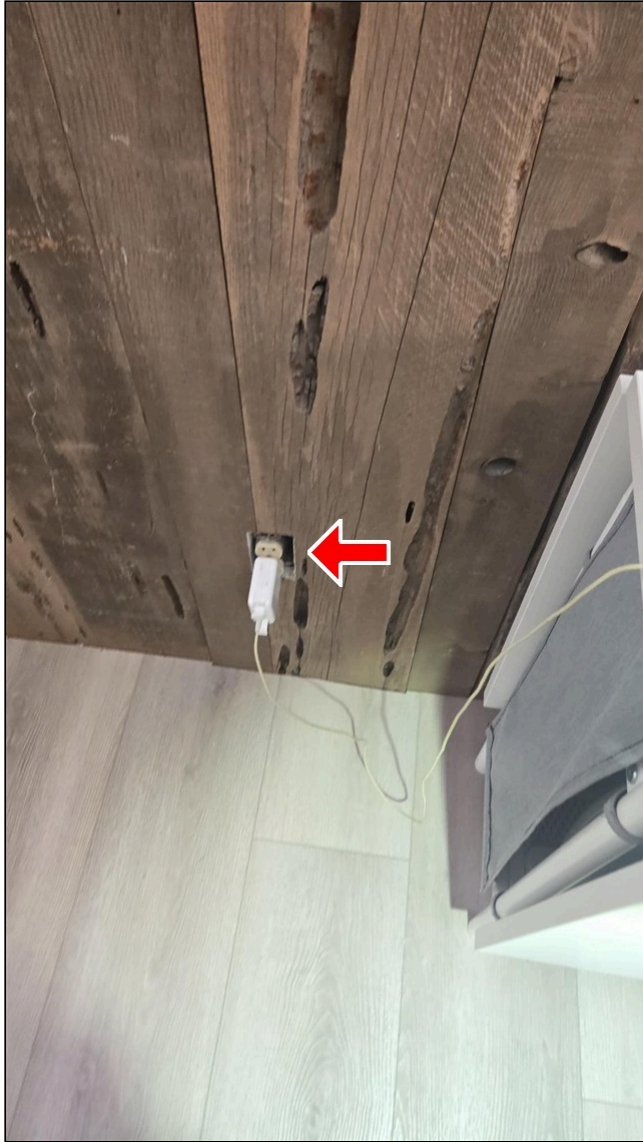
(1) Missing cover plates on multiple light switches and outlets throughout unit B. Recommend installing cover plates as needed.

5.4 Item 1(Picture) Unit B living room outlet, missing cover

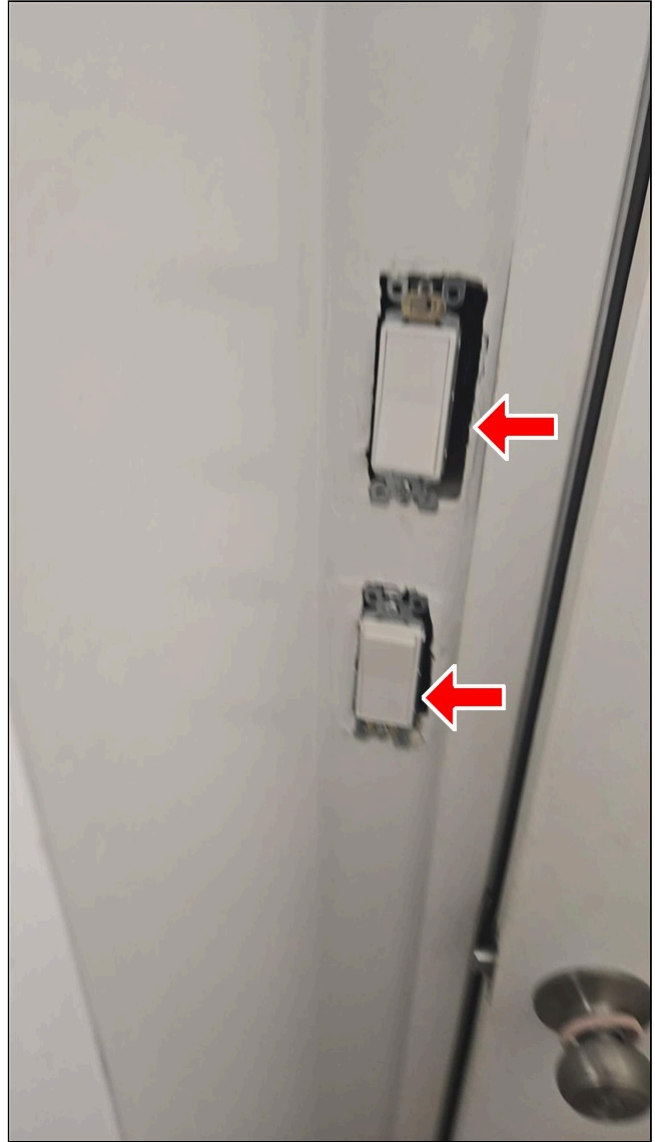
5.4 Item 2(Picture) Unit B switches, missing covers

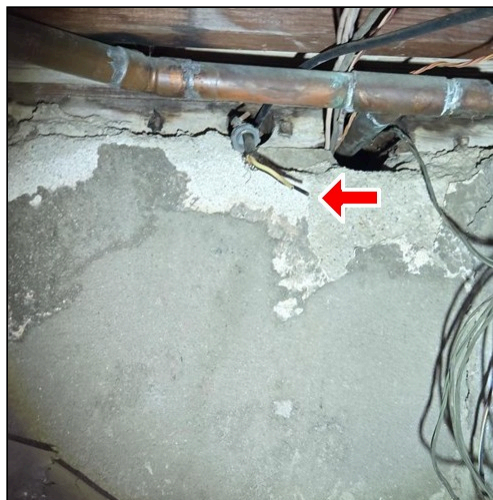
5.4 Item 3(Picture) Exposed wiring, crawlspace

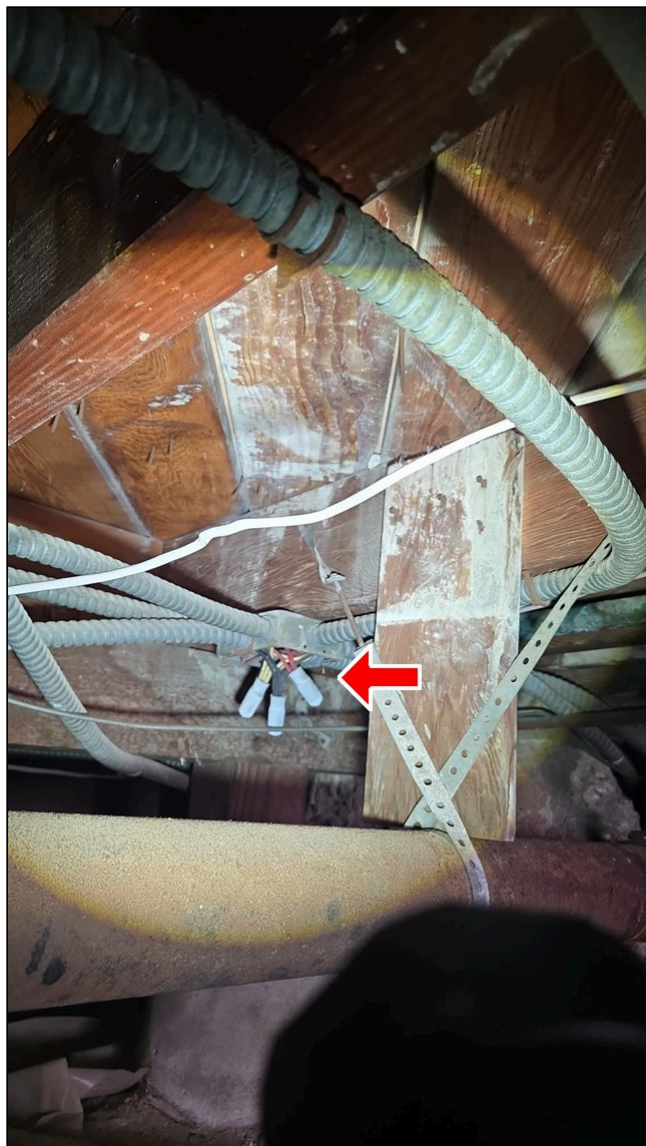
5.4 Item 4(Picture) Missing cover plate, crawlspace

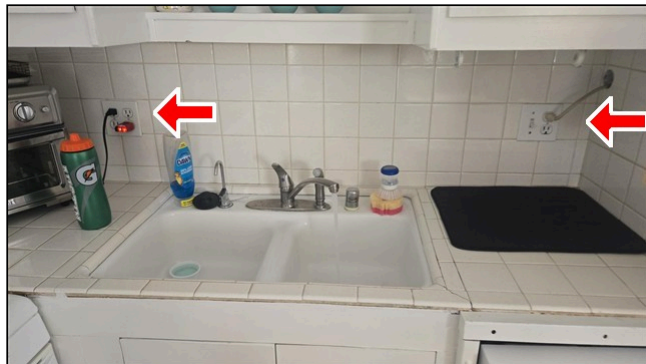
5.5 Item 1(Picture) Unit B kitchen outlets

(1) The kitchen outlets next to kitchen sink in unit B are non protected outlets. Receptacles within six feet of a water source are required to be GFCI protected. These outlets are outdated and considered a safety issue until corrected. Recommend a qualified electrician further inspect and repair or replace as needed.

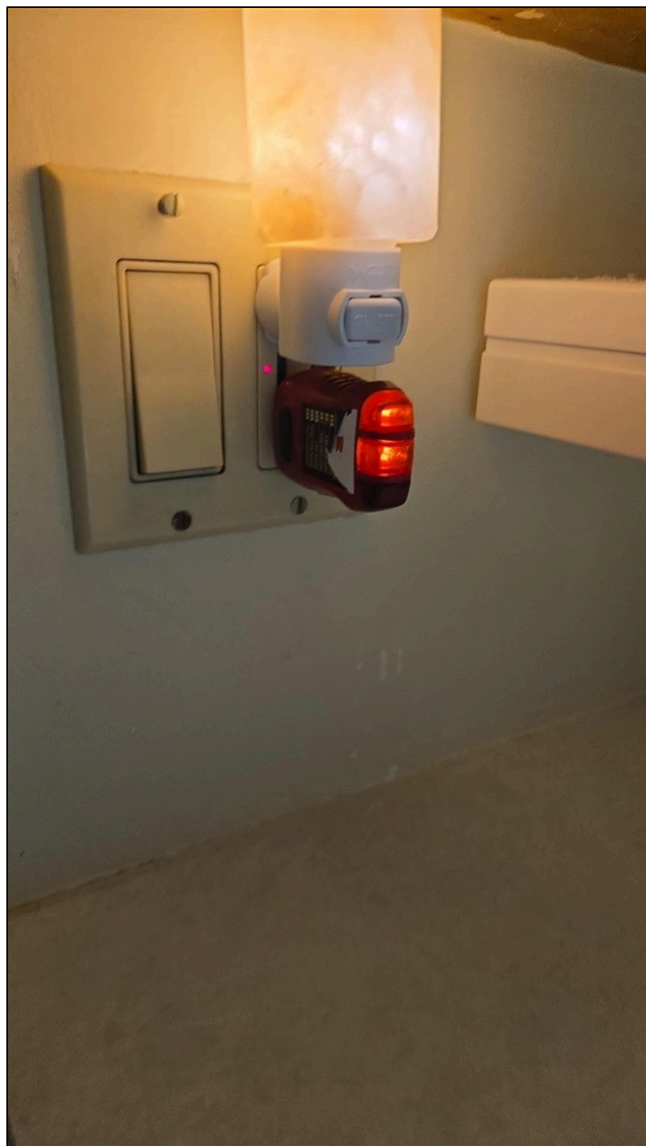
5.6 Item 1(Picture) Unit A primary bedroom bathroom GFCI outlet

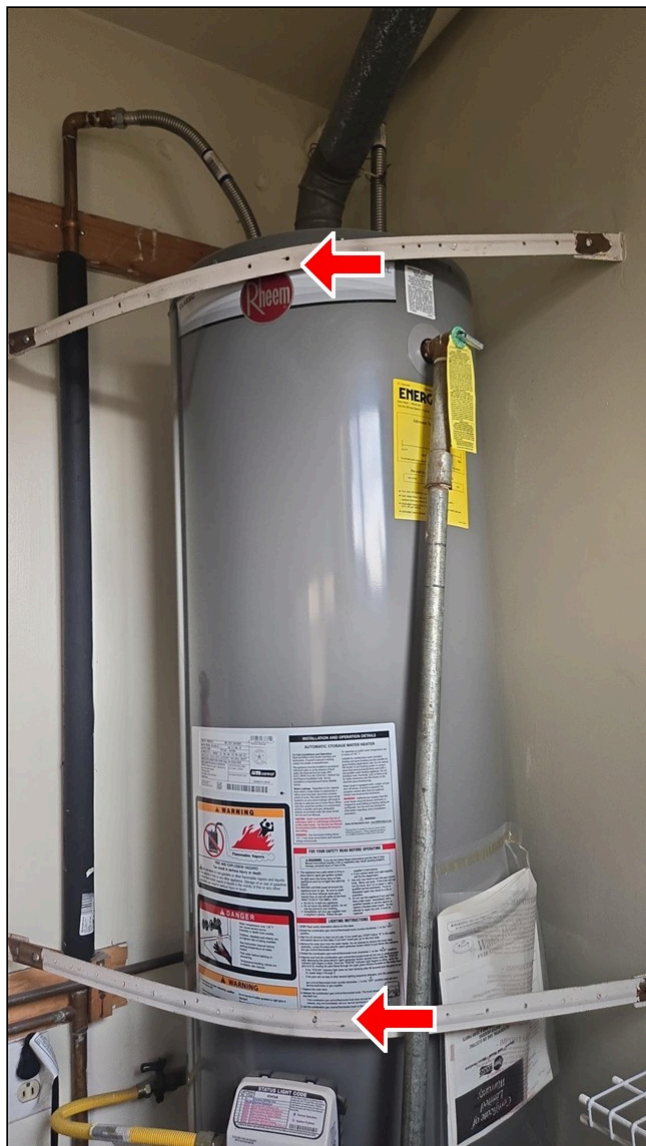
6.2 Item 4(Picture) Water heater, earthquake seismic straps

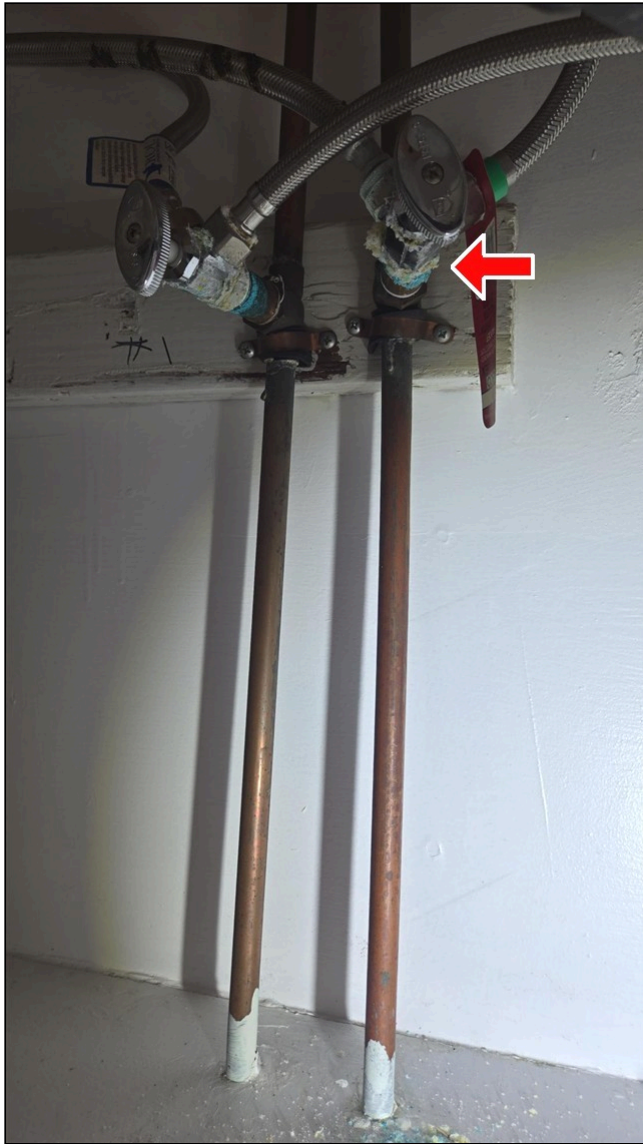
6.3 Item 1(Picture) Corrosion, unit A hall bathroom water supply shut off valves

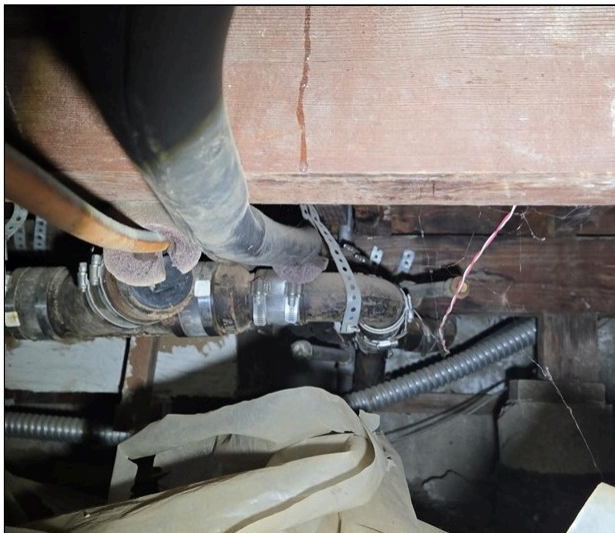
6.3 Item 3(Picture) Copper/galvanized water
supply lines

(2) Galvanized water supply lines found. Water pressure to supply fixtures was adequate. Galvanized plumbing is dated and may corrode from the interior of plumbing line. It is common for signs of rust to come out of fixtures if not run for long periods of time. No rust was found at time of inspection. Recommend a qualified licensed plumber further inspect water supply lines throughout as needed for replacement recommendations.

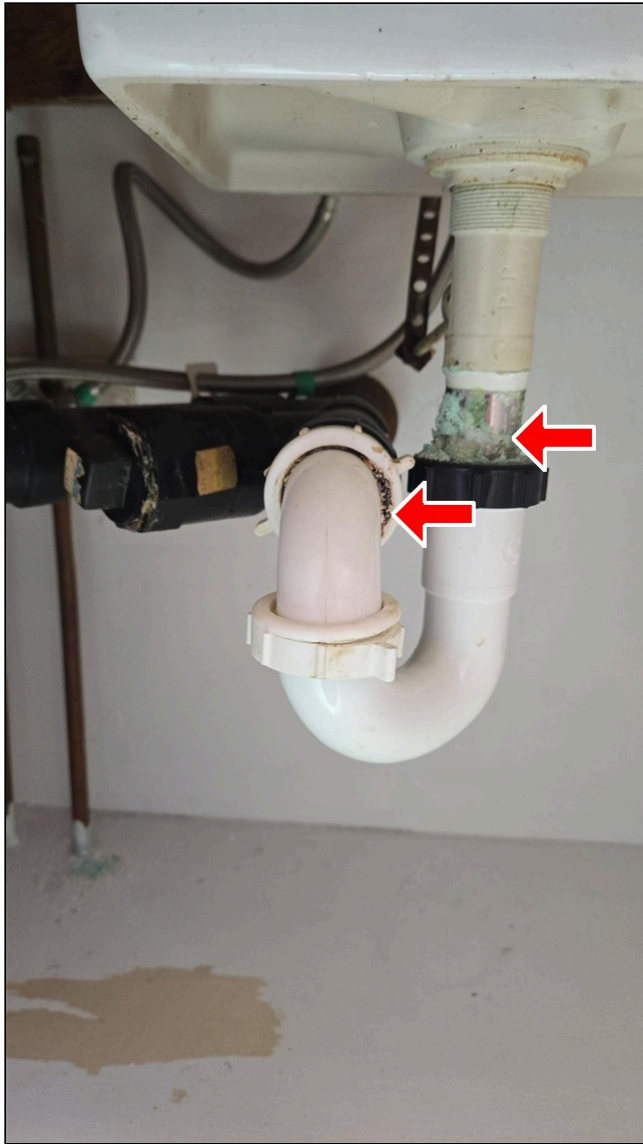
6.5 Item 1(Picture) Unit A hall bathroom sink drains

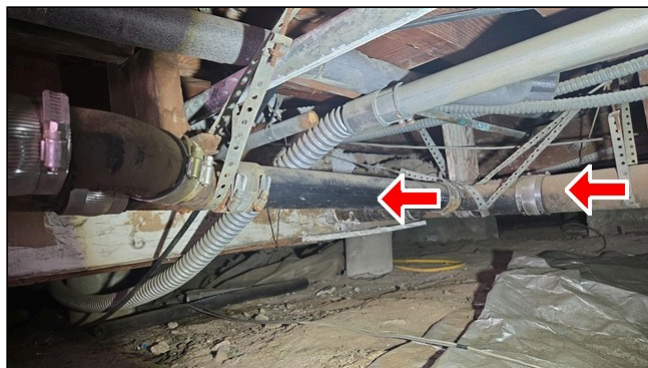
6.5 Item 2(Picture) Cast iron drain lines/ABS repairs, crawlspace

(2) Old cast iron drain lines are present below home in crawlspace. Some repairs and replacement of drain lines with ABS drains are present. Drain lines are dated and inspector is unable to confirm condition of interior of drain line. Active leaking found below unit A and unit B hall bathrooms. Recommend a qualified plumber perform a sewer line inspection to inspect the interior condition of drain line, and repair leaking as needed.

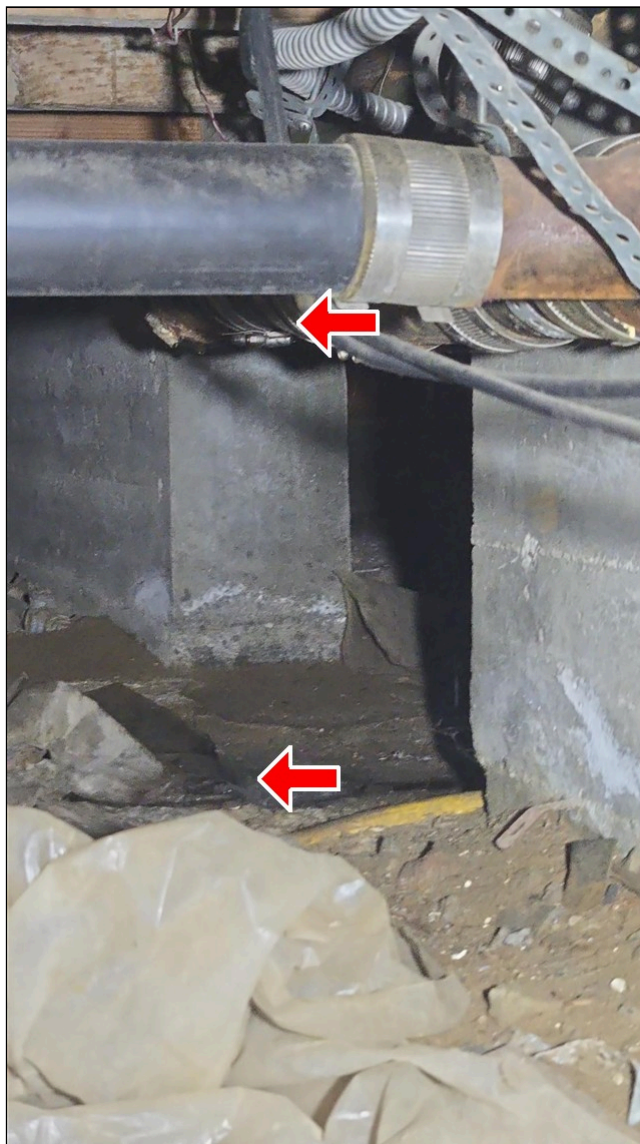
6.5 Item 3(Picture) Active leaking, crawlspace

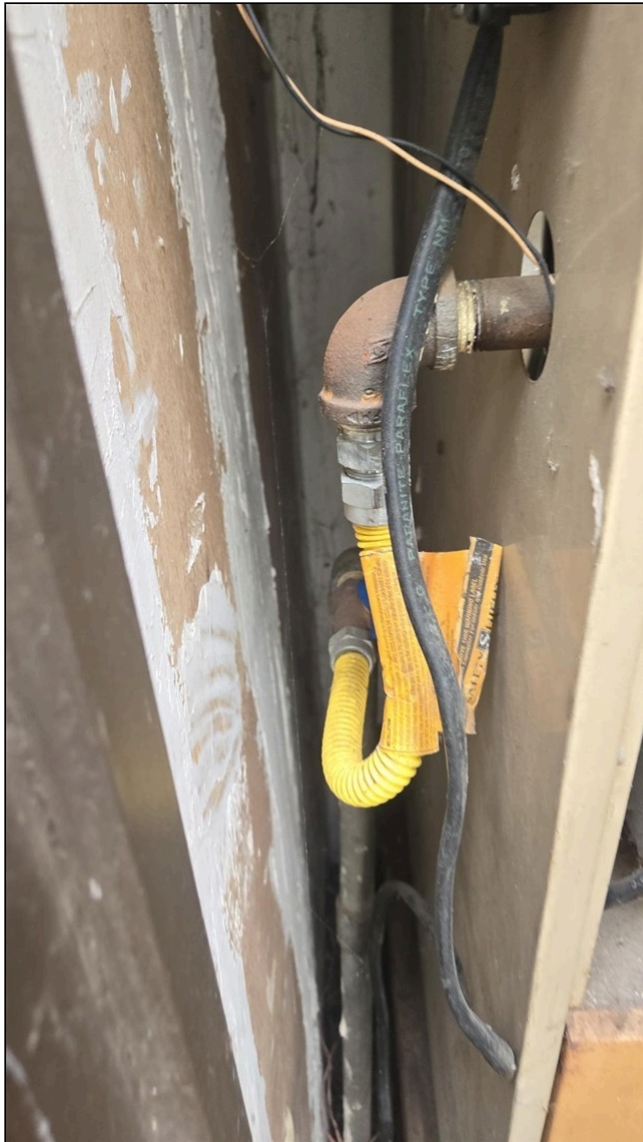
6.6 Item 1(Picture) Heat system #1 gas line

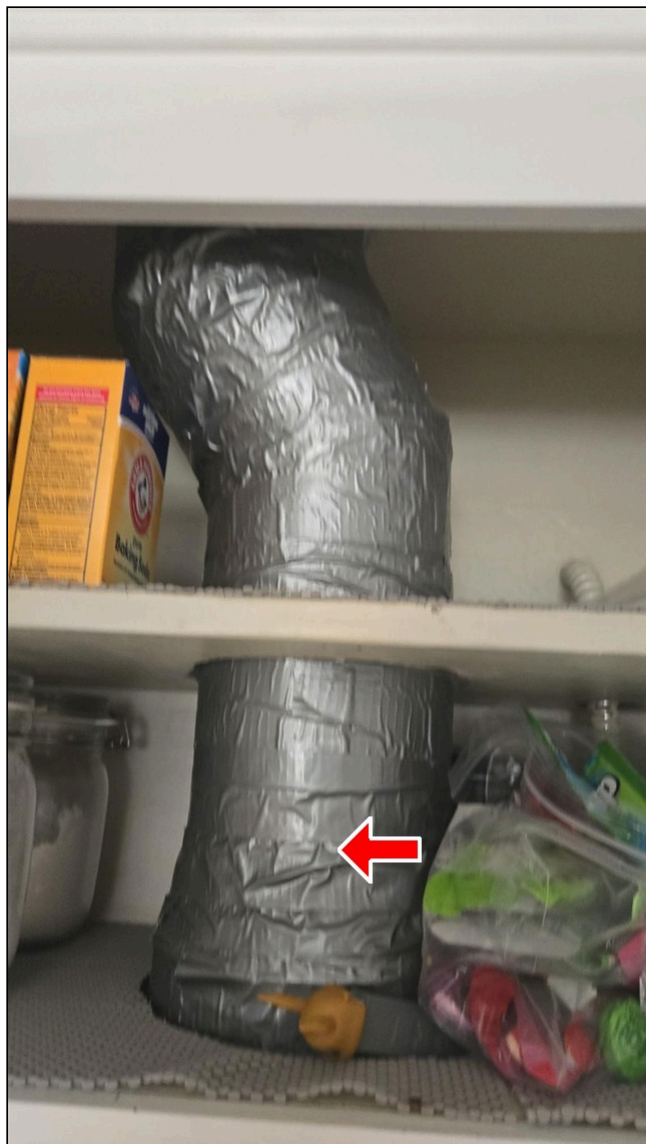
7.2 Item 1(Picture) Unit B range hood vent

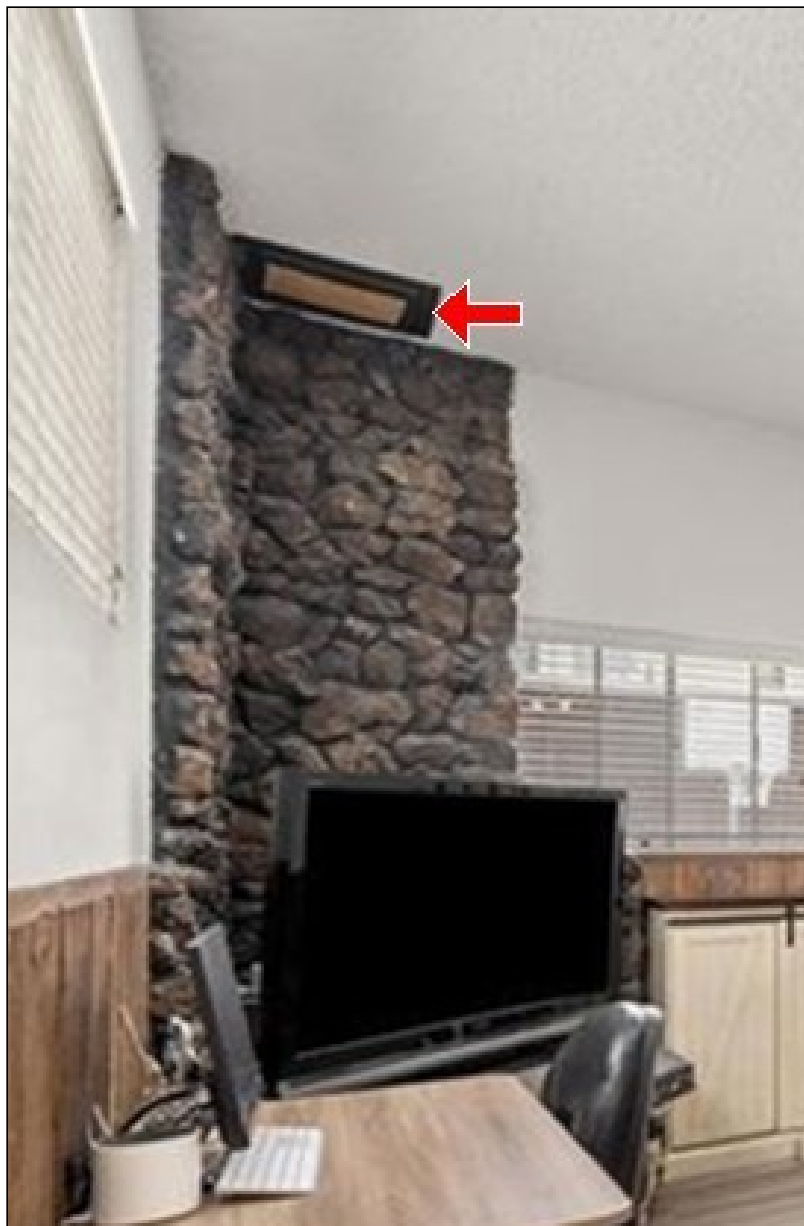
8.2 Item 1(Picture) Flue opening, unit B

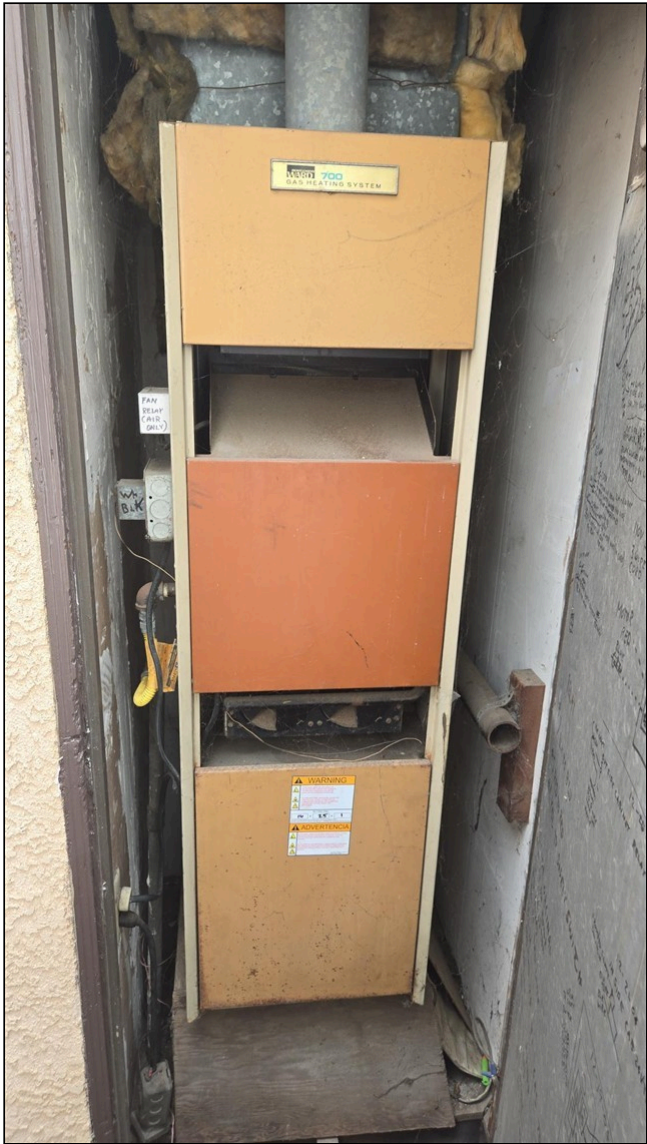
9.0 Item 2(Picture) Heat system #1 information

Model: SRM 54369A

Serial: KN3D104 F3676 3267

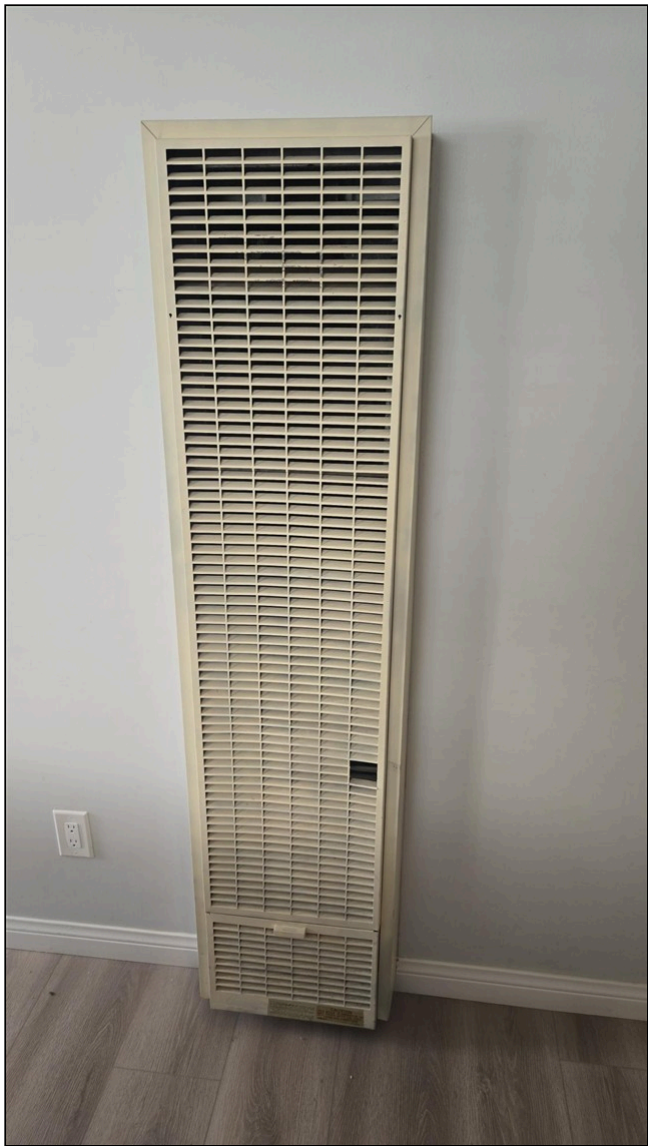
9.0 Item 3(Picture) Wall heating system #2

9.0 Item 1(Picture) Heat system #1
(2) Wall heating system #2 is located inside the living room of unit B.

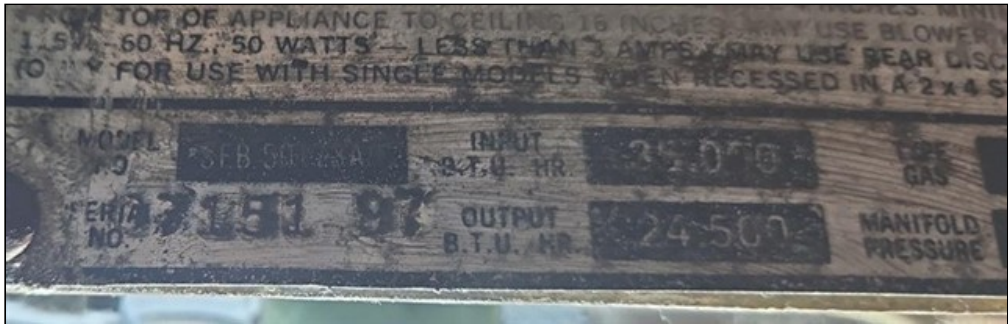
9.0 Item 4(Picture) Heat system #2 information Wall heat system #2 information

Model: BDF 50

Serial: 07151 07

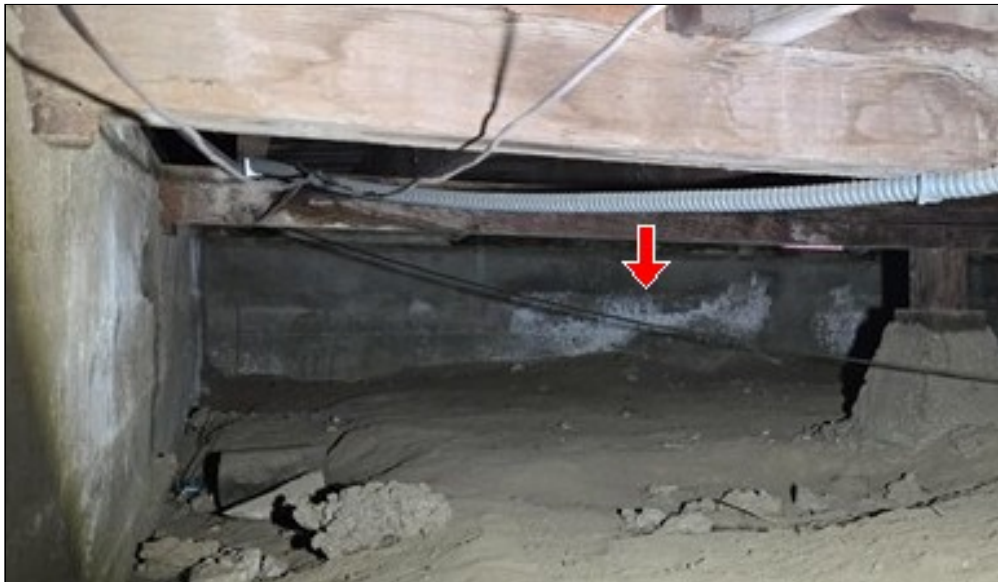
11.0 Item 1(Picture) Efflorescence, crawlspace

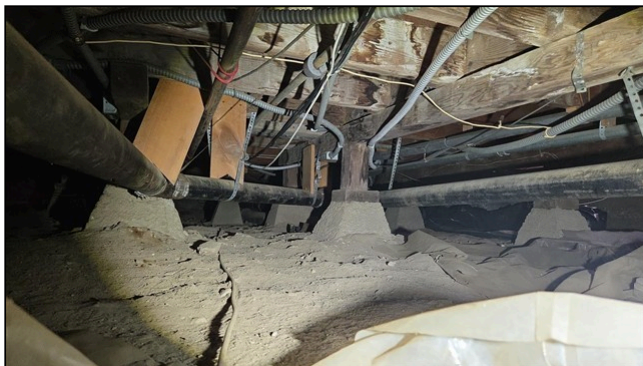
11.0 Item 2(Picture) Restricted access, plumbing

(2) Restricted access to unit A crawlspace, below kitchen area. Recommend a qualified person further inspect once access is provided.
