# THE COMPANY

Home Inspection Group

8026 Carnation Dr, Buena Park, CA 90620

Date of Inspection: 11/5/2025 Time: 9:00 AM

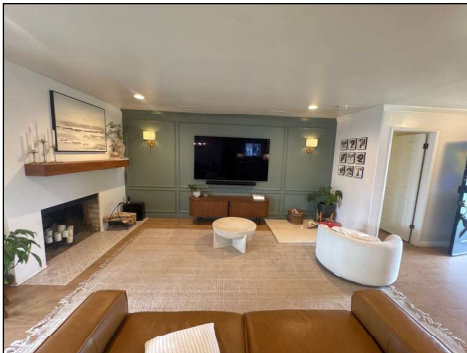
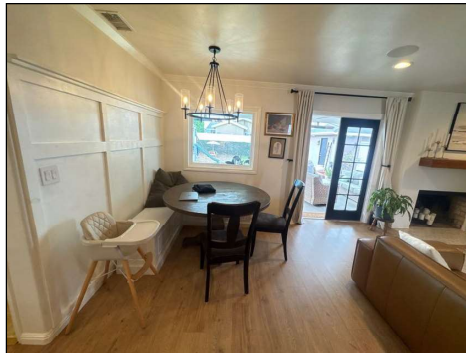
## 1. Wall Conditions

Small cracks/chipped/dirty areas/cosmetic blemishes observed – typical for age of structure • Missing base boards in areas – service recommended • No moisture present when tested with a moisture meter • Some areas not accessible or visible due to access limitations or personal items/furnishings

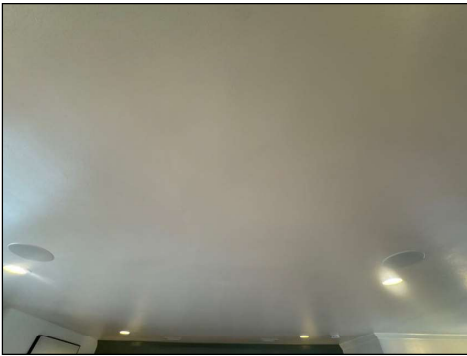
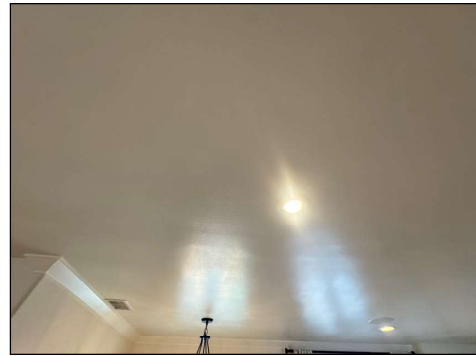
## 2. Ceiling Conditions

Small cracks/chipped/dirty areas/cosmetic blemishes observed – typical for age of structure

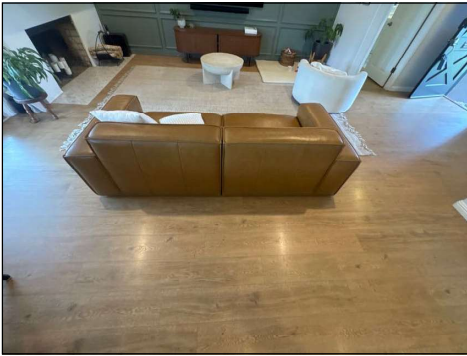
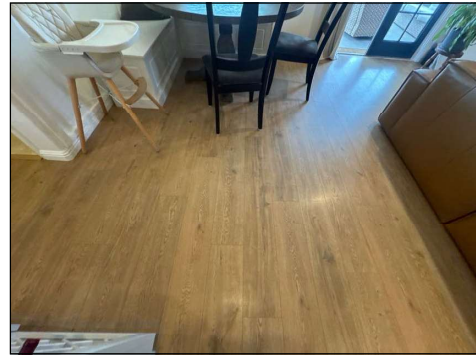
### 3. Floor Conditions

Scratched/worn areas – typical for age and use

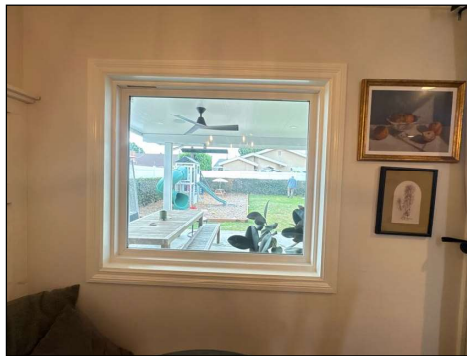
### 4. Window Conditions

Accessible windows were tested and operated at time of inspection • Recommend general window maintenance/lubrication and weather tight service

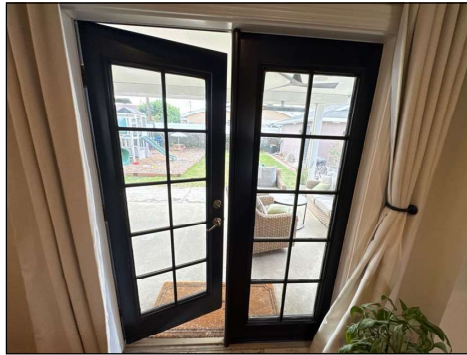
## 6. French Doors

Door(s) operated at the time of the inspection • Worn door(s) with loose/worn hardware/frames/secondary latches – typical for age • Double pane • Tempered glass label observed • Secondary doors and latches may stick if not used often, double doors need routine maintenance and lubrication of all moving parts to operate properly.

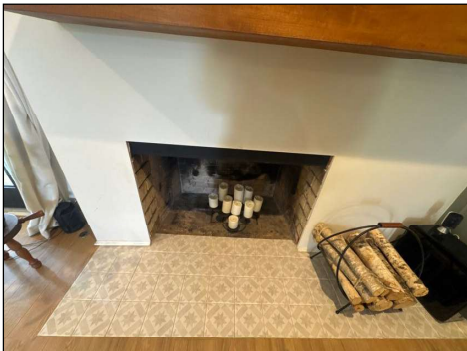
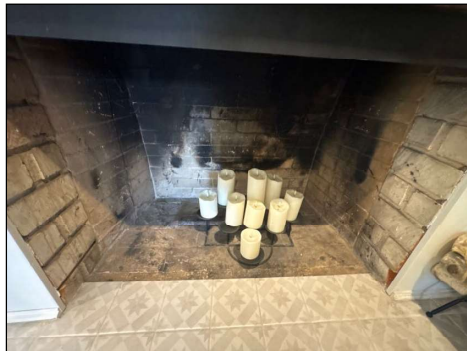
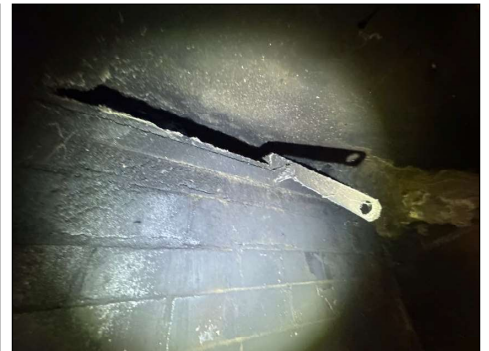
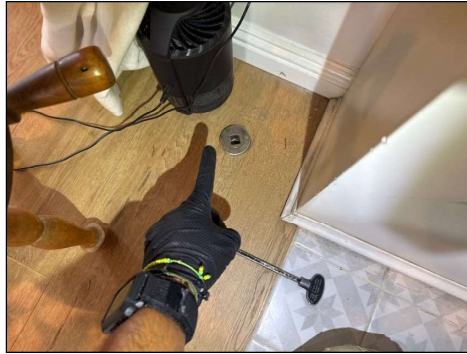
Masonry

The fireplace is visually inspected only, the fireplace is not lit to test flame color or condition. The internal cavity of the fireplace is not inspected. It is recommended that you have an internal inspection of the chimney and a Gas Company evaluation of the fireplace prior to operating the fireplace. • Small cracks/worn areas present – typical for age • Recommend fire caulk/sealing any holes/gaps/cracks • Damper was worn/rusted/dirty – recommend cleaning • Thrash around gas valve - was not able to test – service recommended • **No damper stop clamp – required for cosmetic gas logs, fire-glass or other cosmetic fire system that uses gas at the primary fuel**

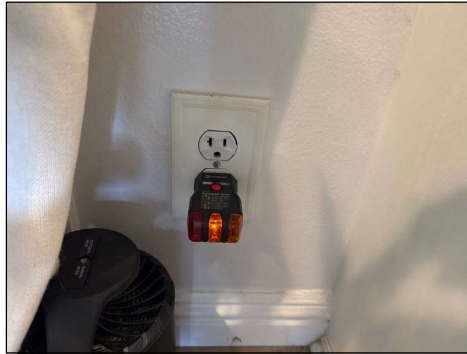
## 9. Electrical

A representative number of receptacles and switches were tested and found to be operational at time of inspection • Loose/worn outlets/switches – typical for age consider upgrading • **Three prong outlet(s) not grounded – service recommended**

| Interior | | |
|---|---|---|
| Page 12 Item: 9 | Electrical | <ul style="list-style-type: none"> <li>• Three prong outlet(s) not grounded – service recommended</li> </ul> |

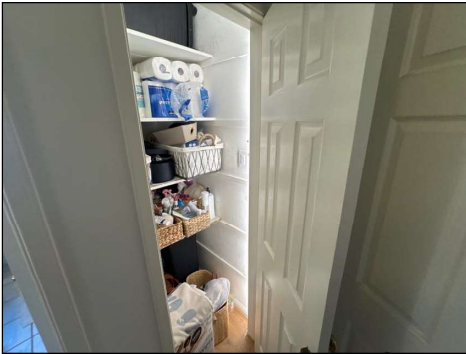
## 10. Closets

Worn closets with loose/worn hardware – typical for age • Some closet areas not visible for inspection due to personal storage

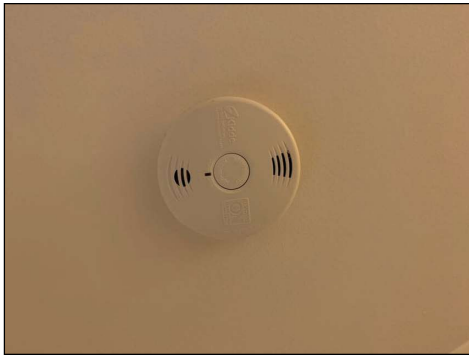
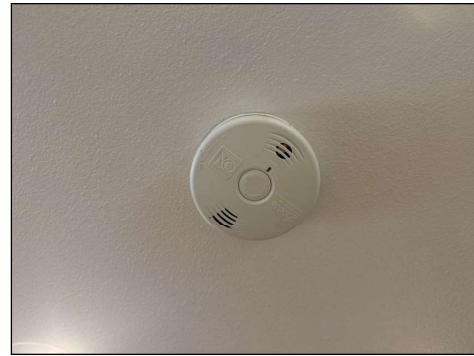
## 11. Smoke Detectors

For safety purposes we recommend that smoke detectors be placed in all hallways outside of sleeping areas (bedrooms) and on all levels of multi-level dwellings. For longer hallways and/or oddly located bedrooms, multiple smoke detectors are suggested and should be placed at each end of the hallways to ensure optimum safety alert. • Operational at time of inspection via factory installed test button • Smoke and Carbon Monoxide combo unit is present

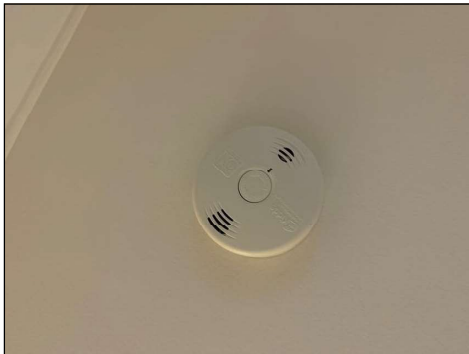
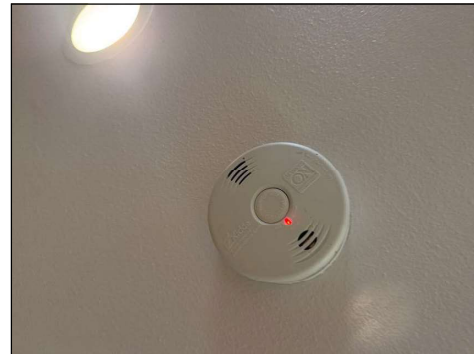
## 12. Carbon Monoxide Detectors

For safety purposes we recommend that carbon monoxide detectors be placed in all hallways outside of sleeping areas (bedrooms) and on all levels of multi-level dwellings. For longer hallways and/or oddly located bedrooms, multiple carbon monoxide detectors are suggested and should be placed at each end of the hallways to ensure optimum safety alert. • Operational at time of inspection via factory installed test button • Smoke and Carbon Monoxide combo unit is present

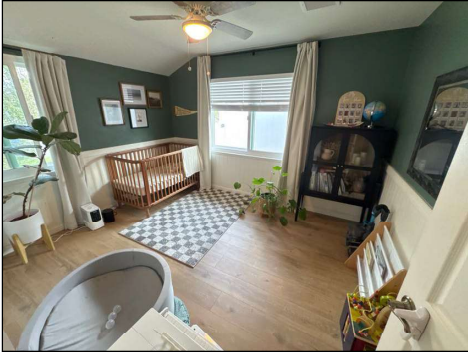
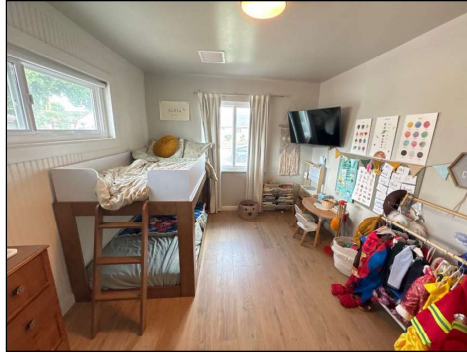
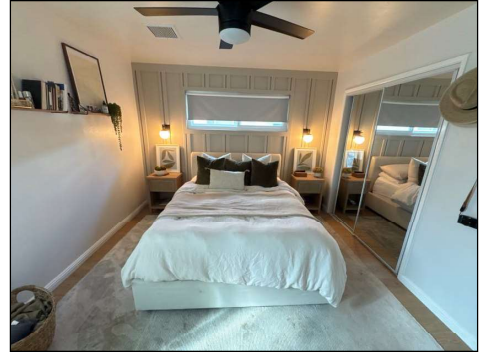
## 1. Wall Conditions

Small cracks/chipped/dirty areas/cosmetic blemishes observed – typical for age of structure • No moisture present when tested with a moisture meter • Some areas not accessible or visible due to access limitations or personal items/furnishings

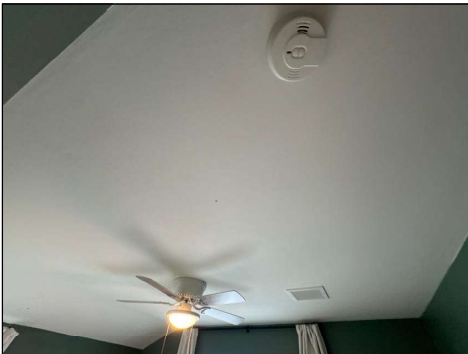
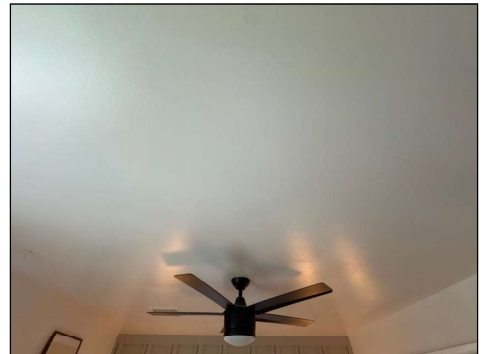
## 2. Ceiling Conditions

Cosmetic blemishes observed – typical for age of structure • Patched/partial painted areas present – consult seller regarding patched areas

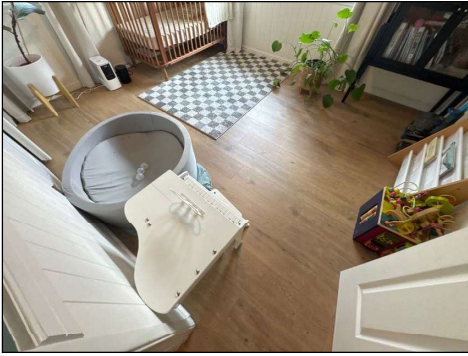
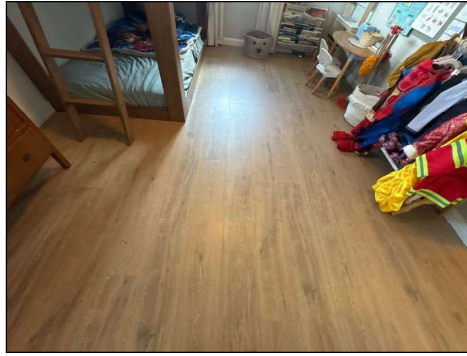
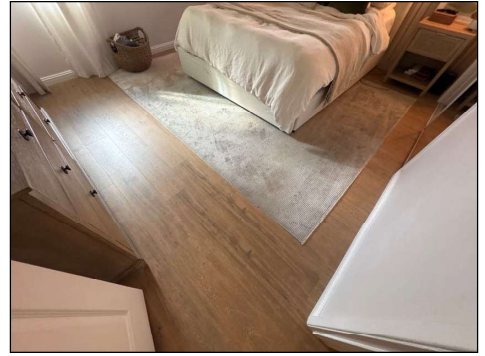
## 4. Floor Conditions

Scratched/worn areas – typical for age and use

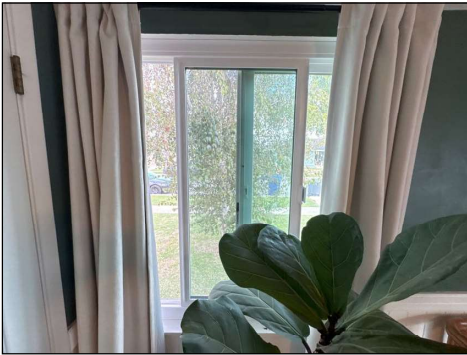
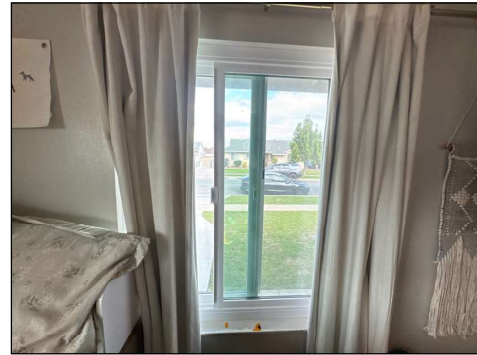
## 5. Window Conditions

Accessible windows were tested and operated at time of inspection • Recommend general window maintenance/lubrication and weather tight service

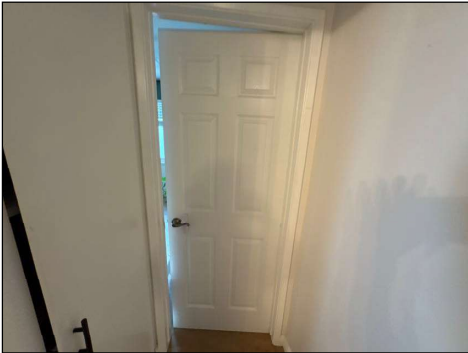
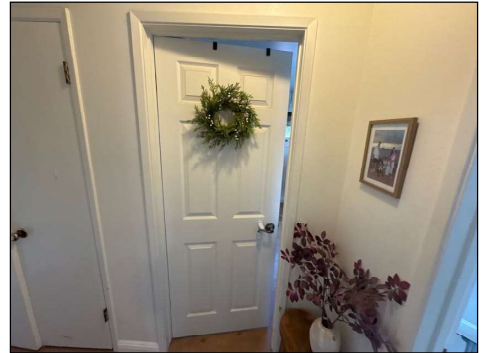
## 6. Doors

Operated at time of inspection

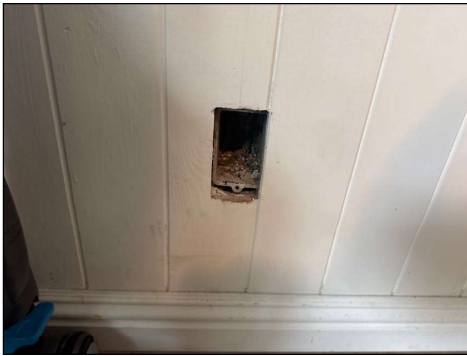
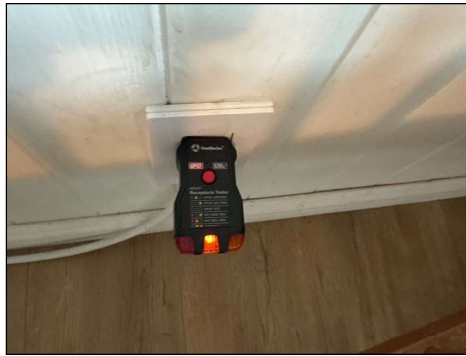
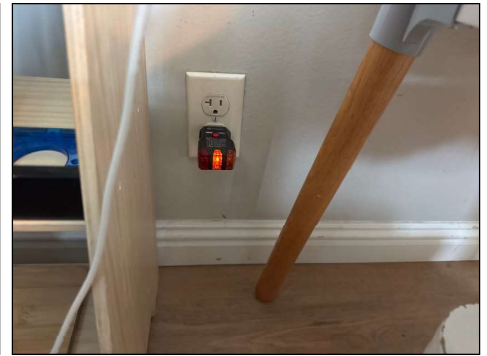
## 7. Electrical

A representative number of receptacles and switches were tested and found to be operational at time of inspection • Loose/worn outlets/switches – typical for age consider upgrading • Junction box missing cover – service recommended

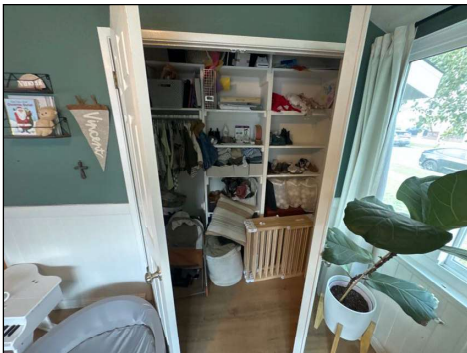
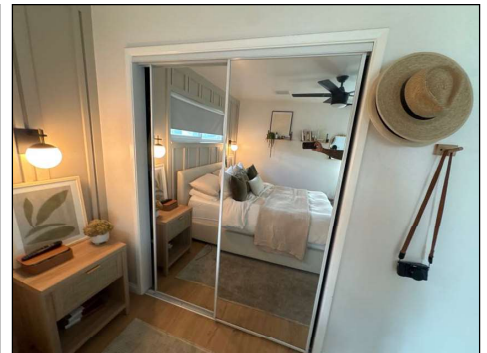
## 8. Closets

Worn closets with loose/worn hardware – typical for age • Some closet areas not visible for inspection due to personal storage

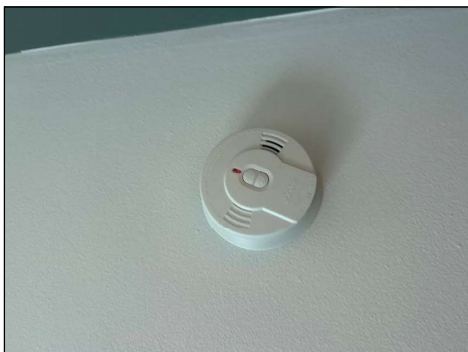
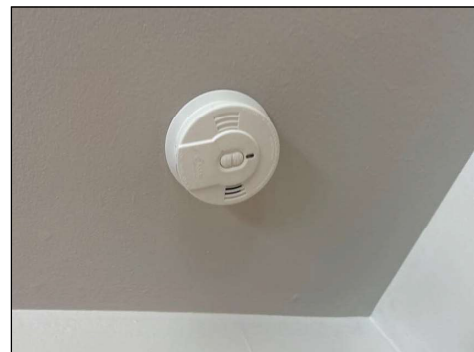
## 9. Smoke Detectors

For safety purposes we recommend that smoke detectors be placed in all sleeping areas (bedrooms) on all levels of multi-level dwellings. • Operational at time of inspection via factory installed test button

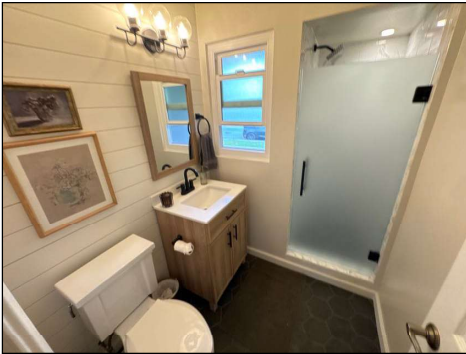
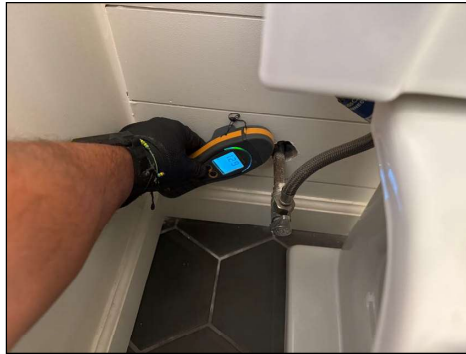
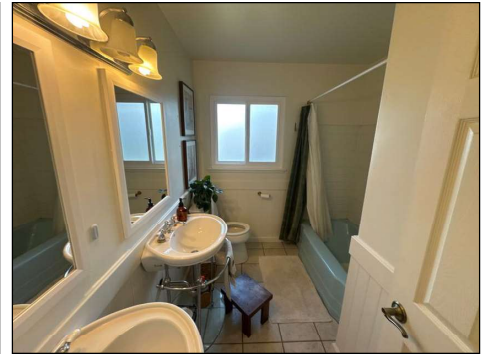
## 2. Wall Conditions

Cosmetic blemishes observed – typical for age of structure • No moisture present when tested with a moisture meter • No visible microbial growth/irregular staining found at the time of the inspection

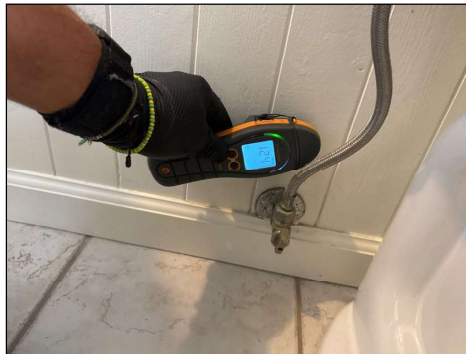
No moisture present when tested with a moisture meter

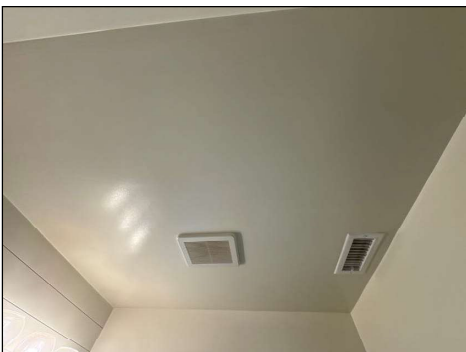
## 3. Ceiling Conditions

No major visible defects observed at the time of inspection

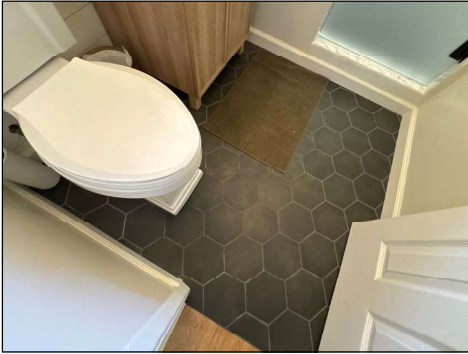
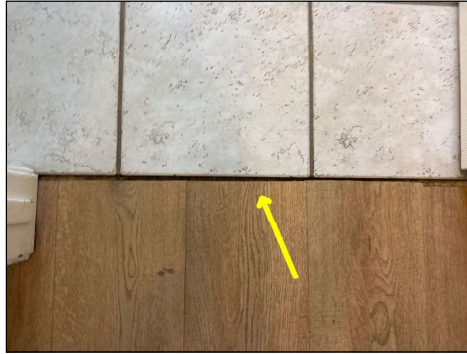
## 4. Floor Conditions

Worn areas – typical for age of the material • Recommend grout and sealer maintenance

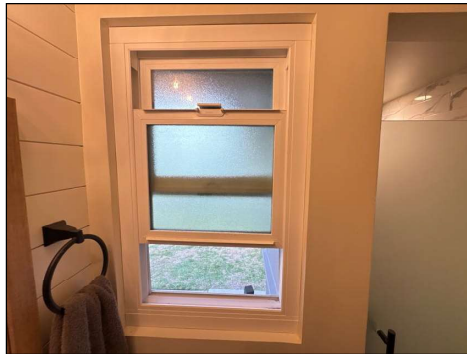
## 5. Window Conditions

Accessible windows were tested and operated at time of inspection • Recommend general window maintenance/lubrication and weather tight service

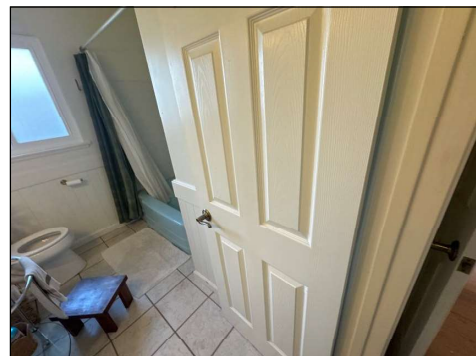
## 6. Doors

Operated at time of inspection

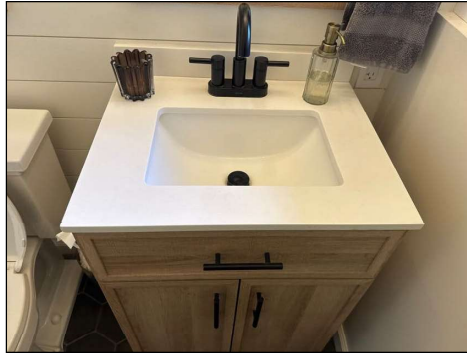
## 7. Counters

Counter is worn and has typical wear for age/small chips • Recommend grout/sealer/stone maintenance

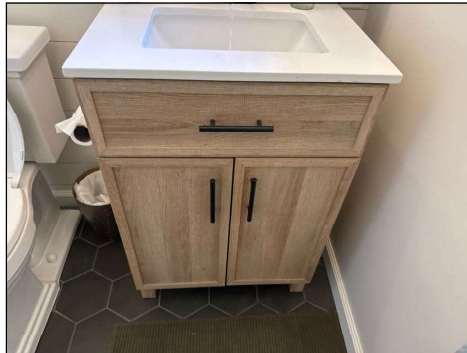
## 8. Cabinets

Worn cabinets – typical for age • No moisture present when tested with a moisture meter • No visible microbial growth/irregular staining found at the time of the inspection

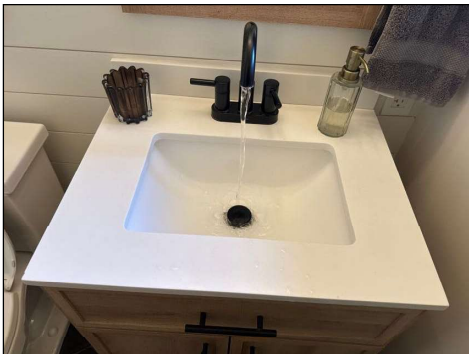
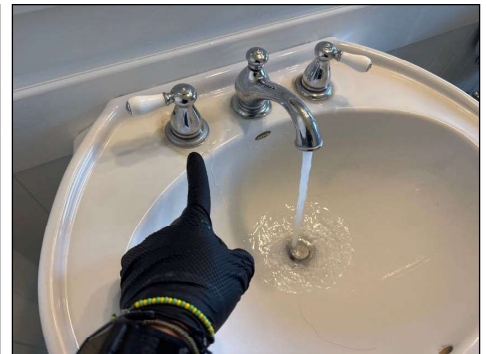
## 9. Sinks

Fixture operated at the time of the inspection • Worn fixture/sink – typical for the age • **Fixtures leak when operating – service recommended- hall**

**Fixtures leak when operating – service recommended- hall**

| Interior | | |
|---|---|---|
| Page 19 Item: 9 | Sinks | <ul style="list-style-type: none"> <li>• Fixtures leak when operating – service recommended- hall</li> </ul> |

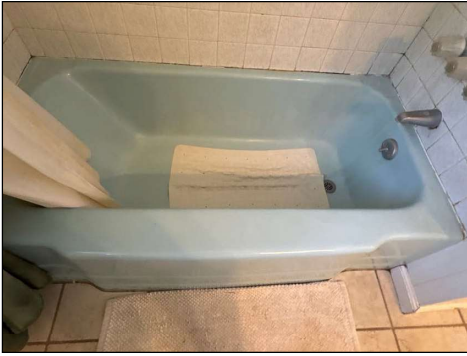
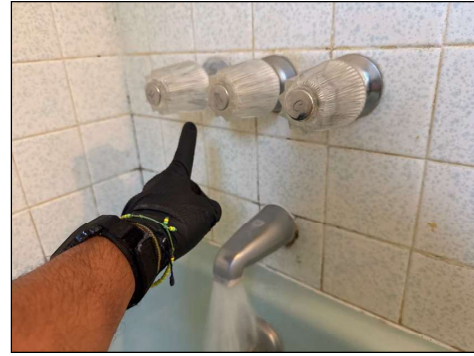
## 11. Bath Tubs

Fixture was tested and operating at the time of the inspection • Fixture was in a worn/older condition at the time of the inspection – typical for age • Recommend upgrading fixtures • Tub is worn/older/stained/scratched/chipped – typical for the age • **Tub fixture leaks when operated – service recommended**

| Interior | | |
|---|---|---|
| Page 19 Item: 11 | Bath Tubs | <ul style="list-style-type: none"> <li>• Tub fixture leaks when operated – service recommended</li> </ul> |

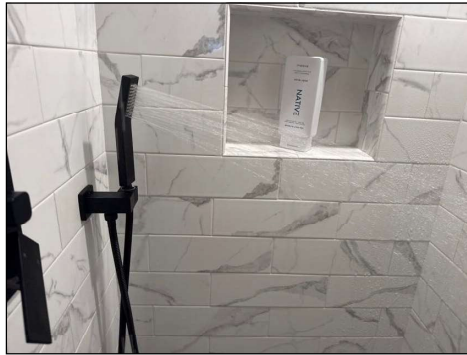
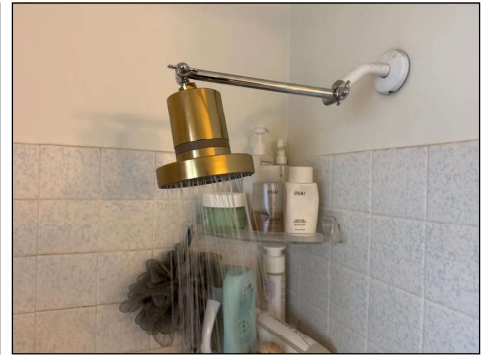
## 12. Showers

Fixture was tested and operating at time of inspection via normal fixture controls • Fixture was in a worn condition – typical for the age

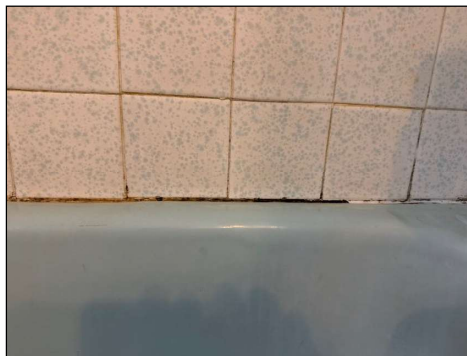
## 13. Shower Walls

Tile and grout present • Wall materials in a worn/stained-faded/old condition – typical for age – recommend routine grout and sealer maintenance • Shower pan is in a worn condition – typical for the age – recommend routine grout and sealer maintenance • Surface microbial growth/irregular staining is present in areas on nonporous surfaces – recommend cleaning and sealing materials regularly • Recommend maintenance and sealing holes & gaps at all wall/plumbing junctures to prevent water infiltration into walls

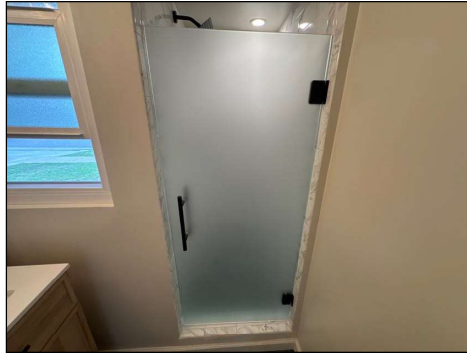
## 14. Enclosures / Shower doors

Operational at time of inspection – Tempered glass label observed • Normal wear for age at the time of the inspection – no major visible defects

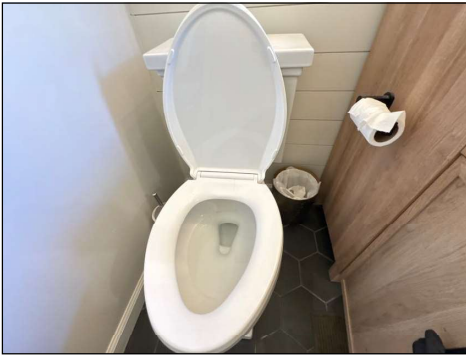
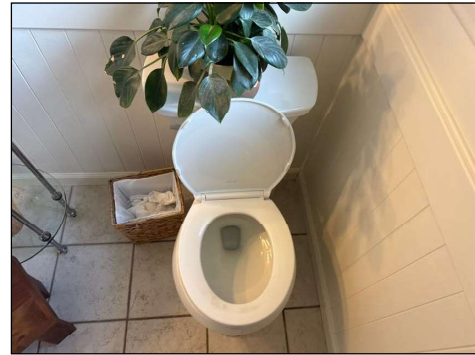
## 15. Toilets

Tested and operational at time of inspection via normal fixture controls, flush test performed • No visible leaking at the time of inspection and flush testing

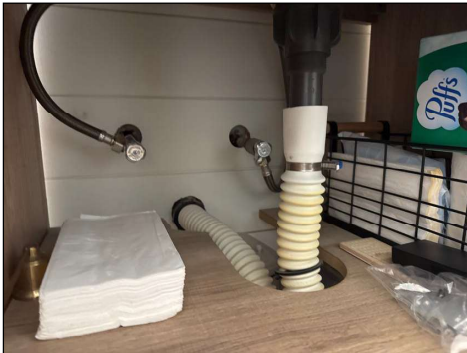
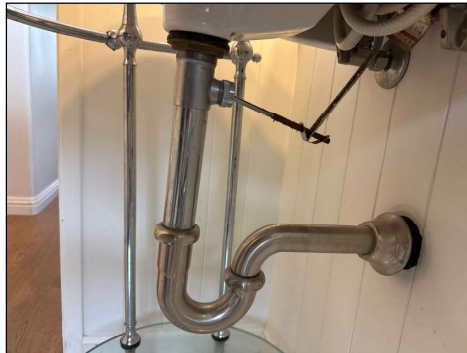
## 16. Plumbing

Operational at time of inspection via normal fixture controls with no major visible defects • No visible leaks found at the time of the inspection after running water at fixtures • Irregular drain present – recommend further evaluation by a plumber

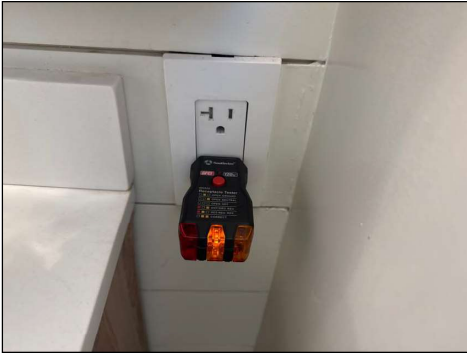
## 17. Electrical

A representative number of receptacles and switches were tested and found to be operational at time of inspection • Outlets/switches had normal wear for age – no major visible defects • Three prong outlet(s) not grounded – service recommended

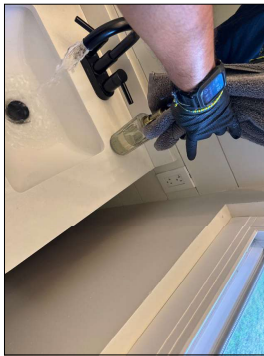
## 18. GFCIs

None installed -Recommend upgrading all receptacle to GFCI protection within 6 feet of all potential wet locations

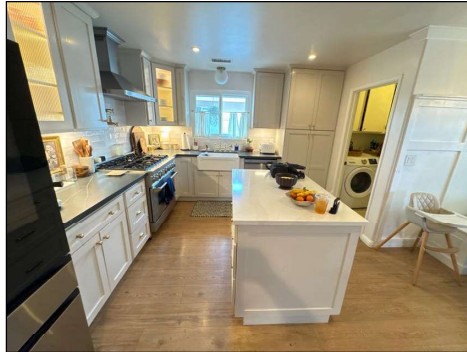
## 1. Wall Conditions

Appliances present and are not moved for inspection – limited inspection of walls, floors, cabinet areas covered by appliances • Cosmetic blemishes observed – typical for age of structure • No moisture present when tested with a moisture meter • No visible microbial growth/irregular staining found at the time of the inspection

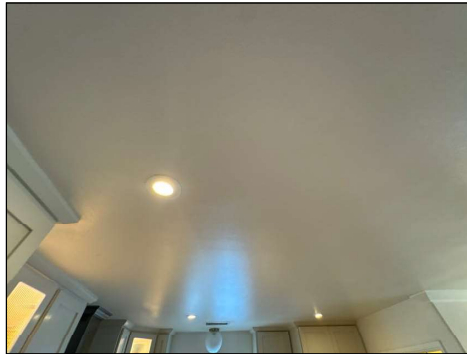
## 2. Ceiling Conditions

Cosmetic blemishes observed – typical for age of structure

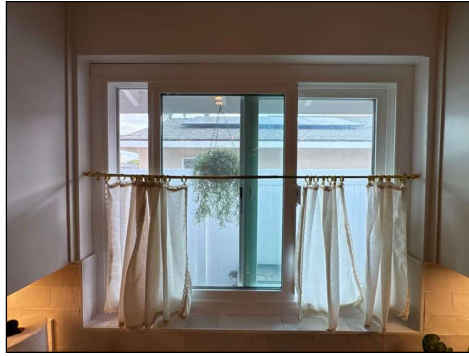
## 4. Window Conditions

Accessible windows were tested and operated at time of inspection • Recommend general window maintenance/lubrication and weather tight service

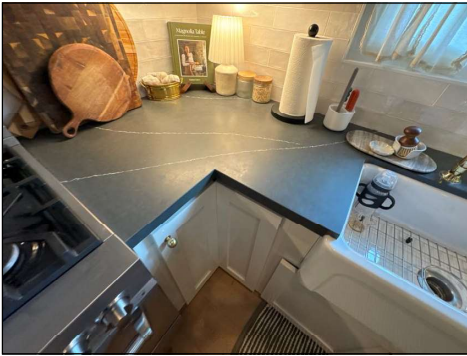
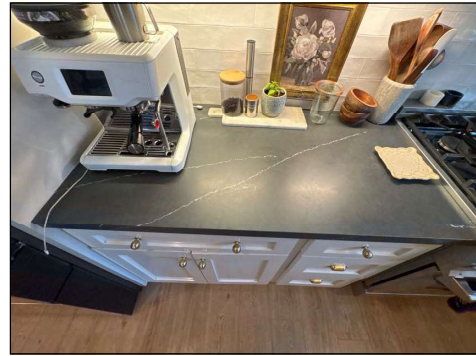
## 5. Counters

Counter is worn and has typical wear for age • Recommend grout/sealer/stone maintenance

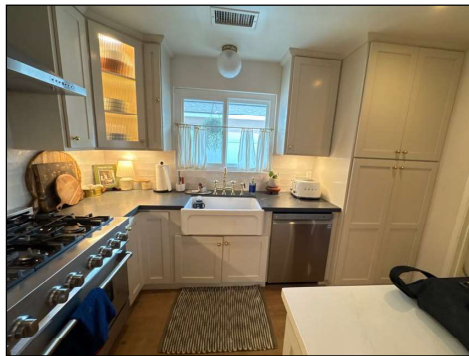
## 6. Cabinets

Worn cabinets – typical for age • No moisture present when tested with a moisture meter • No visible microbial growth/irregular staining found at the time of the inspection • Interior cabinet areas have been painted – paint or patching may cover known past defects – consult the seller/disclosures for all past repairs

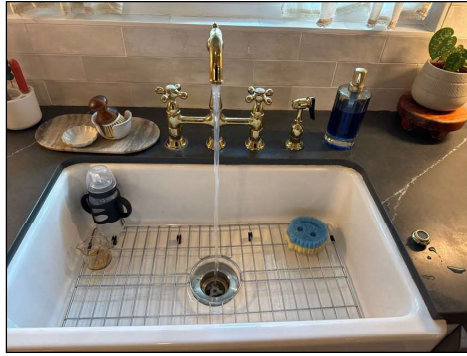
## 7. Sinks

Fixture operated at the time of the inspection • Worn fixture/sink – typical for the age

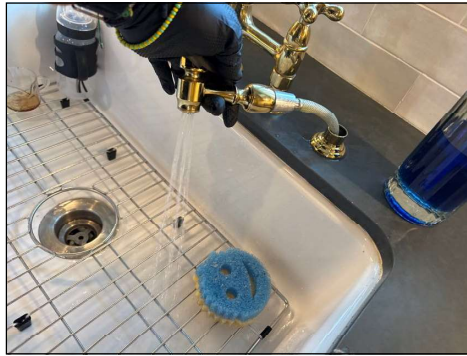
## 8. Spray Wands

Operational at time of inspection • Sprayer leaks – service recommended

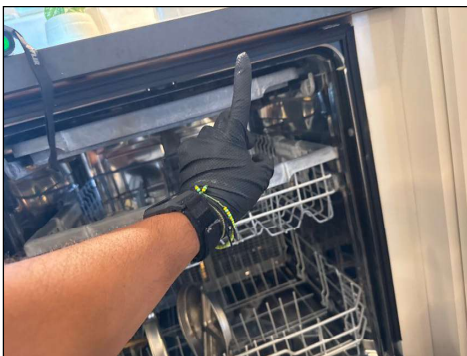
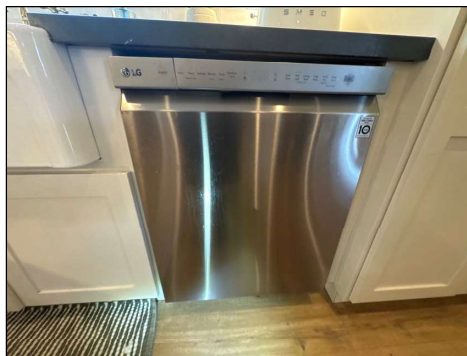
## 9. Dishwashers

The dishwasher inspection is limited and does not include an inspection of the water pump or any hoses inside or beneath the unit. The home inspector cannot predict the remaining life of the dishwasher or any parts within the dishwasher; nor can the home inspector tell you if or how well the dishwasher actually cleans or dries dishes. This inspection allows for one fill and one drain cycle only, the Inspector does not run the dishwasher for any full cycles. • Tested and operational (one fill and drain cycle only, not full cycle) at time of inspection via normal controls • Worn/older unit – typical wear for age and use • Drained properly during inspection • No visible leaks found at the time of the inspection • Lack of a proper air gap noted at dishwasher drain line. In the event of a sewer backup this device prevents sewer matter from entering into dishwasher. Recommend having a qualified plumber install a air gap to prevent possible contamination. • **Drains directly to the disposal without an air gap – improper installation – service recommended** • **Unit not fastened to underside of countertop – tip hazard – service recommended** • **Cracked door – service recommended**

**Cracked door – service recommended**

| Interior | | |
|---|---|---|
| Page 25 Item: 9 | Dishwashers | <ul style="list-style-type: none"> <li>• Drains directly to the disposal without an <u>air gap</u> – improper installation – service recommended • Unit not fastened to underside of countertop – tip hazard – service recommended • Cracked door – service recommended</li> </ul> |

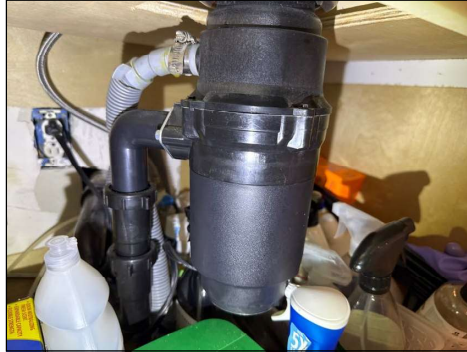
## 10. Garbage Disposals

The garbage disposal has a limited inspection, the Inspector cannot predict the remaining life of the garbage disposal nor determine how well the garbage disposal disposes of food or other items. The sharpness or adequacies of the internal blades is not determined during the home inspection. • Tested and operational at time of inspection via normal controls • Normal wear for age – no major visible defects • No visible leaks at the time of the inspection

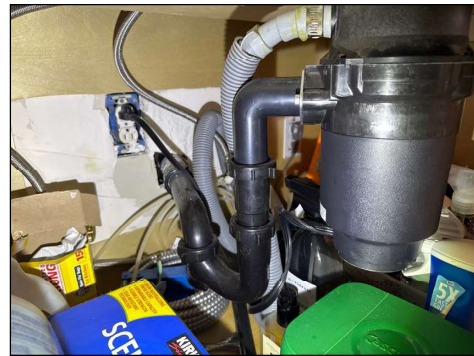
## 11. Plumbing

Operational at time of inspection via normal fixture controls with no major visible defects • Angle stops/hoses/drain pipes are in a normal condition for their age – no major visible defects • No visible leaks found at the time of the inspection after running water at fixtures

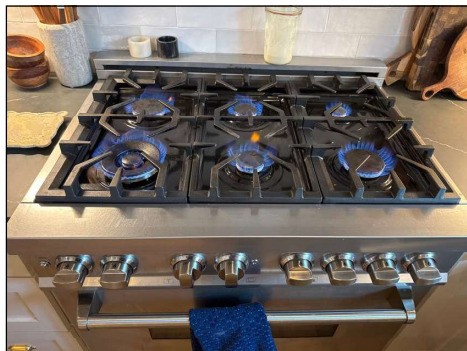
## 12. Ranges

The range or cooktop has a limited inspection, the Inspector cannot predict the remaining life of the unit nor determine the BTUs output by each burner or if/how well the burners will cook food. For gas units – gas leaks cannot be detected with this inspection – a full evaluation by the Gas Company of all gas supplied appliances is recommended beyond this inspection. • Gas supplied unit • Tested and operational at time of inspection via normal controls • Worn unit – typical wear for age and use

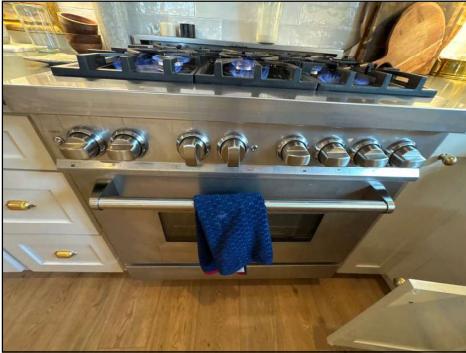
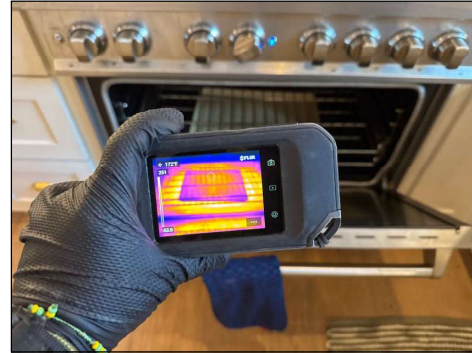
## 13. Ovens

The "Bake" feature is the only feature operated during a home inspection; convection, browning, rotisserie, warming drawers and other features are not tested during the oven inspection. Ovens are tested for basic heating element functionality. The oven cannot be tested to each incremental temperature setting or determine if adequate cooking temperatures can be achieved, nor if temperatures are calibrated with oven settings. We cannot determine if or how well the oven cooks food nor can we predict the remaining life left for the unit. For gas units – gas leaks cannot be detected with this inspection – a full evaluation by the Gas Company of all gas supplied appliances is recommended beyond this inspection. • Gas supplied unit • Tested and operational at time of inspection via normal controls • Worn unit – typical wear for age and use

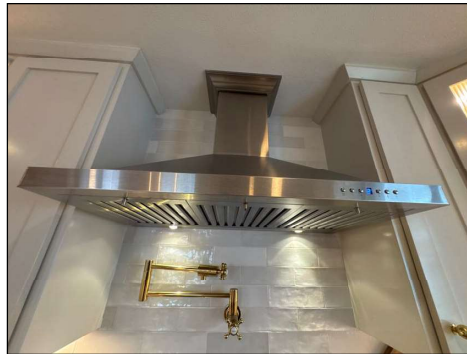
## 14. Exhaust Vents

Hood with fan

The exhaust fan/vent is tested using the normal controls only. No smoke testing or other testing is done to determine the CFMs or how well the unit evacuates air. The home inspector cannot predict the remaining life left in the unit.

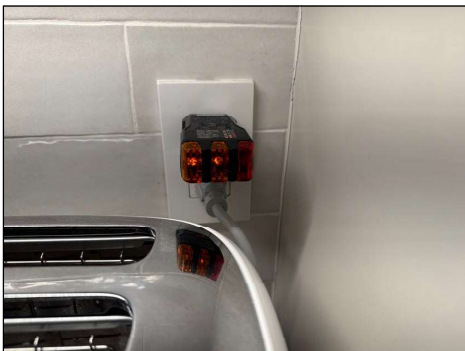
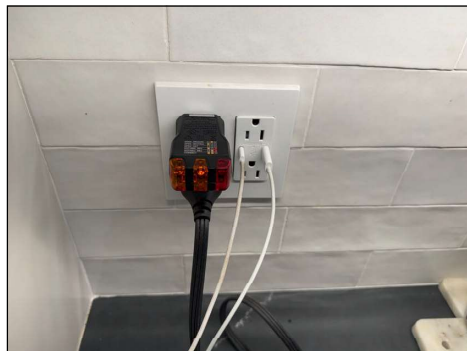
## 15. Electrical

A representative number of receptacles and switches were tested and found to be operational at time of inspection • Outlets/switches had normal wear for age – no major visible defects • Three prong outlet(s) not grounded – service recommended • Outlet cover missing – service recommended

Outlet cover missing – service recommended

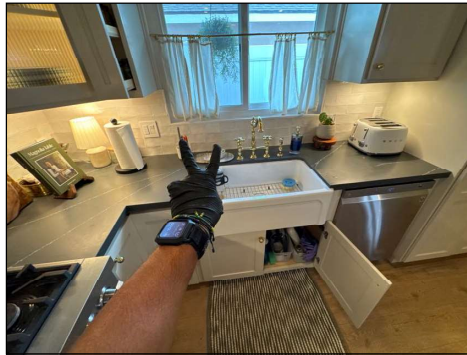
## 16. GFCIs

None installed- Recommend upgrading all receptacle to GFCI protection within 6 feet of all potential wet locations, unless the receptacle is on a circuit dedicated for a specific appliance.

| Interior | | |
|---|---|---|
| Page 28 Item: 16 | GFCIs | <ul style="list-style-type: none"> <li>• None installed- Recommend upgrading all receptacle to GFCI protection within 6 feet of all potential wet locations, unless the receptacle is on a circuit dedicated for a specific appliance.</li> </ul> |

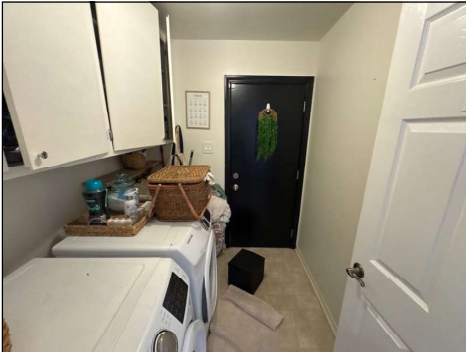
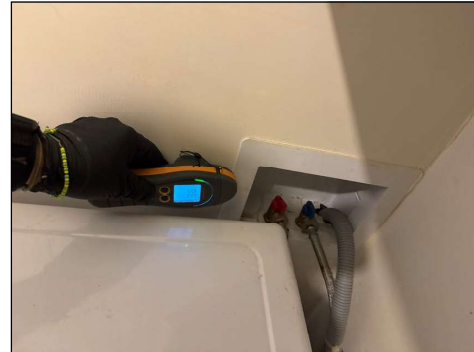
## 2. Wall Conditions

Cosmetic blemishes observed – typical for age of structure • No moisture present when tested with a moisture meter • No visible microbial growth/irregular staining found at the time of the inspection • Some areas not accessible or visible due to access limitations or personal items/furnishings

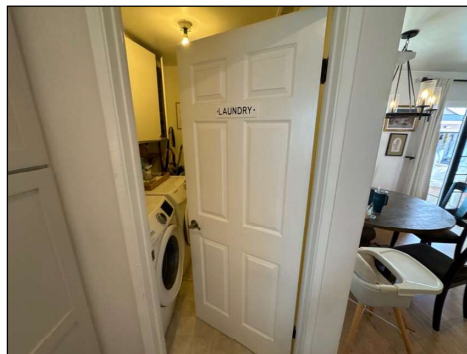
## 6. Doors

Operated at time of inspection • Weathered/worn door(s) – typical for age • Recommend routine maintenance on hardware and weather seals on all exterior doors
