CLARITY PROPERTY INSPECTIONS

REPORT BY CLARITY PROPERTY INSPECTIONS

3628 Los Altos Ct
Merced, CA 95348

JULY 29, 2022

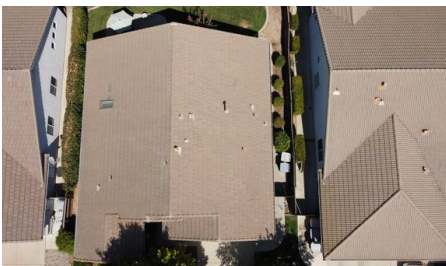
Roof Covering: Roof Covering Tile

The roof covering is in good condition with a few items being noted in my report. The roofing system is comprised of the following:

1. OSB Roof Decking
2. Asphalt Roofing Felt Underlayment
3. Roofing Tiles

The age of the roof covering is approximately 11 years old being installed in 2001. I recommend regular roof inspections to prolong the life of the system.

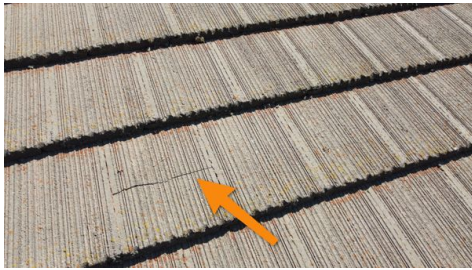
2.1.1 Roof Covering
DEFECT/DAMAGED

I observed areas of cracked/splitting or damaged roof-covering materials. This potentially exposes the waterproof underlayment, causing an entry point of water to the roof decking. I recommend that a qualified roofing contractor make necessary repairs to the roofing system.

Contact a qualified roofing professional.

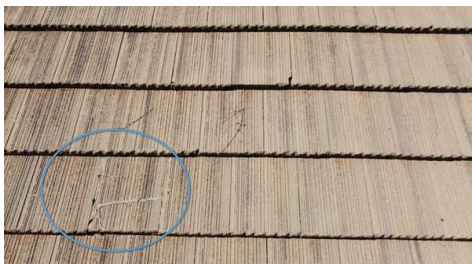
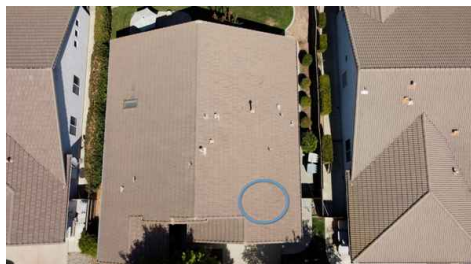
2.1.2 Roof Covering

Prior repair made. Seems to be a quality repair. Monitor performance over rainy season.

Recommend monitoring.

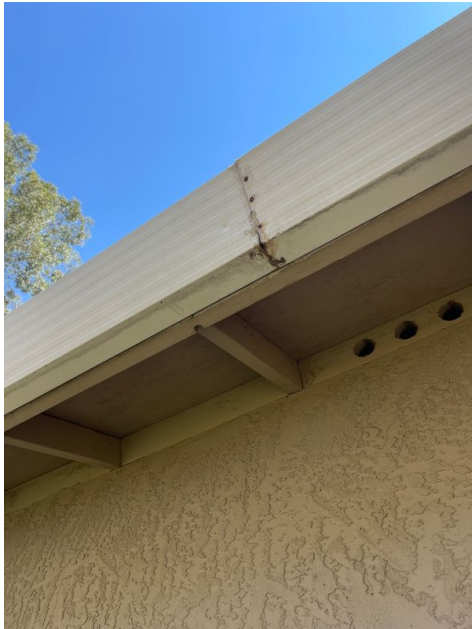
I observed indications of rain water leaking from a gutters, which could result in water not being properly collected and drained away. The gutters are most likely in need of sealant at the joints. The sealant breaks down over time. This is part of a regular maintenance schedule. Every 10 years is a good starting point. Sealing the joints will also help preserve the fascia boards and rafter tails.

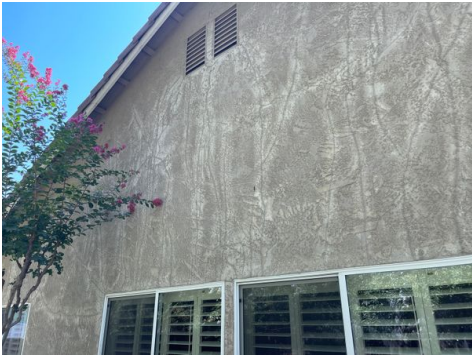
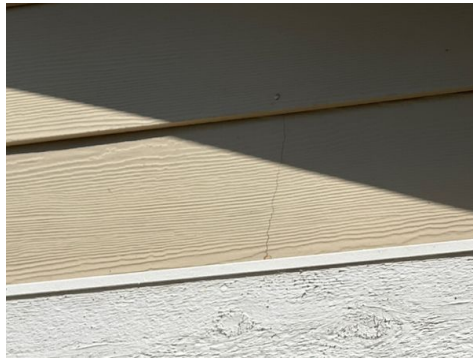
SIDING CRACK: SEALANT AND PAINT

I observed cracks in the siding material. I recommend repair.

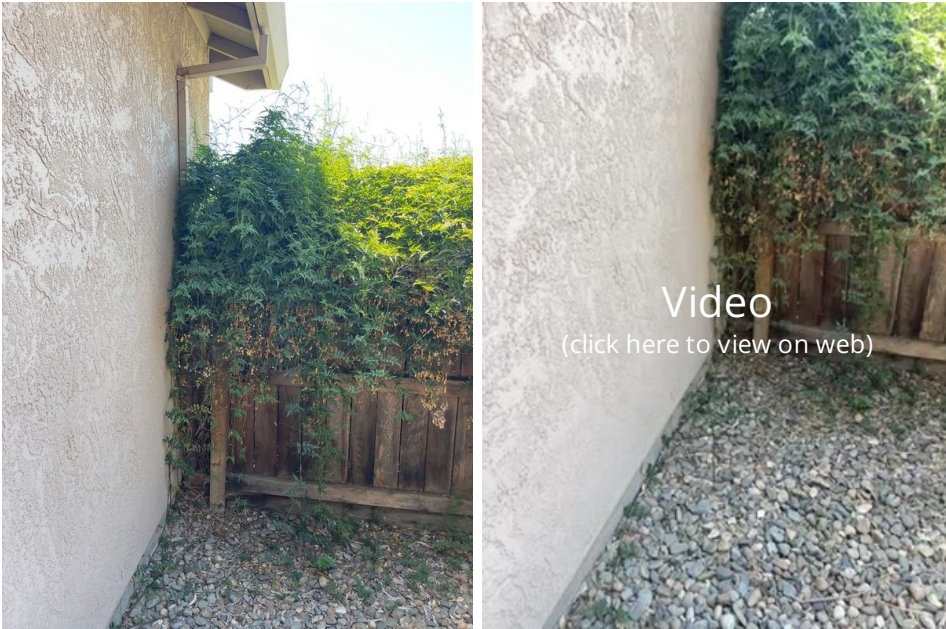
3.3.1 Vegetation, Surface Drainage, Retaining Walls & Grading

DENSE VEGETATION

I observed vegetation around the house in areas. Dense vegetation and landscaping up against or near the house foundation and exterior walls may be prone to water penetration and insect infestation.

Trimming, pruning and some landscaping is recommended.

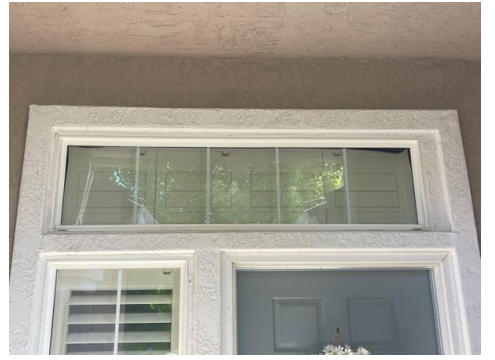
I observed a fogged windowpane (a lost seal) at a window.

If multiple-pane windows appear misty or foggy, it means that the seal protecting the window assembly has failed, and condensation has formed in between the two panes of glass. Condensation in double-paned windows indicates that the glazing assembly has failed and needs repair or replacement. Visible condensation can damage glazing and is the main indication of sealant failure. Condensation is not always visible. If the failure is recent, a failed window may not be obvious, since condensation doesn't usually form until the window is heated by direct sunlight. Windows in the shade may show no evidence of failure, so it is nearly impossible to observe and report all failed double-paned windows.

Contact a qualified window repair/installation contractor.

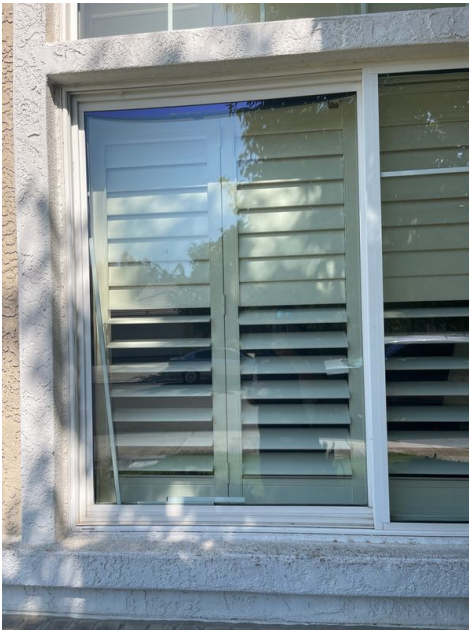
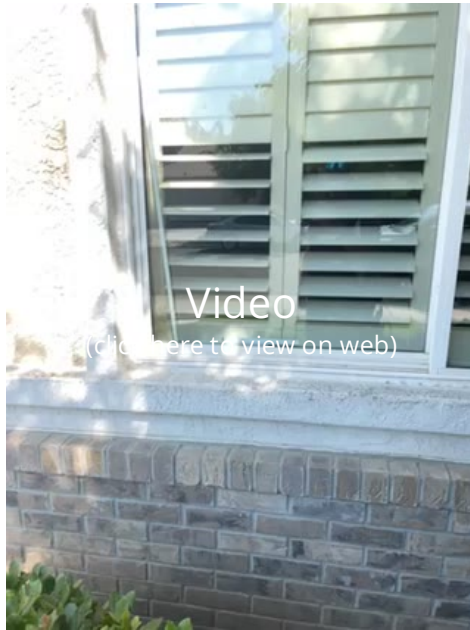
3.6.2 Windows

I observed missing window screen(s). Correction is recommended.

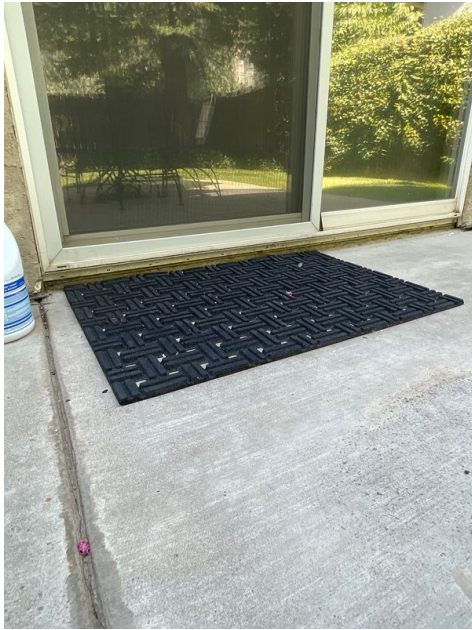
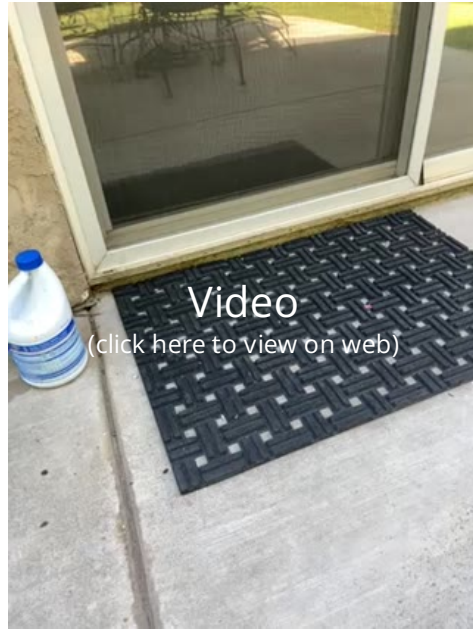
DOOR: SILL DEFECT/DAMAGE

I observed a sill defect/damage at the door. The sill support is missing on the front of the door.

Contact a qualified handyman.

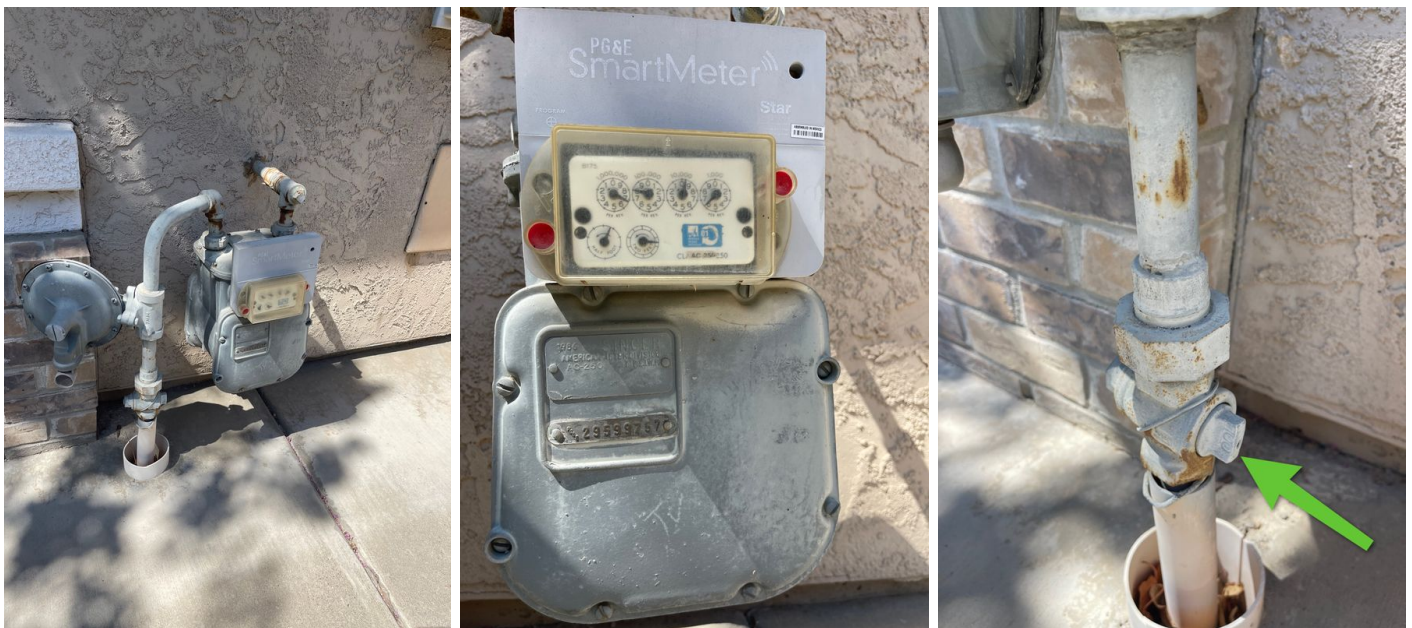
Gas meter is located on the right wall of the exterior of the home. I visually inspected it and have provided images of its condition. The gas shut-off is noted with the green arrow. It is always recommended to have a gas shut-off wrench located at the meter for easy disconnect of gas service to the home.

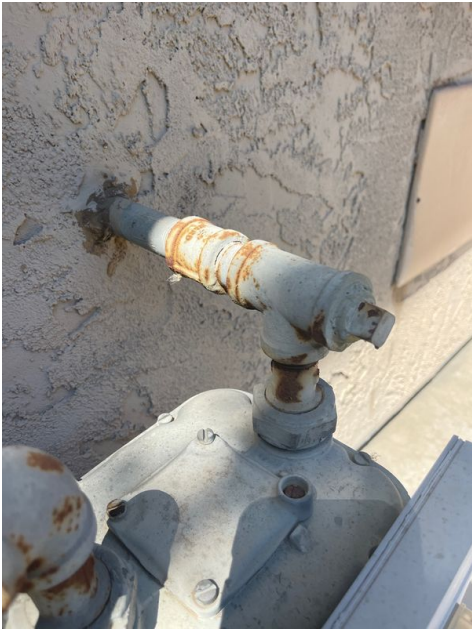
CORROSION: EARLY STAGES

I observe corrosion on the gas pipes. This can lead to corroded threads if left un-attended over a long period of time. This can lead to a gas leak. Paint will reduce corrosion effects.

5 year recommended maintenance schedule.

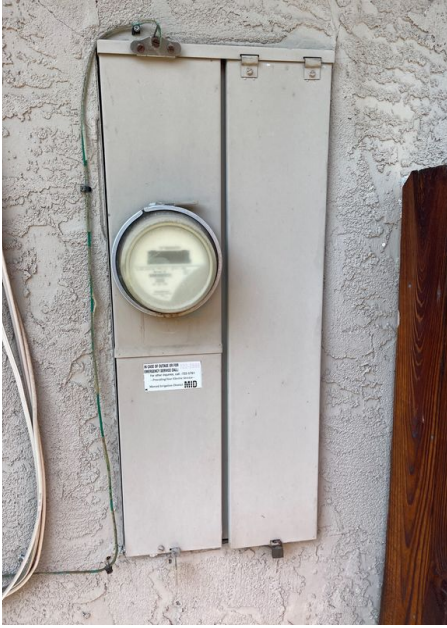
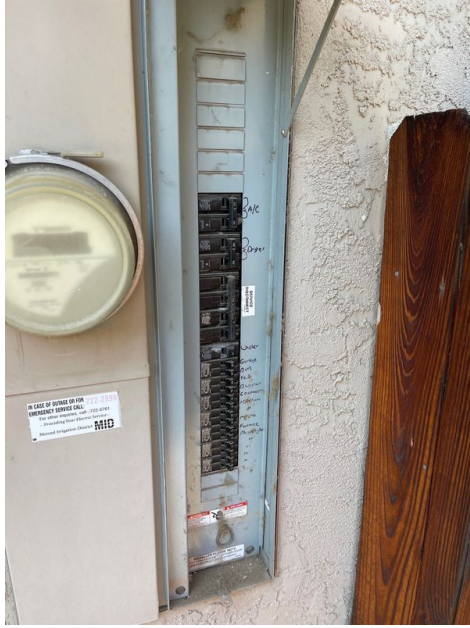
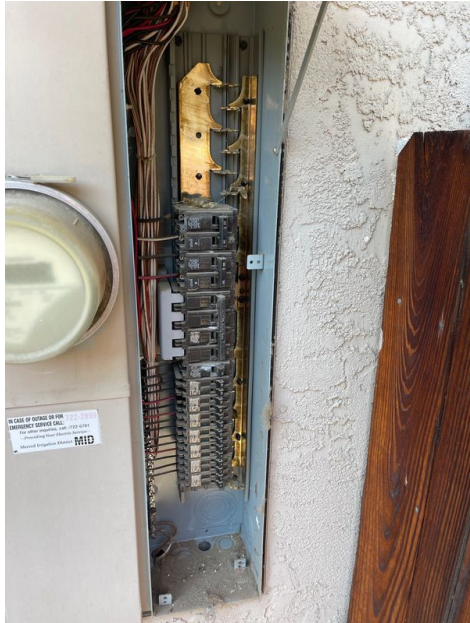
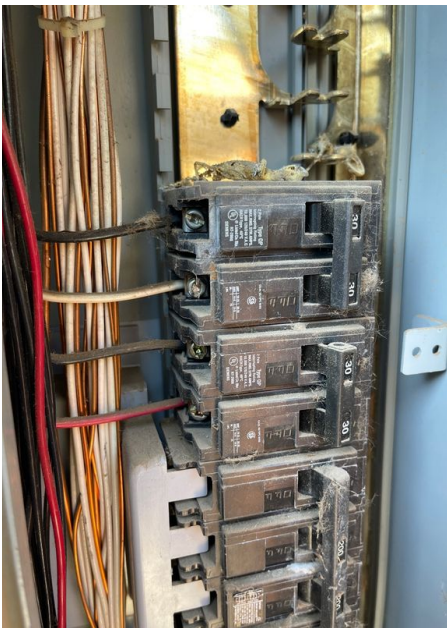
Panelboards & Breakers: Inspected Main Panelboard and Breakers

I inspected the electrical panelboards and over-current protection devices (circuit breakers and fuses).

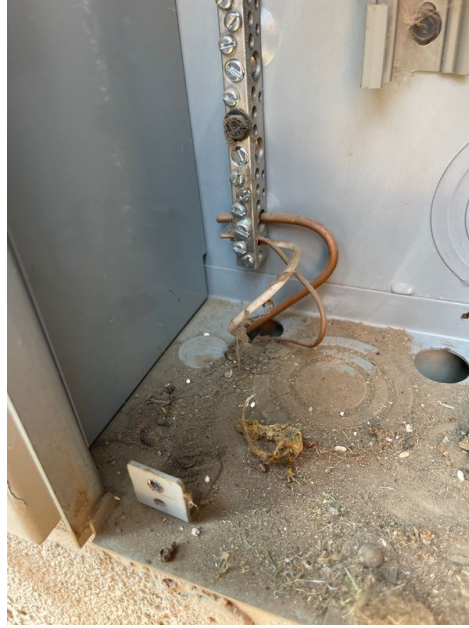
Service Grounding & Bonding: Inspected the Service Grounding and Bonding

I inspected the electrical service grounding and bonding.

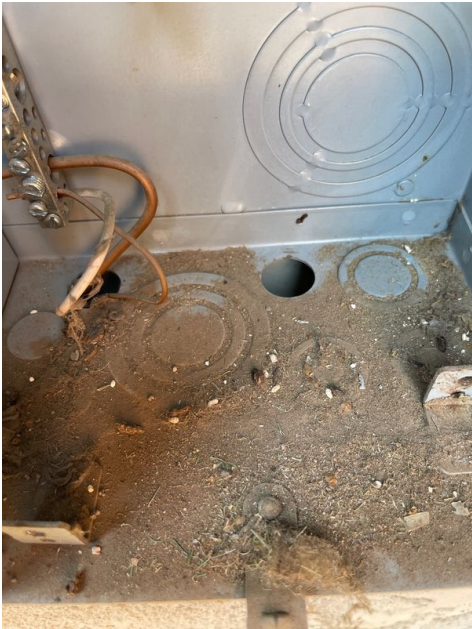
OPEN KNOCKOUT (FILLER PLATE MISSING)

I observed open knockout opening that was not filled. Missing filler plate at the electrical panel box. There were noted debris and lizards in the panels.

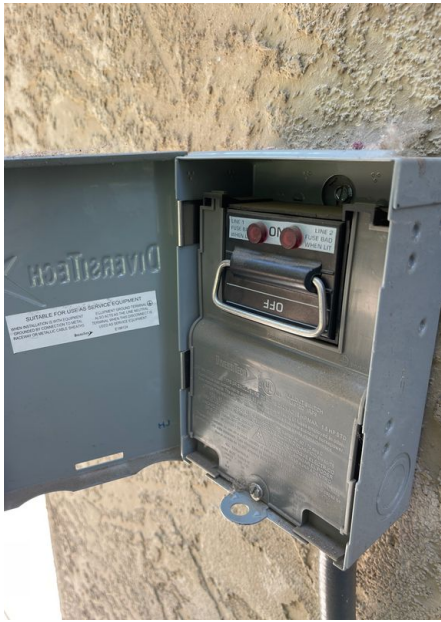
Cooling System Information: Service Disconnect Inspected

I observed a service disconnect within sight of the cooling system.

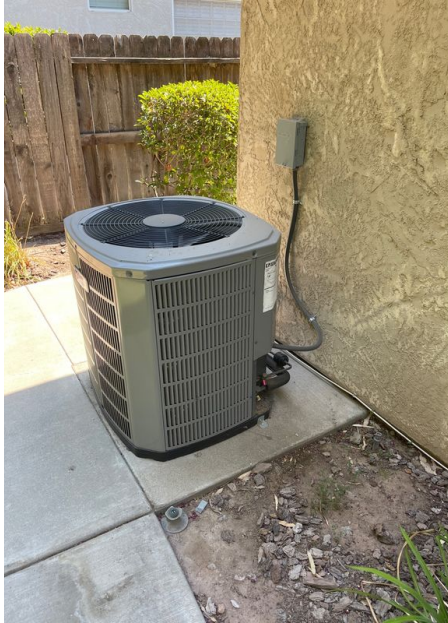
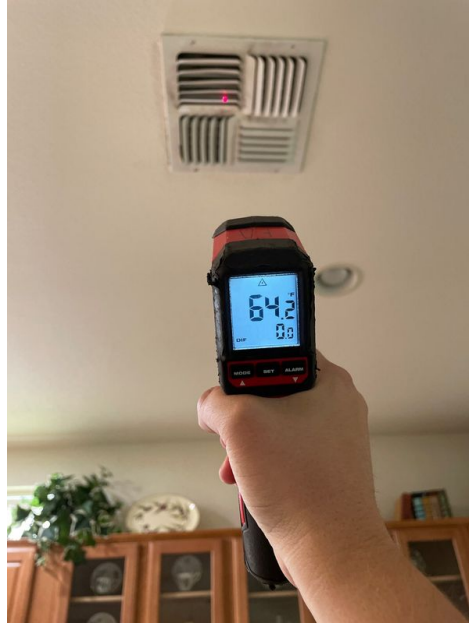
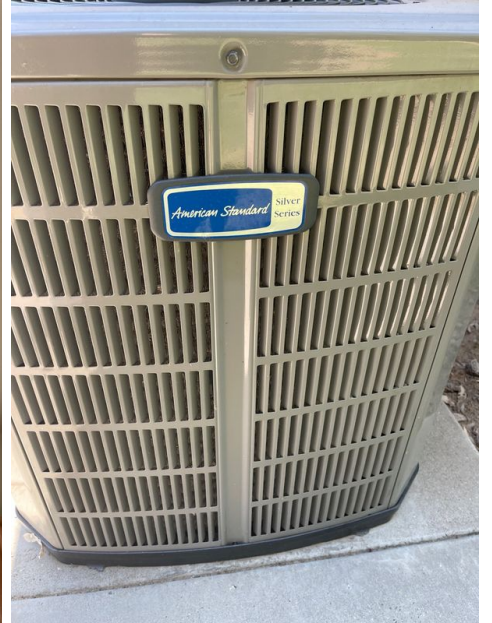
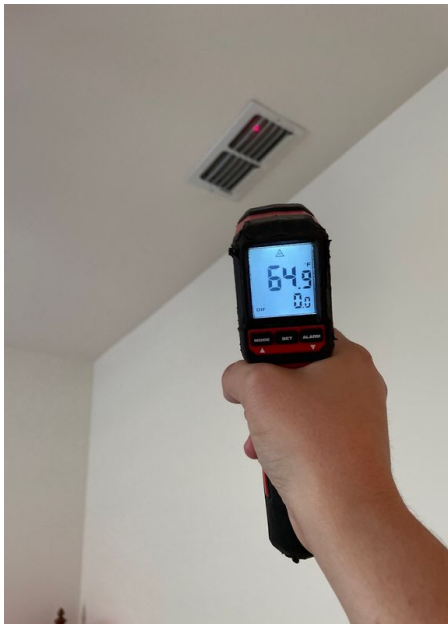
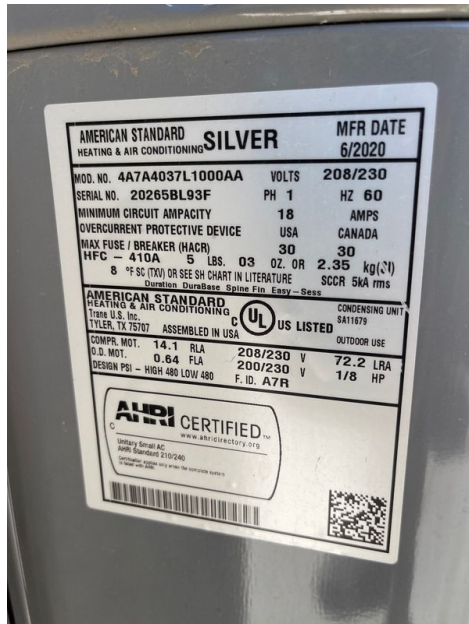
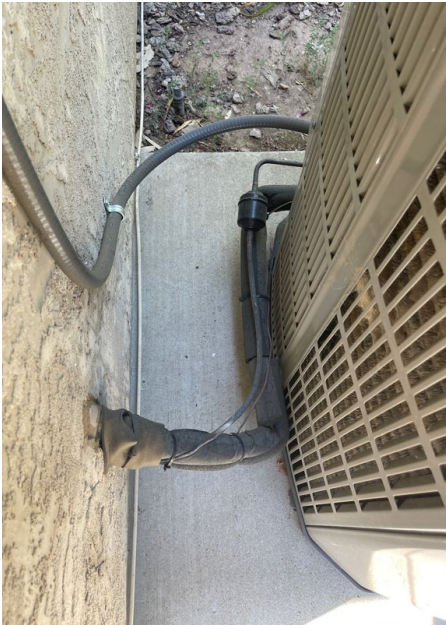
Cooling System Information: Cooling System Information

The air conditioning system was functioning at the time of my inspection. It was producing cool conditioned air that was distributed through the insulated ducting system.

Manufacturer Date and Current Age: 2020 - 2 years old

Location: Backyard and Attic

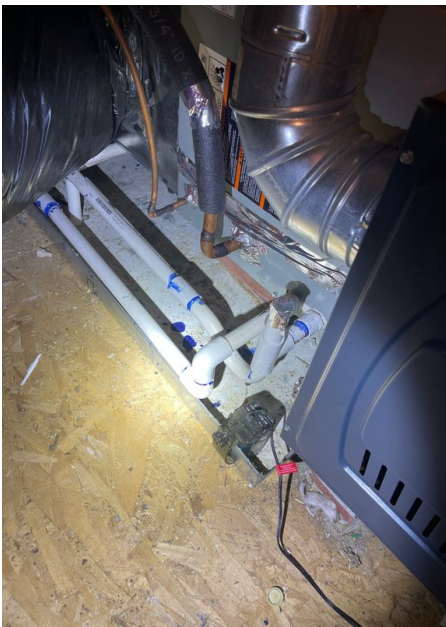
Condensate: Condensate Discharge Confirmed

I observed a discharge pipe apparently connected to the condensate pump installed at the cooling system.

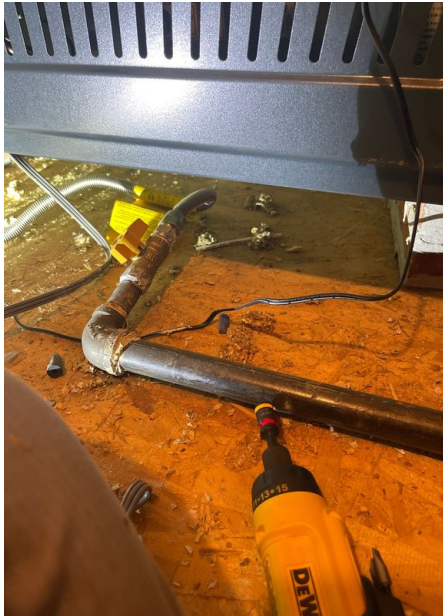
**Heating System Information:
Heating Method**

Forced Air Heating System

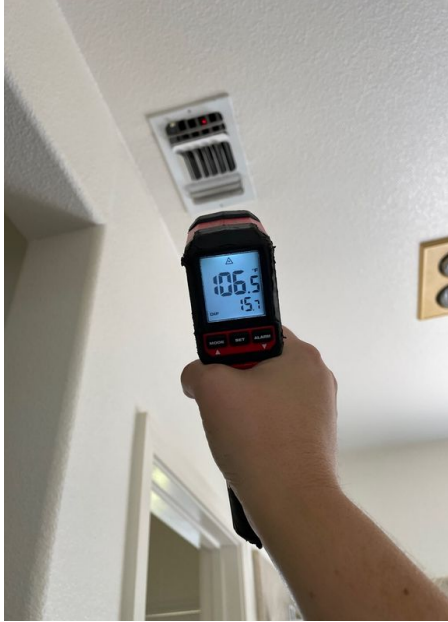
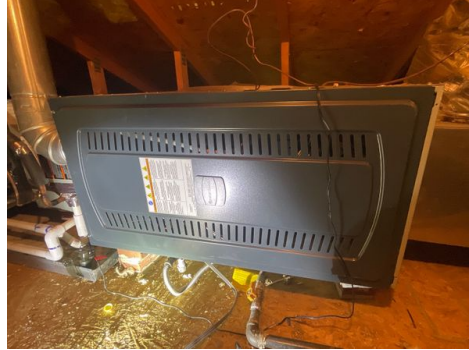
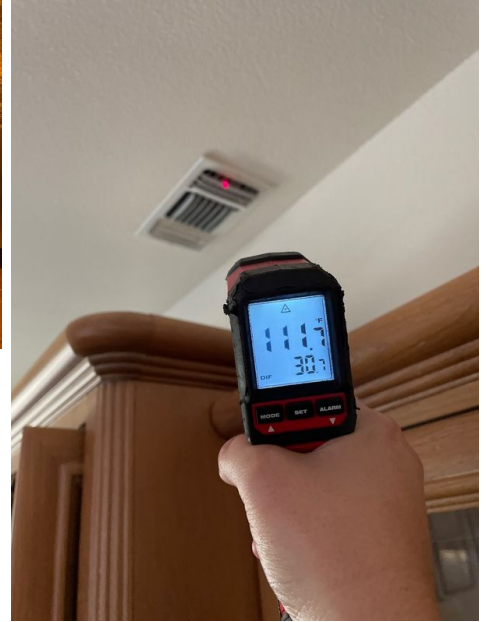
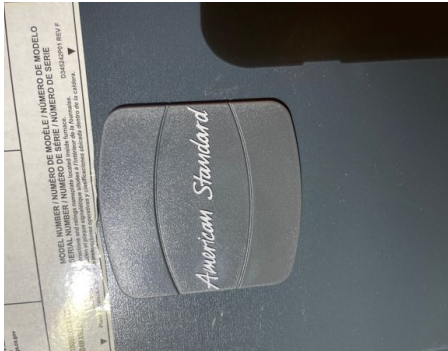
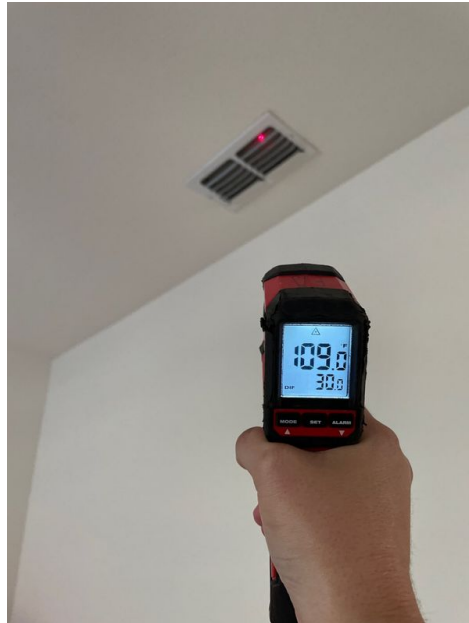
Heating System Information: Heating Unit

The gas fired furnace was functioning at the time of my inspection. The unit was blowing warm conditioned air from the insulated duct system.

Manufacturing Date and Age: 2020 - 2 Years Old

Location: Attic

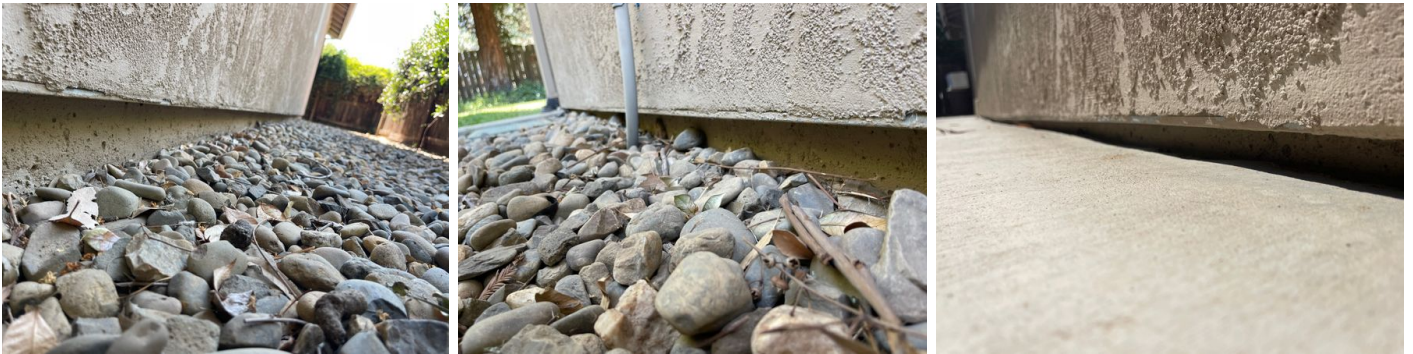
Foundation: Visually Inspected Foundation Condition

Slab on grade foundation was observed. A general walk around inspection was completed. The scope of our inspection is limited. I looked for signs of unusual settling and abnormal cracking.

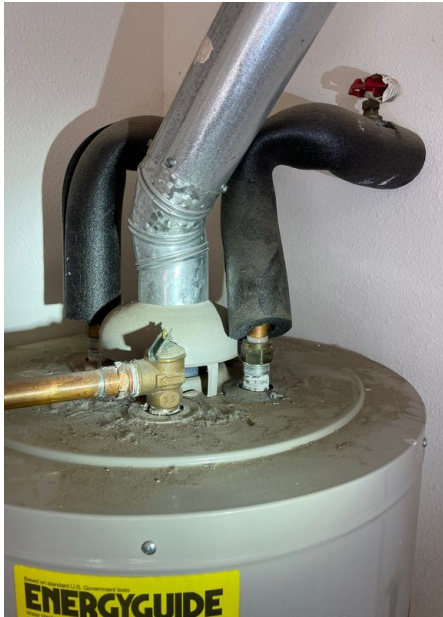
Hot Water Source: Inspected Hot Water Source

I inspected the hot water source and equipment.

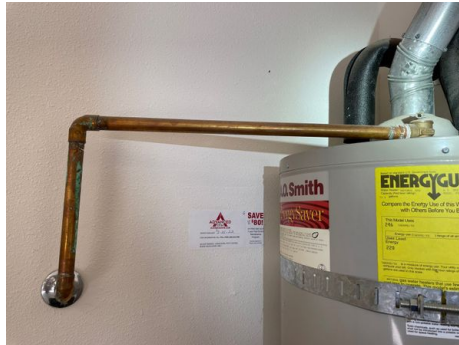
Hot Water Source: Inspected TPR Valve

I inspected the temperature and pressure relief valve.

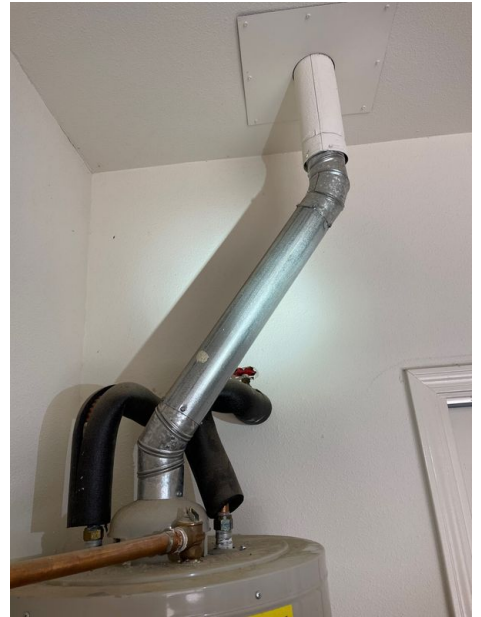
Hot Water Source: Inspected Venting Connections

I inspected the venting connections.

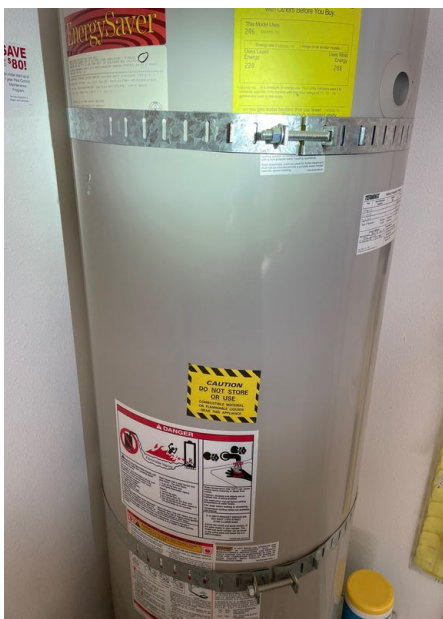
Hot Water Source: Inspected Seismic Bracing

I inspected the seismic bracing for the hot water tank.

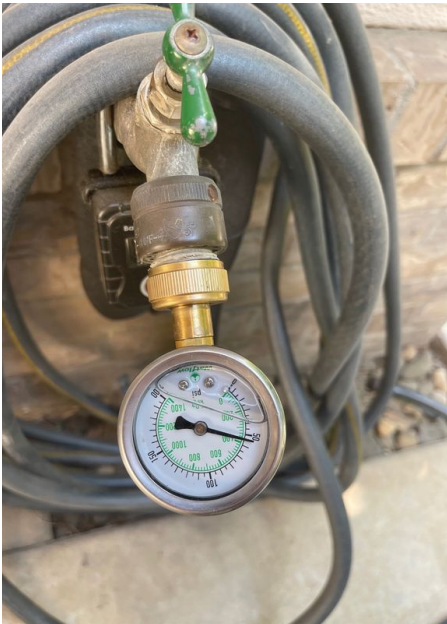
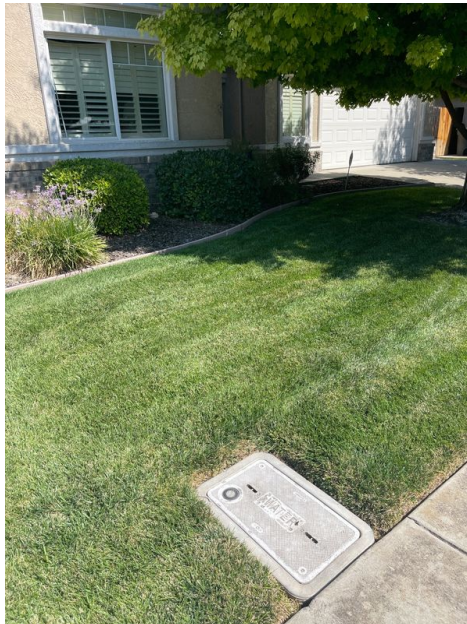
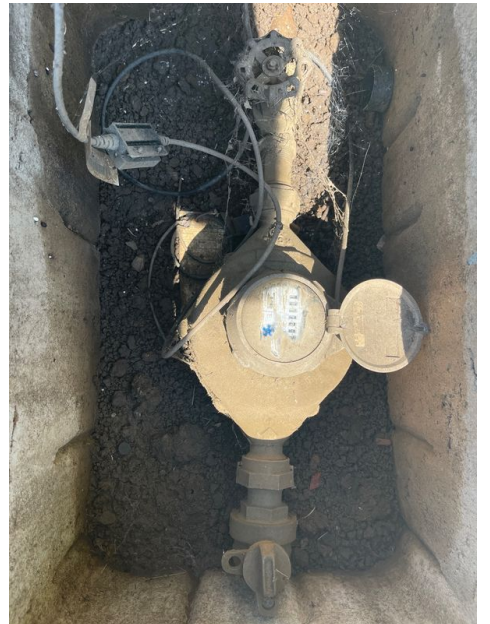
Water Supply : Water Supply Is Public

The water supply to the house appeared to be from the public water supply source.
60 PSI

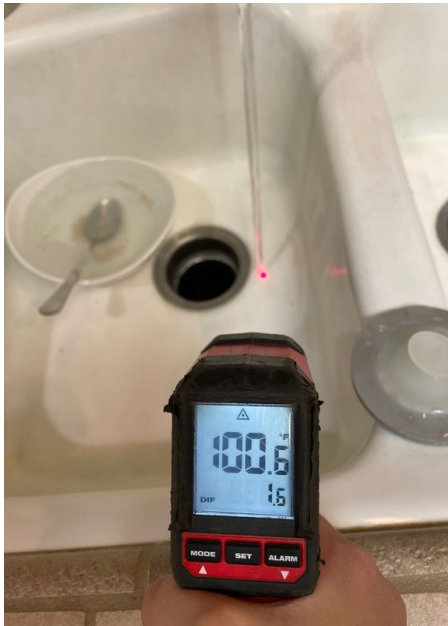
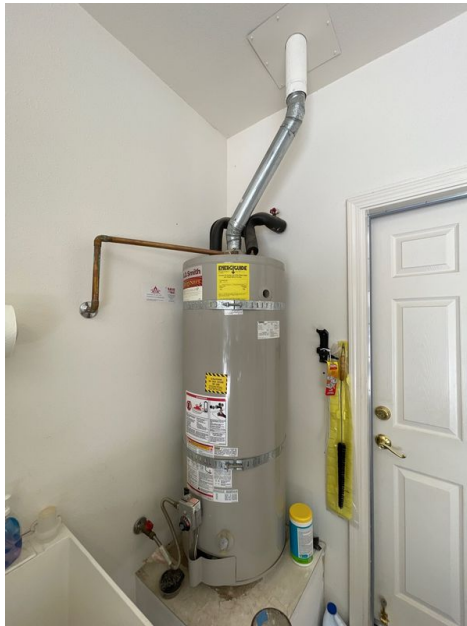
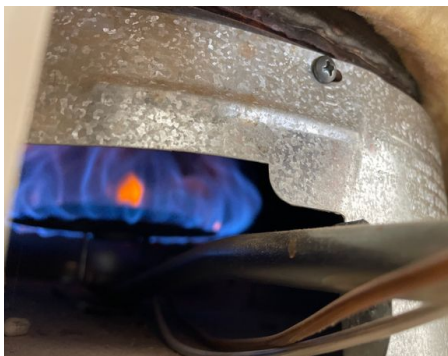
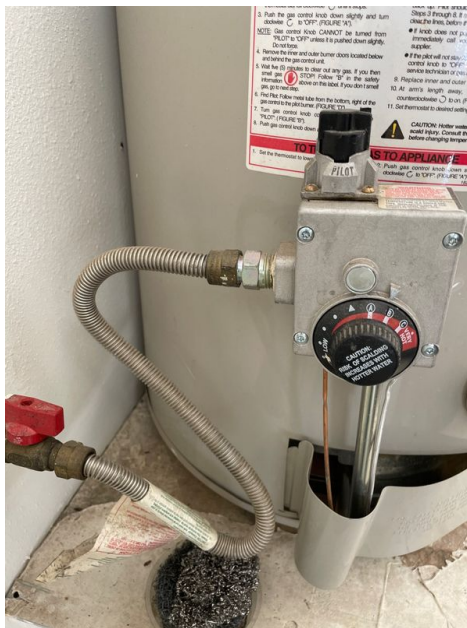
Hot Water Source: Type of Hot Water Source

Gas-Fired Hot Water Tank

I inspected the main source of hot water distribution throughout the home. The unit was functioning at the time of my inspection. The water heater was manufactured in 2001. The unit is 11 years old.

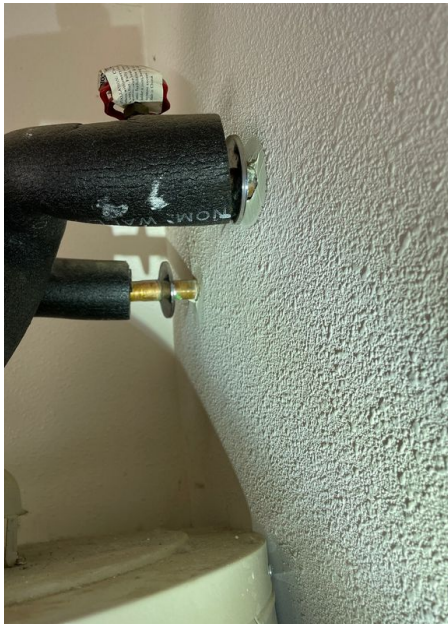
Water Supply & Distribution Systems: Inspected Water Supply and Distribution Pipes

Copper

I attempted to inspect the water supply and distribution pipes (plumbing pipes). Some are located behind walls that are inaccessible. Those that were accessible were noted to be functioning as intended.

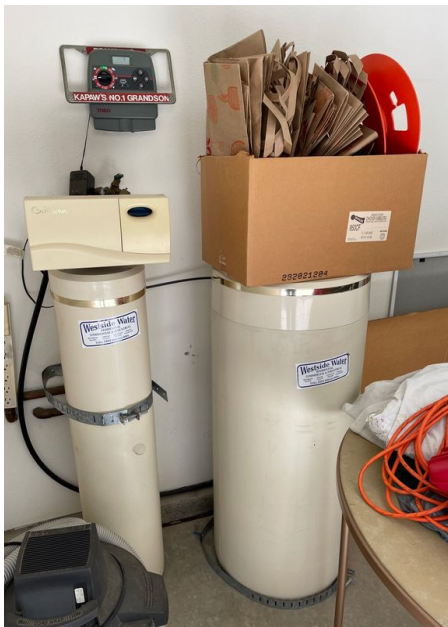
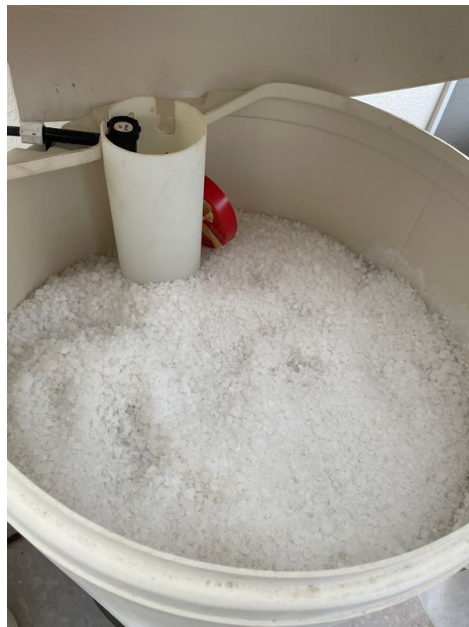
Water Conditioning System: Water Conditioning System

There was a water conditioning system present. The system was powered off and did not appear to be in use. The conditioner tank was full of salt.

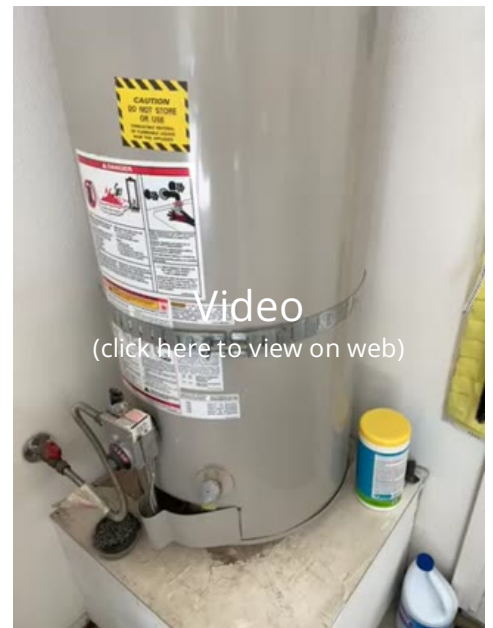
Rumbling or bubbling can be heard when the water heater is heating up. This is typically due to sediment build up in the tank. I recommend flushing the tank to clear the build up and reassessing the system. If this does not solve the problem, I recommend having a professional plumber evaluate the unit.

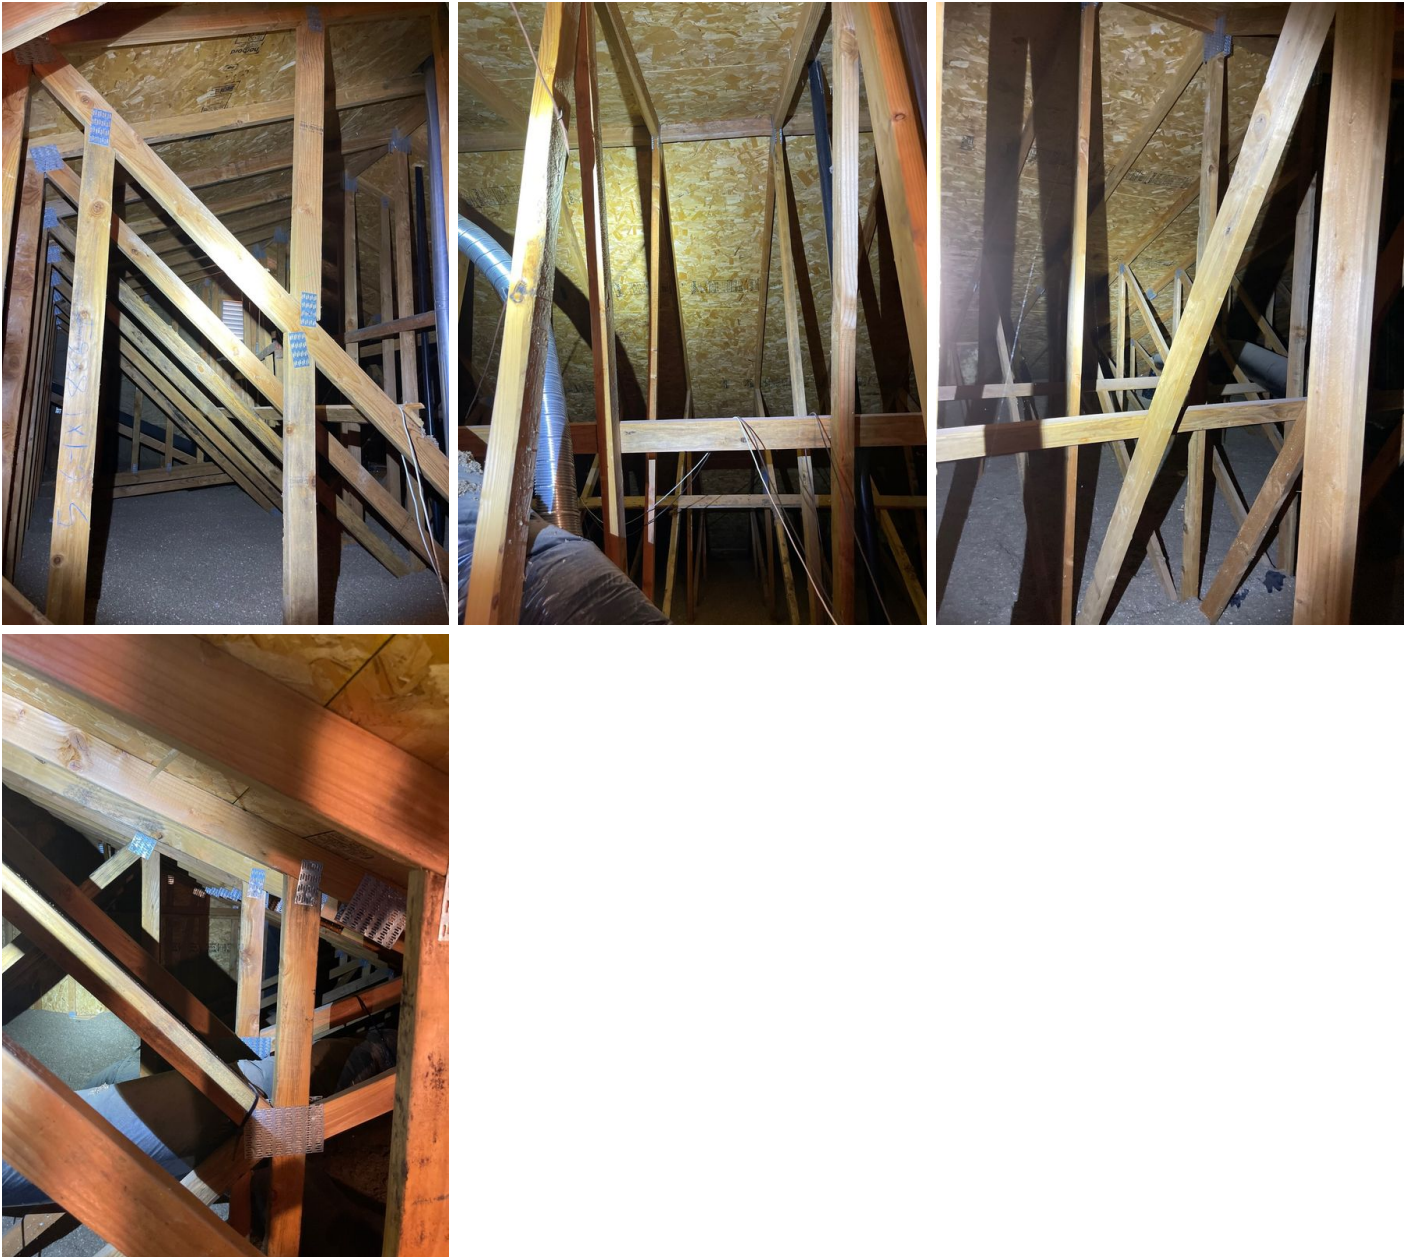
Structural Components & Observations in Attic: Structural Components Were Inspected

Structural components were inspected from the attic space according to the [Home Inspection Standards of Practice](#).

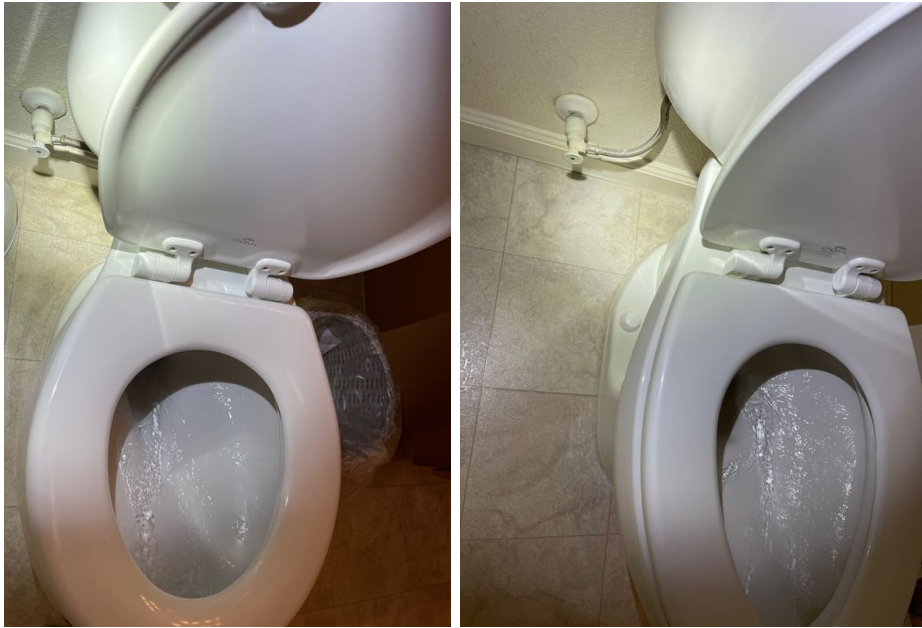
Bathroom Toilets: Toilets Inspected

I flushed all of the toilets.

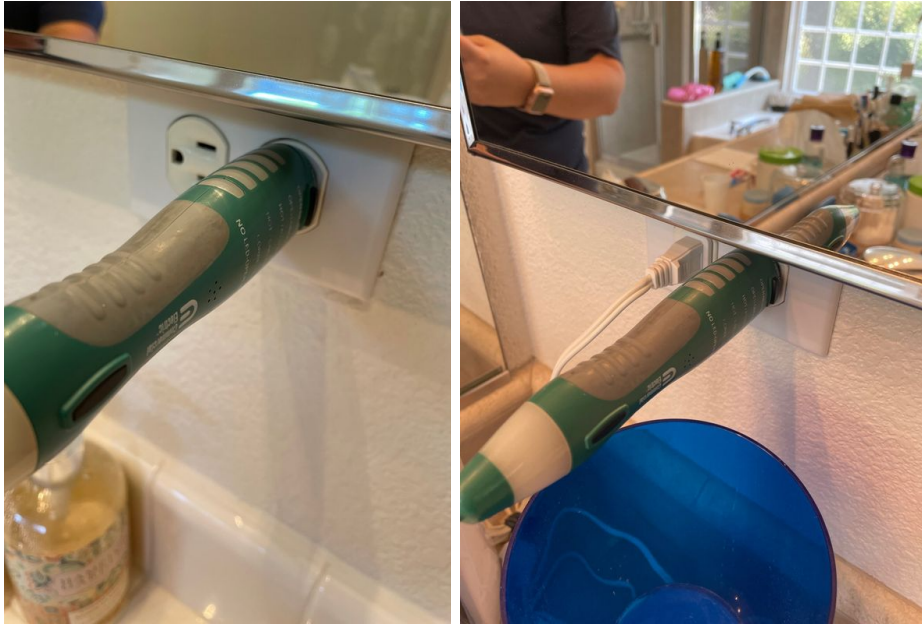
GFCI & Electric in Bathroom: GFCI-Protection Tested

I inspected the GFCI-protection at the receptacle near the bathroom sink by pushing the test button at the GFCI device or using a GFCI testing instrument. All receptacles in the bathroom should be GFCI protected as this is considered a wet location.

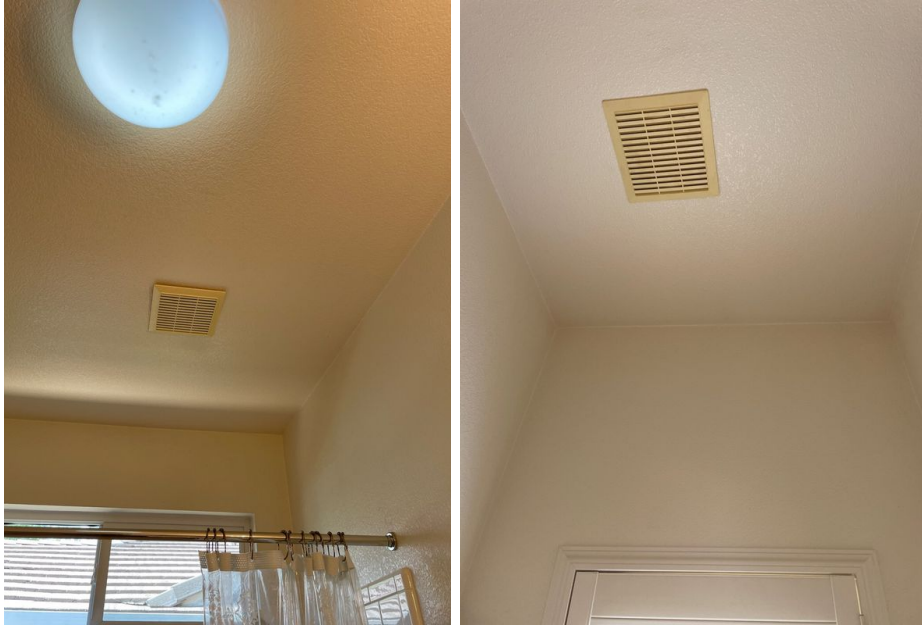
Bathroom Exhaust Fan / Window: Inspected Bath Exhaust Fans

I inspected the exhaust fans of the bathroom(s). All mechanical exhaust fans should terminate outside.

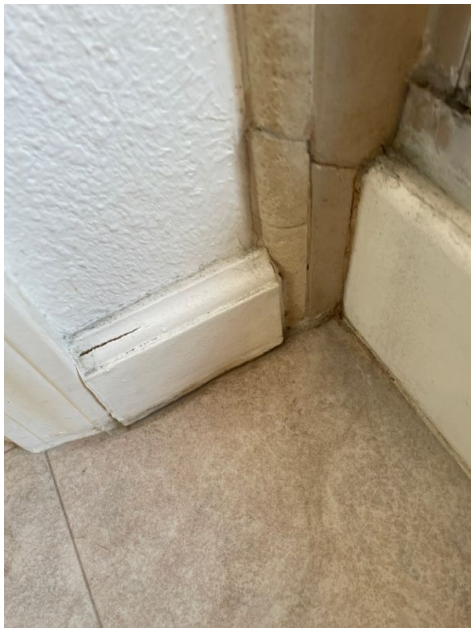
WATER DAMAGE AROUND SHOWER

I observed water damage around shower pan. It has affected the drywall and flooring.

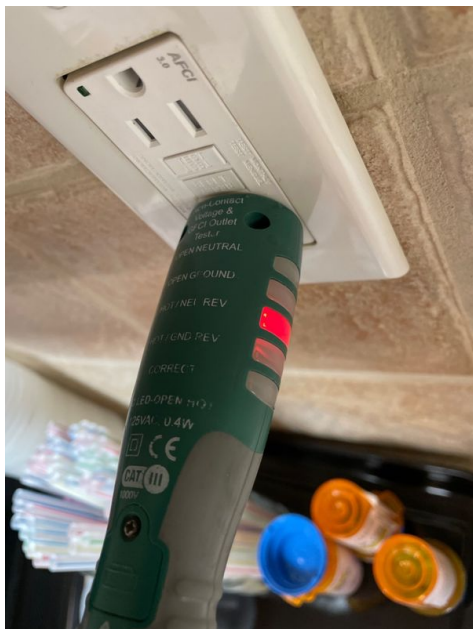
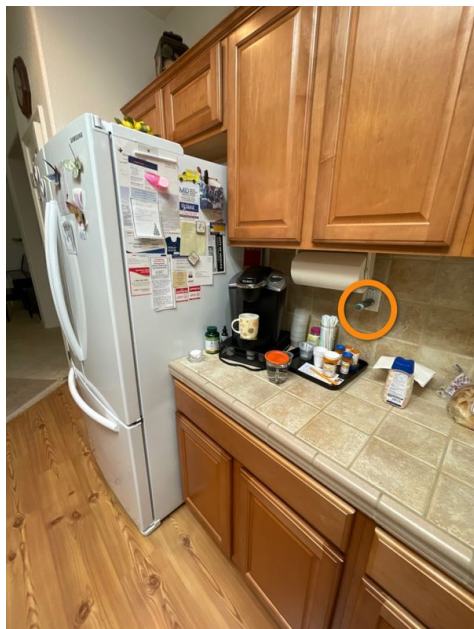
REVERSED POLARITY

I observed indications of one or more wall receptacles that have been wired with reversed polarity. This could create an electrical shock hazard.

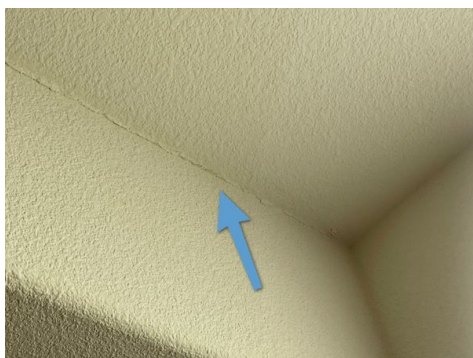
Front Entry

DRYWALL CRACKS

I observed surface cracks at the ceiling and walls of the home. The cracks appeared to be the result of long-term settling. Some settling is not unusual in a home of this age. Monitor these cracks for further movement.

Recommend monitoring.

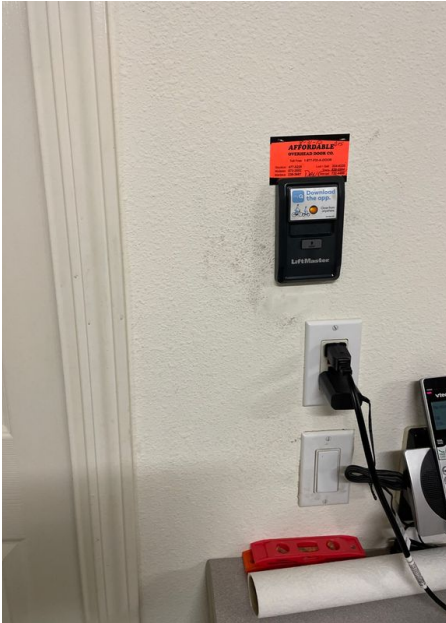
Garage Vehicle Door Opener: Wall Push Button Was Inspected

I inspected the wall button. The wall button should be at least 5 feet above the standing surface, and high enough to be out of reach of small children. I pressed the push button to see if it successfully operated the door.

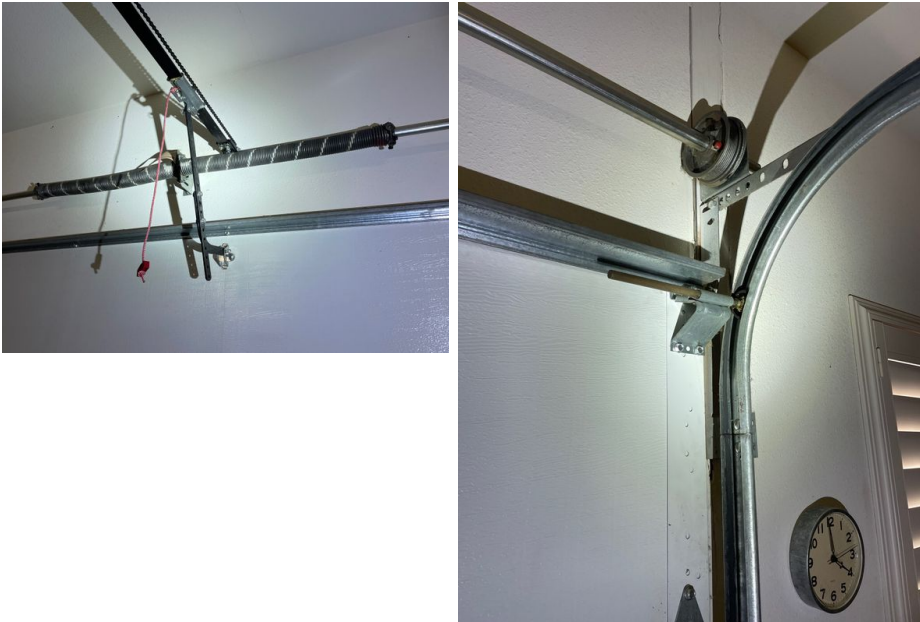
Garage Vehicle Door Opener: Springs, Bracket and Hardware Were Inspected

I closed the door and checked the springs for damage. If a spring was broken, operating the door can cause serious injury or death. I would not operate the door if there was damage. I visually checked the doors hinges, brackets and fasteners. If the door had an opener, the door must have an opener-reinforcement bracket that is securely attached to the doors top section. The header bracket of the opener rail must be securely attached to the wall or header using lag bolts or concrete anchors.

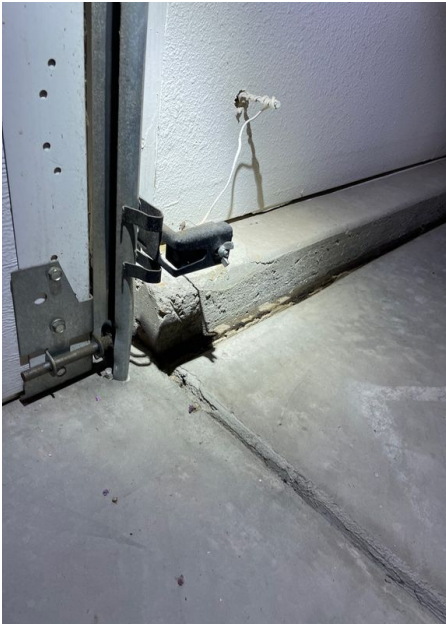
Garage Vehicle Door Opener: Photo-Electric Eyes Were Inspected

I inspected the photo-electric eyes. Federal law states that residential garage door openers manufactured after 1992 must be equipped with photo-electric eyes or some other safety-reverse feature that meets UL 325 standards. I checked to see if photo-electric eyes are installed. The vertical distance between the photo-eye beam and the floor should be no more than 6 inches.

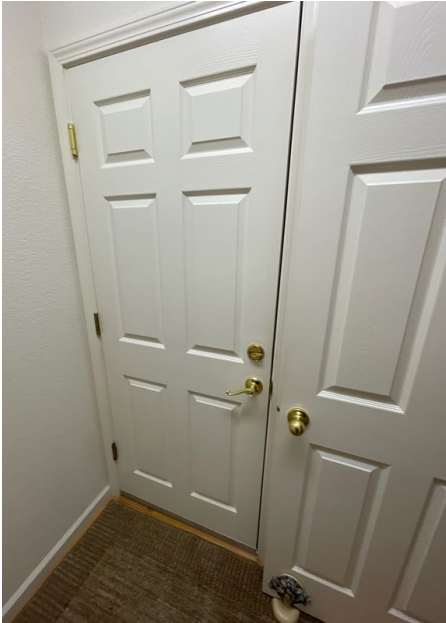
Ceiling, Walls & Firewalls in Garage: Door Between Garage and House Was Inspected

I inspected the door between the attached garage and the house. The door should be a solid wood door at least 1-3/8 inches thick, a solid or honeycomb-core steel door at least 1-3/8 inches thick, or a 20-minute fire-rated door. The door should be equipped with a self-closing or an automatic-closing device.
