CLARITY PROPERTY INSPECTIONS

REPORT BY CLARITY PROPERTY INSPECTIONS

3628 Los Altos Ct
Merced, CA 95348

JULY 29, 2022

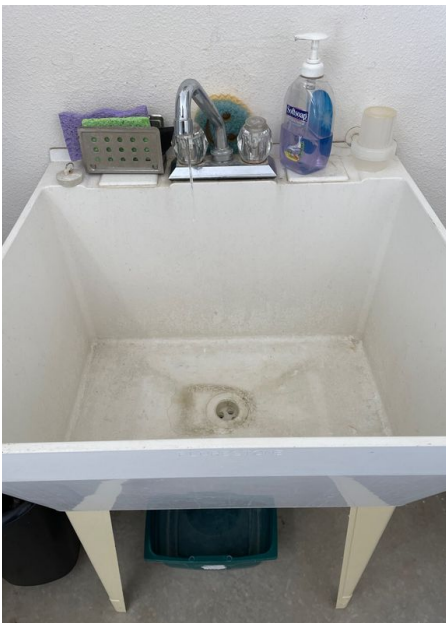
Garage Wash Sink: General Testing

I observed a wash sink in the garage. I tested the unit and observed its performance.

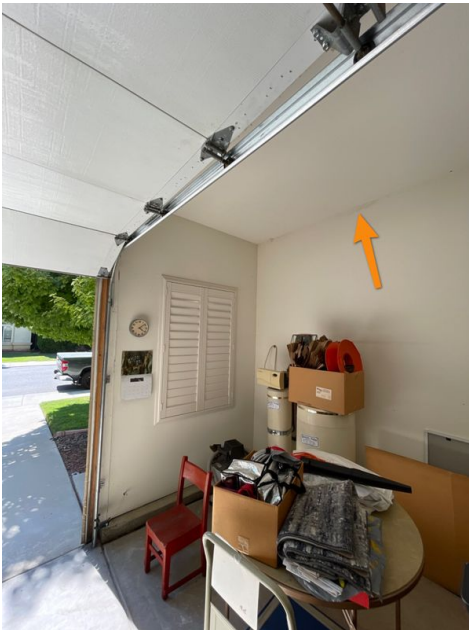
WATER STAINING

I observed indications of water damage/staining. I recommend the source of the area be repaired and monitored. There were repaired tiles in the area.

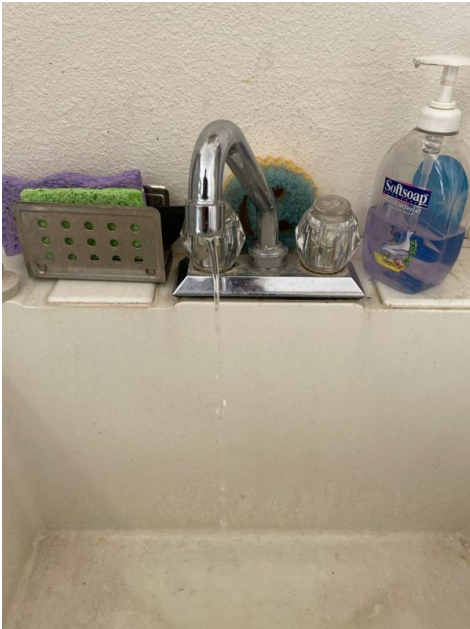
LOW WATER SUPPLY

I observed lower than expected water supply to the sink. Recommend having a contractor evaluate and repair as needed.

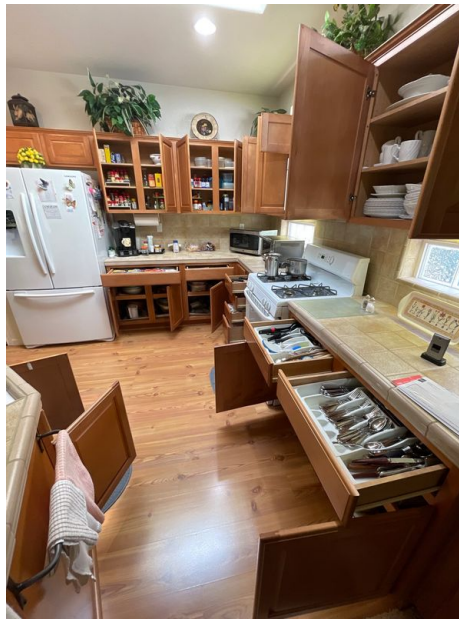
Countertops & Cabinets: Inspected Cabinets & Countertops

I inspected all cabinets and countertop surfaces.

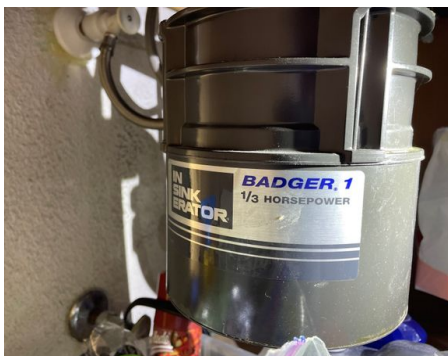
Garbage Disposal: Turned On Garbage Disposal

I turned on the garbage disposal. It ran and functioned as intended.

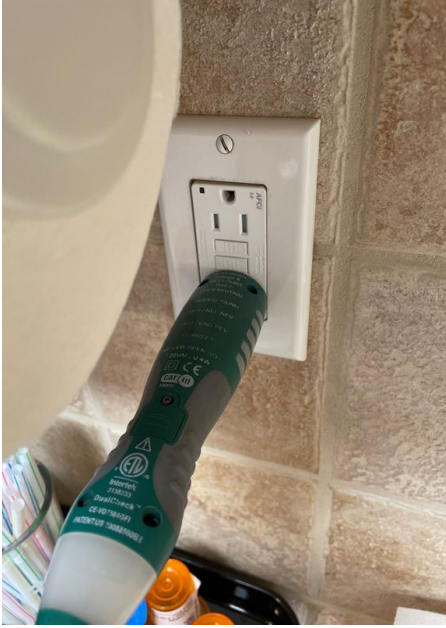
GFCI: GFCI Tested

I observed ground fault circuit interrupter (GFCI) protection in the kitchen.

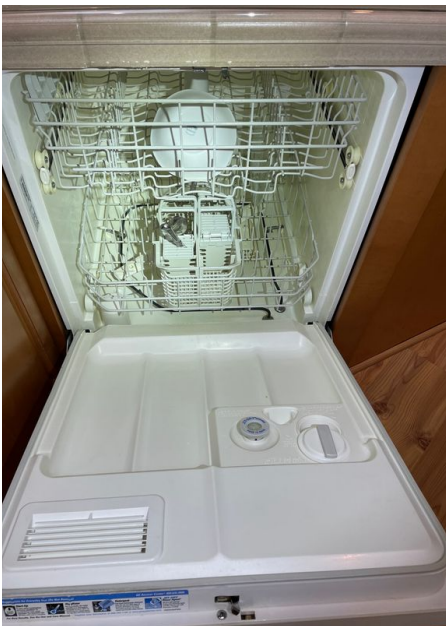
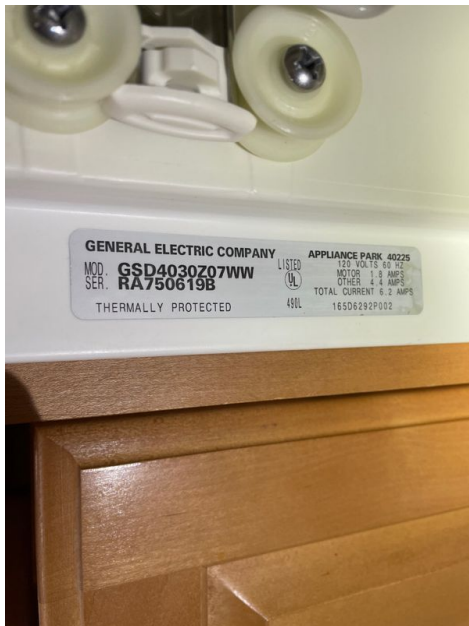
Dishwasher: Inspected Dishwasher

I inspected the dishwasher by attempting to turn it on and letting it run a short cycle.

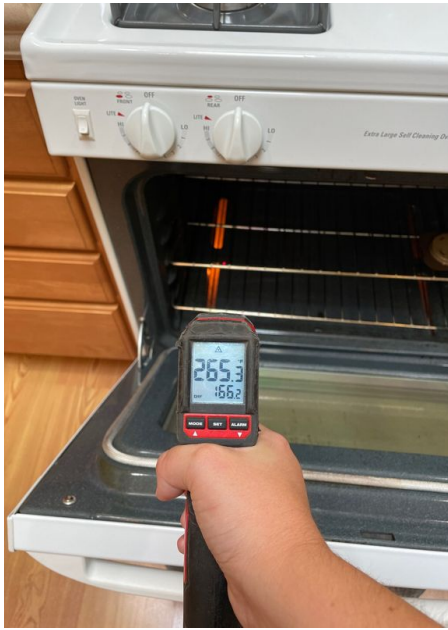
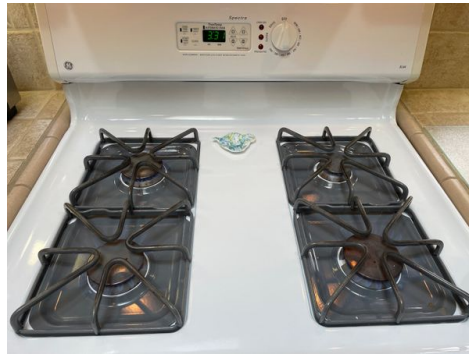
Range/Oven/Cooktop: Turned On Stove and Oven

I turned on the kitchen's stove and oven. The oven produced heat and the burners produced heat unless noted.

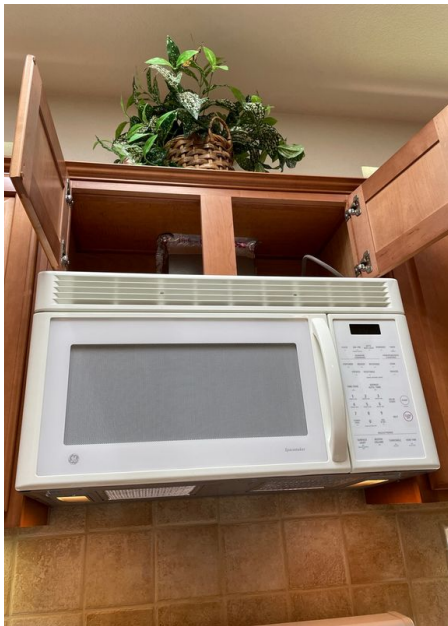
Exhaust Fan: Inspected Exhaust Fan

I inspected the exhaust fan in the kitchen. All mechanical exhaust fans should terminate outside.

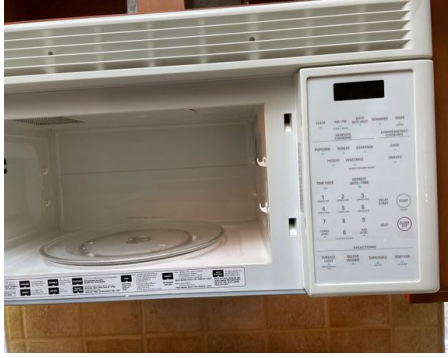
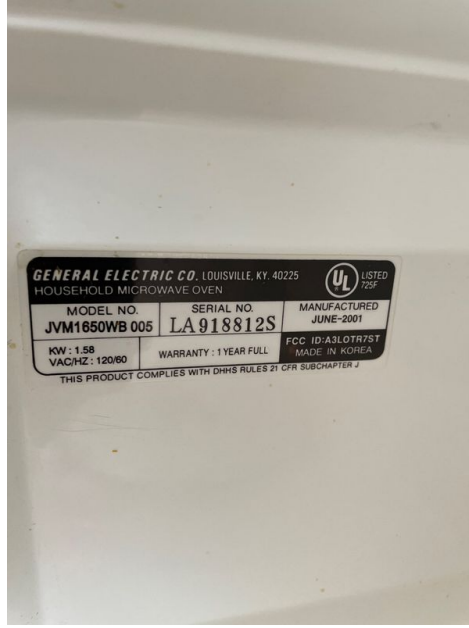
Built-in Microwave: Microwave Turned On

I observed that the microwave turned on. I ran a quick test and it produced microwaves.

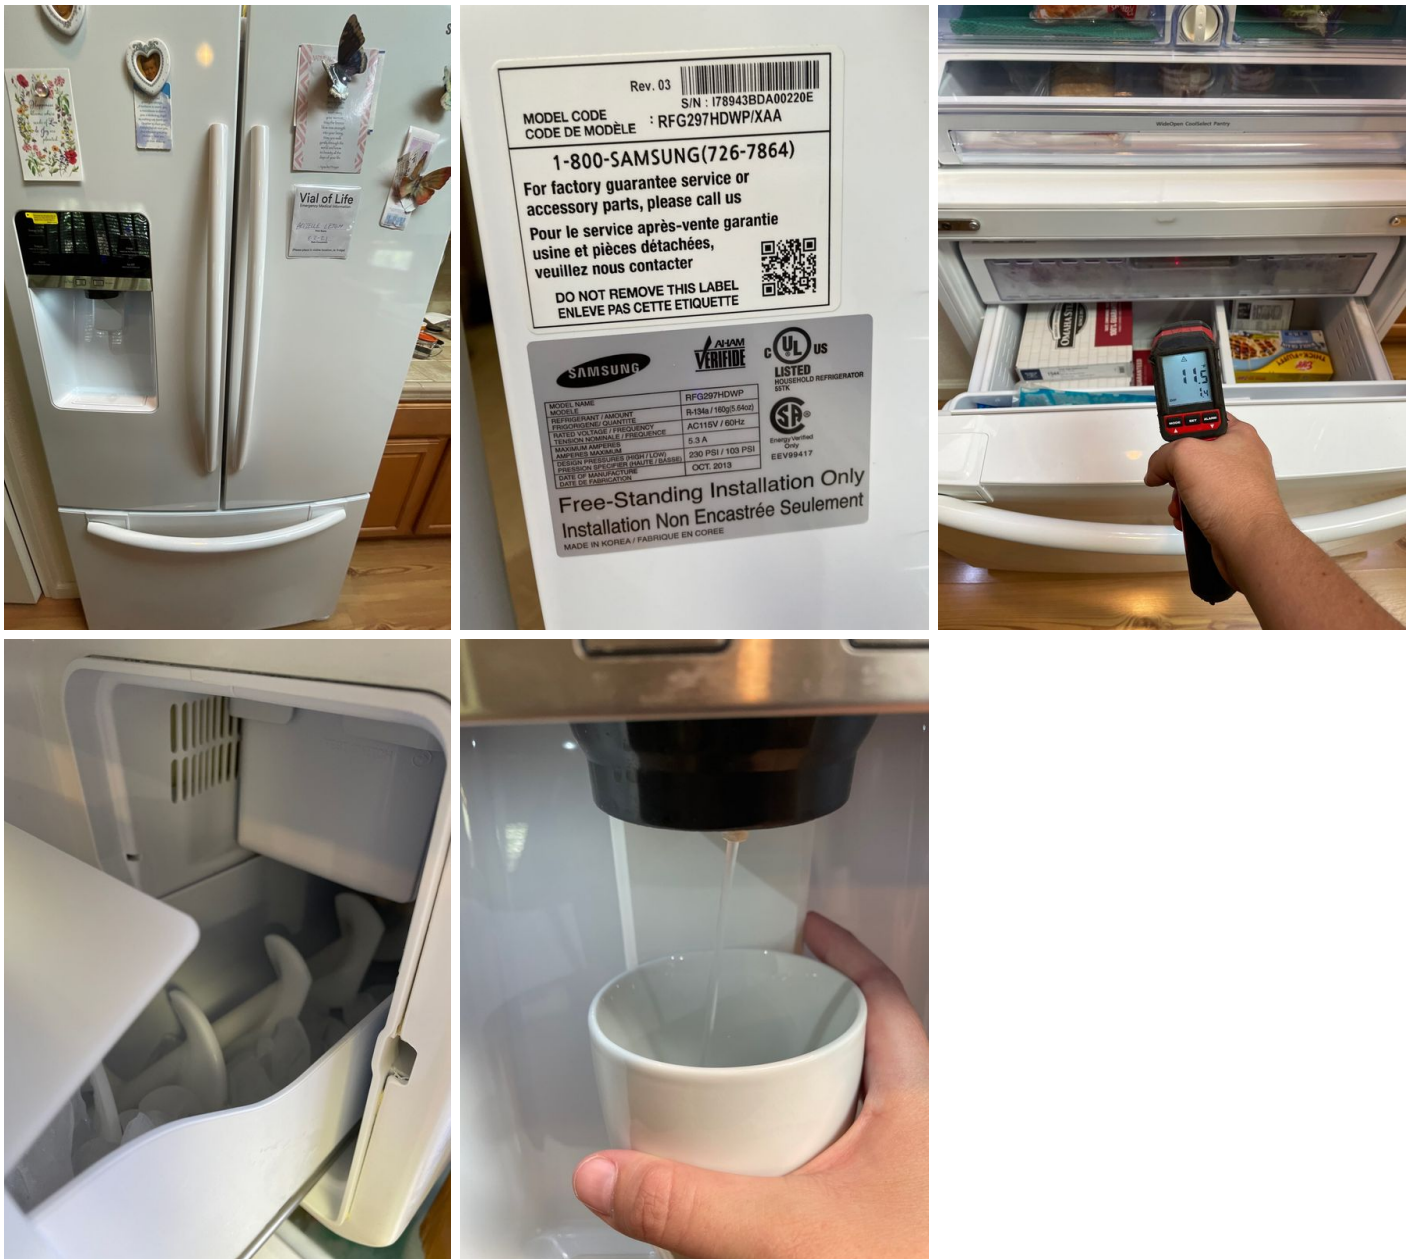
Refrigerator: Refrigerator Was On

I checked to see if the refrigerator was on. I tested both the refrigeration and freezer compartments. They were cold.

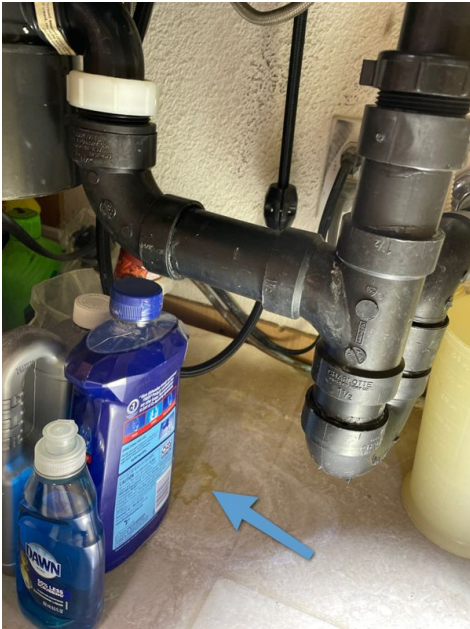
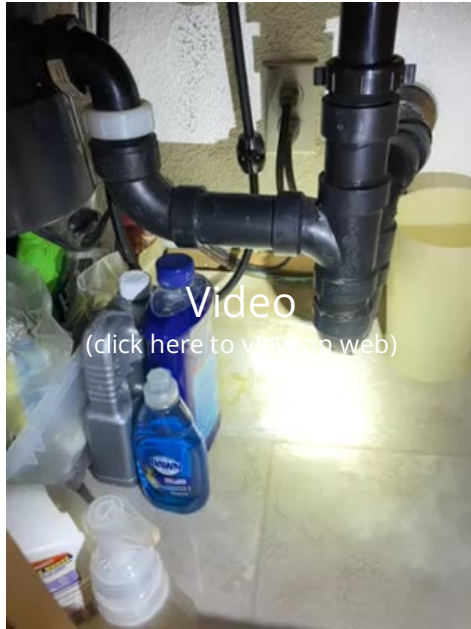
KITCHEN SINK CABINET - WATER STAINING

It was noted during my inspection that the kitchen sink cabinet had old water stains under the drain plumbing. This indicates a leak at one time. It may have been repaired. I could not duplicate the leak and suggest that it be monitored as the sink is used.

Recommend monitoring.

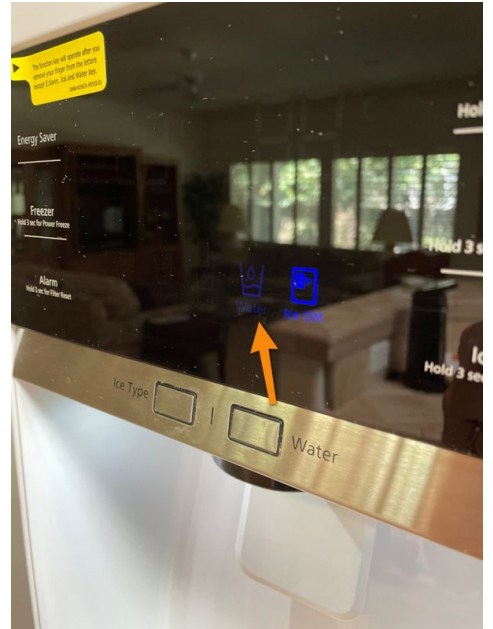
I observed the LCD screen on the refrigerator to be very dim. This may need to be repaired.

Contact a qualified professional.
