# Titus Inspections

# Inspection Report

**Property Address:**  
1287 7th St  
Hermosa Beach CA 90254

| <b>Property Address</b><br>1287 7th St<br>Hermosa Beach CA 90254 | <b>Date of Inspection</b><br>10/14/2025 | <b>Report ID</b><br>251014-01 |

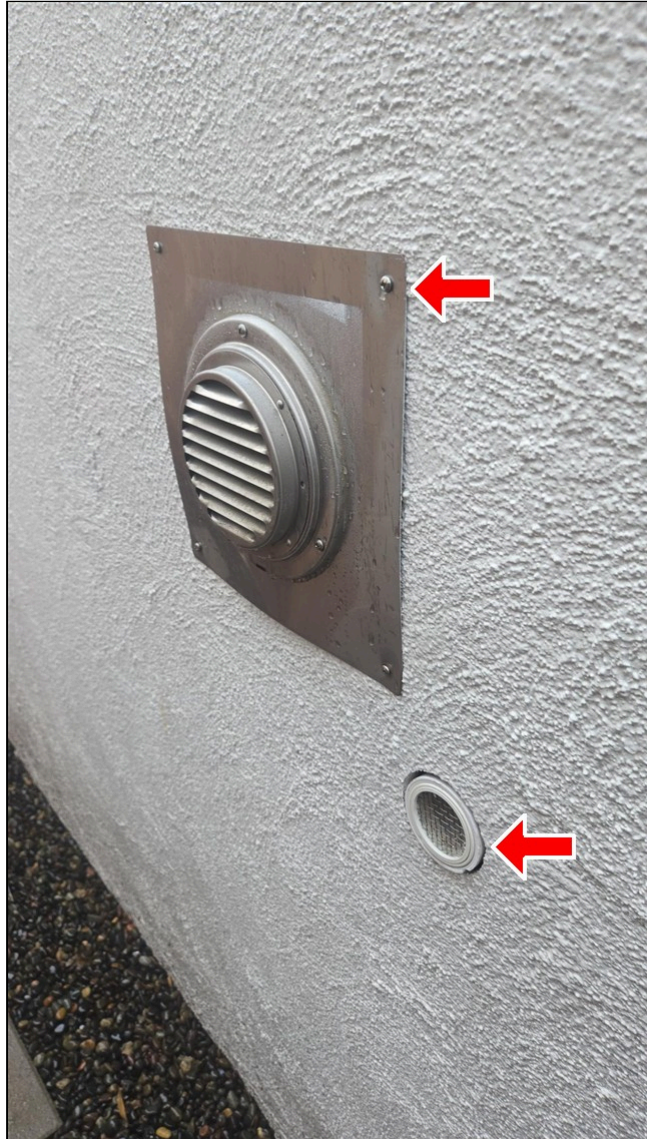
**1.0** Gaps and missing seals on wall penetrations throughout exterior siding. Recommend a qualified person properly seal exterior wall penetrations as needed.

1.0 Item 1 (Picture) Gaps, missing seal, exterior wall

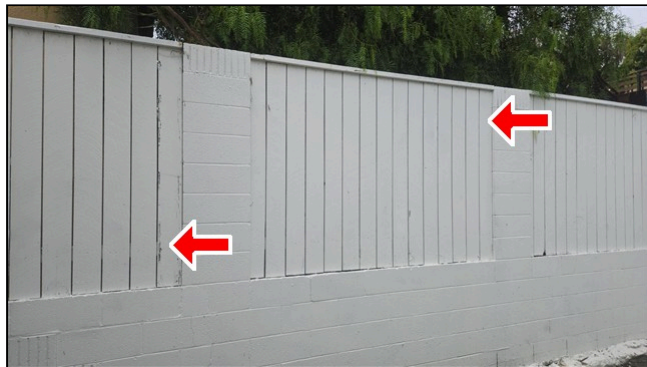
**1.5** Wood fencing has painted-over wood damage. Recommend a qualified person further inspect for repair or replacement recommendations.

1.5 Item 1 (Picture) Painted-over wood damage, fencing

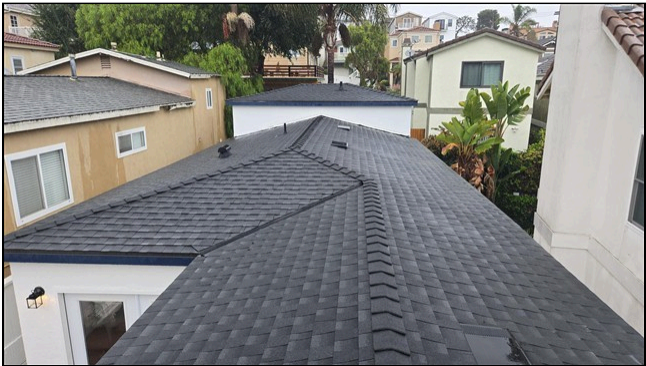
**2.0** Roof covering appears new and is in serviceable condition.

2.0 Item 1 (Picture) Roof covering

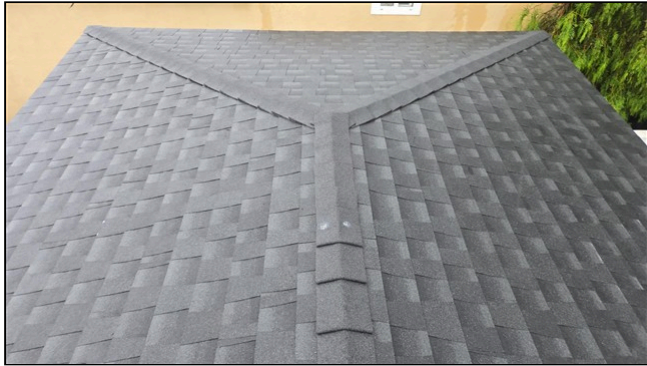
2.0 Item 4 (Picture) Roof covering

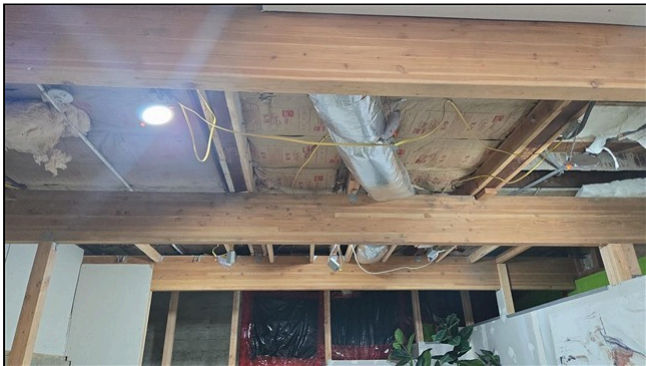
3.0 Basement ceiling has not been installed. Recommend a qualified person install drywall and prep and paint as needed.

3.0 Item 1 (Picture) Unfinished ceiling, basement

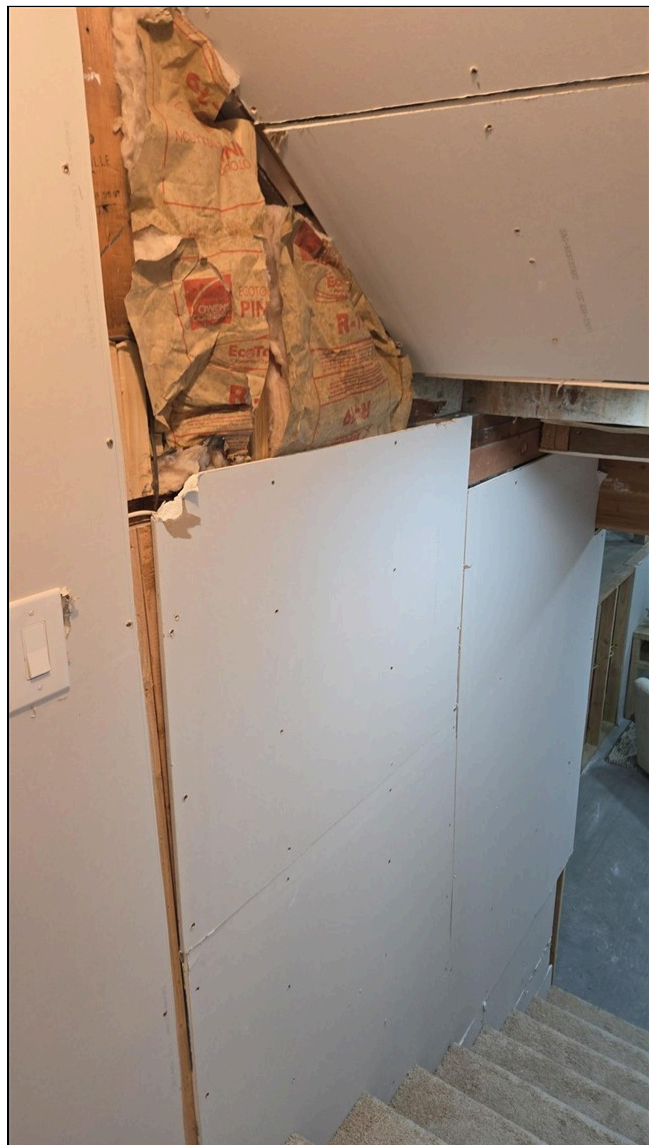
3.1 Unfinished walls inside lower level basement. Recommend a qualified person further inspect and patch, prep, and paint unfinished walls as needed.

3.1 Item 1 (Picture) Basement walls, unfinished

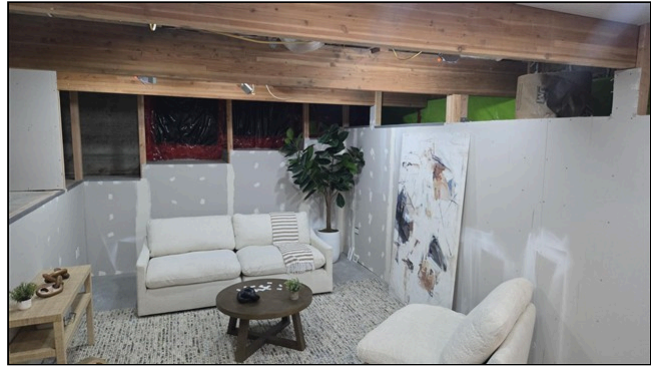
3.1 Item 4 (Picture) Basement walls, unfinished

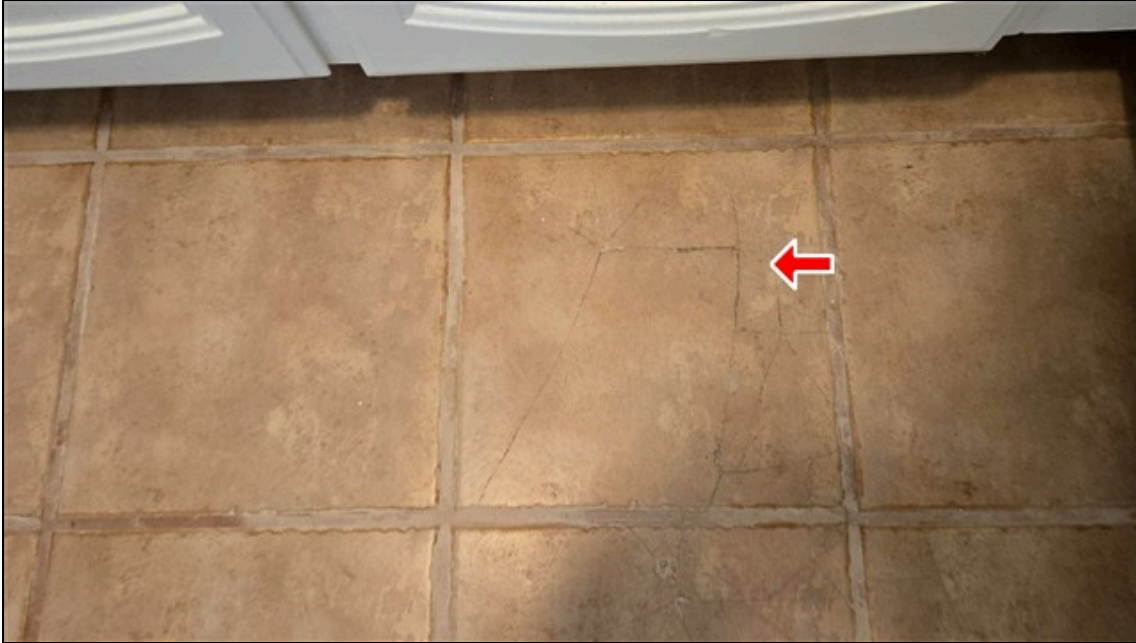
**3.2 (1)** Hairline cracks found on floor tile inside the kitchen. Recommend a qualified person further inspect for repair or replacement recommendations.

3.2 Item 1 (Picture) Kitchen floor tile, hairline cracks

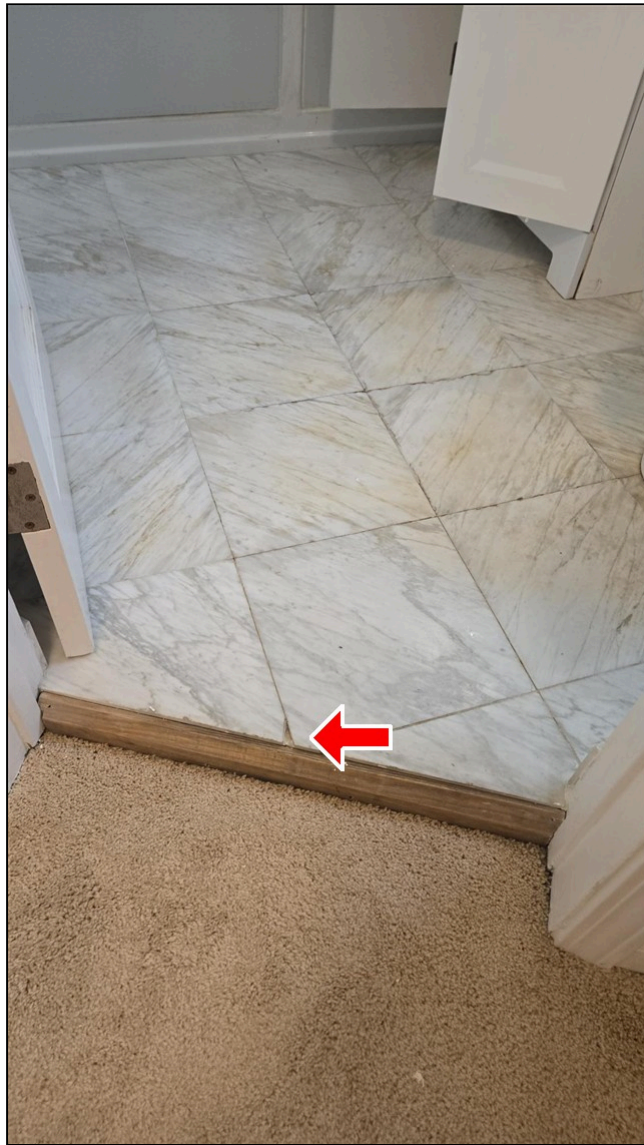
**3.2 (2)** Hall bathroom floor tile has been placed on a raised surface. Multiple tiles are cracked, and grout between tile is cracked and deteriorated. Recommend a qualified floor specialist further inspect floor tile for repair or replacement recommendations.

Raised floor surface indicates possible flooring below tile. Inspector does not test, confirm, or remove tile to inspect floor below. This is for your information.

3.2 Item 2 (Picture) Hall bathroom floor tile

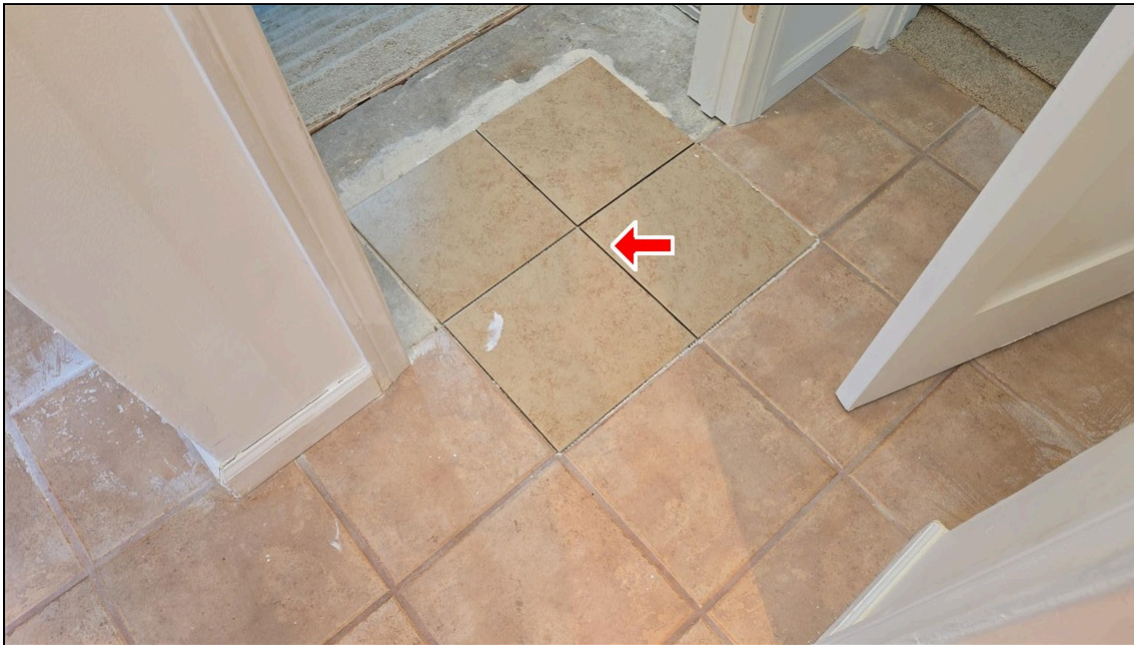
**3.2 (3)** Unfinished floor tile found on lower level surface. Missing grout between replaced tile leading to basement. Recommend a qualified floor specialist further inspect lower level floor tile for repair recommendations.

3.2 Item 3 (Picture) Lower level floor tile

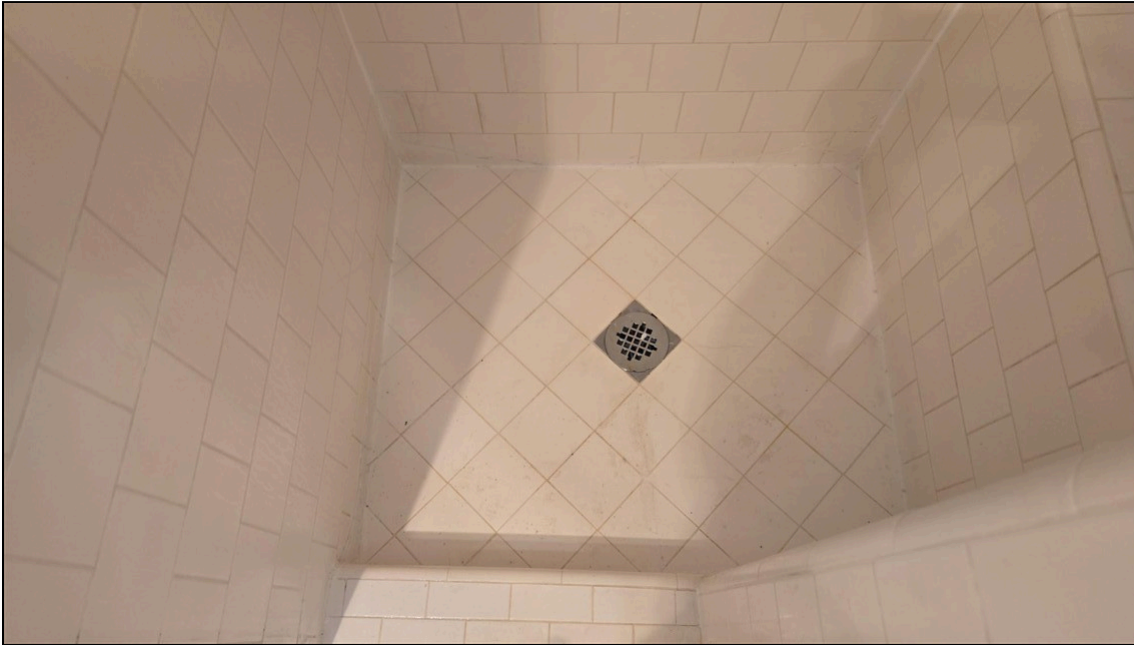
**3.3** Lower level hall bathroom shower walls have multiple repairs and minor cracking on tile. Heavy seals are present. Recommend a qualified person further inspect lower level bathroom shower walls for repair or replacement recommendations.

3.3 Item 1 (Picture) Lower level hall bath shower walls

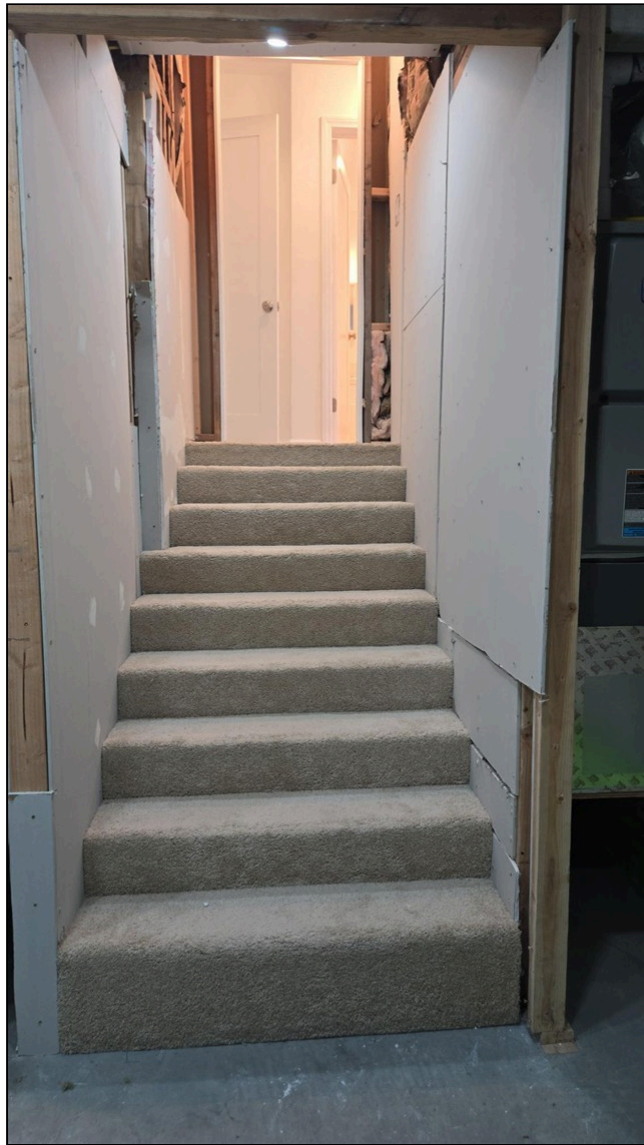
**3.4** Stairwell leading to basement is missing a graspable handrail on either side of stairwell. Recommend a qualified person further inspect and install proper handrail as needed.

3.4 Item 1 (Picture) Missing handrail, basement stairwell

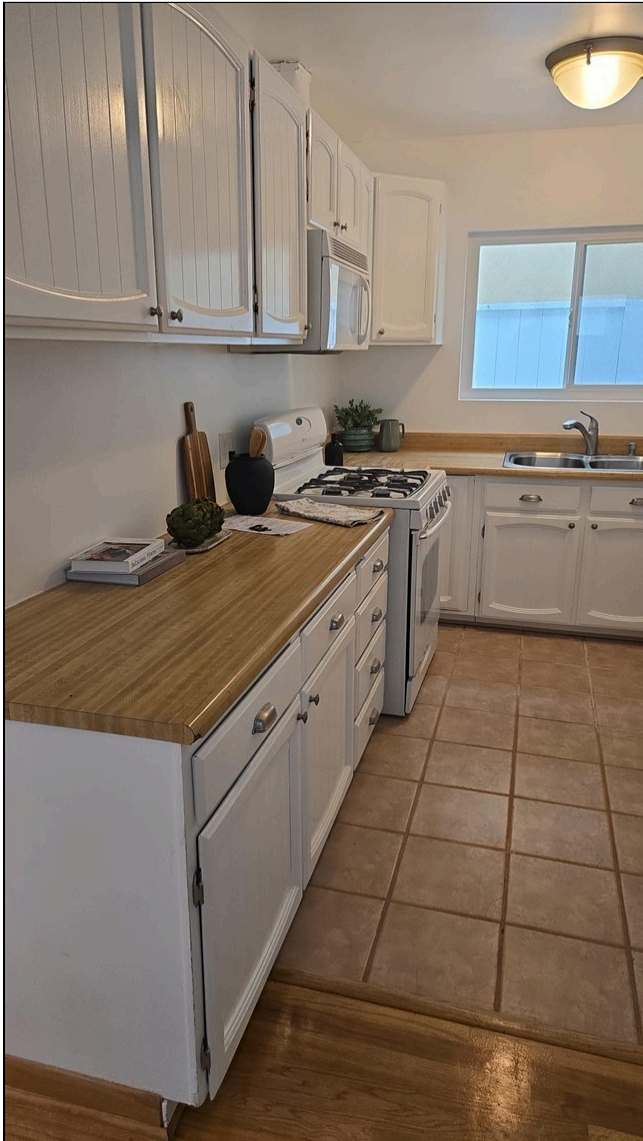
**3.5** Kitchen and bathroom cabinets and counter tops are dated and have normal wear and tear. Recommend a qualified person further inspect for repair recommendations.

3.5 Item 1 (Picture) Kitchen cabinets/ countertops

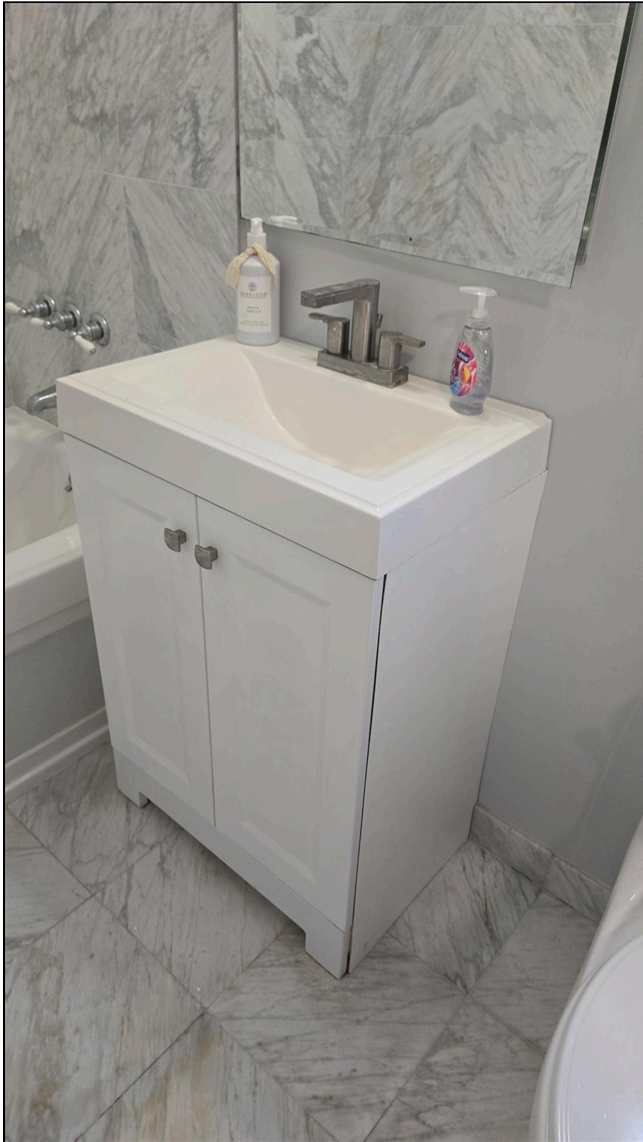
3.5 Item 3 (Picture) Hall bathroom cabinet

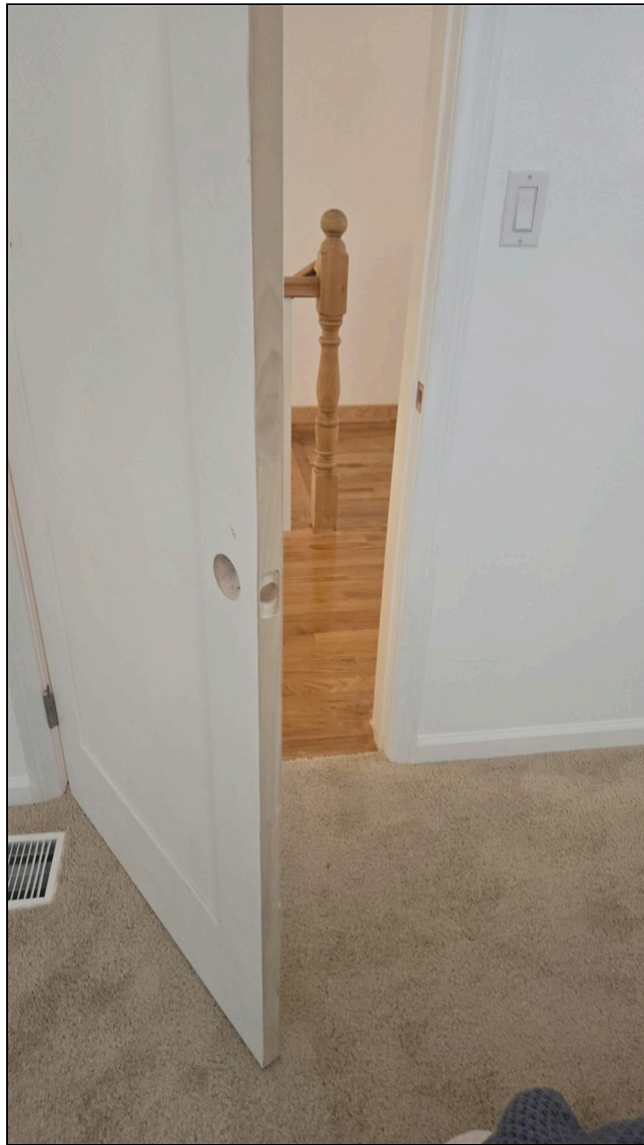
**3.6 (1)** Main level bedroom entry door is missing handle and latch plate. Recommend a qualified person further inspect for repair or installation recommendations.

3.6 Item 1 (Picture) Main level bedroom entry door

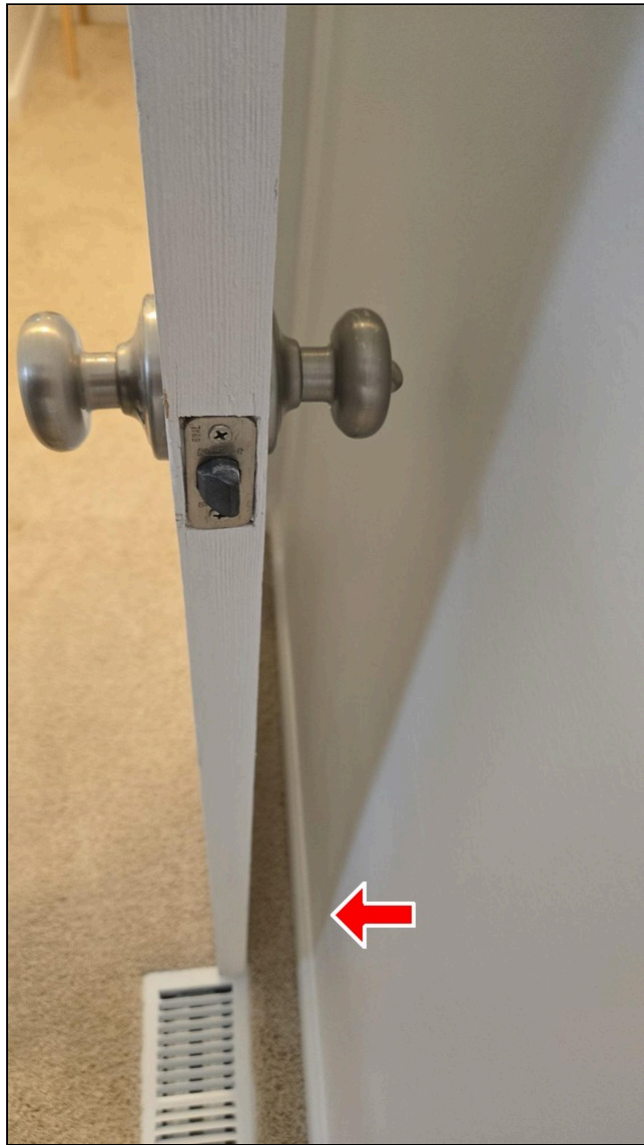
**3.6 (2)** Interior doors throughout home do not have door stops installed. Doors open and make contact with walls. Recommend installing door stops to prevent contact with walls and damage to walls. Install as needed.

3.6 Item 2 (Picture) Missing door stop

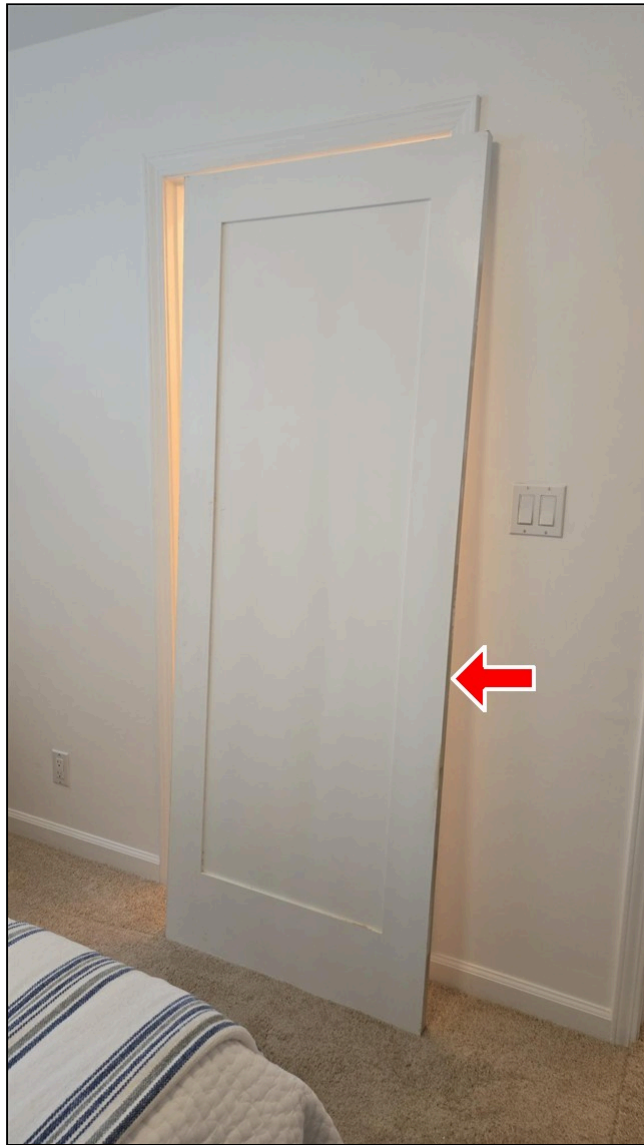
**3.6 (3)** Closet door for lower level bedroom was not installed at time of inspection. Recommend a qualified person install door properly as needed.

3.6 Item 3 (Picture) Lower level bedroom closet door

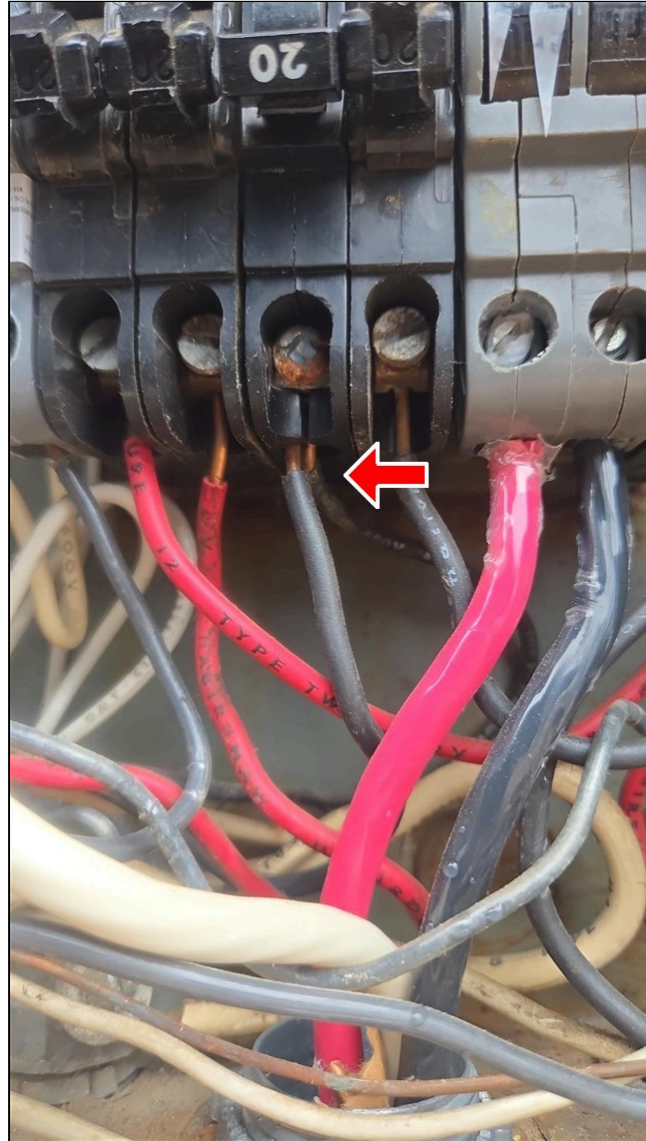
**4.3 (1)** Double tapped breaker located inside distribution panel. This occurs when two wires are connected to one breaker. This may cause wires to over heat and expand, which could cause wires to become loose and possibly arc. Recommend a qualified electrician connect wires in a "pigtail" or add additional breaker. Repair as needed.

4.3 Item 1 (Picture) Double tapped breaker

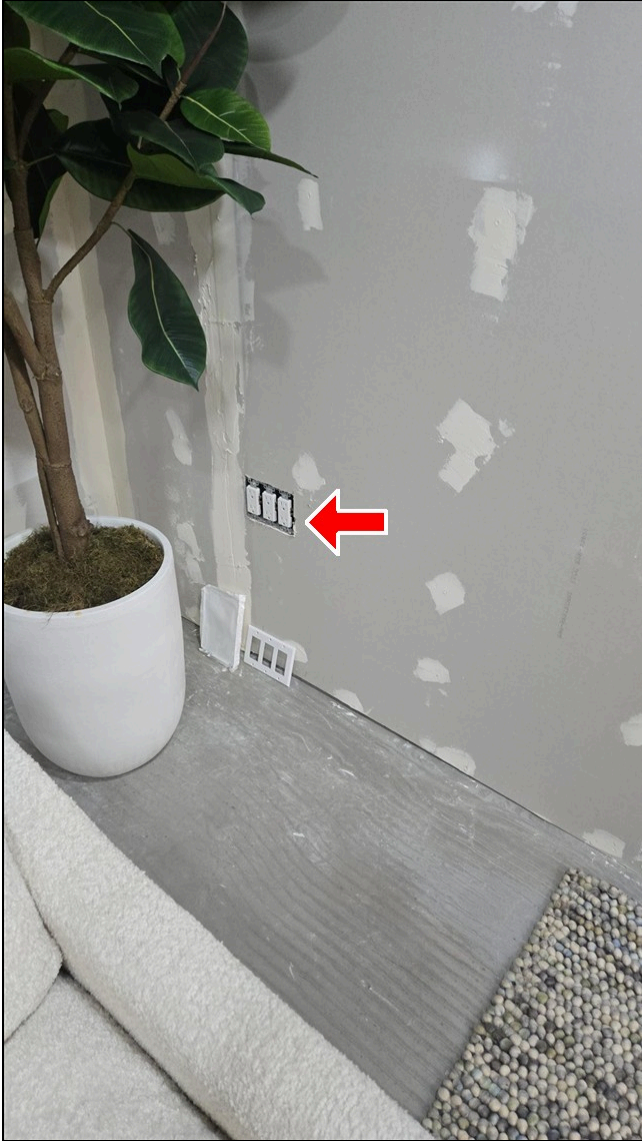
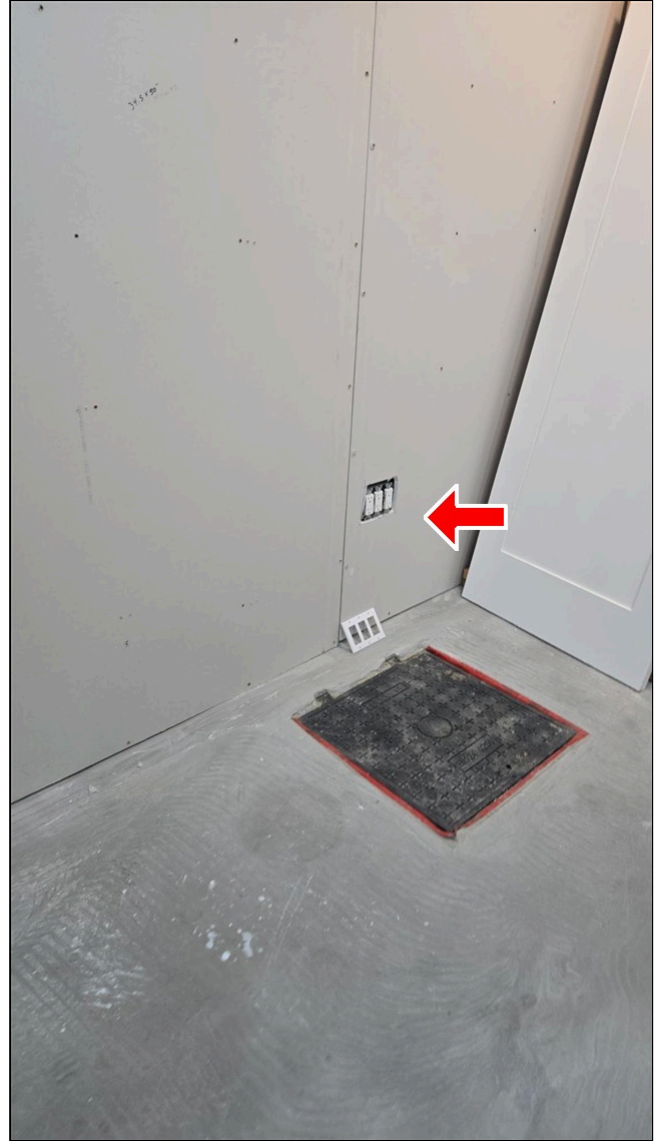
**4.4** Missing cover plates on multiple light switches and outlets throughout basement. Recommend installing cover plates as needed.

4.4 Item 1 (Picture) Missing cover plates, basement

4.4 Item 2 (Picture) Missing cover plates, basement

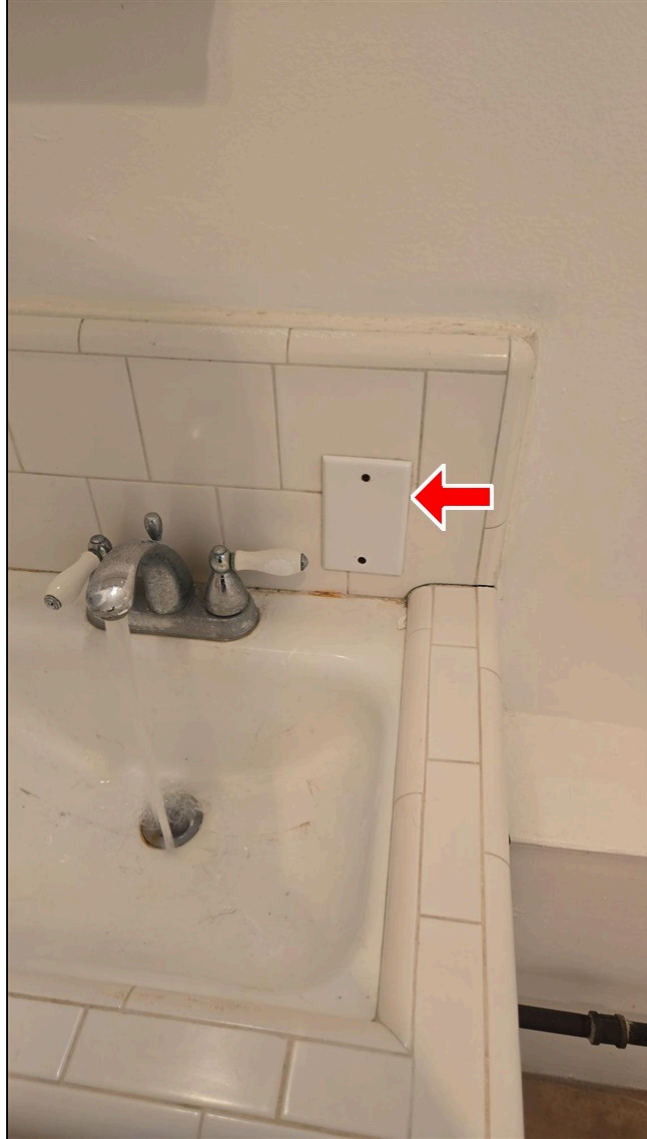
**4.5 (2)** There was no outlet present in lower hall bathroom (washer and dryer outlet is present at laundry area). Recommend a proper GFCI outlet be installed by a qualified electrician.

4.5 Item 2 (Picture) Missing GFCI outlet, lower level hall bathroom

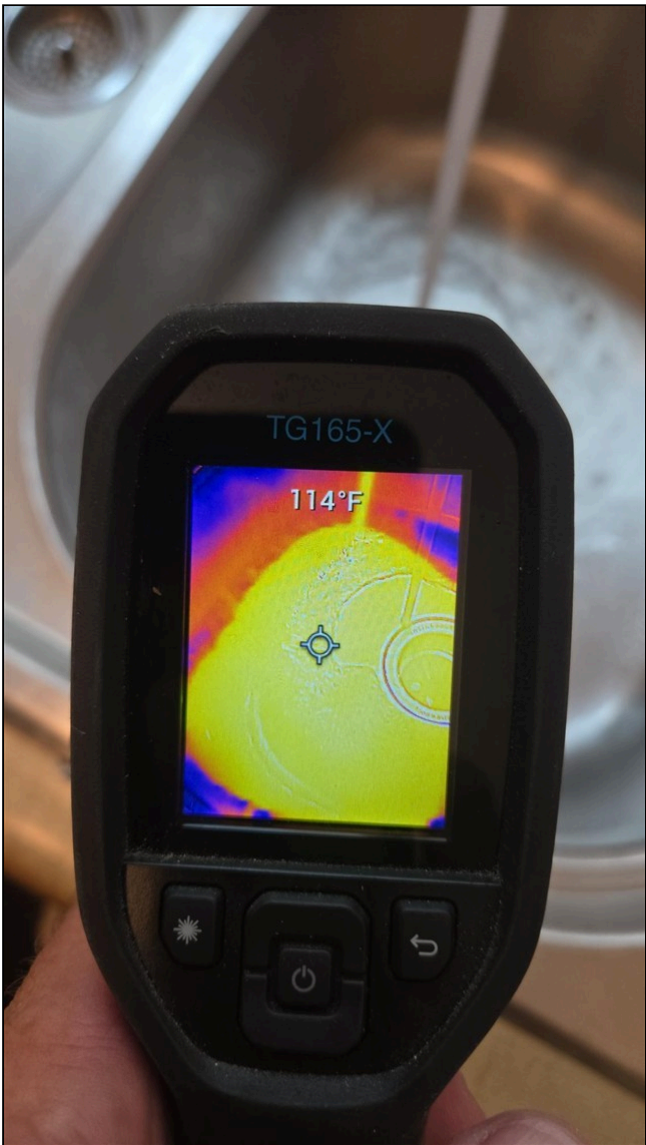
5.2 Item 4 (Picture) Hot water temperature

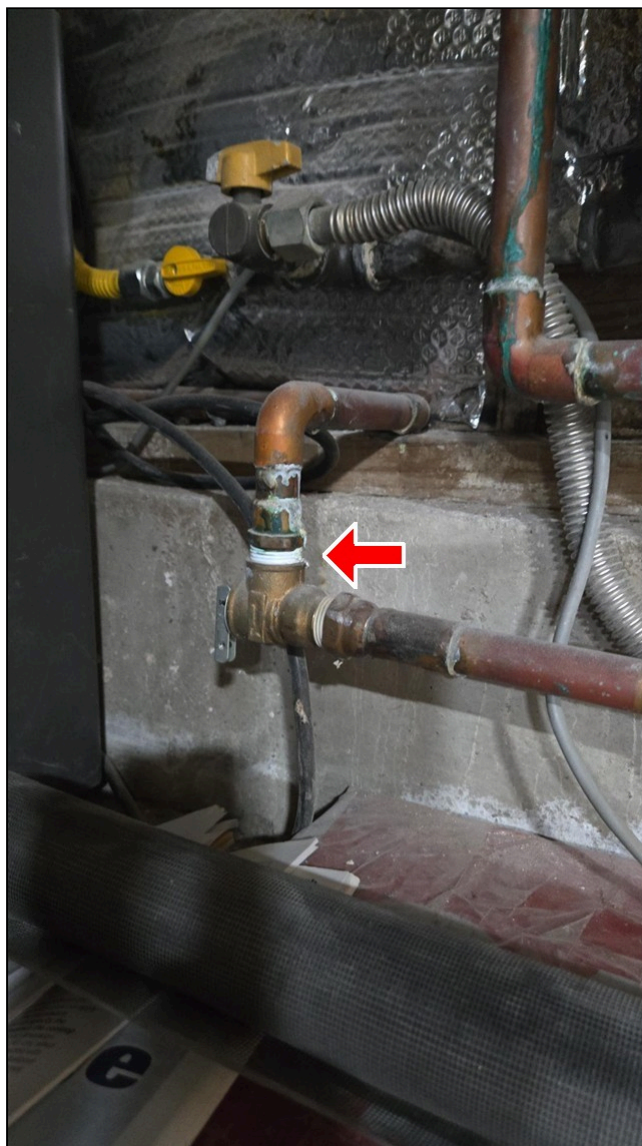
**5.2 (2)** Temperature pressure relief (TPR) valve for tankless water heater is in an improper direction. If valve was to leak, water would fill valve and corrode. Recommend a qualified person further inspect for repair recommendations.

5.2 Item 5 (Picture) TPR valve, water heater

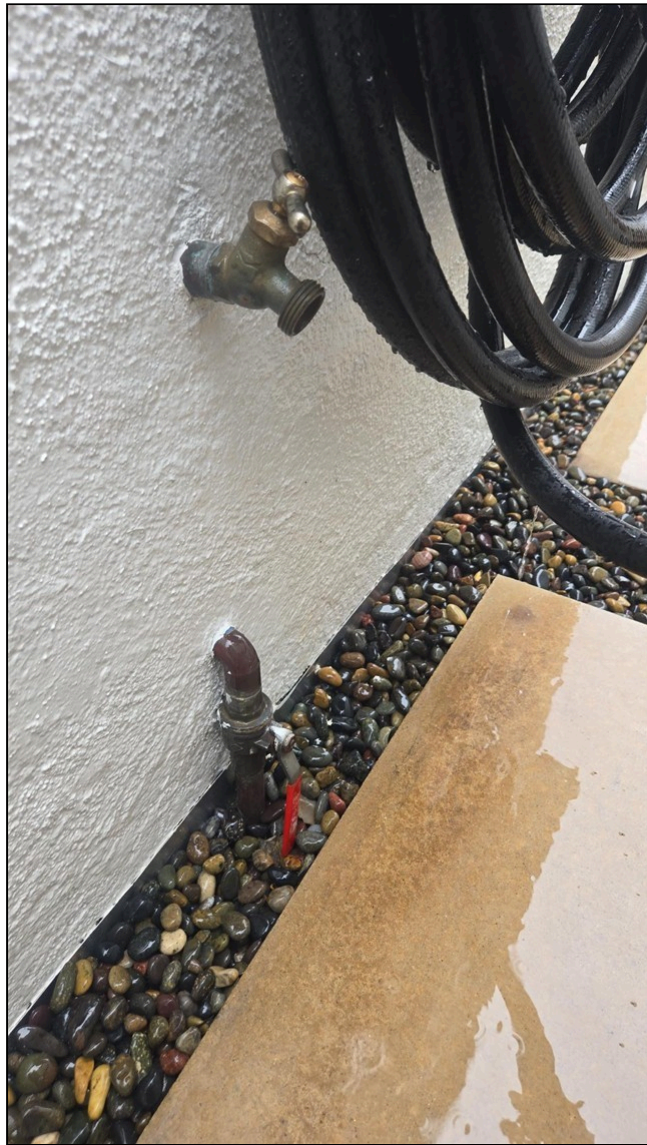
**5.3** Anti-siphon valves are missing on water supply hose bibs on the exterior water supply lines. Anti-siphon valves are needed to prevent contamination of your main water supply by blocking potentially dirty water from flowing back into it, a process called backflow or back-siphoning. They act as a safety device on things like garden hose spigots and irrigation systems, which can become filled with pollutants from a hose submerged in puddles or when fertilizers are on the lawn. By creating an air break or a one-way seal, they stop contaminants from being sucked into your potable water during a sudden drop in water pressure. Recommend a qualified person further inspect and install as needed.

5.3 Item 1 (Picture) Missing anti-siphon valve

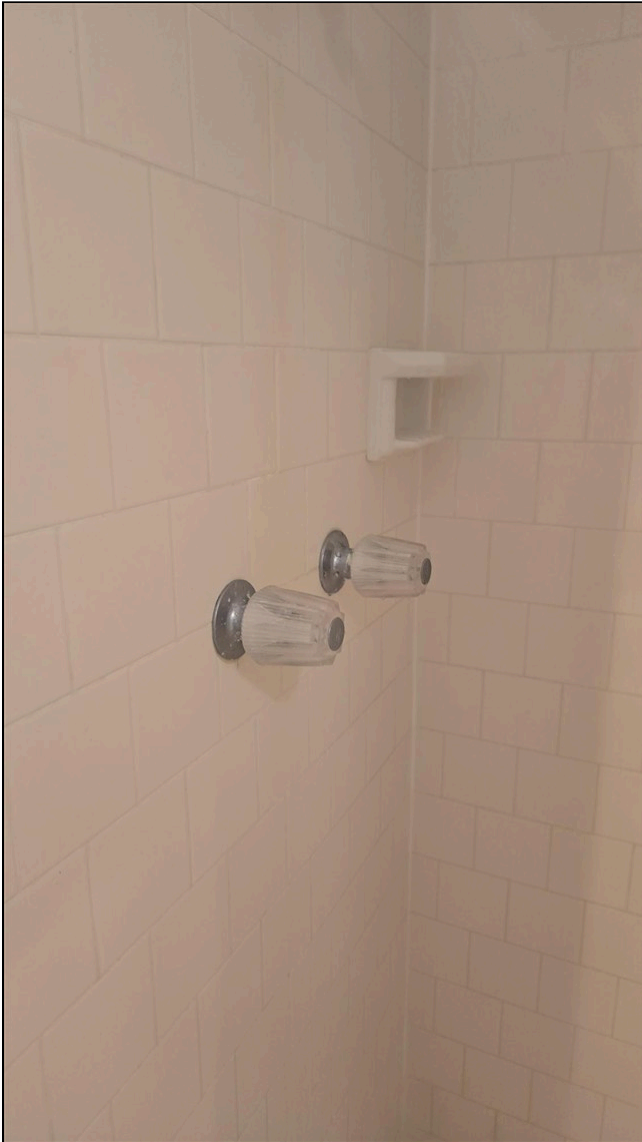
**5.4 (1)** Water supply fixtures and angle valves on water supplies to sinks are dated and have scale and corrosion. Recommend a qualified plumber further inspect for repair recommendations.

5.4 Item 3 (Picture) Dated water supply, lower level hall bathroom

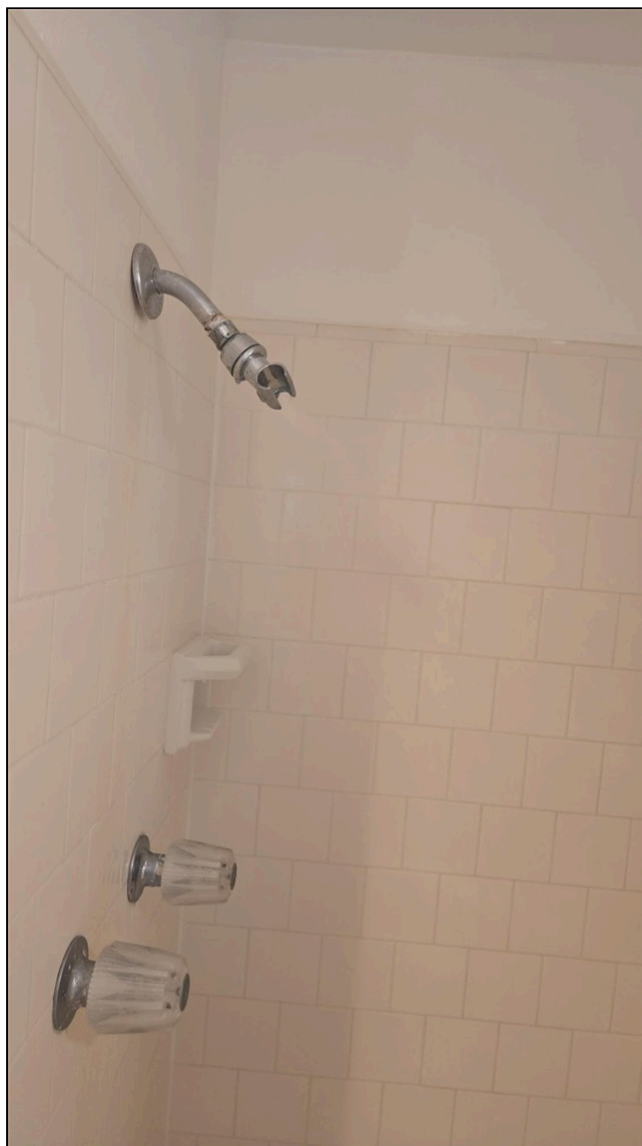
**5.4 (2)** Lower level hall bathroom shower is missing shower head fixture. Recommend a qualified person further inspect for repair recommendations.

5.4 Item 4 (Picture) Lower level bathroom shower head missing

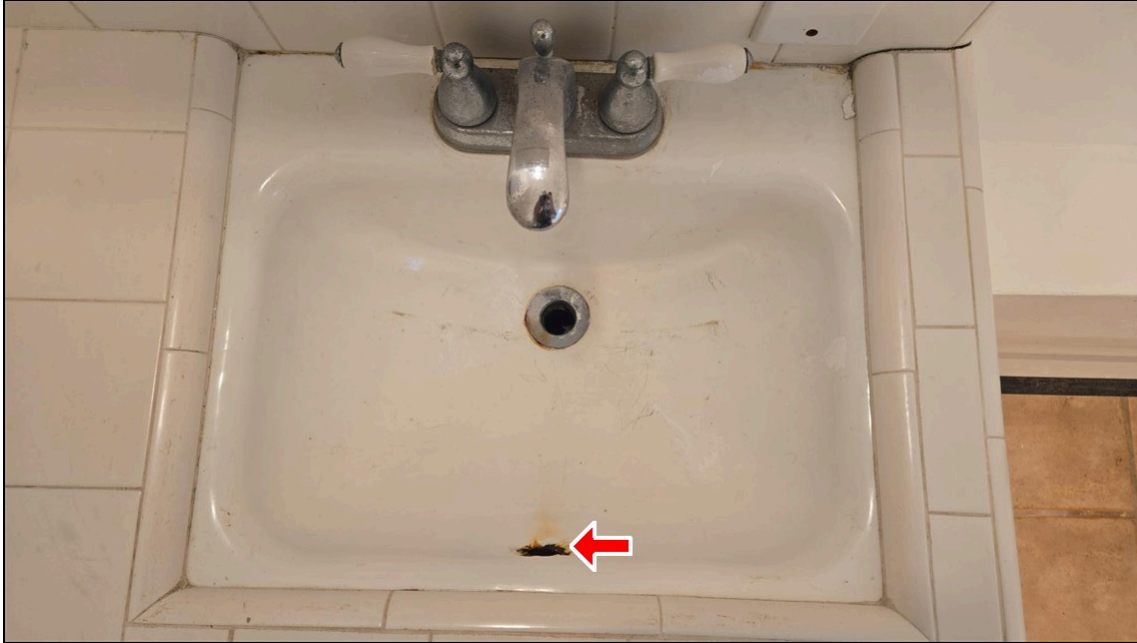
**5.5** Lower level hall bathroom sink has rust development and significant wear and tear. Recommend a qualified person further inspect for repair or replacement recommendations.

5.5 Item 1 (Picture) Lower level hall bathroom sink

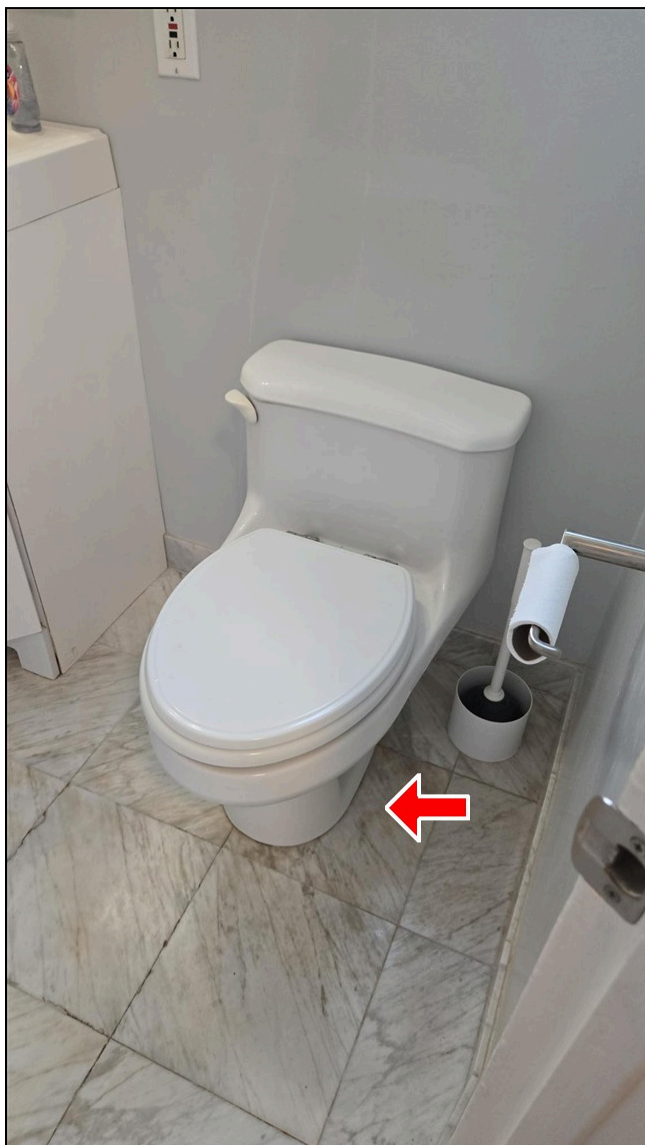
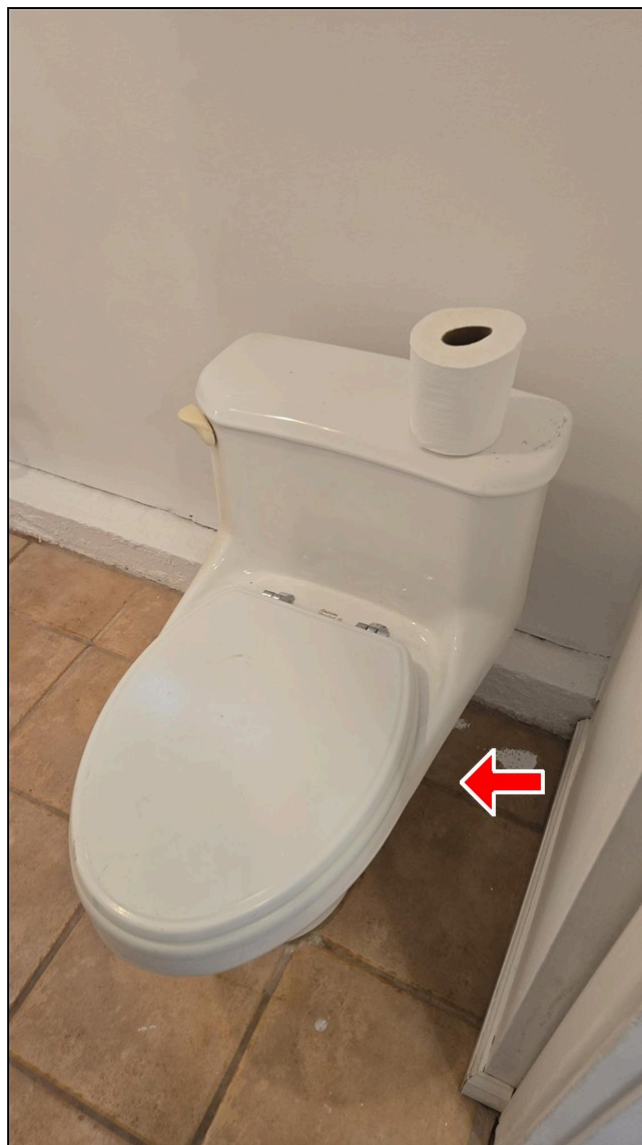
**5.6 (1)** The toilets are loose at floor in the upper and lower hall bathrooms. Repairs may involve re-setting the toilets on a new wax seal. Recommend a qualified licensed plumber repair or correct as needed.

5.6 Item 1 (Picture) Loose toilet, upper hall bathroom

5.6 Item 2 (Picture) Loose toilet, lower level hall bath

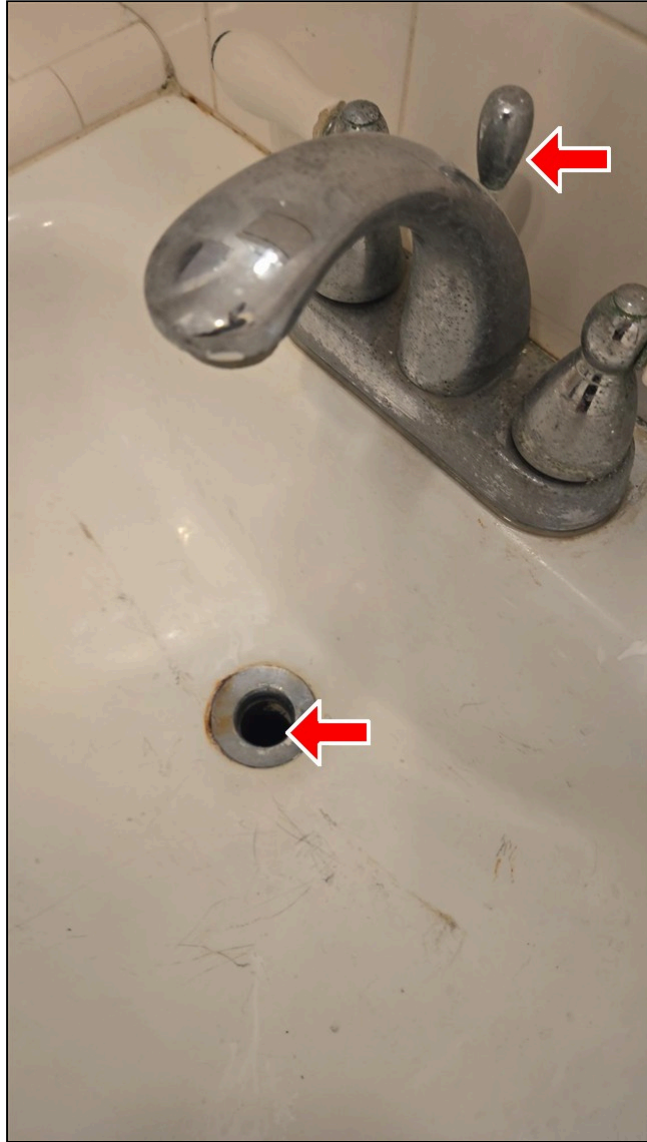
**5.6 (2)** Lower level hall bathroom sink is missing drain stop. Recommend installing drain stop to prevent foreign objects from entering into drain line and causing restriction.

5.6 Item 3 (Picture) Missing drain stop, lower level hall bathroom sink

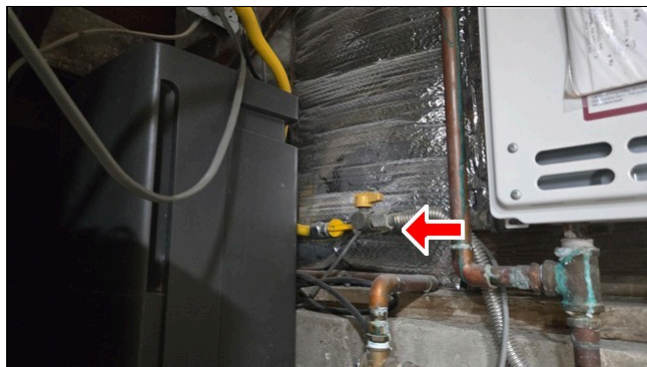
**5.7** Gas furnace and water heater do not have sediment traps installed. Sediment traps are intentionally installed to prevent sediments in gas from restricting the gas valve and burners of the appliance. Recommend a qualified person install sediment traps as needed.

5.7 Item 1 (Picture) Heat system/water heater gas line

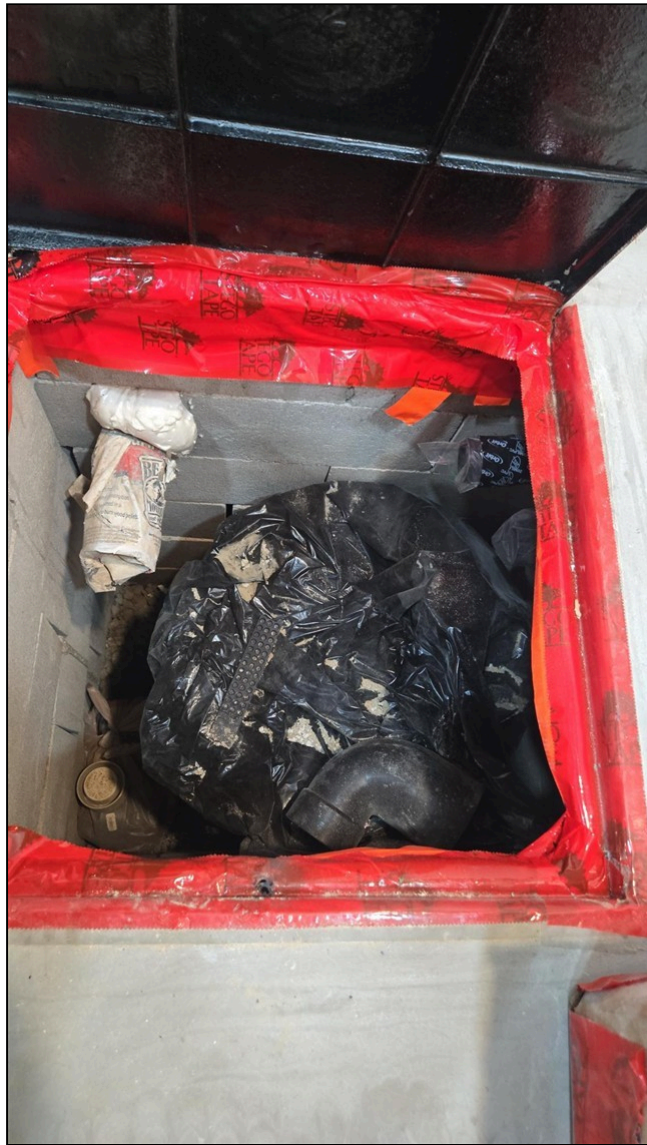
**5.8** Basement has an injection pump or sump pump location in surface. Injection pump or surface drainage pump is not installed. Recommend a qualified licensed plumber further inspect for repair or installation recommendations.

5.8 Item 1 (Picture) Injection/sump pump location, basement

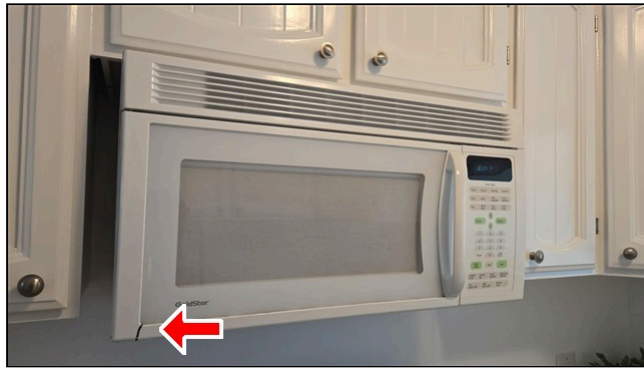
**6.5** Built-in microwave is dated and has cracked door panel. Recommend a qualified person further inspect for repair or replacement recommendations.

6.5 Item 1 (Picture) Built in microwave
