# Titus Inspections

# Inspection Report

**Property Address:**  
1287 7th St  
Hermosa Beach CA 90254

| <b>Property Address</b><br>1287 7th St<br>Hermosa Beach CA 90254 | <b>Date of Inspection</b><br>10/14/2025 | <b>Report ID</b><br>251014-01 |

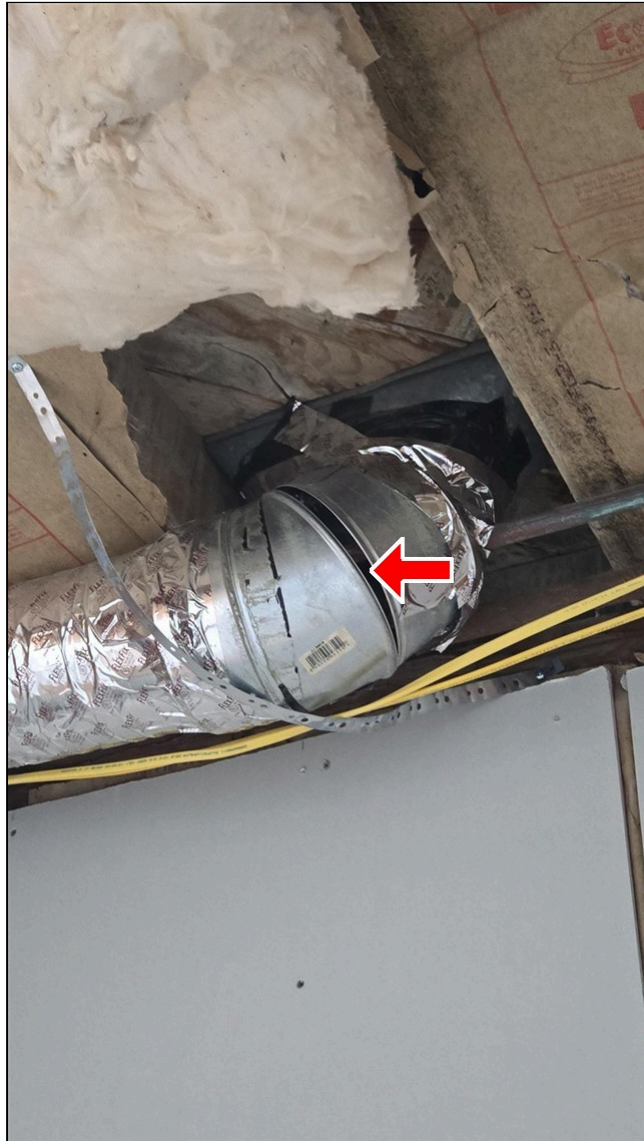
**7.3** Ducting inside basement is not properly installed or connected in multiple areas. Recommend a qualified person further inspect ducting for repair recommendations.

7.3 Item 1 (Picture) Detached ducting, basement

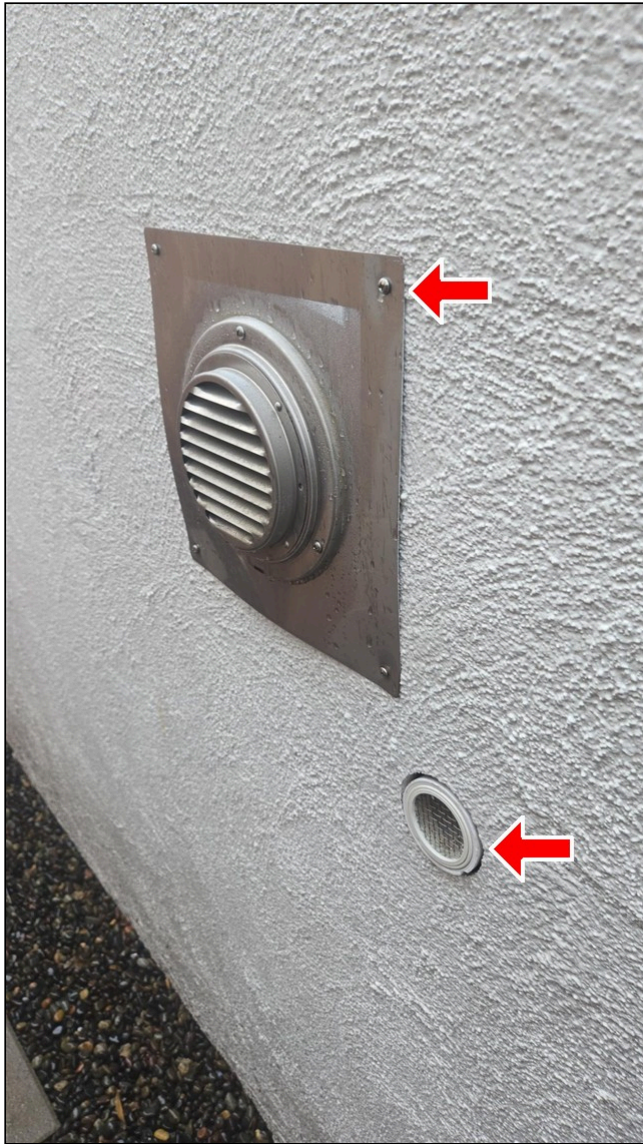
Gaps and missing seals on wall penetrations throughout exterior siding. Recommend a qualified person properly seal exterior wall penetrations as needed.

1.0 Item 1 (Picture) Gaps, missing seal, exterior wall

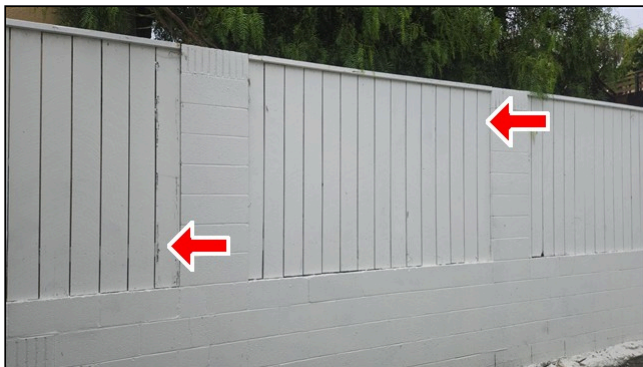
Wood fencing has painted-over wood damage. Recommend a qualified person further inspect for repair or replacement recommendations.

1.5 Item 1 (Picture) Painted-over wood damage, fencing

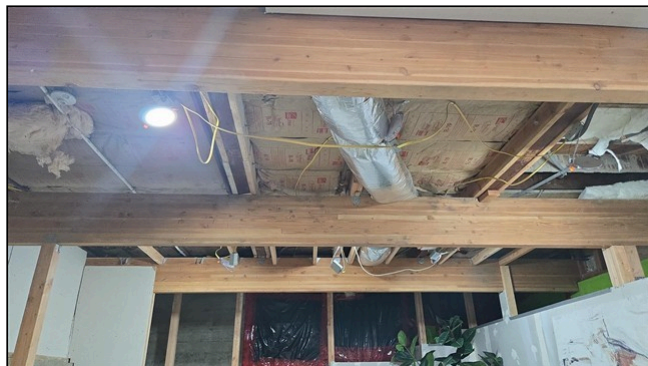
Basement ceiling has not been installed. Recommend a qualified person install drywall and prep and paint as needed.

3.0 Item 1 (Picture) Unfinished ceiling, basement

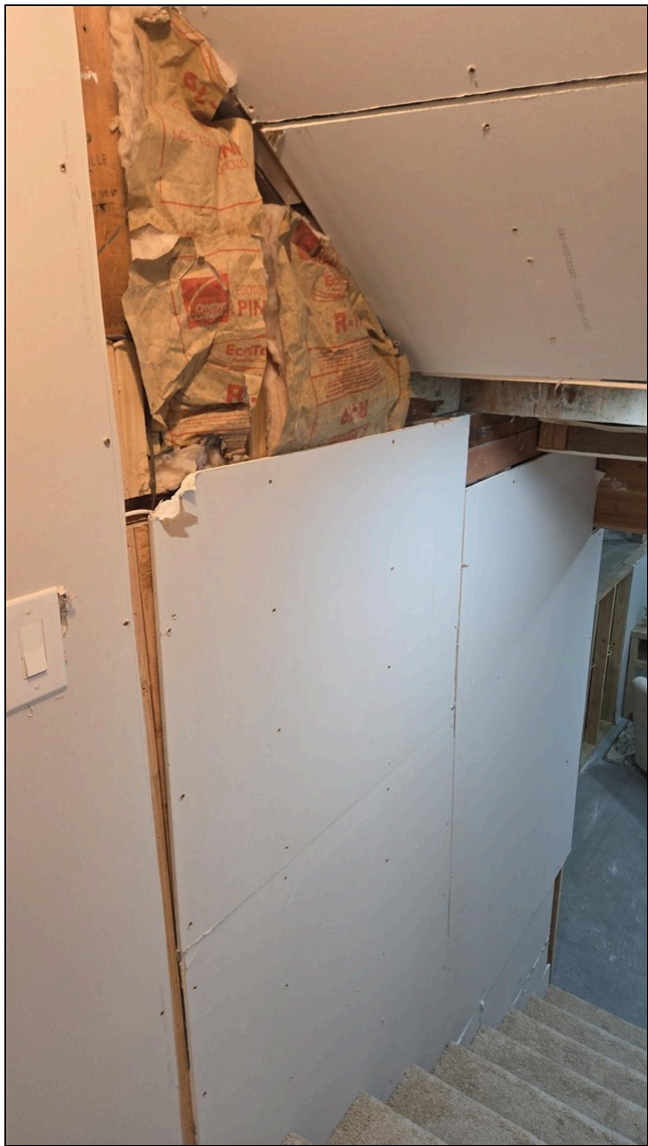
Unfinished walls inside lower level basement. Recommend a qualified person further inspect and patch, prep, and paint unfinished walls as needed.

3.1 Item 1 (Picture) Basement walls, unfinished

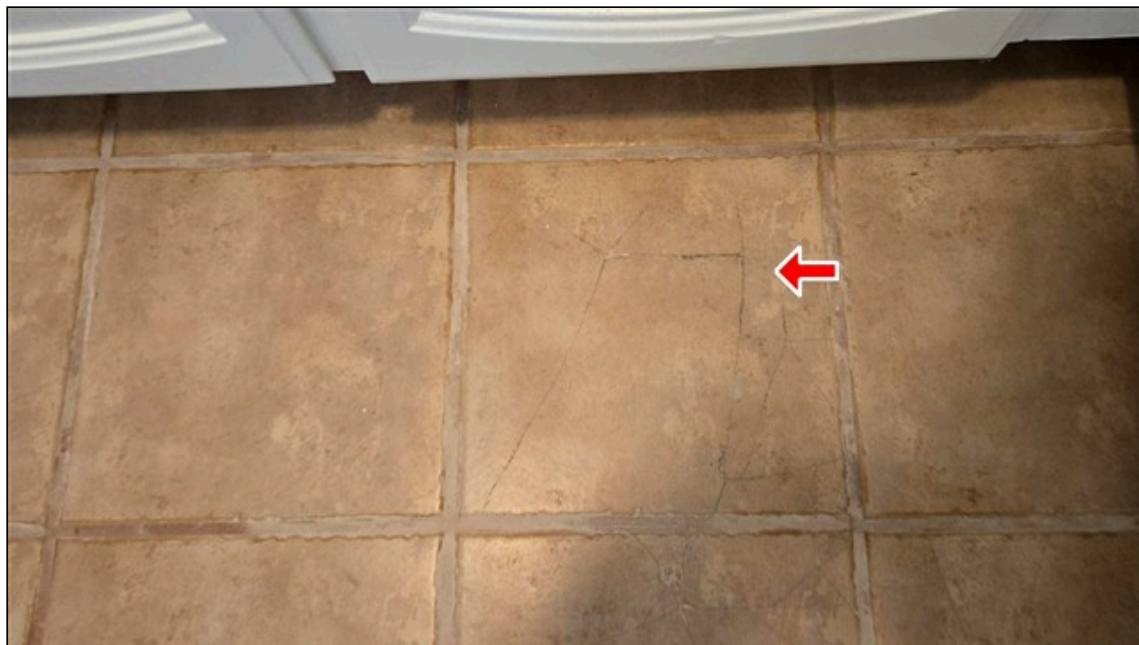
(1) Hairline cracks found on floor tile inside the kitchen. Recommend a qualified person further inspect for repair or replacement recommendations.

3.2 Item 1 (Picture) Kitchen floor tile, hairline cracks

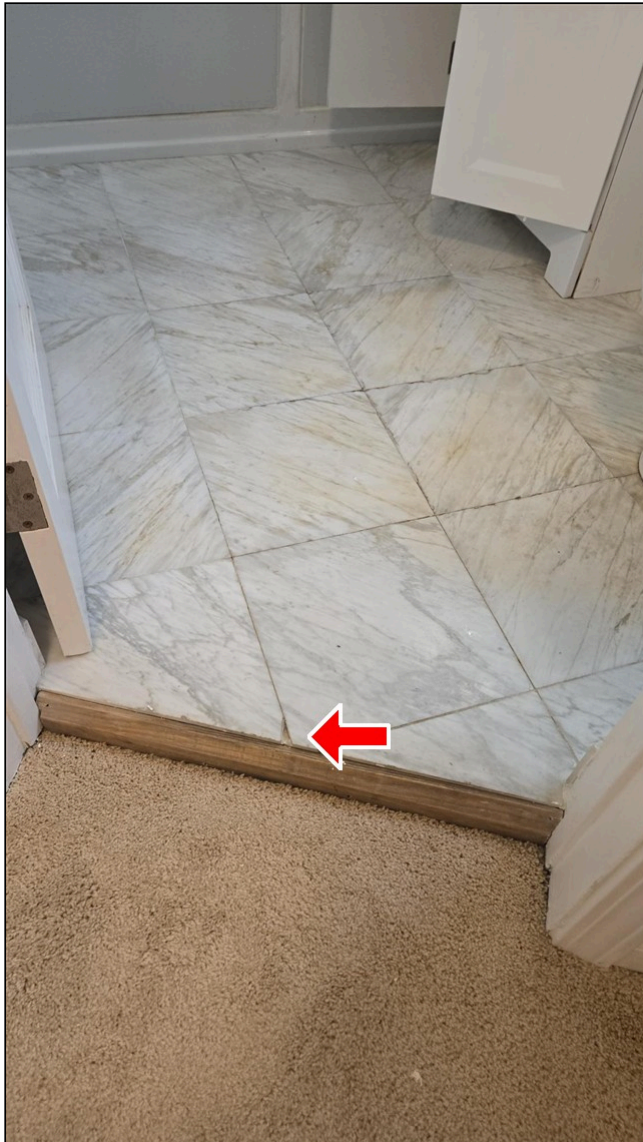
Raised floor surface indicates possible flooring below tile. Inspector does not test, confirm, or remove tile to inspect floor below. This is for your information.

3.2 Item 2 (Picture) Hall bathroom floor tile

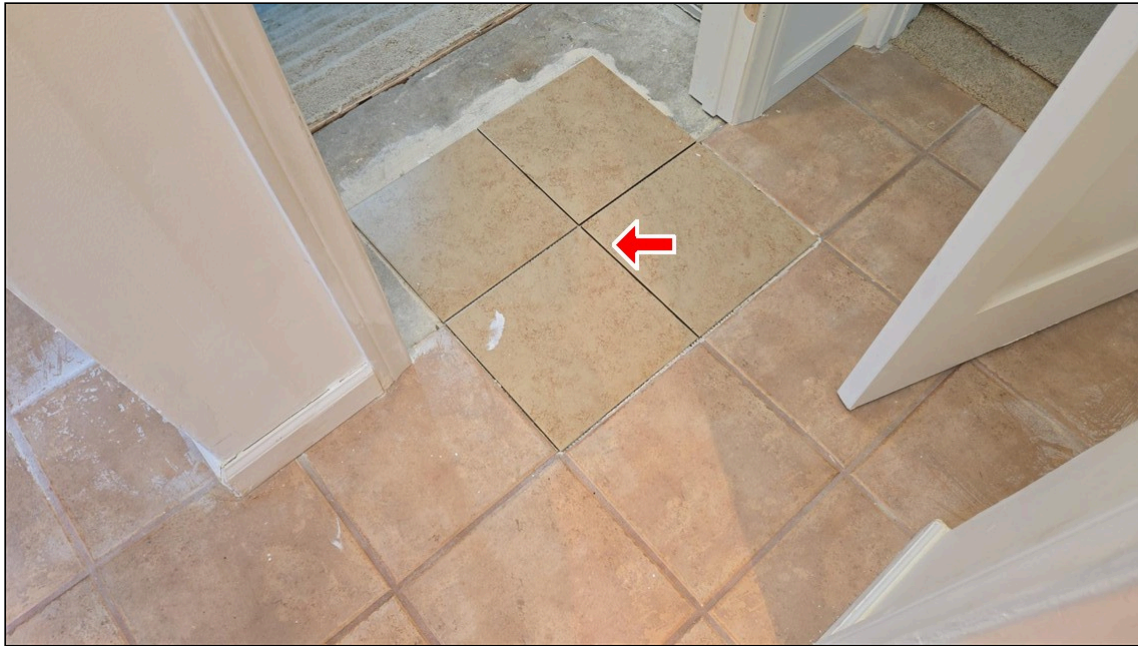
(3) Unfinished floor tile found on lower level surface. Missing grout between replaced tile leading to basement. Recommend a qualified floor specialist further inspect lower level floor tile for repair recommendations.

3.2 Item 3 (Picture) Lower level floor tile

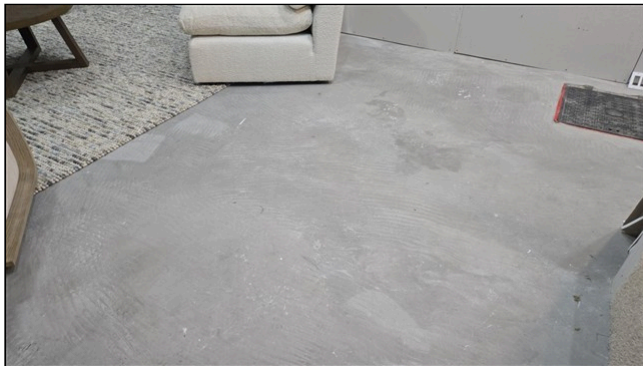
(4) Unfinished concrete flooring found inside basement. Recommend a qualified floor specialist further inspect for installation recommendations.

3.2 Item 4 (Picture) Basement, unfinished flooring

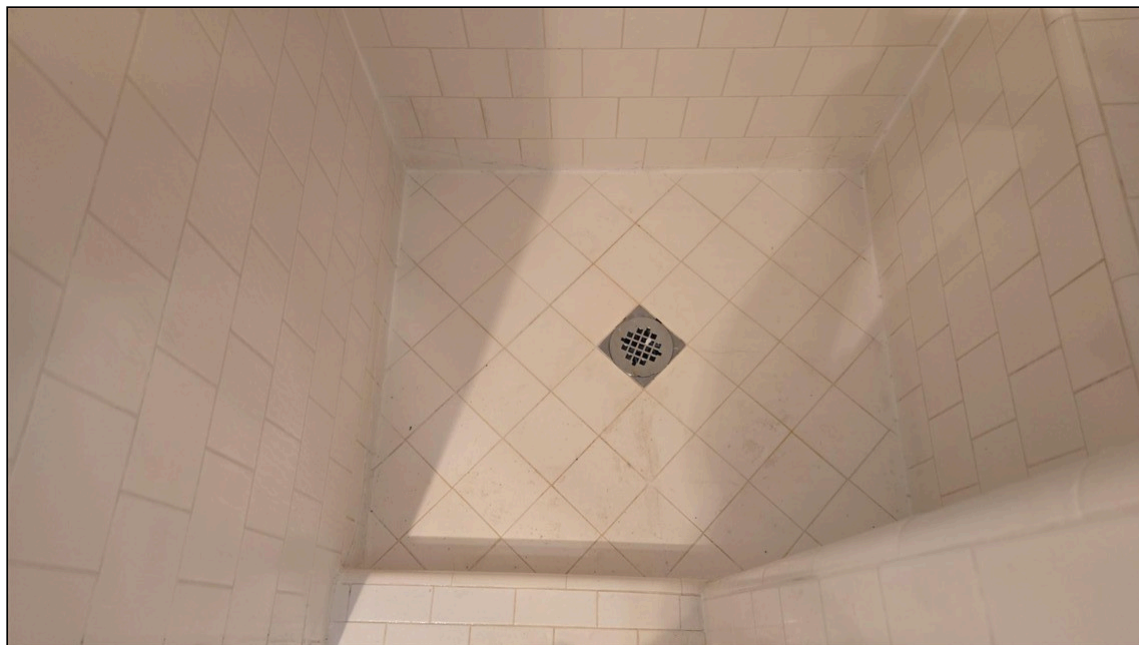
Lower level hall bathroom shower walls have multiple repairs and minor cracking on tile. Heavy seals are present. Recommend a qualified person further inspect lower level bathroom shower walls for repair or replacement recommendations.

3.3 Item 1 (Picture) Lower level hall bath shower walls

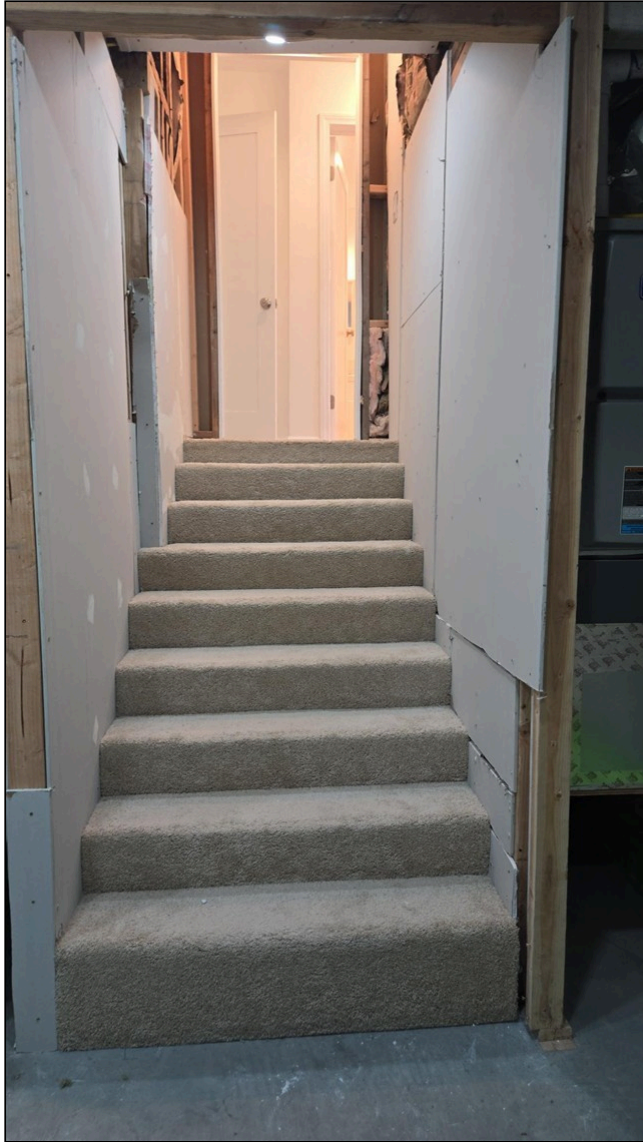
Stairwell leading to basement is missing a graspable handrail on either side of stairwell. Recommend a qualified person further inspect and install proper handrail as needed.

3.4 Item 1 (Picture) Missing handrail, basement stairwell

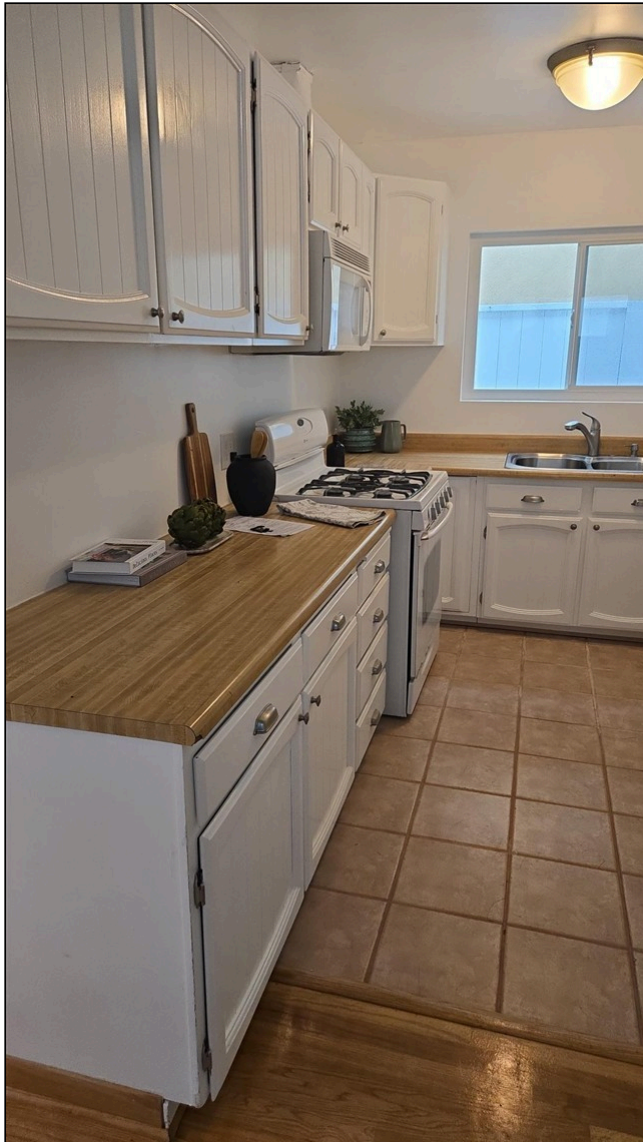
Kitchen and bathroom cabinets and counter tops are dated and have normal wear and tear. Recommend a qualified person further inspect for repair recommendations.

3.5 Item 1 (Picture) Kitchen cabinets/  
countertops

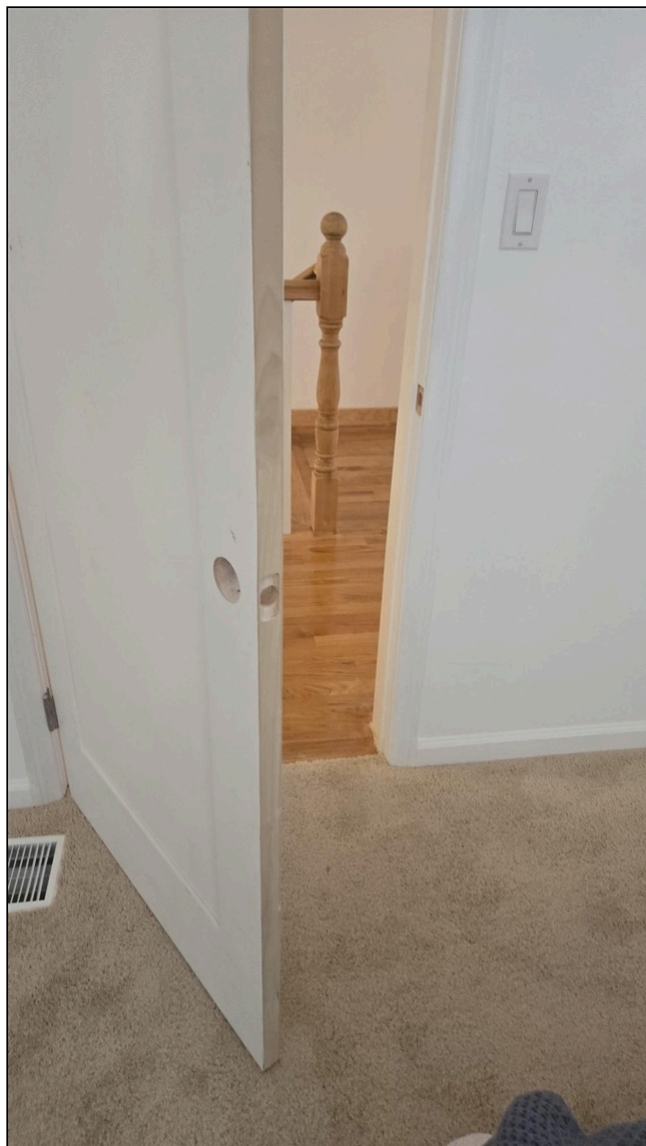
(1) Main level bedroom entry door is missing handle and latch plate. Recommend a qualified person further inspect for repair or installation recommendations.

3.6 Item 1 (Picture) Main level bedroom entry door

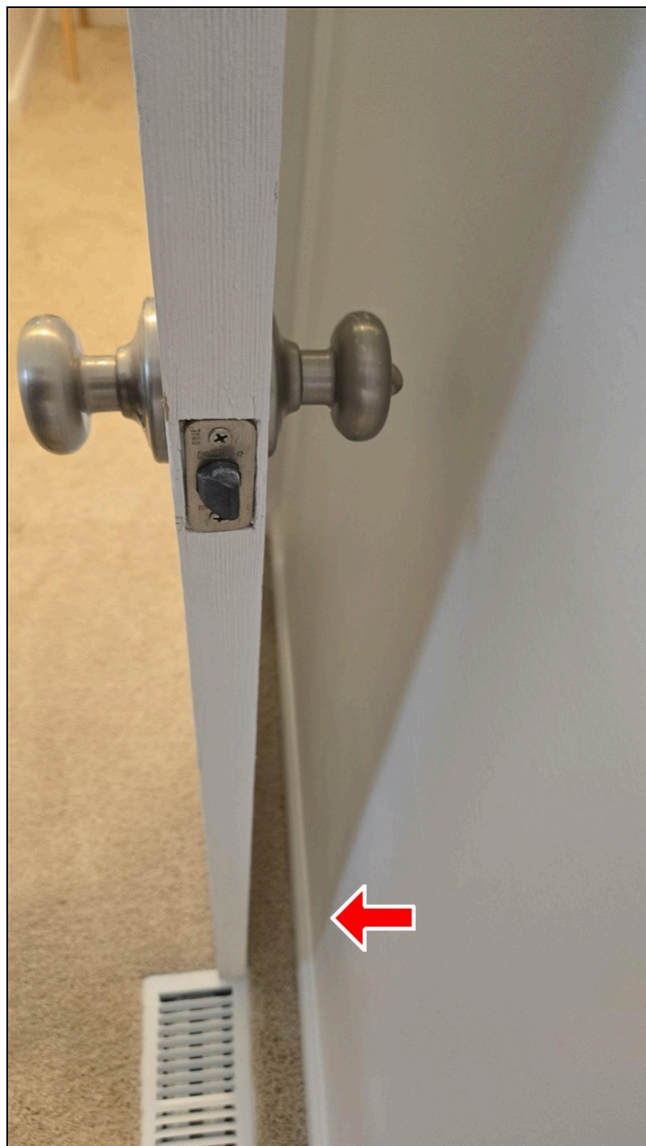
(2) Interior doors throughout home do not have door stops installed. Doors open and make contact with walls. Recommend installing door stops to prevent contact with walls and damage to walls. Install as needed.

3.6 Item 2 (Picture) Missing door stop

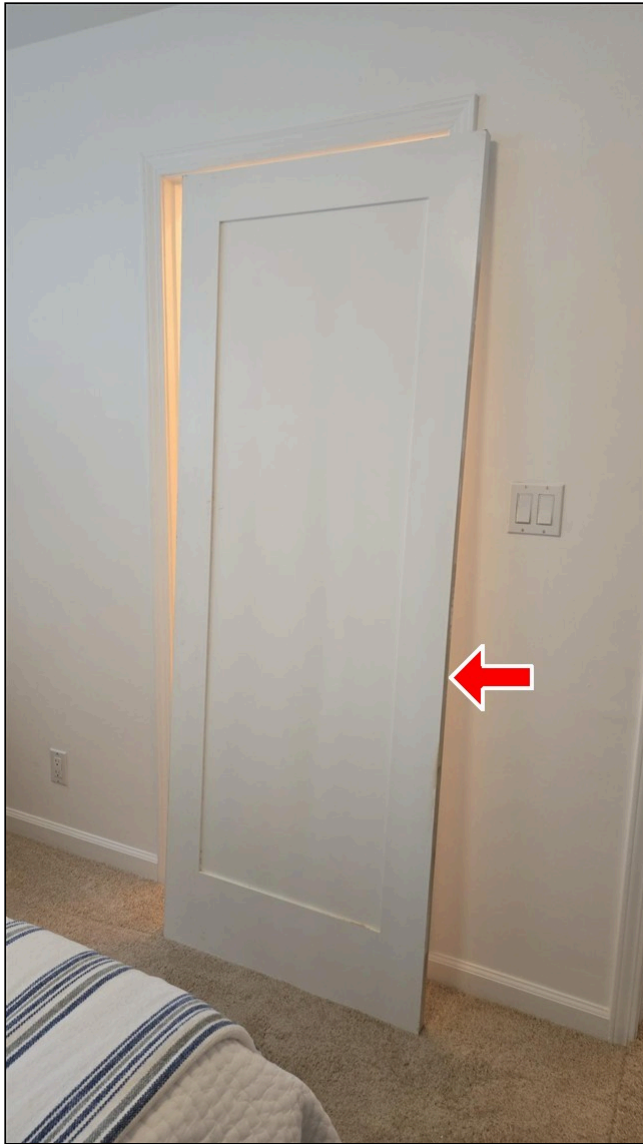
(3) Closet door for lower level bedroom was not installed at time of inspection. Recommend a qualified person install door properly as needed.

3.6 Item 3 (Picture) Lower level bedroom closet door

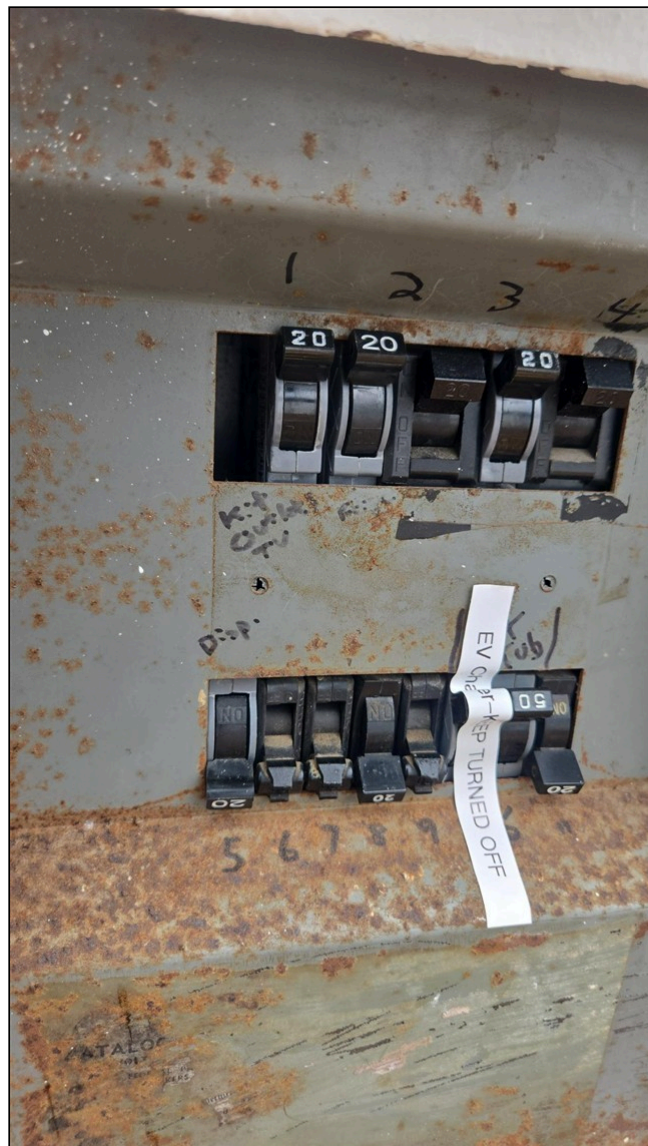
(1) Panel is missing circuit breakers creating gaps that could allow foreign objects to enter behind circuit breaker cover panel. Recommend a qualified electrician further inspect and install knockout covers on open slots as needed.

4.2 Item 1 (Picture) Missing labels, main distribution panel

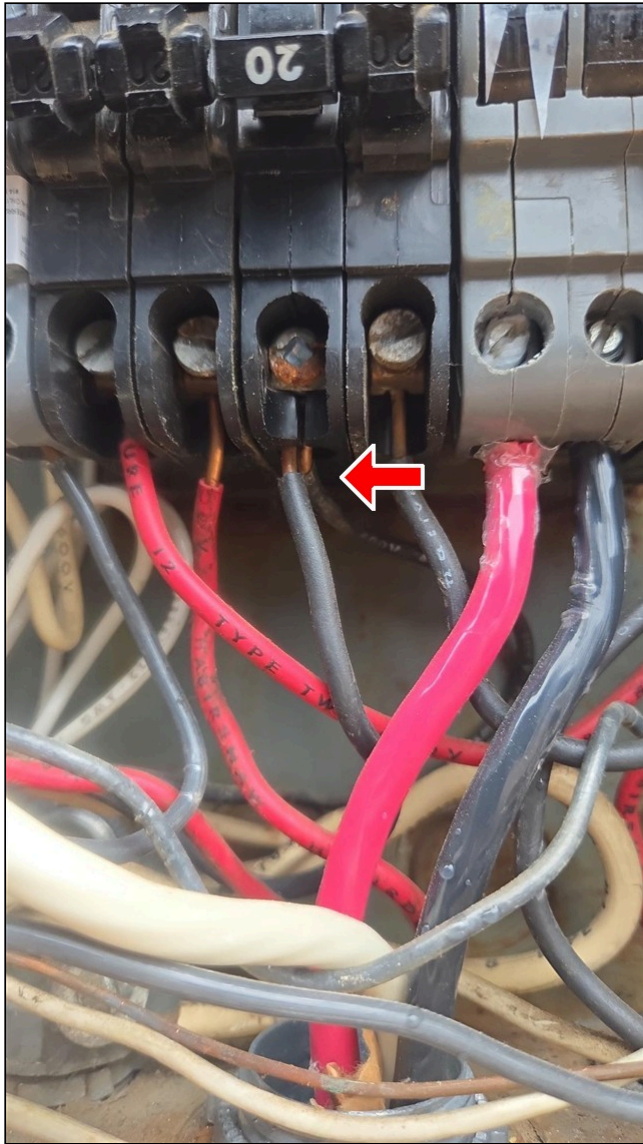
(1) Double tapped breaker located inside distribution panel. This occurs when two wires are connected to one breaker. This may cause wires to over heat and expand, which could cause wires to become loose and possibly arc. Recommend a qualified electrician connect wires in a "pigtail" or add additional breaker. Repair as needed.

#### 4.3 Item 1 (Picture) Double tapped breaker

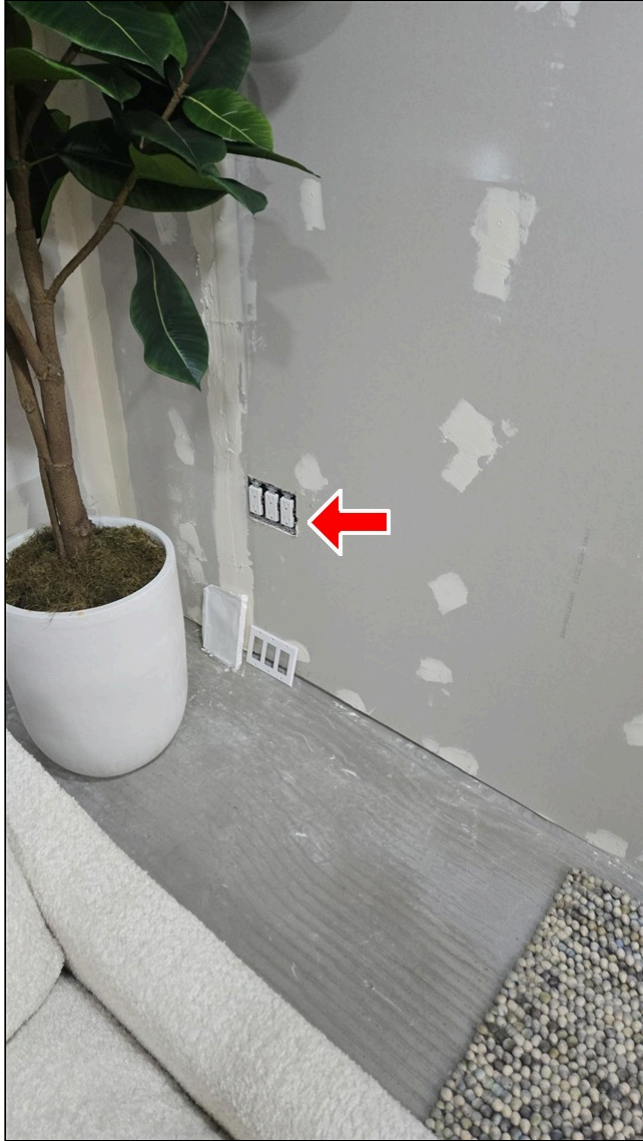
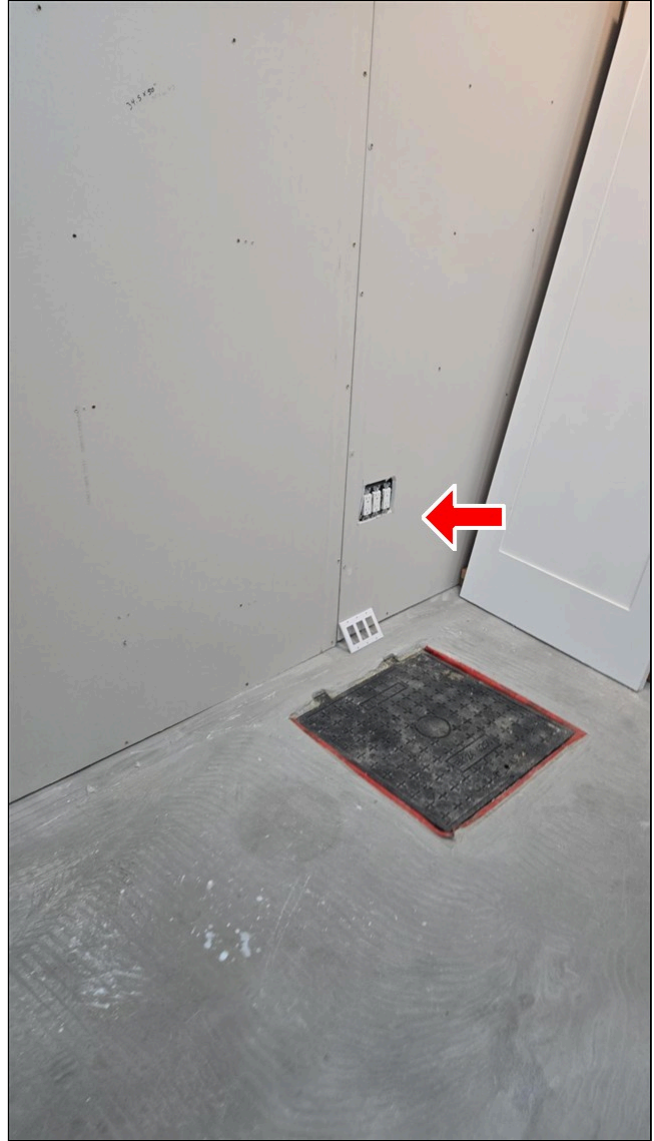
Missing cover plates on multiple light switches and outlets throughout basement. Recommend installing cover plates as needed.

4.4 Item 1 (Picture) Missing cover plates, basement

4.4 Item 2 (Picture) Missing cover plates, basement

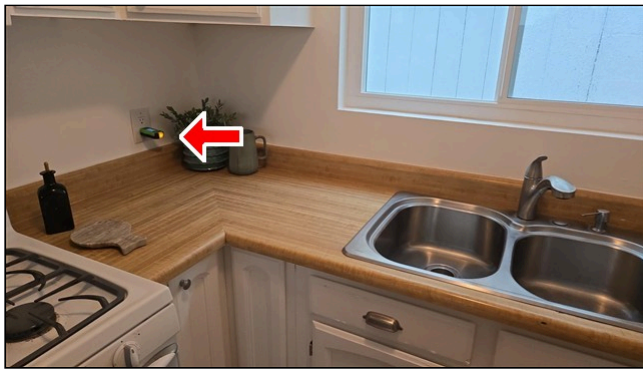
4.5 Item 1 (Picture) Left kitchen sink outlet

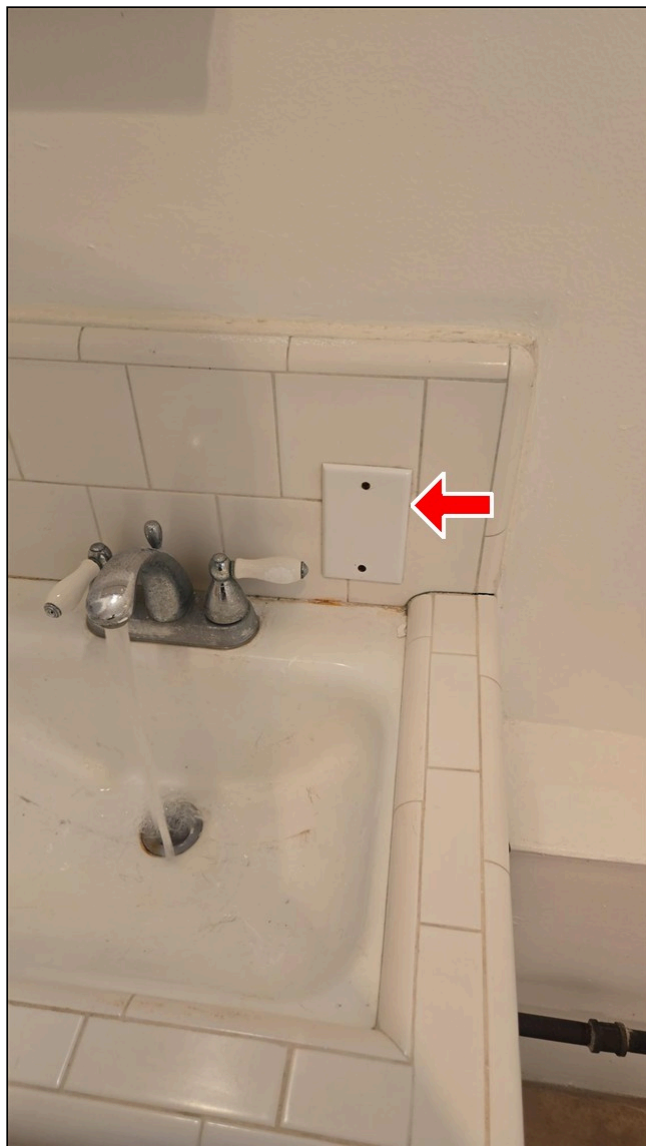
(2) There was no outlet present in lower hall bathroom (washer and dryer outlet is present at laundry area). Recommend a proper GFCI outlet be installed by a qualified electrician.

4.5 Item 2 (Picture) Missing GFCI outlet, lower level hall bathroom

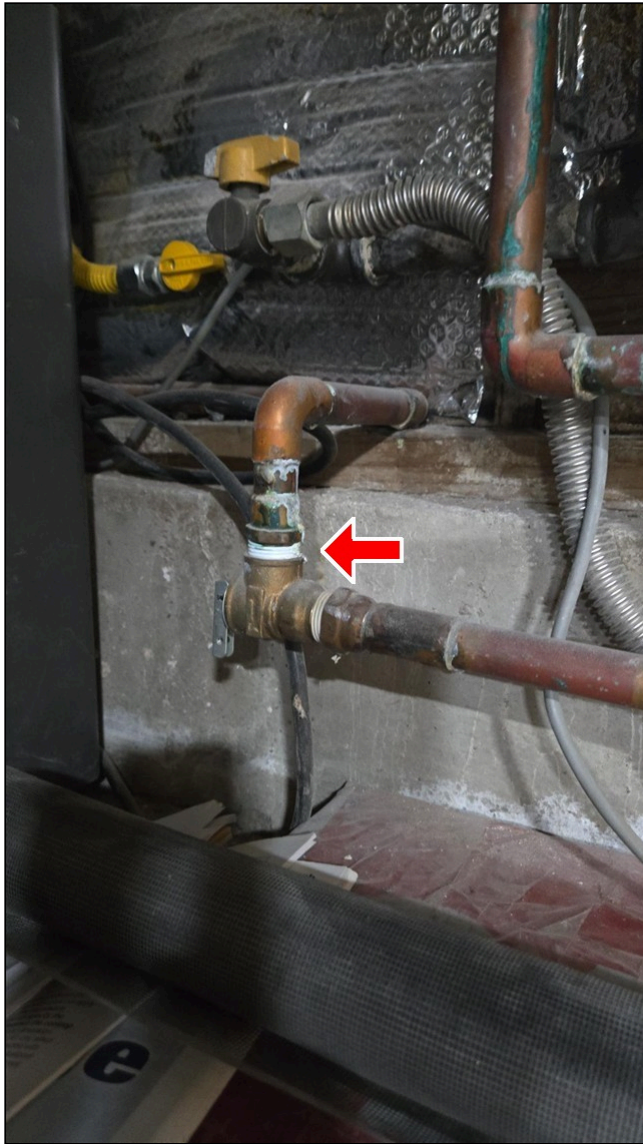
5.2 Item 5 (Picture) TPR valve, water heater

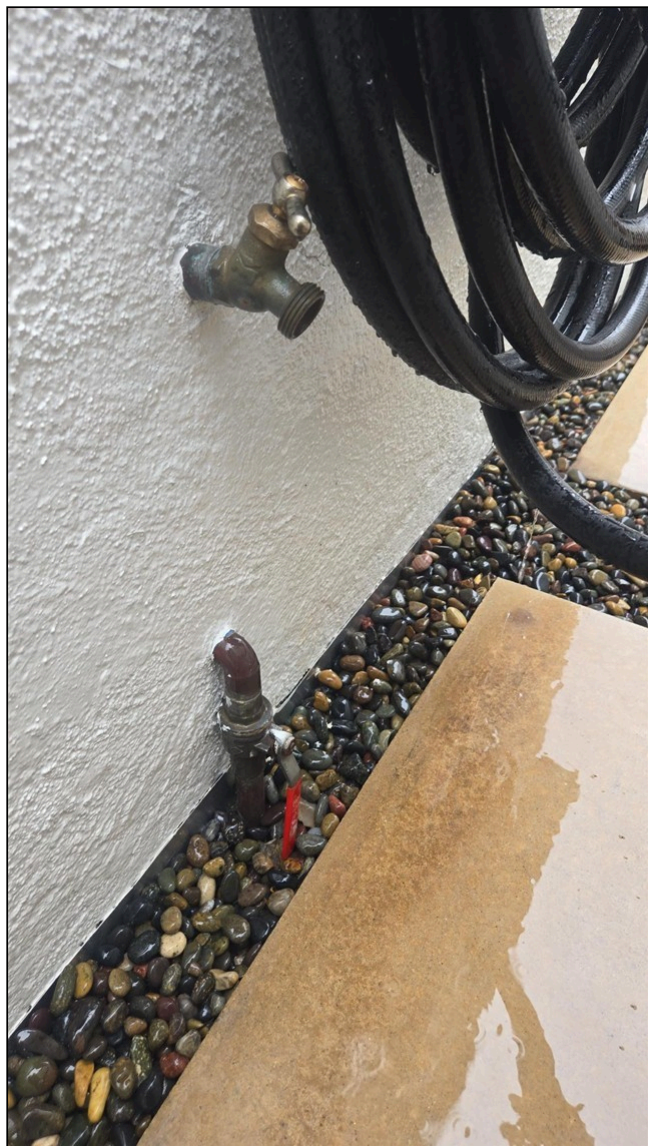
5.3 Item 1 (Picture) Missing anti-siphon valve

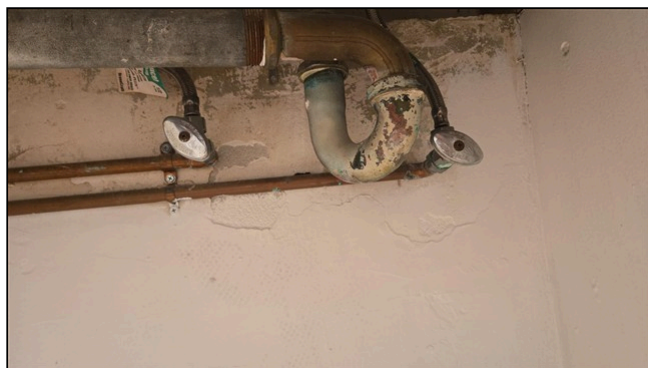
5.4 Item 1 (Picture) Dated angle valves, lower level hall bathroom

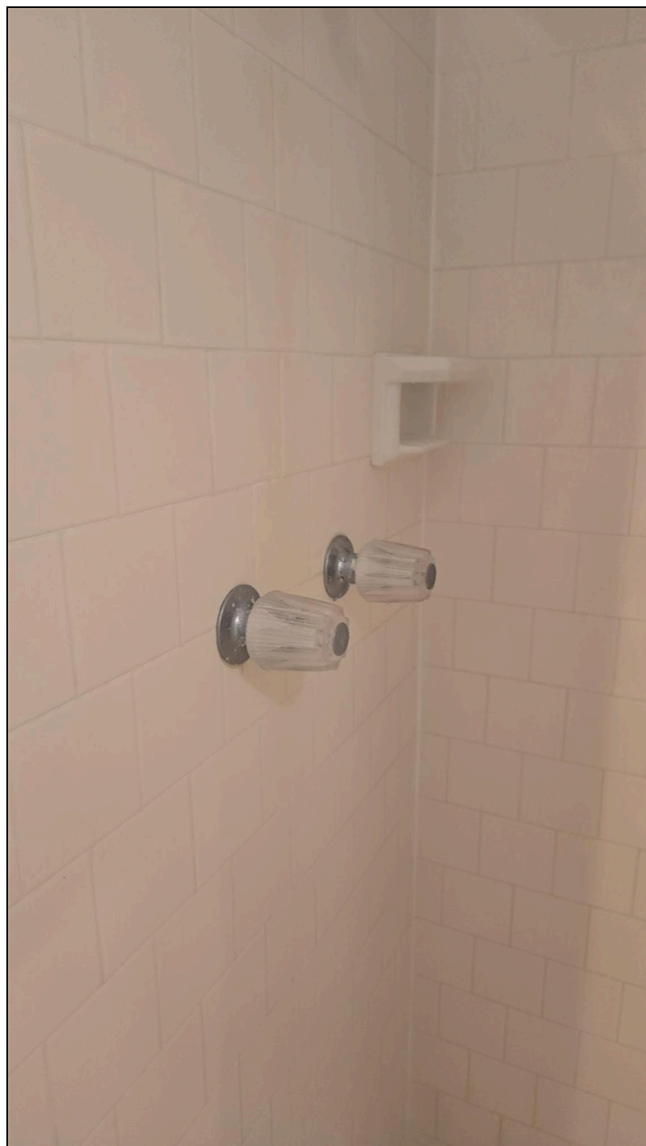
5.4 Item 3 (Picture) Dated water supply, lower level hall bathroom

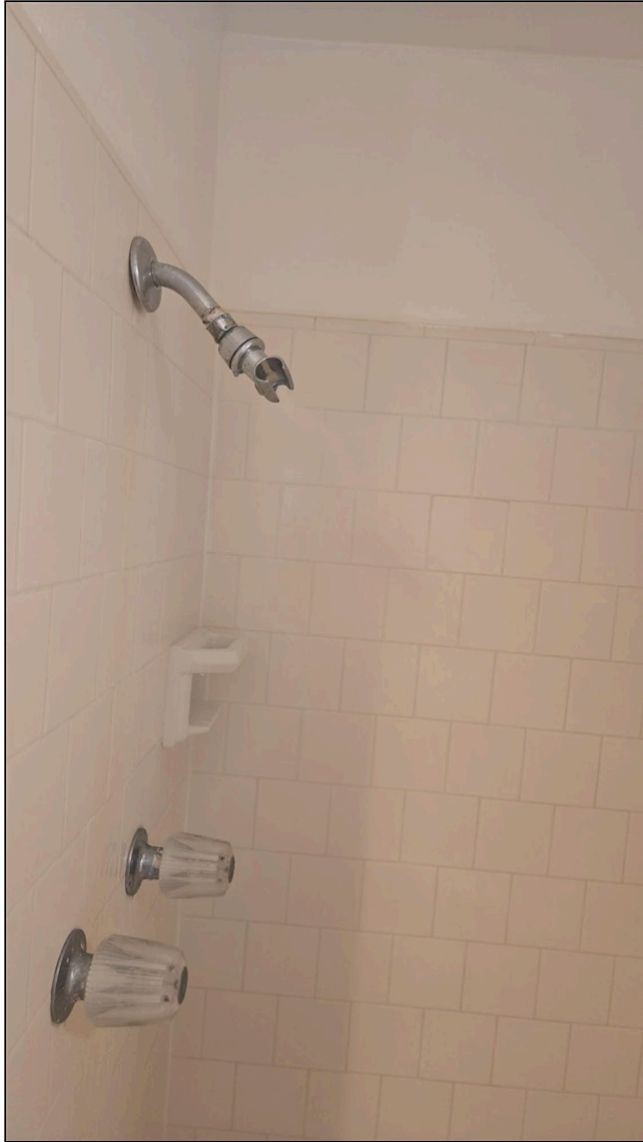
5.4 Item 4 (Picture) Lower level bathroom shower head missing

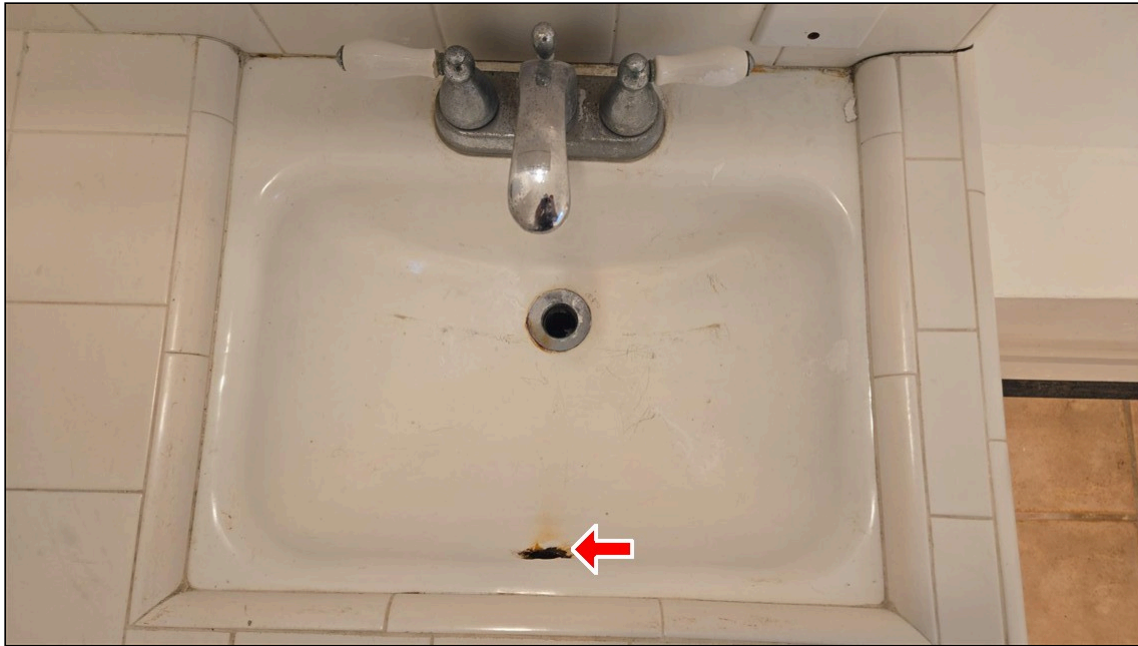
5.5 Item 1 (Picture) Lower level hall bathroom sink

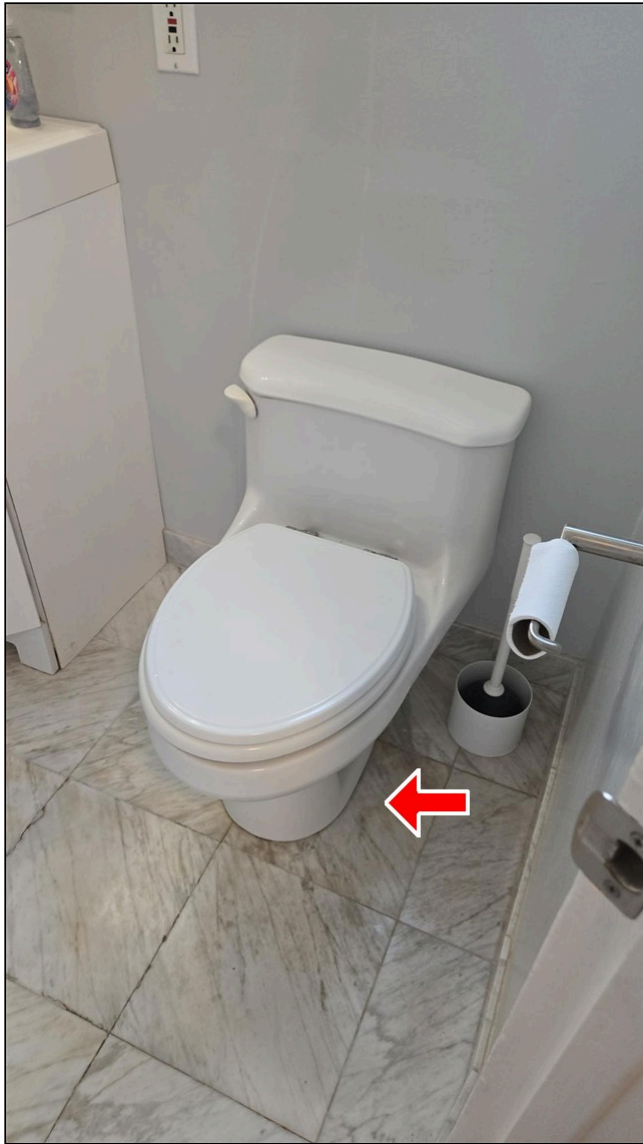
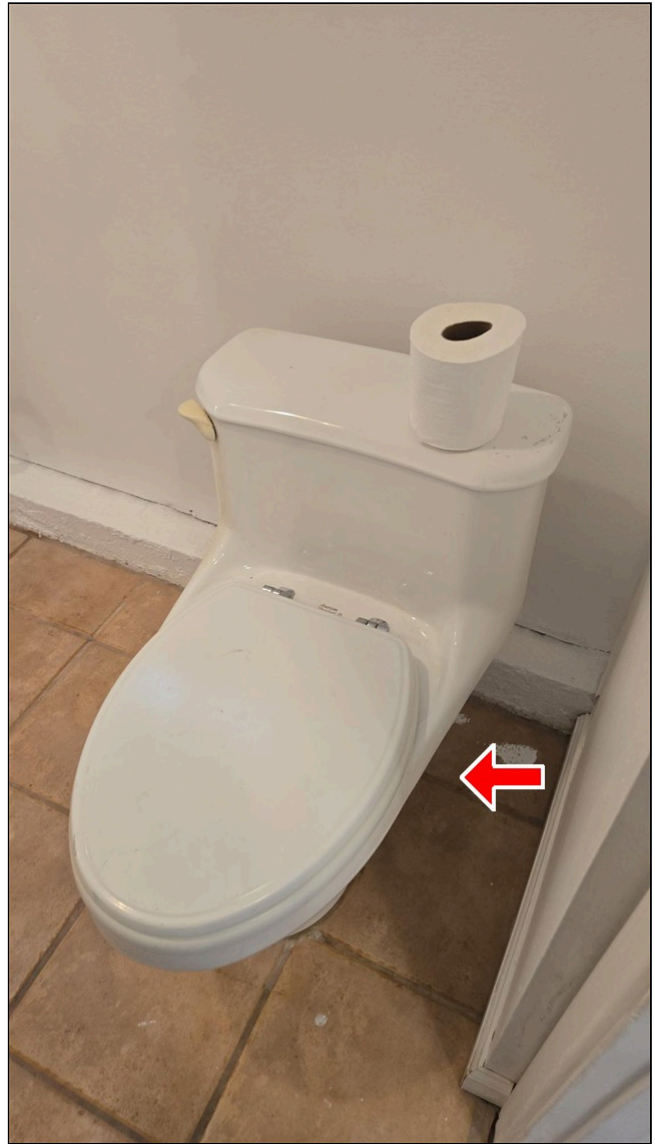
5.6 Item 1 (Picture) Loose toilet, upper hall bathroom

5.6 Item 2 (Picture) Loose toilet, lower level hall bath

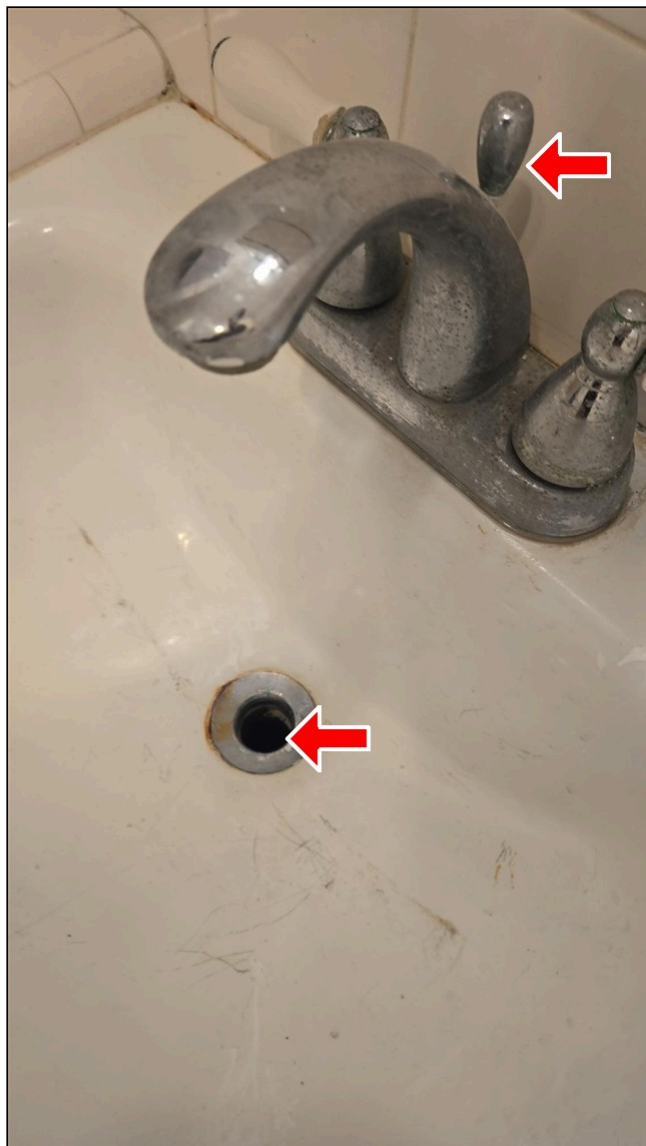
5.6 Item 3 (Picture) Missing drain stop, lower level hall bathroom sink

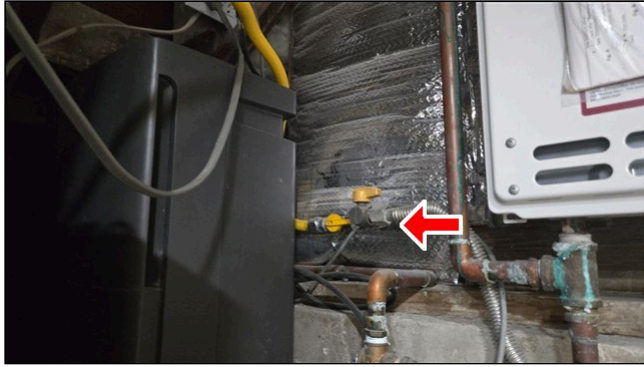
5.7 Item 1 (Picture) Heat system/water heater gas line

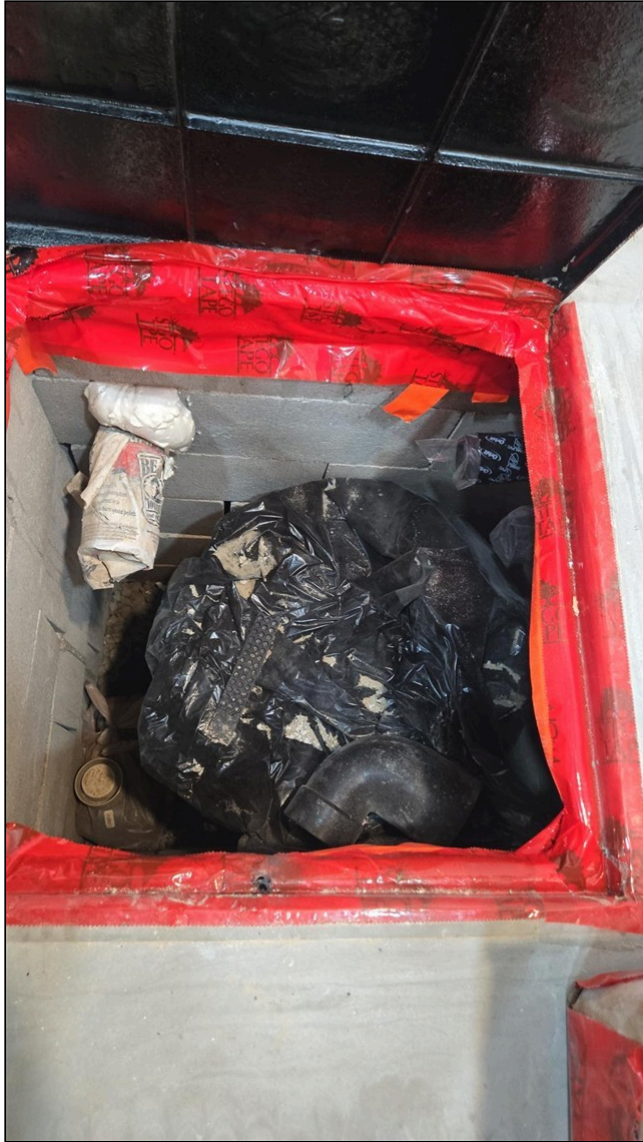
5.8 Item 1 (Picture) Injection/sump pump location, basement

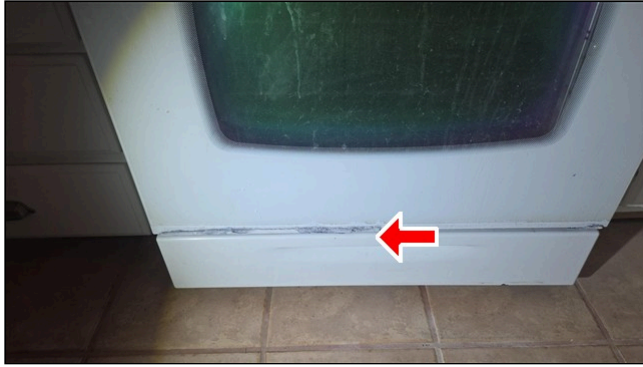
6.1 Item 1 (Picture) Oven door, rust and deterioration

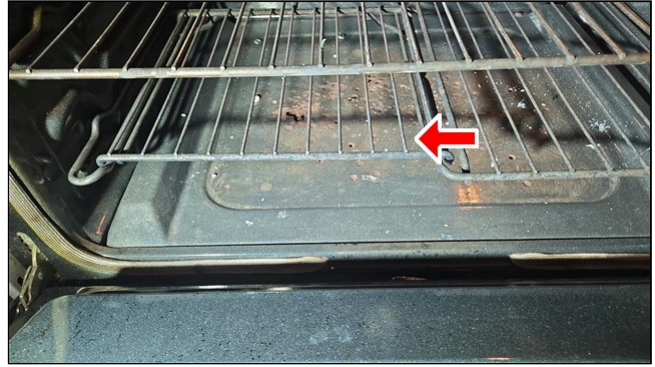
6.1 Item 2 (Picture) Oven panel, rust and deterioration
