# Titus Inspections

# Inspection Report

**Property Address:**  
1287 7th St  
Hermosa Beach CA 90254

| <b>Property Address</b><br>1287 7th St<br>Hermosa Beach CA 90254 | <b>Date of Inspection</b><br>10/14/2025 | <b>Report ID</b><br>251014-01 |

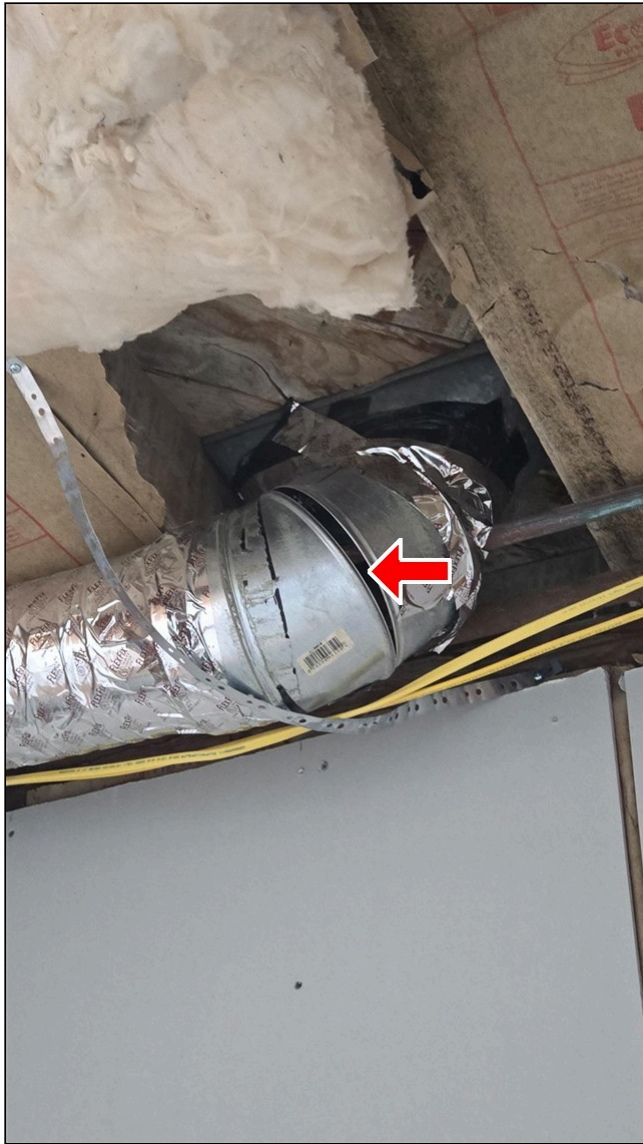
7.3 Item 1 (Picture) Detached ducting, basement
