SUMMARY

28709 Rothrock Dr, Rancho Palos
Verdes, CA 90275
Mustafa & Insiyya Tapiya, Motiwala
04/02/2026

Michael Boeger
ASHI, CREIA, NACHI
Equity Building Inspection
310-540-0200
inspmike@gmail.com

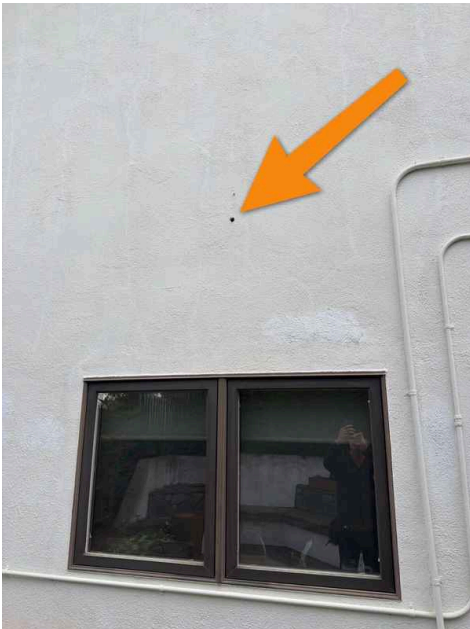
3.2.1 Stucco

STUCCO - GAPS OR HOLES

LEFT SIDE

There was a gap or hole in the stucco siding. This can lead to water infiltration. We recommend repair.

Contact a qualified professional.

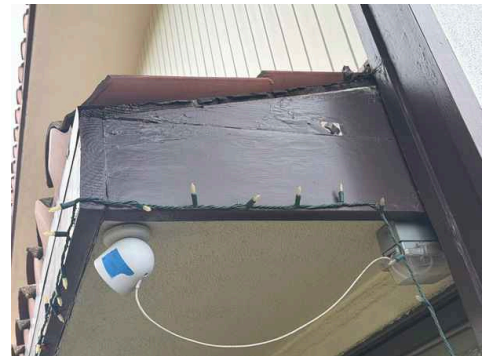
3.4.1 Trim and Flashing
TRIM - DAMAGED

FRONT

Areas of the building trim are damaged. I recommend having these areas evaluated and repaired/replaced as necessary by a licensed contractor. Please see your termite report for possible further information.

Recommendation
Contact a qualified siding specialist.

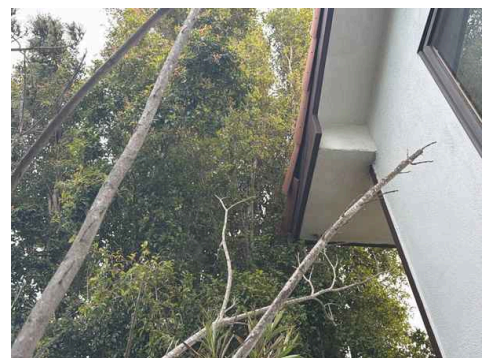
4.4.1 Vegetation
VEGETATION - OVERHANGING THE ROOF

Tree branches were overhanging the roof in areas. Branches overhanging the roof can cause leaves to clog gutters, branches could fall and cause damage, and critters can use branches to get onto the home. I recommend having the overhanging trees evaluated and addressed as necessary.

Recommendation
Contact a qualified tree service company.

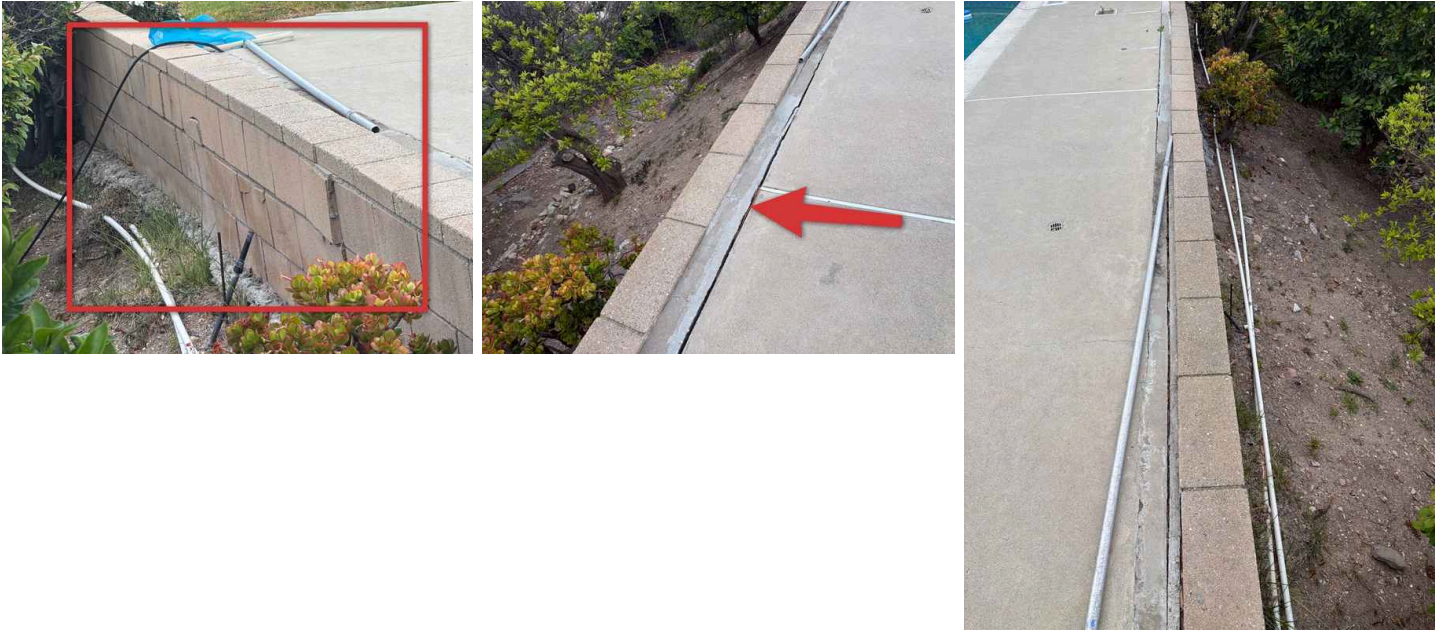
4.12.1 Retaining walls
RETAINING WALL - FAILING/LEANING

Areas of the retaining wall appeared to be failing/leaning. I recommend having the wall evaluated and repaired as necessary by a licensed contractor or structural engineer prior to closing.

Recommendation
Contact a qualified landscaping contractor

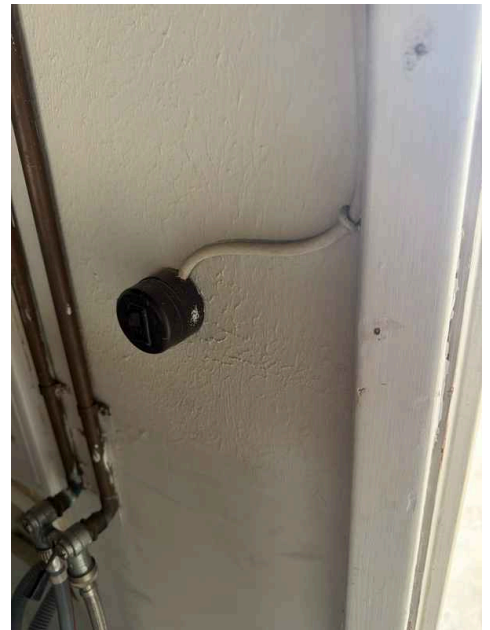
5.5.1 Branch Wiring
EXPOSED WIRING

GARAGE

Electrical wiring discovered without proper conduit protection. This creates potential shock and fire hazards. Electrical wiring must be enclosed in appropriate conduit to prevent accidental contact and reduce risk of electrical incidents.

Recommendation
Contact a qualified professional.

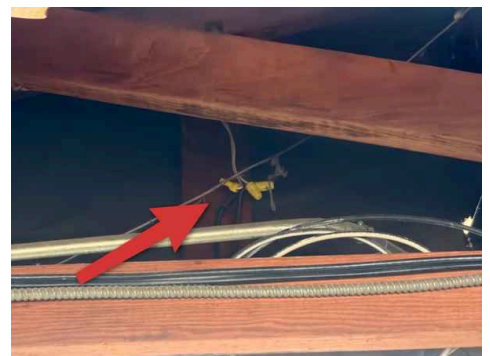
5.5.2 Branch Wiring
WIRING - OPEN SPLICED

GARAGE

Open spliced wiring was observed in areas. This is not a safe method to connect wiring, therefore I recommend having this evaluated and repaired as necessary by a licensed electrician.

Recommendation
Contact a qualified electrical contractor.

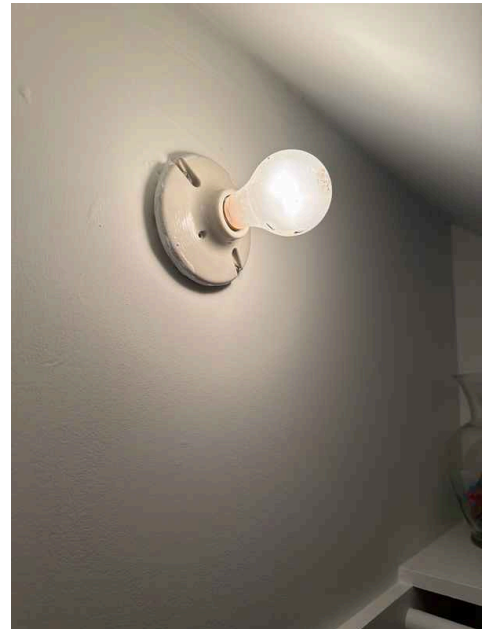
5.8.1 Lighting

LIGHT FIXTURE - MISSING GLOBE - CLOSET

UNDER STAIRS

The light fixture(s) in the closet(s) is missing a globe or cover as required. I recommend having it repaired or replaced.

Contact a qualified professional.

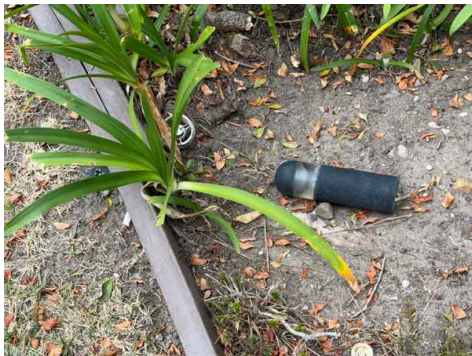
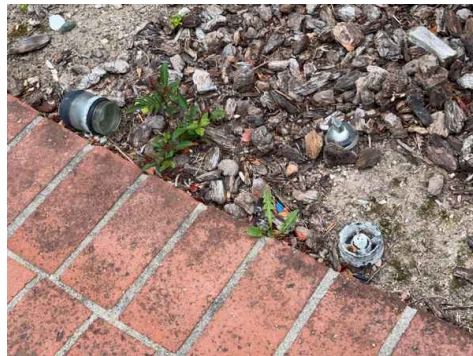
5.8.3 Lighting

LIGHT FIXTURE - IN NEED OF REPAIR

EXTERIOR /NUMEROUS

The light fixture(s) is in need of repair. I recommend having this evaluated and repaired/replaced as necessary by a licensed electrician.

Contact a qualified electrical contractor.

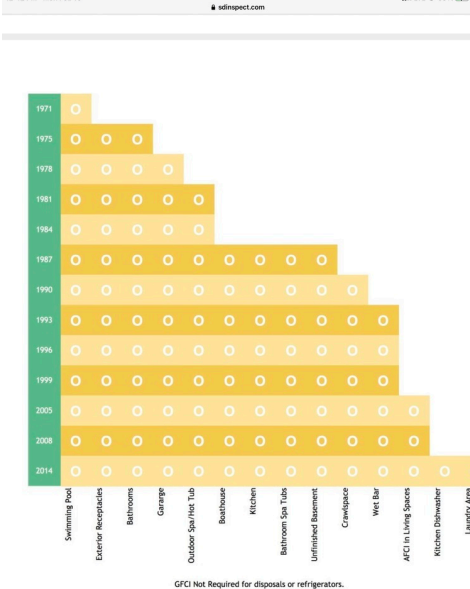
5.12.1 GFCI & AFCI

GFCI PROTECTION NOT INSTALLED

GARAGE, LAINDRY

The receptacle(s) was not GFCI protected at the following areas. Although, these receptacles may not have been required at the original time of construction, we highly recommend they be installed in order to protect against electrical shock. Note: Anytime you upgrade or remodel an area, that area shall conform to the current building standard.

Contact a qualified electrical contractor.

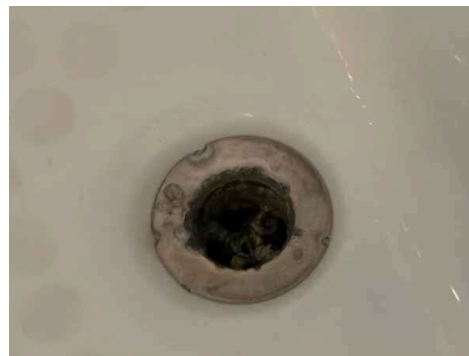
6.4.1 Drain, Waste, & Vent Systems

DRAIN STOP DEFECTIVE

2ND FLOOR HALL BATHROOM

The drain stop is either defective for missing. We recommend further inspection and repair or replacement. Clcik [HERE](#) for information on how to easily repair your drain stop.

Recommendation
Contact a qualified handyman.

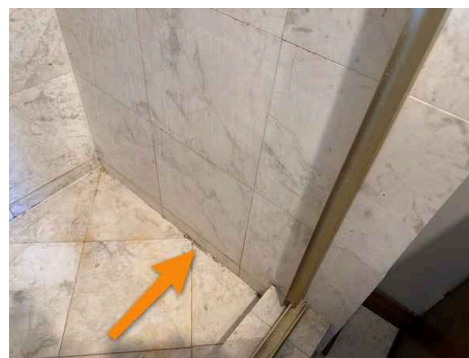
6.10.1 Shower

POOR CAULK CONDITION

BATHROOM

The caulk in the shower is deteriorated or failing. Compromised caulk allows water to penetrate behind fixtures and into wall cavities, potentially causing water damage, mold growth, and structural deterioration. The caulk should be removed and replaced with fresh, waterproof material to restore a proper water-tight seal. (same in hallway bathtub)

Recommendation
Contact a qualified professional.

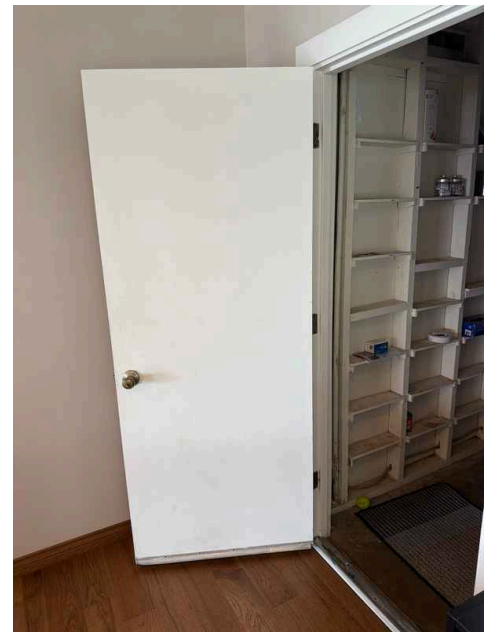
9.3.1 Occupant Doors

SELF-CLOSING DEVICE NEEDS REPAIR OR REPLACEMENT

The garage entry door does not self close and self latch as required. We recommend repair.

Recommendation
Contact a qualified professional.

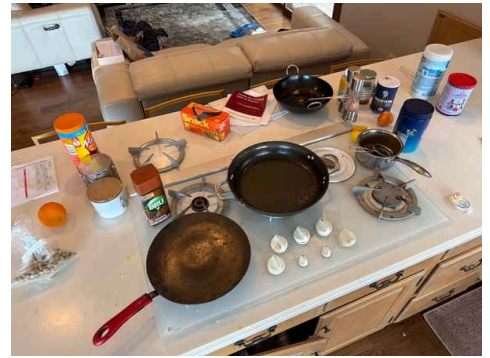
11.5.1 Cooktop

COOKTOP - BURNER NOT OPERATING

The burner(s) were not functioning. I recommend having this evaluated and repaired/replaced as necessary by a qualified appliance repair technician.

Contact a qualified appliance repair professional.

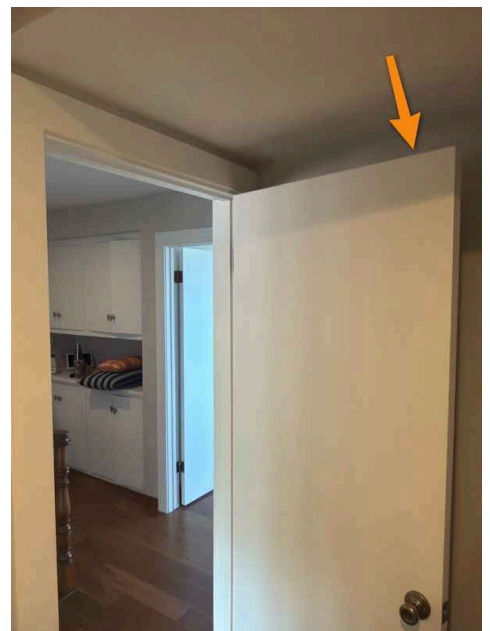
12.3.2 Doors

DOOR RUBS

2ND FLOOR RIGHT SIDE BEDROOM

The entry door rubs when operated. We recommend sanding the door for proper operation.

Contact a qualified professional.

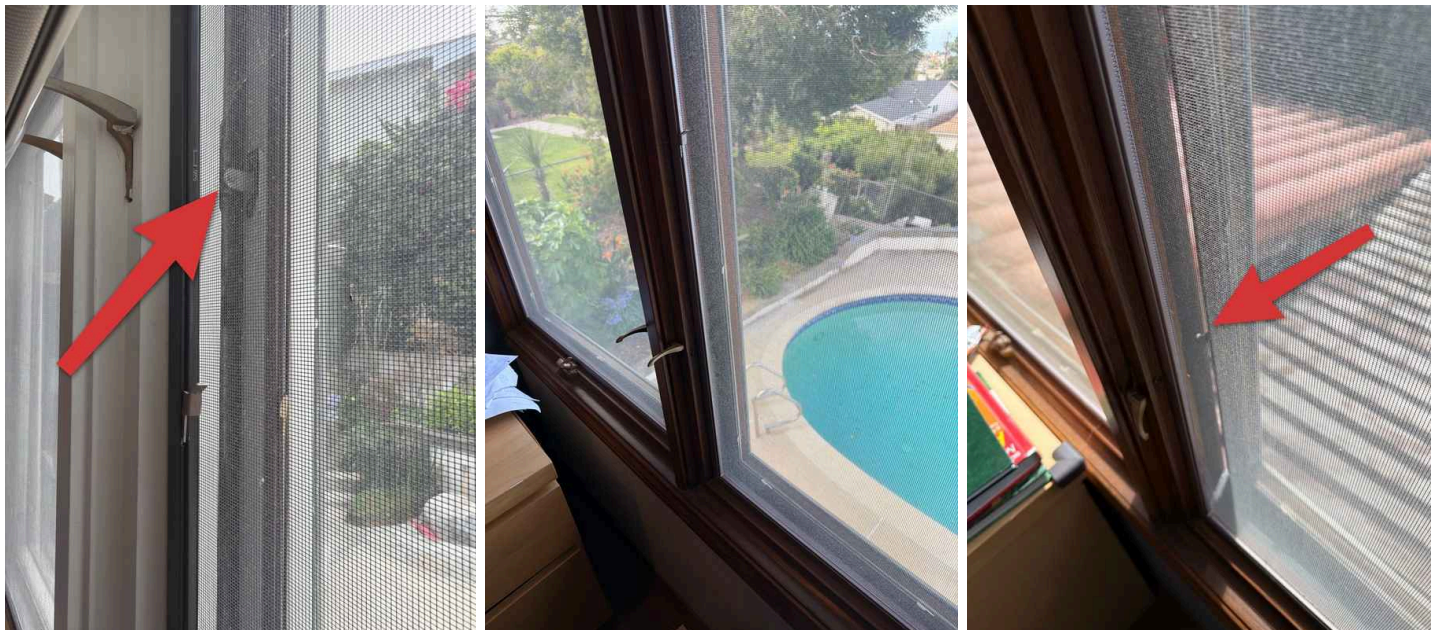
12.4.1 Windows

CASEMENT WINDOW - DOESN'T CLOSE PROPERLY

KITCHEN, UPPER BATHROOMS

One or more casement windows did not close properly. When cranking the window, the window did not close without being pushed from the outside. I recommend having this evaluated and repaired/replaced as necessary by a licensed window contractor prior to closing.

Contact a qualified window repair/installation contractor.

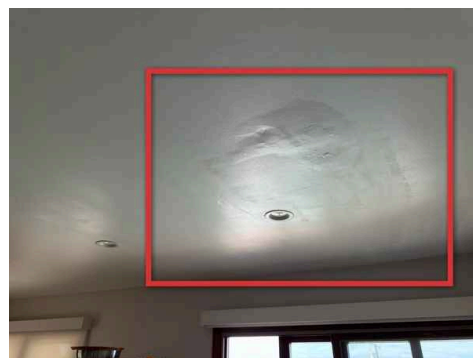
12.7.1 Ceilings

ACTIVE MOISTURE - CONFIRMED WITH A MOISTURE DETECTOR

KITCHEN

A thermal anomaly was observed with a thermal camera. The area was tested with a moisture detector, which showed that there was elevated levels of moisture present. I recommend having the area evaluated and addressed as necessary by a licensed contractor.

Recommendation
Contact a qualified professional.

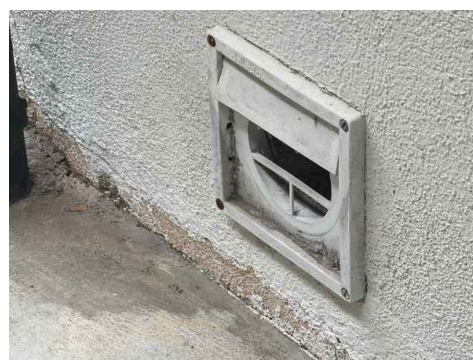
13.9.1 Dryer Vent

NO FLAP

The dryer vent lacks a proper flap at the exterior. We recommend repair.

Recommendation
Contact a qualified professional.

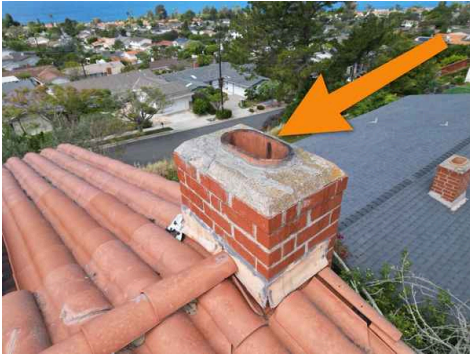
14.9.1 Chimneys & Other Roof Penetrations

NO RAIN CAP/SPARK ARRESTOR

The rain cap and or spark arrestor was missing from the chimney. We recommend repair.

Recommendation
Contact a qualified professional.

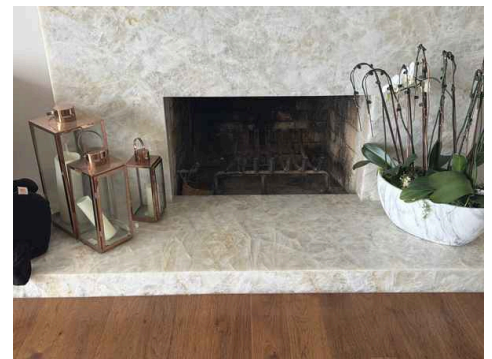
16.2.2 Masonry Wood Burning Fireplace

MISSING DOORS

The fireplace is missing its glass doors or a screen. This is a safety issue and should be installed prior to use.

Contact a qualified professional.

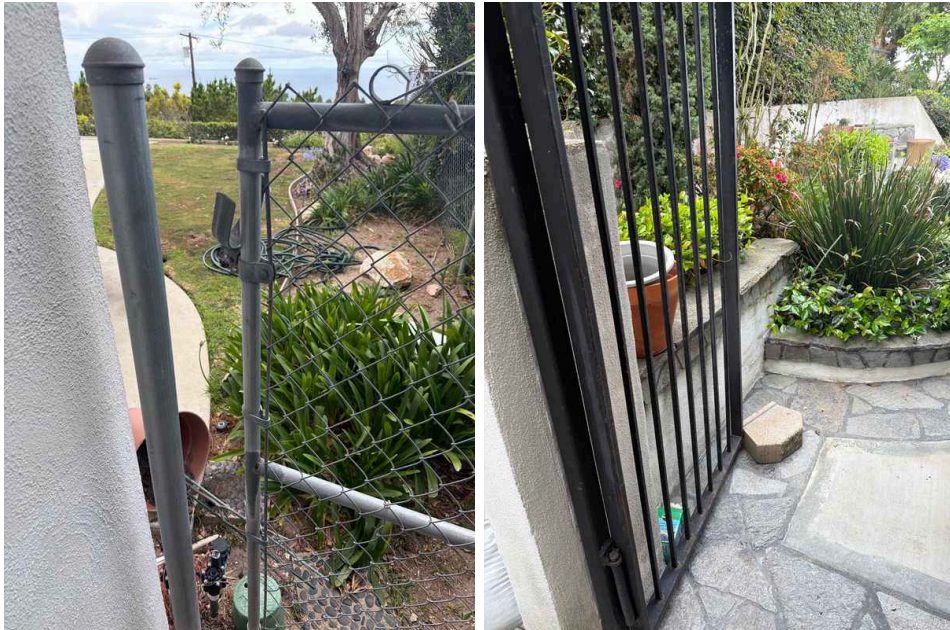
18.3.3 Safety Devices:

GATES OPEN INTO PROPERTY

One or more of the gates push into the property, as opposed to away from it as required. We recommend further inspection and repair.

Recommendation
Contact a qualified professional.

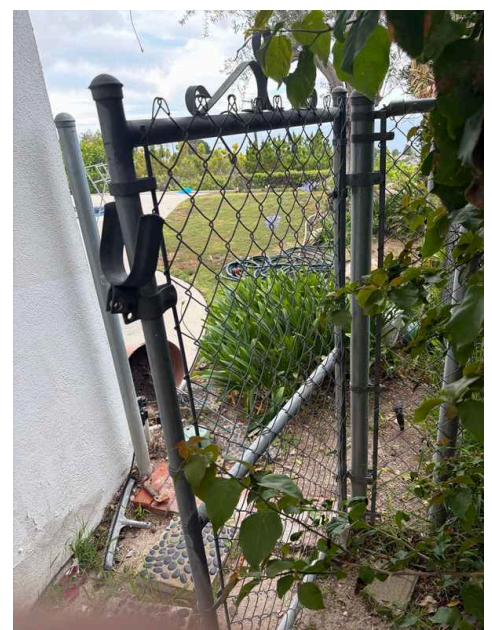
18.3.4 Safety Devices:

FENCE CLIMBABLE

One or more of the fence installation is climbable. This is not an accepted method to use when there was a pool or spa in the backyard as children can easily climb over the fence to gain access. We recommend modification.

Recommendation
Contact a qualified professional.

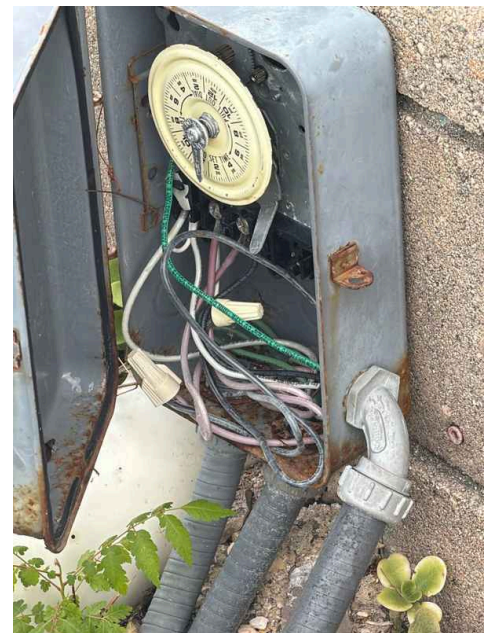
18.7.2 Pool Electrical:

TIMER BOX MISSING

The pool equipment timer box is missing its protective cover. This is a shock hazard. We recommend repair.

Contact a qualified professional.
