Confidential Inspection Report
2640 Via Rivera
Palos Verdes Estates CA 90274

July 24, 2023

<i>Description</i>	Single family house, and garage.
--------------------	----------------------------------

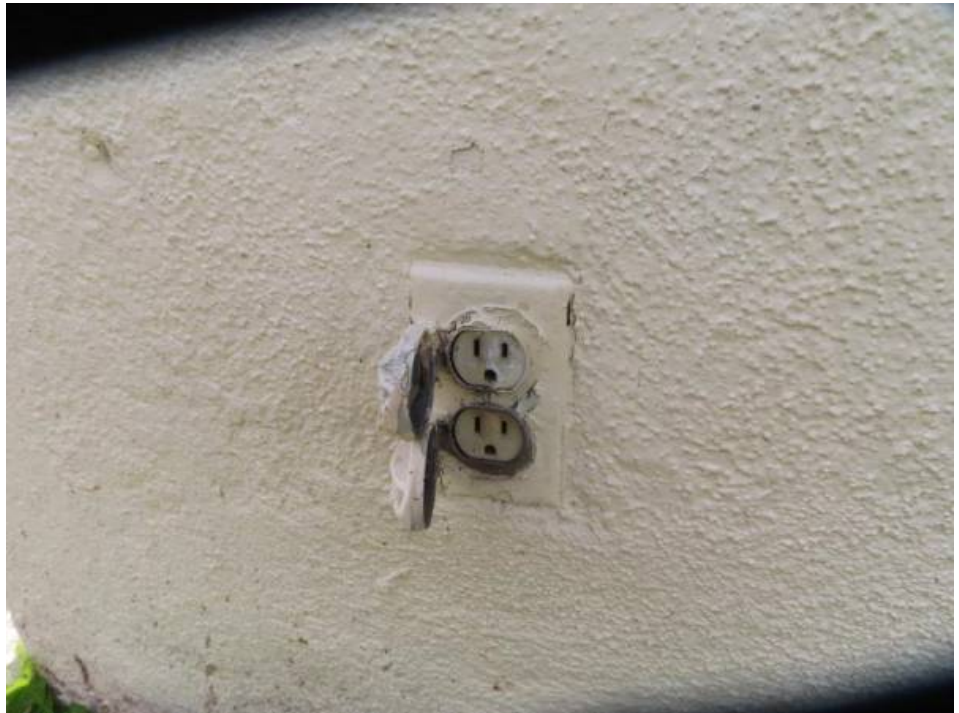
SAFETY: One or more receptacles are not GFCI protected. We recommend installing and maintaining GFCI protection at all exterior receptacles.

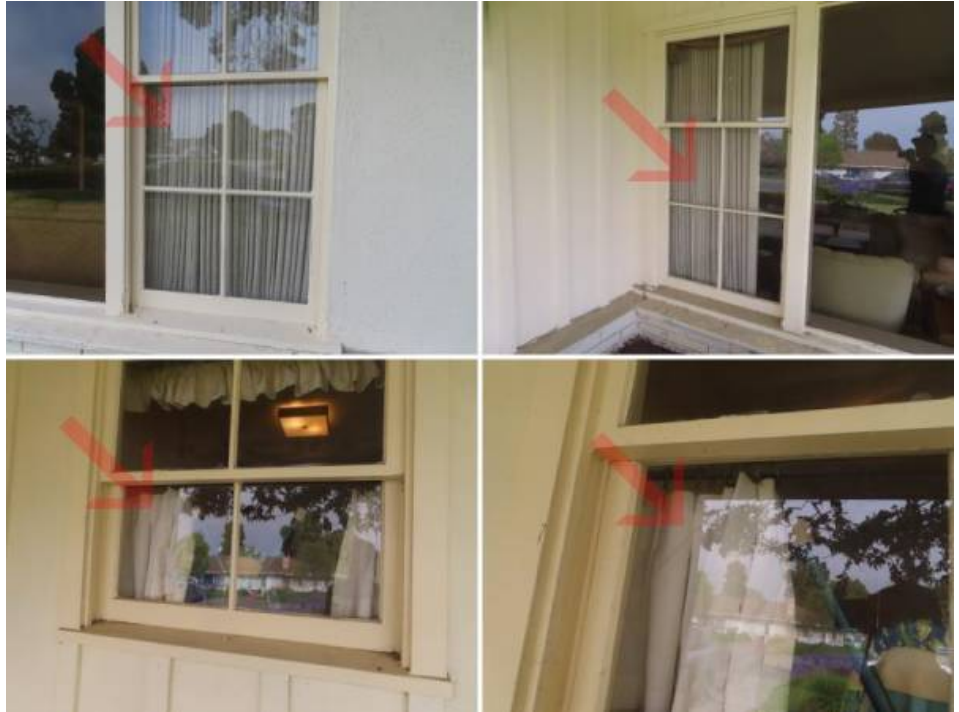
MAINTENANCE: Screen was missing at one or more windows sampled.
MAINTENANCE: Screen was damaged at one or more windows sampled.
MAINTENANCE: Cracked/broken pane at one or more windows sampled.
MAINTENANCE: Paint is deteriorated, loose or peeling. We recommend painting at this time to protect the wood from further deterioration and to enhance its appearance.

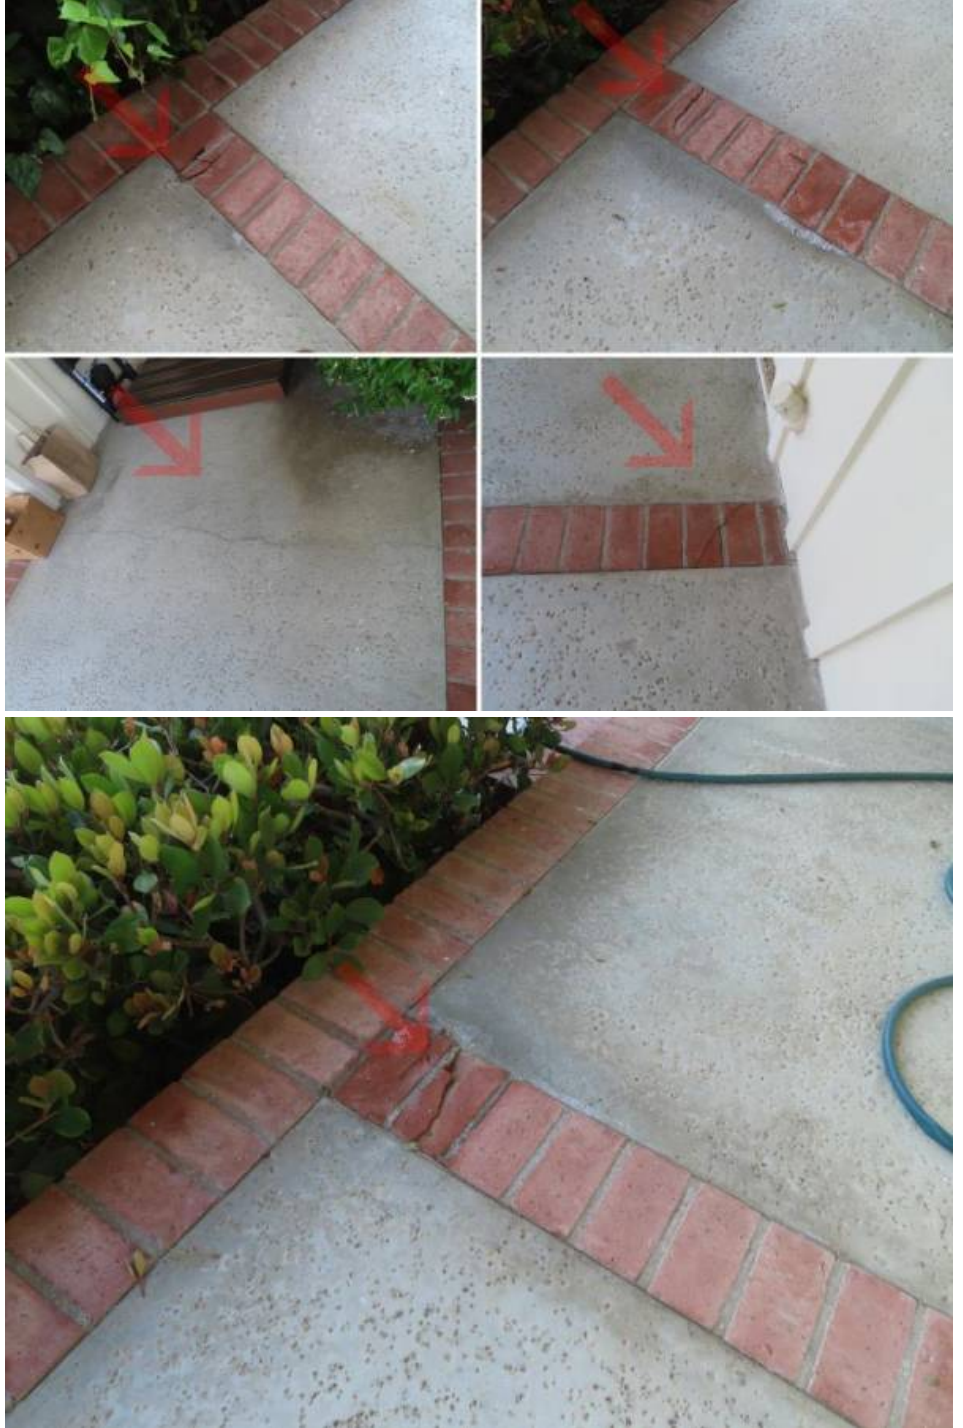
MONITOR: Hairline or moderate sized cracks observed. These appear to be typical settlement and shrinkage cracks. We suggest monitoring and obtaining further evaluation by a licensed waterproofing contractor if a change in size or number is noticed.

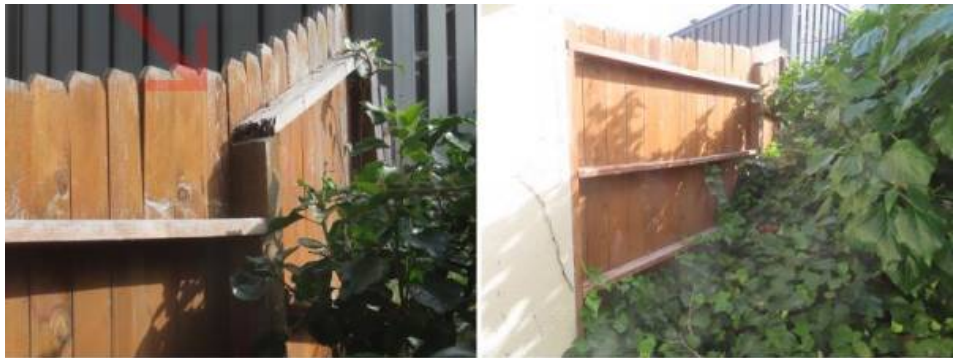
DEFERRED: Insect or moisture damage viewed.

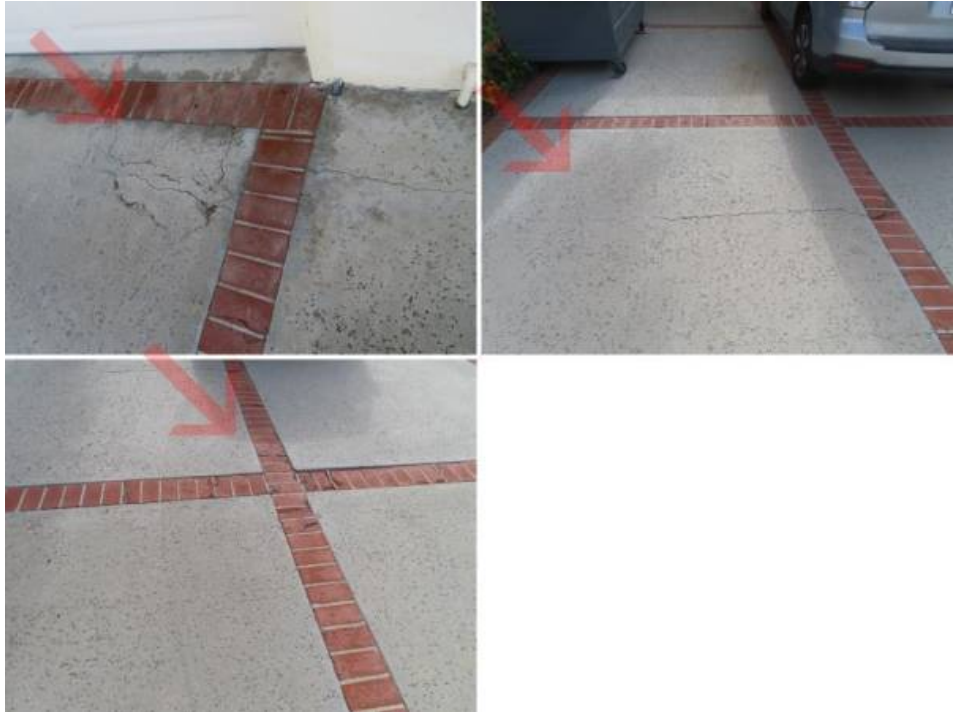
MONITOR: Small cracks viewed in the paving appear to be typical of settlement or shrinkage. We recommend monitoring cracks from time to time. Change in the size or number of cracks may be symptomatic of other conditions such as defective drainage, settlement or soil movement and should be further evaluated by a licensed masonry contractor.

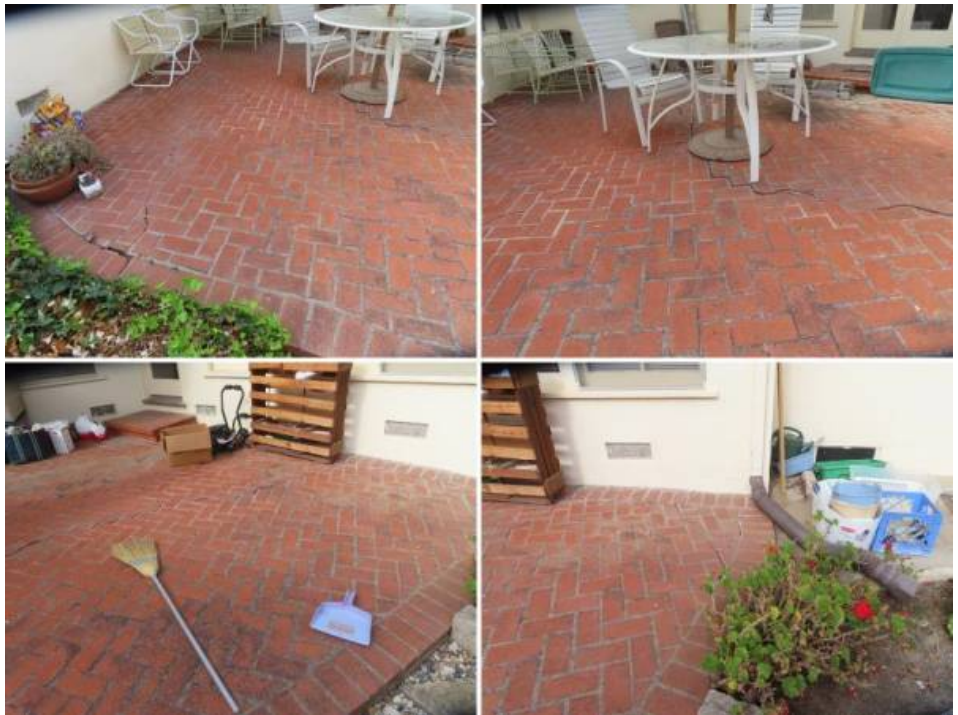
DEFECTIVE: Large crack(s). Moderate to severe cracking of pavement indicating past or present soil movement or settlement viewed. We recommend further evaluation by a licensed geotechnical engineer.

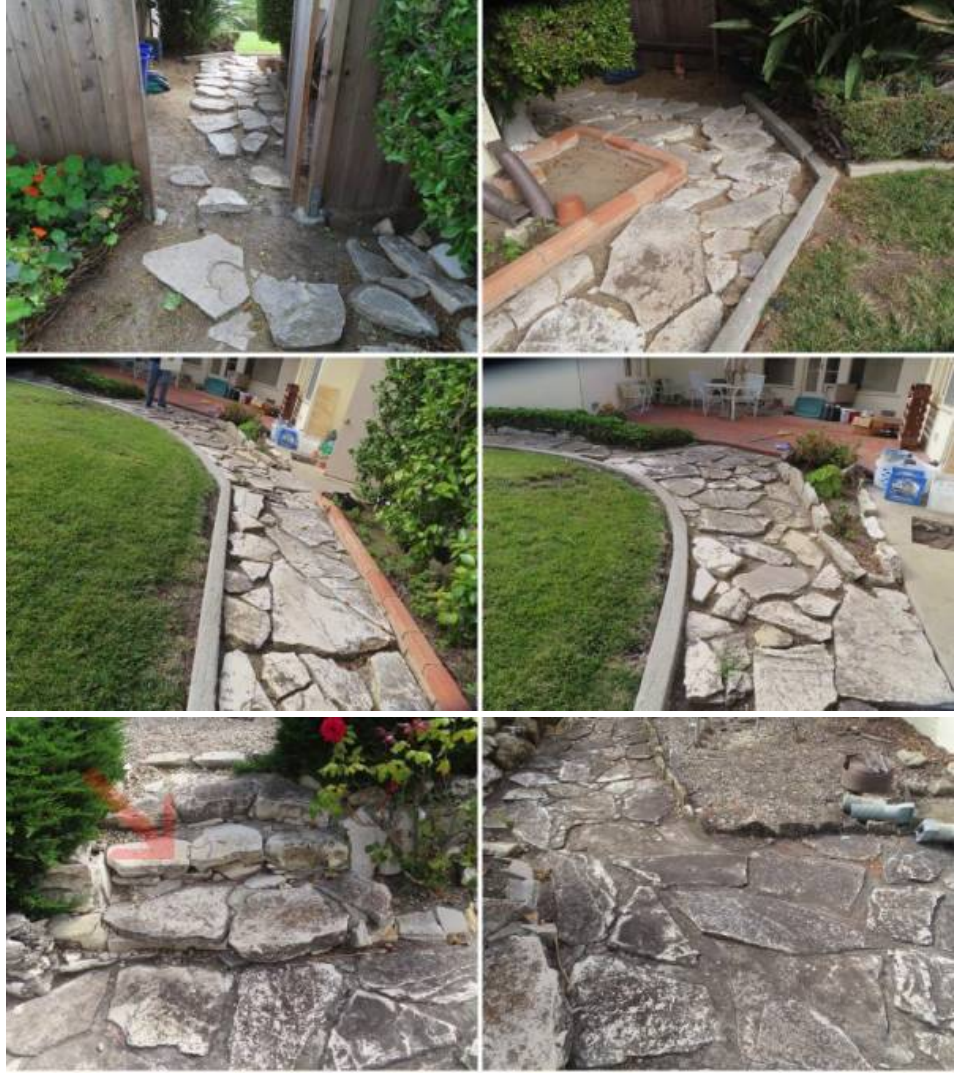
MAINTENANCE: Rock does not appear to have a concrete base, displacement/settlement viewed.

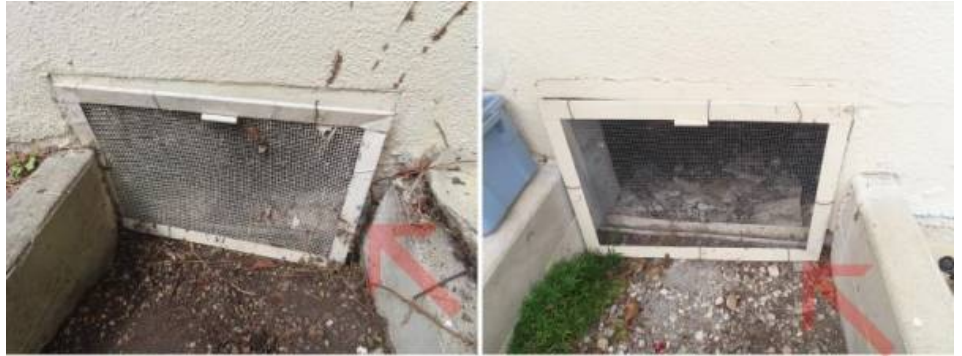
DEFECTIVE: Access cover is damaged, improper or missing. A tight fitting properly screened access cover in good repair is advised for under floor ventilation and to prevent animal or rodent entry.

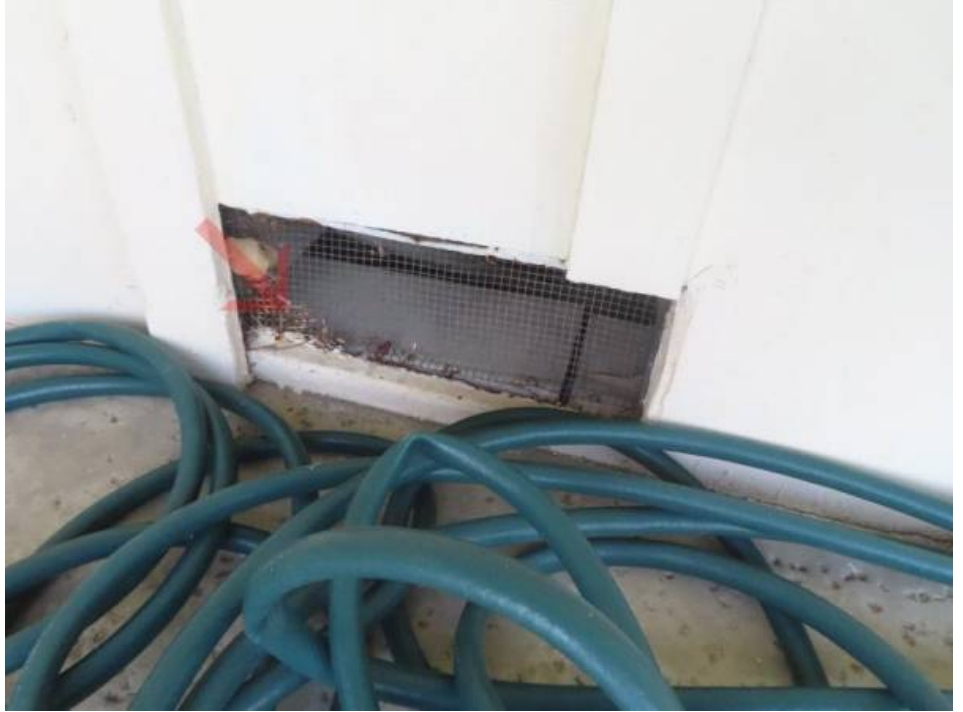
1 Screen on front porch is loose.

MAINTENANCE: Some screens were damaged or missing. We recommend maintaining screens in good repair for proper ventilation and to prevent animal or rodent entry.

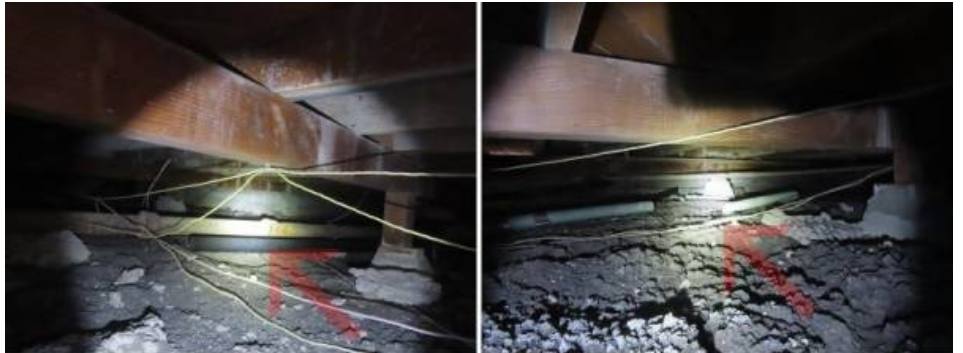
MAINTENANCE: Plastic from repairs, old pipes left in sub area. Recommend removing debris from sub area.

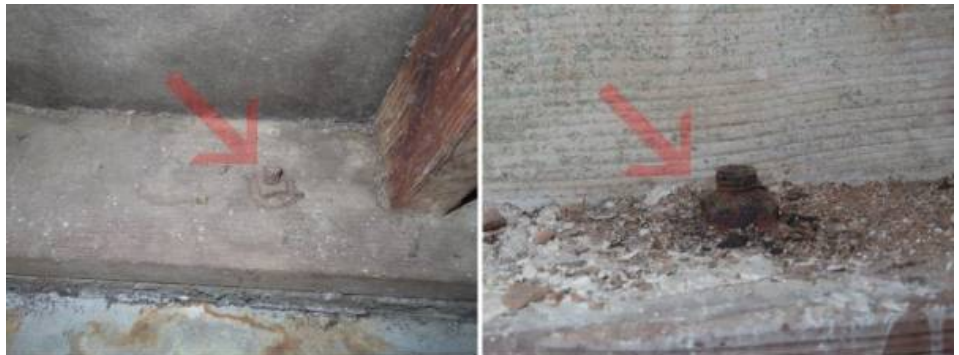
Expansion soil noted.

DEFERRED: Vertical cracks to approximately hairline to 1/8" . Cracks in the foundation are a symptom of other conditions such as poor drainage, settlement or soil movement. We recommend further evaluation by a geotechnical engineer.

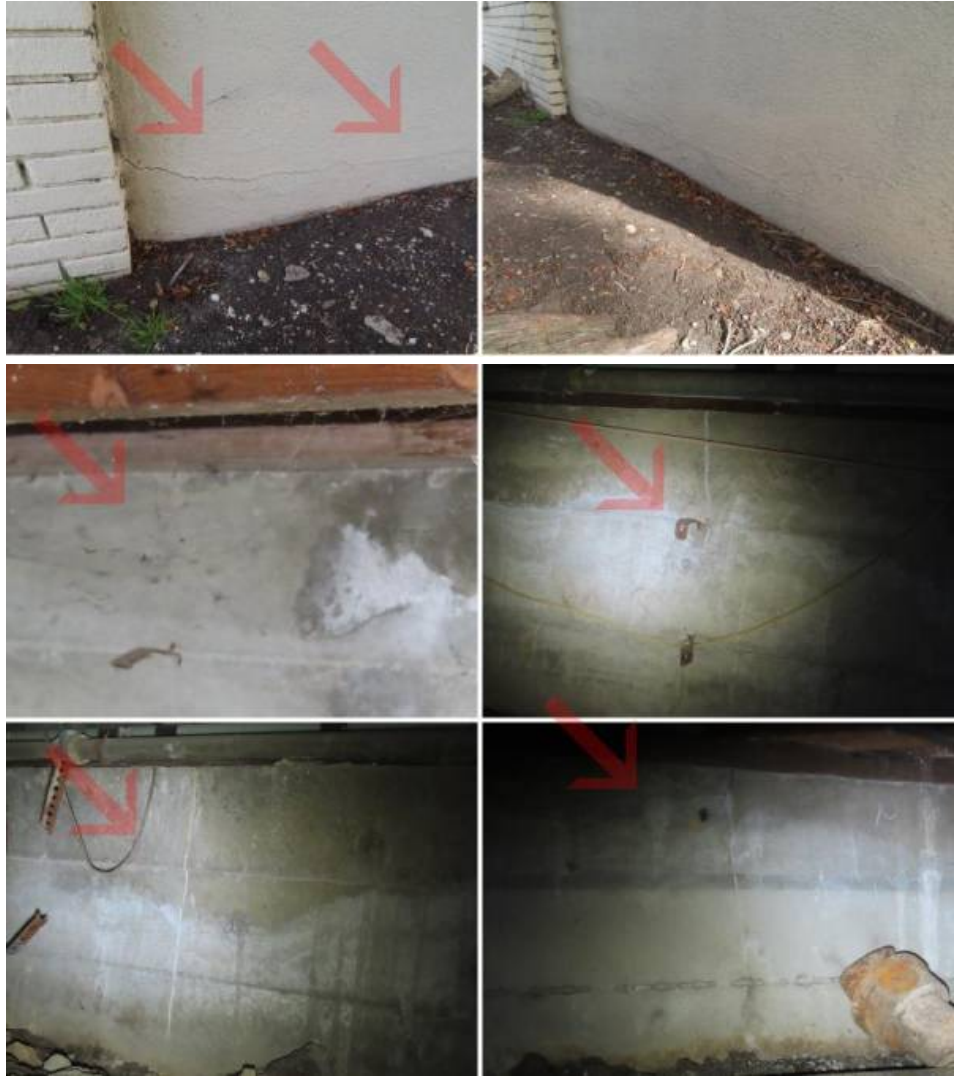
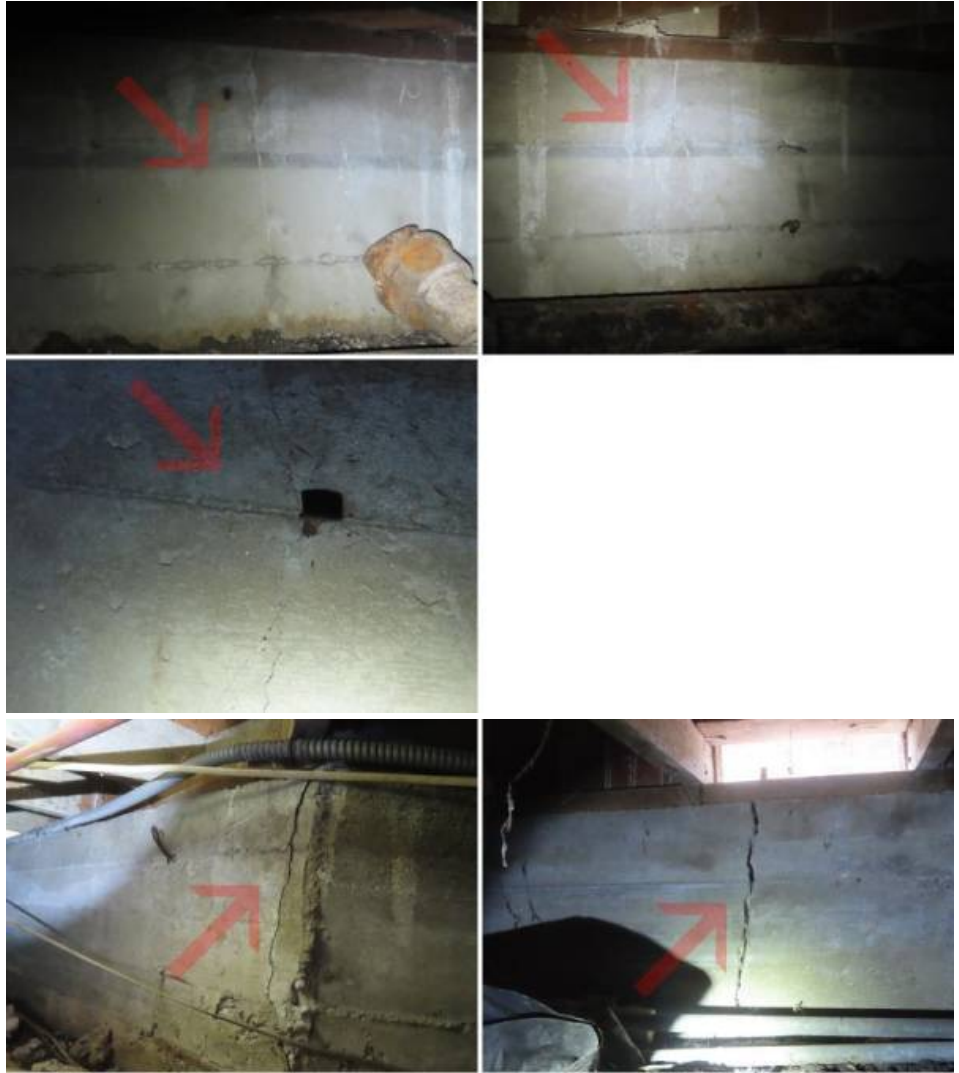
DEFERRED: Cracks noted in the stucco where the wall plate joins the foundation. Cracks like these are fairly common and usually indicate movement at the plate line such as might be experienced from ground acceleration during seismic shaking. A determination on the severity and any loss of component integrity is beyond the scope of a home inspection. We recommend further evaluation by a structural or geotechnical engineer to determine severity and make recommendation for repair if needed.

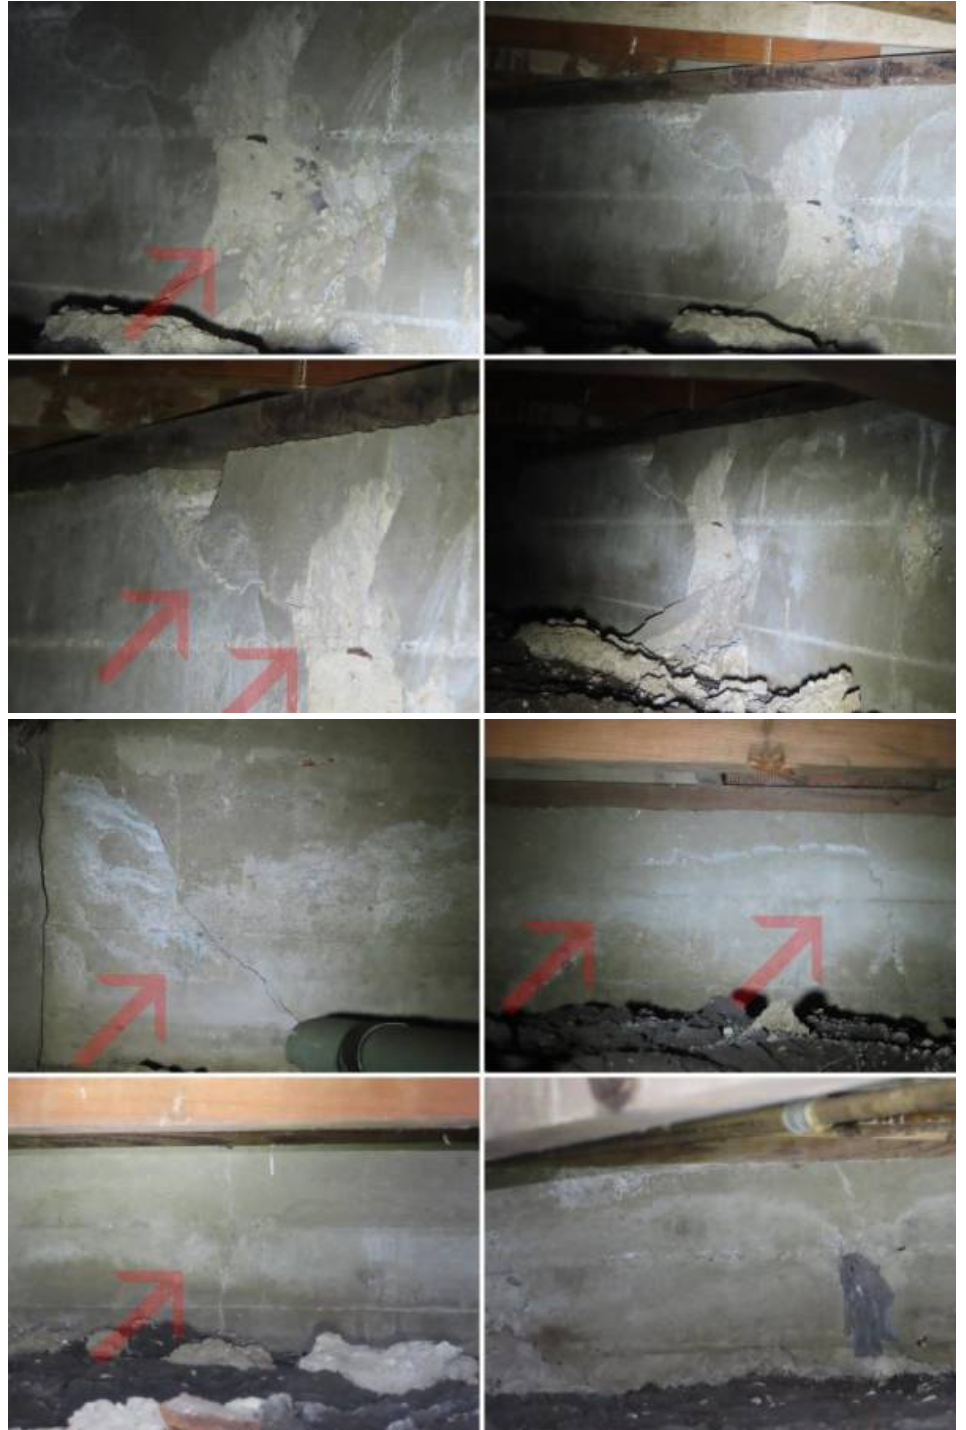
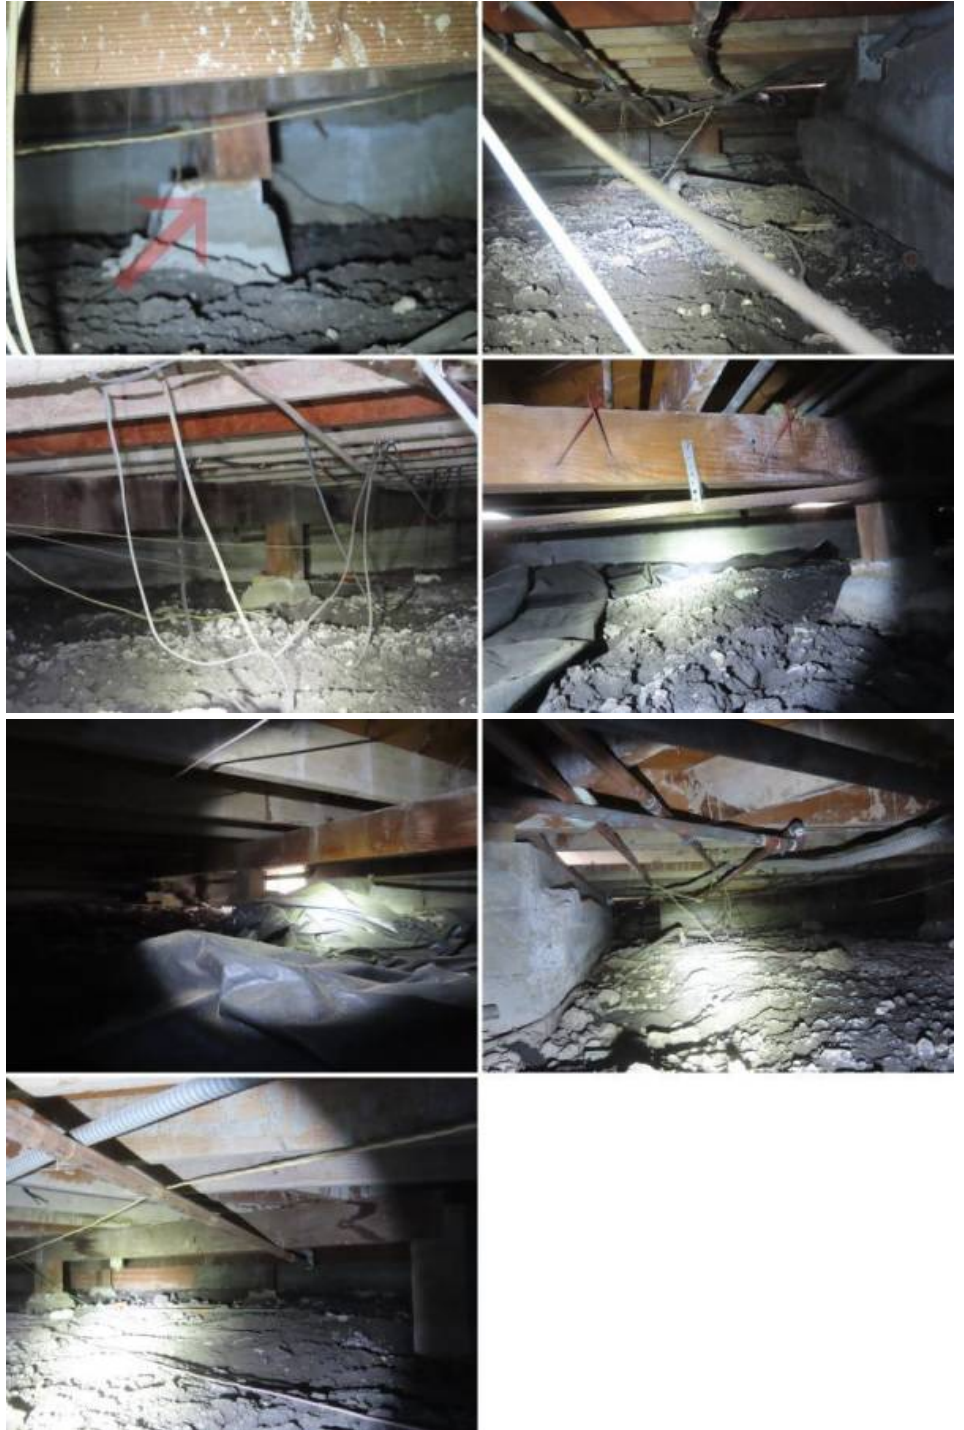
At living room/fireplace wall. Chimney and interior wall have settlement cracks.

DEFECTIVE: Horizontal crack to approximately 1/16"-inch. Horizontal cracks in the foundation usually have structural significance.

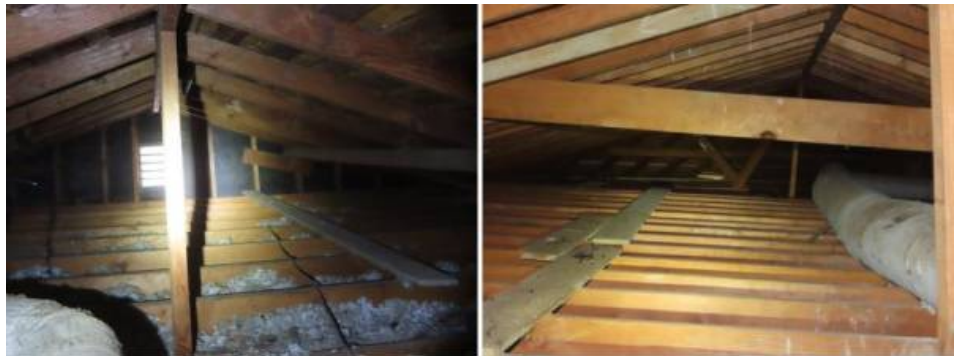
Conventional framing. Solid sheathing over spaced sheathing.

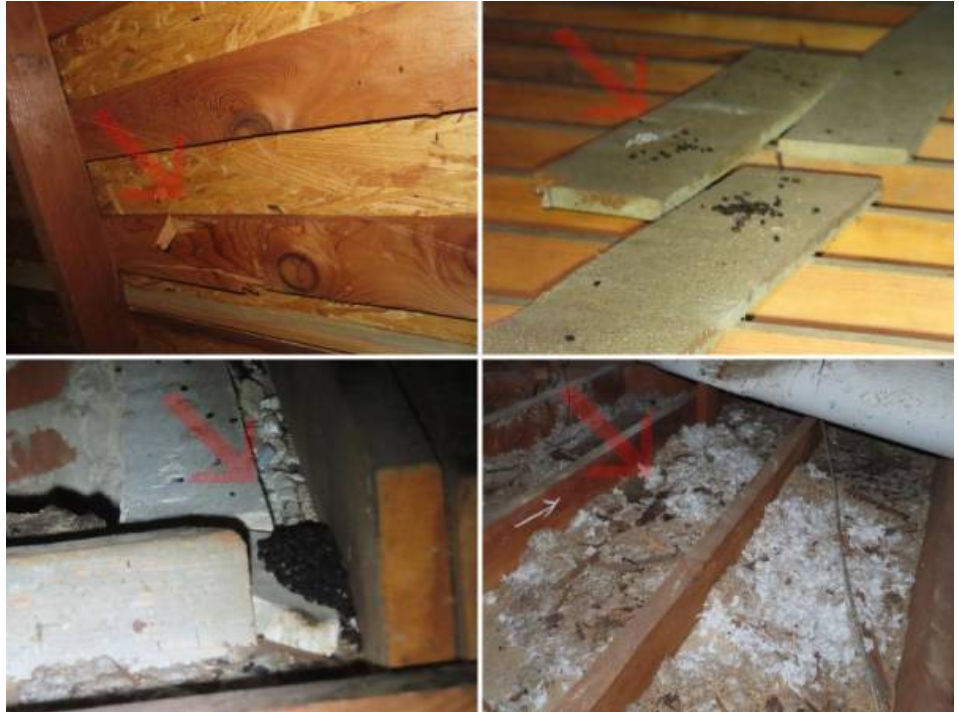
DEFERRED: Termite-like droppings noted. We recommend further evaluation by a licensed pest control operator.

SAFETY: Droppings or other evidence of rodents viewed. We recommend further evaluation by a properly licensed pest control operator.

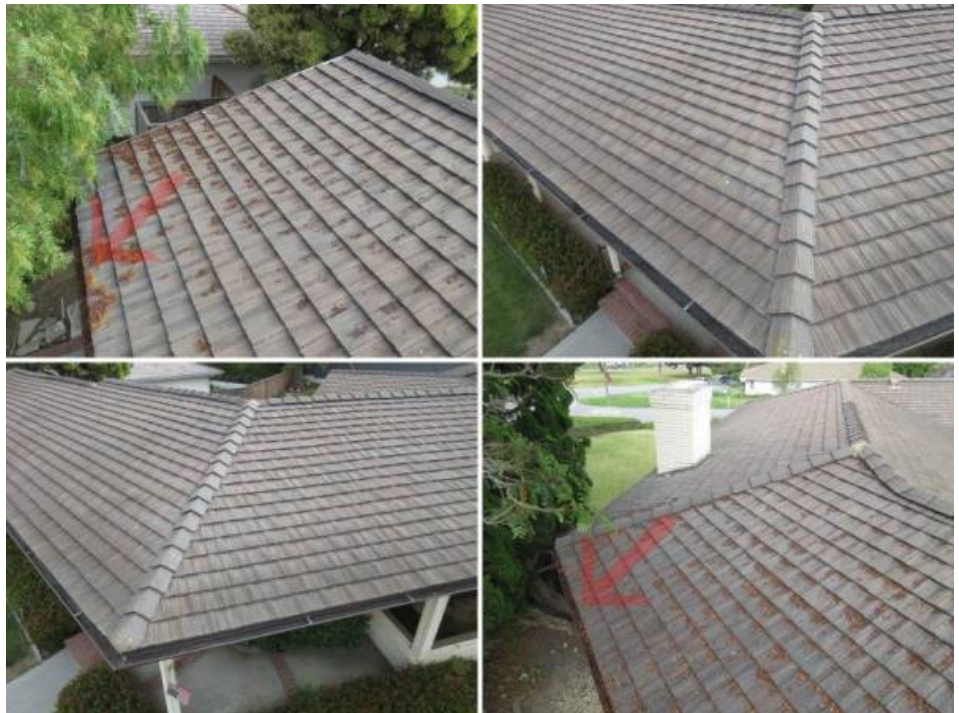
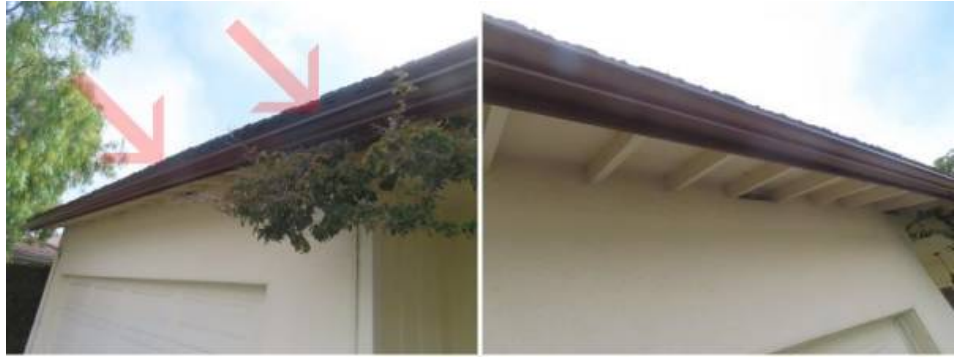
Roof or deck drains / Rain gutters Kitchen to the end of the garage sags, causing gutter to hold water. Recommend repairs at this time.

MAINTENANCE: Rain gutters are improperly sloped or have come loose and do not drain properly. We recommend further evaluation and corrections as needed at this.

MAINTENANCE: Debris noted in the gutters. We recommend cleaning the gutters now and prior to each rainy season and periodically as needed.

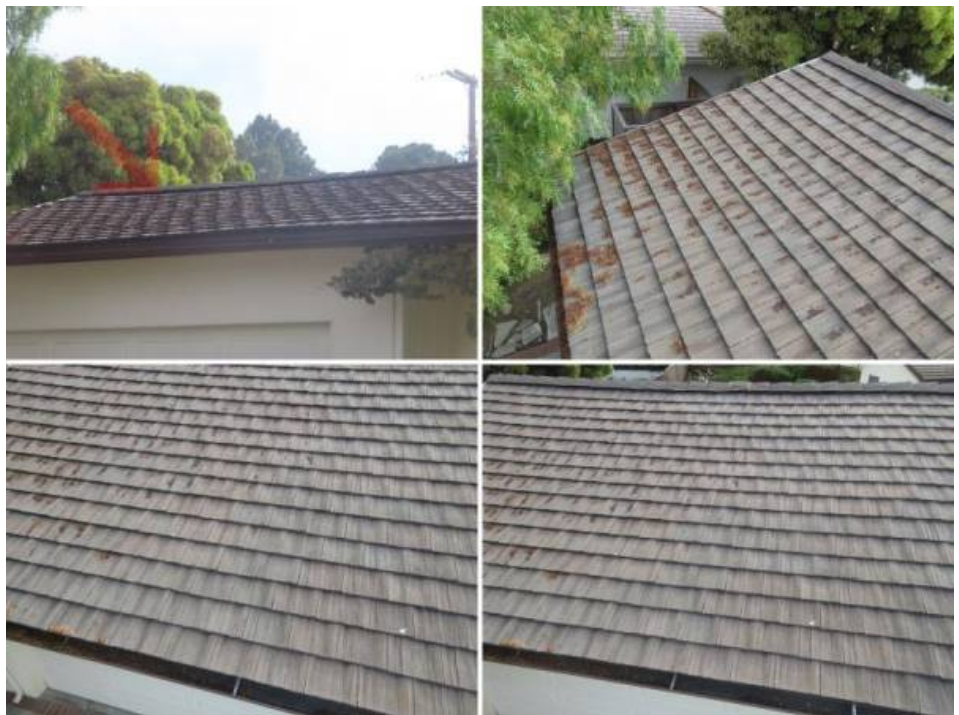
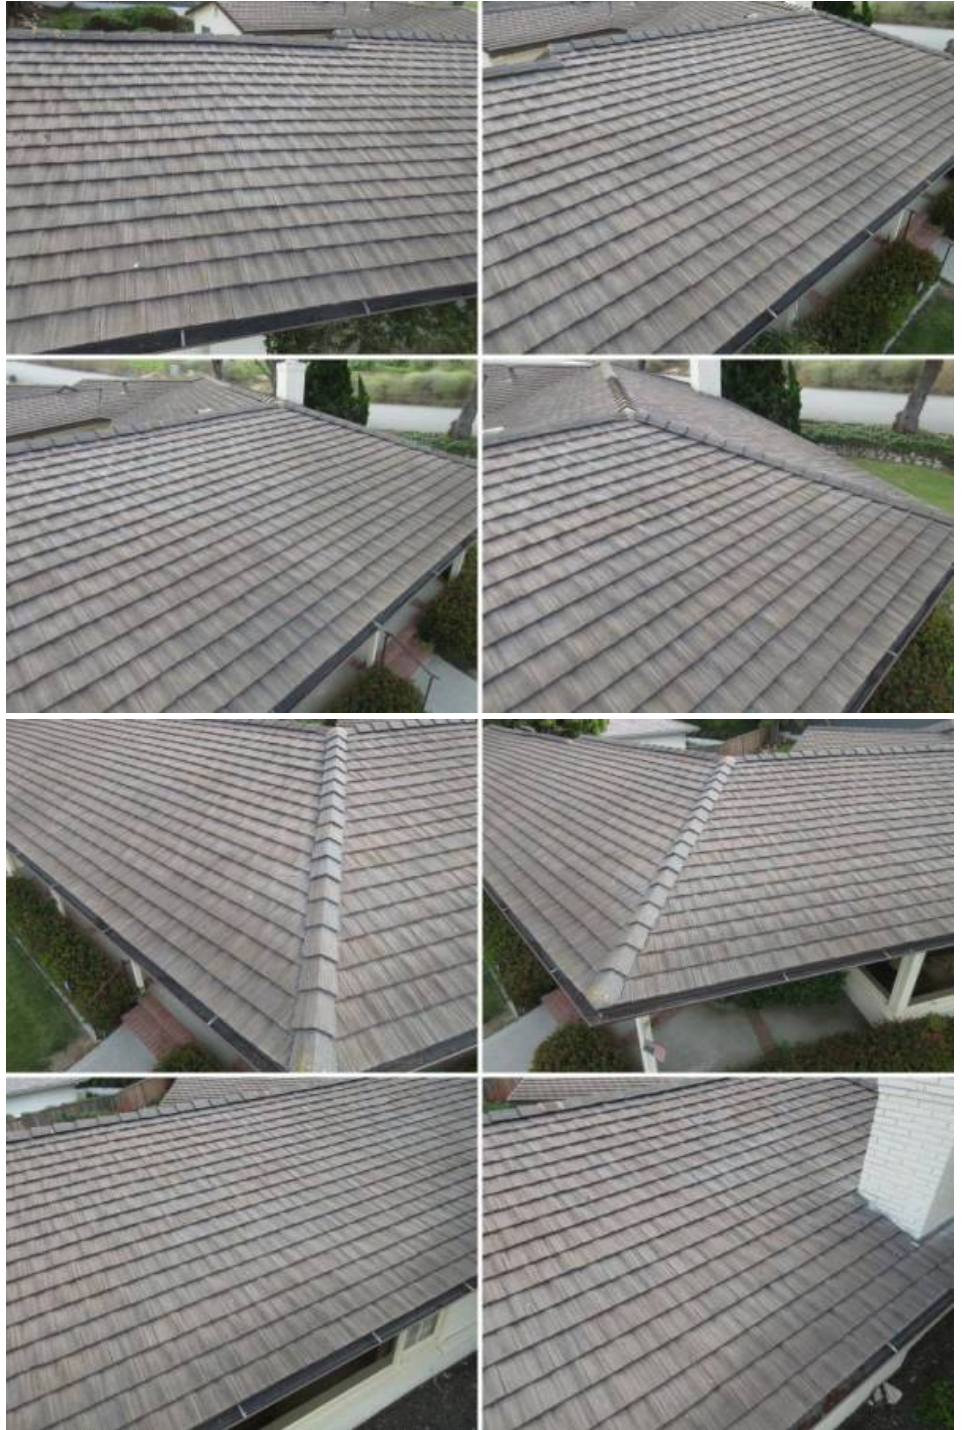
4-5 cracked tiles.

DEFECTIVE: Some broken/cracked or loose tiles observed. Tiles protect the waterproof membrane from exposure to damaging UV rays and broken or loose tiles may fall causing injury to persons or property. We recommend further evaluation and repairs as needed by a licensed roofer at this time.

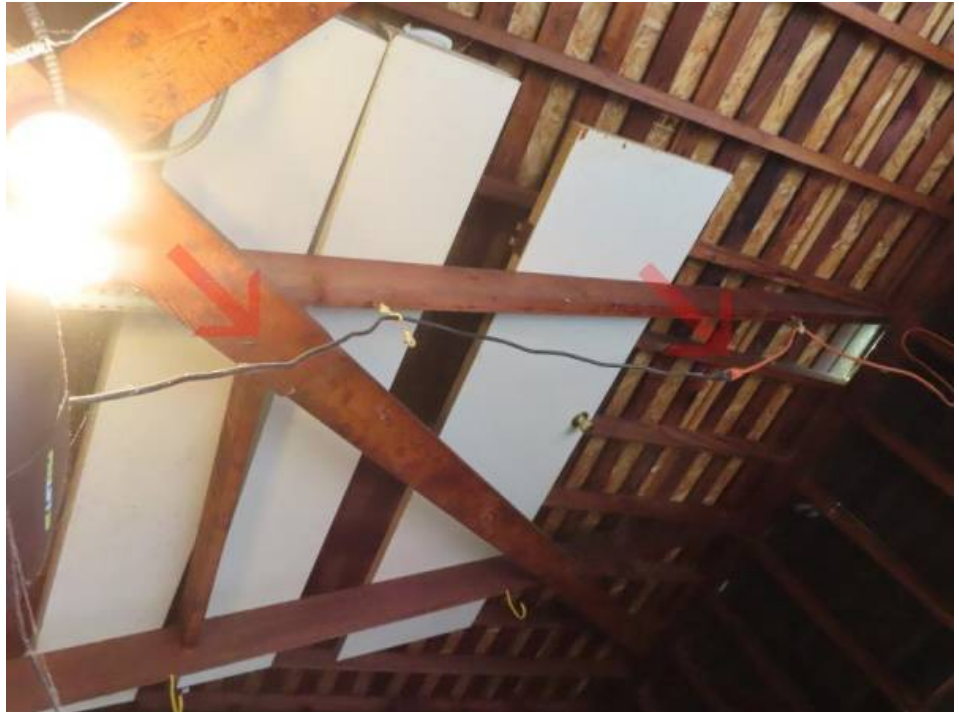
DEFECTIVE: Opener is plugged into an extension cord. Permanently plugged in devices should have an outlet within reach of the appliance's cord.

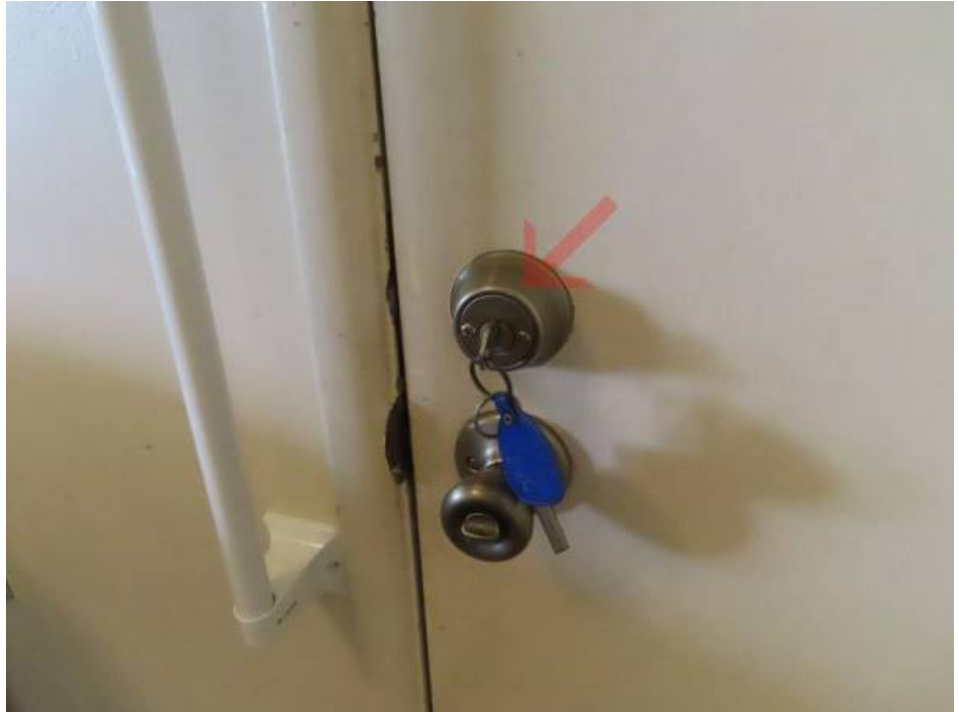
DEFECTIVE: No automatic closing hardware is installed as required for fire protection.

SAFETY: Deadbolt is a double-keyed cylinder and may impede emergency exiting. We recommend replacing double-keyed cylinders with a single-keyed deadbolt for enhanced safety.

MAINTENANCE: Door rubs threshold.

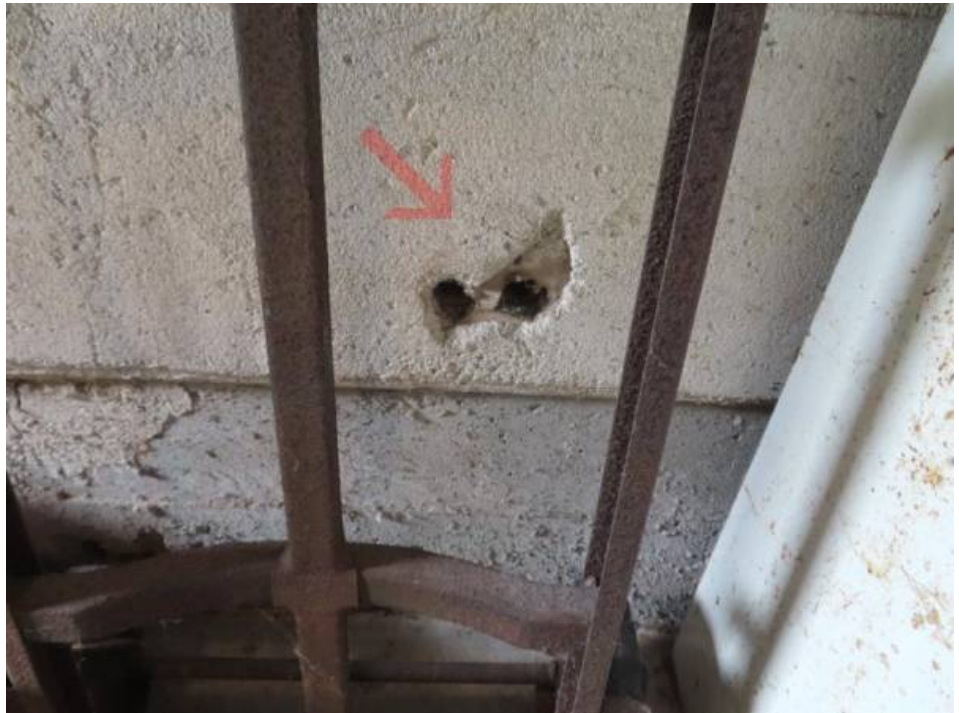
Recommend filling holes.

DEFECTIVE: Holes or other damage noted. Fire separation is designed to slow the spread of fire originating in the garage. We recommend repairs as needed by a licensed drywall or plastering contractor prior to occupancy for safety concerns.

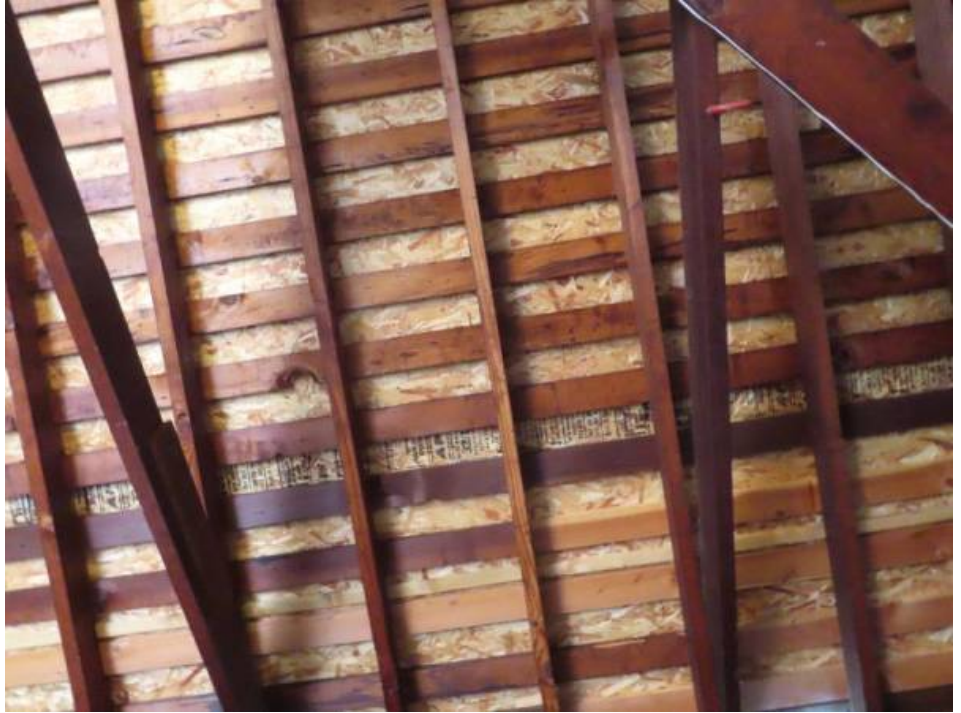
Conventional framing. Solid sheathing over spaced sheathing.

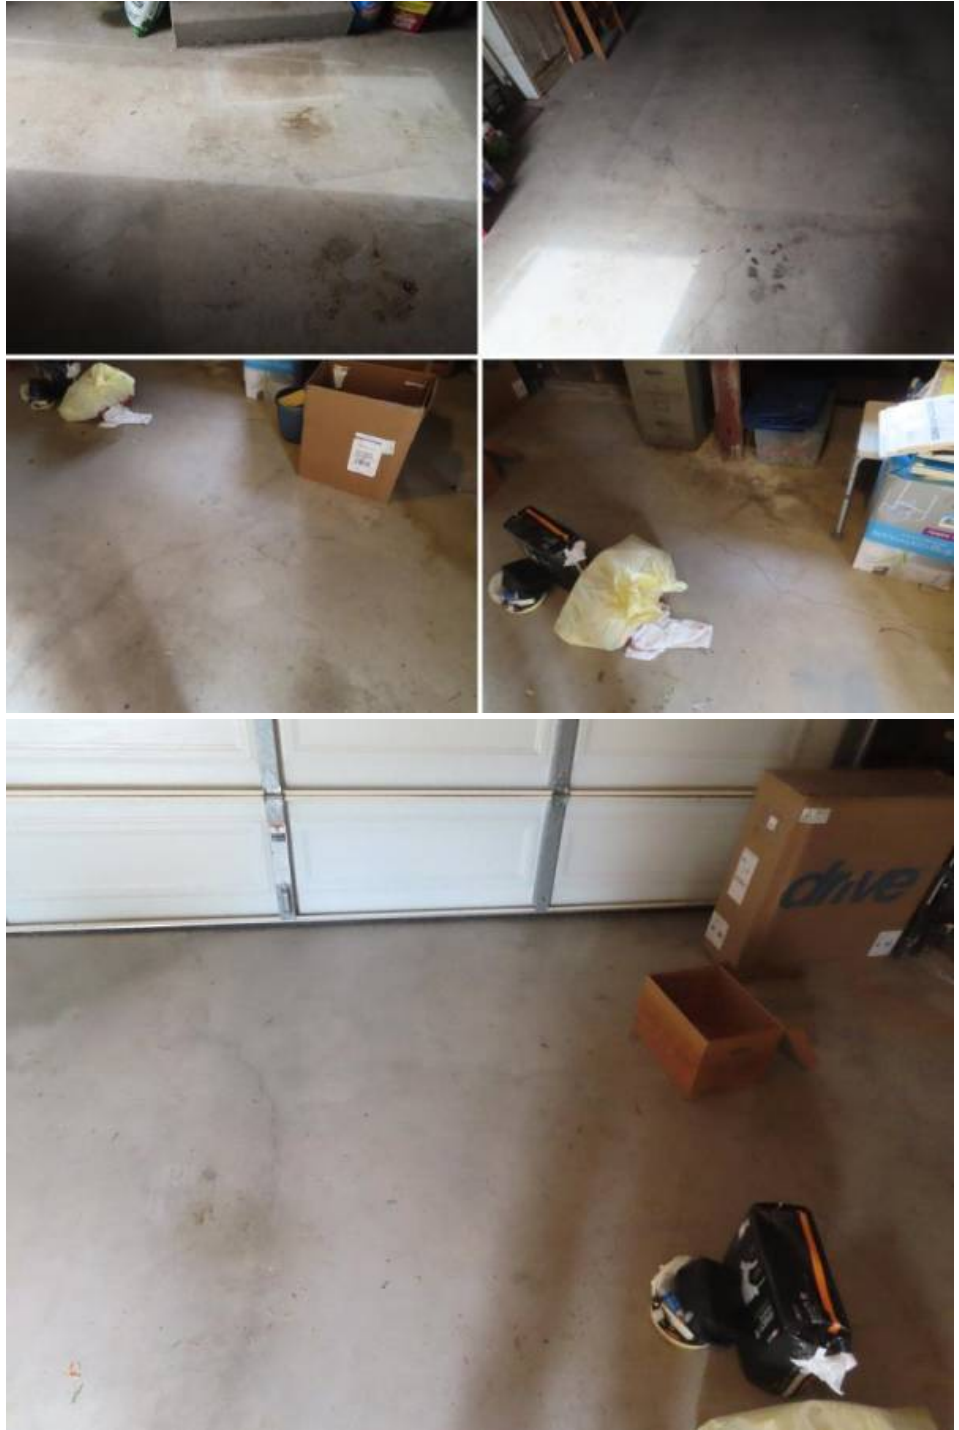
MONITOR: Small cracks observed. These appear to be typical settlement/shrinkage cracks and generally do not have structural significance. We suggest monitoring them from time to time. If any changes are observed we recommend further evaluation by a licensed concrete contractor.

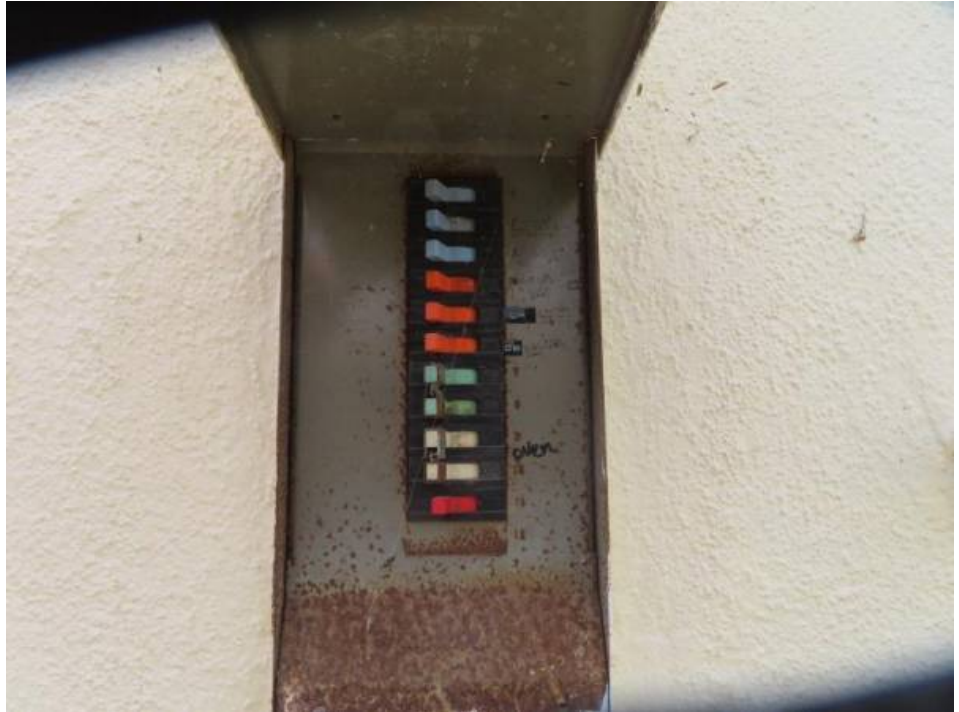
SAFETY: Federal Pacific or Zinsco brand panel present. Electrical panels and circuit breakers are known to deteriorate with age. Many older panels have aluminum bus bars that are susceptible to oxidization, which can compromise the electrical connections. Also, older breakers have a higher failure rate than do modern breakers. Both of these conditions can lead to arcing and overheating, sometimes resulting in an electrical fire. A visual inspection cannot determine if these panels and breakers are performing to their original design specifications. Federal Pacific and Zinsco brands in particular are problematic and we routinely recommend replacing these panels as a safety upgrade.

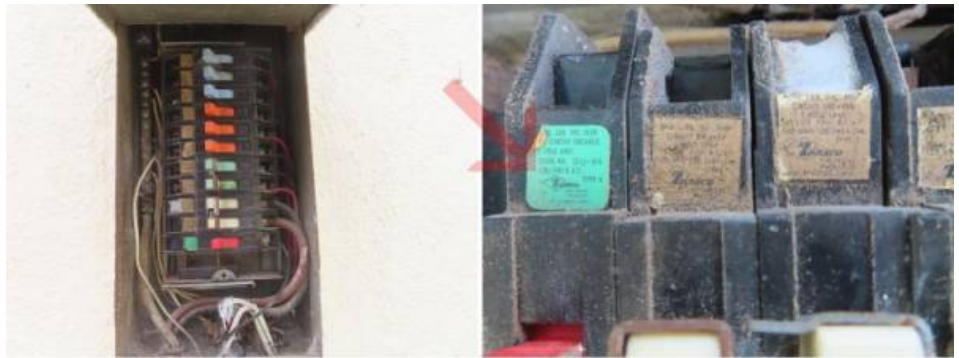
SAFETY: Federal Pacific or Zinsco brand breakers present. Electrical panels and circuit breakers are known to deteriorate with age. Many older panels have aluminum bus bars that are susceptible to oxidization, which can compromise the electrical connections. Also, older breakers have a higher failure rate than do modern breakers. Both of these conditions can lead to arcing and overheating, sometimes resulting in an electrical fire. A visual inspection cannot determine if these panels and breakers are performing to their original design specifications. Federal Pacific and Zinsco brands in particular are problematic and we routinely recommend replacing these panels as a safety upgrade.
