Confidential Inspection Report
2640 Via Rivera
Palos Verdes Estates CA 90274

July 24, 2023

<i>Description</i>	Single family house, and garage.
--------------------	----------------------------------

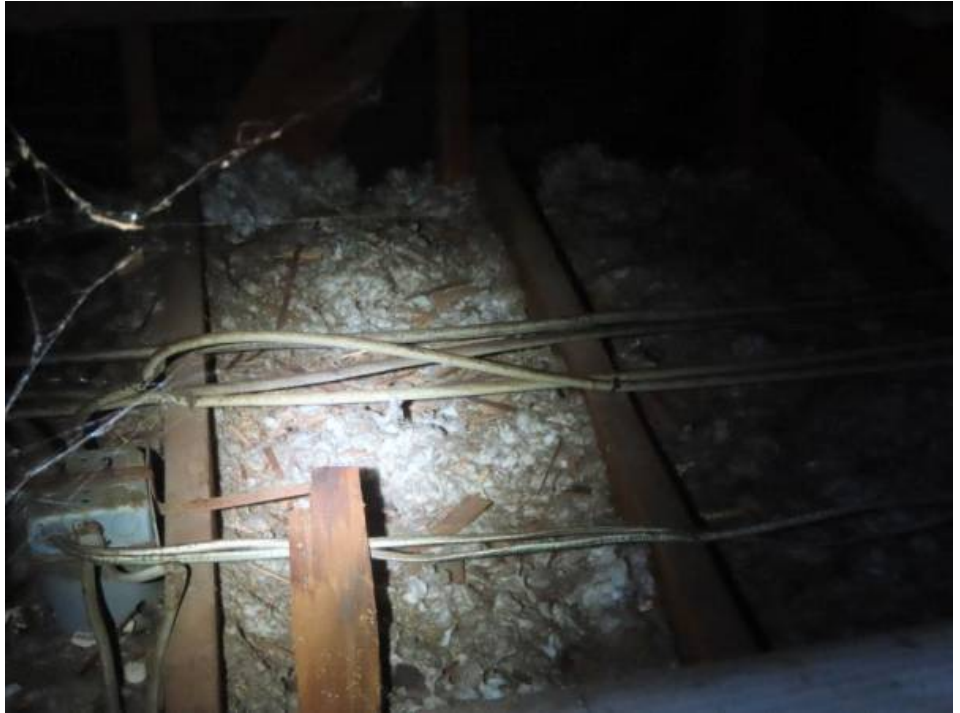
Copper wires with grounding conductor in nonmetallic sheathing.
Copper wires with grounding conductors in metal conduit.
DEFERRED: Cloth covered wiring. This type of covering (no longer used) can become

brittle and deteriorate with age. Most of the wiring is concealed and we routinely recommend further evaluation by a licensed electrician.

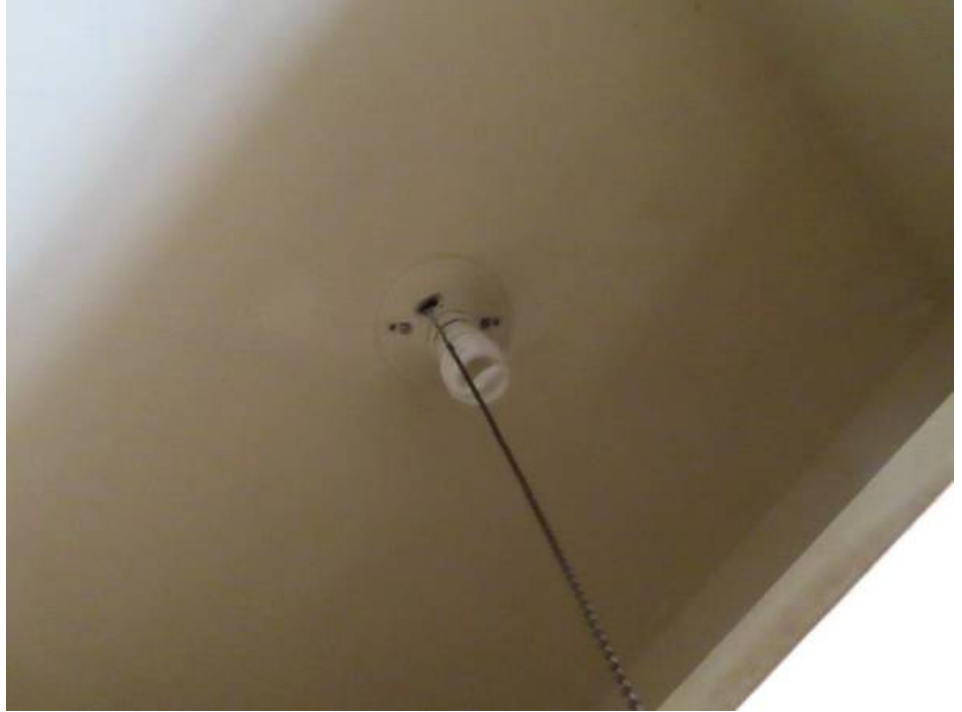
SAFETY: Bare bulb light fixture in a closet, or light fixture is installed too close to storage space at one or more closets. We recommend further evaluation by a licensed electrician for improvement as needed for enhanced fire safety.

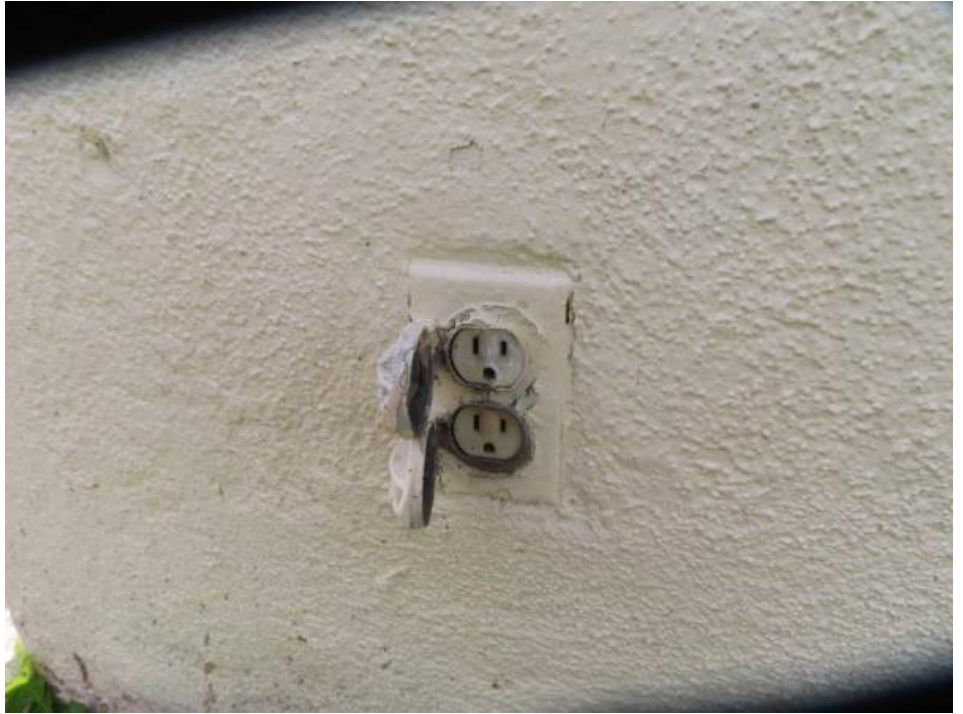
Rear exterior dead.

DEFECTIVE: Receptacle sampled at one or more locations was not operational.

SAFETY: Some two-pronged receptacles viewed. This type of system is common with similar structures of this age. Some plug-in devices, such as lamps and televisions, etc., may not require a grounded receptacle. However, we recommend upgrading to properly grounded three-pronged receptacles where needed, especially at receptacles for appliances, tools and electronic equipment including refrigerators, laundry machines, computers, and for all other appliances and equipment that are supplied with a three-prong grounded plug.

DEFECTIVE: Receptacle sampled was painted at one or more locations. Painting receptacles can block the openings or otherwise compromise the connection at the receptacle. We recommend having all painted receptacles replaced by a licensed electrician.

DEFECTIVE: Cover plate is missing or damaged at one or more locations. Risk of accidental contact with energized parts. We recommend installing or replacing damaged cover plates as needed at this time.

DEFECTIVE: 3-prong grounded type receptacle sampled at one or more locations was not properly grounded.

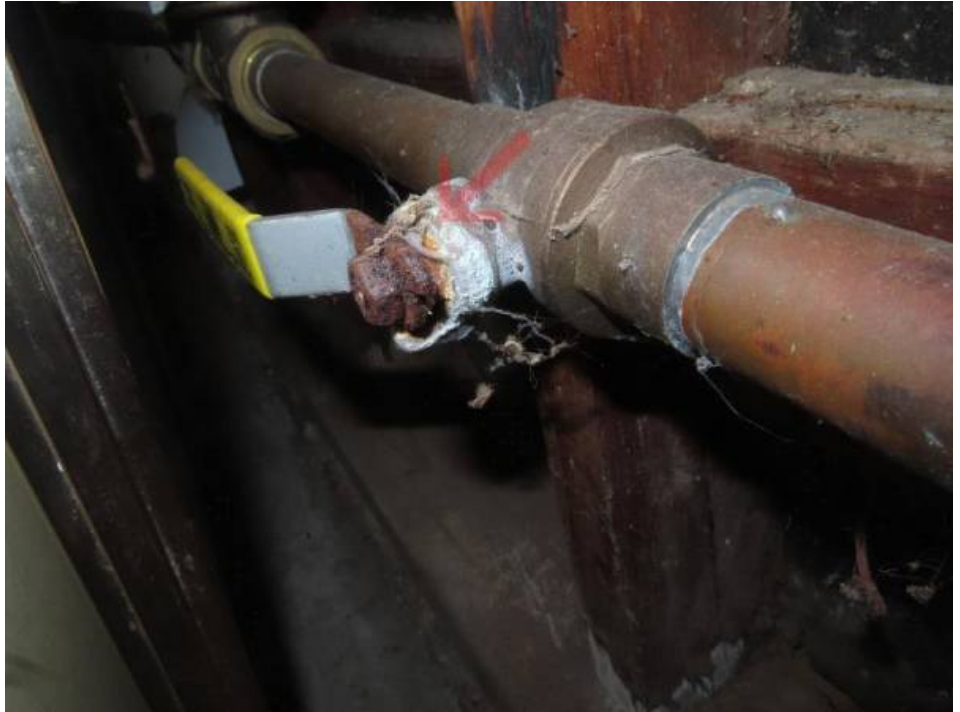
MAINTENANCE: Corrosion at the main valve. We recommend monitoring or replacing corroded parts.

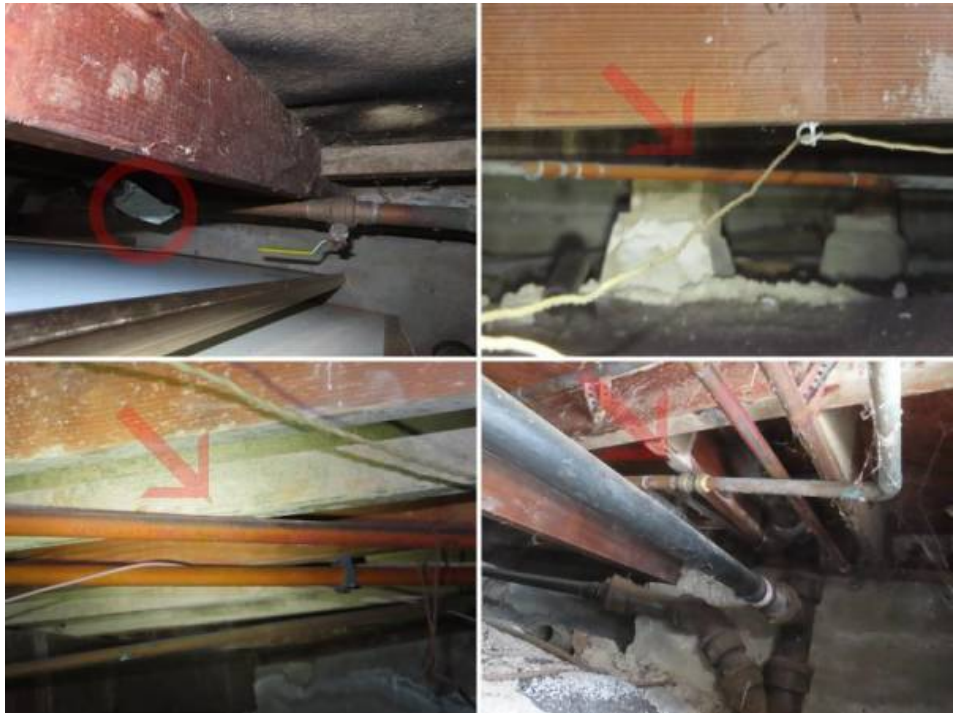
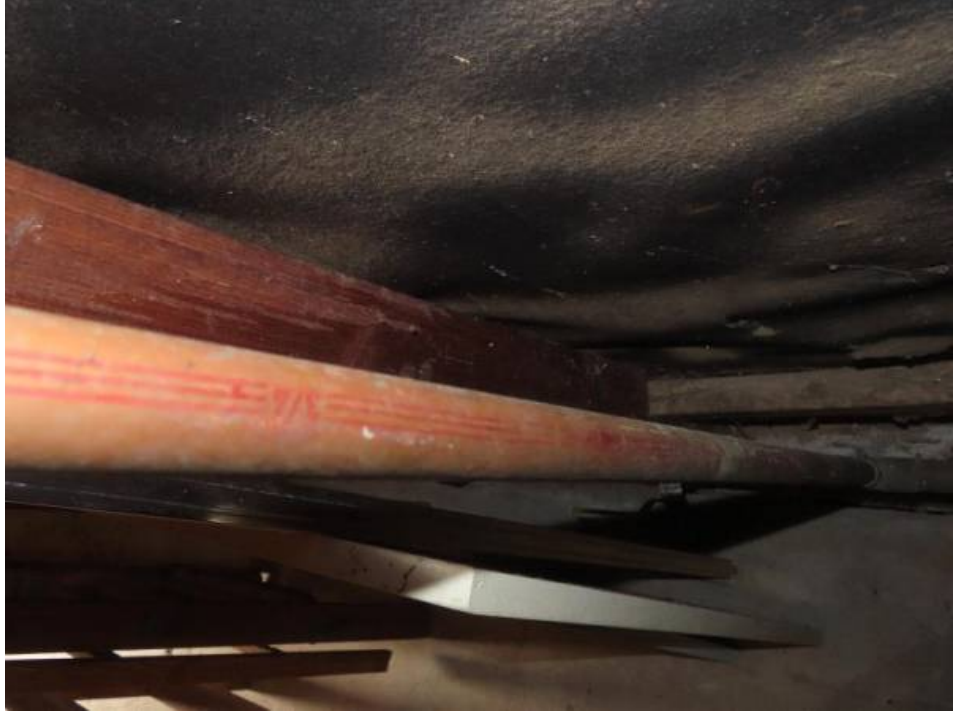
Copper.
Type L, repairs noted, plastic lined noted.
Type M.

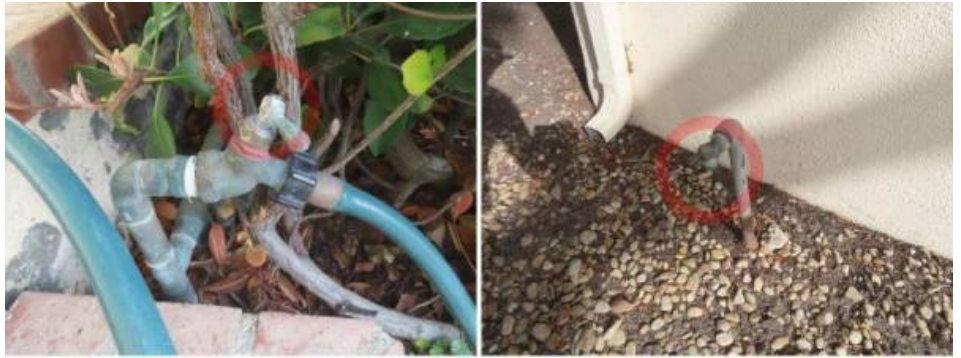
Front planter, broken handle.
MAINTENANCE: Missing/broken handle at one or more locations.
East side.
DEFECTIVE: Did not operate at one or more locations sampled.

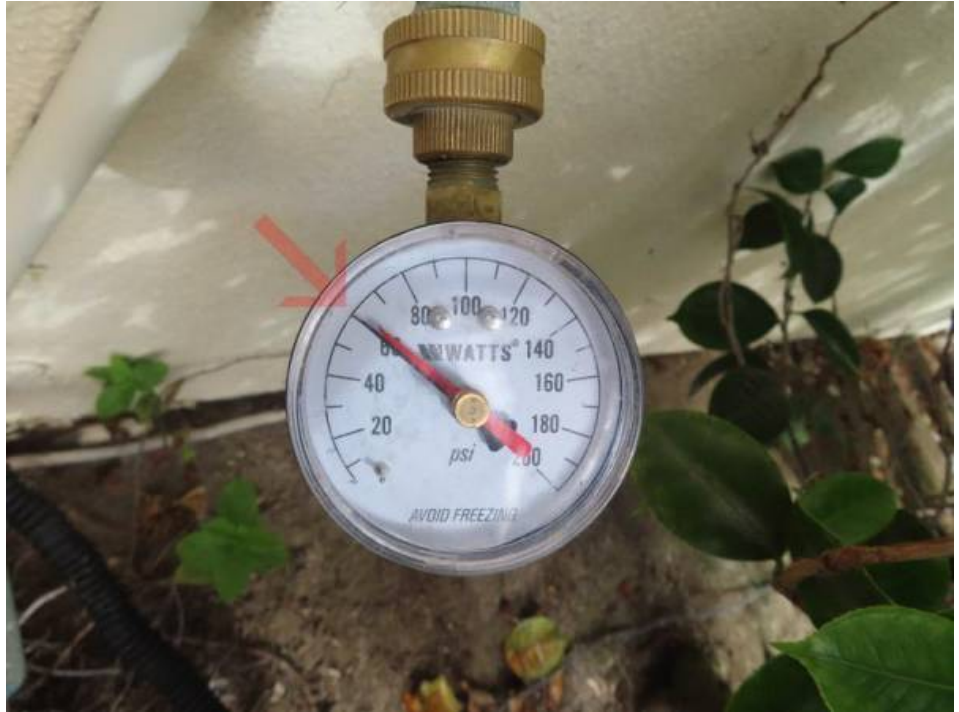
60 psi.
SERVICEABLE.

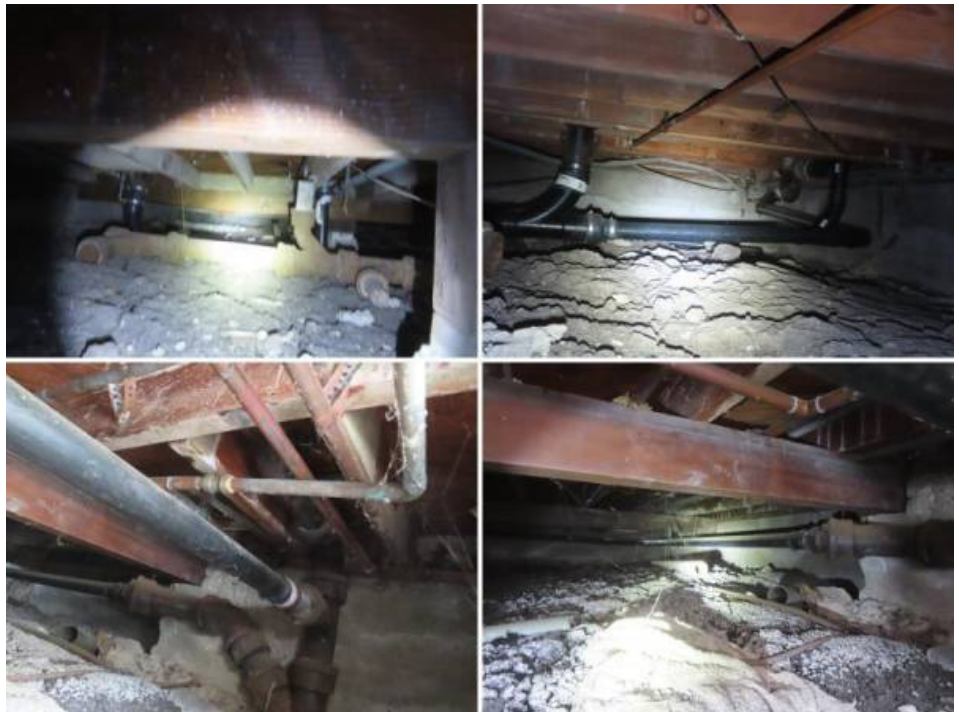
ABS (plastic),
Verticals, cast iron and galvanized steel.

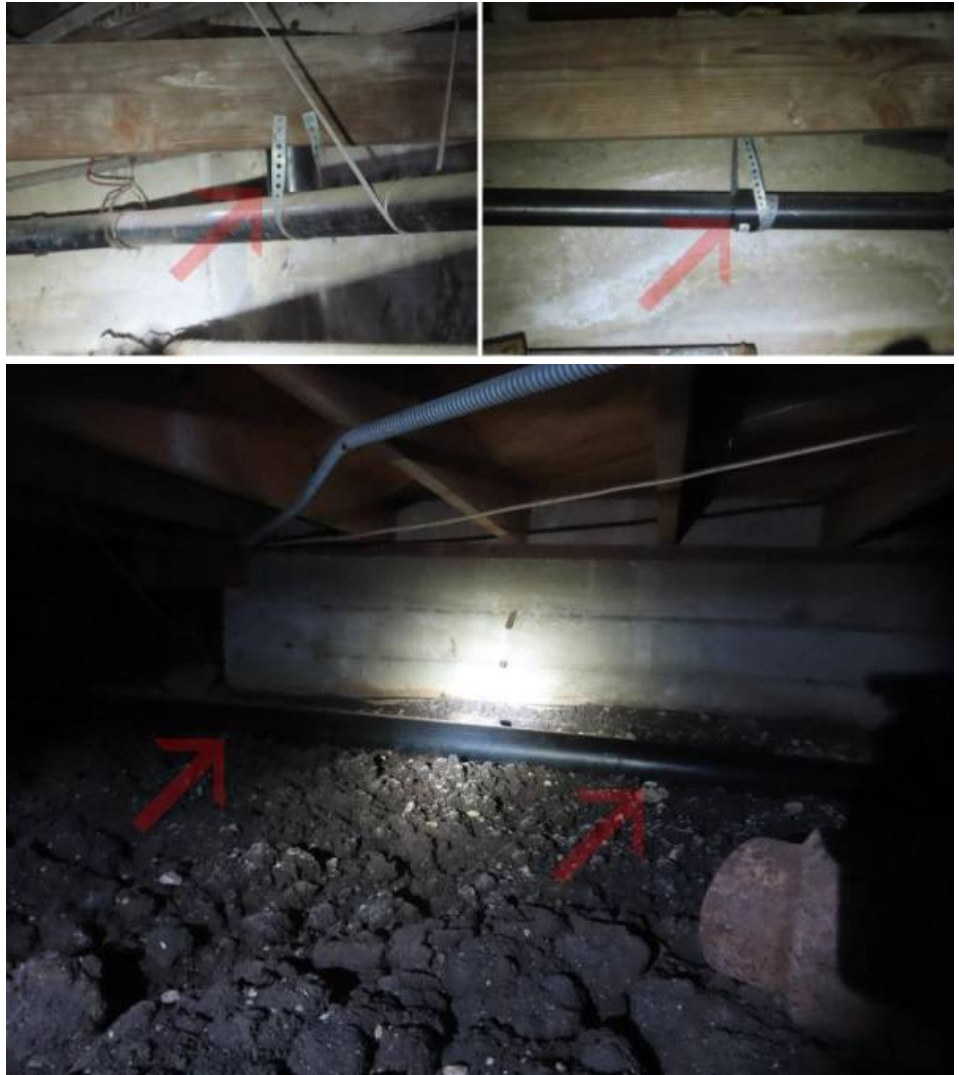
MAINTENANCE: Line is on ground slopes towards the north side of sub area, fall is high in run from bathrooms. When the ground expands it will lift line more. Recommend further inspection and repairs as necessary.

DEFERRED: Metal straps on ABS. Recommend plastic straps to prevent corrosion.

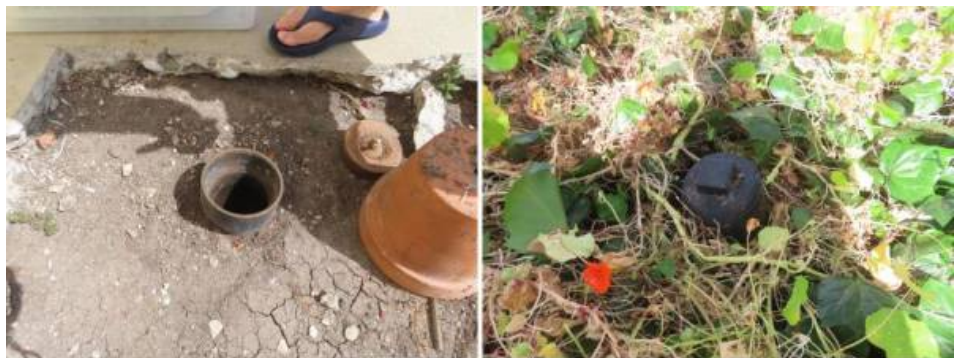
Clean out present.
Sewer inspections are not part of this inspection.

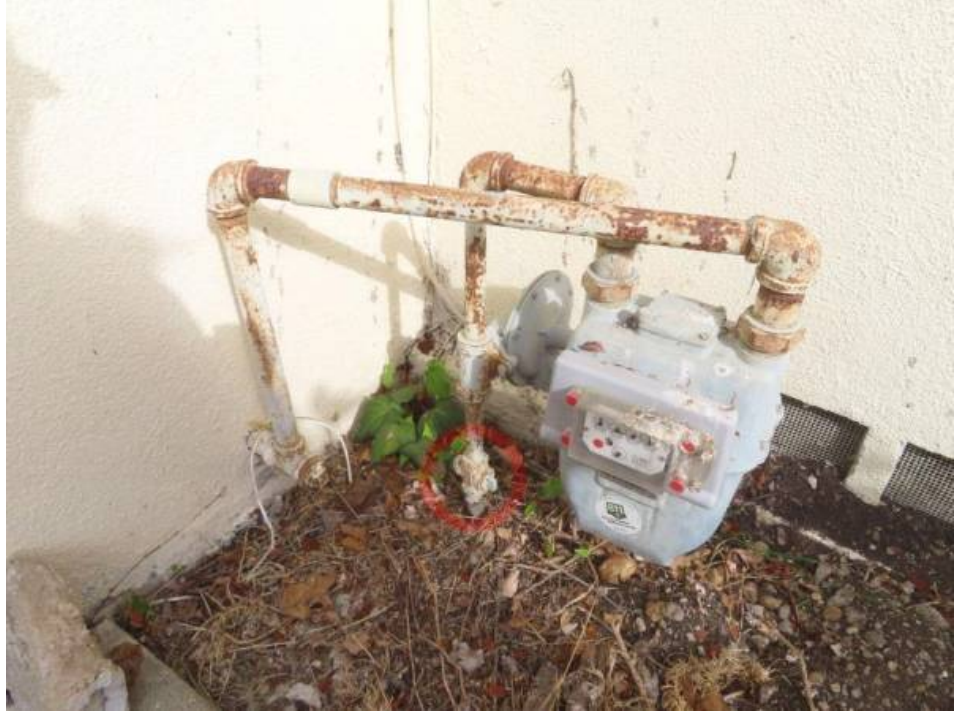
SAFETY: No seismic shutoff valve. We recommend installing a seismic shutoff valve on the gas meter for protection against fire loss in the event of a damaging earthquake. (A seismic shutoff valve is required to be installed on the gas system of residences in the City of Los Angeles prior to the transfer of title.)

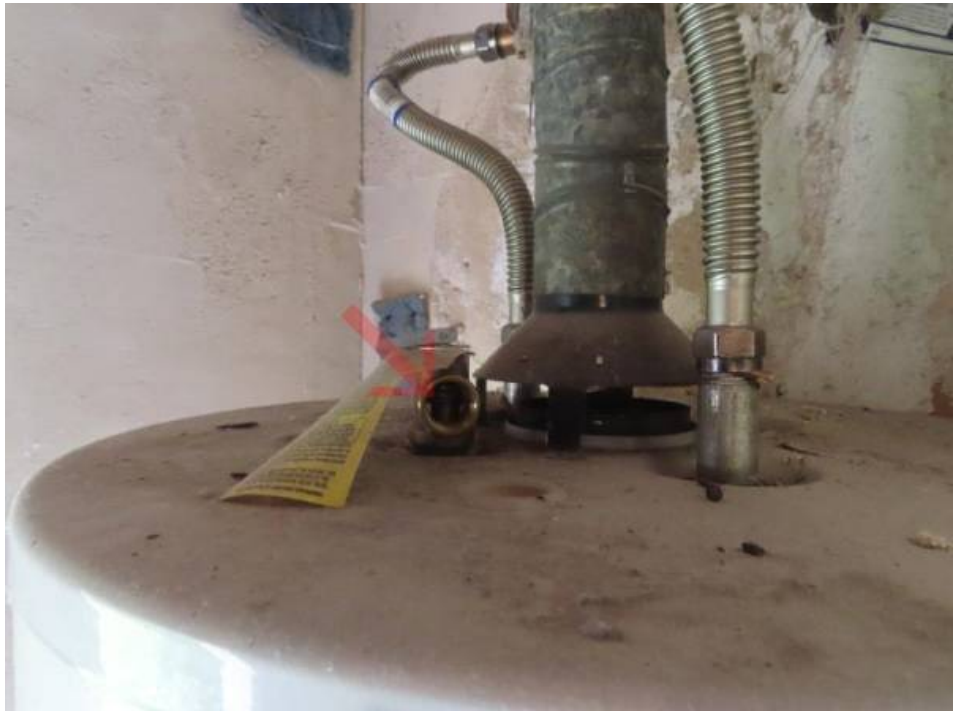
DEFECTIVE: Improper or no discharge line. The discharge piping should be of hard drawn copper or steel or other type approved for hot water distribution. It should be no smaller than the outlet of the valve and must pitch downward to allow complete drainage of the safety relief valve and discharge line. The end of the discharge line should not be threaded and should terminate below the controls at the exterior of the building and within 6" of the ground or other approved location. Valves, reducer couplings, or flexible connectors should not be installed on the discharge line.

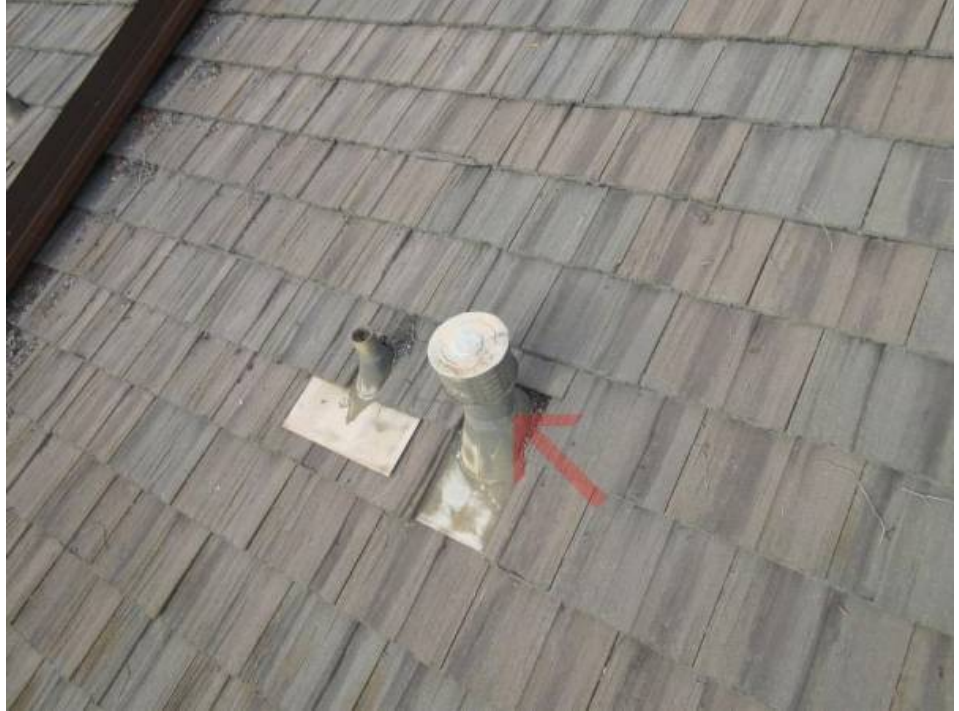
SAFETY: Transite vent pipe(s) observed. Transite is known to contain asbestos and will need special handling if removed or repaired.

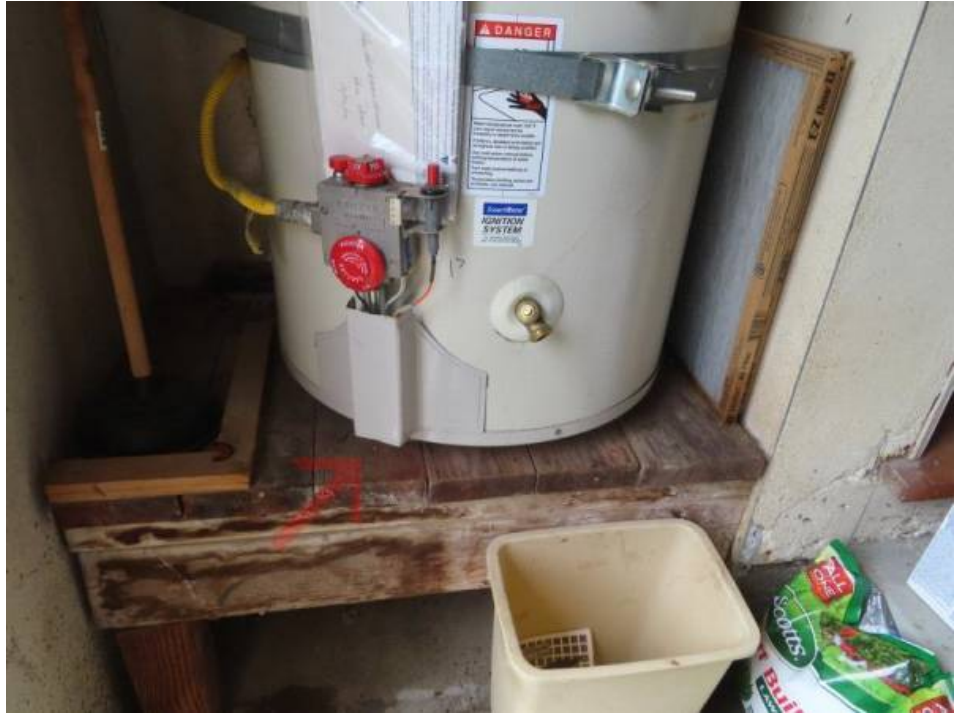
MAINTENANCE: We recommend installing a properly sized catch pan with a drain that terminates at the exterior of the building to prevent damage to structure/belongings in the event the water heater leaks.

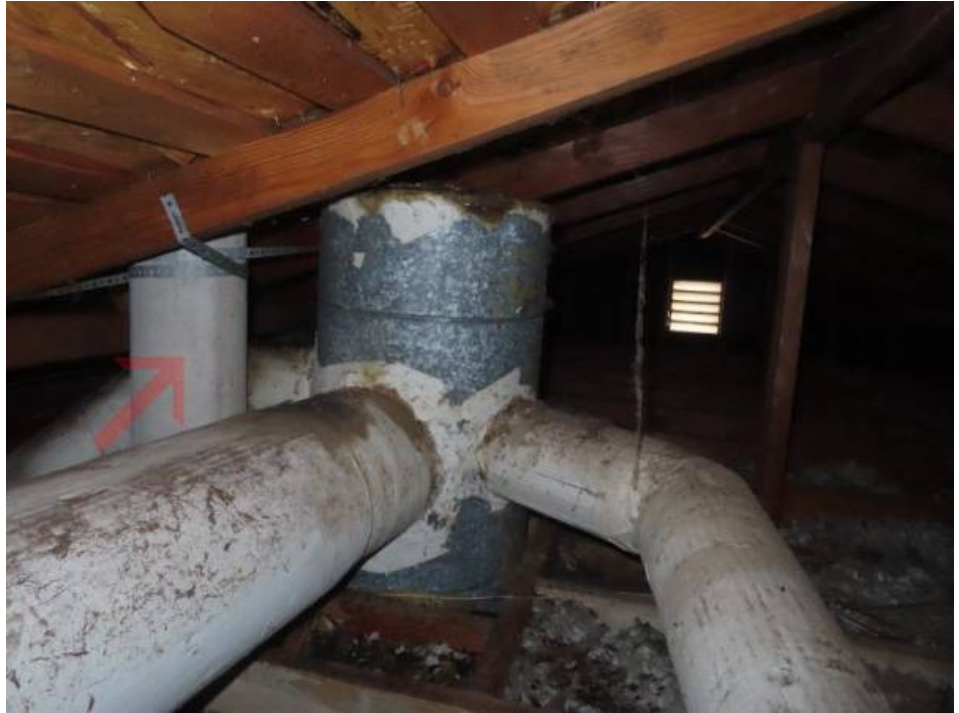
SAFETY: Transite vent pipe(s) observed. Transite is known to contain asbestos and will need special handling if removed or repaired.

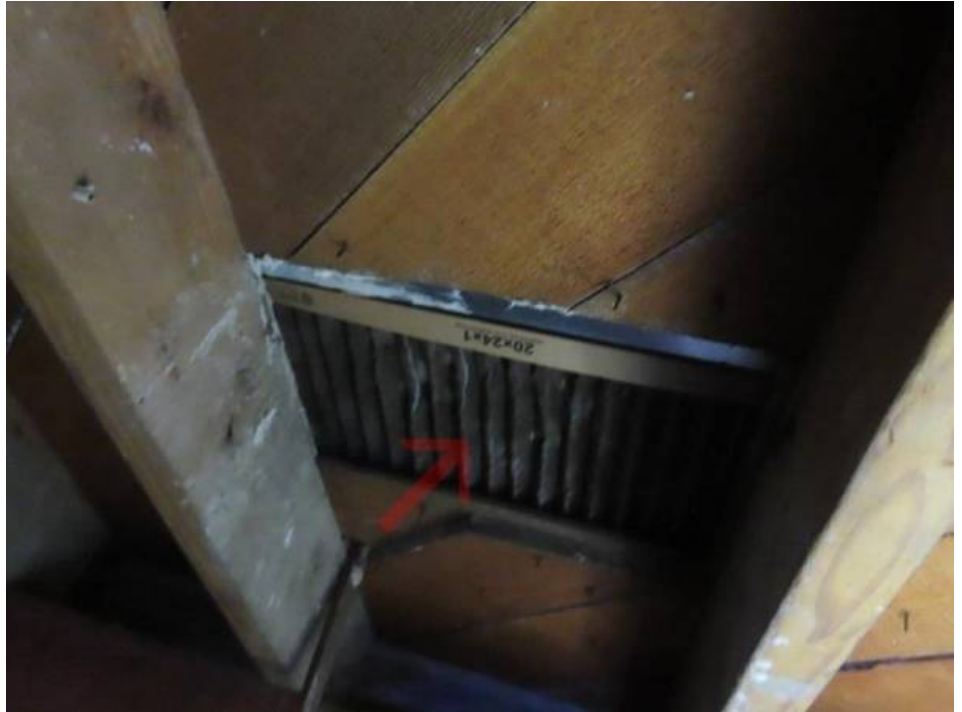
SAFETY: Return air is drawn from the subarea. The air in the subarea can contain spores and other microorganisms, which can be harmful to humans. Recommend further inspection and repairs by a licensed HVAC company.

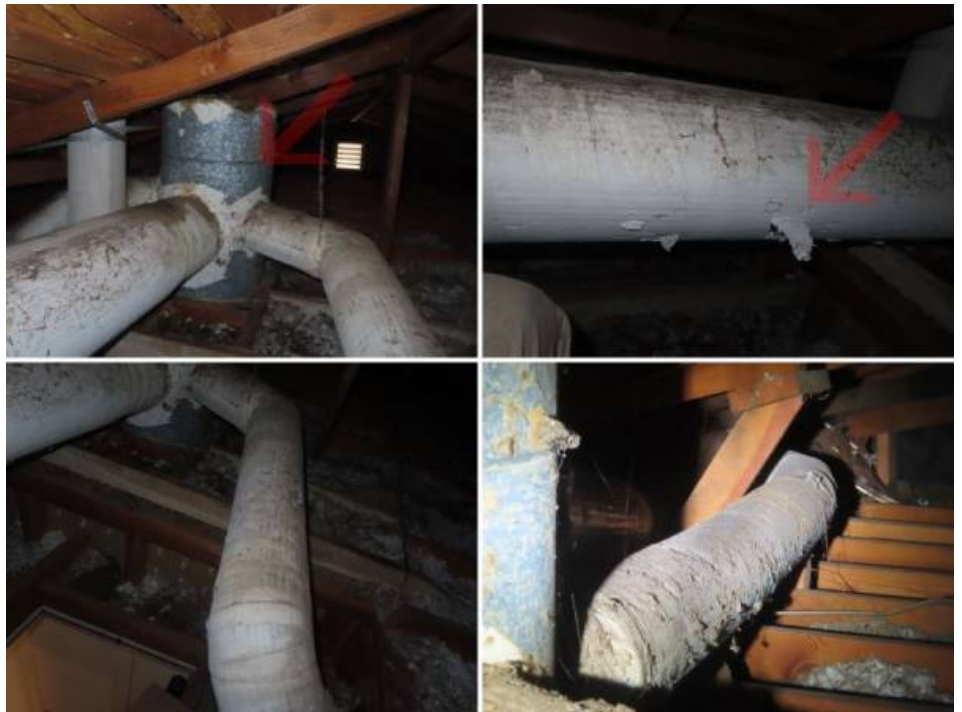
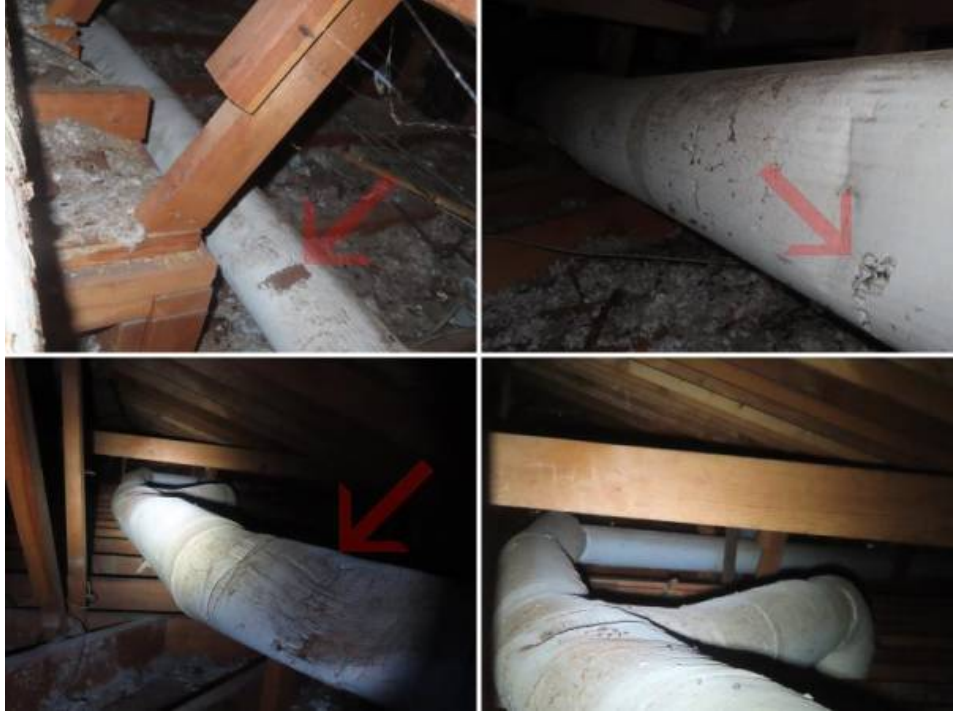
SAFETY: Suspect asbestos material damaged, loose or in friable condition. We recommend further evaluation by a licensed asbestos assessor.

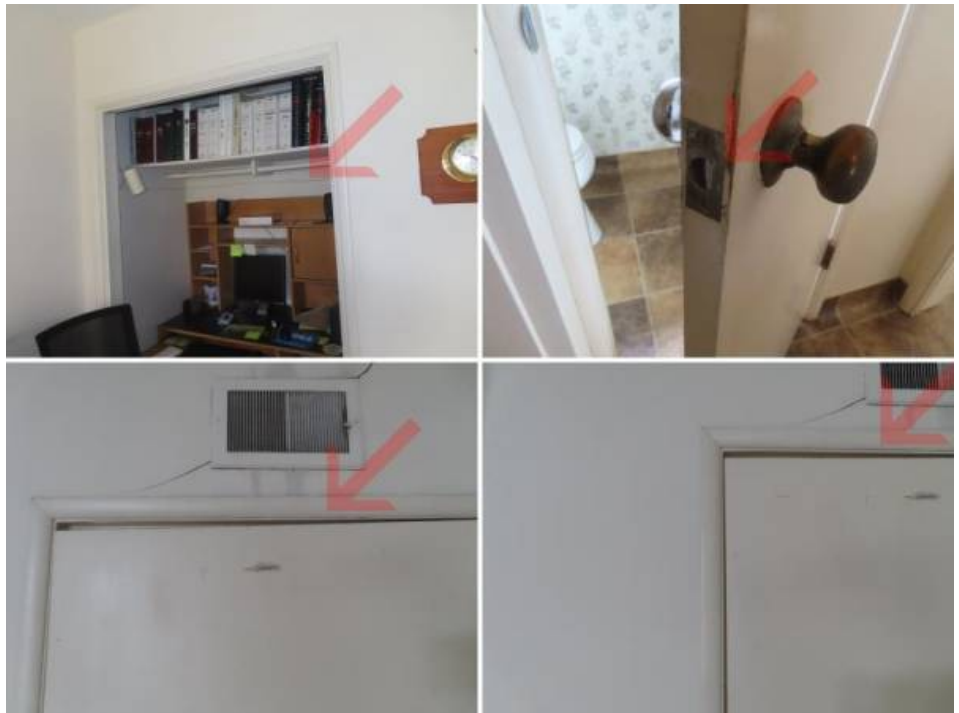
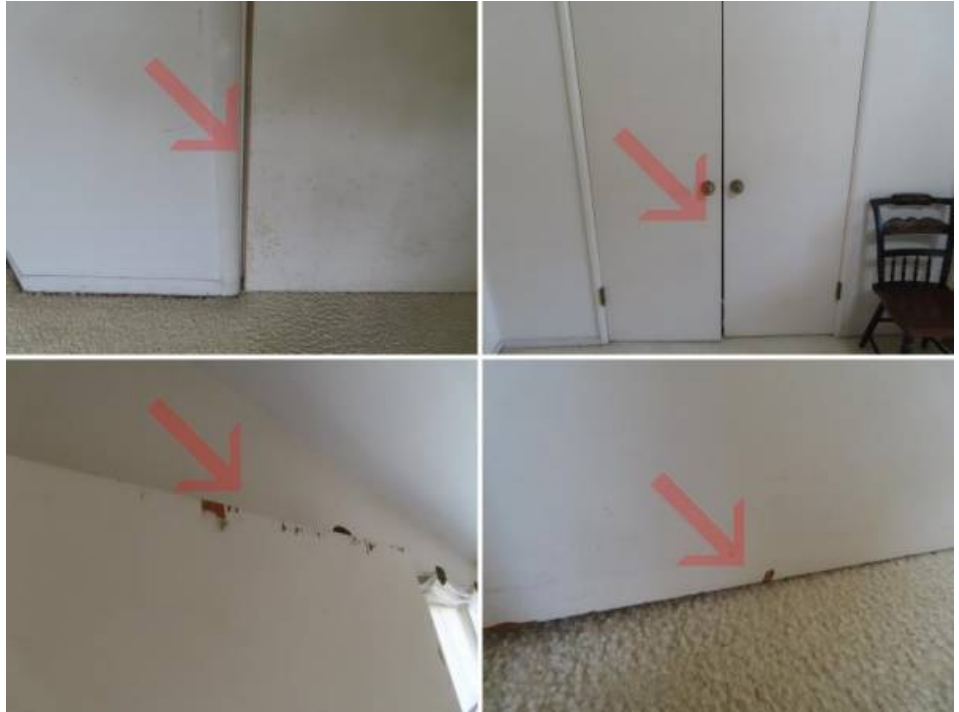
Hall bath, bedroom doors are out of level or rub and stick.

MAINTENANCE: Some doors rub, stick or don't latch. Some shaving/trimming/adjustment is needed.

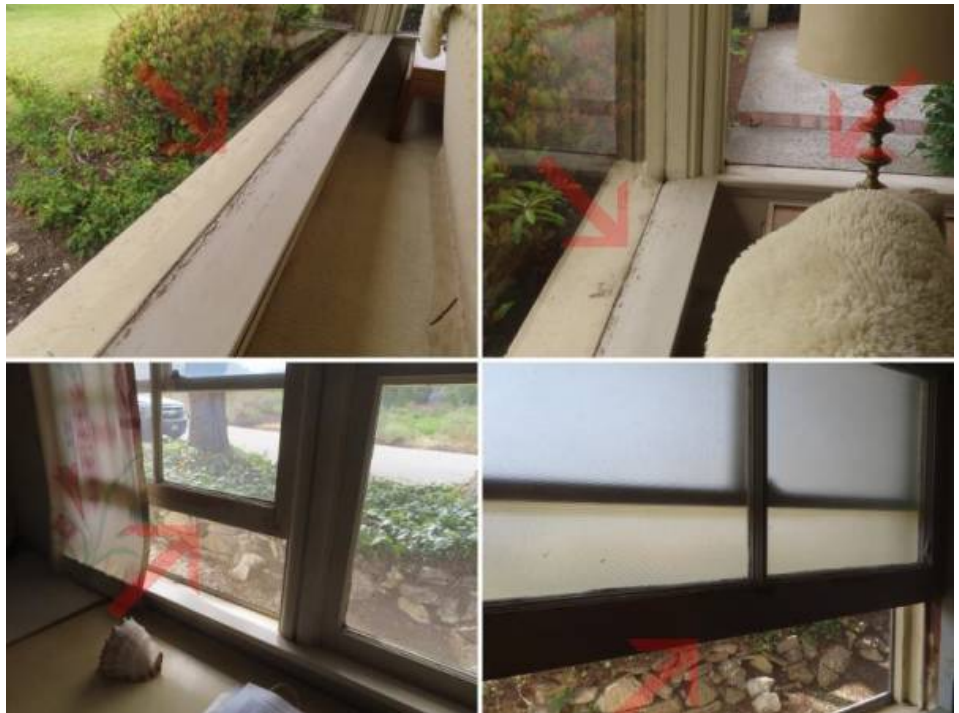
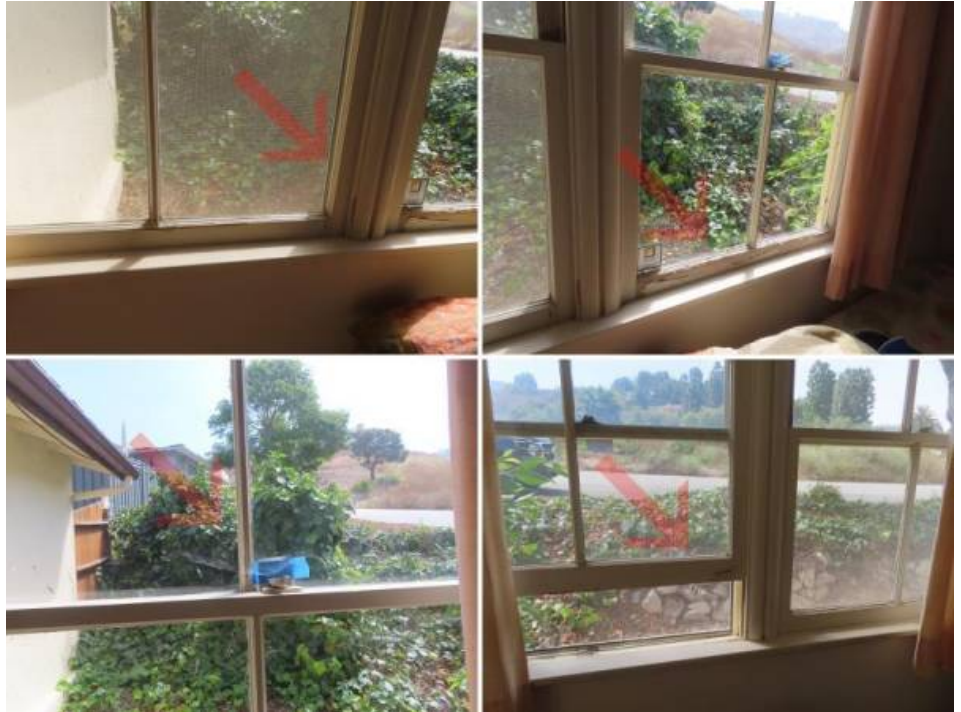
DEFECTIVE: Cracked/broken pane at one or more windows sampled.

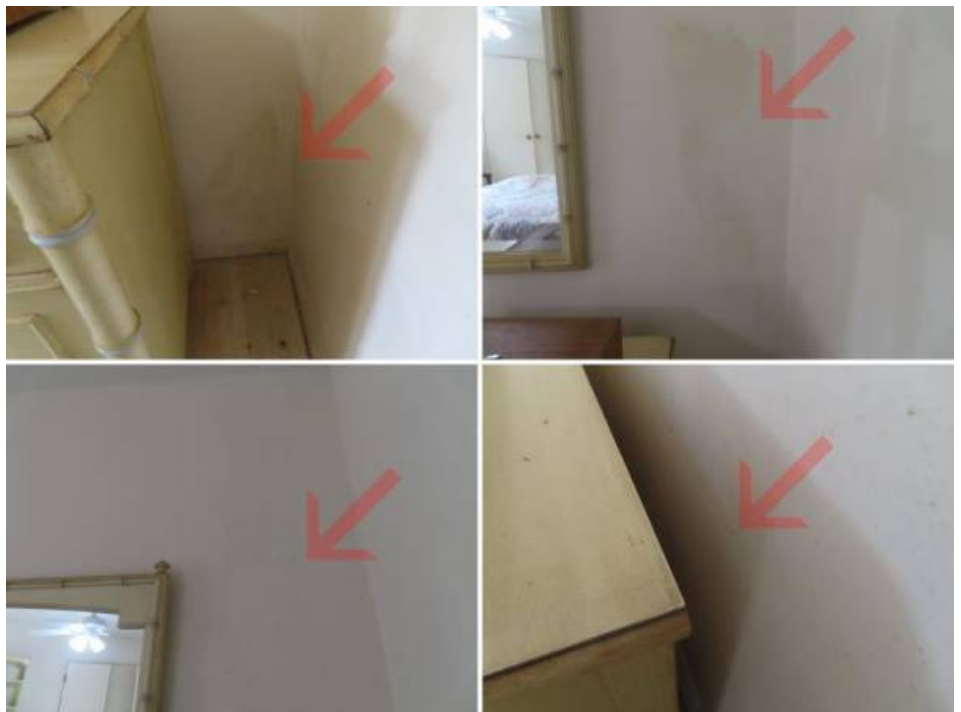
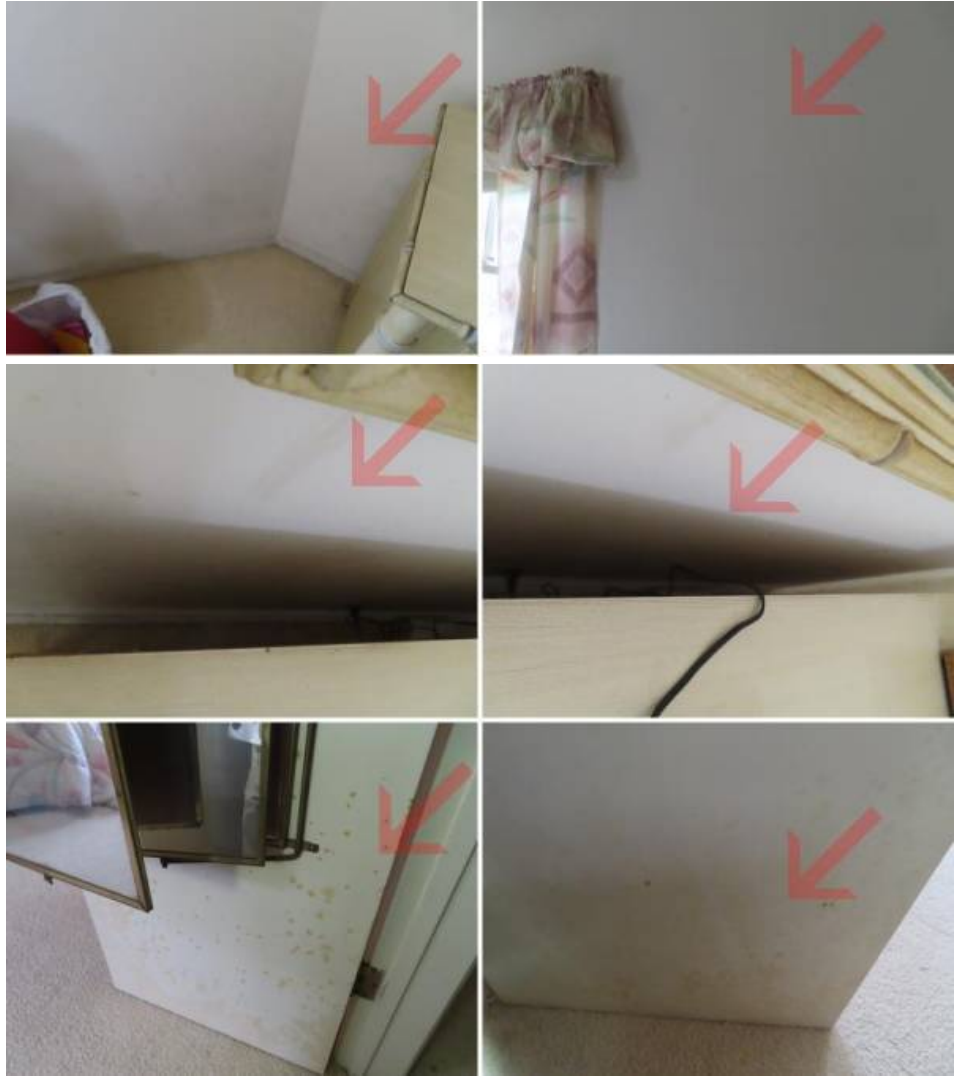
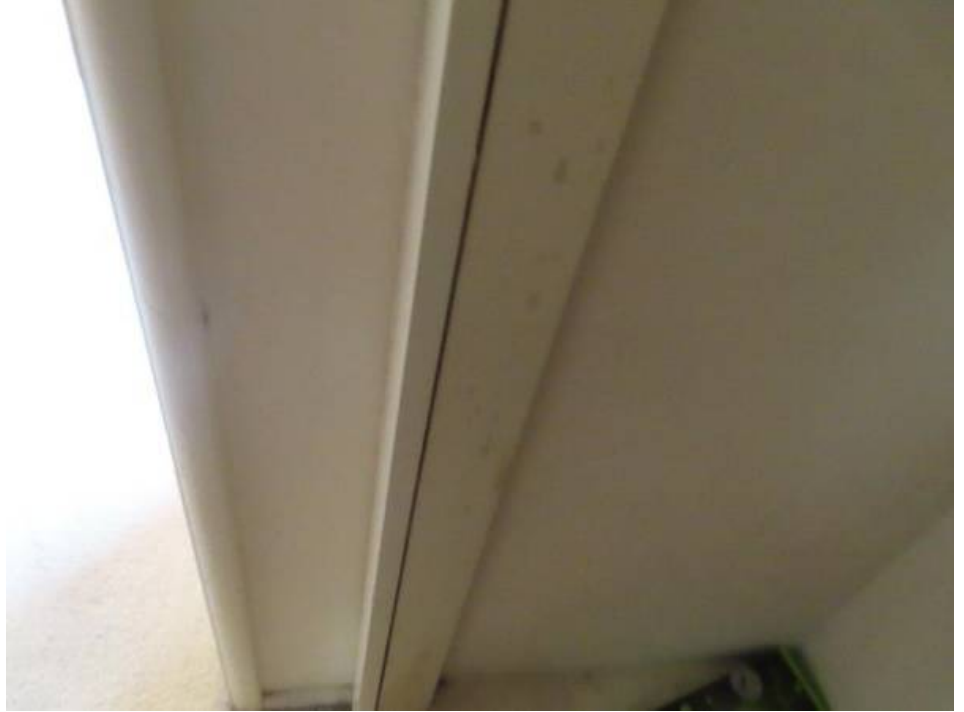
All bedrooms have possible mold condition present. Low air flow and furniture to close to walls can create mold conditions.

SAFETY: Mold/mildew viewed on the walls/ceiling. Mold can cause illness in humans or pets. Babies, children, the elderly and persons with respiratory disease, allergies or compromised immune systems can be especially at risk. We recommend further evaluation by a qualified Environmentalist or Industrial Hygienist to determine if harmful microorganisms are present.

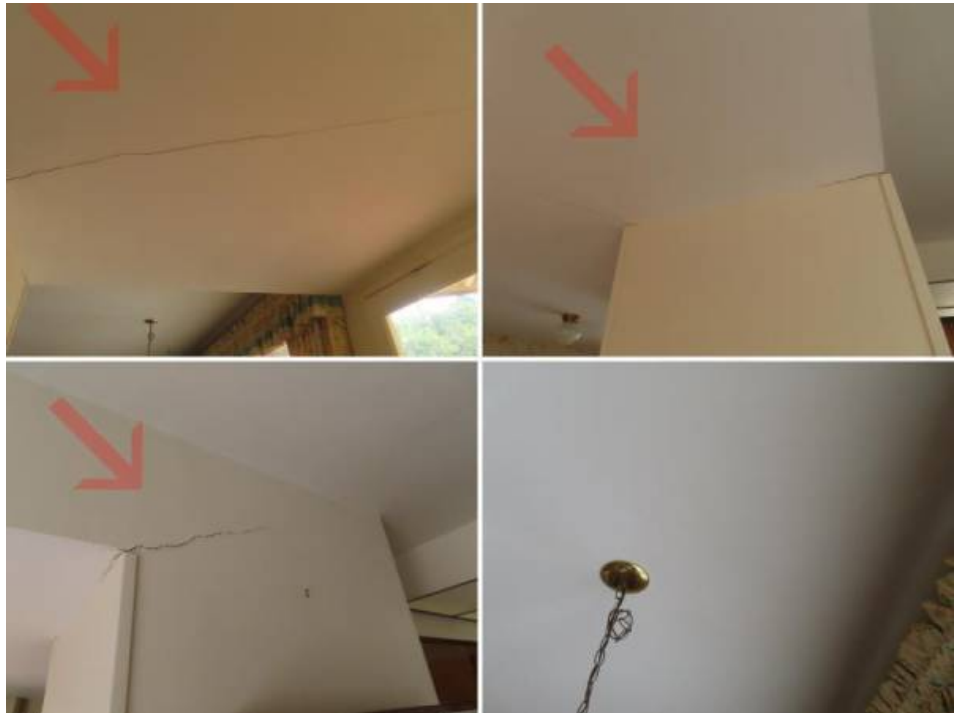
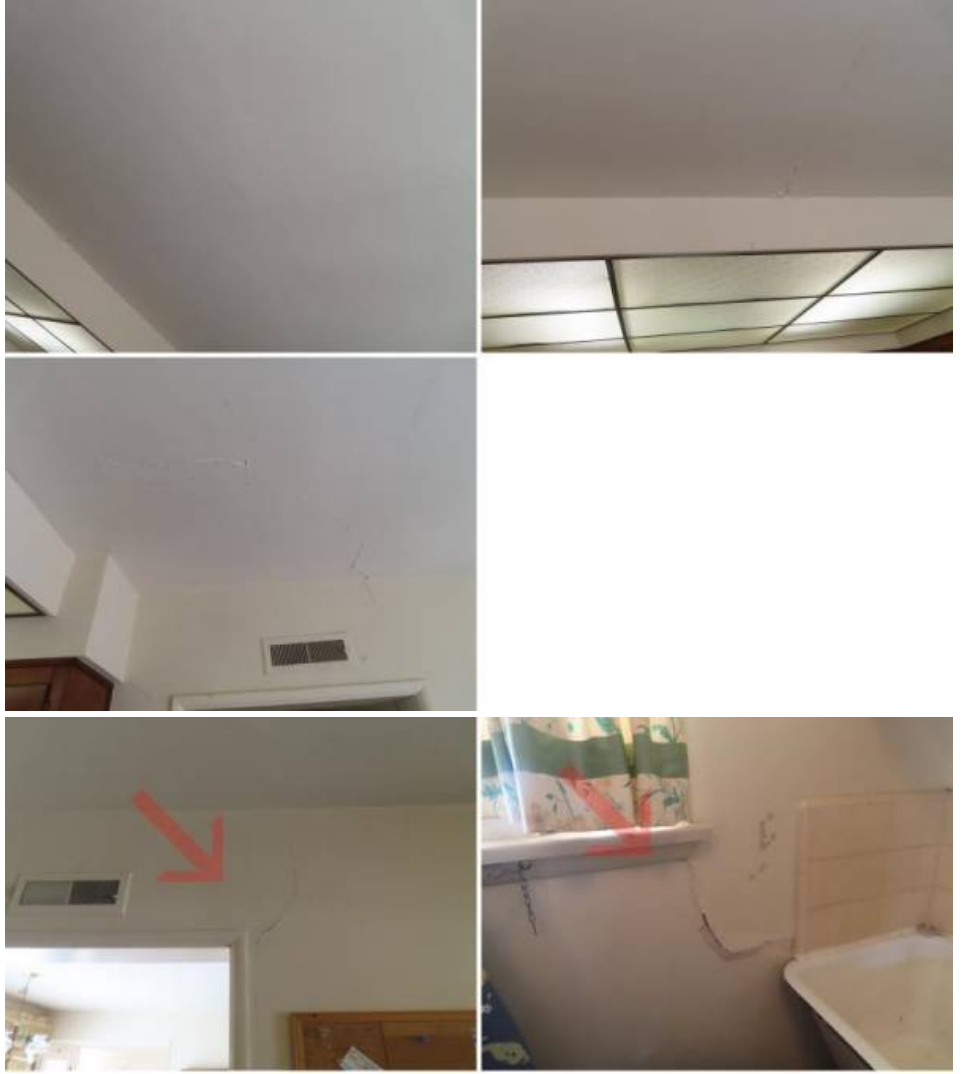
Entry into kitchen/laundry, Living room and 1st bedroom. 3 other bedrooms, have cracks.

MONITOR: Some cracks in the walls and ceilings viewed at various locations likely indicate moderate settlement/movement or seismic racking. We suggest monitoring and if any changes are observed we recommend further evaluation by a structural engineer.
