Confidential Inspection Report
2640 Via Rivera
Palos Verdes Estates CA 90274

July 24, 2023

<i>Description</i>	Single family house, and garage.
--------------------	----------------------------------

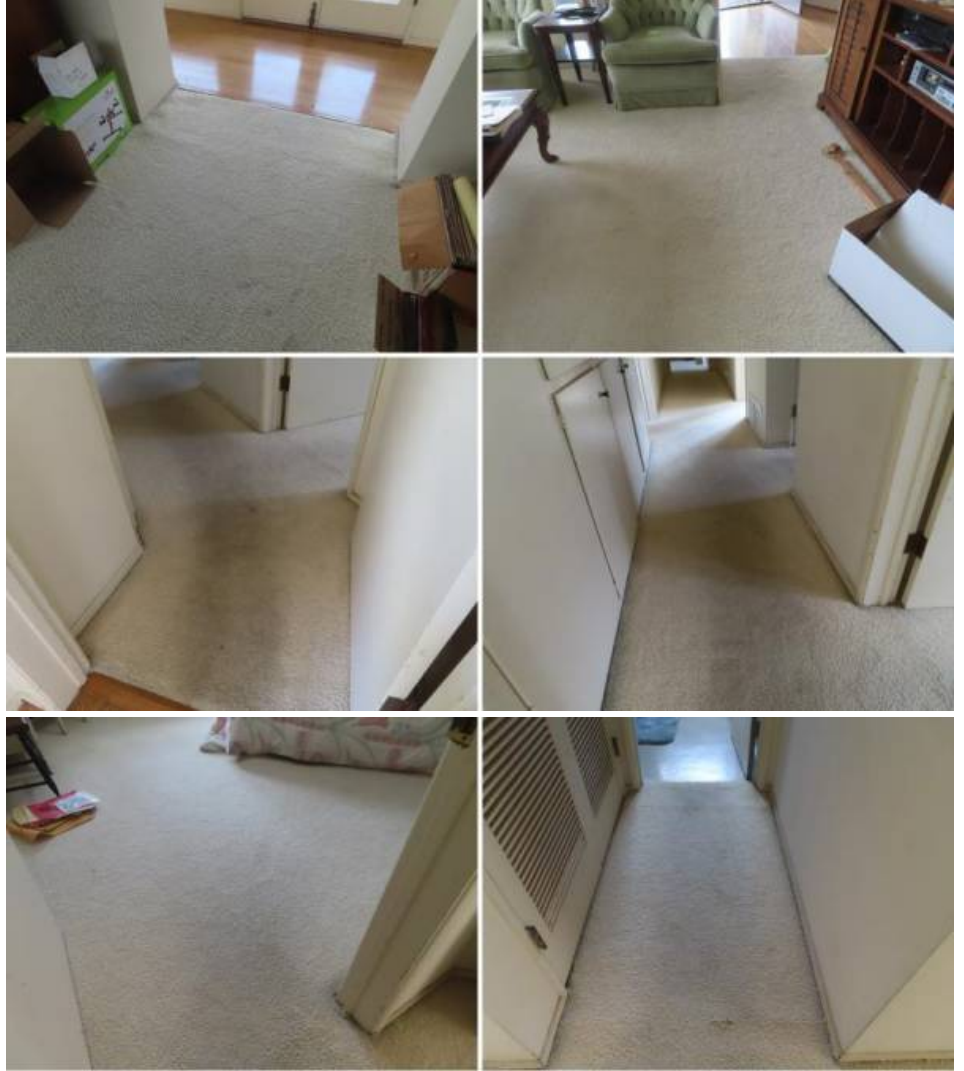
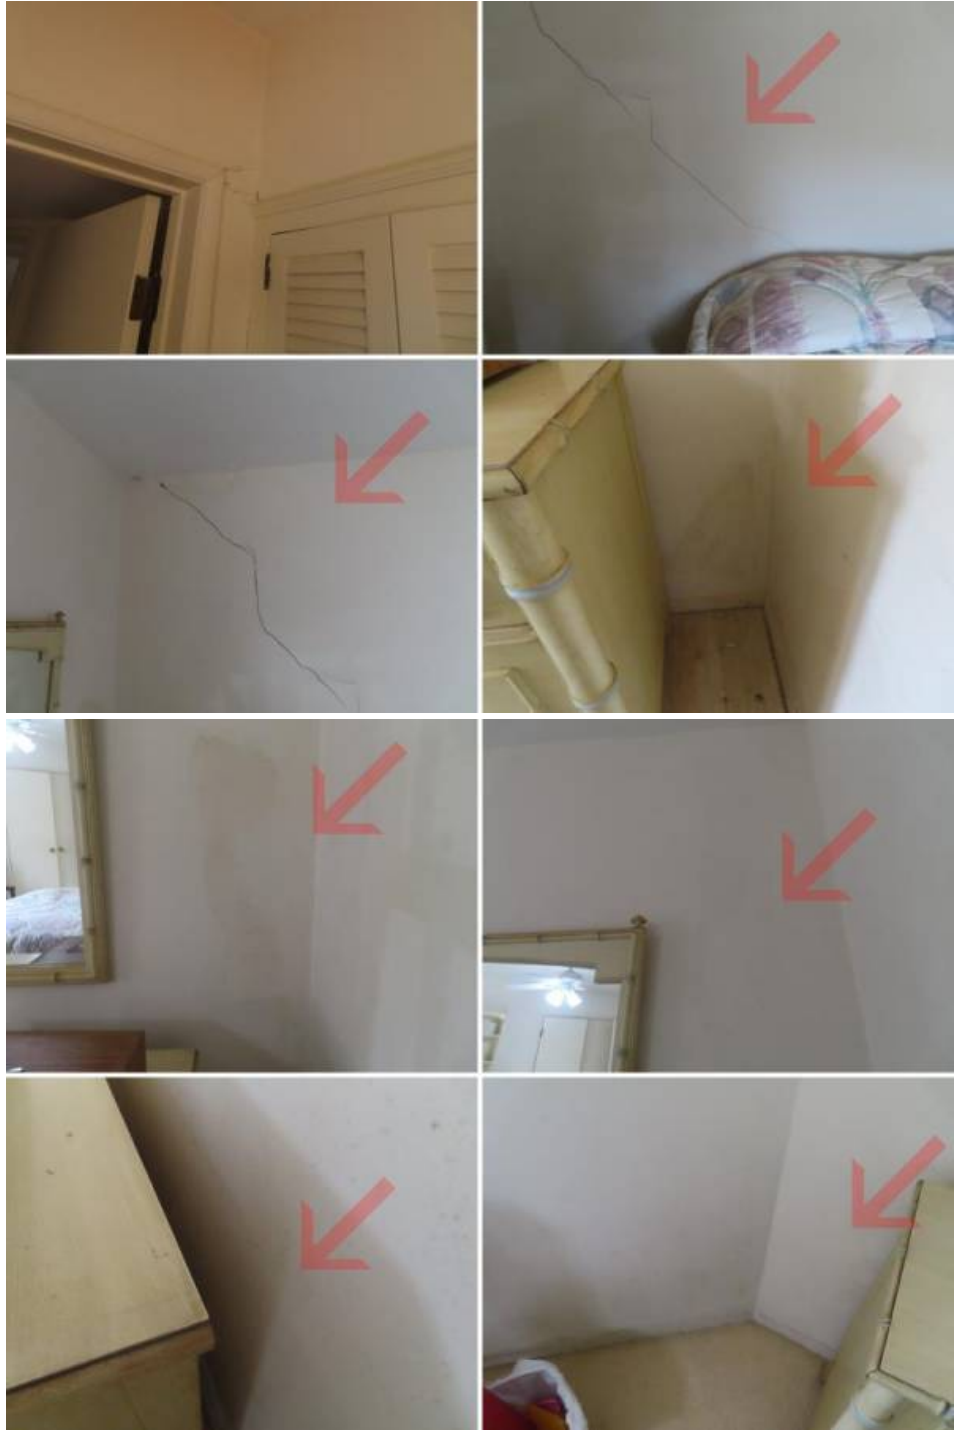
MAINTENANCE: Carpet is noticeably worn.

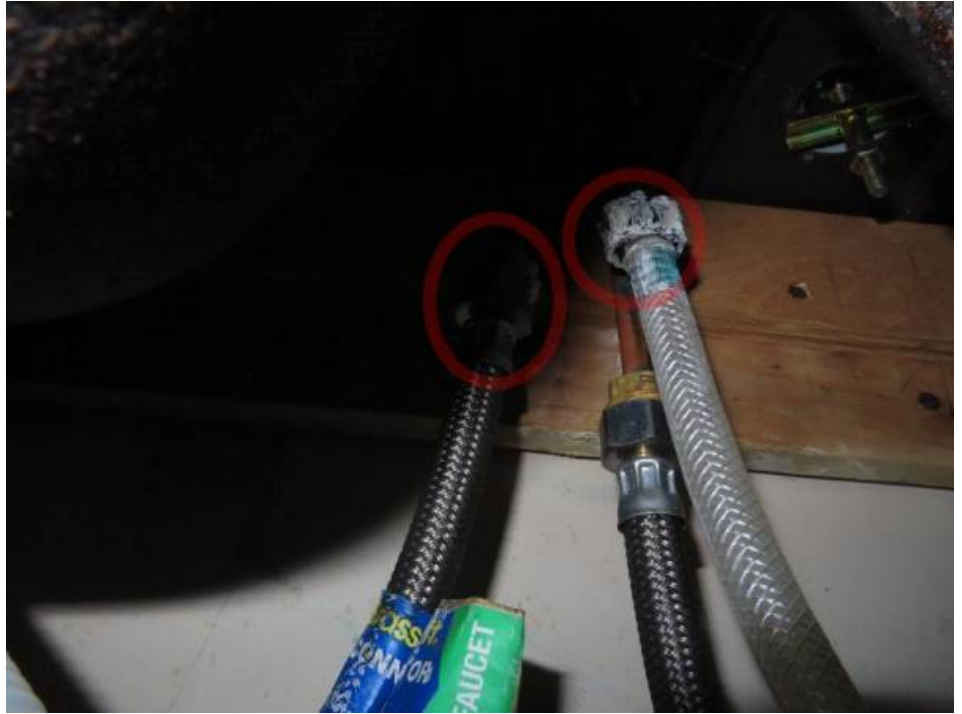
MAINTENANCE: Shutoff valve or connector is corroded. Corroded components will eventually fail; we recommend replacing corroded components when observed.

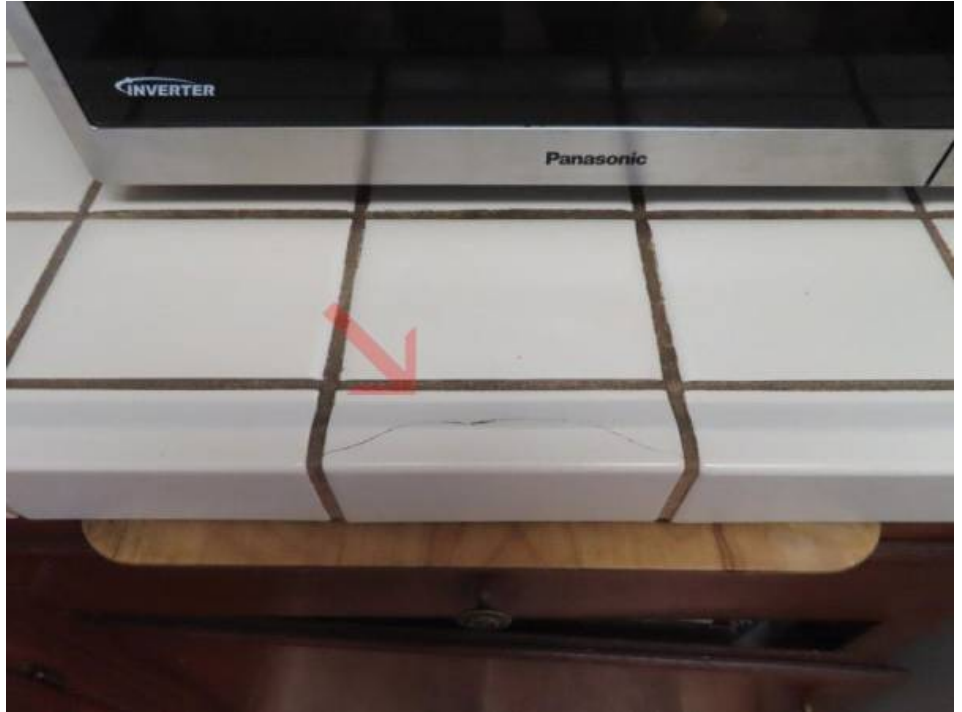
Tile. Chipped or cracked tiles or heavy wear noted.

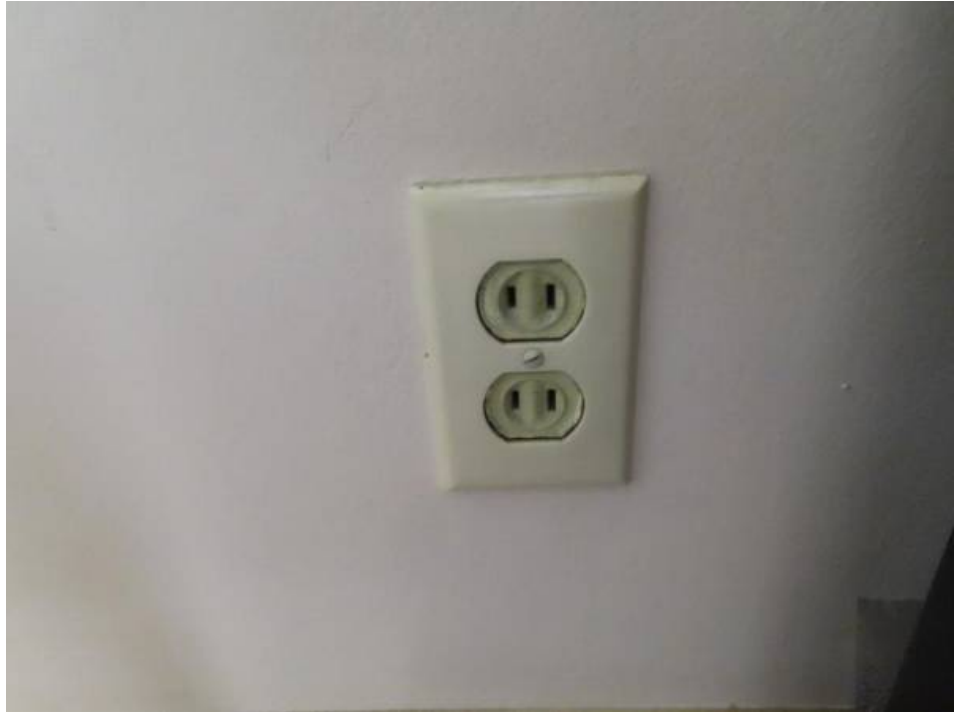
SAFETY: One or more receptacles are not GFCI protected. We recommend installing and maintaining GFCI protection at all kitchen counter receptacles.

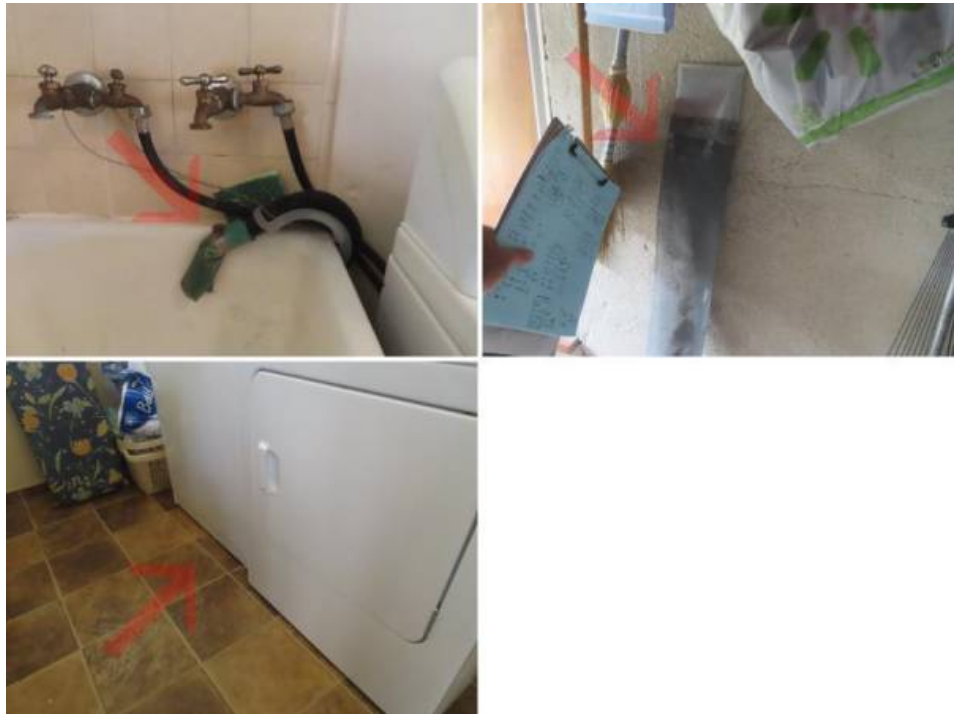
DEFECTIVE: No dryer vent to exterior, vent into garage. Dryers are required to vent to the outside atmosphere

SAFETY: We suggest installing a catch pan with a drain to the exterior to prevent water damage in the event of a leak in the washing machine.

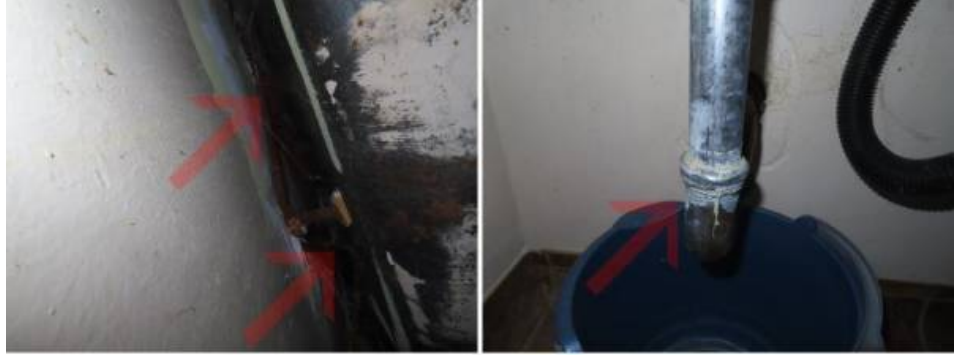
MAINTENANCE: Light corrosion on the drain line. We recommend replacing corroded components before they begin to leak.

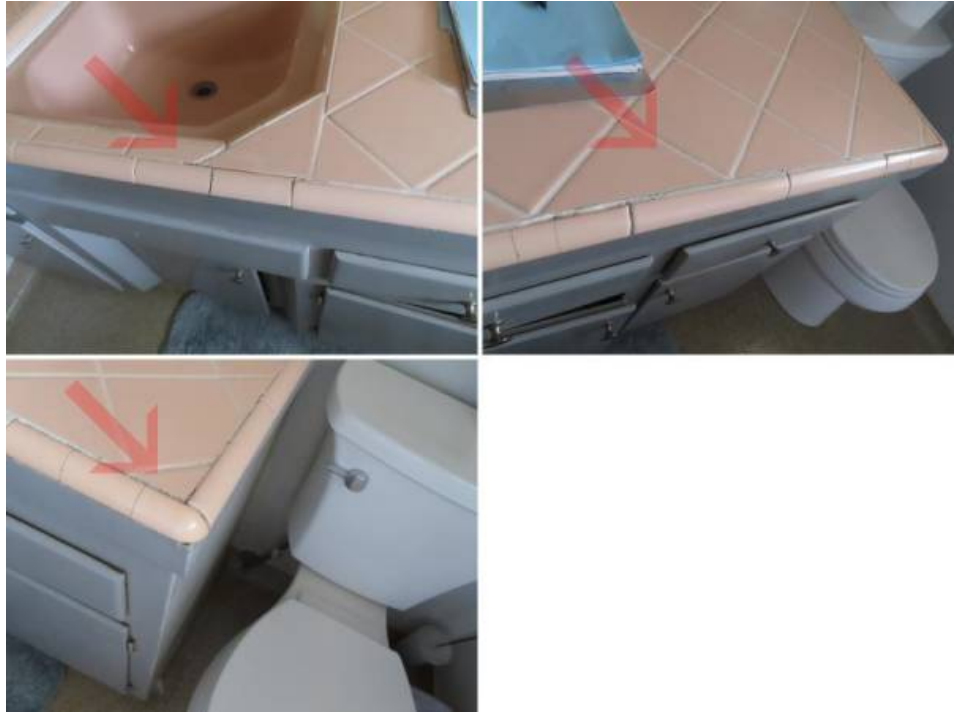
Tile. Chipped or cracked tiles or heavy wear noted.

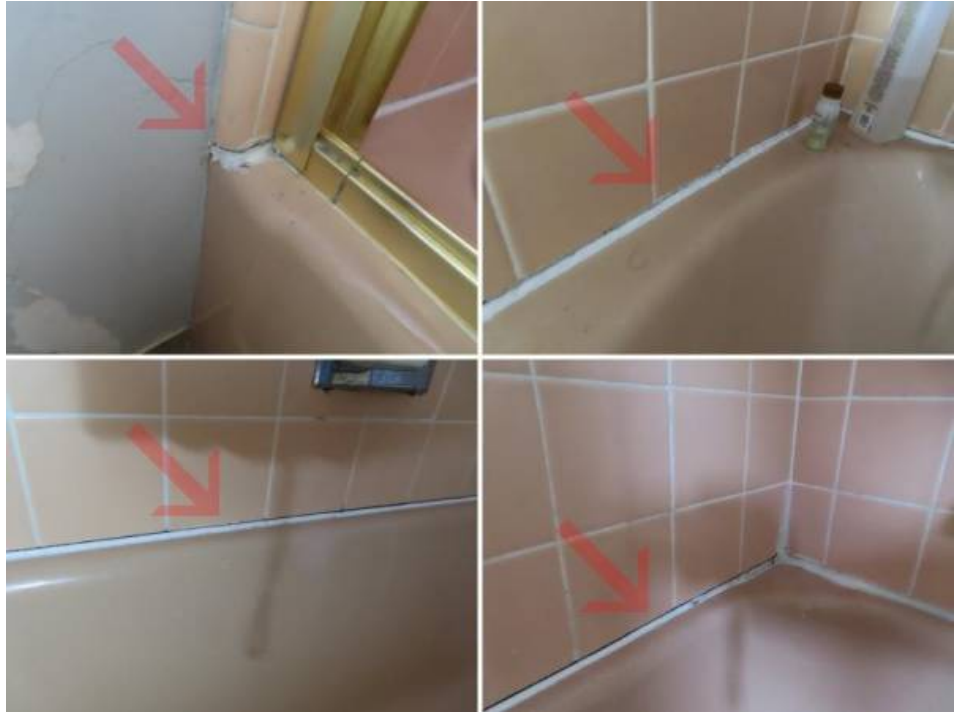
Main bath.
MAINTENANCE: Deteriorated or missing caulking at the bathtub rim, floor, or at the base of the fixtures. We recommend maintaining caulking as needed at this time to prevent water intrusion and subsequent damage.

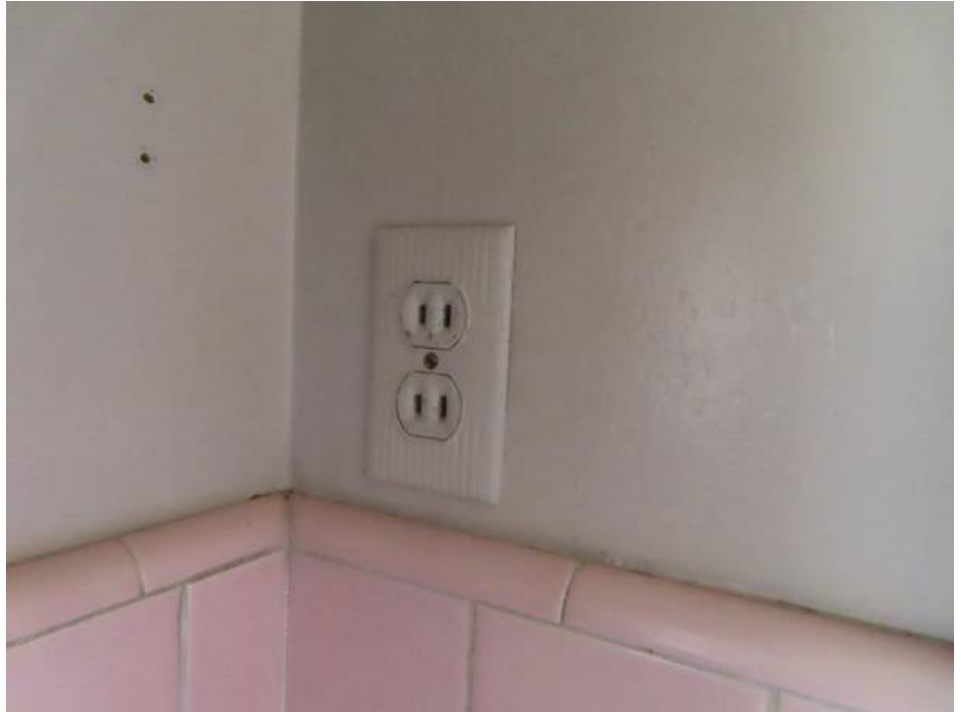
Master bath.
SAFETY: One or more receptacles are not GFCI protected. We recommend installing and maintaining GFCI protection at all bathroom receptacles.

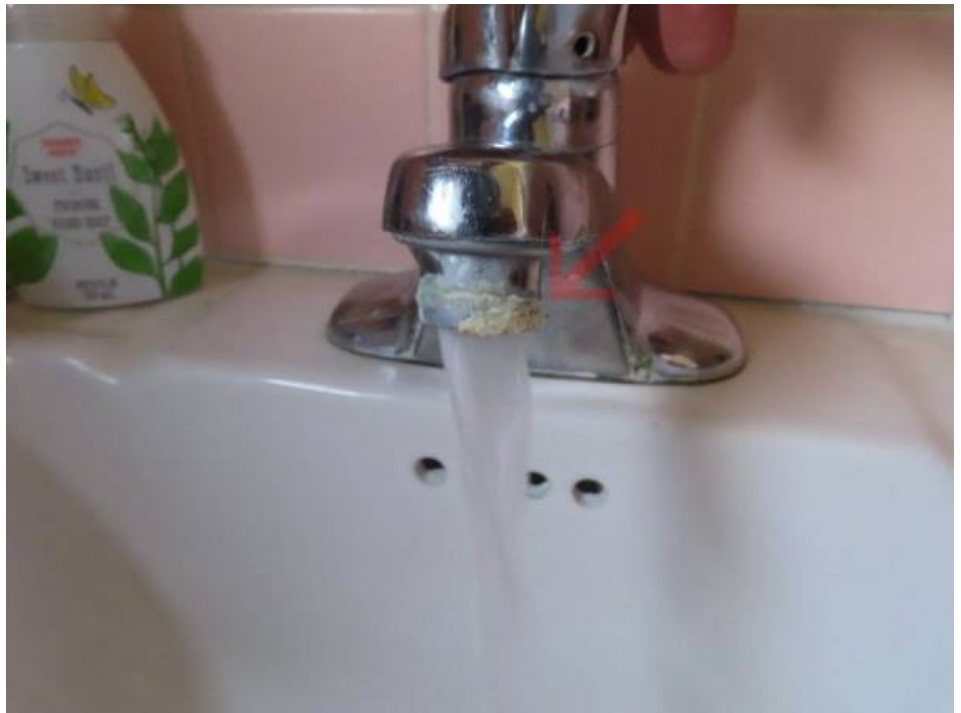
MAINTENANCE: Corroding at spout. Recommend cleaning spout.

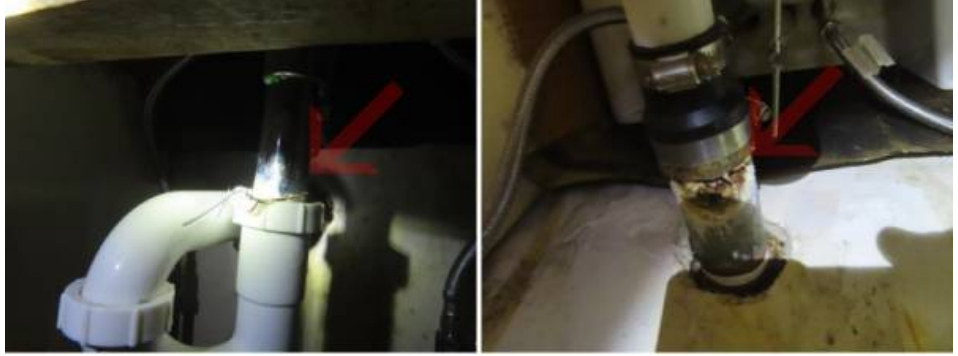
Master bath.

MAINTENANCE: Moderate corrosion on the drain line. We recommend replacing corroded components before they begin to leak.

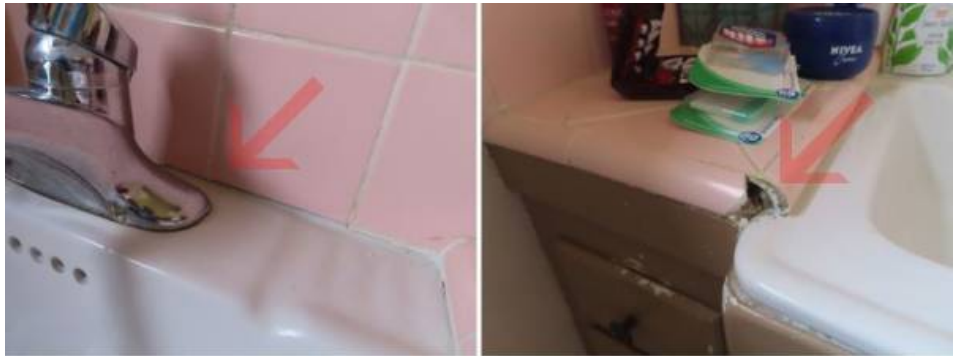
Master bath.
Tile. Chipped or cracked tiles or heavy wear noted.

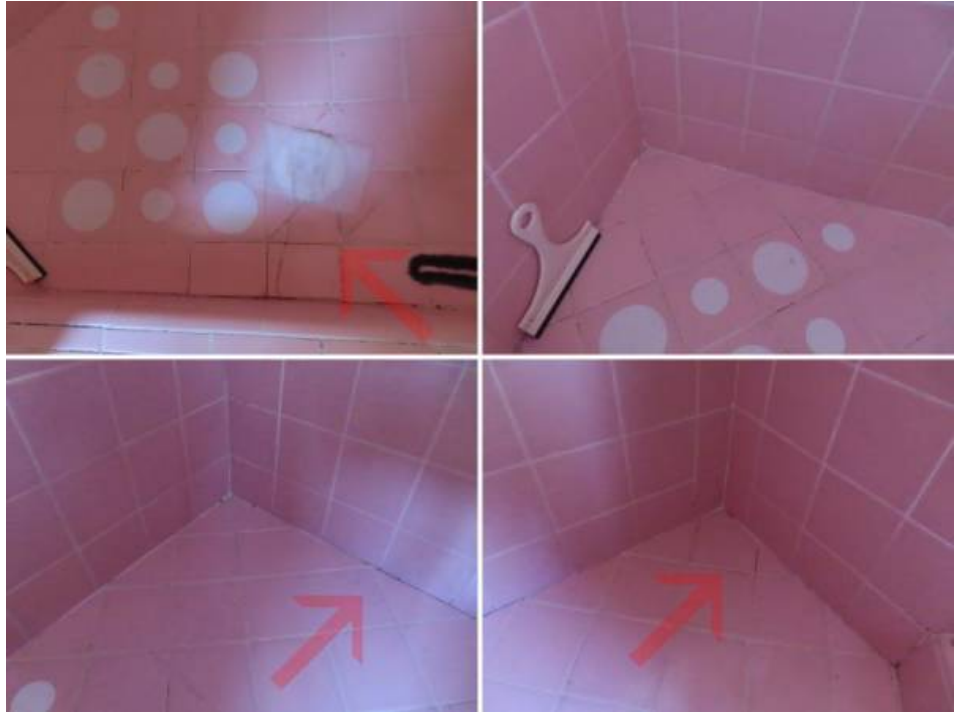
Master bath.
DEFERRED: Cracks in floor of shower.
MAINTENANCE: Caulking is deteriorated or missing at the shower dam, wall or floor. We recommend caulking as needed at this time to prevent water intrusion and subsequent damage.

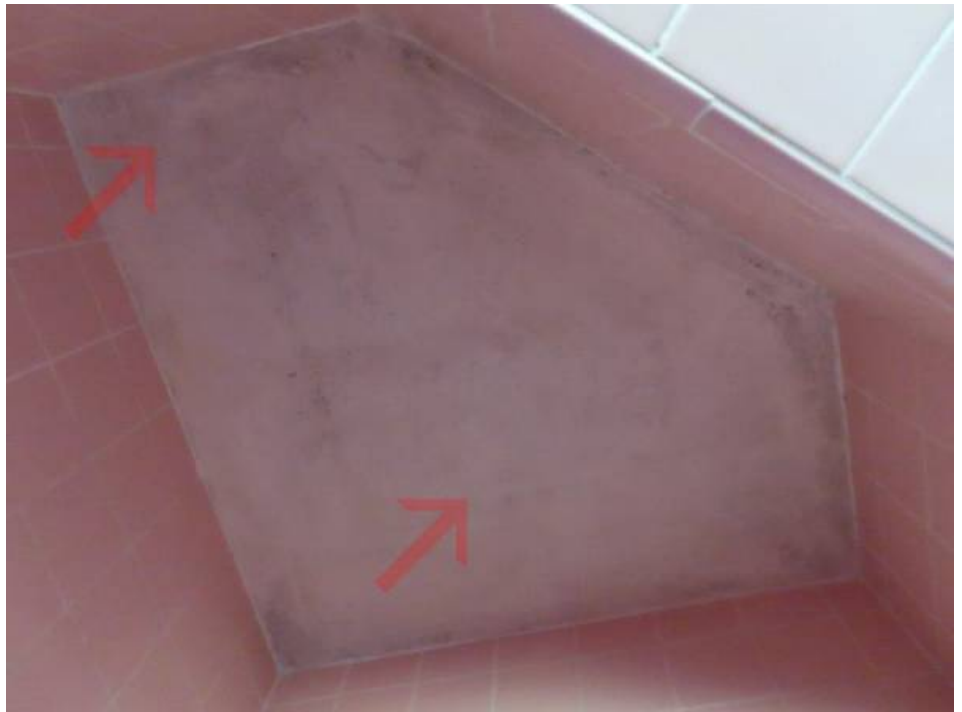
DEFERRED: Mildew-like or mold-like spots viewed on the ceiling or walls might indicate excessive moisture or inadequate ventilation.

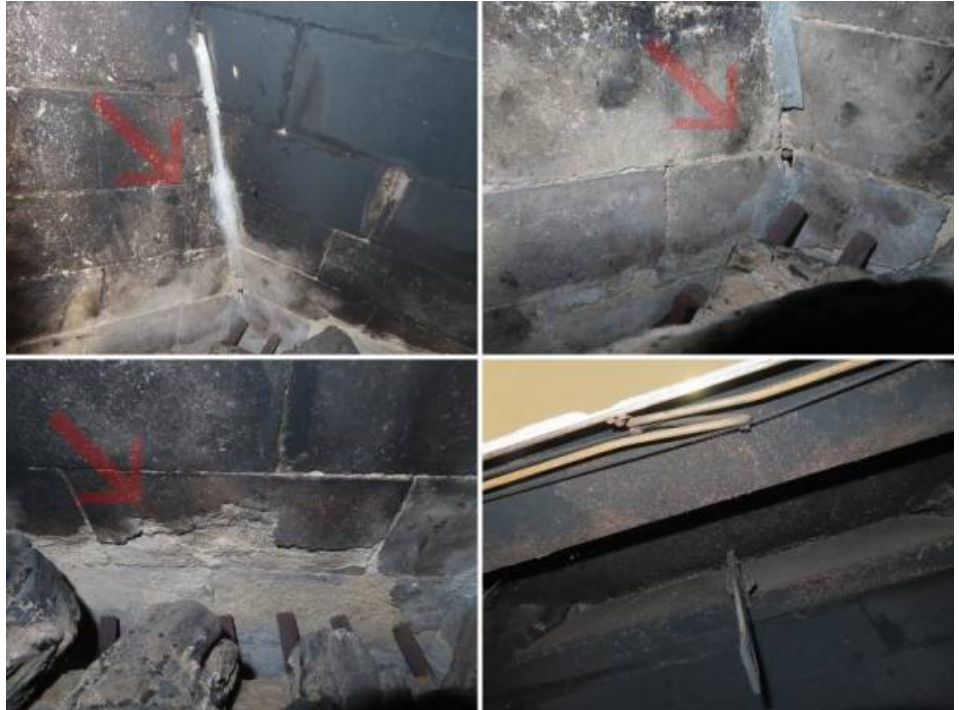
DEFECTIVE: Firebrick mortar is loose or deteriorated or cracked firebricks were viewed. We recommend further evaluation and repairs as needed by a qualified fireplace professional prior to use.

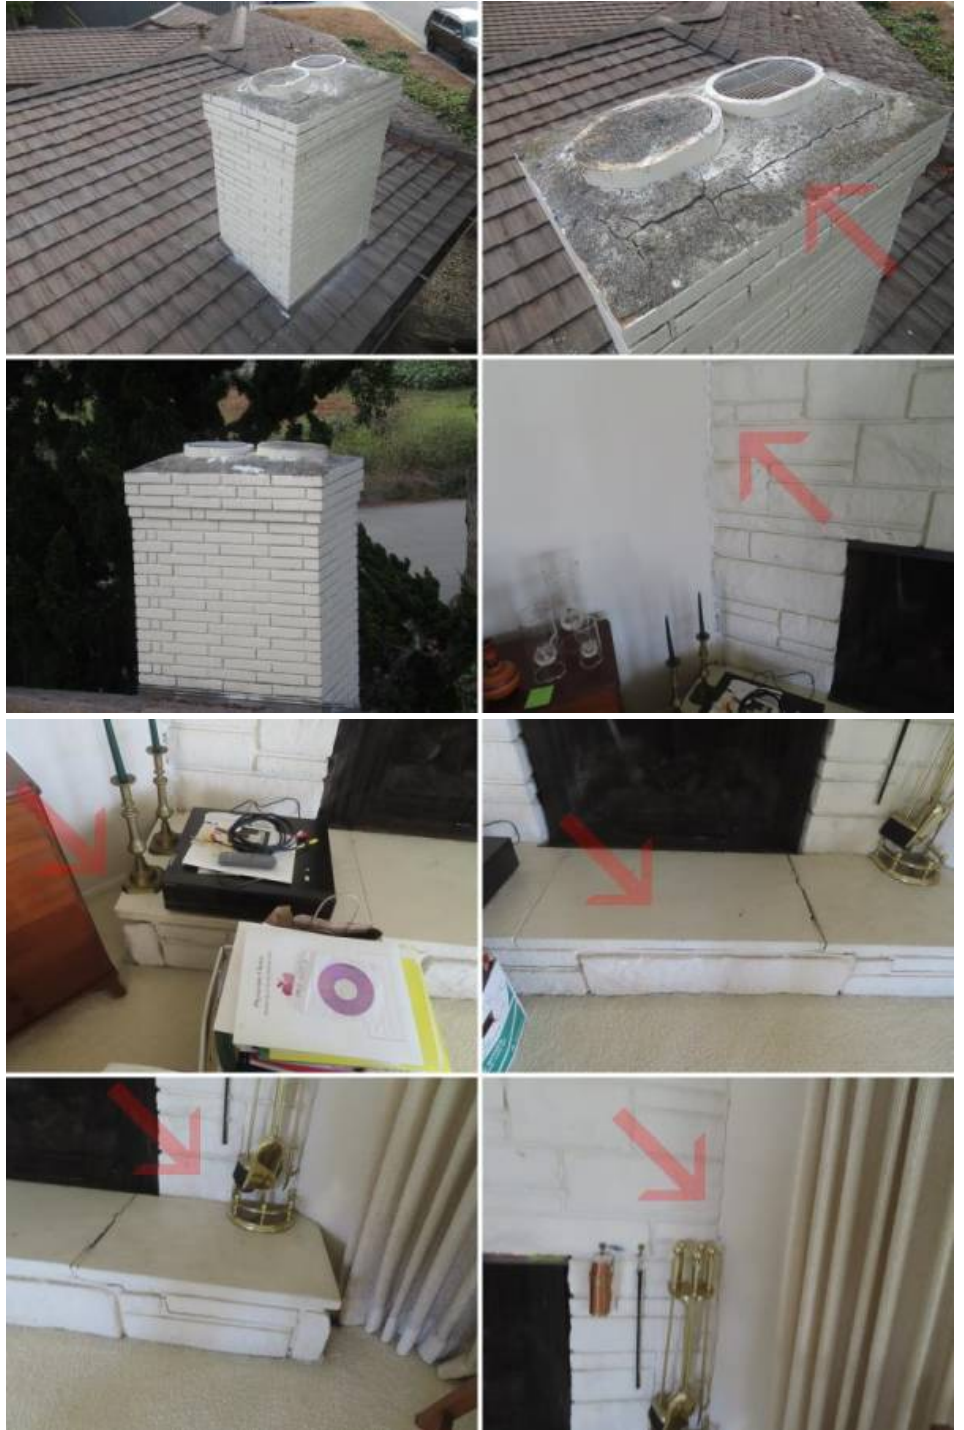
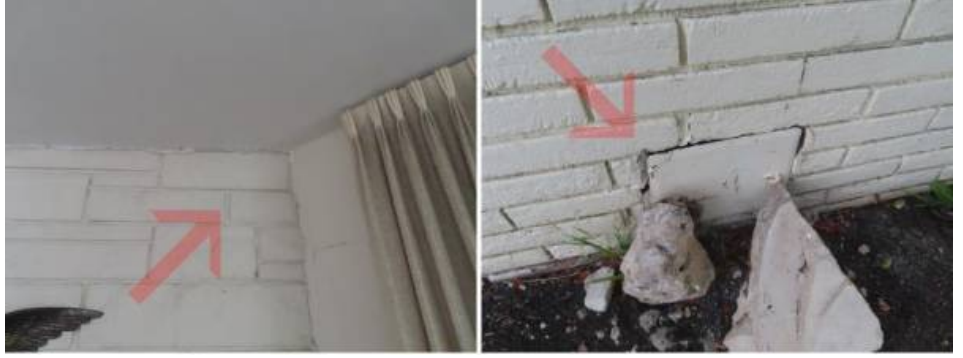
MAINTENANCE: Crown is cracked or otherwise deteriorated. The crown protects the masonry from the effects of weather and needs maintenance/repair at this time. We recommend further evaluation and repair as needed by a qualified fireplace professional.

MAINTENANCE: No rain cap. Rain caps are not required on masonry chimneys; however, they protect the chimney and firebox from deterioration and we recommend installing them on all chimneys.

Interior has settlement cracks and hearth cracks.

DEFECTIVE: Small cracks observed. We recommend further evaluation by a qualified fireplace professional prior to use.
