# McMASTER

## Property Inspection Report

**InspectionNo:** 1813  
**Date/Time:** 3/11/2022 9:29 AM  
**Property Address:** 2321 Gonzaga Ln Riverside, CA

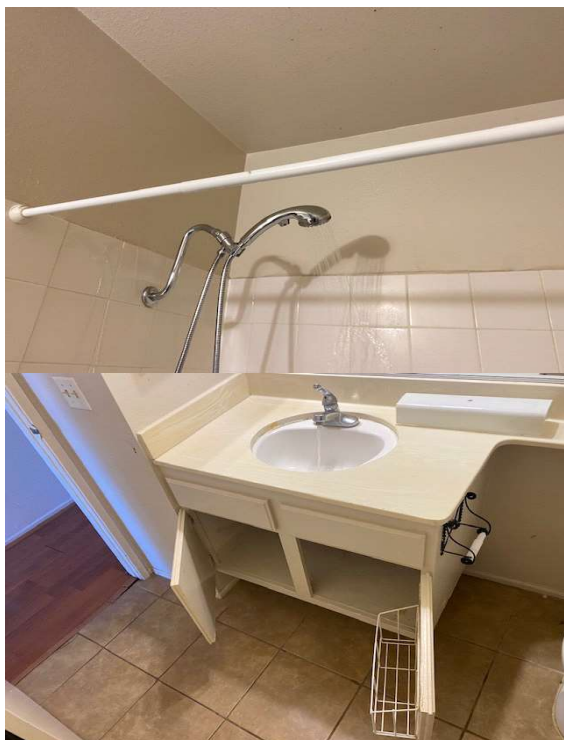
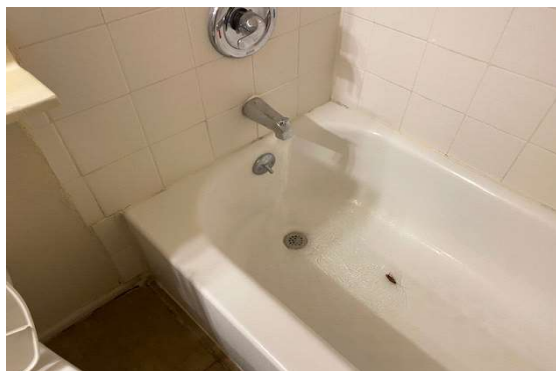
Inspection Area	Good	Fair	Poor	Comment
<b>Bathroom</b>				
Ceiling	X			MOISTURE STAINS, UNKNOWN CAUSE.
Walls	X			
Floor Type	X	X		TILE. SOME CRACKED / DAMAGED TILE(S). LOOSE THRESHOLD.
Doors	X			
Counter Tops	X			SOME CRACKS IN GROUT.
Cabinets	X	X		SOME DOORS / DRAWERS DO NOT OPERATE PROPERLY, DETERIORATION AND STAINS UNDER SINK.
Sinks	X			
Mirrors	X			
Bath Tub	X			
Shower	X			
Shower Walls	X			SOME CRACKS IN GROUT.
Shower Enclosure			X	NONE.
Toilet	X			
Plumbing	X		X	HOT COLD REVERSED AT SHOWER VALVE. LEAK AT SINK FAUCET AT HANDLE WHEN ACTIVATED. .SHUT OFF VALVES UNDER SINK DO NOT OPERATE PROPERLY.
Electrical	X		X	OUTLET(S) ARE NOT GFCI PROTECTED, NTBS
Exhaust Fan	X

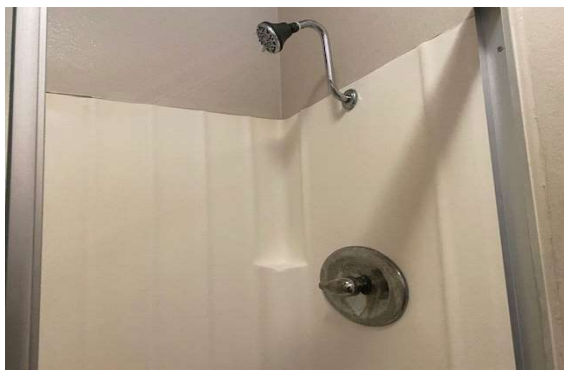
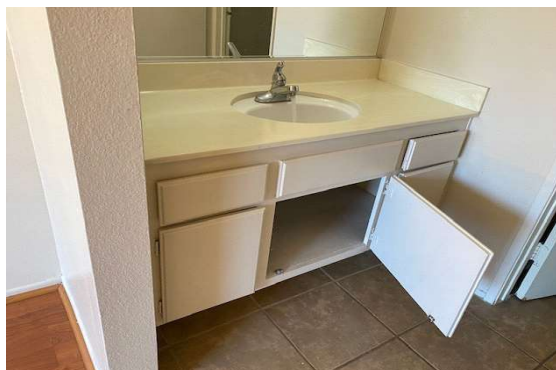
Inspection Area	Good	Fair	Poor	Comment
<b>Bathroom Master</b>				
Ceiling	X			
Walls	X			
Floor Type	X			TILE.
Doors	X			
Counter Tops	X			STAINS, CRACKS IN GROUT.
Cabinets	X	X		SOME DOORS / DRAWERS DO NOT OPERATE PROPERLY, DETERIORATION AND STAINS UNDER SINK.
Sinks	X			
Mirrors	X			
Shower	X			
Shower Walls	X			
Shower Enclosure	X			CORROSION AT CORNERS.
Toilet	X			
Plumbing	X		X	HOT COLD REVERSED AT SHOWER VALVE. LEAK AT SINK FAUCET AT HANDLE WHEN ACTIVATED. .SHUT OFF VALVES UNDER SINK DO NOT OPERATE PROPERLY.
Electrical	X		X	OUTLET(S) ARE NOT GFCI PROTECTED, NTBS
Exhaust Fan	X	X		SOME DEBRIS PRESENT AT COVER.

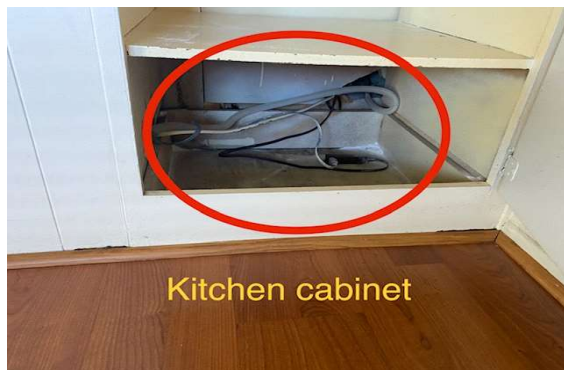
Inspection Area	Good	Fair	Poor	Comment
<b>Kitchen</b>				
Ceiling	X			
Walls	X			
Floor Type	X			TILE.
Counter Tops	X	X		SOME CRACKS IN GROUT.
Cabinets	X	X		SOME DOORS / DRAWERS DO NOT OPERATE PROPERLY. DETERIORATION AND STAINS UNDER SINK.
Sink	X			
Dishwasher	X			A FULL CYCLE IS NOT POSSIBLE DURING THE INSPECTION, THEREFORE WE CANNOT COMMENT ON THE FULL EXTENT OF ITS FUNCTIONS OR THE ABILITY TO CLEAN.
Drain Loop			X	NONE, DRAIN NEEDS TO LOOP HIGHER THAN LOWEST LEVEL OF SINK.
Disposal		X		MAKES IRREGULAR NOISE.
Sink Plumbing	X	X		SHUT OFF VALVES UNDER SINK DO NOT OPERATE PROPERLY.
Range	X	X		(GAS). START UP TEST ONLY. REVIEW WITH SELLER. MINOR DAMAGE.
Oven	X		X	(GAS). START UP TEST ONLY, REVIEW WITH SELLER. MISSING ANTI-TIP DEVICE, NTBS.
Fan and Hood	X		X	MISSING FILTER. GREASE / DEBRIS BUILD UP.
Venting			X	FAN DOES NOT OPERATE.
Electrical	X		X	OUTLET(S) ARE NOT GFCI PROTECTED, NTBS. USING EXTENSION CORD AS PERMANENT POWER, NTBS. FROM WASHER.

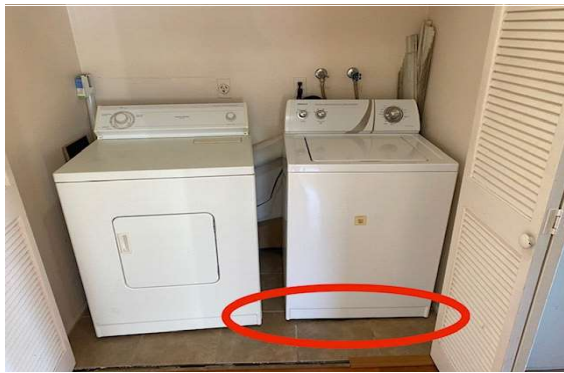
Inspection Area	Good	Fair	Poor	Comment
<b>Laundry Room</b>				
Laundry Location	+	+	+	HALL. NOT RATED
Ceiling	X			
Walls	X			
Floor Type	X		X	UNEVEN IN AREAS, MISSING DRIP PAN.
Doors	X	X		DAMAGED AT MID.
Dryer Vent	X	X		RECOMMEND SERVICE. DAMAGED (CRUSHED) FLEX PIPE.
Laundry Plumbing	X		X	CORROSION AT SUPPLY LINE CONNECTIONS. SHUT OFF VALVE DOES NOT OPERATE PROPERLY.
Waste Line	X			
Gas Line	X			
Electrical	X		X	OUTLET(S) NOT GFI PROTECTED, NTBS.

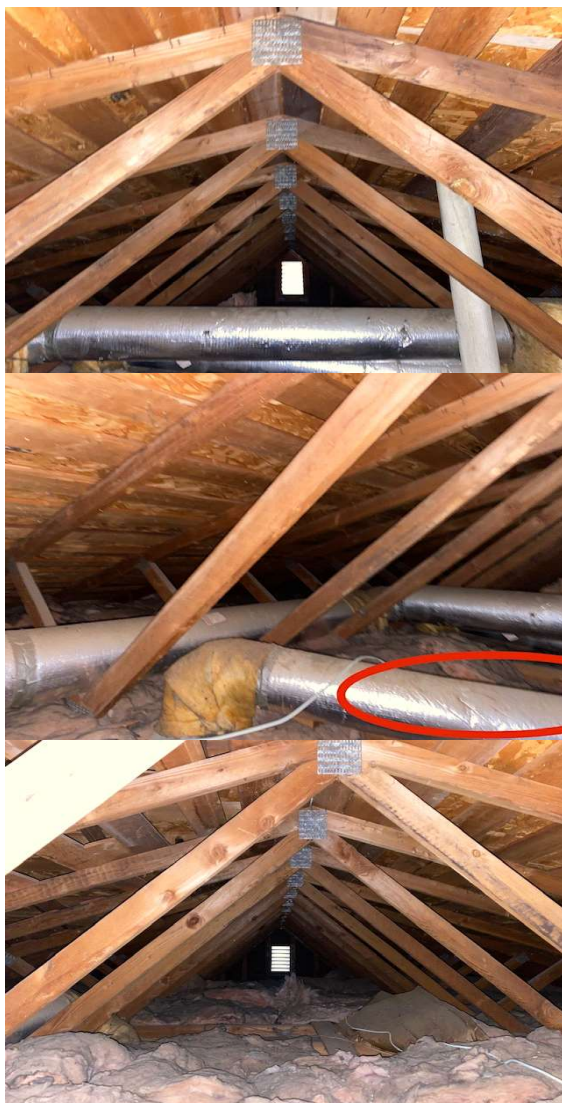
Inspection Area	Good	Fair	Poor	Comment
<b>Attic</b>				
General View	X			
Structural	X		X	(TRUSS / RAFTER FRAMING). EXPOSED OPENING AT FIRE WALL.
Insulation	X			(ROLLED FIBERGLASS).
Attic Ventilation	X			
Duct Work	X	X		SOME MINOR DAMAGE TO WRAPPING MATERIAL.
Attic Electrical	X			
Attic Plumbing	X			
Access	X			
Access Cover	X	X		DAMAGED TRIM.
Access Location	+	+	+	AT HALL. NOT RATED.
Attic Notes	+	+	+	LIMITED INSPECTION DUE LOW VERTICAL CLEARANCE, VIEWED FROM ACCESS OPENING ONLY. NOT RATED.

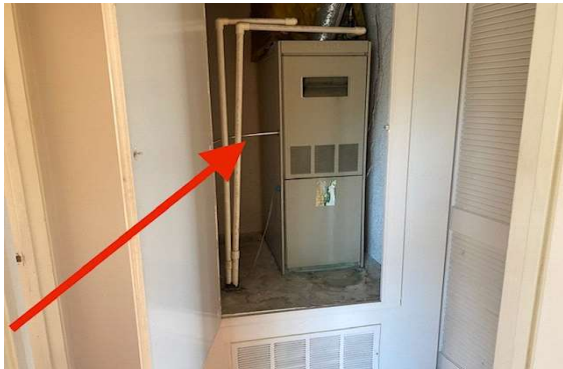
Inspection Area	Good	Fair	Poor	Comment
<b>Heating</b>				
Unit Location	+	+	+	INTERIOR ENCLOSURE. NOT RATED.
Heat Type	+	+	+	GAS. FORCED AIR. NOT RATED.
BTUs	+	+	+	UNKNOWN, REVIEW WITH SELLER. NOT RATED.
Heater Condition	X			NOTE: CONDUCTED PERFORMANCE TEST ONLY. RECOMMEND SERVICE. RECOMMEND FURTHER INSPECTION. (OLDER UNIT).
Temp Differentials	X			
Heating Electrical	X			
Enclosure	X	X		MINOR DAMAGE / DETERIORATION / STAINS TO BASE.
Gas Valve	X		X	PIPE PASSES THROUGH WALL OF UNIT, IMPROPER TYPE SUPPLY LINE MATERIAL, NTBS. MISSING DRIP LEG, NTBS
Vent Pipe	X			
Combustion Air	X			
Filters			X	NEEDS TO BE REPLACED.
Thermostats	X	X		UNIT LOOSE FROM WALL.
Registers	X	X		RECOMMEND SERVICE. MOST RUSTED.

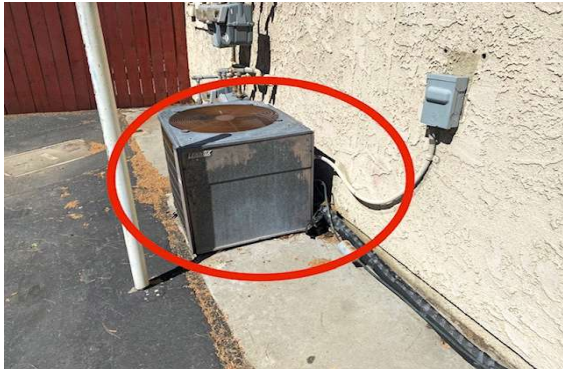
Inspection Area	Good	Fair	Poor	Comment
<b>Cooling</b>				
Unit Location	+	+	+	AT S/SIDE. NOT RATED.
Cooling Type	+	+	+	A/C COMPRESSOR, SPLIT SYSTEM. NOT RATED.
Tons	+	+	+	UNKNOWN TONNAGE, UNABLE TO VIEW LABEL, REVIEW WITH SELLER. NOT RATED.
Cooling Condition			X	NOTE: CONDUCTED PERFORMANCE TEST ONLY. RECOMMEND SERVICE. RECOMMEND FURTHER INSPECTION. (OLDER UNIT).DAMAGED INSULATION AT CONDENSATION LINE, NTBS. MISSING INSULATION AT COOLING LINE.
Temp Differentials			X	BLOWS WARM AIR.
Cooling Electrical	X	X		LOOSE FLEX LINE.
Thermostats	X

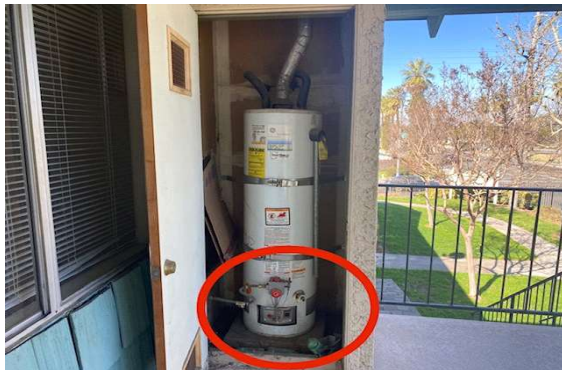
Inspection Area	Good	Fair	Poor	Comment
<b>Water Heater</b>				
Unit Location	+	+	+	EXTERIOR ENCLOSURE. NOT RATED.
Type -Mfg-Year	+	+	+	GAS. (G.E.). NOT RATED. RECOMMEND SERVICE.
Gallons	+	+	+	40. NOT RATED.
Unit Condition	X	X		MISSING LOWER FLAME COVER, RECOMMEND SERVICE.
Wtr Htr Plumbing	X	X		CORROSION/RUST AT SUPPLY LINE CONNECTIONS.
T.P.R.V.	X			
Overflow Line	X			
Wtr Htr Strapping	X			
Gas Valve - Gas Line	X		X	MISSING DRIP LEG, NTBS.
Vent Pipe	X			
Combustion Air	X			
Enclosure	X	X		DEBRIS NEED TO BE CLEARED, SAFETY CONCERN. SOME STAINS AT CEILING/WALLS. UNKNOWN CAUSE.
Base - Platform	X

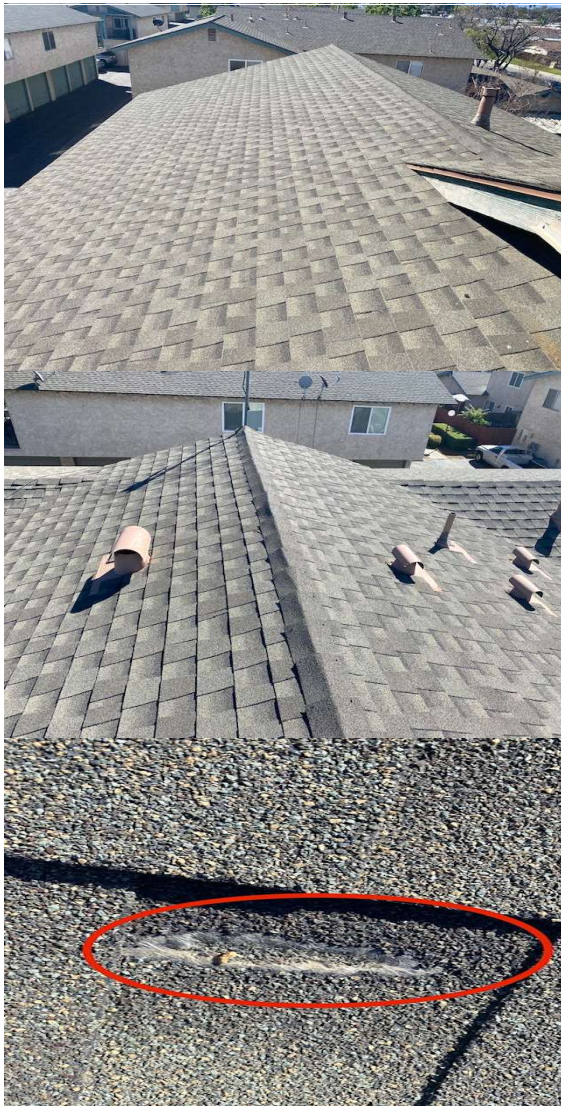
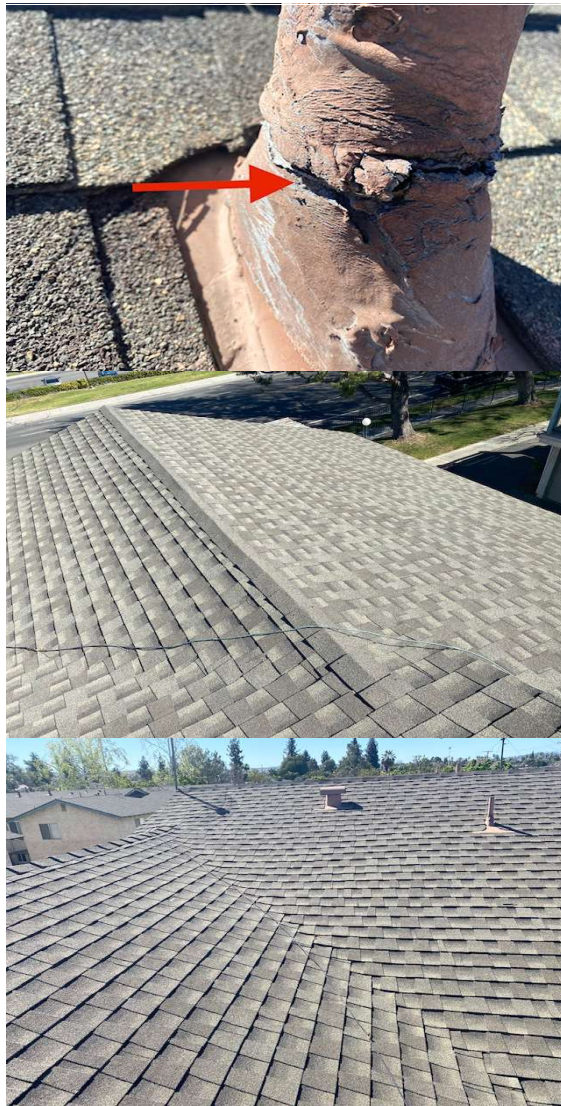
Inspection Area	Good	Fair	Poor	Comment
<b>Roof</b>				
General View	X			
Roof Notes	+	+	+	ASSOCIATION RESPONSIBILITY. REVIEW WITH SELLER. COMMON AREAS, .NOT RATED.
Roof Type	+	+	+	PITCHED, NOT RATED.
Material	+	+	+	COMPOSITION SHINGLE. NOT RATED.
Condition	X			
Flashings	X	X		SOME CRACKS IN MASTIC, RECOMMEND TO BE RE-SEALED.
Vents and Vent Caps	X			
Roof Drainage	X		X	DAMAGED IN AREAS. CORROSION / RUST IN AREAS. DEBRIS NEEDS TO BE REMOVED. DRAIN(S) BLOCKED, NEEDS TO BE CLEARED.
Patio Roof - Framing	X	X		(WOOD TRELLIS).DAMAGE/RUSTED HARDWARE. DAMAGED/FUNGUS WOOD IN AREAS.
Roof General Info	+	+	+	THE REPORT IS AN OPINION OF THE GENERAL QUALITY AND CONDITION OF THE ROOF. THE INSPECTOR CANNOT, AND DOES NOT, OFFER AN OPINION OR WARRANTY AS TO WHETHER THE ROOF HAS LEAKED IN THE PAST, LEAKS NOW OR MAY BE SUBJECT TO FUTURE LEAKS. NOT RATED.

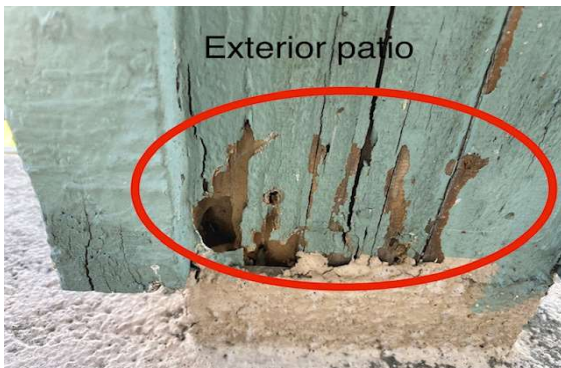
Inspection Area	Good	Fair	Poor	Comment
<b>Grounds</b>				
Patio Deck	X	X		CRACKS IN AREAS.
Steps-Stairs	X			
General Note	+	+	+	ADDITIONS ARE NOT CHECKED FOR PERMITS OR CODE COMPLIANCE, RECOMMEND REVIEW WITH SELLER/AGENT. ASSOCIATION RESPONSIBILITY. REVIEW WITH SELLER. NOT RATED.

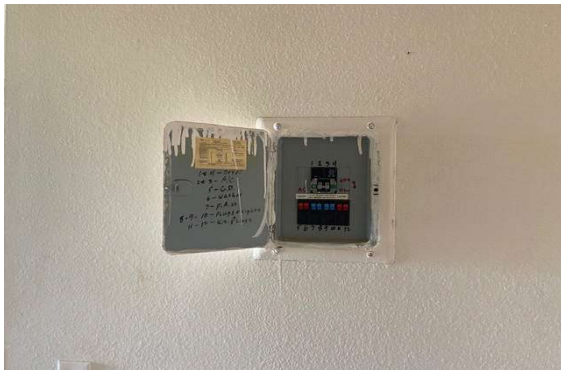
Inspection Area	Good	Fair	Poor	Comment
<b>Electrical</b>				
Entrance Wires	X			
Amps - Volts	+	+	+	120/240 VOLTS. APPROXIMATELY 100 AMP SERVICE. NOT RATED
Meter Location	+	+	+	SOUTH. NOT RATED.
Main Panel	X			
Panel Wiring	X			
Breakers	X		X	NOT ALL BREAKERS ARE NOT CLEARLY LABELED / IDENTIFIED, NTBS.
Fuses	X	X		LOOSE FLEX LINE.
Ground - Bond	X			
Ground Location	+	+	+	WATER MAIN. NOT RATED.
Sub Panel	X			LIMITED INSPECTION, UNABLE TO REMOVE COVER, PAINTED TO THE WALL. REVIEW WITH SELLER.
Exterior Electrical	X			
Electrical Info	+	+	+	INTERNAL WIRING CANNOT BE VIEWED / INSPECTED. LIMITED TO OUTLETS, SWITCHES AND WIRING WHERE VISIBLE OR NOT BLOCKED / OCCUPIED. RANDOM SAMPLING OF SWITCHES AND OUTLETS, NOT ALL SWITCHES AND OUTLETS ARE TESTED. RECOMMEND FURTHER REVIEW WITH SELLER. NOT RATED.
