# WOOD DESTROYING PESTS AND ORGANISMS INSPECTION REPORT

| Building No.<br><b>362</b> | Street<br><b>Calle Lupita</b> | City<br><b>San Luis Obispo</b> | Zip<br><b>93401</b> | Date of Inspection<br><b>07/29/2025</b> | Number of Pages<br><b>1 of 6</b> |

**Report #: 111229**

| General Description:<br><b>Single story; Single family residence; Stucco exterior; Composition shingle roof; Furnished and occupied.</b> | Inspection Tag Posted:<br><b>Garage</b> |

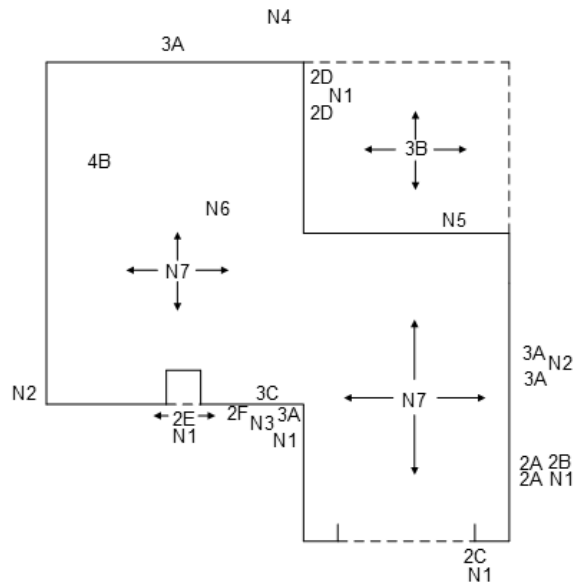
Diagram not to scale  
Finding locations approximate

Key: 1 = Subterranean Termites    2 = Drywood Termites    3 = Fungus/Dryrot    4 = Other Findings    5 = Unknown Further Inspection

| Finding: | 2A | Drywood Termite damage was found at the rafter. |
| Finding: | 2B | Drywood Termite damage was found at the bird block. |
| Finding: | 2C | Drywood termite damage was found at the garage jamb and stucco mold. |
| Finding: | 2D | Minor Drywood Termite damage was found at the bird block and rafter. |
| Finding: | 2E | Minor Drywood Termite damage was found at the sheathing. |
| Finding: | 2F | Drywood Termite damage was found at the sheathing. |

| Finding: | 3A | Fungus damage was found at the roof sheathing of the eave area. |
| Finding: | 3B | Fungus damage was found at the patio cover framing. |
| Finding: | 3C | Fungus damage has occurred to the kitchen sink cabinet due to leakage at the grout. |

Finding: 4A Carpenter bee infestation was found in the patio framing.  
Recommendation: Chemically treat the wood members showing signs of carpenter bee infestation with Taurus Dry. Seal entrance holes with brass wool and latex caulking. No Warranty is offered for this treatment.

Finding: 4B The toilet was found to be loosely bolted to the floor. This creates a potential source of leakage.  
Recommendation: Reset the toilet using a new wax seal and bolts. Additional costs may apply if the toilet flange is found to be damaged or if existing supply line/valve cannot be reused.  
Price: No Bid offered at this time. Owner should contact appropriate tradesman to complete recommended corrections.

| Recommendation: | | Remove and replace the damaged portion of the rafter as needed. |
| Recommendation: | | Remove and replace the damaged portion of the bird block as needed. |
| Recommendation: | | Replace the Drywood termite damaged wood member. |
| Recommendation: | | Repair the minor damage of the wood member with a wood filler. |
| Recommendation: | | Remove and replace the damaged portion of the sheathing as needed. |

| Recommendation: | | Replace the fungus damaged portions of roof sheathing as needed. |
| Recommendation: | | Remove and replace the damaged portions of the patio cover framing as needed to eliminate the fungus infection and damage. |
| Recommendation: | | Remove and replace the damaged portions of the kitchen sink cabinet as needed to eliminate the fungus infection. Make necessary corrections to the grout to eliminate the excessive moisture condition. |
