Inspection Report

Address: 1115 Patricia Ln Paso Robles, CA 93446

4/10/23

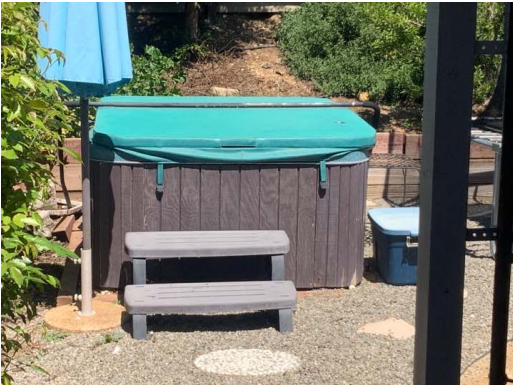
14: Spa - *The locking cover on the spa should be locked at all times when not in use. An unlocked spa cover is considered a safety hazard.*

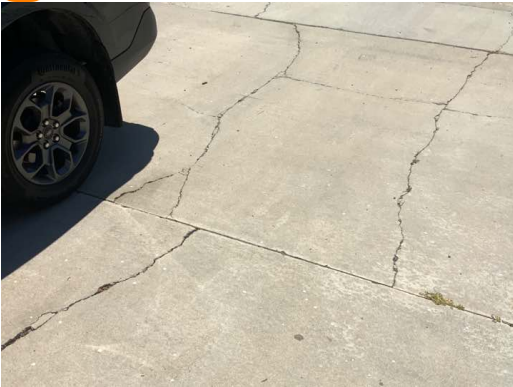
FI **17:** Some typical, common and moderate cracks found in areas of the driveway.

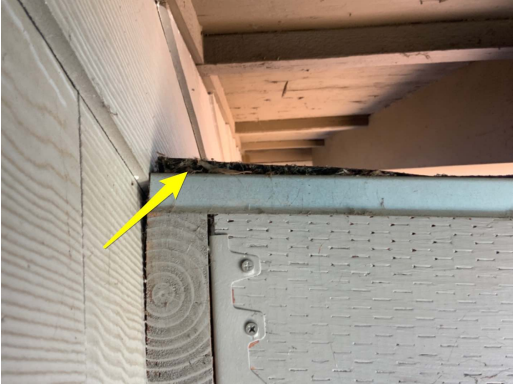
25: Some loose lifting roof material found at areas of the backyard patio cover. Maintenance, repairs or upgrades recommended. Contact a qualified roofer.

Example. Loose lifting roofing material

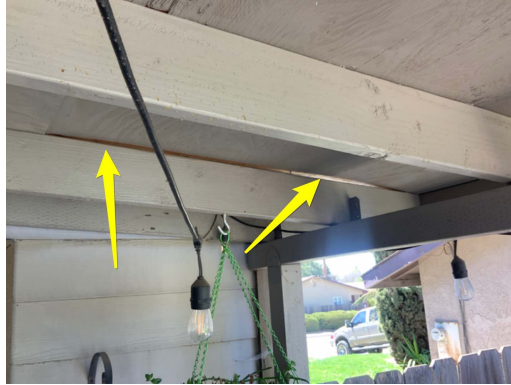
Example. Loose lifting roof plywood

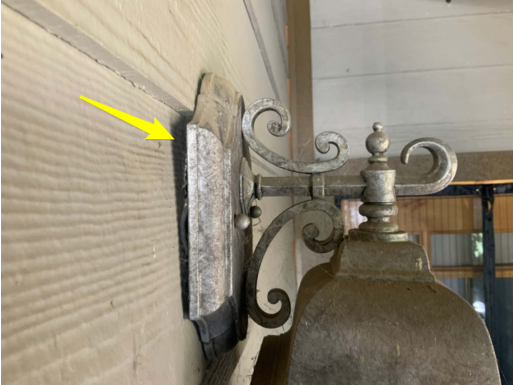
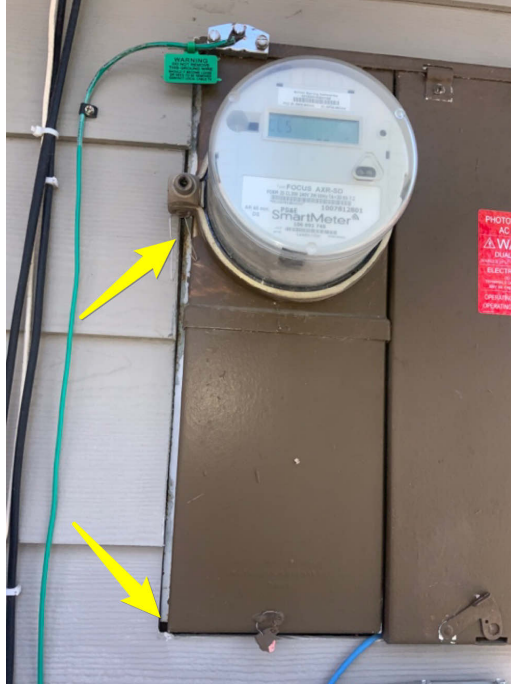
MR 34: Recommend sealing holes in exterior walls to prevent water intrusion around areas such as unused open holes, exterior light fixtures, exterior electrical panels, around exterior electrical boxes, and where utility pipes and/or wires pass through the exterior walls.

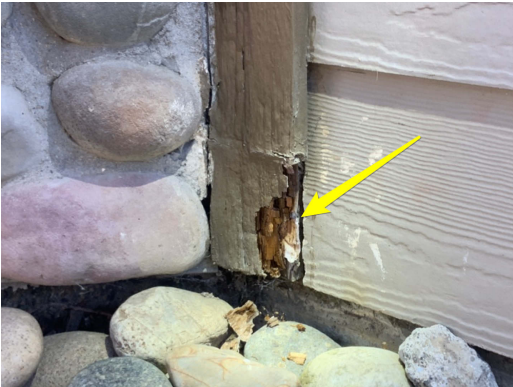
E&C 37: Some Moisture and/or bug type damage & deterioration found at exterior areas such as eaves, fascia and/or trim. Refer to the termite report for locations and extent.

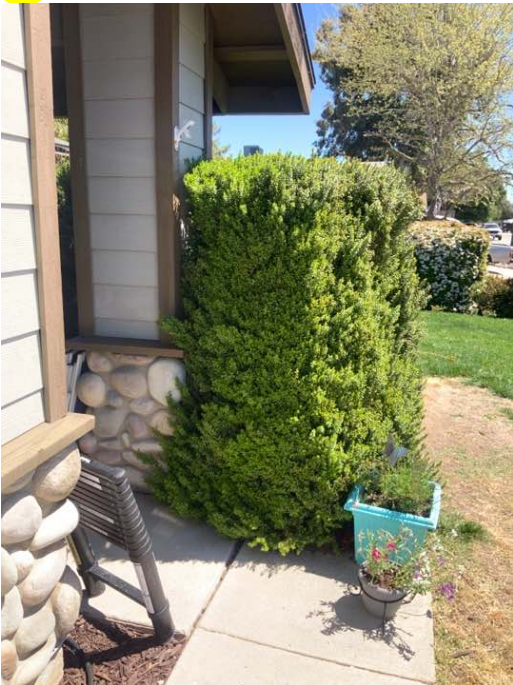
MR 45: Plants and/or Trees touch the buildings exterior. Proper landscape maintenance needed.

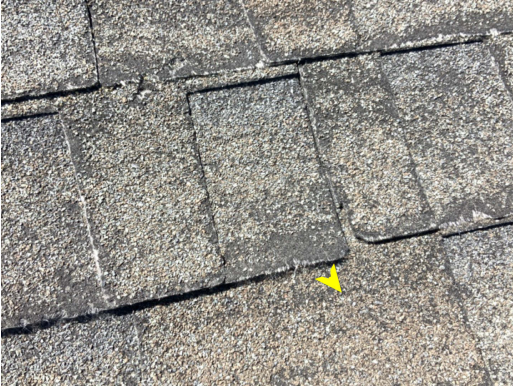
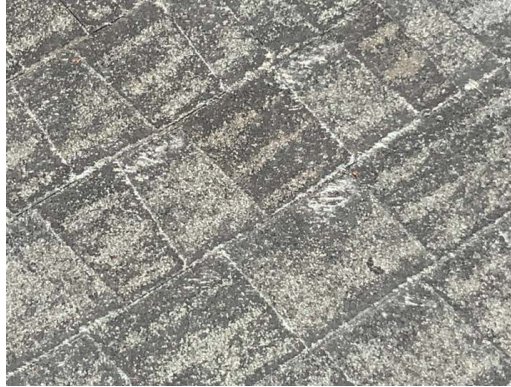
E&C 53: Areas of the Asphalt composition roofing appears to be nearing or at the end of its useful life.
Recommend contacting a licensed roofing contractor for an estimate for replacement.

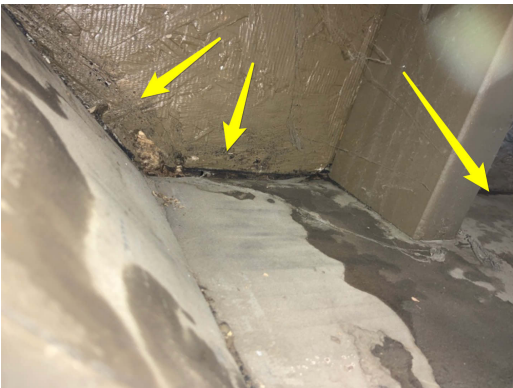
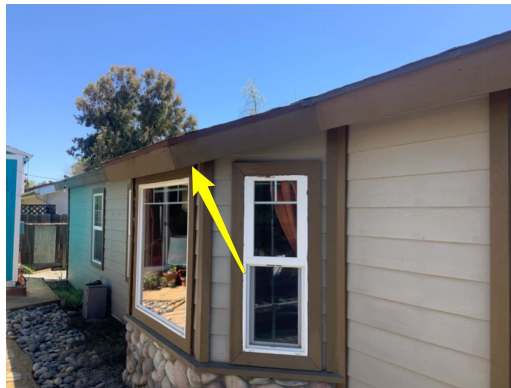
FI 54: Evidence of a past roof leak with moisture stains and/or damage at areas of the roof overhangs.
Recommend additional review by a roofer to determine the cause and repair as needed.

Under the roof overhang, visible moisture staining and damage.

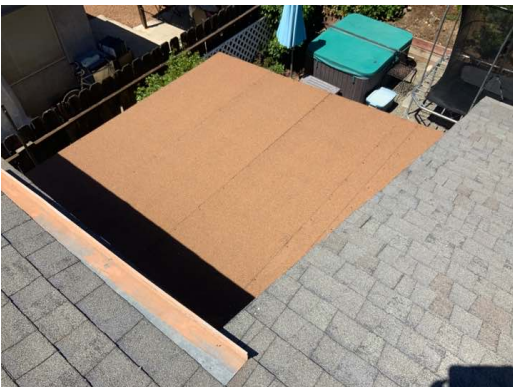
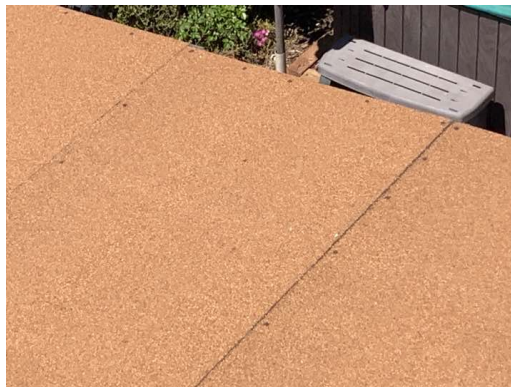
E&C 55: The ROLLED COMPOSITION roof material on the BACKYARD PATIO COVER found improperly installed and/or not installed well.

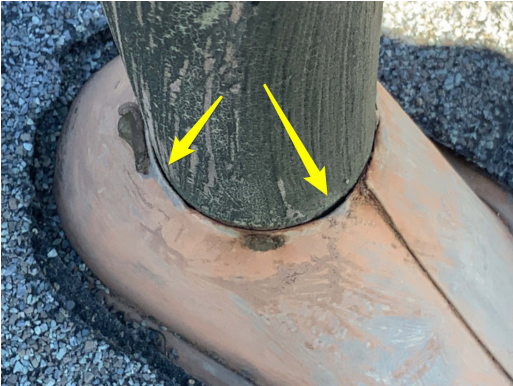
MR 56: Deteriorated sealant at some roof jack flashings. Maintenance recommended to help prevent water intrusion into areas of the attic.

Visible openings and separations

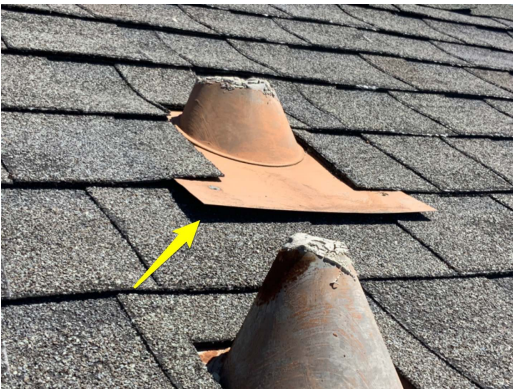
E&C MR 57: Some Loose / Lifting roof flashings. Corrections, maintenance or repairs are recommended to help prevent water intrusion and/or roof leakage from windy wet weather.

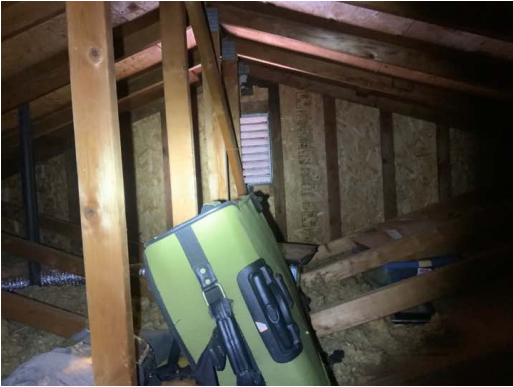
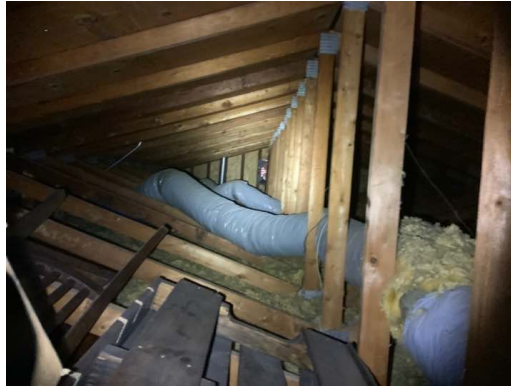
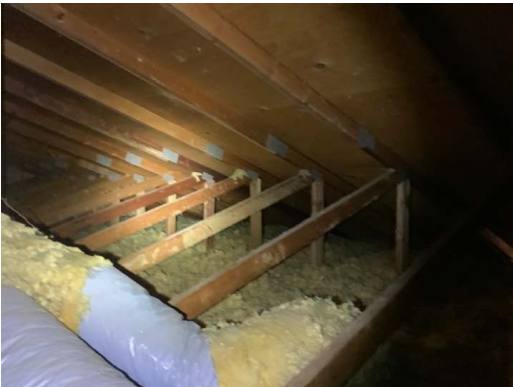
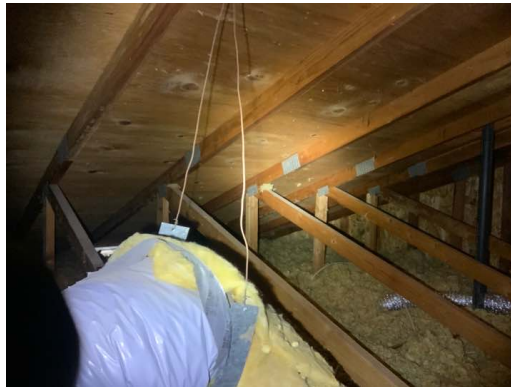
59: ATTIC ACCESS LOCATION: Bedroom Hallway

60: ATTIC CONDITION: No noted framing defects found in the accessible and visible areas of the attic.

61: ATTIC VENTING: Appears Adequate. *However, attic ventilation was not calculated but visually observed.*

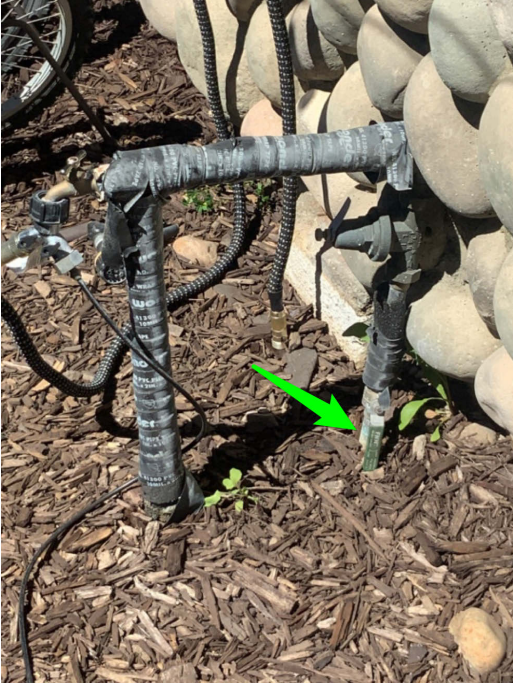
Main water supply shut off valve

64: Main water supply shut-off location: ON THE FRONT OF THE HOUSE. *Main water shut-off valve not tested.*

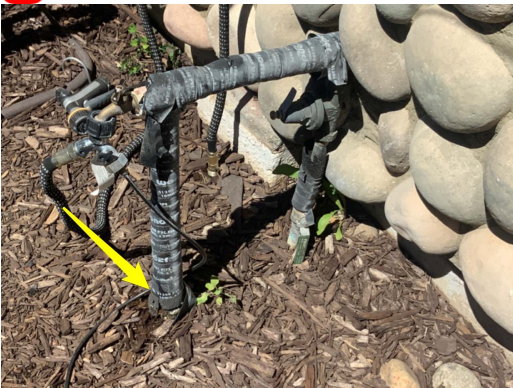
E&C 66: Active water leak noted at the main water supply pipe area.

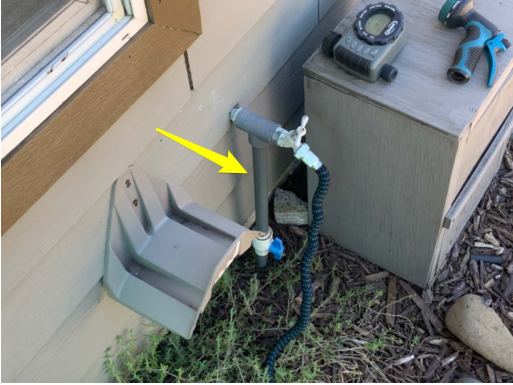
MR 71: Exposed plumbing pipes subject to freezing are not insulated well or have deteriorated insulation in areas on the EXTERIOR.

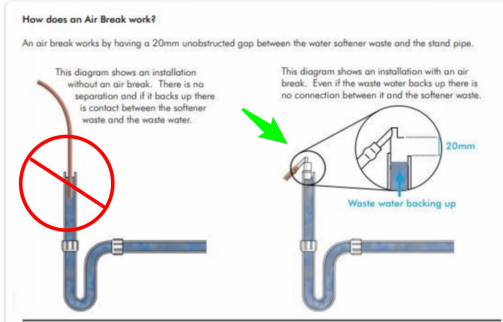
SC 75: An improper and unsafe connection of the water softener drain hose directly into the sewer piping without a proper trap and/or air gap.

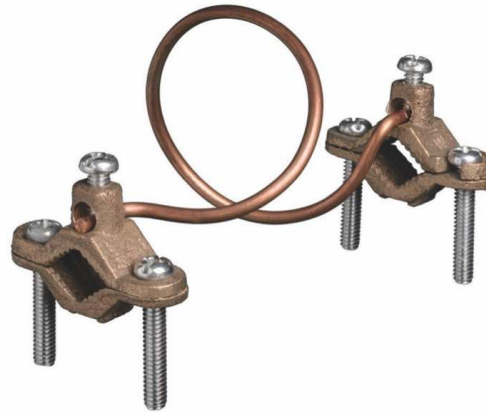
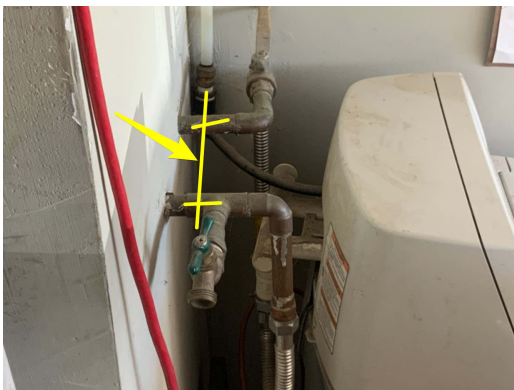
SC 76: Missing a proper bond jumper (ground connection) across the water softener pipes due to the plastic water valve assembly.

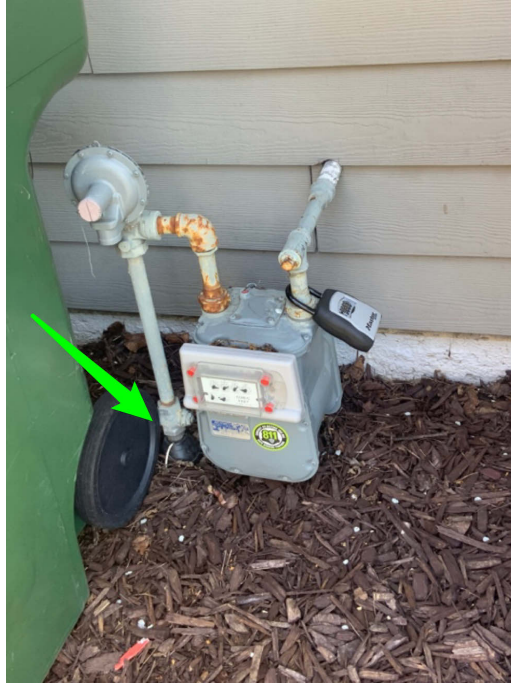
Main shut off valve

CAUTION: If you turn off your natural gas at the meter, leave it off. Do not turn it back on yourself.

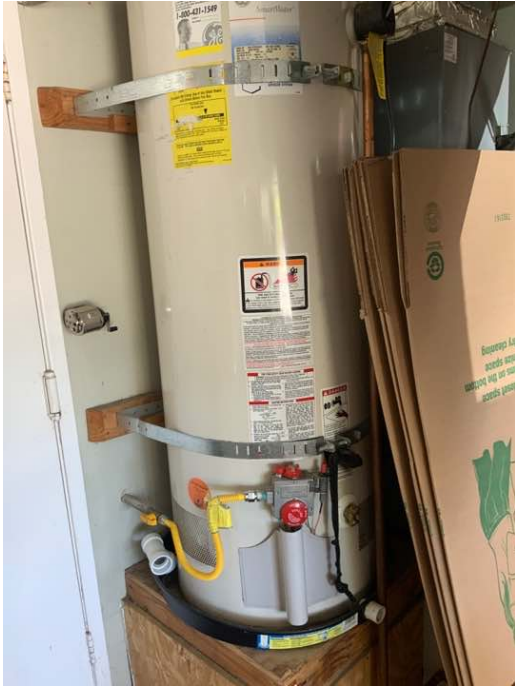
Size: 50 Gallons

Fuel Type: Natural Gas

82: Water Heater Operated when tested.

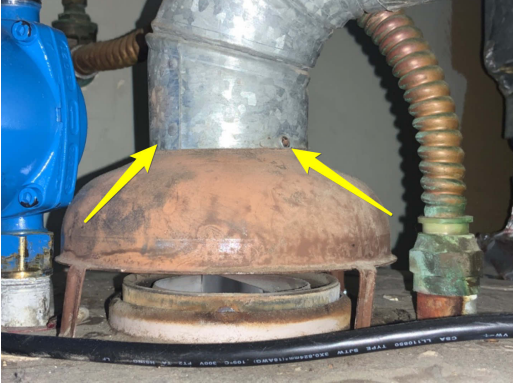
SU 87: Water heater vent connector pipe (single wall) is not properly fastened with the required 3-fasteners at the draft hood per standards.

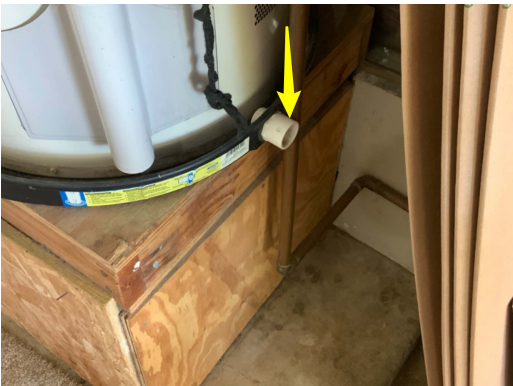
E&C 93: Recommend properly extending the water heater drip pan drain pipe to the floor in the garage or exterior to help prevent damage to the drywall platform and/or enclosure if a leak were to occur.

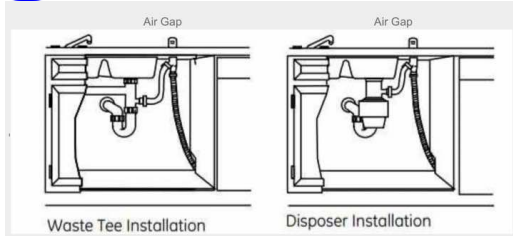
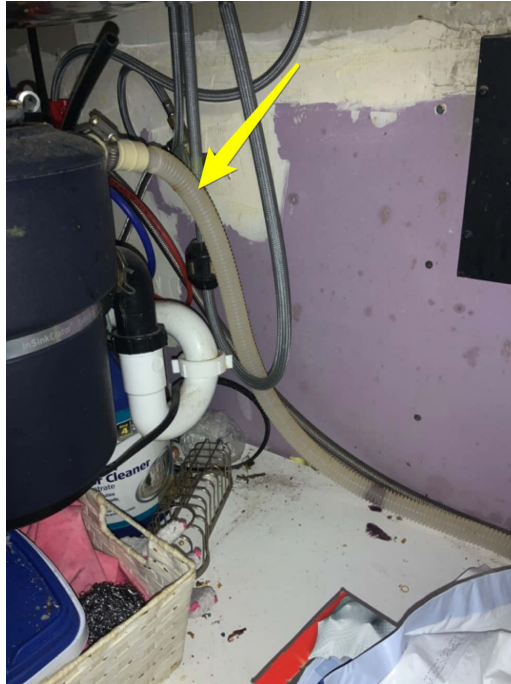
SU 99: Recommend / missing an Air Gap Device at the dishwasher drain.

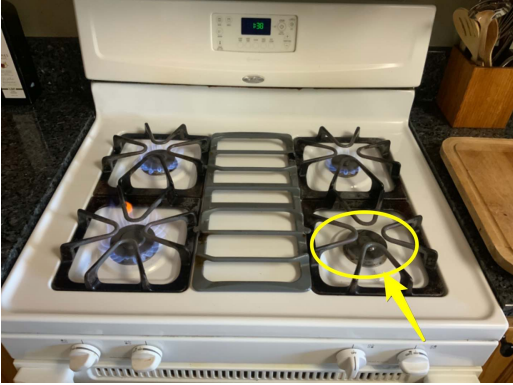
E&C 106: Some of the Cook top burners did not operate or ignite properly when tested. Recommend cleaning / servicing.

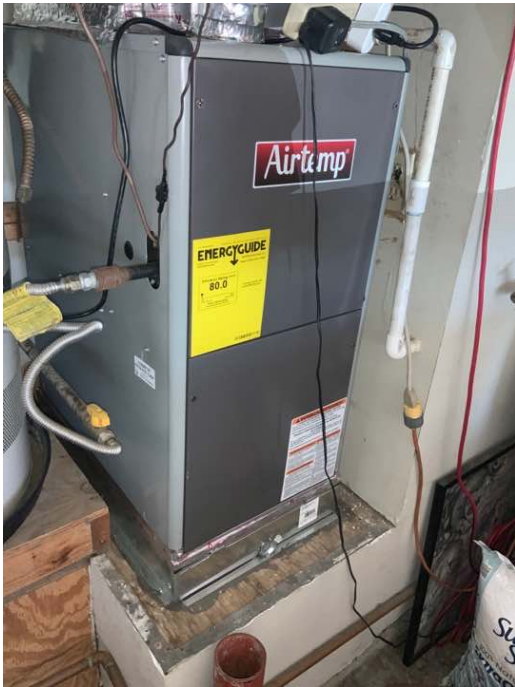
Approx. BTU RATING: **70,000**

152: **FURNACE CONDITION:** The heating system operated when tested.

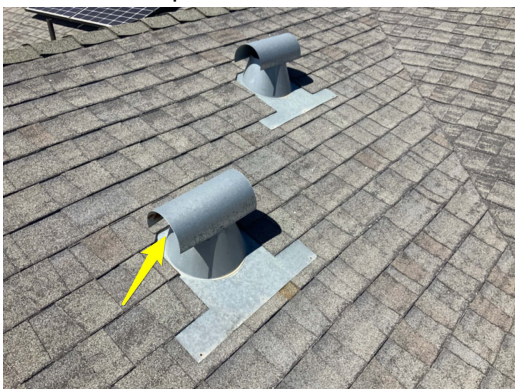
SC 153: Missing a proper "B" vent-type cap at the FURNACE vent pipe roof termination. This is considered a safety hazard and warrants repair, replacement. Contact a qualified HVAC professional familiar with minimum installation requirements

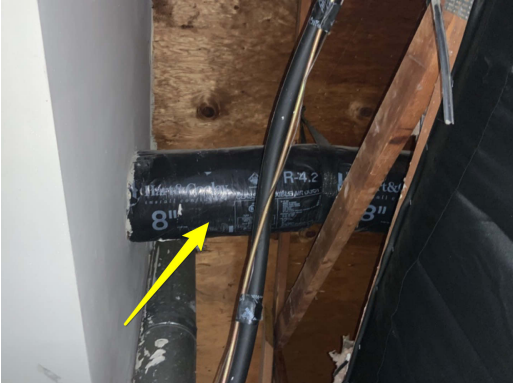
SC 155: Improper use of flexible ducting through the garage firewall from the furnace to an added heating register in the garage. This is considered a break or breach in the garage firewall. Corrections warranted.

Improper use of non-fire rated flex ducting through the garage firewall

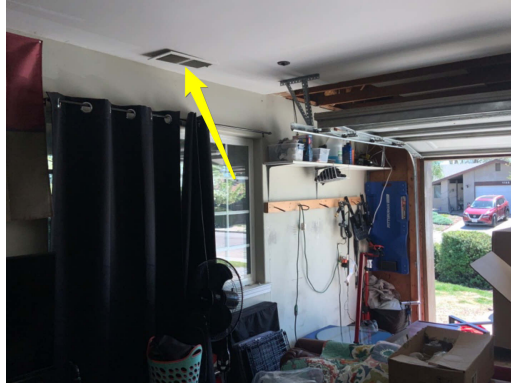
Added Heating register in the garage

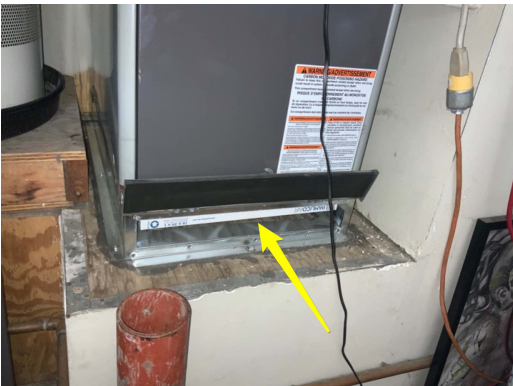
MR 156: Dirty Heating air filter found inside the furnace blower box at the furnace. Recommend cleaning or changing the furnace air filters as part of ongoing maintenance.

Air filter location

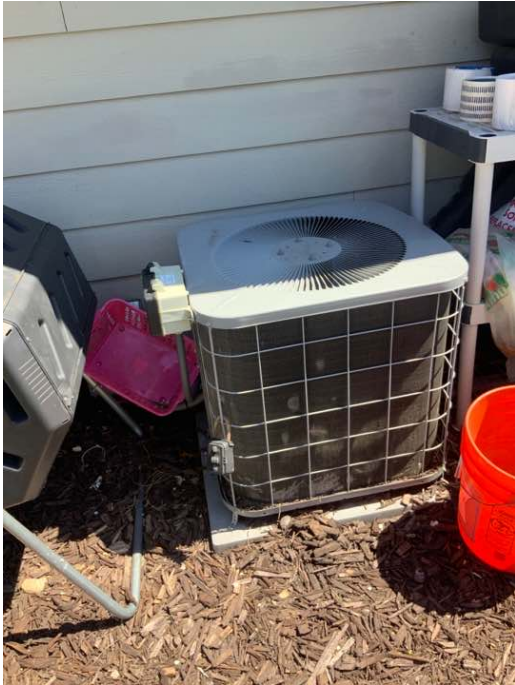
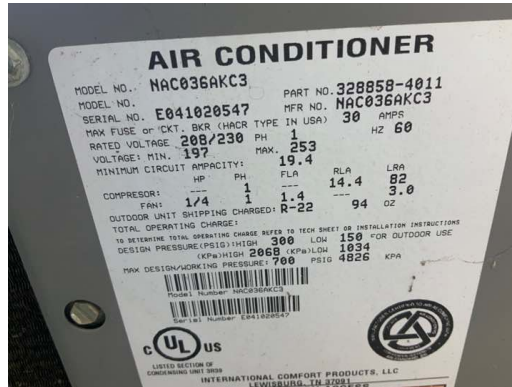
Currently at: 30 Amps

Refrigerant: R-22

160: Split System

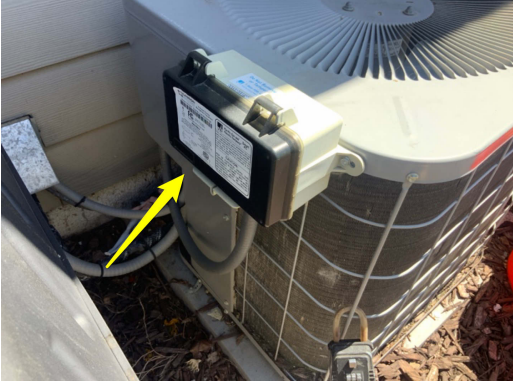
DS 163: Disclosure: PG&E Has installed an energy management system on your air conditioner. An energy management system allows PG&E to turn off your air conditioner if other areas of the state are experiencing electrical shortages. If you wish to have the management equipment removed contact PG&E. This is not a requirement of the system and is not needed for proper or safe operation of the air-conditioning system. The original homeowner it was paid \$50 by PG&E to have this installed.

SU 164: Recommend sealing the hole or opening through the exterior wall where the Air Conditioner's refrigeration pipes enter the building. This will help prevent rodent, bug and /or water intrusion through this area as need per standards.

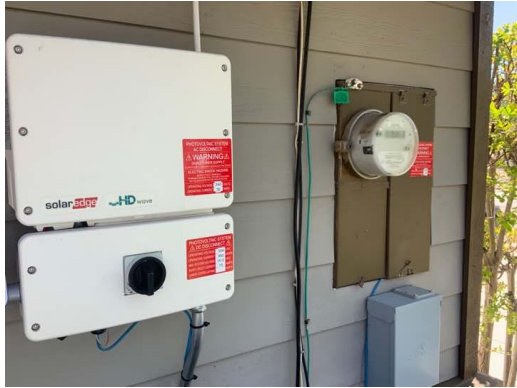
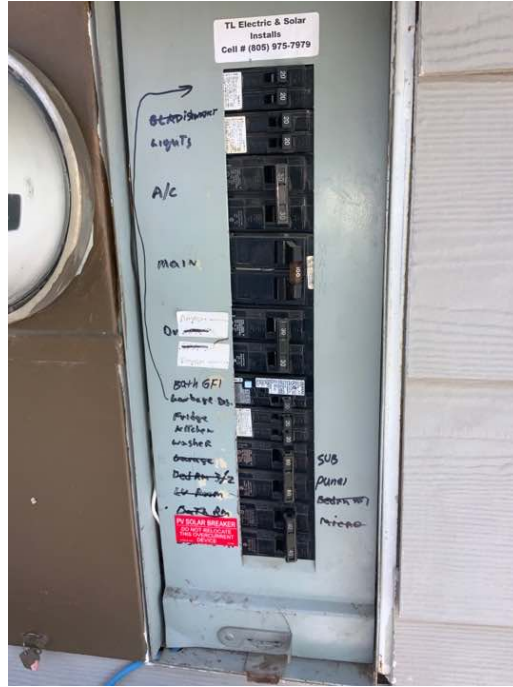
Main Electrical Panel Ampacity: **100**

Panel Voltage: **240 volt**

166: Location: **GARAGE INTERIOR SECONDARY MAIN ELECTRICAL PANEL**

Amps- 100

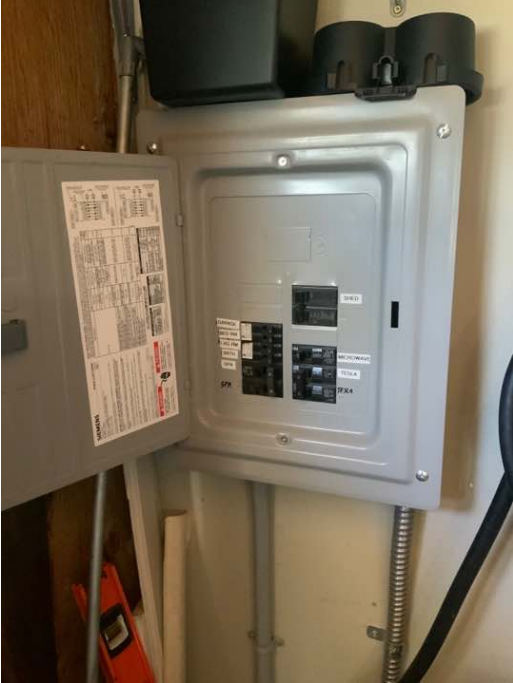
167: PANEL GROUNDING and BONDING appears proper in the MAIN ELECTRICAL PANEL.

Disclosure: *The grounding and bonding of the electrical panel and wiring systems is not tested and not fully visible. The ground clamp and its connections are not fully visible and are not tested per standards.*

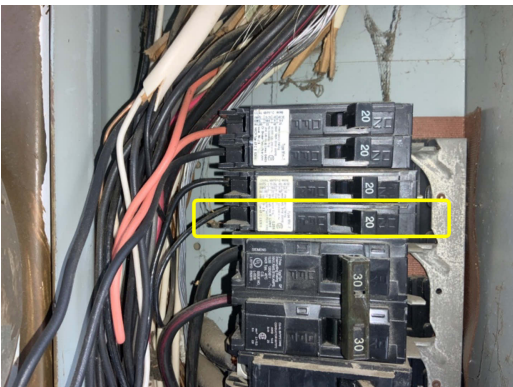
SC 168: Electrical panel defect / Over-fusing (breaker found too large for wire), (15-amp wire on a 20-amp breaker) in the MAIN ELECTRICAL PANEL.

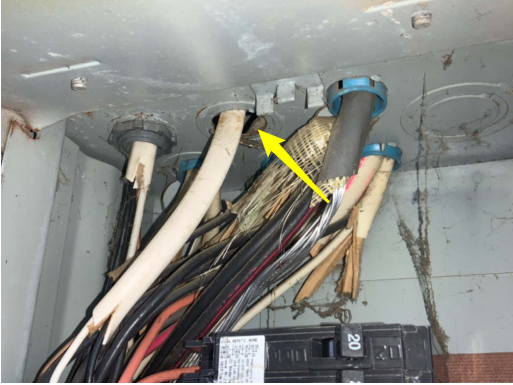
SU 169: Missing a bushing clamp as wires are passing into the MAIN ELECTRICAL PANEL. Wires are improperly rubbing on the sharp metal edge of the electrical panel as they pass through.

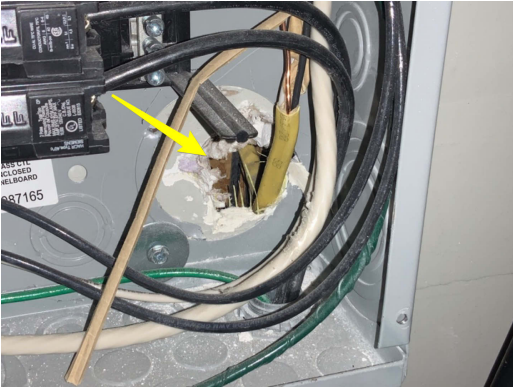
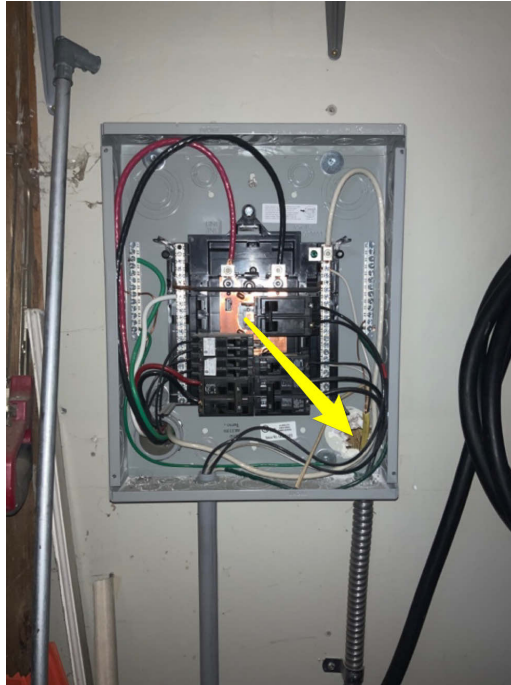
170: Missing a bushing clamp as wires are passing into the GARAGE INTERIOR MAIN ELECTRICAL PANEL. Bushing clamp needed to help prevent critter intrusion in through the wall cavity.

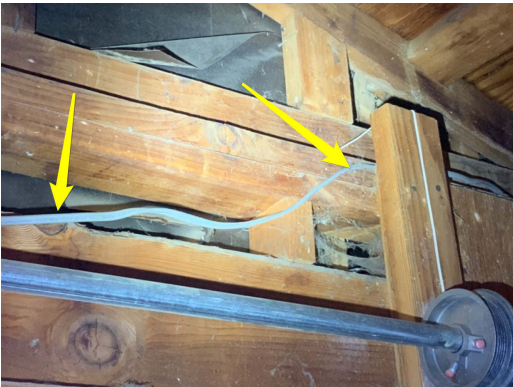
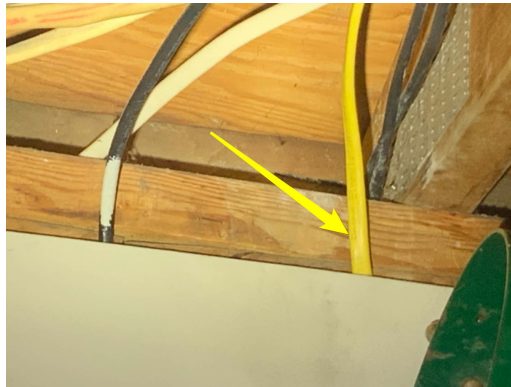
SC 174: Improper and unsafe electrical wiring. Exposed electrical wiring, "Romex" improperly installed subject to physical damage, not in a conduit or raceway per standards: IN AREAS OF THE GARAGE.

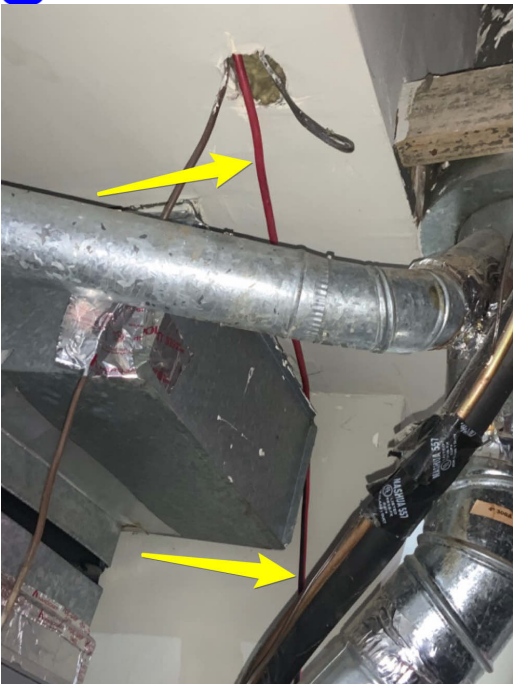
SU 175: Extension cord improperly used as permanent electrical wiring: in the garage above the furnace

Extension cord going up into the attic

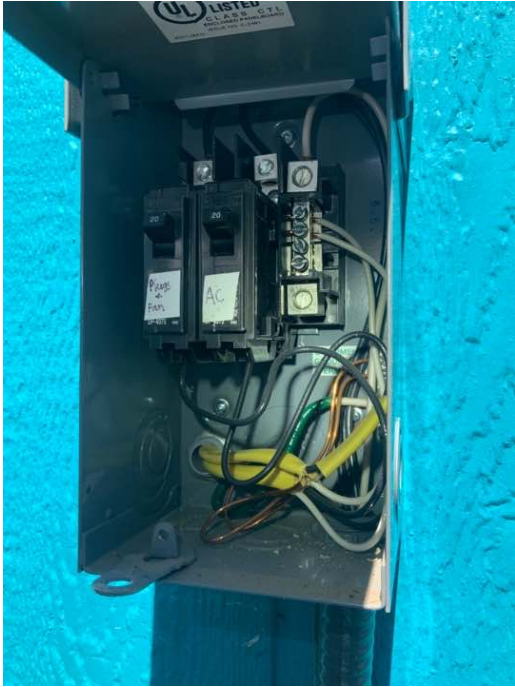
176: Location: **Exterior on the backyard shed/outbuilding.**

Amps: **30**

177: PANEL CONDITION: No visible significant electrical defects noted in the ELECTRICAL SUB-PANEL.

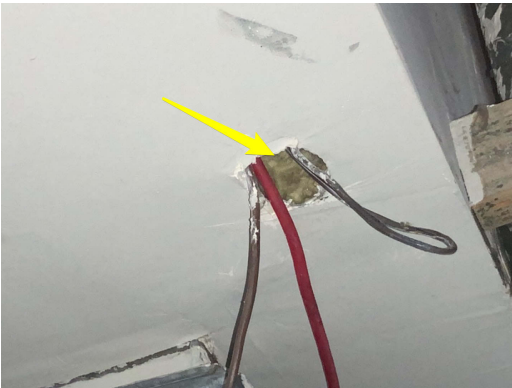
SC 188: Some small holes or openings found in the garage firewall. Corrections warranted for fire safety. Contact an appropriate professional to repair or correct as needed.

Example. Above the furnace in the garage

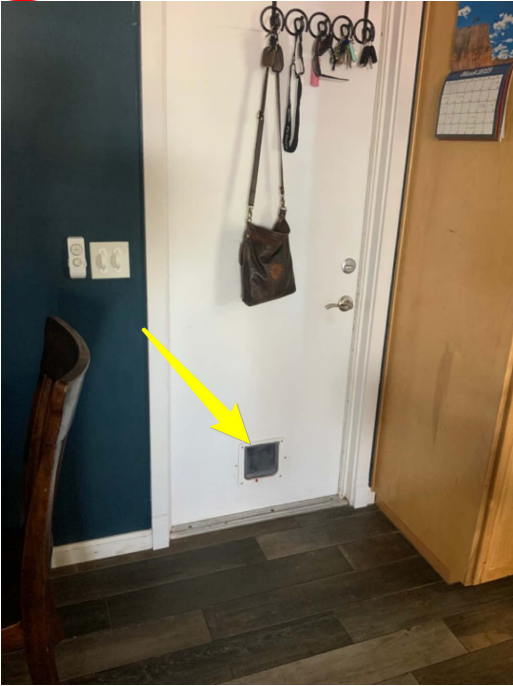
SC 189: A Pet door improperly installed in the garage fire door to the living space.
