# ***Cornerstone Inspection***

## **Property Inspection Report**

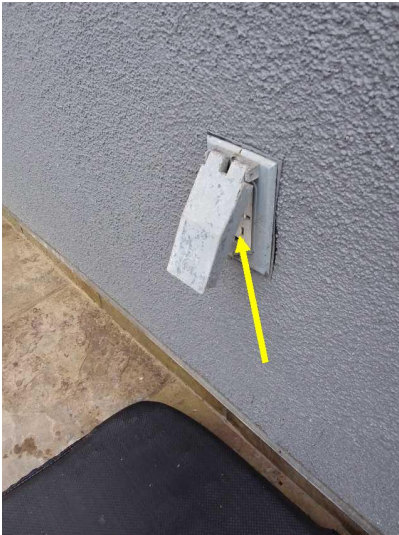
4.1. The outlets are functional and include ground-fault protection.

The outlets are functional and include ground-fault protection.

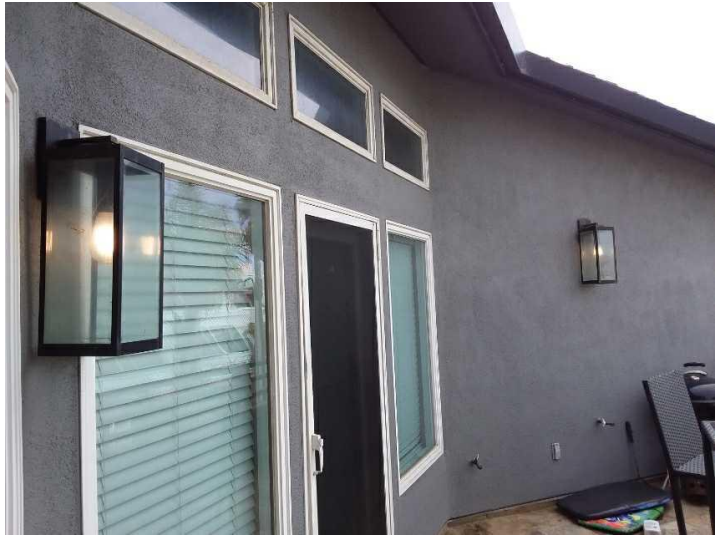
4.2. The lights outside the doors of the residence are functional.

The lights outside the doors of the residence are functional.

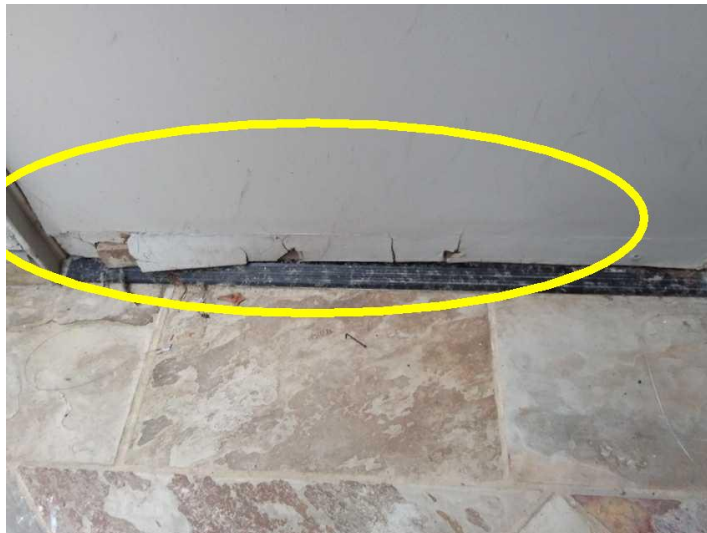
5.1. The finish on some of the exterior doors are weathered, and should be refinished or monitored.

The finish on some of the exterior doors are weathered, and should be refinished or monitored.

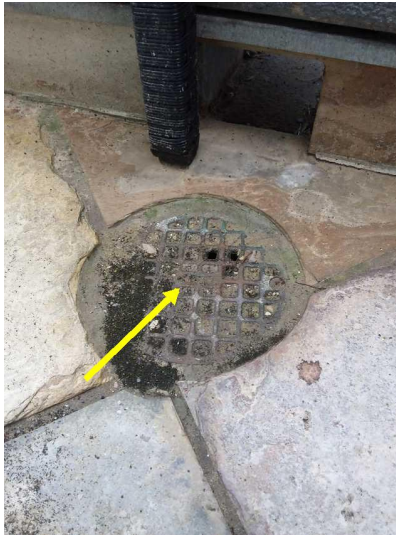
8.3. The balcony drain must be kept clear at all times or moisture intrusion could result.

The balcony drain must be kept clear at all times or moisture intrusion could result.

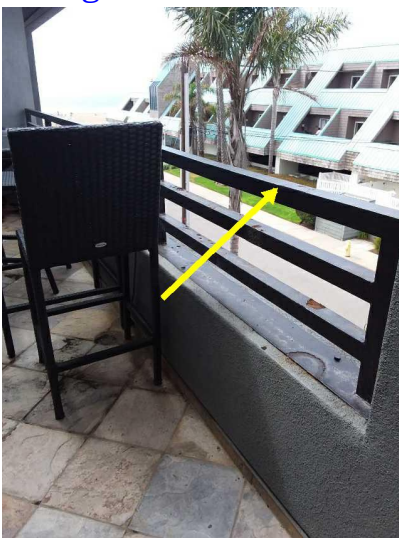
9.1. The balcony/deck guardrail does not conform to common safety standards. Common safety standards require them to be a minimum of 42 inches high when the standing surface is 30" or more above grade.

The balcony/deck guardrail does not conform to common safety standards. Common safety standards require them to be a minimum of 42 inches high when the standing surface is 30" or more above grade.

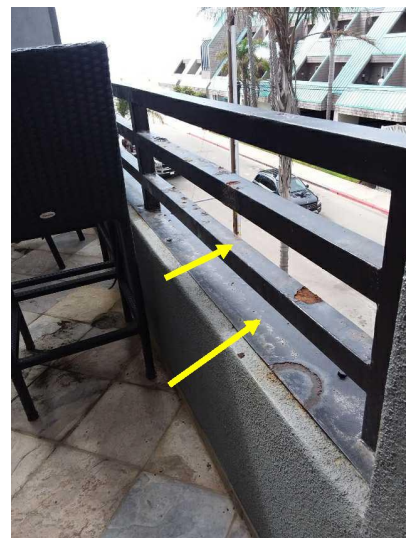
9.2. The balcony/deck guardrail is climbable, and therefore not child-safe. If children occupy or visit this property appropriate precautions should be taken to make the area more secure.

The balcony/deck guardrail is climbable, and therefore not child-safe. If children occupy or visit this property appropriate precautions should be taken to make the area more secure.

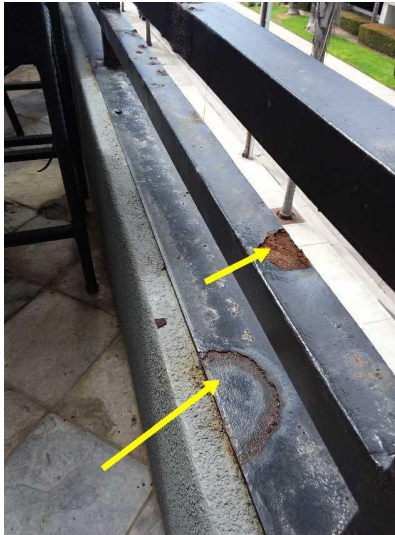
9.3. Sections of the guardrail need maintenance type service such as sealing, staining and or painting.

Sections of the guardrail need maintenance type service such as sealing, staining and or painting.

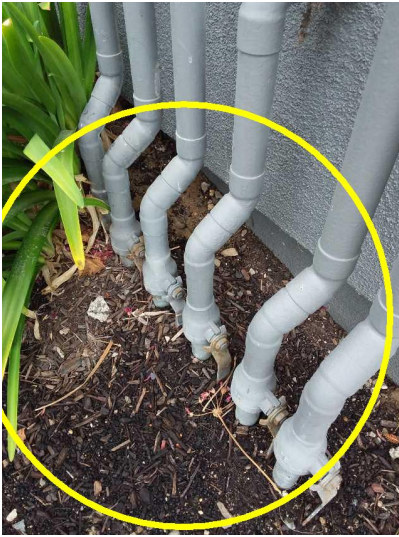
2.2. We were unable to determine which shut-off valve is for your unit. It should be disclosed to You, in case there is need for an emergency shut-off of the water.

We were unable to determine which shut-off valve is for your unit. It should be disclosed to You, in case there is need for an emergency shut-off of the water.

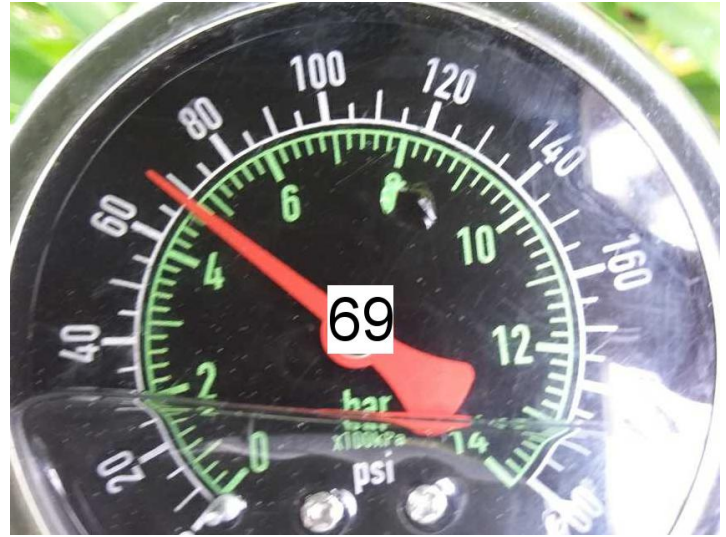
2.3. The water pressure entering the residence is under 80psi and a regulator is not required on the plumbing system.

The water pressure entering the residence is under 80psi and a regulator is not required on the plumbing system.

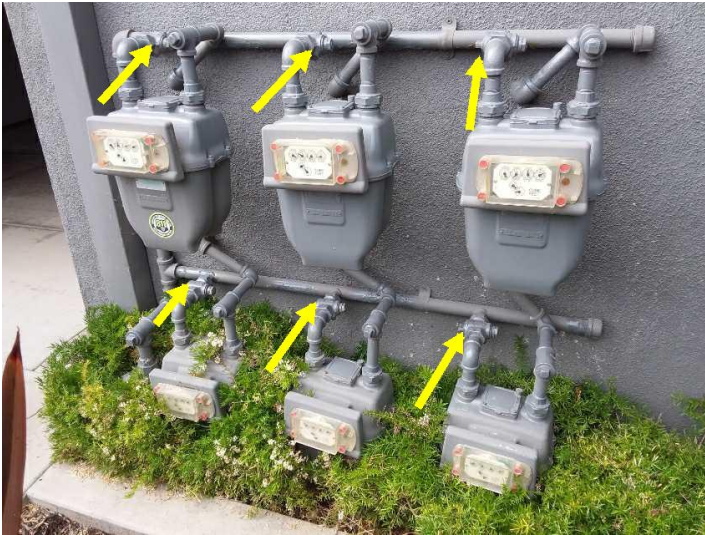
3.2. The gas main shut-off is located on rear of the home, unit or building.

The gas main shut-off is located on rear of the home, unit or building.

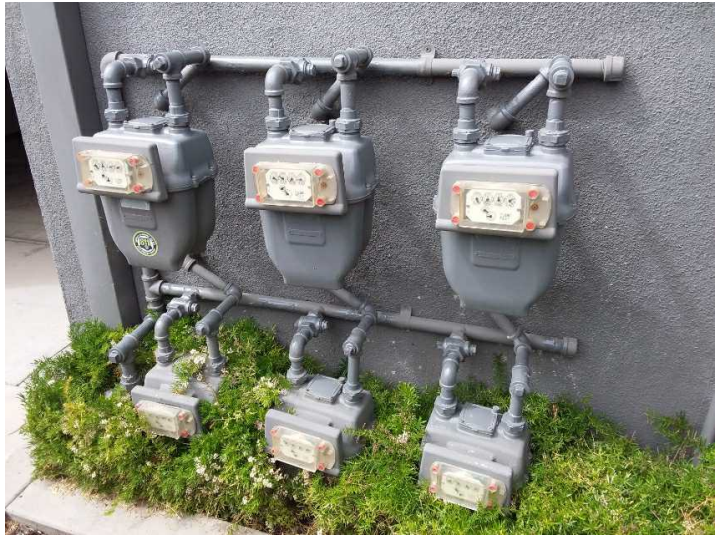
3.3. We were unable to determine which shut-off valve is for your unit. It should be identified and disclosed to you, in case there's need for an emergency shut-off of the gas.

We were unable to determine which shut-off valve is for your unit. It should be identified and disclosed to you, in case there's need for an emergency shut-off of the gas.

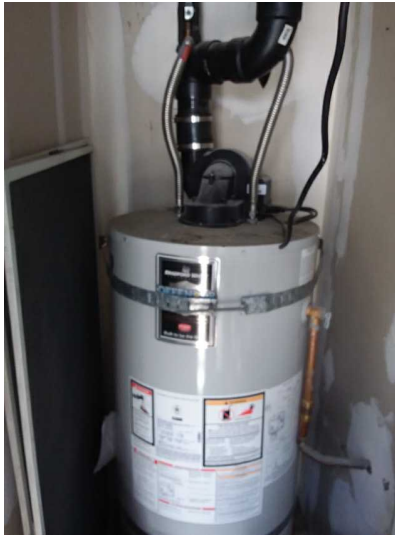
| Page 13 Item: 5 | Gas Water Heater<br>Comments | 5.12. The hot water heater is strapped but not braced properly and should be serviced. Current standards require that the water heater must be strapped AND braced to resist seismic motion. |

5.12. The hot water heater is strapped but not braced properly and should be serviced. Current standards require that the water heater must be strapped AND braced to resist seismic motion.

The hot water heater is strapped but not braced properly and should be serviced. Current standards require that the water heater must be strapped AND braced to resist seismic motion.

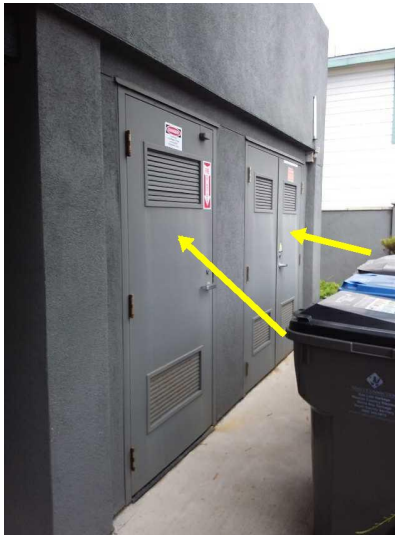
1.2. The main electric panel is under the jurisdiction of the HOA management and was not inspected.

The main electric panel is under the jurisdiction of the HOA management and was not inspected.

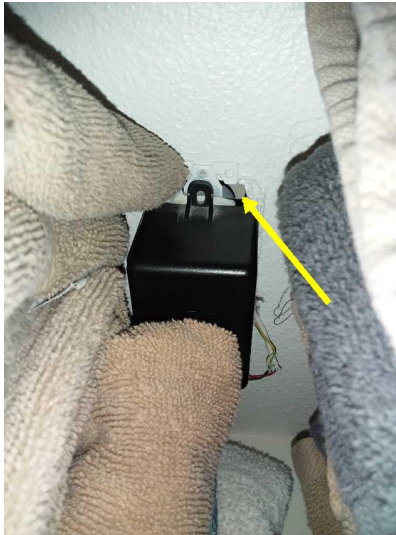
| Page 16 Item: 1 | Main Entry | 1.3. One or more outlet covers is missing and should be installed. |

1.3. One or more outlet covers is missing and should be installed.

One or more outlet covers is missing and should be installed.

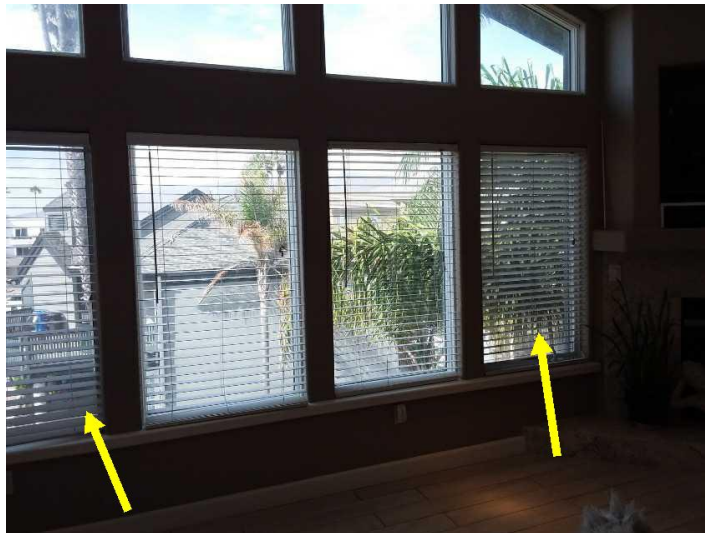
2.3. A lock on the window is missing or does not engage and should be serviced.

A lock on the window is missing or does not engage and should be serviced.

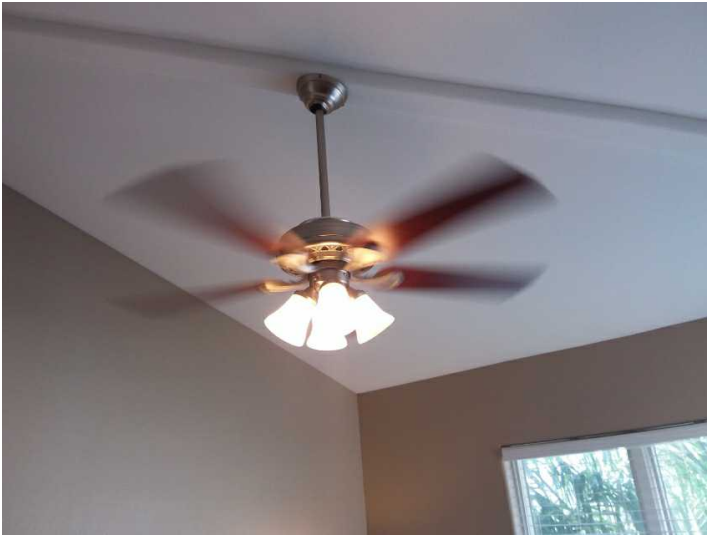
- 2.1. This bedroom is located adjacent to the living room.
- 2.2. The ceiling fan is functional but slightly rocks at high speeds and should be serviced so the fan operates smoothly.
- 2.3. There is no smoke alarm, and although one may not be mandated it is strongly recommended.

The ceiling fan is functional but slightly rocks at high speeds and should be serviced so the fan operates smoothly.

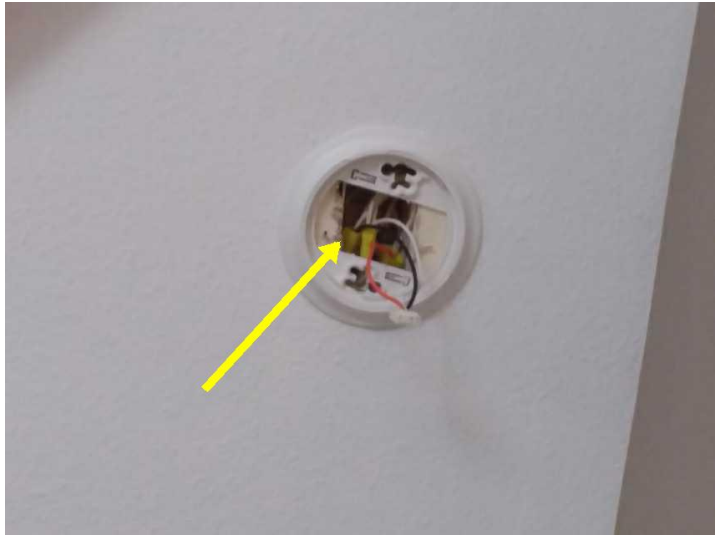
| Page 18 Item: 2 | Bedroom 2 | 2.3. There is no smoke alarm, and although one may not be mandated it is strongly recommended. |

There is no smoke alarm, and although one may not be mandated it is strongly recommended.

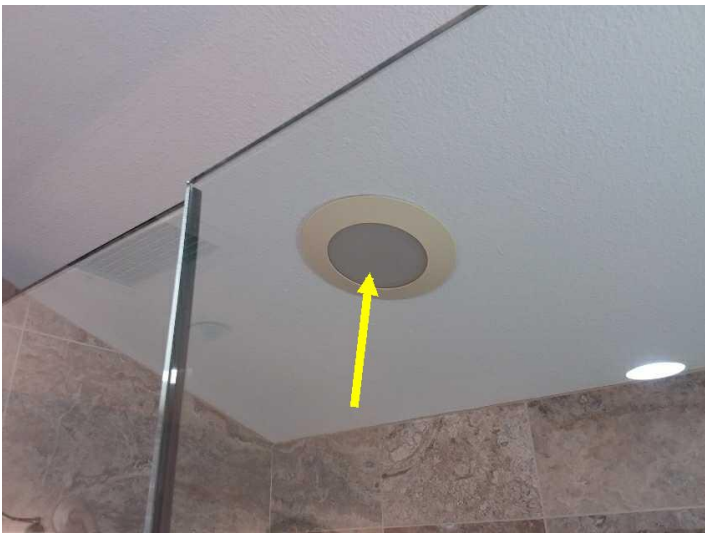
A ceiling light does not respond properly or is flickering and should be serviced.

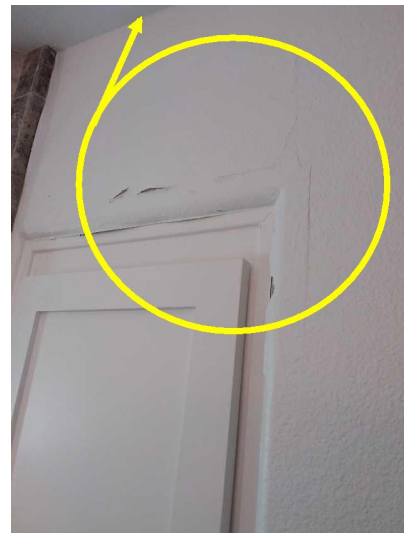
The walls have cosmetic damage that is commensurate with time and use, which you should view for yourself.

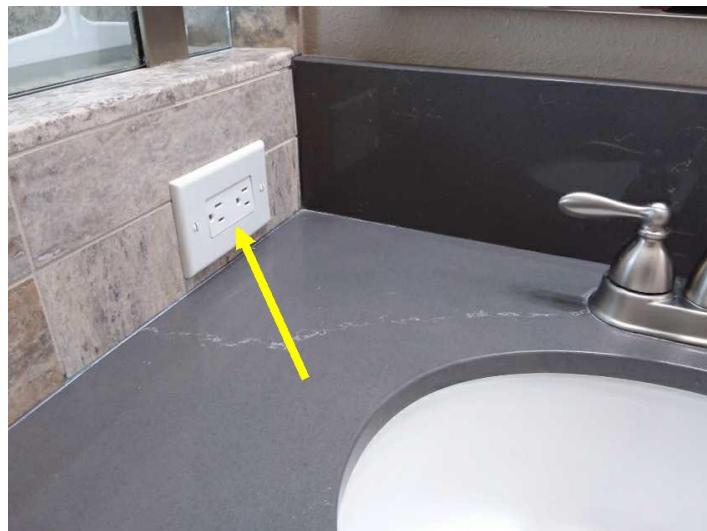
| Page 23 Item: 2 | 2nd Guest<br>Bathroom | 2.14. The outlets are functional, but the left sink outlet should be upgraded to have ground-fault protection. |

- 2.14. The outlets are functional, but the left sink outlet should be upgraded to have ground-fault protection.

The outlets are functional, but the left sink outlet should be upgraded to have ground-fault protection.

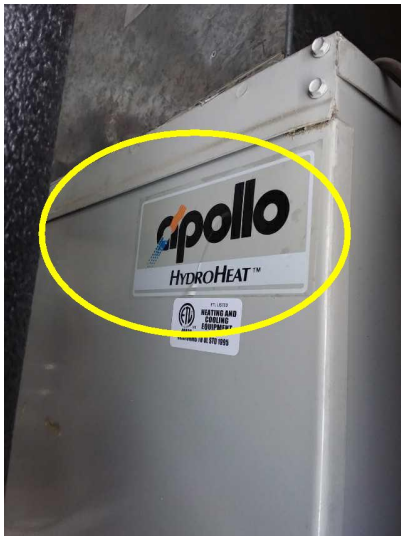
- 1.1. Central heat is provided by a forced-air furnace that is located in an exterior closet.
- 1.2. The burners and heat exchanger are sealed and cannot be viewed.

Central heat is provided by a forced-air furnace that is located in an exterior closet.

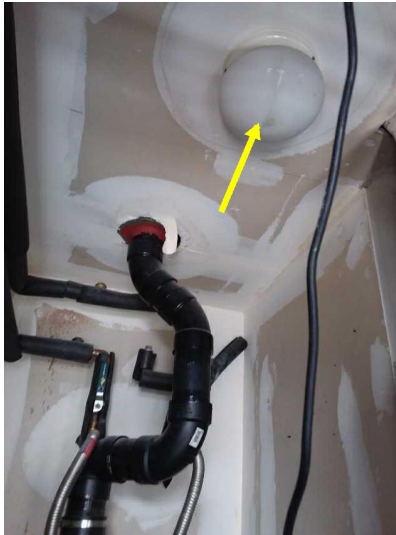
- 1.3. The light in the appliance closet does not respond and should be serviced.
- 1.4. The thermostat is functional.
- 1.5. The ducts are a modern flexible type that have no visible deficiencies. They are comprised of a clear inner liner and an outer plastic shell that encapsulates fiberglass insulation.

The light in the appliance closet does not respond and should be serviced.
