Confidential Inspection Report

LOCATED AT: 77 Tierra Montanosa
Rancho Santa Margarita, CA 92688

INSPECTED ON: Friday, February 18, 2022

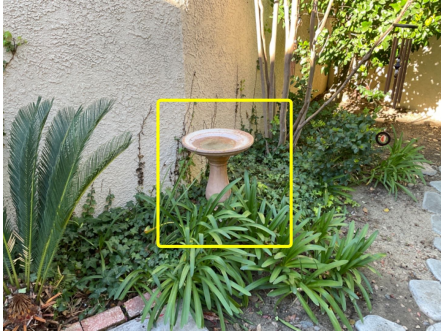
15: Pre-cast concrete accessories noted. Although I disclaim an evaluation of all such items, many consist of heavy, stacked or balanced, components that represent a serious safety hazard, particularly to children. Therefore, you should verify that any such component is adequately anchored or otherwise safe.

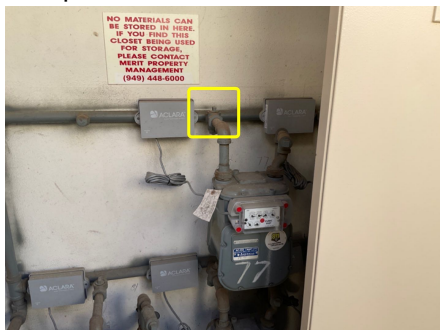
41: Main gas shut-off valve is located at the gas meter. Visible portions of the gas pipes are steel and are in acceptable condition.

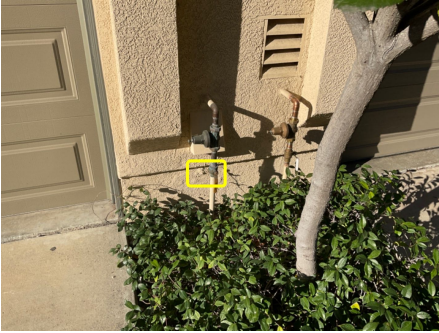
42: HOME SHUT-OFF: House water shut-off valve is located on the back of the house.

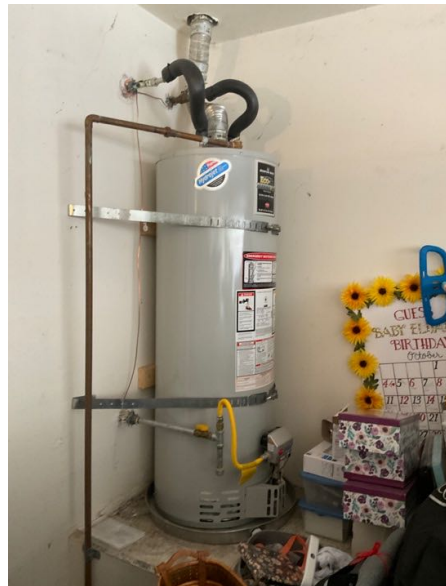
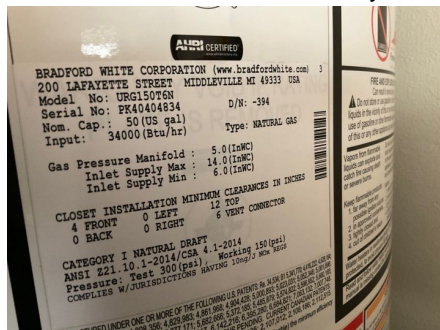
48: MANUFACTURER: 50 gallon, gas, water heater, manufactured by Bradford White.

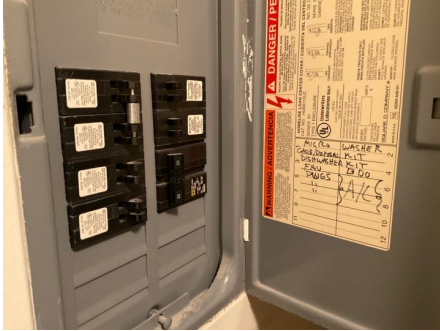
65: PANEL: Sub panel is manufactured by Square D. This panel has an amp capacity of approximately 100 amps/ 240 volts.

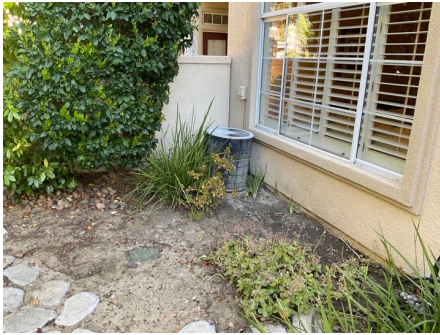
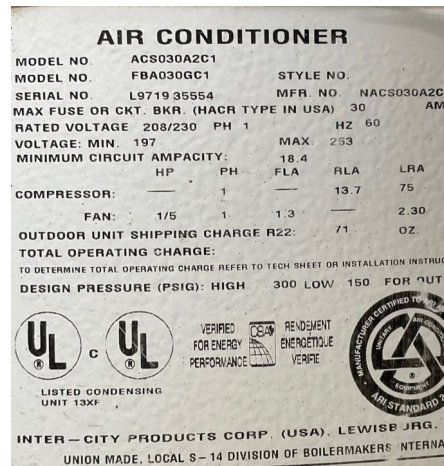
68: MANUFACTURER: The outside air conditioning compressor unit was manufactured by Corsaire. This has a 2.5 ton capacity. This unit uses R22 refrigerant. (R22 refrigerant, sometimes known as Freon, is an environmental danger because it contributes to the depletion of the ozone layer. The U.S. government has placed restrictions on R22 and issued the requirement that R22 refrigerant must be eliminated from use in cooling systems by the year 2020. R22 is no longer manufactured and cannot be used as a refrigerant in new air conditioning systems. R22 was replaced by R-410A, a safer material which is the current and compliant standard refrigerant in air conditioning equipment) refrigerant. The data plate says that the circuit breaker must be no greater than 30 amps. This unit is approximately 25 years old. The average life expectancy of an compressor unit, in Southern California, is approximately 15 years.

69: AGE: Compressor unit is approximately 25 years old and has exceeded its designed life expectancy of 15 years. I make no warranty, guarantee or estimation as to the remaining useful life of this unit. Due to the age, I recommend further evaluation/ service by an HVAC contractor. Budget for replacement in the near future.

70: CONDITION: A/C compressor unit is not at least 3" above the surrounding surface. Recommend correction by an HVAC contractor.

71: CONDITION: Exterior A/C compressor unit mounting pad is not level; this may shorten motor life. Suggest leveling pad.

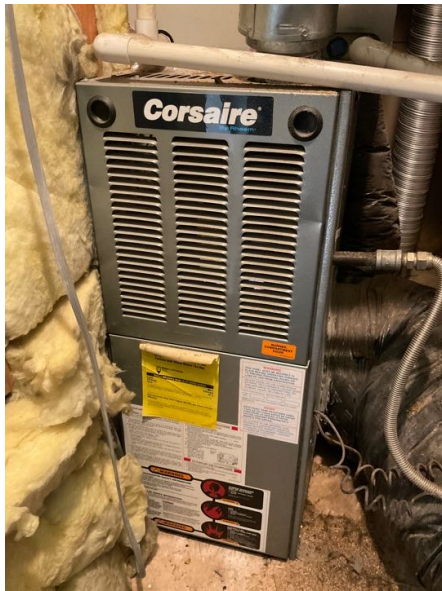
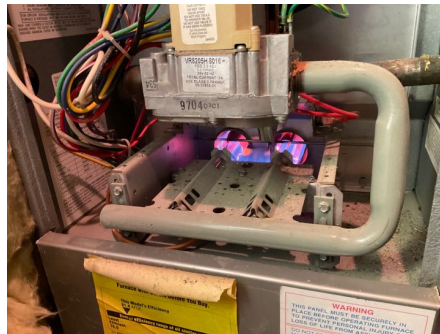
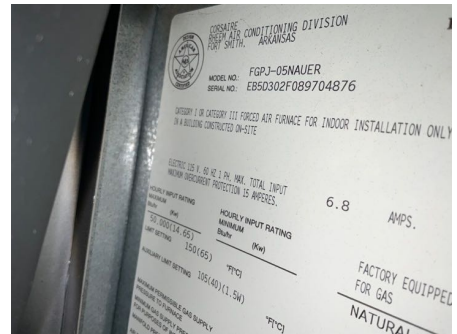
80: MANUFACTURER: Furnace is manufactured by Rheem.

81: TYPE: Gas, forced air, furnace present. Furnace is rated for MAX Input 50,000 BTUs.

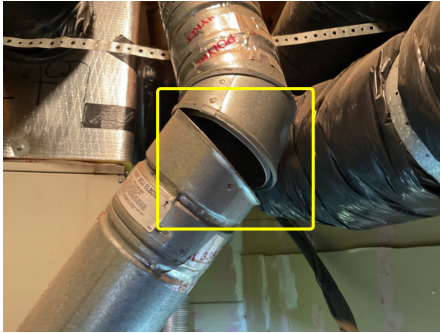
87: EXHAUST VENT: Vent pipe is disconnected. Carbon monoxide is entering the attic. This is a safety hazard. Recommend HVAC contractor repair IMMEDIATELY.

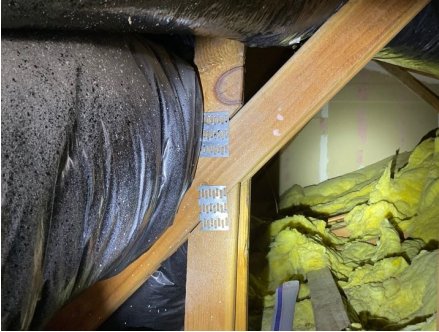
98: TYPE: Fiberglass batts properly averages about 8-10 inches in depth.

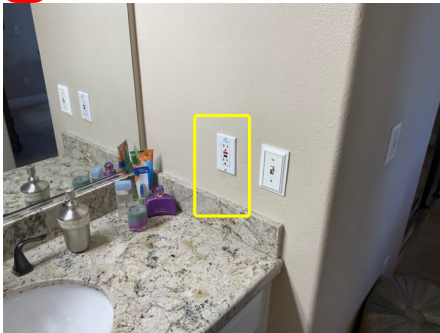
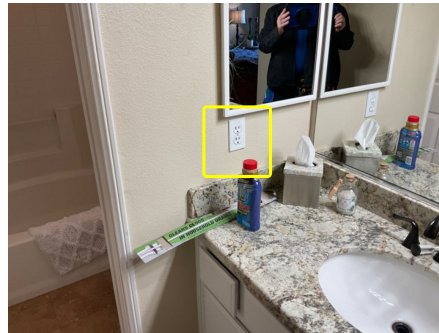
109: Loose receptacle. This is a fire hazard. Recommend repair or replacement by an electrical contractor.

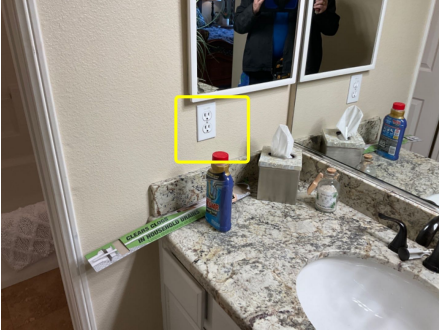
110: GFCI protected receptacle not marked as so. All protected receptacles must be marked as protected to let the user know there is reset somewhere. Recommend correction by an electrical contractor.

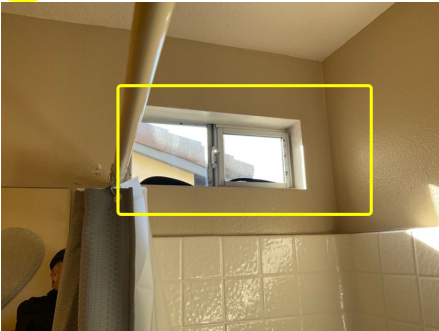
114: CONDITION: Damaged seal. Recommend replacement by a glazing contractor.

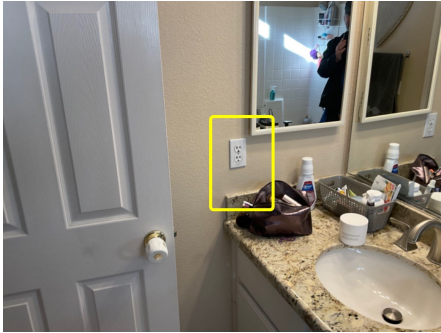
115: GFCI protected receptacle not marked as so. All protected receptacles must be marked as protected to let the user know there is reset somewhere. Recommend correction by an electrical contractor.

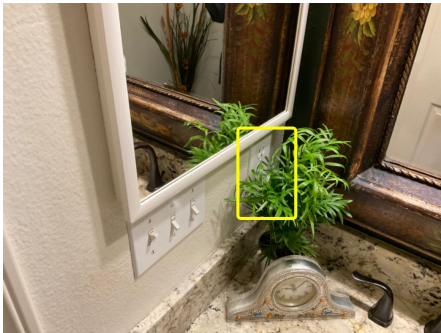
117: GFCI protected receptacle not marked as so. All protected receptacles must be marked as protected to let the user know there is reset somewhere. Recommend correction by an electrical contractor.

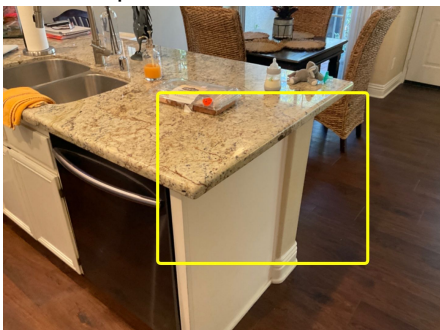
128: Receptacle is missing on the peninsula countertop. There should be a receptacle that serves the peninsula portion of the countertop. Receptacles that are under a 6" overhang or more than 12" below the countertop do not count. This is a safety hazard. Recommend correction by an electrical contractor.

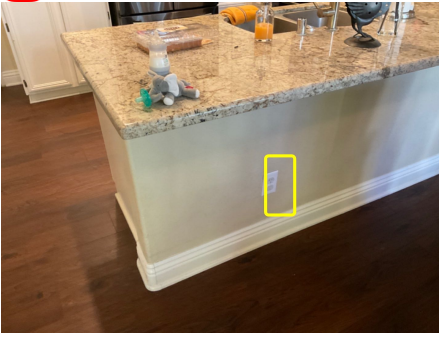
129: Loose receptacle. This is a fire hazard. Recommend repair or replacement by an electrical contractor.

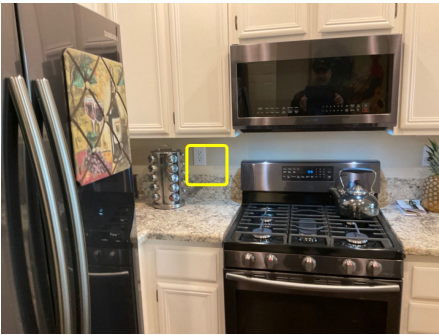
130: GFCI MISSING: No GFCI protection on a receptacle that serves the kitchen countertop. This is a shock hazard. Recommend correction by an electrical contractor.
