Property Inspection Report

78650 Ave 42 #1713, Indio, CA 92203

Date of Inspection: 9/27/2023 Time: 10:00 AM

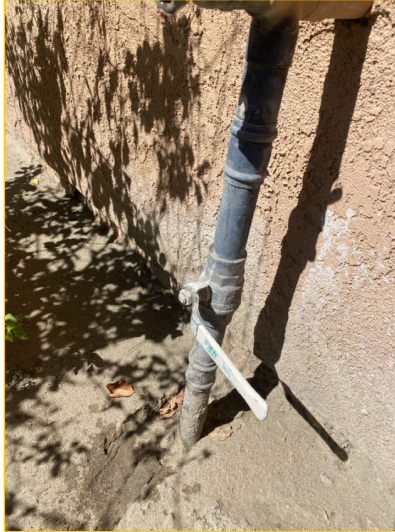
1. Plumbing

Materials: Main water shut off valve noted at front of structure.

- Visible piping appears to be in good condition.

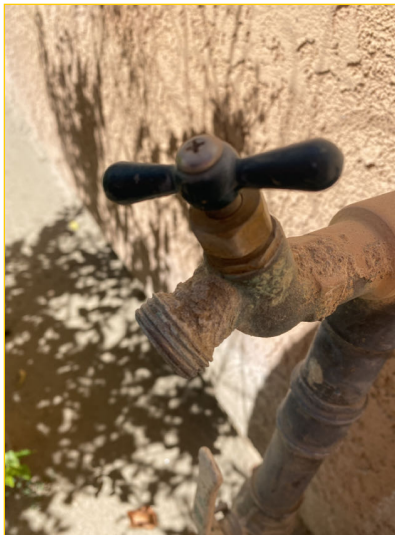
2. Exterior Faucet Condition

Location: Front yard of house.

- Rust/corrosion on exterior faucet noted at time of inspection. Recommend review/repair by licensed plumber.

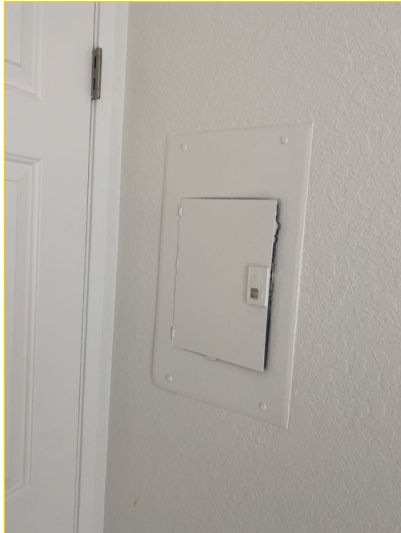
1. Electrical Panel

Location: Sub Panel Location: • Located in the master bedroom.

- No major system safety or function concerns noted at time of inspection at main panel box.

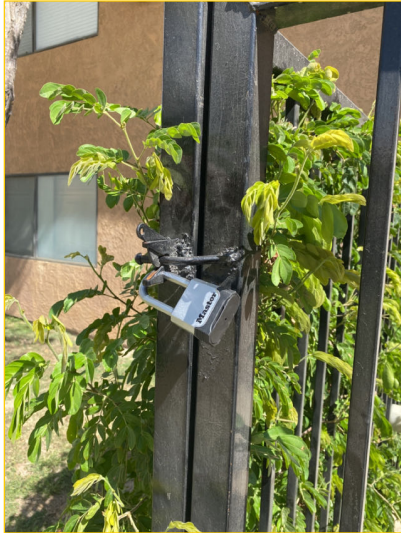
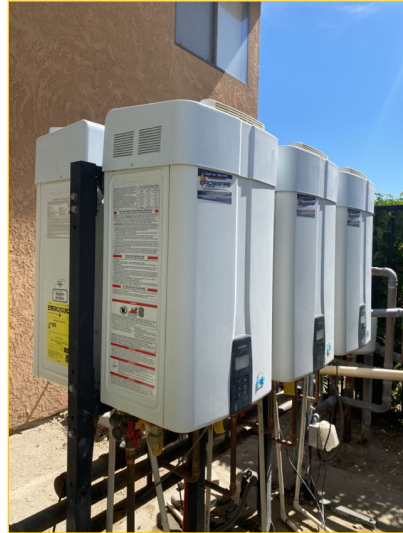
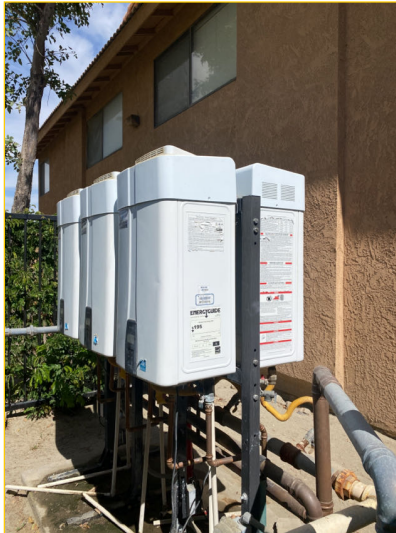
1. Water Heater Condition

- Water heating units were locked on side of building and were not labeled to identify unit that belongs to property. Recommend contacting HOA for disclosure on unit prior to close of sale.

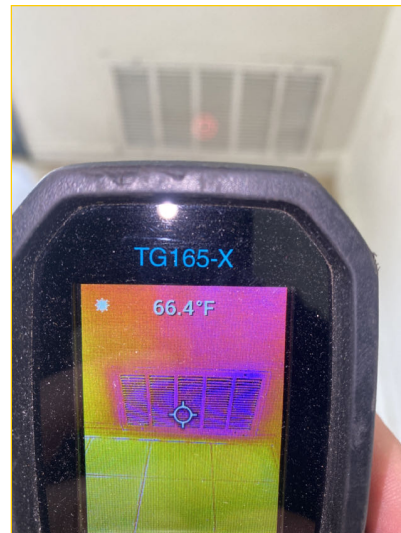
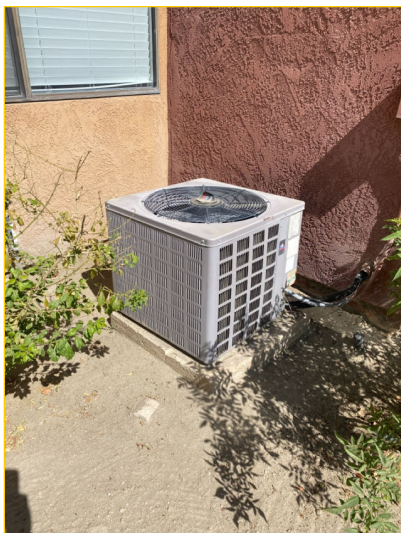
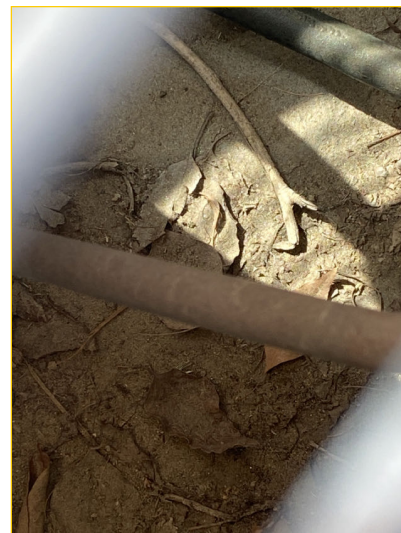
1. AC Condenser Condition

Location: The compressor is located on the exterior grounds.

- Last service date is over one year ago, or is unable to be determined. Although this unit appears to be operating properly from controls at time of inspection we recommend that an HVAC professional check the air conditioning unit for refrigerant levels and cleaning evaporating coils these are areas which cannot be seen without specialized equipment. Inspector recommends a complete inspection prior to close of sale.

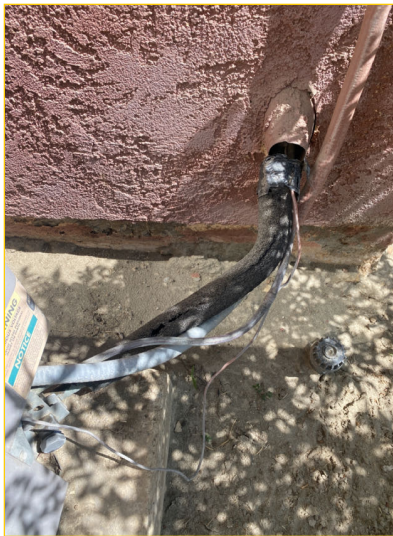
2. Refrigerant Lines

- Insulation on the air-conditioning suction (large, insulated) line was damaged or missing at areas and should be replaced by a qualified HVAC contractor.

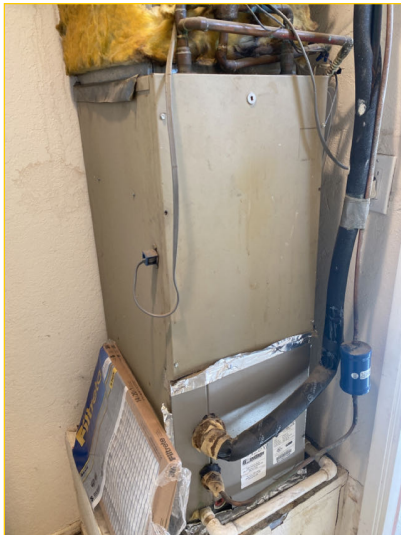
3. Heater Condition

Materials: Location: • The furnace is located in the laundry room
 Materials: Electric forced hot air.

- Electric Furnace: Last service date is over one year ago, or is unable to be determined. Although this unit appears to be operating properly from controls, there are areas which cannot be seen without specialized equipment and training. Furnace specialists recommend a complete inspection annually; consider having unit inspected by certified HVAC technician.

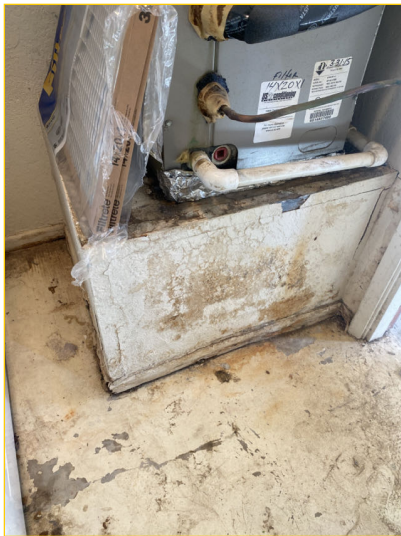
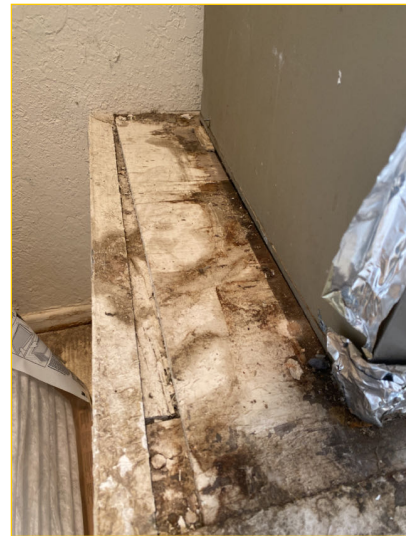
4. Heater Base

- Moisture stains noted on heater base from previous leaks. Areas were dry at time of inspection. Hidden damage may be present. Recommend review/repair by licensed HVAC technician.

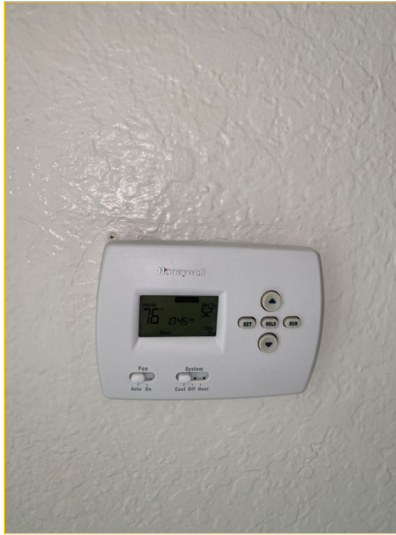
8. Thermostats

- No major system safety or functional concerns noted at time of inspection.

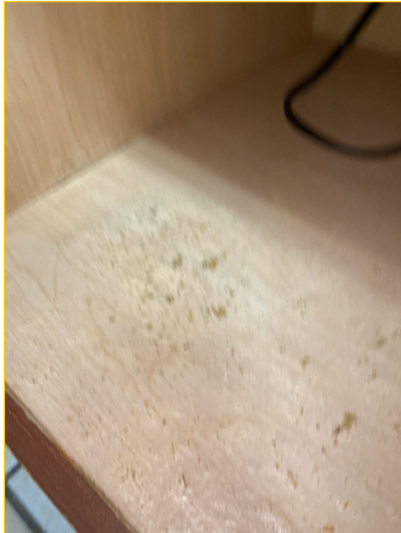
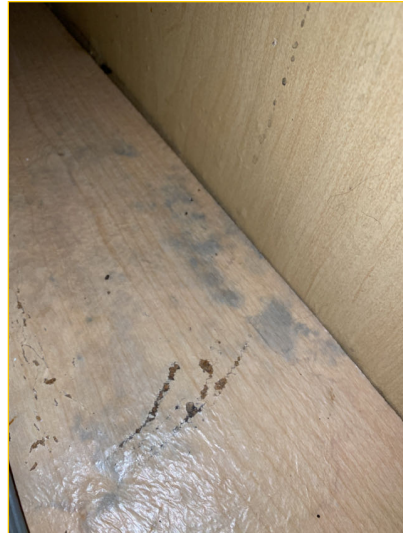
1. Cabinets

- Moisture stains noted in cabinet base under sink from previous leaks. Areas were dry at time of inspection. Hidden damage may be present.

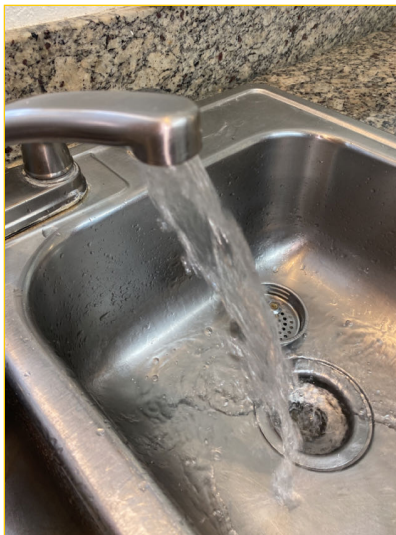
2. Sinks

- Sink faucet aerator is missing. Recommend replacing as needed.

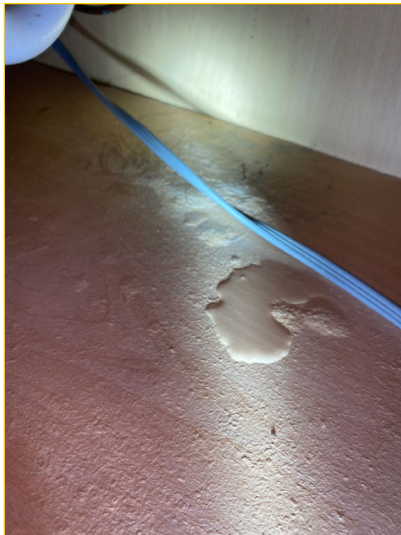
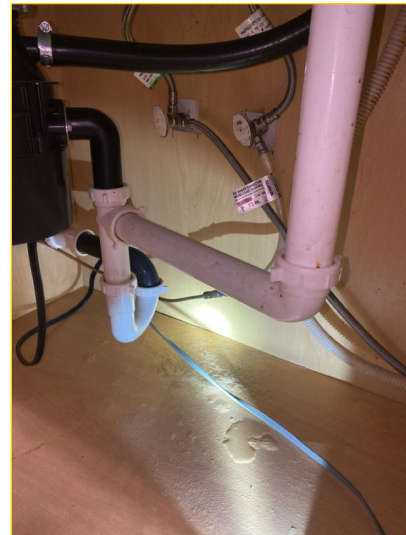
3. Plumbing

- Visible leaking noted under the sink. Recommend review/repair by licensed plumber.

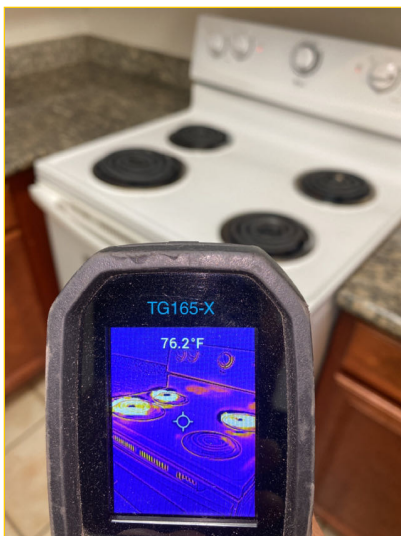
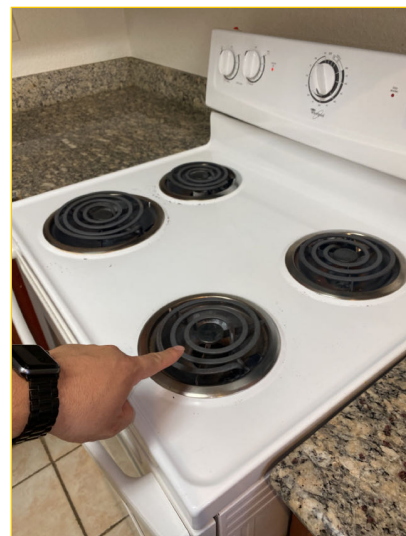
7. Cook top condition

- Electric cook top noted.
- The electric burners igniter failed to ignite the burner.
- The Inspector recommends service by a qualified technician.

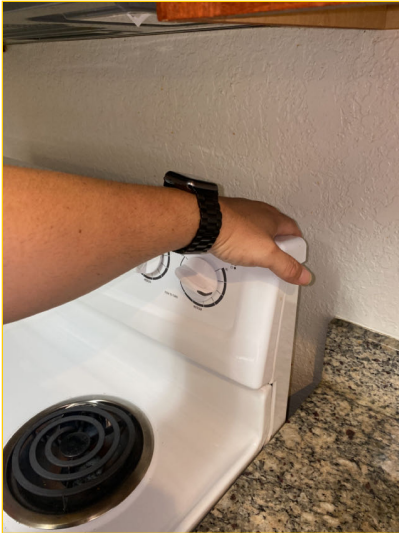
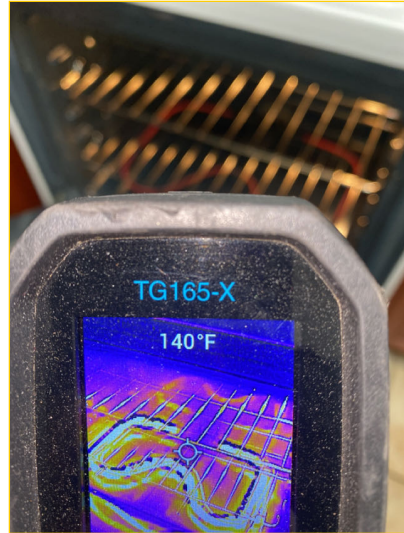
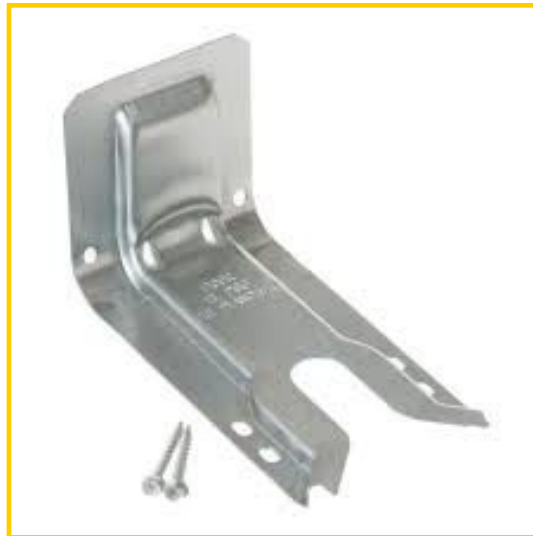
8. Oven & Range

• Anti-tip bracket is missing from range installation. See label inside oven door. All free-standing, slide-in ranges include an anti-tip device and is essential in the safe operation of the range. It provides protection when excess force or weight is applied to an open oven door. Carried by home building centers. Recommend review/repair by licensed contractor.

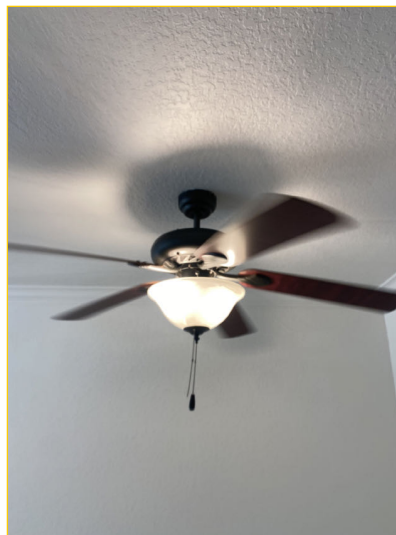
3. Ceiling Fans

- The fan blades wobble when tested. Recommend review/repair by licensed contractor.

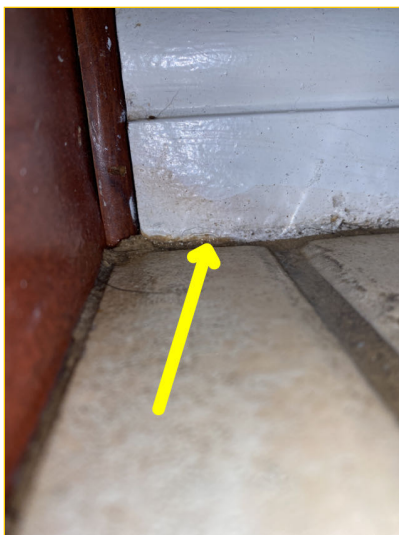
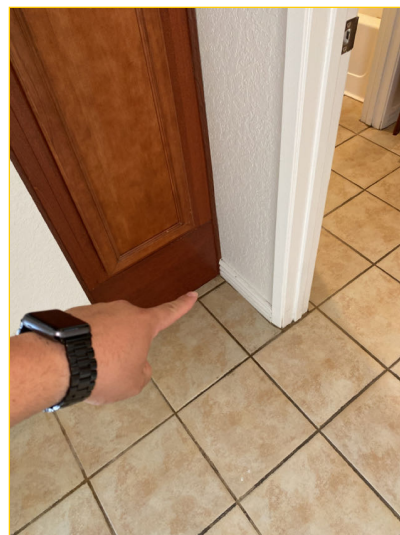
6. Wall Condition

- There is evidence of moisture damage at base boards.

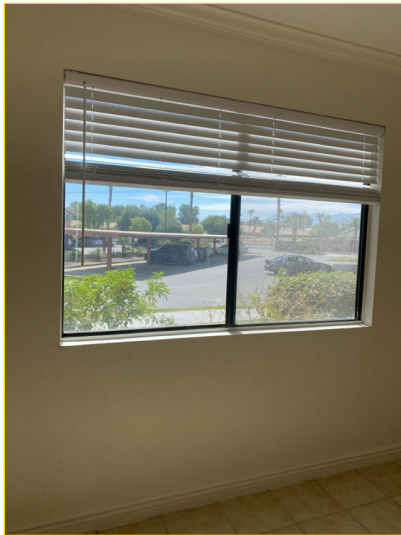
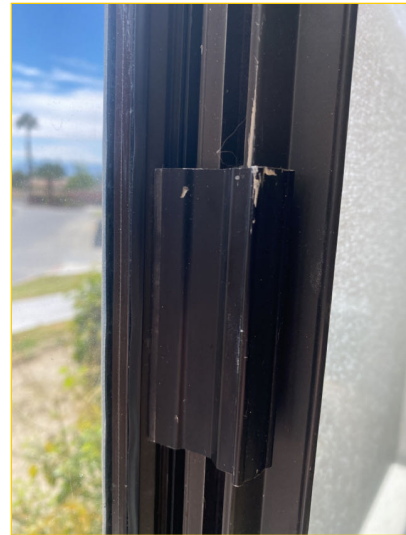
7. Window Condition

Materials: Aluminum framed sliding window noted.

- Window did not lock/latch properly. Recommend review/repair by licensed contractor.
- Window(s) difficult to operate. Recommend review and repair as needed by qualified contractors.

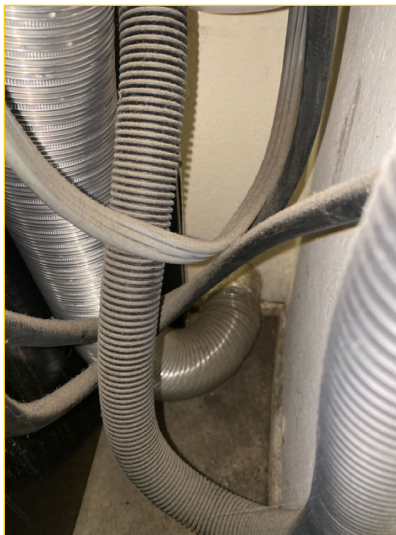
2. Dryer Vent

- General cleaning of the dryer vent is needed prior to use. The dryer vent should be cleaned and inspected every 6 to 12 months as part of regular home maintenance.

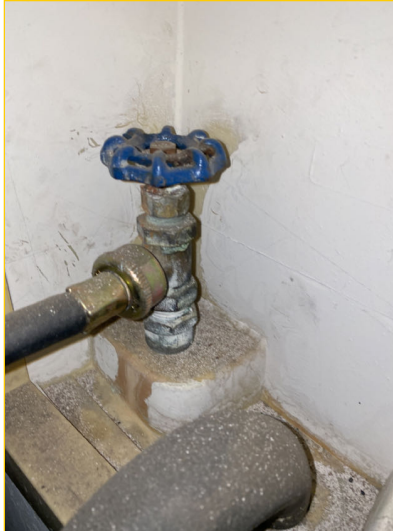
6. Plumbing

Observations:
 • Corrosion at the valve/s indicate past leaking. Mineral buildup has stopped the leak but could possibly start again Recommend repair by a licensed plumber

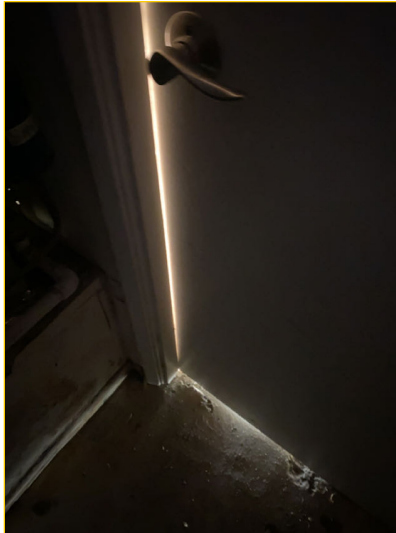
7. Doors

Observations:
 • Visible sunlight though door noted. Recommend repair to prevent insects dust and debris from entering home.

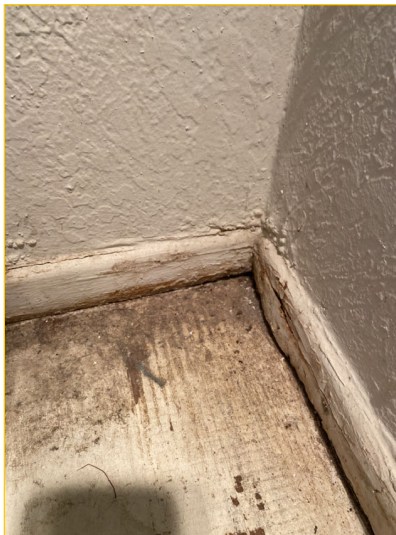
9. Wall Condition

- There is evidence of moisture damage to laundry wall areas We recommend contacting a contractor experienced in remediation to evaluate the area and suggest repair options.

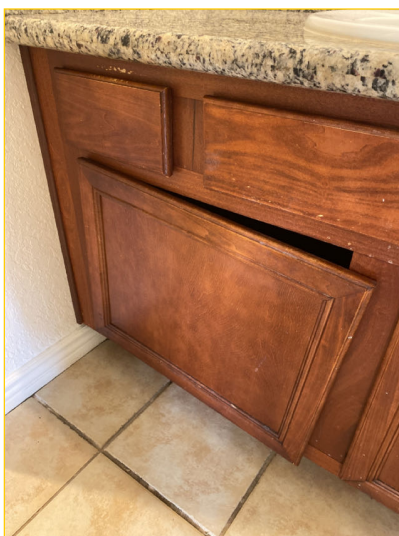
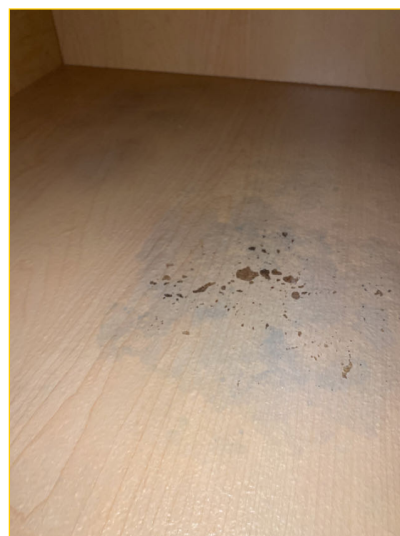
2. Cabinets

- Moisture stains noted in cabinet base from previous leaks. Areas were dry at time of inspection. Hidden damage may be present.
- Wood damage to cabinet base noted at time of inspection. Hidden damage may be present. Recommend review/repair by licensed contractor.
- Some cabinet drawers need hardware repair/adjustment. Recommend review/repair as needed.

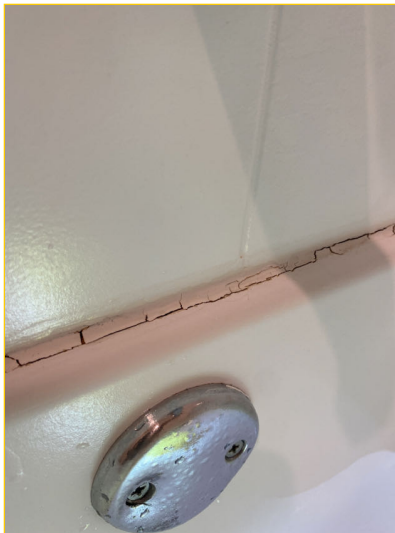
9. Shower Walls

Observations:
 • ****MATERIALS****
 • Fiberglass surround noted.
 • ****OBSERVATIONS****
 • Grout is cracking in the corners. Recommend repairing and re sealing bas needed.

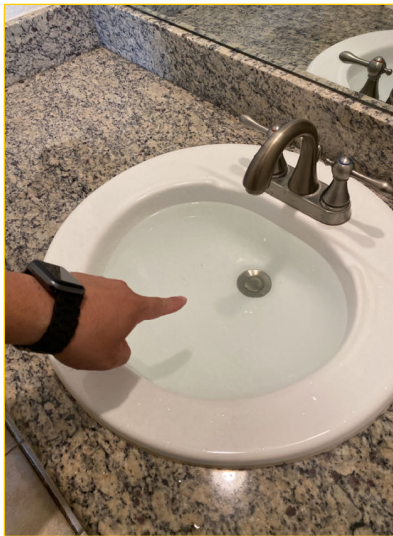
11. Sinks

- The stopper assembly was not operational. Recommend repair as needed.

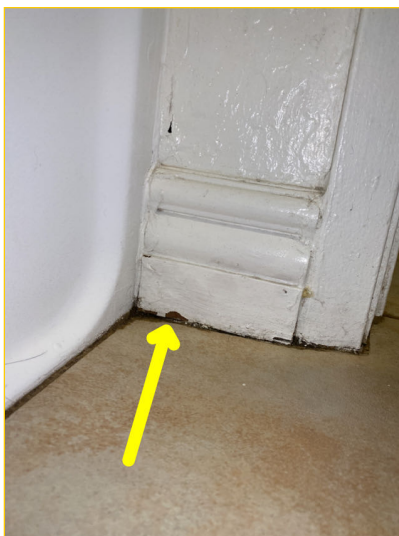
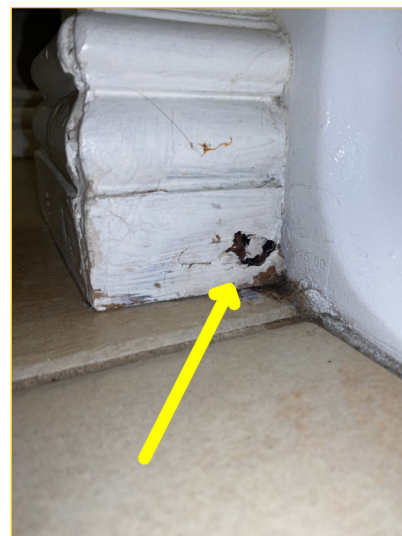
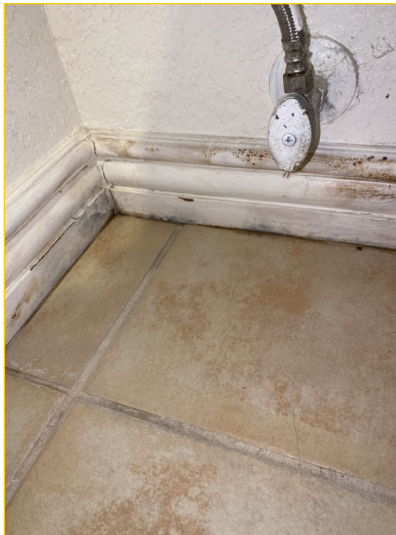
14. Wall Condition

- There were signs of past water damage to baseboard and paneling; however, no active moisture was detected during the inspection.

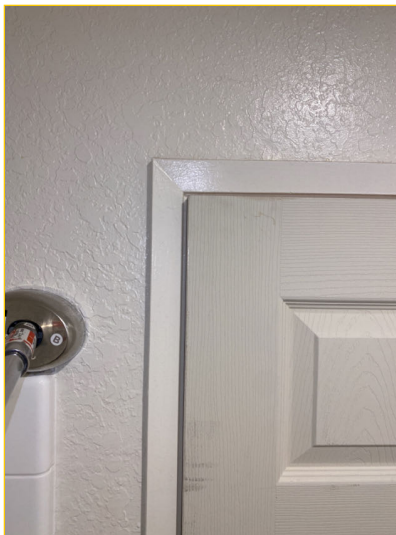
15. Doors

- Door rubs in corner at time of inspection. Recommend repairs as needed.
