Inspection Report

Property Address:
32646 Coastsite Dr #303/C
Rancho Palos Verdes CA 90275

Ferguson Home Inspections

Date: 12/10/2024	Time: 01:00 PM	Report ID: 12102024CoastsiteDr
Property: 32646 Coastsite Dr #303/C Rancho Palos Verdes CA 90275	Customer: Darryl Wiedmann & Jean Fuller	Real Estate Professional: John Duston

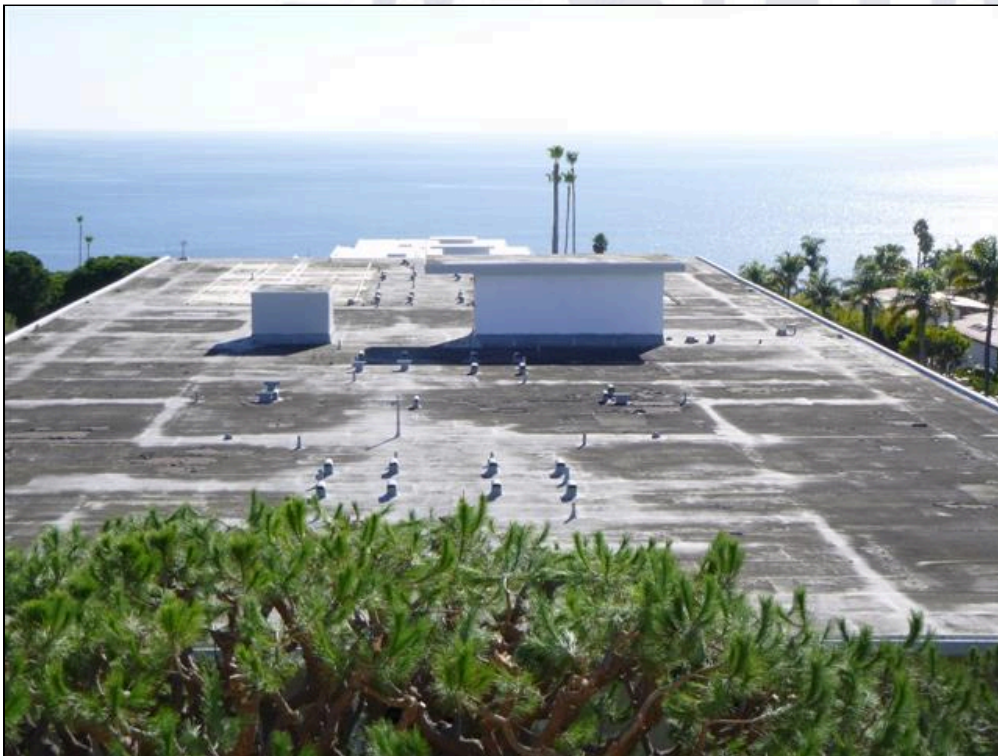
4.0 Item 1(Picture)

4.0 The roof coverings are old and deteriorated and are nearing the end of its useful life and the covering will need to be replaced. While it could last a year or so, some areas may need patching/repairs as leaks develop. Please review with the association and/or a licensed roofer to determine the remaining life expectancy and for costs to repair/remove and replace the existing roofing material as needed.

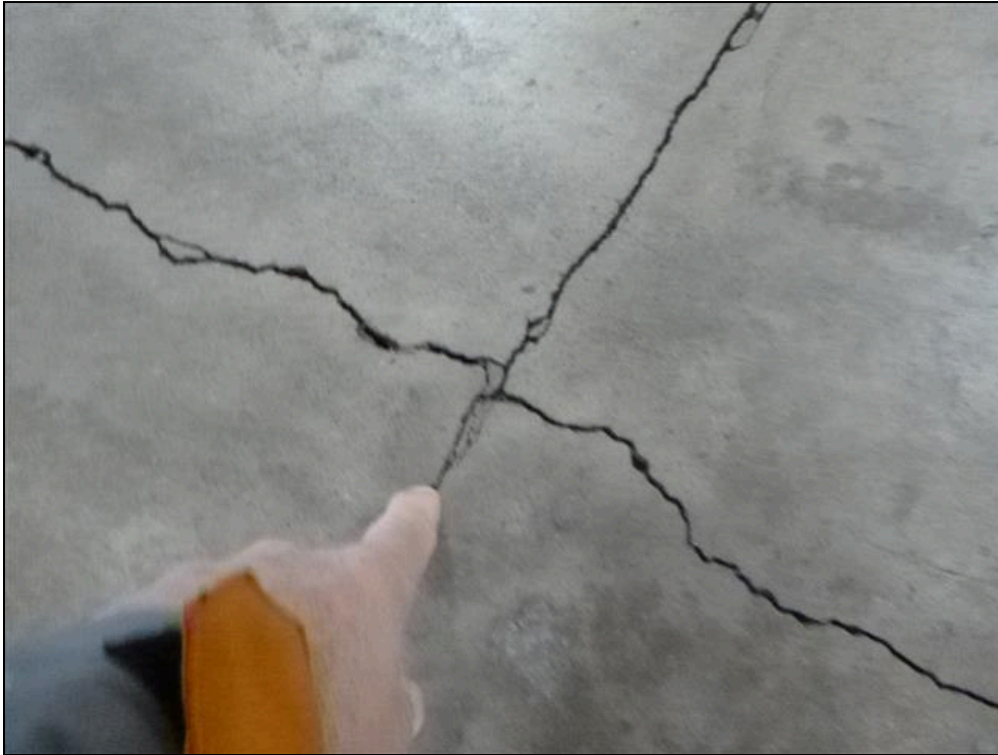
7.0 Item 1(Picture)

7.0 Minor settling/movement/expansion cracks noted.

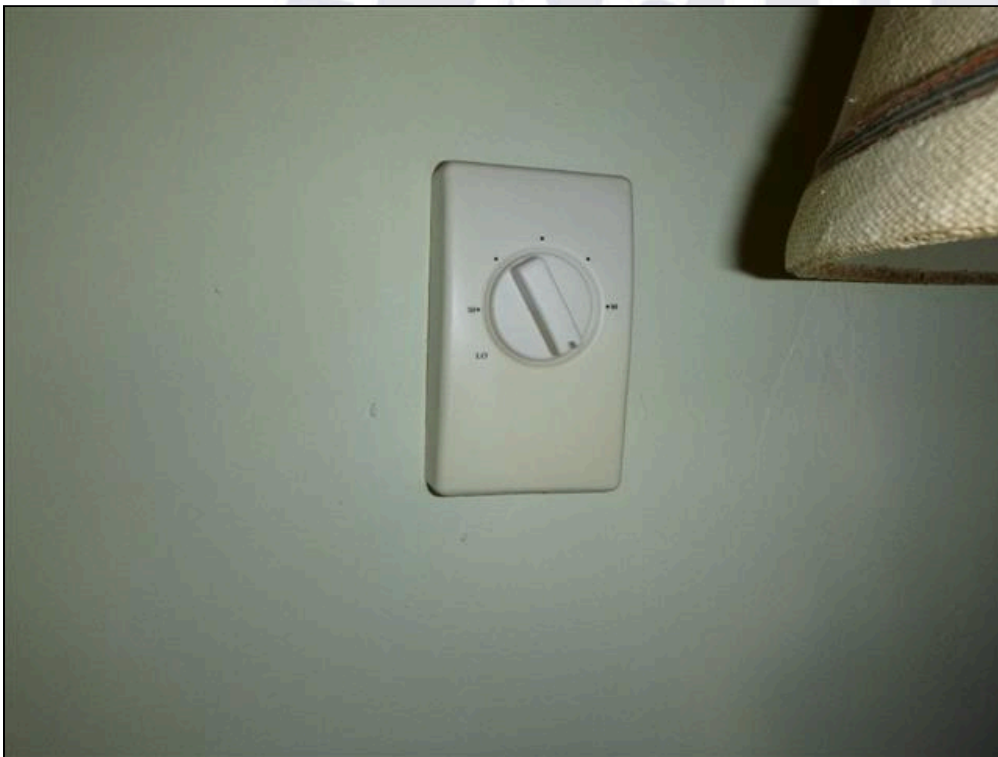
8.1 Item 1(Picture)

8.1 Suggest upgrading with digital programmable thermostat(s) as needed.

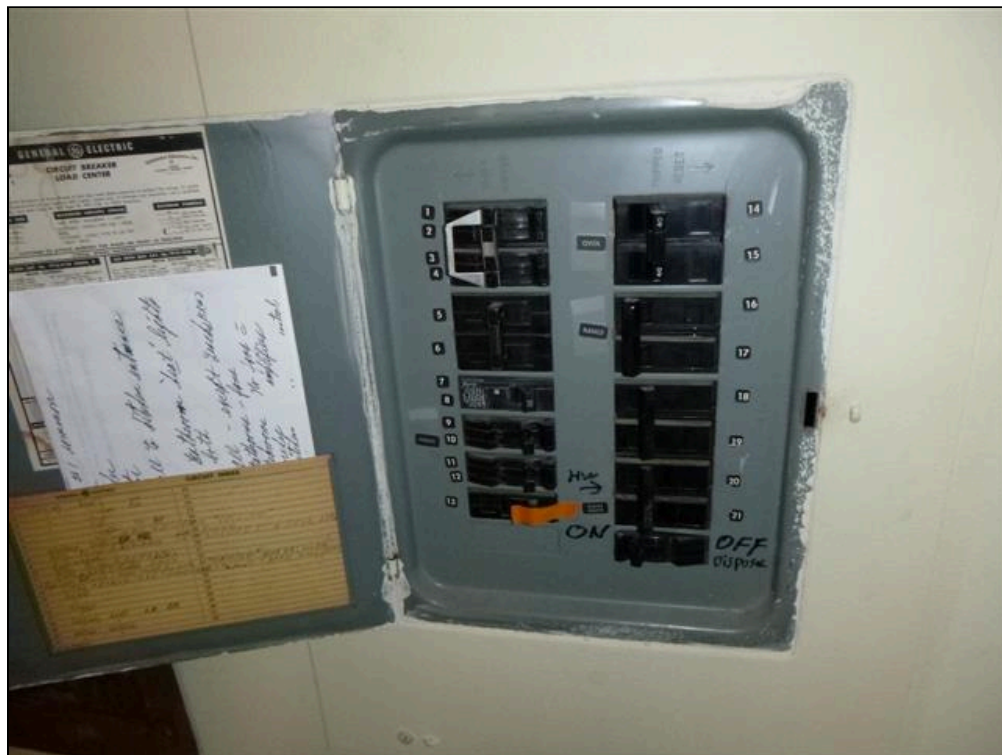
9.1 Item 1(Picture)

9.1 (1) Suggest adding correct/complete indexing/labelling to all breakers for identification of each circuit for safety.

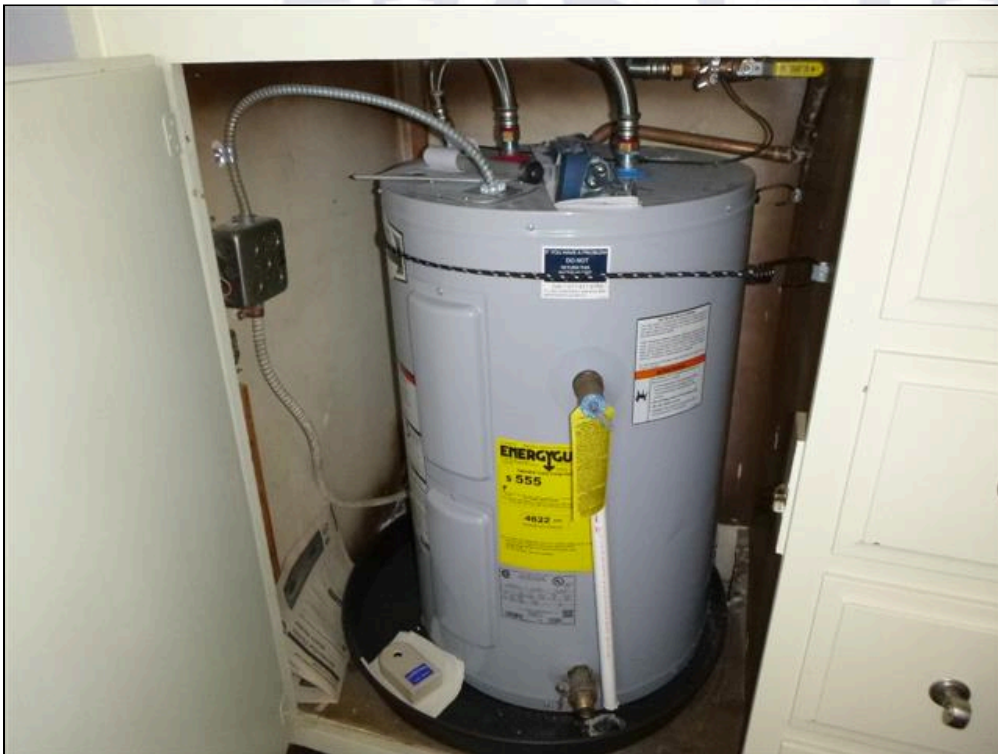
12.0 Item 1(Picture)

12.0 (1) The water heater was operational at the time of the inspection.

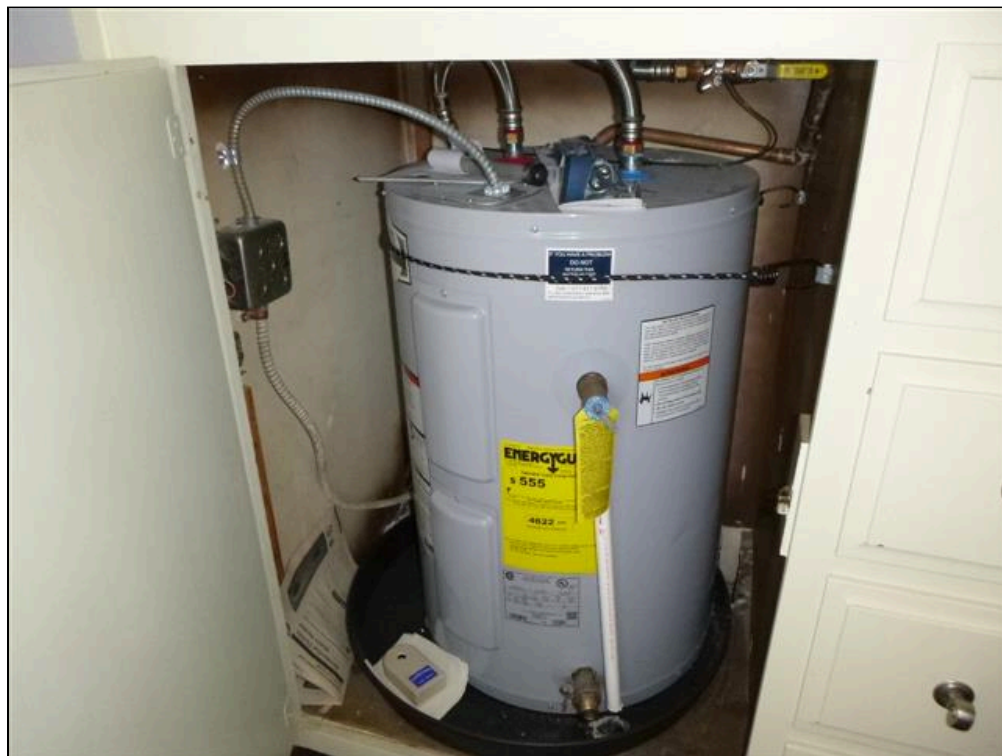
12.0 Item 2(Picture)

12.0 (3) No earthquake seismic straps are installed at the water heater as required. Suggest installation of two seismic straps as required by the State of California for safety.

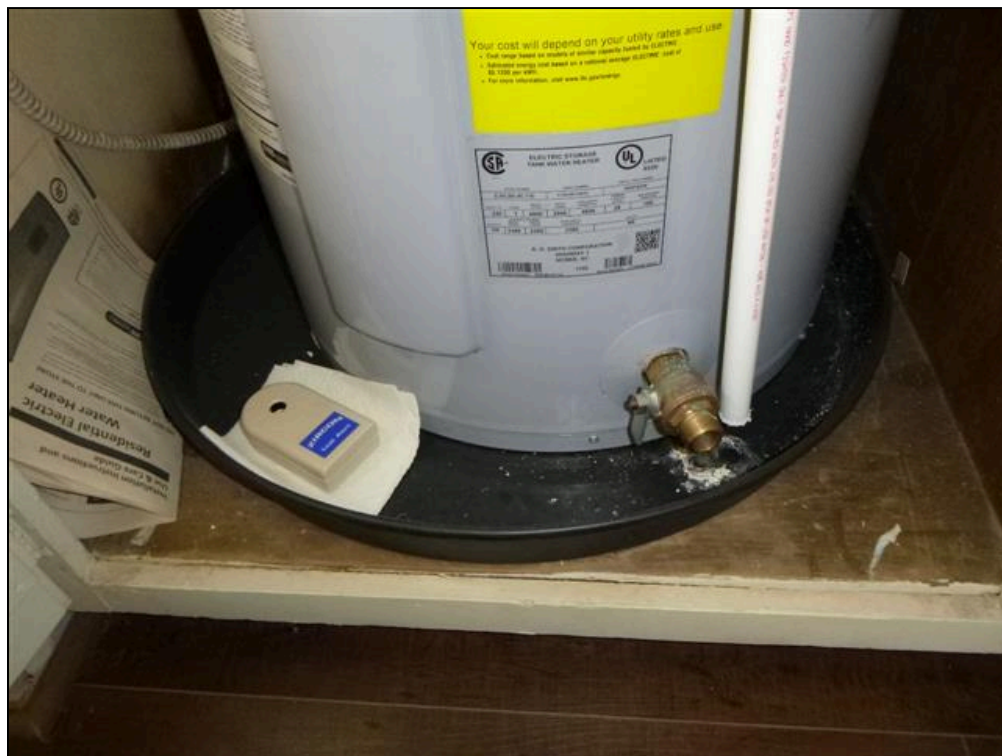
12.0 Item 3(Picture)

12.0 (4) A spill pan is currently installed under the water heater but the inspector was unable to visually confirm any drainage connection to the exterior at the time of the inspection. Suggest review with the seller and/or a licensed plumber for confirmation as needed

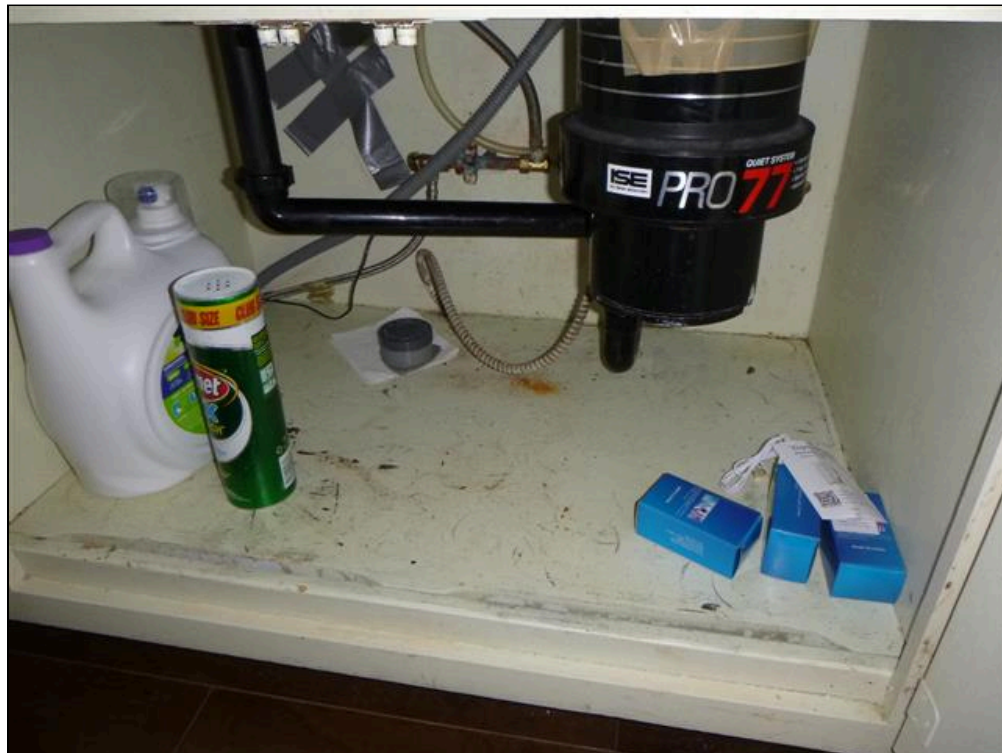
13.5 Item 1(Picture)

13.5 The base cabinet under the sink is stained/deteriorated from previous leaks, suggest repair/replace as needed.

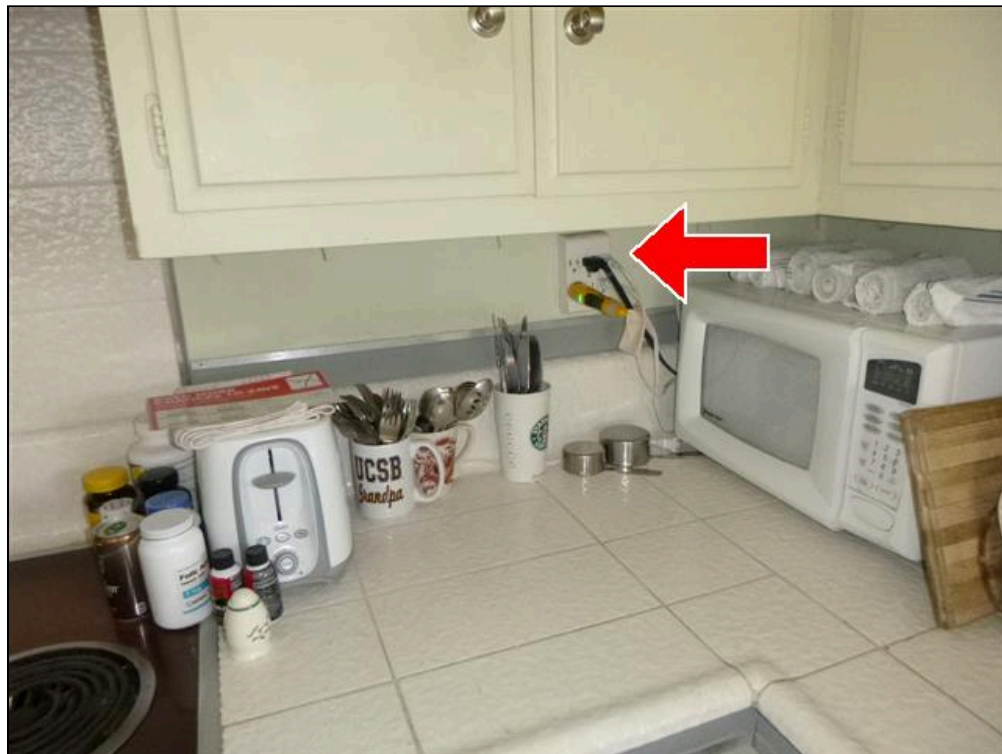
13.7 Item 1(Picture)

13.7 (1) Various light fixtures were inoperable, possible bulbs out and/or a faulty fixture. Suggest review with a licensed electrician for any repair/replacement costs and confirm correct operation as needed.

13.7 (2) Various countertop outlets are not GFCI protected as required. Countertop GFCI outlet(s)/protection has been required within six feet of the sink since 1987 and all countertop outlets since 1996. Suggest review by a licensed electrician for installation costs as required for safety.

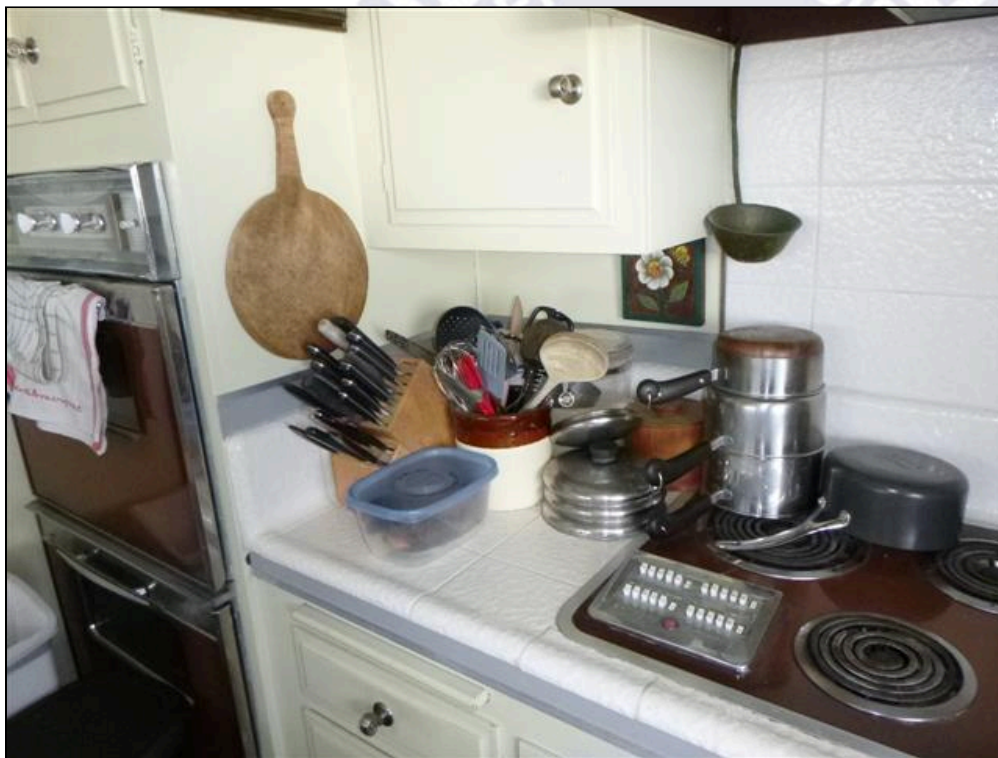
13.7 Item 3(Picture)

13.7 (3) Inadequate/incorrectly installed countertop/appliance outlets/circuits were noted, suggest review with a licensed electrician for installation costs as needed/required.

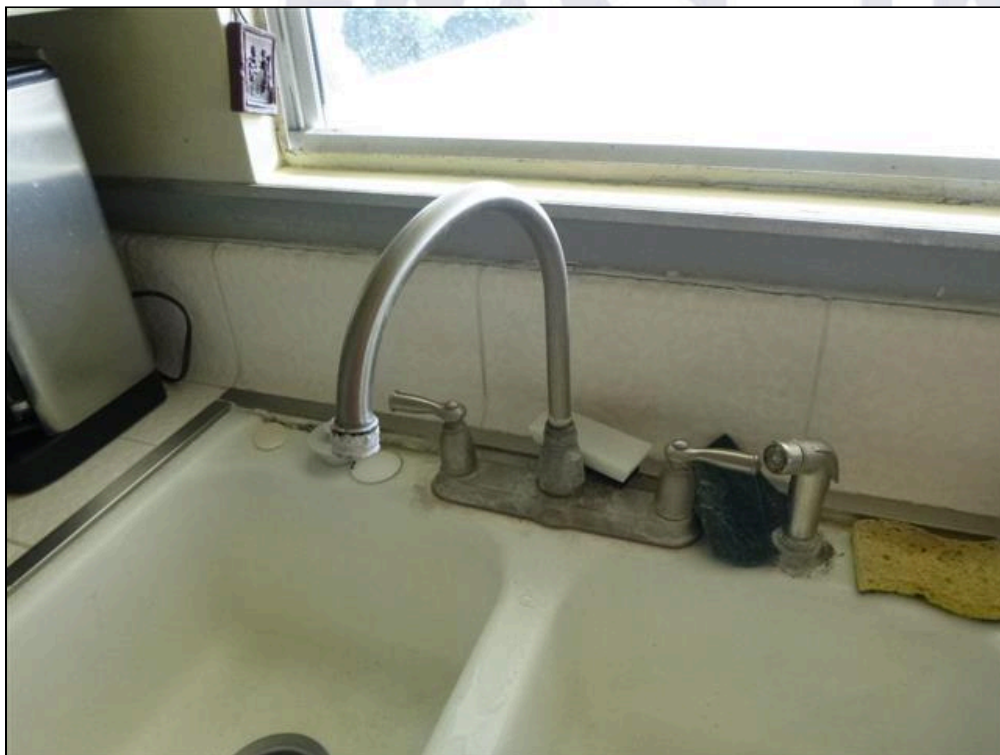
13.9 Item 1(Picture)

13.9 The sink faucet leaks, suggest repair/replace as needed to prevent future and further leaking water from damaging the cabinet base and surrounding areas.

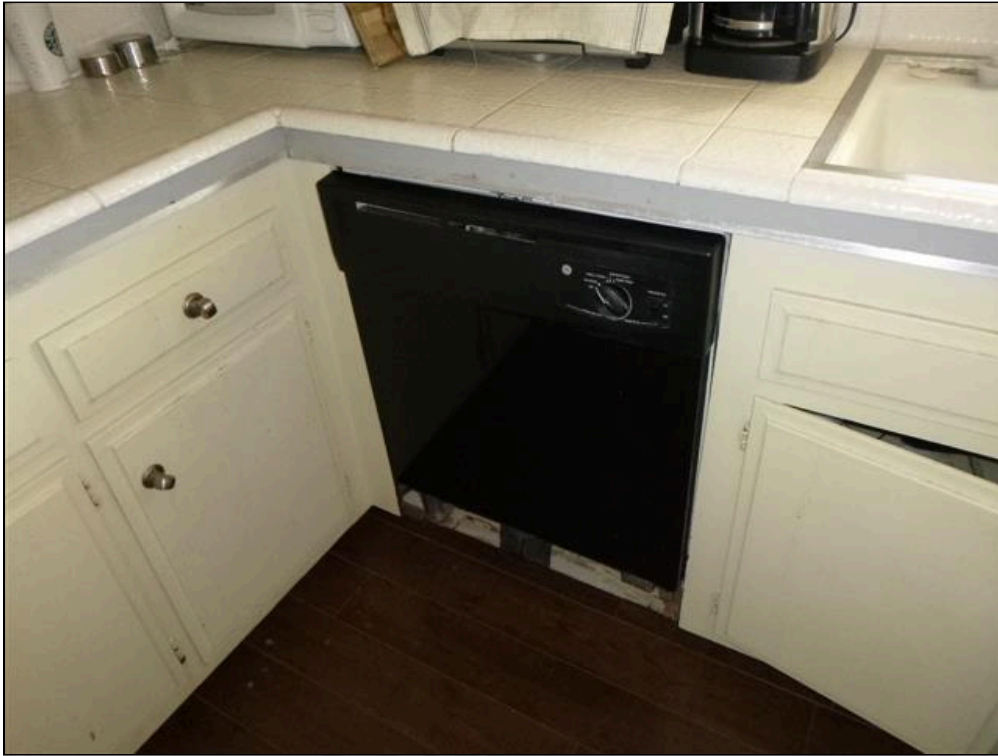
13.11 Item 1(Picture)

13.11 (1) The dishwasher was inoperable at the time of the inspection. Suggest review with a

licensed appliance company for repair/replacement costs and confirm correct operation as needed.

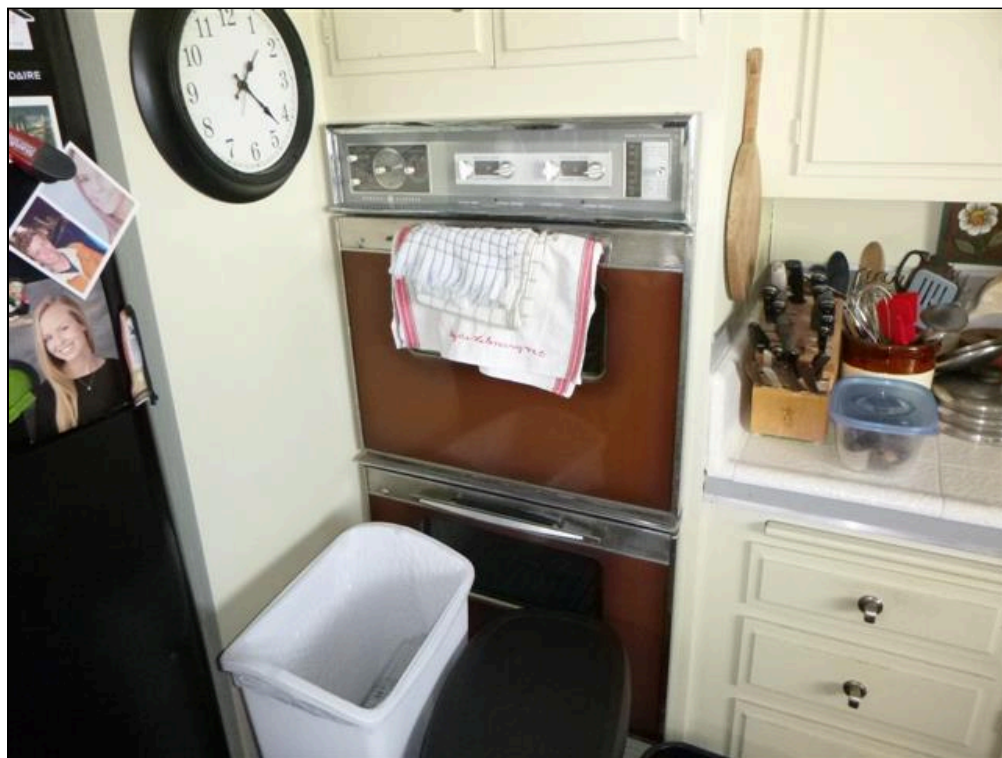
13.13 Item 1(Picture)

and/or a licensed contractor for repair/replacement costs and confirm correct operation as needed.

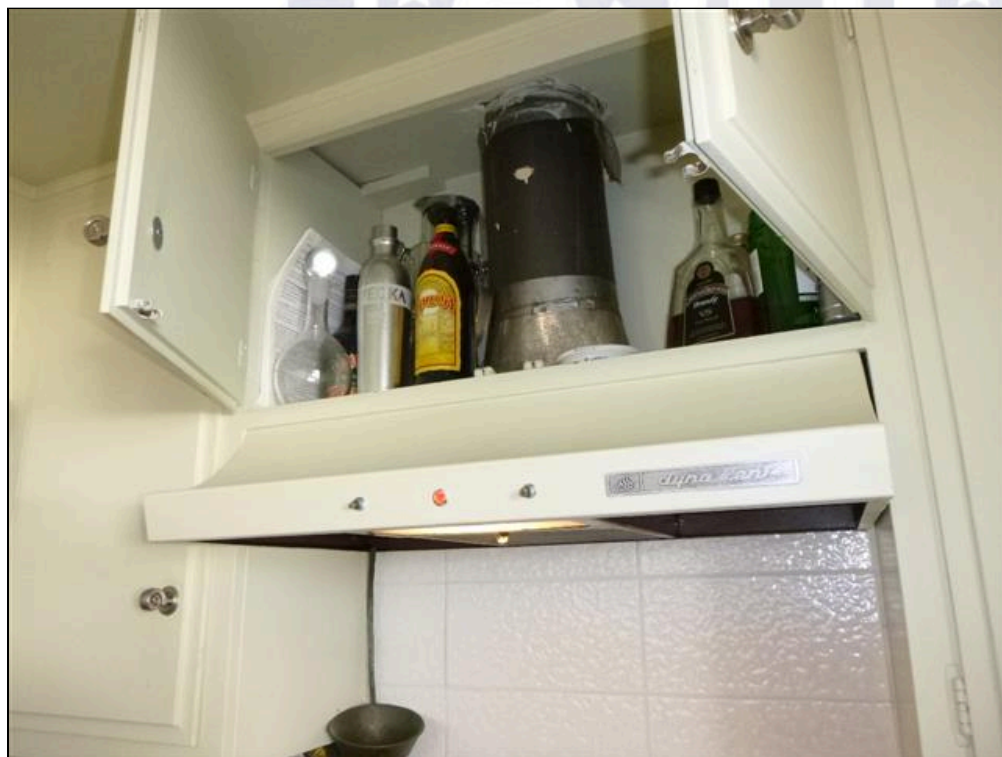
13.14 Item 1(Picture)

13.14 The range/hood vent is inoperable at the time of the inspection, suggest review with a licensed contractor and repair/replace as required for safety.

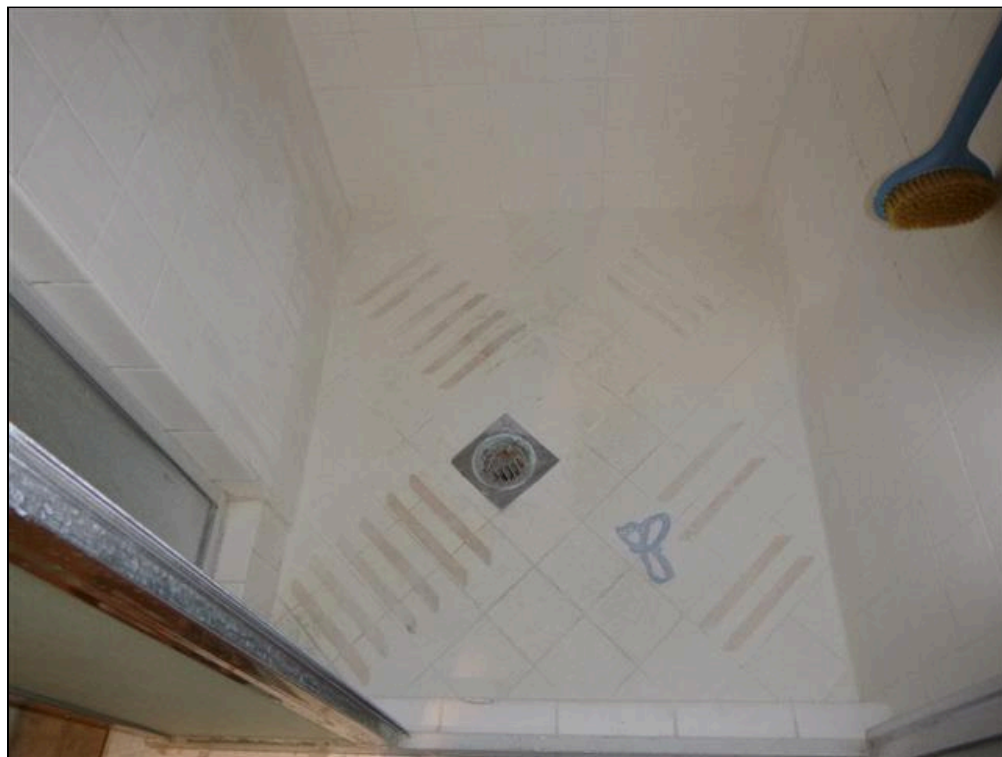
14.7 Item 1(Picture)

14.7 Worn/missing grout noted at the shower base tiles, suggest maintenance/repair/replace as needed.

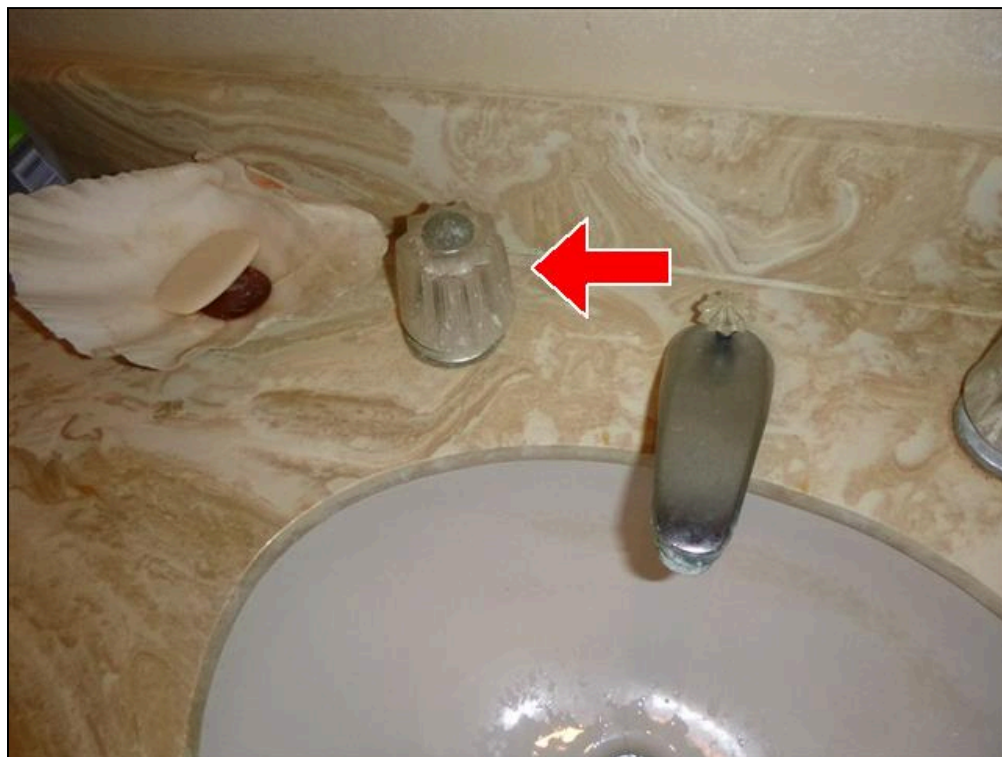
14.11 Item 1(Picture)

14.11 The hot side sink faucet is inoperable, suggest review by a licensed plumber and repair/replace as needed.

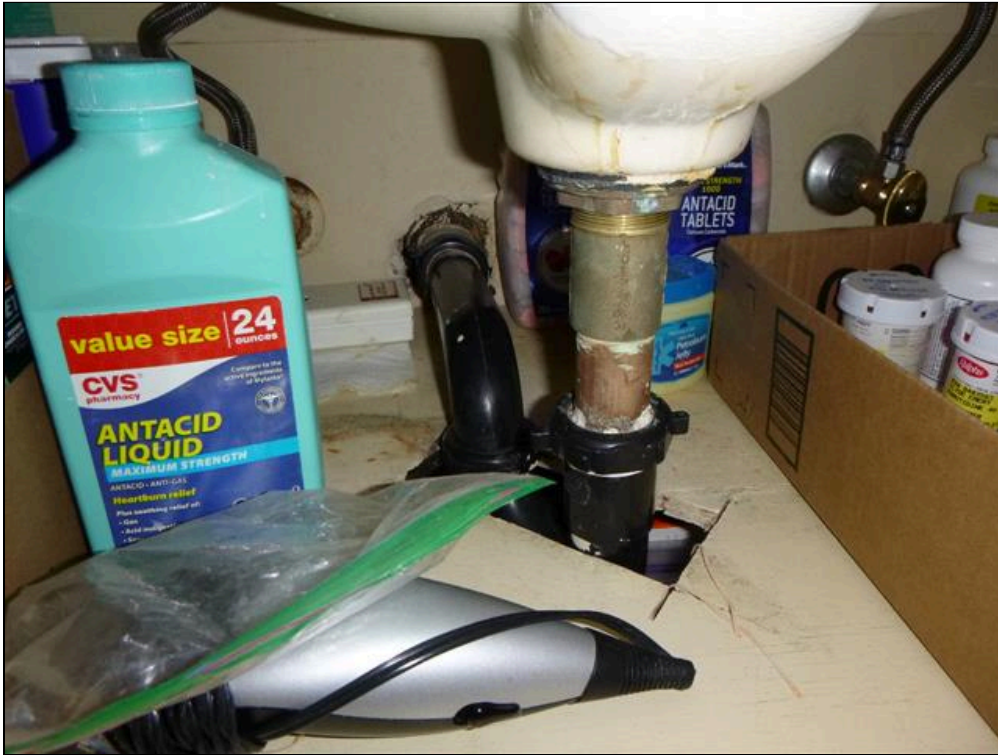
14.12 Item 1(Picture)

14.12 Corrosion/stains noted at the sink drain(s), no leaking noted at the time of the inspection. Suggest review by a licensed plumber for repair/replacement costs as needed.

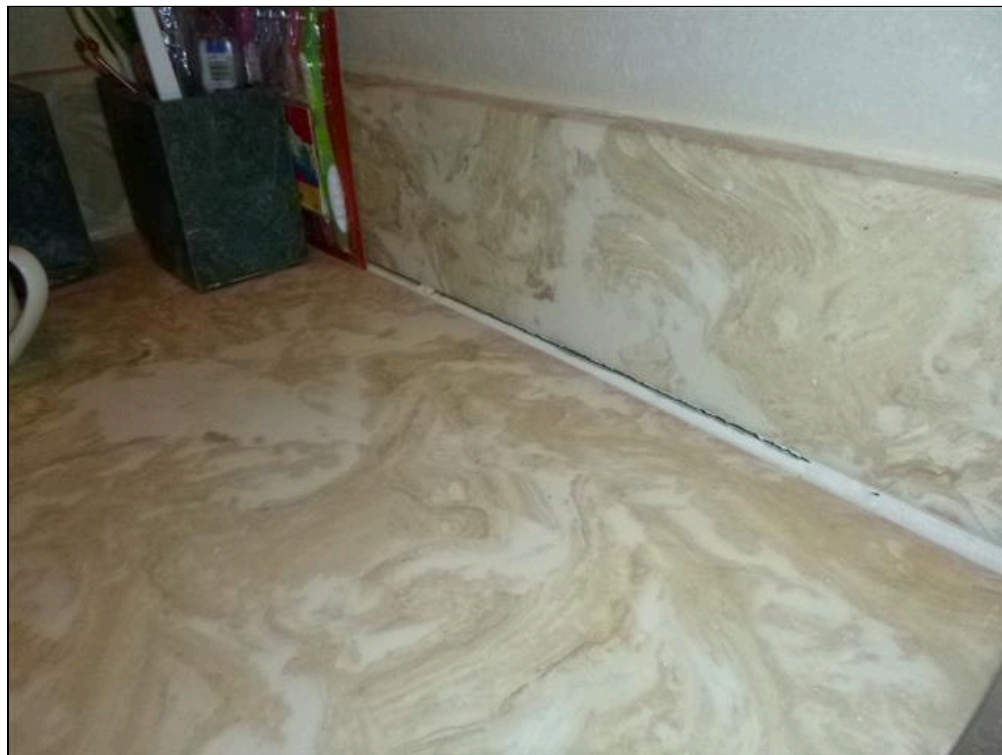
14.14 Item 1(Picture)

14.14 Suggest caulking/grouting at countertop to backsplash to prevent any future water intrusion.

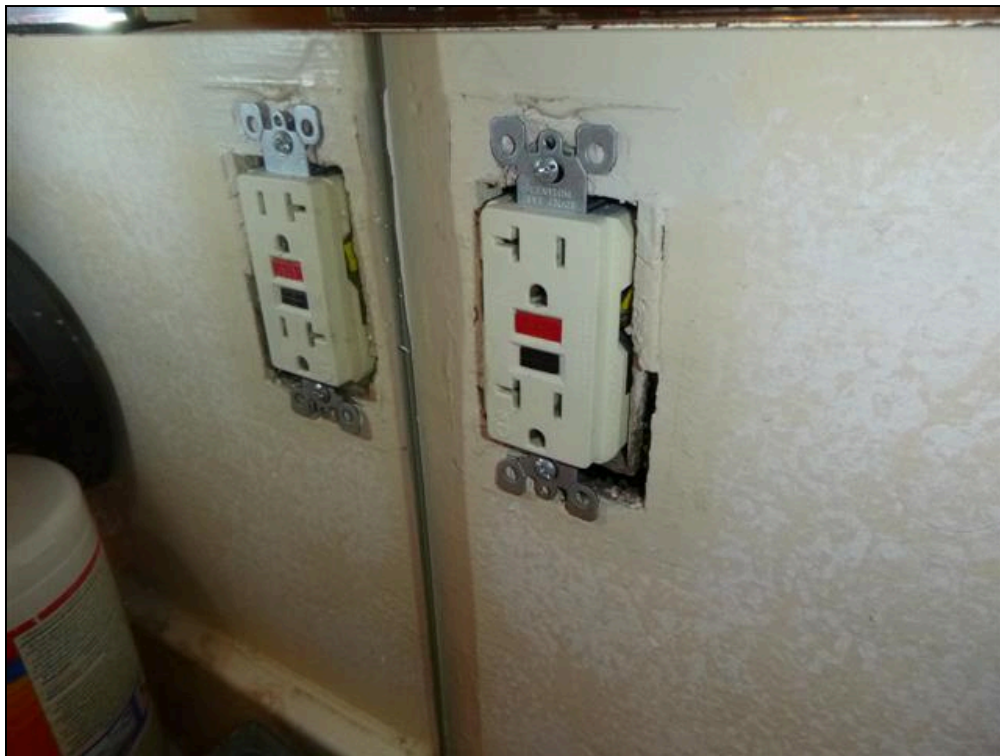
15.4 Item 1(Picture)

15.4 (2) The outlet cover(s) are missing at various areas. Suggest installation for safety.

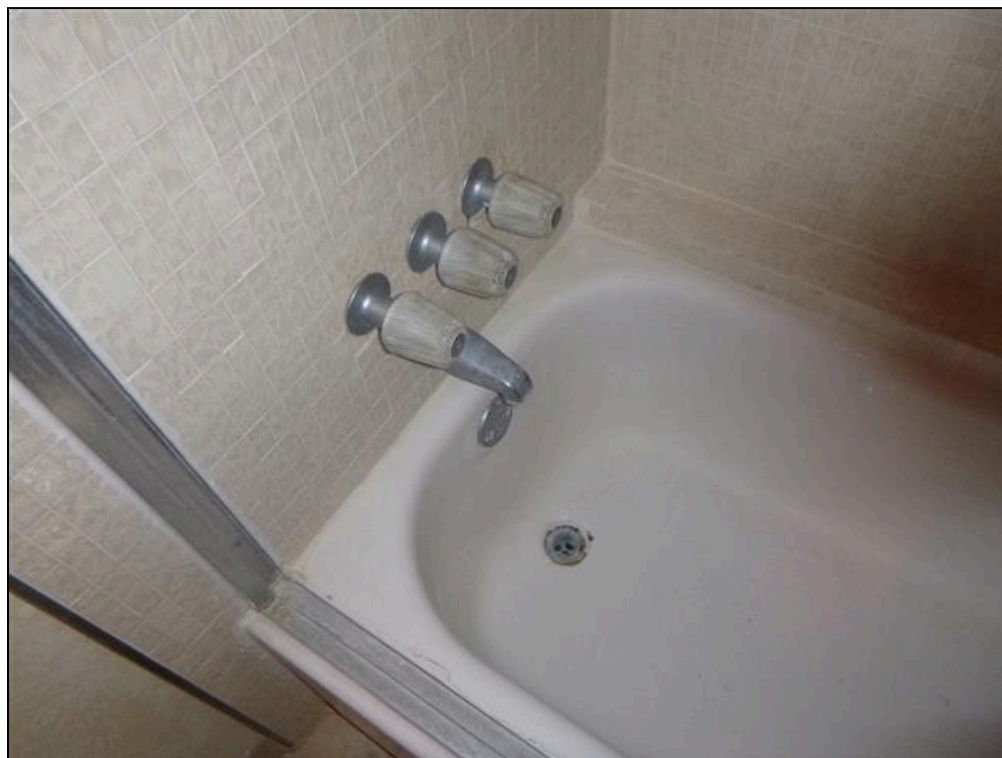
15.8 Item 1(Picture)

15.8 The tub/shower faucet area was not tested as per the tenant due to active leakage to the unit below. Suggest review with the seller and/or a licensed plumber/contractor for any repair/removal/replacement costs as needed.

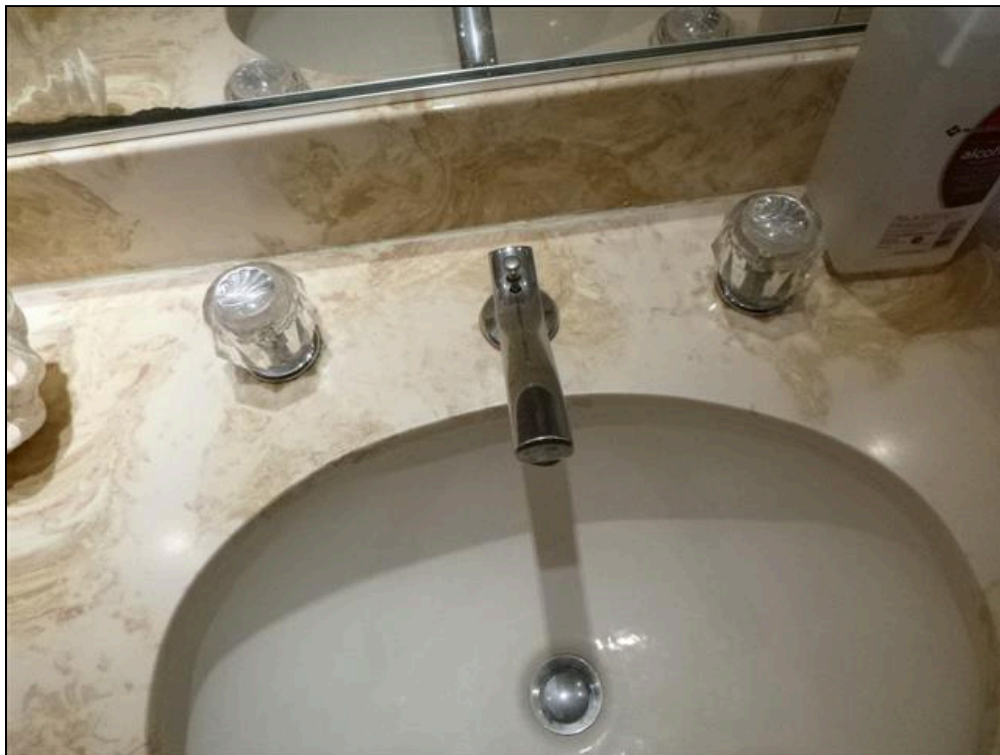
15.13 Item 1(Picture)

15.13 Unable to test the sink faucets at this area as the water was turned off. Suggest review with seller and/or a licensed plumber for any repair/replacement costs as needed.

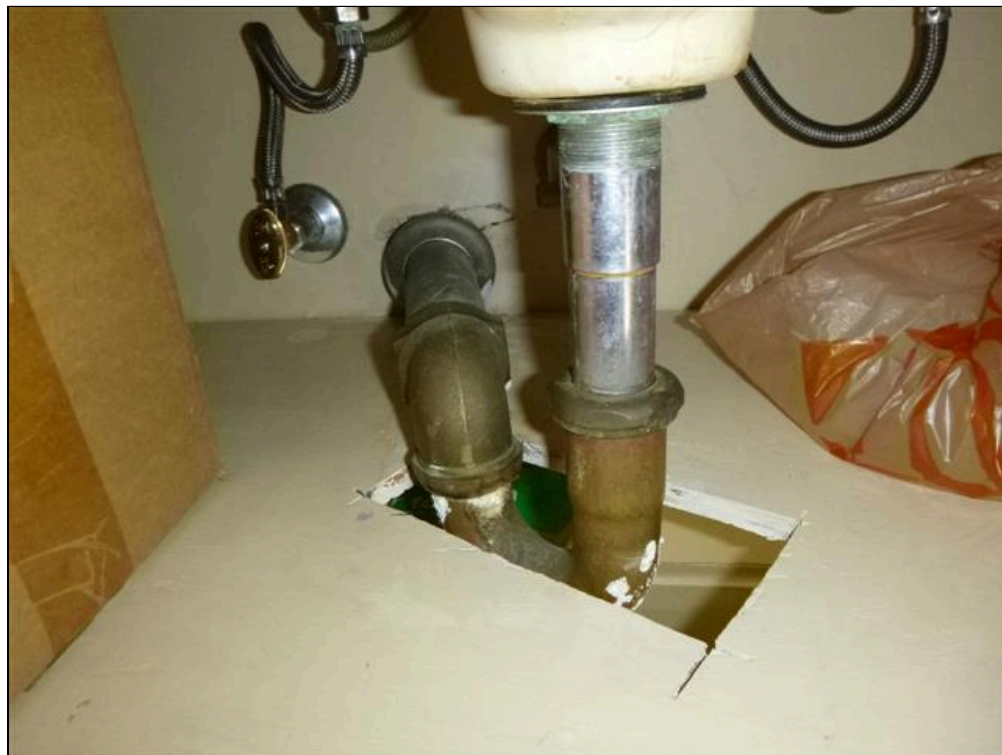
15.14 Item 1(Picture)

15.14 Corrosion/stains noted at the sink drain(s), suggest review by a licensed plumber for any repair/ replacement costs as needed.

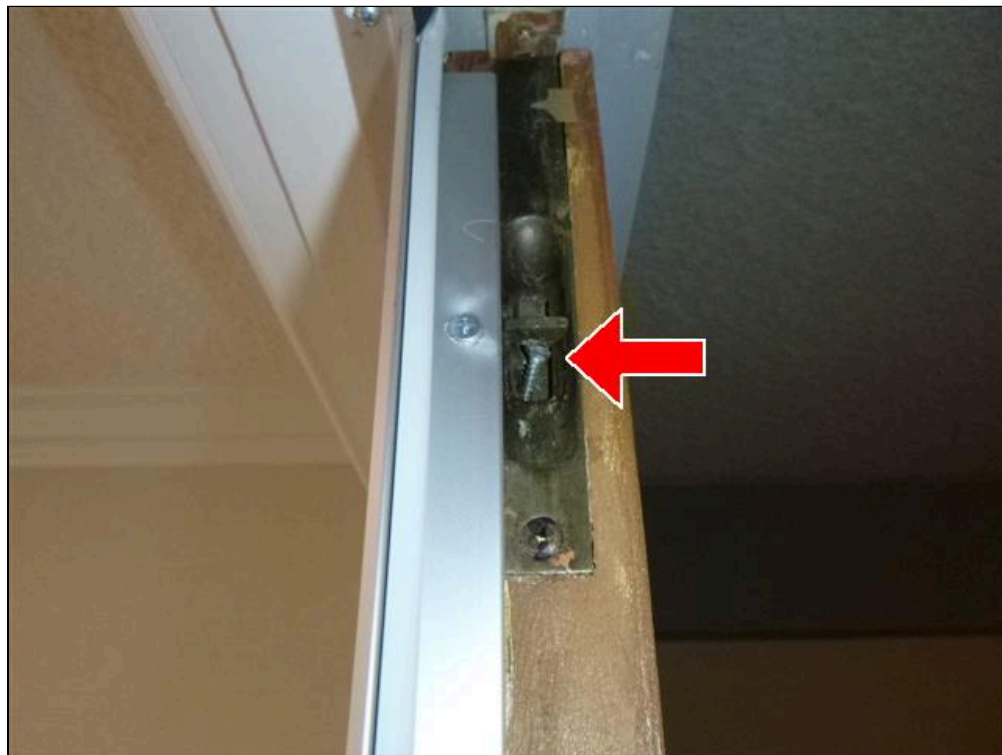
16.3 Item 1(Picture)

16.3 The secondary front door upper latch is stuck in place (due to a screw) and the lower latch was inoperable due to the threshold has not been drilled as required. Suggest review with a licensed contractor for any repair costs and confirm correct operation/locking as needed.

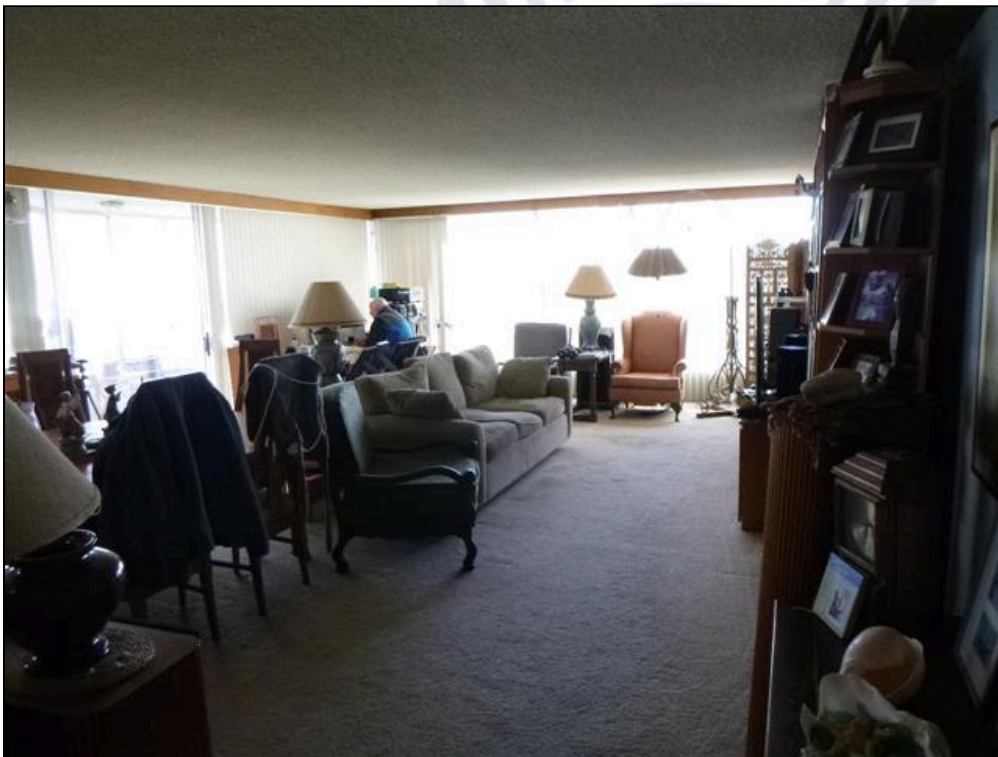
17.6 Item 1(Picture)

17.6 Access within this area was blocked or severely limited at the time of the inspection. An inspection of this area can be performed by appointment and at an additional cost when the area is made accessible.

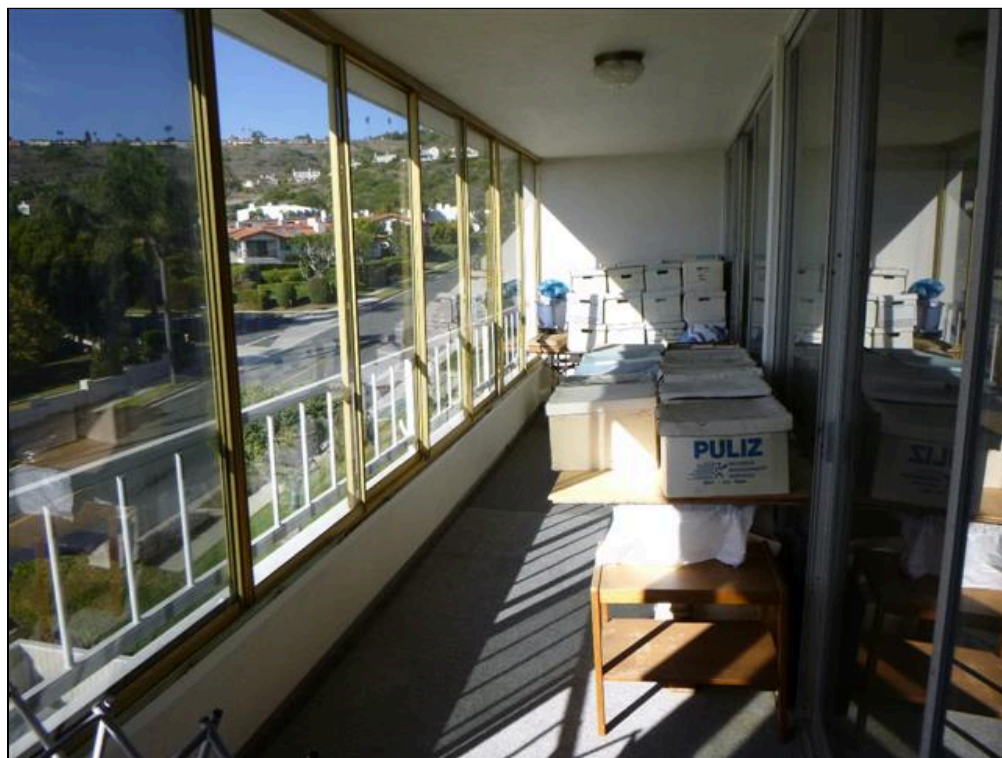
19.3 Item 1(Picture)

19.3 The inspector was unable to determine/verify if the glass sliding door(s) are tempered safety glass (no etching/labelling was visible at the doors at this area). Windows and doors with glass 18 inches off the floor/deck area and/or windows within doors should have safety glass. Suggest review with a licensed contractor for possible costs to upgrade/install safety glass/film as needed.

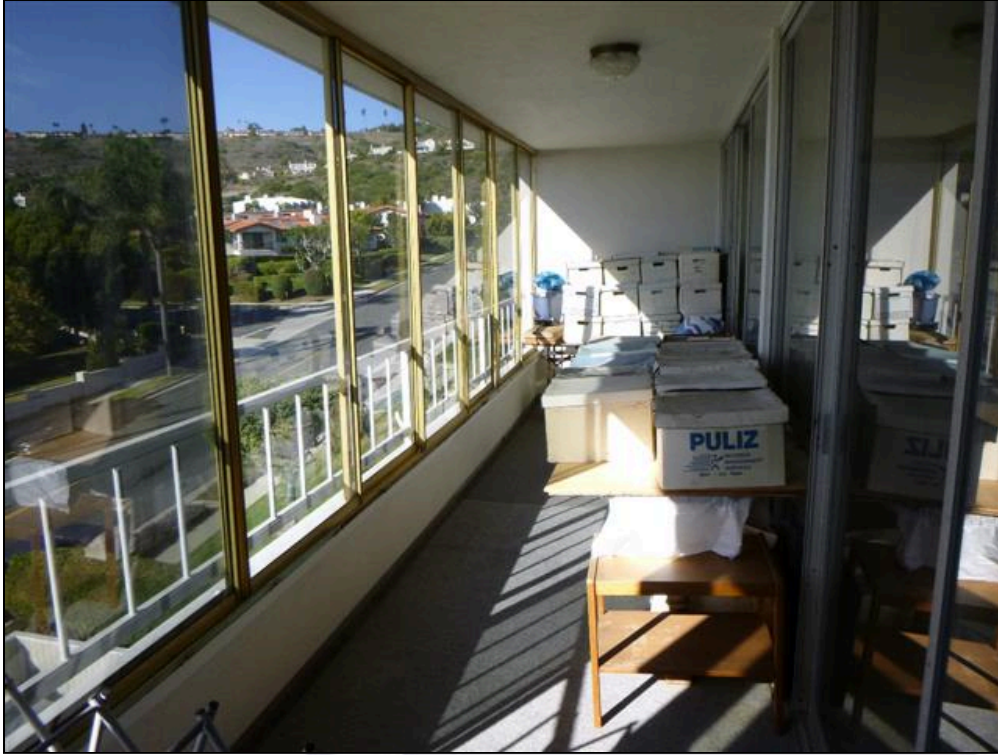
19.6 Item 1(Picture)

19.6 (1) This area/room appears to be the original patio/balcony area that has been enclosed. Suggest review with the seller/association and/or the city on this area as needed.

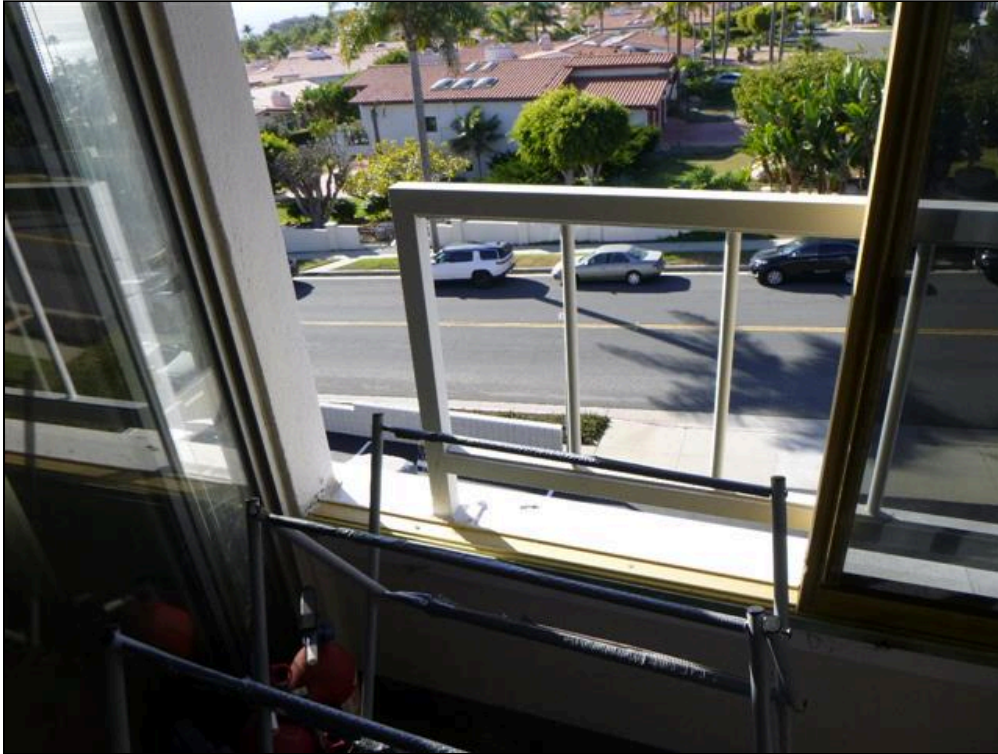
19.6 Item 2(Picture)

19.6 (2) The spacing between the guardrails/newel posts are larger than current requirements, this is a potential safety hazard for a young/small child or animal. Suggest review with the association and/or a licensed contractor for costs to reduce the spacing at the railings/newel post to enhance safety and as per current requirements as an upgrade (currently a 4" inch spacing).

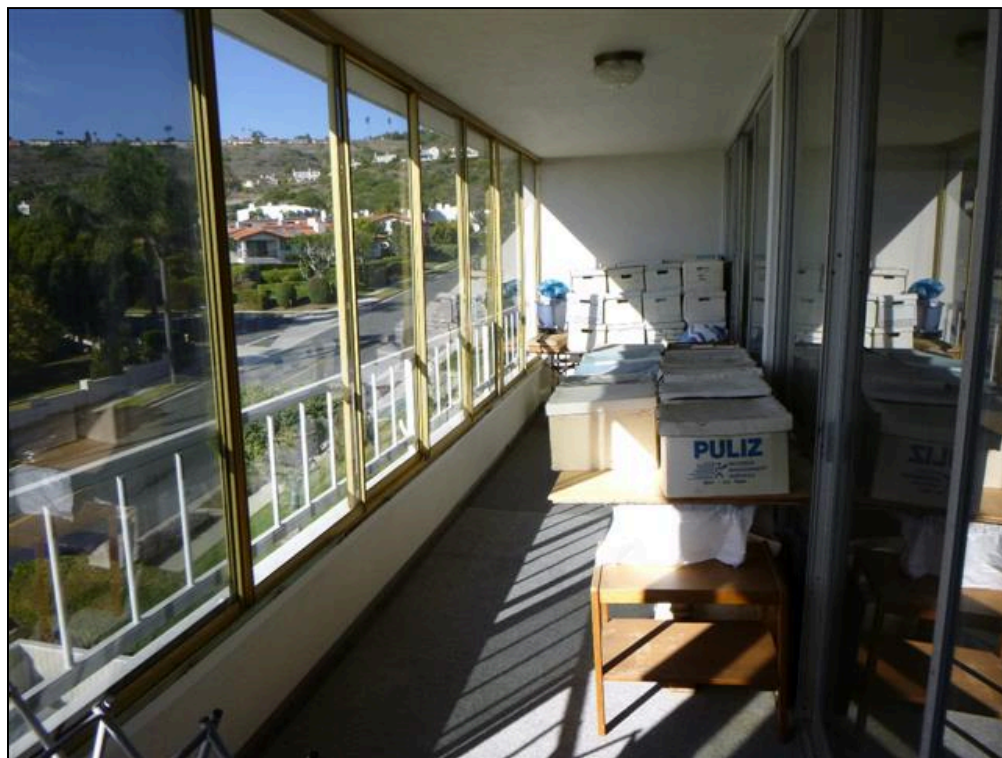
19.6 Item 3(Picture)

19.6 (3) Access within this area was blocked or severely limited at the time of the inspection. An inspection of this area can be performed by appointment and at an additional cost when the area is made accessible.
