Inspection Report

Property Address:
32646 Coastsite Dr #303/C
Rancho Palos Verdes CA 90275

Ferguson Home Inspections

Date: 12/10/2024	Time: 01:00 PM	Report ID: 12102024CoastsiteDr
Property: 32646 Coastsite Dr #303/C Rancho Palos Verdes CA 90275	Customer: Darryl Wiedmann & Jean Fuller	Real Estate Professional: John Duston

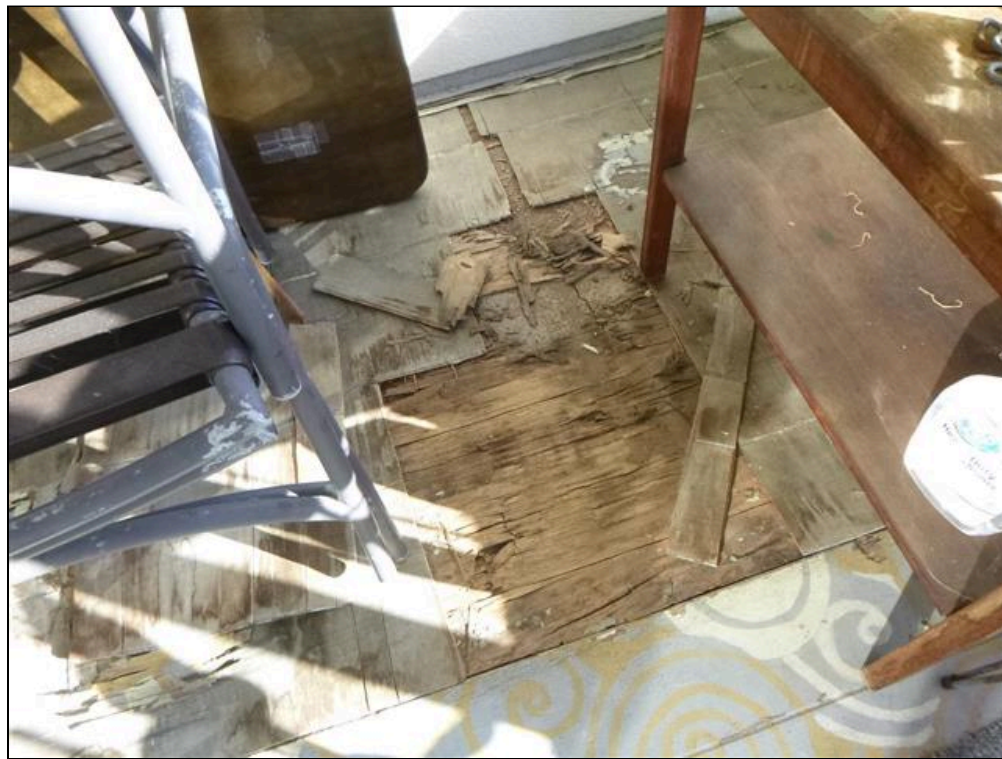
20.0 Item 1(Picture)

20.0 Excessive wood deterioration, soft areas and movement noted at this area (this is a potential safety hazard). Suggest review with the seller/association and/or a licensed contractor for any repair/removal/replacement costs as needed.

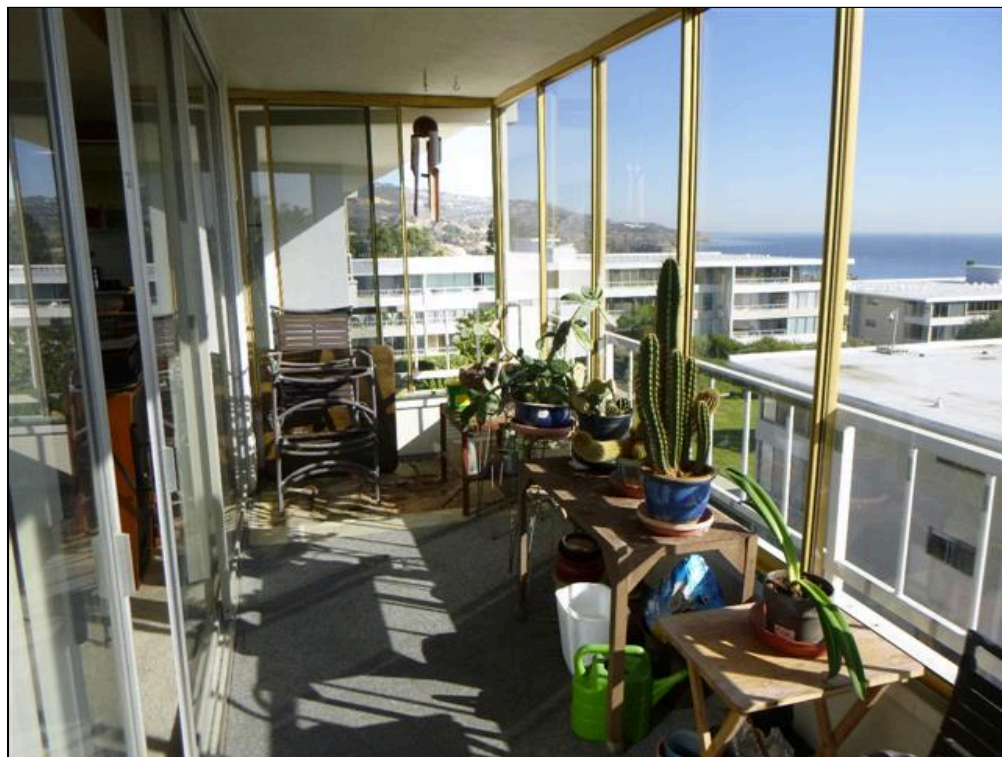
20.6 Item 1(Picture)

20.6 (1) This area/room appears to be the original patio/balcony area that has been enclosed. Suggest review with the seller/association and/or the city on this area as needed.

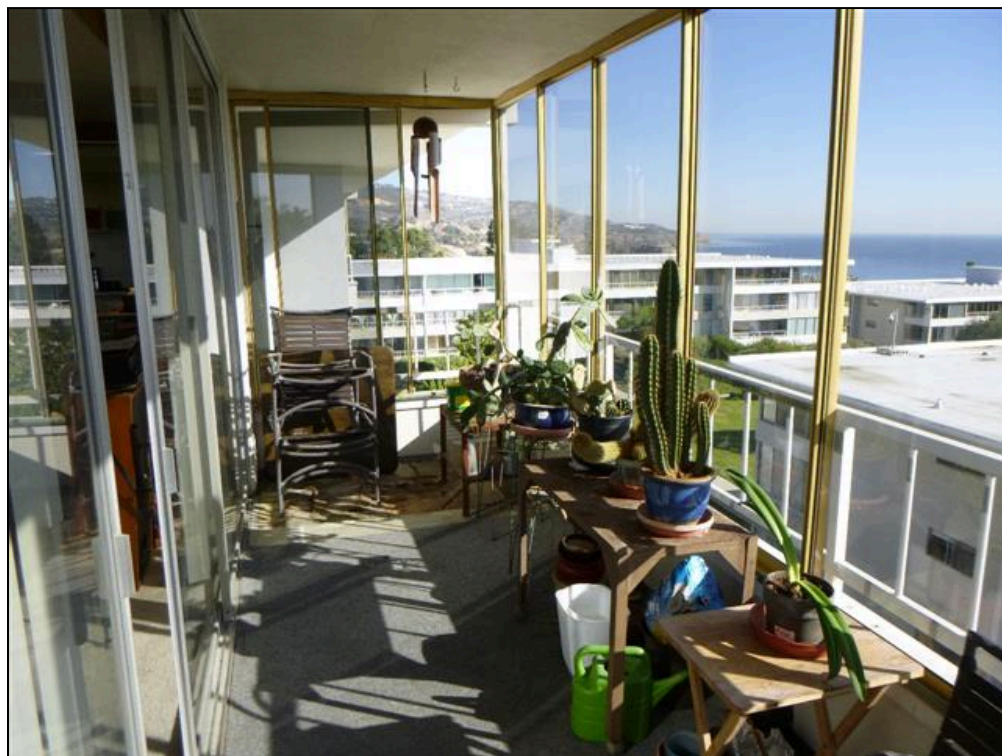
20.6 Item 2(Picture)

20.6 (2) Access within this area was blocked or severely limited at the time of the inspection. An inspection of this area can be performed by appointment and at an additional cost when the area is made accessible.

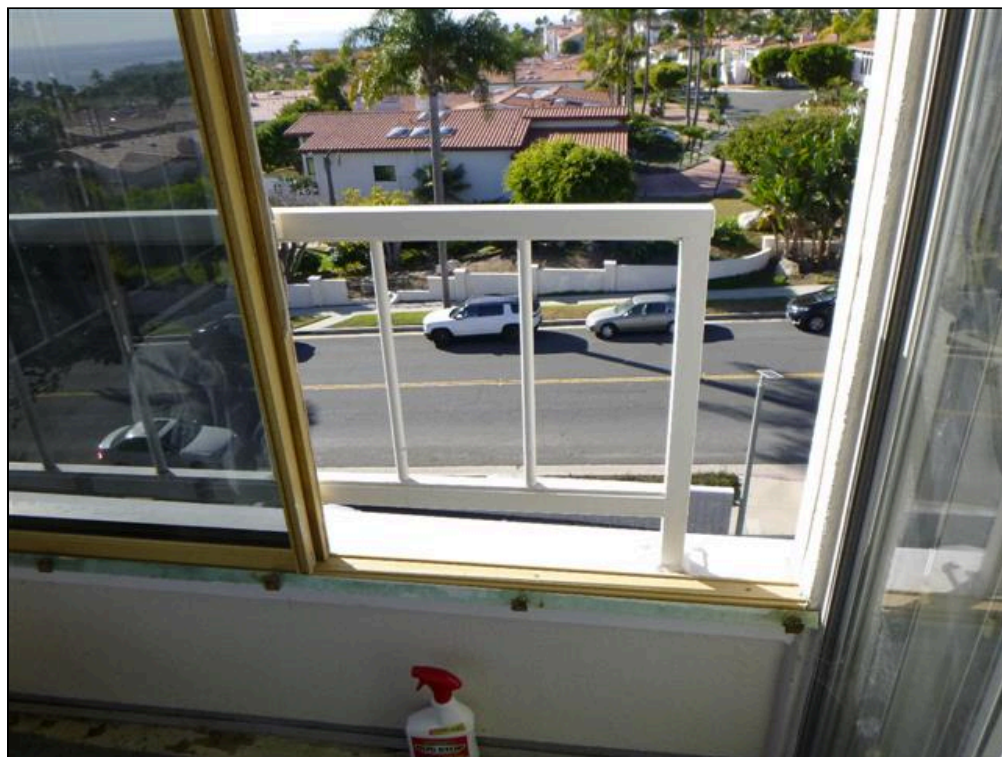
20.6 Item 3(Picture)

20.6 (3) The spacing between the guardrails/newel posts are larger than current requirements, this is a potential safety hazard for a young/small child or animal. Suggest review with the association and/or a licensed contractor for costs to reduce the spacing at the railings/newel post to enhance safety and as per current requirements as an upgrade (currently a 4" inch spacing).

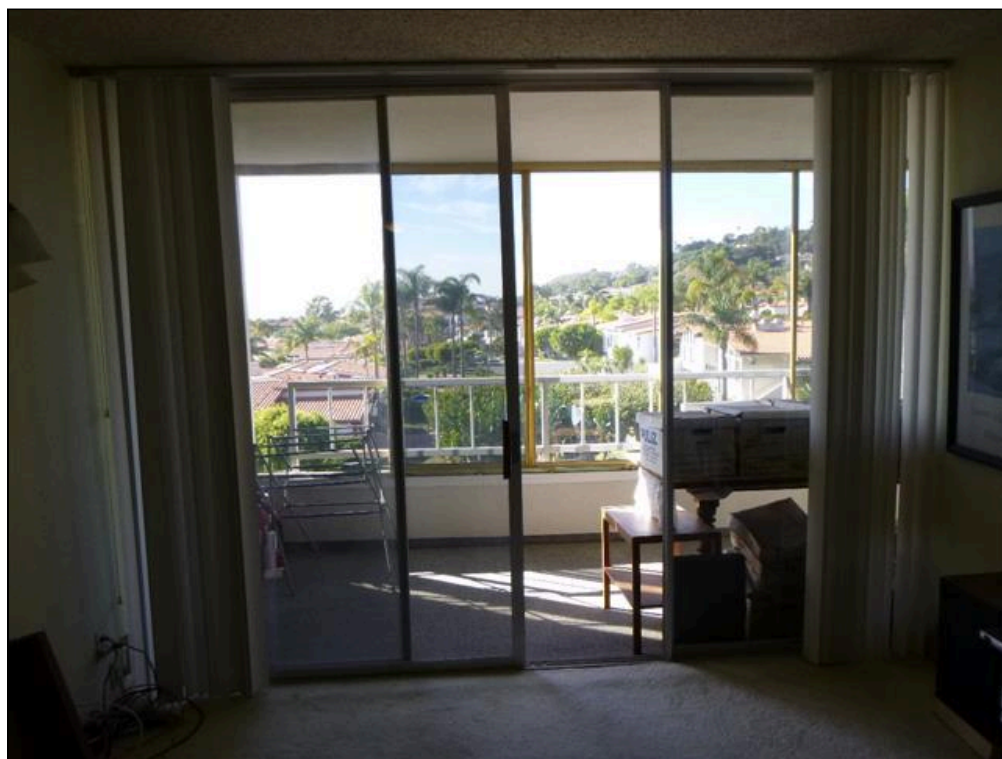
22.3 Item 1(Picture)

22.3 (2) The inspector was unable to determine/verify if the glass sliding door(s) are tempered safety glass (no etching/labelling was visible at the doors at this area). Windows and doors with glass 18 inches off the floor/deck area and/or windows within doors should have safety glass. Suggest review with a licensed contractor for possible costs to upgrade/install safety glass/film as needed.

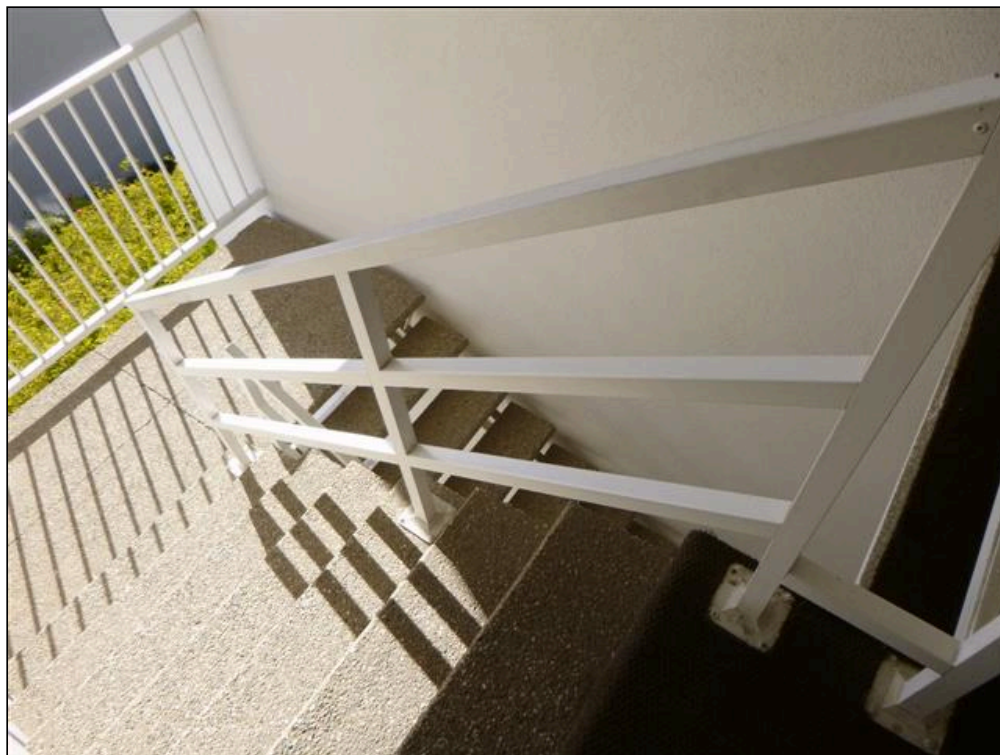
1.1 Item 1(Picture)

The spacing between the guardrails/newel posts are larger than current requirements, this is a potential safety hazard for a young/small child or animal. Suggest review with the association and/or a licensed contractor for costs to reduce the spacing at the railings/newel post to enhance safety and as per current requirements as an upgrade (currently a 4" inch spacing).

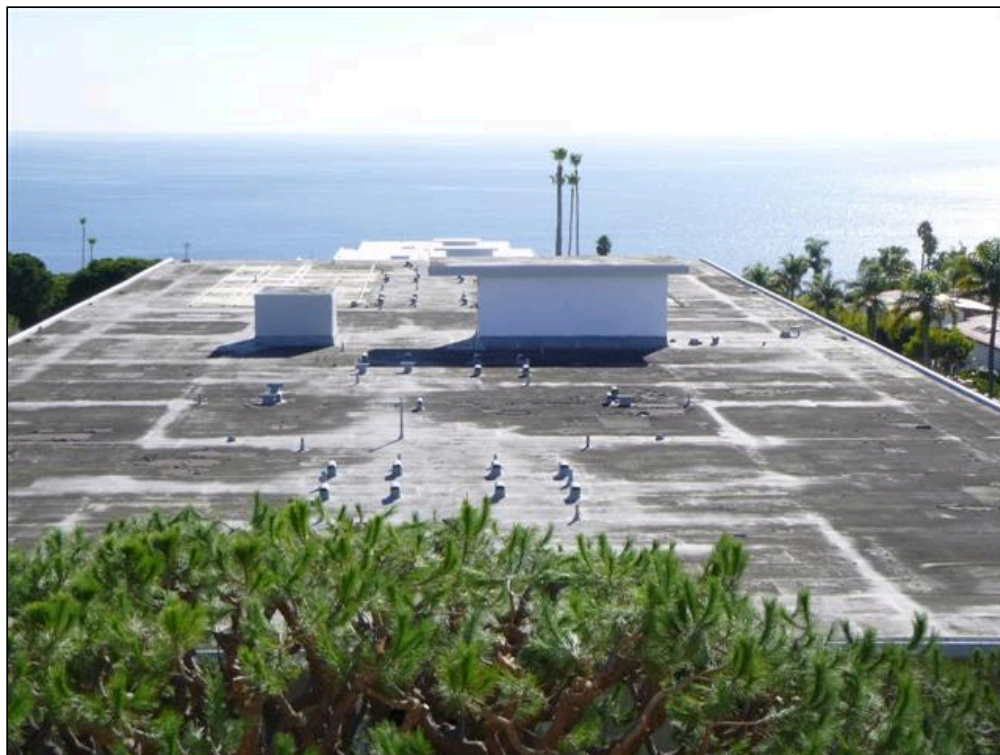
4.0 Item 1(Picture)

The roof coverings are old and deteriorated and are nearing the end of its useful life and the covering will need to be replaced. While it could last a year or so, some areas may need patching/repairs as leaks develop. Please review with the association and/or a licensed roofer to determine the remaining life expectancy and for costs to repair/remove and replace the existing roofing material as needed.

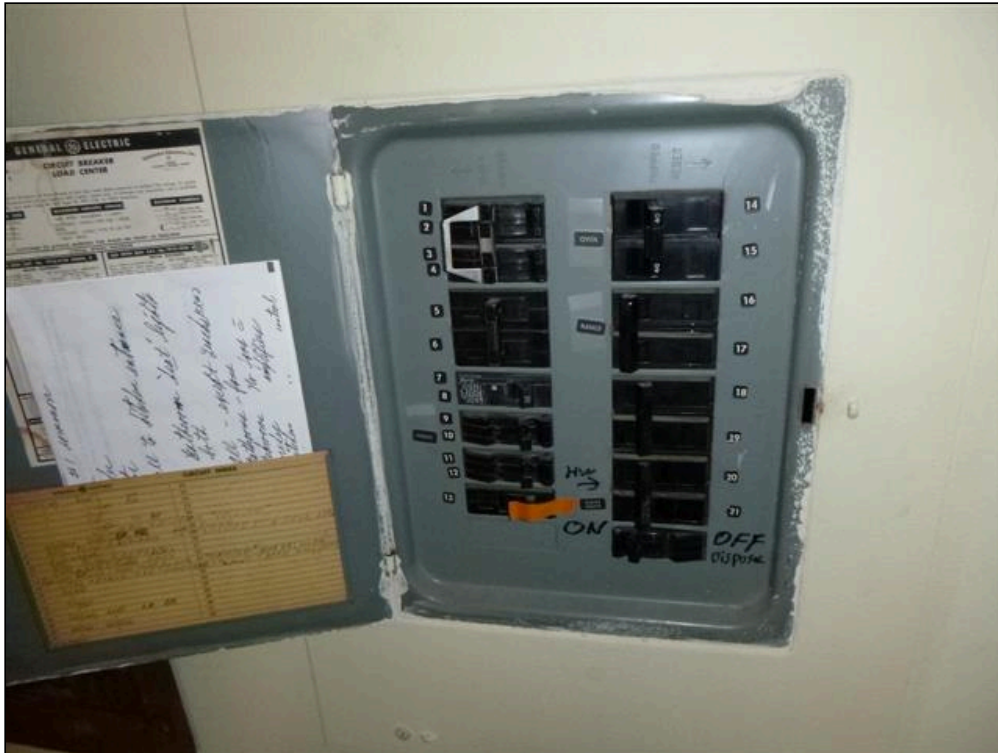
9.1 Item 1(Picture)

(1) Suggest adding correct/complete indexing/labelling to all breakers for identification of each circuit for safety.

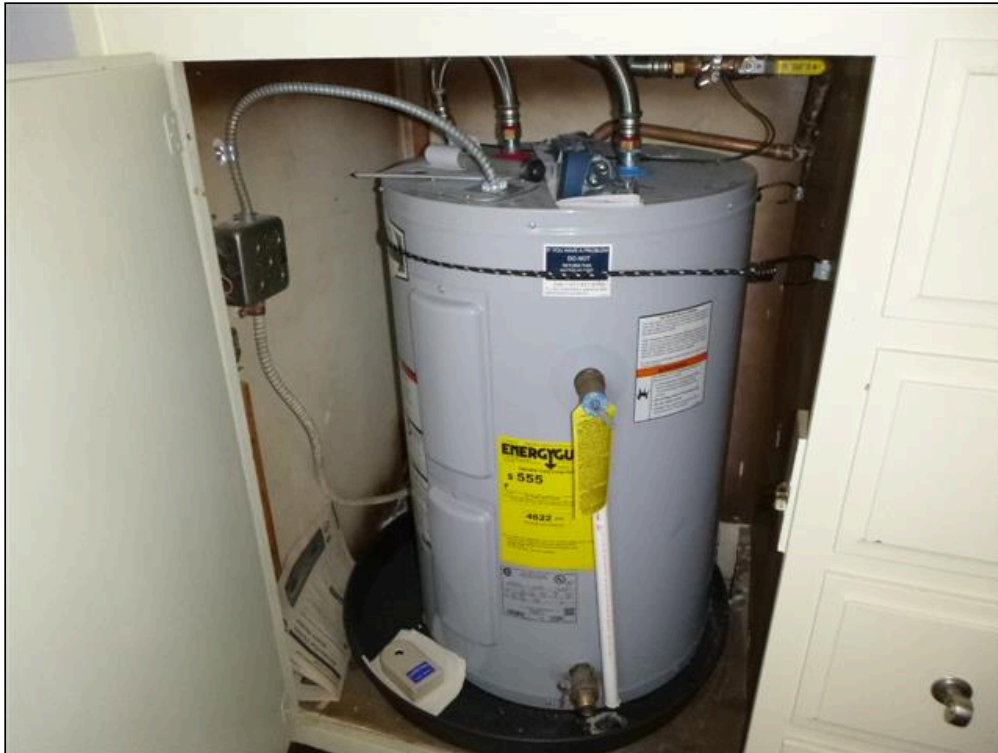
12.0 Item 2(Picture)

(3) No earthquake seismic straps are installed at the water heater as required. Suggest installation of two seismic straps as required by the State of California for safety.

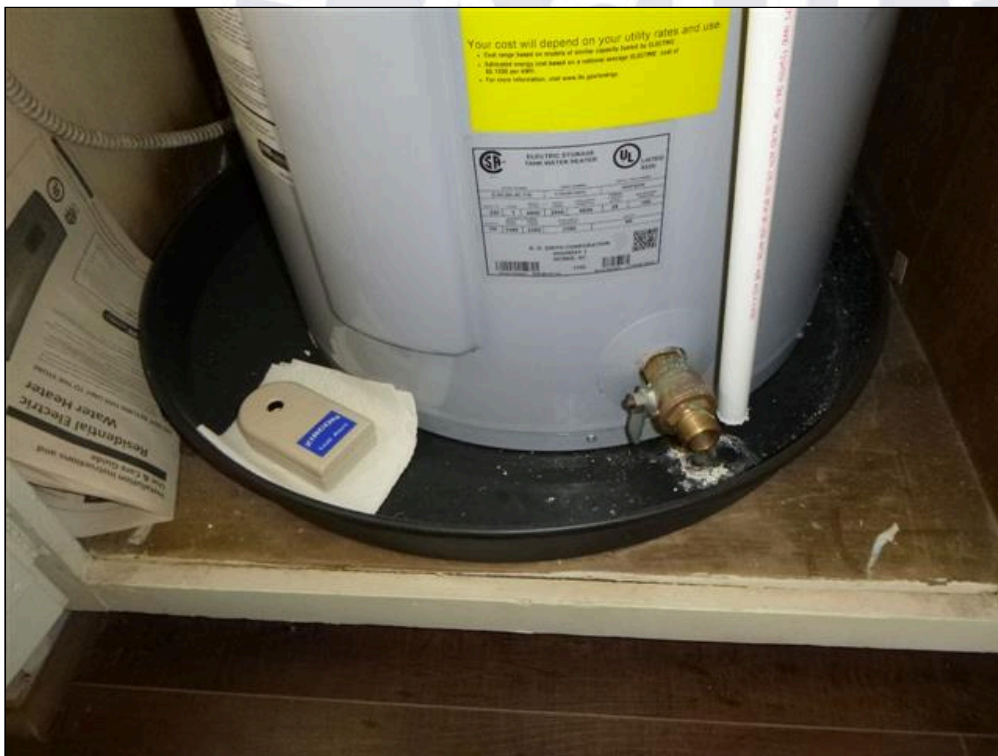
12.0 Item 3(Picture)

(4) A spill pan is currently installed under the water heater but the inspector was unable to visually confirm any drainage connection to the exterior at the time of the inspection. Suggest review with the seller and/or a licensed plumber for confirmation as needed

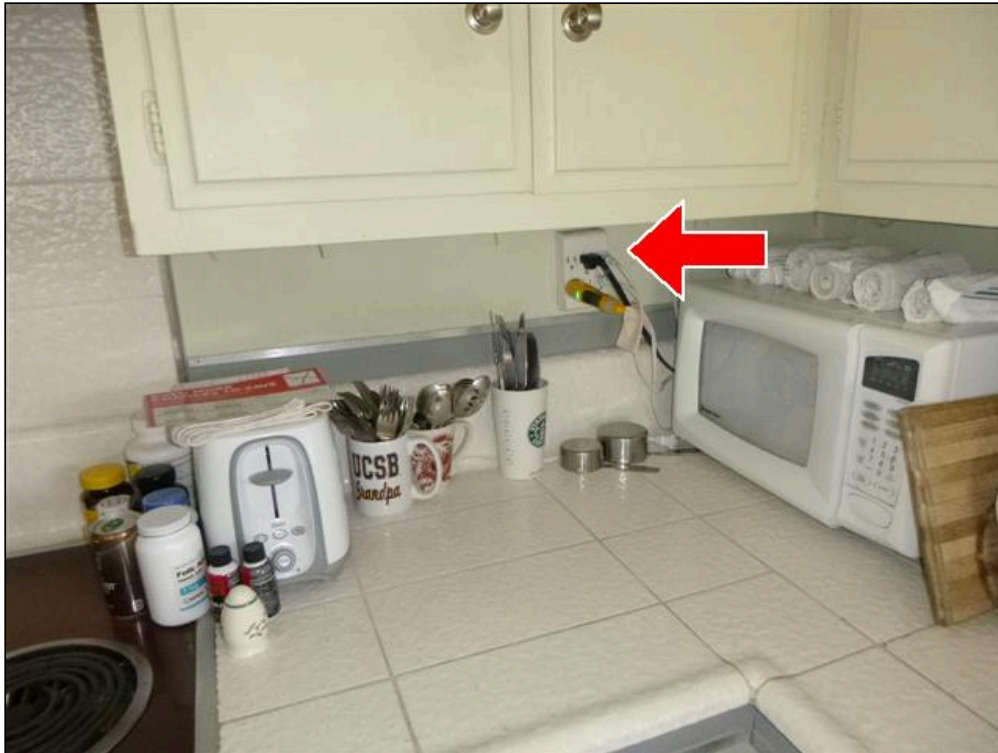
13.7 Item 1(Picture)

(1) Various light fixtures were inoperable, possible bulbs out and/or a faulty fixture. Suggest review with a licensed electrician for any repair/replacement costs and confirm correct operation as needed.
(2) Various countertop outlets are not GFCI protected as required. Countertop GFCI outlet(s)/protection has been required within six feet of the sink since 1987 and all countertop outlets since 1996. Suggest review by a licensed electrician for installation costs as required for safety.

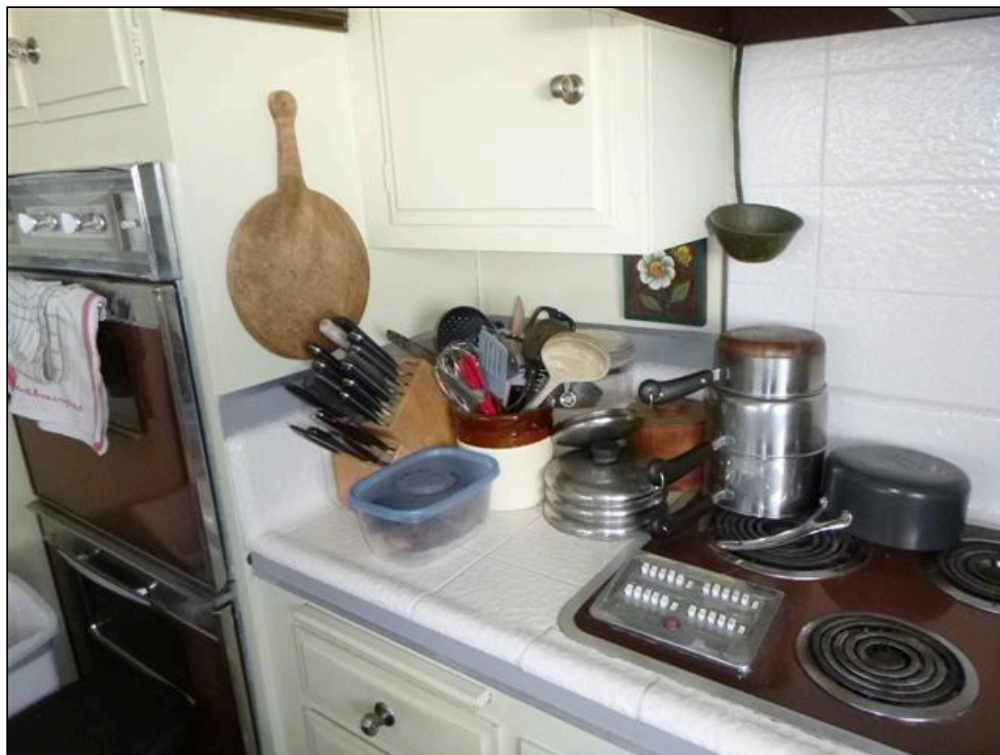
13.7 Item 3(Picture)

13.7 (3) Inadequate/incorrectly installed countertop/appliance outlets/circuits were noted, suggest review with a licensed electrician for installation costs as needed/required.

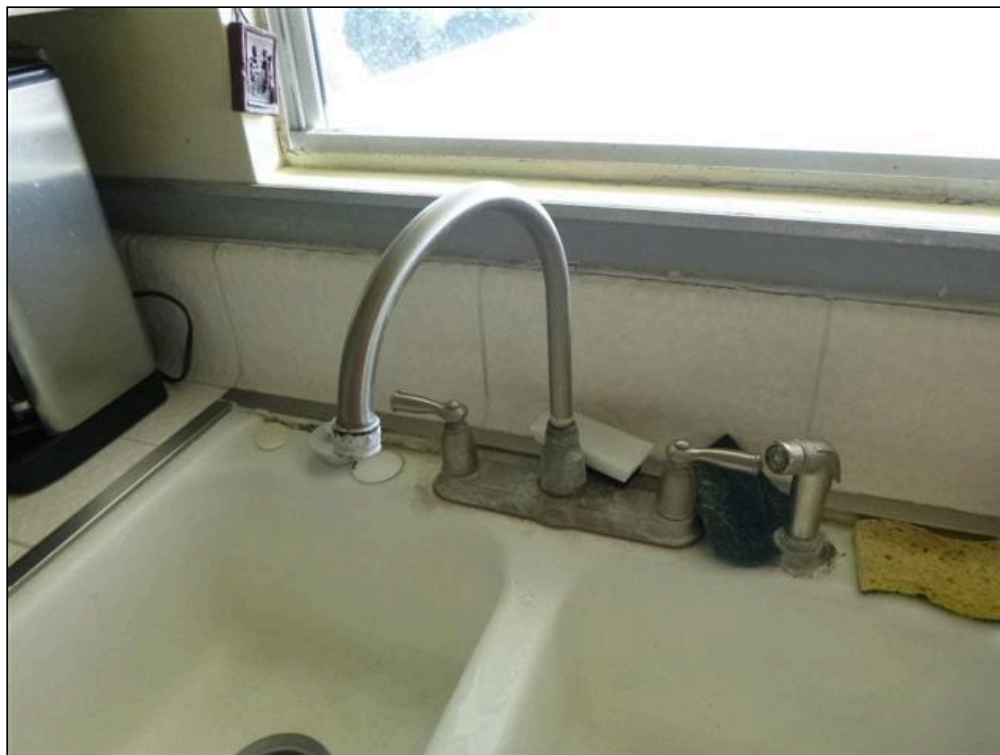
13.9 Item 1(Picture)

The sink faucet leaks, suggest repair/replace as needed to prevent future and further leaking water from damaging the cabinet base and surrounding areas.

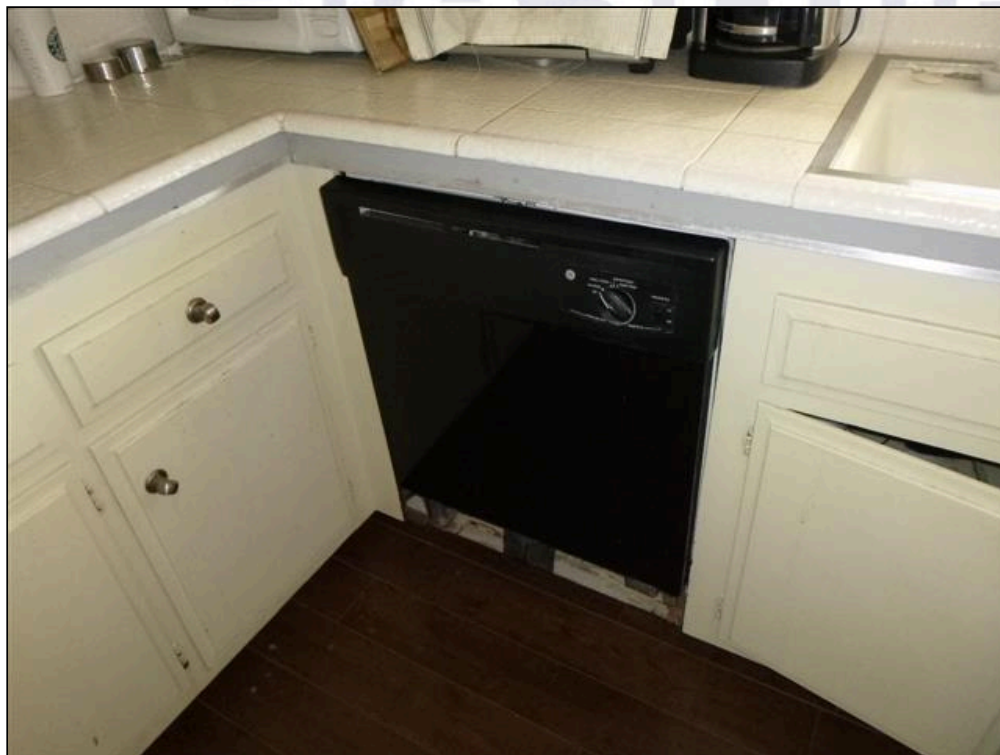
13.11 Item 1(Picture)

(1) The dishwasher was inoperable at the time of the inspection. Suggest review with a licensed appliance company for repair/replacement costs and confirm correct operation as needed.

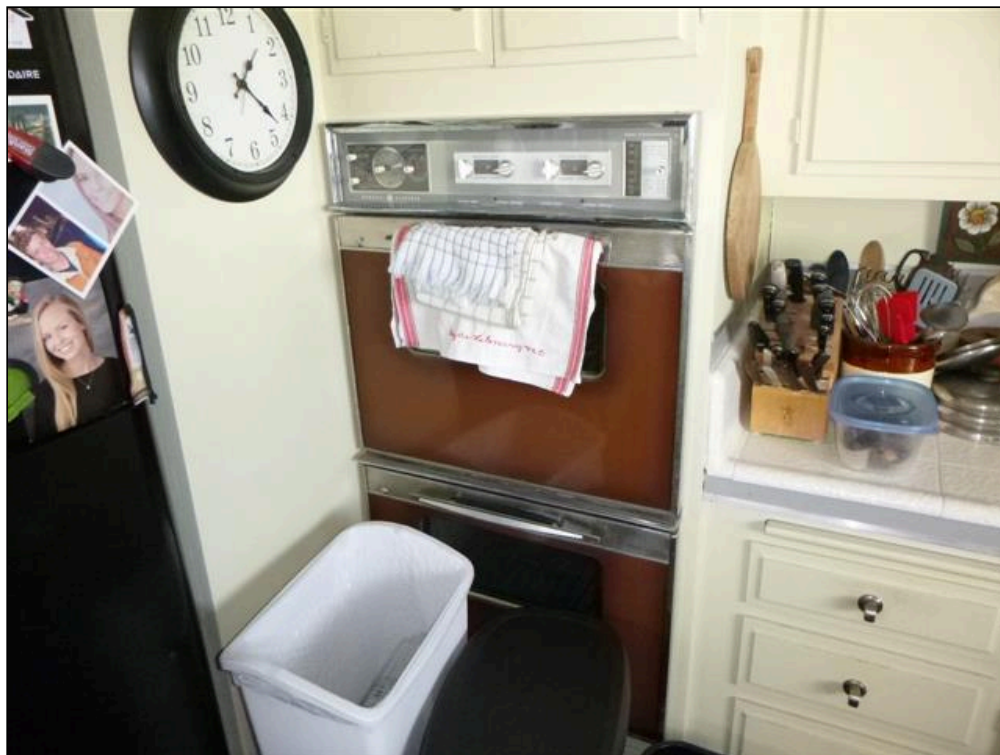
13.13 Item 1(Picture)

The oven system was inoperable at the time of the inspection. Suggest review with the seller and/or a licensed contractor for repair/replacement costs and confirm correct operation as needed.

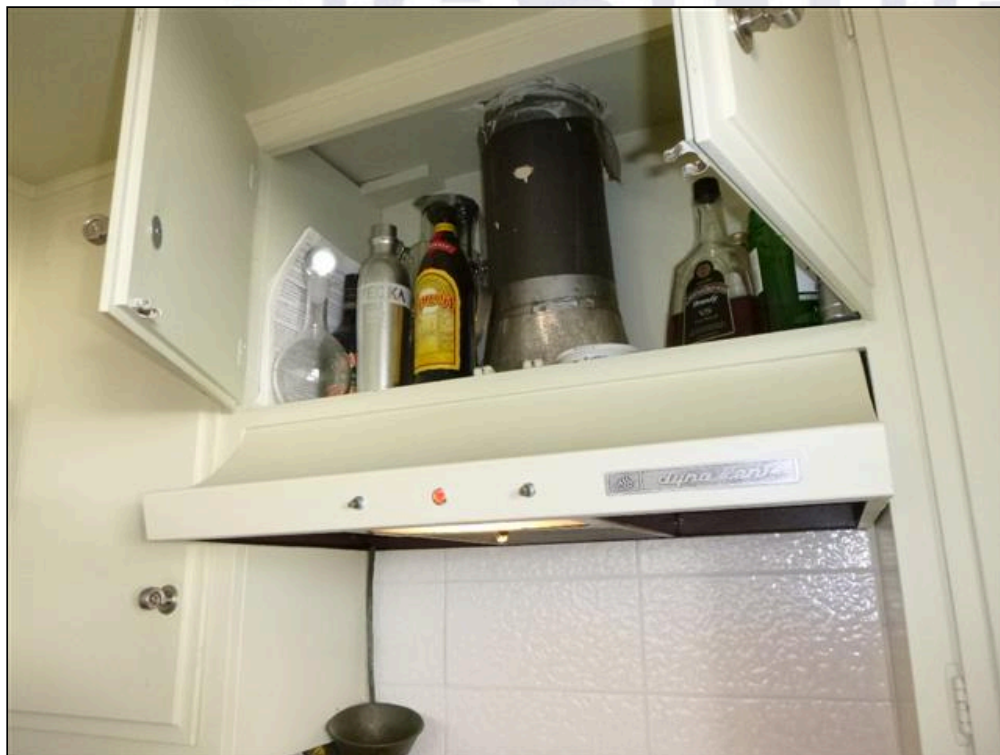
13.14 Item 1(Picture)

The range/hood vent is inoperable at the time of the inspection, suggest review with a licensed contractor and repair/replace as required for safety.

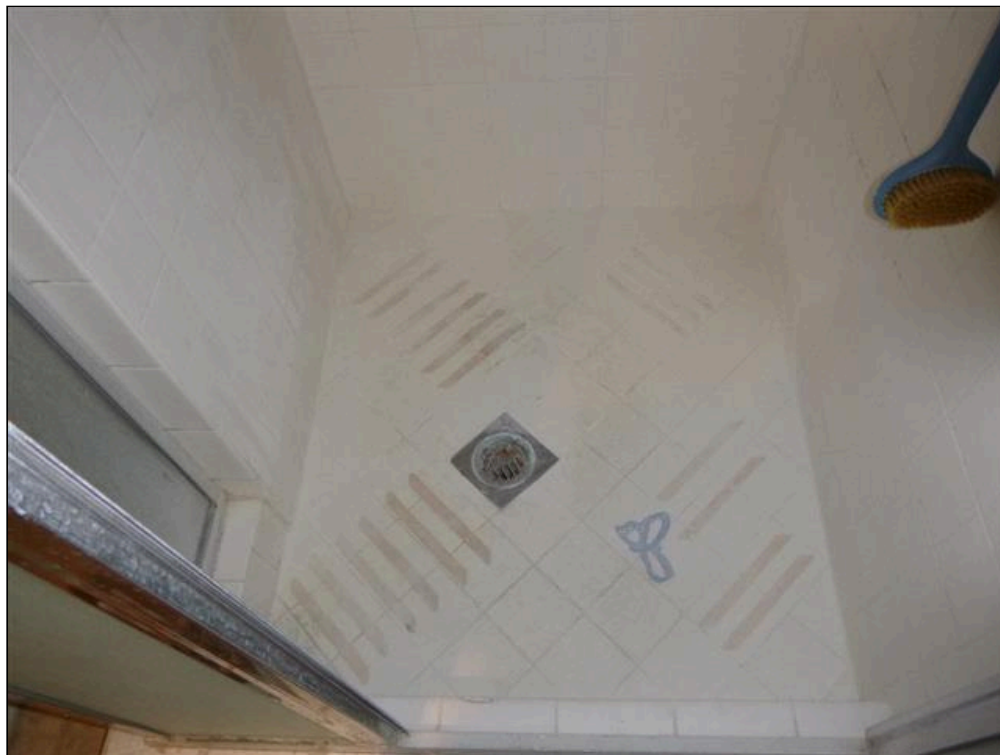
14.7 Item 1(Picture)

Worn/missing grout noted at the shower base tiles, suggest maintenance/repair/replace as needed.

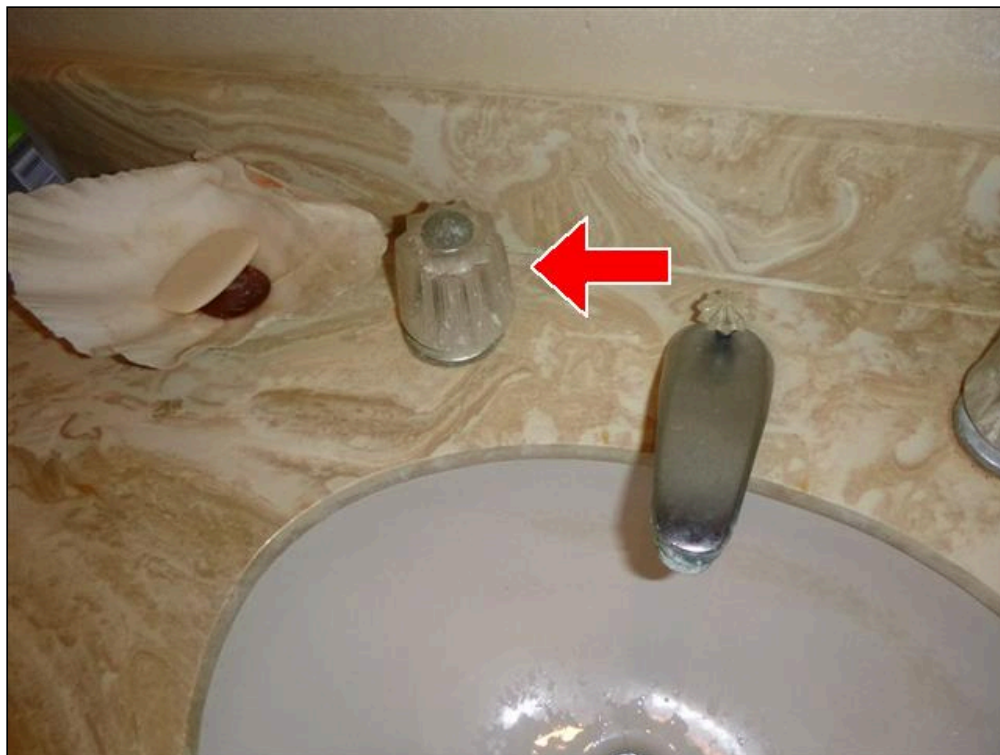
14.11 Item 1(Picture)

The hot side sink faucet is inoperable, suggest review by a licensed plumber and repair/replace as needed.

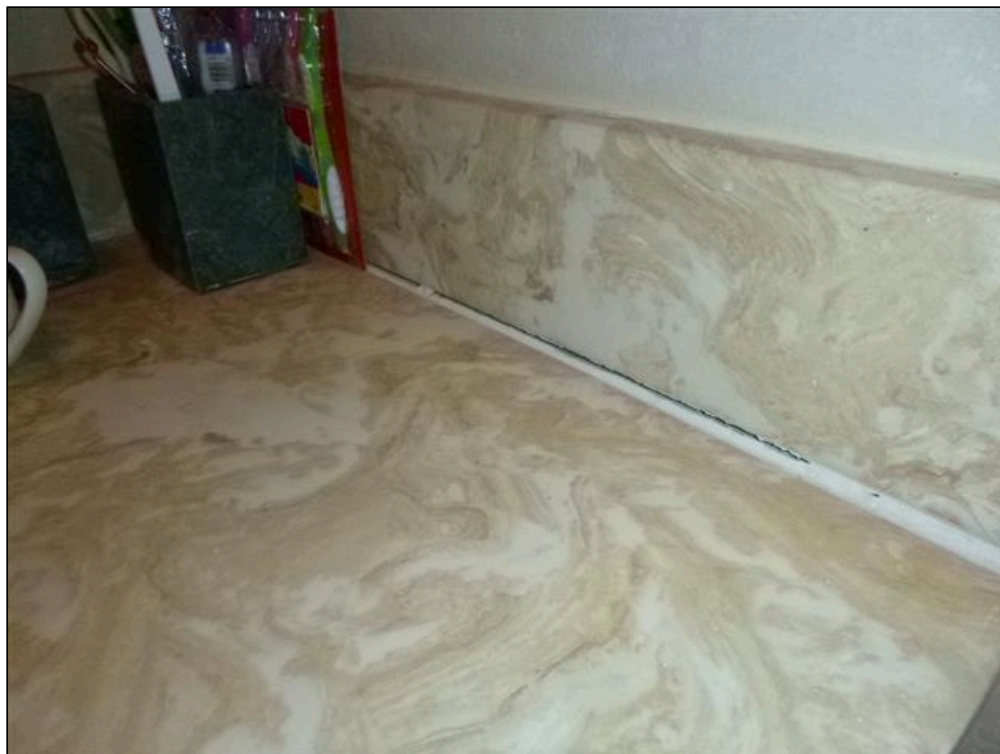
14.14 Item 1(Picture)

Suggest caulking/grouting at countertop to backsplash to prevent any future water intrusion.

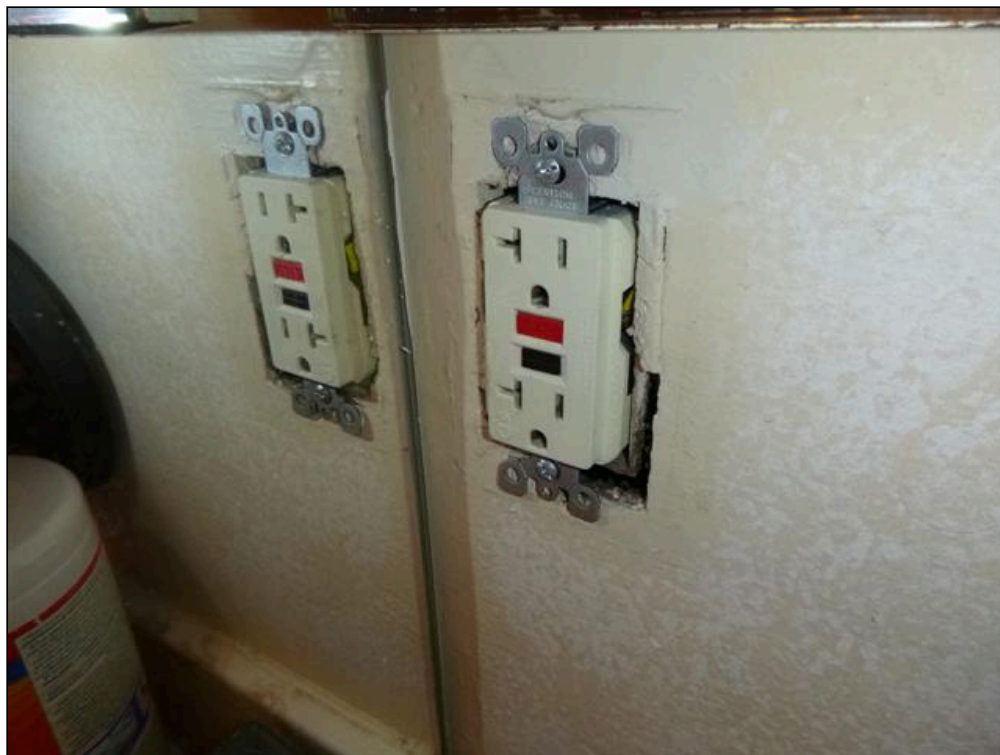
15.4 Item 1(Picture)

(2) The outlet cover(s) are missing at various areas. Suggest installation for safety.

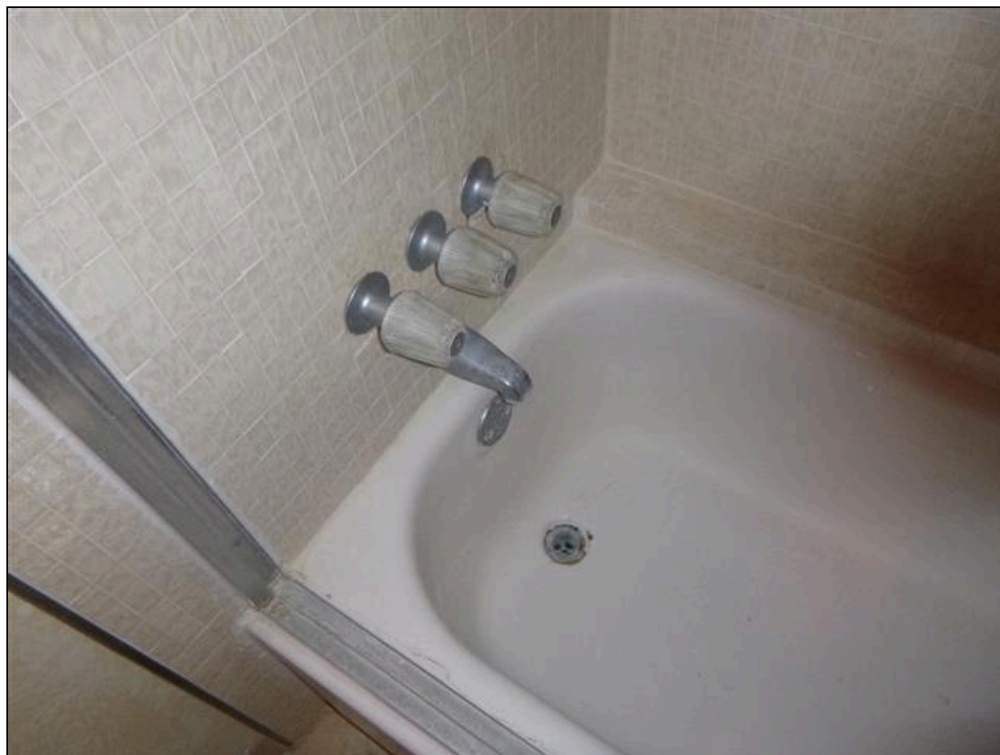
15.8 Item 1(Picture)

The tub/shower faucet area was not tested as per the tenant due to active leakage to the unit below. Suggest review with the seller and/or a licensed plumber/contractor for any repair/removal/replacement costs as needed.

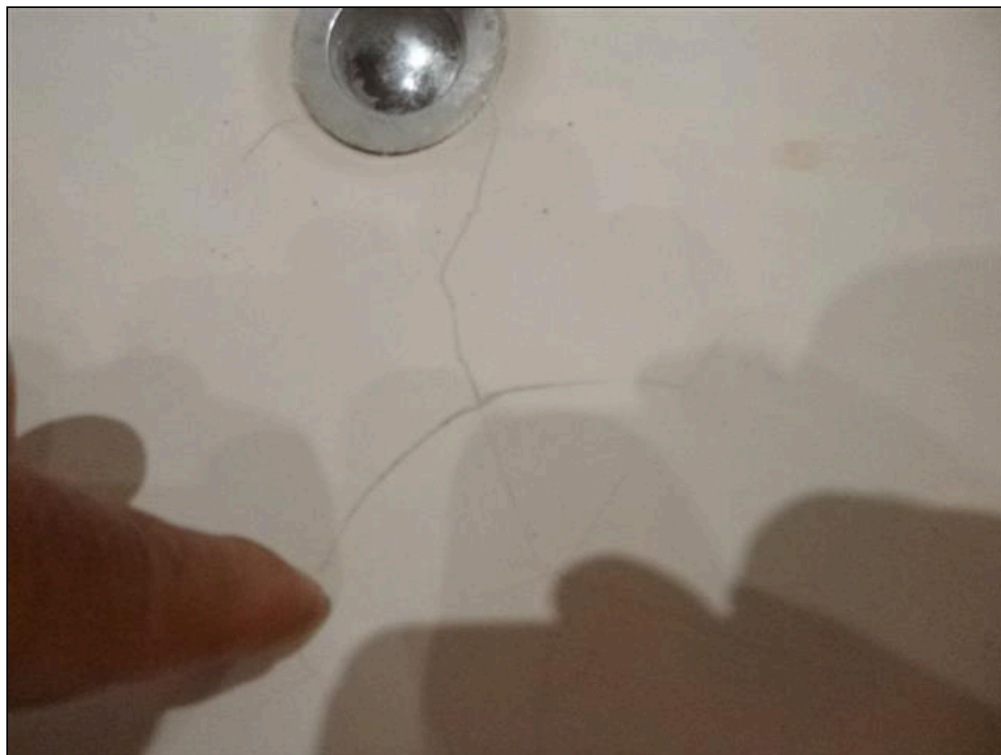
15.12 Item 1(Picture)

(1) Hairline surface cracks noted at the sink, suggest repair/replace as needed.

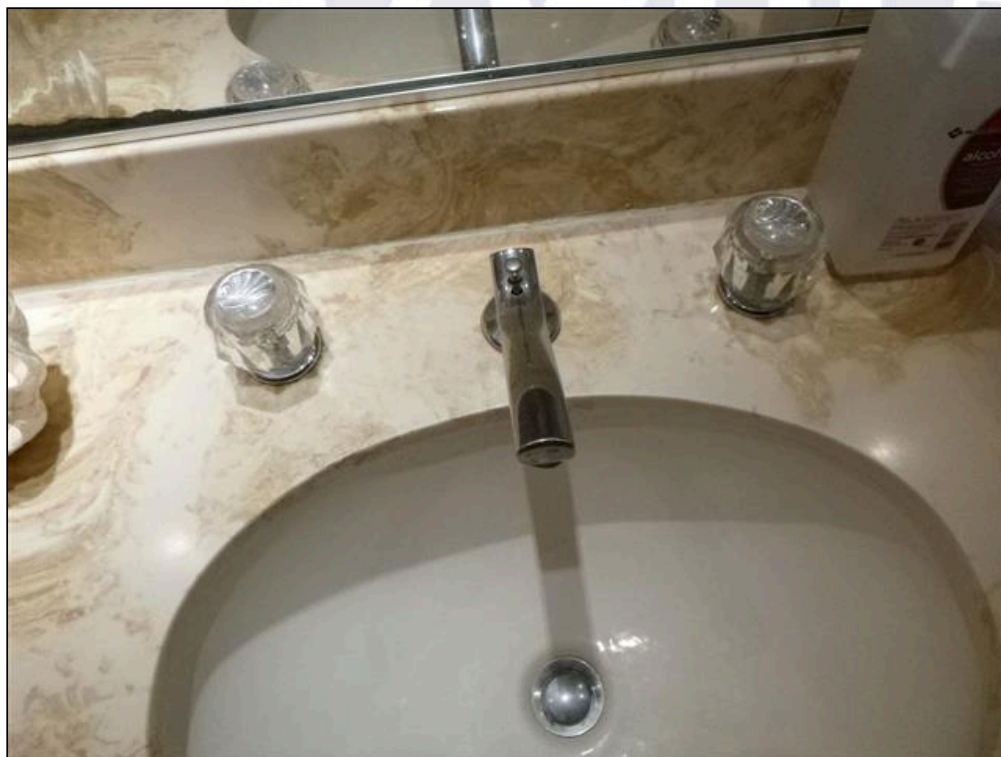
15.13 Item 1(Picture)

Unable to test the sink faucets at this area as the water was turned off. Suggest review with seller and/or a licensed plumber for any repair/replacement costs as needed.

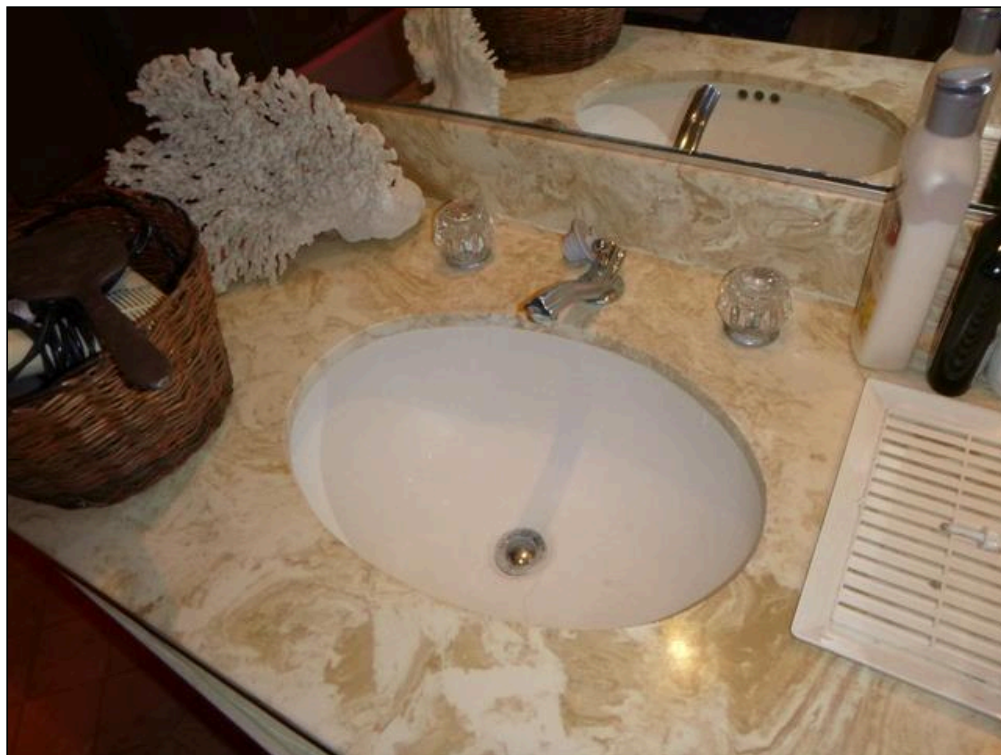
15.13 Item 2(Picture)

15.13 Unable to test the sink faucets at this area as the water was turned off. Suggest review with seller and/or a licensed plumber for any repair/replacement costs as needed.

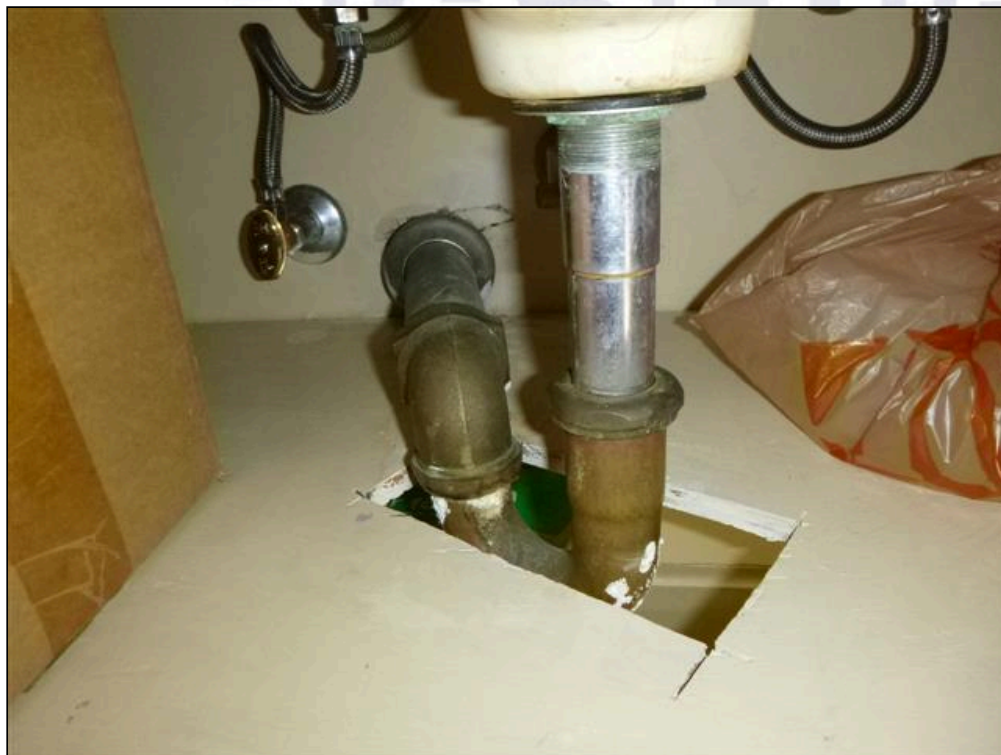
15.14 Item 1(Picture)

Corrosion/stains noted at the sink drain(s), suggest review by a licensed plumber for any repair/ replacement costs as needed.

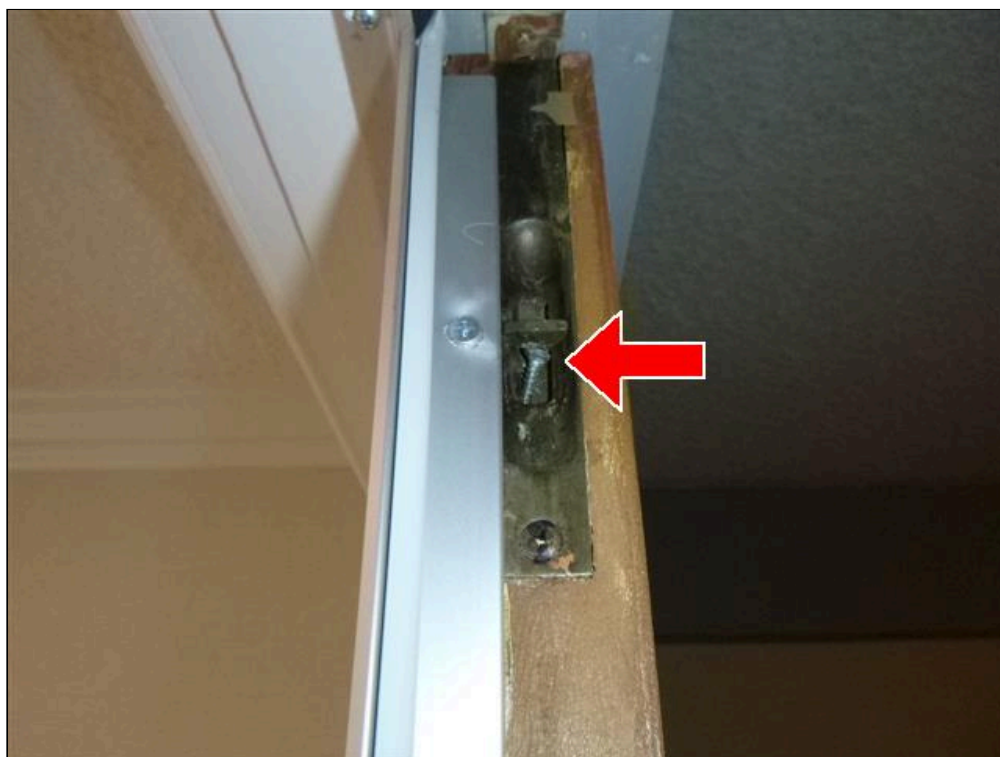
16.3 Item 1(Picture)

The secondary front door upper latch is stuck in place (due to a screw) and the lower latch was inoperable due to the threshold has not been drilled as required. Suggest review with a licensed contractor for any repair costs and confirm correct operation/locking as needed.

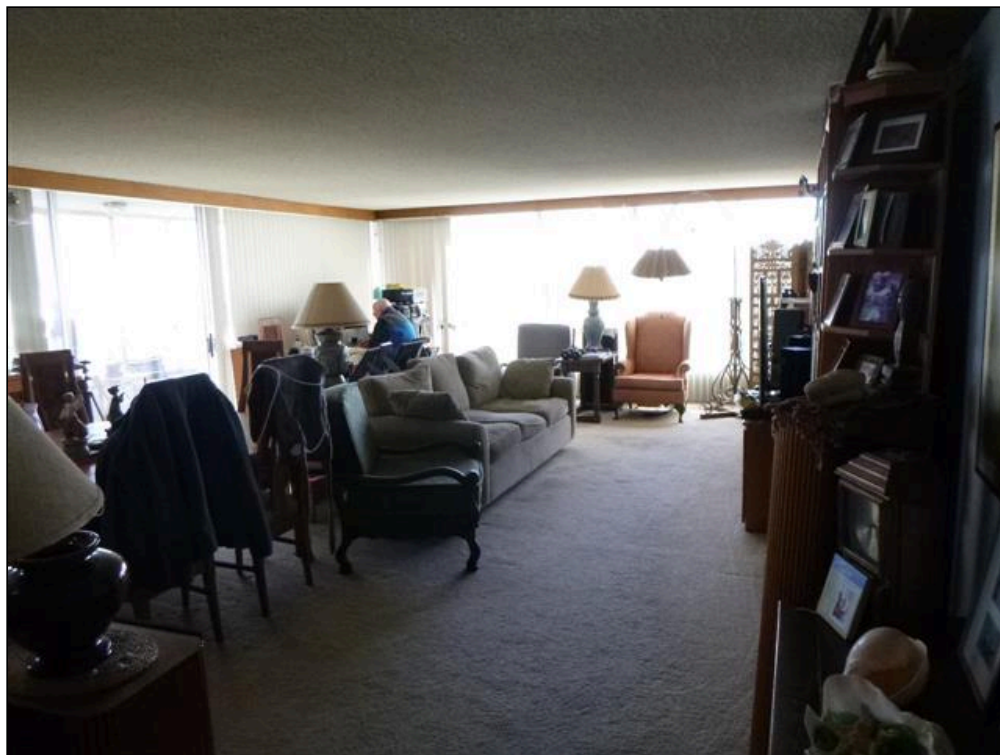
17.6 Item 1(Picture)

Access within this area was blocked or severely limited at the time of the inspection. An inspection of this area can be performed by appointment and at an additional cost when the area is made accessible.

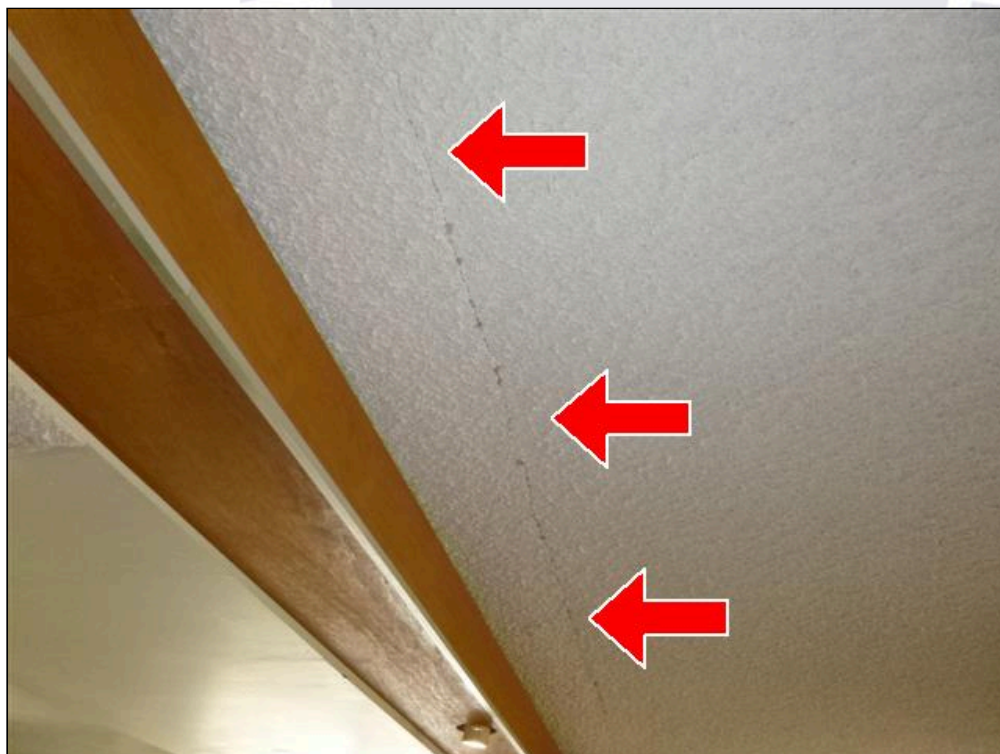
18.2 Item 1(Picture)

Settling cracks and patching noted, suggest repair as needed.
