Inspection Report

Property Address:
32646 Coastsite Dr #303/C
Rancho Palos Verdes CA 90275

Ferguson Home Inspections

Date: 12/10/2024	Time: 01:00 PM	Report ID: 12102024CoastsiteDr
Property: 32646 Coastsite Dr #303/C Rancho Palos Verdes CA 90275	Customer: Darryl Wiedmann & Jean Fuller	Real Estate Professional: John Duston

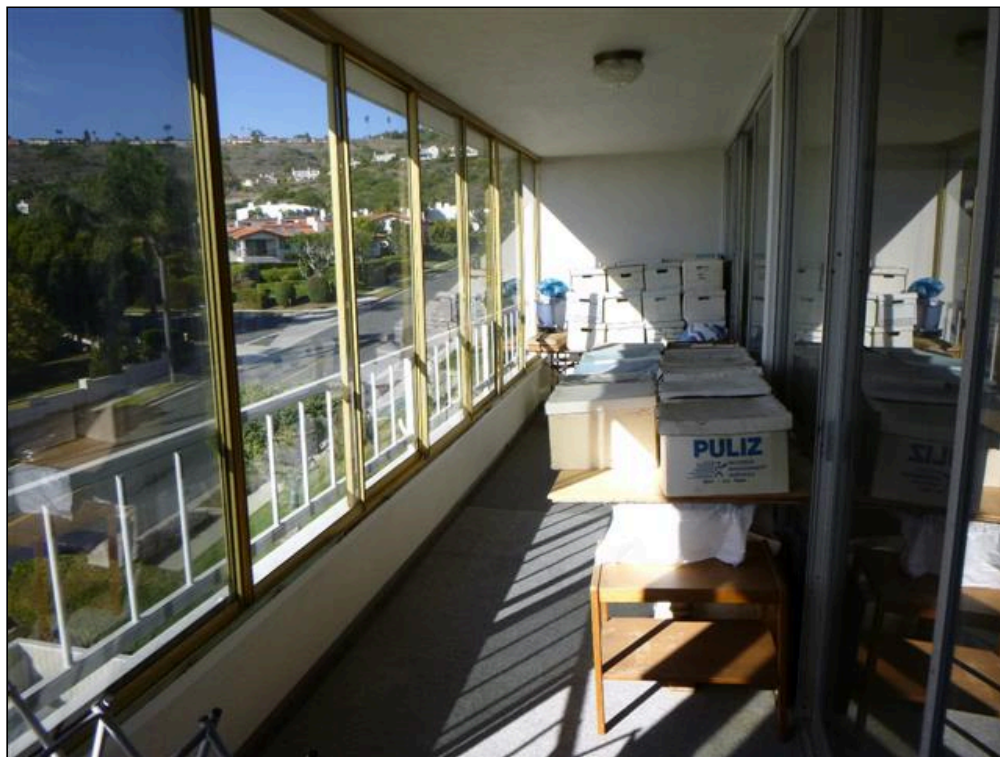
19.3 Item 1(Picture)

The inspector was unable to determine/verify if the glass sliding door(s) are tempered safety glass (no etching/labelling was visible at the doors at this area). Windows and doors with glass 18 inches off the floor/deck area and/or windows within doors should have safety glass. Suggest review with a licensed contractor for possible costs to upgrade/install safety glass/film as needed.

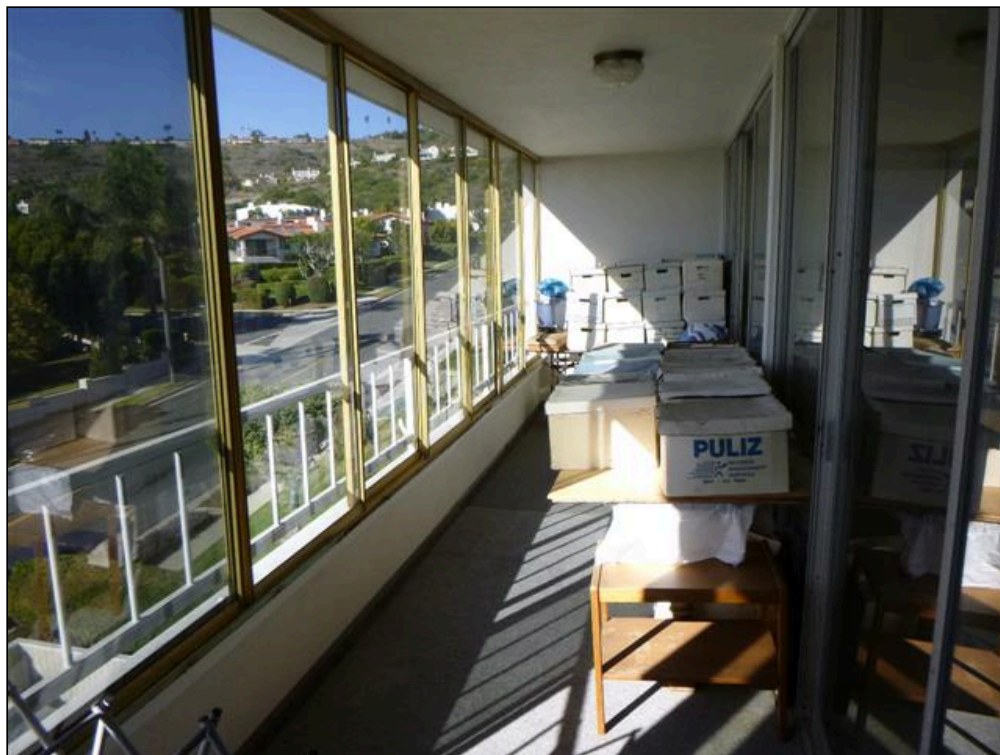
19.6 Item 1(Picture)

(1) This area/room appears to be the original patio/balcony area that has been enclosed. Suggest review with the seller/association and/or the city on this area as needed.

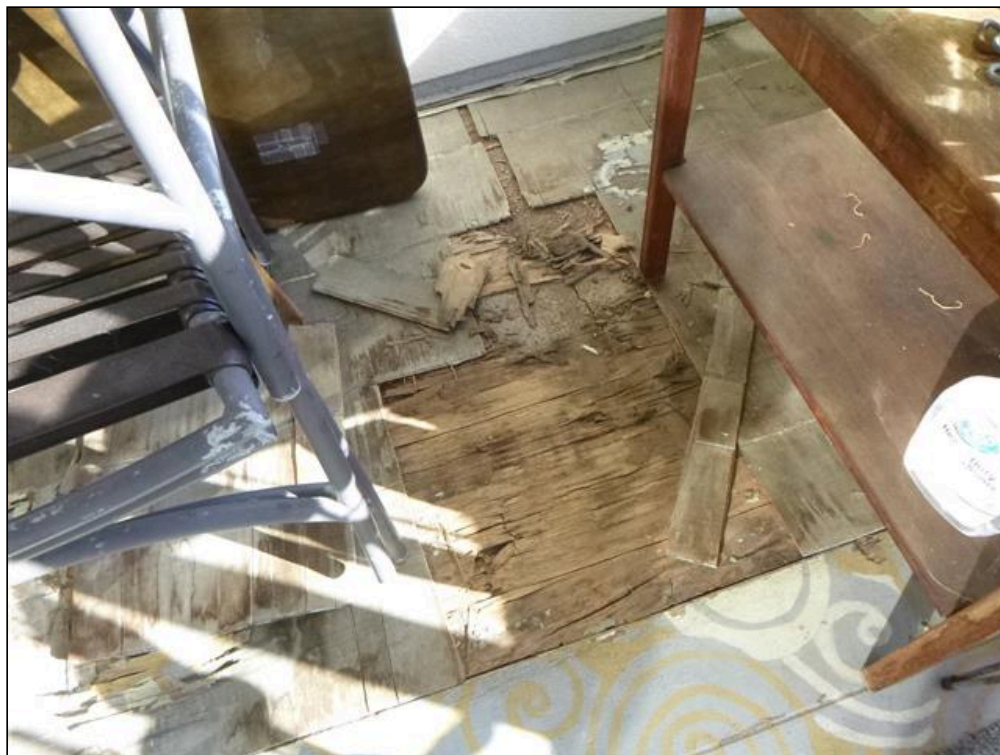
20.0 Item 1(Picture)

20.0 Excessive wood deterioration, soft areas and movement noted at this area (this is a potential safety hazard). Suggest review with the seller/association and/or a licensed contractor for any repair/removal/replacement costs as needed.

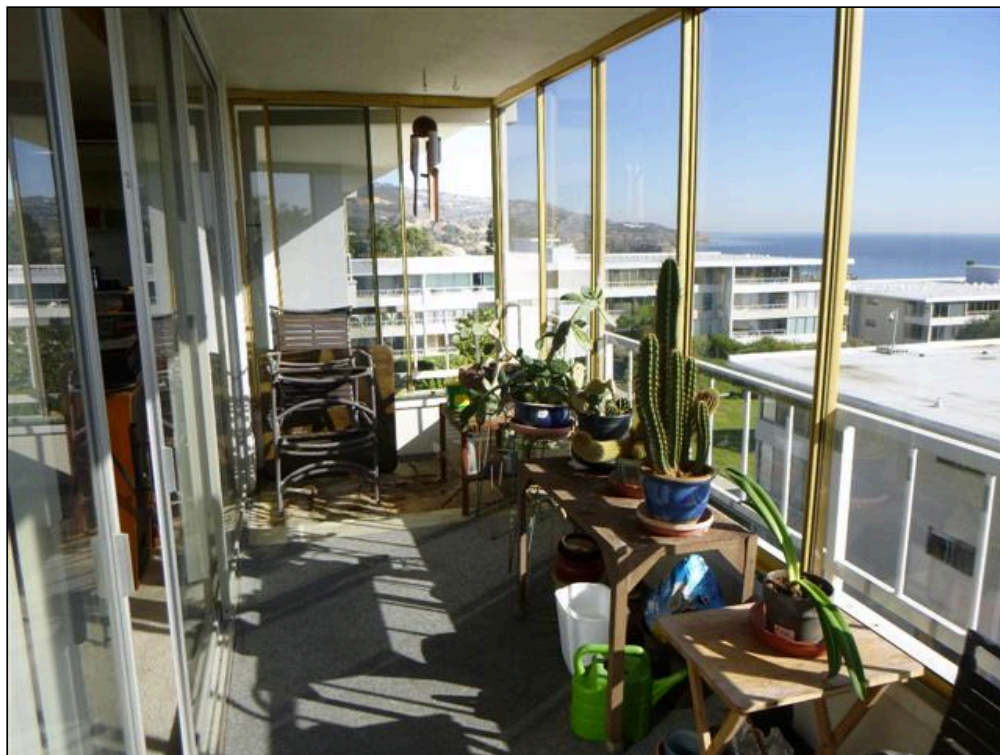
20.6 Item 1(Picture)

(1) This area/room appears to be the original patio/balcony area that has been enclosed. Suggest review with the seller/association and/or the city on this area as needed.

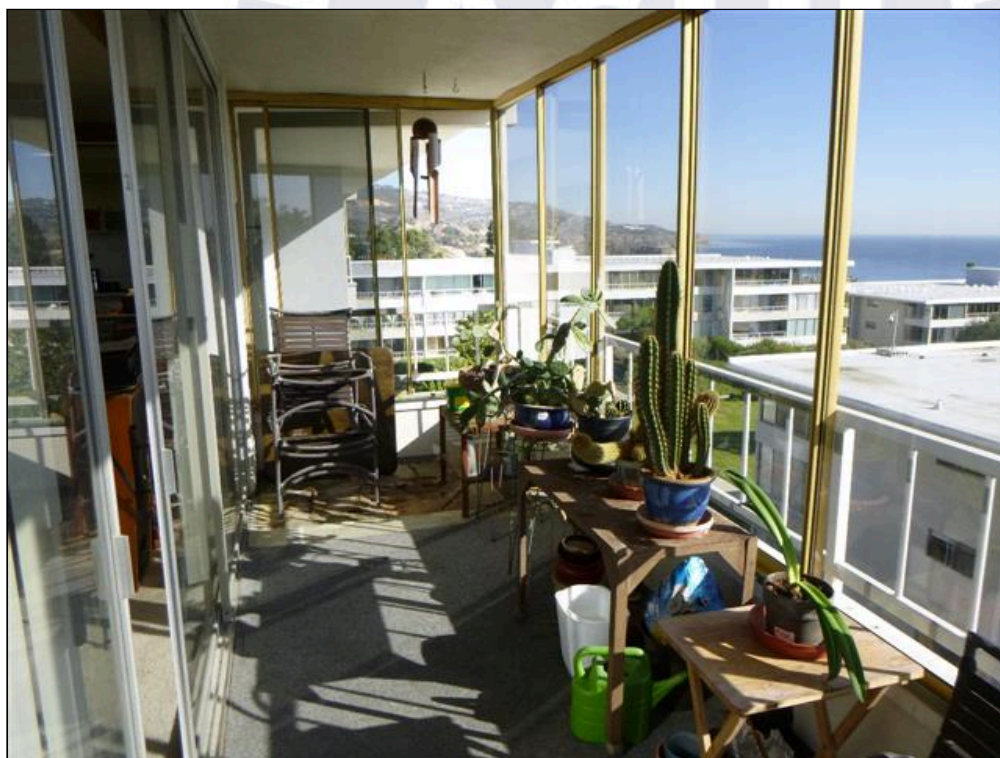
20.6 Item 2(Picture)

(2) Access within this area was blocked or severely limited at the time of the inspection. An inspection of this area can be performed by appointment and at an additional cost when the area is made accessible.

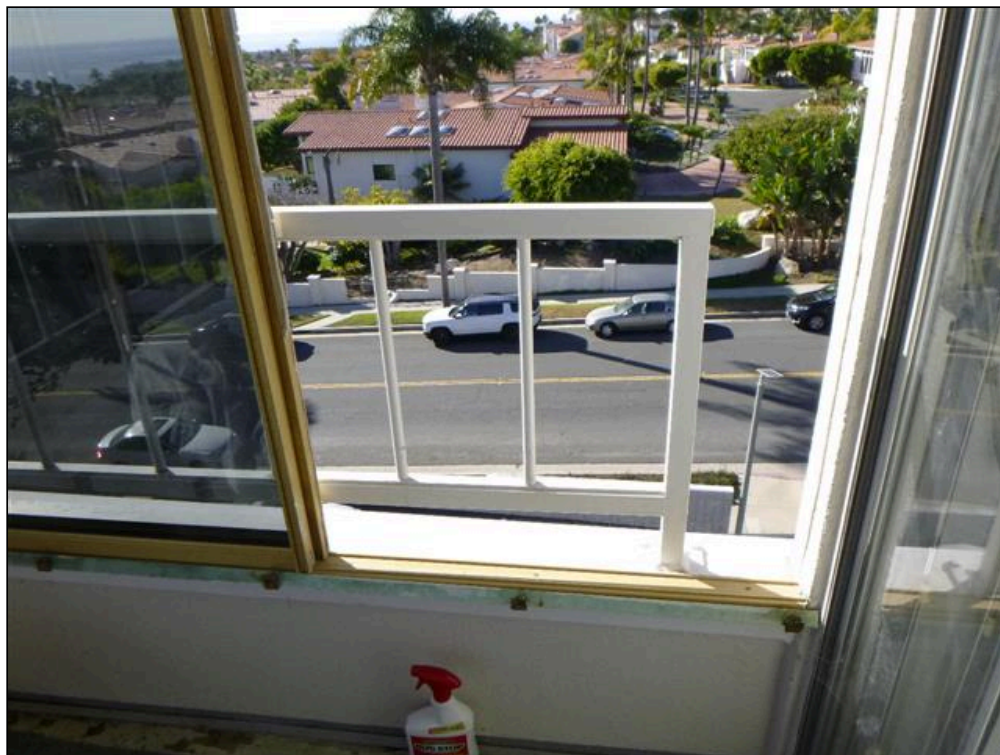
20.6 Item 3(Picture)

20.6 (3) The spacing between the guardrails/newel posts are larger than current requirements, this is a potential safety hazard for a young/small child or animal. Suggest review with the association and/or a licensed contractor for costs to reduce the spacing at the railings/newel post to enhance safety and as per current requirements as an upgrade (currently a 4" inch spacing).

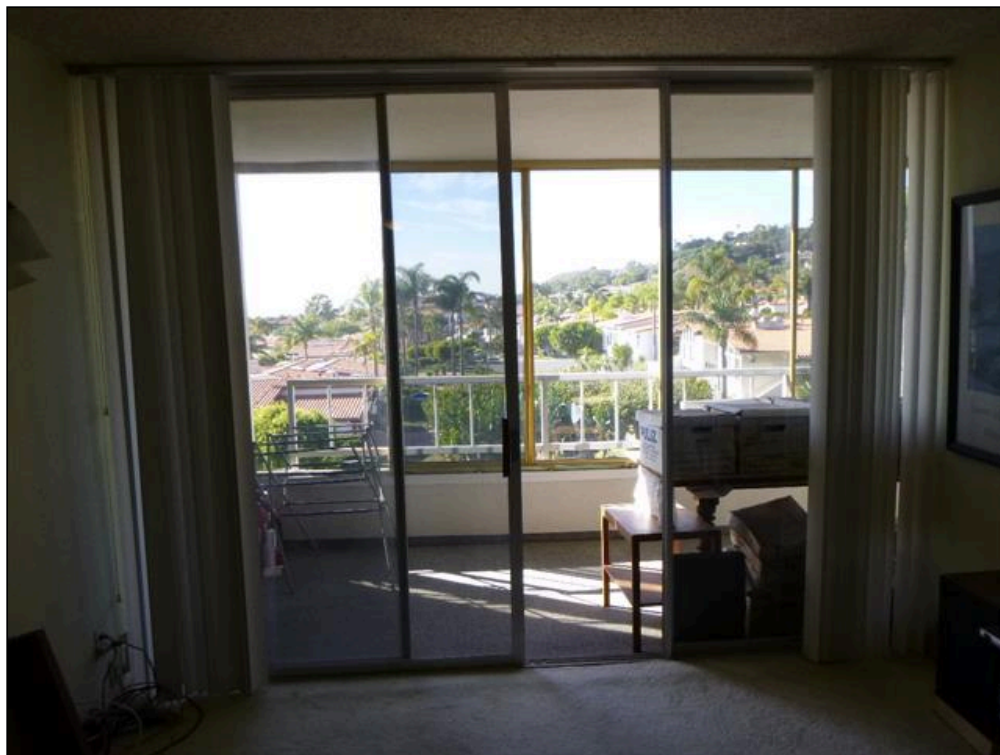
22.3 Item 1(Picture)

22.3 (2) The inspector was unable to determine/verify if the glass sliding door(s) are tempered safety glass (no etching/labelling was visible at the doors at this area). Windows and doors with glass 18 inches off the floor/deck area and/or windows within doors should have safety glass. Suggest review with a licensed contractor for possible costs to upgrade/install safety glass/film as needed.

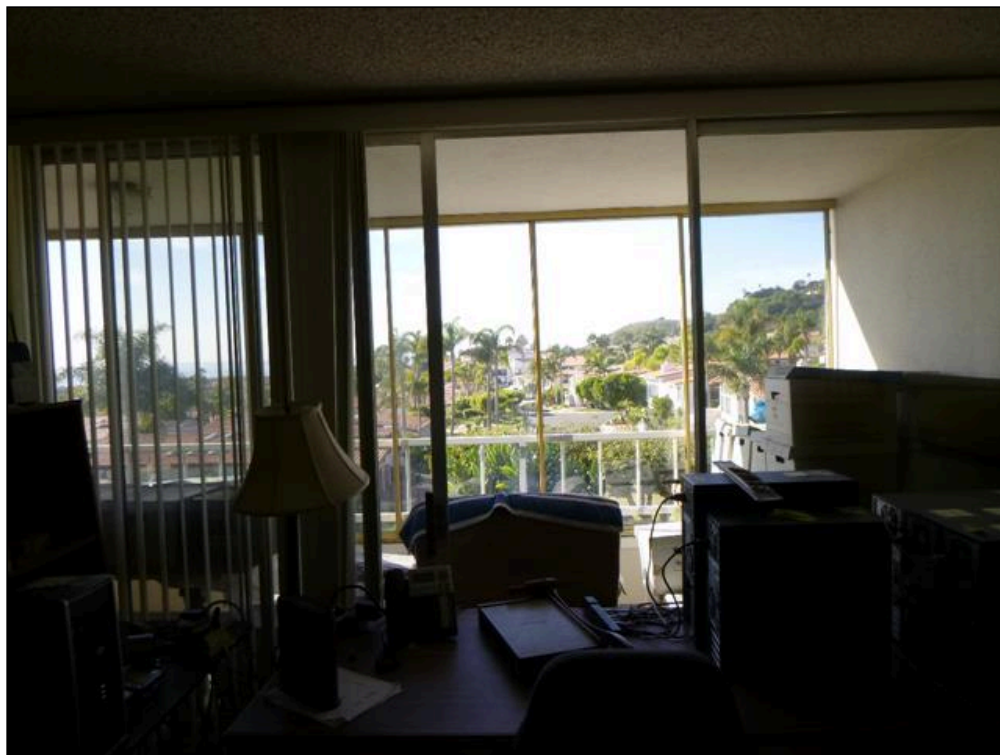
23.3 Item 1(Picture)

23.3 The inspector was unable to determine/verify if the glass sliding door(s) are tempered safety glass (no etching/labelling was visible at the doors at this area). Windows and doors with glass 18 inches off the floor/deck area and/or windows within doors should have safety glass. Suggest review with a licensed contractor for possible costs to upgrade/install safety glass/film as needed.
