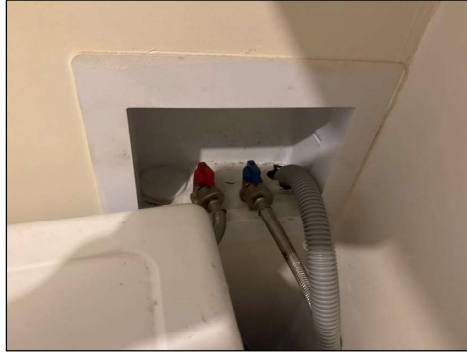
## 9. Plumbing

Visible fixtures had normal wear for age at the time of the inspection – no major visible defects • No visible leaks at time of inspection

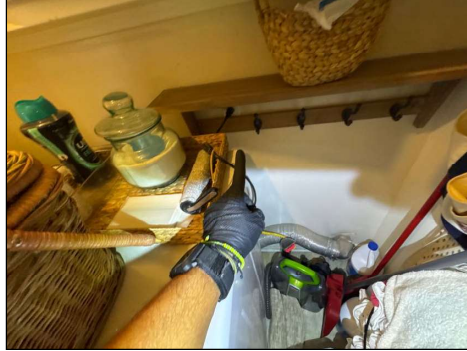
## 12. GFCIs

Recommend upgrading all receptacle to GFCI protection within 6 feet of all potential wet locations, unless the receptacles are on a dedicated circuit for appliances. • None installed recommend upgrade for increased safety • **Recommend upgrading all receptacle to GFCI protection within 6 feet of all potential wet locations, unless the receptacles are on a dedicated circuit for appliances.**

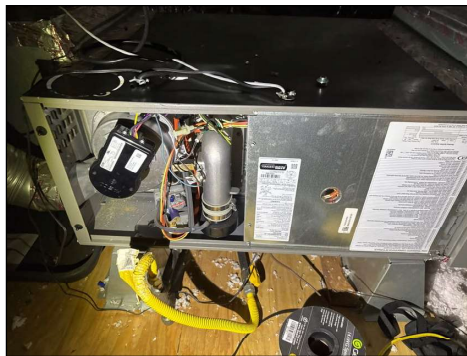
## 1. Heaters

**Location:** Attic

**Type:** Gas fired forced hot air

Operated at time of inspection • Visible areas of unit have normal wear for age at the time of the inspection – no major visible defects – recommend seasonal service and maintenance to extend the life of the unit

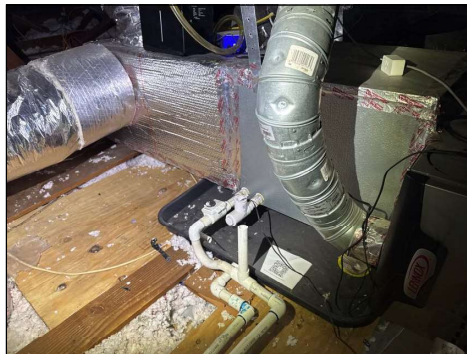
## 2. A/C Evaporator Coil Box

The visible areas of the coil box have normal wear at the time of inspection – no major visible defects

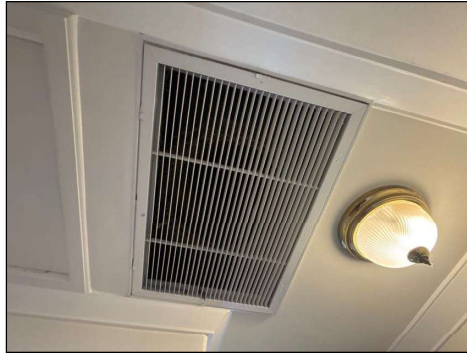
## 4. Air Supply

Recommend seasonal service and maintenance to ensure that all areas are sealed/cleaned/dry and functioning normally at all times • Visible areas have normal at time of inspection – no major visible defects  
• No visible microbial growth/irregular staining at the time of the inspection

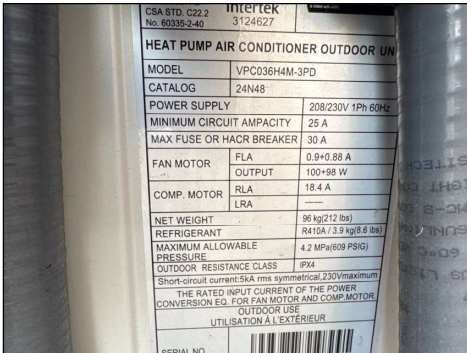
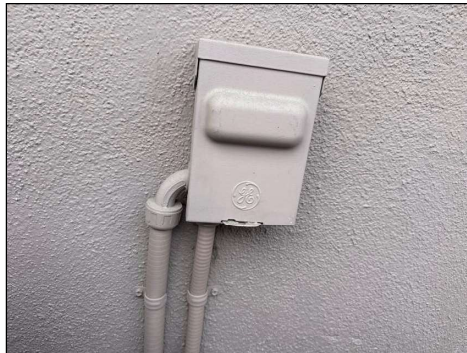
## 6. Electrical

Operating properly at the time of the inspection – no major visible defects

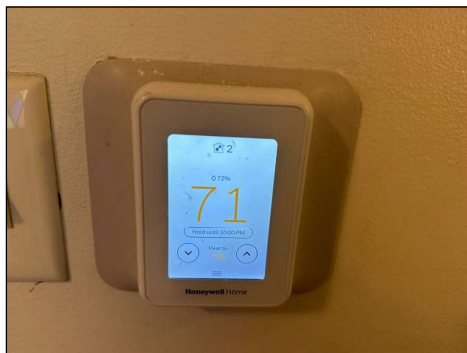
## 7. Thermostats

Digital type present – functional day of the inspection

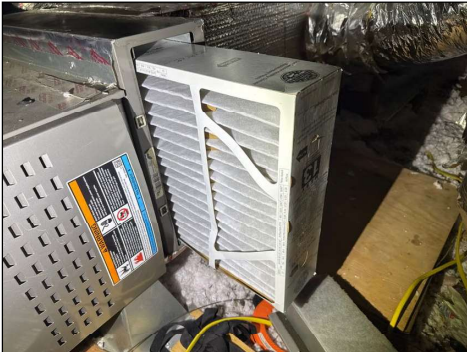
## 8. Filters

Located on the side of the heater

We recommend that the filters be changed or cleaned every 3 to 6 months depending on the usage of the heating and air conditioning systems

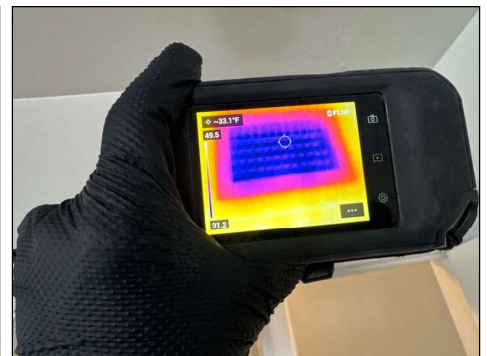
## 9. Registers

Representative number tested and functional day of the inspection • All visible register covers have normal wear at the time of the inspection – no major visible defects

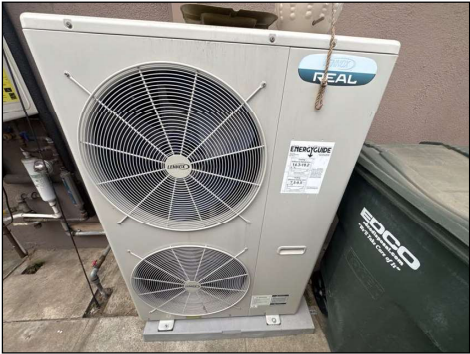
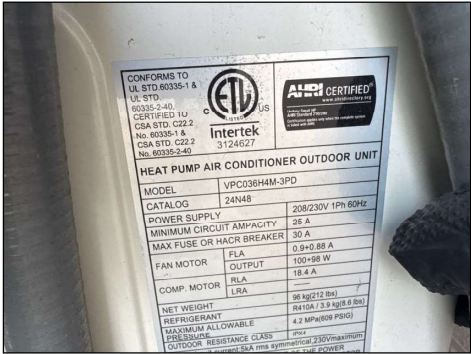
## 12. Air Conditioning Compressors

Operated at the time of inspection • Visible areas of unit have normal wear for age at the time of the inspection – no major visible defects – recommend seasonal service and maintenance to extend the life of the unit • Recommend regular service/maintenance to extend the life of the unit(s)

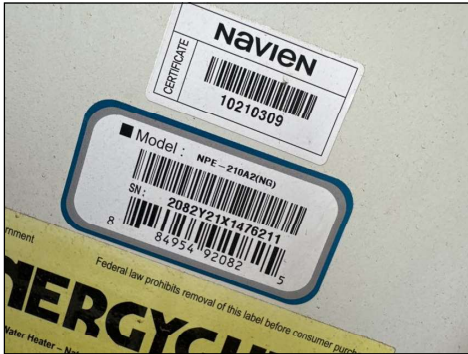
## 1. Water Heaters Condition

**Number of gallons:** Tankless demand unit (not original to this structure – check all installation permits to ensure that this unit was installed to city code and manufacturer specifications)

Operated at the time of the inspection – Gas unit • Visible areas of unit have normal wear for the age at the time of the inspection with no major visible defects • This is a newer unit (not original to this structure) – check all installation permits to ensure that this unit was installed to city code and manufacturer specifications

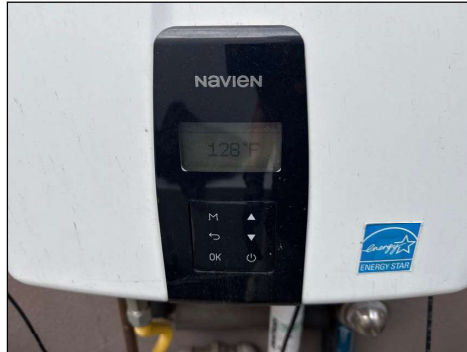
## 7. Water Heater Temperature

Note: Tankless water heater temperature reading is taken from the tankless thermostat control display but may not represent the actual temperature at the interior fixtures within the structure – see all photographs for temperature readings at the fixtures

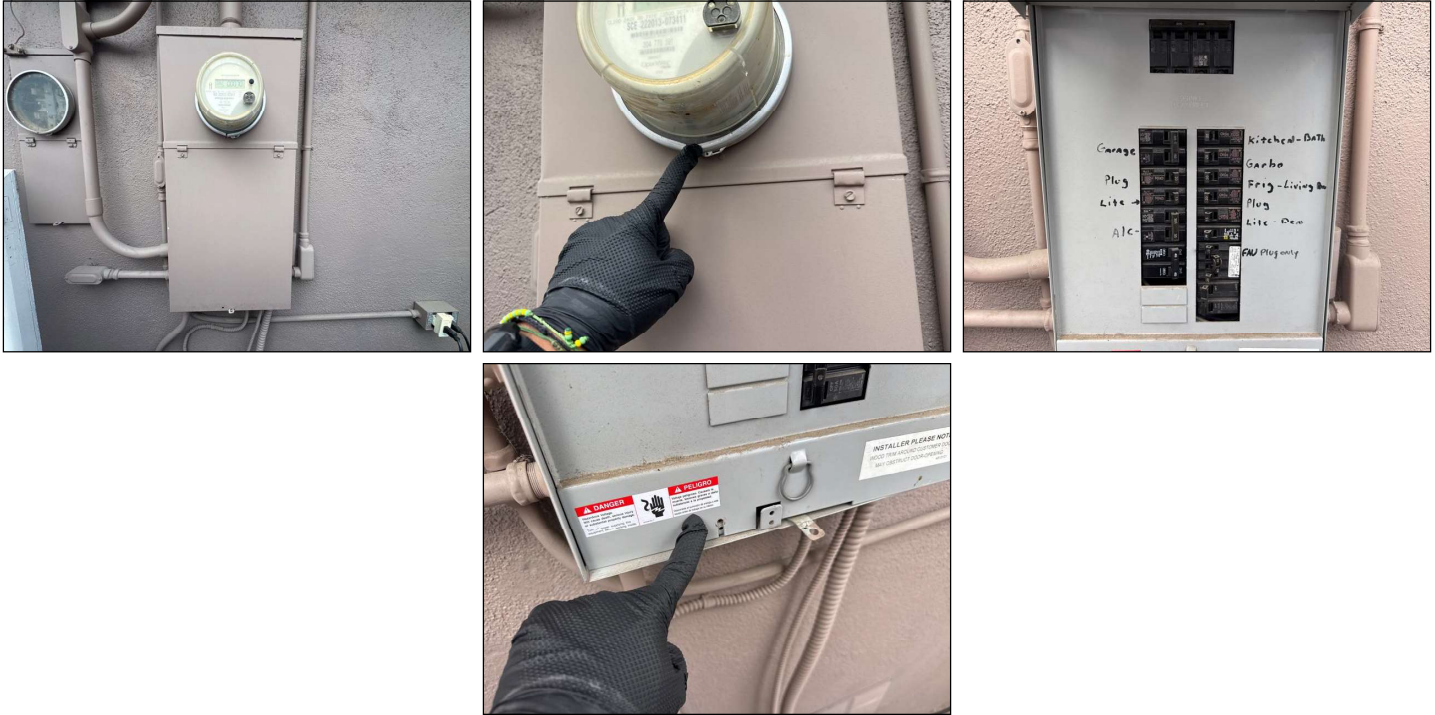
Worn/weathered panel – typical for age and weather exposure • Missing meter lock – service recommended • Panel cover screw(s) missing – recommend installing appropriate screws

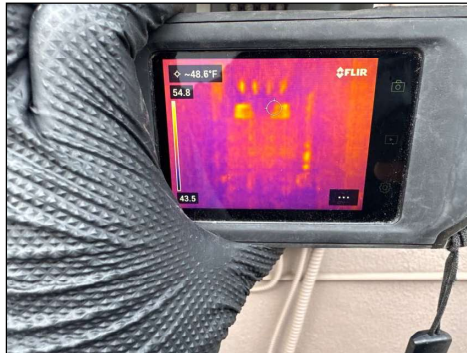
**Evidence of alterations to the panel – different types/brands of breakers are present – check permits to ensure proper installation to building/electrical codes**

**Thermal Image View – Normal temperature readings with no visible signs of overheating at time of inspection**

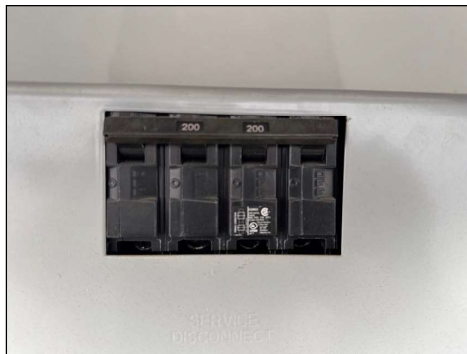
## 4. Breaker Amp Capacity

Main breaker rating per label: 200 AMPS

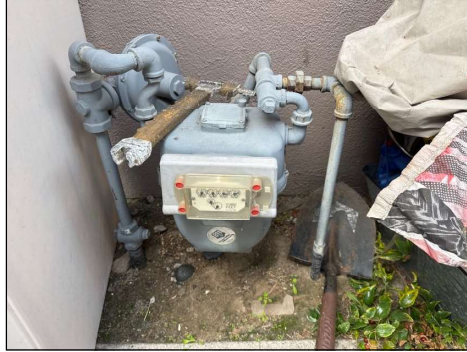
Natural gas present

- Worn valve – typical for age
- Recommend gas valve wrench be placed near valve for optimal preparedness
- Minor rusting – typical for exterior weathering – recommend rust treatment
- No seismic safety valve present – recommend installation for increased safety

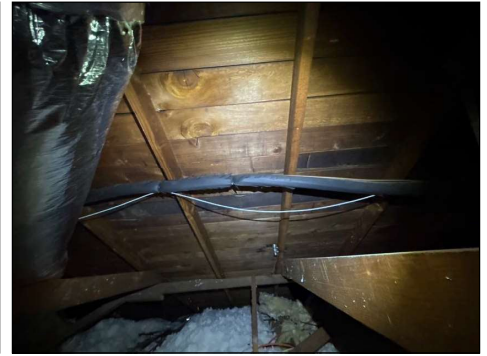
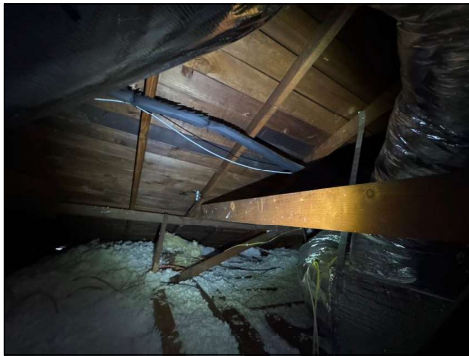
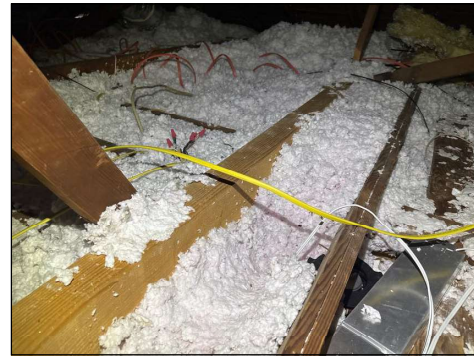
Conventional framing present, normal wear at time of inspection – no major visible defects • Cracking small at wood members – typical for age • Consult the Termite Report for all wood areas in the attic • Stains present on wood members of structure – evidence of past moisture entering structure – monitor for future moisture intrusion

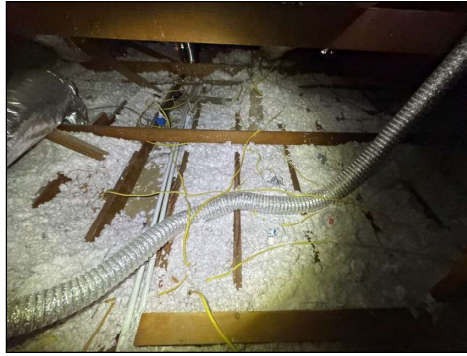
**Material type:** Loose fill

**Approximate depth:** 8 inches

No visible signs of rodents at this inspection – we recommend pest services seasonally as needed • All visible insulation appears to have normal wear for age with no major visible defects at the time of the inspection

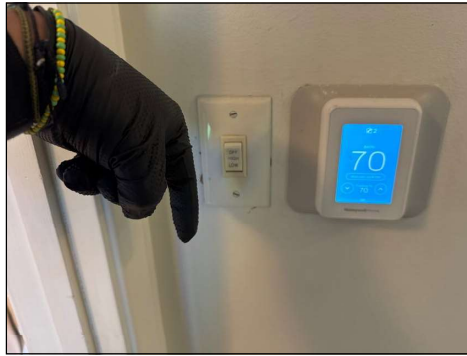
## 4. Ventilation

Existing ventilation appeared to be adequate on the day of the inspection

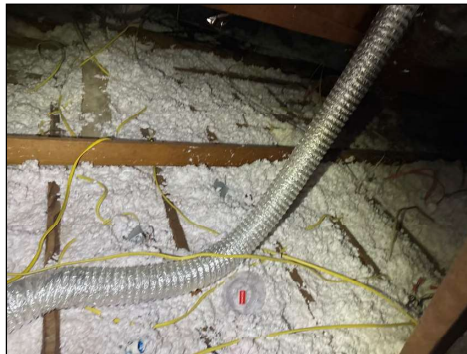
## 6. Exhaust Vents

All visible vents appear to be in normal condition where visible – no major visible defects • **Plastic venting found in attic (metal now required) – service recommended**

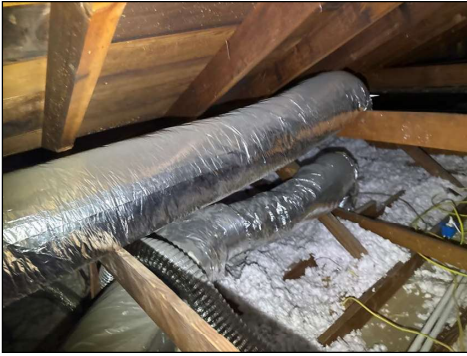
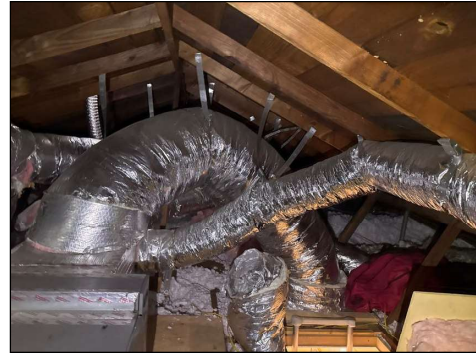
## 7. Duct Work

All visible/accessible duct areas have normal wear for age at the time of the inspection – no major visible defects

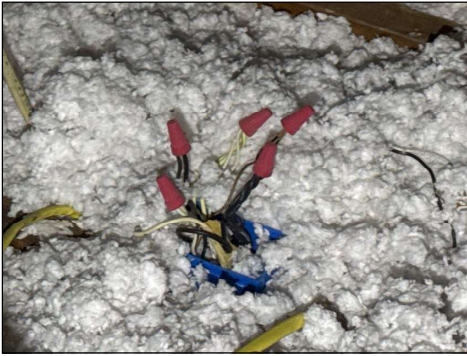
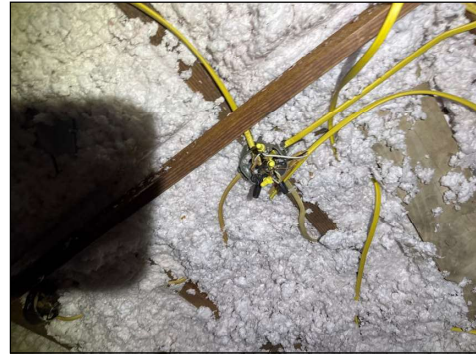
## 8. Electrical

Evidence of electrical alterations in the attic – check all permits for electrical alterations to ensure that all electrical was installed to city/county electrical code • Visible wiring in attic is in a worn and older condition typical for the age the of structure • Some areas not visible due to access hindrances or limitations • **Cover missing at junctions box(es) exposing connections – service recommended**

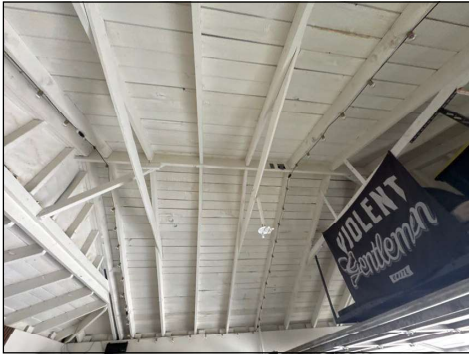
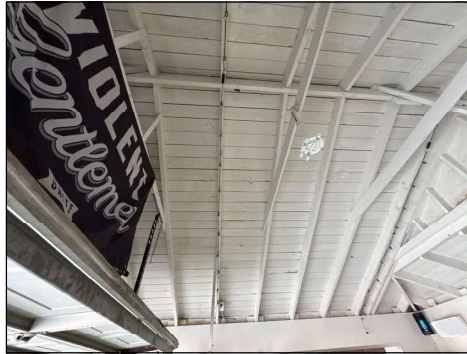
## 2. Rafters & Ceilings

Exposed wood rafters/joists – consult the Termite Report for all wood • **Stains at roof framing - dry at time of inspection – inquire with seller regarding status**

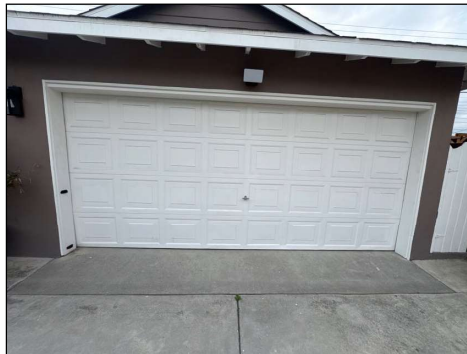
## 3. Main Automotive Doors

**Type:** Metal sectional

Worn/weathered door – typical for age and exposure to weather • Recommend weather tight service/maintenance to prevent moisture intrusion around main door areas

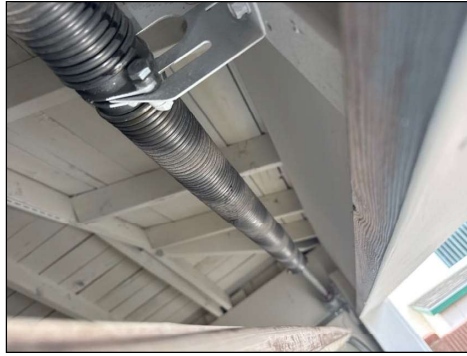
## 4. Hardware/Springs

Garage doors require periodic maintenance and is recommended to ensure that all hardware is properly lubricated and secured • Normal wear at time of inspection – no major visible defects

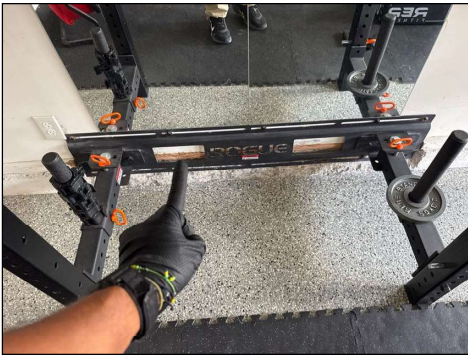
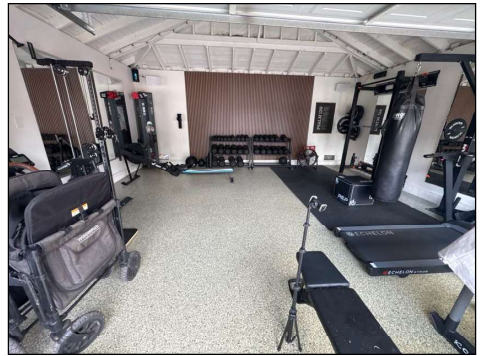
## 6. Walls

Small cracks/holes/chipped/dirty areas/cosmetic blemishes observed – typical for age of structure • No moisture present when tested with a moisture meter • No visible microbial growth/irregular staining found at the time of inspection • Personal items/storage/etc. are present and prevent a complete inspection of wall areas

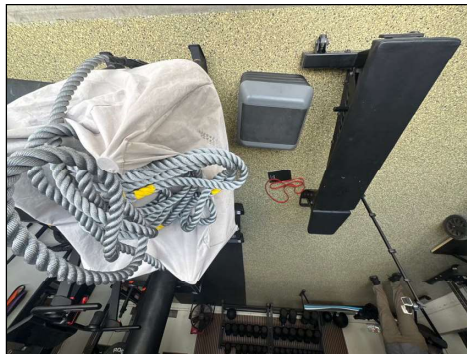
## 8. Slab

Small cracks/chipped areas – typical for the age of the materials • Epoxy coated or concrete painted – prevents complete inspection

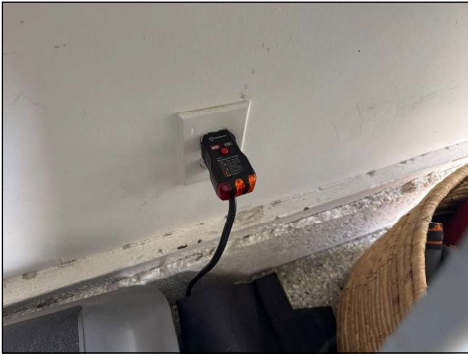
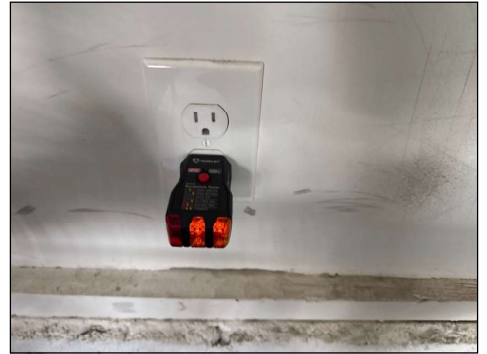
## 9. Electrical

A representative number of receptacles and switches were tested and found to be operational at time of inspection • Loose/worn outlets/switches – typical for age consider upgrading

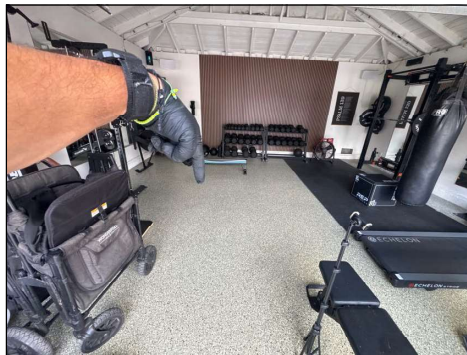
## 10. GFCIs

Recommend upgrading all accessible receptacles below 8 feet to GFCI protection within 6 feet of all potential wet locations or where potential ungrounded power tools could be used, unless these outlets are on dedicated circuits meant for appliances. • **None installed – recommend upgrade for increased safety**

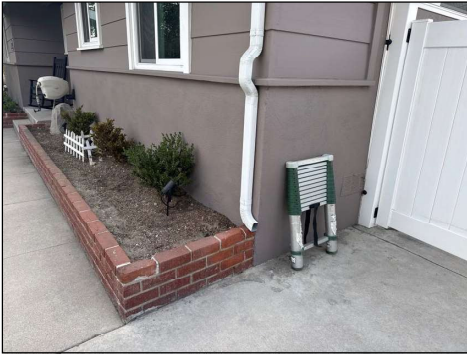
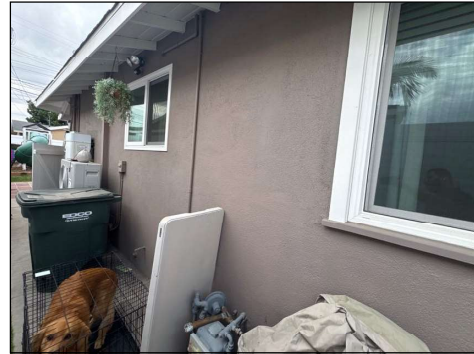
Worn/weathered at time of inspection where visible

- Recommend sealing any holes/gaps or cracks to prevent moisture or pest entry • Stucco requires periodic seasonal maintenance, consult an exterior finish contractor for maintenance tips/schedules/suggestions

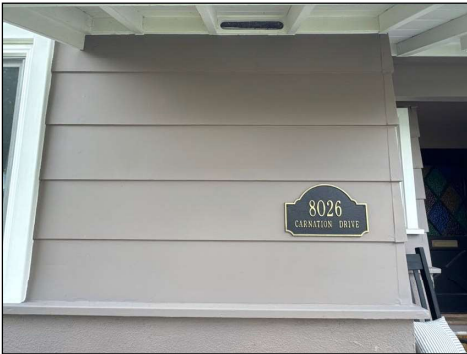
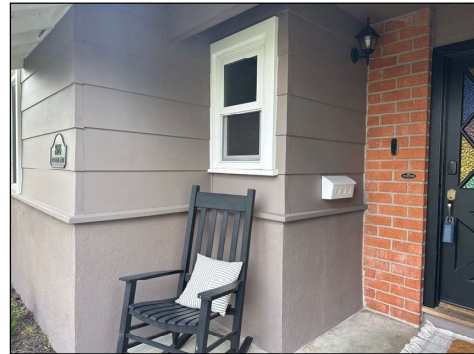
## 2. Siding

**Constructed of:** Wood • Brick

Worn/weathered/cracked materials where visible – recommend siding maintenance

- Recommend maintenance to seal all gaps, cracks and openings
- Siding requires periodic seasonal maintenance, consult an exterior finish contractor for maintenance tips/schedules/suggestions

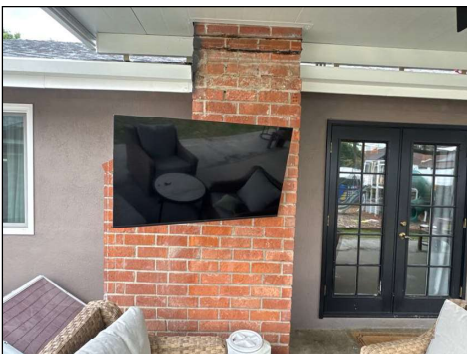
## 3. Lower Half of Chimney

Small cracking or chipping observed – typical of age – recommend maintenance/sealing

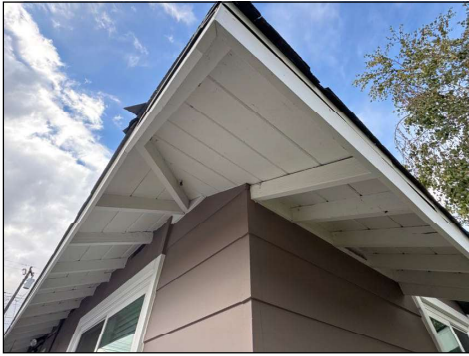
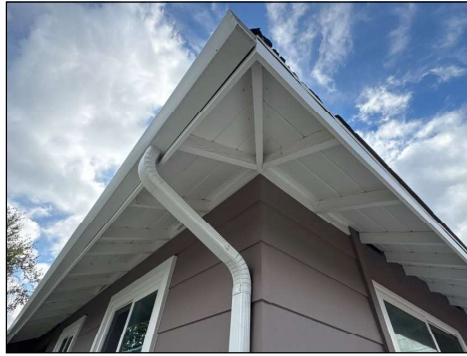
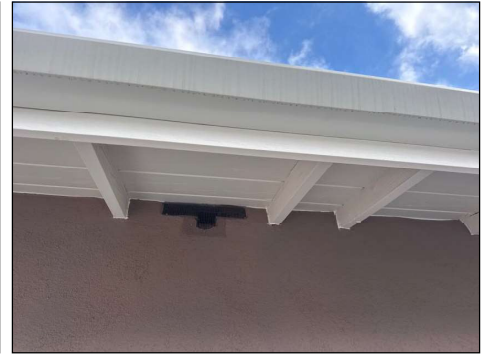
## 6. Eaves & Fascia

Cracking/weathering/worn where visible – typical for age and weather exposure • Consult the Termite Report for all wood areas at the structure

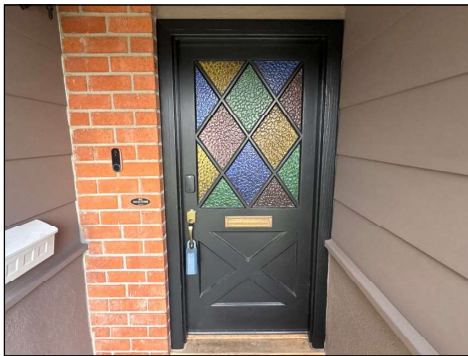
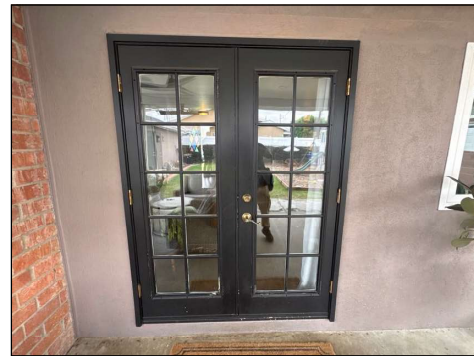
## 8. Exterior Doors

Exterior doors require seasonal maintenance to extend lifespan and maintain weather tight seals • See interior section for more information • All visible and accessible doors were tested during this inspection • Worn/weathered – recommend weather tight service/maintenance • Maintain weather tight seals at all doors

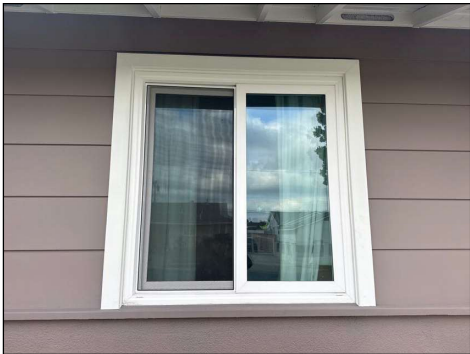
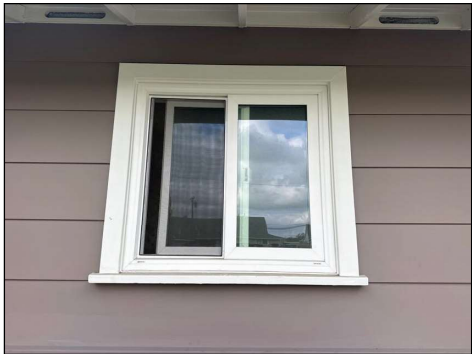
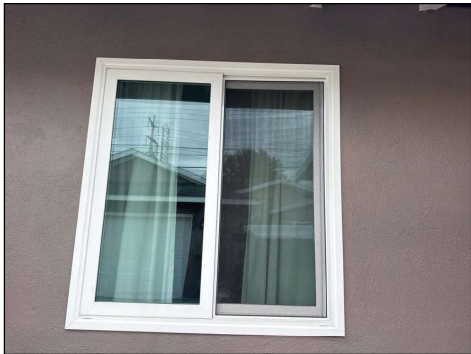
## 9. Exterior Windows

Exterior windows require seasonal maintenance to extend lifespan and maintain weather tight seals • See interior section for additional information – some exterior window areas may not be visible due to height/limited access/vegetation/etc. • Worn windows/screens – typical for age • Recommend weather tight service/maintenance

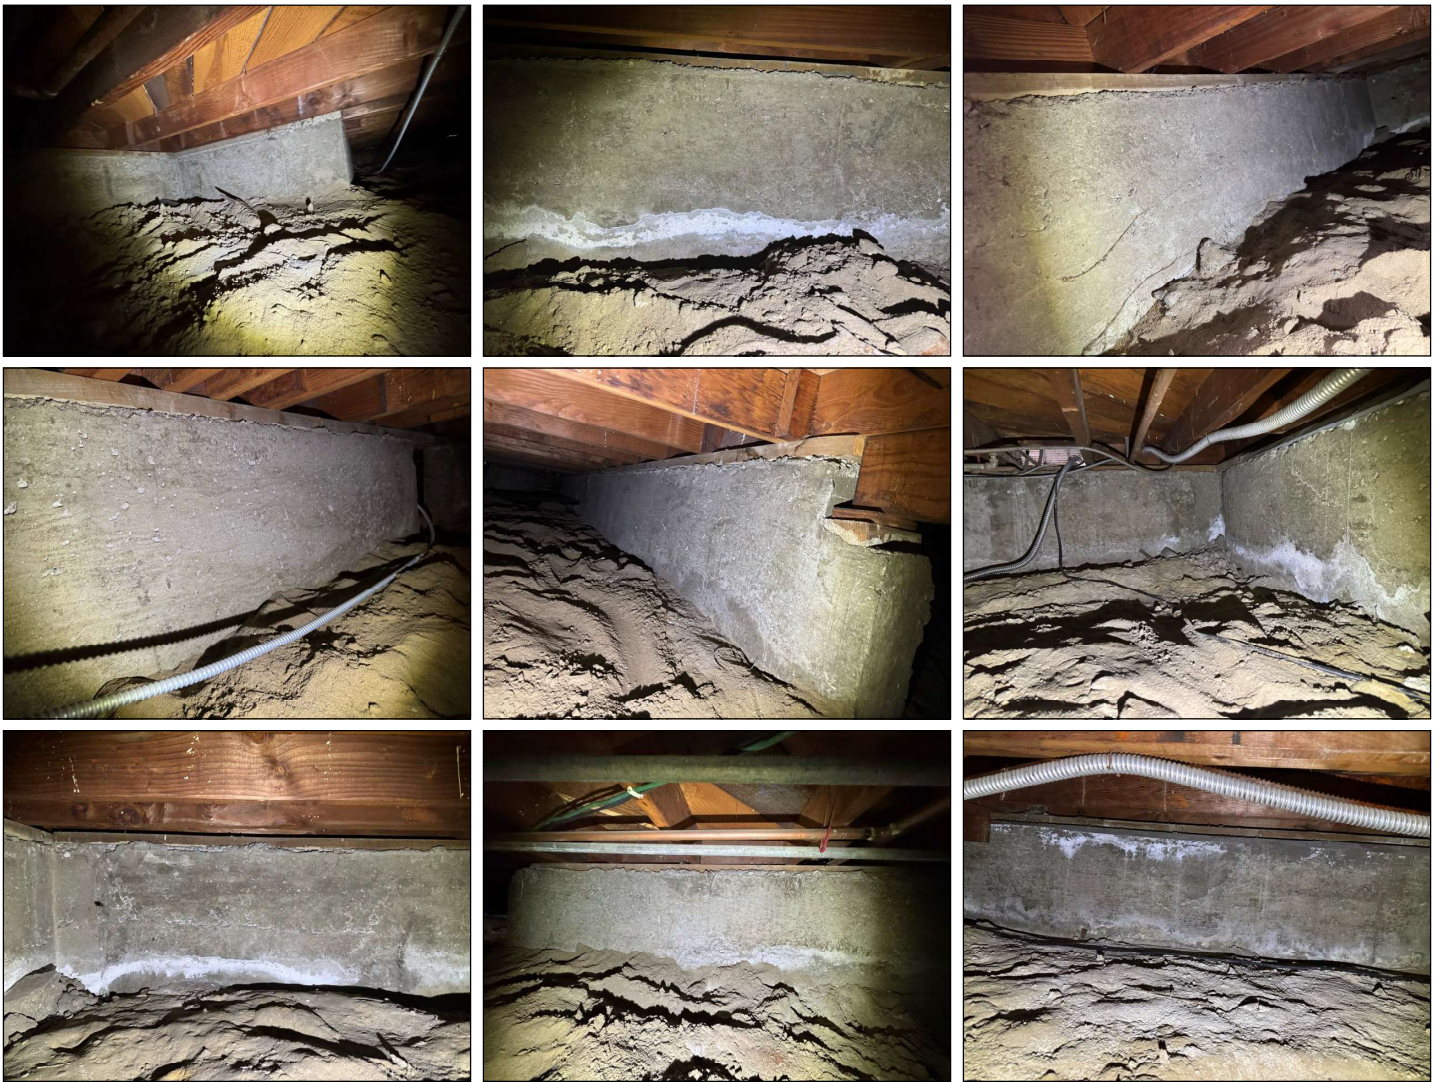
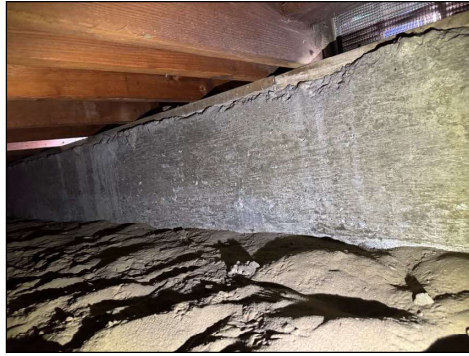
## 3. Foundation Walls

Constructed of: concrete • Visible foundation wall areas are worn and stained areas – typical for age of the structure and material • Normal settlement present – no major visible cracks or deterioration found at the time of the inspection • Efflorescence present – indicates past moisture accumulation – monitor for further moisture intrusion

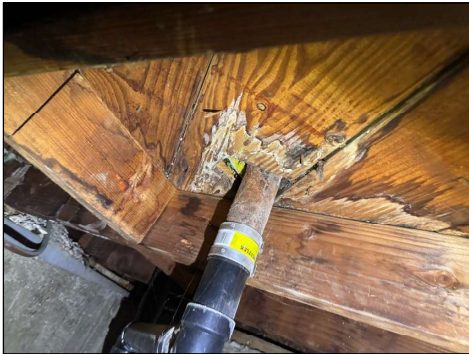
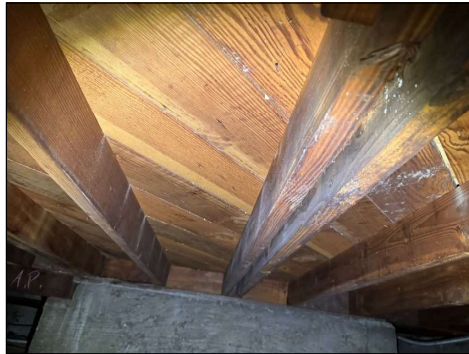
## 5. Sub Flooring

Stained areas present – consult the Termite Report for any wood/moisture issues • **Evidence of moisture problems under bathroom – the source of the problem cannot be determined by the inspector – recommend further evaluation and service as required**

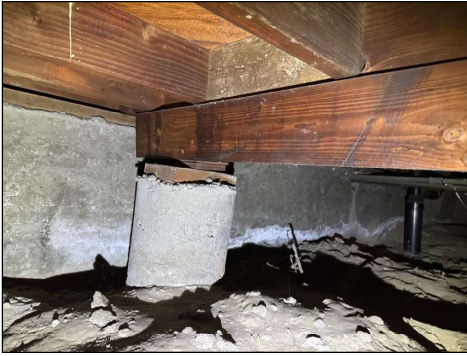
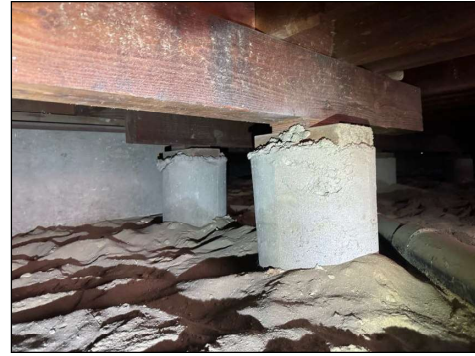
## 6. Posts and Girders

Stained and worn areas – typical for age of structure

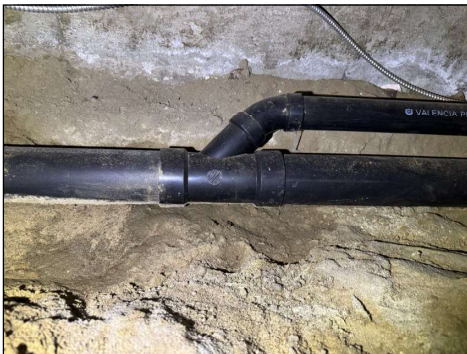
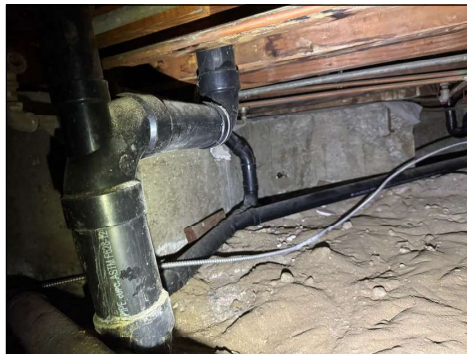
## 11. Plumbing

Evidence of altered plumbing/piping under the structure – check all installation permits to ensure that all plumbing was installed to city/county building code. The home inspector is not a building code violation inspector. • The inspector ran water while inspecting under the structure areas • Visible/accessible plumbing areas have worn and older piping in typical condition for the age of the structure • Recommend a Licensed Plumber for further evaluation • **Leak found under tub – service recommended** • **Copper tubing discolored – electrolysis present in areas - visible leaking in one area - service recommended** • **Damp areas below or around drains lines that area touching or entering the soil – possibly a sign of a drain leak below the soil – recommend a Licensed Plumber for further evaluation**

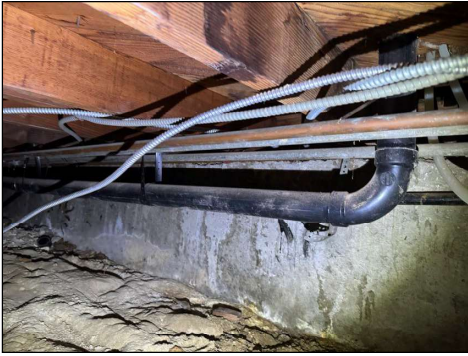
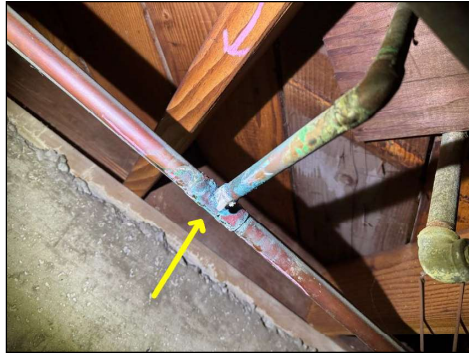
**Copper tubing discolored –  
electrolysis present in areas -  
visible leaking in one area - service  
recommended**

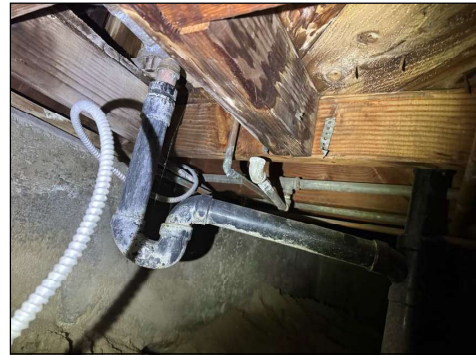
**Leak found under tub – service recommended**

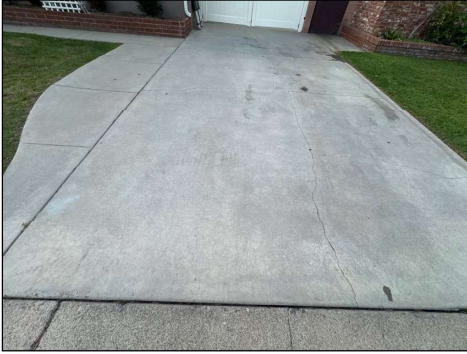
Worn with common cracks/chips – typical for age of material • **Walkway displacement/uplifted/uneven areas – potential tripping hazard – service recommended- front**

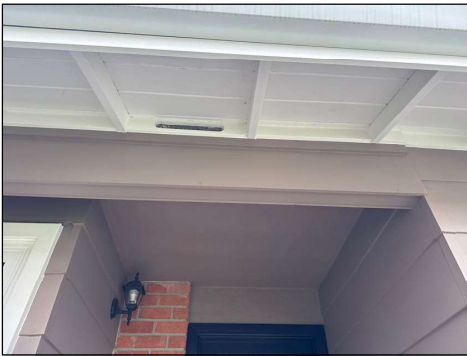
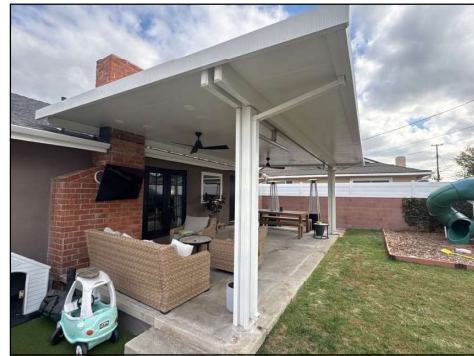
## 2. Patio and Porch Roofs

**Constructed of:** Aluminum • Same as main structure – porch

See main roof page for porch/patio areas • Worn/weathered materials – typical for age • Consult the Termite Report for all exterior wood conditions

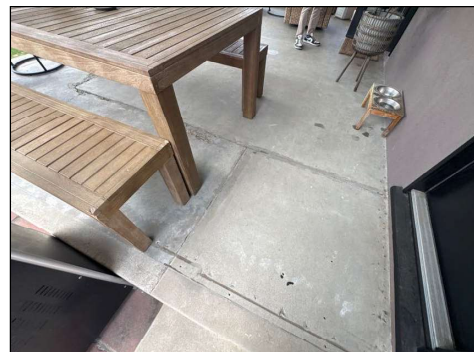
## 3. Patio and Porch Decks

Worn with common cracks/chips – typical for age of material

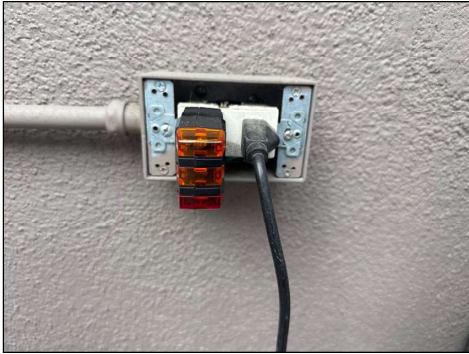
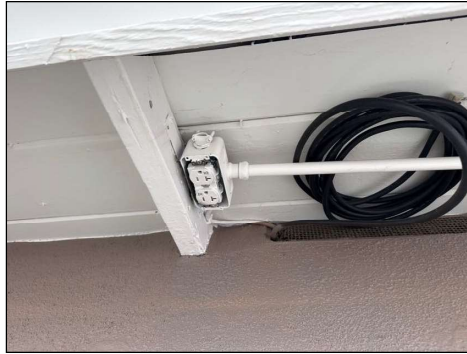
## 4. Exterior Electrical

- The visible and tested fixtures/switches/outlets were in a loose/worn condition – typical for age
- Electrical fixtures need to be caulked/sealed to wall attachments to help prevent moisture entry
- **Exterior outlet/switch covers are missing or not of proper exterior weather proof type – service recommended**

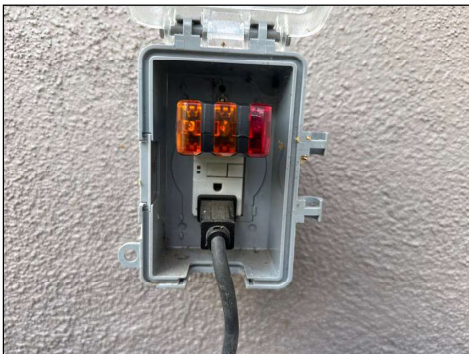
## 5. GFCIs

- None visible/installed recommend upgrade for increased safety
- **GFCI upgrades are recommended on exterior outlets for increased safety**

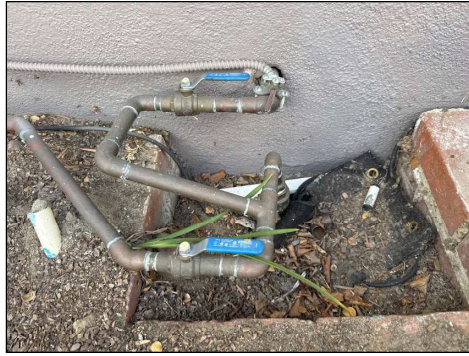
**Type of plumbing:** Copper piping is not original to the structure – check all permits to ensure piping was installed to city/county plumbing codes

No visible leaking found at the main valve area at the time of the inspection • Main ball valve is worn – typical for age • Location: north side

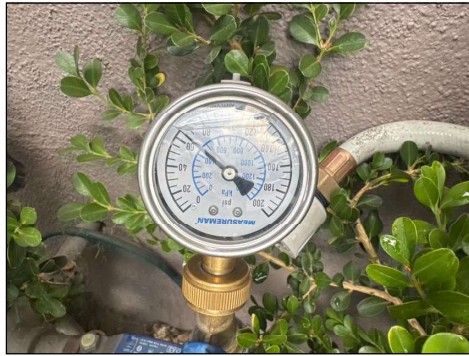
## 8. Water Pressure

Recommended water pressure is between 55 to 80 pounds per square inch (psi) • Water Pressure can fluctuate depending upon time of day and municipal service adjustments • Approximate pounds per square inch: 65

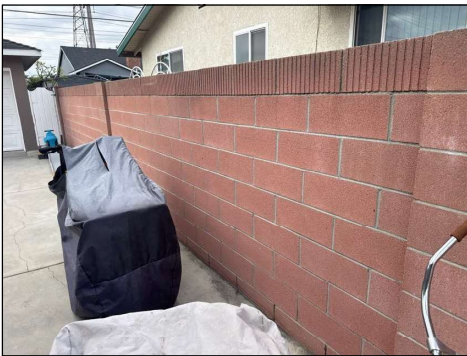
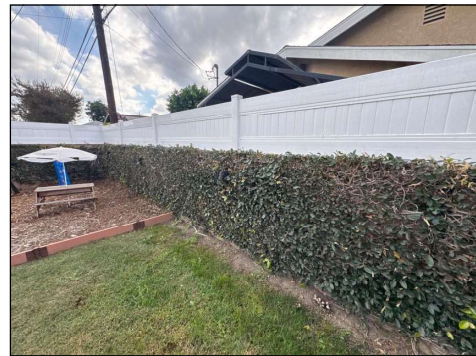
## 10. Fencing and Walls

Visible fencing/wall areas are worn and weathered – typical for the age of the materials

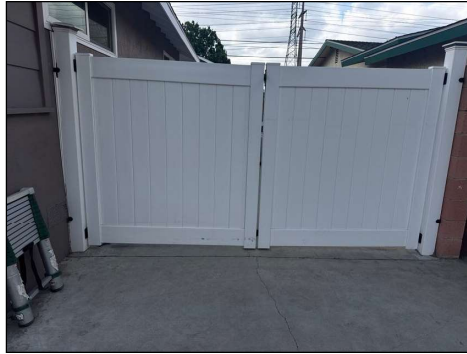
## 11. Gates

Operated on the day of the inspection • Weathered and worn materials – typical for age

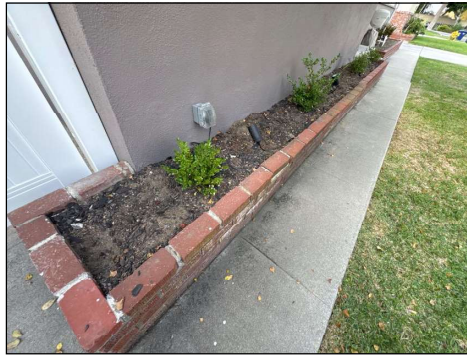
## 12. Planters

Recommend trimming trees or bushes that are in contact or proximity to home, as branches can abrade roofing or siding • Loose/cracked materials present – service recommended • Moisture barrier or waterproofing not visible in planter built against the structure – recommend further evaluation

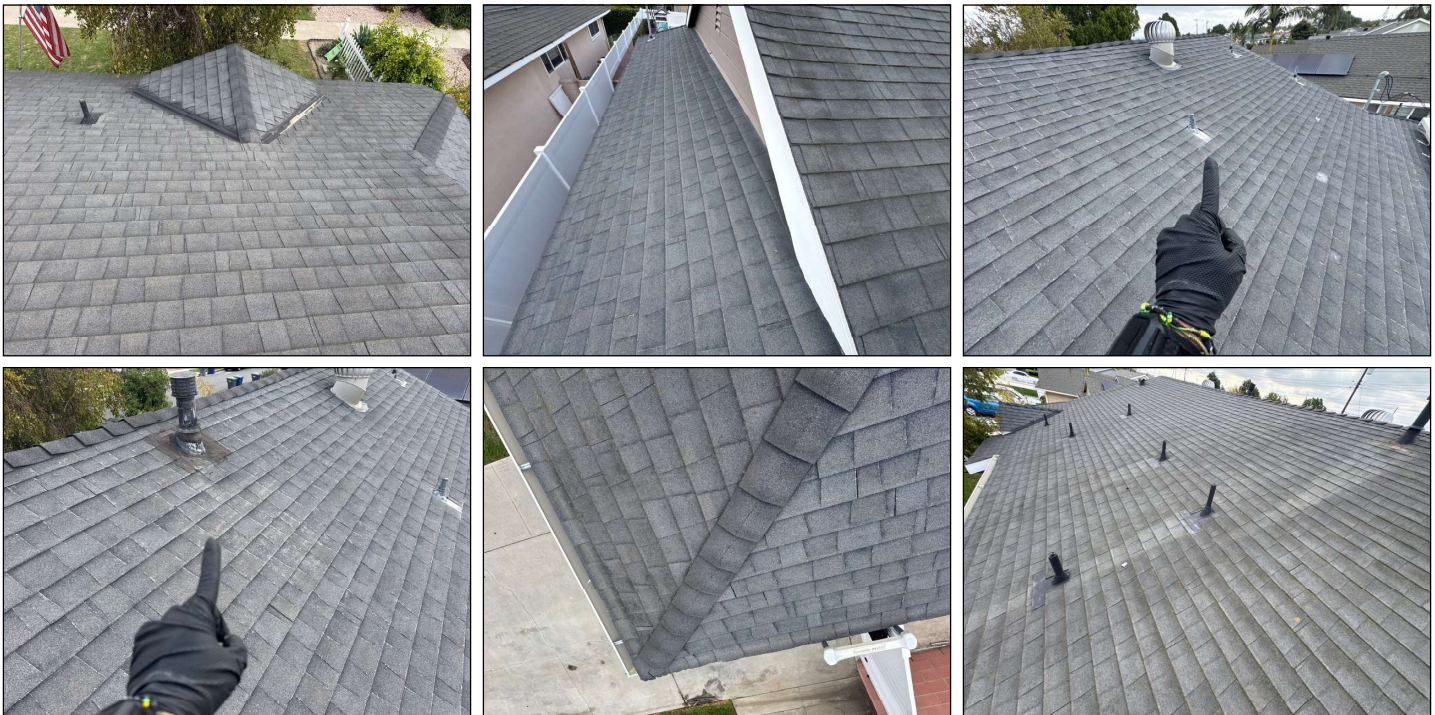
Worn and weathered materials present – typical for age and weather exposure – roof needs maintenance • Recommend evaluation by a Licensed Roofing Contractor • **Shingles exhibited extensive/abnormal granule loss – service recommended/evaluated by a roofer • Damaged shingles in areas – service recommended**

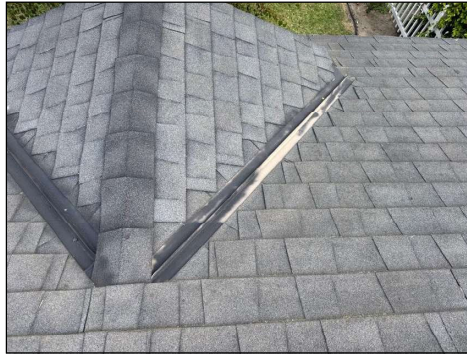
## 2. Flashings

Worn/weathered/rusted/bent – typical for age – recommend seasonal mastic maintenance to prevent moisture intrusion

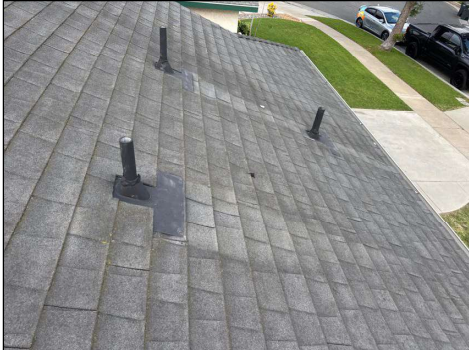
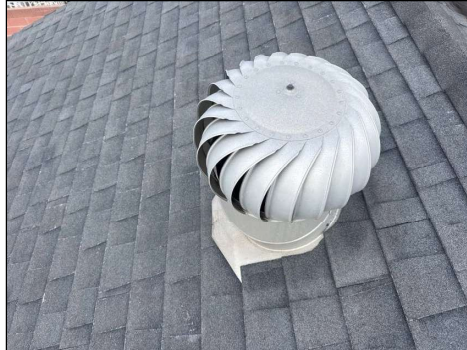
## 4. Vents and Vent Caps

Worn/weathered cap(s) – recommend seasonal maintenance to ensure that caps do not become loose or develop other defects • **Mastic at vent(s) is weathered and cracked – service recommended and resealed at all penetration points**

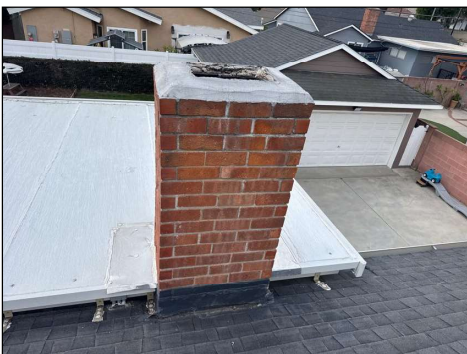
## 5. Chimneys

Worn/weathered chimney – recommend seasonal maintenance and care

- **Unlined chimney present – service recommended**

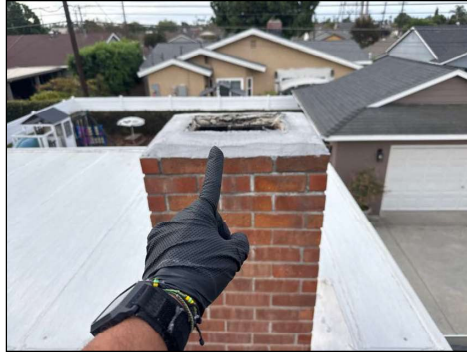
## 6. Spark Arrestors

No spark arrestor/rain cap present – recommend installation
