WOOD DESTROYING PESTS AND ORGANISMS INSPECTION REPORT

Building No. 918	Street Salem St	City Chico	ZIP 95928	Date of Inspection 08/02/2023	Number of Pages 5
---------------------	--------------------	---------------	--------------	----------------------------------	----------------------

CORRECTED REPORT

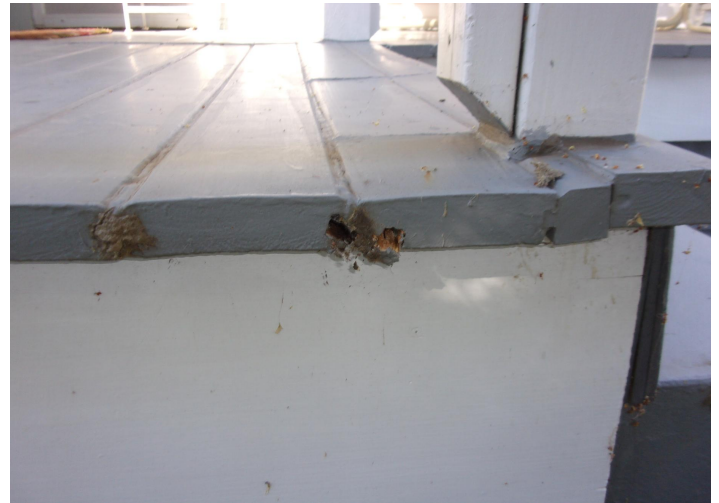
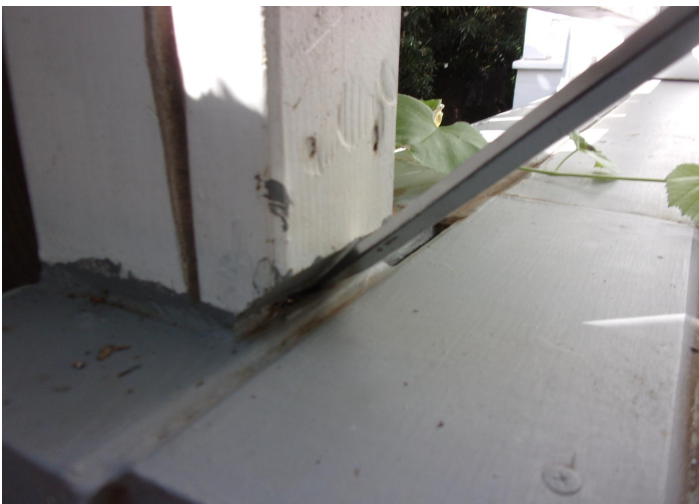
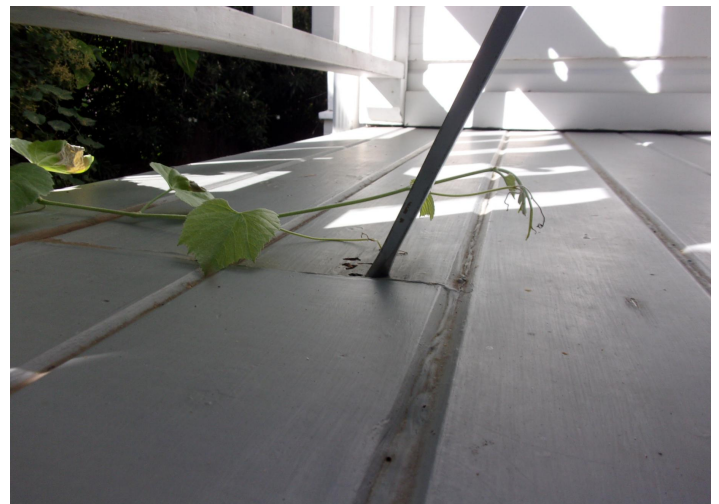
4A

FINDING: Fungus infection/damage noted at the front porch decking. Damage may extend into inaccessible areas.

RECOMMENDATION: Remove the fungus damaged portions of the decking. Call for a reinspection of the inaccessible areas. The inaccessible areas will be inspected for a fee if made accessible by the interested parties at his/her expense. A supplemental report will be filed at such time. No opinion is rendered concerning the conditions in the area at this time. Replace with new material. Scrape and/or power wash fungus infected wood members and treat with a registered fungicide.

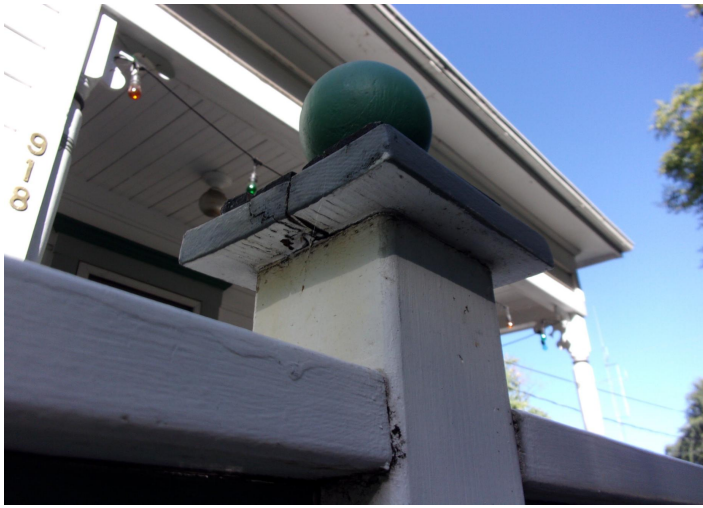
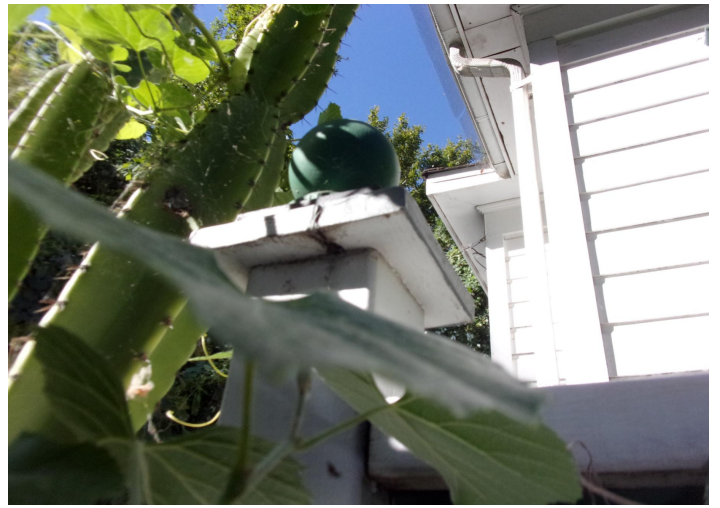
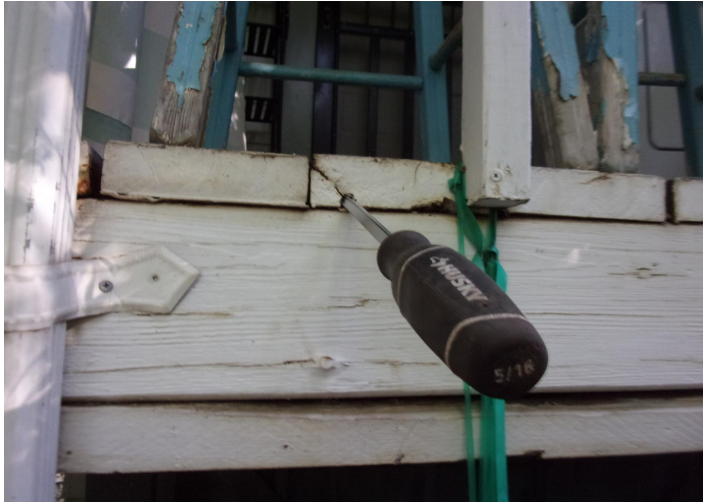
4B

FINDING: Fungus damage noted at the deck railing post caps.

RECOMMENDATION: Remove the fungus damaged portions of the railing post caps and replace with new material.

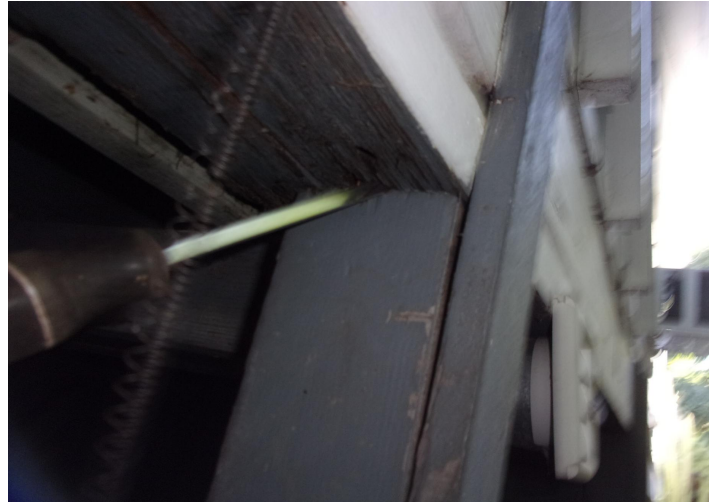
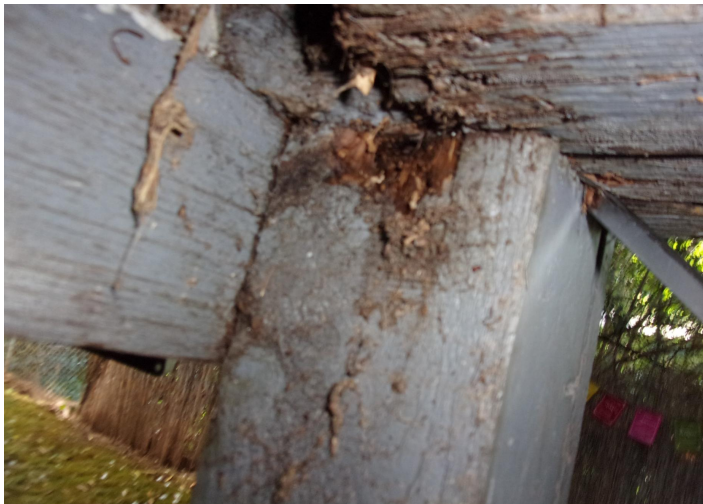
9A

FINDING: Fungus infection/damage noted at the decking and joists. Damage may extend into inaccessible areas.

RECOMMENDATION: Remove the fungus damaged portions of the decking and joists. Call for a reinspection of the inaccessible areas. The inaccessible areas will be inspected for a fee if made accessible by the interested parties at his/her expense. A supplemental report will be filed at such time. No opinion is rendered concerning the conditions in the area at this time. Replace with new material. Scrape and/or power wash fungus infected wood members and treat with a registered fungicide.

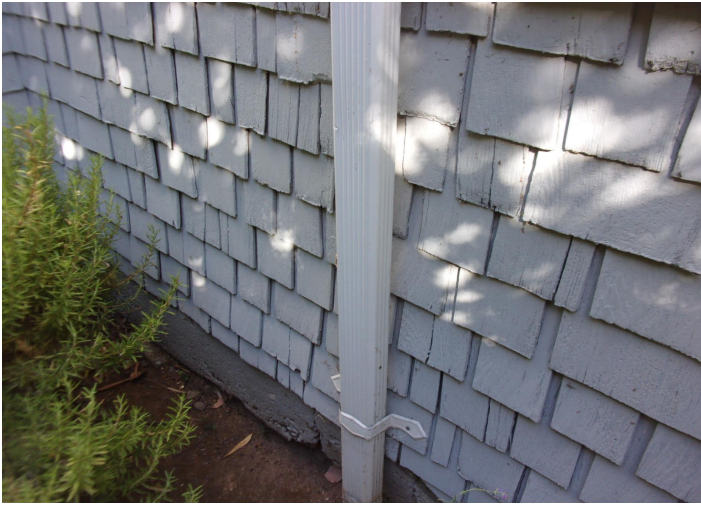
11A

FINDING: Fungus damage noted at the shake siding. Damage may extend into inaccessible areas.

RECOMMENDATION: Remove the fungus damaged portions of the shake siding. Call for a reinspection of the inaccessible areas. The inaccessible areas will be inspected for a fee if made accessible by the interested parties at his/her expense. A supplemental report will be filed at such time. No opinion is rendered concerning the conditions in the area at this time. Replace with new material.

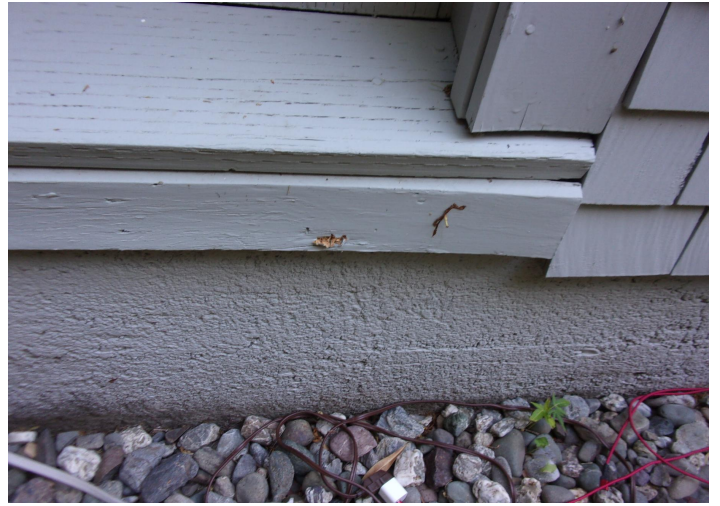
11B

FINDING: Fungus damage noted at the basement window trim. Damage may extend into inaccessible areas.

RECOMMENDATION: Remove the fungus damaged portions of the window trim. Call for a reinspection of the inaccessible areas. The inaccessible areas will be inspected for a fee if made accessible by the interested parties at his/her expense. A supplemental report will be filed at such time. No opinion is rendered concerning the conditions in the area at this time. Replace with new material.

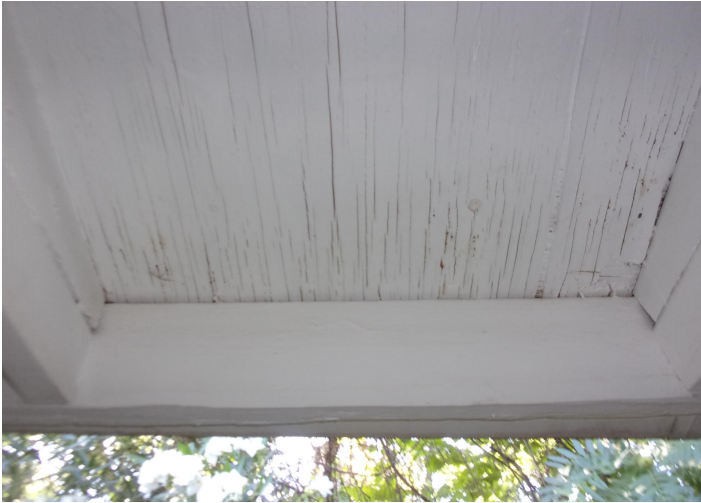
11C

FINDING: Stains were noted at the eaves.

RECOMMENDATION: Interested parties should engage the services of a licensed contractor to check for leaks and to perform any corrective work needed.
