CAL WEST HOME INSPECTION

Property address: **94 New Season**

Inspection date: **Monday, December 6, 2021**

Pre-Listing Property Inspection Report

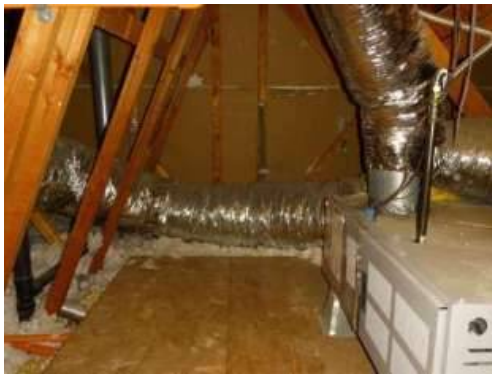
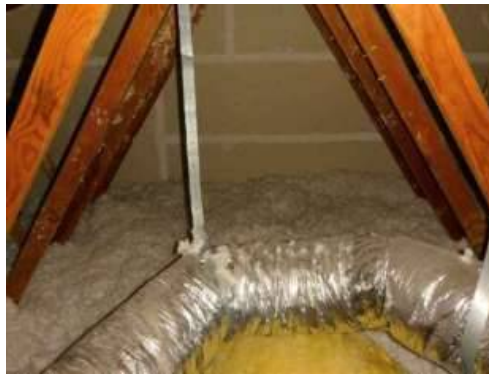
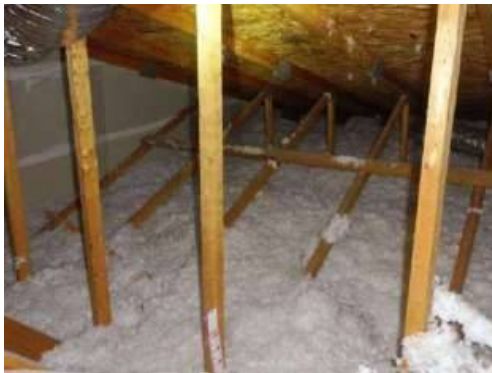
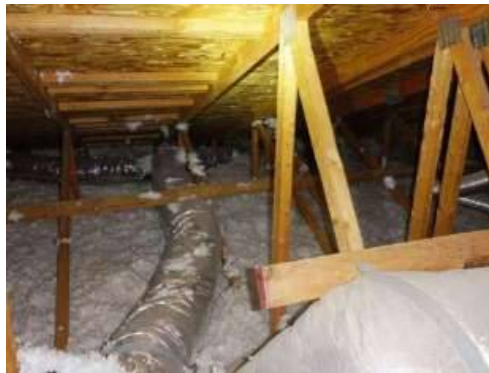
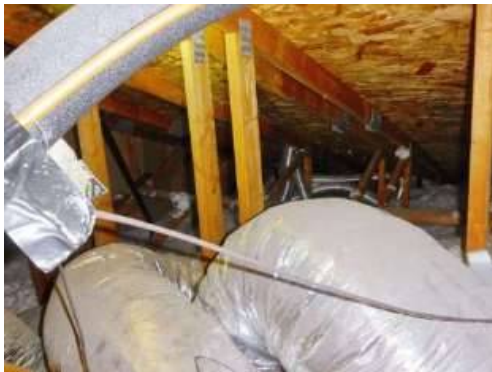
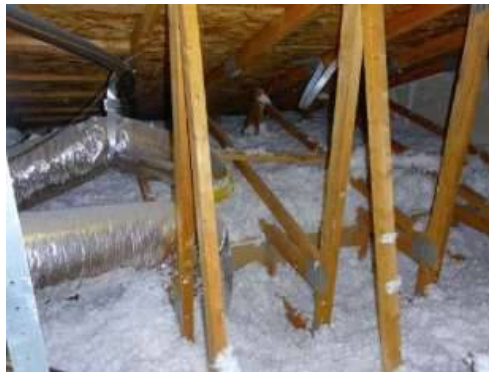
10) **Evaluate, Comment** - The attic space was viewed from the furnace platform(s) due to the small attic space. Consult with the owner for more information on any known issues, past repairs or modifications made in the attic space. See sample picture(s) below.

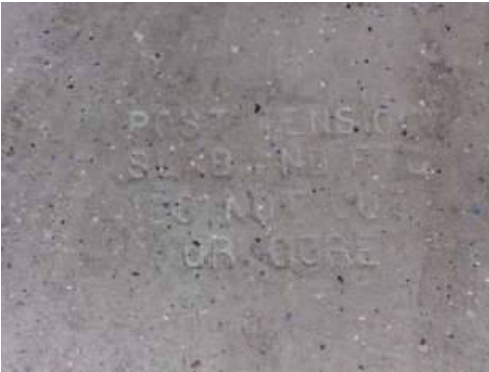
Photo 11-1

11) **Safety, Comment** - Post tension cables in slab and/or footing. Do not cut or core.

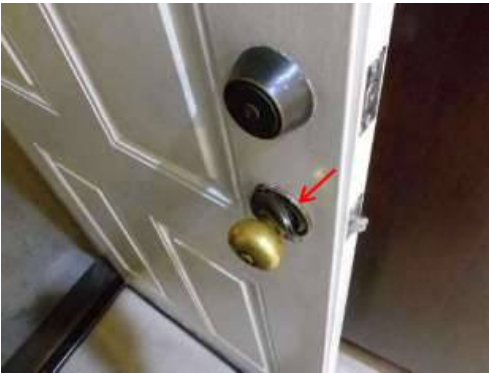
Photo 12-1

12) **Repair/Replace** - Garage door hardware, including locksets were damaged. Recommend that a qualified person repair or replace as necessary. See sample picture(s) below

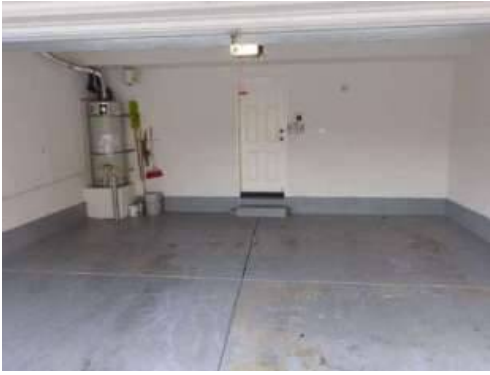
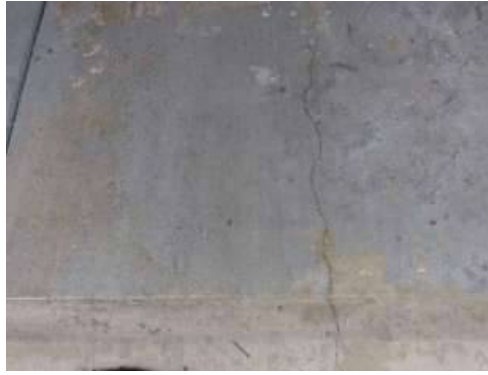
14) **Comment** - Minor cracks and/or deterioration noted in the concrete slab and/or stem walls are typical. Minor marks or deterioration noted in walls and ceilings are typical. Appears serviceable with wear and conditions consistent with the age of the structure and materials. Repair or seal as necessary. See sample picture(s) below.

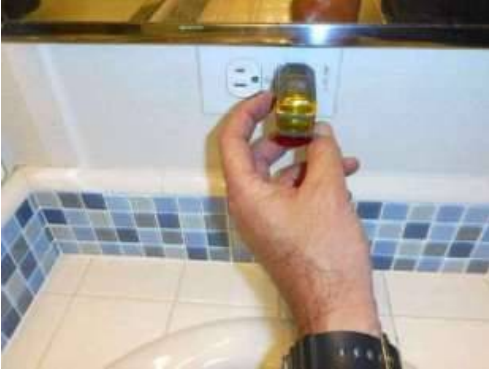
Photo 15-1

15) Safety, Repair/Replace, Evaluate - One or more ground fault circuit interrupter (GFCI) receptacles (outlets) would not trip at the bathroom(s). Second floor bathroom(s). Labeled as GFCI protected. This is a potential shock hazard. Recommend that a licensed electrical contractor evaluate and repair as necessary. See sample picture(s) below

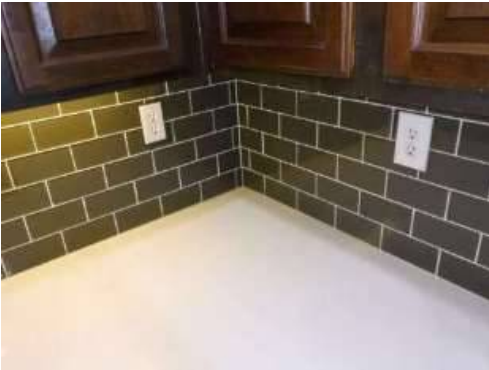
Photo 16-1

16) Safety, Repair/Replace, Evaluate - One or more electric receptacles (outlets) at the kitchen, garage and/or exterior had no visible ground fault circuit interrupter (GFCI) protection. If not GFCI-protected, receptacles in wet areas pose a shock hazard. Recommend that a licensed electrical contractor evaluate and install GFCI protection if necessary and per standard building practices. General guidelines for GFCI-protected receptacles include the following locations:

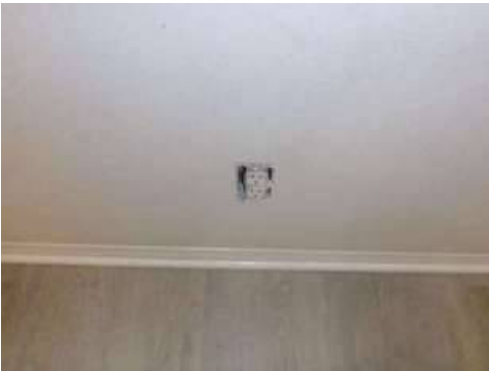
Photo 17-1

17) Safety, Repair/Replace, Evaluate - Missing or broken cover plates found at one or more locations. This is a safety hazard. Recommend that a licensed electrical contractor evaluate and repair as necessary. See sample picture(s) below

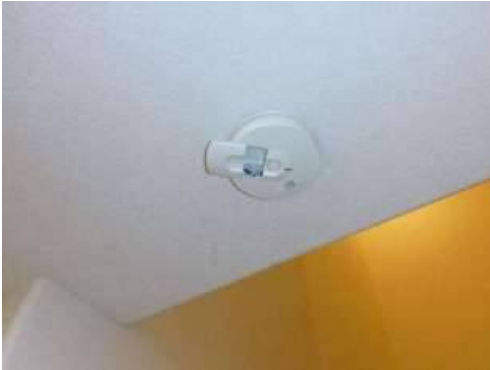
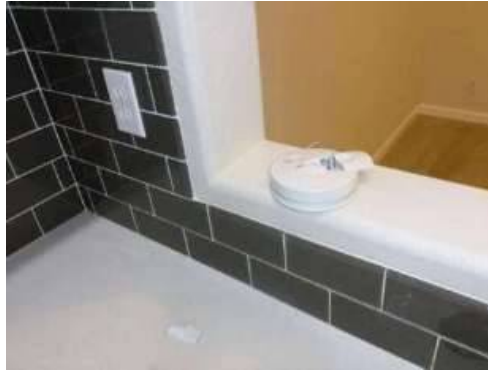
18) Safety, Repair/Replace - Smoke alarms were missing from bedrooms. On site but not installed. Additional smoke alarms should be installed as necessary so a functioning alarm exists in each hallway leading to bedrooms, in each bedroom and on each level. For more information, visit: <https://www.reporthost.com/?SMKALRM>

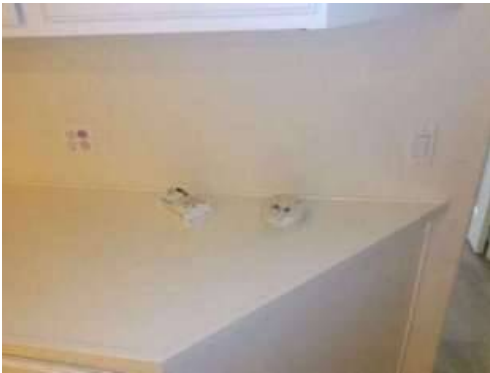
Photo 19-1

19) Safety, Repair/Replace - Carbon monoxide alarms were missing from one or more sleeping areas. On site but not installed. This is a potential safety hazard. Some states and/or municipalities require CO alarms to be installed in the vicinity of each sleeping area, on each level and in accordance with the manufacturer's recommendations. Recommend installing additional carbon monoxide alarms per these standards. For more information, visit: <https://www.reporthost.com/?COALRM>

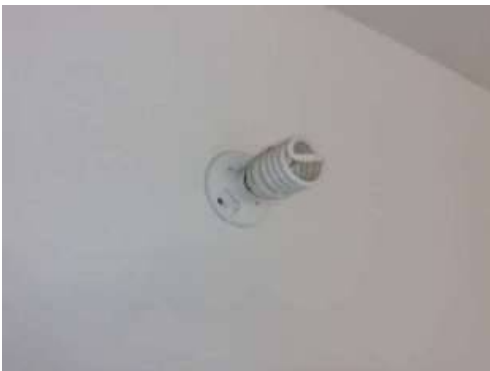
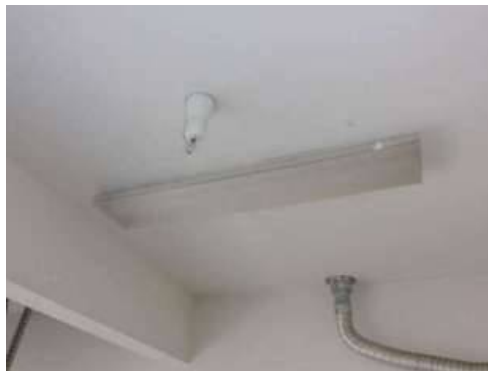
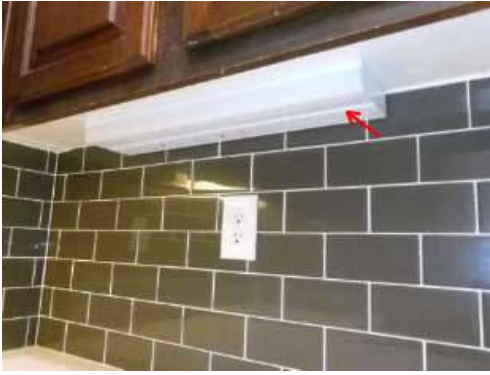
21) Evaluate - Bulbs in one or more light fixtures were missing, broken or not operational. These light fixtures couldn't be fully evaluated. If replacement bulbs are inoperable, then recommend that a licensed electrical contractor evaluate and repair or replace light fixtures as necessary. See sample picture(s) below

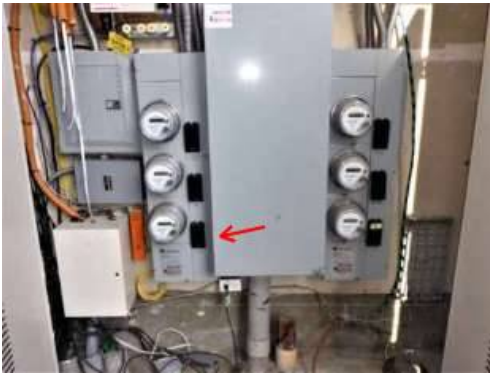
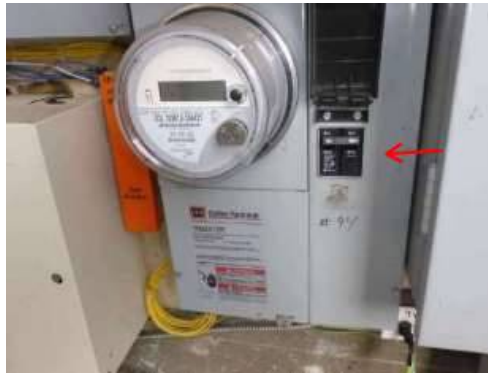
22) **Comment** - The main electrical service panel and disconnect location #A.

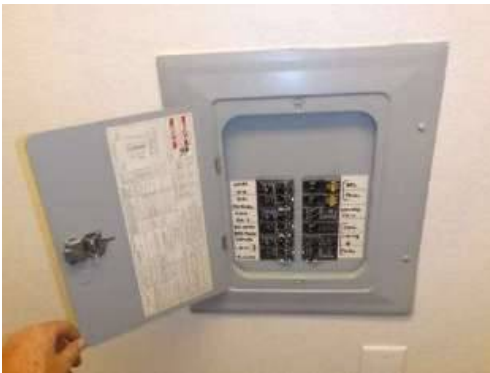
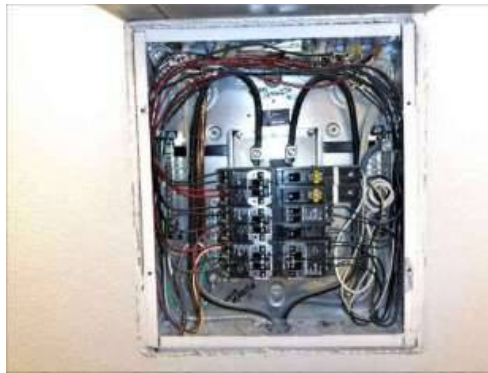
23) **Comment** - Sub-panel #B was located in the laundry.

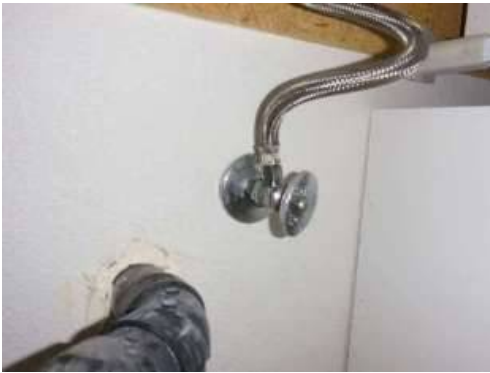
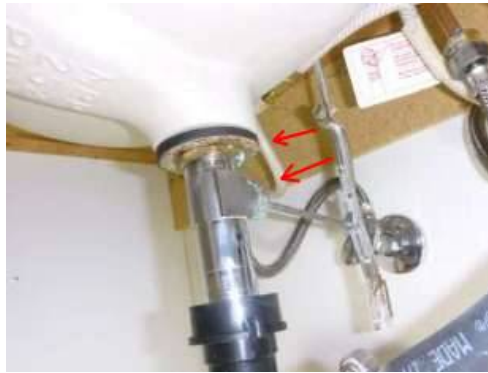
24) Repair/Replace, Evaluate - Minor rust or corrosion was found on water supply lines and/or drain lines. Leaks can occur as a result. Recommend that a qualified plumber evaluate and repair or replace components as necessary. See sample picture(s) below.

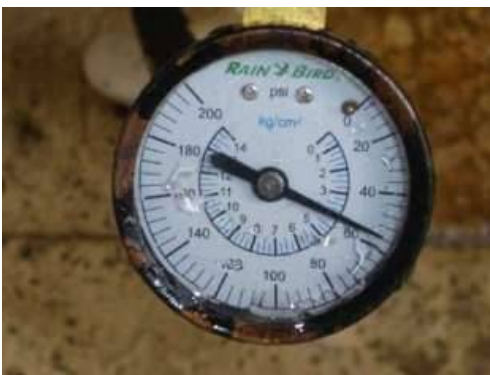
Photo 29-1

29) Comment - The normal water pressure range for a building is 40-80 PSI. Water pressure at the time of inspection was 56 psi.

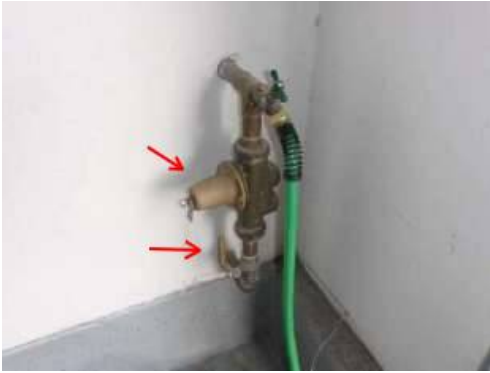
Photo 30-1

30) Comment - The water main shut-off valve. Pressure reducing valve installed.

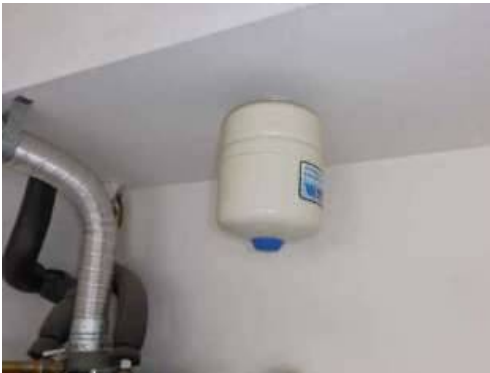
Photo 31-1

31) **Comment** - Expansion tank installed.

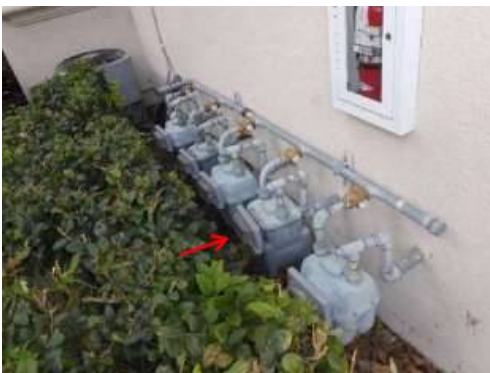
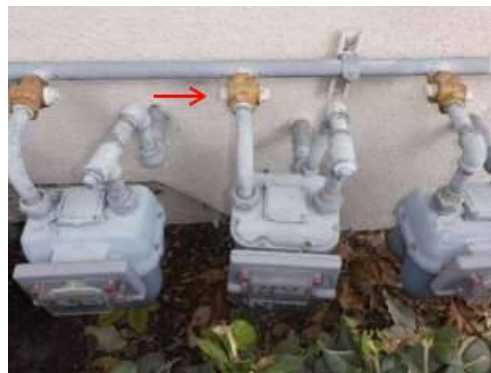
32) **Comment** - The gas meter and the shut-off valve.

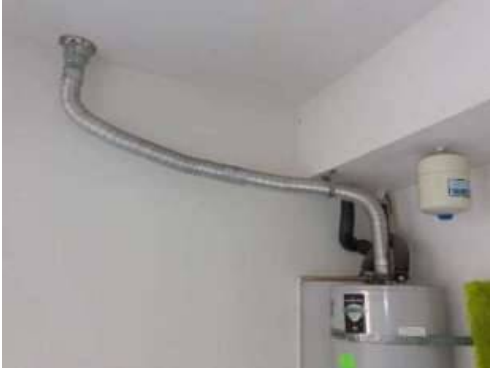
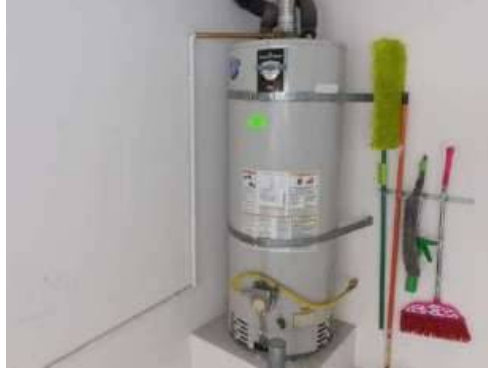
33) Comment - Water heater.

34) Comment - The estimated useful life for most water heaters is 8-12 years. This water heater appeared to be beyond this age and/or its useful lifespan and may need replacing at any time. Recommend budgeting for a replacement in the near future, or considering replacement now before any leaks occur. The client should be aware that significant flooding can occur if the water heater fails.

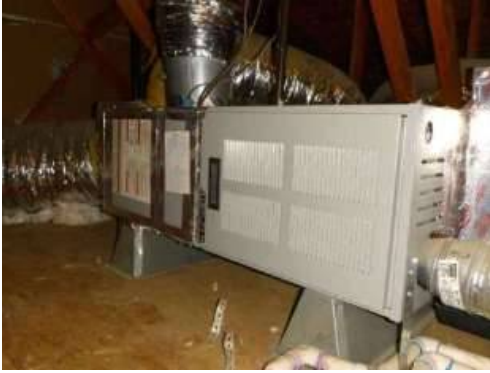
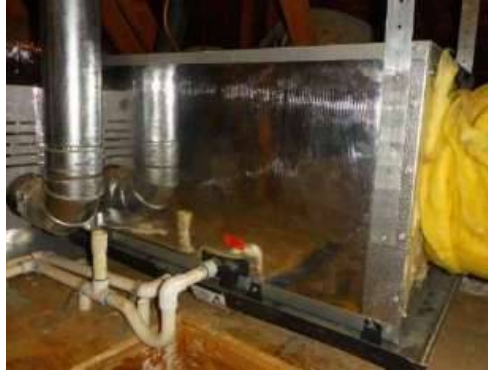
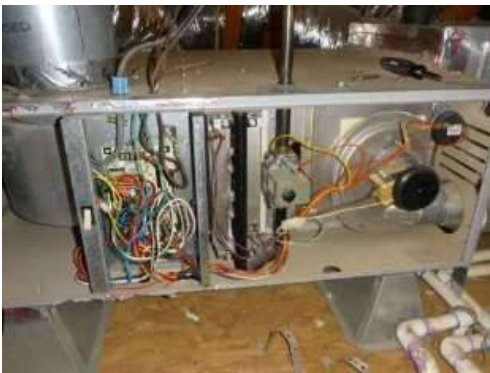
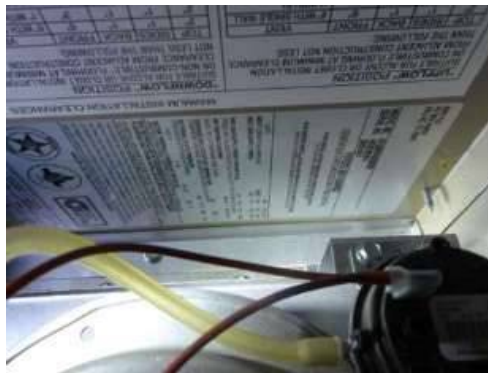
37) Comment - Forced Air Furnace(s).

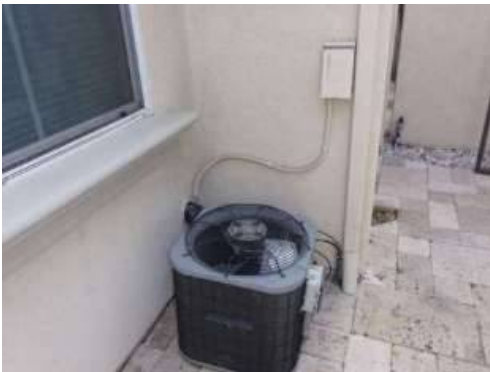
Photo 38-1

38) Comment - AC Condenser(s) or Heat pump(s).

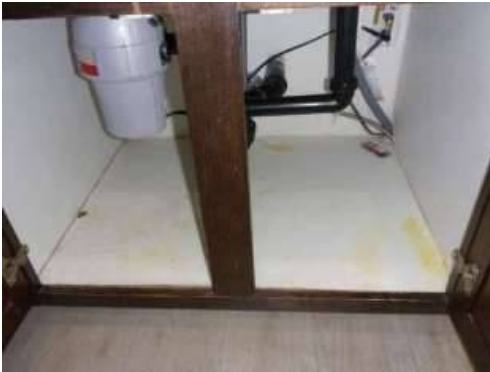
Photo 41-1

41) Repair/Maintain, Monitor - Stains were found in the shelving or cabinets under the sink. Minor water damage. Stains found on the garbage disposal. Plumbing leaks may have occurred in the past. No leaks detected at time of inspection. Consult with the property owner for more information. Repair or clean as necessary and monitor in the future. See sample picture(s) below.

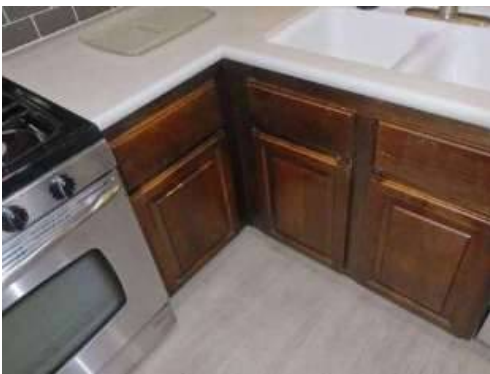
Photo 42-1

42) Repair/Maintain - The finish on one or more drawer fronts or cabinet doors were deteriorated. Recommend that a qualified person repair as necessary. See sample picture(s) below.

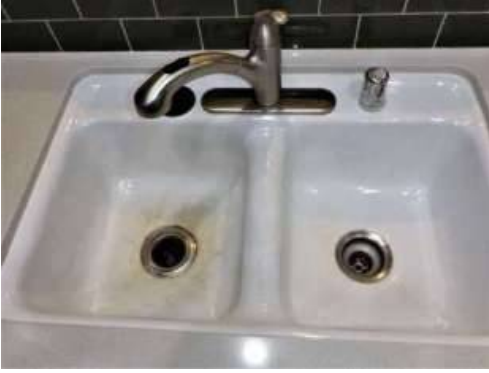
Photo 43-1

43) Repair/Maintain - The kitchen sink had minor wear, stains or deterioration.

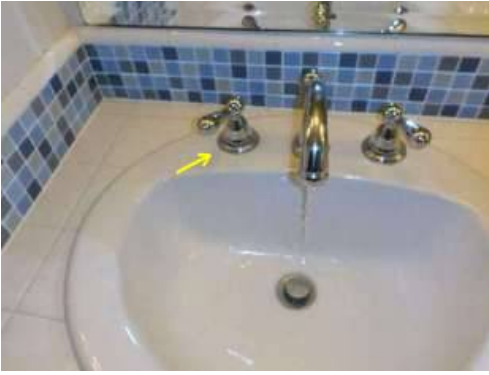
Photo 46-1

46) **Repair/Replace, Evaluate** - One or more sink faucet handles were leaking at bathroom location(s) #A. The hot water supply flow for the sink at location(s) #A was low or inoperable. Recommend that a qualified plumber evaluate and repair as necessary. See sample picture(s) below

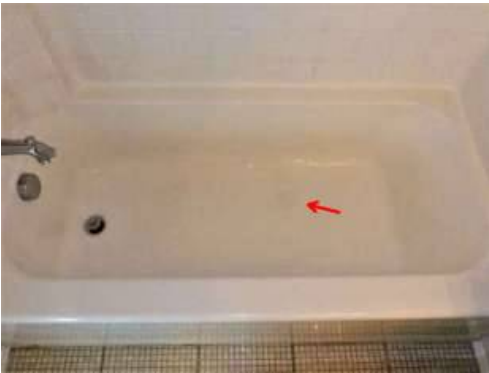
Photo 47-1

47) Repair/Maintain, Comment - The bathtub at location(s) #C was damaged or deteriorated. See sample picture(s) below

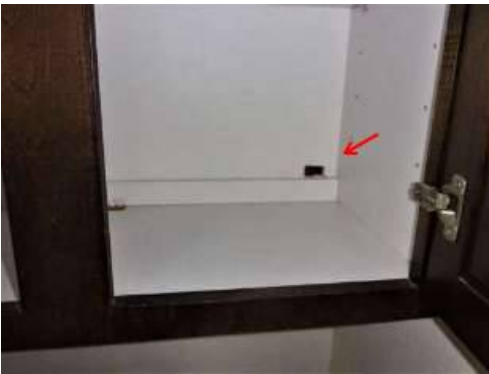
Photo 49-1

49) Repair/Maintain - Wall damage or hole(s) were found at bathroom location(s) #A. Toilet room cabinet. Repair as necessary. See sample picture(s) below.

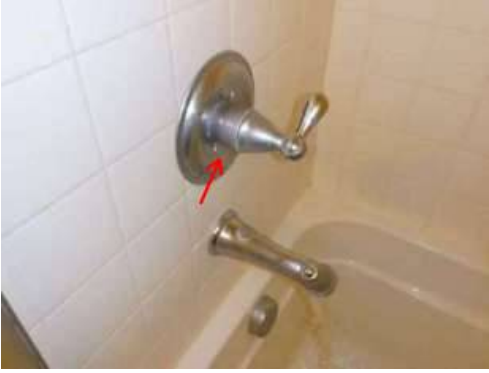
Photo 50-1

50) Repair/Maintain - The tub/shower controls were leaking at bathroom location(s) #A. And the tub spout was turned. Repair as necessary.

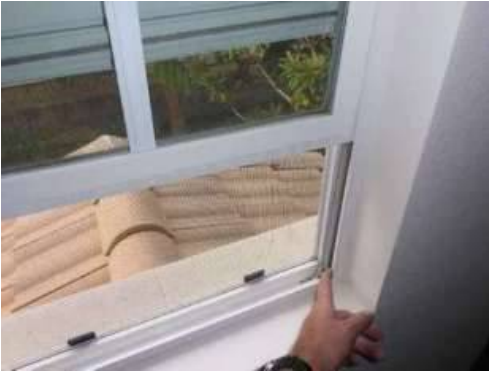
**Photo 54-1**

54) Repair/Maintain - The sash-side spring or control mechanisms in one or more windows were broken. The window(s) were difficult to operate as a result, and not square in their frames or tracks. Recommend that a qualified contractor or service technician repair as necessary. See sample picture(s) below. For example: Master bathroom, toilet room.

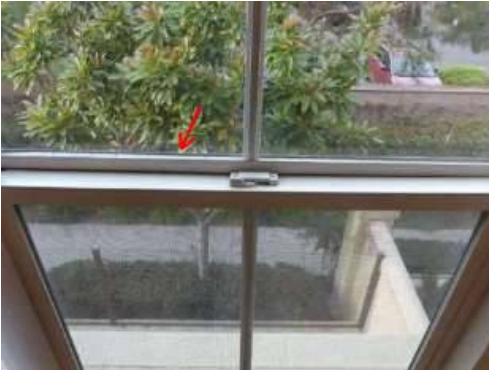
**Photo 56-1**

56) Evaluate, Monitor - Interior window gasket material appeared to be breaking down in one or more dual pane windows. Monitor. See sample picture(s) below.

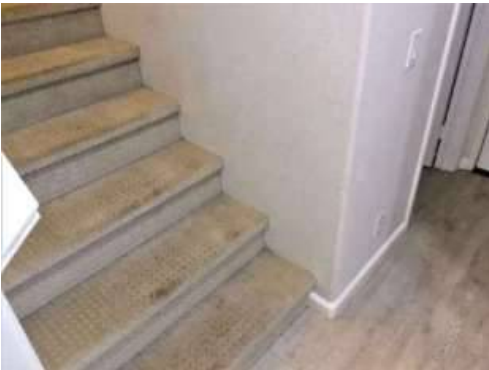
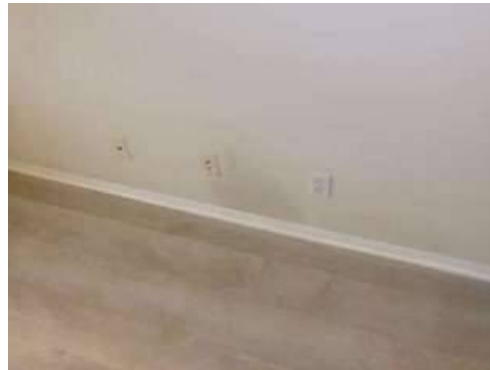
57) Comment - Minor cracks, substandard paint, nail pops, marks and/or deterioration noted in walls and ceilings are typical. Appears serviceable with wear and conditions consistent with the age of the structure and materials. Repair or seal minor cracks or deterioration as necessary. See sample picture(s) below.
