WOOD DESTROYING PESTS AND ORGANISMS INSPECTION REPORT

Building No. 14623	Street Colter	City Magalia	ZIP 95954	Date of Inspection 06/27/2022	Number of Pages 8
Stone Ridge Termite and Pest P.O. Box 6927 Chico CA 95927 (530) 228-1964 (530) 876-9271 stoneridge0790@sbcglobal.net Fax (530) 876-9273				Report # : 40058 Registration # : PR3779 Escrow # : <input type="checkbox"/> CORRECTED REPORT	
Ordered by: Carl Henker Coldwell Banker C&C Properties chenker@coldwellbankerchico.com		Property Owner and/or Party of Interest: Steve Laird 1210 Dog Leg Dr Chico CA 95928 ChicoHomeSales@gmail.com		Report sent to: Carl Henker Coldwell Banker C&C Properties chenker@coldwellbankerchico.com	
COMPLETE REPORT <input checked="" type="checkbox"/> LIMITED REPORT <input type="checkbox"/> SUPPLEMENTAL REPORT <input type="checkbox"/> REINSPECTION REPORT <input type="checkbox"/>					
GENERAL DESCRIPTION: Single family residence; vacant, detached garage				Inspection Tag Posted: Subarea Other Tags Posted: None noted

14623	Colter	Magalia	CA	95954
Address of Property Inspected		City	State	ZIP
06/27/2022	40058			
Date of Inspection	Corresponding Report No.		Escrow No.

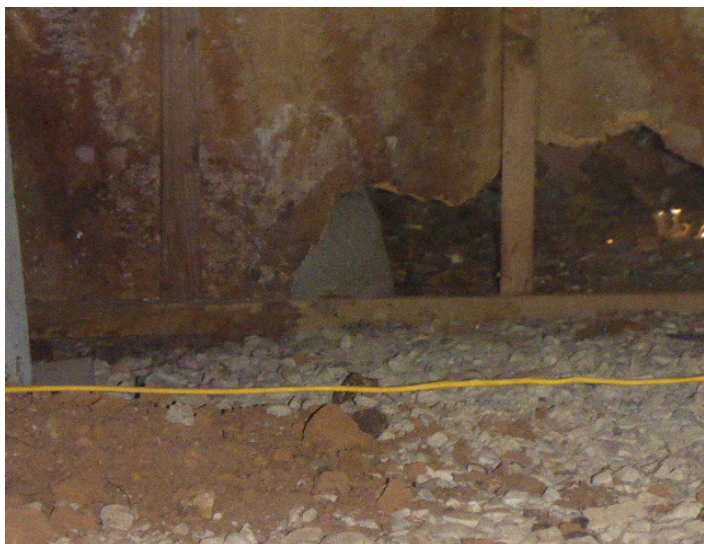
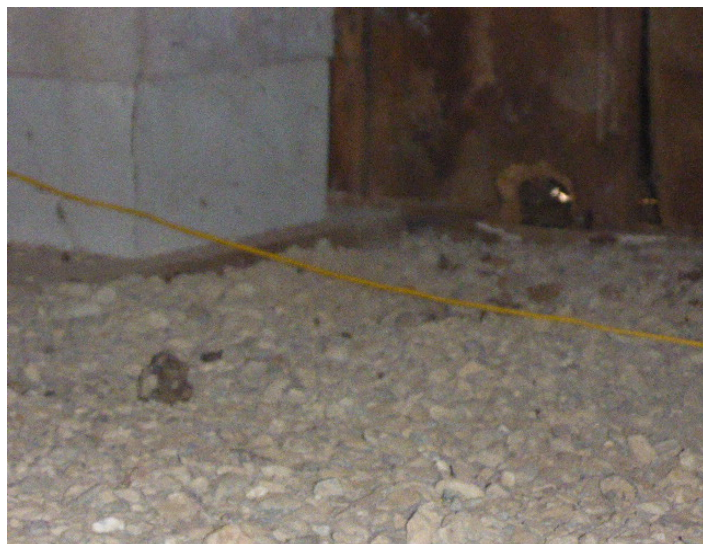
1A

FINDING: Fungus infection, fungus damage and earthwood contacts were noted at the skirting and skirting frames. Damage may extend into inaccessible areas.

RECOMMENDATION: Remove the fungus damaged portions of the skirting and skirting frames. Call for a reinspection of the inaccessible areas. The inaccessible areas will be inspected for a fee if made accessible by the interested parties at his/her expense. A supplemental report will be filed at such time. No opinion is rendered concerning the conditions in the area at this time. Replace with pressure treated material as needed to break the earthwood contacts.

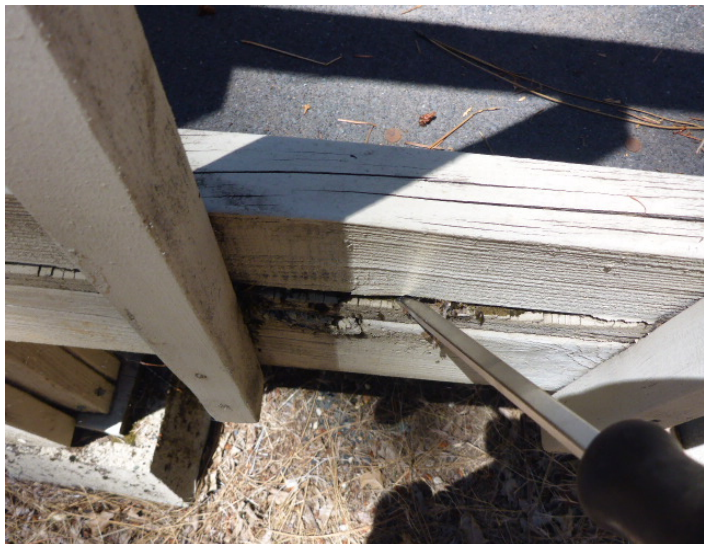
4A

FINDING: Fungus infection/damage noted at the front porch ramp plywood decking and joists. Damage may extend into inaccessible areas.

RECOMMENDATION: Remove the fungus damaged portions of the plywood decking and joists. Call for a reinspection of the inaccessible areas. The inaccessible areas will be inspected for a fee if made accessible by the interested parties at his/her expense. A supplemental report will be filed at such time. No opinion is rendered concerning the conditions in the area at this time. Replace with new material. Scrape and/or power wash fungus infected wood members and treat with a registered fungicide.

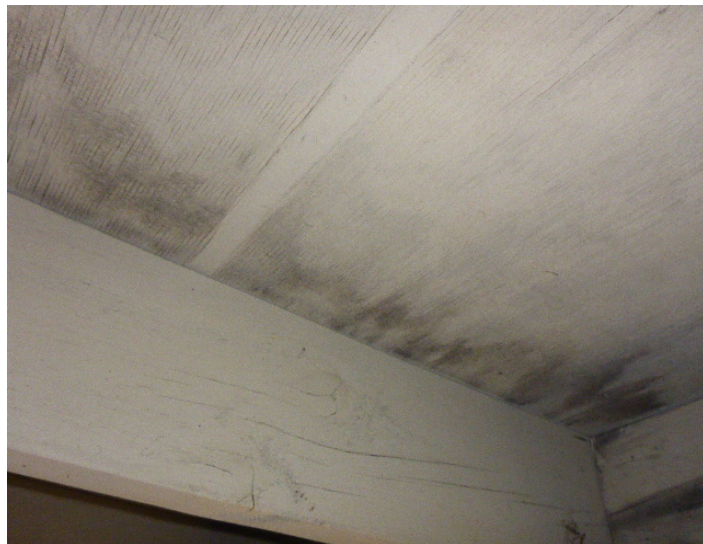
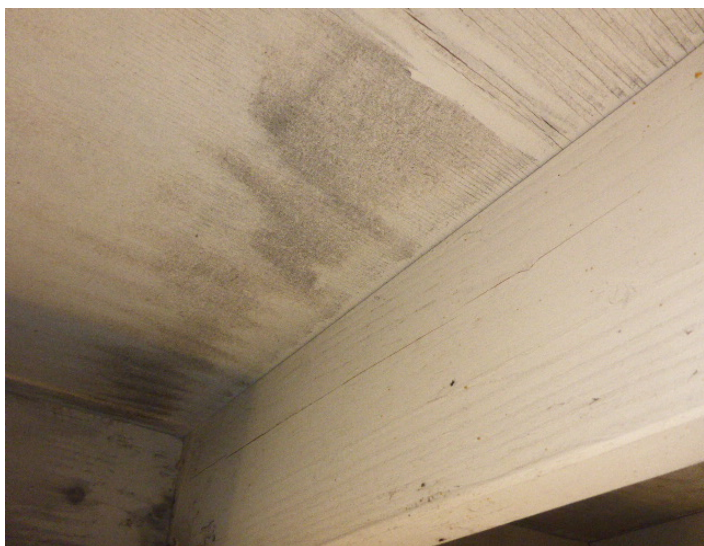
4B

FINDING: Stains were noted at the front deck cover roof sheathing and rafters. Unable to determine if stains are active or

passive.

RECOMMENDATION: Interested parties should engage the services of a licensed contractor to check for leaks and to perform any corrective work needed.

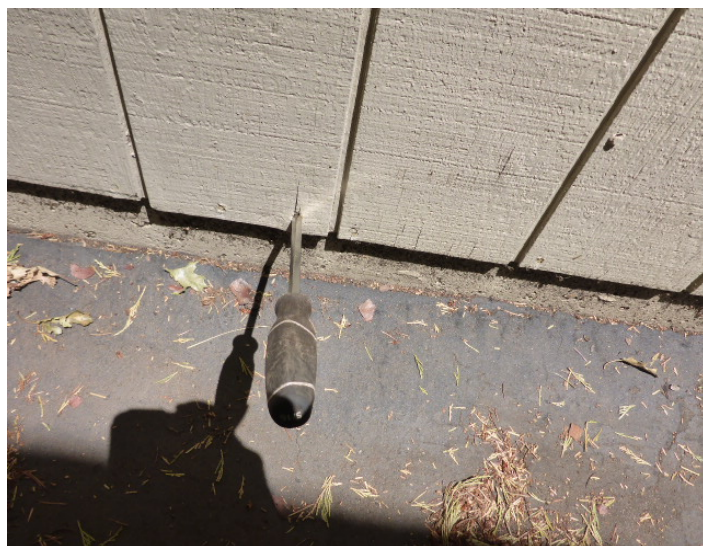
8A

FINDING: Fungus damage noted at the garage siding. Damage may extend into inaccessible areas.

RECOMMENDATION: Remove the fungus damaged portions of the siding. Call for a reinspection of the inaccessible areas. The inaccessible areas will be inspected for a fee if made accessible by the interested parties at his/her expense. A supplemental report will be filed at such time. No opinion is rendered concerning the conditions in the area at this time. Replace with new material.

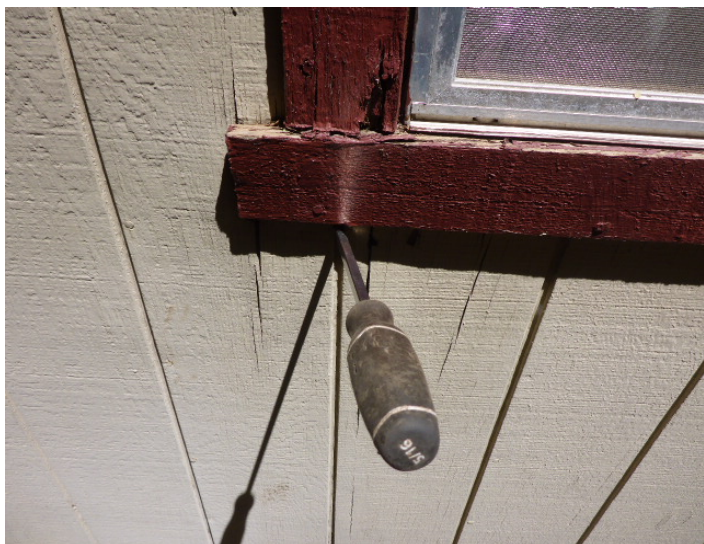
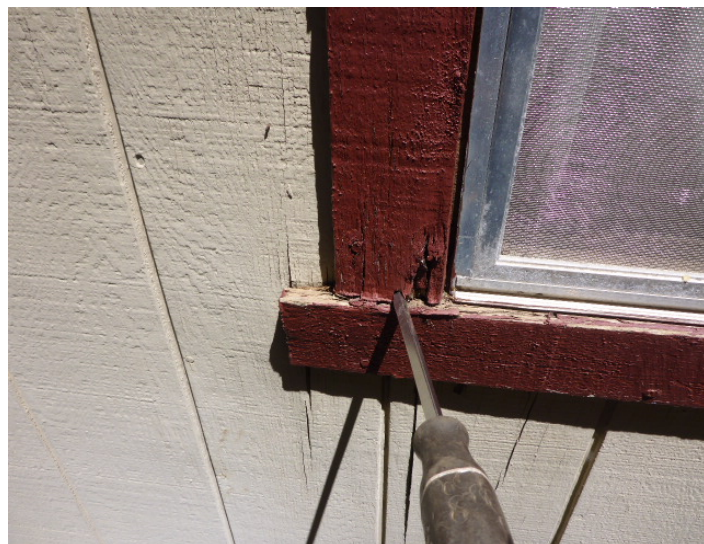
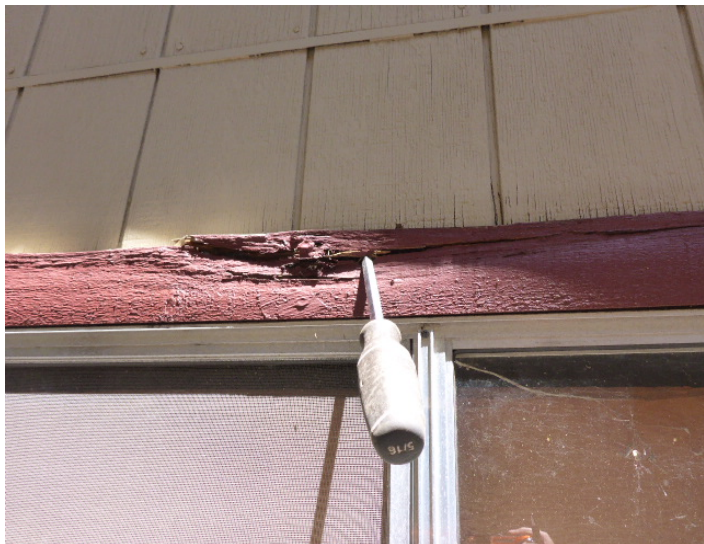
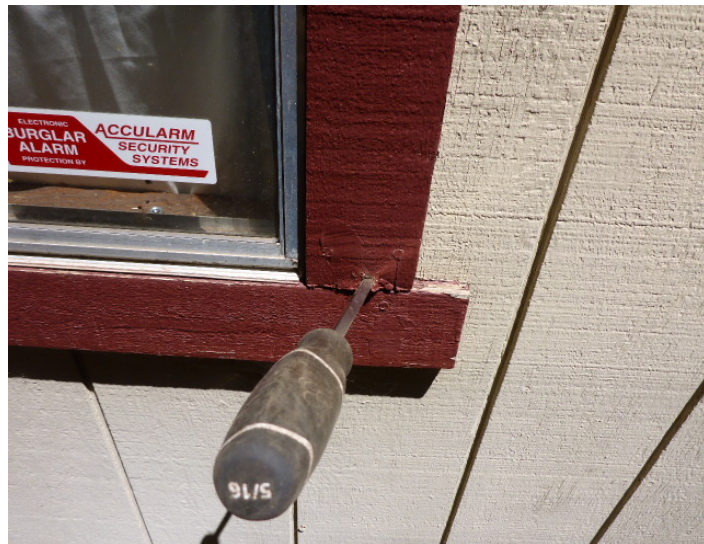
8B

FINDING: Fungus damage noted at the garage window trim and header trim and adjacent siding. Damage may extend into inaccessible areas.

RECOMMENDATION: Remove the fungus damaged portions of the window trim and siding. Call for a reinspection of the inaccessible areas. The inaccessible areas will be inspected for a fee if made accessible by the interested parties at his/her expense. A supplemental report will be filed at such time. No opinion is rendered concerning the conditions in the area at this time. Replace with new material.

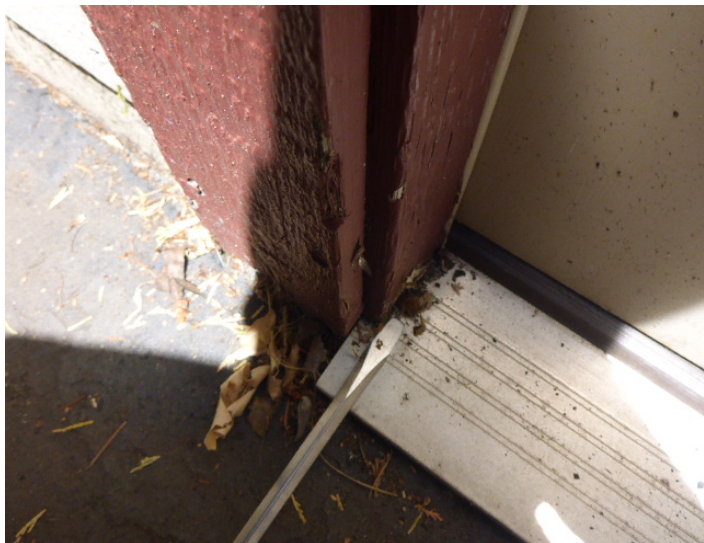
8C

FINDING: Stains and fungus damage noted at the garage door, jambs and trim. Damage may extend into inaccessible areas.

RECOMMENDATION - Interested parties should engage the services of a licensed contractor to check for leaks and to perform any corrective work needed. Remove the fungus damaged portions of the door, jambs and trim. Call for a reinspection of the inaccessible areas. The inaccessible areas will be inspected for a fee if made accessible by the interested parties at his/her expense. A supplemental report will be filed at such time. No opinion is rendered concerning the conditions in the area at this time. Replace with new material.

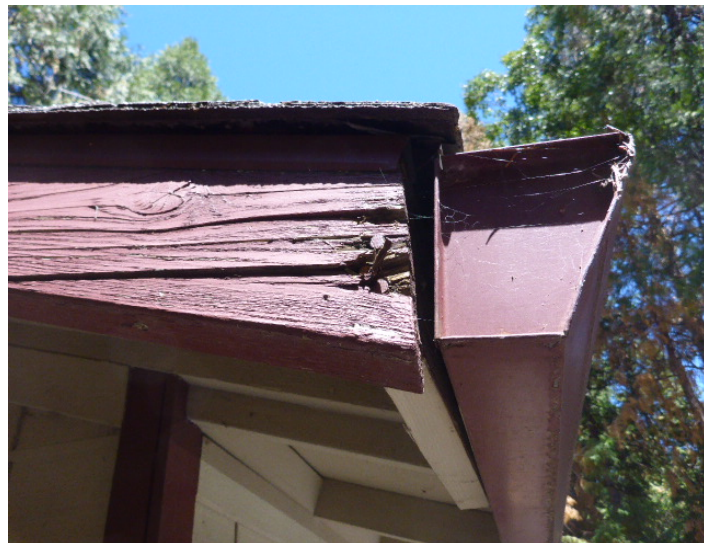
8D

FINDING: Stains and fungus damage noted at the barge rafters at the eaves. Damage may extend into inaccessible areas.

RECOMMENDATION: Interested parties should engage the services of a licensed contractor to check for leaks and to perform any corrective work needed. Remove the fungus damaged portions of the barge rafters. Call for a reinspection of the inaccessible areas. The inaccessible areas will be inspected for a fee if made accessible by the interested parties at his/her expense. A supplemental report will be filed at such time. No opinion is rendered concerning the conditions in the area at this time. Replace with new material.

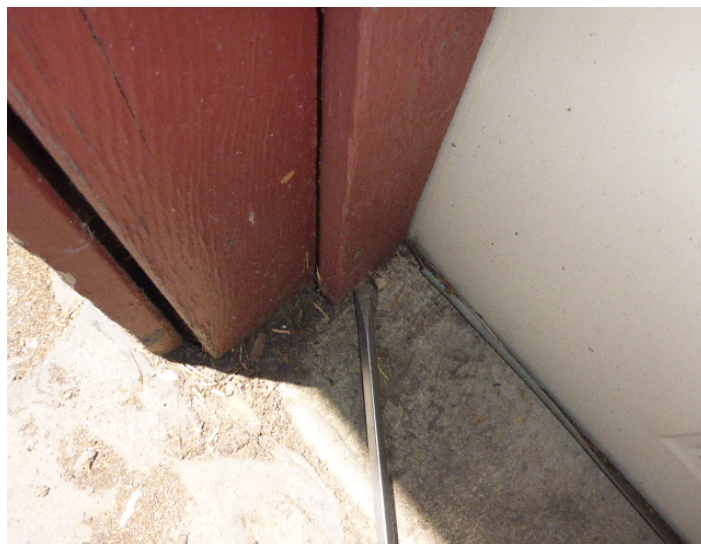
8F

FINDING: Stains and fungus damage noted at the garage door frames and trim. Damage may extend into inaccessible areas.

RECOMMENDATION: Interested parties should engage the services of a licensed contractor to check for leaks and to perform any corrective work needed. Remove the fungus damaged portions of the door frames and trim. Call for a reinspection of the inaccessible areas. The inaccessible areas will be inspected for a fee if made accessible by the interested parties at his/her expense. A supplemental report will be filed at such time. No opinion is rendered concerning the conditions in the area at this time. Replace with new material.

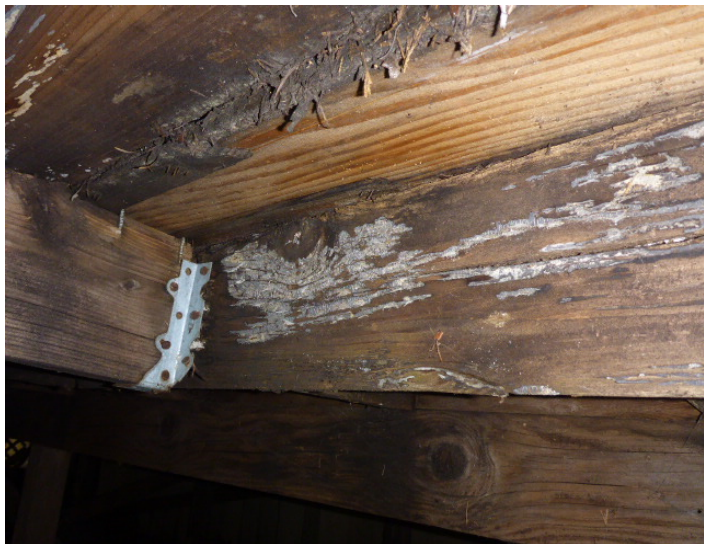
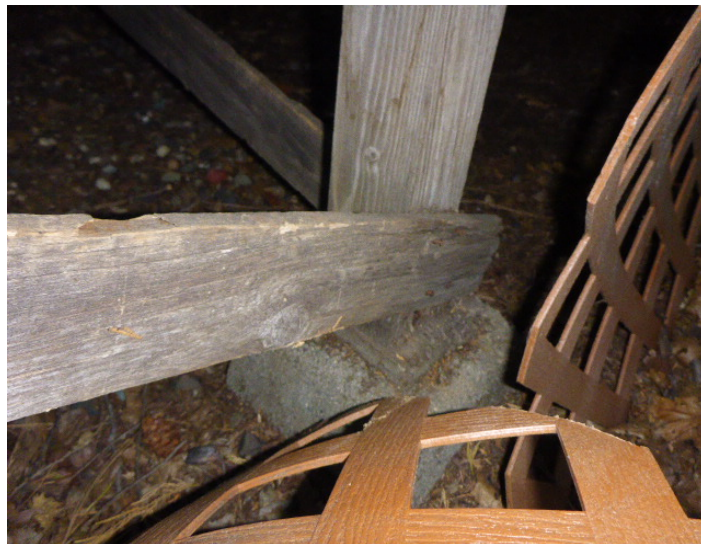
9A

FINDING: Fungus infection/damage noted at the decking, joists, support posts/pads, cross bracing and girders. Damage may extend into inaccessible areas.

RECOMMENDATION: Remove the fungus damaged portions of the decking, joists, support posts/pads, cross bracing and girders. Call for a reinspection of the inaccessible areas. The inaccessible areas will be inspected for a fee if made accessible by the interested parties at his/her expense. A supplemental report will be filed at such time. No opinion is rendered concerning the conditions in the area at this time. Replace with new material. Scrape and/or power wash fungus infected wood members and treat with a registered fungicide.

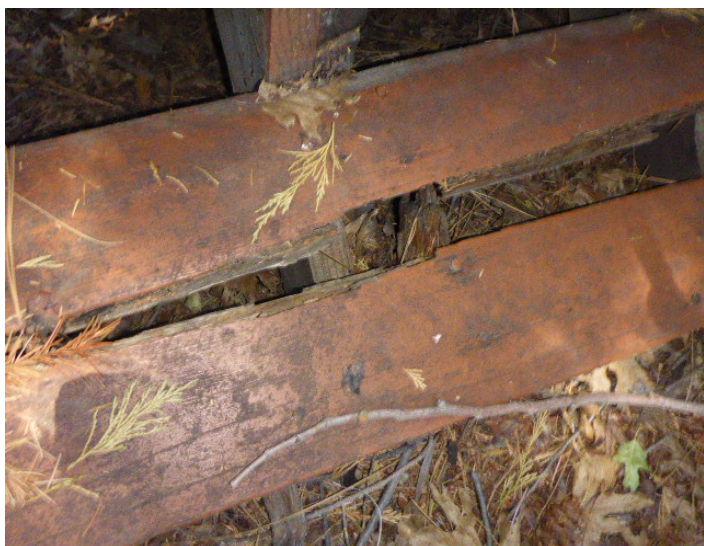
9B

FINDING: Fungus infection/damage and earthwood contacts were noted at the deck steps/stringers.

RECOMMENDATION: Remove the fungus damaged portions of the steps/stringers and replace with new material. Regrade the soil levels as needed to break the earthwood contacts.

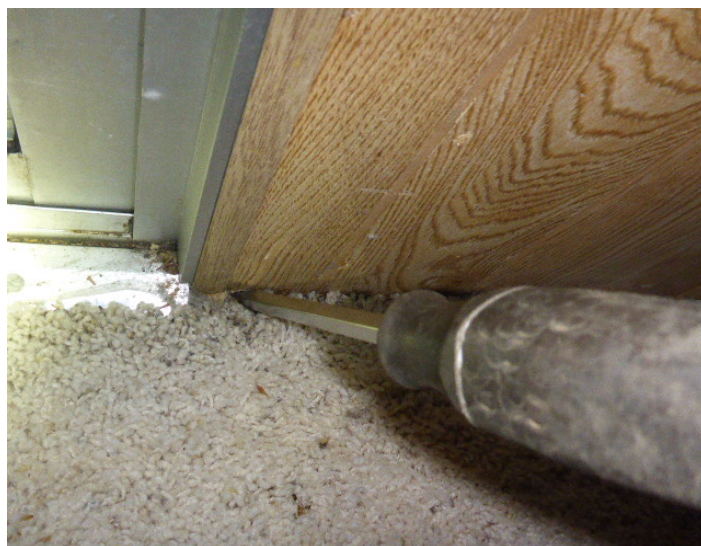
10A

FINDING: Stains and fungus damage noted at the dining room floor and wall panel adjacent to the sliding glass door. Damage may extend into inaccessible areas.

RECOMMENDATION: Interested parties should engage the services of a licensed contractor to check for leaks and to perform

any corrective work needed. Remove the fungus damaged portions of the floor and wall panel. Call for a reinspection of the inaccessible areas. The inaccessible areas will be inspected for a fee if made accessible by the interested parties at his/her expense. A supplemental report will be filed at such time. No opinion is rendered concerning the conditions in the area at this time. Replace with new material.

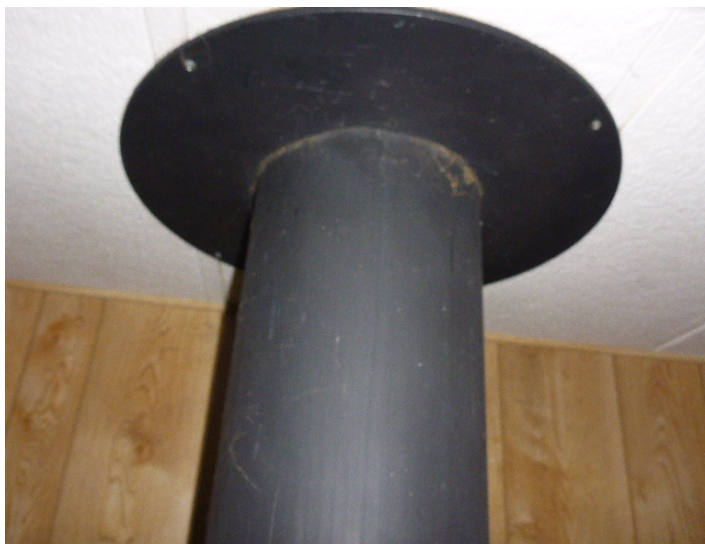
10C

FINDING: Stains were noted at the wood stove flue pipe. Unable to determine if stains are active or passive.

RECOMMENDATION: Interested parties should engage the services of a licensed contractor to check for leaks and to perform any corrective work needed.

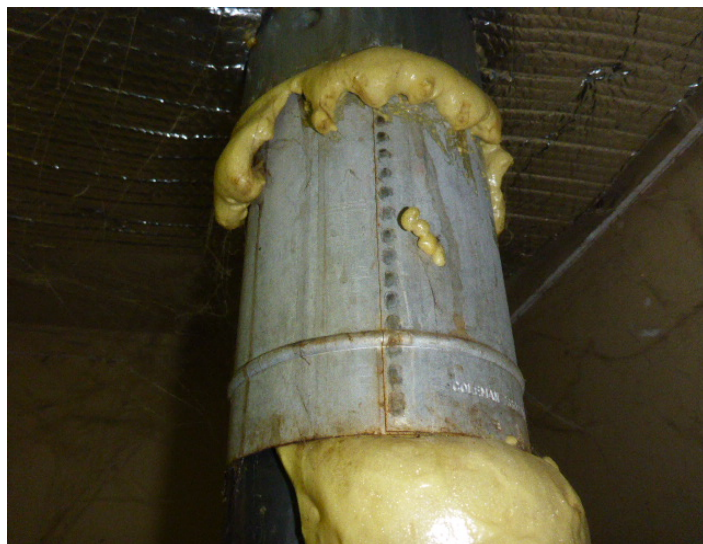
10D

FINDING: Stains were noted at the furnace exhaust pipe. Unable to determine if stains are active or passive.

RECOMMENDATION:- Interested parties should engage the services of a licensed contractor to check for leaks and to perform any corrective work needed.

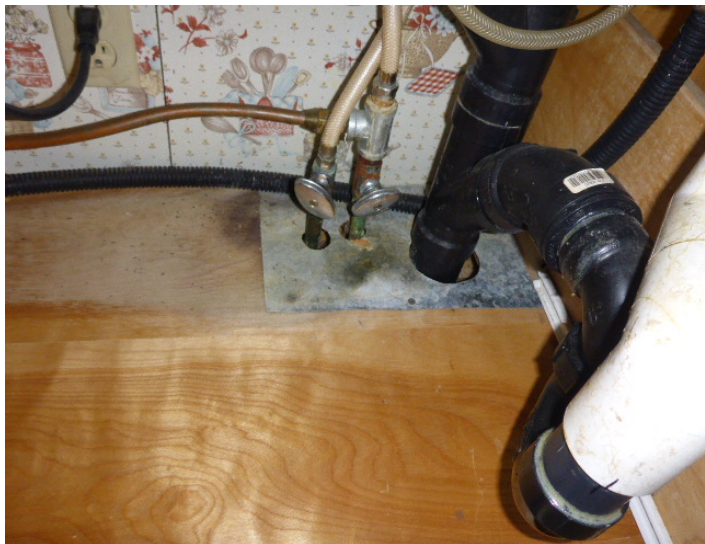
10E

FINDING: Stains (dry) were noted at the kitchen sink cabinet bottom.

RECOMMENDATION: Interested parties should engage the services of a licensed plumber to check for leaks and make repairs as needed.

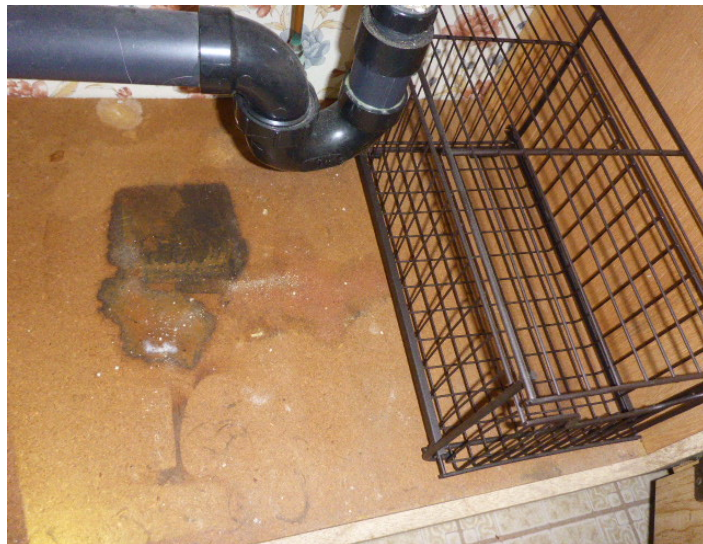
10F

FINDING: Stains (dry) were noted at the master bathroom sink cabinet bottom.

RECOMMENDATION: Interested parties should engage the services of a licensed plumber to check for leaks and make repairs as needed.

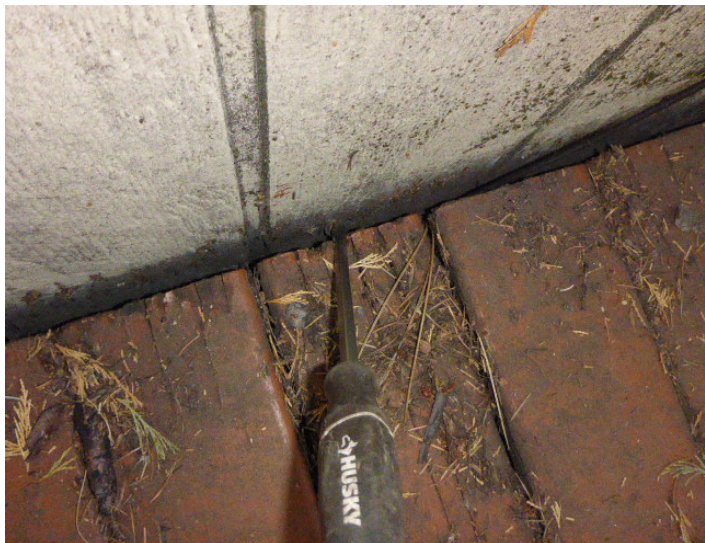
11B

FINDING: Fungus damage noted at the siding adjacent to the decking. Damage may extend into inaccessible areas.

RECOMMENDATION: Remove the fungus damaged portions of the siding. Call for a reinspection of the inaccessible areas. The inaccessible areas will be inspected for a fee if made accessible by the interested parties at his/her expense. A supplemental report will be filed at such time. No opinion is rendered concerning the conditions in the area at this time. Replace with new material.
