**408 East Clarion Drive
Carson CA 90745**

Client(s): Ngo
Inspection Date: 6/30/2024
Inspector: Tony Genova ,

Date: 6/30/2024	Time: 10:00:00 AM	Report ID: 1052127
Property: 408 East Clarion Drive, Carson, CA 90745		Prepared By: Tony Genova

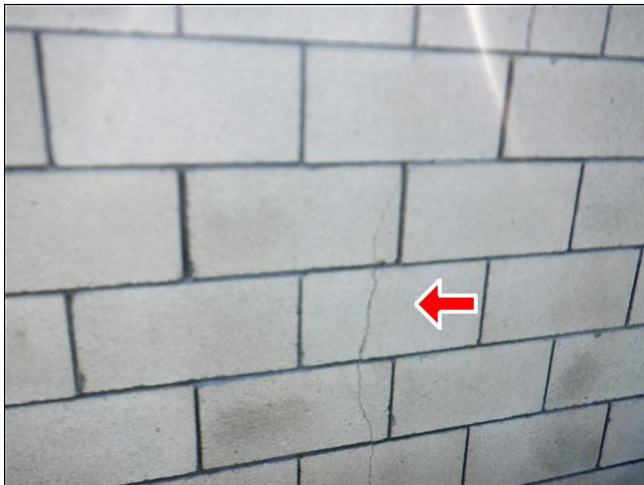
GRADING, DRAINAGE, RETAINING WALLS [Inspected]

- ⬆ ♦ The grading is inadequate around the exterior of the building. This can promote water entry into the building or foundation.
 - Have a qualified contractor or landscaper regrade the yard as needed.
- ⬆ ♦ The retaining wall shows some settlement cracks, but appears stable.

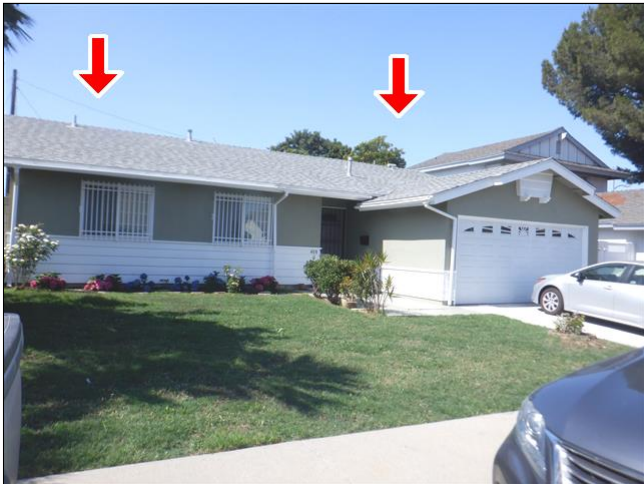
ROOF COVERINGS [Inspected]

- ◆ The roof covering appears to be adequately installed and functional. There are no signs of unusual or excessive wear of the roofing components. No immediate attention is required, other than any exceptions noted. New roof.

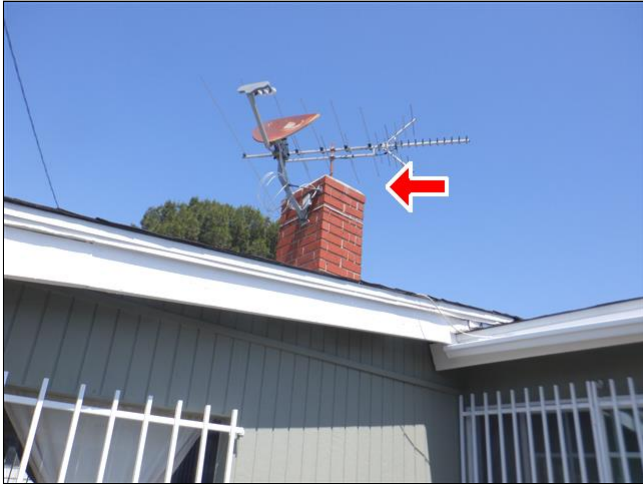
CHIMNEYS [Inspected]

- ◆ No proper spark arrestor or rain cap is installed at the living room fireplace chimney flue terminal(s). Caps help prevent the escape of hot embers or rain entry.
- A combination chimney cap/spark arrestor should be installed.

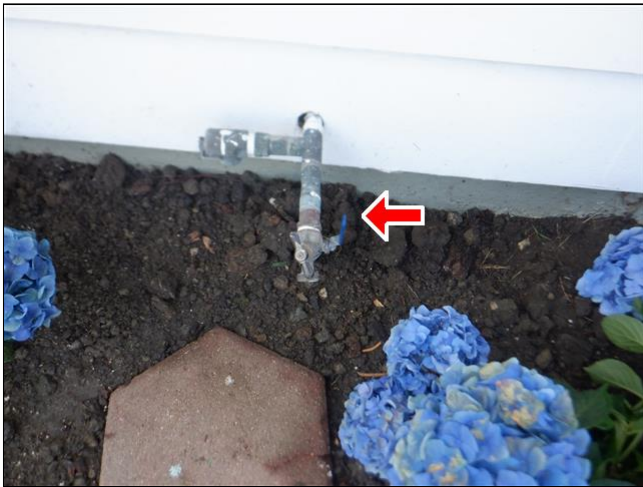
MAIN WATER SHUT-OFF [Inspected]

- ◆ Ball valve is present.

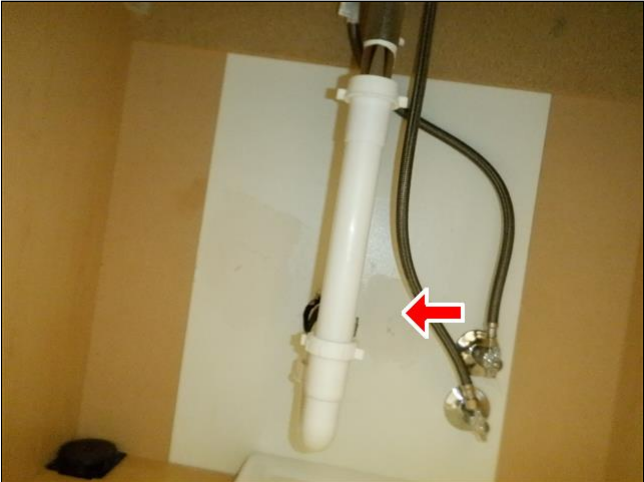
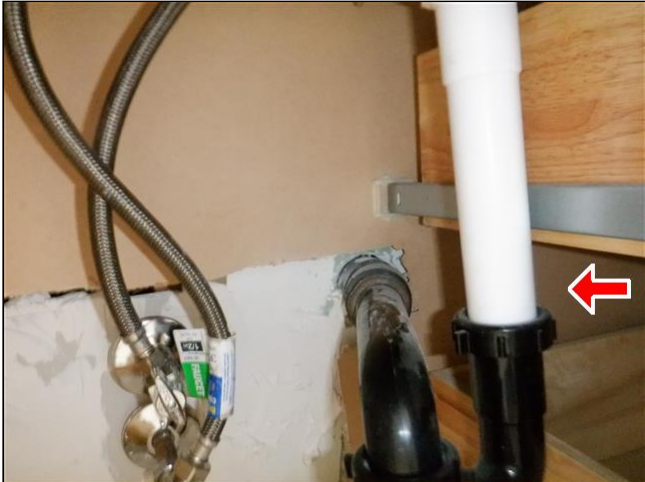
PLUMBING FIXTURES and DRAINS [Inspected]

- ◆ Back flow prevention devices are now required on exterior hose bibs to prevent contamination of the domestic water supply. These devices are inexpensive and available at most hardware stores. Consider upgrading the hose bibs by installing back flow devices.
- ◆ The drains from all functional fixtures were tested during this inspection, and appear functional, other than any exceptions noted. Each emptied in a reasonable amount of time, and did not back up when other fixtures were drained simultaneously.

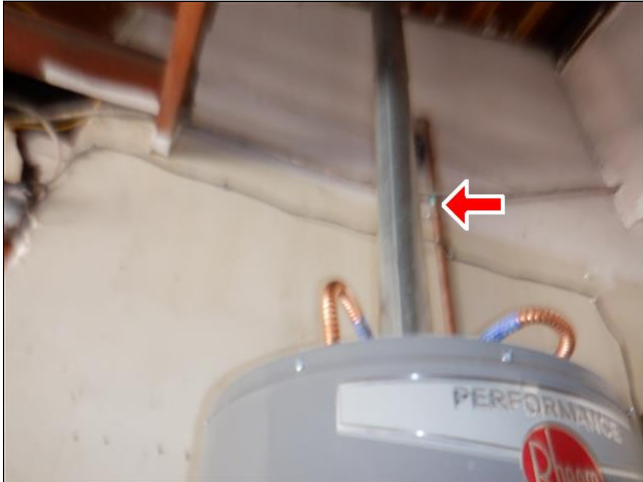
WATER HEATER COMBUSTION and VENTING [Inspected]

- ◆ Vent inspected.

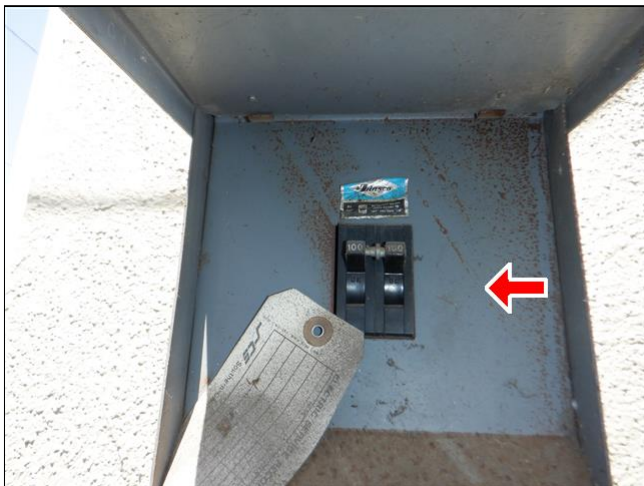
MAIN DISTRIBUTION PANEL [Inspected]

- ♦ Main cover not removed and inspected.

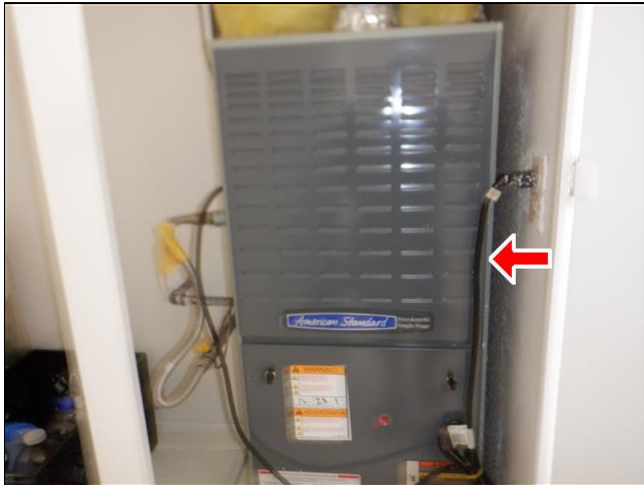
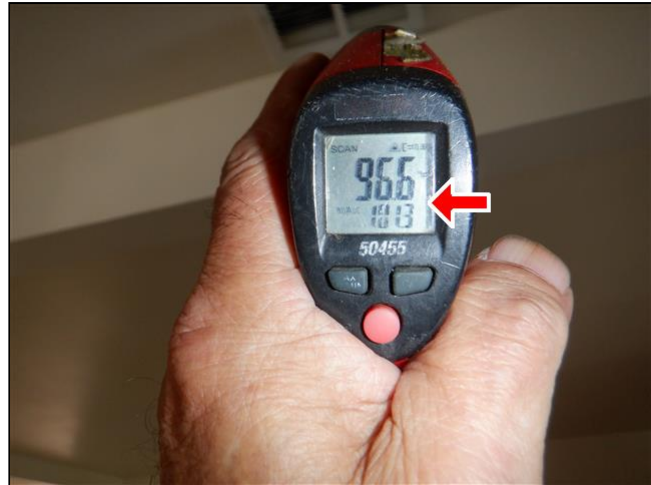
HEAT - GENERAL CONDITIONS [Inspected]

- ◆ The heating system responded to normal operating controls. Components are in adequate condition, other than any exceptions noted. Routine maintenance is recommended prior to close of escrow.

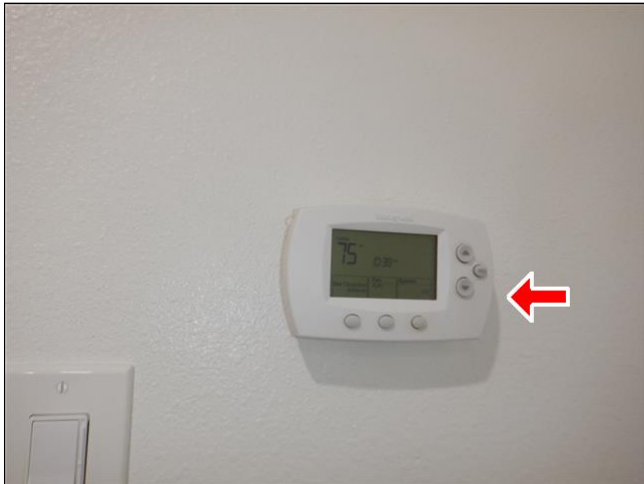
THERMOSTATS [Inspected]

- ◆ Tested

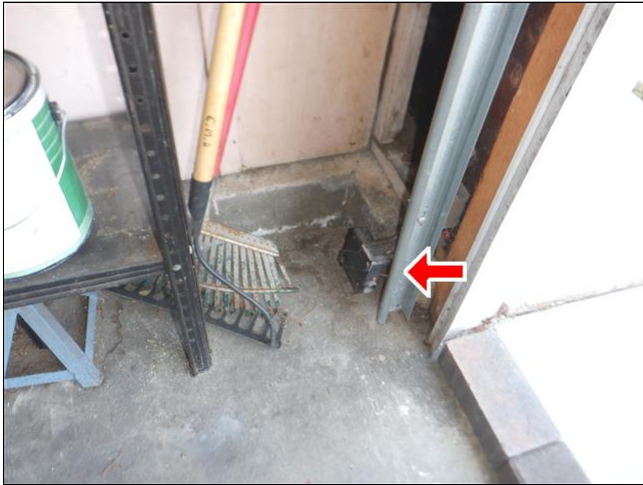
GARAGE DOOR OPERATORS [Inspected]

- ◆ The garage door opener raises and lowers the door properly and it stopped and reversed when the light beam was interrupted. We did not test the auto-reversing or stop function of the opener by physical force because of the potential to damage the door or the opener.

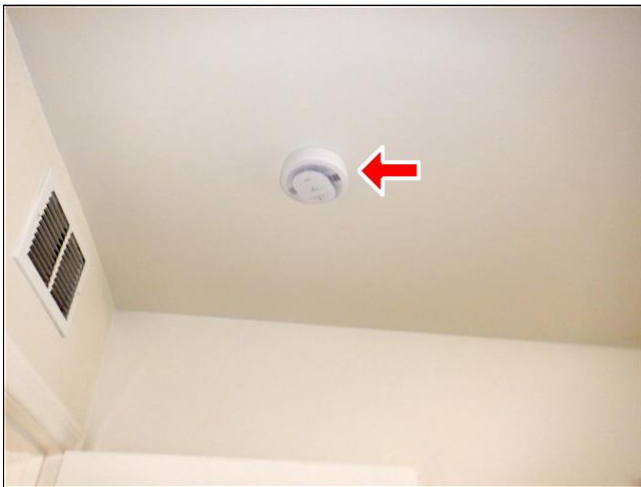
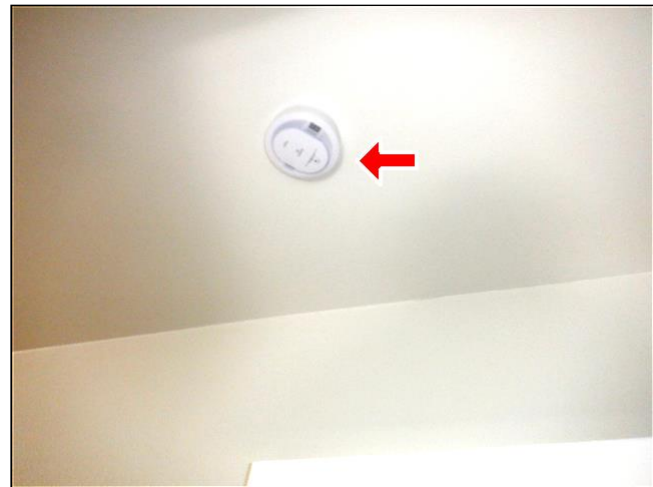
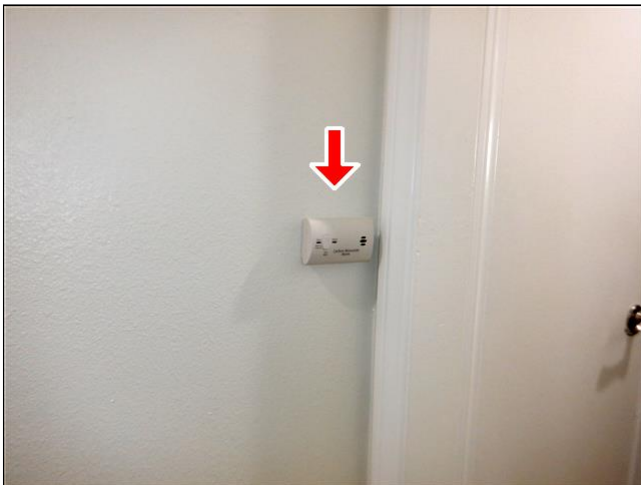
- ◆ Smoke & C/O detectors are present.

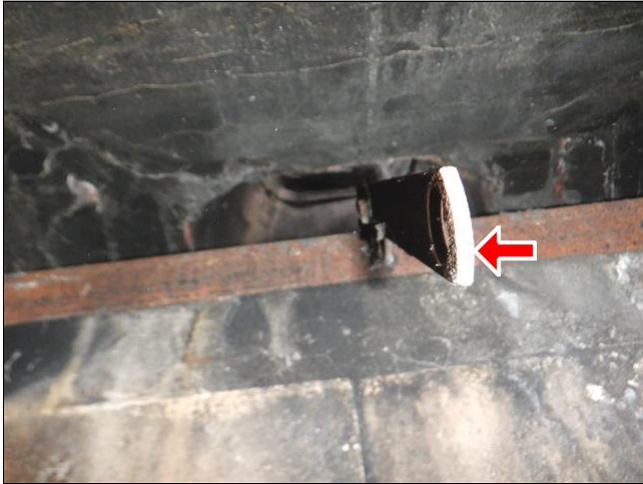
- ✗ ◆ The living room gas log fireplace is not equipped with a damper clamp that stops the damper from fully closing. This is an important safety feature that ensures toxic gases go up the chimney, instead of escaping to the interior.
- An approved damper clamp should be installed.

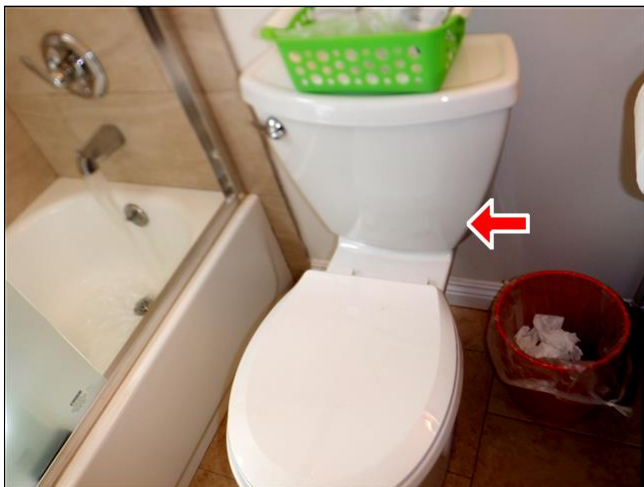
TOILET(S) [Inspected]

- ◆ Toilets are 1.6 gallons or smaller.

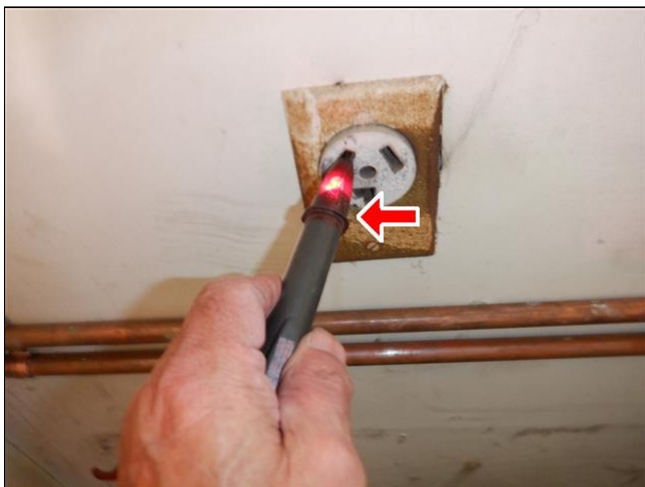
- ◆ 240 line is present.
