Maffei Property Inspections

Property Inspection Report

50 Knightsbridge Ln, Chico, CA
Inspection prepared for: Natalie Korber
Date of Inspection: 4/20/2023 Time: 9am
Age of Home: approx 36 yrs Size: approx 1100 sf
Weather: Sunny and Dry

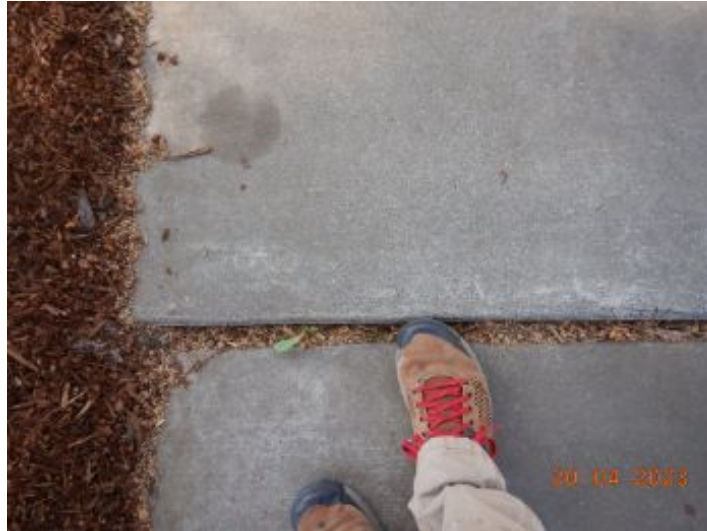
1. Driveway and Walkway Condition

- Trip hazards noted in the driveway and front walkway.

Example of trip hazard

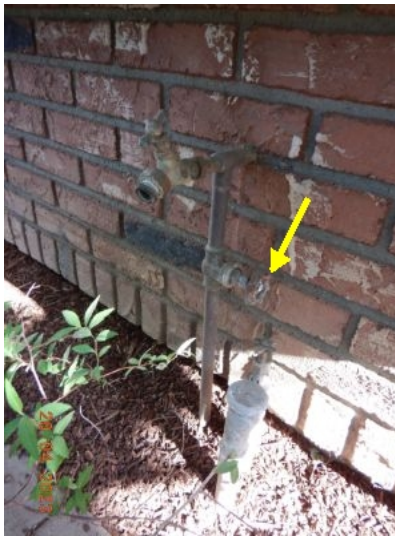
Main water shutoff

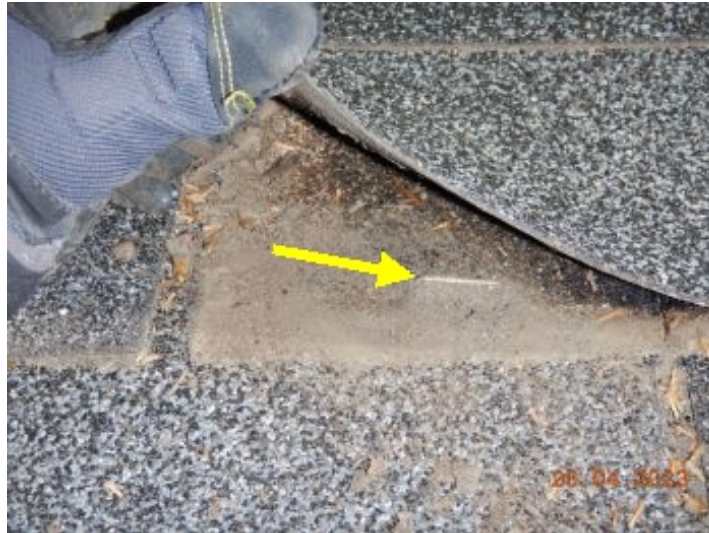
1. Roof Condition

- In at least three locations new shingles appear to have been spliced into the existing roof. Reason unknown.
- **Lifting shingles in the south facing fields appeared to be caused by fasteners backing out of the roof**

Example of fastener backing out

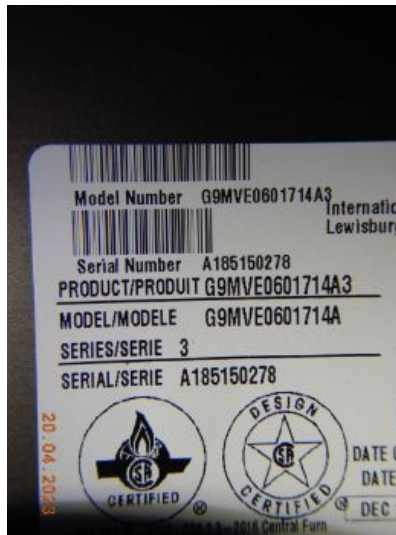
1. Heater Condition

- Appeared functional at time of inspection.
- Make: Day & Night

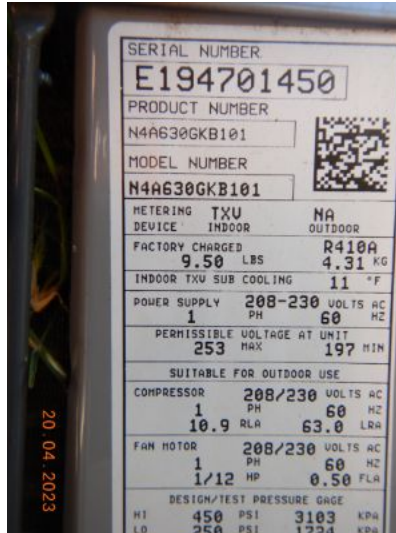
6. AC Compress Condition

Location: The AC condenser was located on the north side of the home.

- Make: ICP Inc (manufactured around 2019).

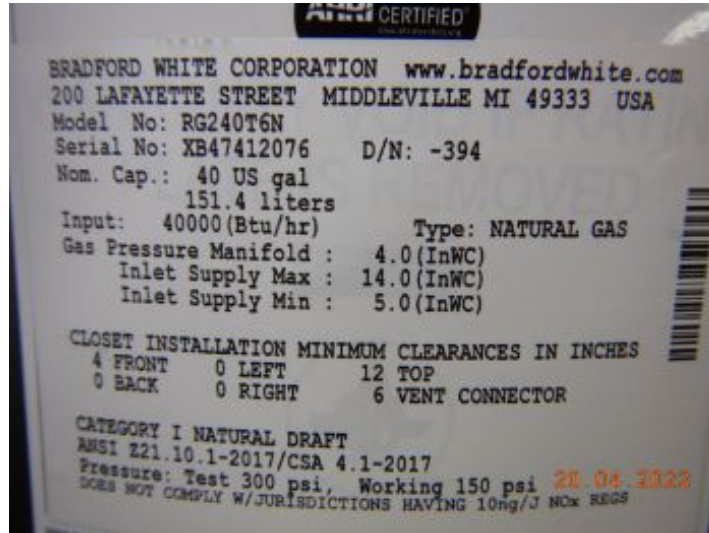
1. Water Heater Condition

Heater Type: Gas.
 Location: Water heater located in garage.
 Observations:
 • Make: Bradford White (manufactured around 2017)

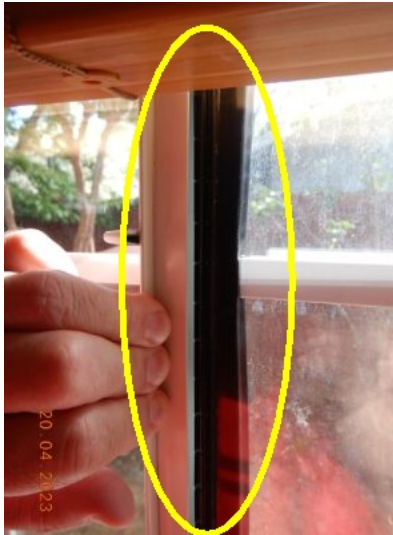
11. Window Condition

- Windows were dirty.
- When opening the east window in the family room, the metal frame of the window pulled away from the glass.

Window frame and glass
