Confidential Inspection Report

3852 E. 15th St.
Long Beach CA 90804

February 29, 2024

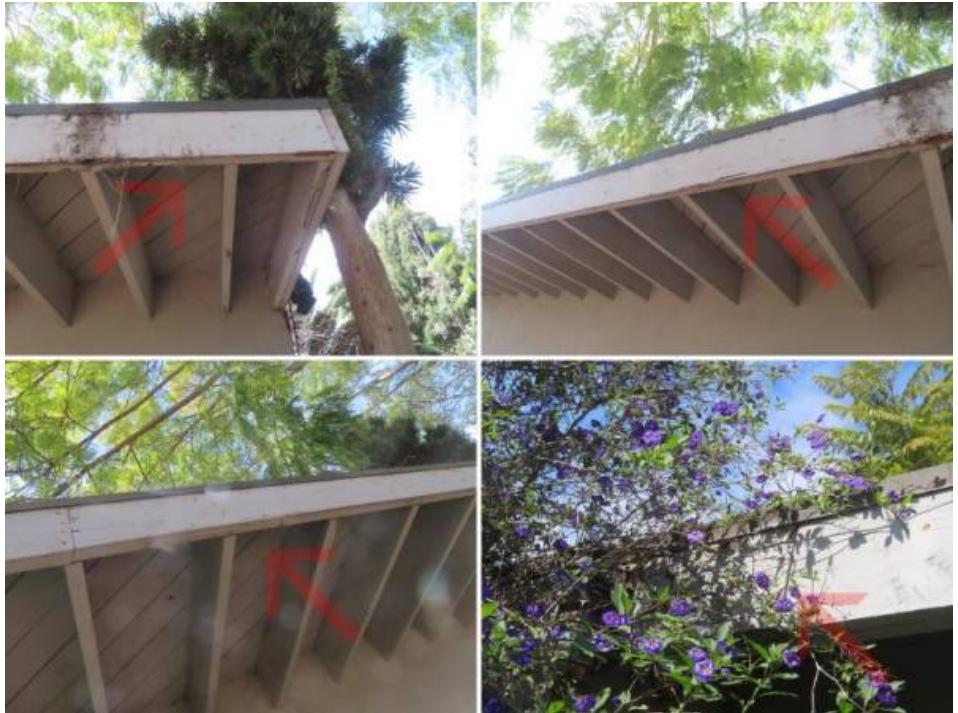
Fascias

DEFERRED: Rot/insect damage viewed one or more locations.

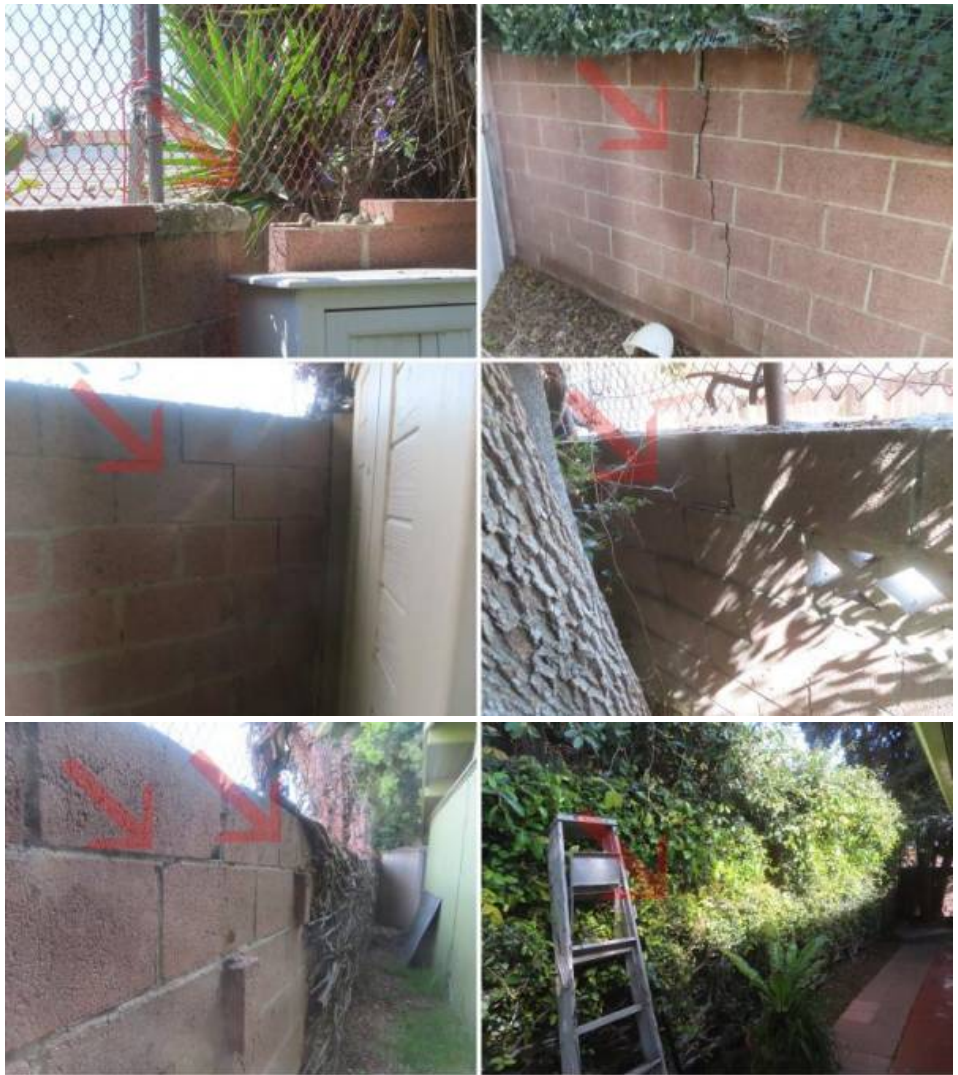
Concrete block fences

DEFERRED: Settlement/soil movement cracks.

DEFERRED: Some of the fence is concealed with vegetation.

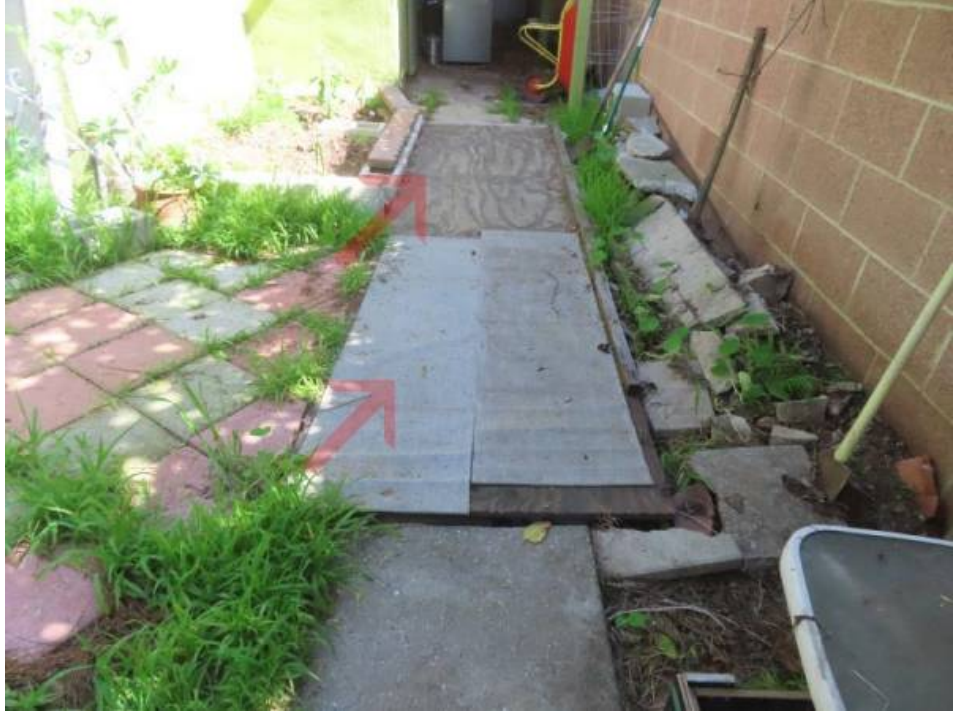
Concrete

MONITOR: Small cracks viewed in the paving appear to be typical of settlement or shrinkage. We recommend monitoring cracks from time to time. Change in the size or number of cracks may be symptomatic of other conditions such as defective drainage, settlement or soil movement and should be further evaluated by a licensed masonry contractor.

MAINTENANCE: Tree(s) roots appear to be raising the paving. We recommend consulting with a licensed landscaping contractor or arborist for remedial advice.

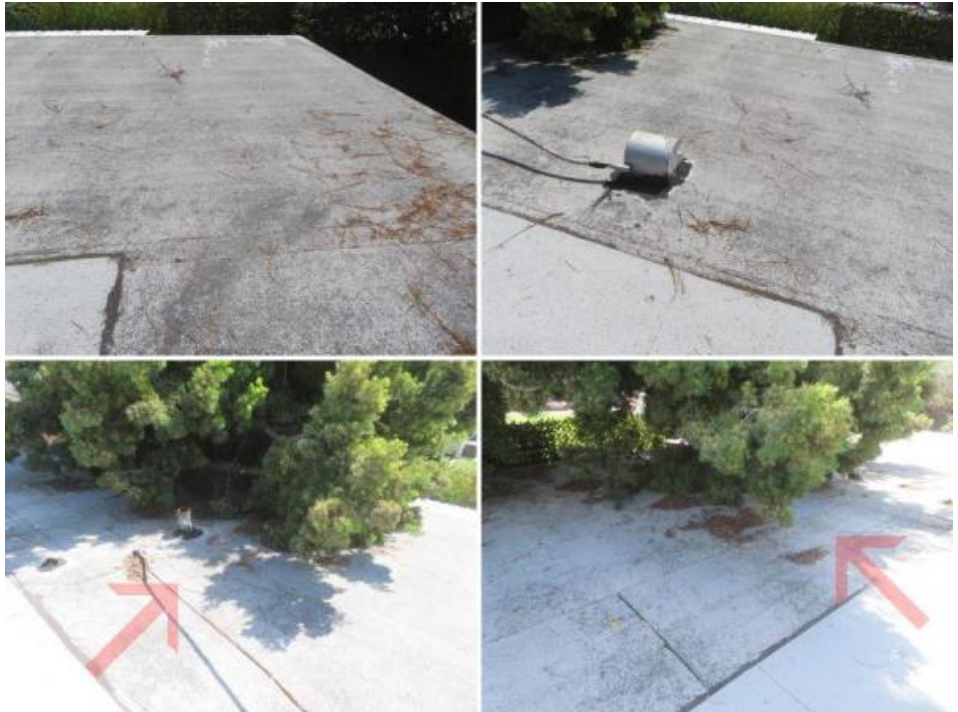
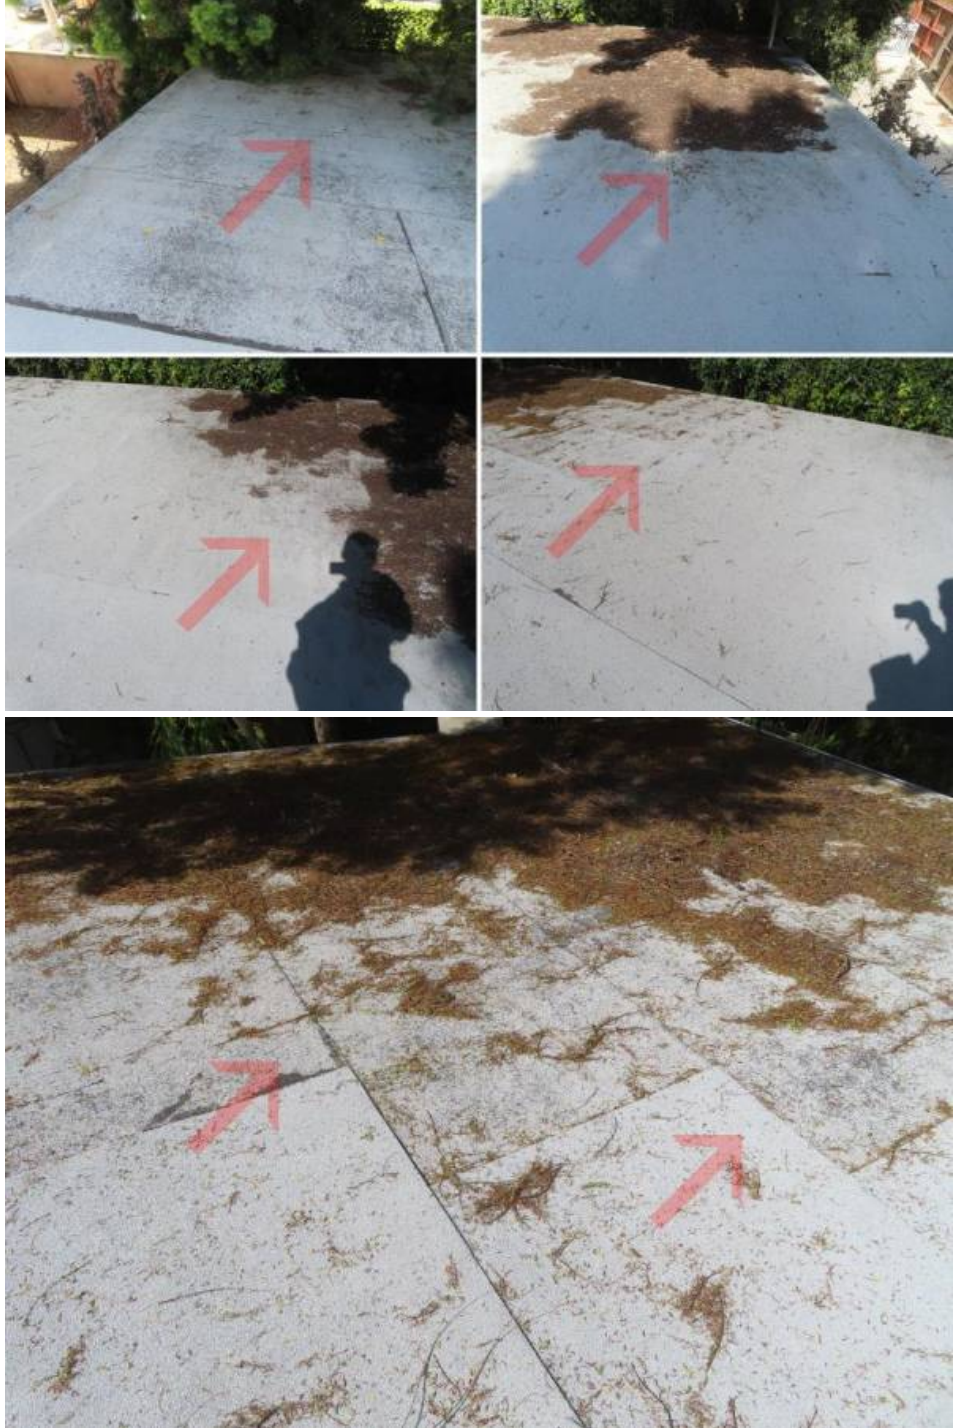
DEFECTIVE: Deteriorated areas of cracking/alligatoring.

DEFERRED: Vegetation or other debris on roof. We could not view the roof covering in this area and recommend removing debris and further evaluation by a licensed roofer.

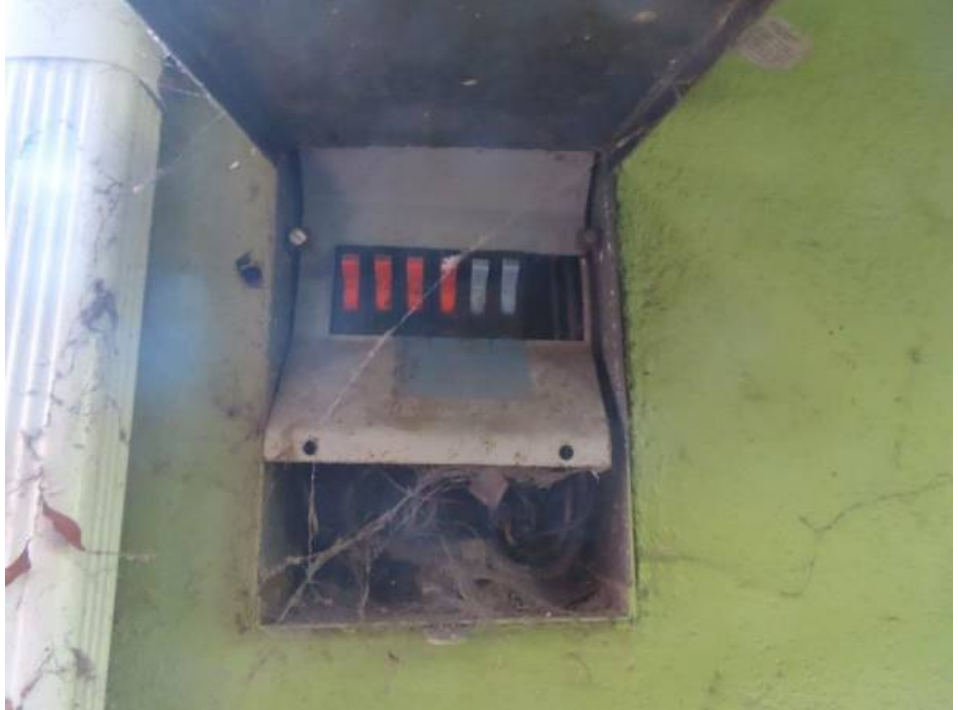
Panel observations, exterior

SAFETY: Federal Pacific or Zinsco brand panel present. Electrical panels and circuit breakers are known to deteriorate with age. Many older panels have aluminum bus bars that are susceptible to oxidization, which can compromise the electrical connections. Also, older breakers have a higher failure rate than do modern breakers. Both of these conditions can lead to arcing and overheating, sometimes resulting in an electrical fire. A visual inspection cannot determine if these panels and breakers are performing to their original design specifications. Federal Pacific and Zinsco brands in particular are problematic and we routinely recommend replacing these panels as a safety upgrade.

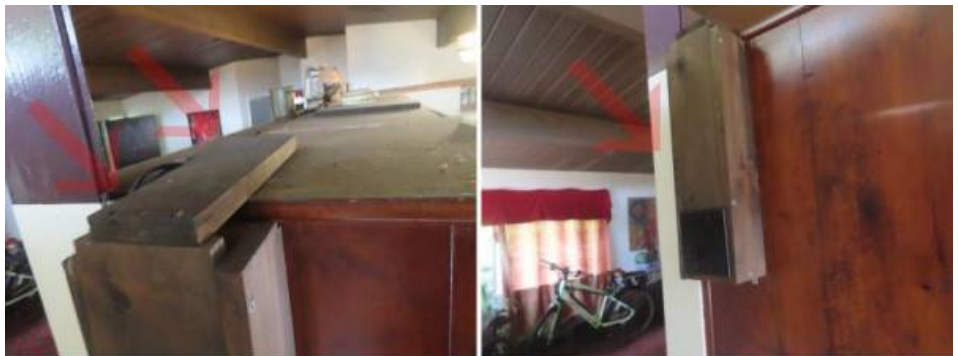
Interior wiring observations

DEFECTIVE: Improperly wired light switch at the end of the kitchen cabinet into living room. The box protrudes into the walkway and can be knocked loose if ran into or bumped. Recommend further inspection by a licensed electrician and repairs as needed.

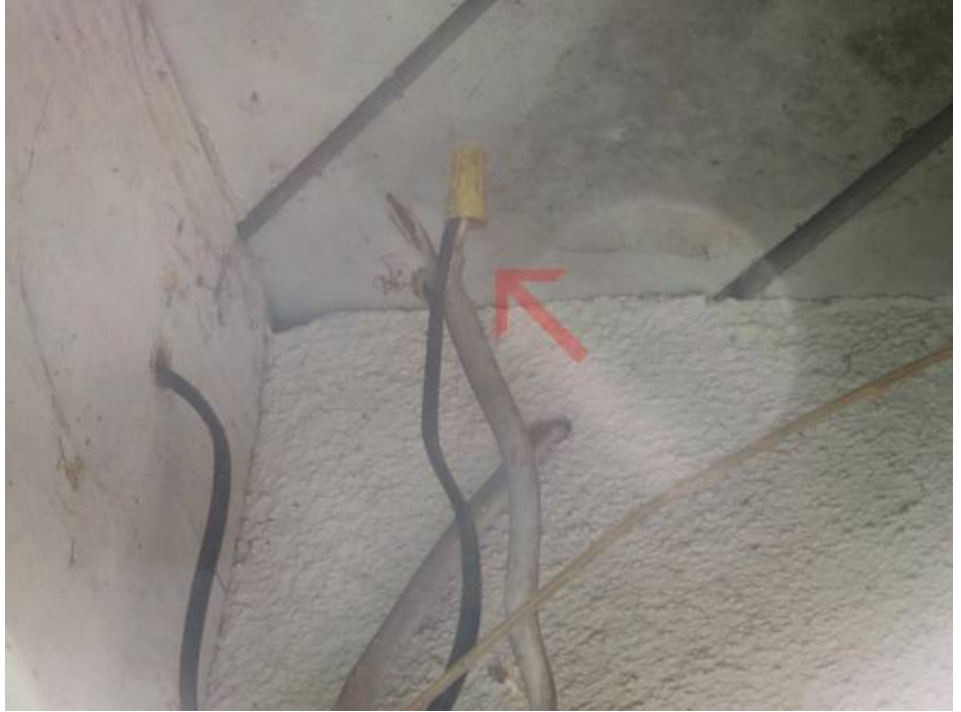
Exterior wiring observations

Rear eave.

DEFECTIVE: Open splice(s). Covered junction boxes are required anywhere wires are spliced to contain sparks in the event of arcing at the connection.

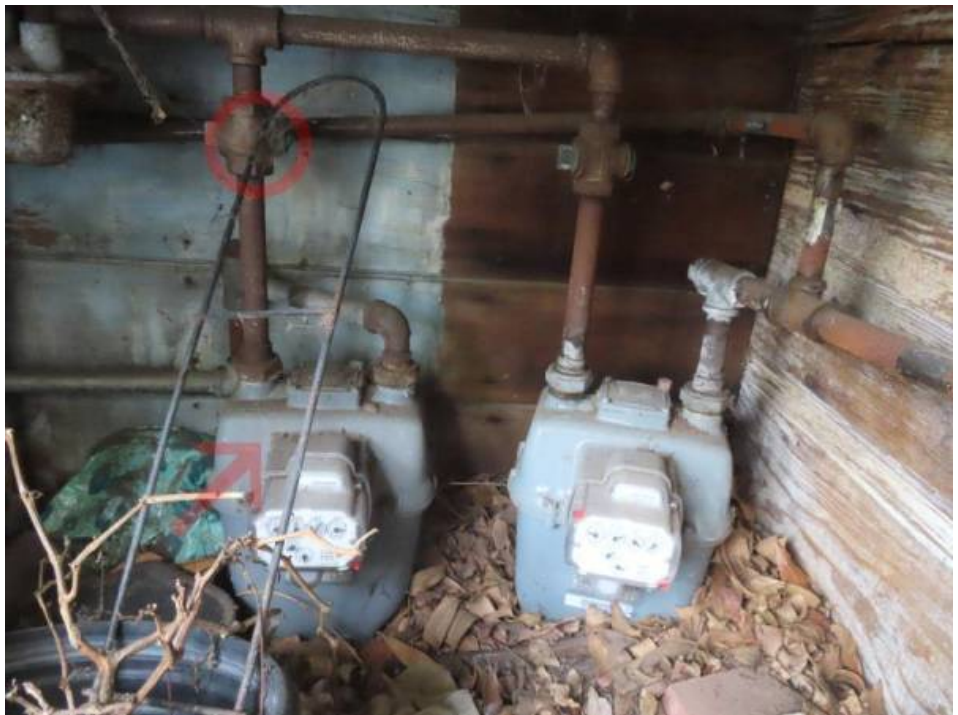
Gas shutoff at meter

SAFETY: We recommend keeping a wrench attached to the meter to turn off the gas for emergency needs (available in most hardware stores).

SAFETY: No seismic shutoff valve. We recommend installing a seismic shutoff valve on the gas meter for protection against fire loss in the event of a damaging earthquake. (A seismic shutoff valve is required to be installed on the gas system of residences in the City of Los Angeles prior to the transfer of title.)

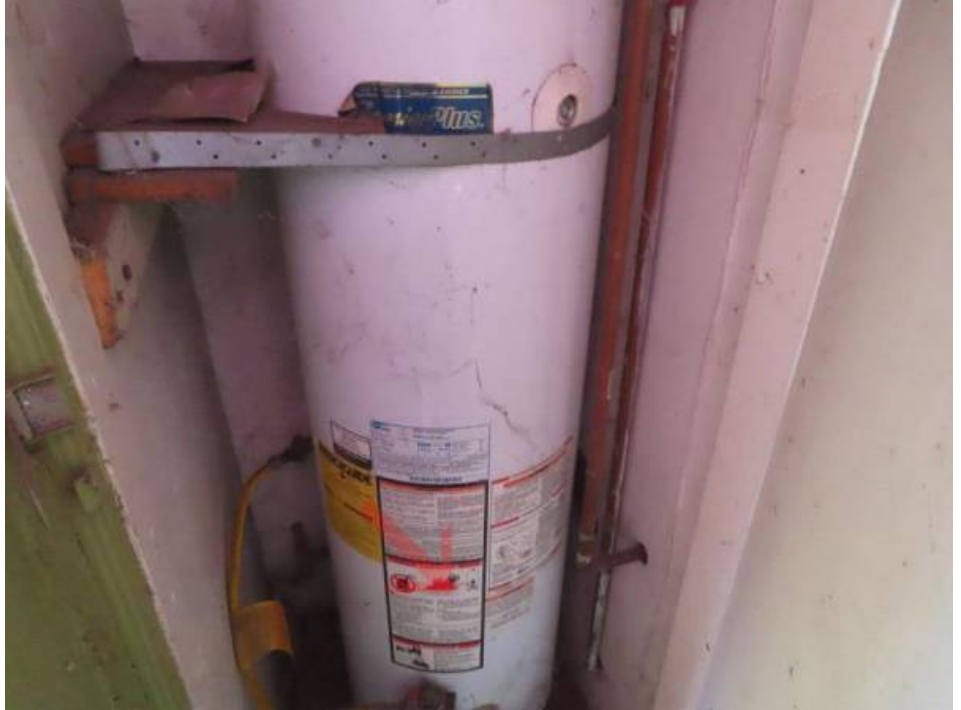
Seismic bracing

DEFECTIVE: Not adequately braced, anchored or strapped to resist toppling or horizontal displacement due to earthquake motion. Minimum requirements for water heaters to 50 gallons capacity are two approved straps properly located and anchored with minimum 1/4" X 3" lag bolts into the studs (or the structural equivalent where stud attachment is not an option).

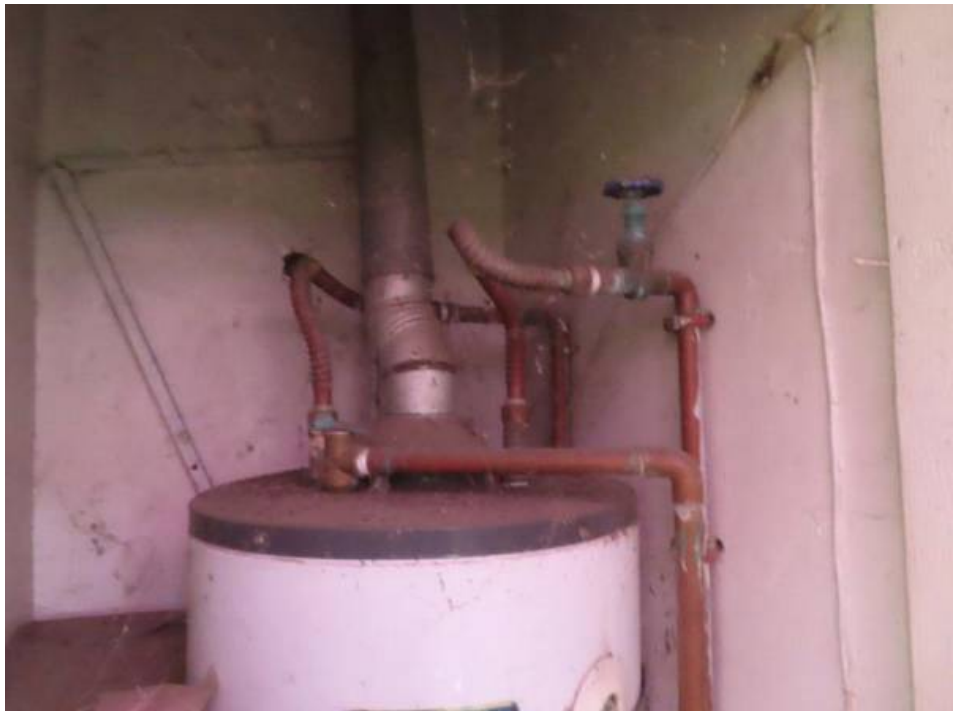
SAFETY: Transite vent pipe(s) observed. Transite is known to contain asbestos and will need special handling if removed or repaired.

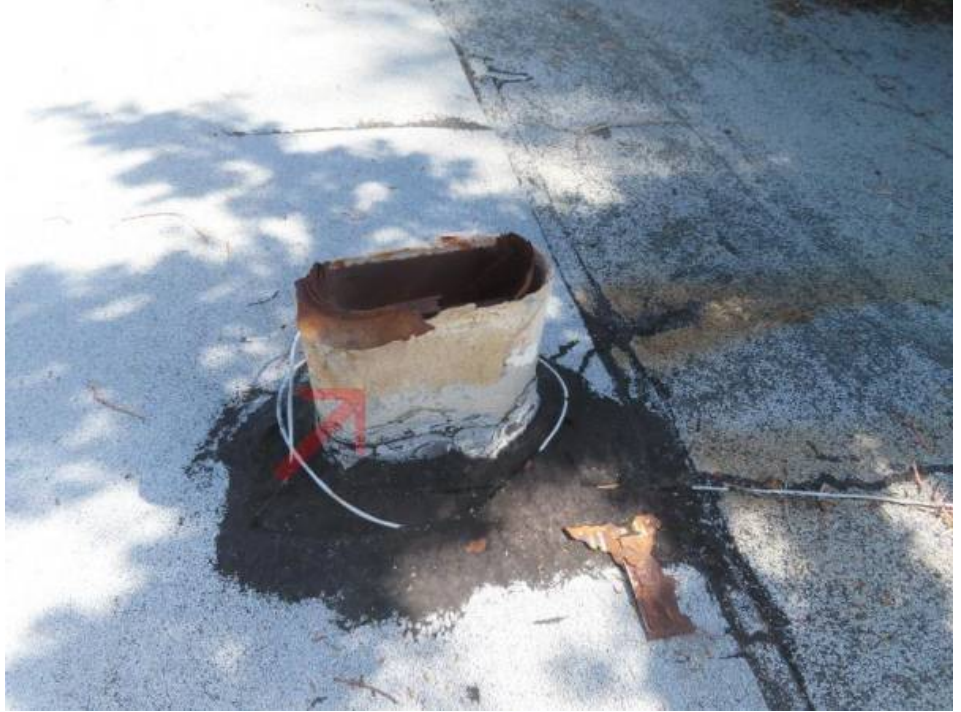
Exhaust flue

SAFETY: Transite vent pipe(s) observed. Transite is known to contain asbestos and will need special handling if removed or repaired.
 DEFECTIVE: Vent cap is damaged, missing or improper type. We advise replacing missing or damaged vent caps to guard against wind and rain intrusion.

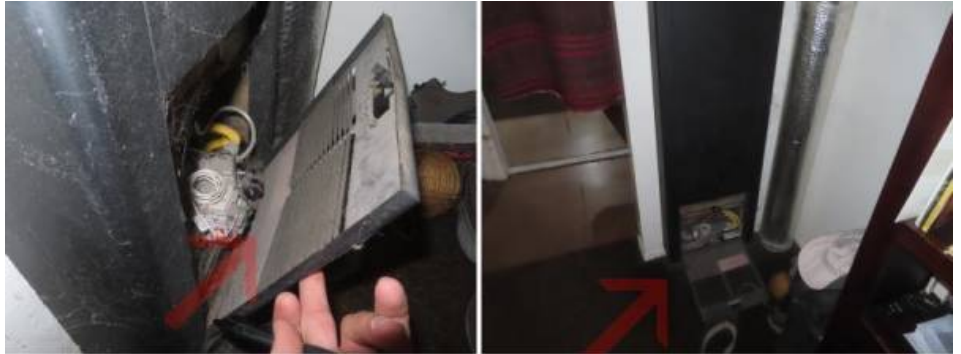
Inspector's notes

DEFECTIVE: Replacement parts prevent cover from closing.

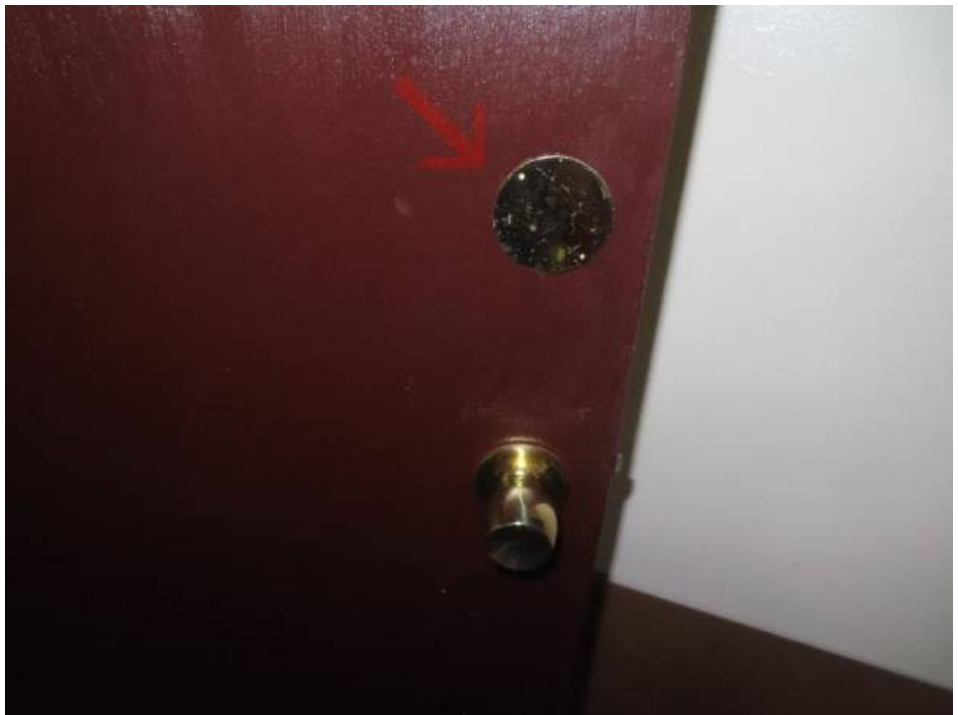
Main entry door

SAFETY: Door is a hollow core type. We recommend installing solid core doors at all exterior locations for enhanced security.

SAFETY: No deadbolt installed. We recommend installing a modern deadbolt that meets current security standards.

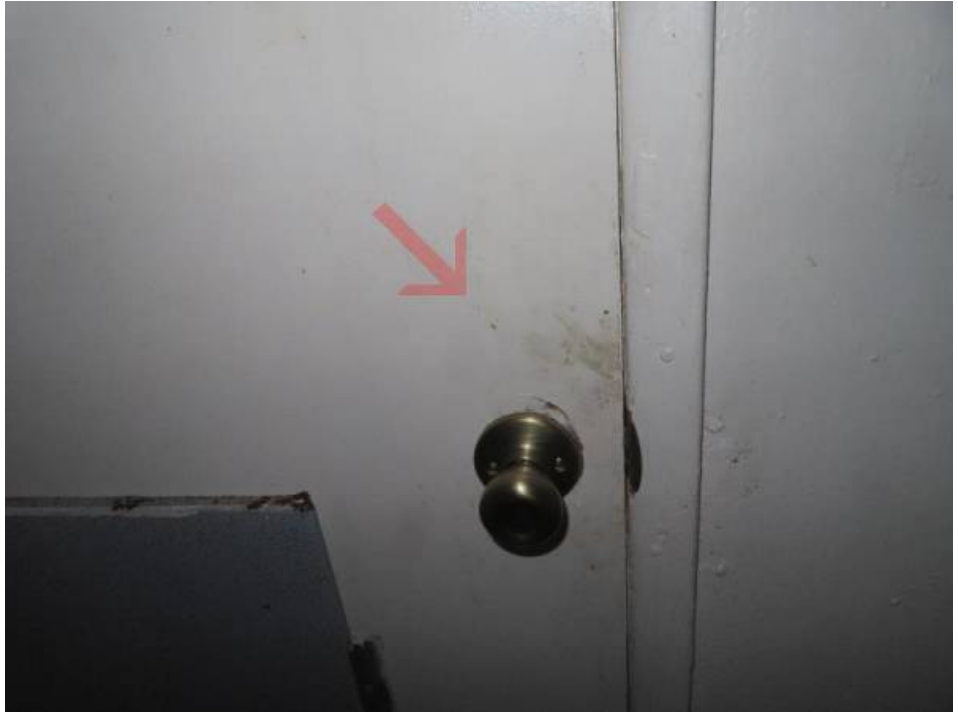
Exterior doors

SAFETY: No deadbolt installed. We recommend installing a modern deadbolt that meets current security standards.

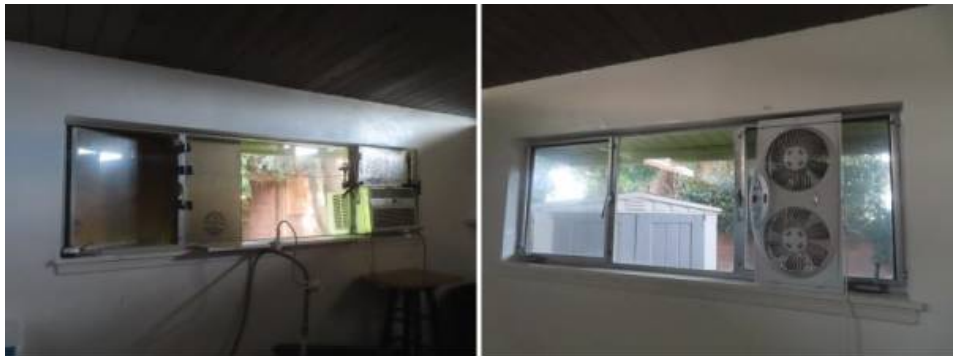
MAINTENANCE: Hardware on one or more windows sampled was difficult to crank.

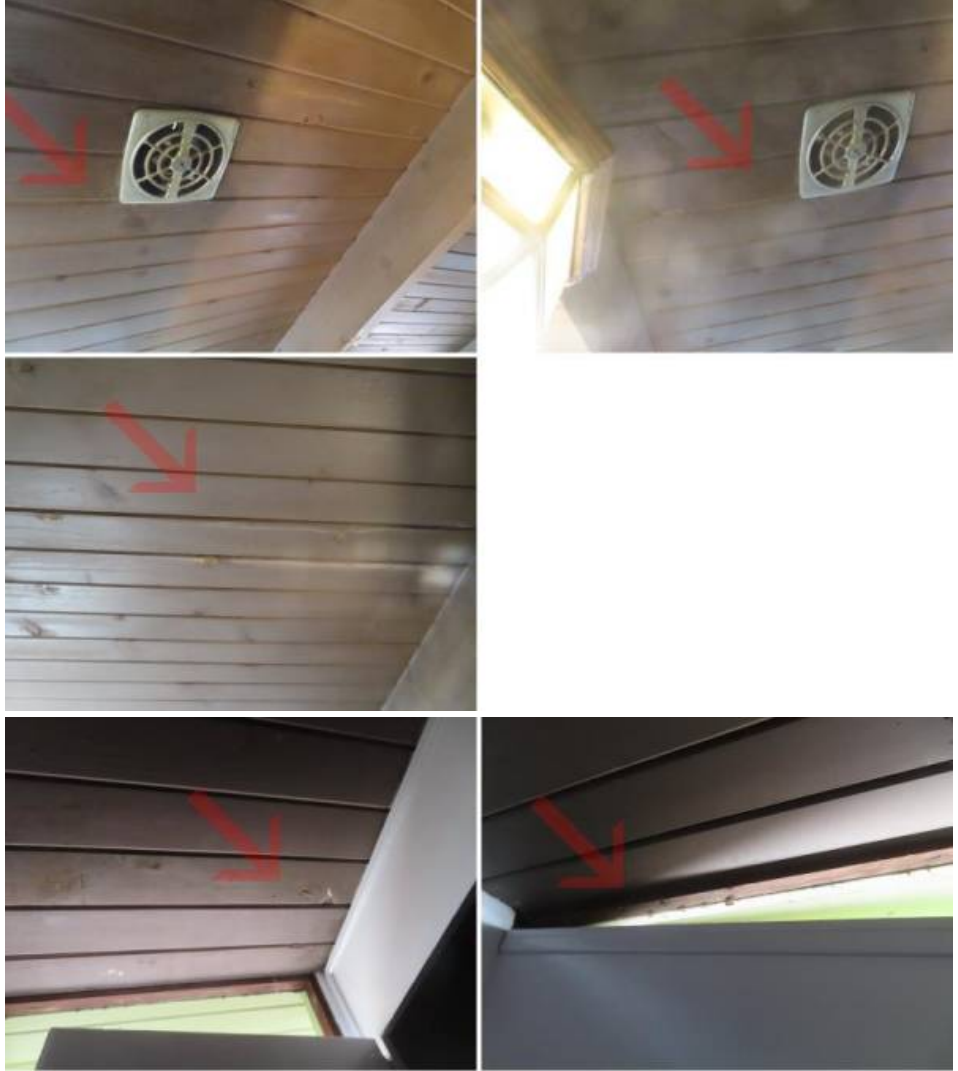
Kitchen stove vent.

DEFERRED: Moisture stains noted on the ceiling were dry at the time of our inspection and could be from a repaired or intermittent leak. We suggest asking the current owner for any knowledge or history of leakage and monitoring from time to time.

Front bedroom.

DEFERRED: Possible moisture/insect damage at ceiling and trim to window. Recommend further inspection by a licensed pest control company.

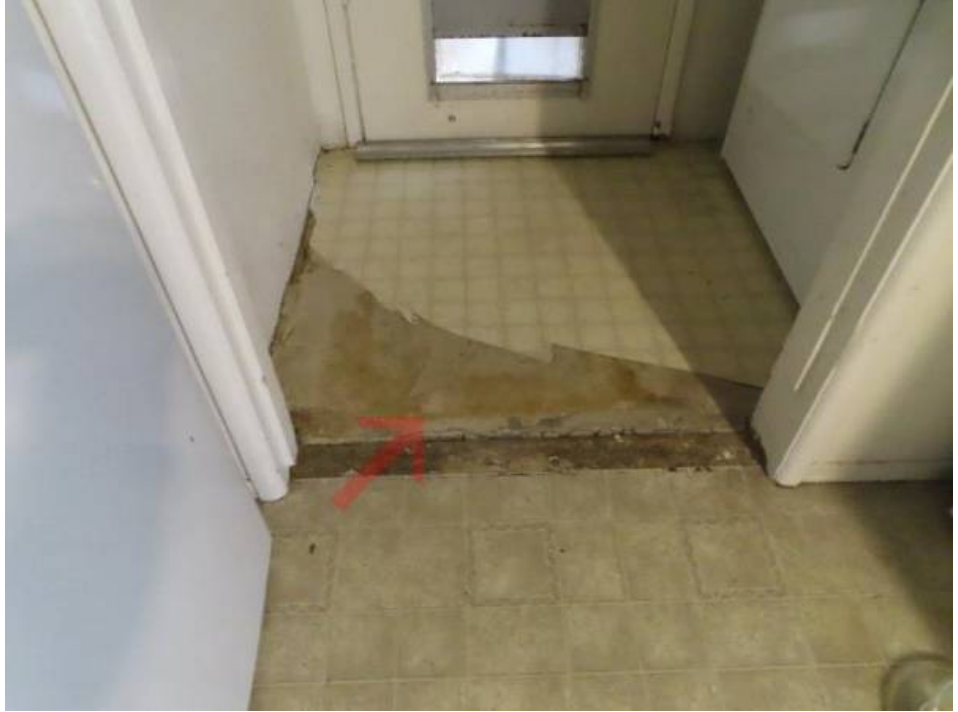
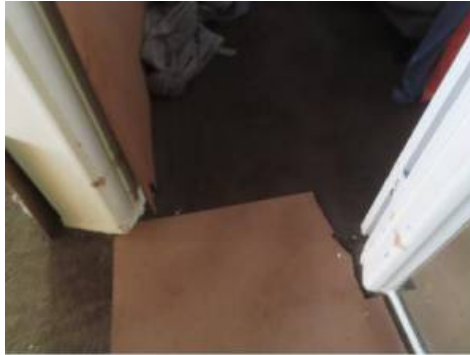
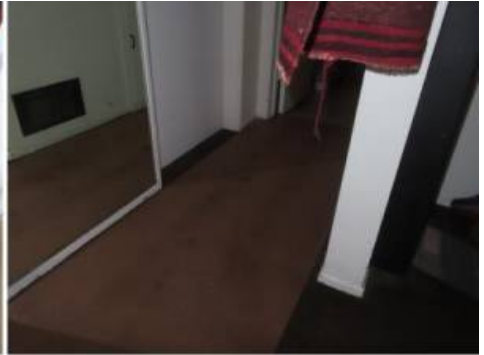
Vinyl Flooring

MAINTENANCE: Small tears, gouges or excessive wear viewed at various locations.

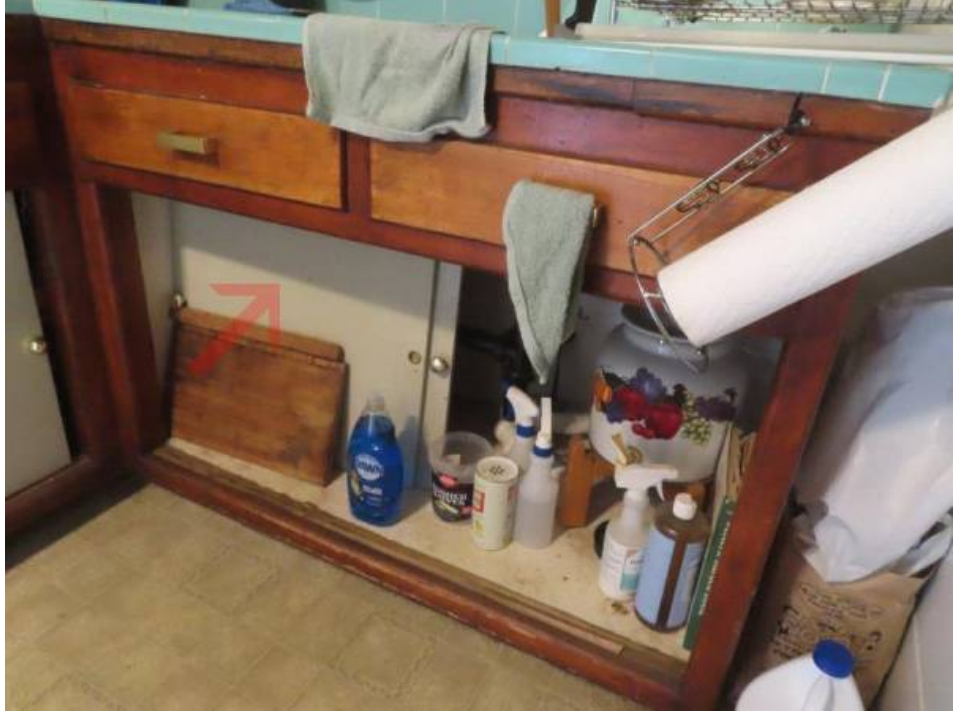
Cabinets

DEFERRED: Doors off the guides.

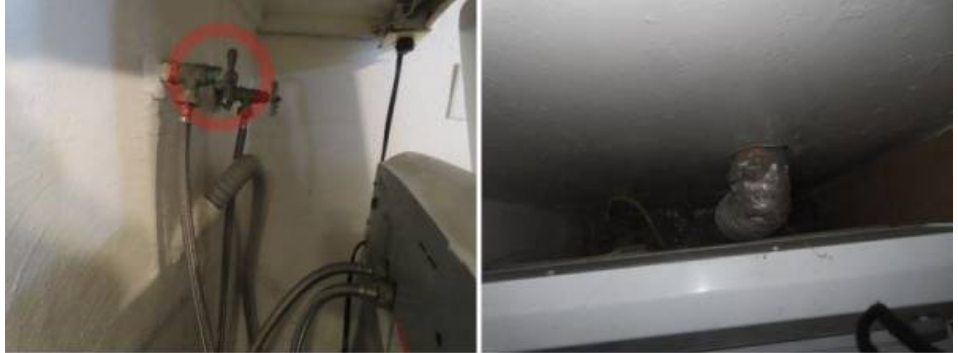
MAINTENANCE: Hot shut off corroding. Recommend replacing corroded parts before a leak occurs.

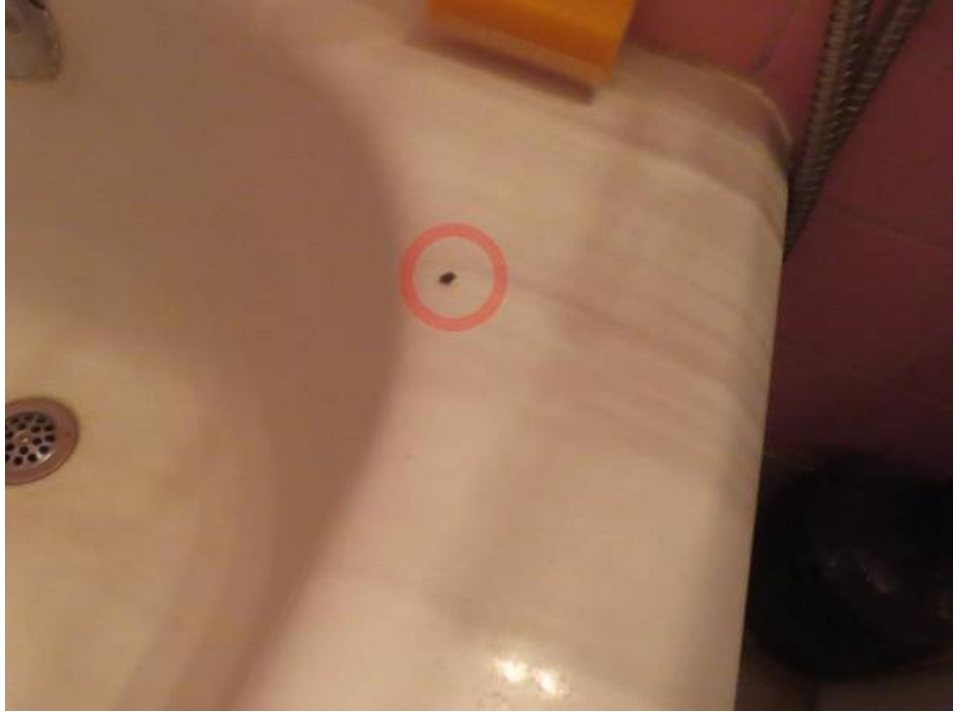
Bathtub

SERVICEABLE.
Small chip. Finish is chipped, peeling or possibly stained.
