Confidential Pre-Listing Inspection Report 1502 East 57th St. Long Beach, CA

February 14, 2025

1502 E 57th St. Long Beach, CA

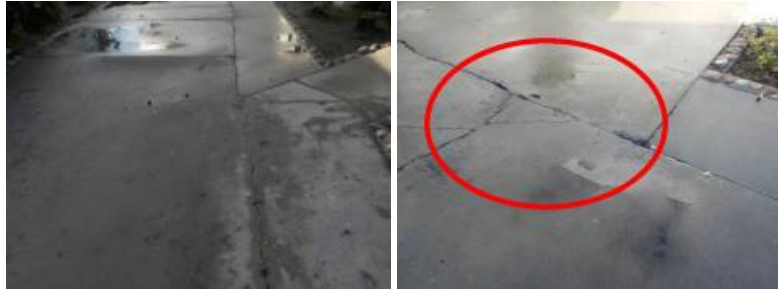
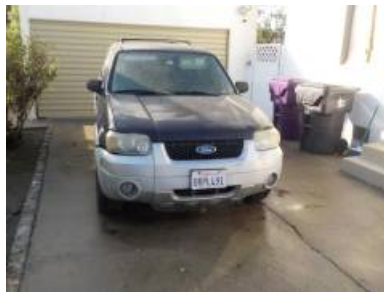
Cracks and stains observed are typical.

Unable to fully inspect due to a parked vehicle.

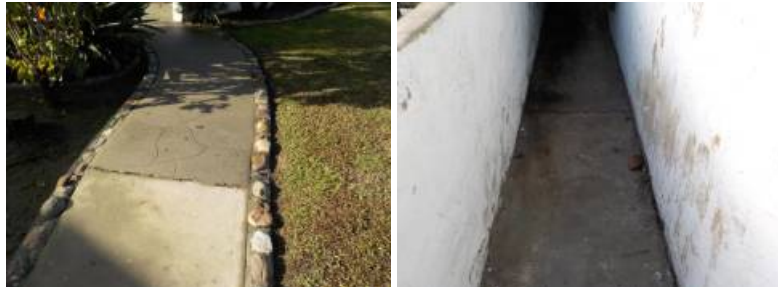
Cracks and stains observed are typical.

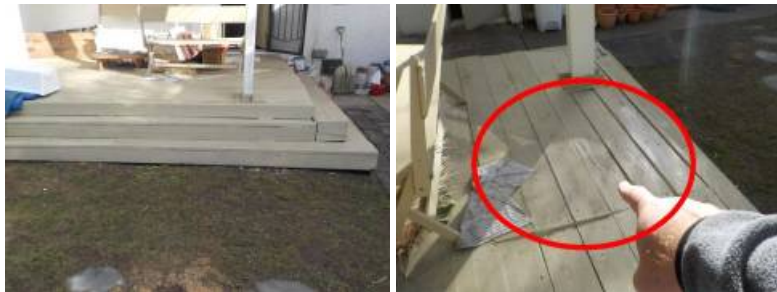
Dry rot (damage) and termite activity is present in multiple areas - improper

Please Note: review the termite inspection report for more information including recommended remediation.

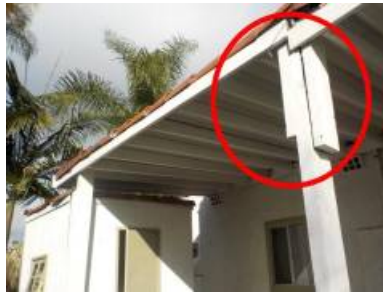
Dry rot (damage) and termite activity is present in multiple areas - improper

Please Note: review the termite inspection report for more information including recommended remediation.

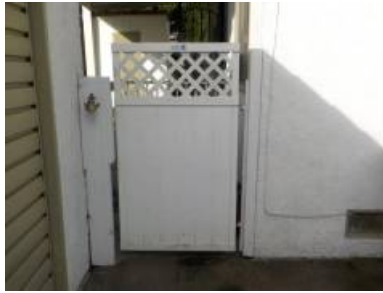
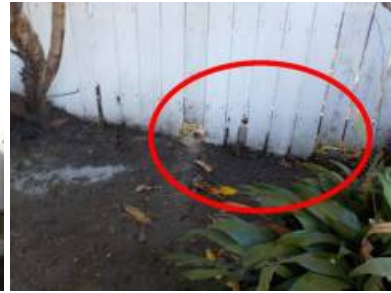
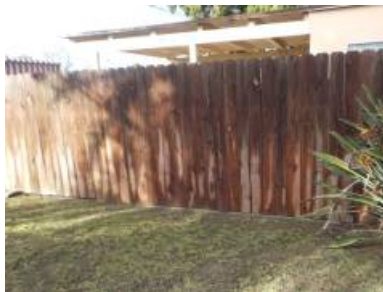
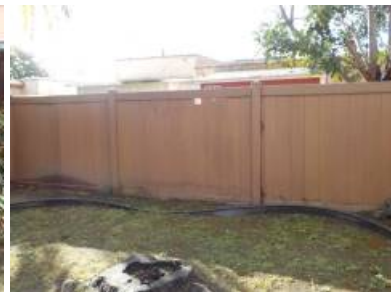
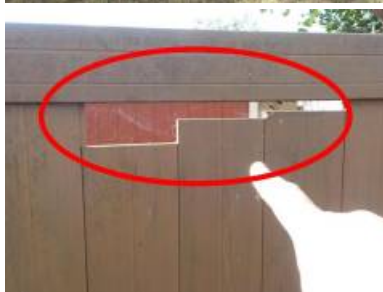
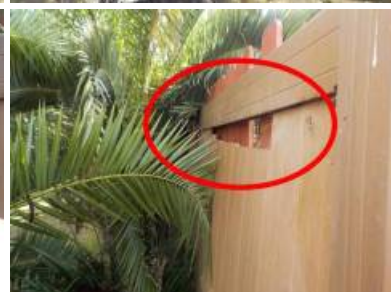
Cracks present are typical

Damaged/incomplete in multiple areas - improper**Recommend further inspection and deemed necessary repairs by a qualified service provider**

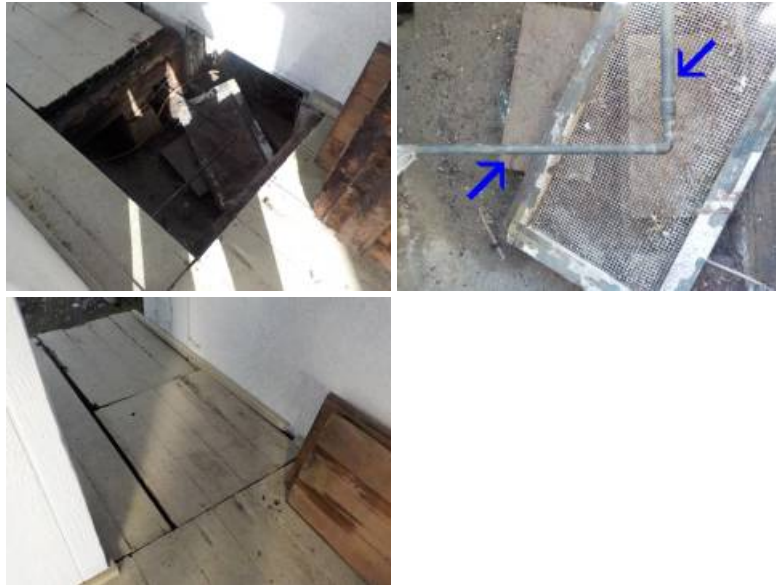
Entire crawlspace floor is saturated (wet) likely due to the recently concluded rain (unsafe condition)

Recommend a thorough inspection of the crawlspace area by a qualified service provider after safe access is available

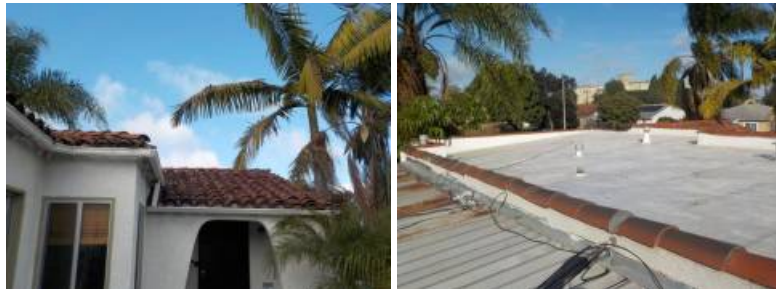
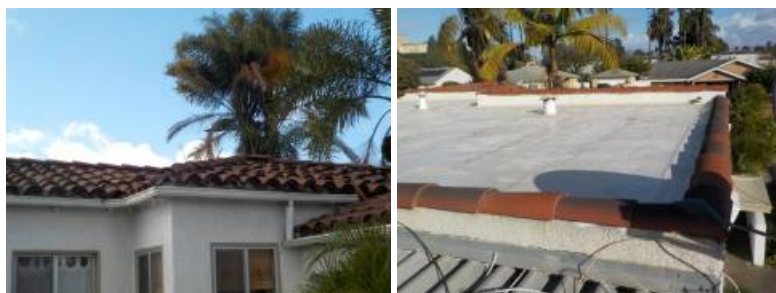
Roof Covering: Clay Tile (Spanish "Barrel" Style) & Bituminous membrane.

Roof Covering Condition: General condition appears serviceable with signs of weathering and aging. Regular maintenance and inspections are advised.

Please Note: in no way can inspector determine if there will be any roof leaks. If client seeks that kind of certainty they should hire a licensed roofing contractor to perform a comprehensive inspection and "leak free certification" of the entire roof structure.

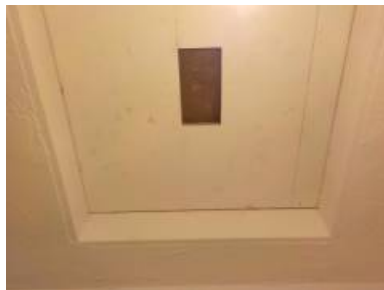
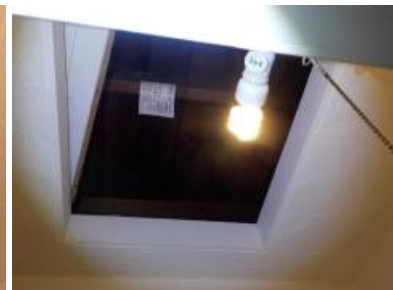
Evidence of rodent activity (droppings) is observed - improper (appear to be older)

Remediation by a licensed exterminator is required to restore to normal conditions.

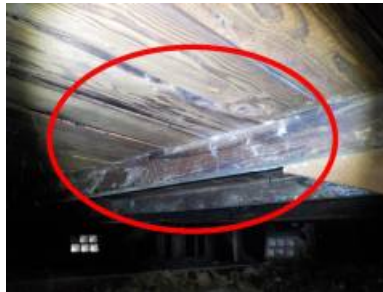
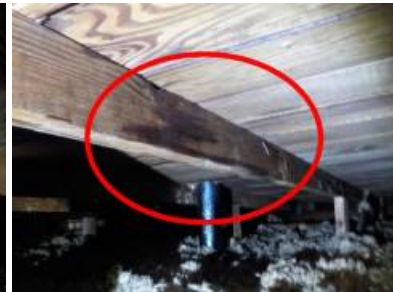
Moisture staining is viewed (no leaking is observed - recent rains just concluded prior to the inspection)

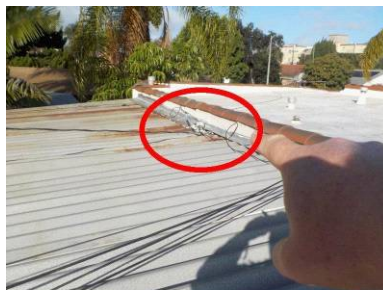
Weather head does not have the required clearance above the roof - improper

Weather head has inadequate clearance

Recommend further inspection and deemed necessary repairs by a licensed electrician.

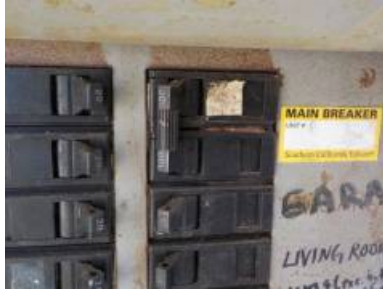
100 amps.

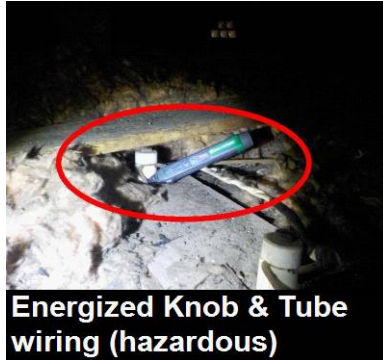
Knob & Tube (original) wiring is observed (energized) - possible safety hazard

Energized Knob & Tube wiring (hazardous)

Recommend further inspection and deemed necessary repairs by a licensed electrician

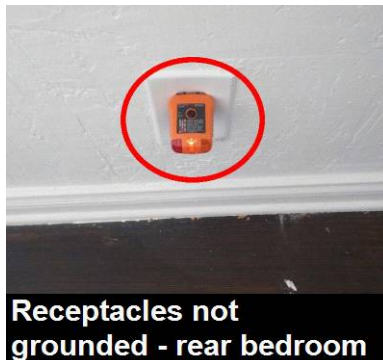
A representative sampling of outlets was tested. As a whole, outlets throughout the house are in serviceable condition with the following observed:
Many outlets: receptacles are not grounded - improper
This is a safety and liability issue
Recommend further inspection and deemed necessary repairs by a licensed electrician.

Receptacles not grounded - rear bedroom

Recommend further inspection and deemed necessary repairs by a licensed electrician.

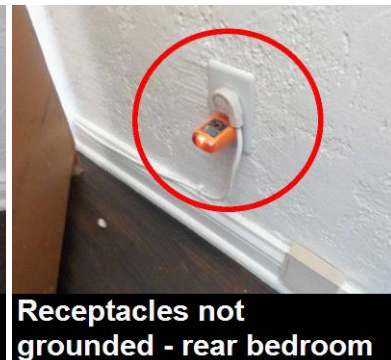
Many outlets: **receptacles are not grounded - improper**

Receptacles not grounded - rear bedroom

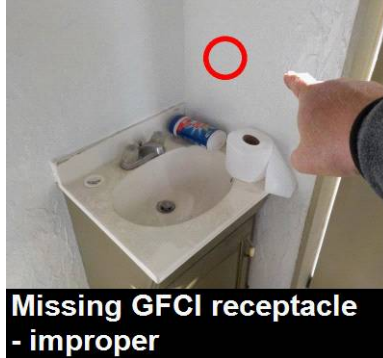
Missing GFCI receptacle - improper (at least 1 GFCI receptacles is required within 3' of a sink)

This is a safety and compliance issue.

Installation of GFCI receptacles at all outlets within 6' of the water source (sink) are required to restore to safe and compliant conditions.

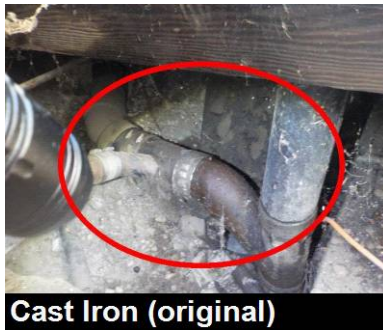
Cast Iron (original)
Material has exceeded its typical useful life
Recommend further inspection and deemed necessary repairs by a licensed plumber.

Cast Iron (original)

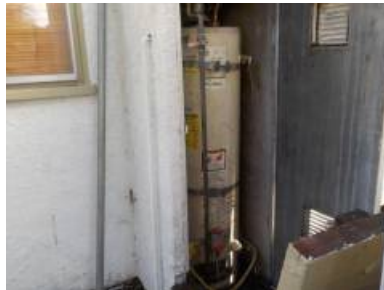
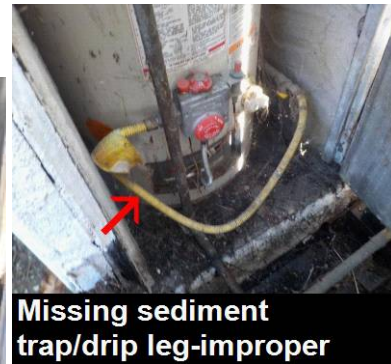
☐ ☐ ☒ Appears serviceable with the following noted:
Strapped properly
Natural gas connector installed - proper
Gas connector missing sediment trap (drip leg) - improper
TPR Valve installed - proper (not tested)
Pressure relief valve drain line is missing - improper
(requirement is to terminate no higher than 6" off of the floor/ground)
Water shut off valve installed - proper
Venting appears serviceable
These are safety, liability and/or compliance issues
Recommend repairs by a licensed plumber or qualified service provider to restore to safe and compliant conditions

Missing sediment trap/drip leg-improper

Please Note: recommend the installation of a thermal expansion tank

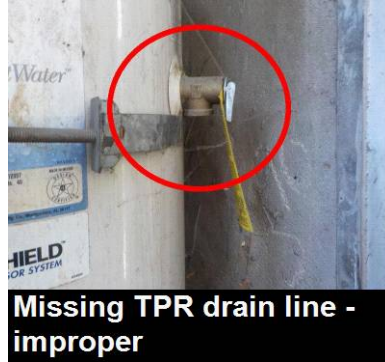
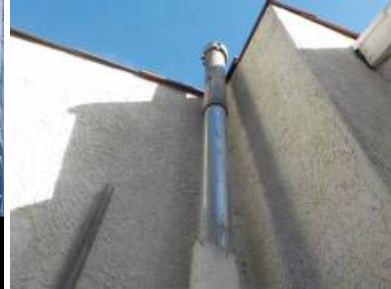
Gas connector missing sediment trap (drip leg) - improper

Recommend repairs by a licensed plumber or qualified service provider to restore to safe and compliant conditions

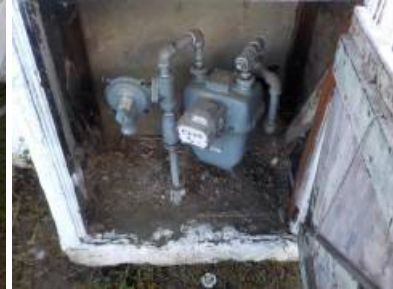
Please Note: **there is no emergency gas shut-off valve wrench - improper.**

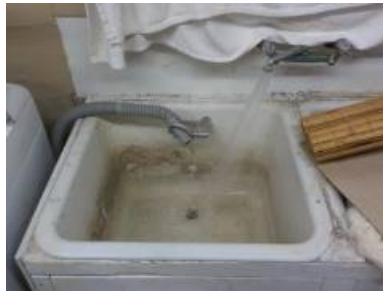
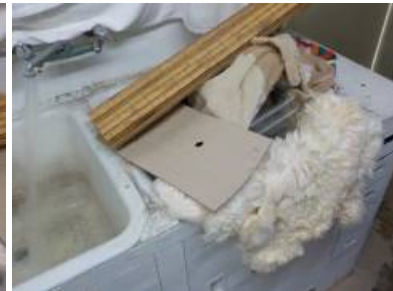
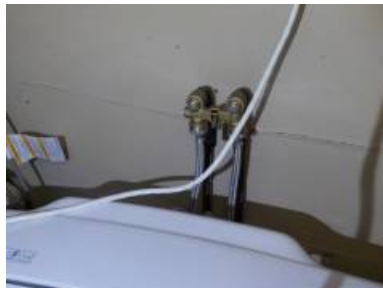
Due to the age and as a matter of preventative maintenance it is highly recommended to replace the angle stop
Failure of aging angle stops could result in serious water damage.

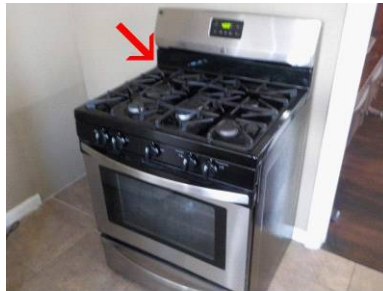
Missing the anti-tip bracket: improper

Recommend installation of an anti-tip bracket to restore to safe conditions

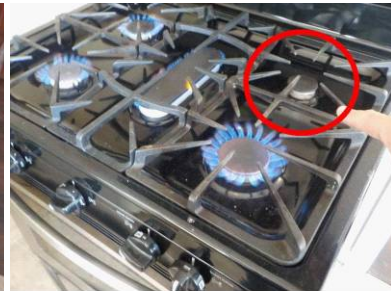
Igniter not functioning - improper

Recommend repairs by a qualified service provider to restore to normal operating conditions

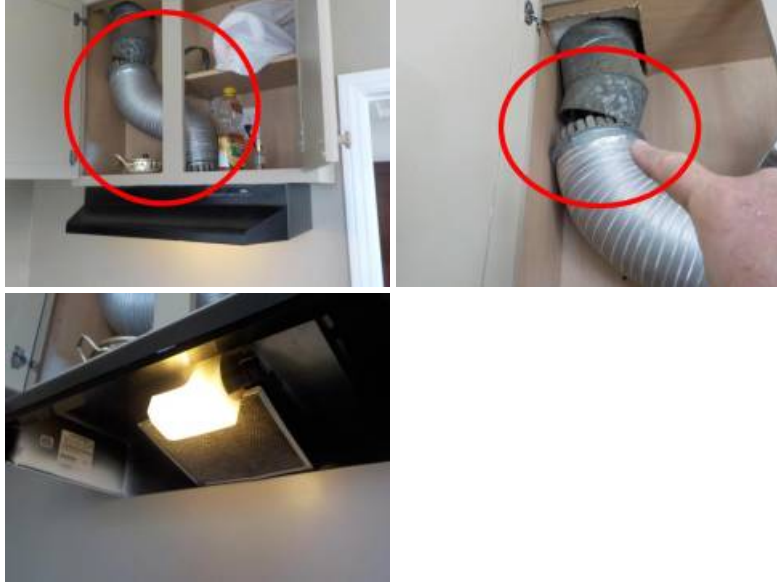
Ventilation/Light:

Multiple sections of the ducting are not connected - improper

Recommend remediation.

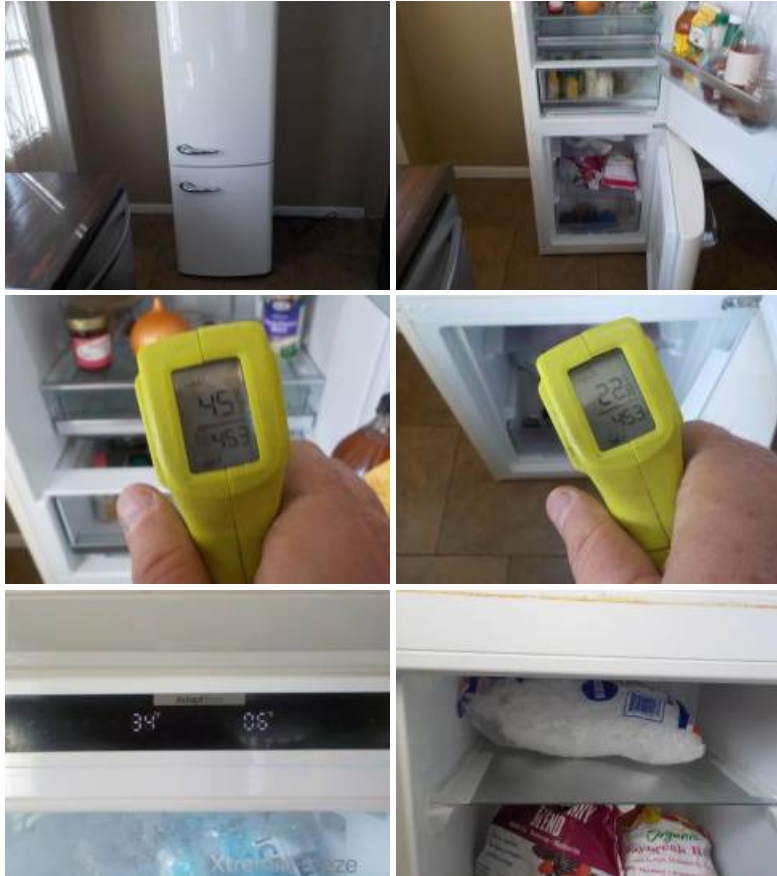
Refrigerator:

No ice maker (bagged ice is viewed)

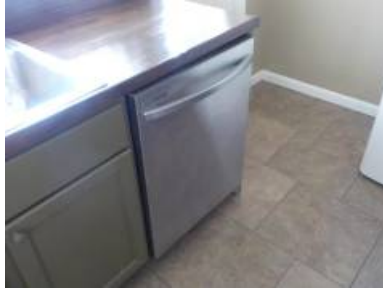
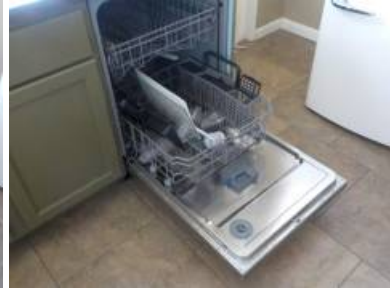
Dishwasher:

Appears serviceable
Air-Gap is installed.

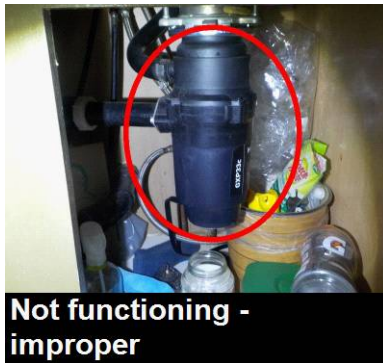
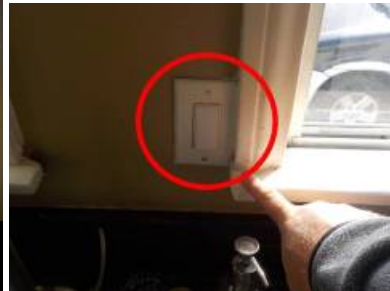
Not functioning - improper

Recommend further inspection and deemed necessary repairs by
a qualified service provider.

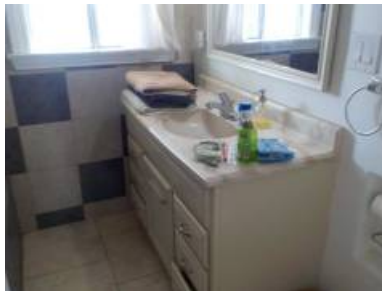
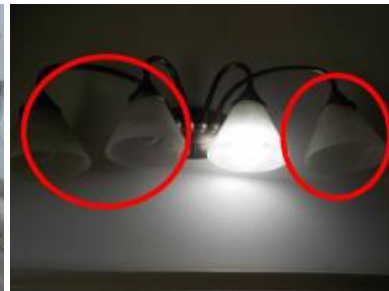
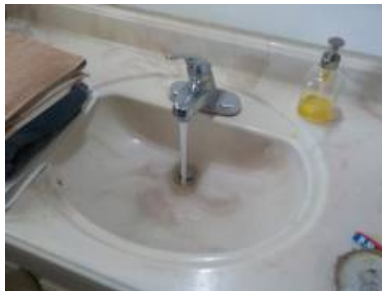
Appears serviceable with the following observed:
Multiple vanity lights are not functioning (possible burnt bulbs)
 Recommend repairs.

Due to the age and as a matter of preventative maintenance it is highly recommended to replace the angle stops
 Failure of aging angle stops could result in serious water damage.

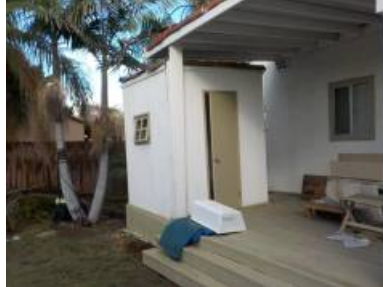
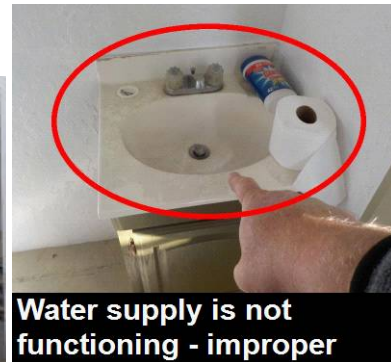
Due to the age and as a matter of preventative maintenance it is highly recommended to replace the angle stops
Failure of aging angle stops could result in serious water damage.

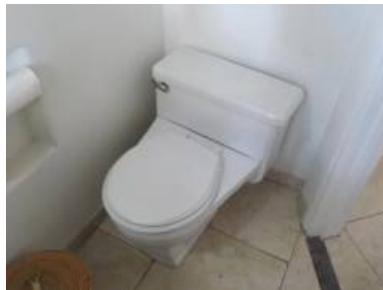
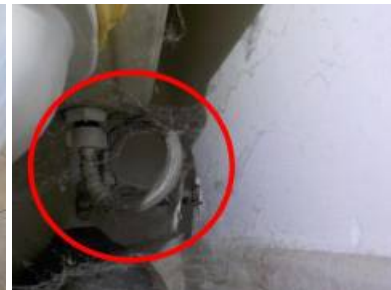
Due to the age and as a matter of preventative maintenance it is highly recommended to replace the angle stop
Failure of aging angle stops could result in serious water damage.

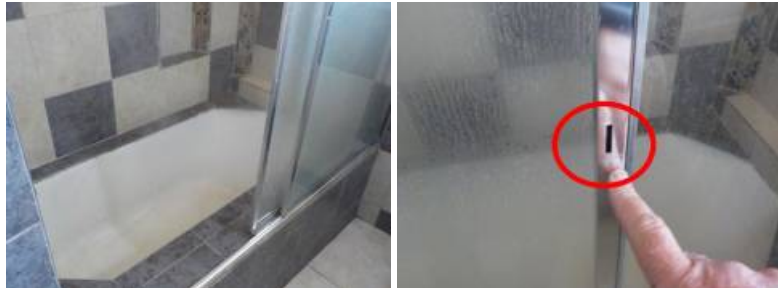
Enclosure door missing handle

Please Note: Caulk and seal all tub and shower fixtures to wall to help prevent possible moisture intrusion.

Recommend remediation

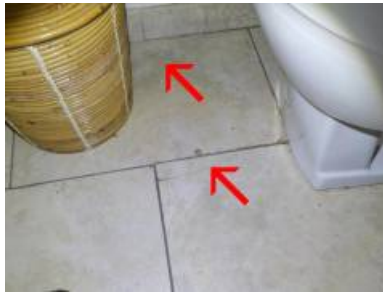
OK MM RR
☐ ☒ ☐ Appear serviceable with the following observed:
Hall Bath: **multiple tiles are cracked**
Recommend remediation.

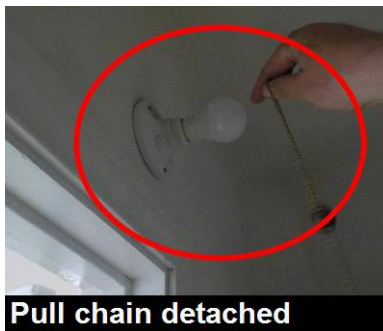
☐ ☒ ☐ Appear serviceable with the following observed:
Hallway: **light fixture is not functioning (pull chain is detached)**
Recommend remediation.

Pull chain detached

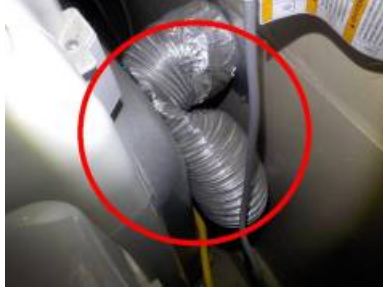
Dryer Vent:

- ☐ ☒ ☐ A dryer vent is provided - appears serviceable with the following observed:
Kinks are viewed
Recommend remediation.

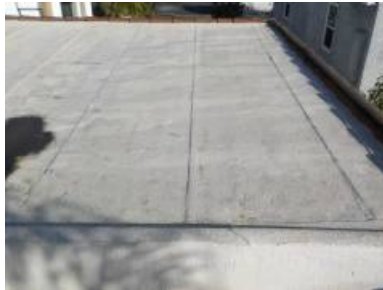
Pooling/ponding of moisture is viewed (poor draining) - improper.
Further inspection and deemed necessary repairs by a licensed roofing contractor or qualified service provider is required to restore to normal conditions

**Pooling/ponding
moisture - improper**

This should be done prior to the end of the buyers contingency period.

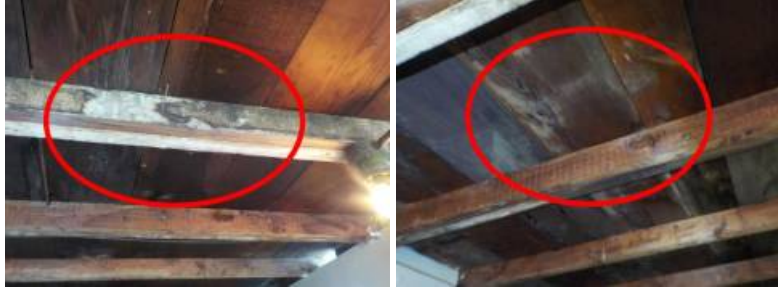
The rafters appear to be in satisfactory condition with the following observed:

Moisture staining is viewed (no leaking is observed - recent rains just concluded prior to the inspection)

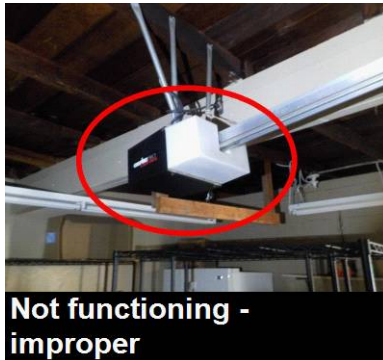
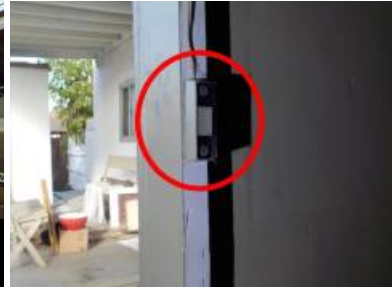
Mechanized opener is not functioning - improper

Repairs by a qualified service provider are required to restore to normal operating conditions

Please note: due to the above noted defect the reverse sensor/safety system could not be tested.

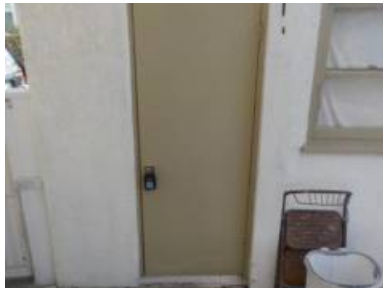
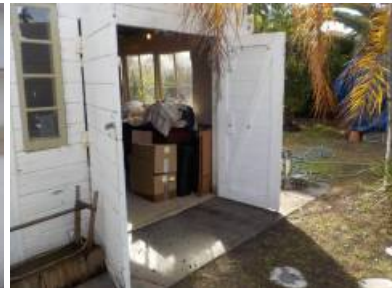
Service Door:

Both:
Appears serviceable with significant weathering at rear doors.

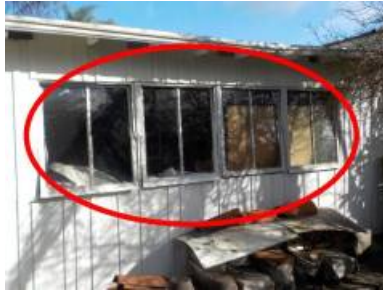
Windows:

Some windows are difficult to operate - improper

Please Note: **windows have exceeded their typical useful life.**

Recommend further inspection and deemed necessary repairs by a licensed window contractor or qualified service provider to restore to normal operating conditions.

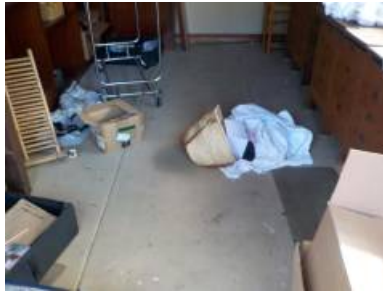
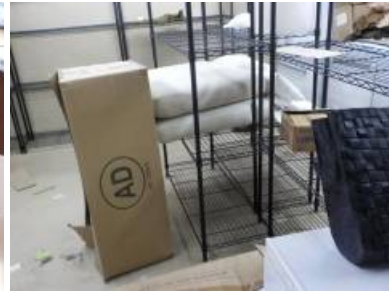
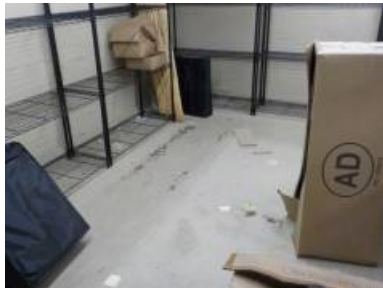
Concrete
Typical cracks and stains observed

Please Note: unable to fully inspect due to stored personal items.
