Real Estate Inspection Report

**6621 Glade Ave
Woodland Hills, CA 91303**

Inspector - Jerry Corum
Confidential and Proprietary

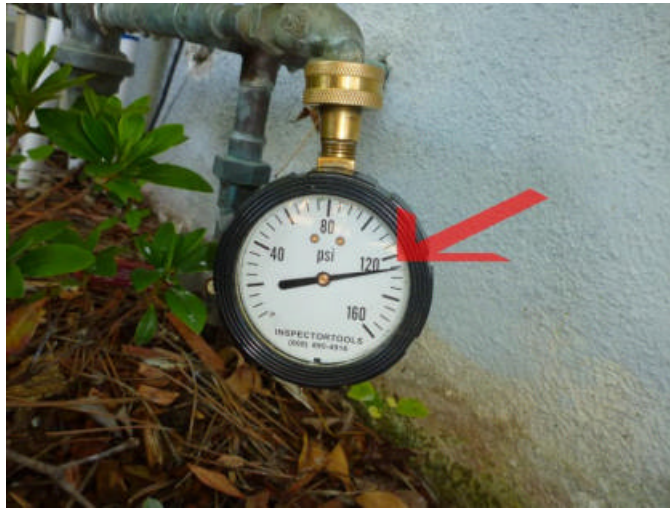
WATER PRESSURE:

Needs Attention. The pressure is over 80 psi. This is too high, it should be between 40 and 80. The pressure regulator should be adjusted or replaced to bring this down into proper range.

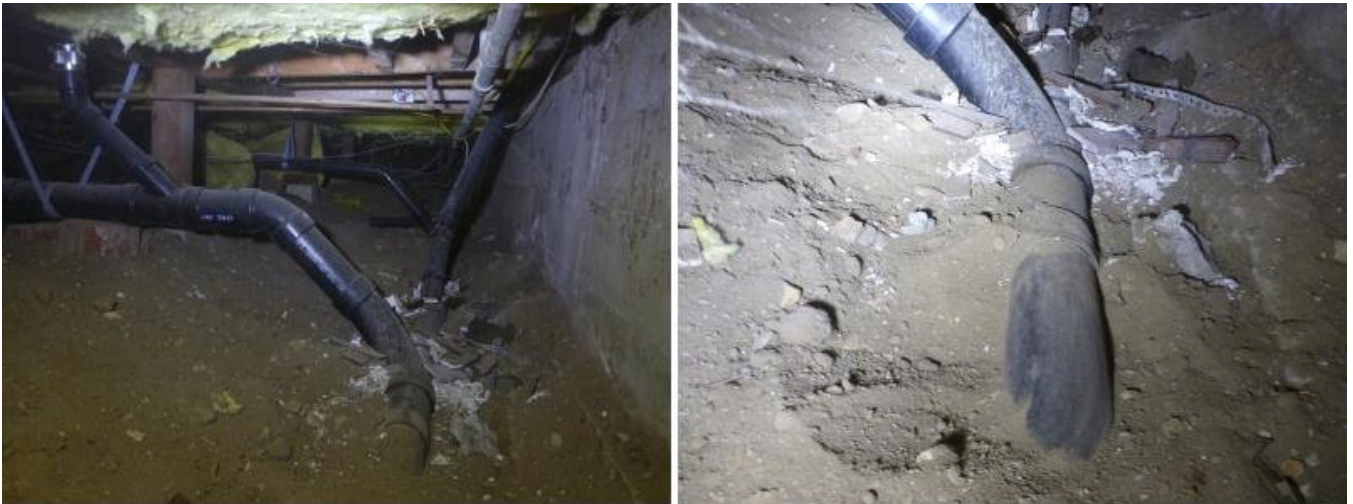
WASTE LINE MATERIAL:

The piping that takes the waste water out to the sewer system has been upgraded with some newer plastic piping in areas but there is still some of the older original lines in use in the system. The older piping that takes the waste water to the sewer system is made of cast iron where visible.

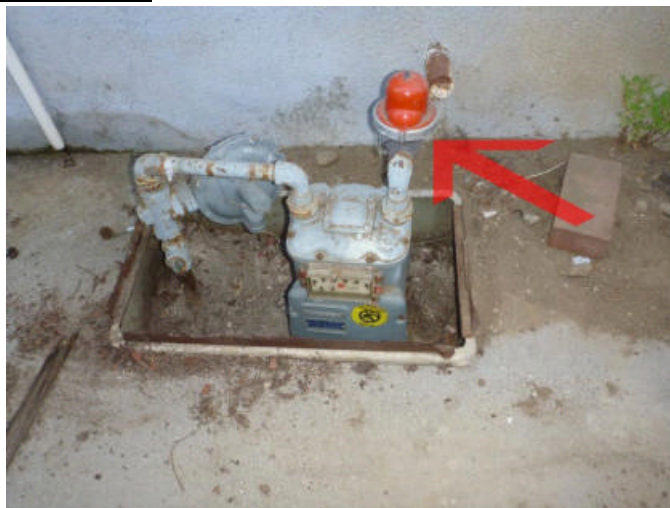
SEISMIC GAS SHUT OFF VALVE:

There is an automatic seismic gas shut-off valve installed on the main gas line. It is beyond the scope of this general inspection to determine its operating status or if it has been sized correctly for this gas system. If further information is desired or required it is advised to consult a qualified plumbing contractor.

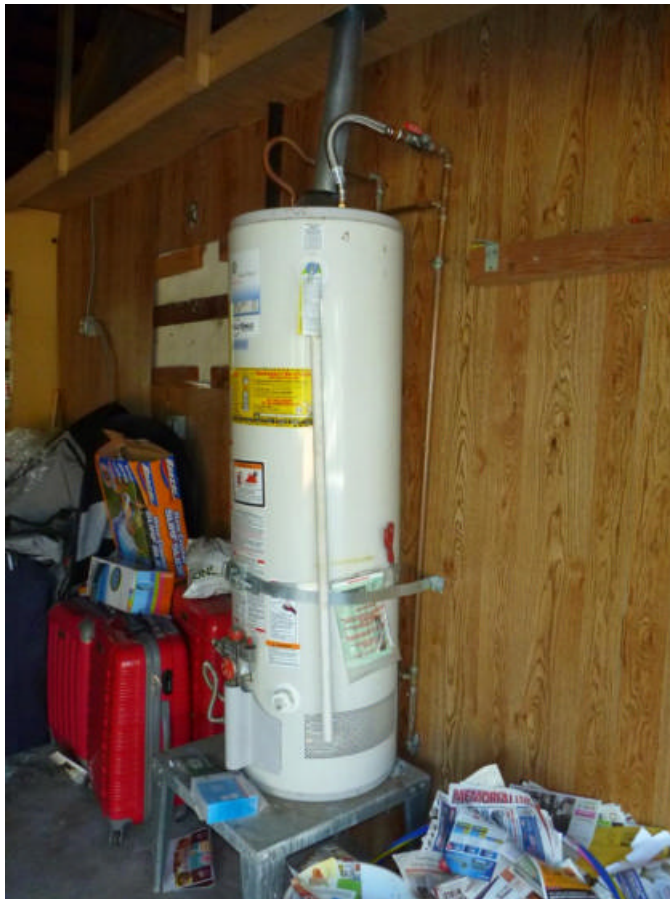
LOCATION:

The water heater is located in the garage.

There is no barrier or post in front of the water heater as recommended to protect from vehicle impact.

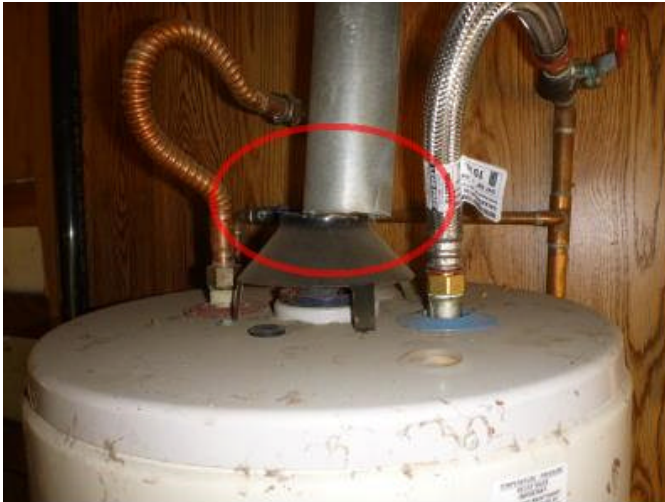
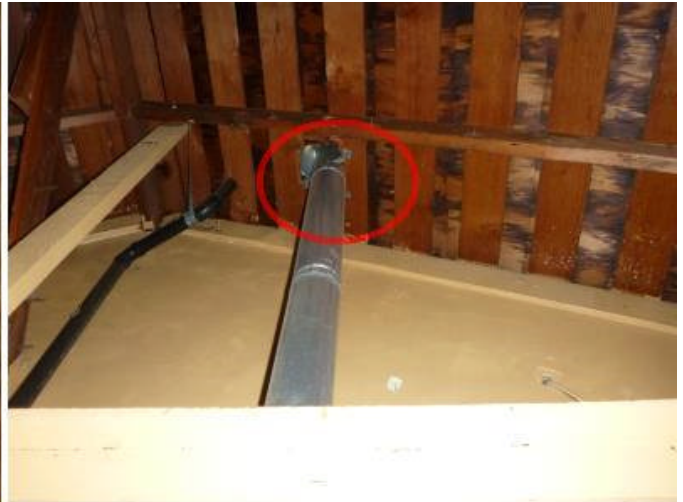
VENTING:

Not Acceptable. The water heater exhaust vent is disconnected, poorly connected or not properly connected. This can allow exhaust gases to escape and is considered a health and safety hazard and should be repaired by a qualified plumber.

The water heater vent is too close to combustible material. It needs to have adequate clearance to minimize any possibility of a fire hazard. The metal flue pipe is touching wood framing or roofing. This is a fire risk and requires prompt repair.

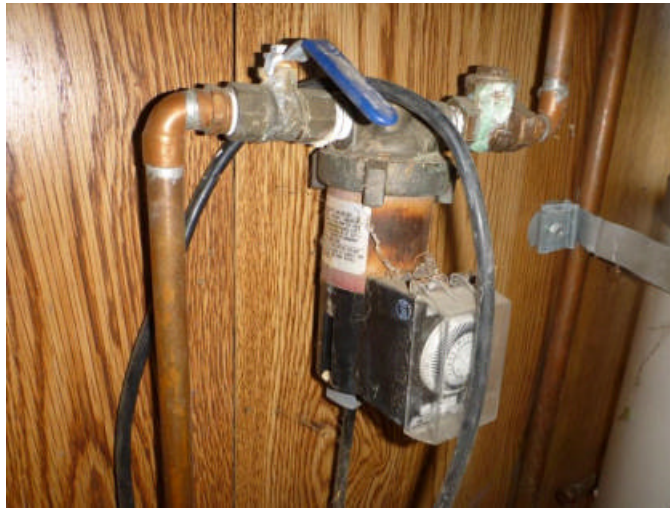
RECIRCULATING PUMP:

Needs Attention. The re-circulating system was unplugged and off line when it was first located. It was plugged in to see if it would operate but it did not work and was left unplugged.

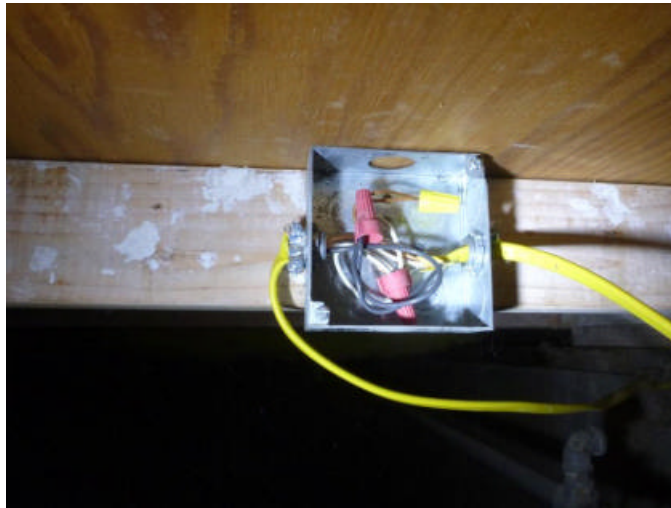
WIRING CONDITION:

Needs Attention: There are open junction boxes with wires exposed. These need to be completed and have covers installed for safety, in the crawl space under the building.

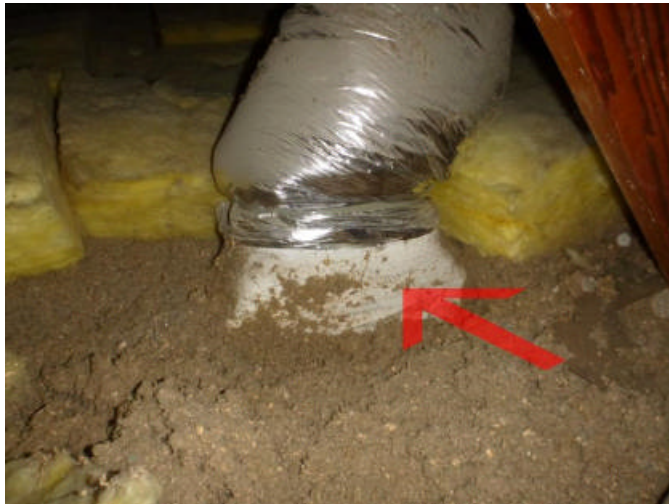
DUCTING AND AIR FLOW:

Needs Attention. The insulation of portions the ducts is the type of material that is often found to contain asbestos. It would have to be tested in a laboratory to confirm what its composition is.

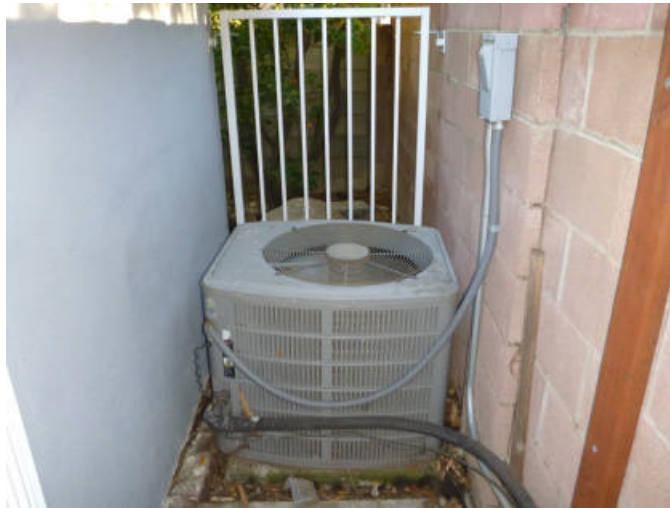
LOCATION:

The condenser for the air conditioning is located in the rear yard.

Needs Attention. The air conditioning system is older and well into its life. It is currently working but it is not known how much longer it will last. It should have proper maintenance on a regular basis to ensure it is operating as efficiently as possible.

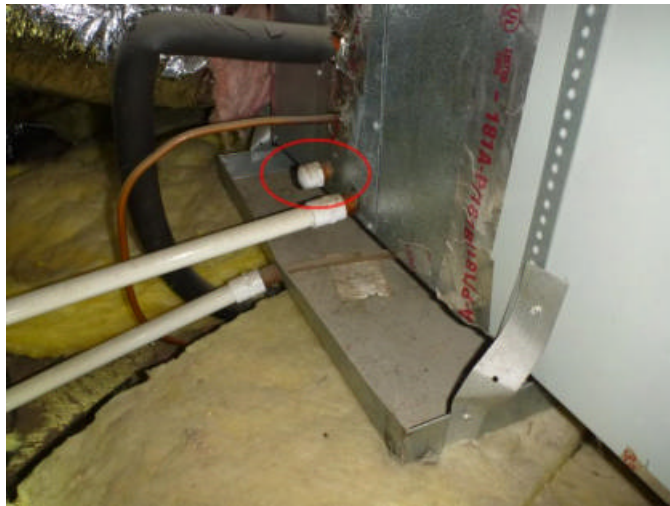
CONDENSATE LINE:

Needs Attention. The secondary drain opening is capped and is not functional.

All air conditioning pulls moisture from the air and this moisture has to be taken somewhere. There is supposed to be a main condensate line to do this and a back up/secondary in case the primary line fails.

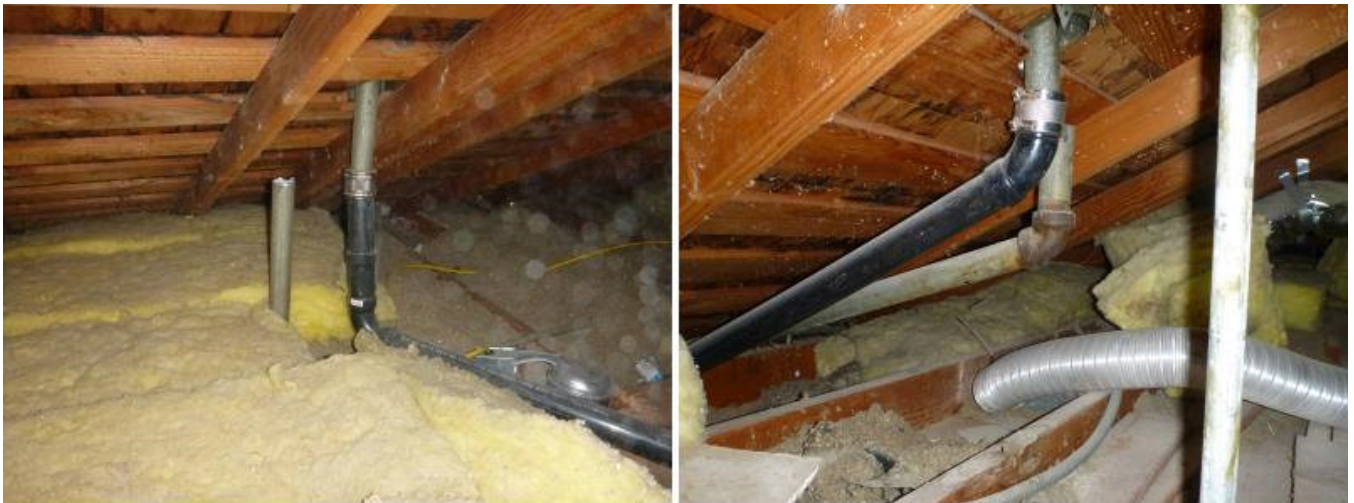
ATTIC FRAMING CONDITION:

Needs Attention: There are areas of stains on the framing lumber - it is unknown if this is from a current or past roof leak.

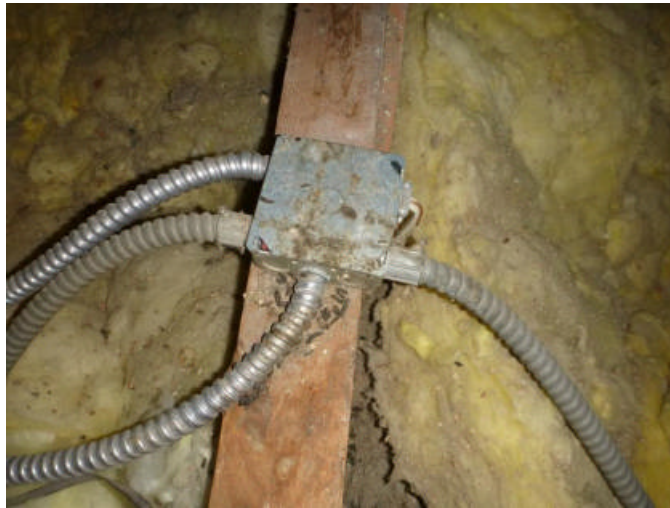
ATTIC CONDITION:

Needs Attention: Rodent droppings were observed in the attic. It is advised to have a specialist in this area examine the structure and property to determine the presence or not of any infestation and recommend any corrective measures.

There are abandoned gas appliance vent pipes in the roof/attic. The older cast sections of this pipe are a type often known to contain asbestos.

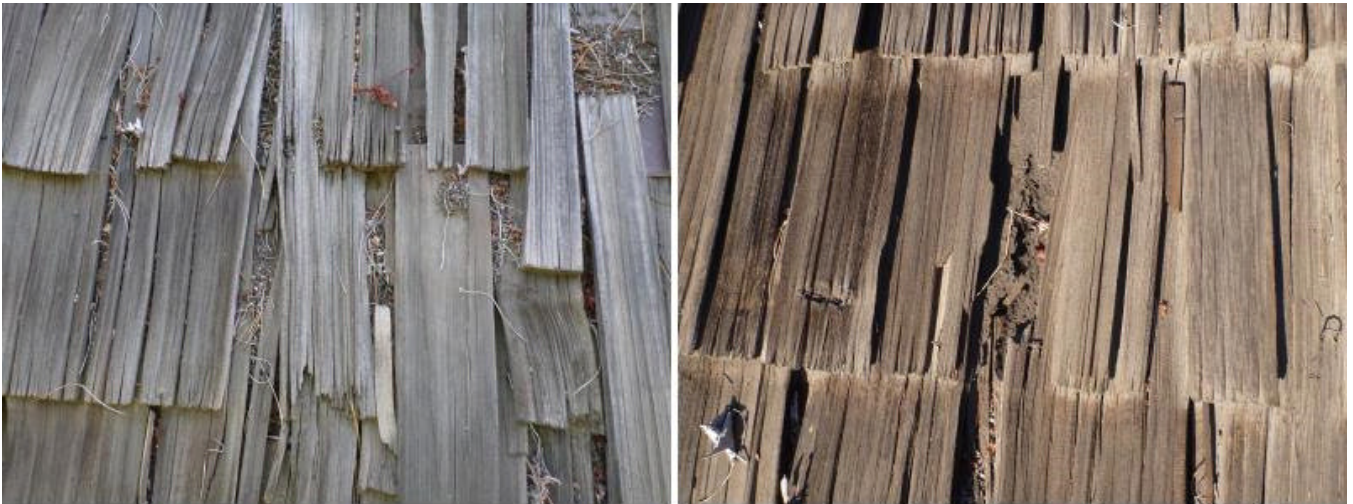
ROOF COVERING STATUS:

Needs Attention: On the wood roof, the wood shingles are older, warping and deteriorating. They are nearing the end of their life and the time to replace them.

There are areas of displaced, damaged and deteriorated wood shingles which need repairs at this time. Previous repairs were also noted.

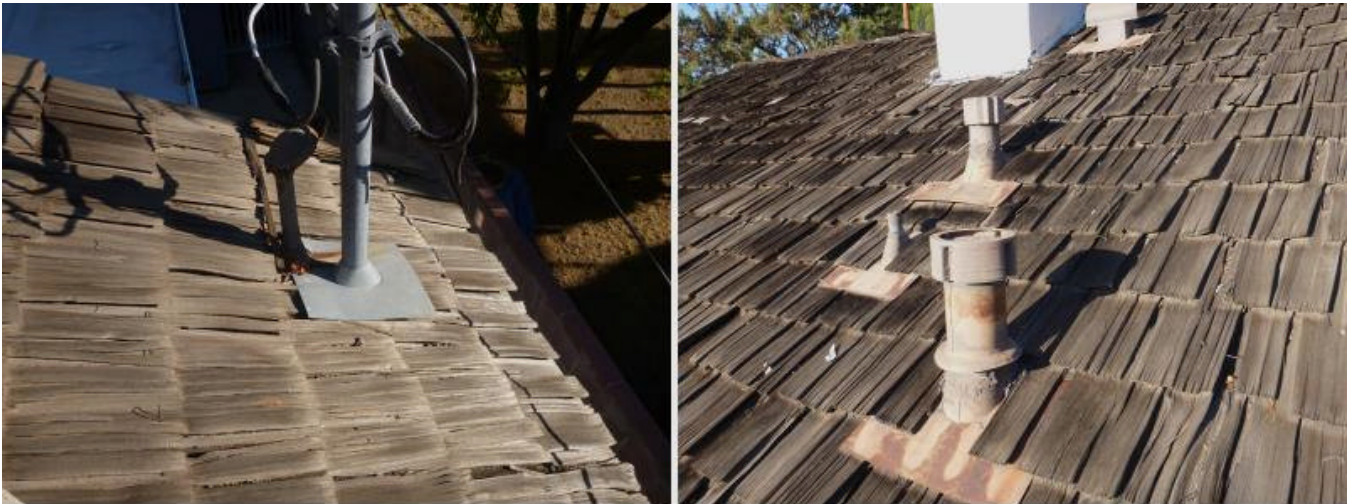
CONDITION:

Needs Attention: The flashing is not standard and may not be a reliable installation, such as at the electrical service mast. It will require high maintenance to ensure that it remains leak free.

The metal flashing is rusting and corroded in areas. The mastic is cracked in areas and is not reliable to ensure a watertight seal.

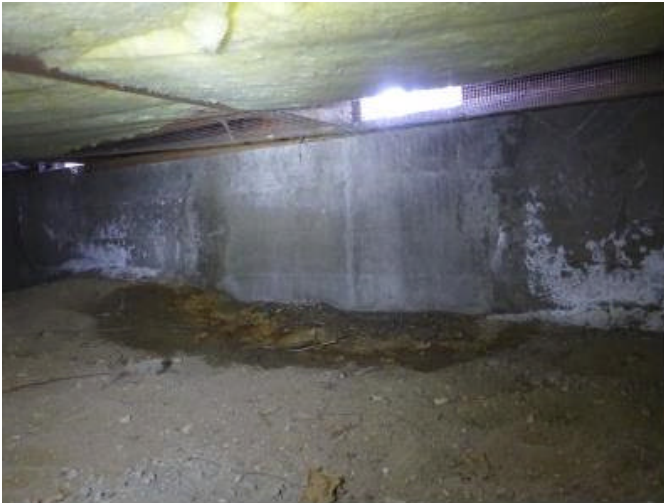
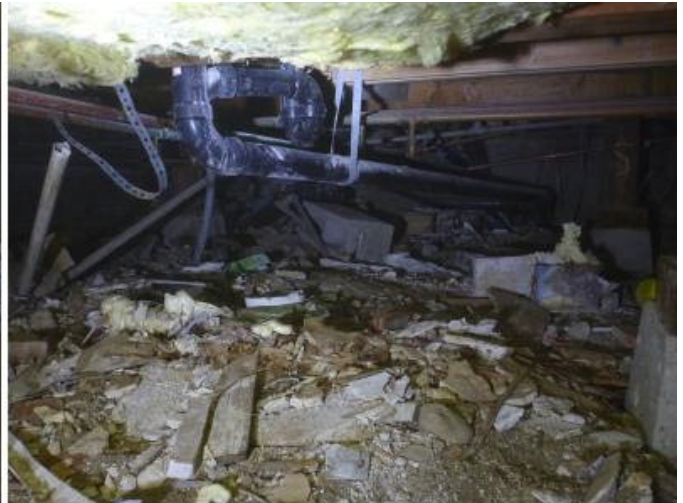
CRAWL SPACE:

Needs Attention: There are areas of damp soil under the building on the right side.

The crawl space has debris in it, it is advisable to have it removed and the area cleaned up (photo is at left rear). Wood / cellulose especially should be removed to help prevent future infestations.

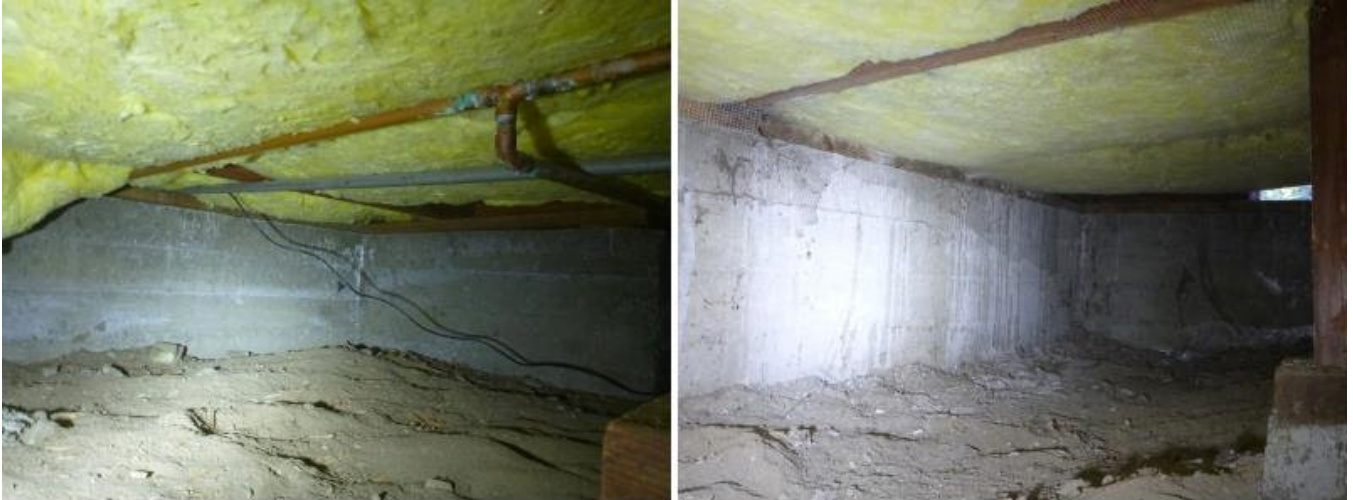
RAISED FOUNDATION:

The concrete foundation has some typical cracking, but was in functional condition for a building of this age. Cracking does not appear to be significant at this time. If a more detailed evaluation is required, it could be obtained from a structural engineer or foundation specialist.

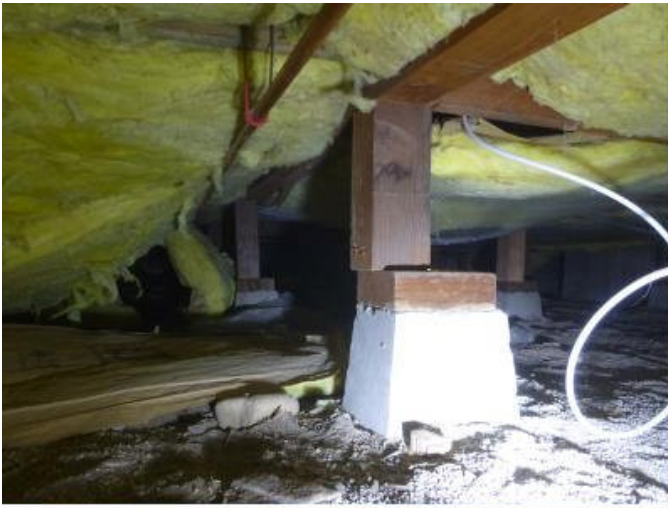
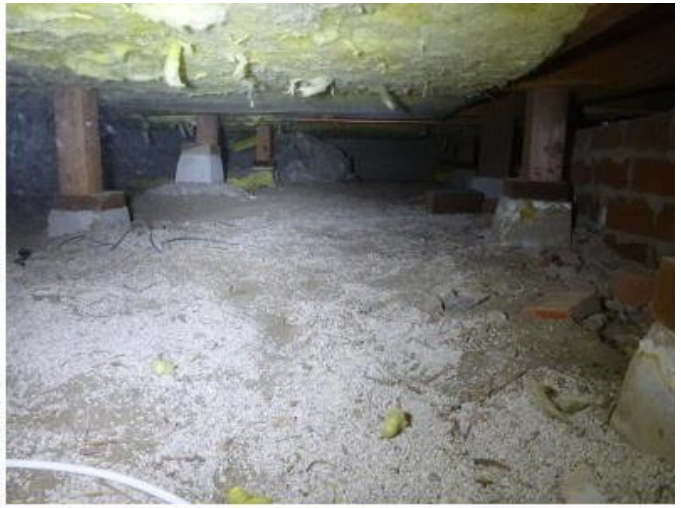
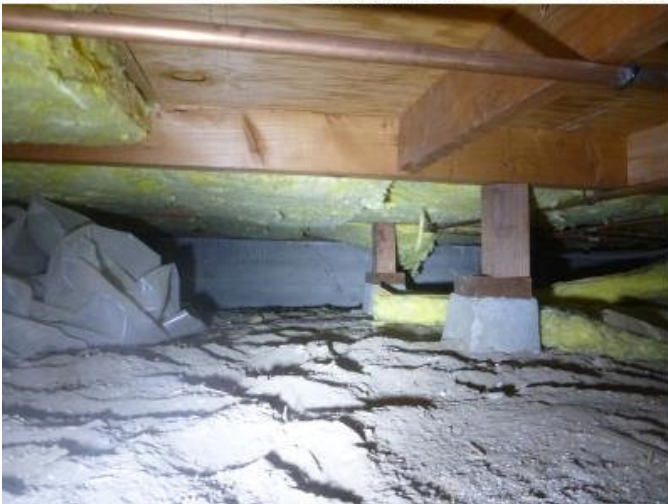
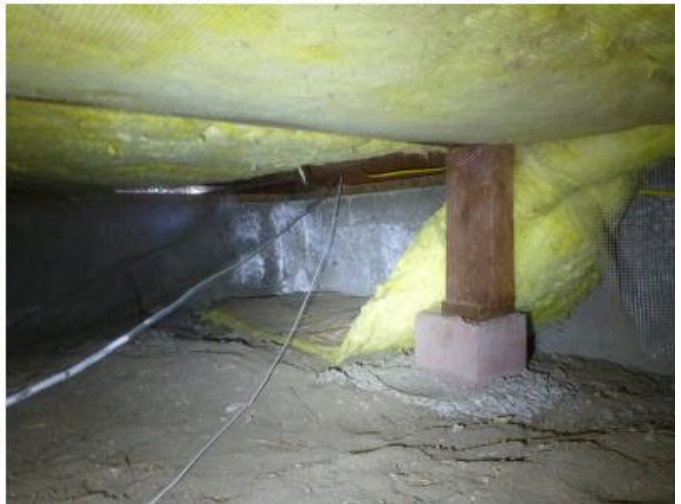
POSTS AND PIERS:

Needs Attention: There are posts that are not sitting squarely on the pier but are hanging out over the edge. Some posts have shifted and are out of plumb.

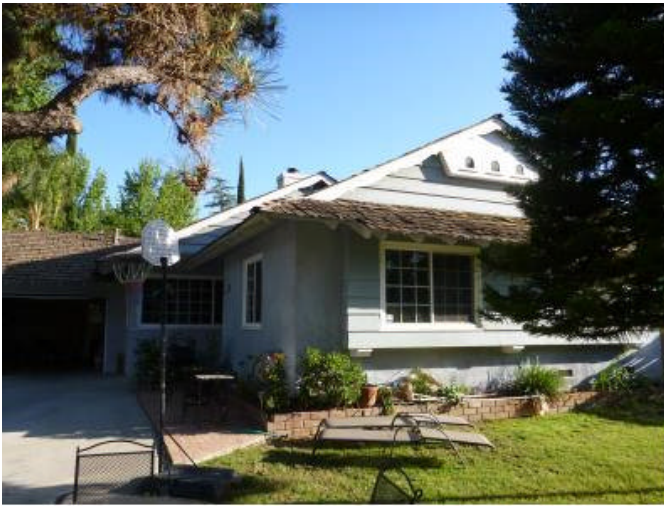
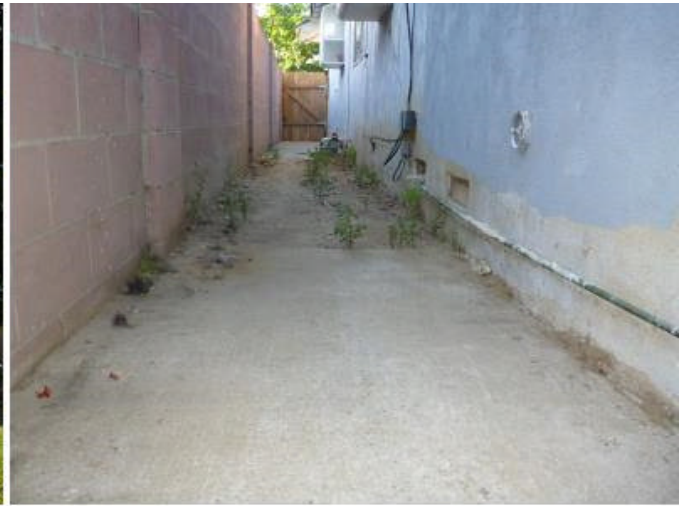
DRAINAGE CONDITION:

Needs Attention: There are planters that may not be properly drained and may not have proper moisture barriers to prevent seepage into the structure.

There are areas where the water may pond instead of flowing off the site. The landscaping slopes toward the structural foundation in areas. This can cause over-saturation of the soil at the structural footings which is the chief cause of foundation settlement. Slope should fall away from the foundation at a minimum of 1/4 inch per foot and extend at least 10 feet away from the foundation.

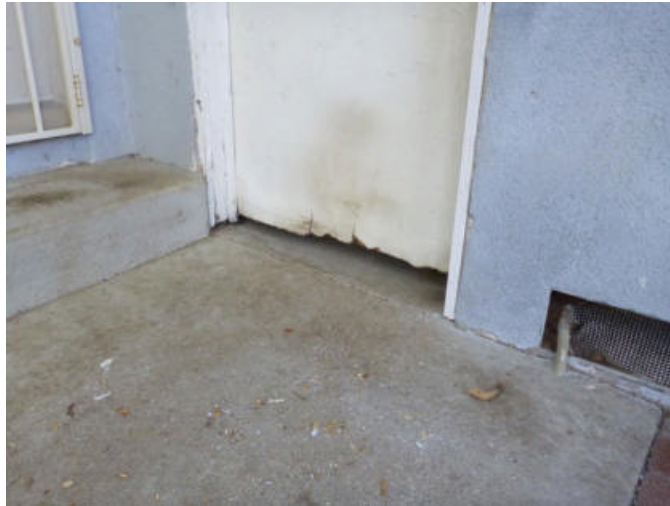
CONDITION:

Needs Attention: The exterior side door has areas wear and deterioration to the surfaces.

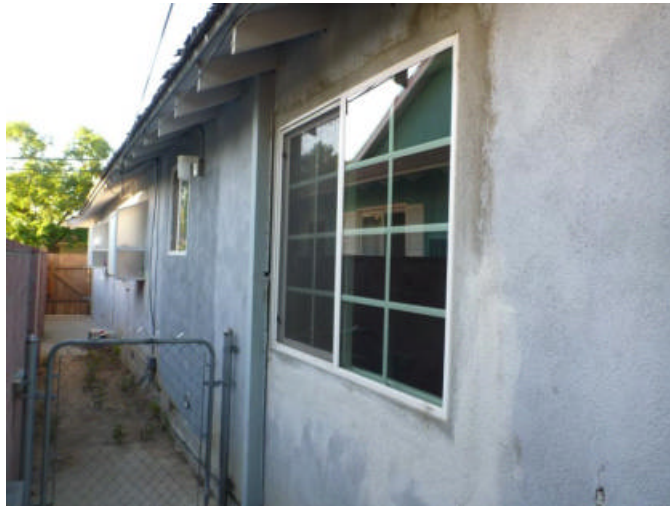
CONDITION:

Needs Attention: The stucco has peeling and some deterioration in areas near the level of the soil. There are areas of rough patching, around the windows.

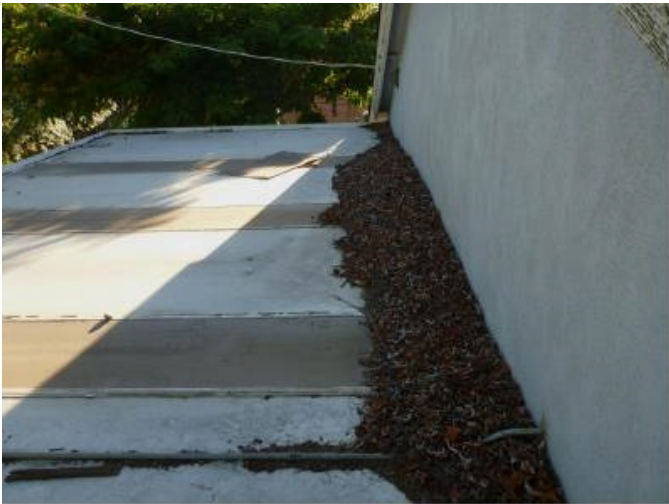
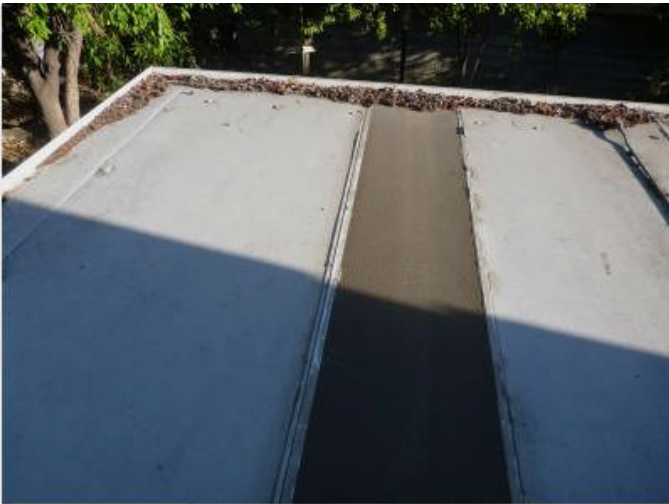
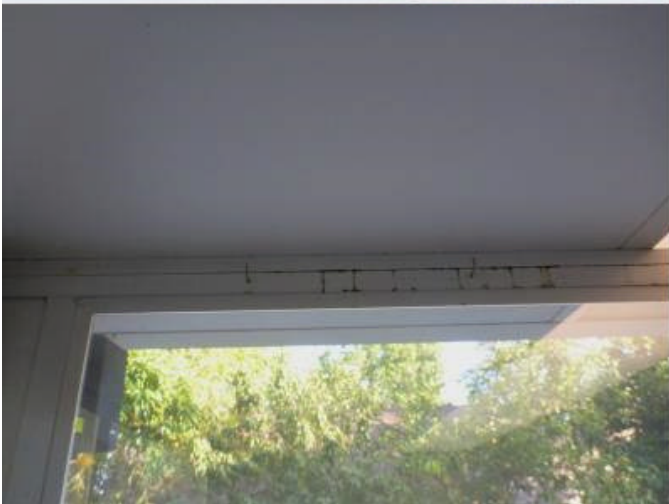
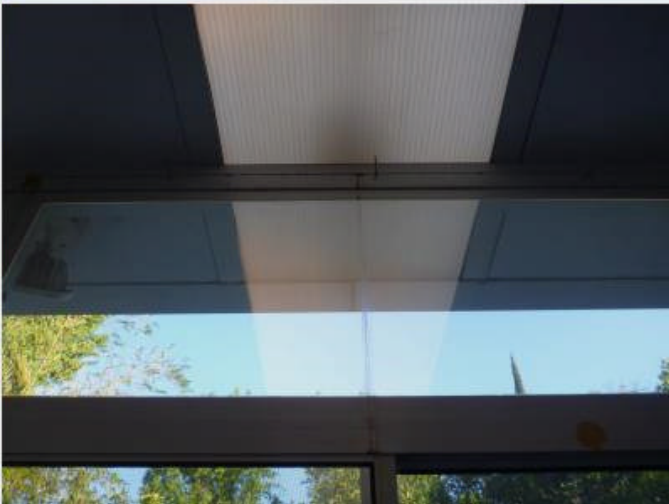
CONDITION:

Needs Attention: There is debris on the top of the enclosure, and at the edge drain. There are areas of staining and rusting inside the enclosure below the covering.

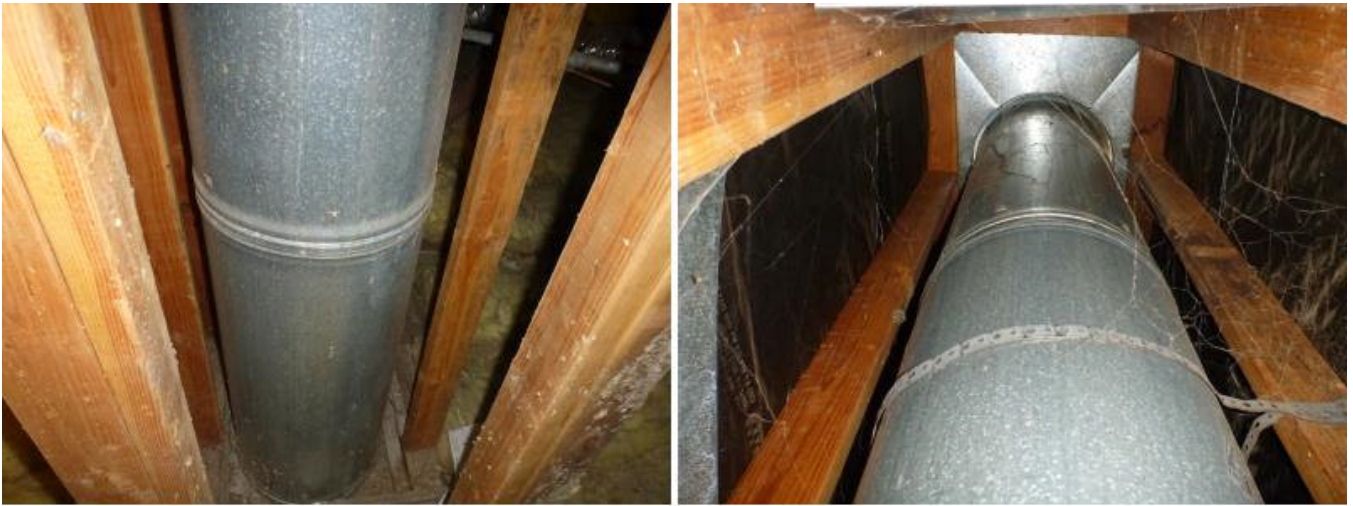
CONDITION:

Needs Attention: The flue pipe does not appear to be adequate clearances to combustible materials in the wood framing. It is advisable to have a chimney specialist examine the structure and make all needed repairs to ensure a safe and properly operating fireplace and chimney.

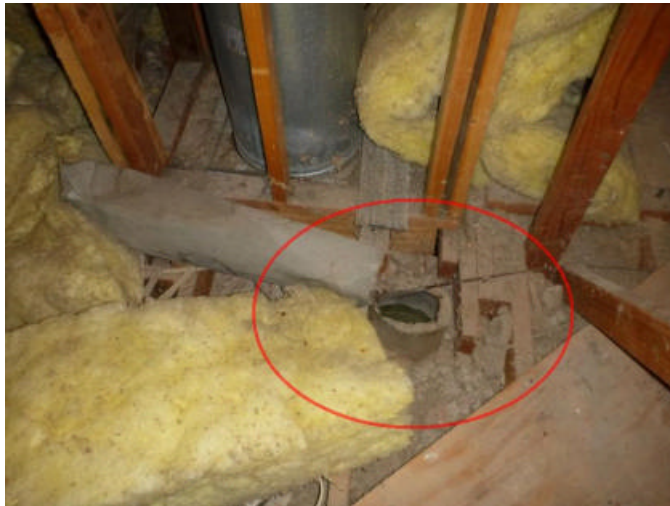
VENTILATION FAN:

Not Acceptable: The exhaust piping is missing in the attic and this does not vent to the exterior.

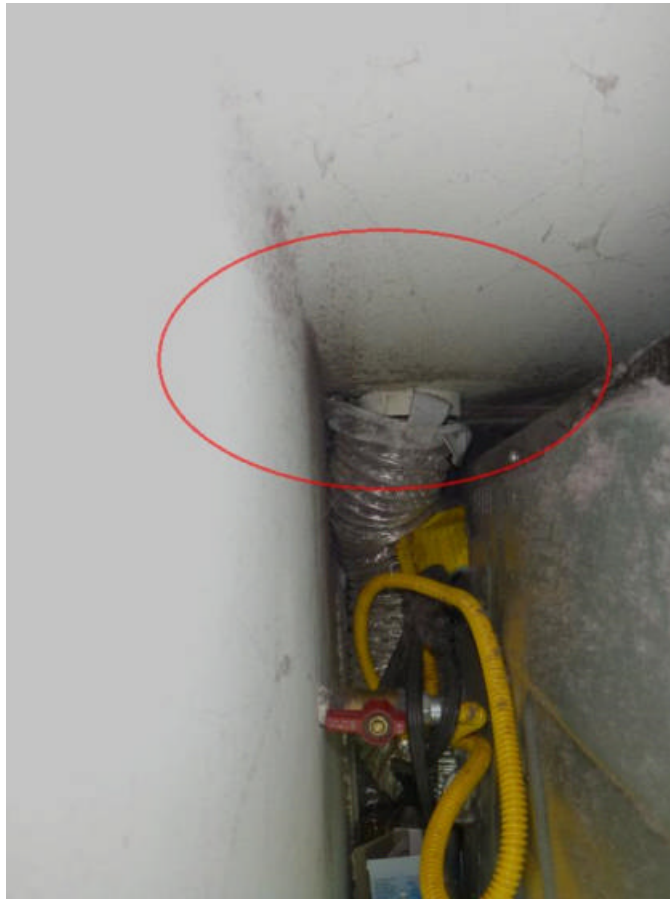
CONDITION OF CLOTHES DRYER HOOKUPS:

Needs Attention: There is damage to the dryer vent line and the moisture and lint are not venting properly to the exterior.

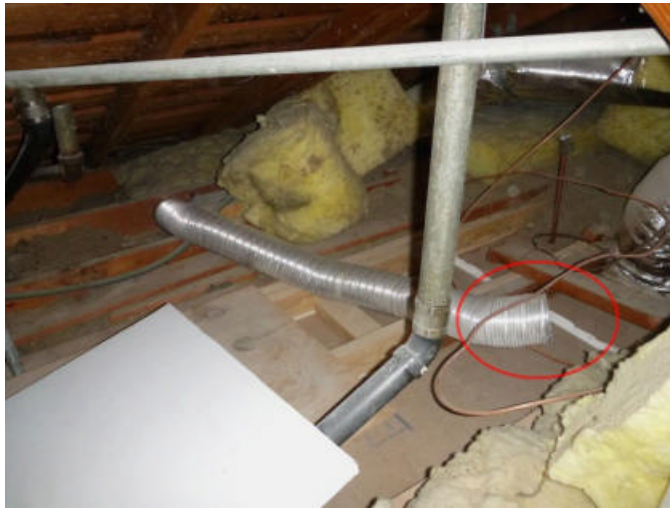
BATH VENTILATION:

Needs Attention: The ventilation fan in the bathroom does not vent the exterior of the building. The exhaust is going into the attic instead.
