A BETTER HOME INSPECTION BY FORSTERS, INC.

RESIDENTIAL PROPERTY INSPECTION REPORT

1454 15th St
Imperial Beach, CA 91932

06/07/2024

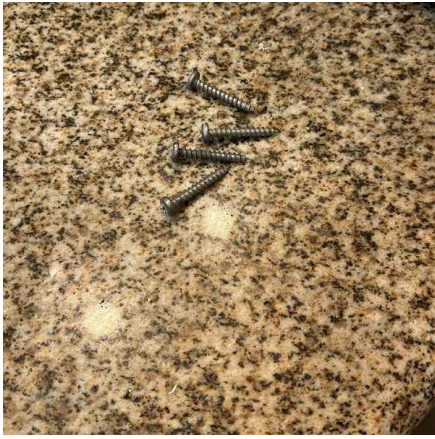
Sharp-pointed metal screws hold panel cover in place. These are a potential hazard as they may puncture wire insulation, becoming a shock hazard. These screws should be replaced with approved, flat-tipped screws.

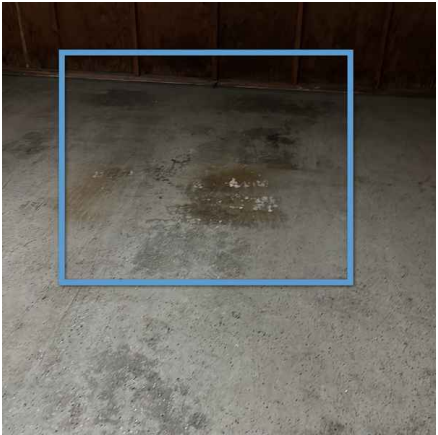
Garage floor shows visible staining from oil/grease. Recommend scrubbing with a degreaser or cleaning solution.

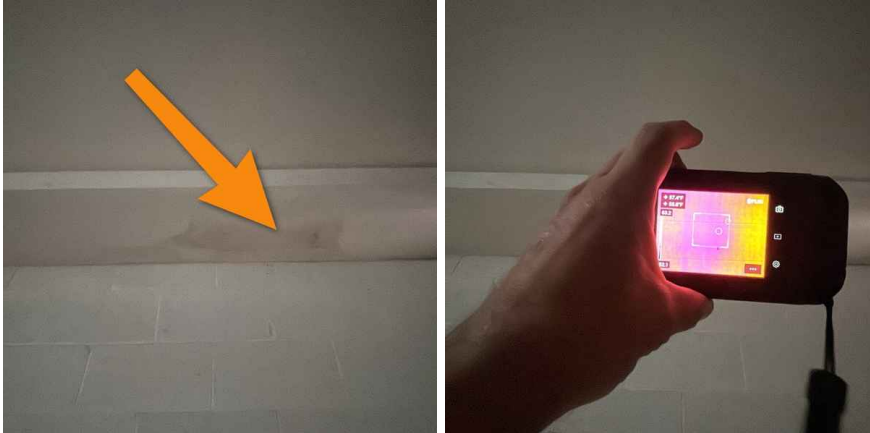
6.1.2 Interior Areas

GARAGE - WALLS/CEILING STAINS - DRY

There are stains noted to the garage wall/ceilings. This can potentially be due to past or current water intrusion. Stains tested dry at the time of inspection. Recommend further evaluation and correction as needed by licensed professional.

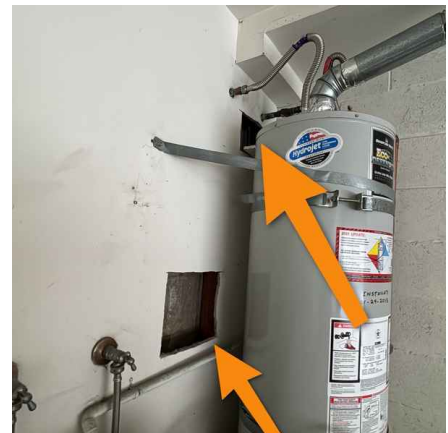
6.1.3 Interior Areas

GARAGE - DRYWALL DAMAGE

Garage wall and/or ceiling had damaged drywall. Recommend further evaluation and correction as needed by licensed professional.

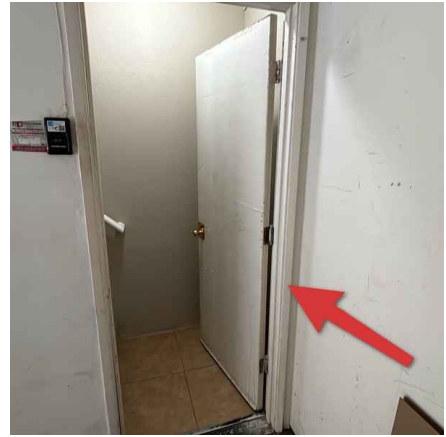
FIREWALL DOOR - NOT FIRE RATED

Door separating garage and home does not meet safety standards. Doors in firewalls must be at least 1 3/8-inch thick, metal/steel/Solid Wood, or a 20-minute fire-rated door. **Recommend further evaluation and correction as needed by licensed professional.**

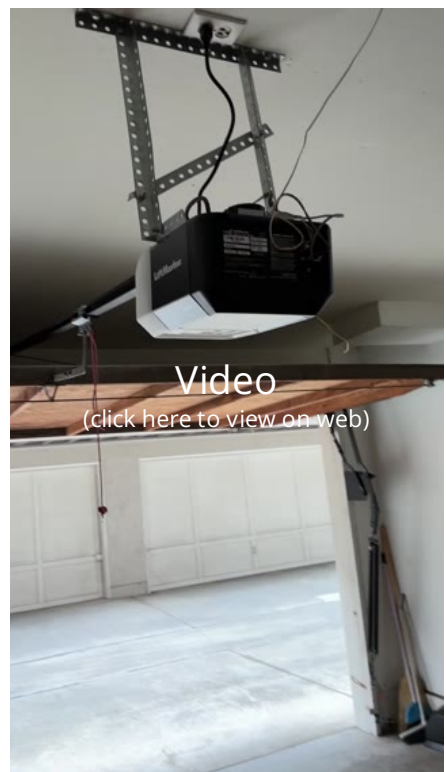
AUTOMATIC OPENER - FURTHER EVALUATION NEEDED

Recommend having the garage door unit evaluated by a garage door specialist. During operation, system sticks, does not fully open.

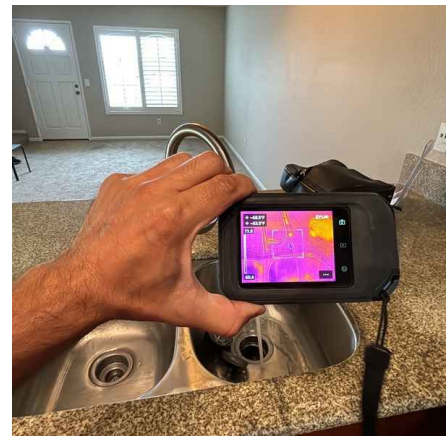
7.1.2 Kitchen Sink

KIT FAUCET(S) - NO/INADEQUATE HOT WATER

Inspector was unable to get hot water to flow from the kitchen sink fixture, Recommend further evaluation and correction as needed by licensed professional.

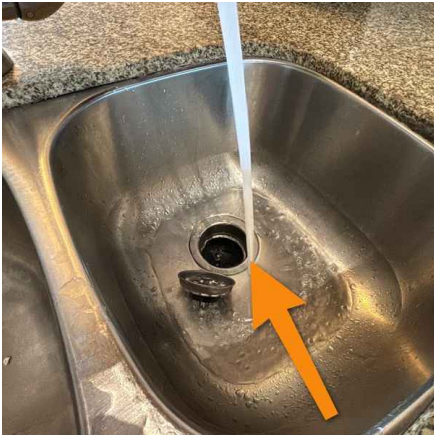
7.3.1 Garbage Disposal

GARBAGE DISPOSAL - RUBBER INSERT

Damaged/missing rubber insert noted at the time of the inspection. Recommend installing a new rubber insert to prevent splash back/injury from items ejected during disposal operation.

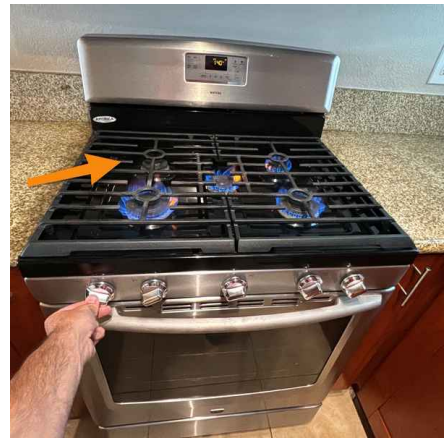
7.7.1 Cooktop

COOKTOP - BURNER NOT OPERATING

Burner does not ignite/heating element(s) did not heat up when turned on. Recommend qualified professional evaluate & repair.

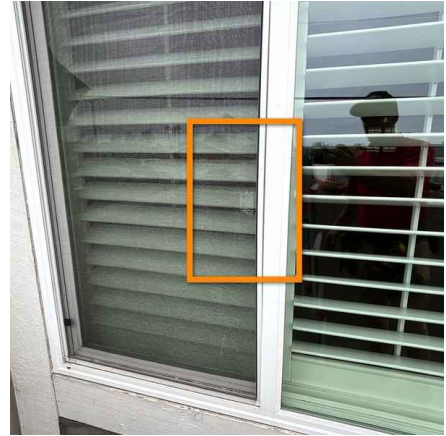
Window screens were damaged/torn or out of spline in areas around the home, recommend repair as needed.

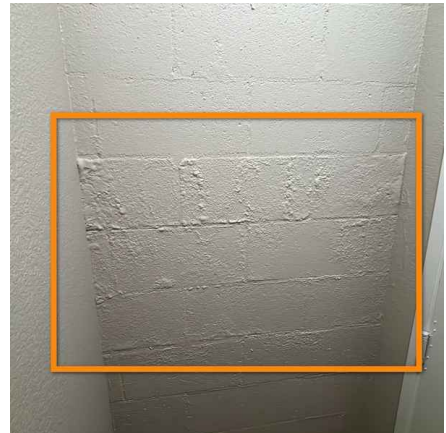
Patches/repairs noted to the drywall/plaster/ceiling in areas. Recommend asking seller for more information.

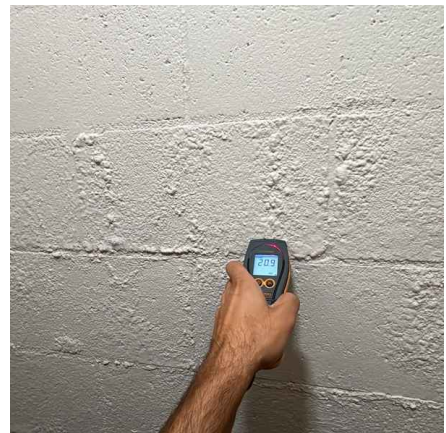
8.4.2 Walls/Ceilings

WALL(S)/CEILING(S) - STAINS ELEVATED MOISTURE LEVEL

There were areas to the home that were observed with a elevated moisture level(s). Recommend further investigation to determine source of moisture intrusion and all repairs to be made.

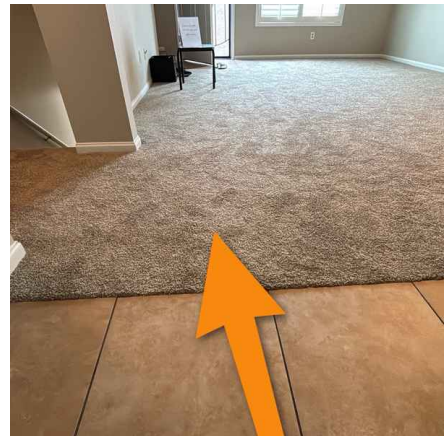
Uneven floors were noted in certain locations of the home, likely caused by settling and shifting; not all areas may be shown. If a more detailed report is desired, we recommend further evaluation and repair as needed.

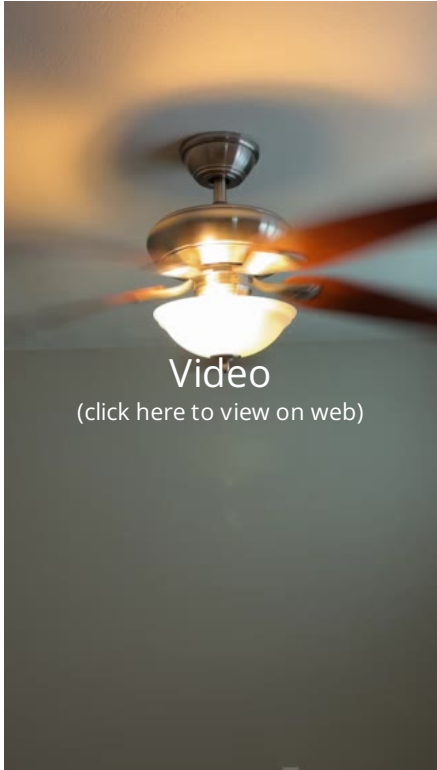
Ceiling fan was observed to be unstable during operation. Cause could be due to weight balance problems or frame issue. Recomemnd further evaluation and repair or replace.

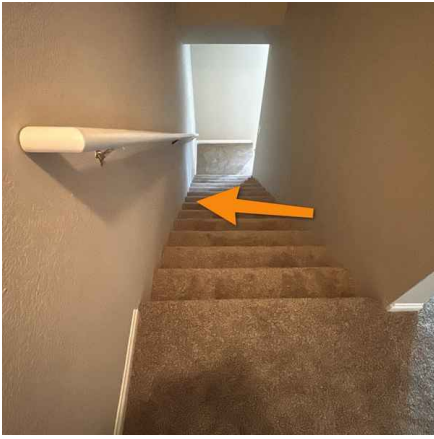
STAIRS UNEVEN

Stairs seem uneven on one side. Recommend further evaluation from a licensed professional.

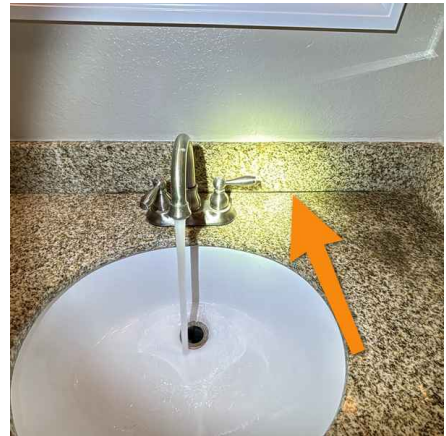
BR SINK - DARK CAULKING/GROUT

Dark caulking/grout noted around the bathroom sink, recommend removal/replace as needed.

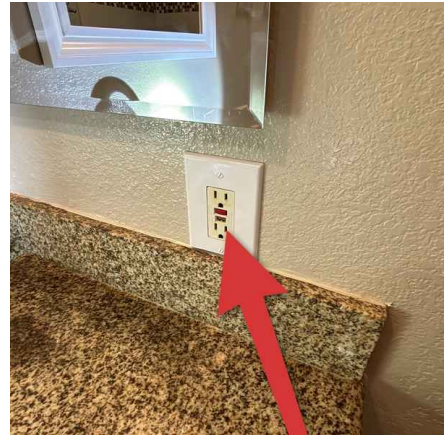
GFCI button is missing and/or damaged in one or more areas. Outlet can not be reset if it was tripped. **Recommend further evaluation and correction as needed by licensed professional.**

Recommendation
Contact a qualified professional.

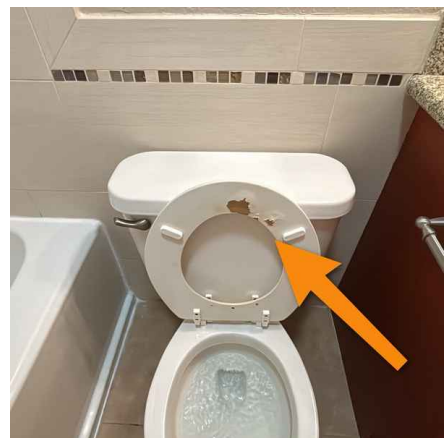
Toilet seat/lid is loose or damaged in one or more areas.
Recommend further evaluation and correction as needed by licensed professional.

Recommendation
Contact a handyman or DIY project

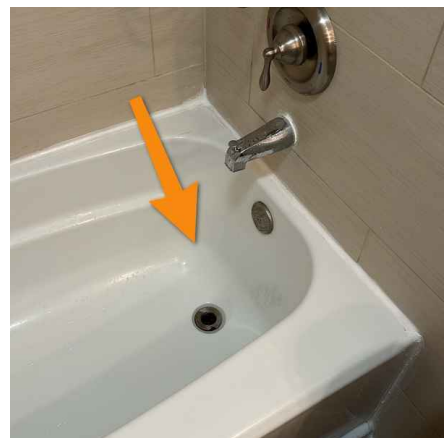
Stopper is missing/damaged or inoperable. Recommend further evaluation and correction as needed by licensed professional.

Recommendation
Contact a qualified professional.

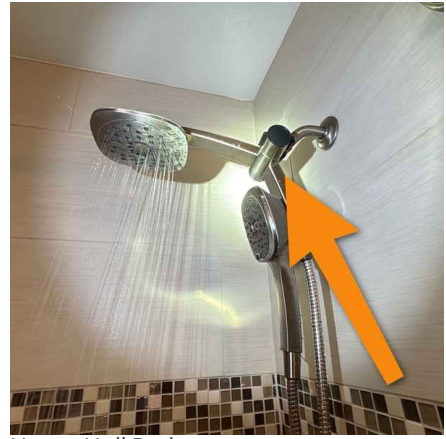
Shower head leaks when tested. Recommend further evaluation and correction as needed by licensed professional.
