# Inspection Report

Prepared for: Yolanda Halley  
5575 Heidi St, La Mesa, CA 91942  
Inspection Date: 07/07/2026

Inspector: Joshua Parks | Parks Pools Inc  
parkspools619@gmail.com

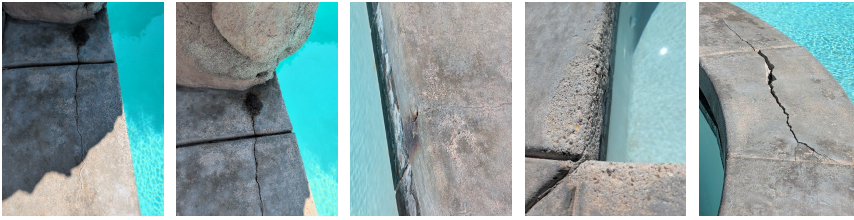
### COPING DEFECT(S)

- \* Crack(s) was/were noted in the coping at time of inspection.
- This allows water to penetrate below coping and cause possible erosion / freeze damage.
- Recommend coping be repaired or replaced.
